Appendix A – Program Area Responses

Mine Safety and Health Administration
1100 Wilson Boulevard
Arlington, Virginia 22209-3939

Corrective Actions Response to Recommendations of the
Internal Review Report

Please find attached the corrective actions that address the recommendations from the Mine Safety and Health Administration's (MSHA) internal review of the April 5, 2010 Upper Big Branch (UBB) mine disaster. They are from the Administrators of Coal Mine Health and Safety and Metal Nonmetal Health of Safety, and the Directors of Education and Policy Development, Technical Support, Program Evaluation and Information Resources, and the Office of Assessments, Accountability, Special Enforcement and Investigations. These are in addition to several actions already taken by MSHA following the UBB tragedy. Some recommendations directed to the Office of Assistant Secretary are addressed below.

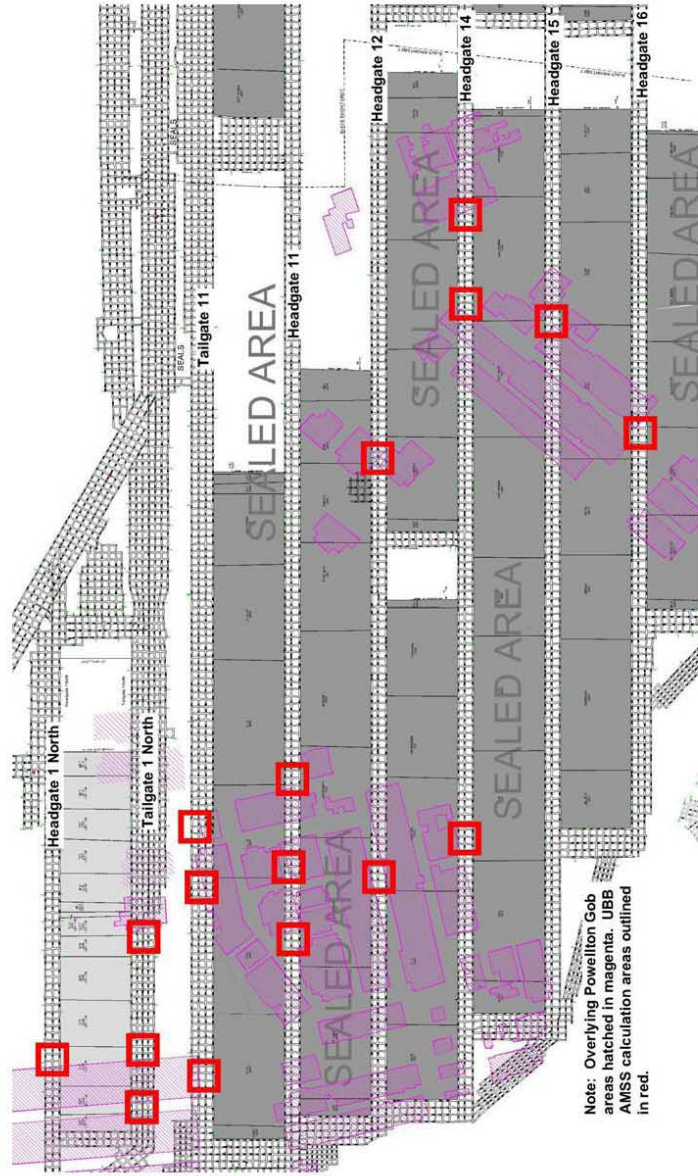
Appendix 2
Location of UBB AMSS Evaluations

The RCD cannot comment on the actual ground conditions encountered with the longwall extraction for the sites evaluated. The AMSS local stability prediction for Tailgate 1 North and Headgate 1 North is a “Green” condition which suggests that a major interaction is unlikely. AMSS local stability predictions for the Headgates 11 through 16 sites are a combination of “Green” and “Yellow” conditions. A “Yellow” condition suggests that a major interaction is considered likely unless a pattern of supplemental support is installed. Rib instability is also likely.
