BEACHAM/WILLIAMS STREET CORRIDOR STUDY

CITY OF CHELSEA,
MASSACHUSETTS

JUNE 26 2018

TECHNICAL APPENDIX

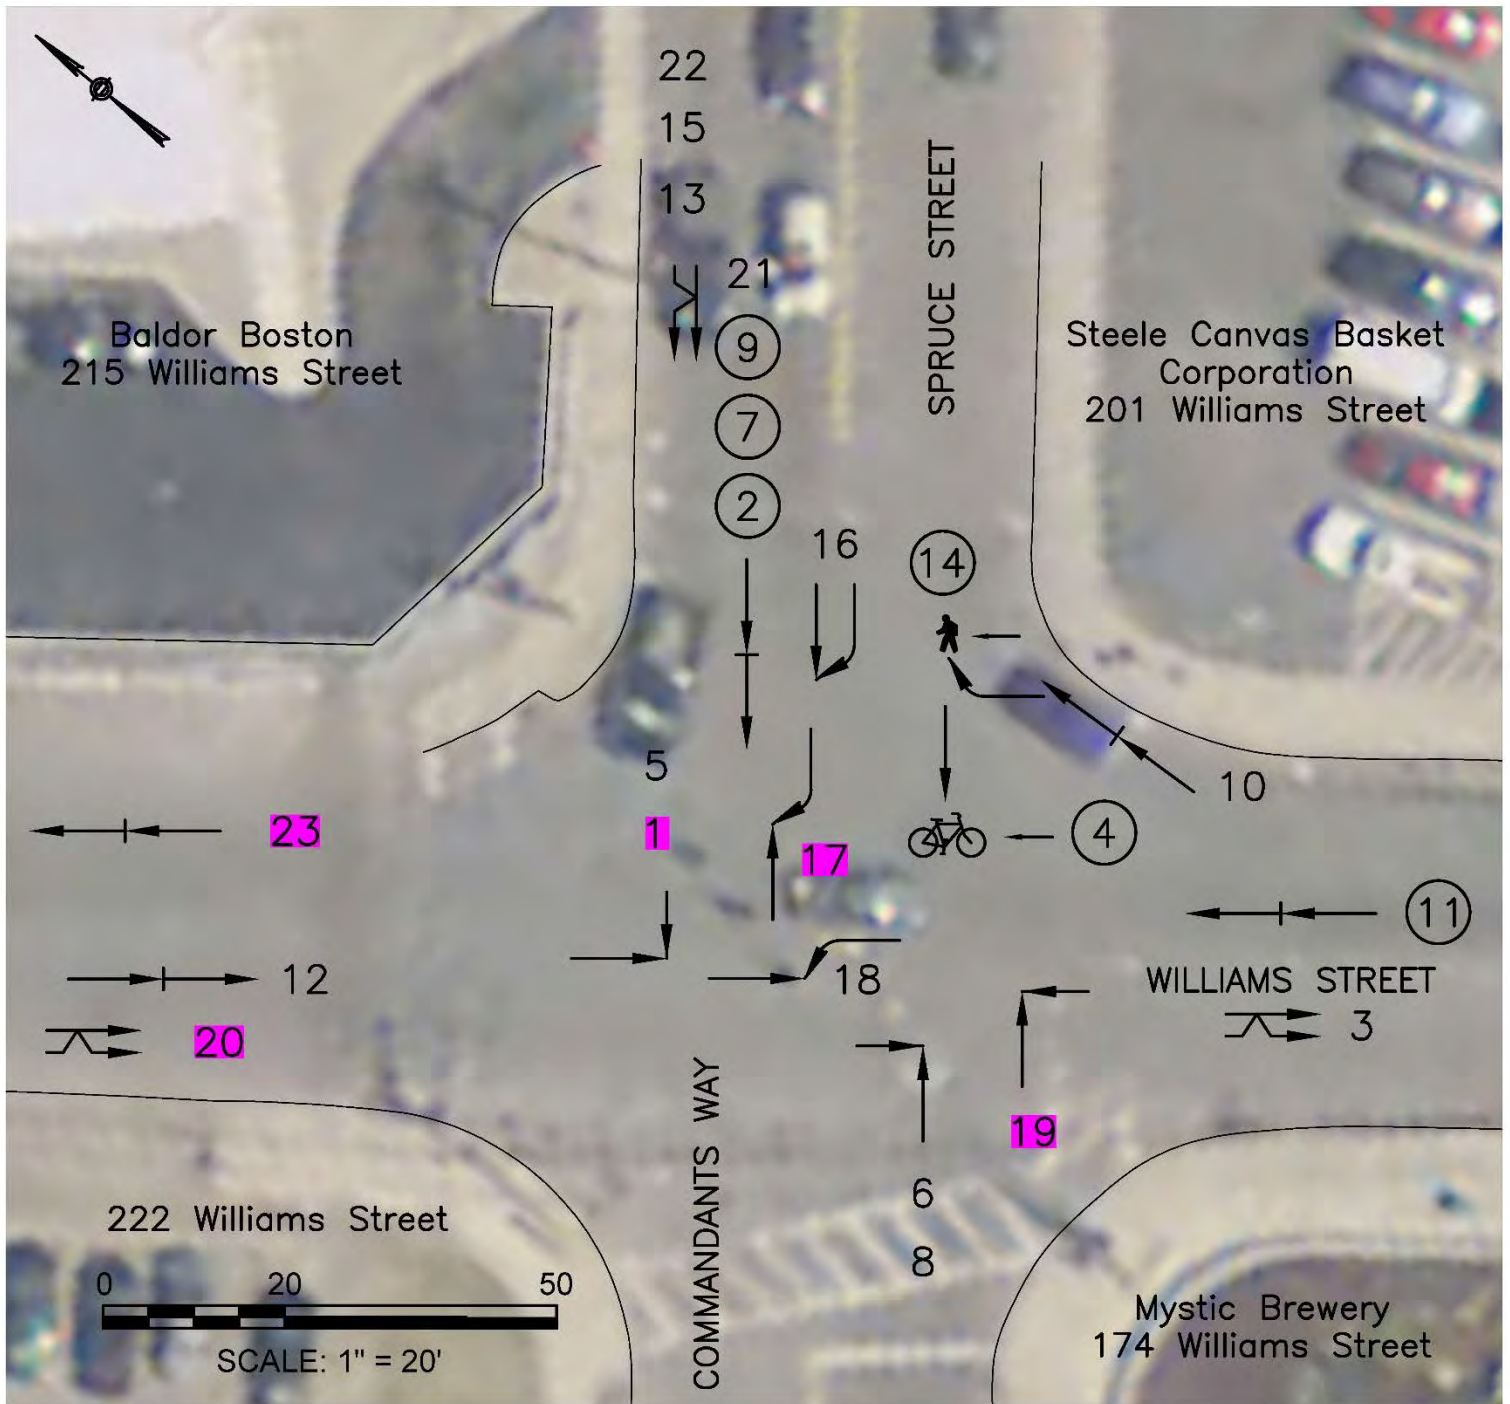
PROJECT: CHSELSEA - BEACHAM STREET/ WILLIAMS STREET ROAD SAFETY AUDIT
 INTERSECTION: COMMANDANTS WAY/ SPRUCE STREET
 FIGURE NO.: 2
 PERIOD: JANUARY 2014 TO DECEMBER 2016
 SOURCE: CHSELSEA POLICE DEPARTMENT
 PREPARATION: STANTEC - JULY 2017

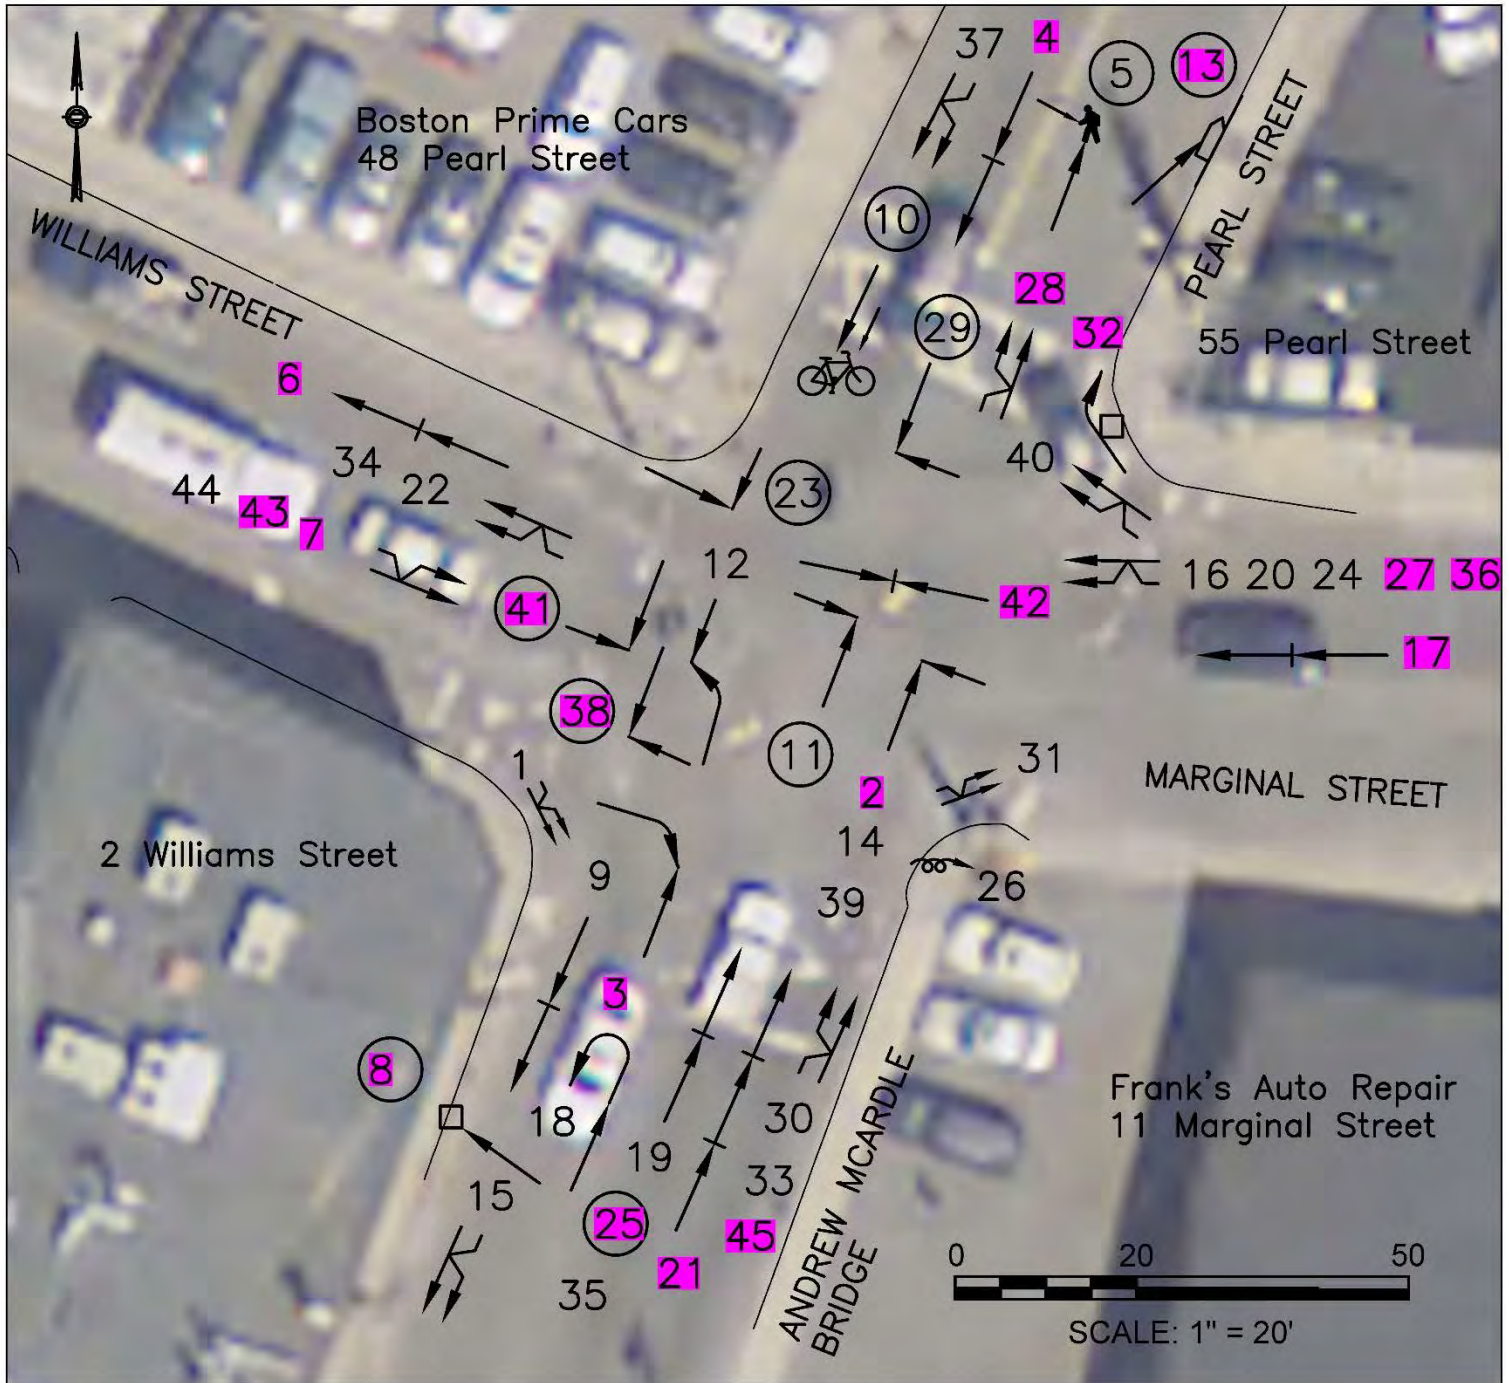
PROJECT: CHelsea - BEACHAM STREET/ WILLIAMS STREET ROAD SAFETY AUDIT
 INTERSECTION: PEARL STREET/ ANDREW MCARDLE BRIDGE
 FIGURE NO.: 4
 PERIOD: JANUARY 2014 TO DECEMBER 2016
 SOURCE: CHELSEA POLICE DEPARTMENT
 PREPARATION: STANTEC - JULY 2017

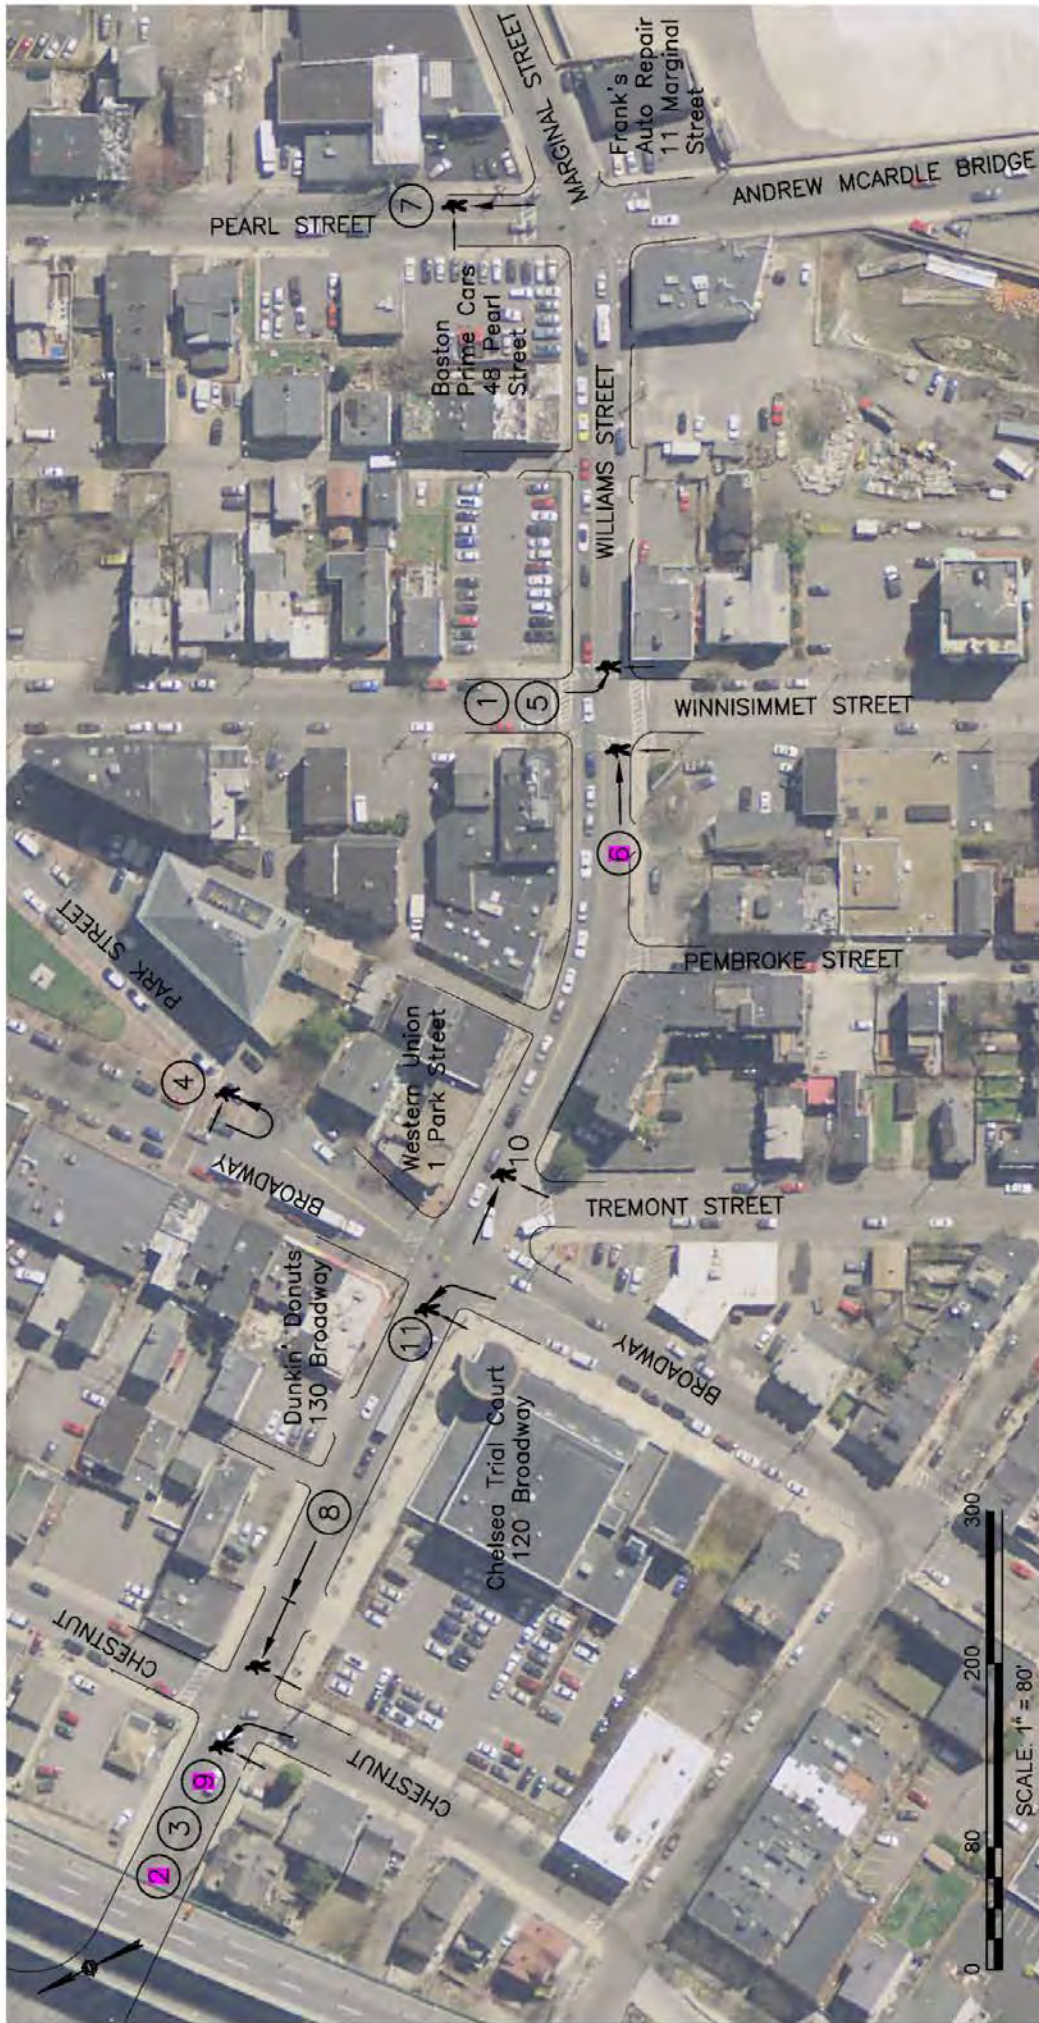
CRASH DIAGRAM
 PROJECT: CHELSEA - BEACHAM STREET/ WILLIAMS STREET ROAD SAFETY AUDIT
 INTERSECTION: CHESTNUT TO PEARL STREET - PEDESTRIAN AND BICYCLE CRASHES
 FIGURE NO.: 5
 PERIOD: JANUARY 2012 TO DECEMBER 2016
 SOURCE: CHELSEA POLICE DEPARTMENT
 PREPARATION: STANTEC - JULY 2017

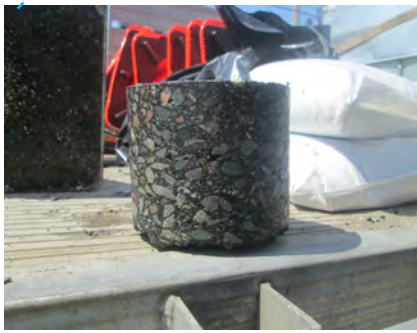
CORE 7
 370' s of Justin Dr.; 4' off E curb

CORE 7			TEST PIT 8			CORE 9		
	DEPTH	CLASSIFICATION		DEPTH	CLASSIFICATION		DEPTH	CLASSIFICATION
Bit Conc	4.75"	Bituminous Concrete	Bit Conc	8.75"	Bituminous Concrete	Bit Conc	6.75"	Bituminous Concrete
Base	N/A	Granular Base	Base	10.25"	A-1-b	Base	N/A	Granular Base
			Sub Base	16"	A-1-b
