# LOCAL ROAD SAFETY PLAN

**BOONE COUNTY**  
KENTUCKY

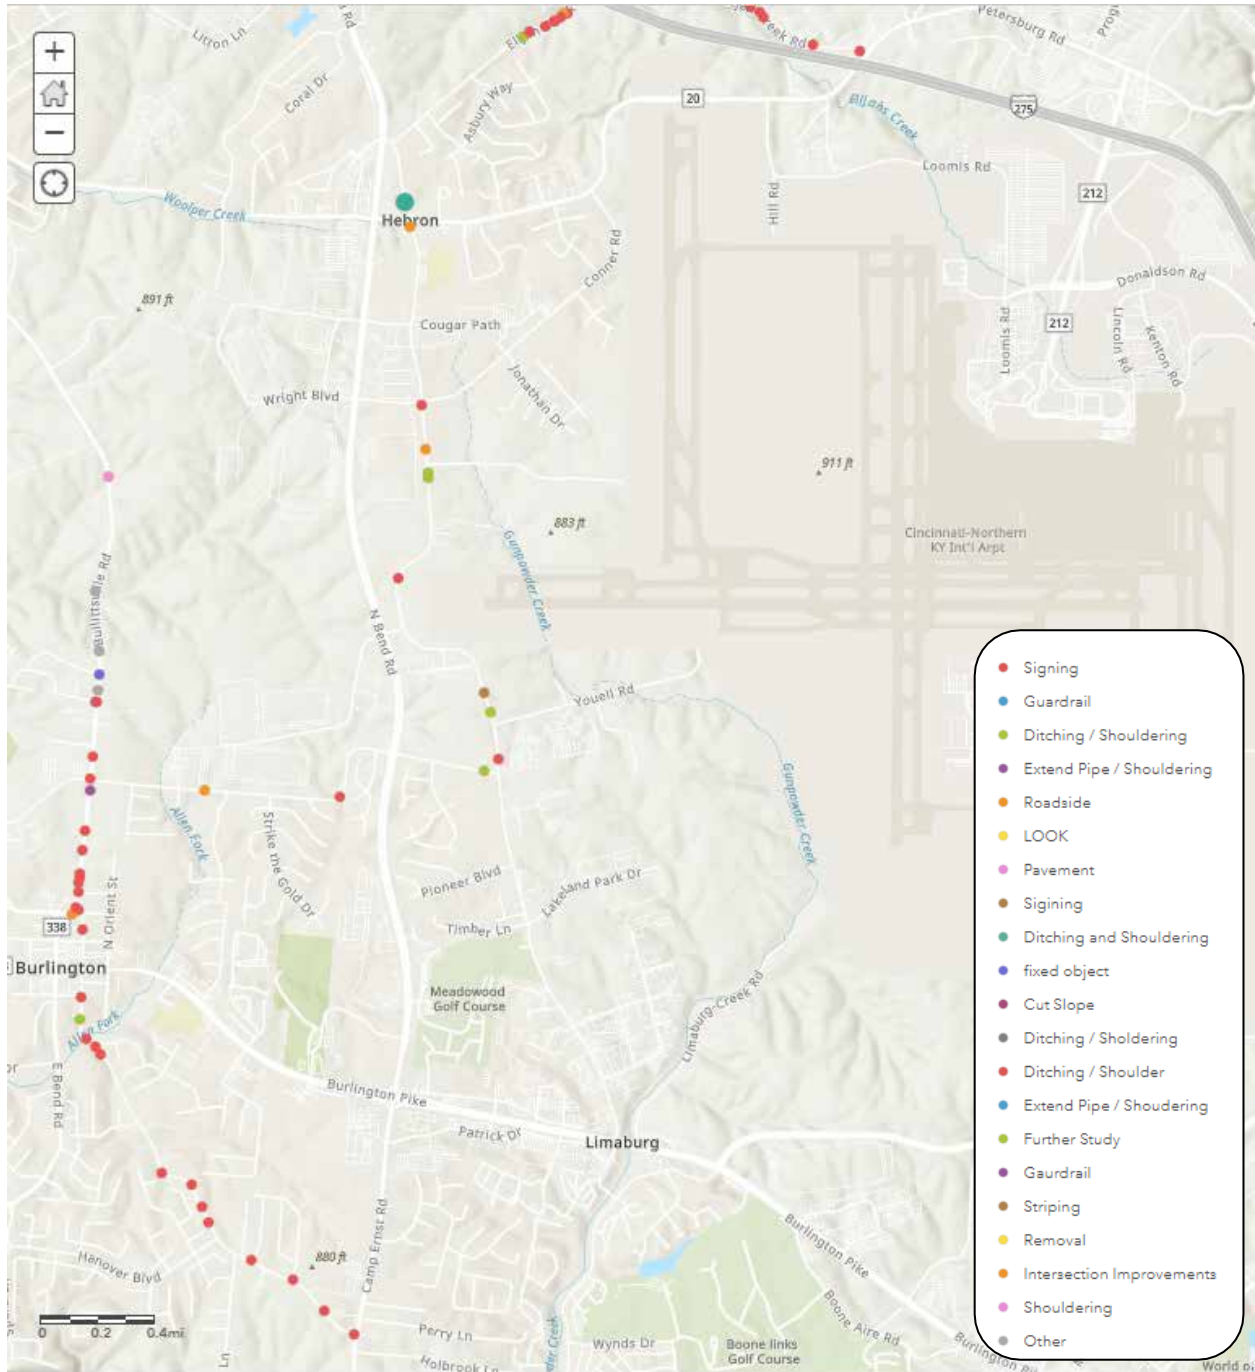
Figure A1-2: Identified Roadway Hazards

A field review of Limaburg Road identified several issues along the roadway which are located in Figure A1-2. Each of these issues is discussed below.

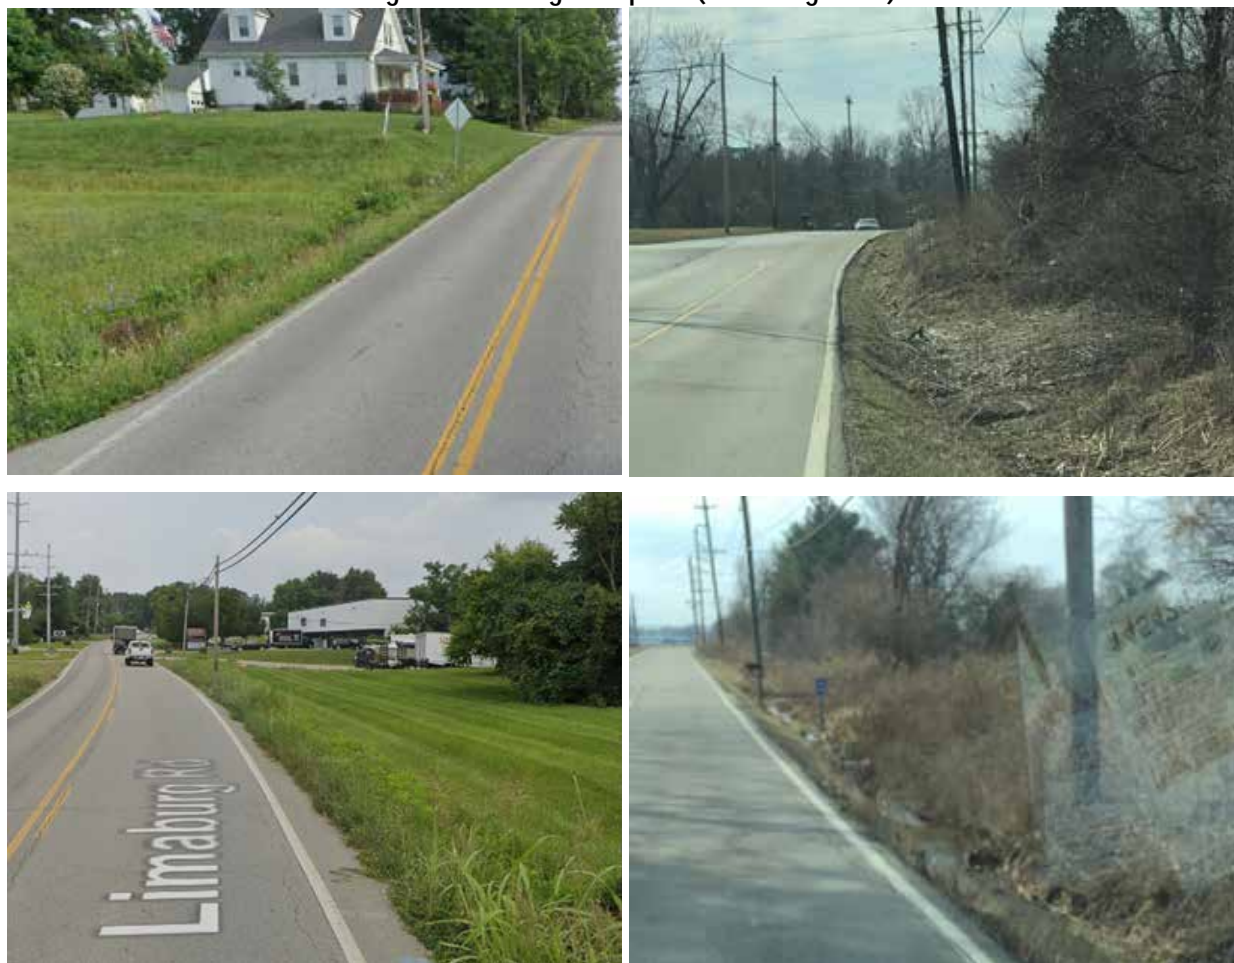
Figure A1-4: Edge Drop Off (Limaburg Road)

Roadway edge drop offs are also prevalent along the corridor primarily due to roadside drainage ditches and narrow right of way. Steep fill slopes also present a hazard where no shoulder as present. In these instances a vehicle that may depart the roadway slightly can either overcorrect to get back onto the roadway heading into oncoming traffic or fully depart the roadway and crash into a fixed object or

embankment. Driver inattention was cited in 31 crashes and overcorrecting/oversteering was cited in 3 crashes on the corridor. Figure A1-4 shows some examples of these edge drop offs.

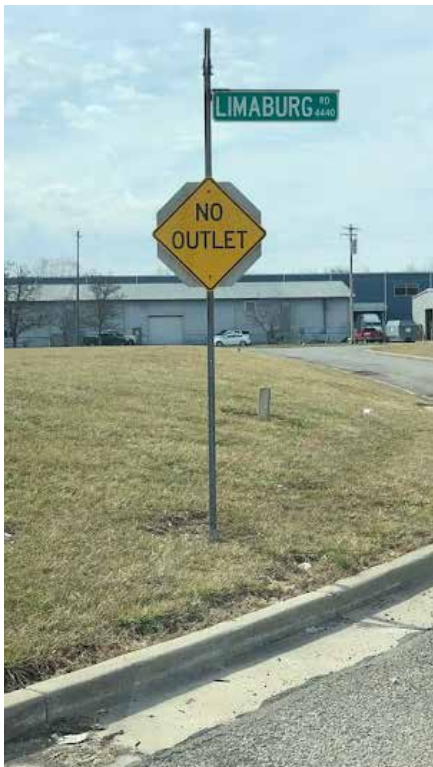
Figure A1-6: No Outlet Sign

The no outlet sign shown in **Figure A1-6** obscures the shape of the stop sign from the opposite approach. In doing so, the stop sign may not be as readily recognizable in low visibility conditions or if retroreflectivity of the stop sign is compromised.

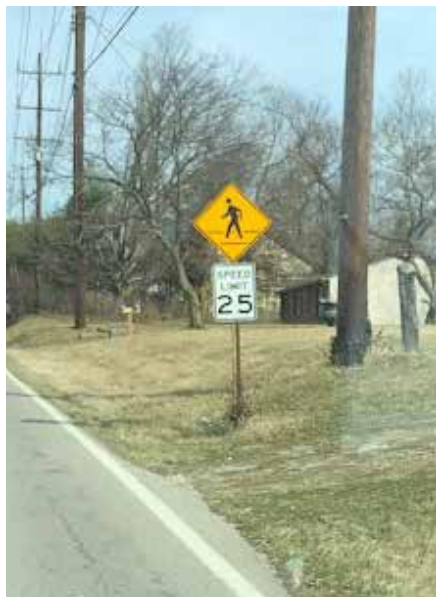
**Figure A1-7: Pedestrian Crossing and Speed Limit**

The pedestrian crossing sign mounted on the same post as the 25 mph speed limit sign shown in **Figure A1-7** can cause confusion as to whether the 25 mph speed is the regulatory speed limit or an advisory speed associated with the pedestrian crossing.

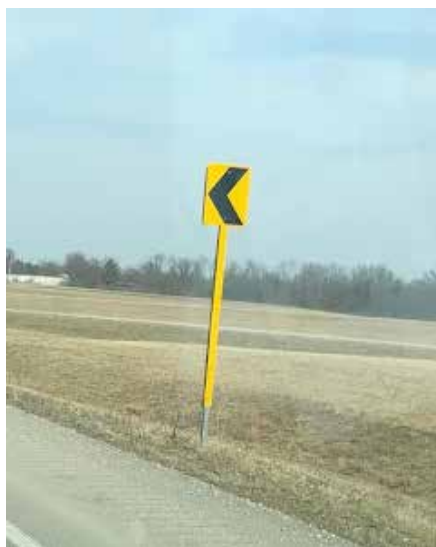
**Figure A1-8: Horizontal Alignment Chevron**

The Chevron sign shown in Figure A1-8 is placed high above the roadside, estimated at approximately 7 feet. While this placement meets MUTCD guidance; chevrons are permitted to be placed lower than other signs with a minimum height of 4 feet. This lower height places the sign more in line with the drivers line of sight and the vehicles headlights and can provide additional guidance through curves.

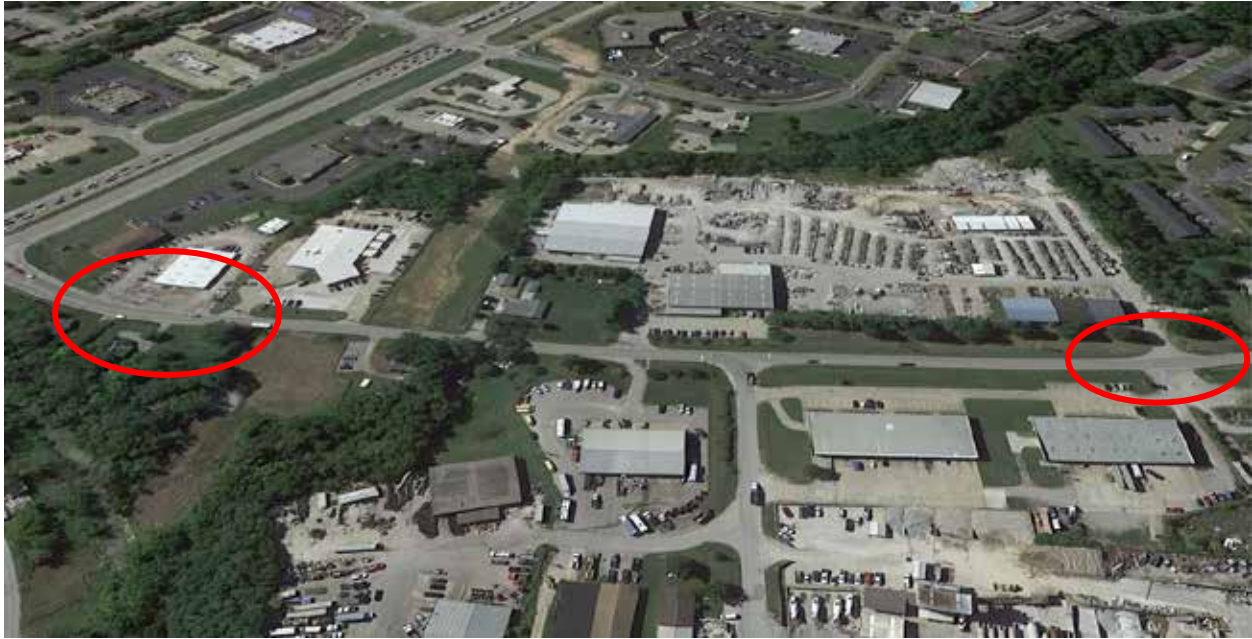
**Figure A1-9: Limaburg Road North Bend Road to Distribution Drive**

As indicated above the majority of rear end crashes on the corridor are located on the southern end of Limaburg Road south of Lakeland Park Drive. This area has the highest concentration of commercial uses on the corridor and a high density of higher volume driveways, as shown in **Figure A1-9**. In addition, several driveways and intersections are poorly defined as highlighted in **Figure A1-9** and shown in **Figure A1-10**. The high concentration of driveway and unclear entry / exit points can cause confusion as to the intended path of turning drivers and increase the potential for rear end and angle crashes.

6. Consider Access Management alternatives along the corridor including consolidation, delineation or restriction of access points and the evaluation of auxiliary turn lane warrants for high volume intersections, specifically on the south end of corridor.

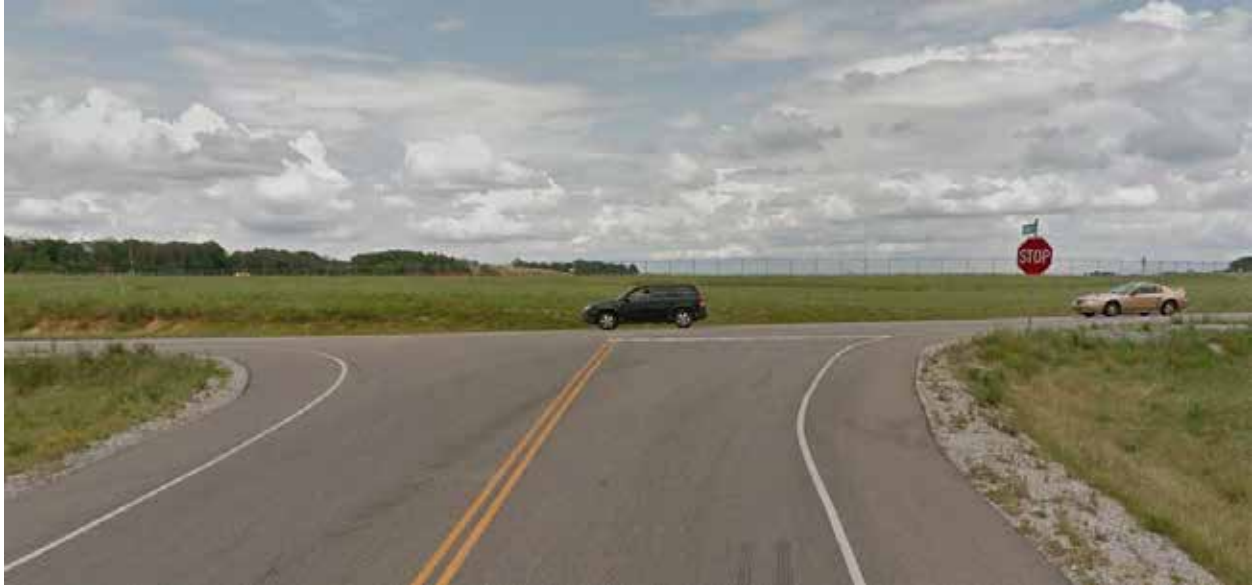
**Figure A1-13: Eastbound Approach of Gateway Boulevard at Limaburg Road**

Several crashes, including 3 single vehicle crashes, a rear end and an angle crash have occurred at the intersection of Gateway Boulevard and Limaburg Road. This intersection is a standard 'T' intersection with stop control on Gateway Boulevard. Gateway Boulevard approaches CVG Runway 9 which is relatively featureless and may not clearly communicate that the roadway is ending, especially in low-light or low visibility conditions (See **Figure A1-13**). Additionally, a review of typical traffic conditions from the Google Traffic API indicate slow moving traffic along this link during the PM peak hours when all of the identified crashes have occurred (**Figure A1-14**).

7. Install a double arrow (W7-1) at the 'T' intersection of Gateway Boulevard and Limaburg Road.

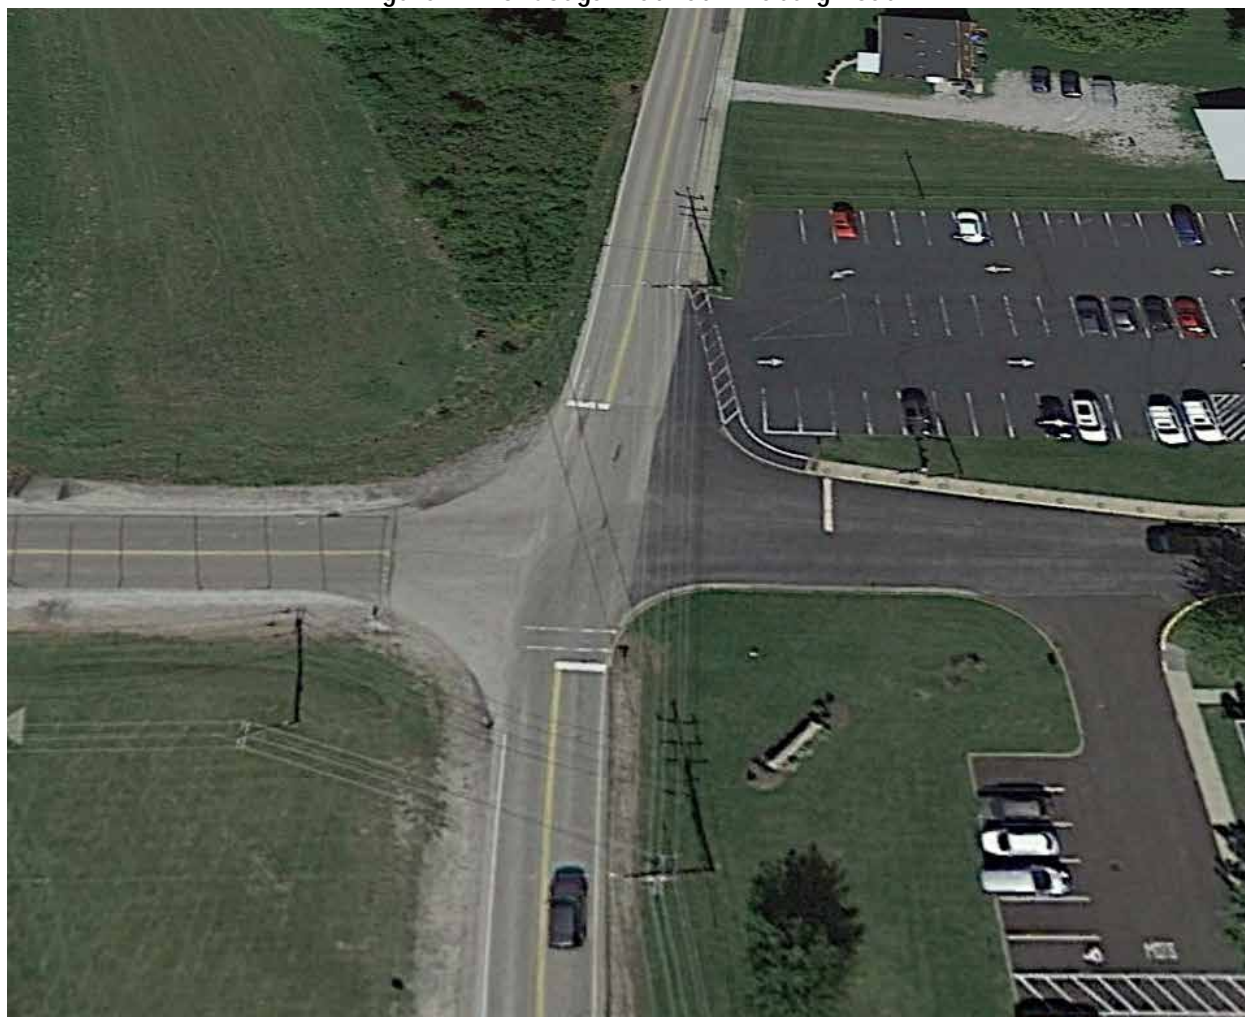
**Figure A1-15: Cougar Path at Limaburg Road**

The intersection of Cougar Path at Limaburg Road is a 4-way stop controlled intersection. In addition, an uncontrolled entrance to a parking lot is also within the physical intersection area (**Figure A1-15**). Stop signs are present on all approaches; “All Way” supplemental plaques are present on the NB and EB approaches, and “4-way” supplemental plaques are present on the WB and SB approaches. Pavement markings are used to delineate a pedestrian crosswalk and the intended entrance. Stop Ahead and Intersection Ahead warning signs are installed on Limaburg road and a Stop Ahead sign is present on the eastbound approach of Cougar Path. The Stop Ahead sign is approximately 650 feet prior to the intersection and the intersection Warning sign is approximately 4450 feet prior to the intersection. The Stop Ahead sign also appears to potentially be partially blocked by vegetation (**Figure A1-16**). The MUTCD recommends a minimum placement of 100 feet prior to the intersection for an approach speed of 35 mph. Four angle crashes occurred at the intersection, which may be attributable to either a vehicle disregarding the stop sign or associated with entering the parking area at the intersection. Significant congestion also appears to be present at the intersection during the AM peak period (**Figure A1-17**).

8. At the intersections of Cougar Path/Limaburg Road and Conner Road/Limaburg Road, eliminate the use of the Intersection Warning signs and relocate Stop Ahead signs to within the MUTCD minimum spacing standards consistent with approach speeds. Provide "All Way" plaques for all approaches at both intersections.
9. Consider relocation of the parking lot entrance in the NE quadrant of the intersection of Cougar Path and Limaburg, 50 feet north on Limaburg Road to remove it from the primary intersection. This would require reversing the circulation pattern within the parking lot.

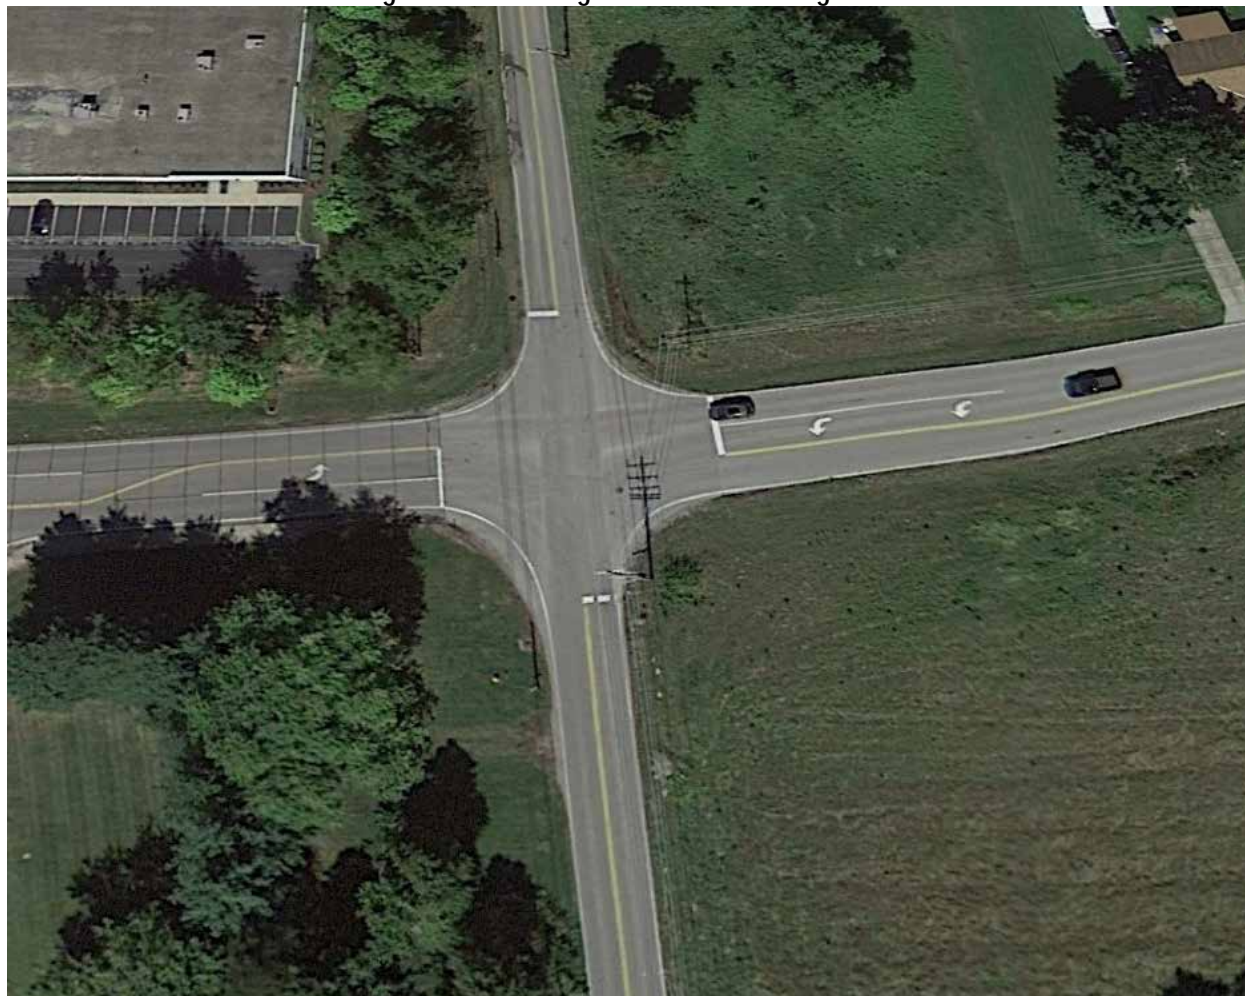
**Figure A1-18: Cougar Path at Limaburg Road**

The intersection of Conner Road at Limaburg Road is a 4-way stop controlled intersection. There is a single approach lane in each direction, with auxiliary left turn lanes on Conner Road (**Figure A1-18**). Stop signs are present on all approaches; an “All Way” supplemental plaque is present on the southbound approach and a “4-way” supplemental plaque is present on the northbound approach. No supplemental plaques are present on the eastbound and westbound approaches of Conner Road. Stop Ahead and Intersection warning signs are installed on Limaburg road. The Stop Ahead signs are approximately 350 feet prior to the intersection and the Intersection warning sign is approximately 250 feet prior to the intersection. The MUTCD recommends a minimum placement of 100 feet prior to the intersection for an approach speed of 35 mph and 175 feet for an approach speed of 45 mph. Four rear-end crashes and 1 angle occurred at the intersection, primarily on the northbound approach.

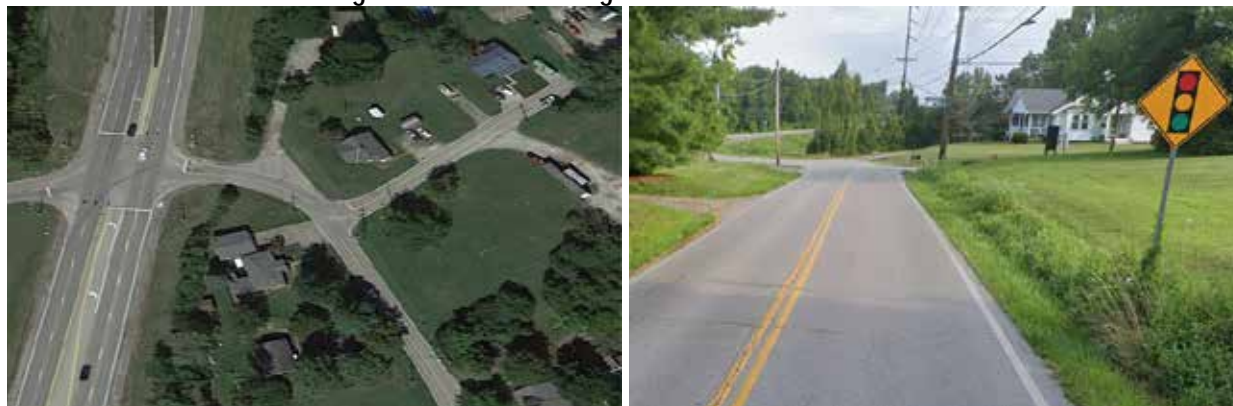
Figure A1-19: Limaburg Road at North Bend Road

The intersection of Limaburg Road with North Bend Road is the northern terminus of Limaburg Road and is controlled by a traffic signal installation. The intersection is directly after a sharp curve of approximately a 150 foot radius. A Signal Ahead warning sign is present, approximately 330 feet prior to the intersection. A driveway located at the apex of the curve, as well as the vegetation and embankment on the west side of the roadway presents a visual trap, making it difficult to identify the curvature of the

roadway. The roadway also maintains a wide shoulder resulting from the previous alignment of Limaburg Road that may appear to be a right turn lane to approaching drivers. Two single vehicle crashes have occurred near the intersection of Elijah Creek Road, directly south of North Bend Road and two same direction sideswipe crashes have occurred at the intersection in addition to a rear end, angle and backing crash.

10. Improve the Limaburg approach to North Bend Road to eliminate the visual trap and increase visibility of the roadway curvature.
  - a. Install chevrons along the curve
  - b. Remove additional pavement leading to driveway location within the curve
  - c. Relocate the Signal Ahead sign closer to the intersection, approximately 250 feet prior to the intersection (near side of Elijah Creek Road)

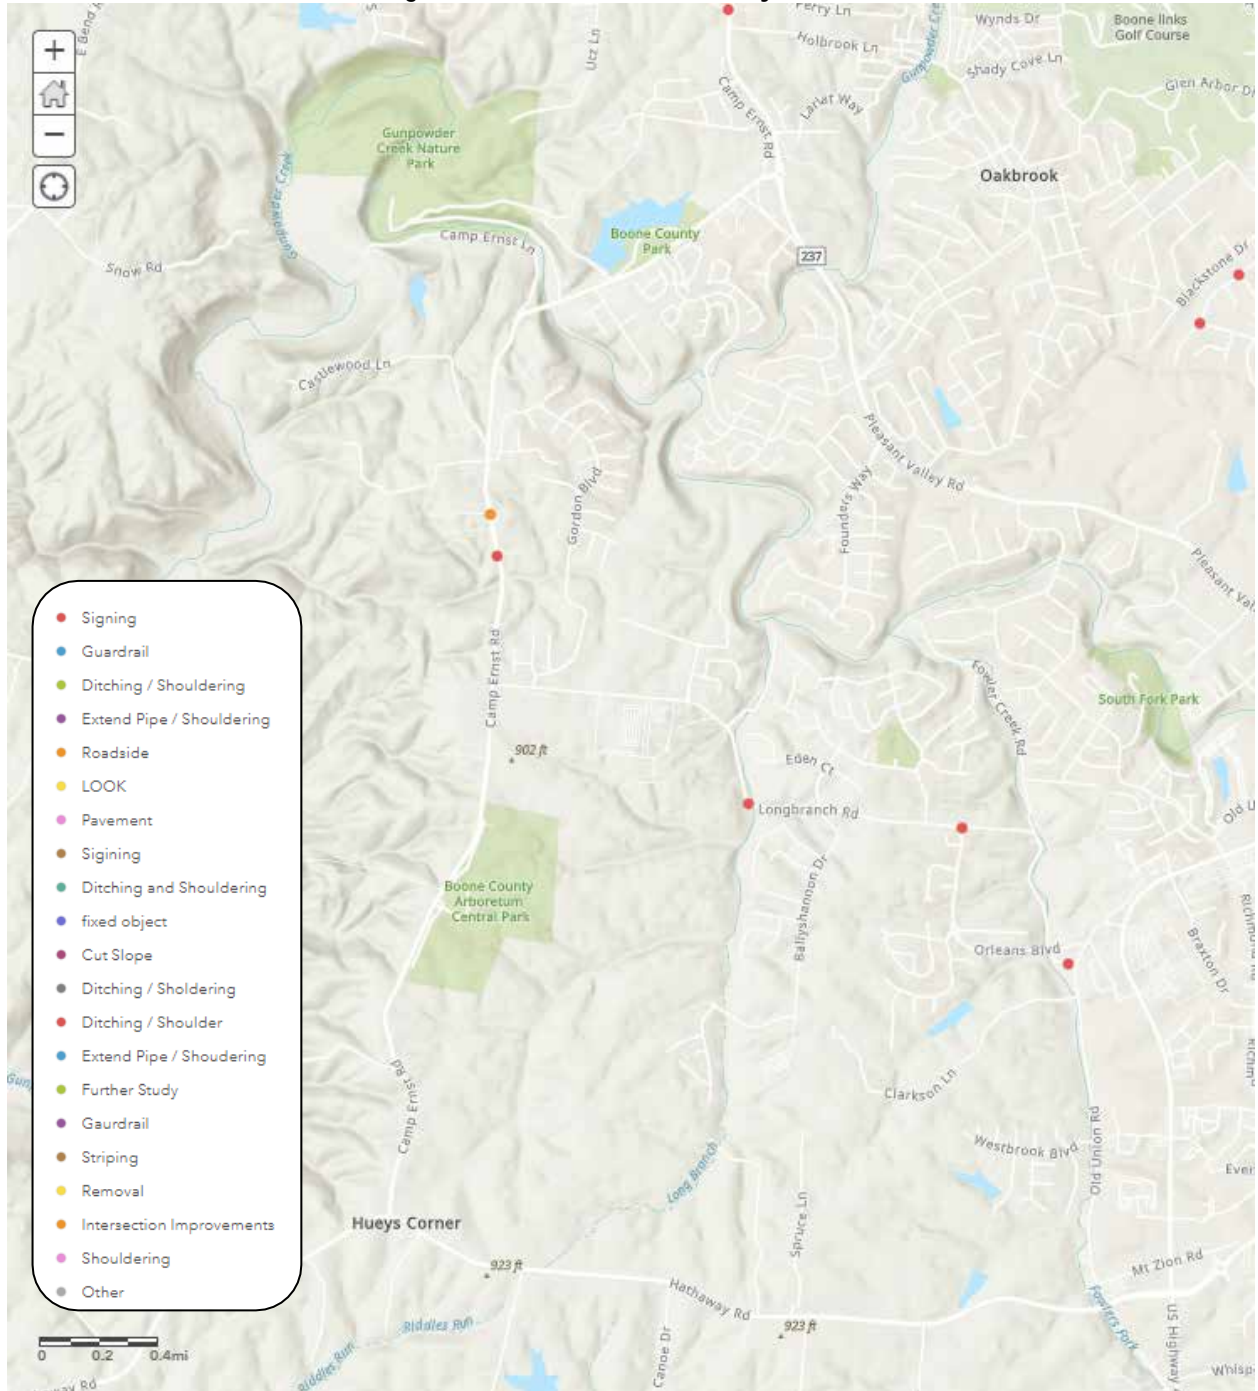
Figure A2-2: Identified Roadway Hazards

A field review of Camp Ernst Road was conducted and identified several issues along the roadway which are located in Figure A2-2. Each of these issues is discussed below.

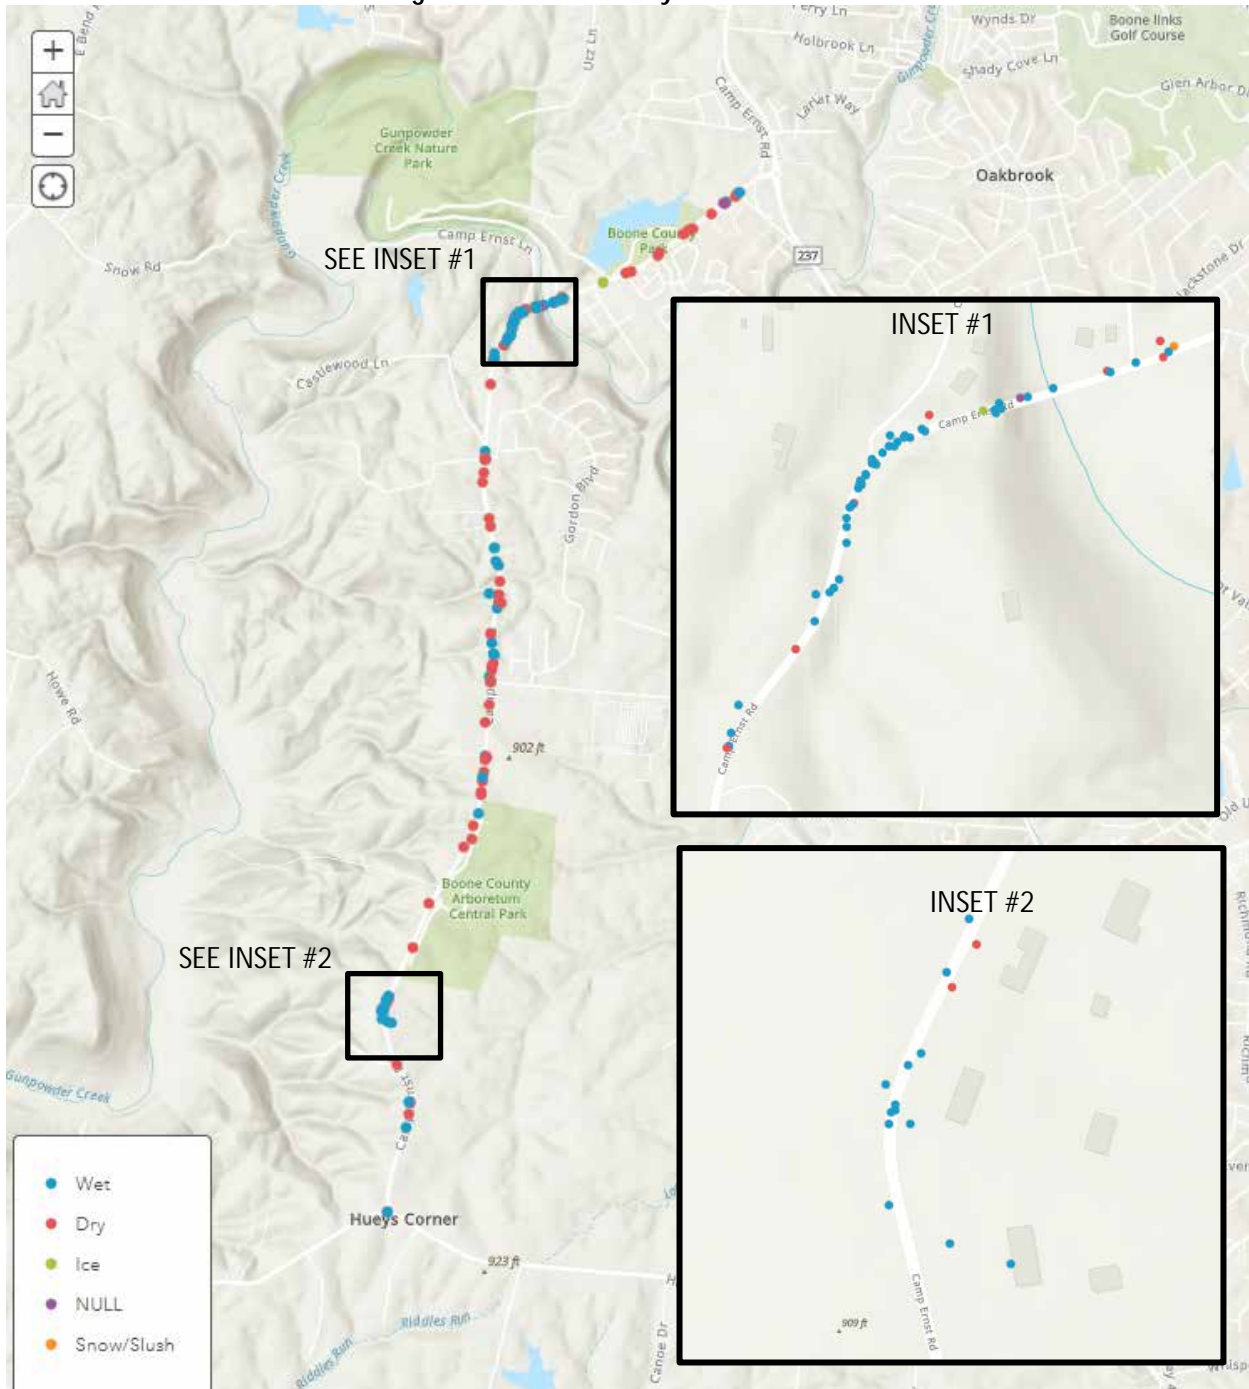
Figure A2-3: Crashes by Road Condition

A review of road conditions for all crashes was conducted to determine if wet conditions contributed to crashes in the area. This review is shown in **Figure A2-3**. As is evident from the figure 2 areas have a high concentration of wet road crashes, indicated in blue in the figure. These are near Camp Ernst Lane and the curve directly south of the Boone County Arboretum Central Park.

**Wet Crash Location No. 1.** The northern location near the intersection of Camp Ernst Lane experience 56 crashes within the 5-year study period, 41 of which involved a wet pavement condition. The curve has a radius of approximately 400 feet and proper superelevation, though it is located on a downward grade from the south as it approaches Gunpowder Creek. The intersection of Camp Ernst Lane near the apex of the curve, further complicates the negotiation of the curve as it can cause a visual trap as to the intended path of the curve.

**Wet Crash Location No. 2.** The southern location, shown in Inset No. 2 experienced 15 crashes over the 5-year study period with 13 involving wet pavement conditions. The curve has a radius of approximately 400 feet with proper superelevation. Curve warning signs are present from the south, as the curve develops after a vertical crest. Advanced curve signs are not present from the north (**Figure A2-5a**). Chevrons are located throughout the curve. A secondary entrance to the Boone County Knothole Baseball complex is located at the north PC of the curve (**Figure A2-5b**). The road appears to have good drainage ditches on both sides with the water flowing off the roadway (**Figure A2-6**). Approximately 400 feet to the north, ditches are not as prominent as through the curve, but any flow from this area is not anticipated to impact the operations of the curve itself where crashes are occurring. If drainage is not an issue as it appears, a lack of pavement friction may be contributing to the high number of wet weather crashes.

1. Continue to monitor crash history at the northern high crash curve, recently improved with the HFST to ensure that crashes have been sufficiently addressed by the improvement.
2. Evaluate drainage at the southern high crash curve location near the Boone County Knothole Baseball Complex to ensure that standing or sheeting water on the roadway is not the primary cause of the high wet pavement crash frequency. If drainage is deemed sufficient, consider a similar HFST application as was installed for the northern curve.
3. Provide improved ditching and shouldering throughout the corridor to relocate drainage ditches away from roadway to increase recovery area for vehicles. This may require relocation of driveway crossdrains to provide adequate slope within the ditch. A similar project was recently completed by a home owner along Camp Ernst Road as shown below.

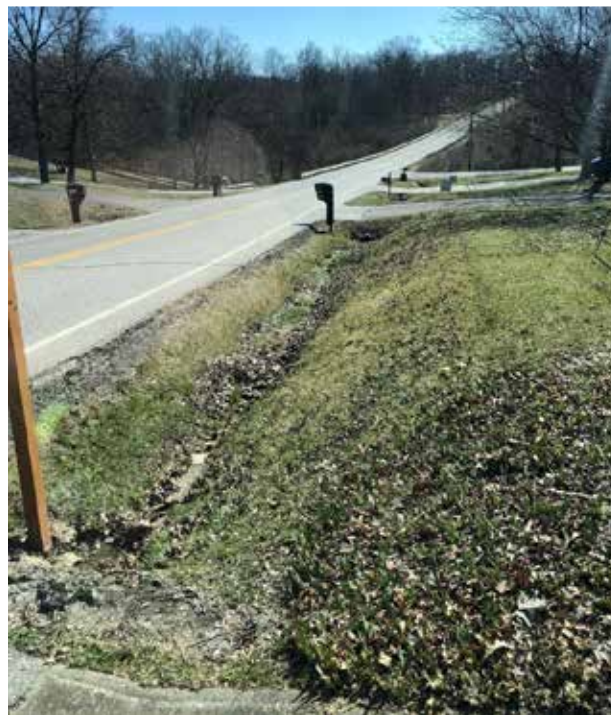
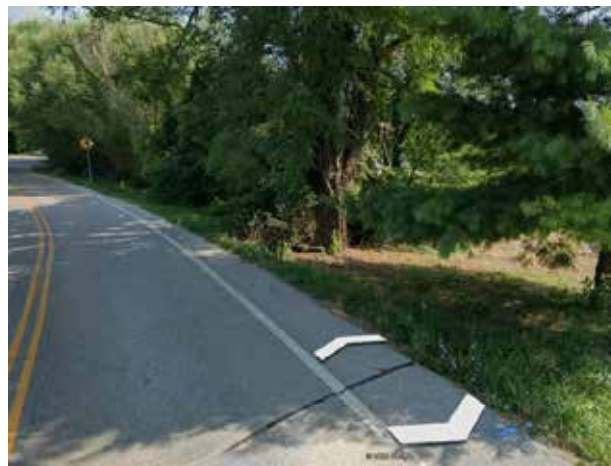
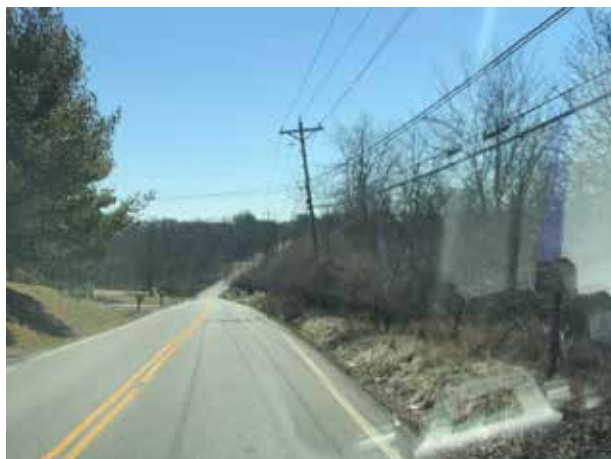
**Figure A2-7: Edge Drop Offs on Camp Ernst Rd**

Roadway edge drop offs are prevalent along the corridor primarily due to roadside drainage ditches and narrow right of way. Steep fill slopes also present a hazard where no shoulder as present. In these instances a vehicle that may depart the roadway slightly can either overcorrect to get back onto the roadway heading into oncoming traffic or fully depart the roadway and crash into a fixed object or embankment. Driver inattention was cited in 20 crashes and overcorrecting/oversteering was cited in 10 crashes on the corridor. **Figure A2-7** shows some examples of these edge drop offs.

4. Consider the adoption of county ordinance for new driveway permits to require driveway crossdrains 8-10 feet back from edge of pavement to increase available room for ditches and allow the provision of an adequate ditch slope.

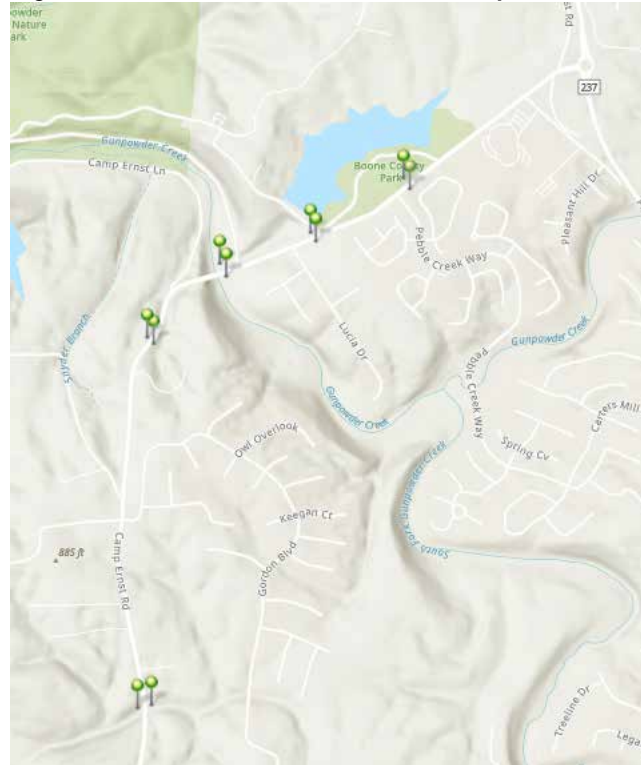
**Figure A2-8: Guardrail Installations Camp Ernst Road**

Minimal guardrail exists along Camp Ernst Road, compared to other roads in the areas, however, all installations that are present appear to not meet minimum guardrail height requirements, or provide crash worthy end treatments. In addition, guardrail installation near the Boone County Park and Camp Ernst Lake appear to be unwarranted and not protecting against fixed objects and/or critical slopes. Unnecessary guardrail installation, are in fact fixed objects directly adjacent to the roadway. **Figure A2-8** shows the guardrail installations along the corridor, and **Figure A2-9** shows typical guardrail installations and end treatments.

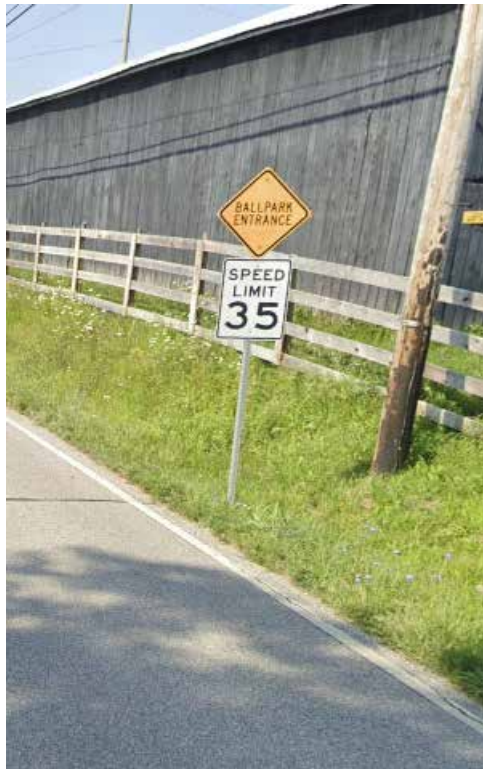
**Figure A2-10: Ballpark Entrance and Speed Limit**

A Ballpark Entrance sign mounted on the same post as the 35 mph speed limit sign shown in **Figure A2-10** can cause confusion as to whether the 35 mph speed is the regulatory speed limit or an advisory speed associated with the entrance.

5. Review all signing on corridor and document sign type, location, post type and condition within a sign management database. Install signing consistent with MUTCD recommendations. Specifically horizontal alignment signing and object markers should be installed where warranted.

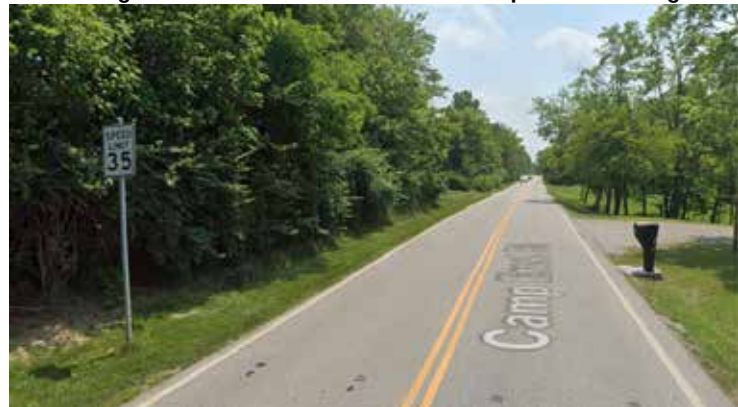
**Figure A2-11: Left Side Mounted Speed Limit Sign**

Speed Limit signs mounted on the left side of the road (**Figure A2-11**) as opposed to the right side of the road may not meet driver expectations and cause drivers to be unaware or confused by the sign due to its location.

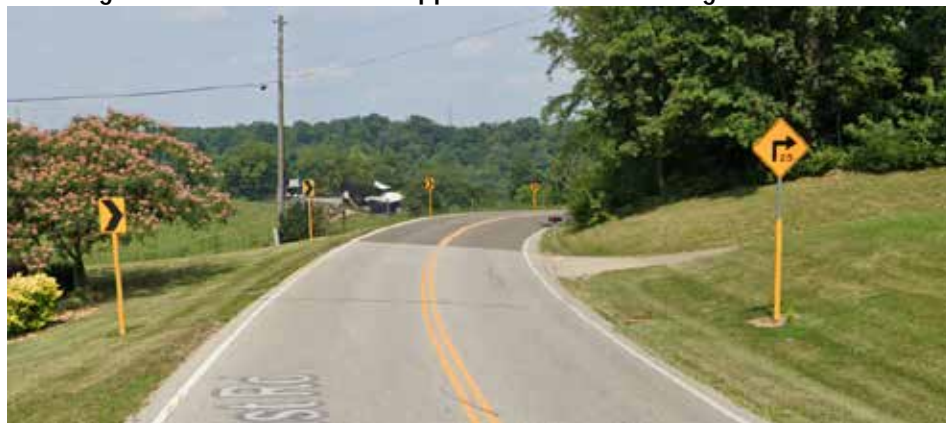
**Figure A2-12: Northbound approach to Northern High Crash Curve**

The Curve warning signs on the northern high crash curve (**Figure A2-12**), does not have an advance curve warning with advisory speed plaque to provide drivers adequate distance to slow down prior to entering the curve.

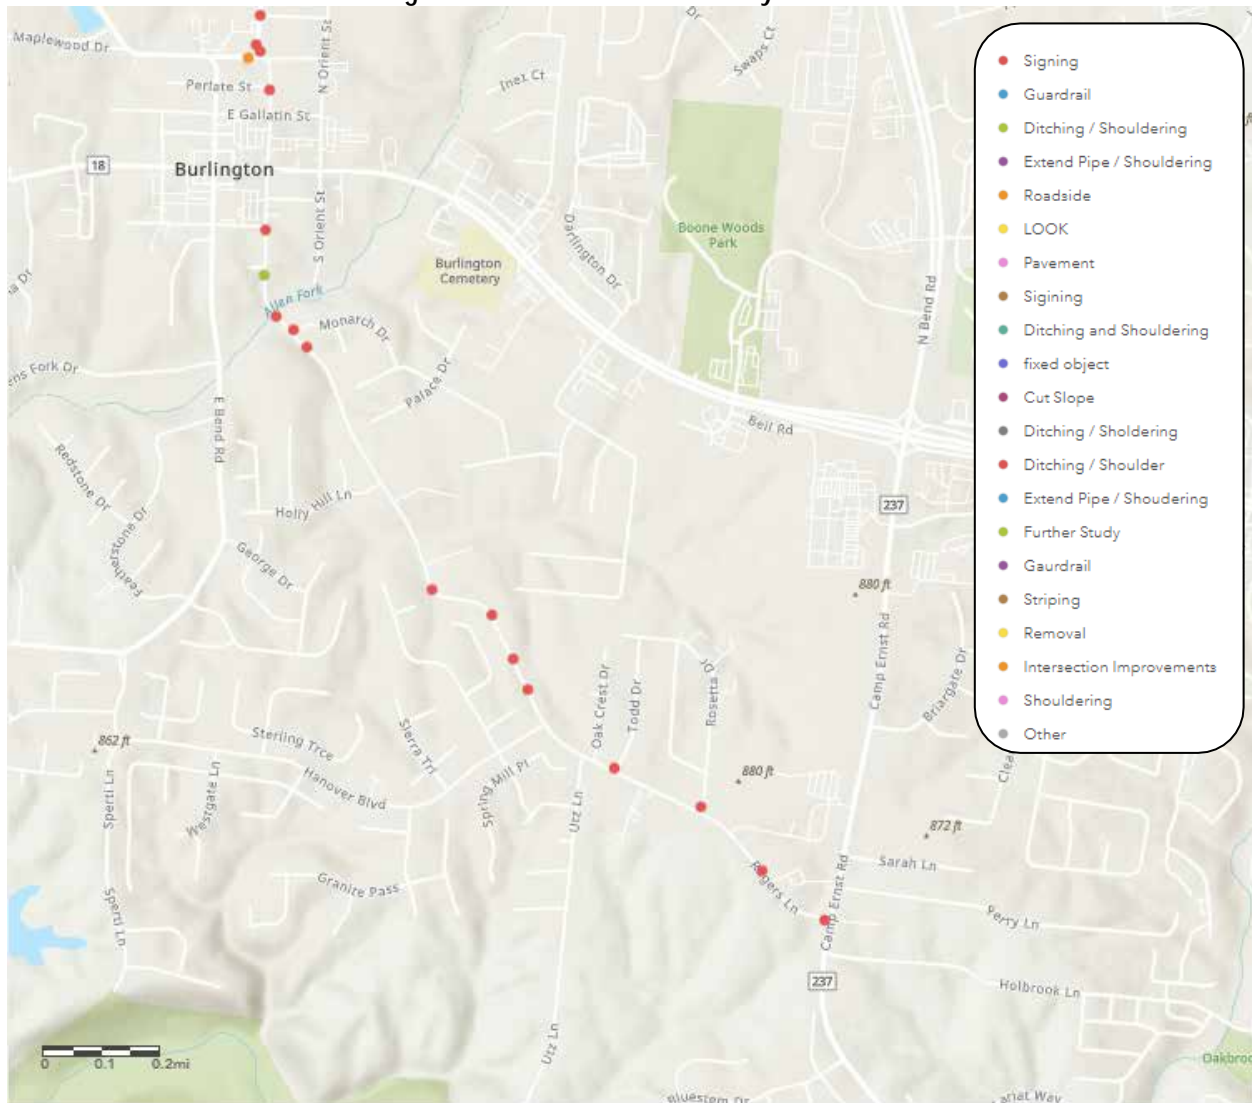
Figure A3-2: Identified Roadway Hazards

A field review of Rogers Lane was conducted and identified several issues along the roadway which are located in Figure A3-2. Each of these issues is discussed below.

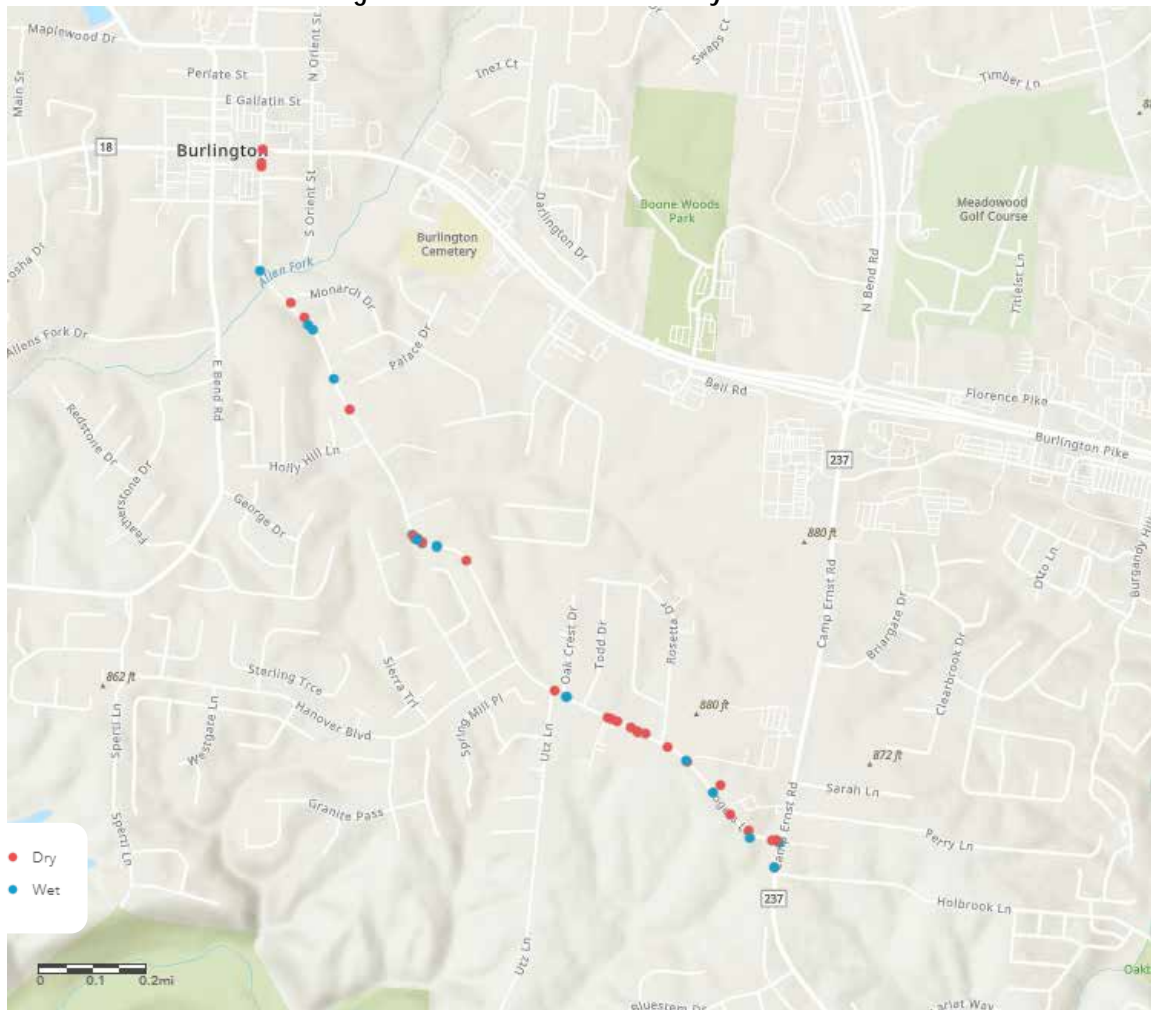
Figure A3-3: Identified Roadway Hazards

A review of road conditions for all crashes was conducted to determine if wet conditions contributed to crashes in the area. This review is shown in **Figure A3-3**. As is evident from the figure, 2 areas have a small concentration of wet road crashes, indicated in blue in the figure. These are between Allen Creek Crossing and Monarch Drive (5 of 8 crashes) and near the reverse curve between Holly Hill Lane and Hanover Boulevard (11 of 15 crashes).

1. The areas identified as having higher frequency wet-weather crashes should be observed during rain events to determine if drainage in the area and/or sheet flow presents an increased hazard for crashes. If drainage is determined to be sufficient, friction tests should be conducted to determine if additional treatments such as HFST would be warranted.

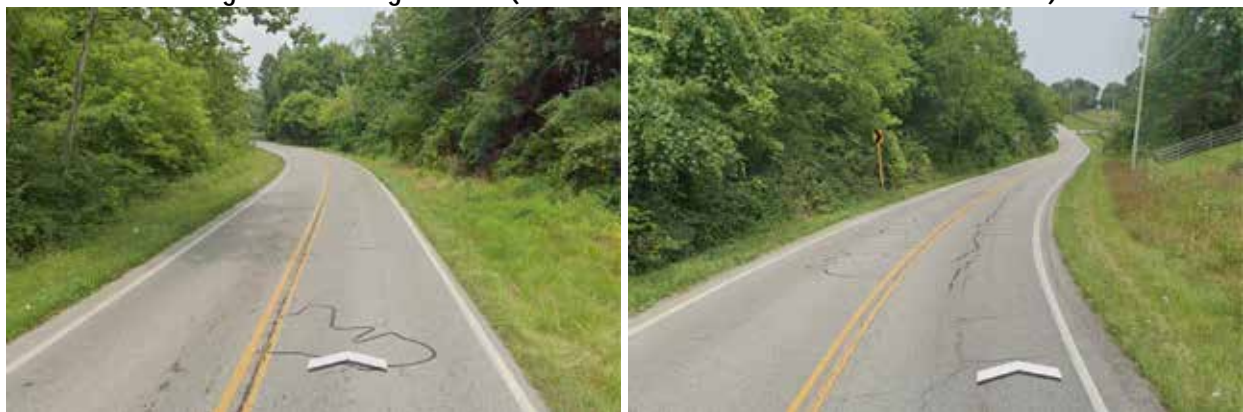
Figure A3-4: Rogers Lane (South of Monarch Drive and Reverse Curve)

The concentrations of wet weather crashes may be the result of blocked drainage ditches or may result from sheet flow over the roadways as both roadways are superelevated and on grade with a high resulting relative gradient. (See **Figure A3-4**) Observation of these areas during rain events are necessary to detect any drainage or wet weather related issues.

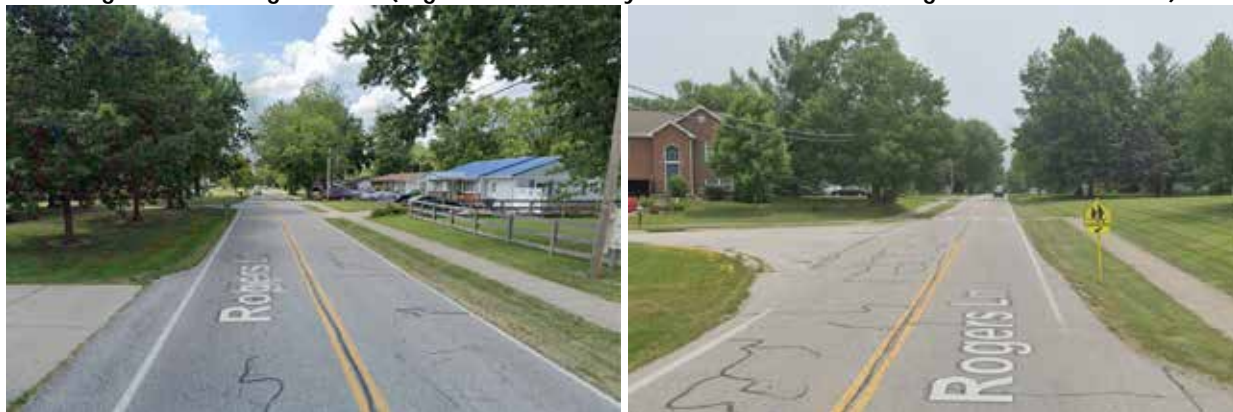
Figure A3-5: Rogers Lane (High Access Density and Pedestrian Crossings South of Utz Lane)

As indicated above, the south end of the Rogers Lane Corridor has a high concentration of rear end and angle crashes as shown in Figure A3-1. In this area, residential properties have direct driveway access increasing access density, and several pedestrian crossings connecting sidewalks along Rogers Lane and

adjacent residential neighborhood streets are present (Figure A3-5). The speed limit on Rogers Lane is 35 mph through the entire corridor, even with the significant land use change south of Utz Lane.

2. Consideration should be given to lowering the speed limit on the southern section of Rogers Lane south of Utz Lane. The lower speed limit may be warranted due to the increased number of access points, residential driveways and the presence of Camp Ernst Middle School.
