# LOCAL ROAD SAFETY PLAN

**BOONE COUNTY**  
KENTUCKY

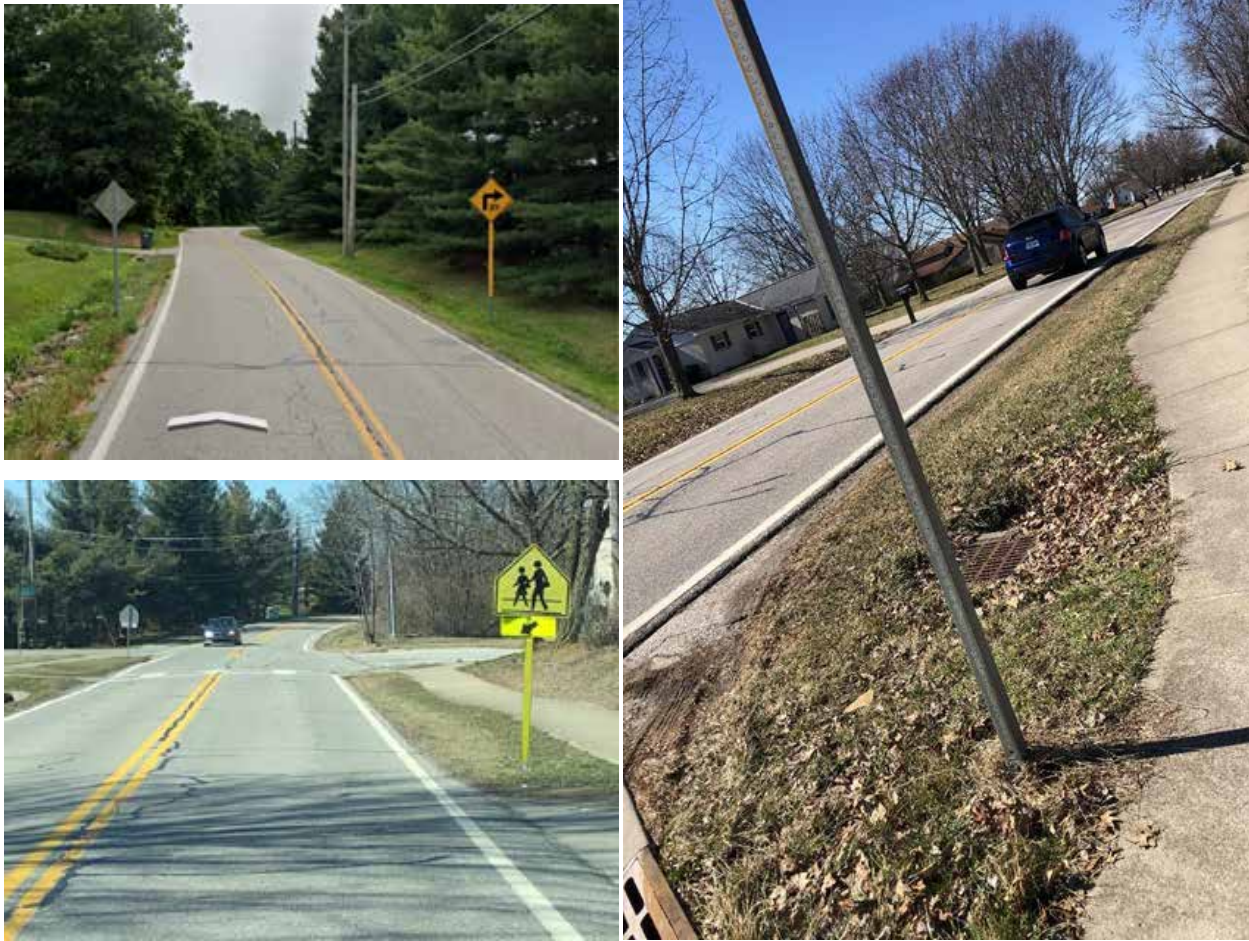
Figure A3-7: Roger Lane Signing Examples

Good signing exists on the corridor as shown in Figure A3-6. However, inconsistencies in signing applications are present with signing practices inconsistent with MUTCD guidance, reduced sign reflectivity and mixed installation materials including non-crashworthy installations, as well as varied sign heights as shown in Figure A3-7.

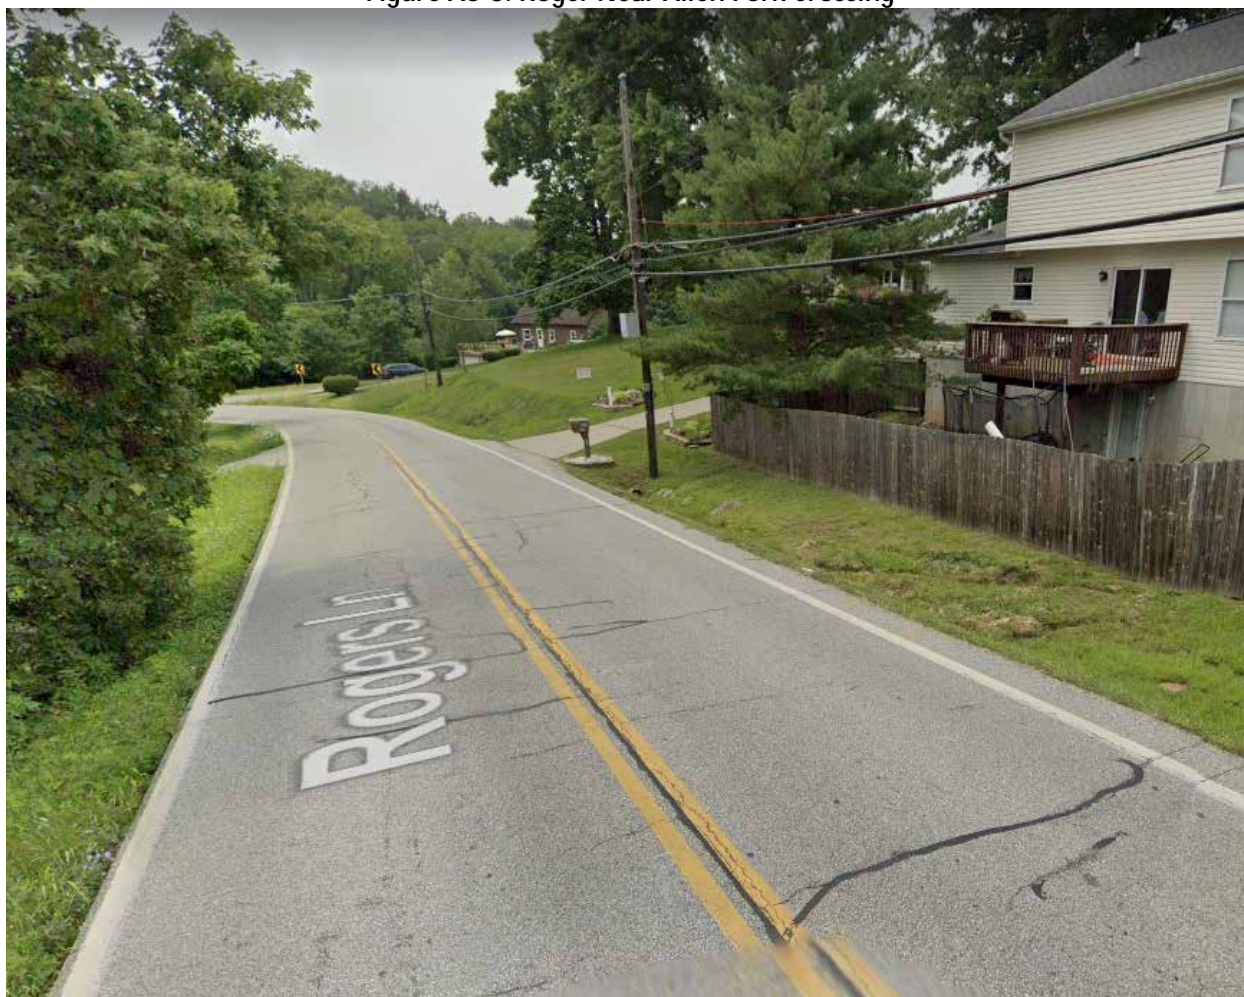
Figure A3-8: Roger Near Allen Fork Crossing

On the northern section of the corridor, driveway culverts are placed relatively close to the road edge, which minimizes available space for the roadside ditch. As the ditch erodes this creates edge drop offs which can lead to overcorrection for errant drivers and contribute to single vehicle, head-on or sideswipe crashes. (Figure A3-8)

3. Provide improved ditching and shouldering where feasible to relocate drainage ditches away from roadway to increase recovery area for vehicles. This may require relocation of driveway crossdrains to provide adequate slope within the ditch. A similar project was recently completed by a home owner along Camp Ernst Road as shown below.

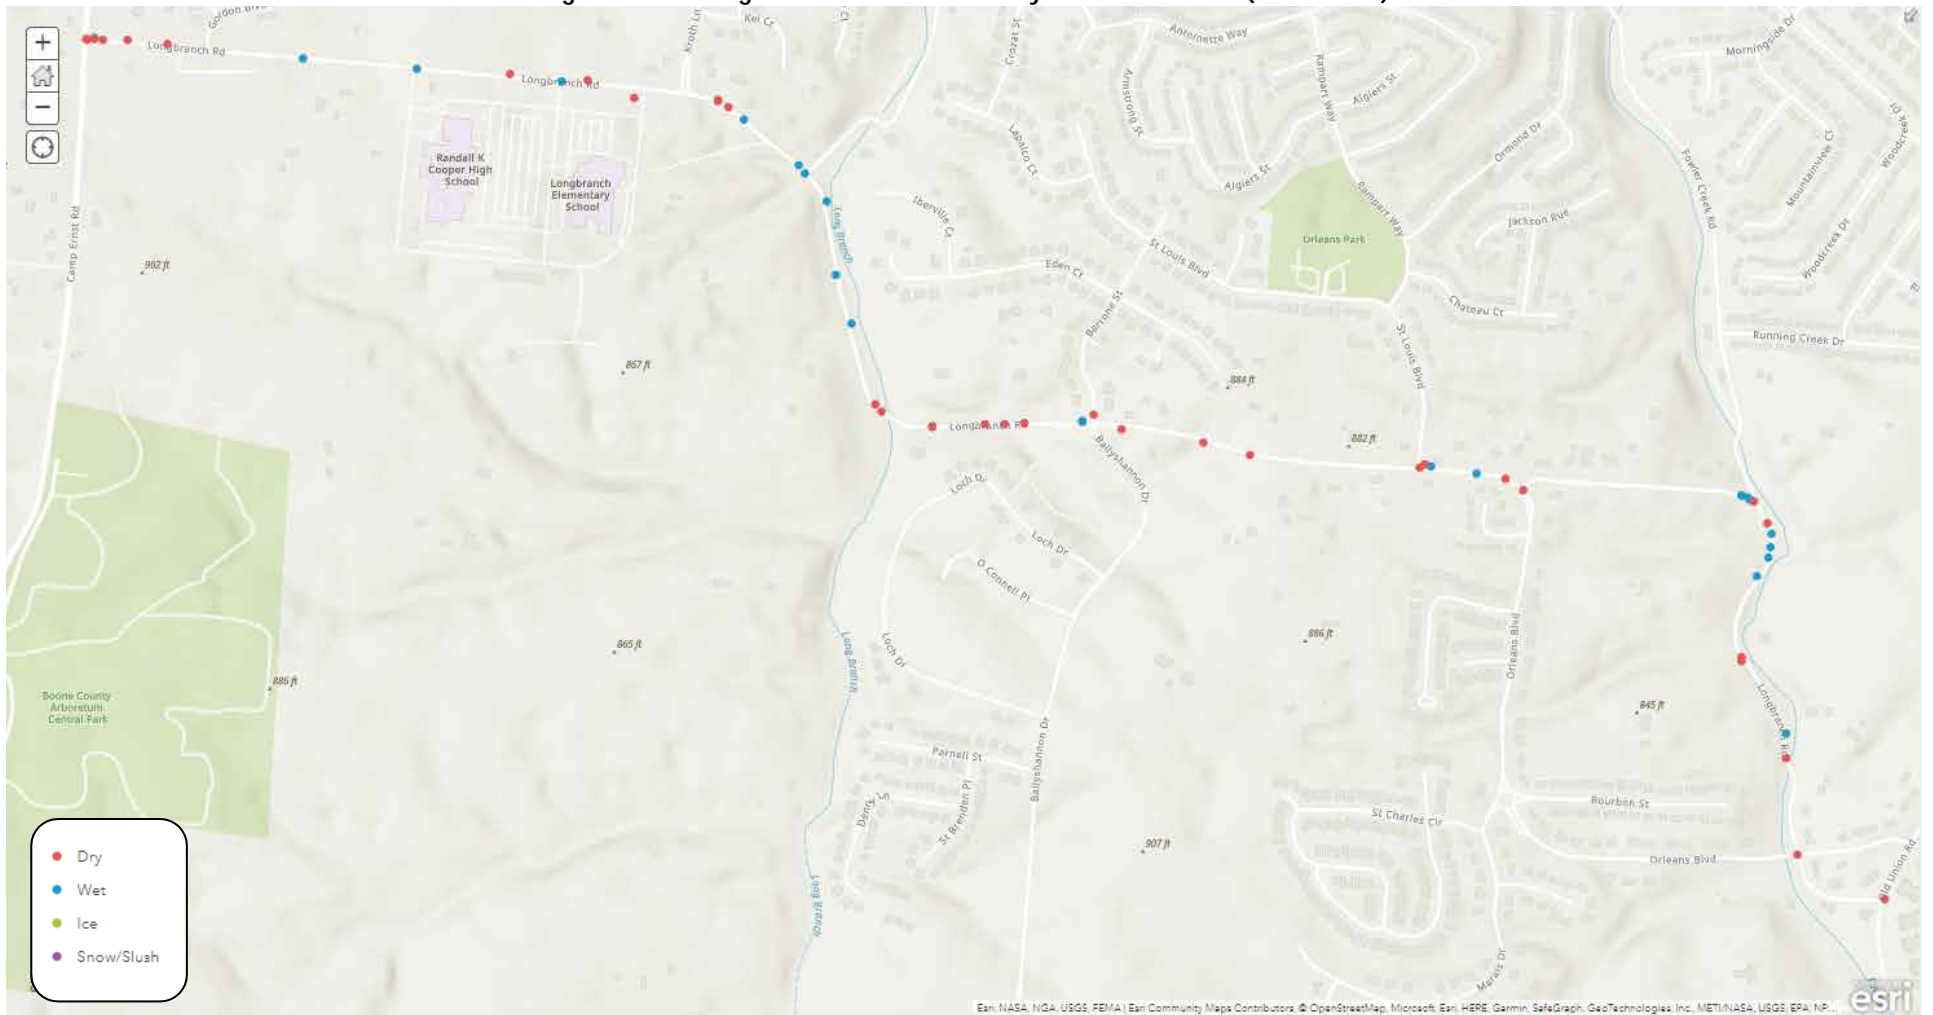
Figure A4-3: Longbranch Road Crashes by Road Condition (2016-2020)

A review of road conditions for all crashes was conducted to determine if wet conditions contributed to crashes in the area. This review is shown in **Figure A4-3**. As is evident from the figure, 2 areas have a small concentration of wet road crashes, indicated in blue in the figure. These are between Hidden Creek Drive to the Longbranch Creek crossing (6 of 8 crashes) and near Fowler Creek Road (9 of 11).

1. The areas identified as having higher frequency wet-weather crashes should be observed during rain events to determine if drainage in the area and/or sheet flow presents an increased hazard for crashes. If drainage is determined to be sufficient, friction tests should be conducted to determine if additional treatments such as HFST would be warranted.

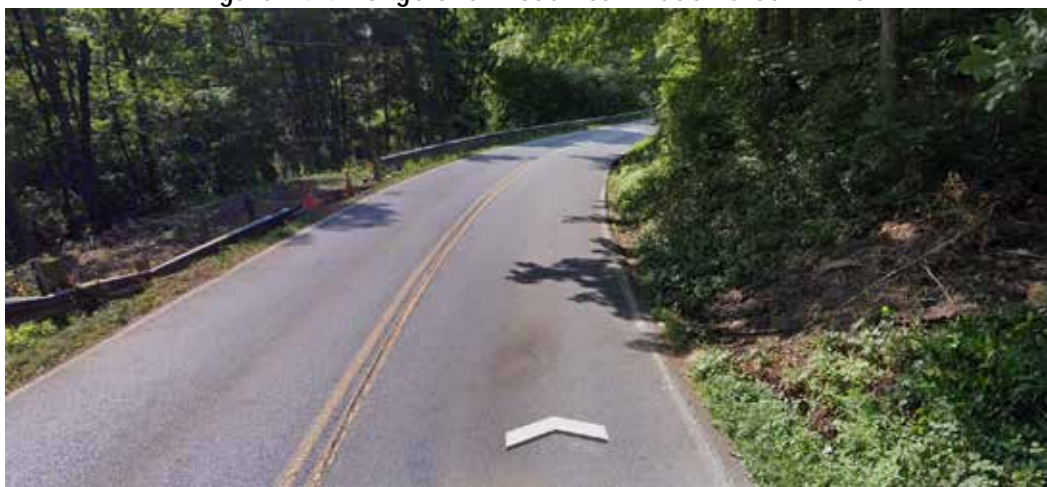
**Figure A4-4: Longbranch Road near Hidden Creek Drive**

The concentrations of wet weather crashes near Hidden Creek Drive may be the result of poor drainage, especially on the cut side along slopes, where space for proper roadway ditches is not available (**Figure A4-4**).

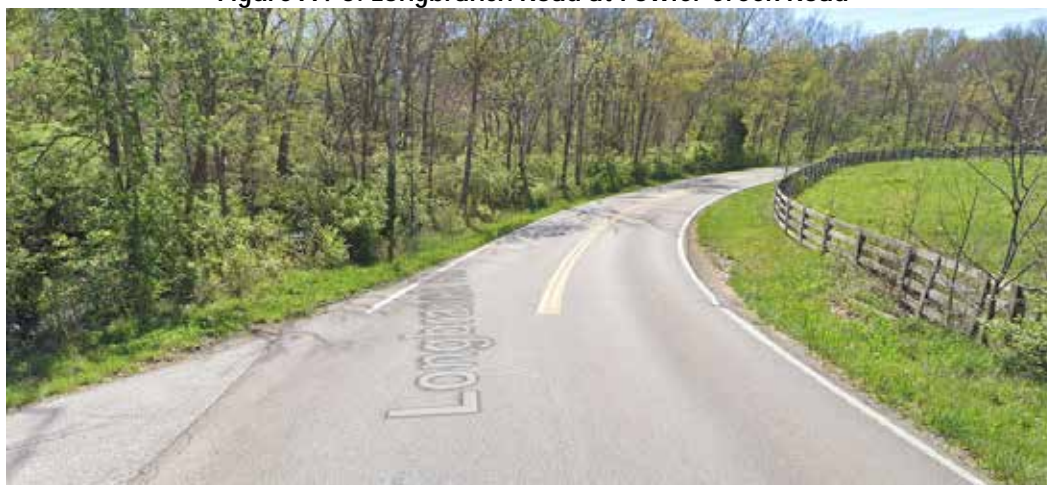
**Figure A4-5: Longbranch Road at Fowler Creek Road**

Similar issues may also exist near Fowler Creek Road, where ditches along the inside of the curve are minimal. Vegetation growth in this area may also prevent water from draining to the cross-drain and hold water on the roadway (**Figure A4-5**).

Observation of these areas during rain events are necessary to detect any drainage or wet weather related issues.

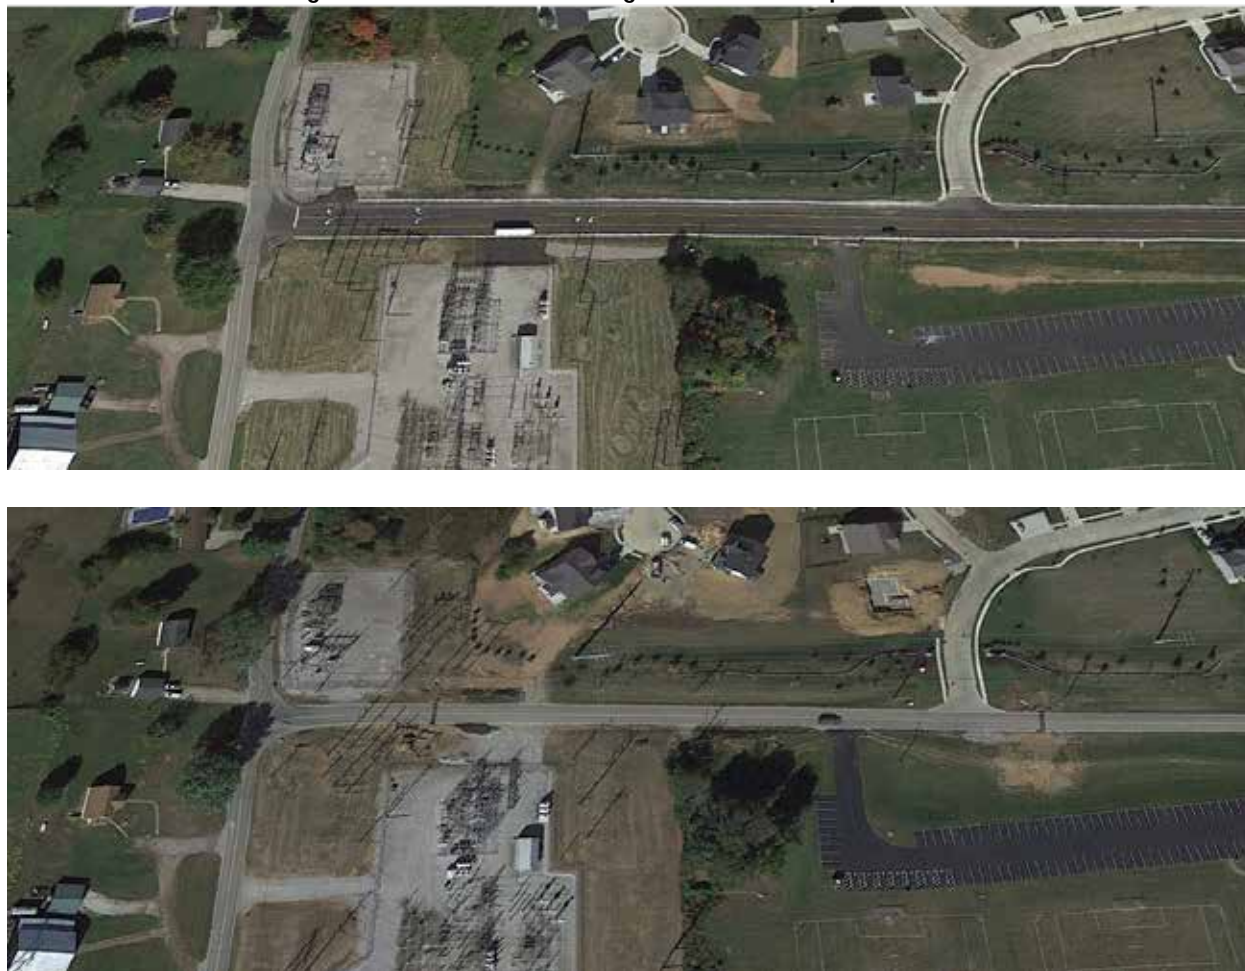
**Figures 4-3a and A4-3b: Longbranch Road Improvements**

As is evident from the crash diagram in Figure A4-1, a higher concentration of crashes is present on the approach to Camp Ernst Road. It is noted that Longbranch Road approach to Camp Ernst Road was widened in early 2021. **Figure A4-3a and A4-3b** show the before and after improvements at the intersection. Since the completion of the development, no crashes have been documented along Longbranch Road.

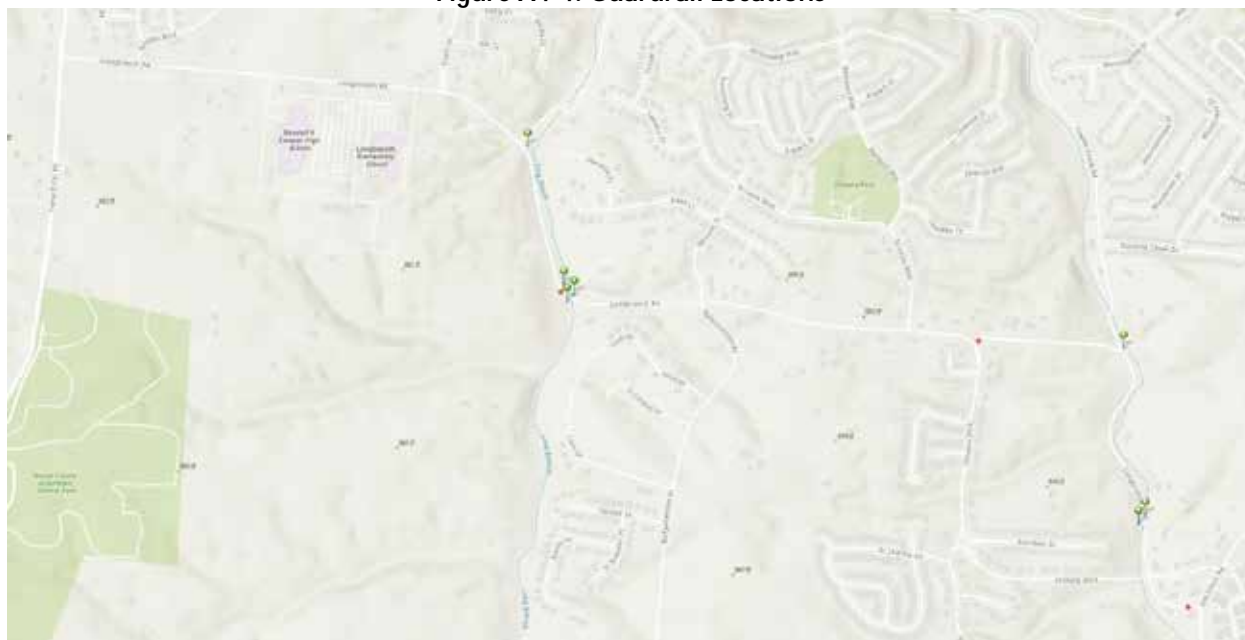
Figure A4-4: Guardrail Locations

Several instances of guardrail are present on Longbranch Road as shown in **Figure A4-4**, and appear to not meet minimum guardrail height requirements, or provide crash worthy end treatments. **Figure A4-5** shows typical guardrail installations along the corridor

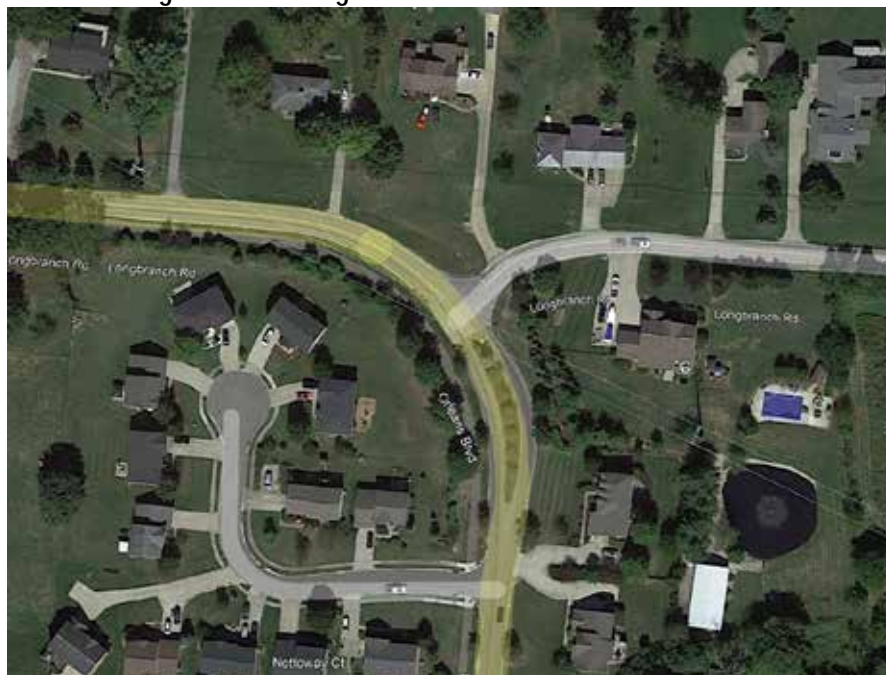
**Figure A4-6: Longbranch Road at Orleans Boulevard**

Longbranch Road was realigned in the early 2000's to continue straight to Orleans Boulevard. The realignment of the roadway within a long tangent section, introduced a short curve (radius approximately 250 feet) to each approach of Longbranch Road (**Figure A4-6**). The continuation of Longbranch is still visible and creates a visual trap for approaching drivers (**Figure A4-7**). The landscaped berm on the southside of the roadway restricts visibility of the continuation of Orleans Boulevard which further contributes to the visual trap. Several single vehicle and rear end crashes have occurred at this location.

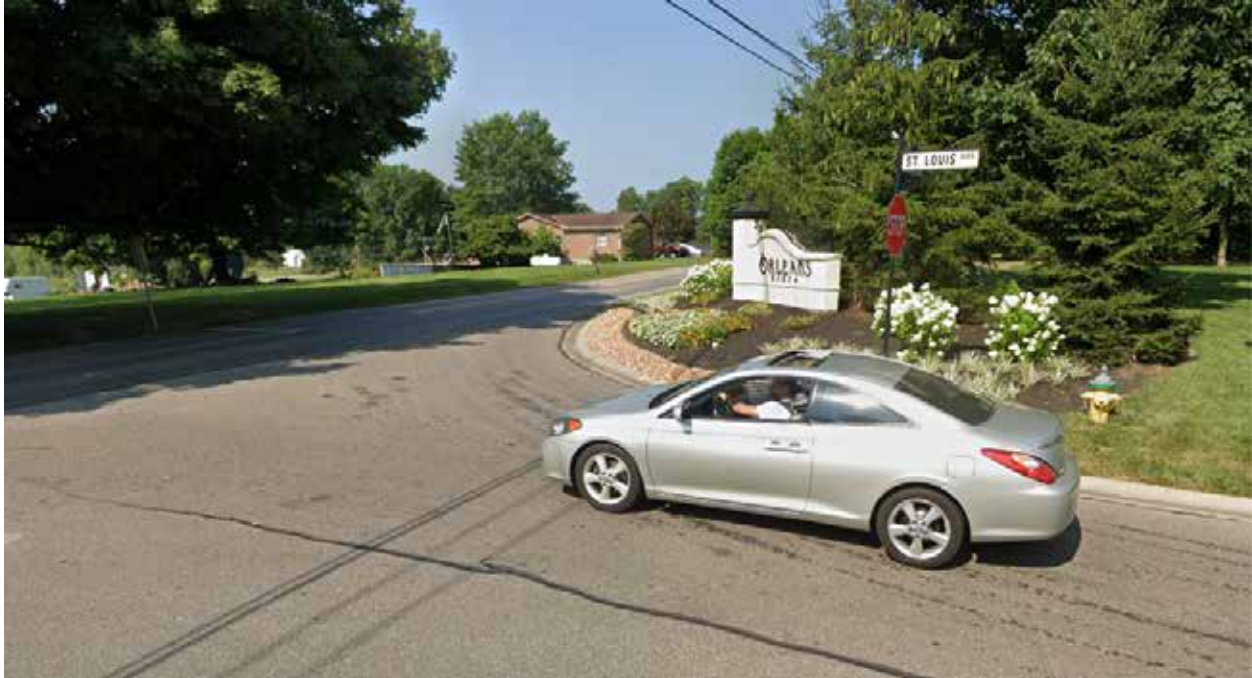
Figure A4-8: St. Louis Blvd at Longbranch Road

Several Crashes were noted at the intersection of St. Louis Boulevard and Longbranch Road including 3 angle crashes and 3 single vehicles crashes. During field review it was noted that the stop sign for the intersection is set approximately 35 feet back from the intersection due to the large curb return radius and the landscaped entrance (Figure A4-8) . From this location sight distance is severely restricted as shown in Figure A4-9.

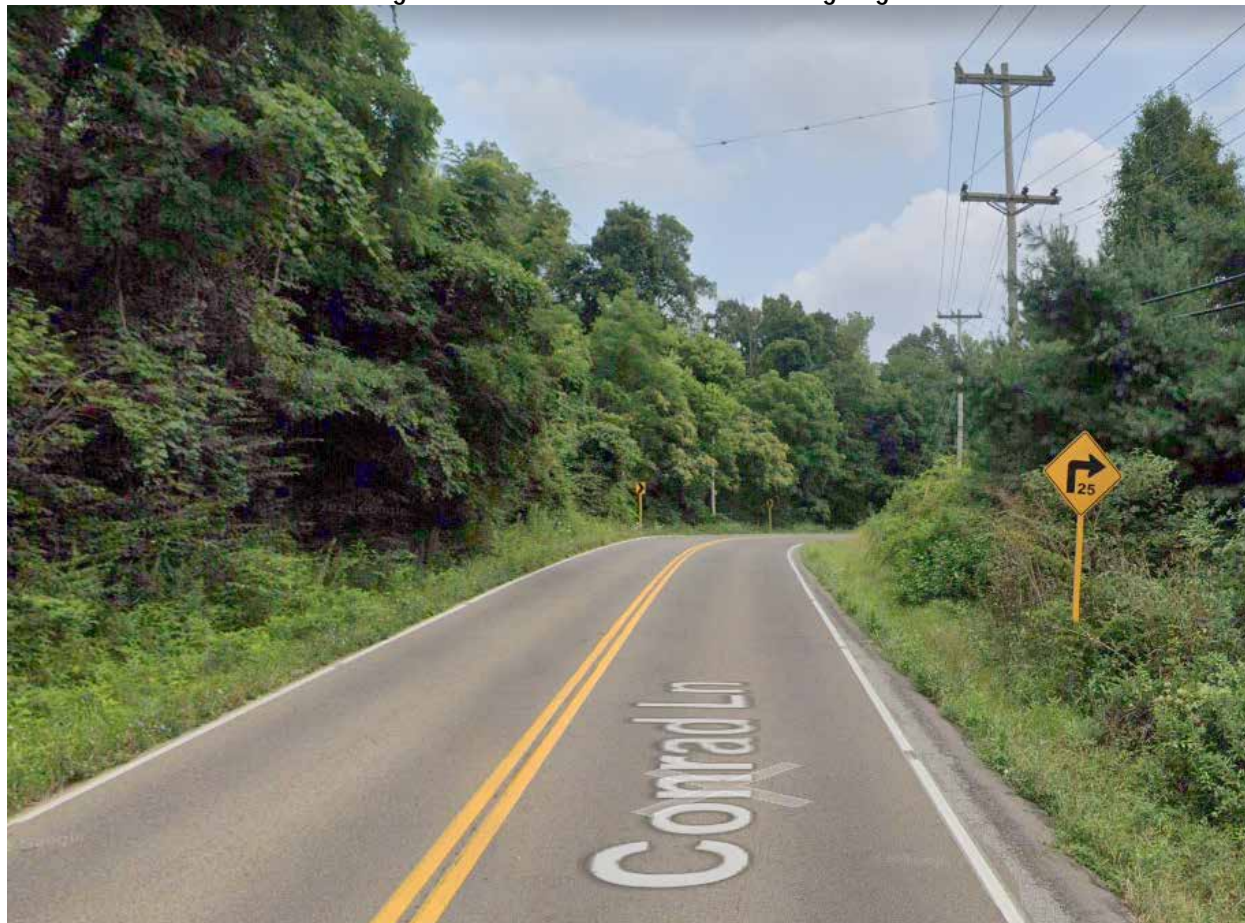
Figure A5-4: Conrad Road 'S' Curve Signing

As is evident from Figure A5-3, there is high concentration of crashes near the 'S' curve, primarily dominated by wet pavement conditions. It is noted that this section of roadway was treated with a high friction surface treatment in 2020. Additionally, enhanced horizontal alignment signing is present at this location (**Figure A5-4**). In the curve nearest to Northbend Road, a W1-1a sign is used as an advanced curve warning sign, though the MUTCD identifies the W1-1a for supplemental signing only at the PC of the curve. Additionally, dense vegetation on the outside of the curve has the potential to restrict visibility of the chevron signs.

Several instances of signing were identified that are inconsistent with MUTCD requirements and recommendations, such as the W1-1a sign shown in Figure A5-4. Additionally, “No Outlet” signs are present mounted to the back of stop signs, which can obscure the shape of the stop sign at these locations (Figure A5-9).

4. Install signing consistent with MUTCD recommendations. Specifically horizontal alignment signing and object markers should be installed where warranted. When determining horizontal alignment signing needs it is recommended that the prevailing speed of the roadway be considered in addition to the posted speed limit.

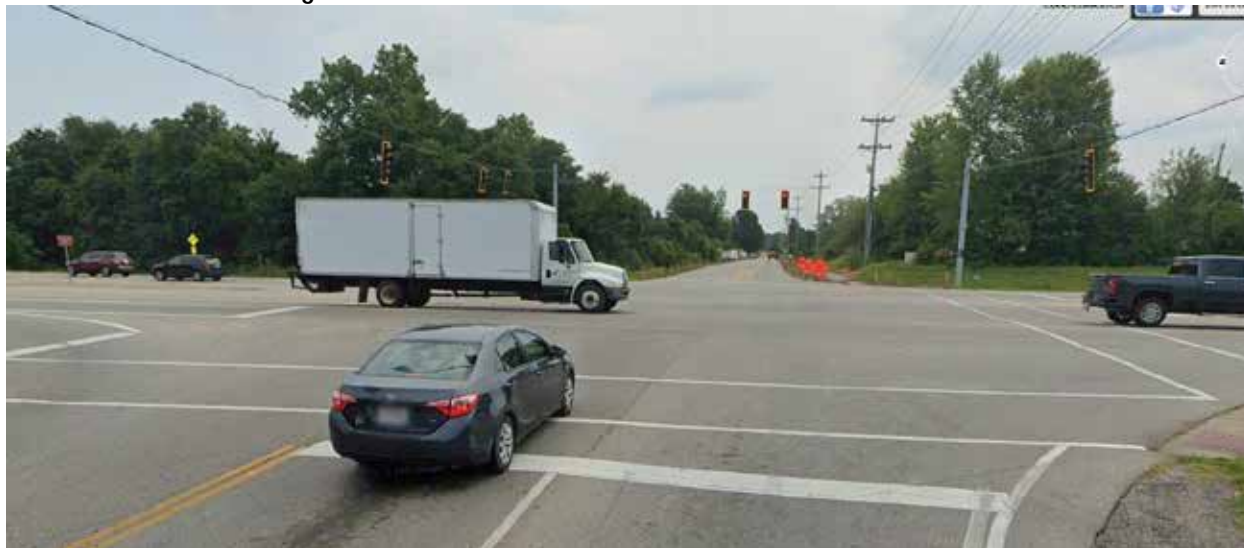
Figure A5-5: Conrad Lane at Northbend Road Intersection

Several crashes are also noted on the approach to and at the intersection of Conrad Lane and Northbend Road. It is noted that traffic signal head enhancements included retroreflective backplates have been installed at this location (Figure A5-5).

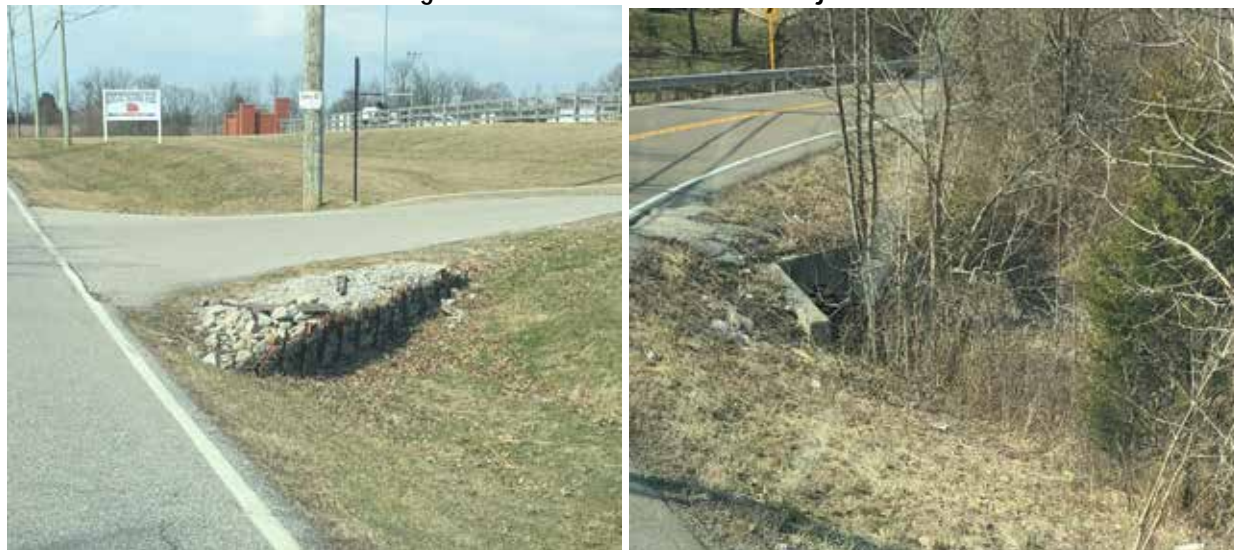
**Figure A5-7: Conrad Lane Fixed Object**

Clear zone through Conrad lane is generally good with minimum encroachment on ROW from vegetation and other hazards. However, several fixed objects have been noted as shown in **Figure A5-7** near the Boone County Readiness Center. It is also noted that a drainage tile does not appear to exist under the driveway which may lead to water running over the roadway.

3. Remove Fixed objects within 5 feet of the roadside where feasible. If removal is infeasible, the use of Type 2 or Type 3 Object Markers is recommended.

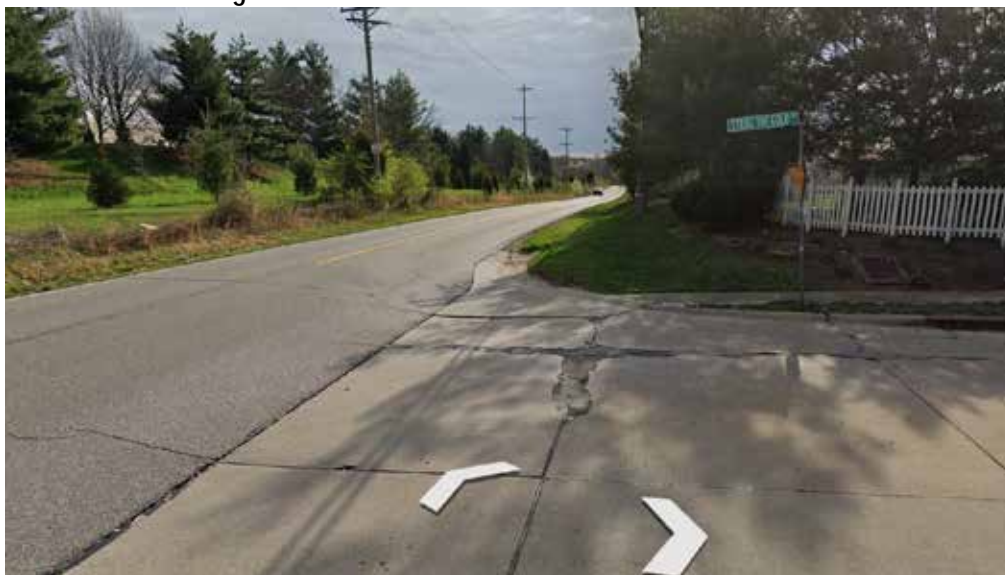
**Figure A5-8: Strike the Gold Drive at Conrad Lane**

Five crashes are recorded at that the intersection of Strike the Gold Drive, including 3 rear end crashes and 2 angle crashes. It is noted that vegetation and trees east of the intersection may restrict sight distance of approaching traffic, especially for traffic stopped at the stop sign location (**Figure A5-8**).

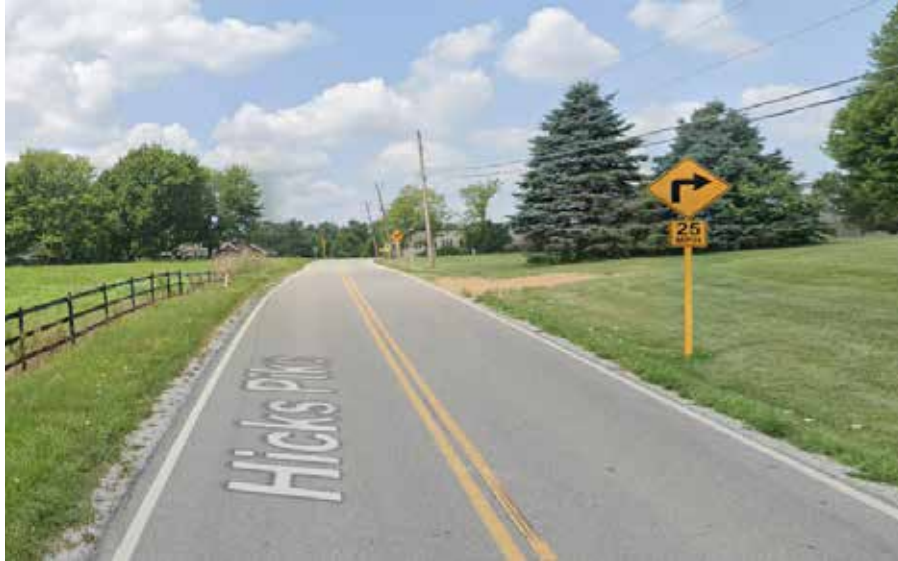
**Figure A6-3: 90 Degree Turn Near New Haven Elementary**

Six crashes have occurred at the 90 degree turn near New Haven Elementary. Five of the six crashes were single vehicle crashes and 1 was a head on crash. Horizontal alignment signing with reflective post strips is present at the intersection as shown in **Figure A6-3**.

1. 90 Degree Turn near New Haven Elementary School
  - a. Relocate Utility Pole and provide curve widening to mitigate head-on and single vehicle crashes.
  - b. Improve signing to provide additional chevrons and/or large arrow signs
  - c. Consider paving the gravel driveway within right-of-way near the turn to limit gravel on roadway.
2. Consider providing centerline markings and a stop bar along New Haven School Road to delineate the intended vehicle path entering and exiting the intersection as shown in Figure A6-16, below.

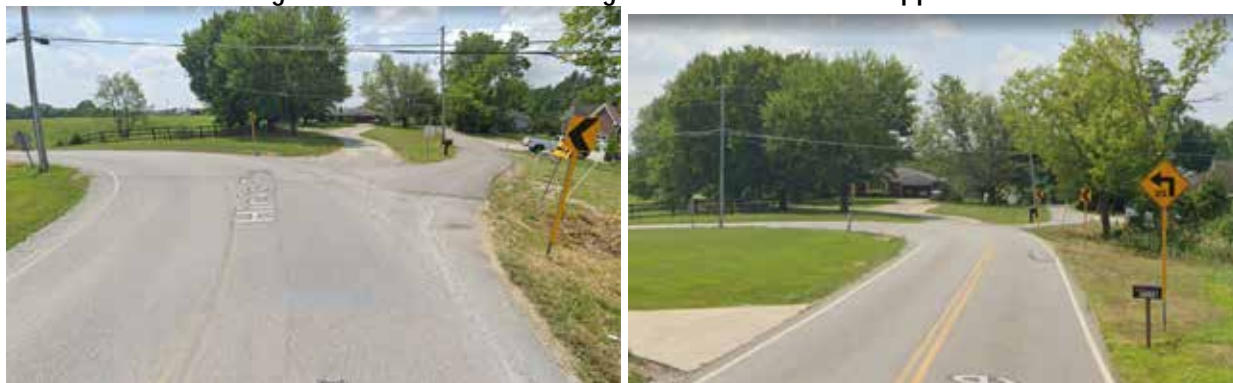
Figure A6-5: Hicks Pike 90 Degree Turn Southbound Approach.

A pedestrian crossing sign is also present at the apex of the curve adjacent to a utility pole (**Figure A6-4**). Several signs, including the Large Arrow Sign at the turn also appear to be undersized (**Figure A6-4**). Additionally, The intersection of Huey Place and a residential driveway at this location further complicate the signing and geometrics of the curve. From the north only two chevrons are present at the turn, primarily oriented towards the tangent of the roadway. It is also noted that gravel from one of the driveways is present on the roadway which could contribute to loss of control crashes (**Figure A6-5**).

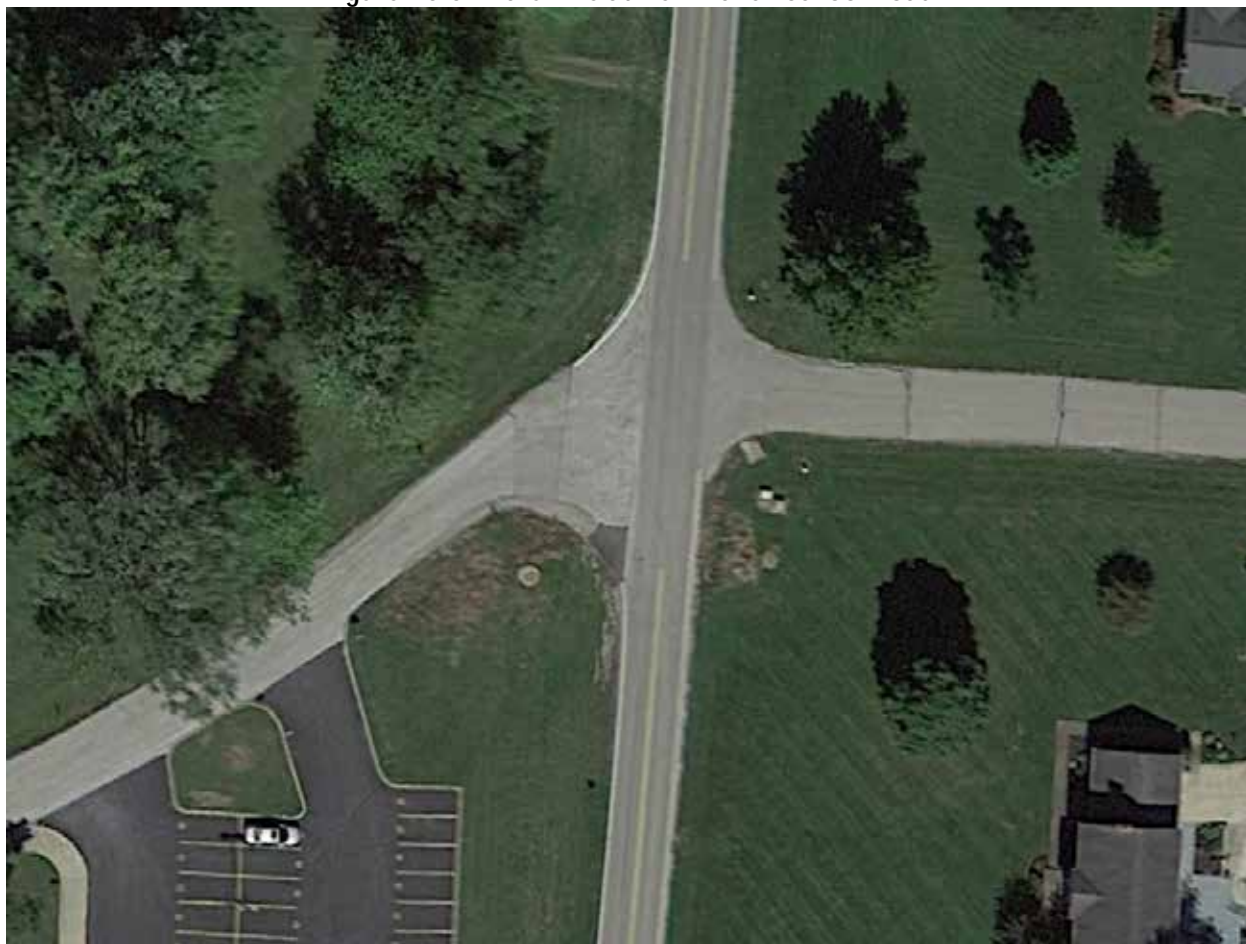
Figure A6-6: Hicks Pike at New Haven School Road

Two angle crashes are present on New Haven School Road, opposite Harmony Hill Road. The wide entrance to New Haven School Road is necessary due to the grade of the approach and turning bus traffic, but also complicates the geometry of the intersection. Further New Haven School Road is relatively narrow (18 feet) and the significant widening at the intersection, may make the intended vehicle path difficult to discern (Figure A6-6).

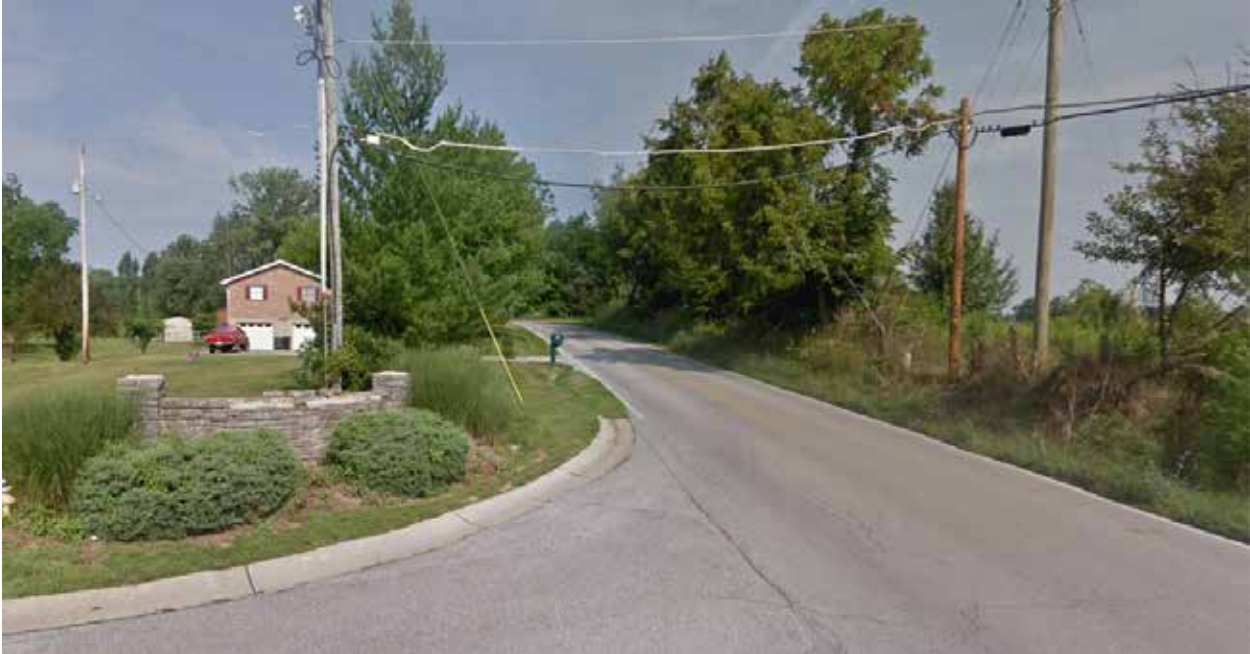
Figure A6-8: Sight Distance to the west from Tollhouse Road

Sight distance is restricted to the west on Hicks Pike due to the presence of a slight horizontal curve and vegetation (Figure A6-8). This location is the site of 9 crashes including sideswipe, rear end and single vehicle crashes. The eastbound approach is downgrade and prevailing speeds along the roadway were observed to exceed the posted speed limit, which may lengthen stopping sight and intersection sight distance requirements at this location. Vegetation can also limit the visibility of the intersection when approaching from the west (Figure A6-9).

5. Clear Roadside vegetation on the eastbound approach to Tollhouse Road to provide adequate intersection sight distance. It is recommended that intersection sight distance be established based on the 85<sup>th</sup> percentile speed on the roadway and not the posted speed limit.

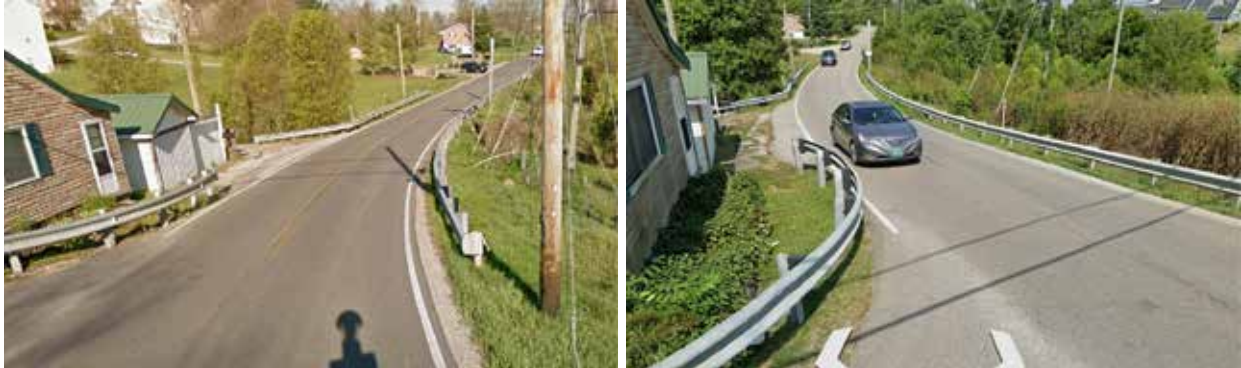
**Figure A6-9: Narrowed Roadway near Richwood Church Road**

A building located in the northwest quadrant of the intersection of Hicks Pike and Richwood Church Road provides minimal setback and separation from both roadways. The building also presents a sight distance restriction for vehicle turning from Richwood Church Road. Guardrail has been installed and on the opposite side of the roadway which presents a narrowing of the roadway. Centerline markings appear worn at this location, likely due to vehicles shying away from the guardrail and encroaching on the centerline. Two sideswipe opposite direction crashes are present at near location. Guardrail on the

north side of the road also does not provide a crashworthy end treatment.

4. Richwood Church Road Intersection
  - a. Reconfigure guardrail on southside of roadway near building to increase setback from roadway. Current placement is 10 feet from the building, this may be decreased to 5 feet maintain clear zone for guardrail deflection while minimizing roadside obstructions.

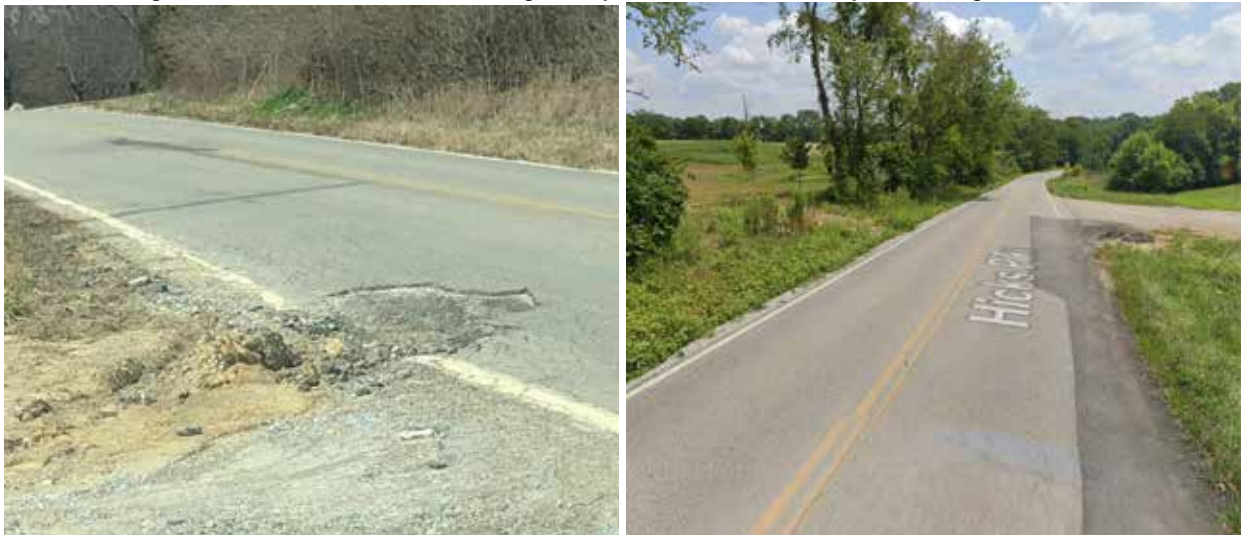
**Figure A6-10: Before/After of Edge Drop off and Pothole Repairs along Hicks Pike .**

Edge drop offs were identified along Hicks Pike, but appear to have been repaired with DGA shouldering and partial width pavement repairs (Figure A6-10).

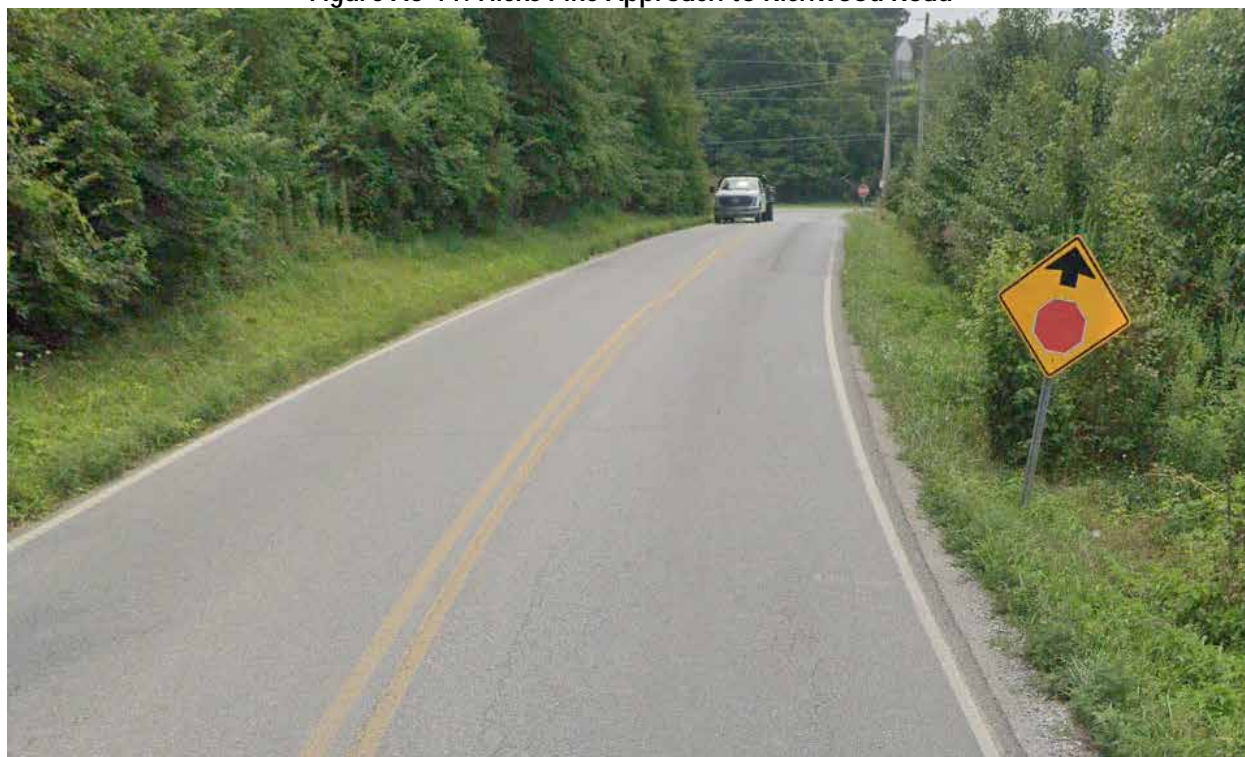
Figure A6-11: Hicks Pike Approach to Richwood Road

The intersection of Hicks Pike at Richwood Road is a stop controlled 'T' intersection with stop control on Hicks Pike. Two single vehicle crashes are present at the intersection. A Stop ahead sign is present 320 feet away from the intersection within the limits of a horizontal curve (Figure A6-11). The stop ahead sign appears below the minimum 5-foot sign height recommended by the MUTCD.

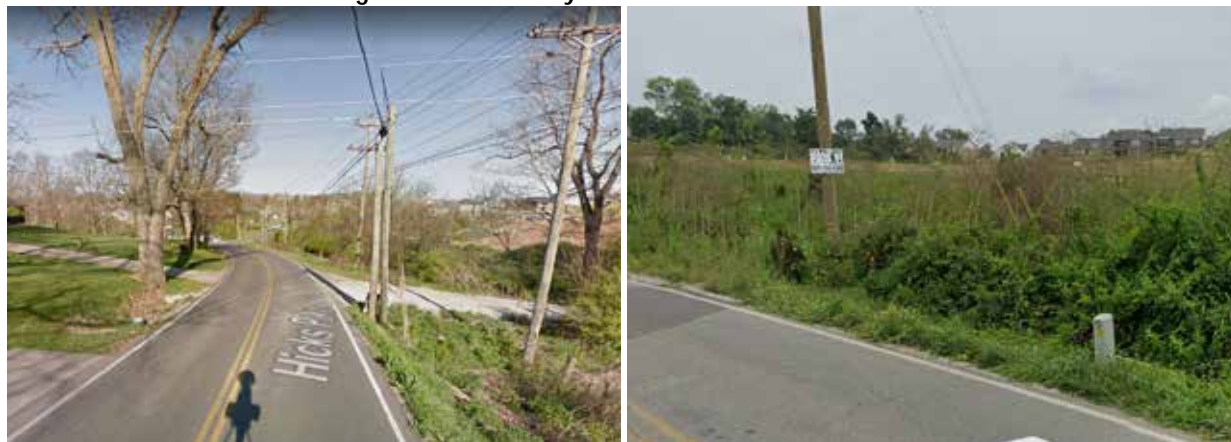
Figure A6-12: Utility Pole Locations on Hicks Pike

The primary fixed objects on the corridor are utility poles, located a minimum distance from the roadway as shown in **Figure A6-12**. Fixed objects, especially those on the outside of horizontal curves have the potential to increase the frequency and severity of crashes for vehicles departing the roadway.

11. Remove Fixed objects where feasible. If removal is infeasible, the use of Type 2 or Type 3 Object Markers is recommended.

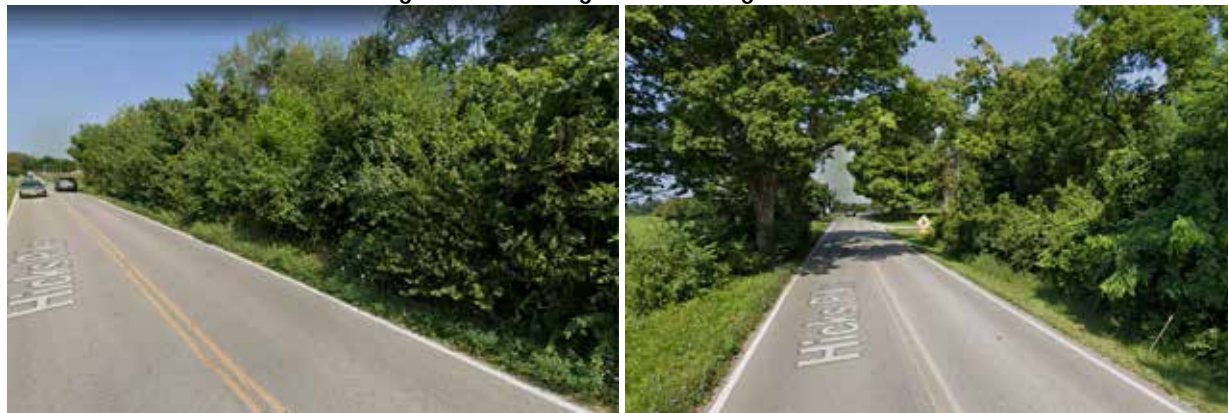
**Figure A6-13: Vegetation along Hicks Pike**

Vegetation along the roadway can become overgrown and present a visual narrowing of the roadway (**Figure A6-13**). This may also restrict sight distance around curves, at intersections and obscure signing

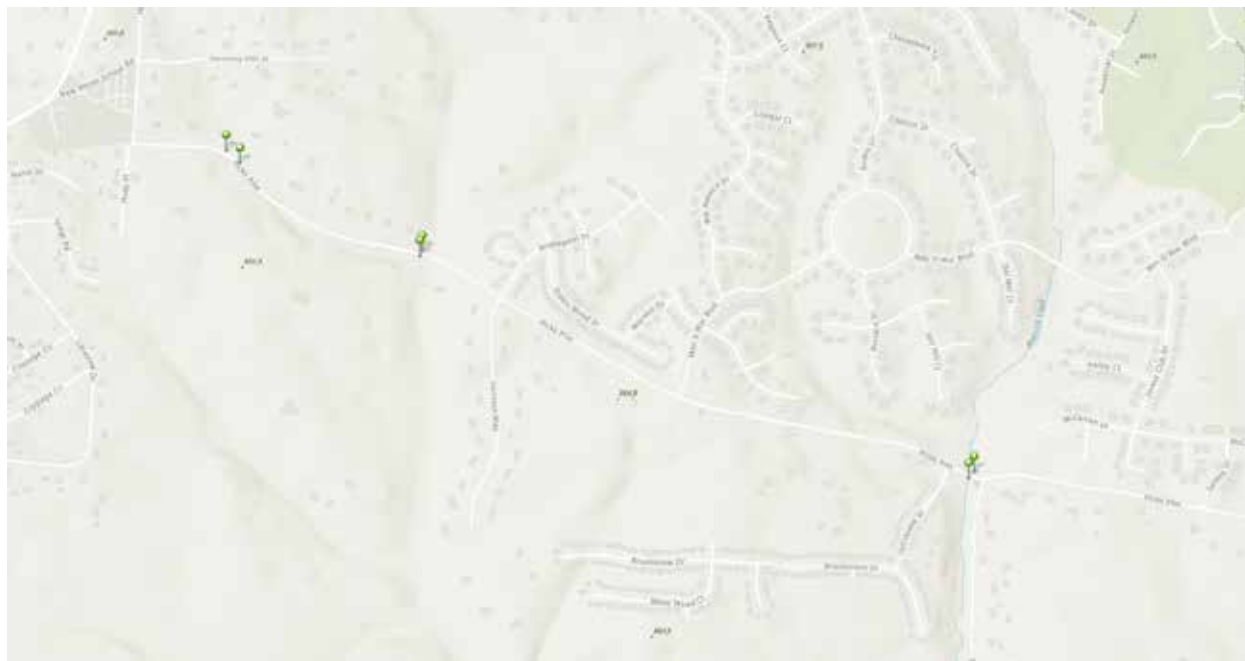
**Figure A6-14: Guardrail Locations along Hicks Pike**

Several instances of guardrail are present on Hicks Pike as shown in **Figure A6-14**, and appear to not meet minimum guardrail height requirements, or provide crash worthy end treatments. **Figure A6-15** shows typical guardrail installations along the corridor.
