# LOCAL ROAD SAFETY PLAN

**BOONE COUNTY**  
KENTUCKY

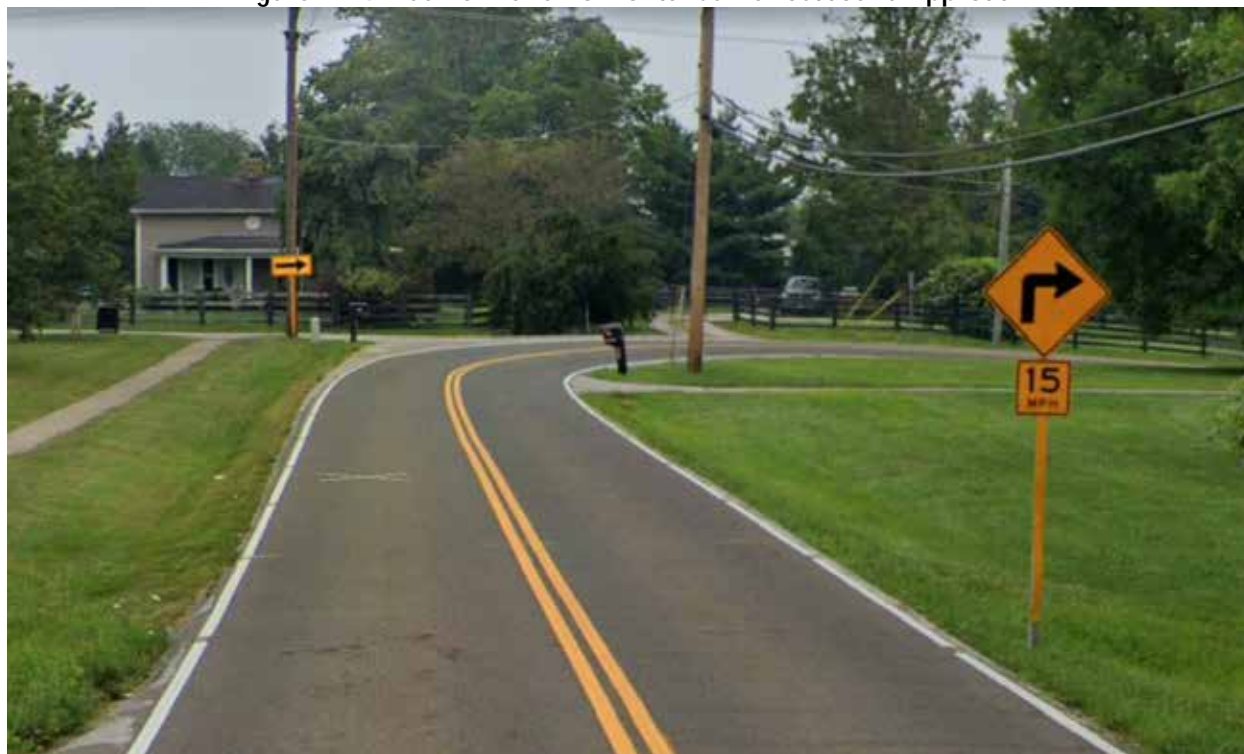
Figure A7-4: Beemon Lane Horizontal Curve Eastbound Approach

A high friction surface treatment was applied in 2020. During 2021, not crashes were recorded at this location. The high friction surface treatment and eastbound approach to the curve is shown in **Figure A7-4**.

1. Continue to monitor crash experience at Horizontal Curve after installation of the High Friction Surface Treatment. If crashes are shown to increase, consider curve widening within the available pavement section to address head-on, angle and sideswipe crashes as shown in **Figure A7-6**.

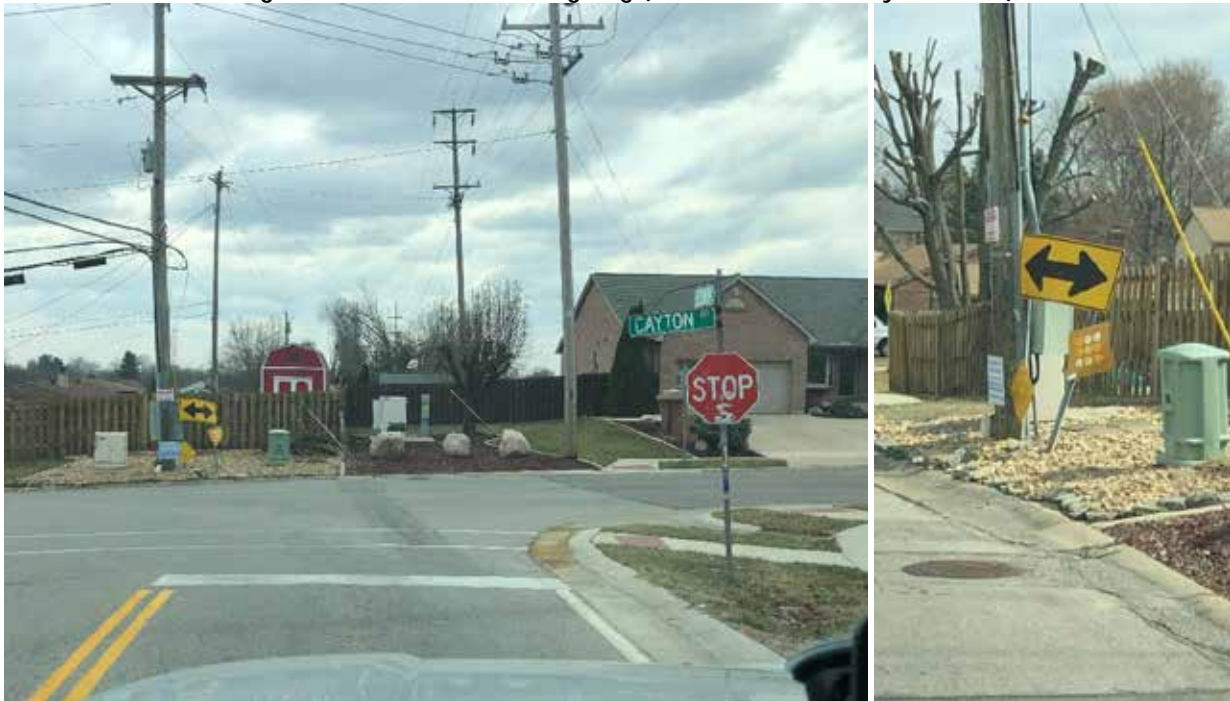
**Figure A7-5: Intersection Signing (Beemon Lane at Cayton Road)**

Signing at the intersection with Cayton Road has been vandalized and/or compromised through impacts (**Figure A7-5**). Three crashes have occurred near the intersection including 2 rear end crashes 1 resulting from a vehicle backing out of a driveway.

12. Conduct a speed study using the methodology in the FHWA USLIMITS program to evaluate the appropriateness of the 35 mph speed limit on Beemon Lane in light of the crash history and adjacent land use and access density.
13. Replace signing at the intersection of Beemon Lane and Cayton Road to replace damaged signs.

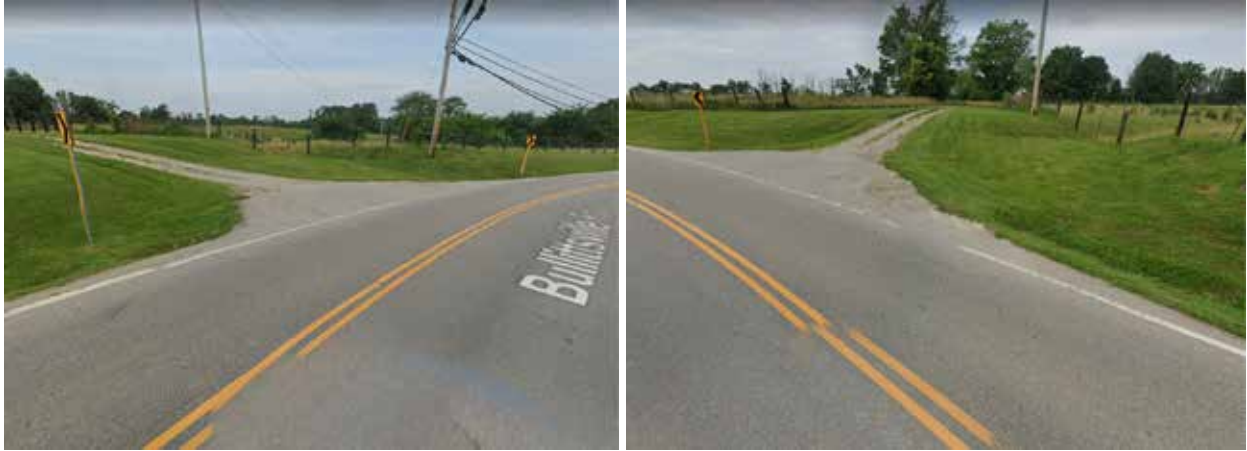
**Figure A8-4: Gravel washout at Horizontal Curve**

Potential drainage issues were identified in the field review at this location resulting from a farm entrance that appears to have blocked drainage culvert. Washed out gravel from the drive was present,

which may be indicative of water running over the driveway (Figure A8-4).

1. The areas identified as having higher frequency wet-weather crashes should be observed during rain events to determine if drainage in the area and/or sheet flow presents an increased hazard for crashes. If drainage is determined to be sufficient, friction tests should be conducted to determine if additional treatments such as HFST would be warranted.

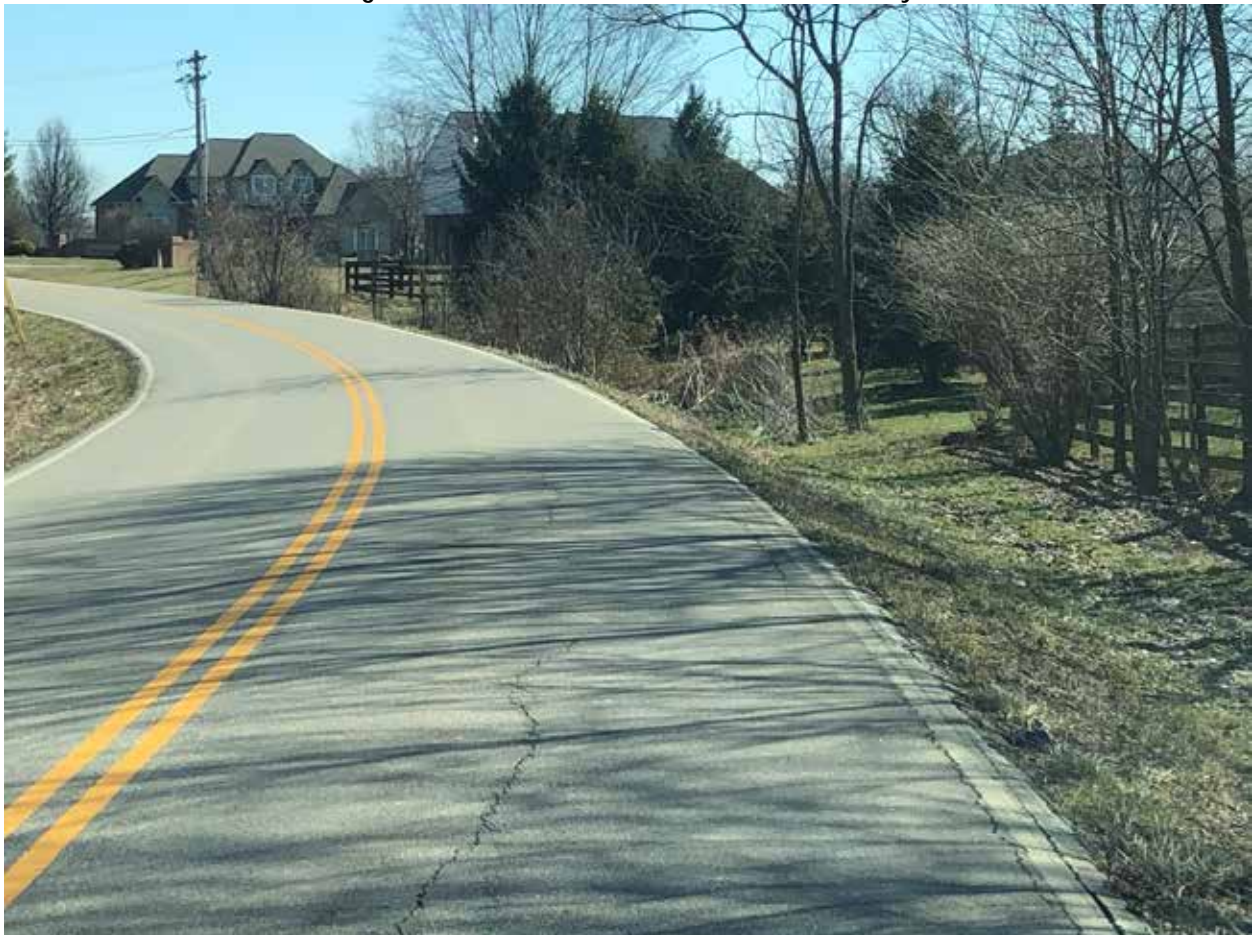
**Figure A8-5: Horizontal Curve near Brent's Way**

The horizontal curve west of Brent's way provides a sharp drop off due to the superelevation of the curve. Advanced curve signing is present, but chevrons are not (Figure A8-5).

4. Review all signing on corridor and document sign type, location, post type and condition within a sign management database. Install signing consistent with MUTCD recommendations. Specifically horizontal alignment signing and object markers should be installed where warranted. Advanced warning signs should be checked for placement to ensure that warning signs are not placed too far in advance of hazardous conditions (Recommended no greater than 100 feet greater than MUTCD minimum distance).

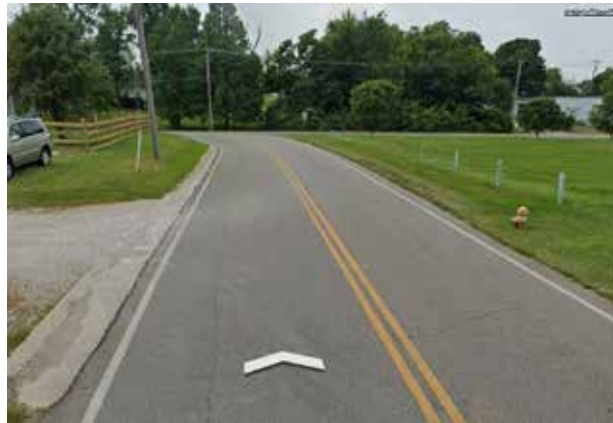
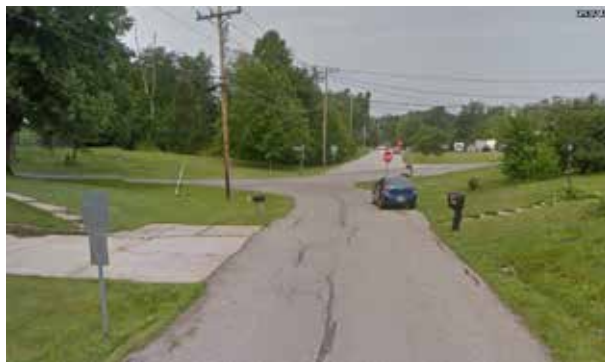
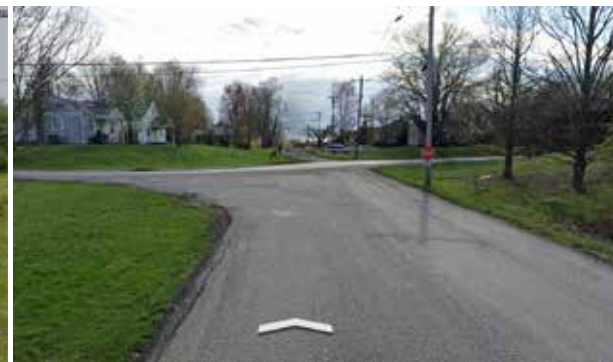
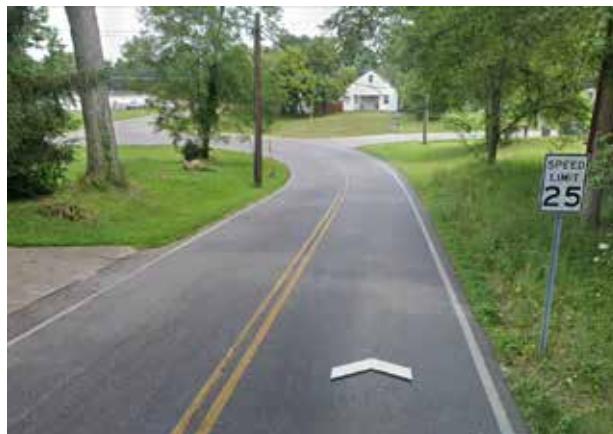
Figure A8-9: N, E, S, W approaches to Bullitsville Rd/Temperate Street

The intersection of Bullittsville Road is a skewed/offset intersection that presents challenges to drivers when negotiating. Temperate Street intersection Bullittsville Road at stop controlled approaches in the middle of an 'S' Curve. No control is present on Bullittsville Road (Figure A8-6). Three crashes were recorded at the intersection during the study period (Figure A8-7). It is noted that no horizontal alignment signing is present through the 'S' Curve. A horizontal alignment sign (Figure A8-8) is present 275 to 325 feet in advance of the curve on Bullittsville Road. Figure A8-9 shows the approaches to the intersection from the North, West, East and South.

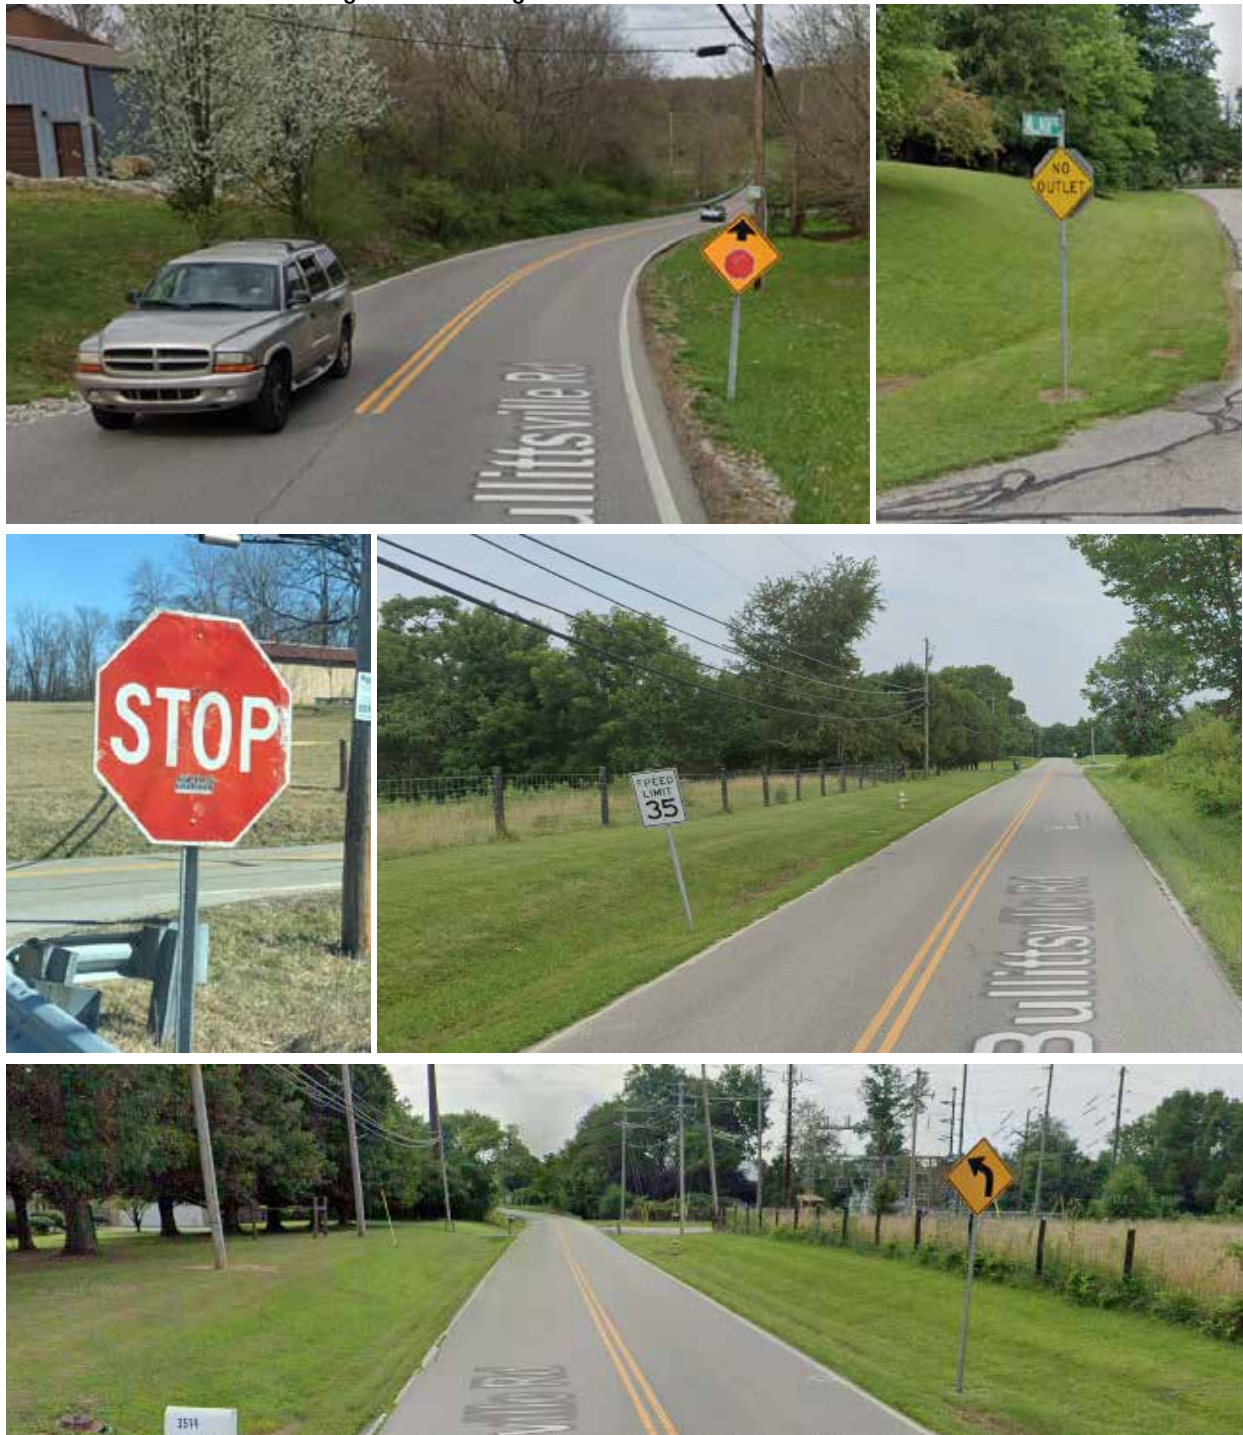
Figure A8-10: Sign Installations on Bullittsville Road

Signage along the corridor is well placed and provides sufficient information, however, inconsistencies in placement, installation and maintenance are present. **Figure A8-10** shows the following issues:

1. "Stop Ahead Sign" appears below 5 ft minimum height near Millakin Place (symbol faded)
2. "No Outlet" sign mounted to back of Stop Sign obscuring sign shape.
3. "Stop Sign" sheeting faded and vandalized at Petersburg Road
4. "Speed Limit Sign" mounted on left side of road south of Cornerstone Drive
5. Curve Sign too Small (3514 Bullitsville Road)

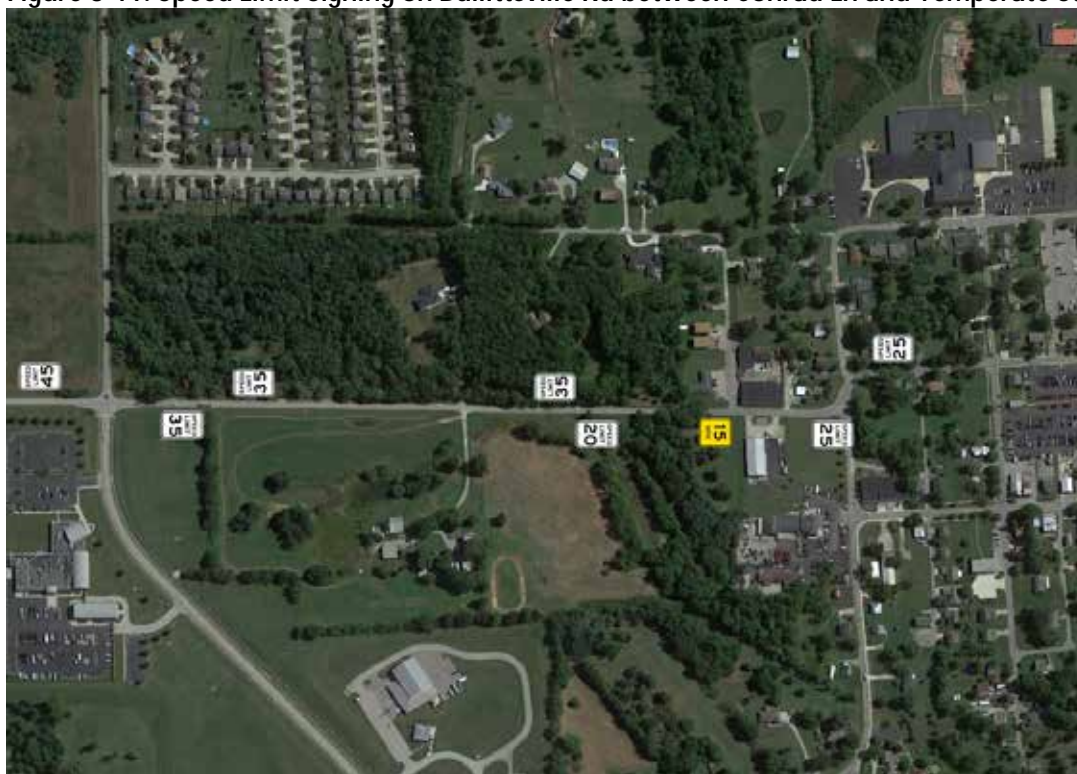
Figure 8-11: Speed Limit Signing on Bullittsville Rd between Conrad Ln and Temperate St.

In addition to the sign installation consistency, speed limit signs on the southern end of the corridor near the Temperate/Garrard Street intersection are inconsistent with a 25 mph speed limit northbound and a 20 mph speed limit with a 15 mph advisory speed southbound. Figure A8-11 shows the speed limit signs in this area.

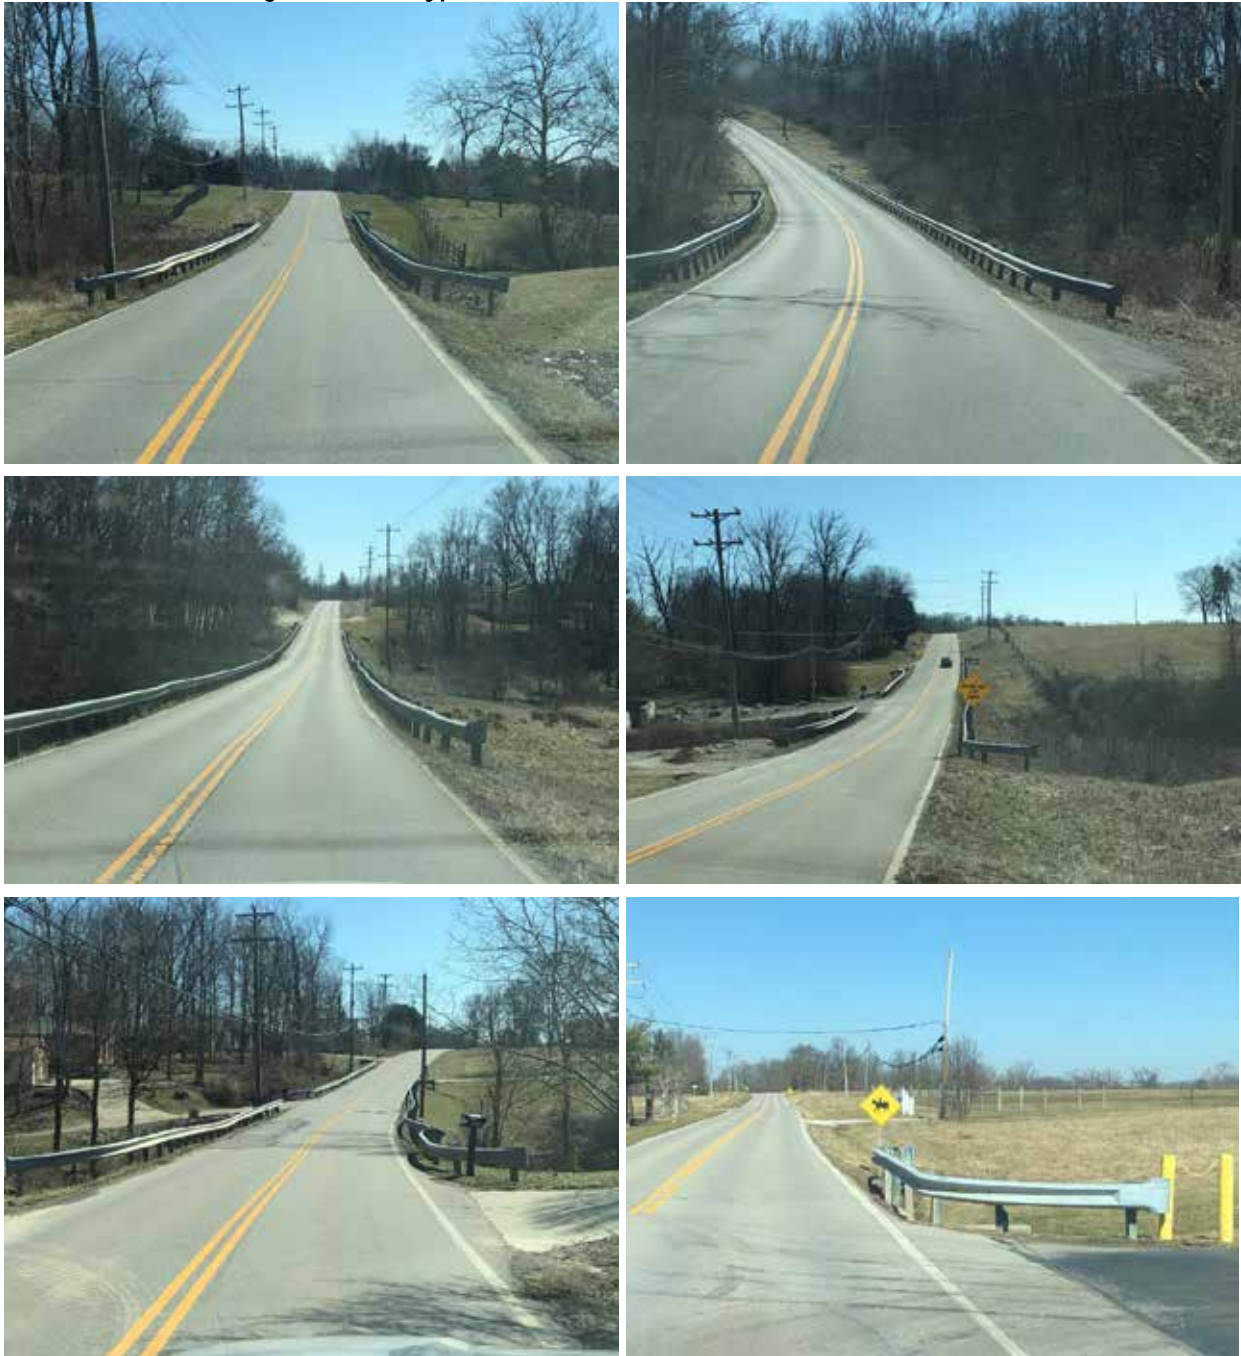
Figure A8-13: Typical Guardrail Installations on Bullitsville Road

Several instances of guardrail are present on Bullittsville Road shown in **Figure A8-12**, and appear to not meet minimum guardrail height requirements, or provide crash worthy end treatments. **Figure A8-13** shows typical guardrail installations along the corridor.

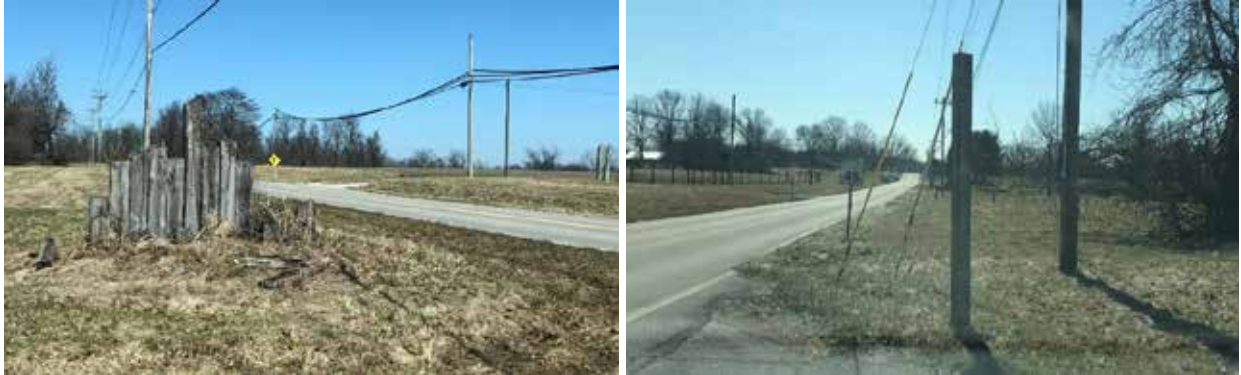
Figure A8-14: Fixed Objects near Federalist Trail

Fixed objects within the right of way of Bullitsville Road are also present throughout the corridor. Several of these, including in the vicinity of Federalist Trail appear to be easily removed (**Figure A8-14**). Fixed objects, especially those on the outside of horizontal curves have the potential to increase the frequency and severity of crashes for vehicles departing the roadway.

7. Remove Fixed objects within 5 feet of the roadside where feasible. If removal is infeasible, the use of Type 2 or Type 3 Object Markers is recommended.

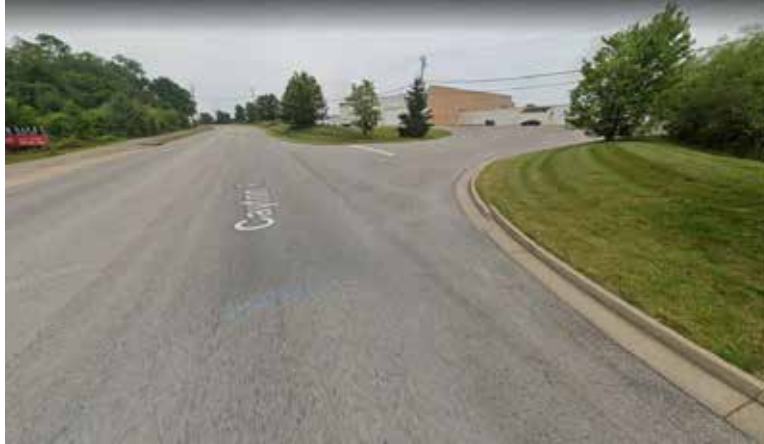
Figure A9-4: Rear Entrance to Florence Square

Potential drainage issues were identified in the field review at this location resulting from sheet flow from the rear parking area of the retail buildings flowing onto Cayton Road at the driveway access shown in Figure A9-4. A drainage ditch is present along this parking area, but vegetation appears that it may prevent drainage to the ditch instead following the flow of the pavement (Figure A9-5).

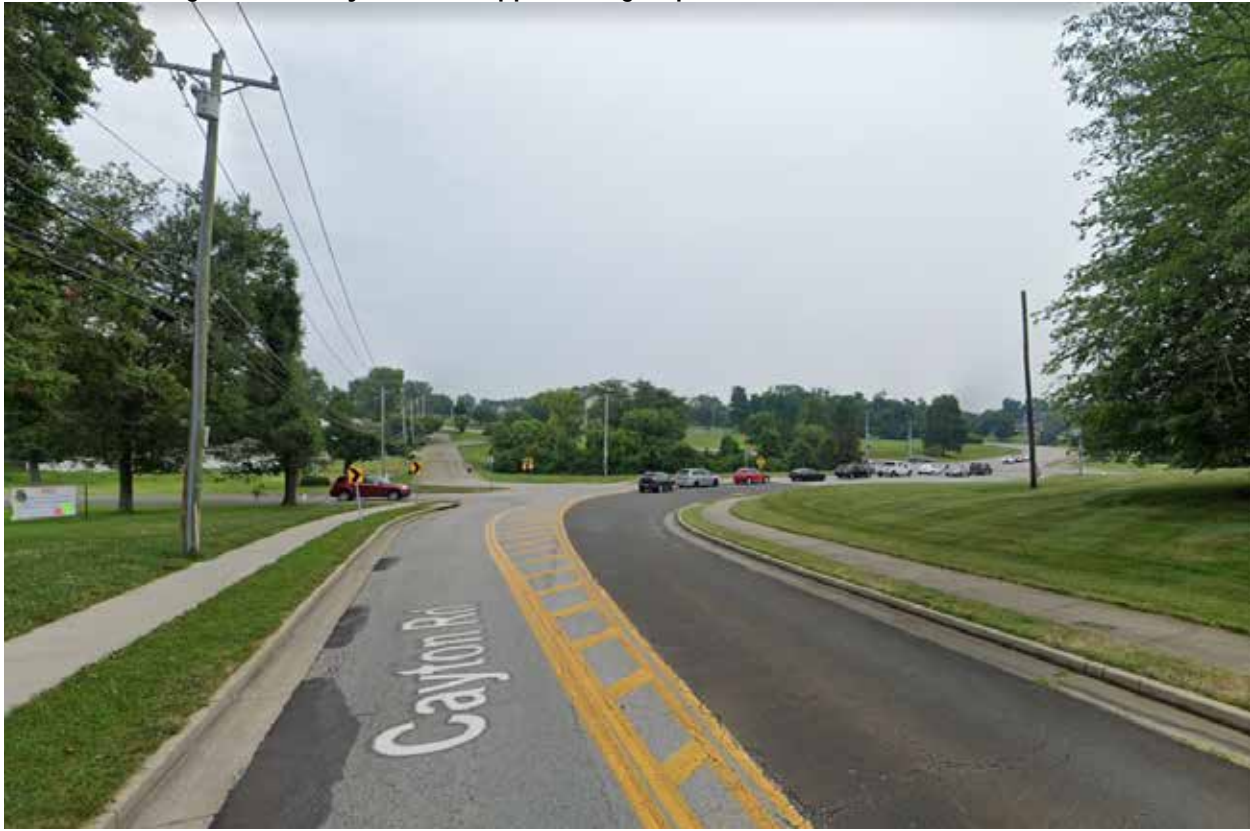
Figure A9-7: Cayton Road Approaching Hopeful Church Road from the North

Cayton Road at Hopeful Church Road  
Several crashes are present at the intersection of Cayton Road and Hopeful Church Road, which is a signal controlled intersection. The north leg of Cayton Road approaches through a sharp curve to the resulting from realignment of Cayton Road, due to the reconstruction of Hopeful Church Road (Figure A9-6). Signal head visibility is limited approaching the intersection the north due to the roadway curvature (Figure A9-7). It is also noted that the signal ahead warning sign is oriented perpendicular to the roadway in the approach curve, and not oriented toward approaching traffic.

1. Cayton Road at Hopeful Church Road
  - a. Consider near side signal head and side mounted lane use sign to provide direction to vehicles as sight distance to signal is restricted on southbound approach of Cayton Road.
  - b. Relocate and/or reorient signal ahead sign so that it is visible prior to location.
  - c. Install back plates to increase conspicuity of signal heads.
2. Cayton Road at Connector Road
  - a. Reconfigure westbound Cayton Road to a through-right lane and an exclusive left turn lane to avoid confusion intended traffic destination and align left turns on Cayton Road as shown in **Figure A9-11**. Provide left turn lane pavement markings for northbound Connector Road.

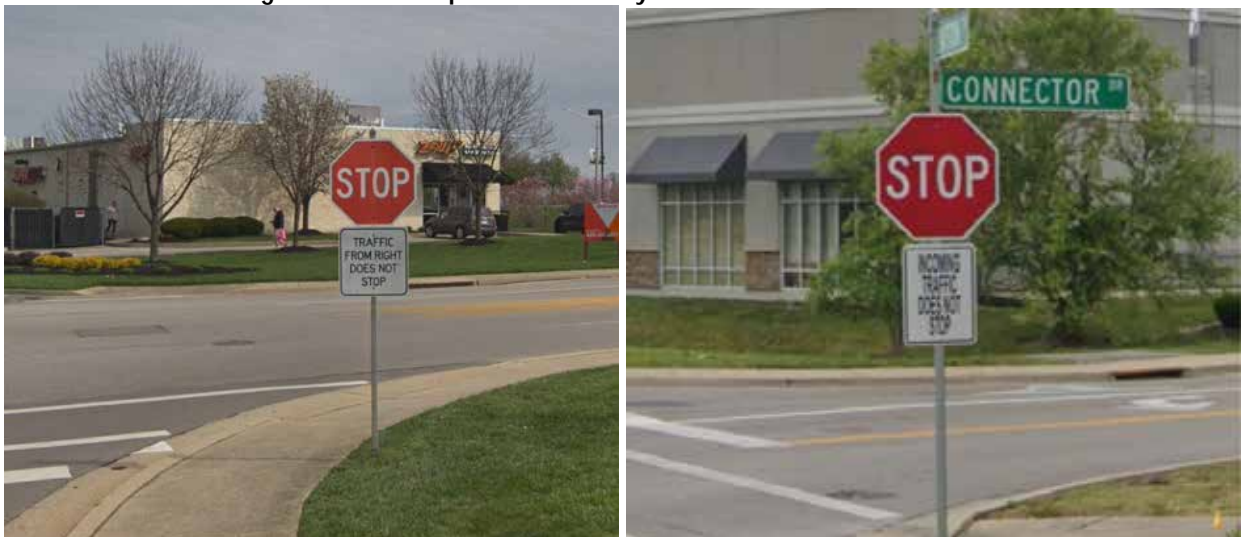
Figure A9-10: Stop Control on Cayton Road and Connector Road

Supplemental plaques are present on the stop-controlled approaches indicating that incoming traffic does not stop (Figure A9-10).

- b. Long term solutions for the intersection may include reconfiguration of the intersection to reduce size and clarify intended vehicle paths. Alternative intersection designs such as a modern roundabout or turn restrictions may also be considered, though any alternatives should consider interactions with adjacent intersections, traffic signals and business access.
- c. Modify supplemental plaques on Cayton Road and Connector Road to current MUTCD standard signs (W4-4bP and W4-4aP) (**Figure A9-12**)

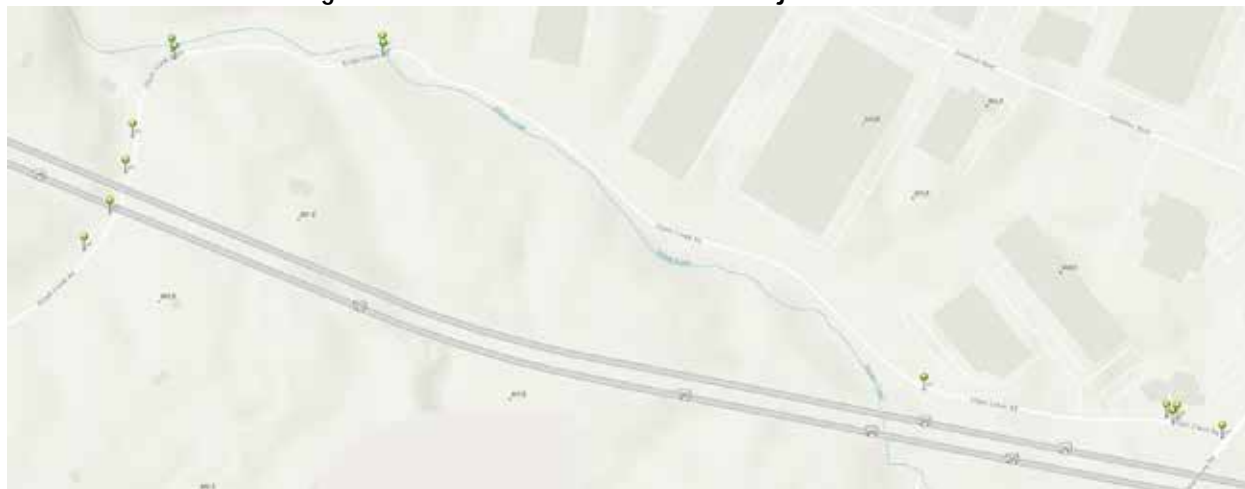
**Figure A10-3: Guardrail Locations on Elijah Creek Road**

Twelve guardrail installations primarily on the eastern portion of Elijah Creek Road north of I-275 as shown in **Figure A10-3**. Most installations do not appear to meet minimum guardrail height requirements, or provide crash worthy end treatments. **Figure A10-4** shows typical guardrail installations along the corridor.

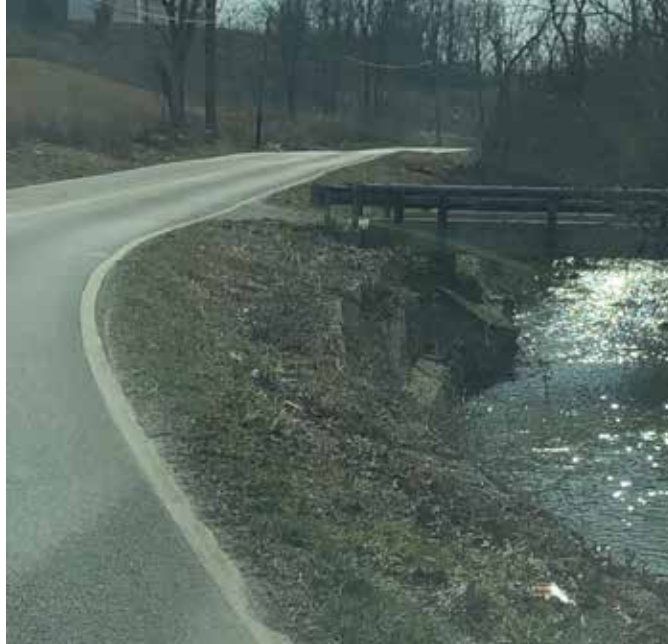
**Figure A10-5: Potential Guardrail Installation at 1459 Elijah Creek Road**

In addition to guardrail installations that should be upgraded and/or removed some potential guardrail applications were found along Elijah Creek due to critical drop off heights and the presence of water which can increase the severity of crashes. Figure A10-5 shows a potential area near 1459 Elijah Creek Road.

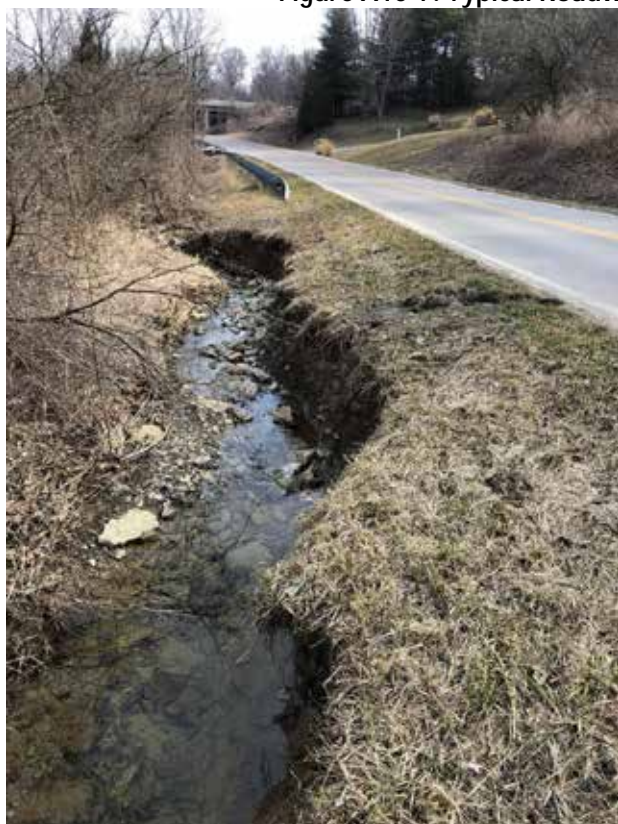
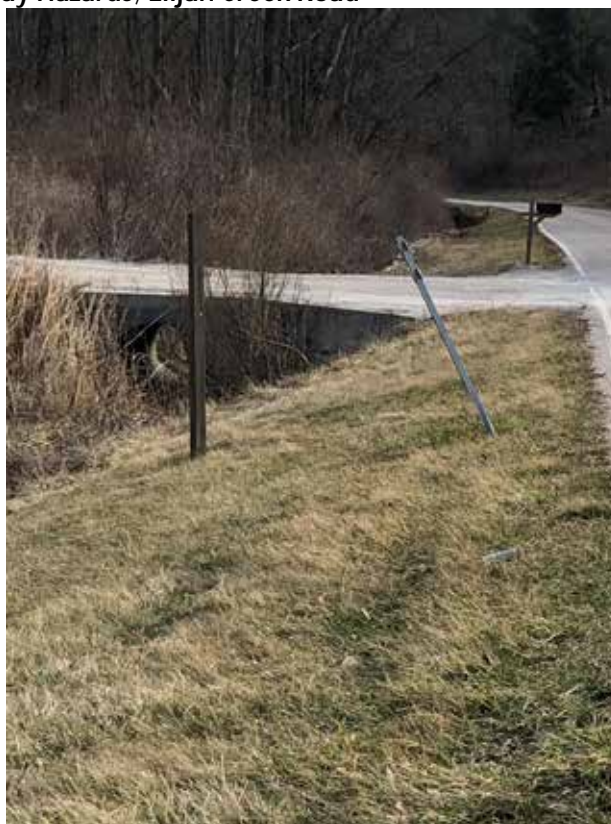
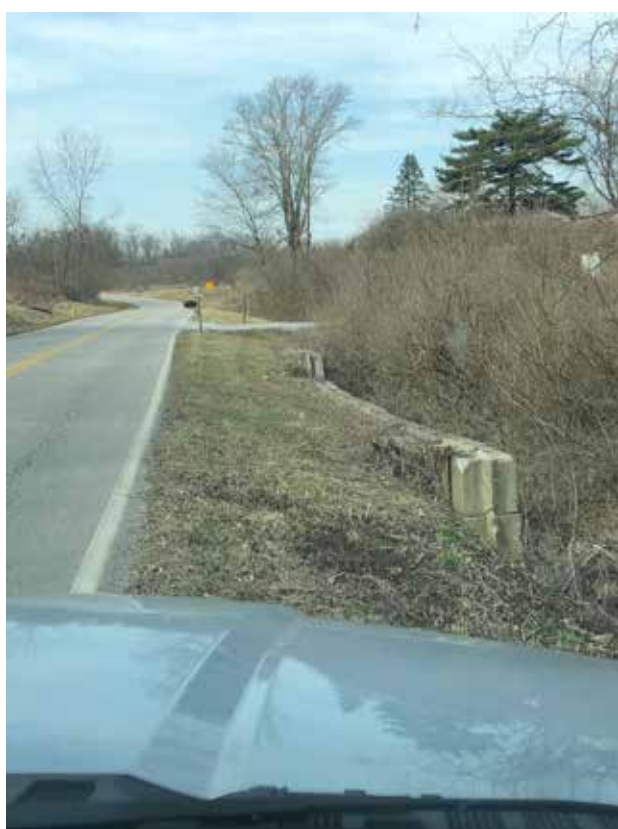
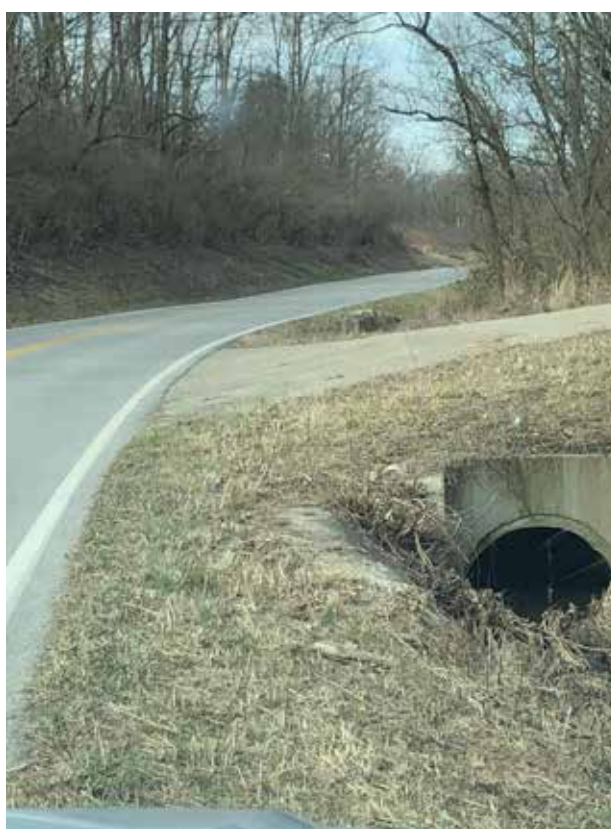
Figure A10-7: Typical Roadway Hazards; Elijah Creek Road

Several roadside hazards were also identified with a concentration just west of I-275, and between I-275 and the road terminus at Petersburg Road. These include edge drop offs, steep ditches, headwalls and fixed objects along the roadway. These are shown in **Figures A10-7 and A10-8**.

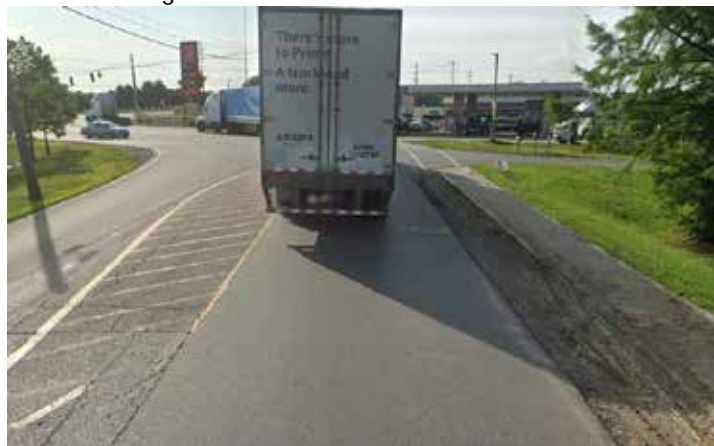
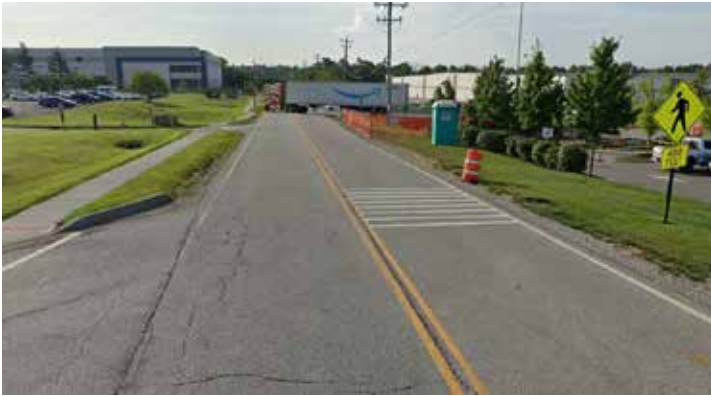
A field review indicates pedestrian paths extremely close to the truck traveled lane. Truck rutting is clearly evidenced immediately adjacent to the sidewalk and possibly on the sidewalk.

Truck tracking out of their lane is evident and cause for concern.

1. Evaluate existing striping and signage for repair, replacement or addition within normal work programs.
2. Pursue funding for a capital program improvement. Poor access and congestion issues contribute to increased crash activity. Addition of a center turn lane for access and separation of pedestrians with new sidewalk and MUP. Barriers may be required where positive space separation cannot be obtained for pedestrians. Seek completion of the capital improvement through use of the Complete Street countermeasure.

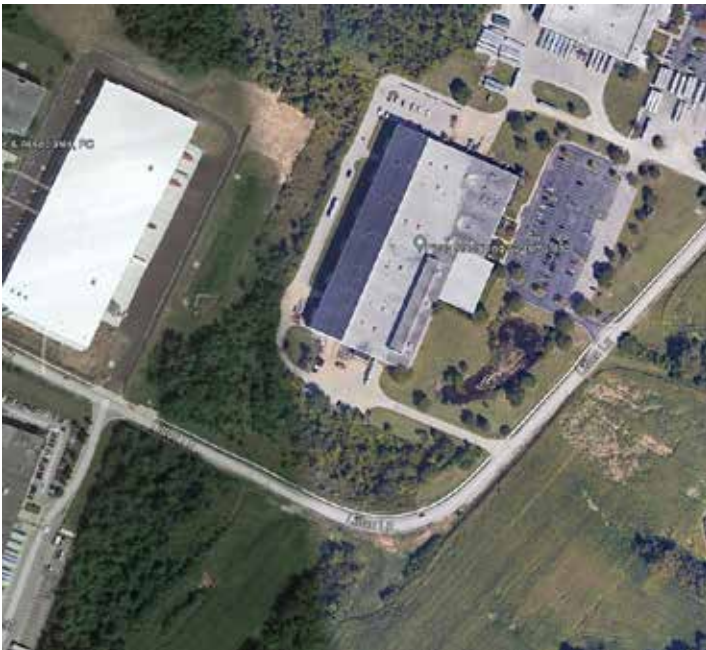
### Horizontal Curvature

Litton Lane is comprised of a near 90 degree curve near the midpoint of the 1 mile dead-end road. Increased speed results in a significant amount of crashes on the outside of the curve.
