Historical Review

Of Selected Mining Sites In The Silver Trail Region

Prepared for
Waste Management Program
Indian and Northern Affairs Canada

March 2004

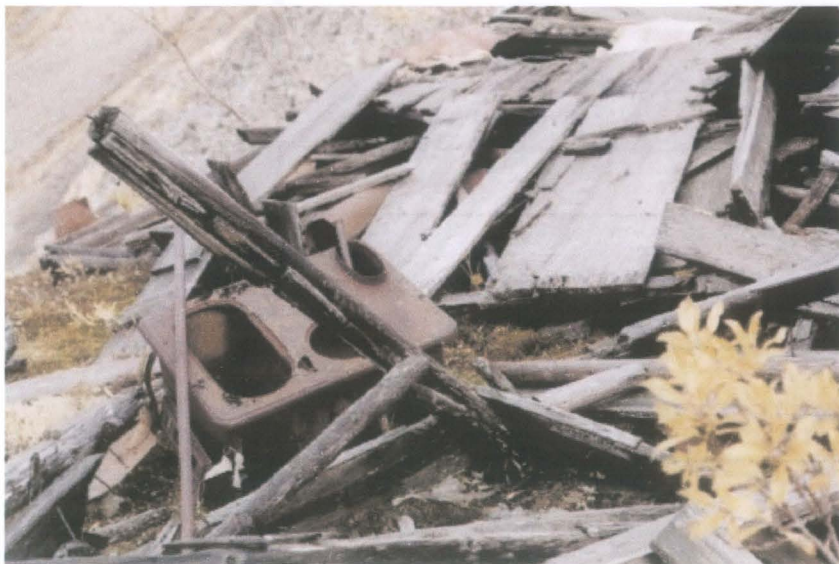
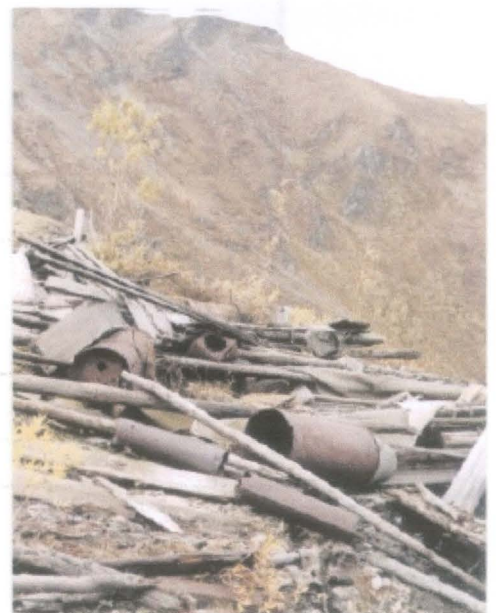
The shaft is a major public safety issue. The photos below show a fair amount of metal debris, wire, cable and exposed nails in the lumber. There is always the possibility that someone could be hurt during investigation of the site.

From an environmental perspective we feel that the material at this site could be removed, the wooden debris could be placed in the shaft and then burnt. All metal debris could be stock piled for removal, either by the labours tack of skidding it up the hill with a winch line or placed into a sling net for long line removal with a helicopter.

Once all debris is burnt and waste cable and metal removed, we feel that what remains of the shaft could be hand filled with the local rock.

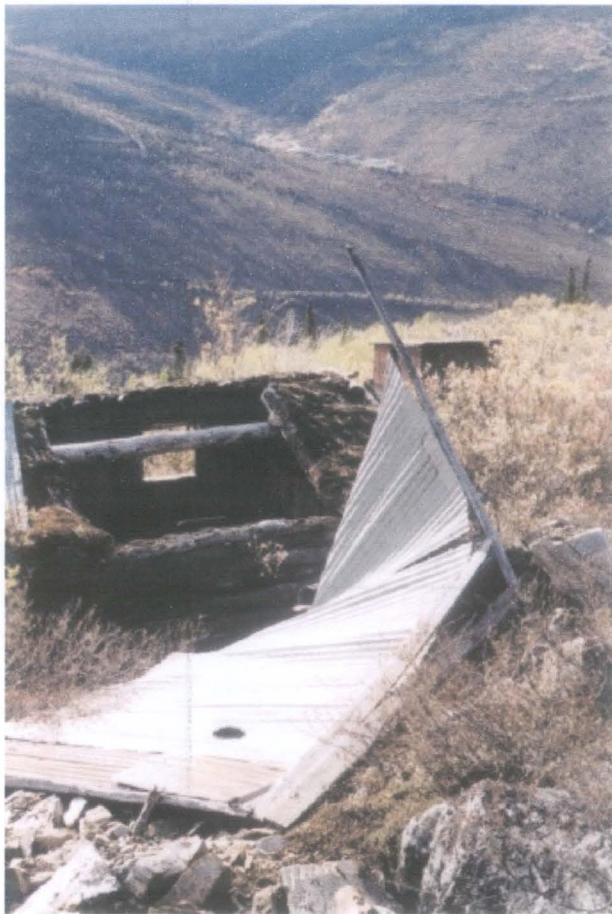
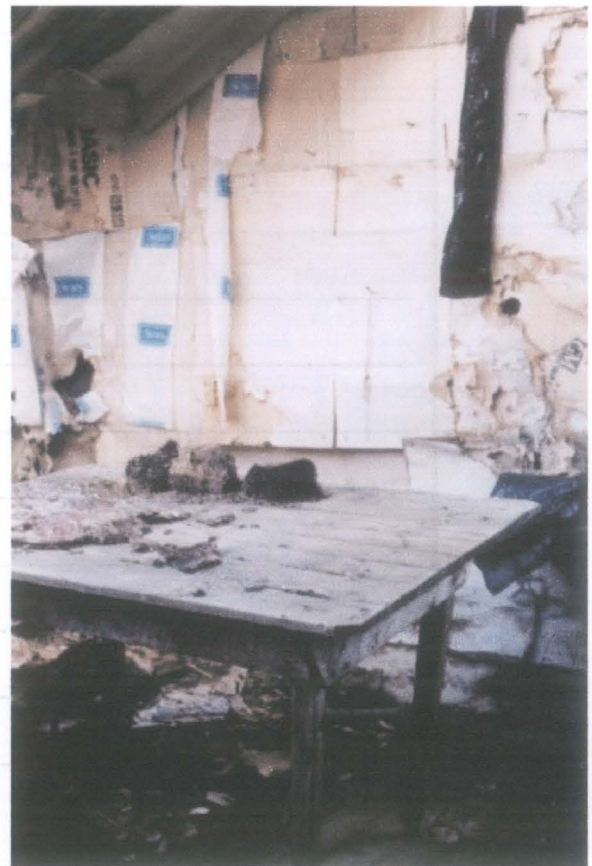
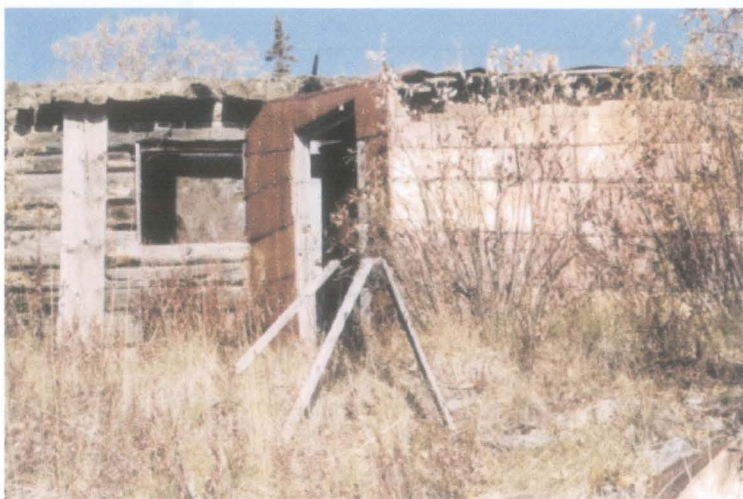
There has been further deterioration to the building at this site. The log cabin roof has partially blown off since the last inspection. The cabin walls and ridge pole, although weathered are quite stable, the stringers supporting the remaining sod roof are a major hazard as they are rotting through

Photos:
Top left, overview of cabin
Top right, inside cabin
Left, south side of cabin & Entrance

Due to the moisture the buildings main structure could and should be saved, by pulling down the hazardous sod roof and stabilizing the structure from the elements.

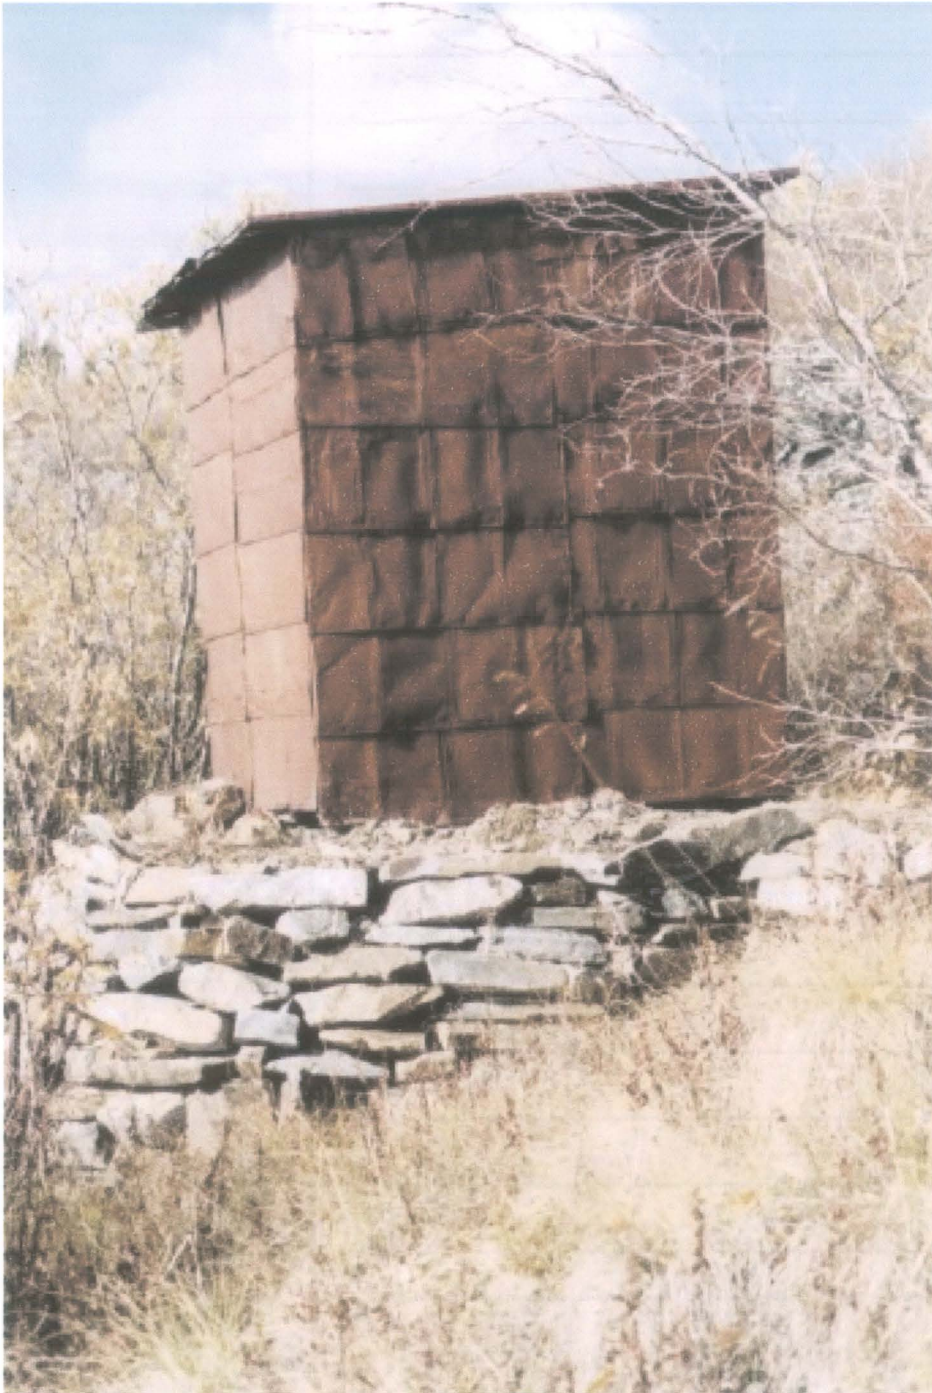
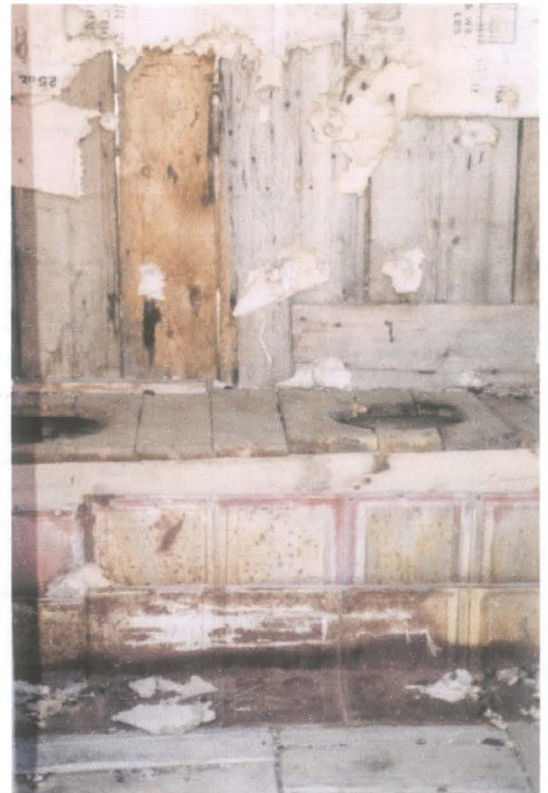
Outhouse

The outhouse is in excellent condition, and a great example of some of the early Yukon ingenuity. The stone base rockwork has stood up well along with the tin siding made from the old five gallon pails.

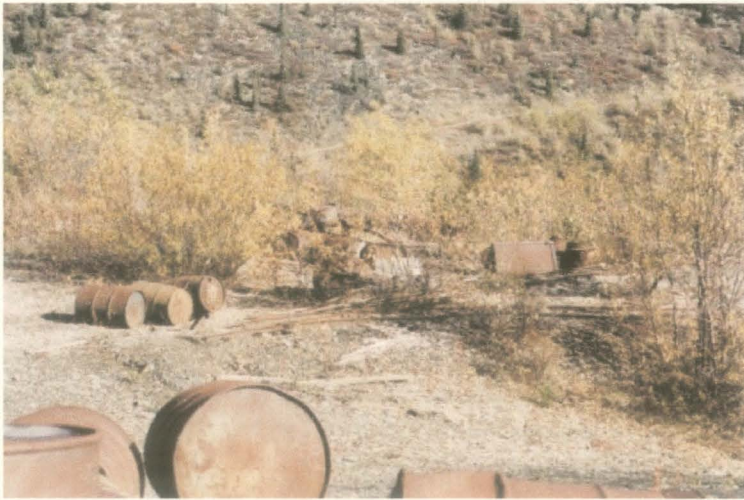
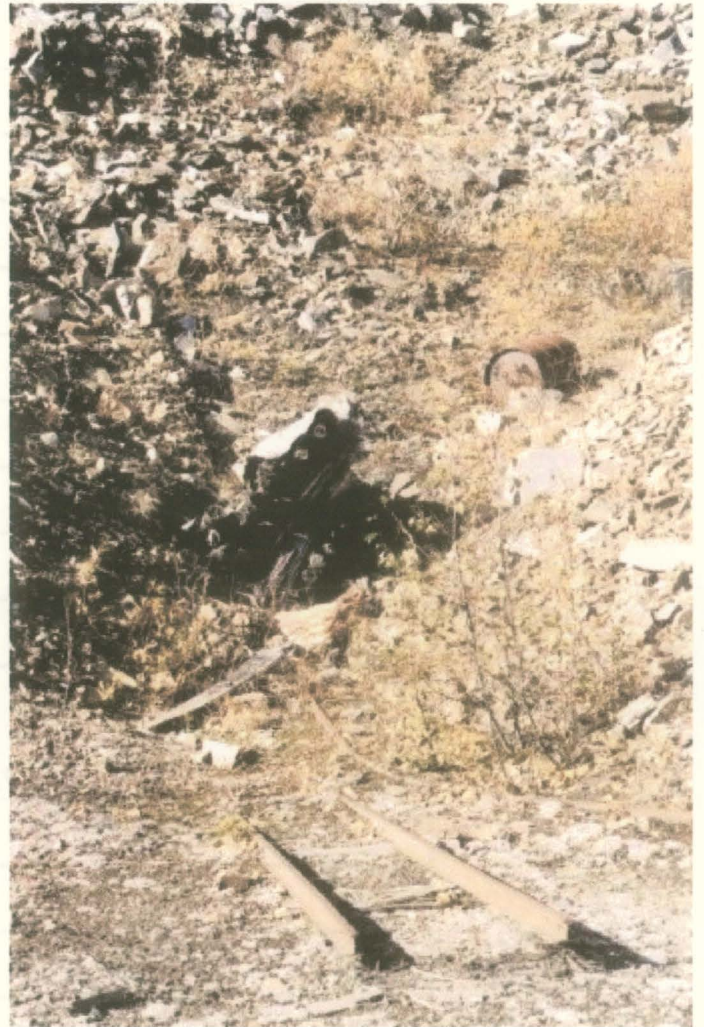
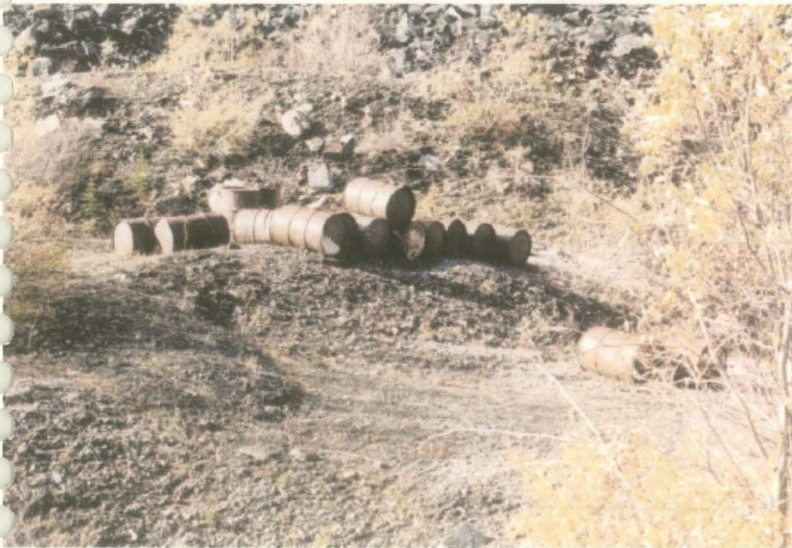
The Vanguard adit is in a state of collapse and has not changed since the last time of inspection, there are drums, steel rail and a mining car on the dumpsite as stated in previous reports. There is no discharge from the adit and with it being collapsed is inaccessible to the general public.

Above and bottom left, empty fuel drums and debris.

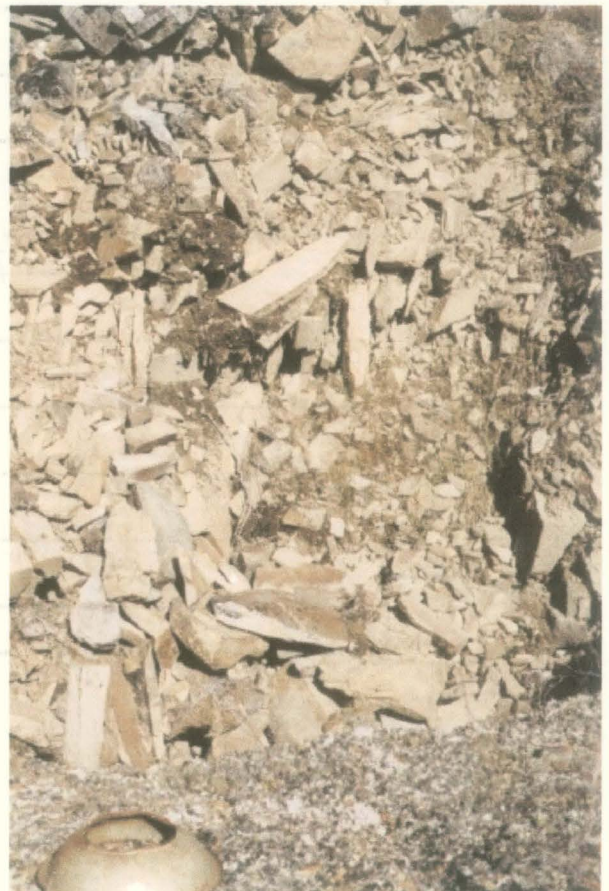
Number one shaft, left, has been collapsed by the trenching done on the East side of the cabin, there is cribbing exposed in the side hill cut done by the cat.

Number two shaft right, is located just north and up slope of the cabin, this shaft has collapsed leaving a one-meter depression.

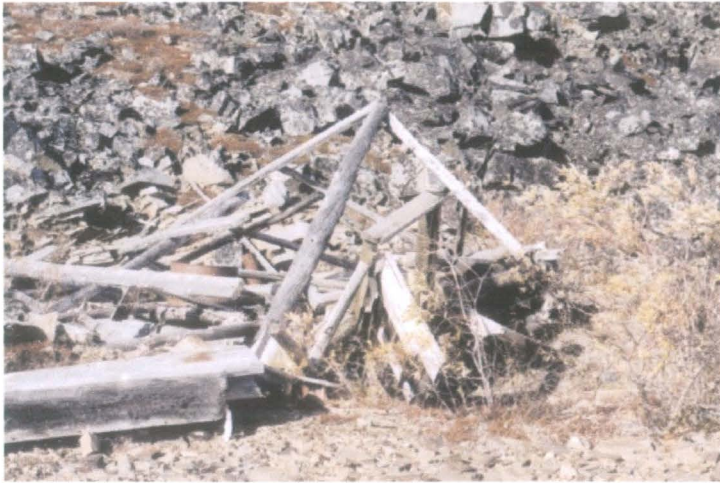
Shaft three and four are located near the collapsed tent frame, which is above the adit. The tent frame is in the same state as when last inspected.

Shaft three, right, still has cribbing showing and is collapsed at six feet below the surface.

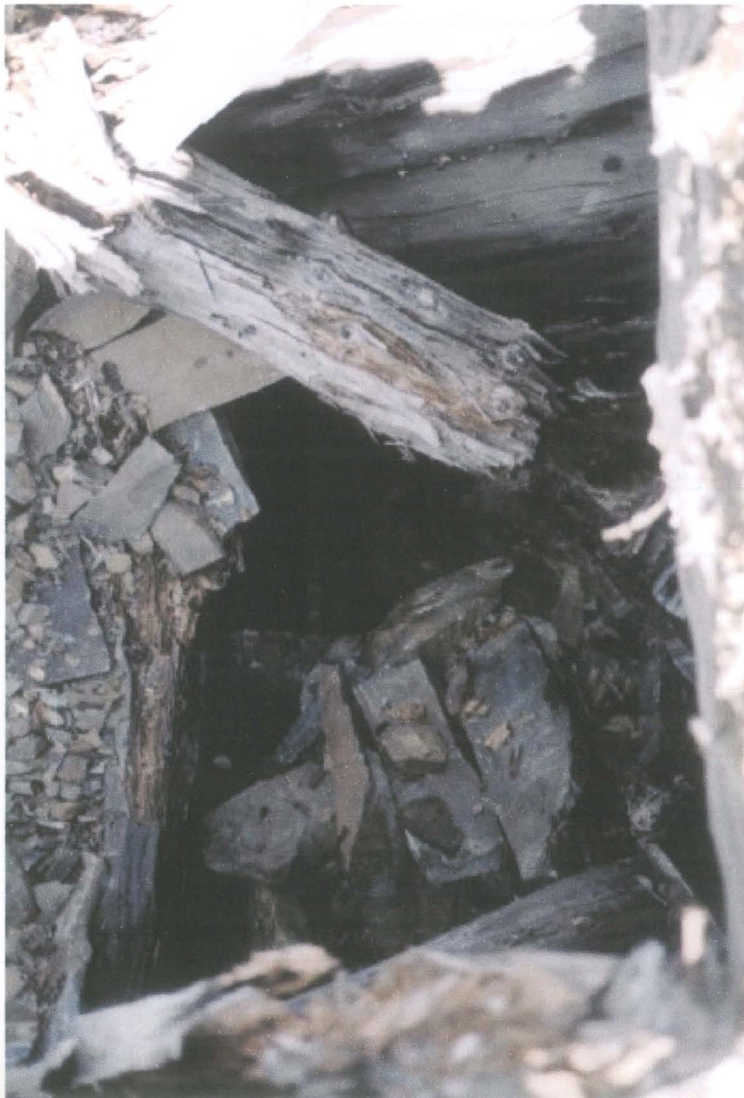
Shaft four, left is in extremely poor condition, and has deteriorated since the last inspection; The shaft depth is roughly 8ft from the surface.

The top edge of the shaft is very unstable, and dangerous.

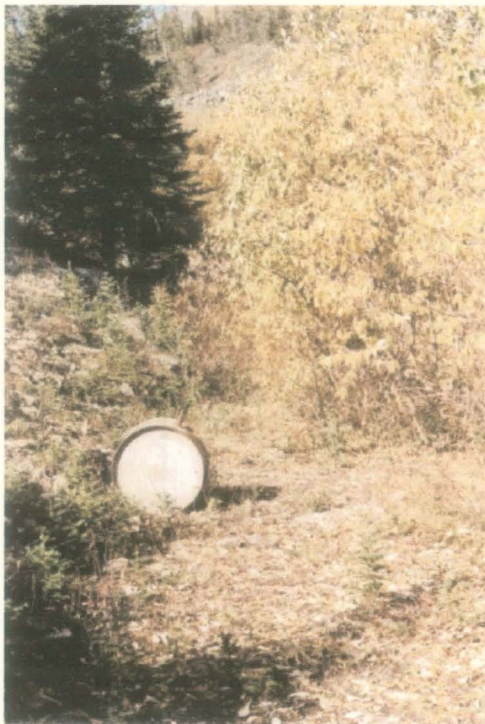
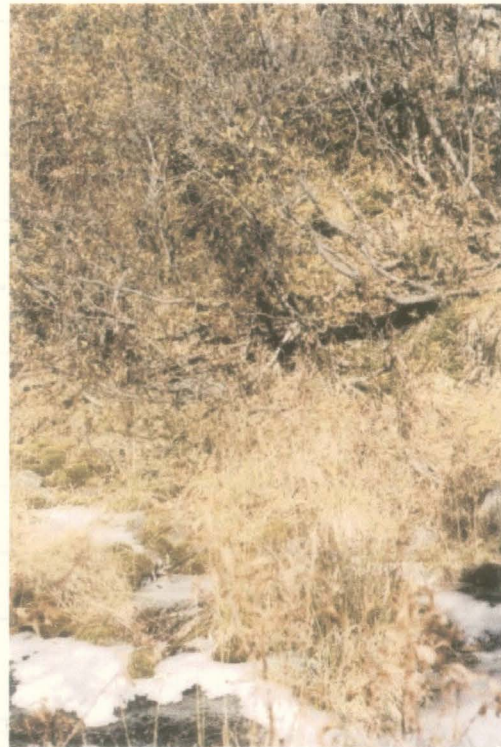
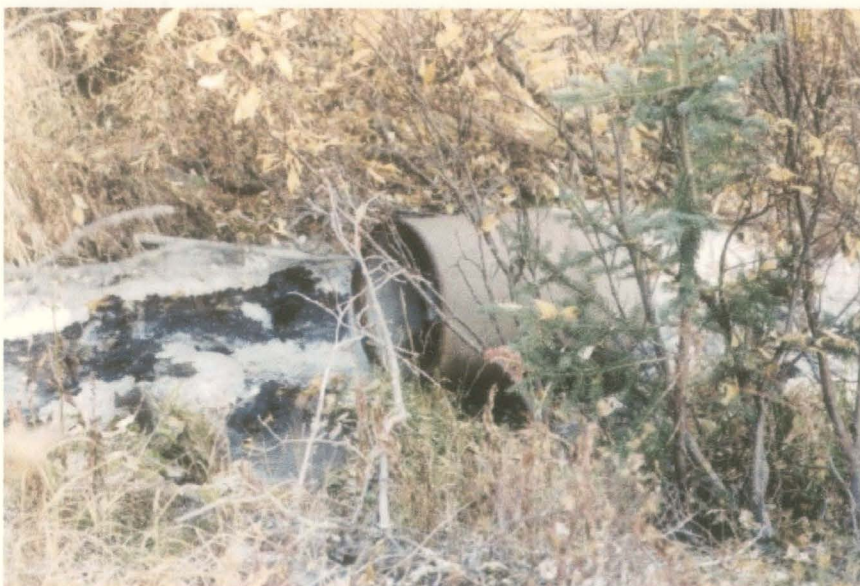
There was a lot of solid waste material scattered around the site drums, steel rail, pipe, and various wood and small metal debris. We also did not find any water discharge from any of the workings or trenching that had been done. The only potential for contamination would be during spring freshet, as melting water moves over the exposed waste rock piles and trench walls.

Photos: Empty fuel drums and pipe in and near the creek

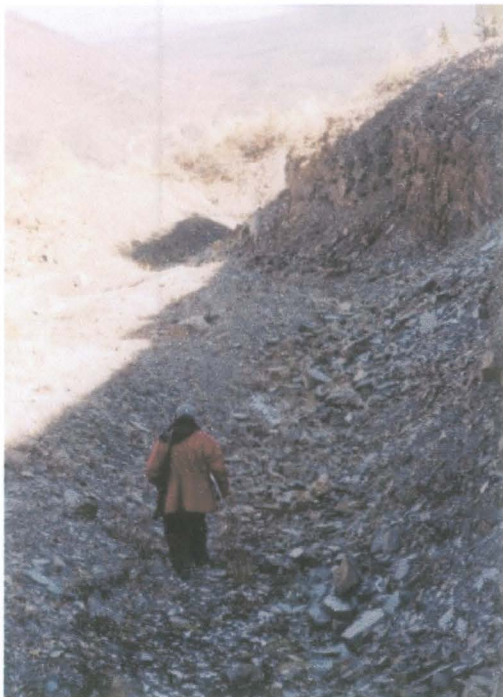
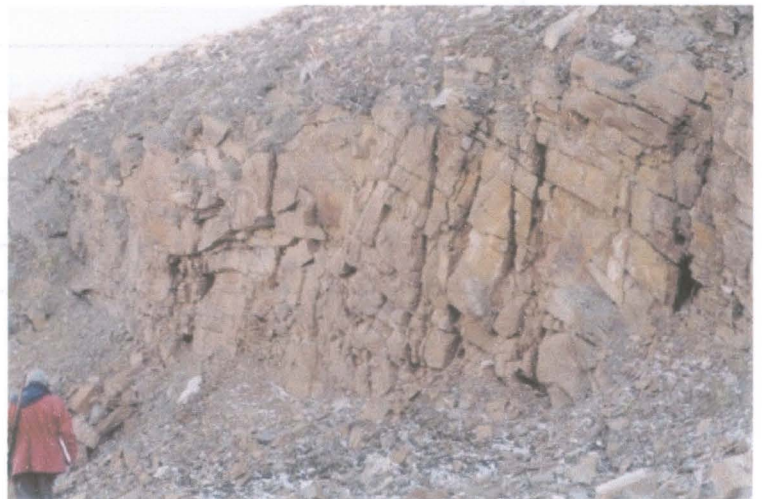
Photos: trenching

Trench #4 is located directly upslope of the adit 100m. The south sloping wall of this trench shows some instability as large boulders have broken loose and settle in the trench bottom. The walls of trenches 1,2, and 3, which are south, and upslope of trench #4 seem to be stable. There is no debris in trenches 2, 3, and 4, but located at the south-western end of trench #1 is a collapsed tent frame with assorted metal debris and one 45-gallon drum.

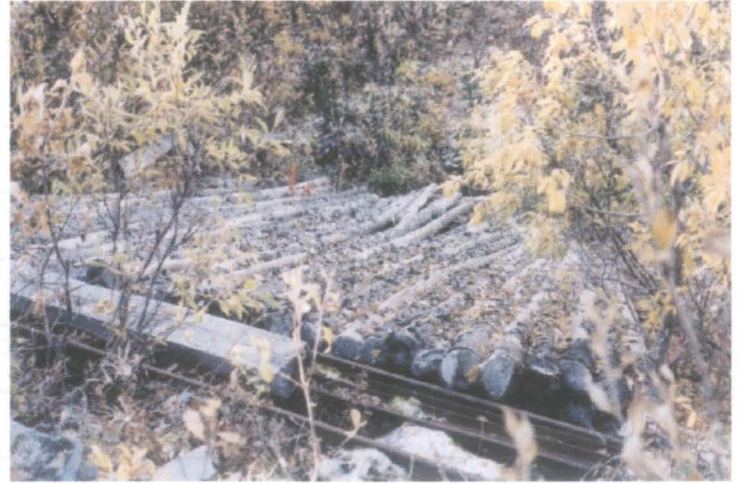
Photo: above, waste dump

There is a flat fifty by one hundred meter dump that extends to the east of the adit.

There is numerous amount of metal and wood debris scattered over the surface, approximately 300 feet small gauge rail, steel pipe, metal tent frame, rebar, drill steel and car batteries. The rail system is still intact along with a couple of old mining cars.

Environmentally we recommend that the shaft and the open adit's access be secured so there is no danger to the general public. The dumpsite at the adit should be cleaned of all loose debris, and discarded electrical batteries. The two frame structures on the upper road landing could be left intact as they are in a relatively stable state, we suggest that the garbage and hard refuse be cleaned.

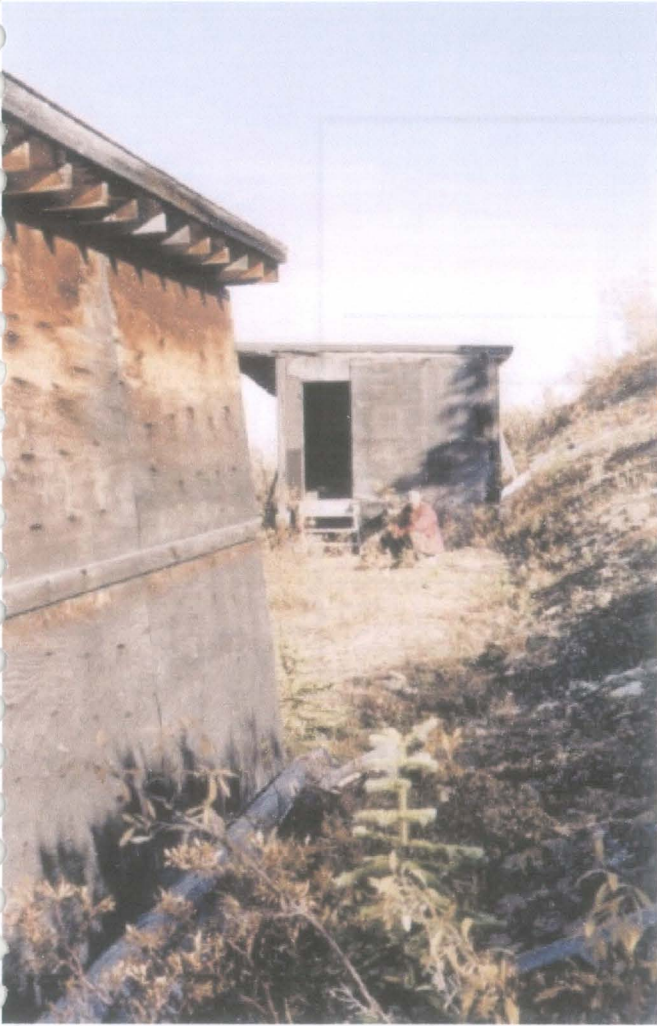
There are two frame buildings and one collapsed cabin, associated with this site. The two-frame building is situated at the end of the upper road that accesses the trench workings. The first building is a 2 X 8 frame trailer that is sheeted in with plywood; it is approximately 30 feet long by 12 feet wide. The building was probably used as sleeping quarters as there are four old metal bed frames inside along with more domestic debris.

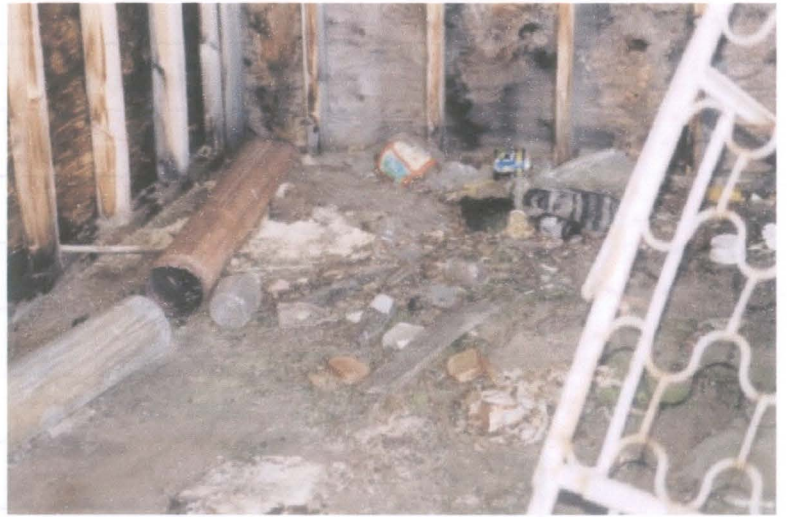
The second building is approximately 75 meters east and is also of frame construction, the interior has one bed frame and a table.

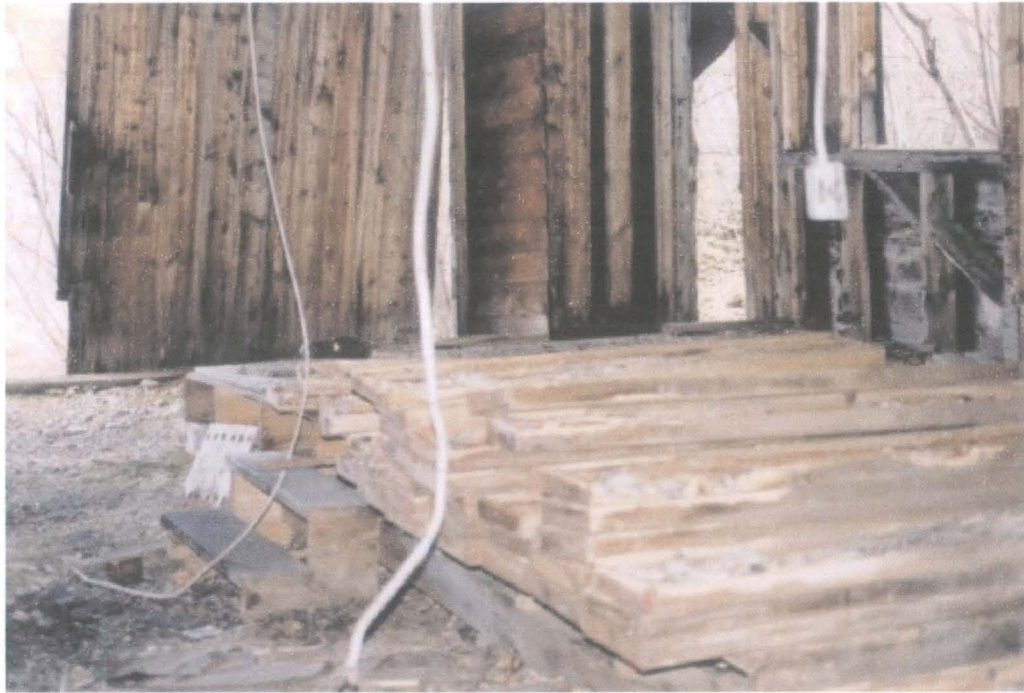
Photo: core storage inside of the upper building

There are six 45-gallon drums along with some minor metal debris scattered in the bush around this building.

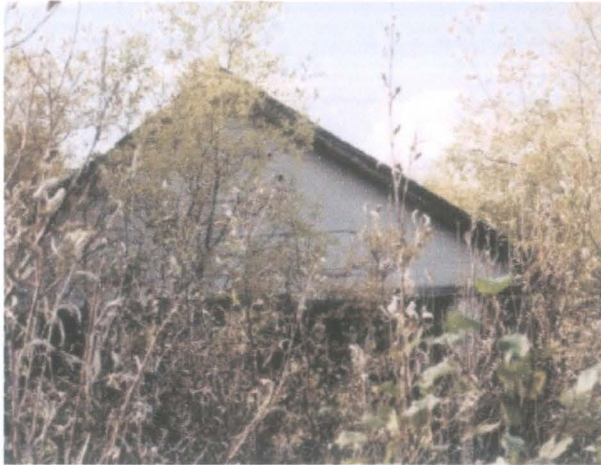
There were no contaminants of concern noted in any of the previous studies, although in the study they did note the asbestos tarpaper on the core shack.

We feel this does constitute a hazard to human health and warrants remediation. The other issue we feel that deserves attention is the dumpsite at the lower adit. This dumpsite is consistently sloughing down directly into Crystal Creek; it has invaded the creek bed and forced the creek to be diverted directly at the base of the dumpsite.

Clean up and closure of the two adits on this site would be the primary consideration. Removal of the asbestos tarpaper at the upper core shack is also recommended.

All the loose debris and asbestos tarpaper should be removed from the site along with the hard materials i.e.; rail, drums, and water tanks.

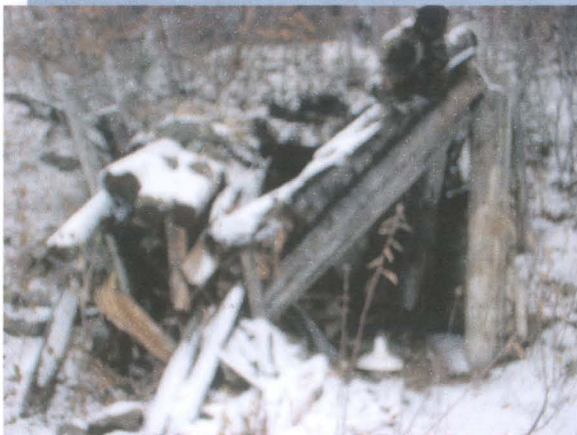
In re-assessing this site we did not find any major changes since the last time it was inspected. All waste material and drums are as stated in the Yukon Min file report#105 M 20. The only changes we noted were the further deterioration of the adit portal, which has partially collapsed on one side and the storage shed was no longer locked. There was no material or contaminants inside of this shed other than some waste cardboard boxes.

Photos: above, side view of adit.

Right, front view of adit

The major concern as stated earlier is the safety issue with the adit. In this case we feel that what's left of the adit portal could be burnt, and then back fill the open adit to seal it from access.

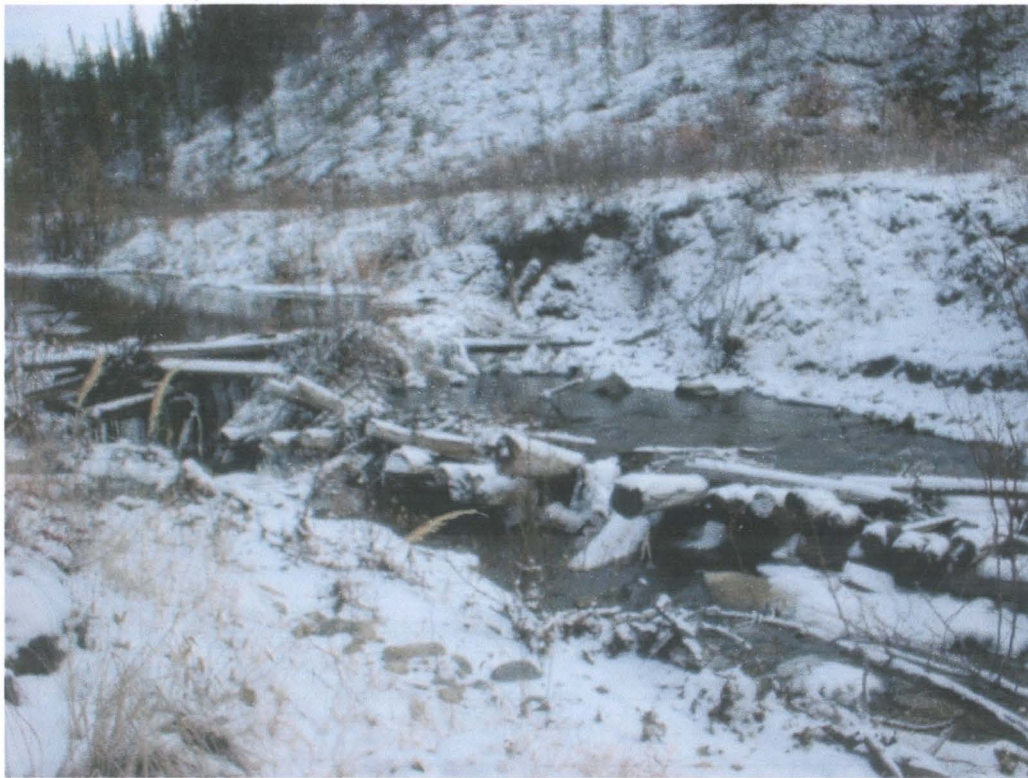
The beaver dam is still in place just above the second of the two washed out bridge crossings.

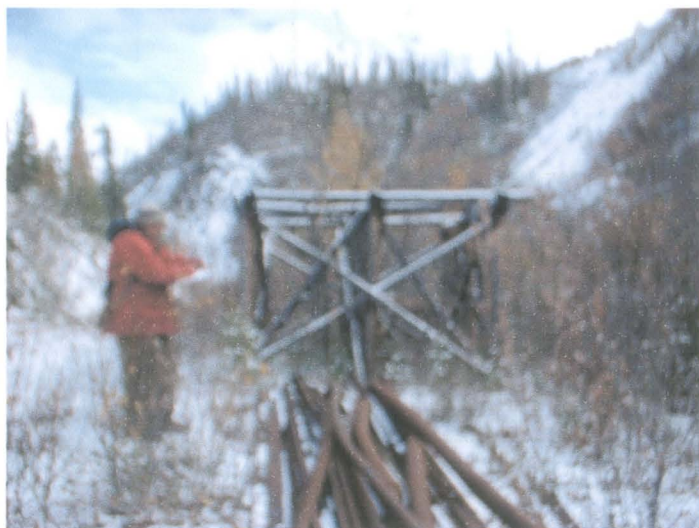
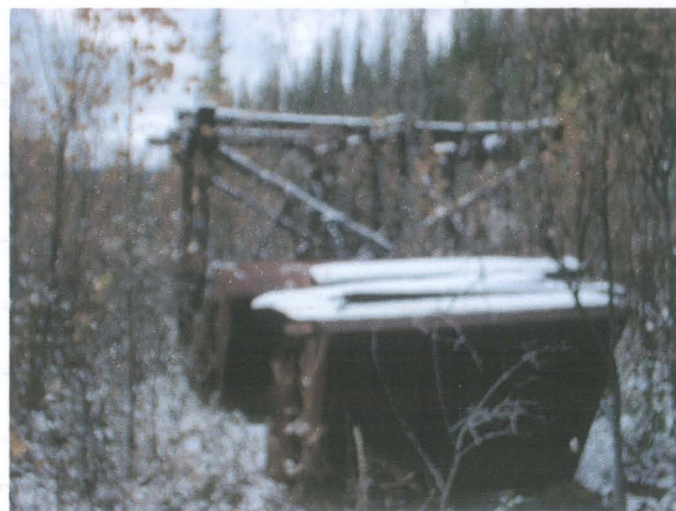
The wooden cache, two mining cars and rail are still stockpiled below the adit workings, on the lower road.

The steel rail and ore cars could be removed relatively easily following the lower road, the plywood structures could be burnt or removed if they are thought to be of some value to the community.

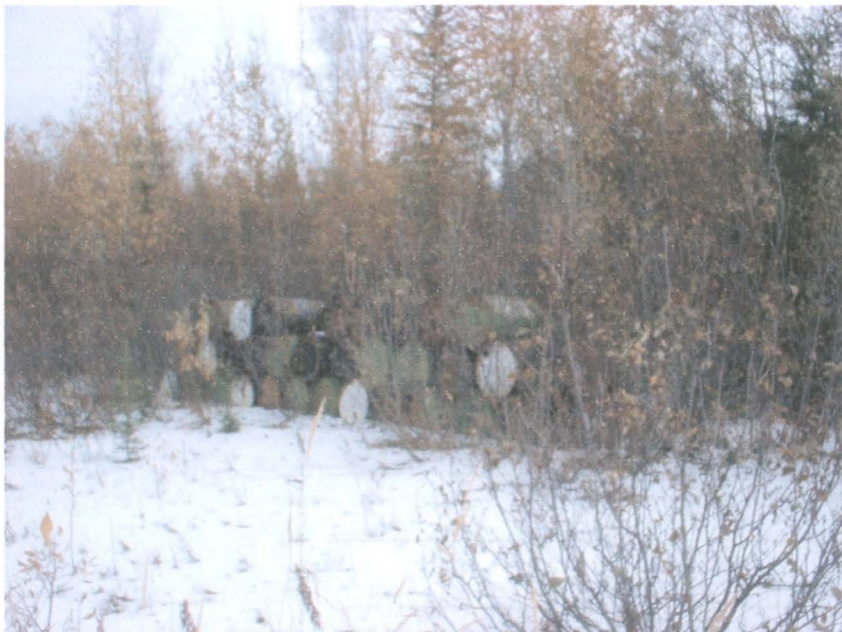
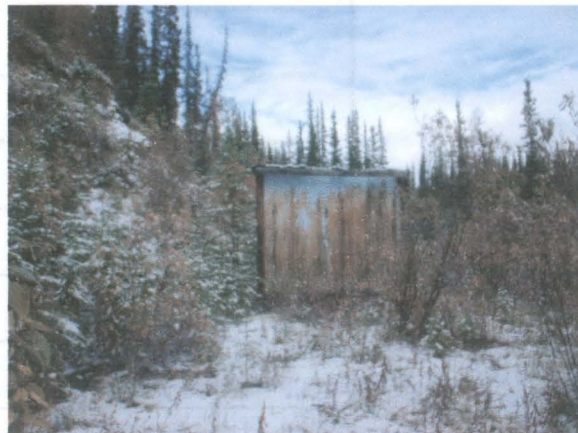
Photos: right, empty fuel drums.
Left, storage shed

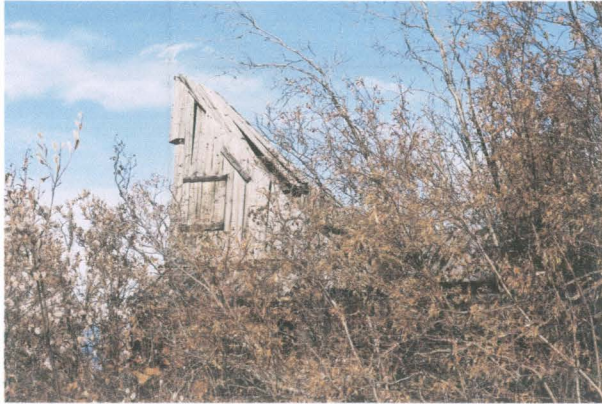
The interior of the head frame is extremely well preserved

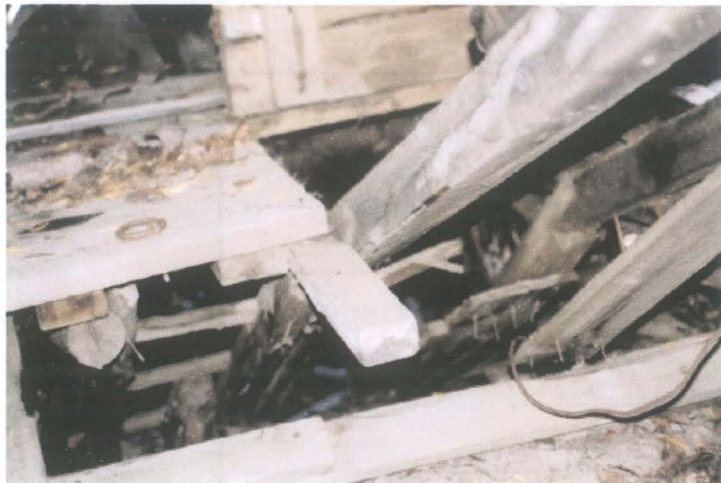
Photo: above. Shaft with trap door, ladder and bucket

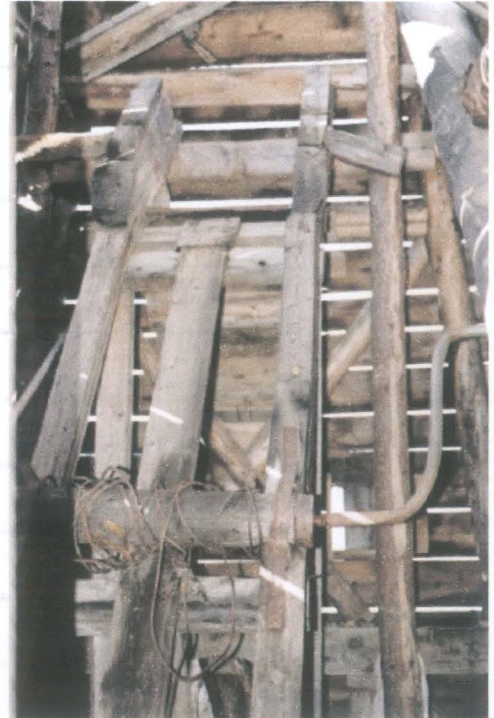
Photo: above, Windless for pulling ore out the shaft

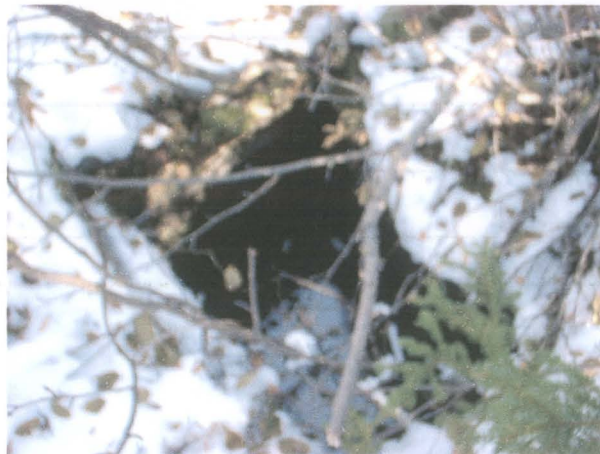
Up slope from the bunk house there is another series of timbered shafts, below, and more test pits, in this area we found a total of 11 more shafts, some extremely dangerous.

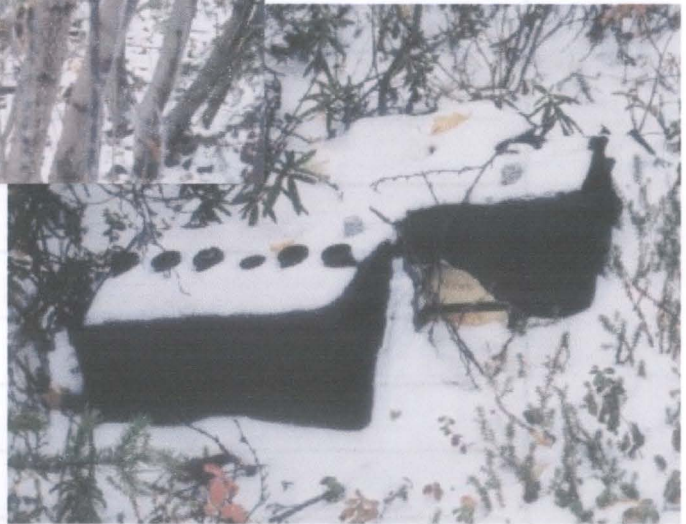
Photo: Right and below batteries and empty fuel drums scattered throughout the site.

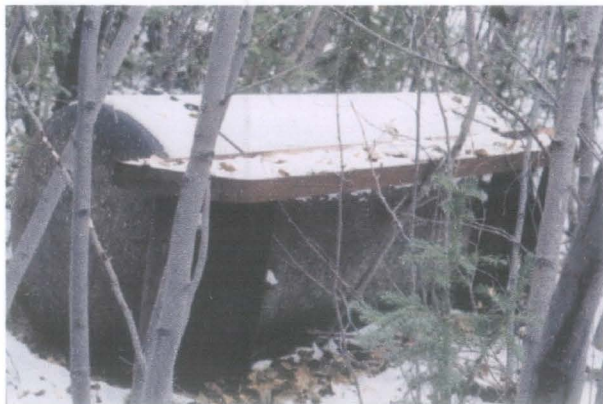
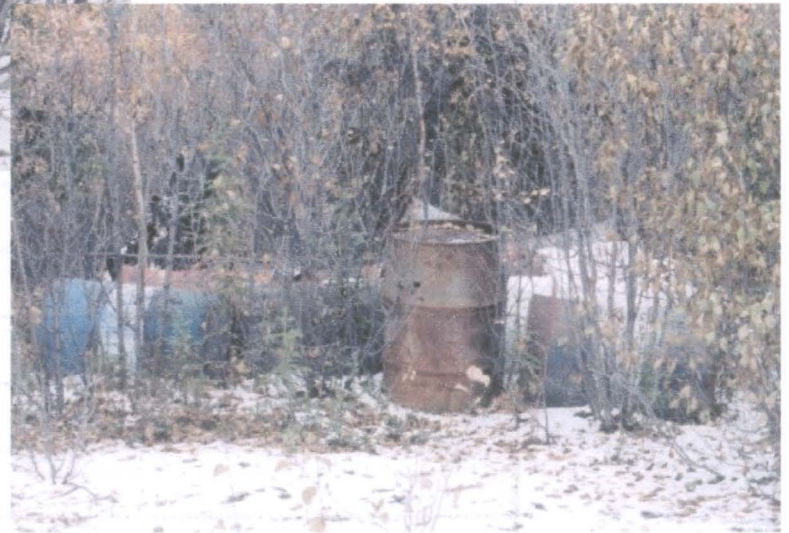
Photo: above, fuel tank on skids

Right: truck box containing waste rock

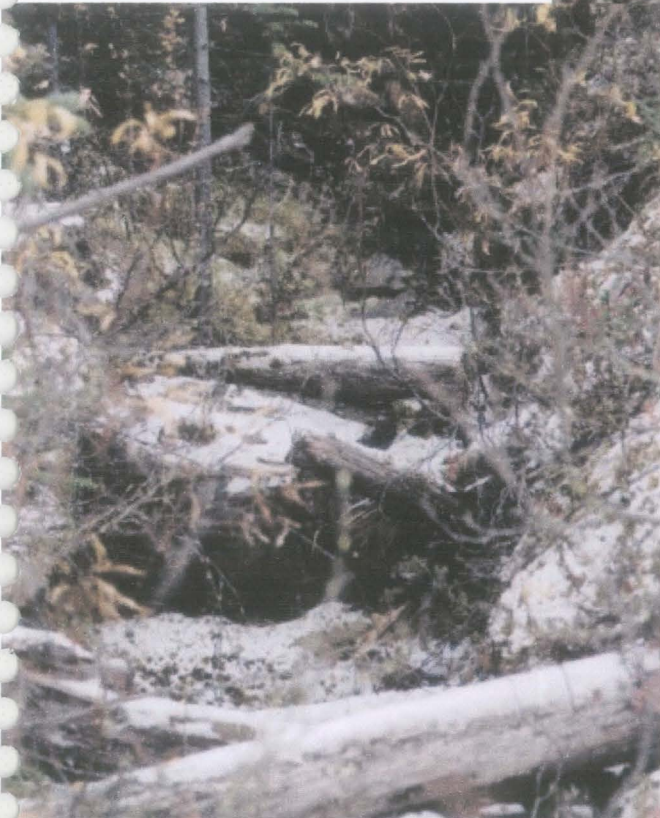
Shaft # 5 left, is approximately 100 meters north of the main storage shed and off the end of a shallow trench which is down slope of the shed.

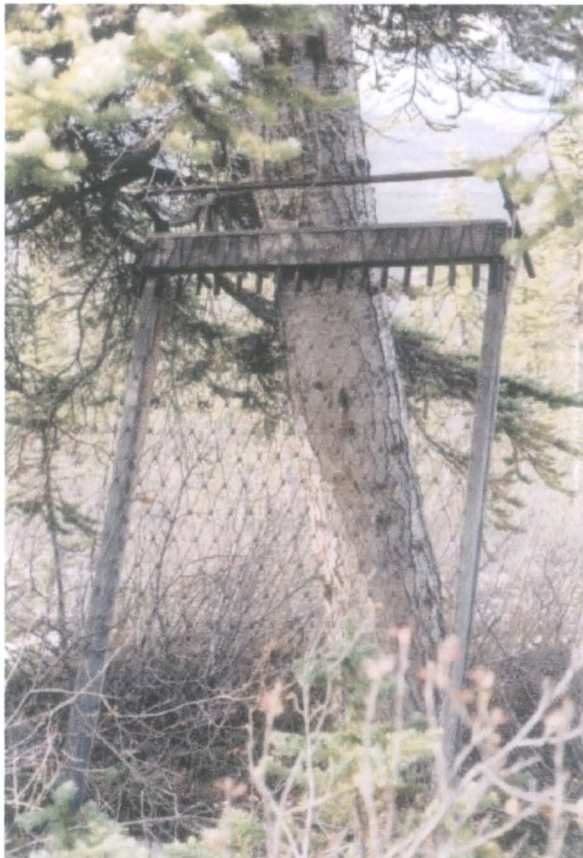
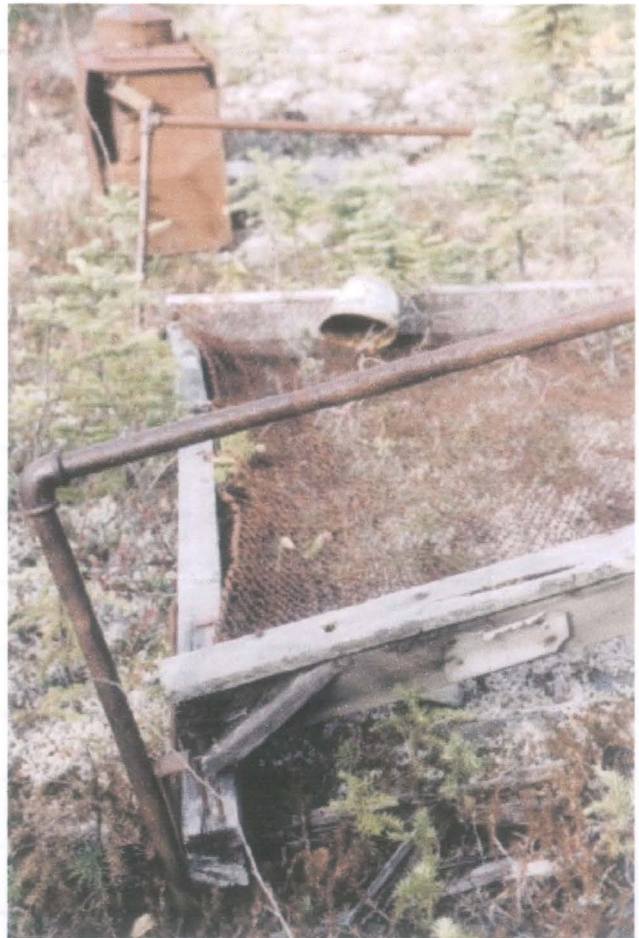
Photos: hand made bed frames

There are some interesting artifacts at the site, artifacts include: windless, wooden ore bucket, hand made bed frames and bottles. It is recommended these items be stored for future exhibit work.

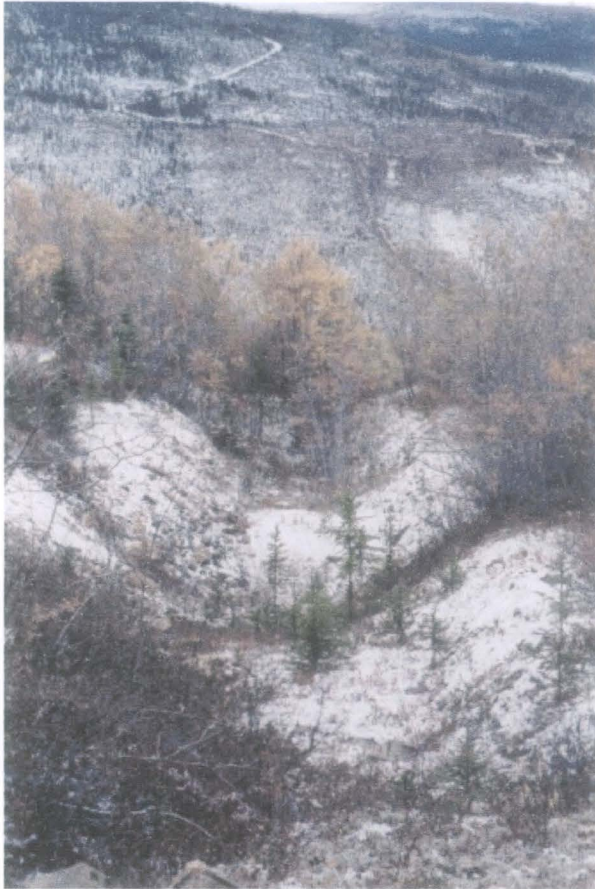
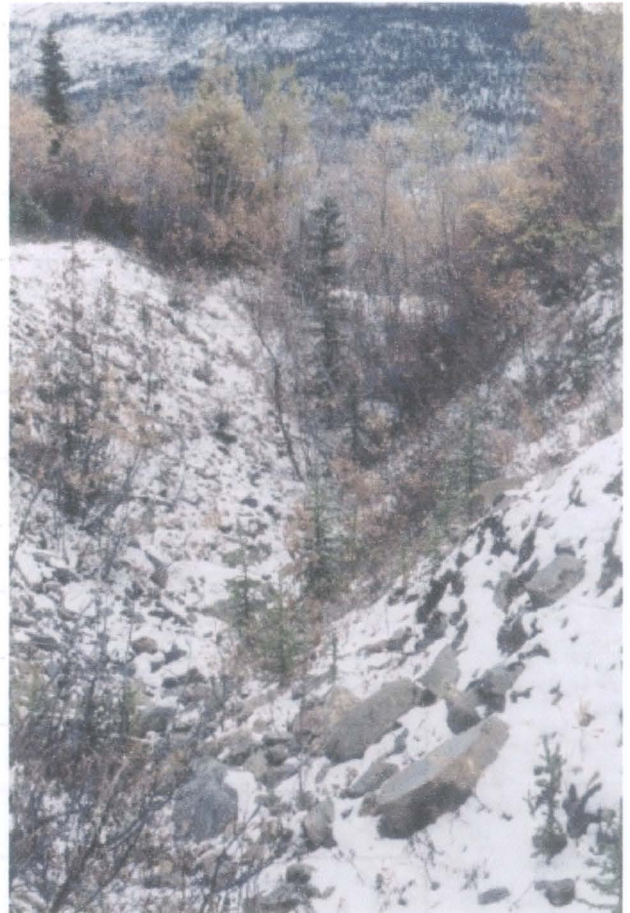
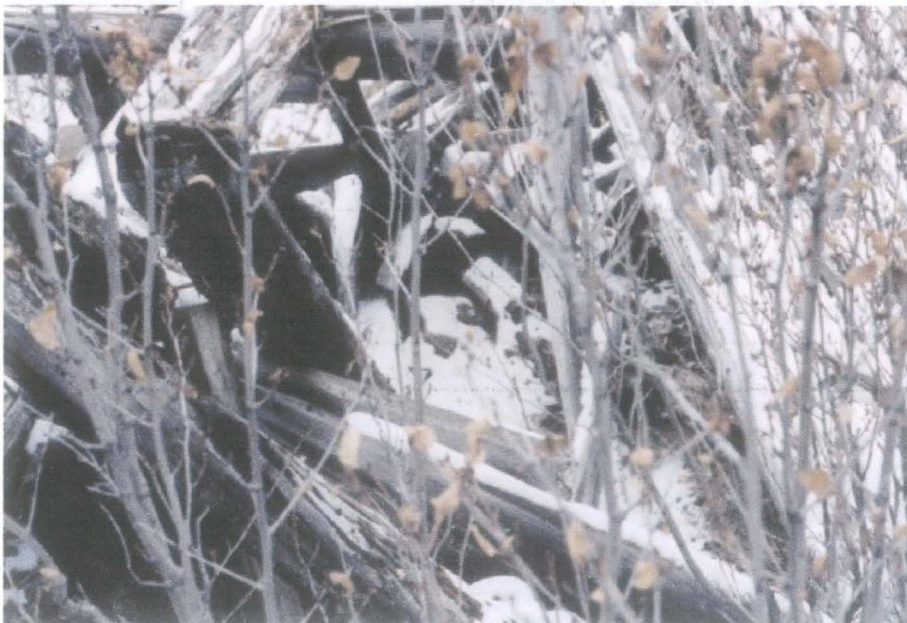
As stated in previous studies we found five trenches and two partial buildings associated with the Ironclad site.

Photos: Above trenching
Left, collapsed building
