Historical Review

Of Selected Mining Sites In The Silver Trail Region

Prepared for
Waste Management Program
Indian and Northern Affairs Canada

March 2004

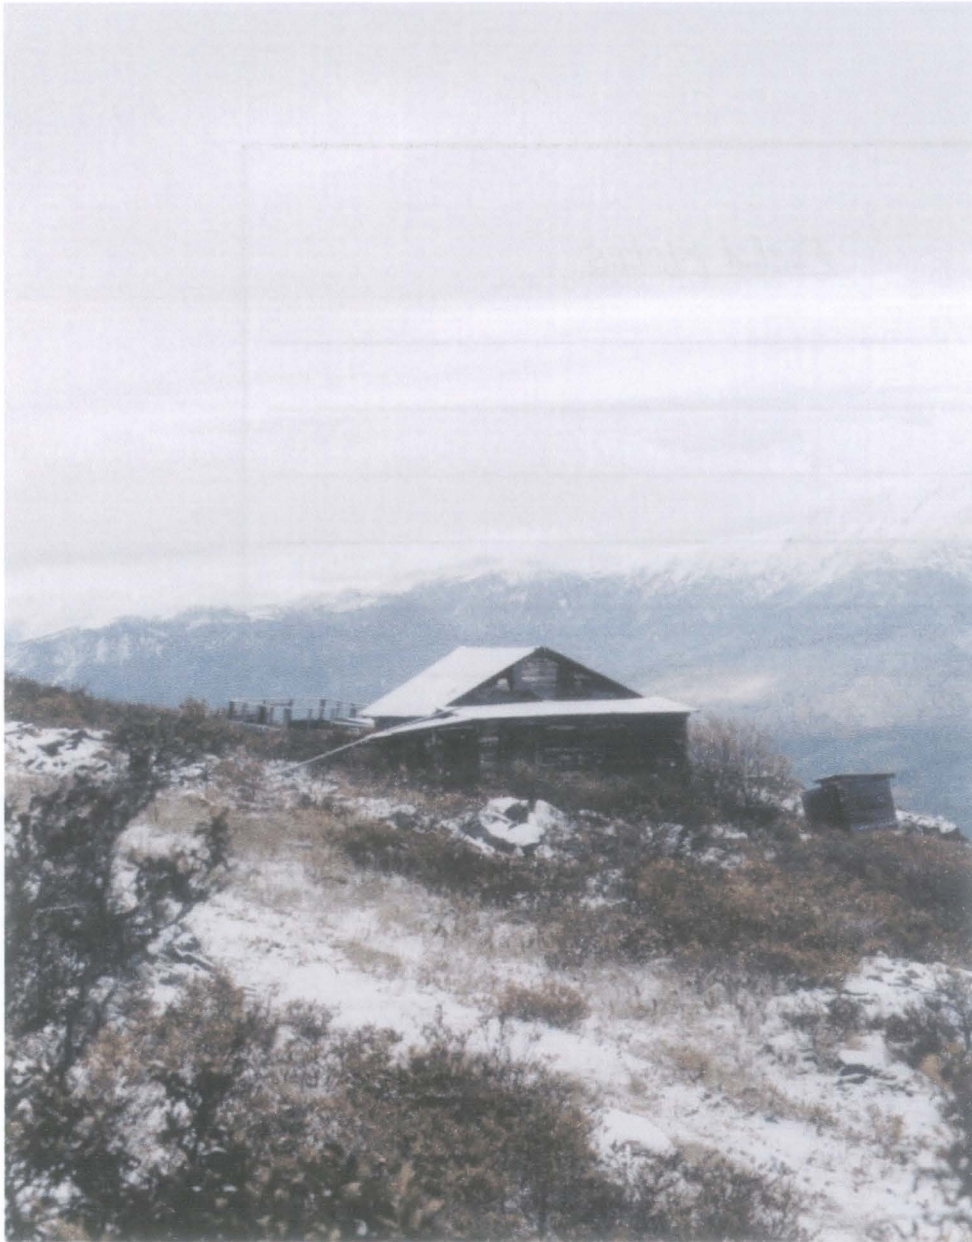
The main building is holding its own with the elements for now. There did not seem to be any glaring dangers, though that is not to say there is no risk to entering the main building.

In the not to distant future if the building is not stabilized, the 1x8 planks will weaken further over the floor joists causing a high risk of someone breaking through the floor. Because there is no roofing material the weakening of the wall studs and the roofing boards will eventually cause this building to collapse as the other structures have done around it.

Restoration or stabilization of the building will vary depending on funding available, though the most immediate action would be to install tin on the roof and bracing, to prevent further deterioration to the structure. Assessment of the site by the Heritage branch will determine the extent of stabilization necessary for the preservation of the building

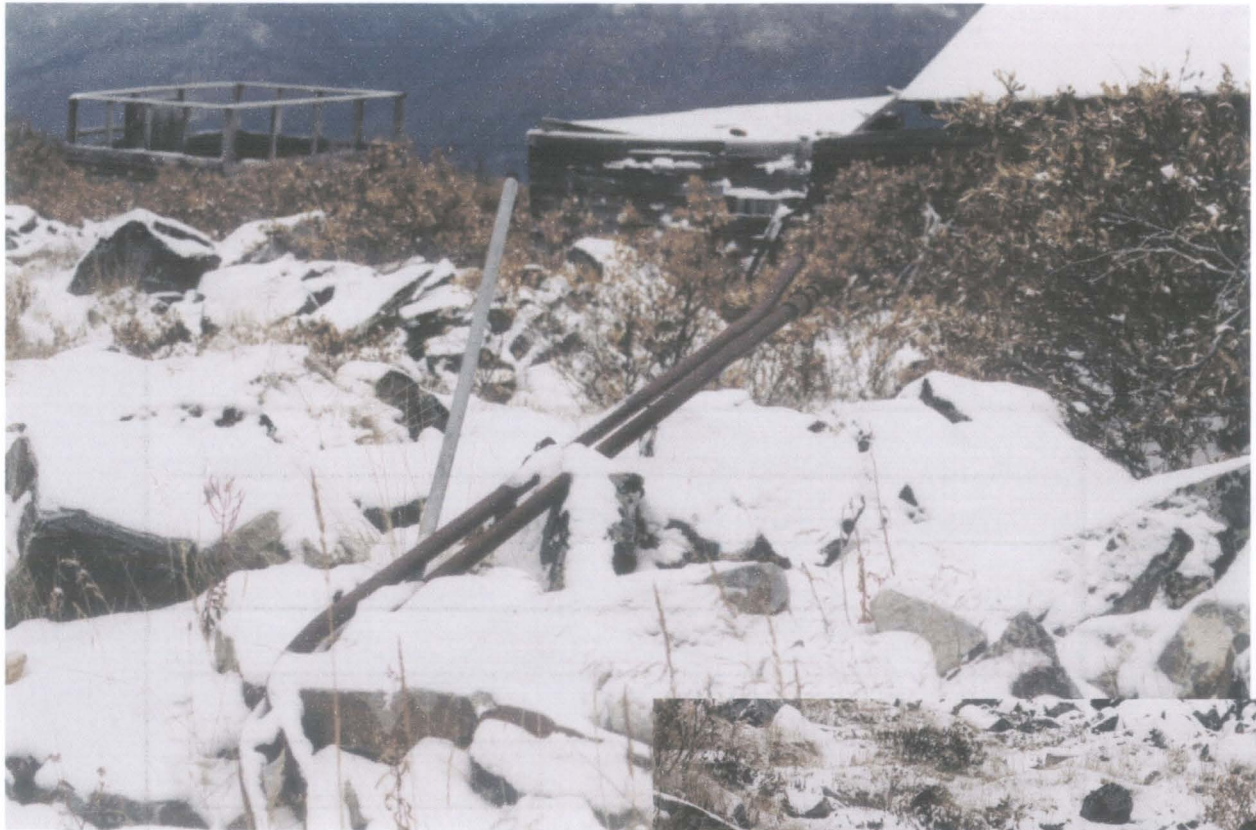
Near the main cabin the debris mainly consists of items such as stovepipe, safety's for the roof, general refuse, rusty cans, bottles and several lengths of 1/12" pipe.

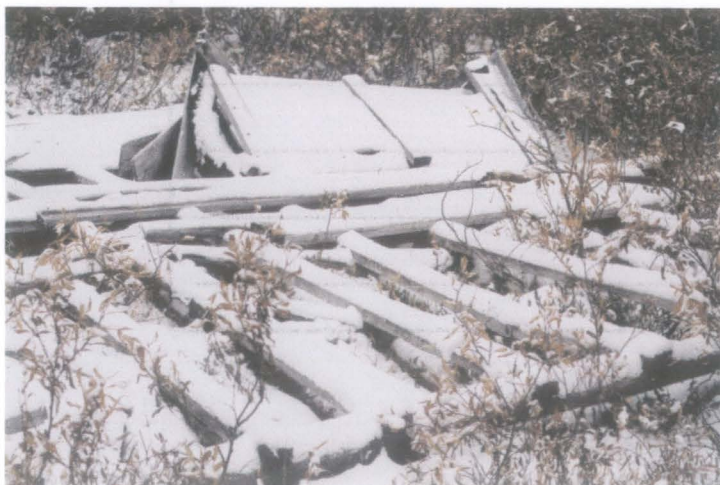
In our assessment there seems to be a fair amount of building material that could be recycled.

Lumber and other materials from the site could be salvaged and then stored for reuse in the stabilization of the existing buildings.

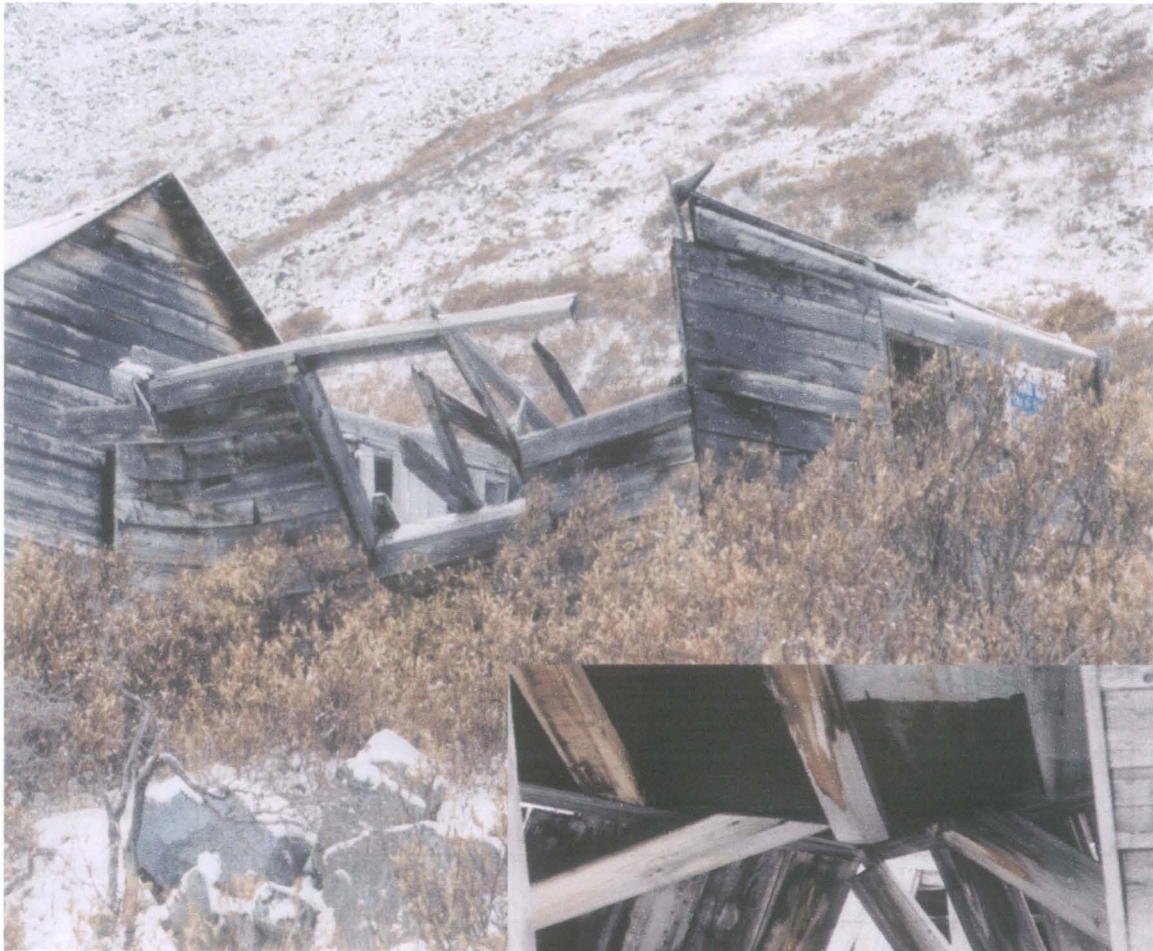
Right: Shed entrance

The shed roof has collapsed with nails exposed and one wall has buckled ready to fall away from the rest of the building. This structure poses public safety concerns.

The restoration of the shed would be extensive and costly. Possible considerations would be to dismantle the building and reuse the lumber elsewhere.

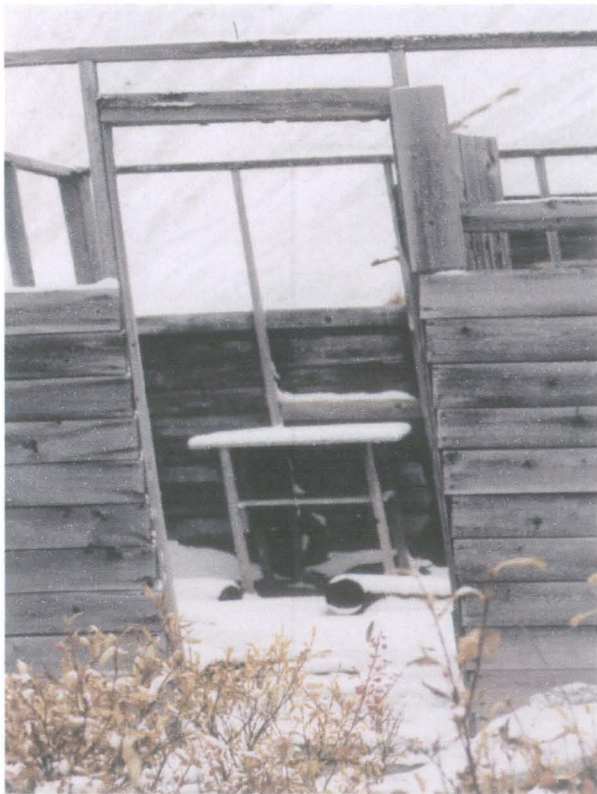
Tent frame: Left This structure remains in good condition and does not warrant any safety concerns

At this time though stabilization through cross bracing would help to keep the structure in this state.

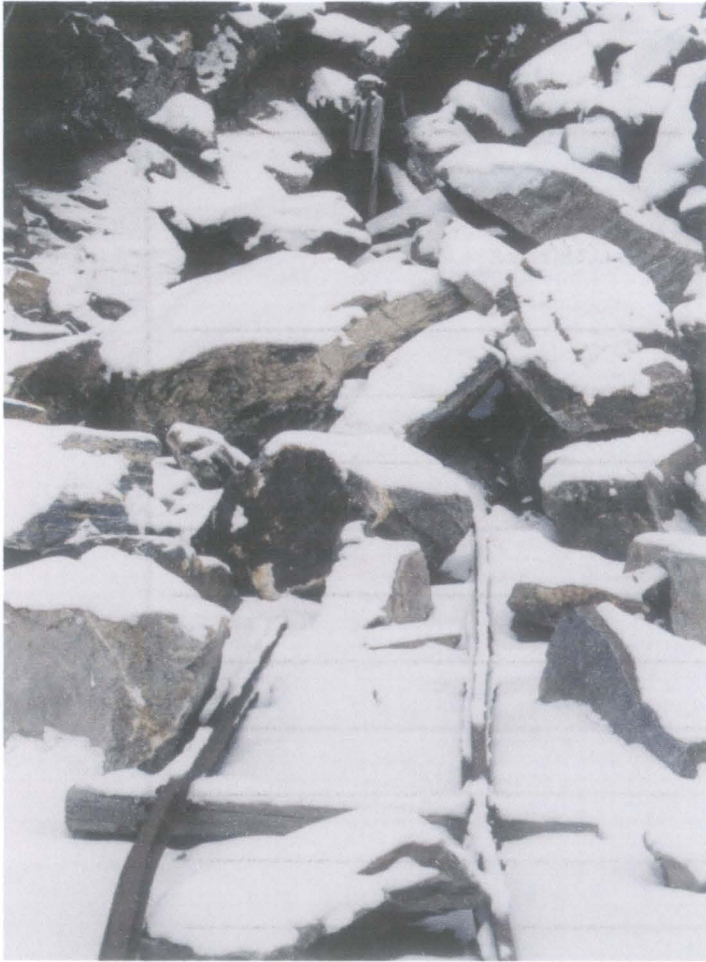
The second and lower adit; Adit has a rail and trestle extending from the collapsed portal; this rail ends at a wooden platform on the edge of the dumpsite, with some of the rail extending down the dump slope.

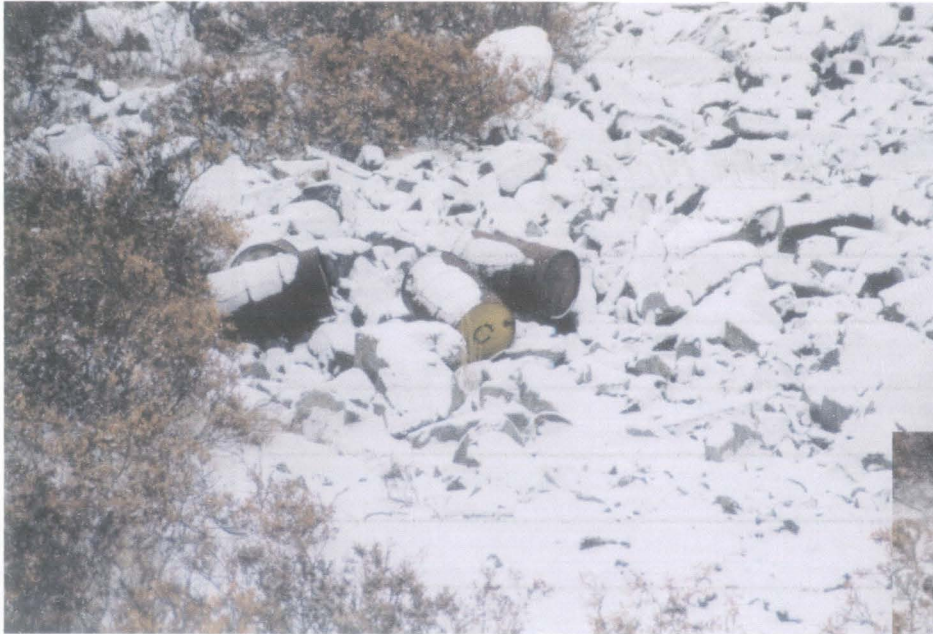
Photos: empty fuel drums and ore cars below the waste dump

There are 15 forty-five gallon drums scattered over the Gambler Site, principally down slope from the adit and upper workings. These drums were found to be empty and did not pose an environmental contaminant spillage concern.
