Investigation of Sliver-Spall Damage at Offutt Air Force Base, Nebraska

Toy S. Poole and Raymond S. Rollings

March 2009

Final report

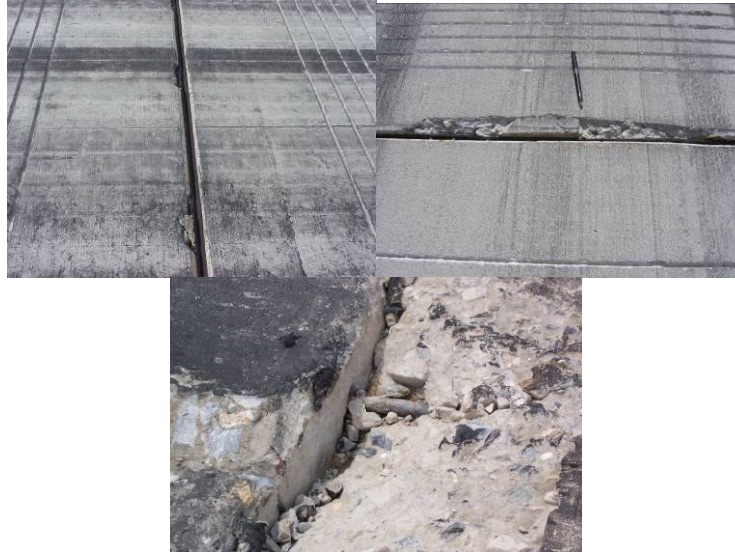
Figure 1. Examples of runway joint spalling: (top left) low-severity spalling, Elmendorf AFB; (top right) medium-severity spalling, Offutt AFB; (bottom) high-severity spalling, Bagram AB

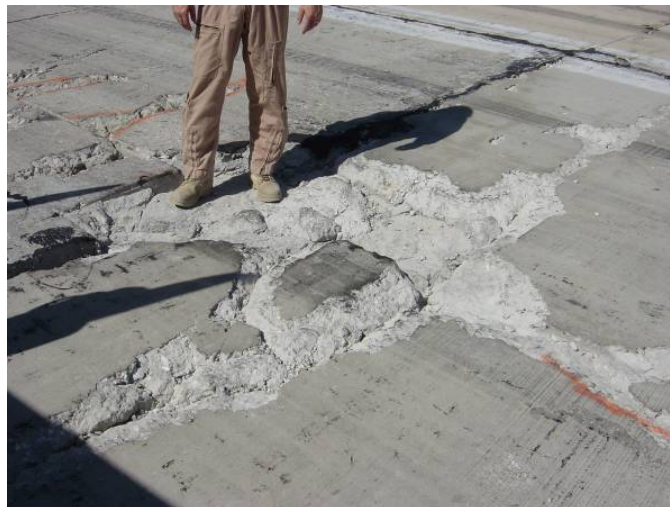
Structural loads. As pavement structural capacity is reached and exceeded by applied aircraft traffic, pavement deflections and formation of structural transverse and longitudinal cracks can lead to extensive spalling along joints, corners, and cracks. In one of the Corps of Engineers' full-scale accelerated traffic tests used to develop military rigid airfield structural design procedures, spalling at joints developed under traffic to such an extent that the section was considered failed even without any of the cracking normally used to define structural failure (Rollings and Witeczak 1990). An example of spalling caused by excessive structural loading is shown in Figure 2. In such cases, the pavement structural capacity is being exceeded, and major rehabilitation is warranted. Ad hoc patching is inadequate for such conditions.

Figure 2. Extensive spalling along joints and cracks caused by excessive structural loading, Bagram AB runway.

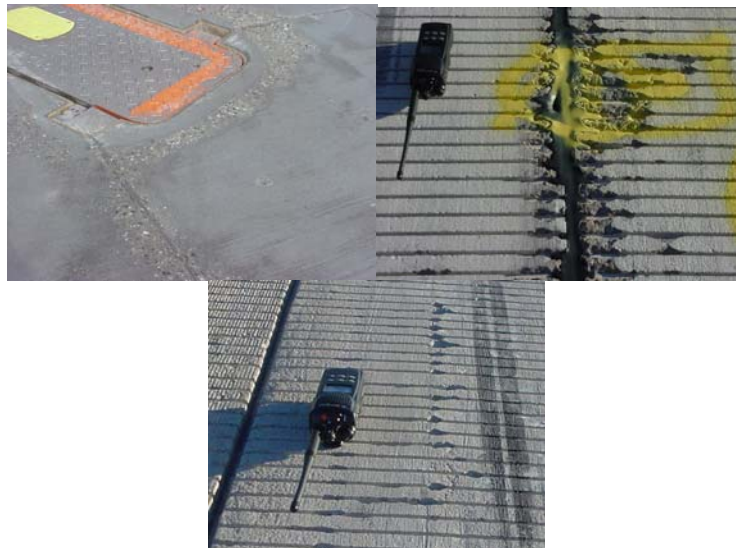
Improper equipment usage can, however, cause damage. Myrtle Beach and Cannon AFB have both had past damage to runway centerlines from improper use of equipment by inexperienced personnel, but these are the only major snowplow-caused spalling incidents that required investigation by AFCESA (Rollings 1998, Rollings et al. 2008). Some examples of snowplow damage to USAF pavements are shown in Figure 3.

Figure 3. Examples of snowplow damage to USAF airfield pavements: (top left) scraping around raised obstacle; (top right) inexperienced operator damaged centerline, compounded by improper grooving pattern passing through crowned centerline; (bottom) pavement grade change outside of smoothness tolerances resulting in dragging of blade tip of snow-clearing equipment.

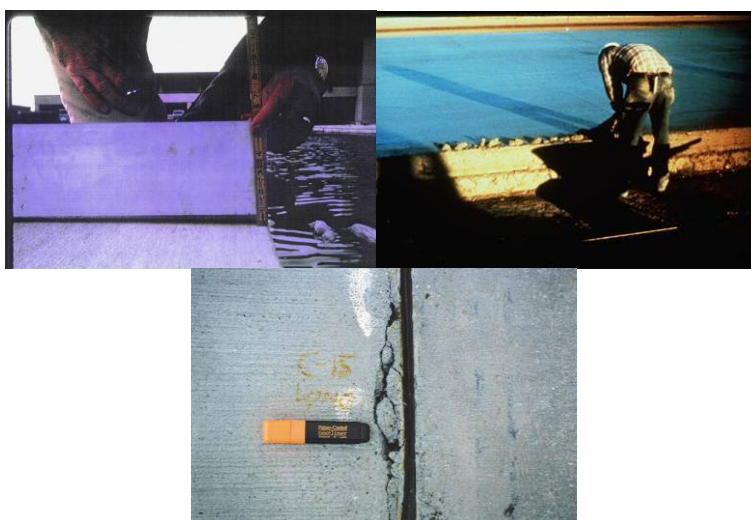
When a slip-form paver pulls forward, the unsupported edge may slump downward, and attempts to repair this by hand with mortar are almost always unsatisfactory (Figure 4). These mortar repairs to the downward-slumped concrete surface often result in severe spalling that can be continuous down whole lanes (Rollings 1998). If edge slump occurs on a slip-formed pavement, poor concrete mixture proportions or varying proportions are often the cause of the problem. Edge slump cannot be repaired, so the paving process should be stopped and adjustments made in the concrete mixture proportions or equipment to resolve the issue.

Figure 4. Examples of edge-slump problems with slip-form paving at Travis AFB: (top left) example of edge slump; (top right) attempts to repair by hand; (bottom) failure of edge-slump repairs.

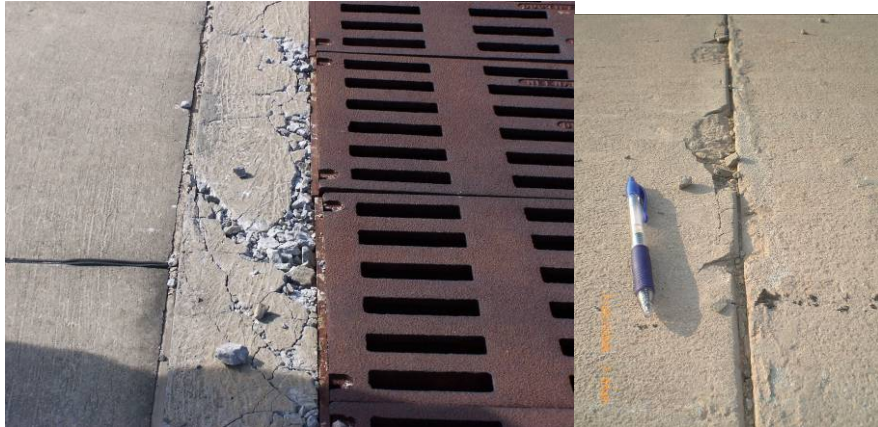
If the expansion joint is not maintained properly or if it is not constructed properly, restrained movement can lead to spalling, as seen in Figure 5. Similarly, if contraction joints are not kept sealed and if incompressible debris accumulates in the joint, the debris-filled joint cannot accommodate the concrete expansion. The restraint against the concrete expansion can lead to spalling, as shown in Figure 5. Rollings and Rollings (1991) describe the development of widespread spalling on an Air National Guard taxiway that developed due to lack of joint sealant maintenance.

Figure 5. Examples of spalling from volume change restraint: (left) expansion joint material does not extend full depth of pavement, so concrete pavement movement causes spalling at the trench drain, Hurlbert AFB, Florida; (right) debris-clogged joints cannot accommodate temperature-induced movement in concrete pavement, leading to spalling, Middle Eastern airfield.

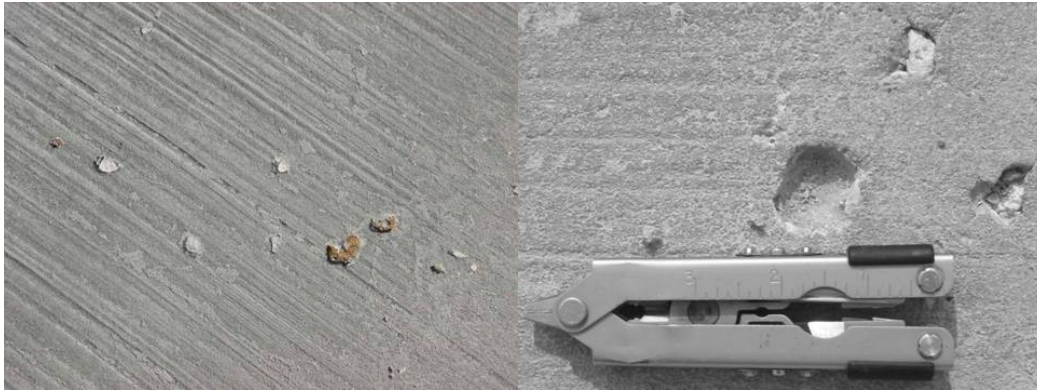
Figure 6. Examples of popouts: (left) Laughlin AFB, TX; (right) Middle Eastern airbase

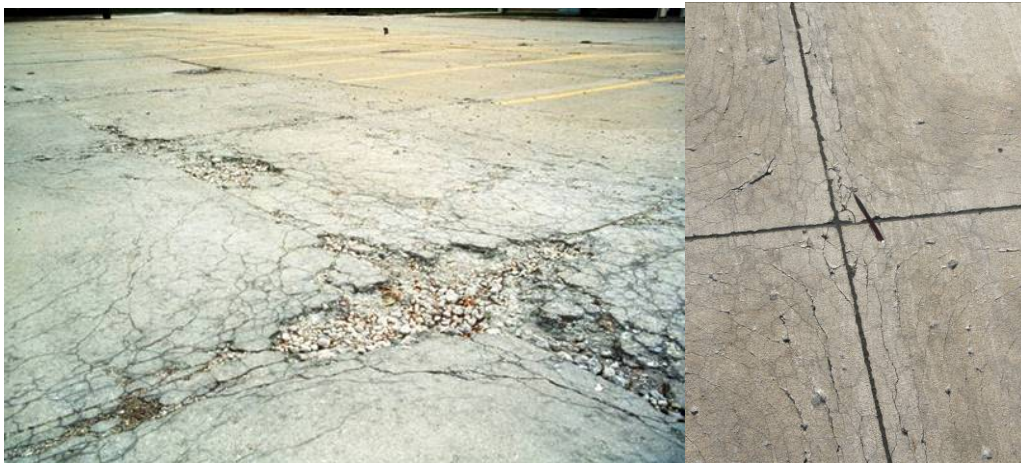
Figure 7. Examples of D-cracking: (left) severe spalling from D-cracking at Grissom AFB, IN; (right) moderate D-cracking with popouts, St. Joe ANG facility, MO.

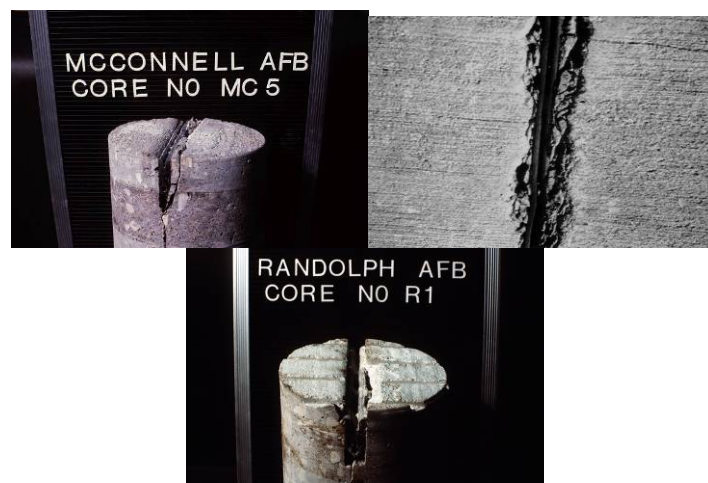
Four runway and apron projects at Grissom AFB, five runway, taxiway, and apron projects at McConnell AFB, and one runway project at Randolph AFB all suffered extensive sliver spalling such as shown in Figure 8 (Rollings and Wong 1992; Rollings 1998; Rollings et al. 2008). Investigations found these pavements were low on air, had high spacing factors, and were vulnerable to freezing and thawing damage, even in mild climates. Figure 9 shows the relation between the spacing factor and occurrence of sliver spalling on these three bases and on one that had no sliver spalling for which data were available. This figure lends credence to application of the 0.20-mm criterion for identifying potential sliver spalling vulnerability in USAF airfields.

Figure 8. Examples of sliver spalls: (top left) McConnell AFB, KS; (top right) Grissom AFB, IN; (right) Randolph AFB, TX.

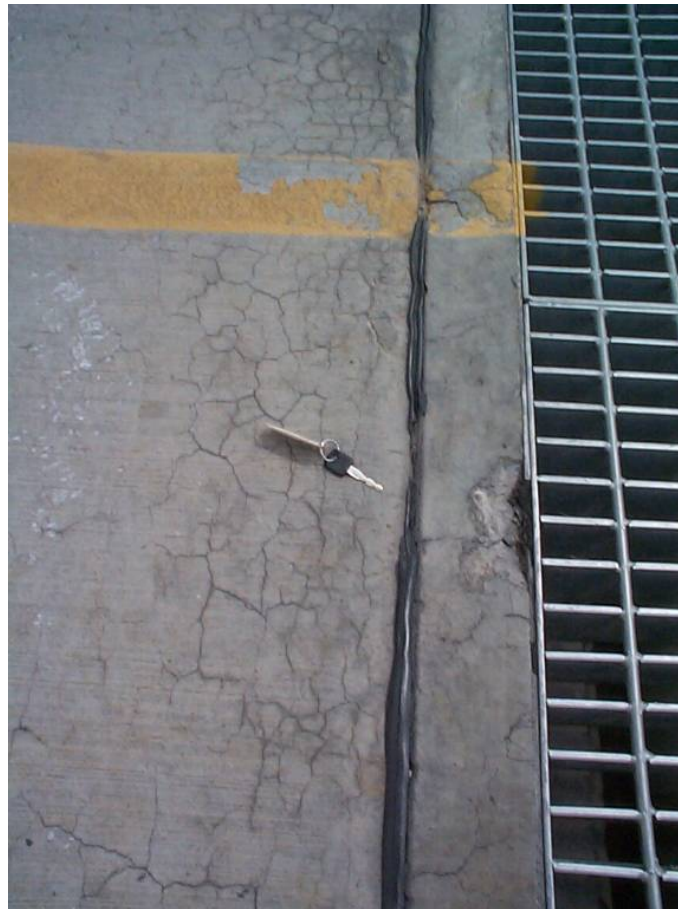
The volume change inherent in alkali-aggregate gel formation and absorption of water puts the concrete pavement in compression (closing joints, heaving shoulders) and can damage adjacent structures, utilities, and pavement. Where these compressive forces are sufficiently large, pavement joints can spall. The pattern of cracking that normally also

accompanies this volume change can encourage this spalling to develop. An example of spalling from alkali-silica reaction expansion is shown in Figure 10.

Figure 10. Example of spalling from alkali-silica reaction compressing expansion joint causing spalling at trench drain, Holloman AFB, NM.

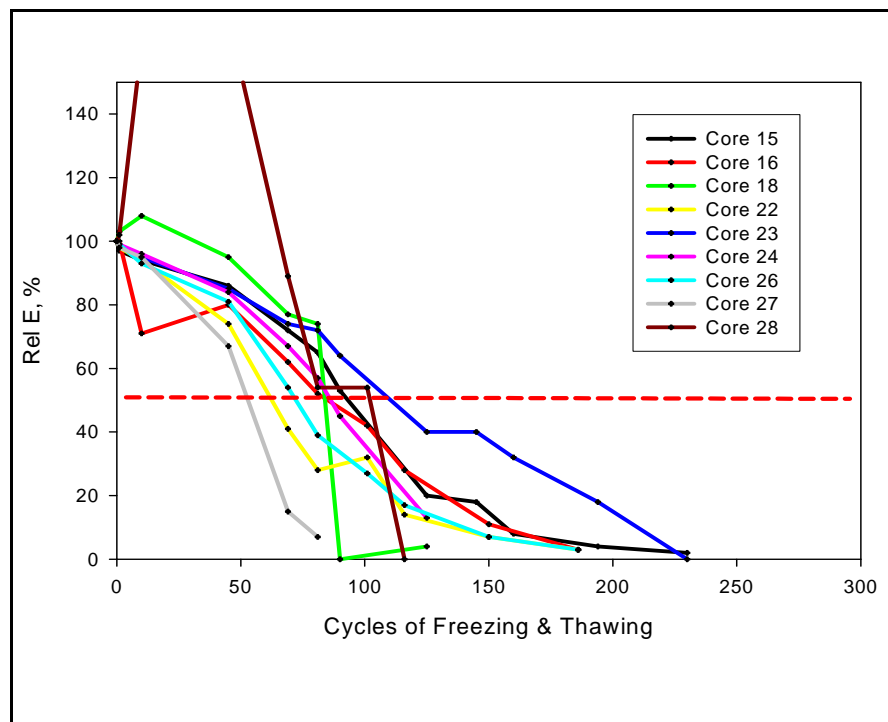
Figure 14. Relative modulus of elasticity versus number freezing and thawing cycles for nine specimens from Offutt AFB.

In general, the specimens from both of these projects did not perform particularly well in the C 666 environment. In both cases, the Rel E fell below 50% within 50 to 100 cycles of freezing and thawing. This would not be considered durable concrete by most standards. However, as will be presented and discussed below, interpretation of these results is not simple.

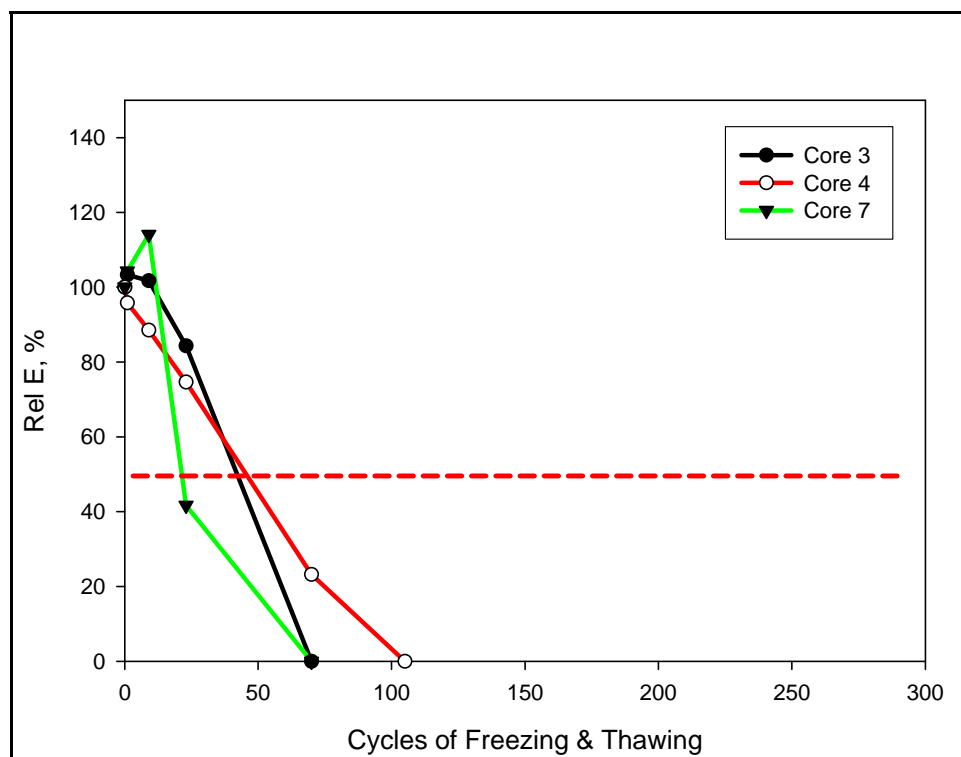
Figure 15. Relative modulus of elasticity versus number freezing and thawing cycles for three specimens from Eppley Field.

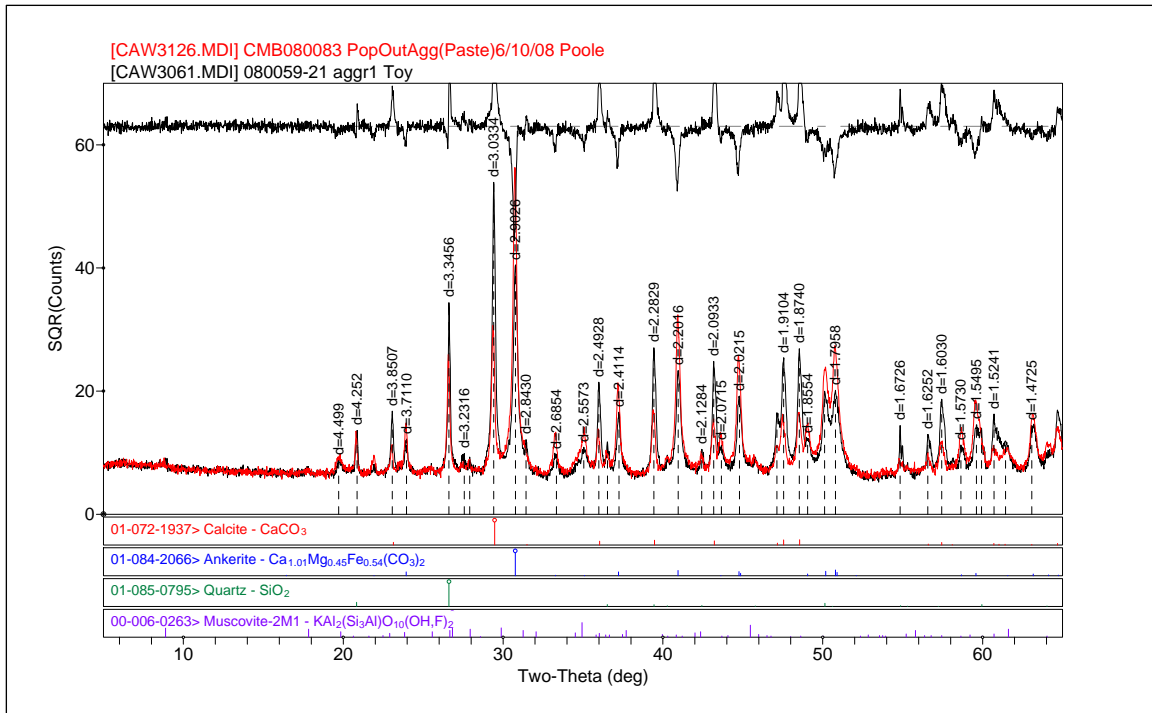
Figure 50 shows the XRD patterns for this rock type, which features ankerite more than most of the other mineral forms found in the concrete. This detail may be significant, since ankerite (in the literature occasionally and also in the authors' experience) is an indicator of rocks susceptible to alkali-silica reaction, and one reference was found for its apparent sensitivity to calcium chloride deicing salts (Dubberke and Marks 1987). There was also a small amount of the clay, muscovite, which could also contribute to unsound performance.

Figure 50. XRD patterns for coarse aggregate particles type causing the common surface popouts observed in the new construction. The rock is a dolomite with higher amounts of the mineral ankerite than the other aggregates used in the concrete. The pattern in red is a composite sample made up of rock from a number of popouts in Taxiway C. The pattern in black is the aggregate particle in Core 21 (Figure 45).

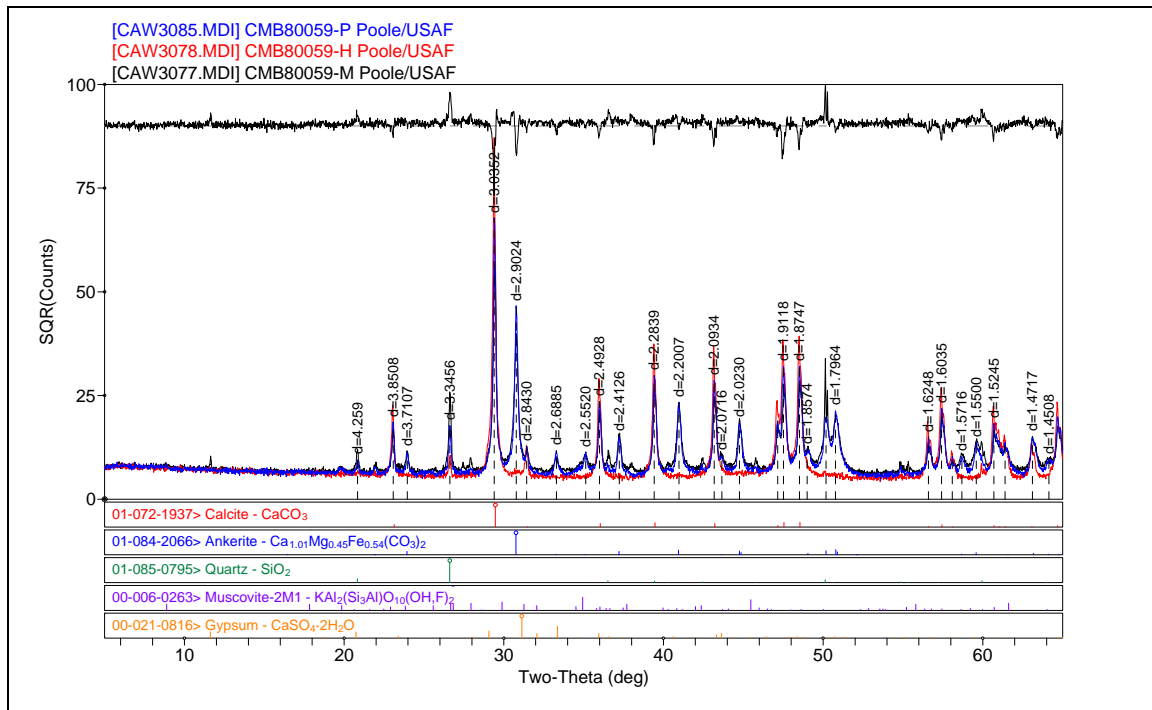
Figure 51 shows XRD patterns for three other damaged aggregate particle types found in C 666 specimens that appeared to be other than the white dolomite described above. Two of these (patterns P and M) appear to be the same mineralogy as the suspect dolomite described above. The other pattern is a pure limestone, but contains a small amount of gypsum, which could be significant, depending on the abundance of this aggregate in the concrete.

Figure 51. Other coarse aggregate mineralogies found in rock damaged by high numbers of cycles of freezing and thawing.

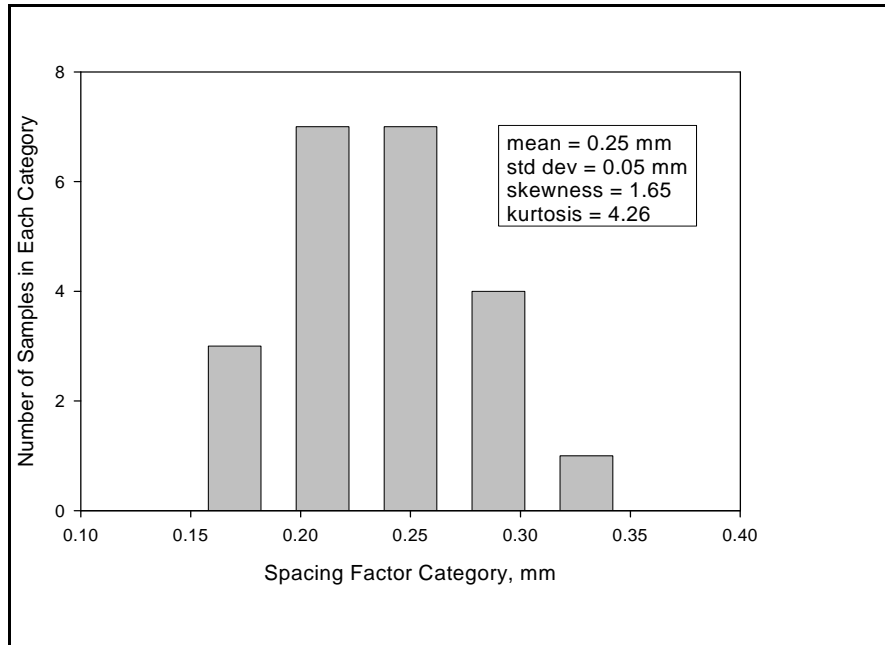
Perhaps the most notable feature of the descriptive statistics is the variability and skew in the spacing-factor data. Figure 53 shows the frequency distribution in this property. The skewness statistic of 1.65 is greater than the critical value of 1.28, which is the maximum expected for a data set of this size if values are purely random. There were a number of observations of spacing factor around 0.30 mm and higher (maximum observed = 0.42 mm). A spacing factor of 0.30 mm may be the upper tolerable value for concrete experiencing many cycles of freezing and thawing while saturated.

This variability in spacing factor is well outside that expected from the random error of the test method, 7% (CV) reported in C 457. The CV among the data reported in Table 5 is 20%. This indicates that the observed high values are not plausibly attributable to observations simply being on the tails of a normal random frequency distribution.

Figure 53. Frequency distribution of spacing factor among samples.
