RESEARCH ARTICLE

Failure modes in cedar tree revetments: Observations on rivers and streams in eastern Kansas, USA

How to cite this article: Shelley, J., Haring, C., & Chrisman, N. (2022). Failure modes in cedar tree revetments: Observations on rivers and streams in eastern Kansas, USA. *River Research and Applications*, 1–11. <https://doi.org/10.1002/rra.3997>

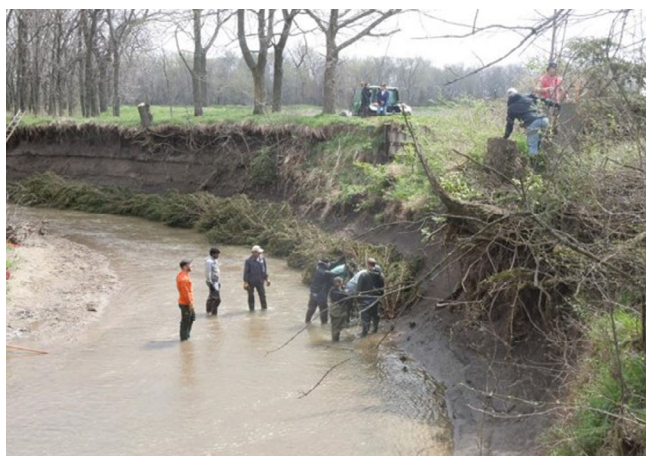
Multiple sites showed evidence of recent bed degradation, the lowering of local base level due to channel incision processes. These channel geomorphic processes have been qualitatively described in Channel Evolution Models (Cluer & Thorne, 2013; Hawley, Bledsoe, Stein, & Haines, 2011; Schumm, Harvey, & Watson, 1984; Simon & Hupp, 1986) that predict channel widening and deepening conditions in degrading channels. At the Wolfley Creek project (Site 12), the bed degraded, which stranded the revetment above the new, unprotected toe. Figure 4 shows the installation of a single row of cedar trees lining the toe of Wolfley Creek. In Figure 5, the single row of cedar trees is visibly perched above the base flow water surface. Multiple knickpoints ranging from 150 to 300 m upstream provided further indication of recent degradation. Based on installation notes (pers. commun., Charles Barden, 2020) and channel changes upstream viewed during the site visit, the channel lowered 0.3 to 0.6 m in elevation since construction of the revetment.

FIGURE 4 Construction of the cedar tree revetment on Wolfley Creek April 2017 (Nassar, 2019) [Color figure can be viewed at wileyonlinelibrary.com]

At Wolfley Creek, widespread revetment failure had not occurred as of the visit. At other sites where a resistant toe was absent, this level of degradation could lead to toe undercutting and slope failure.

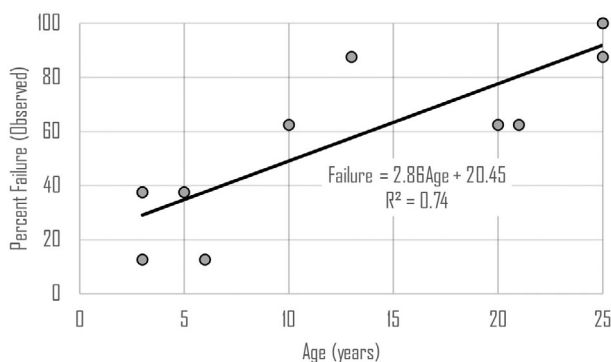
Correlation analysis indicated that the percent failure correlates strongest with the age of the project and second with the bank height. Figure 12 presents a linear best-fit equation between project age and observed failure percentage. This indicates that progressive weakening from repeated bending, oscillations due to loose cables, channel degradation, flanking, and other processes that occur over time may be significant failure mechanisms.

**FIGURE 12** Failure rate as a function of project age

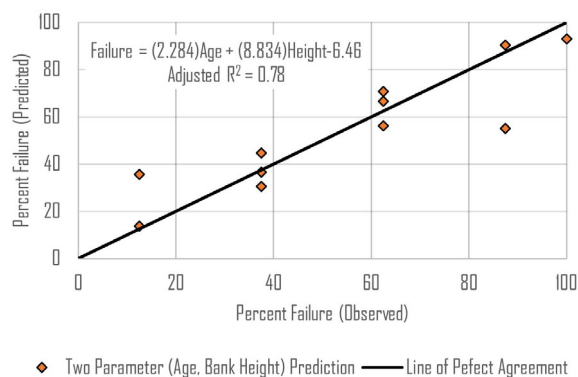
The bank height was also weakly correlated with the age of the project (the bank height is smaller at newer projects), but including both parameters in a multivariate regression yielded a slightly stronger prediction. The first parameter (age) has a p -value of 0.0024. The second parameter (bank height) has a p -value of 0.07. Figure 13 shows the agreement of the multivariate equation with the observed values.

**FIGURE 13** Failure rate as a function of age and bank height [Color figure can be viewed at wileyonlinelibrary.com]

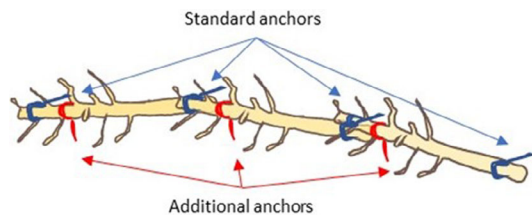
FIGURE 14 Concept for a third anchor oriented downward [Color figure can be viewed at wileyonlinelibrary.com]

Bending stress can be reduced significantly by adding a third anchor between the typical two anchors at the location of maximum moment (Figure 14). This echoes other authors' suggestions that additional anchoring could reduce failures in woody debris structures (D'Aoust & Millar, 2000; Miller & Craig Kochel, 2013; Shields Jr., Knight, Morin, & Blank, 2003). The results in Table 6 indicate that with only two anchors, bending stress may induce failure even in the as-built condition should a sufficiently large hydrologic event occur. Using the equations presented in the Methods section and the dimensions shown in Figure 3, the bending stress is minimized to 17% of the original stress by adding a third anchor 23% of the way from the existing tip anchor to butt anchor, which is the location of maximum moment. Moreover, a third anchor placed at the location of the maximum moment would significantly reduce the magnitude of cyclical bending of the tree, which might decrease weakening over time and lead to increased longevity. Differing dimensions of any given tree will dictate a slightly different optimum placement location for the third anchor, but the anchor should be closer to tip rather than in the middle. To reduce floating should some erosion occur behind the revetment, the additional “middle” anchor should be anchored to the bank or bed below the revetment rather than level with the existing anchors.

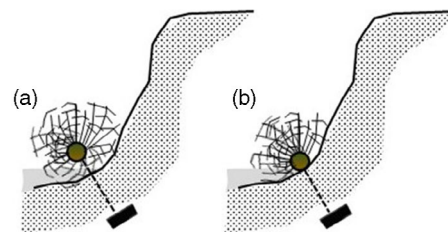
FIGURE 15 (a) Configuration of visited revetments. Branches between the trunk and the bank may break off over time. (b) Suggested configuration. Bank-side branches removed and trunk installed in contact with soil [Color figure can be viewed at wileyonlinelibrary.com]

Finally, the branches on the bank side of the revetment could be trimmed to allow the trunk of the cedar to be flush with the bank (Figure 15)—a technique practiced with success by the Anoka Conservation District in Minnesota, USA (Pers. Commun., Mollie Annen, 2021) but not widely utilized elsewhere. This would eliminate loose cable due to the deterioration of the bank side branches and allow

tighter anchoring to the bank, which would decrease the impacts of trees floating and oscillating and could lead to greater sediment retention.
