# Memorandum

**File:** 07-LA-010-45.73  
59-93034-N  
0000001016- 6SSCN  
Gary Avenue UC  
Bridge No. 53-0855

**Subject:** **Evaluation of Fault Rupture Potential, Gary Avenue UC, Bridge No. 53-0855, Post Mile 45.73, Interstate 10 (San Bernardino Freeway), Los Angeles County, California**

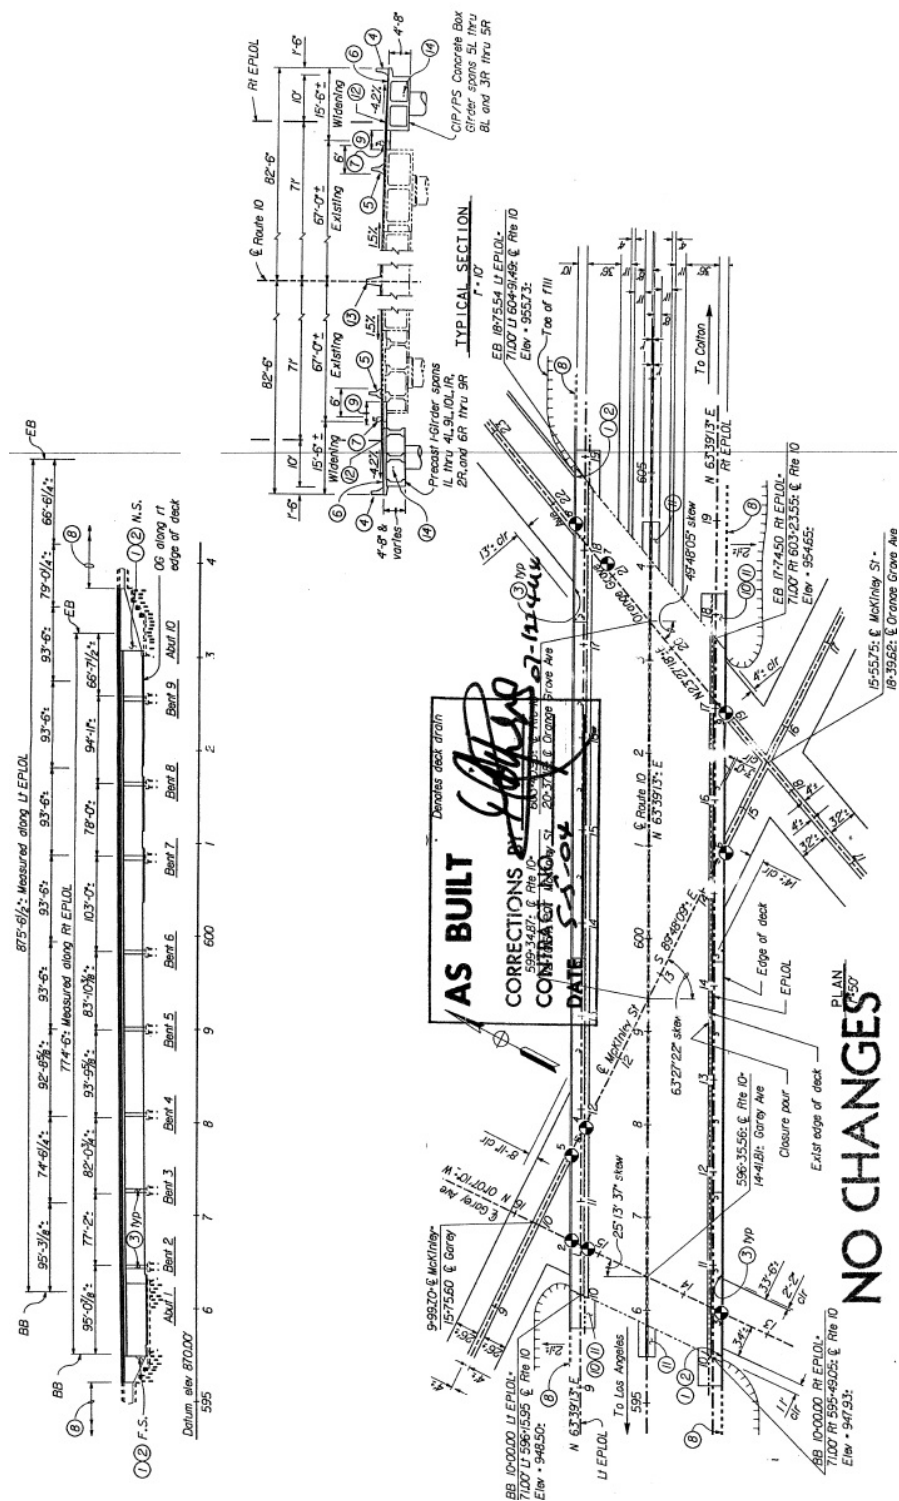
The bridge was again widened in 2004 by additions to the respective outside edges of the existing structure. The resultant bridge is now about 822 feet long (centerline), and 164 feet wide (Figure 2).

Figure 2: Gary Avenue Undercrossing Elevation and General Plan, After As-Built General Plans, 2004.  
 (Note: Bent 10 and Abut 11, Abut 10 is incorrect)

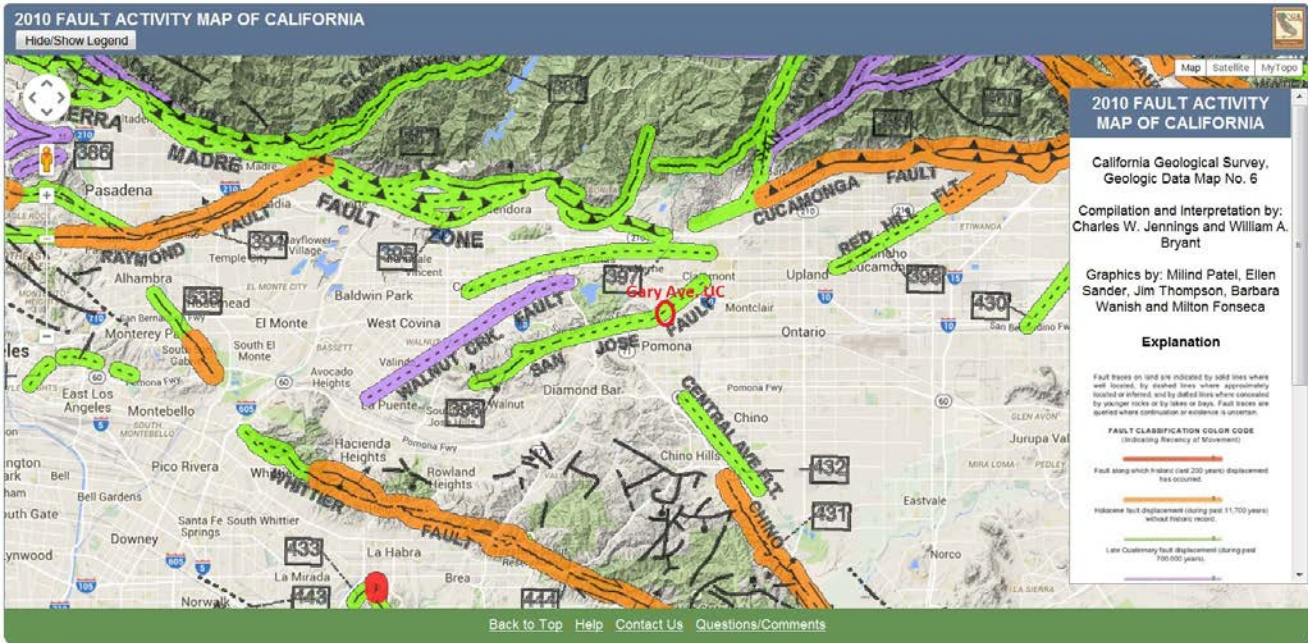
The San Jose fault (SJF) is a northeast trending, 20 mile (32 km) long, north dipping, sinistral strike slip fault, with a minor reverse component. It extends east from the central part of the San Jose Hills, through the campus of Cal Poly Pomona, south of and adjacent to Interstate 10 along the margin of the San Jose Hills. Then near the eastern edge of the San Jose hills the fault bends to the northeast, crossing Interstate 10, and continuing towards the City of Claremont (Figure 3). The fault is poorly exposed in the Miocene rocks of the San Jose Hills of the Cal Poly campus. To the east of Cal Poly the inferred fault is expressed as a surficially concealed shallow groundwater barrier in the Holocene aged valley fill alluvium near the southern flank of the San Jose Hills, and beyond (Figure 4). The expected maximum moment magnitude earthquake for the San Jose fault is  $M_w = 6.6$  with a slip rate of 0.6 mm/yr (Caltrans, 2012).

Figure 3: Regional Fault Activity Map (CGS, 2010).
