Sinking of US Cargo Vessel SS *El Faro*  
Atlantic Ocean, Northeast of Acklins and Crooked Island,  
Bahamas  
October 1, 2015

NTSB/MAR-17/01  
PB2018-100342

# Marine Accident Report

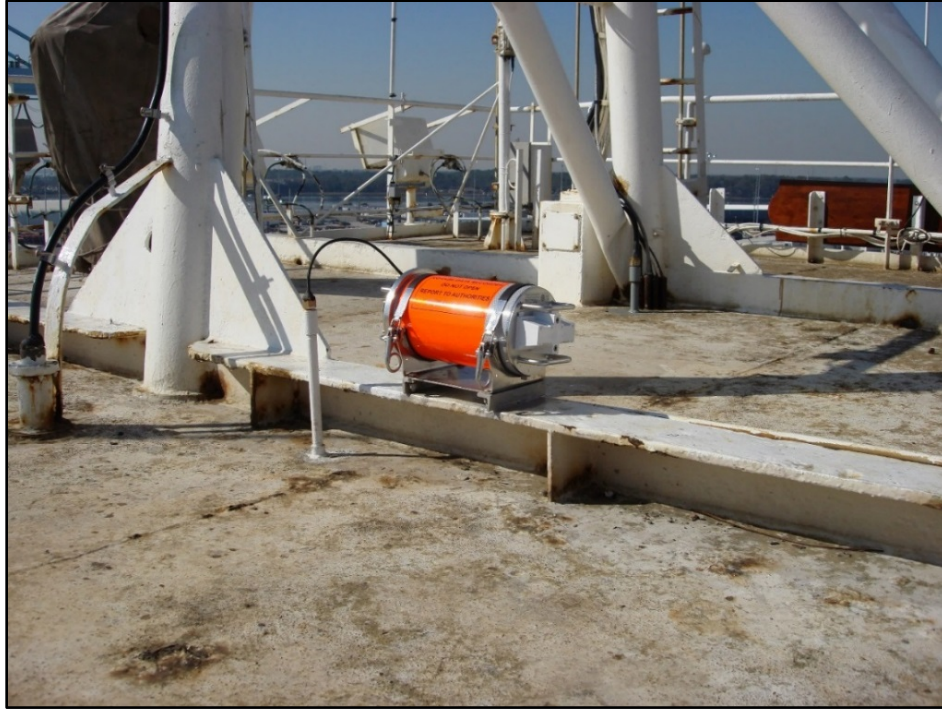
**Voyage Data Recorder.** As required, *El Faro* was equipped with a simplified VDR (S-VDR) that was installed in January and February 2009.<sup>78</sup> The device was a Northrop Grumman Sperry Marine Voyage Master II, manufactured by Danelec Marine (Birkerød, Denmark). The VDR capsule was attached to a steel channel at the base of the antenna mast on the deck above the bridge (figure 15).

**Figure 15.** VDR capsule on deck above *El Faro*'s navigation bridge. (Radio Holland photo<sup>80</sup>)

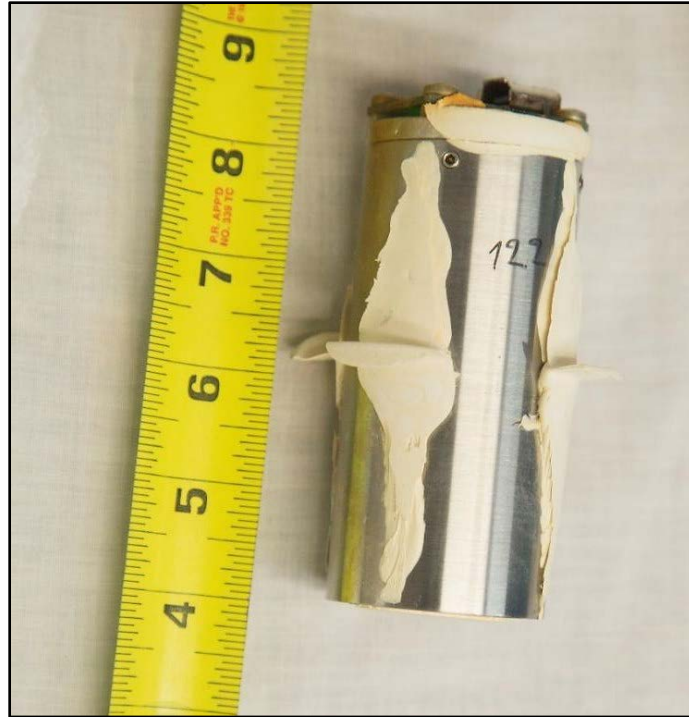
The VDR data were stored on a flash memory chip inside a protective capsule. On August 8, 2016, after the capsule was recovered from *El Faro*'s wreckage, it was submerged in a bath of distilled water aboard the Navy vessel *Apache*, then disassembled and inspected for possible damage to the internal recording medium. Inside the capsule, layers of protective materials housed an inner capsule containing the circuit board assembly that stored the nonvolatile memory (figure 16).<sup>82</sup> The circuit board assembly was inspected for visible signs of damage or corrosion (figure 17) before being transported to the NTSB laboratory in Washington, DC, on August 12.

**Figure 16.** Inner VDR capsule assembly after removal from outer capsule.

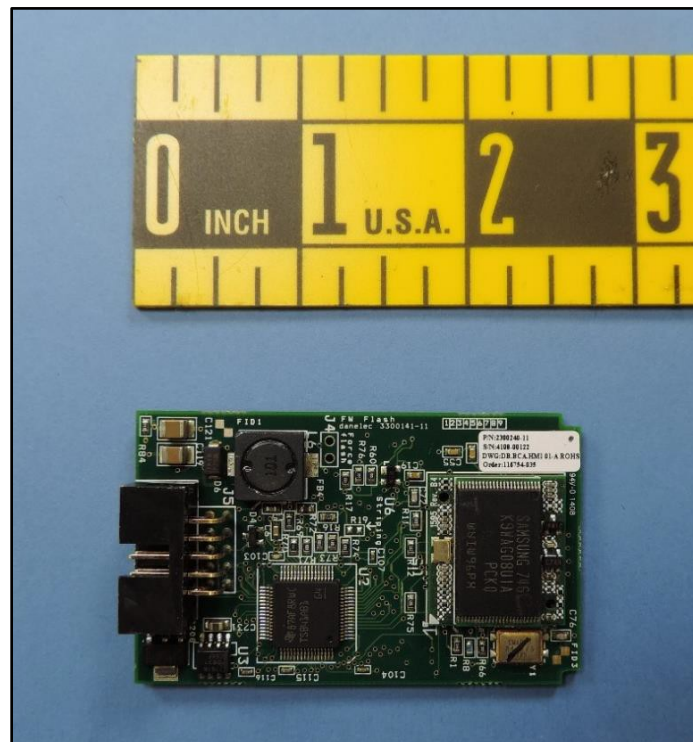
**Figure 17.** Circuit board assembly from inner VDR capsule.

On August 15, 2016, at the NTSB laboratory, the circuit board assembly from the inner VDR capsule was connected to a functioning surrogate assembly, provided by Danelec. The manufacturer provided technical support and witnessed downloading of the VDR data. A forensic write-blocking bridge was used to copy data from the circuit board assembly.<sup>83</sup> Using manufacturer-provided VDR playback software, the data were exported to a common data file structure for further analysis.<sup>84</sup>

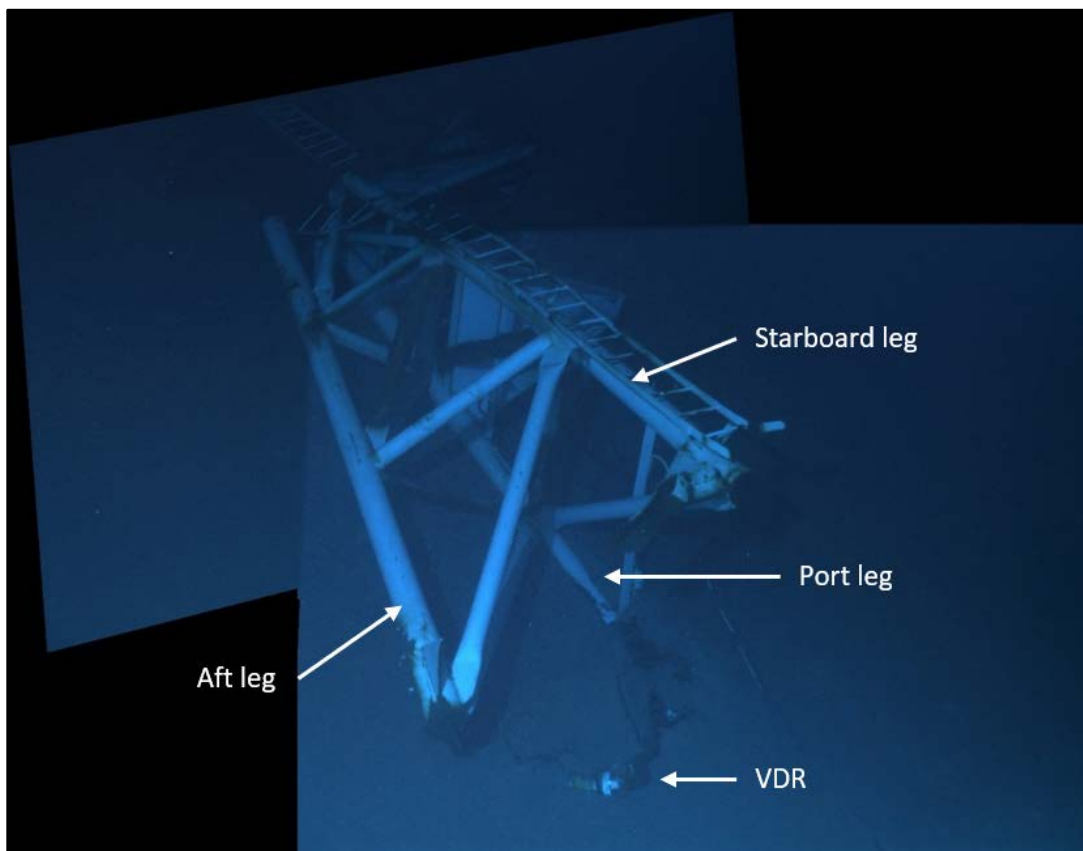
The tripod mast and VDR capsule were discovered on the seafloor about 1,640 feet (0.28 nm) north of the main hull (figure 29). The large structural members were intact, but the overall structure was bent aft. The VDR was attached to the port leg and buried in mud.

**Figure 29.** Mast and VDR capsule on seafloor. (Photomosaic image from mission 2)

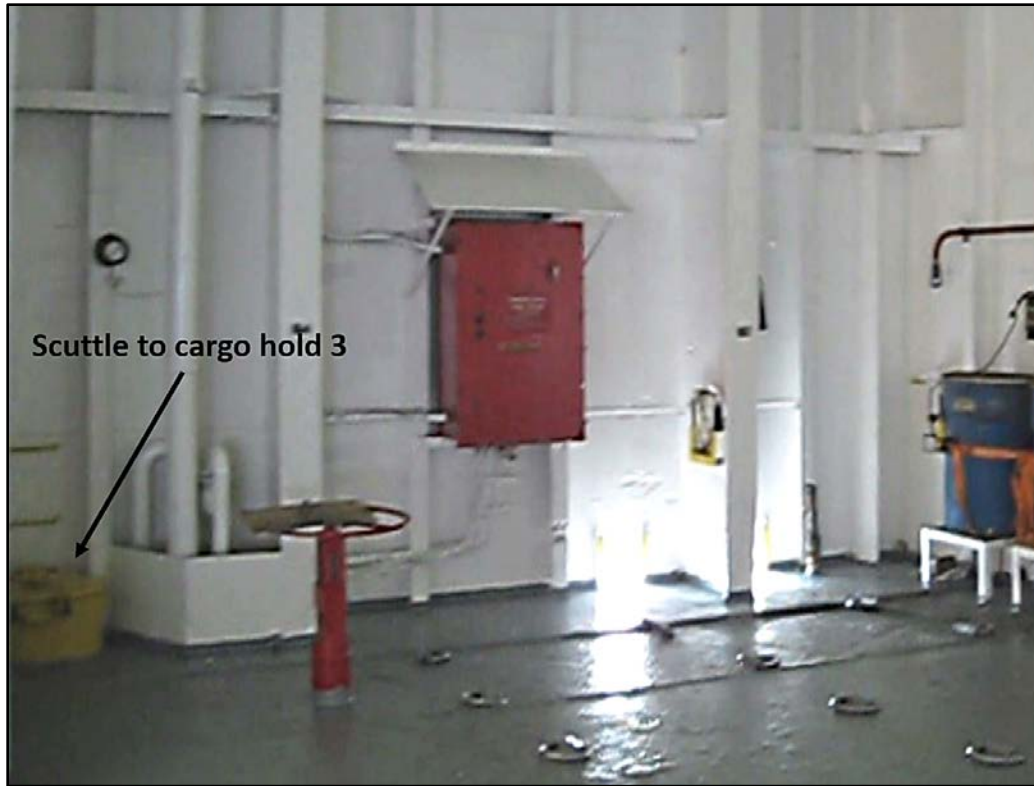
The VDR recording indicates that the vertical-access scuttle on the starboard side of the second deck that led to hold 3 was open during the accident. General arrangement drawings (such as figure 56) show that the second deck had two scuttles (called RWTHs [raised watertight hatches] on the drawings), through the second deck to hold 3, at frame 163 on the starboard side and at frame 138.5 on the port side. Hold 2A also had two such accesses. Figures 57 and 58 show the scuttle on the starboard side of the second deck to hold 3 and the scuttle on the port side to hold 2A.

**Figure 57.** Second deck scuttle to hold 3. (Photo by former *El Faro* second mate)

The steel plates or covers to the scuttles were characterized by crew and officers as being heavy and hard to open. A former *El Faro* chief mate and captain stated that he had “never seen one pop open on its own.” Another former captain of *El Faro*, who had nearly 27 years’ experience as captain or chief mate on that ship and other vessels of the *Ponce* class, stated, “I don’t see a wave getting in there and lifting [a scuttle]. Even if it was not dogged.”

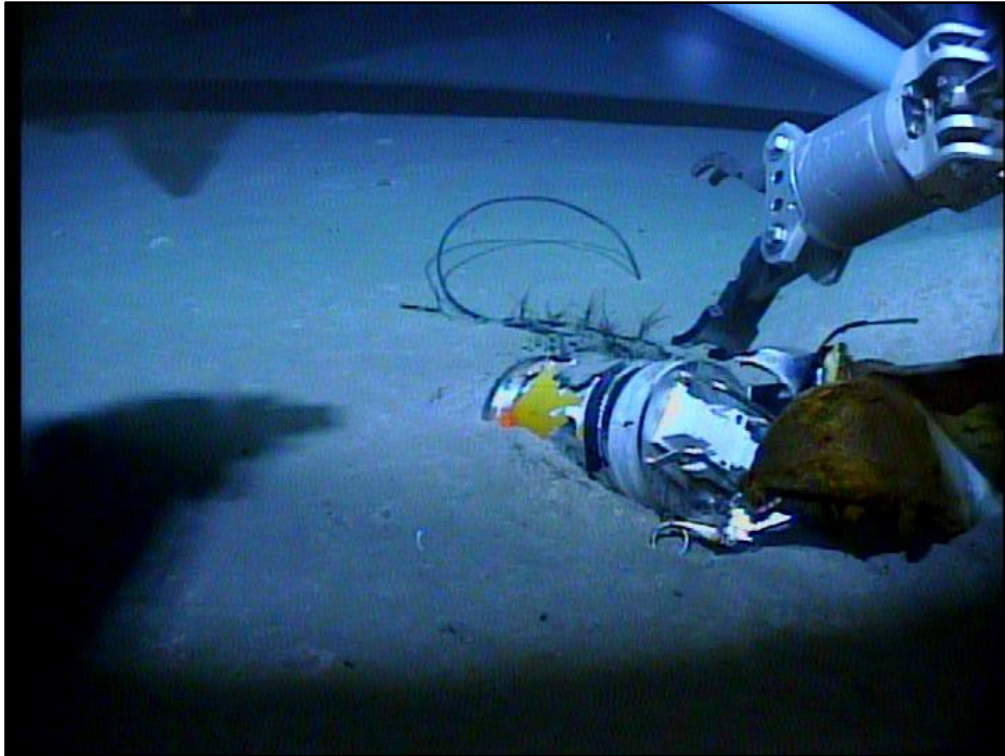
**Figure C-2.** CURV-21 freeing VDR capsule from seafloor. (US Navy photo)

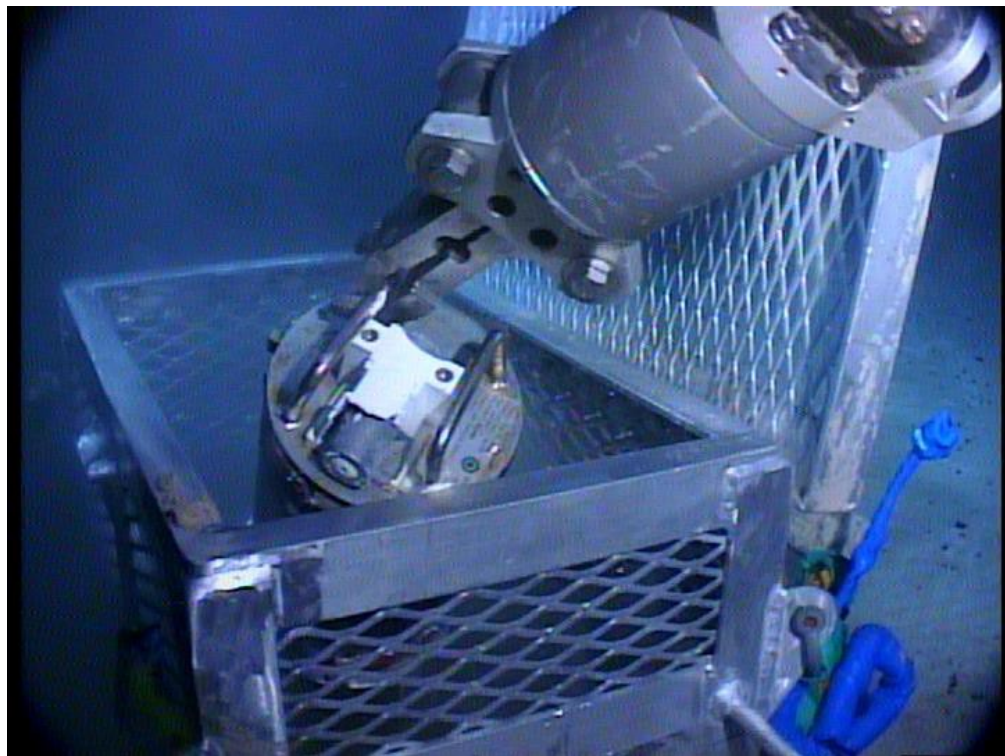
**Figure C-3.** CURV-21 placing VDR capsule in basket for transport to surface. (US Navy photo)
