ASANTE TRADITIONAL BUILDINGS: SURVEY AND CONDITION ASSESSMENT

January 2014

Survey, Assessment, and Report by:

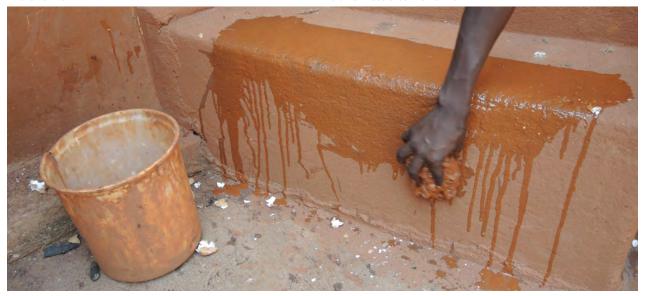
Red Clay Slurry Application at Abirim

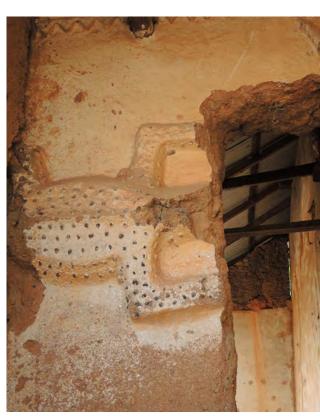
Decoration in Poor State of Conservation at Adarko Jachie

- -Halt work on the new decorative elements.
- -Reduce the effect of water splashing against the wall of the shrine by fixing roof gutter on the northern side of the shrine room.
- -Create drainage slopes with laterite on the eastern side where the wall is severely undermined.
- -Install wooden posts to support house roof.
- -Document the remaining decorations for future restoration.

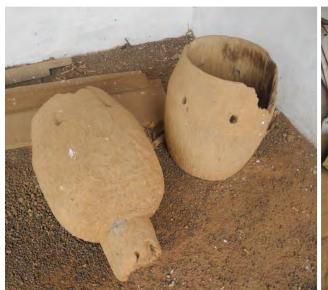
Movable heritage is in very poor condition and none of the stools and chairs can be used; the drums are beyond repair.

Drums at Asawase Schnapps at Asawase

6 The furniture is in very poor condition to the extent that none of the stools and chairs can be used and the drums are beyond repair.

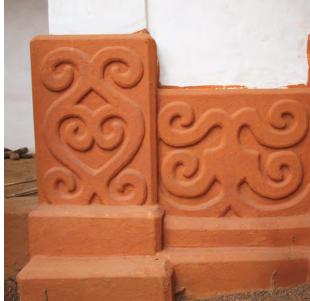
Decoration Detail at Asawase

The site itself is in a good state of conservation. The walls are stable and most of the decorative elements are in good condition despite one being partially broken above the entrance. One of the panels has received new decorations under the auspices of GMMB. However, the panel needs to be redone as it lacks depth in the layering. Good archival photographs are available to reconstruct the decorative elements. GMMB trained three students from the Junior Secondary School for one week and small decoration samples were produced.

5 Decorative elements partially broken above the entrance.

- -Add one truck of laterite at the back of the building to replace the eroded soil.
- -Replace roofing sheets, one hundred ten, and ridge caps.
- -Recreate the decorative element.
- -Adjust the drainage slope along the Drummers' Room.
- -Restore the decorative element above entrance door.

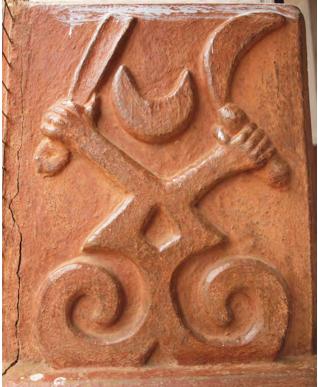
Decoration Detail at Entrance to Asawase

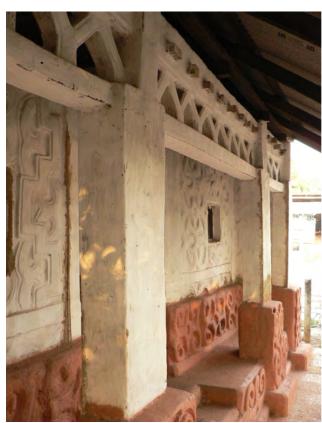
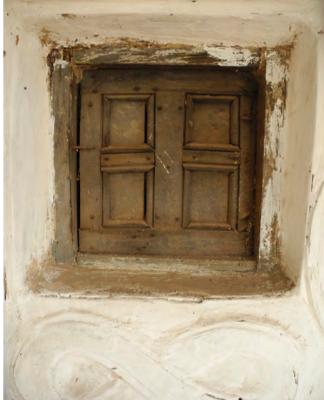
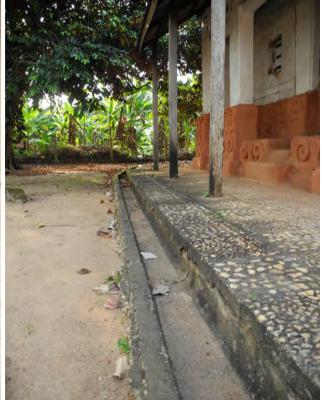
The walls are in good condition and only three minor cracks are visible towards the anterior. However, traces of termites are visible all around the building, especially at the base. Termites have also adversely affected all wooden elements such as the four wooden posts supporting the roof overhang. The door and the only remaining wooden window shutter have been partially destroyed by termites. The other shutter, once wooden, has been replaced by three precast concrete blocks.

Decorative elements are all visible, but slight deterioration can be seen. Elements of concrete plaster

have detached from the wall, but the process is slow and was also observed ten years ago. Perforations made by insects can be seen in various parts along the wall base mainly on the principle elevation.

Decorated Wall and Beam at Asenemaso

Window at Asenemaso

- -The two drains should be cleared.
- -The four wooden posts need to be replaced with treated wood, 3 x 3", preferably with a termite shield installed.

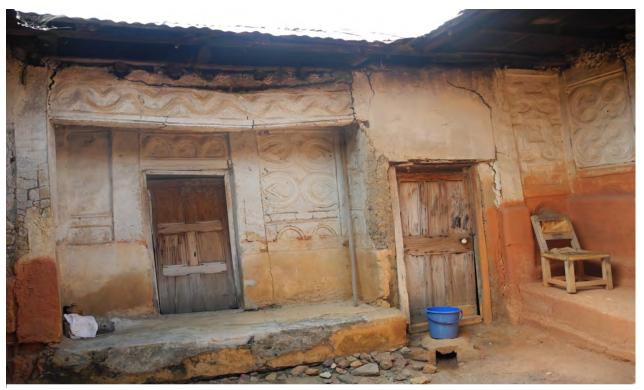
Courtyard of Chief's Palace at Bodwease

In sharp contrast, the Chief's Palace is in extremely poor condition. This is very worrying because the central room where the chief receives the village elders keeps a high level of authenticity. Maintaining this authenticity will be a real challenge. Any intervention should be made with the greatest care to avoid falsifying this unique testimony. For example, it is important to accurately measure the level of restoration if conservators intervene. The destruction of this element would be an irreparable loss. All the rooms have lost their roofs and part of the walls except the central room where the chief sits. It is therefore urgent to react quickly so as to avoid losing this last element.

- -Preparation of a risk management and conservation strategy.
- -Cleaning the ruins and dismantling the broken roofs.
- -Work on the drainage to avoid water stagnation in the ruins.
- -Reconstruct the missing walls of the Palace.
- -Remove and replace the roofs of the Palace.
- -Restore the damaged decoration.
- -Underpin the heavily eroded exterior wall bases.

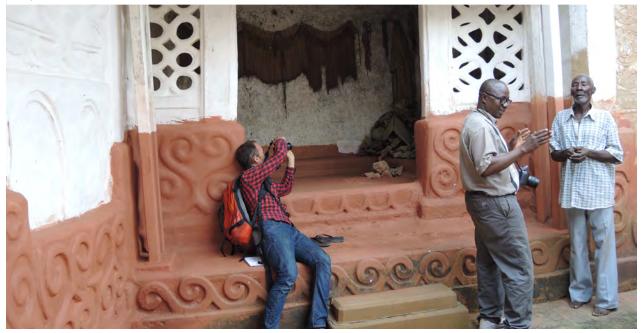
Shrine Room at Bodwease

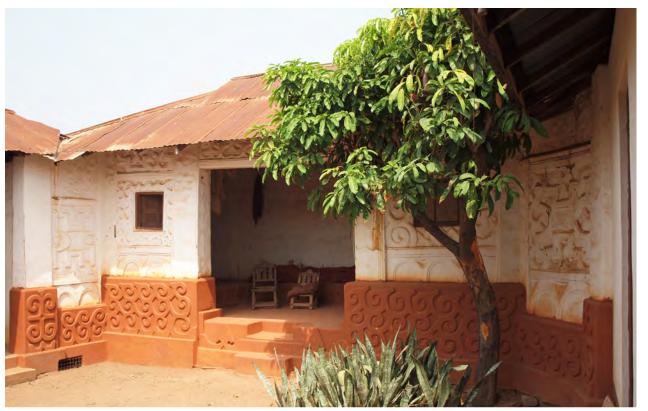
Courtyard at Edwenase

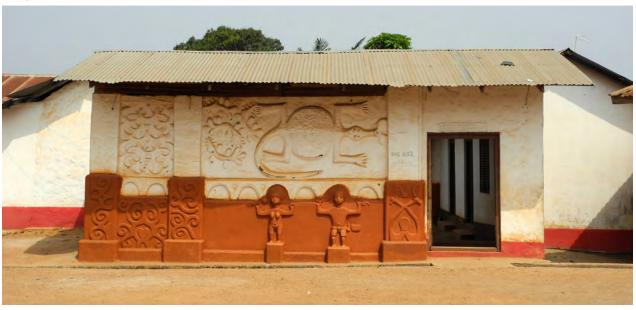
Front Elevation at Edwenase

The roof needs attention and water is dripping on the decorative elements in several places leading to slight erosion. Repairs to decorative elements fourteen years ago have not been altered and are, in general, in very good condition. This includes the large decorated wall outside the shrine where only the nose of the figurine on the right hand side is broken. Some termite holes are visible, but no major destruction was observed.

- -Replacement of the roofing sheets, approximately ninety sheets, and timber support elements.
- -Treatment of doors and other wooden parts with insecticide.
- -Treatment and filling of termite holes.
- -Restoration of the damaged decorative elements.
- -Replacement of the drop ceiling above the shed in the courtyard of the house.

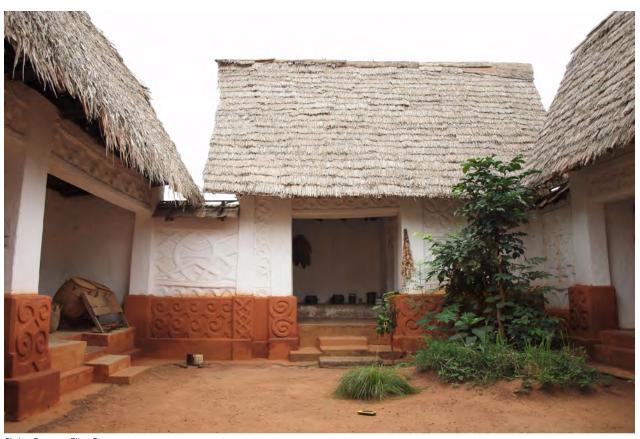
Shrine Room at Ejisu-Besease

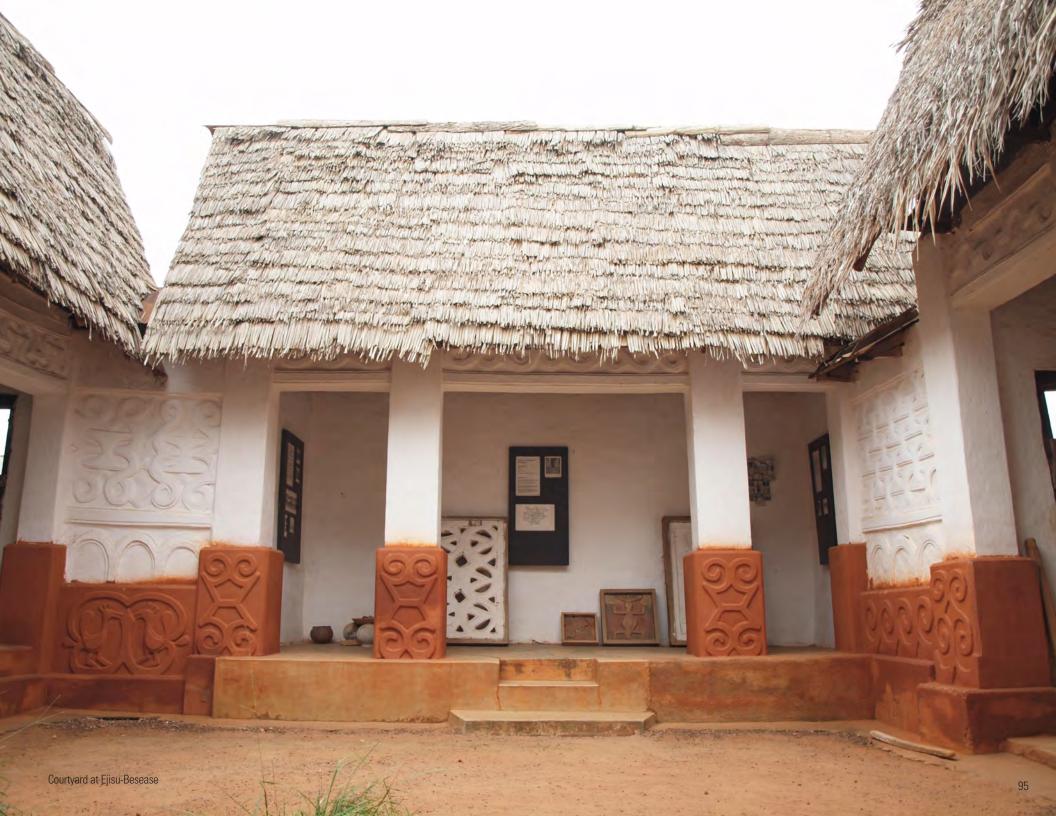
EJISU-BESEASE: State of Conservation Visual Summary

1 Some roof elements are leaking.

(2) Humidity is very high in the wall base due to the dome-shaped courtyard.

5 The high humidity level is affecting decorative elements and there are cracks in the cement plaster at plinth level.

6 Some raffia shingles need to be replaced.

7) The adjoining house is leaking. One of the roofing sheets is already torn.

8) There is only one damaged roadside signboard left from 1998 work.

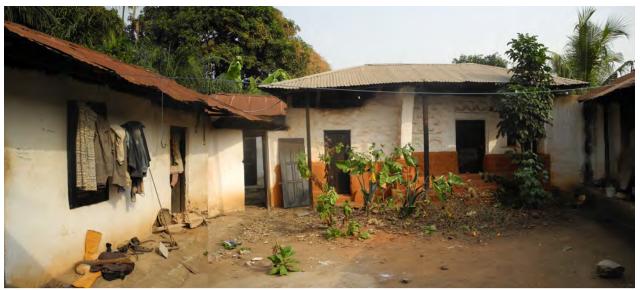
Courtyard at Kentinkrono

Despite the fact that people live here, this site is poorly maintained. The courtyard is used for indoor farming and the Drummers' and Singers' Rooms are used as storage spaces for tools and building materials. The activities taking place in the shrine are neither compatible with its function nor its status as World Heritage Site. This being said, the structure is perfectly sound and the decorations are in very good condition. It is only the roof that is getting old and needs replacement in several places.

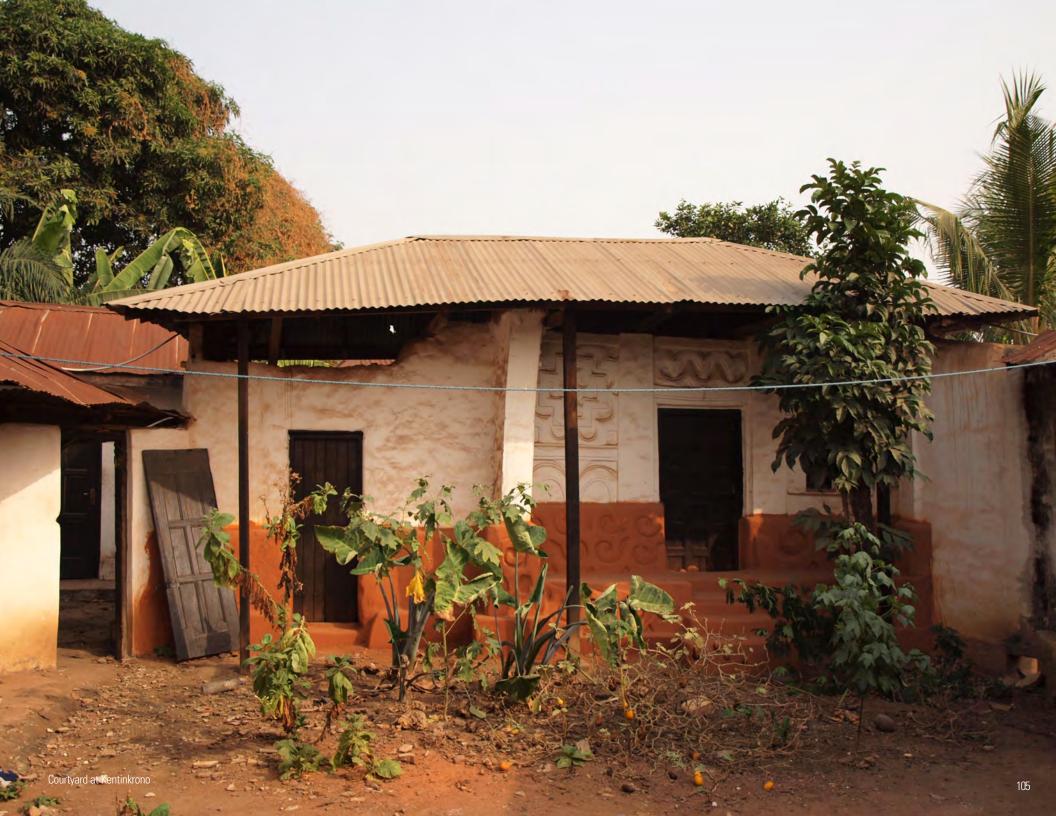
KENTINKRONO: State of Conservation Visual Summary

(4) The roof is in poor condition, many parts are leaking.

5 The walls are in poor condition due to the roof leakages and short overhangs.

- **Urgent Work Needed**-Request that site users better respect this sacred and important building.
- -Replace roofing sheets, approximately eighty sheets.

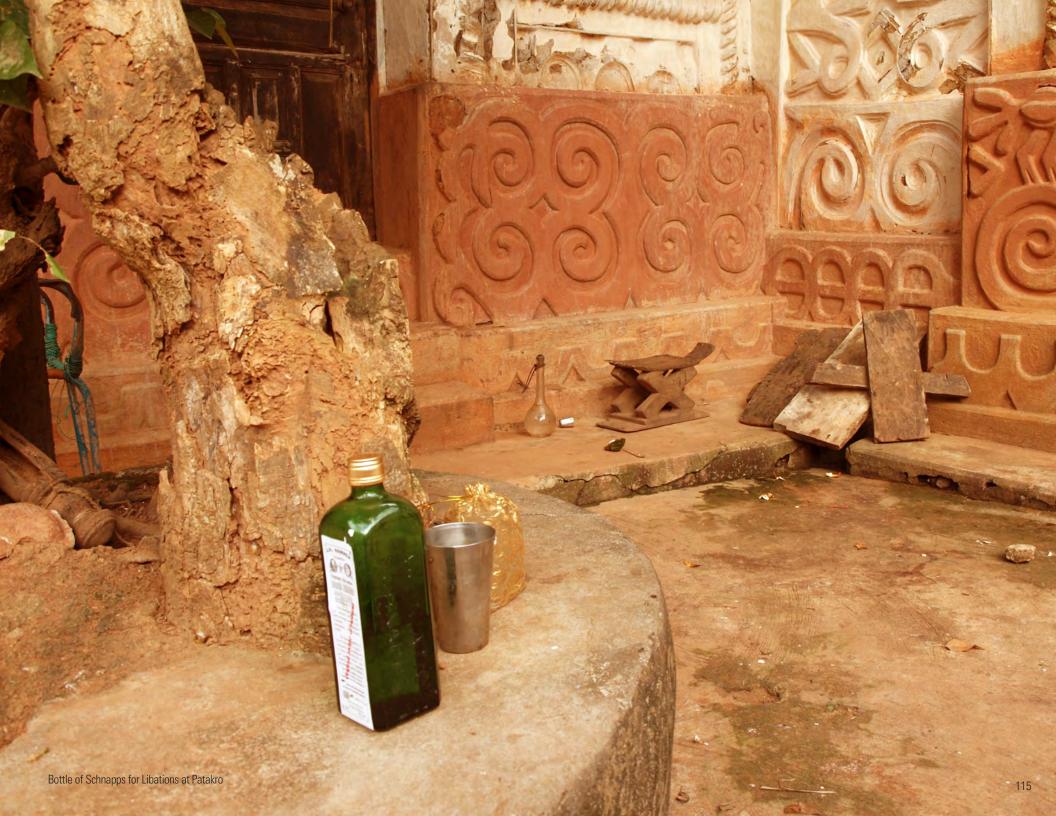
PATAKRO: State of Conservation Visual Summary

1) Roof eaves are too short and do not protect decorative elements. Several sheets are leaking.

(6) The sand-cement screed on the external walls contains a great deal of damage and many parts have started to peel off.

- -Extend the roof eaves all around the courtyard.
- -Restore the decorative elements.
- -Re-roof the four rooms at the back.
- -Replace the missing door in the first room.
- -Break the sand-cement plaster where it has started peeling off and replace with stabilized soil plaster.
- -Treat the wood.

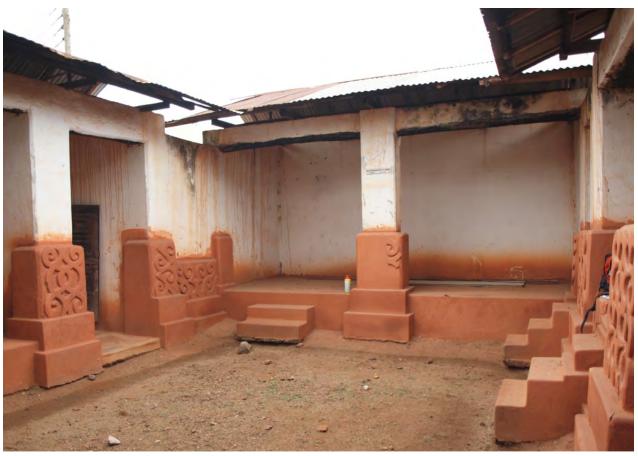
Courtyard at Saaman

Rainwater management is key to the continued preservation of this site. The gutters are currently forcing water into the building and lack proper drainage which has resulted in severe erosion and high humidity. Connections between various roof lines are poorly designed. At the back of the Singer's Room outside the building, several humidity problems also occur due to the topography and nearby refuse heaps. The slopes allow high quantities of water to flow towards the shrine including rain water but also bathing water from the neighbors' house.

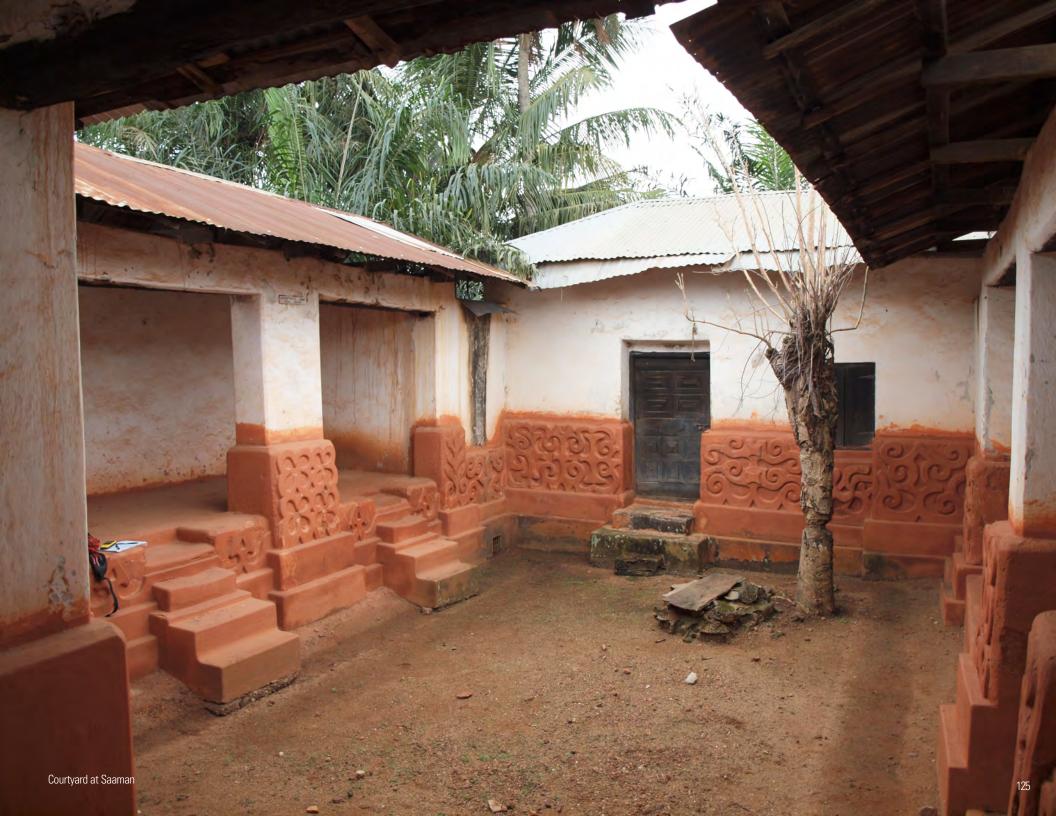
SAAMAN: State of Conservation Visual Summary

4 GMMB conducted repairs on the roof above the Drummers' Room in 2013.

2 The courtyard is dome-shaped and water flows towards the walls and columns. Humidity at the base is therefore very high.

3 Drainage around the building is not efficient. Humidity in and around the building is extremely high.

6 Garbage heaps exist behind the building.

- -Introduce soft landscaping on the ground around the shrine to reduce humidity, especially behind the Drummers' Room
- -Landscape the courtyard
- -Trim branches of the sacred tree but also branches of the raffia palm tree at the back
- -Design new water gutters under the roofs
- -Landscape the courtyard to drain water towards the center rather than on the edges
- -Shift the refuse waste piles further away from the building
- -Restore the decorative elements once the roof problem is fixed
- -Install road signage
