APPENDIX C
Aerial and Site Photos

Supplemental Environmental Baseline Survey – Republic of Palau

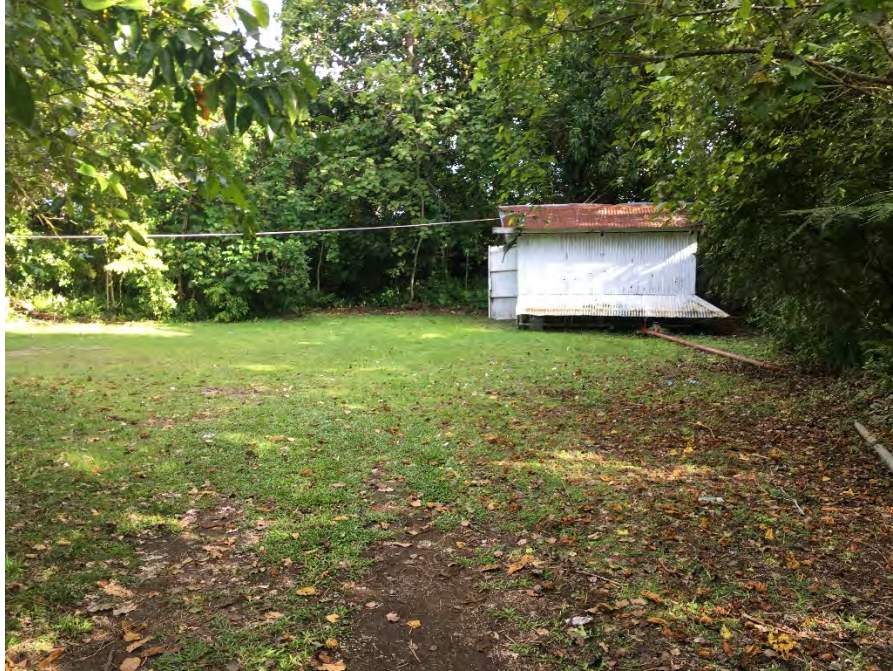
Photo No. 65 – 20 November 2019
Sample point 19PA-SW-02 looking southeast to the landfill on Angaur Island. Looking southeast.

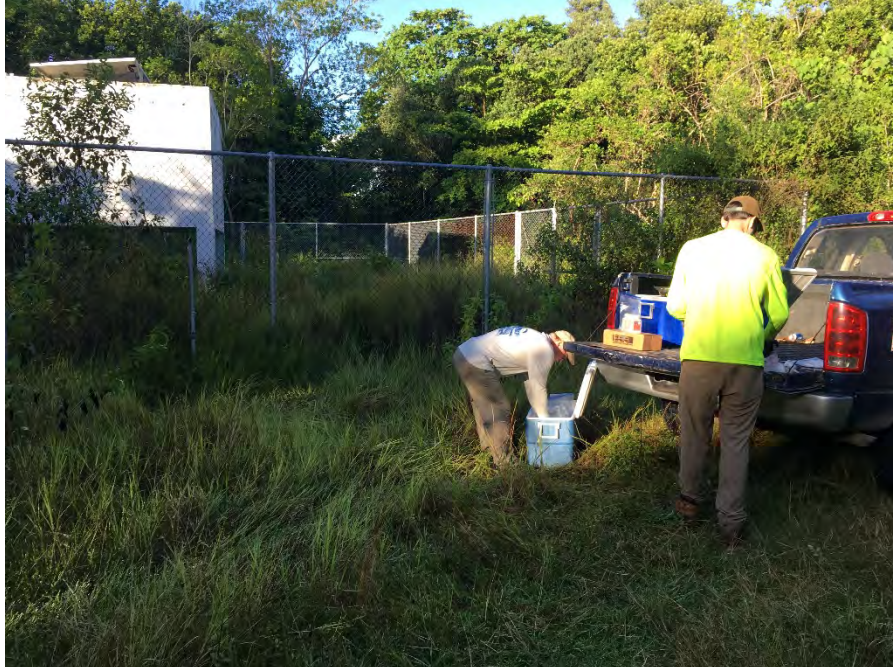
Photo No. 66 – 20 November 2019
WWII era well used to supply Angaur with running water. Sample location 19PA-GW-01.
Looking southeast.
