Dysartgallen Church & Graveyard

Ballinakill, County Laois.

CONSERVATION MANAGEMENT PLAN

November 2020

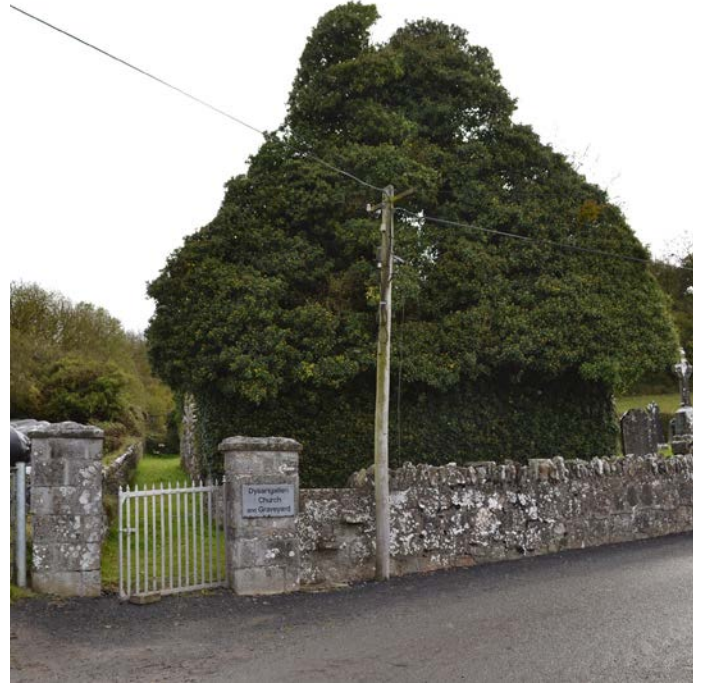
West gable prior to trimming.

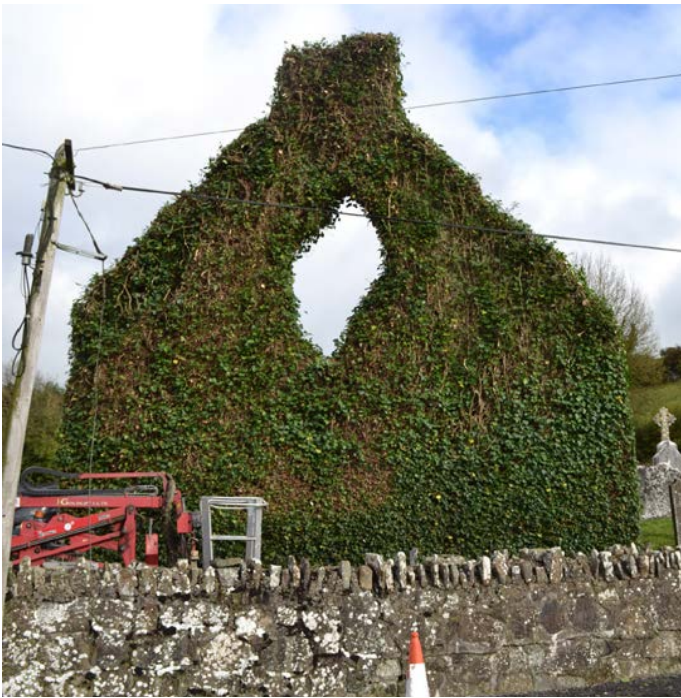
West gable after trimming.

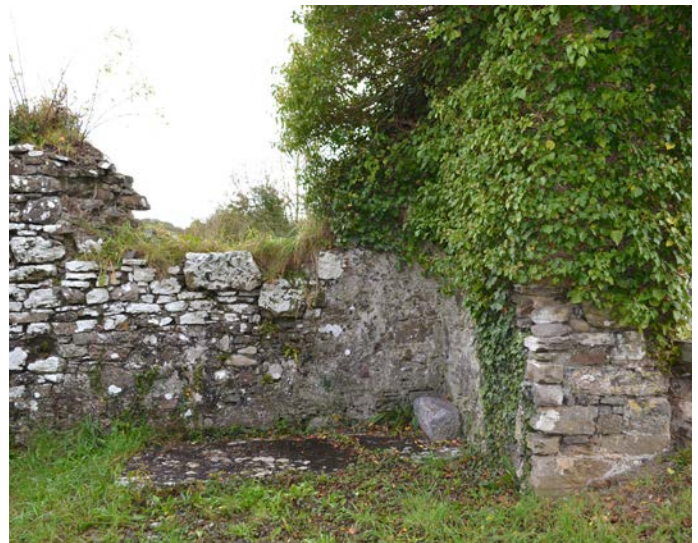
Corner of nave where north wall meets east gable, section of lime plaster still intact.

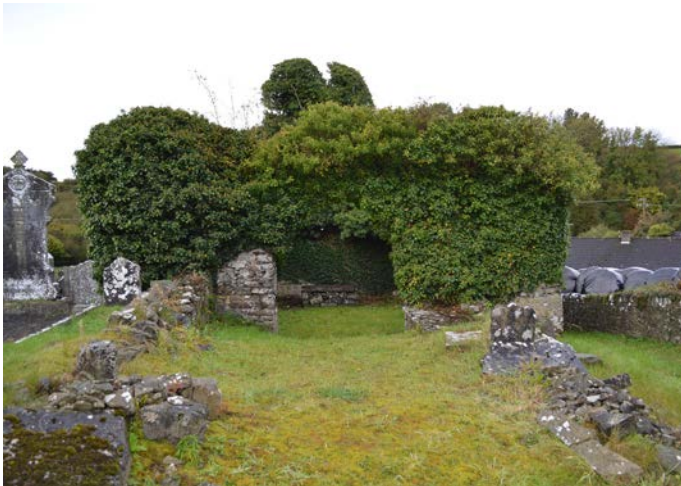
View of the east end prior to trimming.

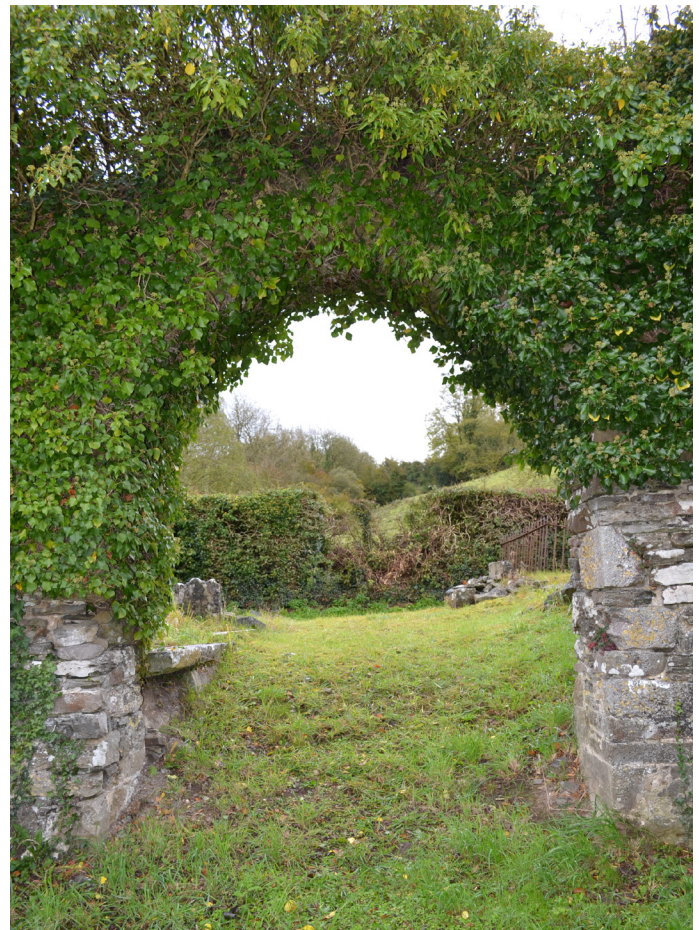
Chancel arch from nave prior to trimming.

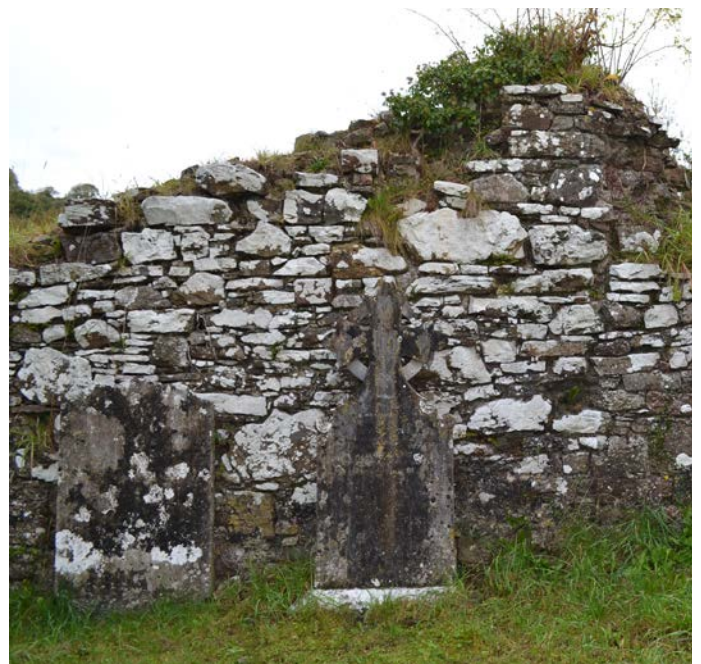
Detail of exposed masonry on the north wall of nave. Headstones laid against the nave wall.

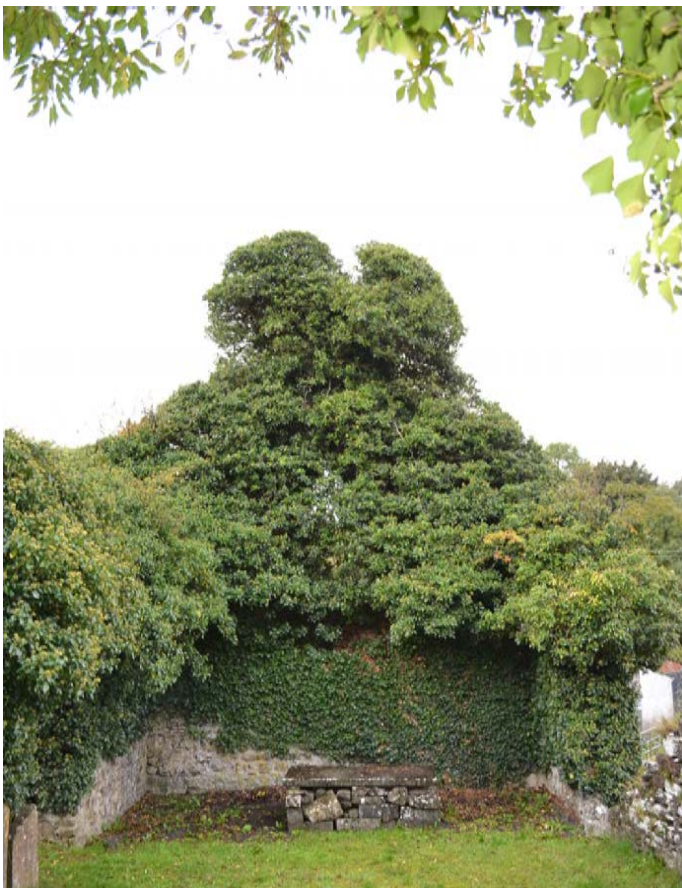
West gable from the nave before trimming.

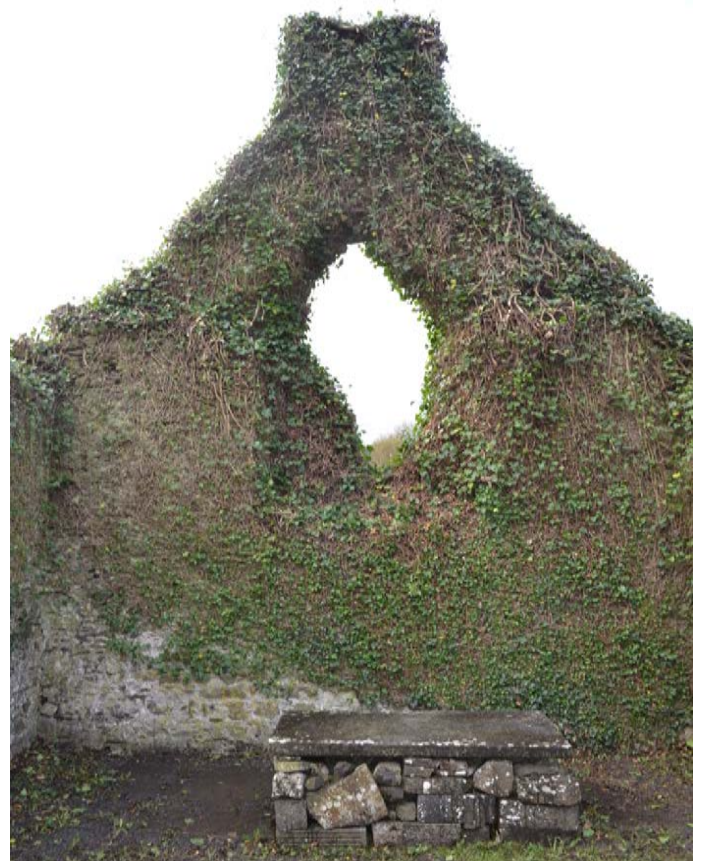
West gable from the nave after trimming.

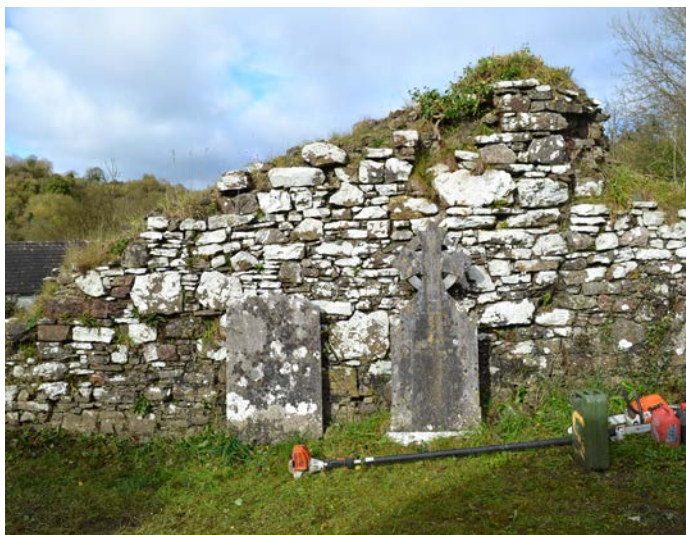
View of north wall masonry from nave.

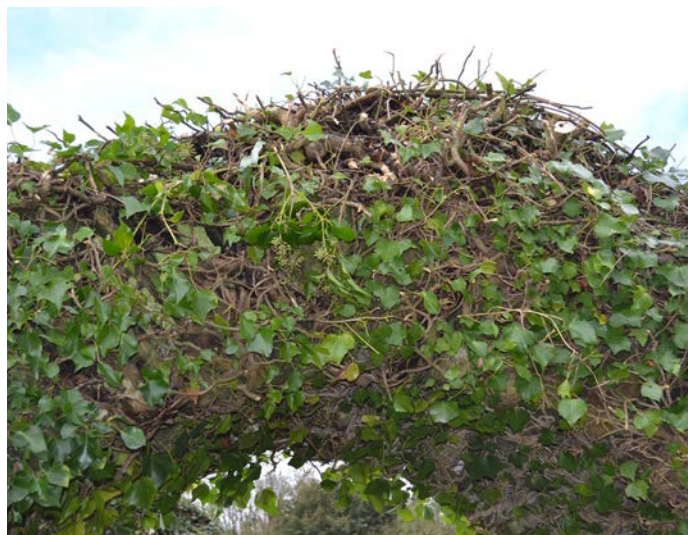
Detail of chancel arch from nave after trimming.

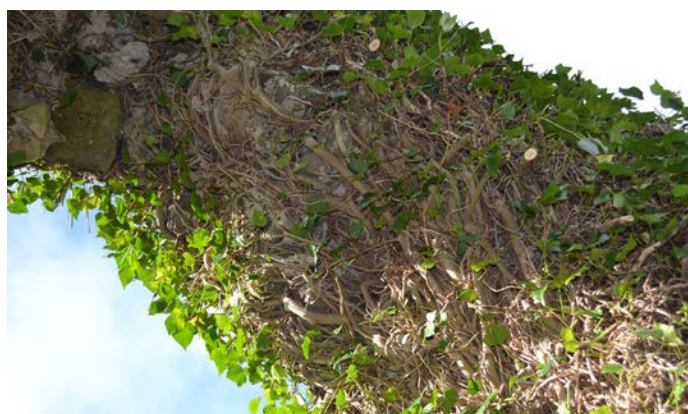
Detail of underside of chancel arch after trimming.

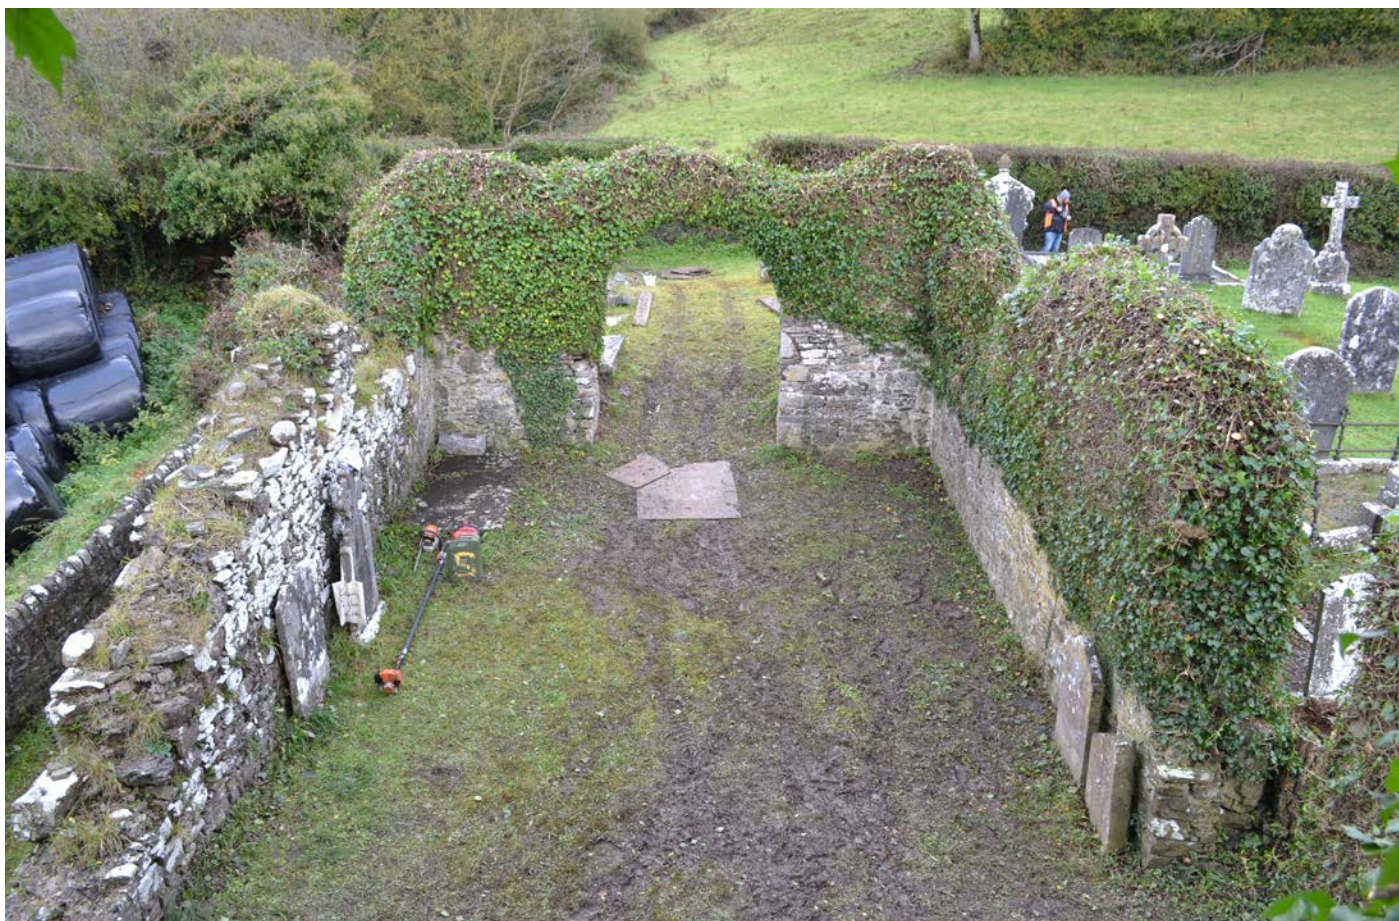
View of the nave through the west window looking down to chancel arch after trimming.

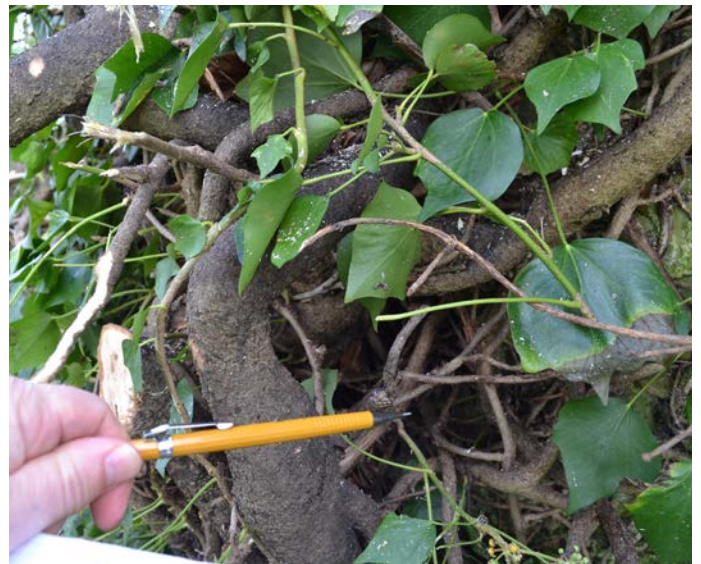
Close up of ivy stems on west gable after trimming.

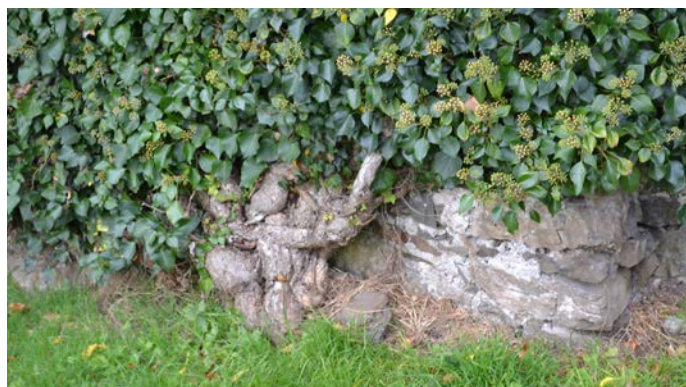
Typical ivy root on south wall.

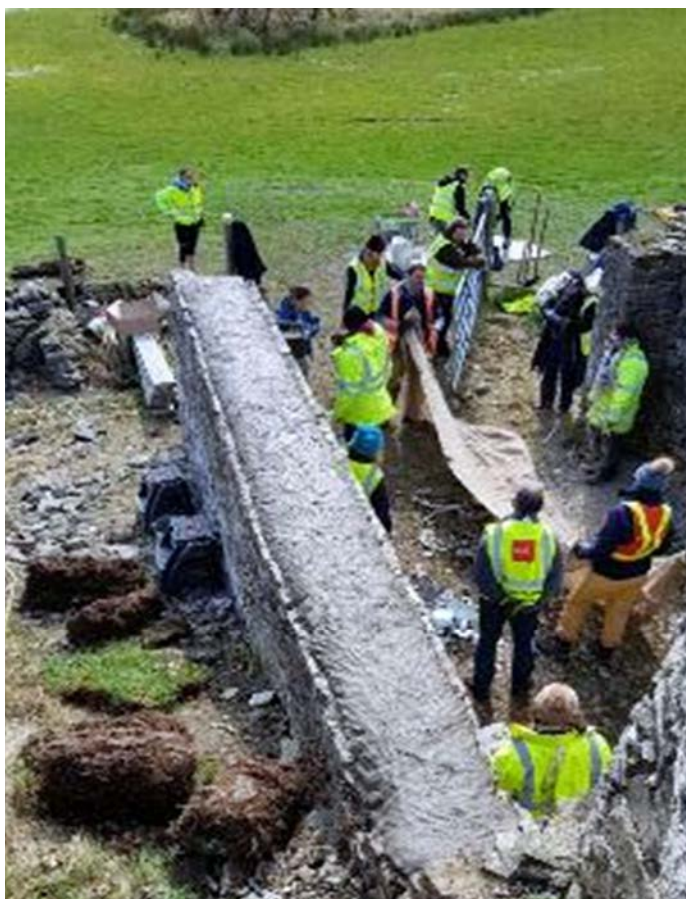
Example of soft cappings detail to stone walls, clay layer installed prior to laying sod.

- Careful control and removal of vegetation
- Repairs to top of gable walls and the arches within the two gables – most urgent
- Repairs to all wall tops in general – urgent
- Repairs to all vertical faces of walls
- Addition of soft top to south and north walls for additional protection

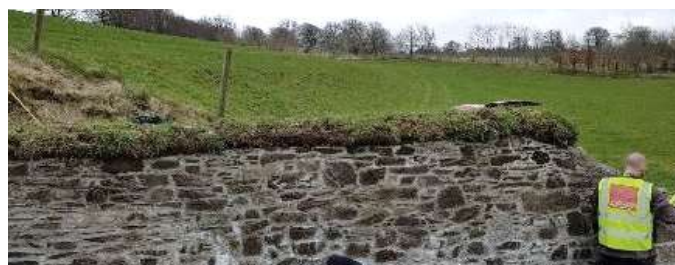
Example of a completed soft capping to wall head.
