NIST Special Publication 901

The January 17, 1995 Hyogoken-Nanbu (Kobe) Earthquake

*Performance of Structures, Lifelines, and Fire
Protection Systems*

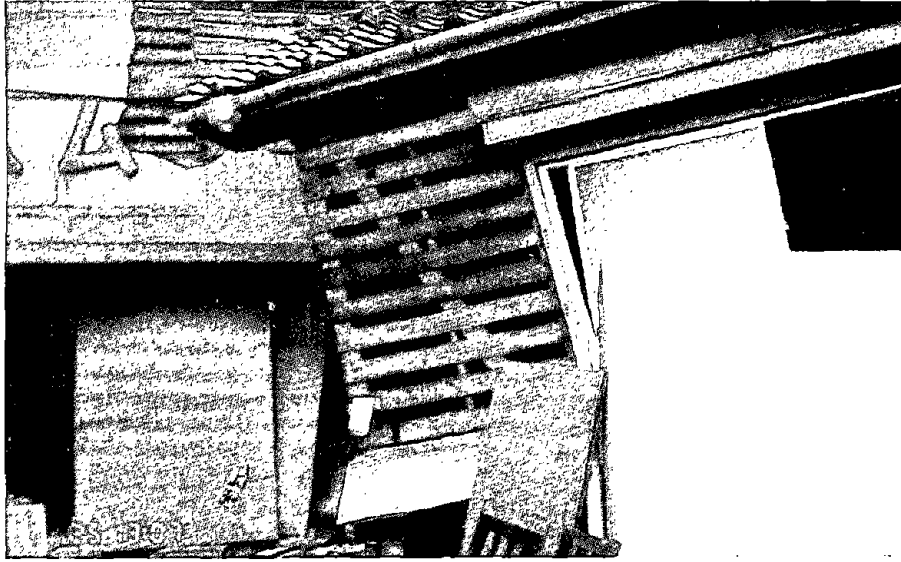
Figure 3.3.6 Intact upper story (braced) of a collapsed unit - Ohkabe construction.

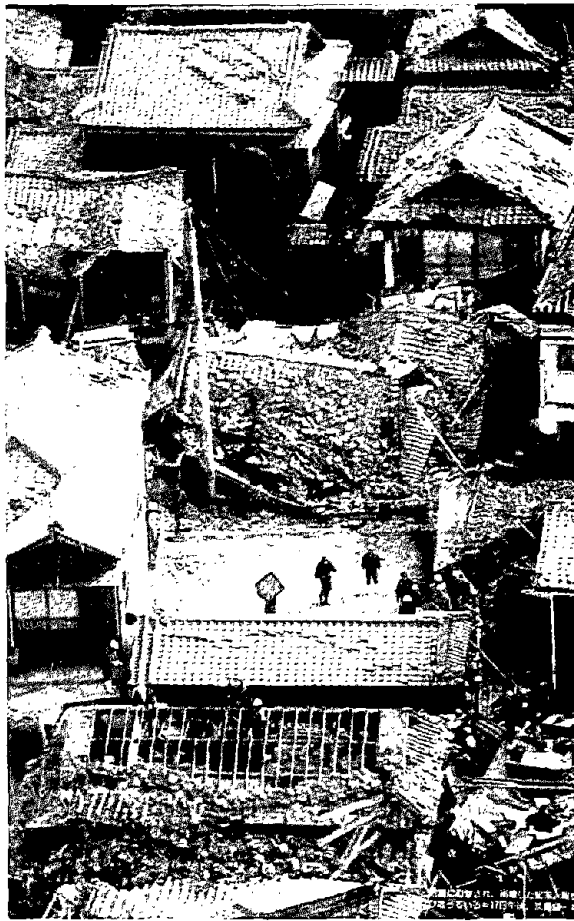
Many severely damaged houses had heavy ceramic roof tiles set on soil as bedding (see Figure 3.3.7). It is believed that heavy tiled roofs were preferred not only for the aesthetic and architectural reasons, but also because they could not be easily dislodged by gusty winds in a typhoon. The heavy roofs of these houses have contributed a great deal to their collapse. On the other hand, some of the older houses which used less elaborate and less expensive synthetic roofing made of light material performed well in this earthquake.

Figure 3.3.7 Collapse of some heavy tiled roof houses - Shinkabe construction.

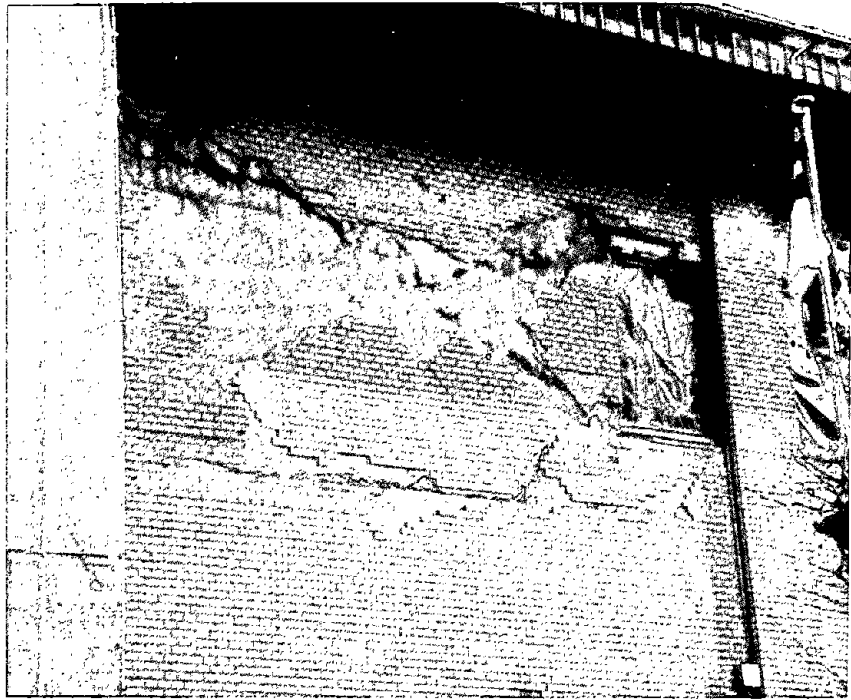
Figure 3.4.2 Damage to shear walls - Kobe Central Post Office.

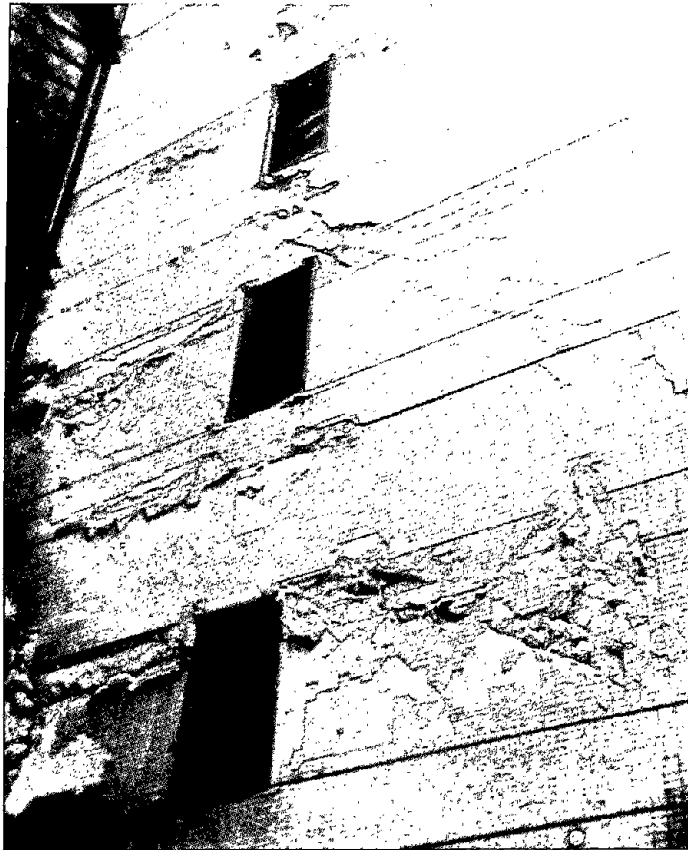
Figure 3.4.3 Damage to shear walls - office building in downtown Kobe.

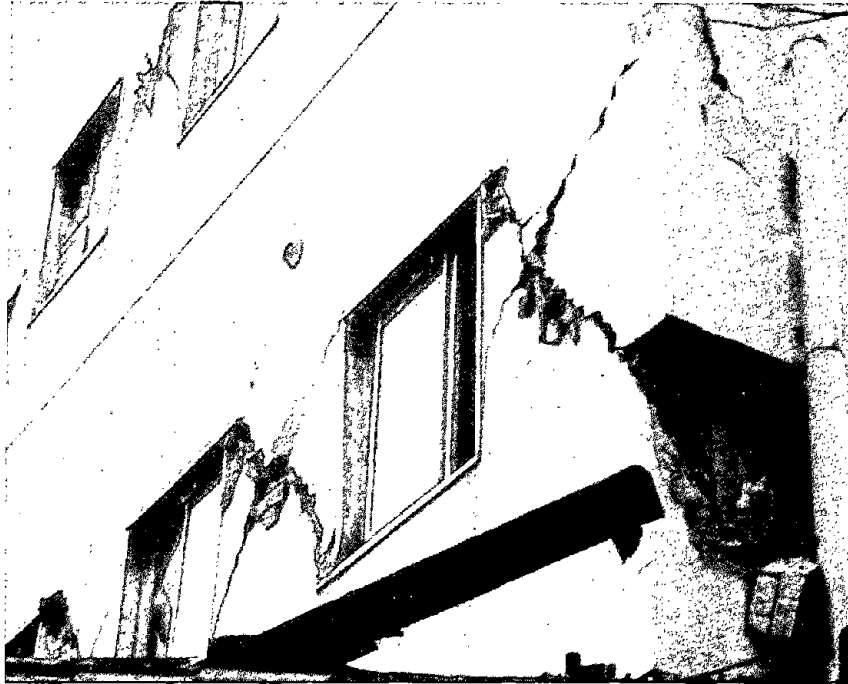
Figure 3.4.4 Diagonal tension cracks - apartment building in Nishinomiya area.

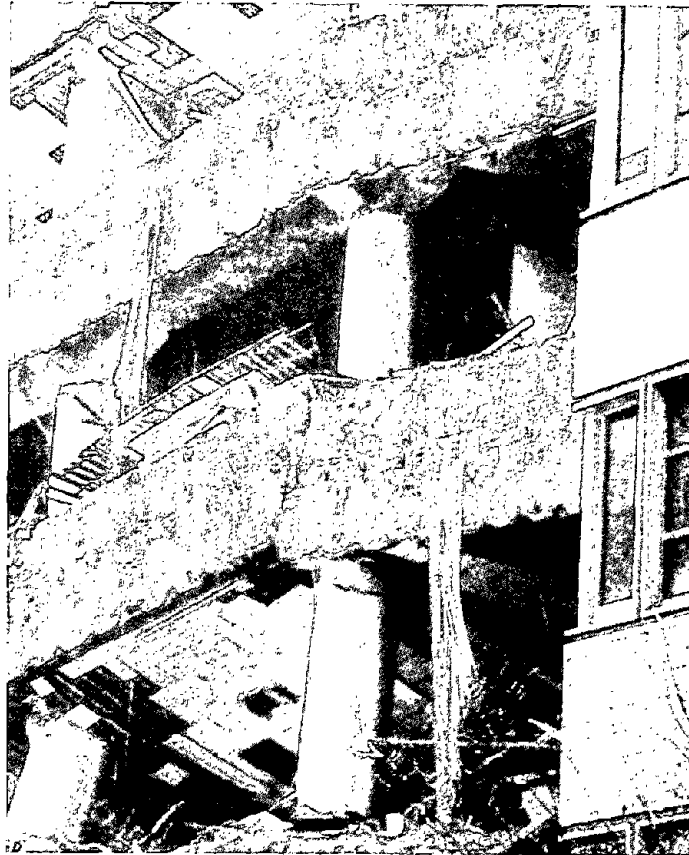
Figure 3.4.13 Strong beam-weak column failure.

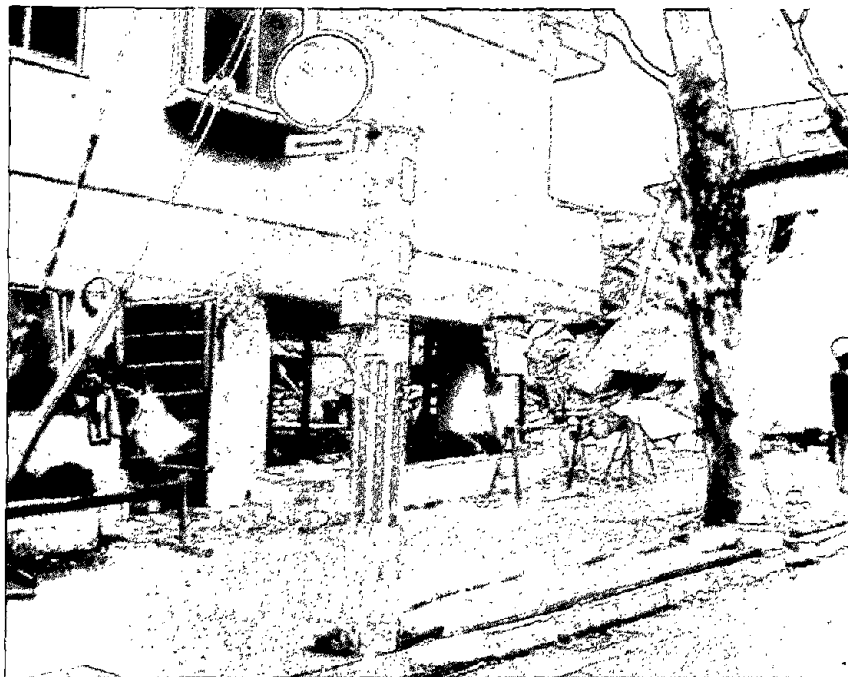
Figure 3.4.14 Collapsed first story near JR Line.

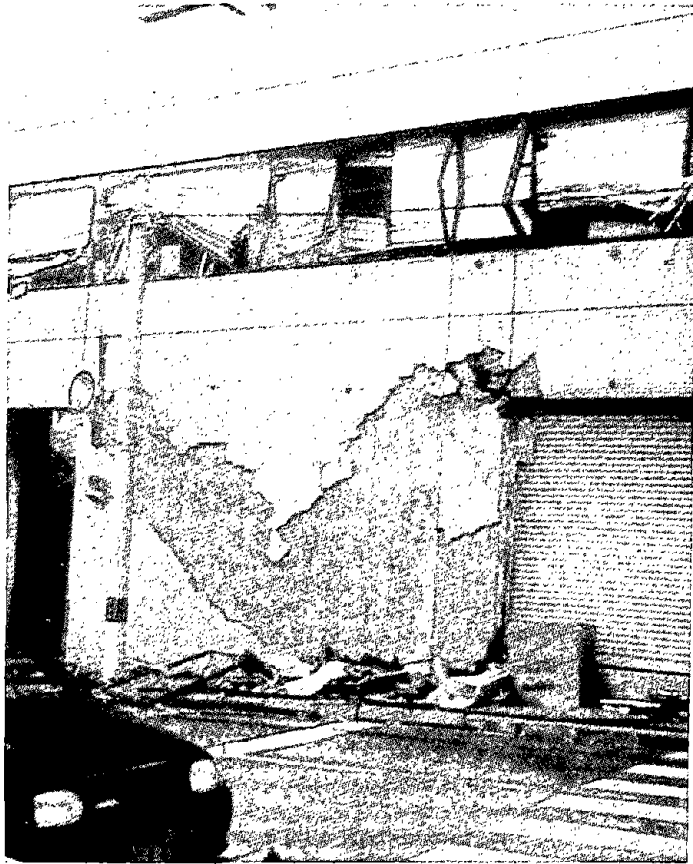
Figure 3.4.17 Second story collapse - Miyagi Hospital.

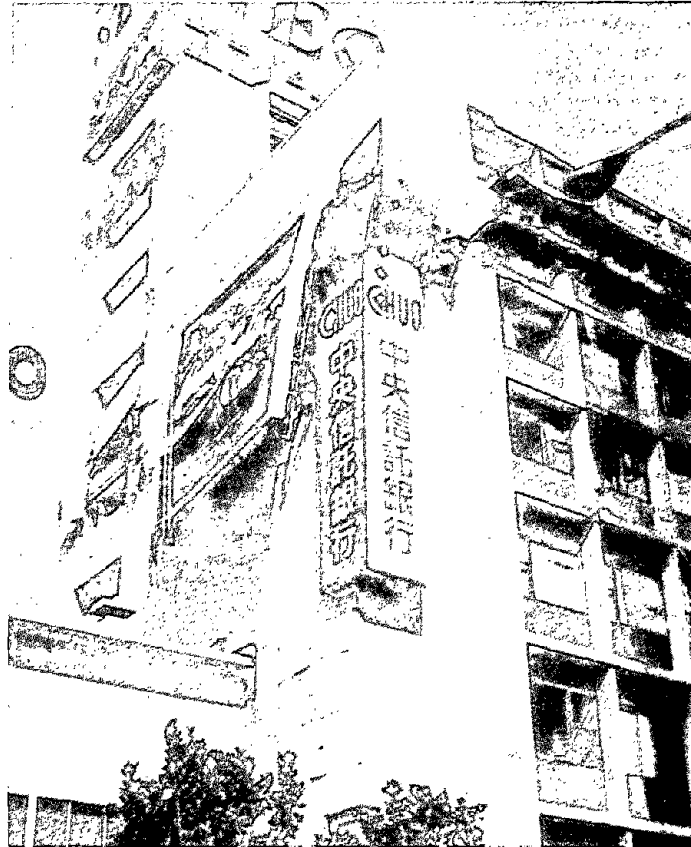
Figure 3.4.21 Upper story collapse - Downtown Kobe.

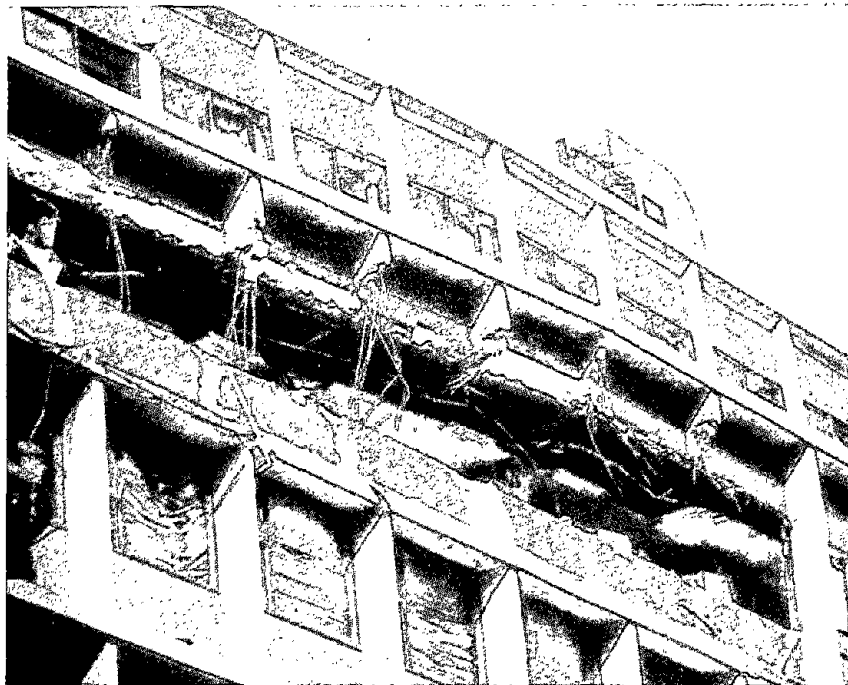
Figure 3.4.22 Upper story collapse - Downtown Kobe.

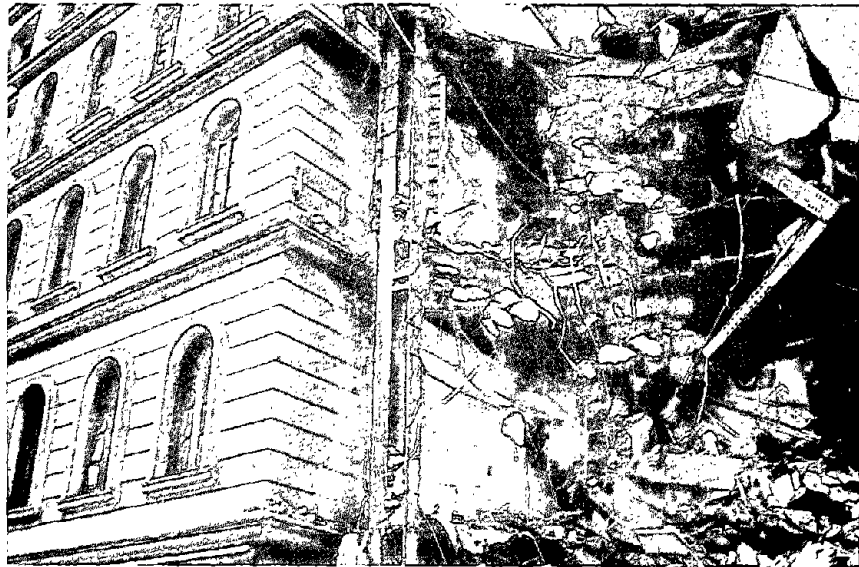
A 3-story steel frame building (Tanigawa Building) on Flower road in downtown Kobe also suffered beam-to-column connection failures (Figures 3.5.22 and 3.5.23). It is clearly seen that weld joint failure caused H-shaped girders to fall.

Figure 3.5.22 Collapse of the 3-story Tanigawa building on Flower Road in Kobe. This two-way steel frame was constructed of H-shape beams welded to columns.

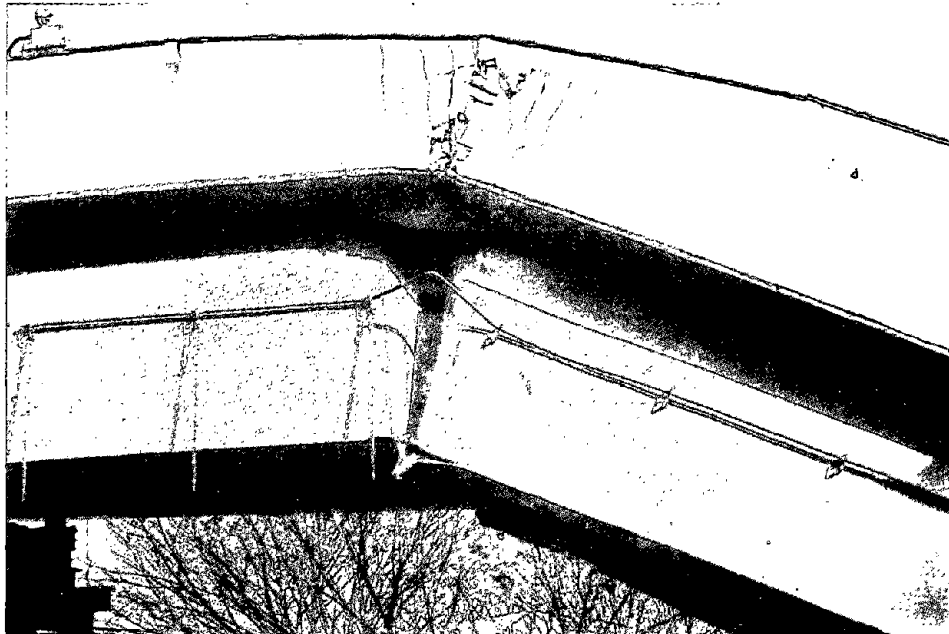
Figure 4.2.29 Girder web failure due to unseating of the Southeast Ramp at Minatogawa Interchange.

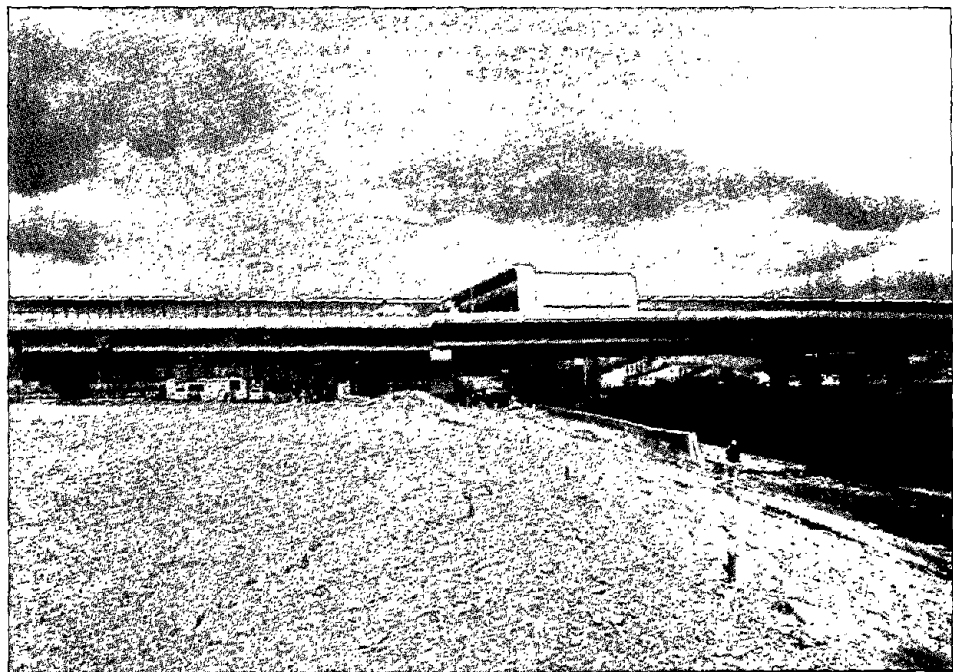
Figure 4.2.42 Distant view of the Shukugawa Bridge showing lateral deformation of the foundation soils and spreading to the right (to the center of the channel).

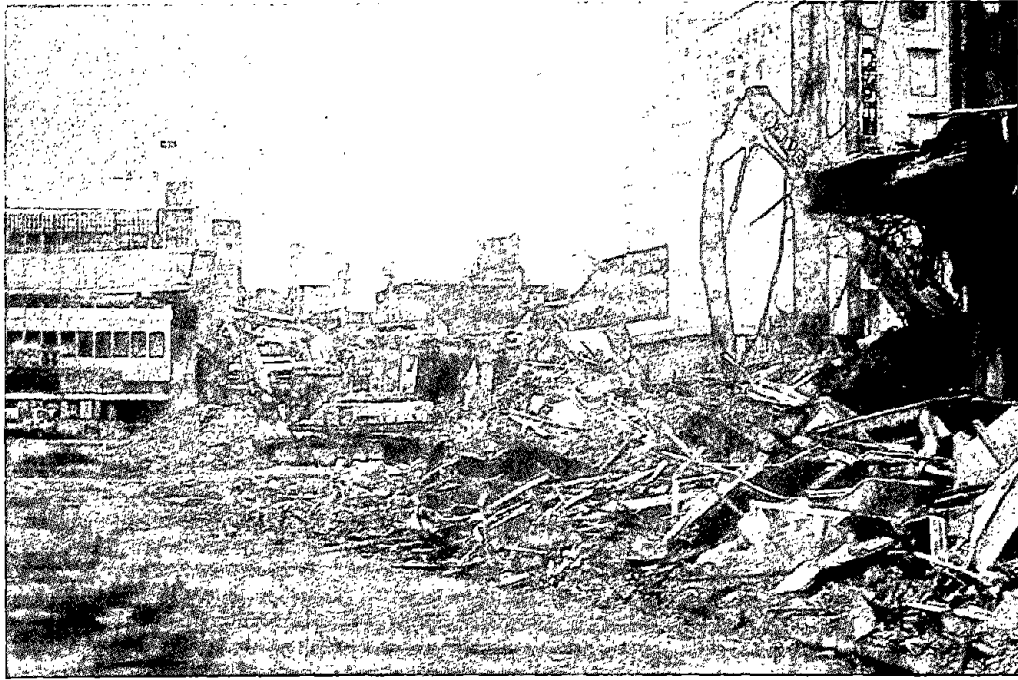
Itami Line The Shin-Itami station collapsed (Figure 4.3.11). The elevated station was at the end of the Itami Line. Railroad tracks gradually rose through a segment of elevated embankment and a series of elevated structures and ended at this station. The collapse may have been caused by a whipping action.

Figure 4.3.11 Collapsed Shin - Itami Station.

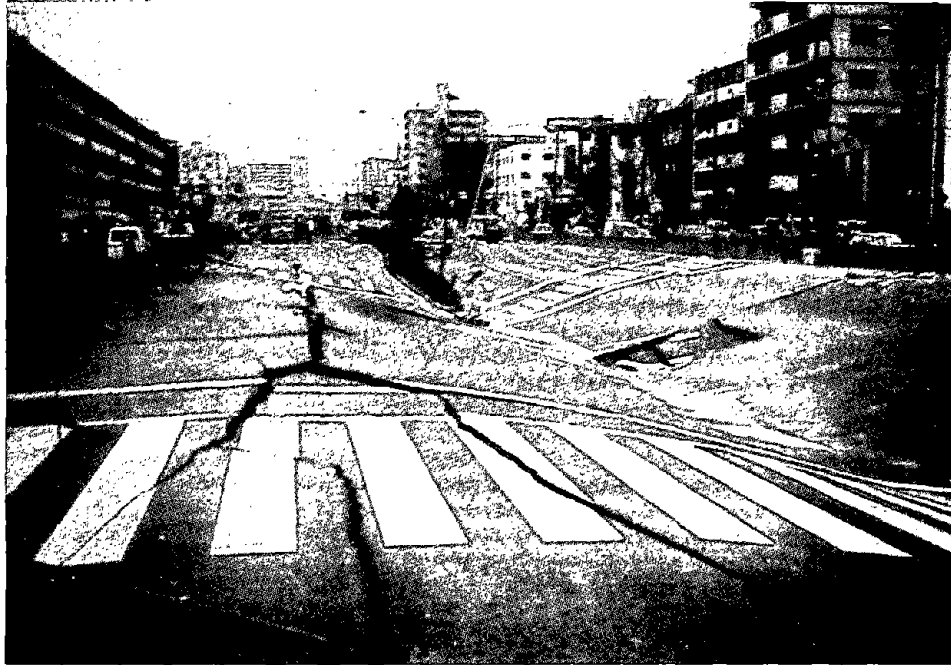
Figure 4.3.21 Subsidence of street surface over the collapsed Daikai Station.

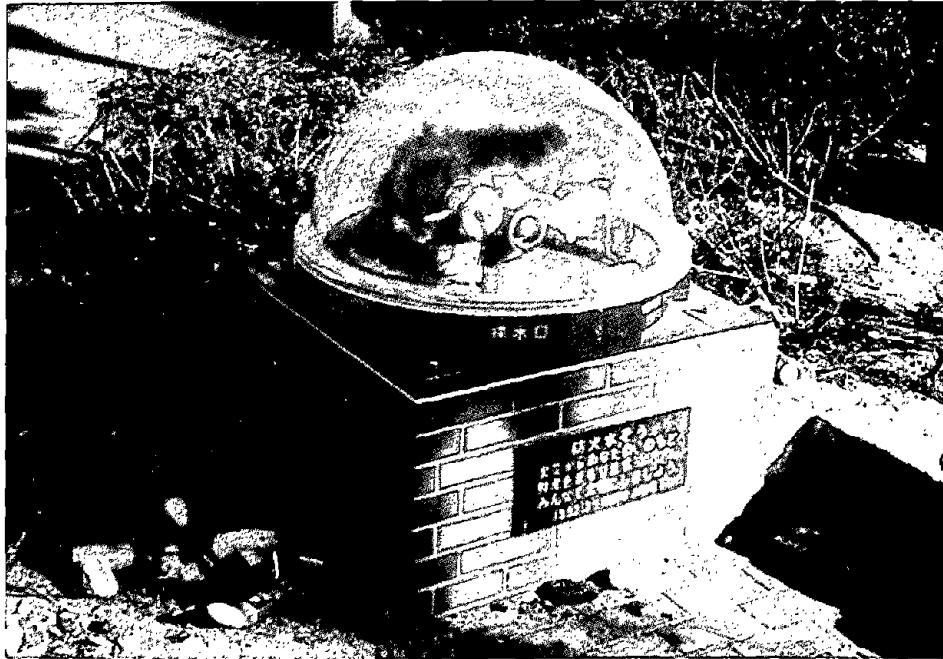
There are a number of cisterns (Photo 1) located throughout the City for use for fire suppression. The urban area is laid out on a 400 m by 400 m grid. Three quadrants of the grid each has a fire hydrant, and the four quadrant has a cistern. There is one special radio system for communication between the water and fire departments during emergency response situation.

Photo 1 Cistern for water for fire protection in Kobe.

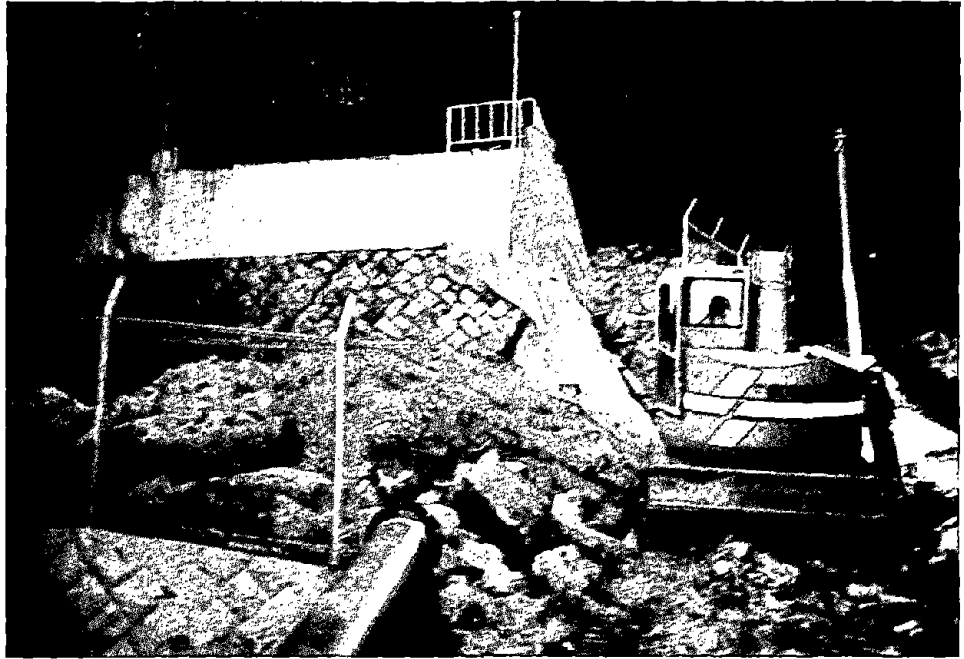
Photo 13 Broken lines to/from backwash tank at the Motoyama Water Purification Plant.

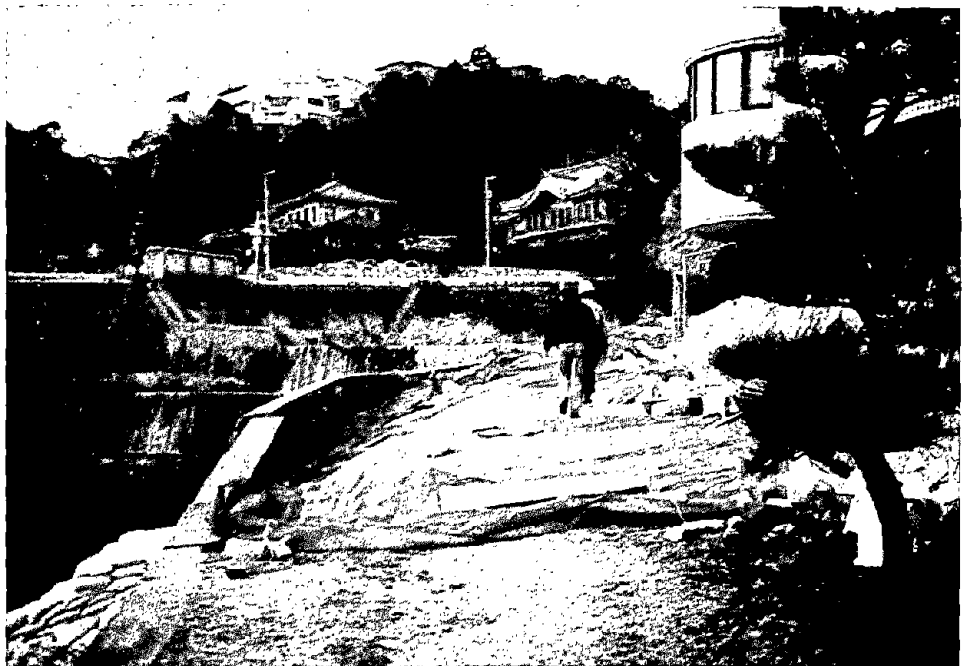
Photo 14 The retaining wall on the left cracked damaging the overflow line from the Motoyama Plant's intake box.

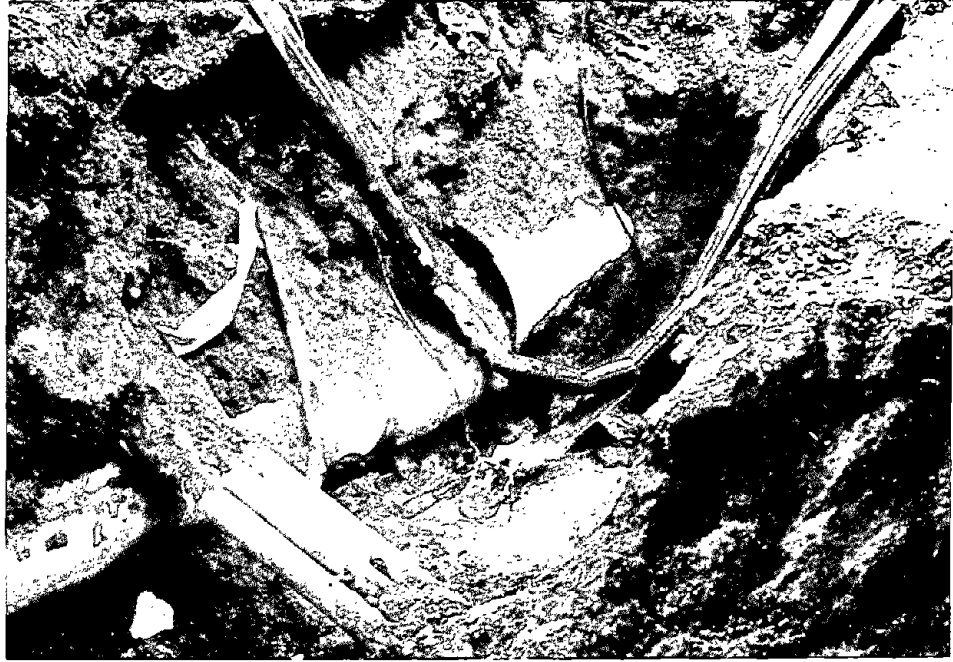
Photo 16 Repair of 700-mm welded steel pipeline which ruptured at a weld on the north side of Port Island in an area affected by liquefaction induced lateral spread. This line carries the entire potable water supply for the island.

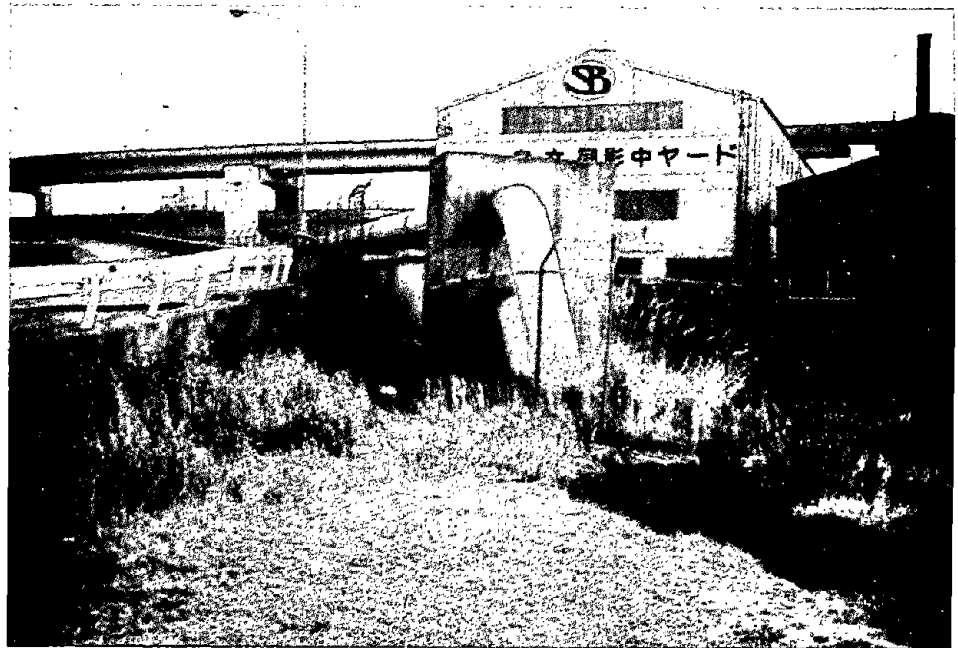
Photo 17 Ground cracking from lateral spread in fill area along a water way. Immediately behind the crack, a pipeline emerges out of the ground to be supported on the bridge.

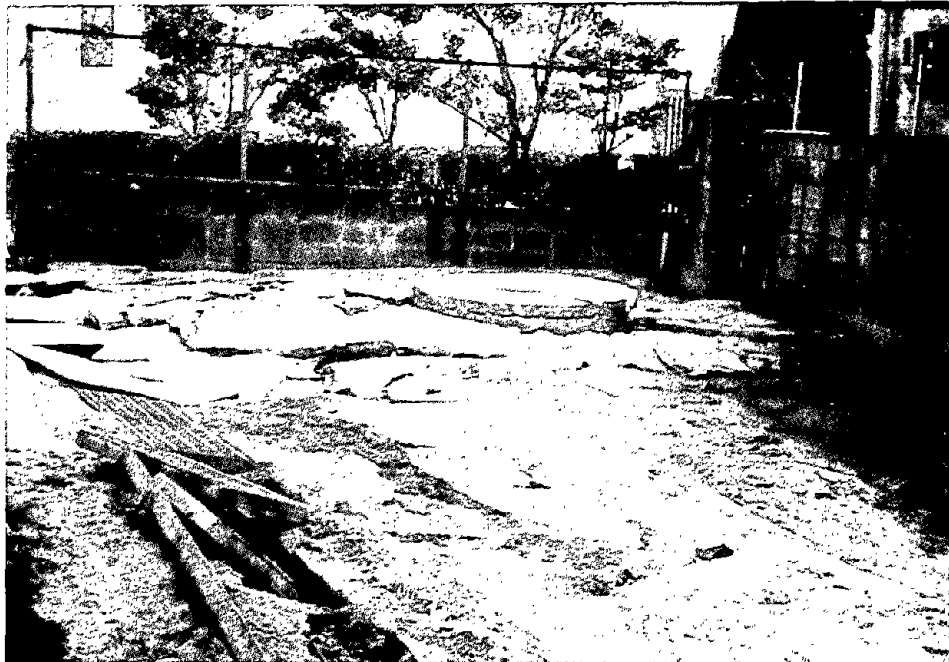
Photo 25 Manhole floated as a result of liquefaction near the wastewater treatment plant.

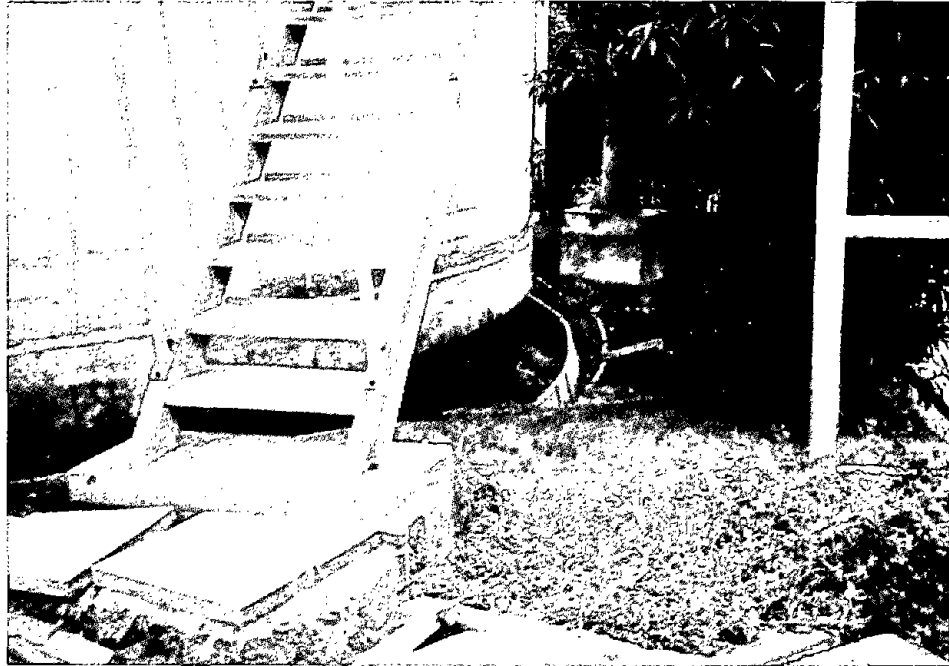
Primary and secondary clarifiers and aeration basins were pile supported. The primary clarifiers were 8 m deep so the pile length subjected to liquefied sand was relatively small. Secondary clarifiers and aeration basins were only 4 m deep which subjected a longer pile length to liquefaction and lateral movement and resulted in some pile damage. Aeration tank joint separation is shown in Photos 33 and 34. Photo 35 shows scrapper chains which came off of sprockets. Concrete piles supporting digester tanks closest to the channel cracked at their tops. Photos 36 and 37 show broken sludge digester connecting piping.

Photo 37 Differential settlement between pipe and non-pile supported structures damaged piping throughout the plant.

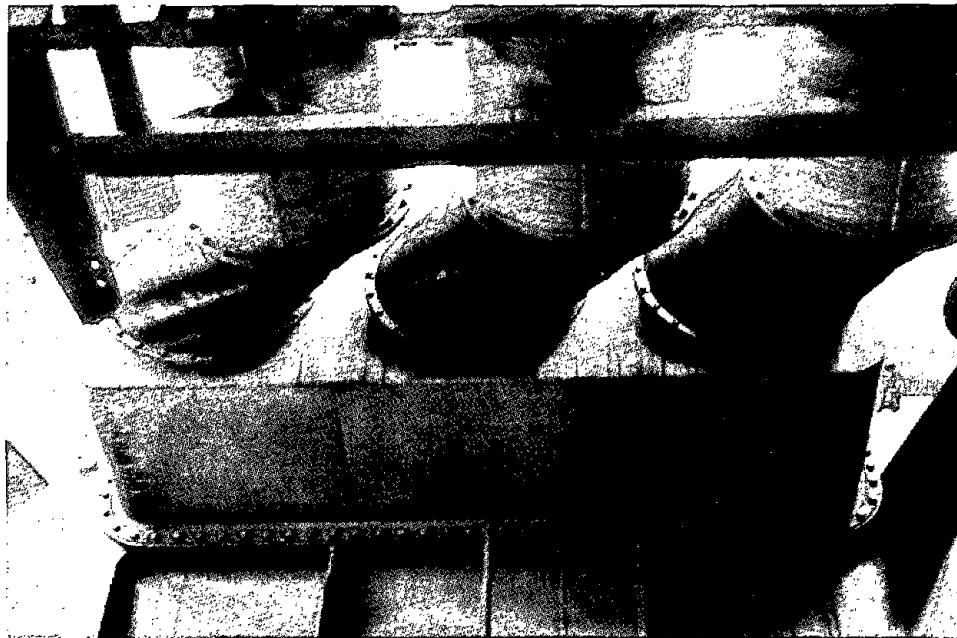
Figure 5.4.34 Offset in bus covers caused by the failure of transformer anchorage and its movement.

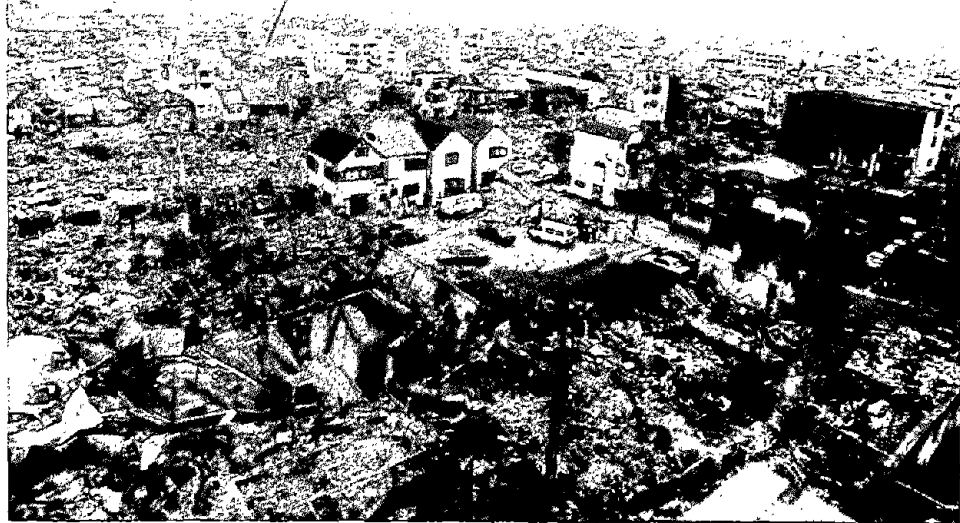
Figure 6.2.3 View of post earthquake fire damage in Nada Ward, Kobe (Site No. 8).

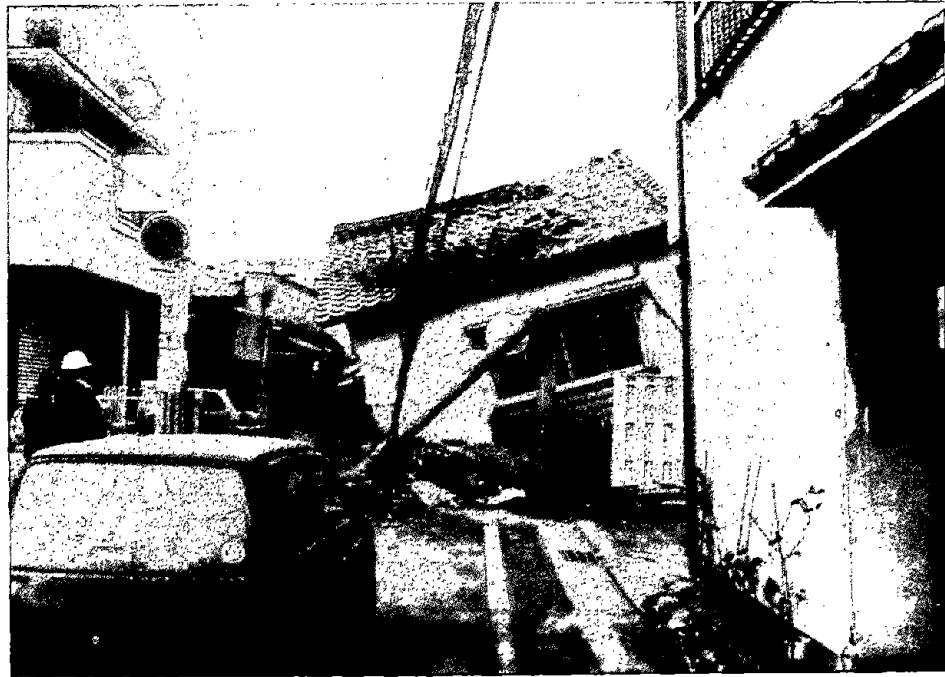
knocked down by the earthquake or torn from collapsed buildings creating potential arcing situations. Some electric lines were still connected to partially collapsed buildings (Figure 6.2.7). These lines may have stretched, creating a reduced cross sectional area of the wire, which could cause

ignition of a fire due to overheating. Insulation may have pulled away from the wires making short circuits or ground faults more likely. The majority of the fire damage occurred in areas of predominantly wooden construction which provided fuels to sustain and spread fires which ignited.

Figure 6.2.7 Example of electric power lines connected to a damaged house.

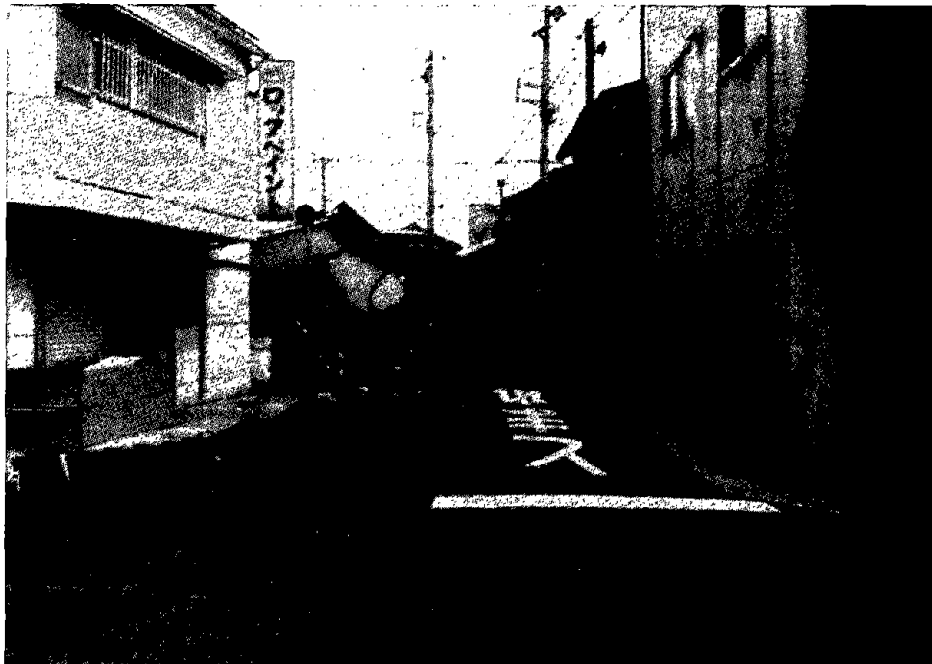
Figure 6.2.10 Collapsed structure across street.

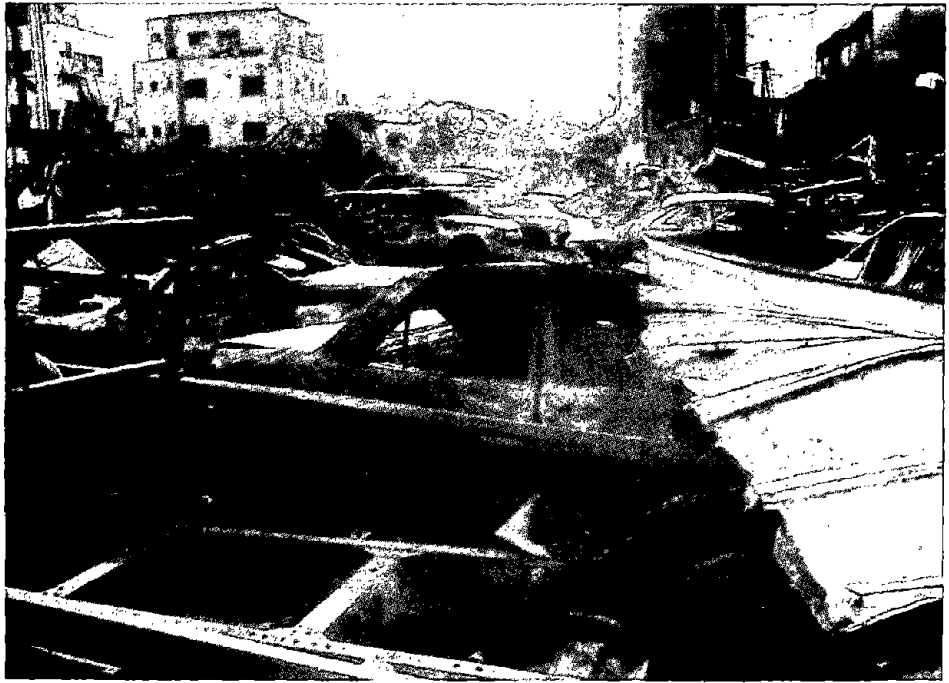
Automobiles were identified by Murosaki [5] as a mechanism for fire spread. Burnt automobiles were seen in narrow alleys between burnt structures. The automobiles, serving as a source of fuel, spread fire from one building to the other. Parking areas with burnt cars were also observed (Figure 6.2.11). Without the fuel provided by the autos, the parking areas would have acted as fire breaks (Figure 6.2.12).

Figure 6.2.11 Parking area where automobiles contributed to fire spread between buildings.

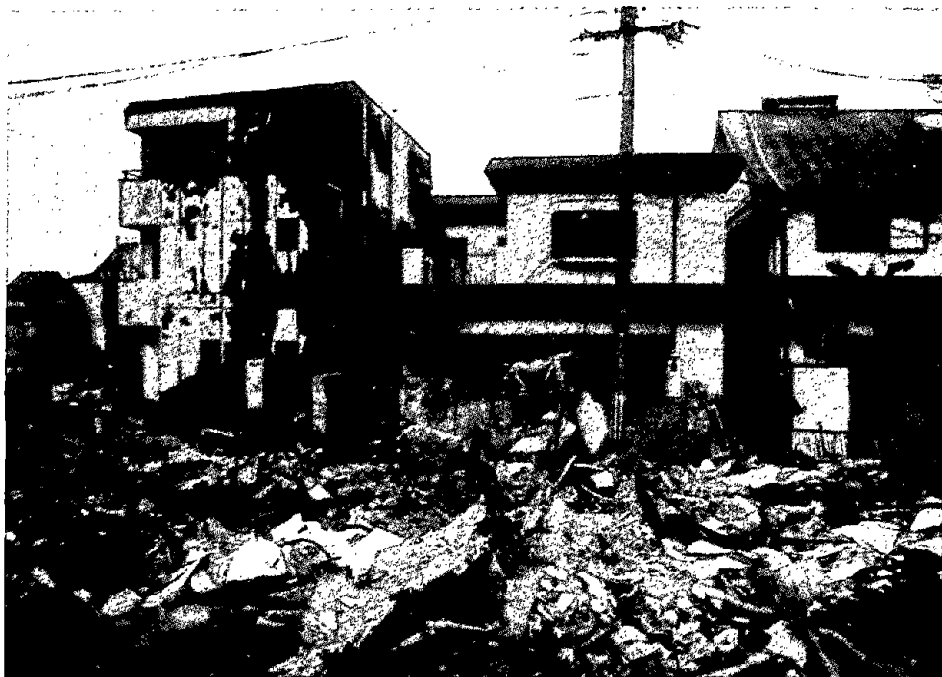
Figure 6.2.18 Burned out structure constructed from fire resistive materials.

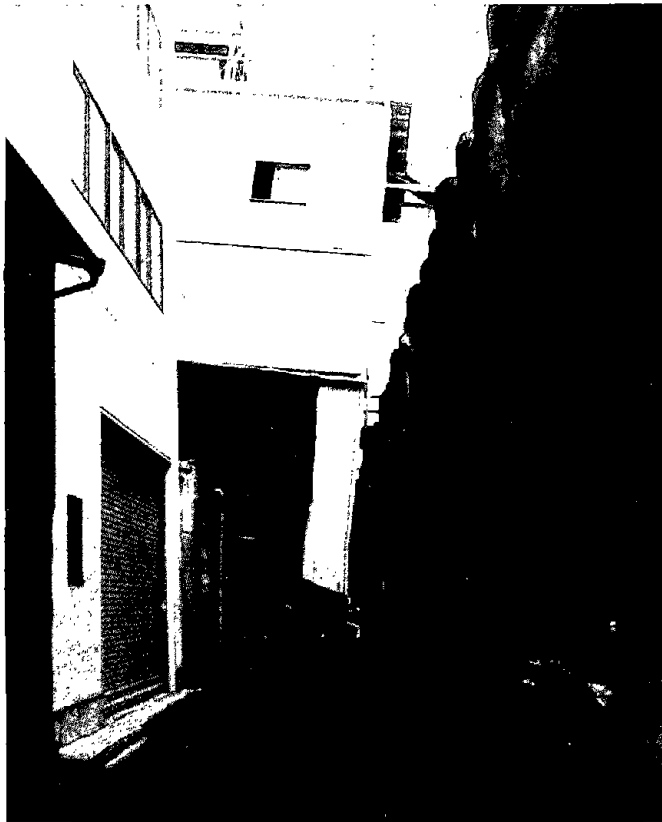
Figure 6.2.23 Road blocked by three story building.

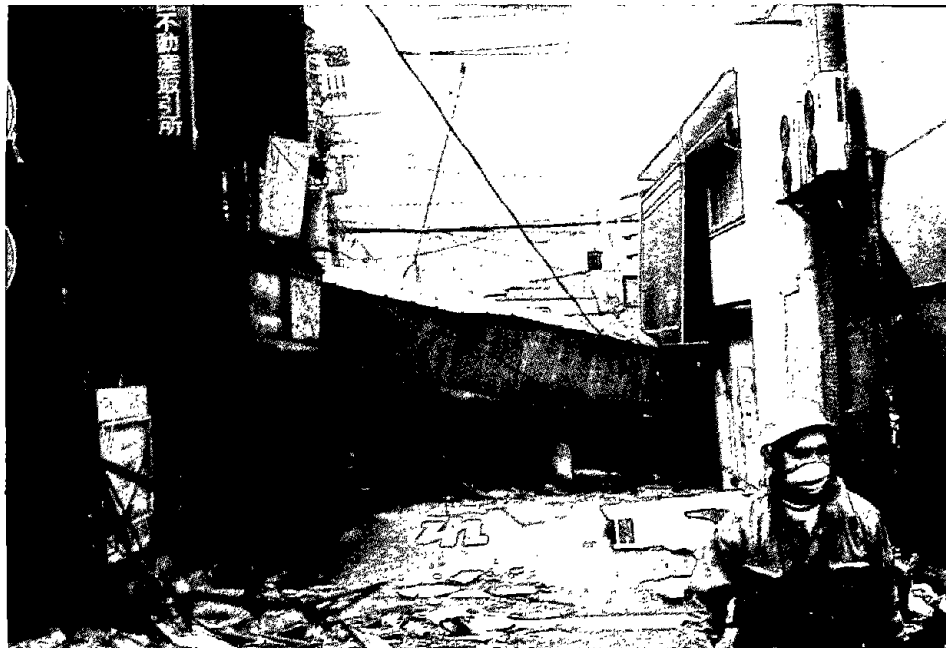
Figure 6.2.24 Road blocked by collapsed structure.

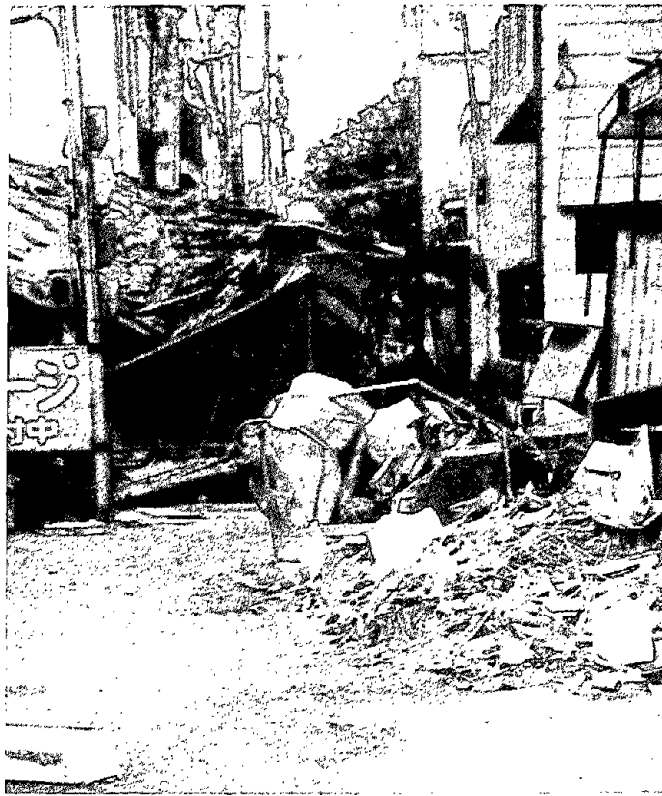
Figure 6.225 Road blocked by collapsed structure.

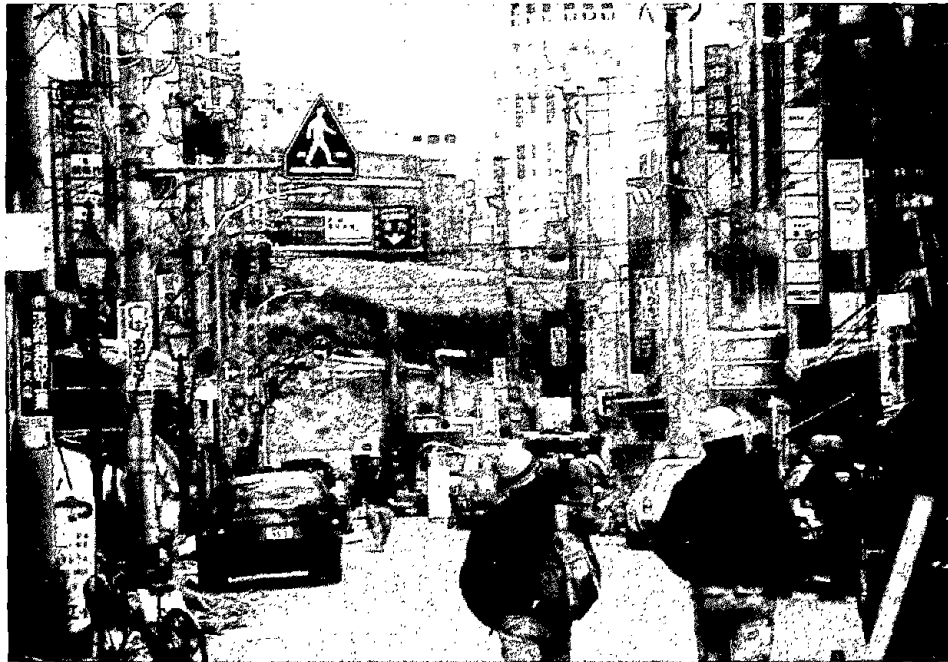
Figure 6.226 Collapsed train overpasses such as this one divided Kobe north and south.

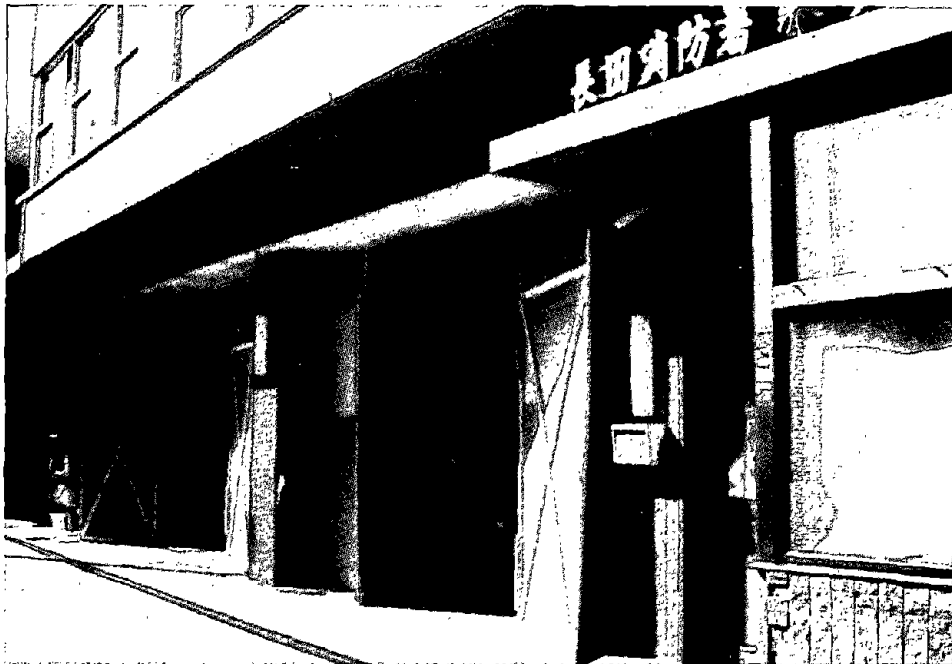
Figure 6.2.28 Fire station damaged by the earthquake.
