A BUILDING STONE AND SLATE SURVEY OF THE CALLANDER CONSERVATION AREA

OPEN REPORT OR/11/011

A building stone and slate survey of the Callander Conservation Area: recording, matching and sourcing for the built heritage

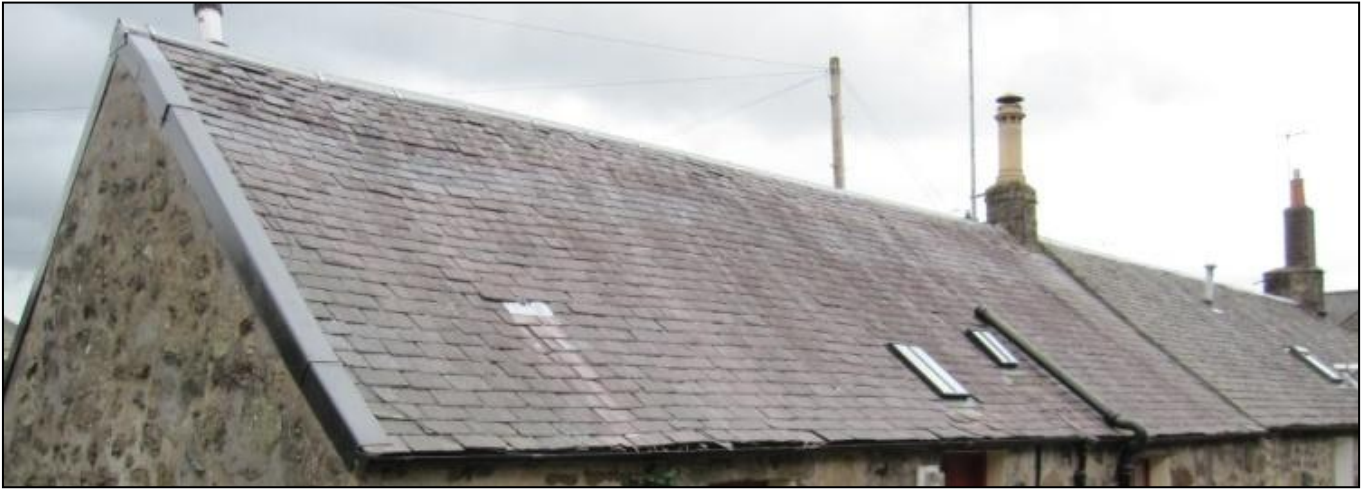
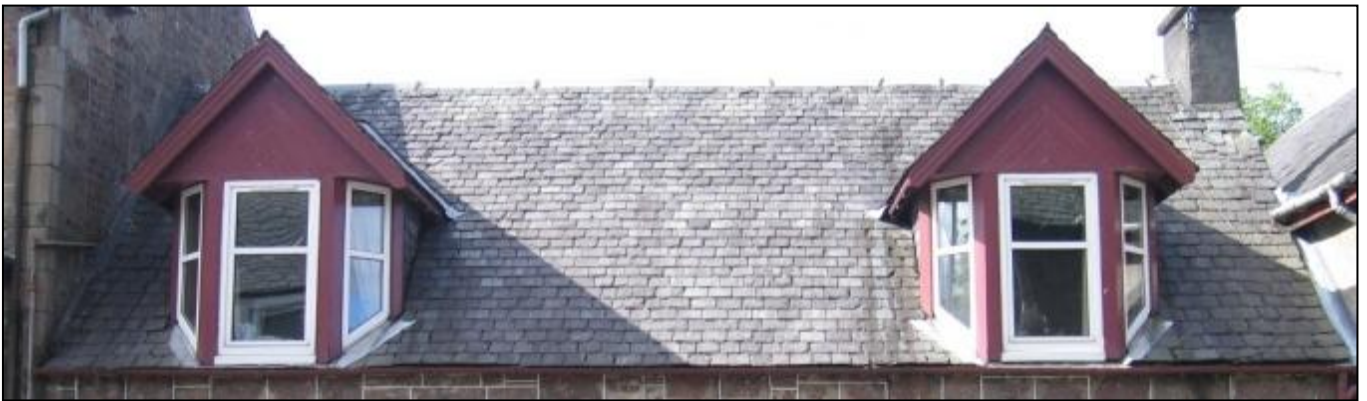
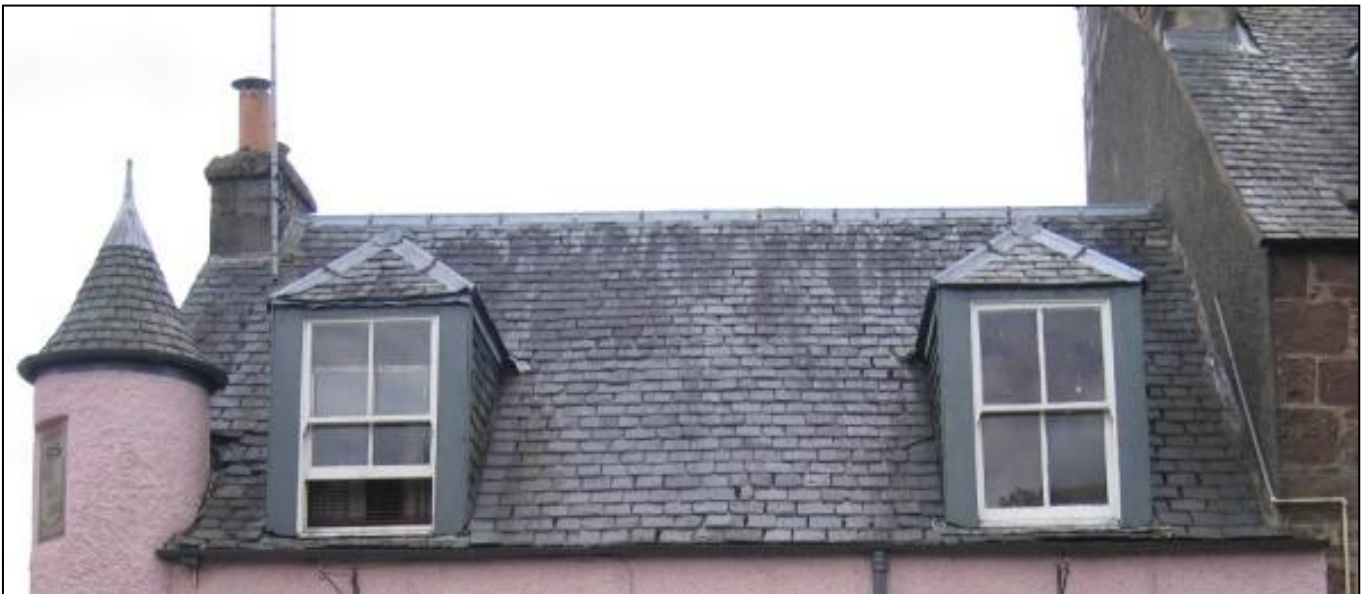
Figure 15 Examples of roofing styles in the Callander Conservation Area.

at the chimney wallhead. The rear feu plots of Ancaster Square North (4A and 8A) retain their original thackstones along the base of the chimneys (Figure 15); these buildings currently have Welsh slate or corrugated iron roofing, both of which were common post-rail replacements of thatch roofs. There are no thatched roofs in Callander today.

The slate quarries at Aberfoyle are the closest source of roofing slate, and almost certainly supplied the earliest roofing slate used in the town. Scottish Highland Border slate [SHB] is found on early to mid 19th century (pre-rail) buildings throughout the Callander Conservation Area. However, slate production at the Aberfoyle quarries began before the 1750s (and continued until the mid 20th century), so roofs of Scottish Highland Border slate may have existed in Callander at an earlier date. Scottish Highland Border slates are typically relatively small and thick. They were traditionally produced in a variety of lengths and widths, and laid with the largest slates at the base of the roof and the smallest at the top ('diminishing courses'). This method was introduced for purely economic reasons, as it made best use of all the material produced. It also resulted in a distinctive roofscape character (Figure 15).

Middle: Roof with Scottish Highland Border [SHB] slate, displaying random widths and diminishing courses.

Bottom: Roof with Scottish West Highland [SWH] slate, displaying random widths and diminishing courses.

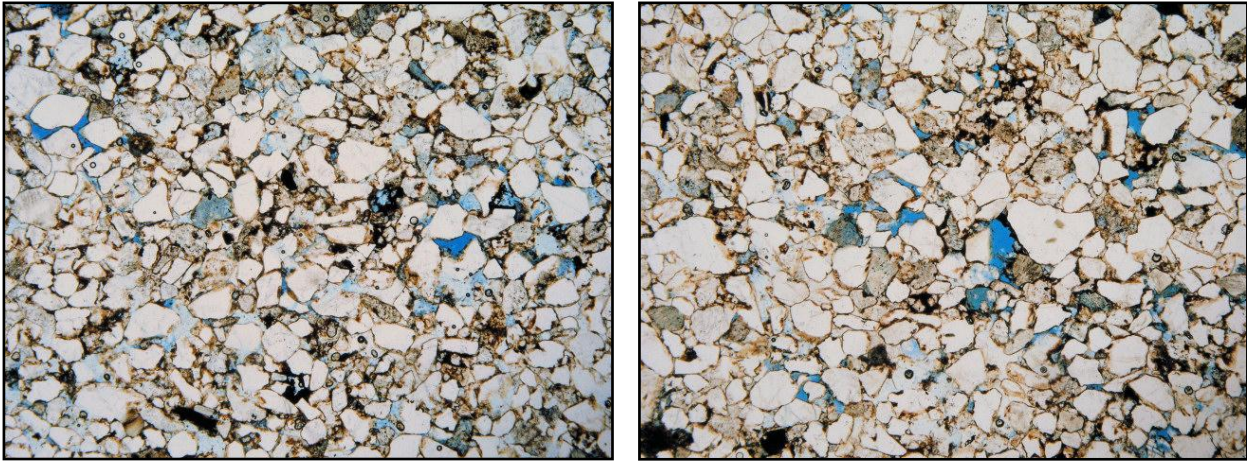
The sample has a moderate open porosity (c.9%), moderately communicated with a range of pore sizes and conduits. The sandstone is moderately compacted, with punctual and long contacts binding the grains, and weakly cemented by clay, iron oxide and calcite.

Based on the relative proportions of the main types of detrital grain, the rock classifies as **subfeldspathic-arenite**.

Figure 3: Microphotographs from the sample from 1 Cross Street ('Desirables'). Images taken with plane polarised light. Pore space is highlighted in blue dye resin. The field of view is c.3.3mm wide.

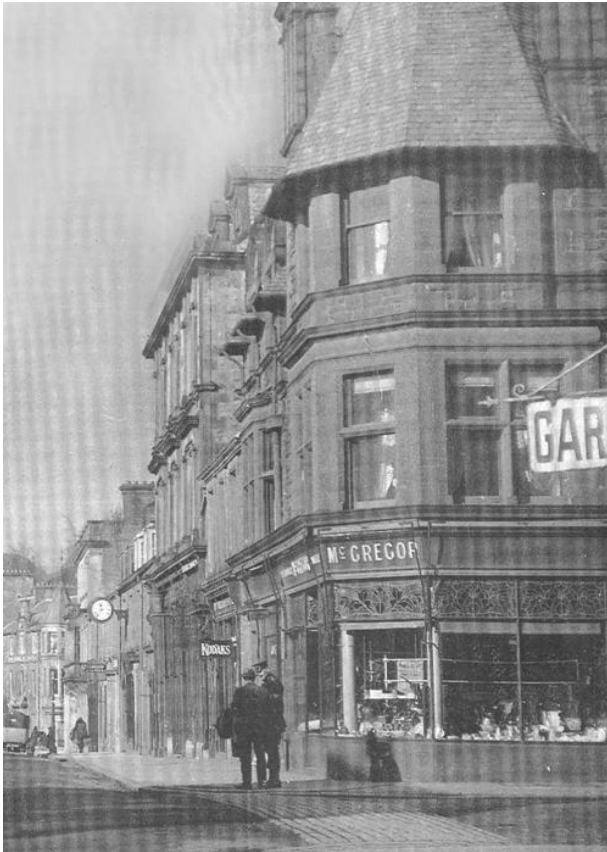
When an impermeable surface is applied to stone, decay is often enhanced due to trapped water behind the coating. The underlying stone is weakened and becomes friable. All surveyed elevations of the Desirables building are over-painted. Where the paint is already flaking the stone appears weakened and is friable.

Figure 6 1920s photograph of the intersection of Main Street and Cross Street showing McGregor's as the present day 'Desirables' shop. The walling is irregularly coursed squared rubble with rock-face finish and the dressings are smooth ashlar. No over painting is present at the time of this photograph (Byrom, 8).

The building was not painted until the late 1950s, as is illustrated in Figures 9 and 10 (Old Callander and the Trossachs, Bernard Byrom, 2005). Due to the soft nature of this sandstone, the paint has proven detrimental to the underlying masonry, and should be removed if this can be done without significant damage. The recommended removal method is first with wire brush and water cleaning systems (e.g. DOFF Systems) to remove the existing paint layer; and then to dress back any damaged stone to a healthy surface. Further analysis should be undertaken prior to paint removal, and test trials completed before work begins.

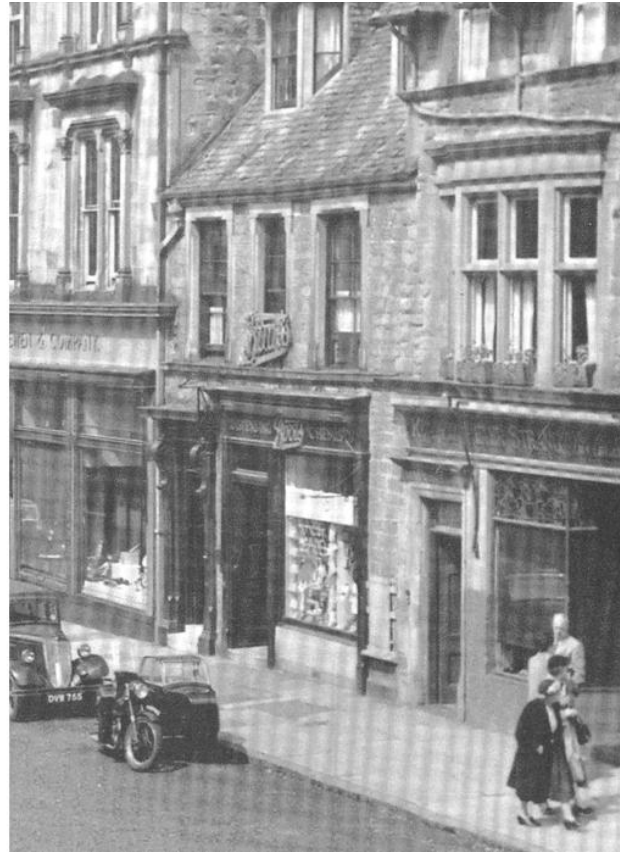
Figure 7 1950s photograph of Main Street showing the edge of the present day 'Shell Centre'. The original stonework of the first floor canted bay window is present; however, possible salts or carbonate efflorescence are visible in the stonework just above the bay window near the rainwater goods. This indicates excess water penetration beneath the wallhead dormers, most likely due to early stages of failing rainwater goods. No over painting is present at the time of this photograph (Byrom, 9).
