Specialist Ecological Report:

Construction of a 132 kV power line from the proposed Tshatane switching substation to the existing Lesideng substation within Fetakgomo, Greater Tubatse and Makhudutamaga Local Municipalities of Sekhukhune District.

Dr Wynand Vlok (BioAssets)

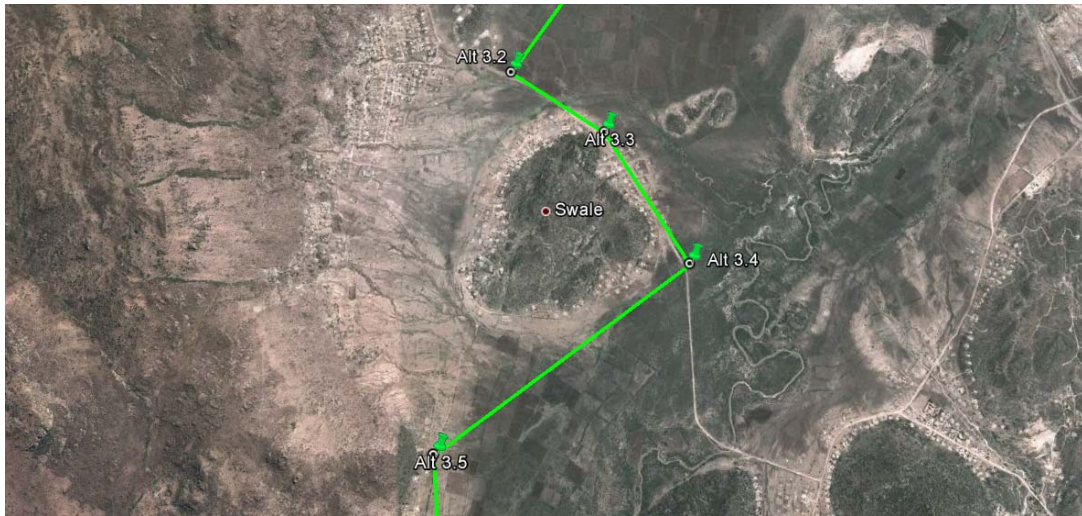
Figure 69: Aerial view of the sector – note land use and erosion.

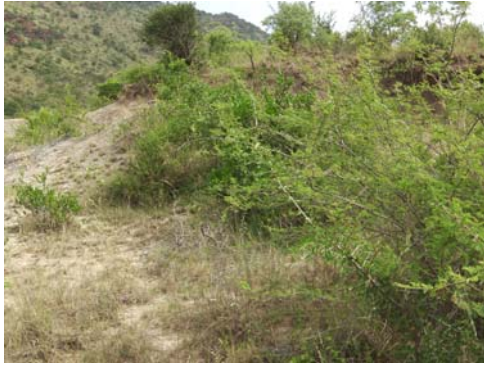
Figure 77: Impacts next to the road related to erosion, grazing and wood harvesting resulting in encroachment.

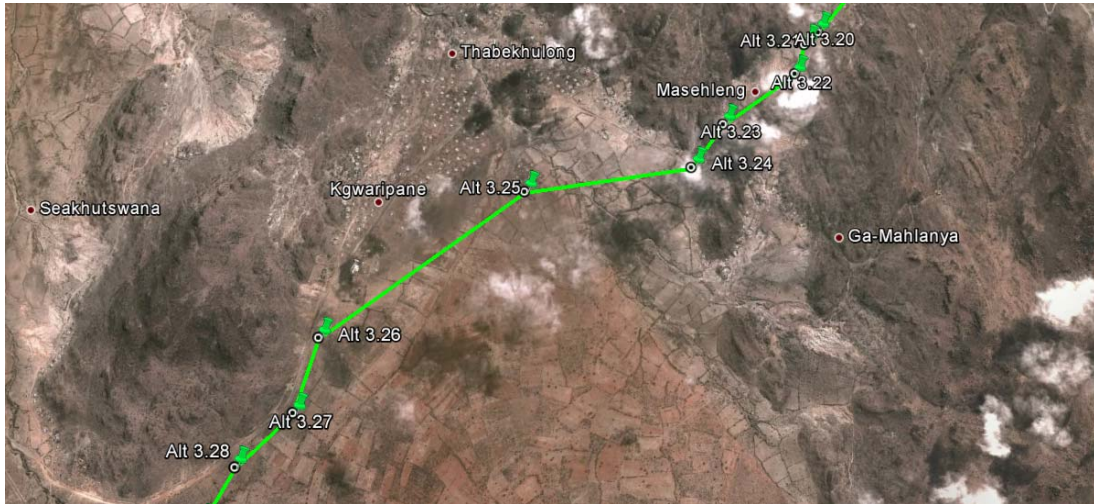
Figure 85: Aerial view of the sector – note land use and erosion.
