Southeast Trees:

A Multi-Site Tree Planting and Evaluation Project in Southeast Los Angeles County

Part 1. Introduction and El Dorado East Regional Park

DONALD R. HODEL

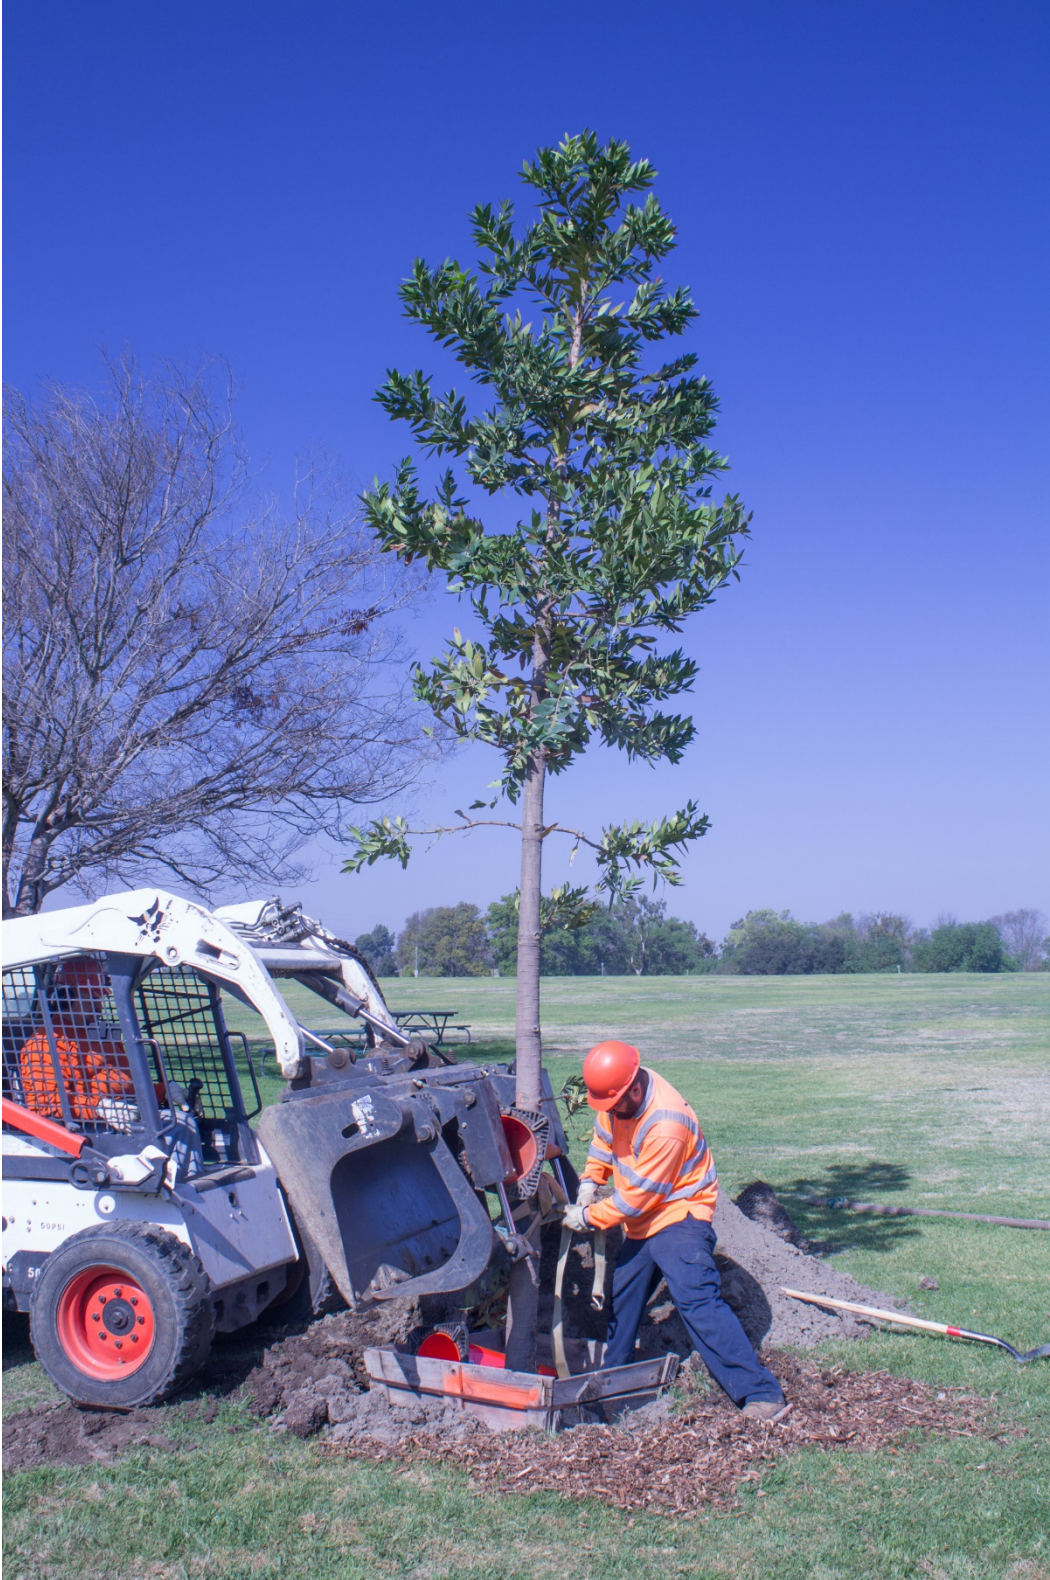
7. We made a planting in February 2018 of larger trees in 24-inch boxes and 30-gallon tubs, as here with *Agathis robusta*, which West Coast Arborists, Inc. donated and planted.

Agathis robusta 33.8228324N, 118.086686W 2018-02-ED42 Fig. 7

Rating: 5.

Notes: This plant, donated as a 30-inch box size, has been a steady but slow grower with few problems. It had a meter-long trunk wound on the northwest side that has covered over nicely. Some leaves are showing minor yellowing, perhaps because it settled after planting and became covered with excess soil although the offending soil has now been removed.

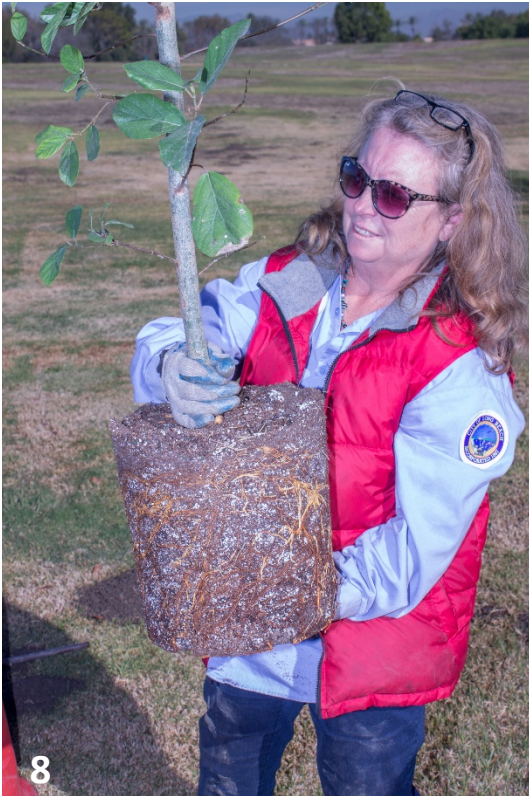
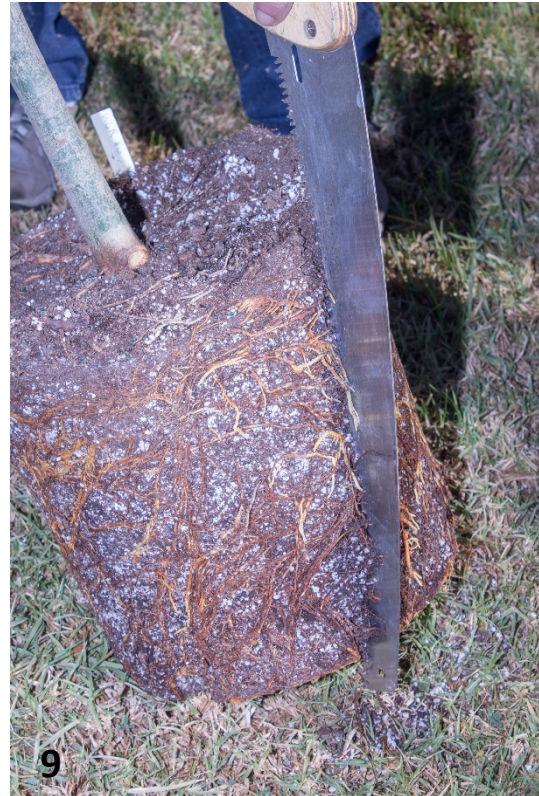
8–9. We carefully inspected root systems before planting and if necessary corrected circling or kinked roots.

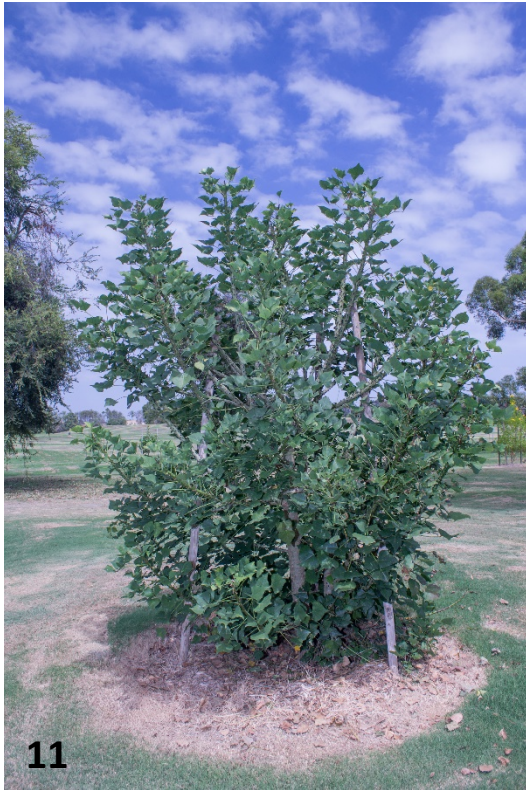
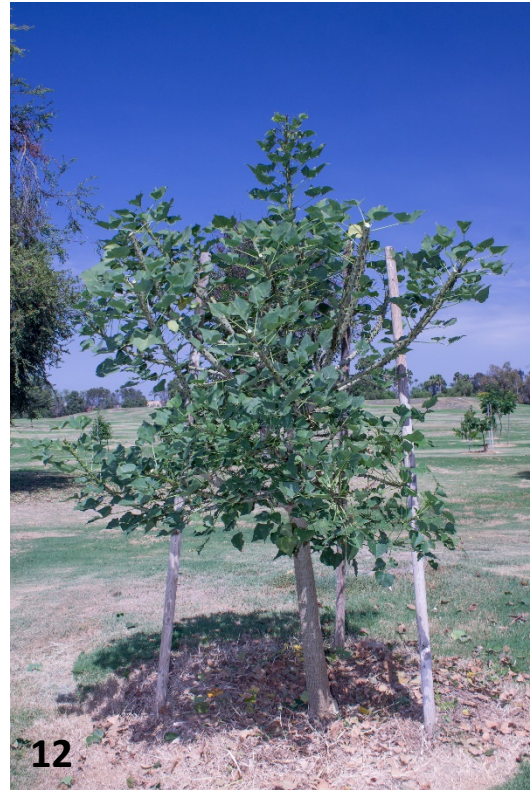
11–12. Structural pruning of *Erythrina sandwicensis* showing before (left) and after (right) pruning.

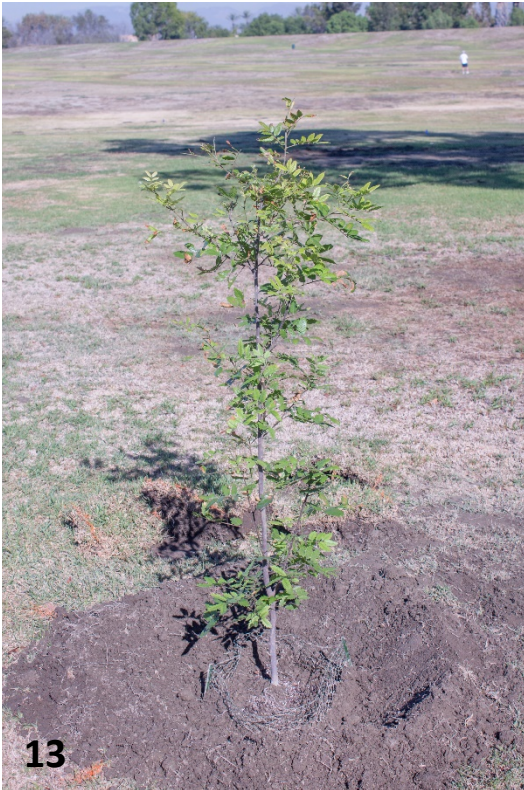
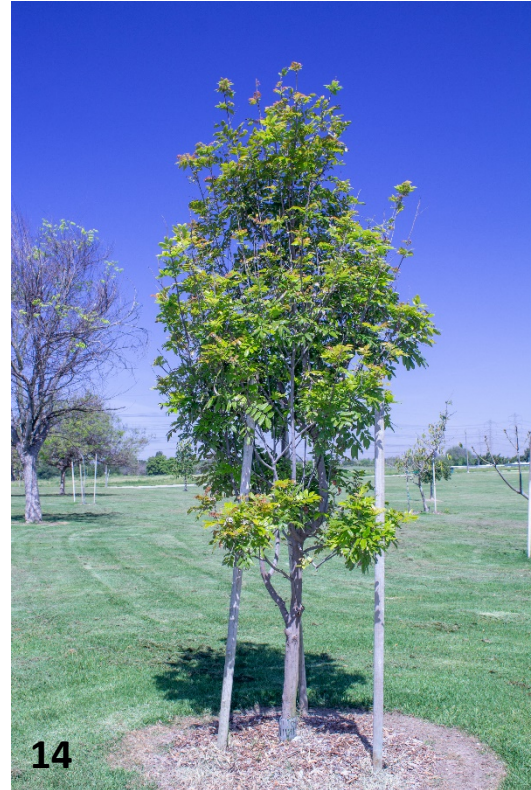
13–14. *Alectryon excelsus* 2015 and 2020.

Alectryon excelsus 33.8225498N, 118.0875880W 2015-12-ED66 Figs. 13–14

Rating: 3.

Notes: This plant with attractive glossy green leaves and curious fruits looking like a black gum drop nestled in a red raspberry, has been a steady, moderate grower with some problems. It frequently produces chlorotic foliage and typically has an abundance of epicormic growth.

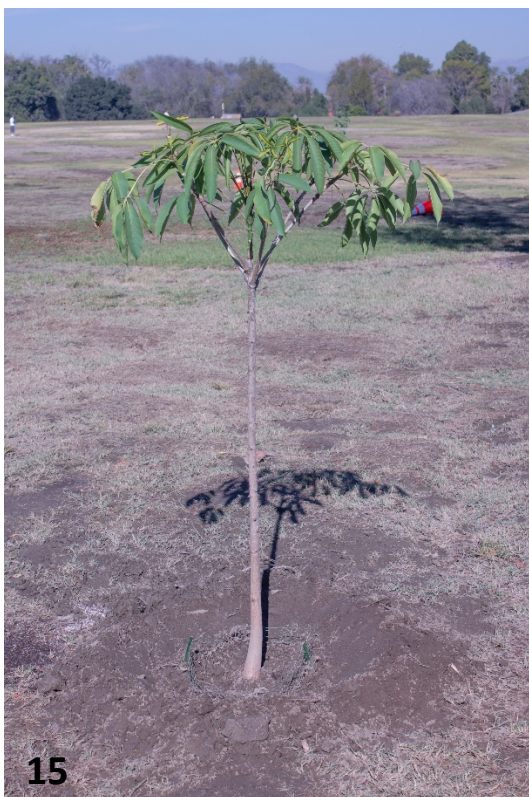
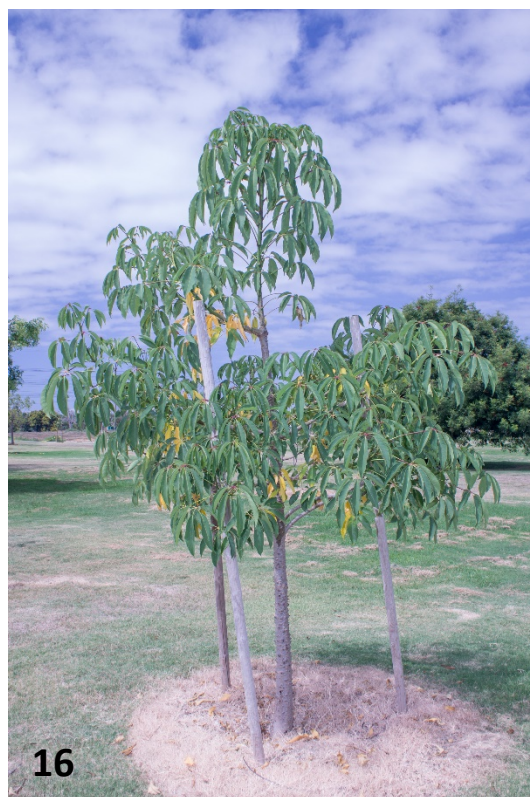
15–16. *Bombax ceiba* 2015 and 2017.

Bombax ceiba 33.8224767N, 118.087944W 2015-12-ED27 Figs. 15–16

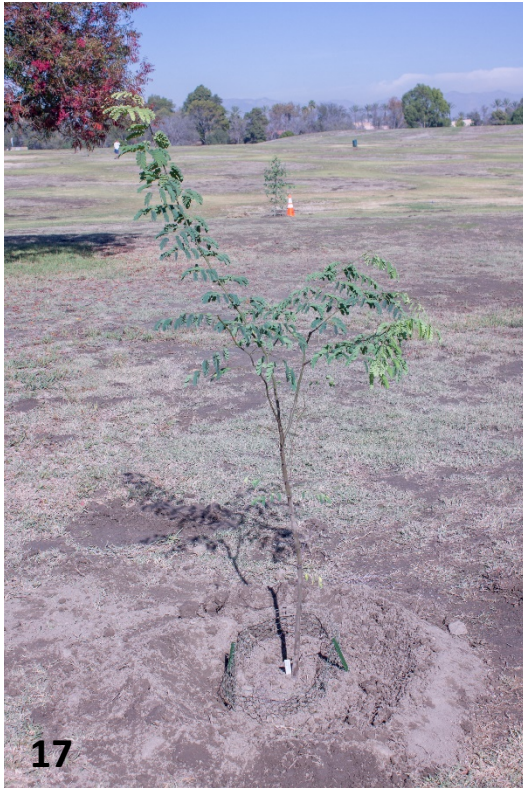
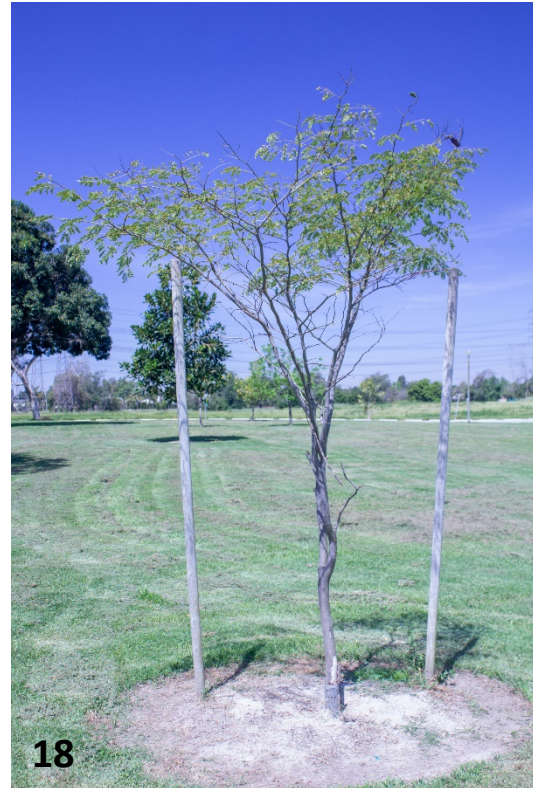
17–18. *Caesalpinia ferrea* 2015 and 2020.

Rating: 4.

Notes: This plant has grown slowly and has few problems. A moderate amount of structural pruning was necessary to attain and maintain a strong central leader. It attained maturity and flowered in 2018.

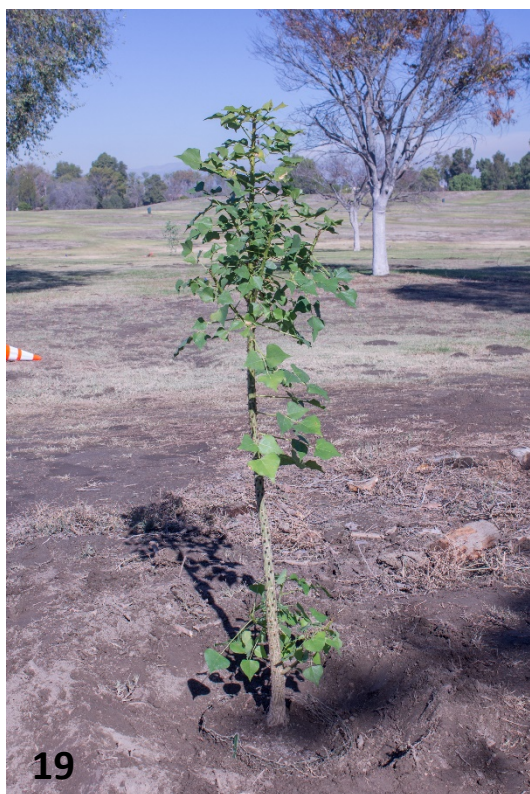
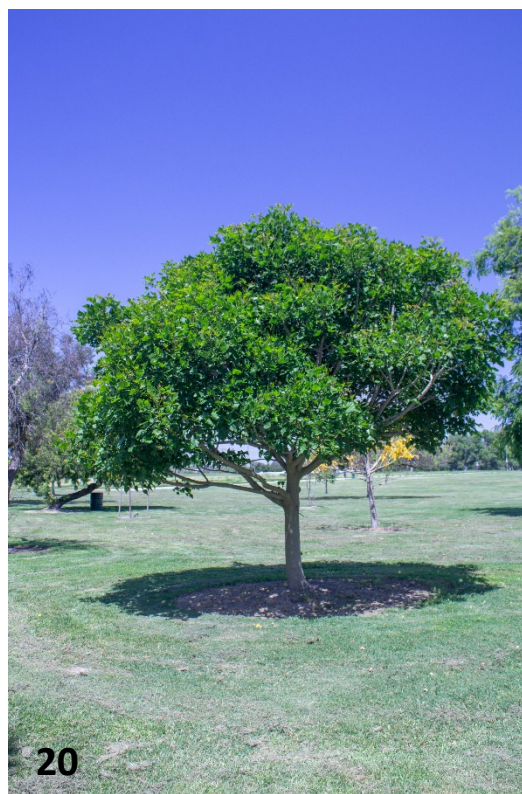
19–20. *Erythrina sandwicensis* 2015 and 2020.

Erythrina sandwicensis 33.8224084N, 118.0878950W 2015-12-ED69 **Figs. 19–20**

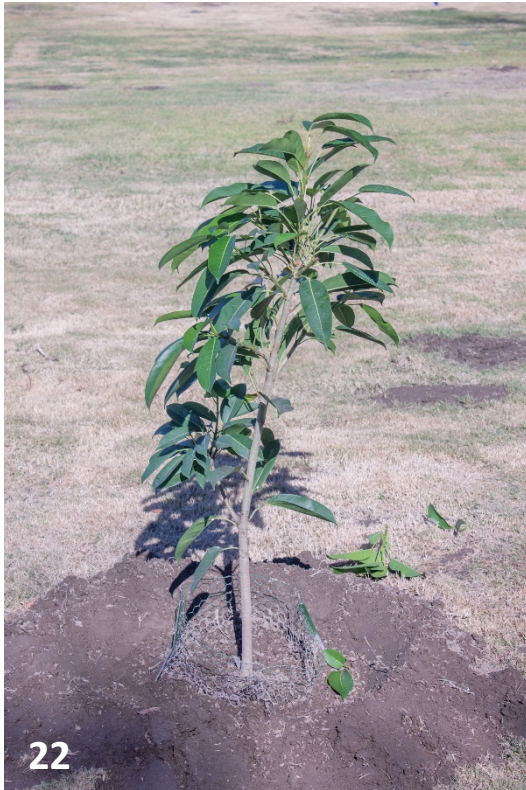
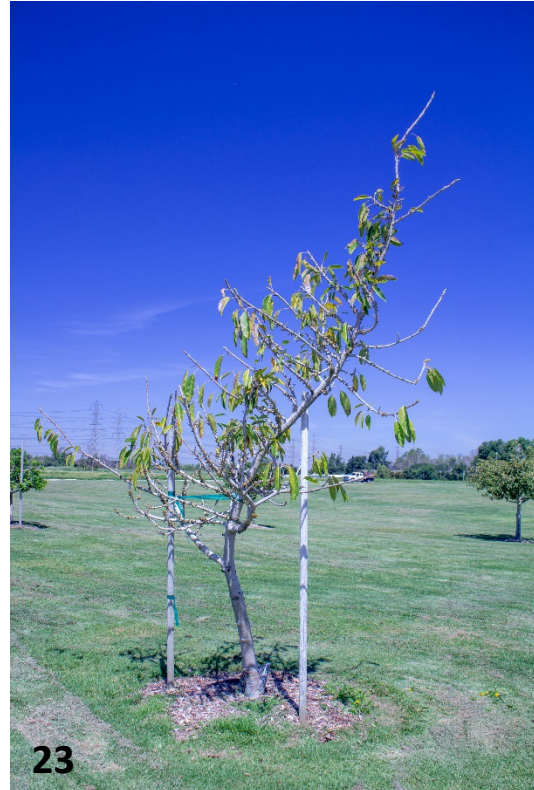
22–23. *Ficus caulocarpa* 2015 and 2020, the latter just coming out of dormancy.

Notes: This handsome plant has been a steady grower with few problems. It typically suffers slight leaf damage from the cold but recovers quickly in the spring and summer. Judicious structural pruning has been needed to attain and maintain a suitable central leader. It was erroneously planted as *F. superba* but the petiole epidermis flaking off proximally and distally confirms *F. caulocarpa*. It attained maturity and produced figs in 2019.

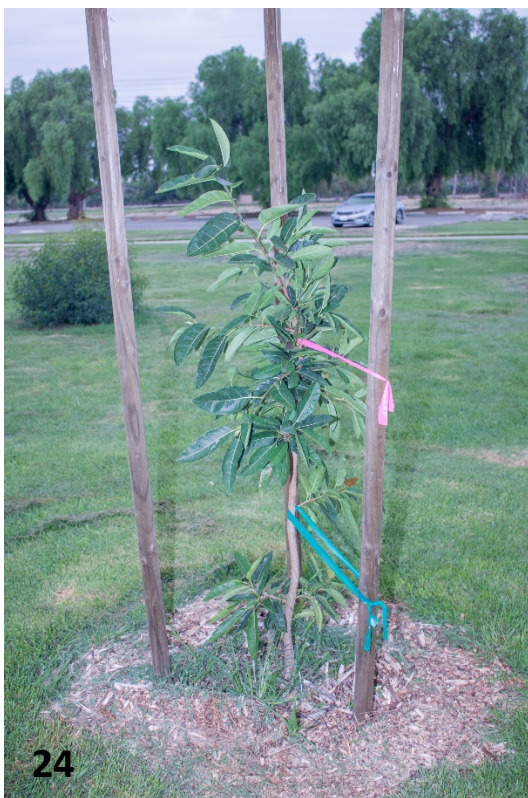
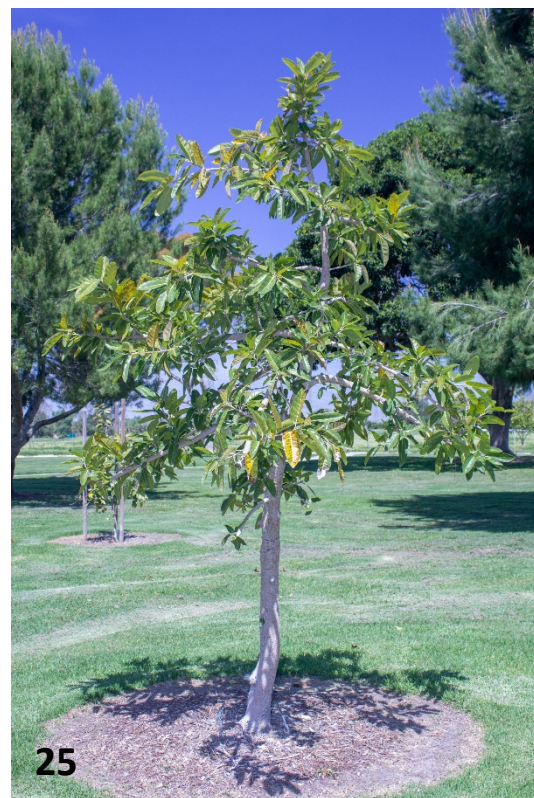
24–25. *Ficus cordata* 2016 and 2020.

Ficus cordata 33.8223032N 118.088578W 2016-06-ED13 **Figs. 24–25**

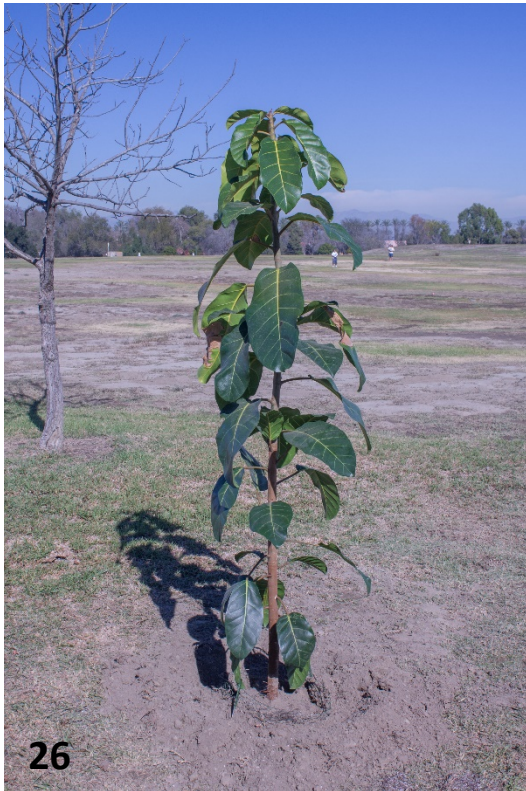
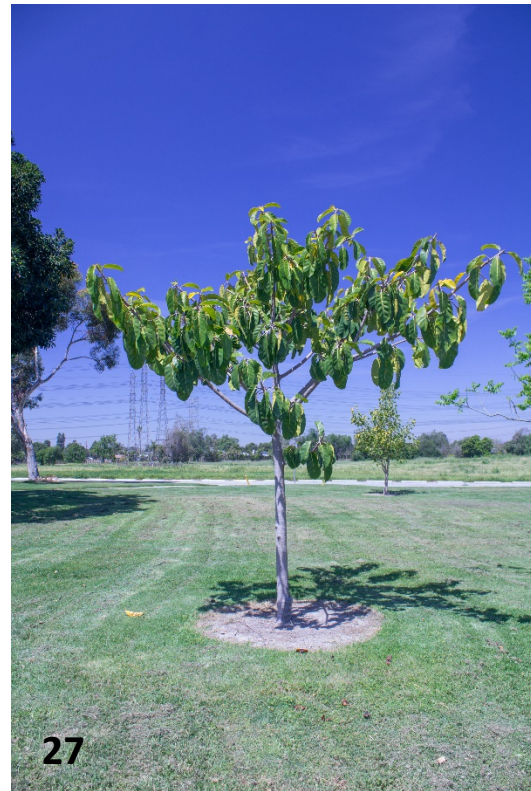
26–27. *Ficus lutea* 2015 and 2020.

Ficus lutea 33.8227262N, 118.088518W 2015-12-ED16 **Figs. 26–27**

Rating: 5.

Notes: This plant, a steady grower with no problems, has unusually large, thick, handsome leaves with prominent, cream-colored nerves. Growth seems to slow when water is insufficient.

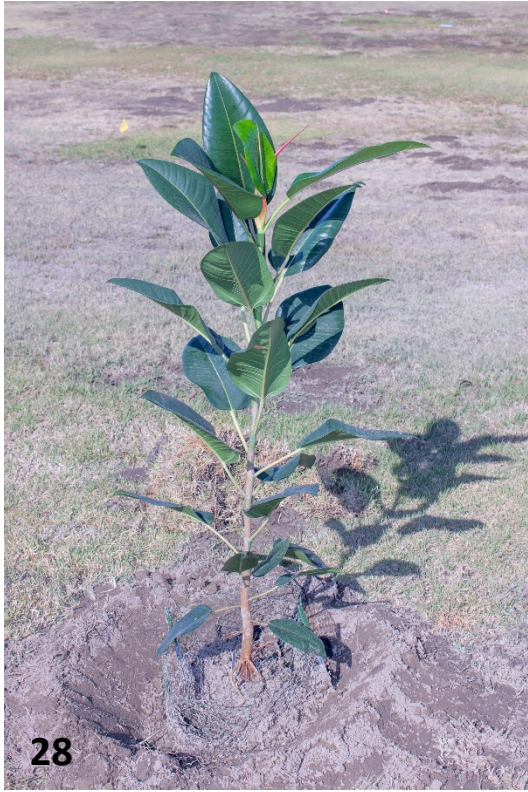
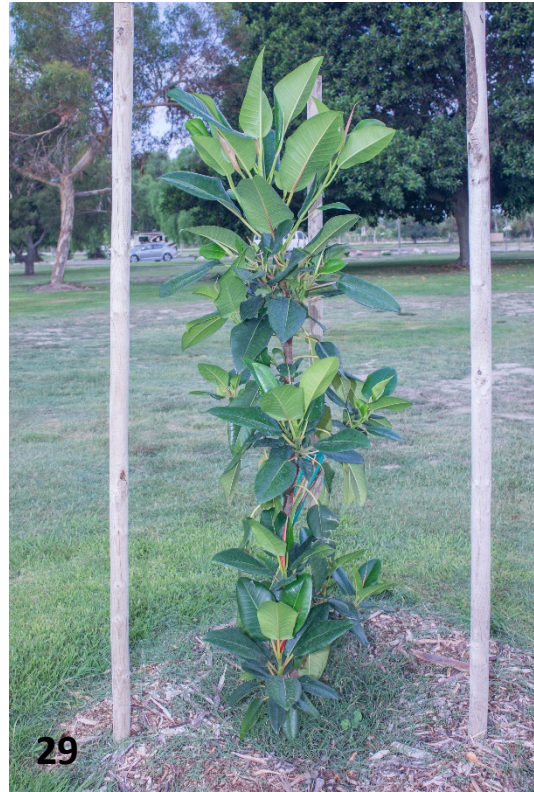
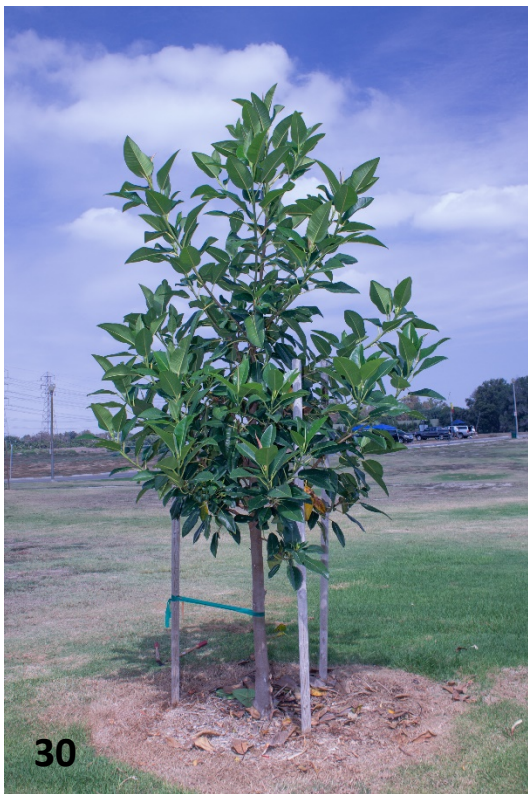
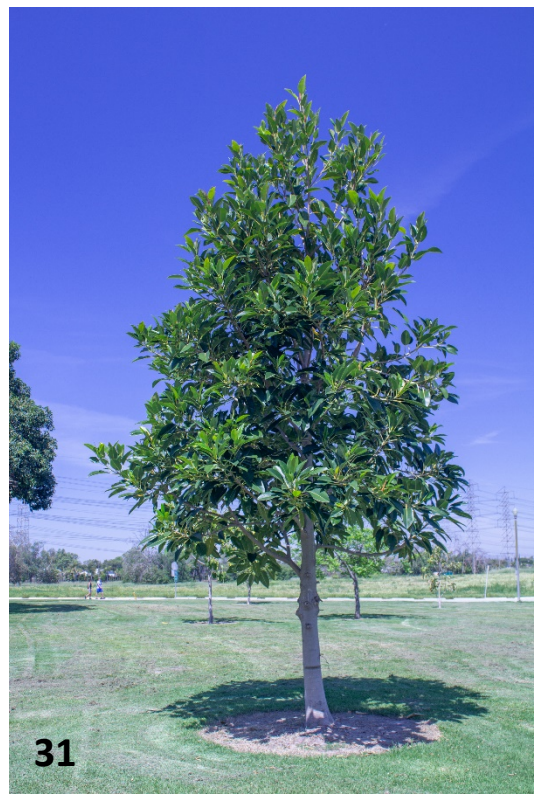
28–31. *Ficus macrophylla* 2015, 2016, 2017, and 2020.

Ficus macrophylla 33.8226741N, 118.088335W 2015-12-ED19 Figs. 28–31

Notes: This handsome plant, grown from a seedling extracted from the base of a large, upright-growing tree, has been a strong, vigorous, upright grower with few problems. A minor leaf bud blight was observed in December 2019.

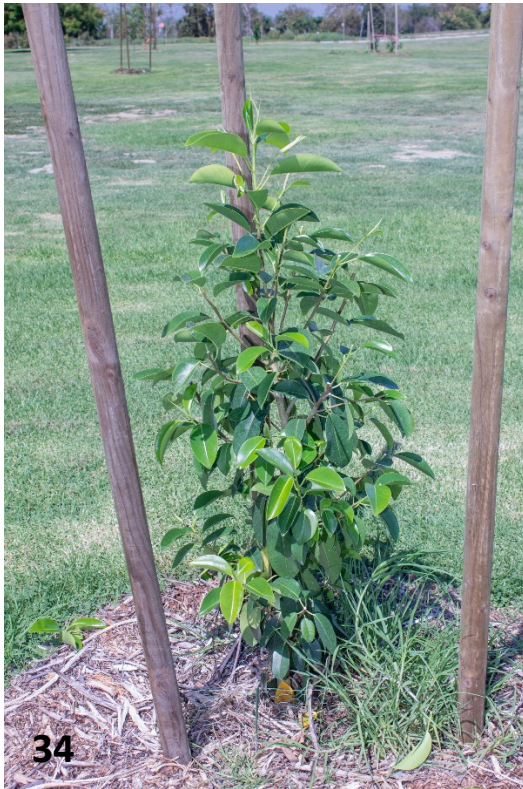
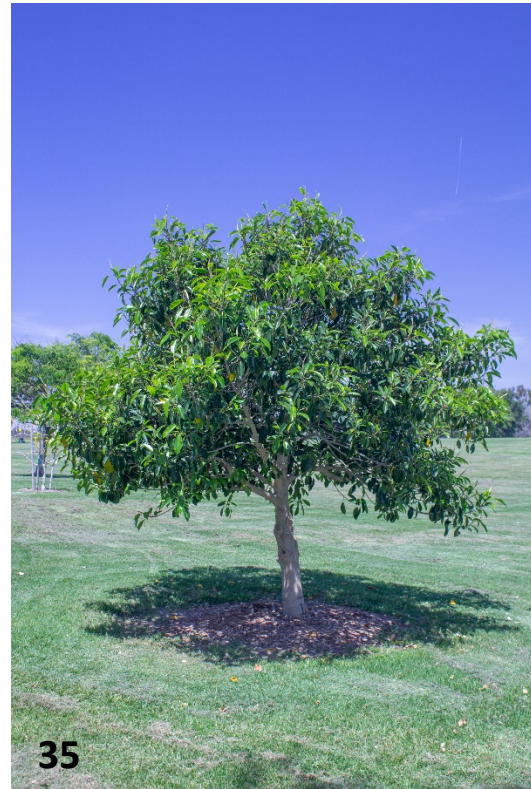
34–35. *Ficus obliqua* 2016 and 2020.

Ficus obliqua 33.8227459N, 118.087273W 2016-06-ED35 Figs. 34–35

Rating 5.

Notes: A purchased plant, this handsome species has been a fast, strong grower with no problems.

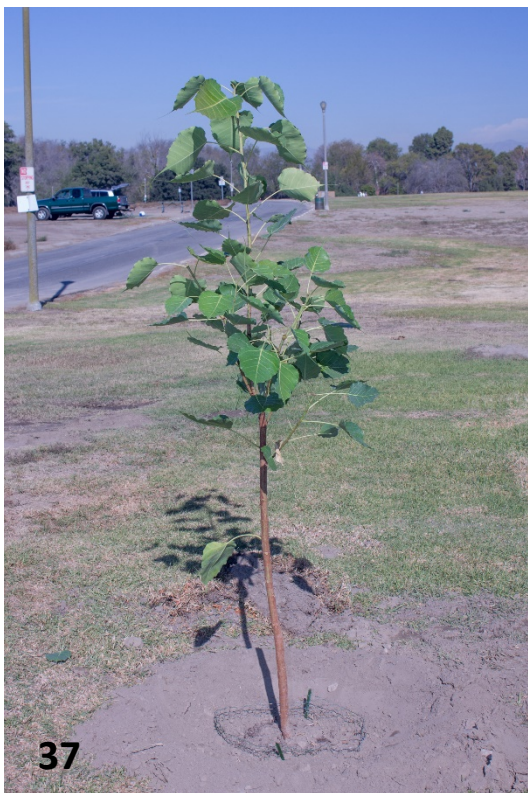
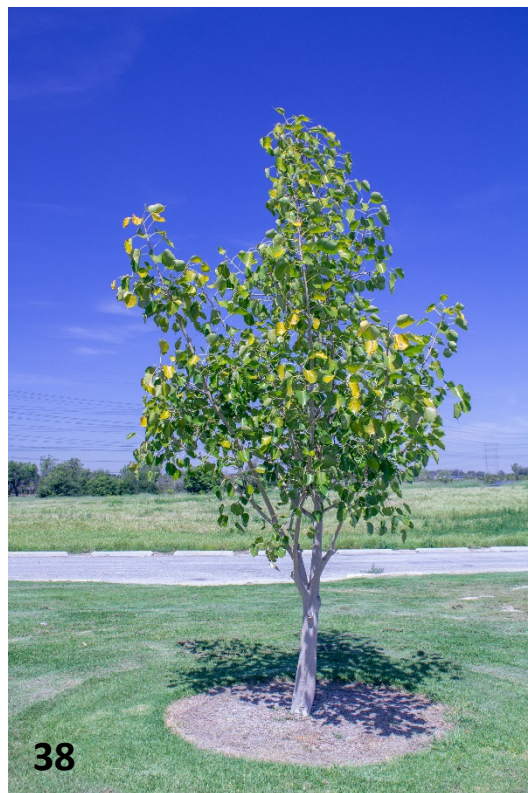
37–38. *Ficus religiosa* 2015 and 2020.

Ficus religiosa 33.8228208N, 118.088722W 2015-12-ED17 **Figs. 37–38**

Rating: 4.

Notes: This cutting-grown plant has been a moderate grower with no problems. Its slower growth compared to its companion species might be due to less water.

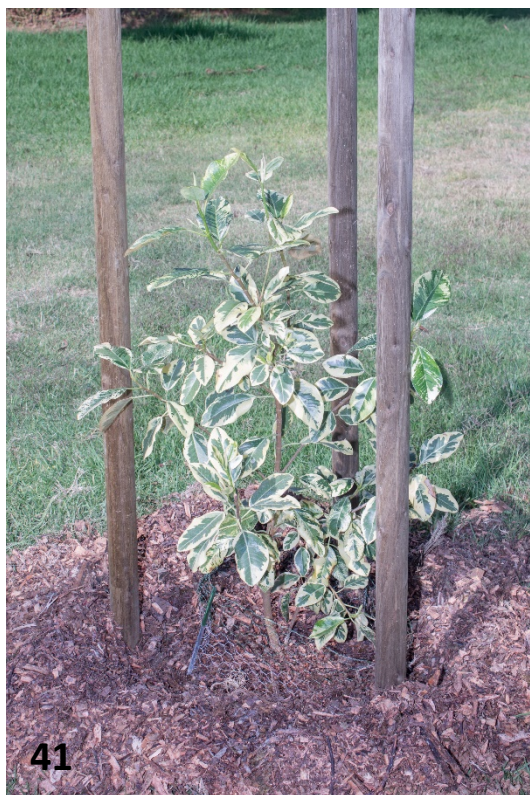
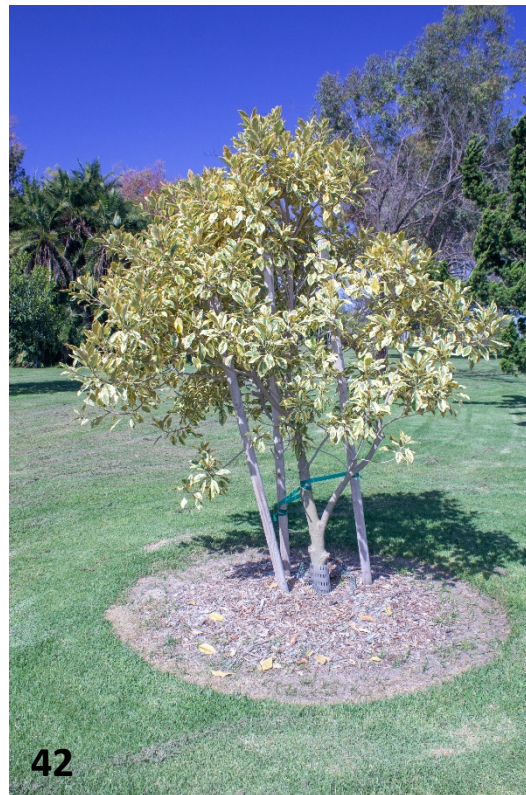
41–42. *Ficus rubiginosa* 'Variegata' 2016 and 2020.

***Ficus rubiginosa* 'Variegata'** 33.8225548N, 118.0868240W 2016-10-ED53 **Figs. 41–42**
VARIEGATED RUSTY LEAF FIG

Rating 5.

Notes: This handsome plant has been a moderate grower with no problems.

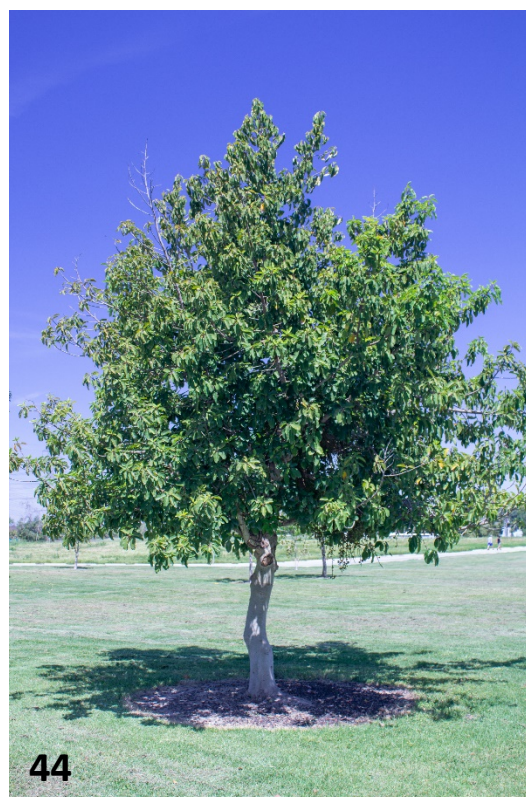
43

43–44. *Ficus sur* 2015 and 2020.

Notes: This handsome, cutting-grown plant grew extremely fast initially, despite having been killed to the ground by cold its first two winters (2015–2016 and 2016–2017), each time recovering during the following growing season from basal sprouting and growing to two m tall by August. Each time I had to select one of the basal sprouts as the new leader, removing the rest, and after doing so in late 2017, no further serious cold damage occurred but the plant

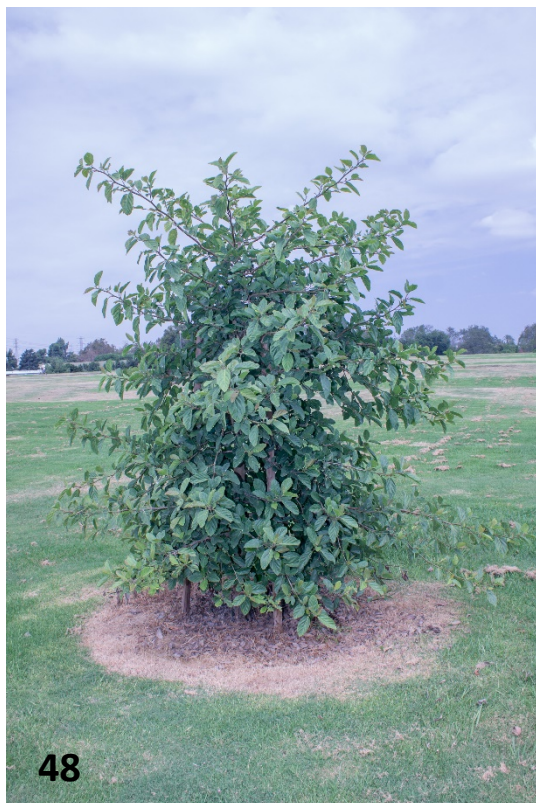
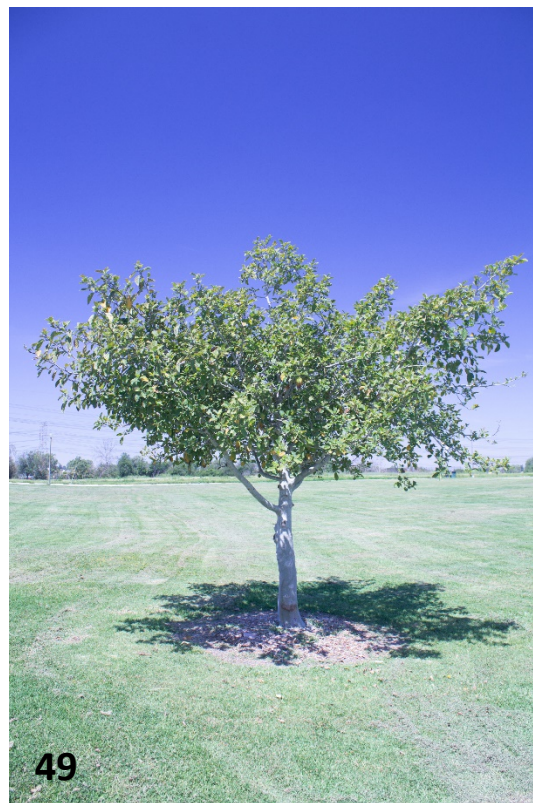
Notes: This handsome, cutting-grown plant grew extremely fast initially, despite having been killed to the ground by cold its first two winters (2015–2016 and 2016–2017), each time recovering during the following growing season from basal sprouting and growing to two m tall by August. Each time I had to select one of the basal sprouts as the new leader, removing the rest, and after doing so in late 2017, no further serious cold damage occurred but the plant slowed remarkably over the last two years, perhaps from gophers that breached the gopher basket and tunneled around the base of the tree. This plant is the *Ficus cocculifolia* form,

48–49. *Ficus sycomorus* 2017 and 2020.

considered a synonym of the highly variable *F. sycomorus* and characterized by a strong central leader and upright growth, whitish bark with an attractive greenish tinge, and leaves uncannily like those of the alder, *Alnus rhombifolia*. It attained maturity in late 2019 and produced a few, large, oblate figs directly from proximal parts of major branches near the central leader.

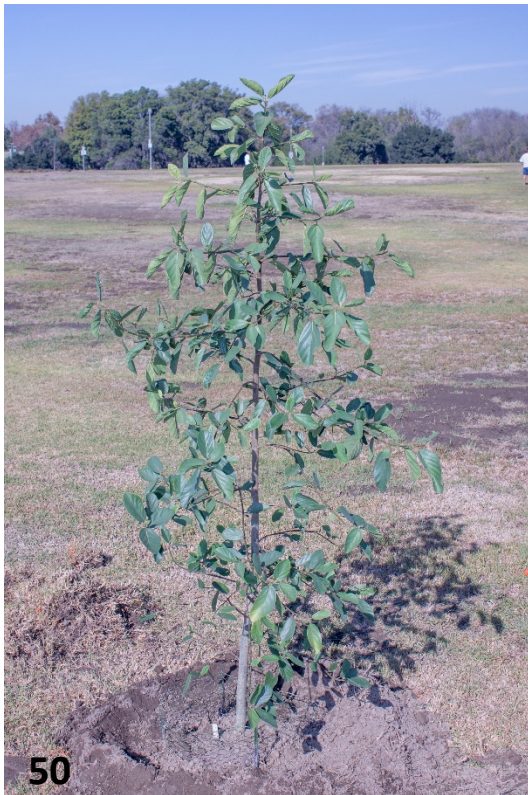
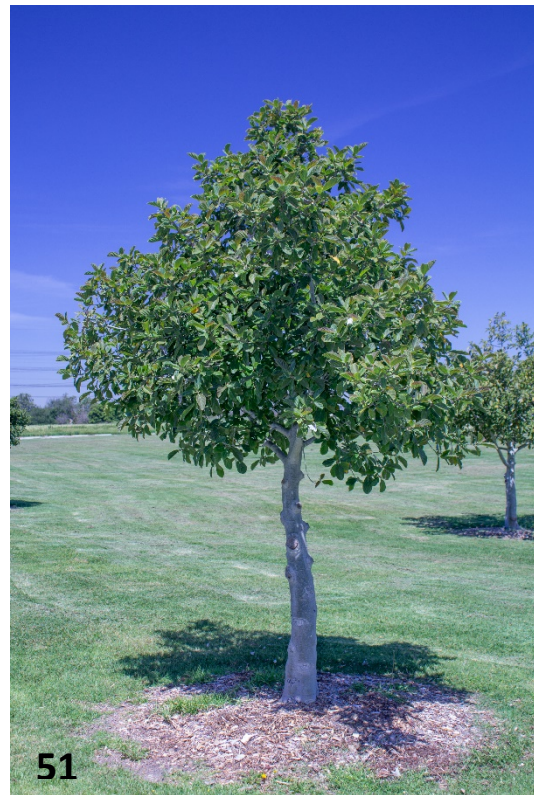
Notes: This handsome, cutting-grown plant was initially fast growing but has slowed somewhat over the last two years. It suffered moderate leaf burn and slight shoot tip dieback from cold during the first winter (2016–2017). This plant is the *Ficus cocculifolia* form, considered a synonym of the highly variable *F. sycomorus* and characterized by a strong central leader and upright growth, whitish bark with an attractive greenish tinge, and leaves uncannily like those of the alder, *Alnus rhombifolia*.

50–51. *Ficus sycomorus* 2015 and 2020.

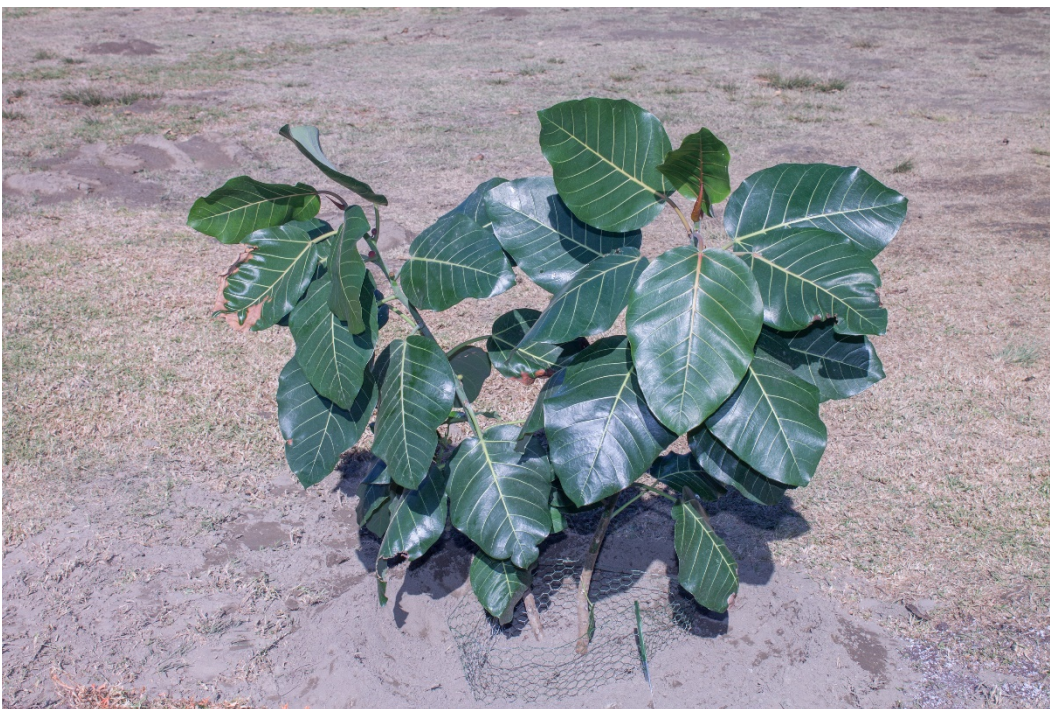
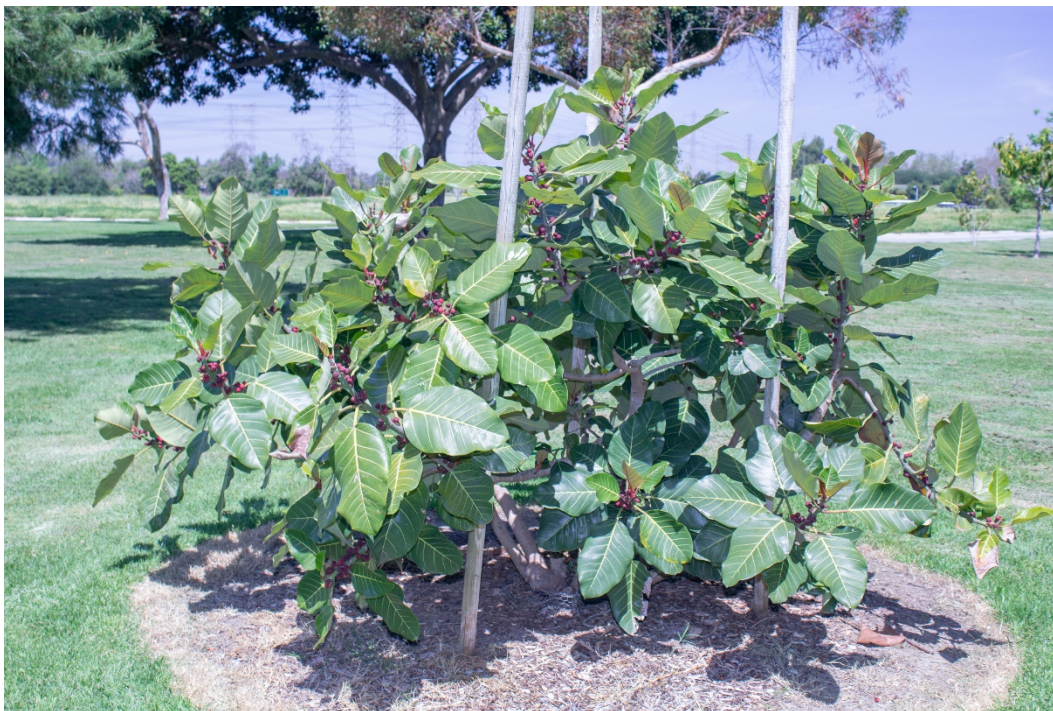
Notes: This extremely handsome plant has grown moderately for four years, making a mound-shaped, multi-trunked shrub, which was recently pruned up to make a tree. It suffered only slight cold damage during some winters but defoliated and had reduced growth during the summer of 2018 when irrigation was interrupted. This plant has large, nearly leathery, wide, heart-shaped leaves with prominent white nerves adaxially and striking pinkish nerves abaxially. It attained maturity in late 2019 and carries red figs. This species occurs naturally in wet, swampy areas in Africa and tends to produce abundant aerial roots. Indeed, a spectacular specimen at Legoland in Carlsbad, California, heavily festooned with an abundance of aerial roots, appears much like a miniaturized tropical banyan (*Ficus benghalensis*). Hopefully this spectacular appearance can be attained with this specimen.

52. *Ficus trichopoda* 2015.

53. *Ficus trichopoda* 2020.

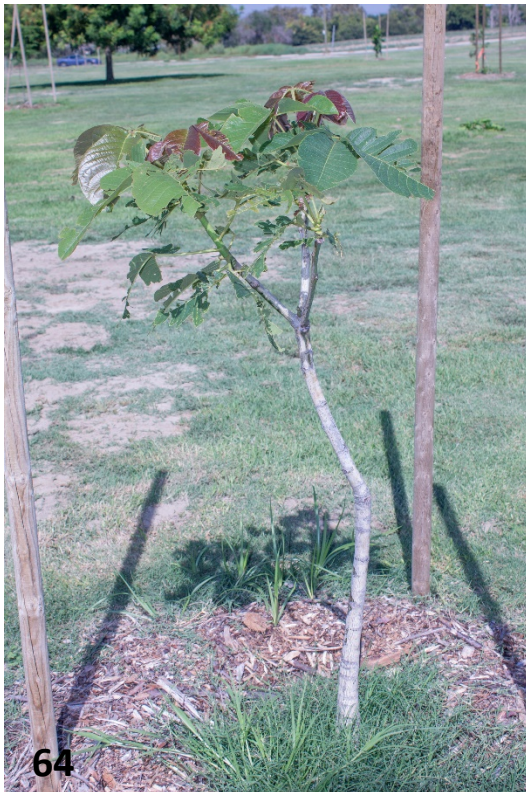
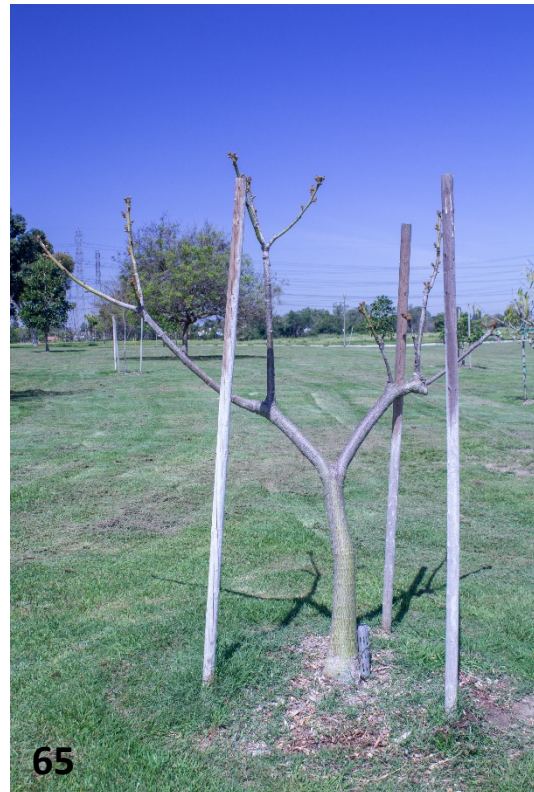
Notes: This Hawaiian endemic, a purchased plant and formerly known as *Munroidendron racemosa*, has been a steady, moderate grower. New growth is often stunted and distorted, likely from eriophyid mites in the vegetative buds.

64–65. *Pseudobombax grandiflorum* 2016 and 2018, the latter with buds ready to break.

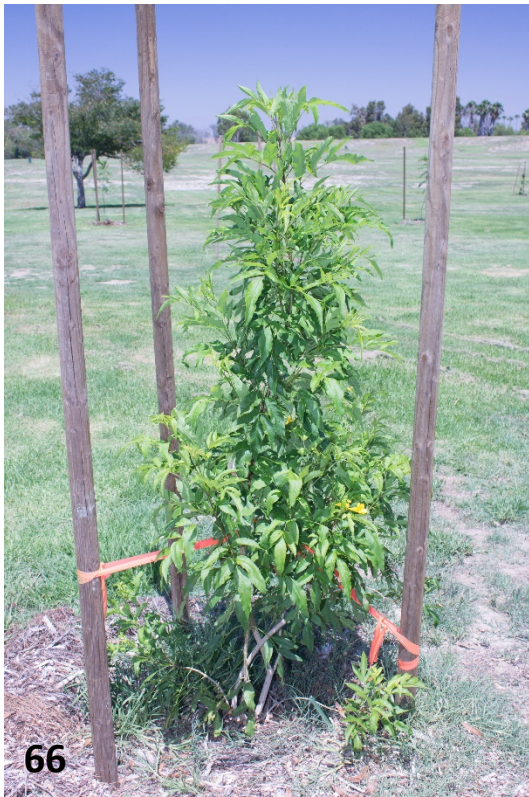
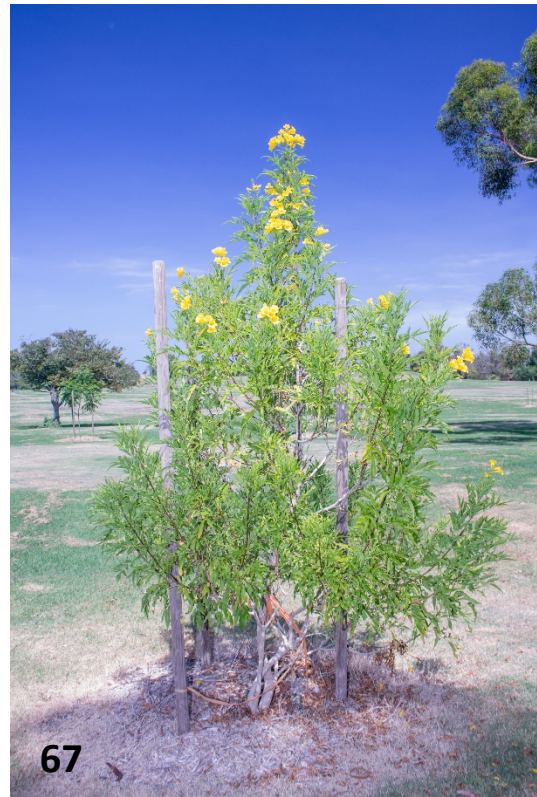
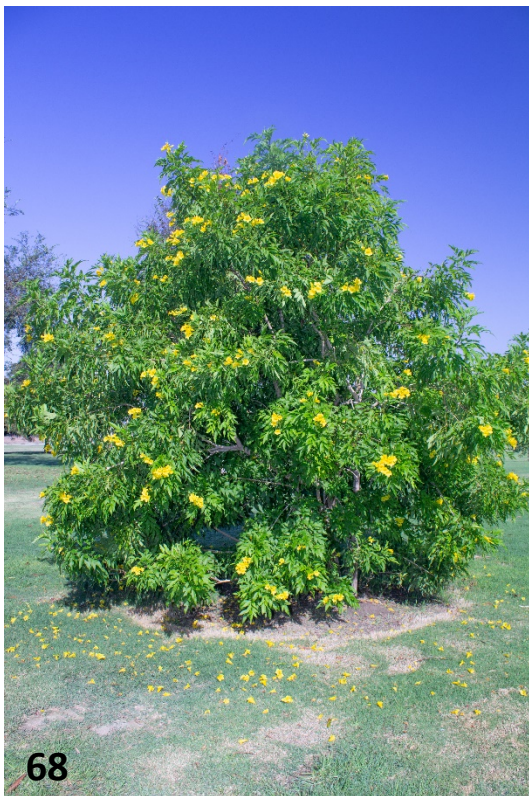
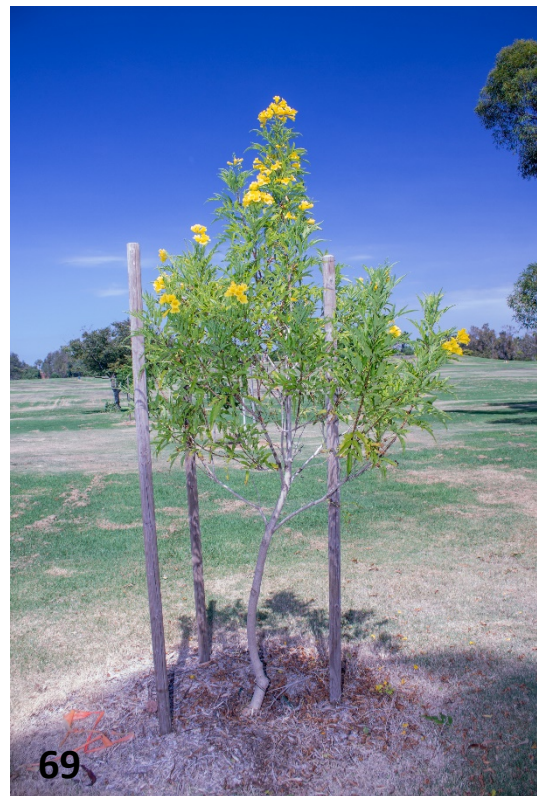
Notes: This plant has struggled and grown slowly.

66–69. *Tecoma stans* 2016, 2017, 2019, and 2020, the latter after it was pruned up.
