River Rehabilitation Works 2013 Ovens River; Germantown Reach

Upper Ovens Valley Landcare Group

Prepared by Riparian Management Services

March 2013

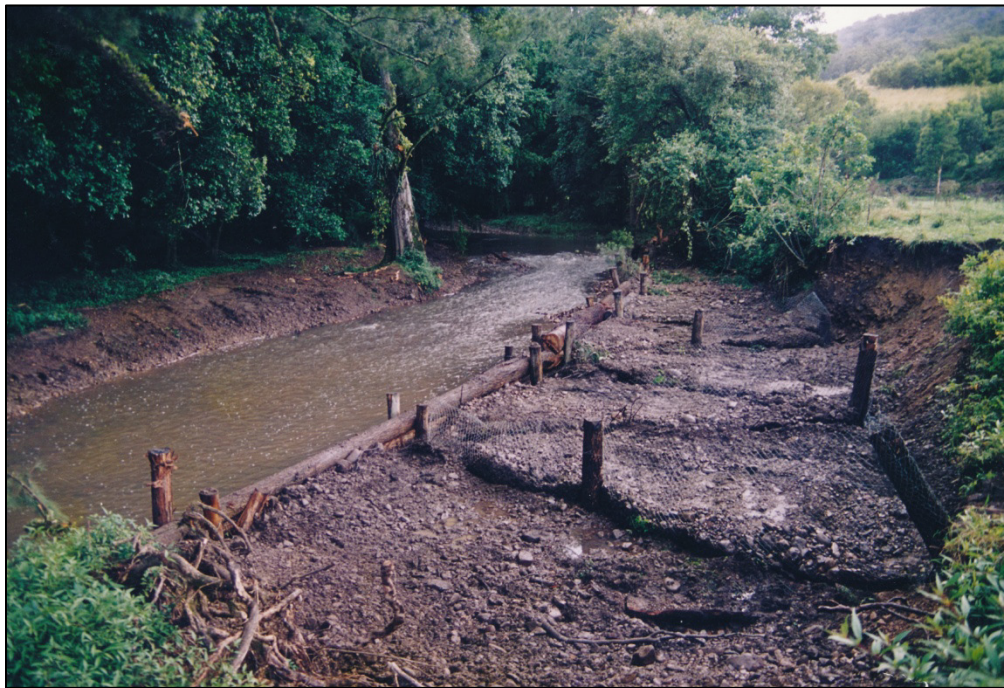
Photo 6. Bend re-alignment structure, Myall River, Mid-North coast of NSW, late 1990s. The development of a break-out point has been prevented by re-aligning the main channel using a hardwood log front wall, backfilled with point bar gravel & chainmesh laterals. The chainmesh catches flood debris & encourages deposition on the created bench, which in turn leads to the natural regeneration of native riparian plants.

Poorly aligned eroding bends that are potential breakout points where chute cutoff channels may develop have been marked on the map sheets. A range of 'off-the-shelf' erosion control designs exist^{8&9} to rehabilitate sites like this and these should be addressed as a matter of priority. Photo 6 shows an example of the sort of bend re-alignment works that can be used. This project was designed and installed by the author of this report in the late 1990s. In addition, appendix 3 contains RMS "standard designs" for typical bank and bed erosion control structures that would be suitable for use within the project reach.
