**UNITED STATES AIR FORCE**  
**GROUND ACCIDENT INVESTIGATION**  
**BOARD REPORT**

**Hazardous Materials Storage Building**  
**18TH LOGISTICS READINESS SQUADRON**  
**18TH WING**  
**KADENA AIR BASE, JAPAN**

**TYPE OF ACCIDENT: FIRE**  
**LOCATION: BUILDING 3150, KADENA AIR BASE, JAPAN**  
**DATE OF ACCIDENT: 22 JUNE 2020**  
**BOARD PRESIDENT: COLONEL DOMINIC A. SETKA, USAF**  
**Conducted IAW Air Force Instruction 51-307**

**Hazardous Materials Storage Building Fire  
Kadena Air Base, Japan  
22 June 2020**

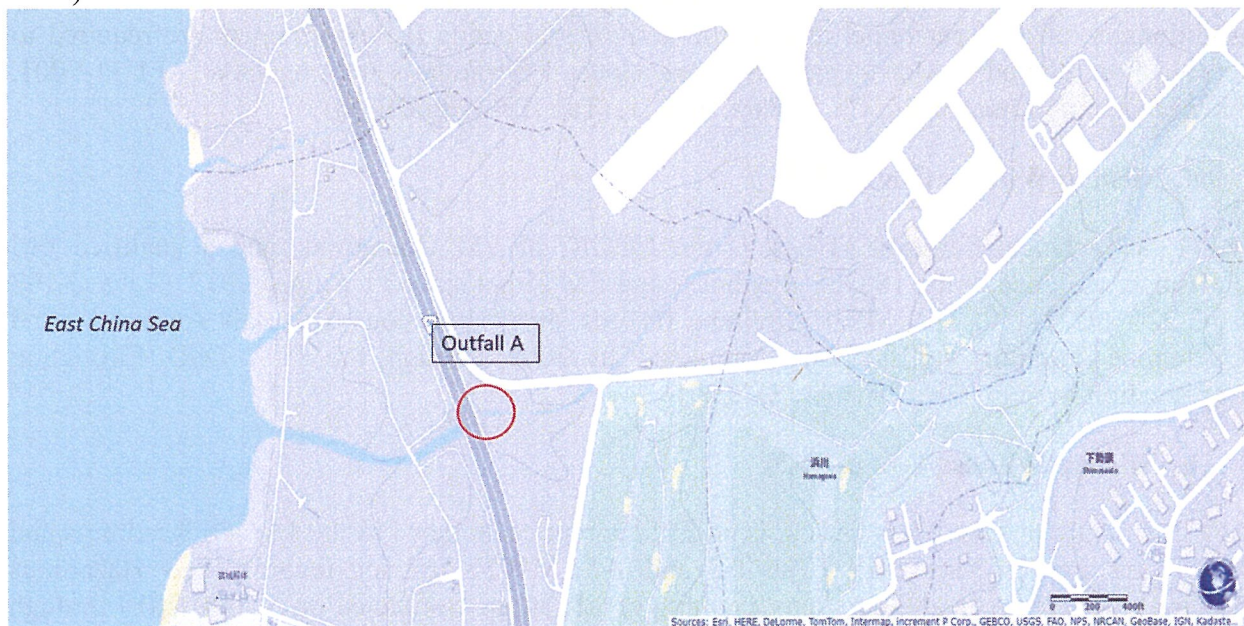
**Figure 16:** Outfall A Boundary (Tab Z-10)

Three sets of sampling for CH were conducted IAW the 2018 Japan Environmental Governing Standards (JEKS), Ch. 4, at the Outfall A boundary on 25 June 2020, 1 July 2020, and again on 16 July 2020. (Tab W-2, Tab BB-1 to BB-3, and Figure 16) JEKS are the Final Governing Standards for U.S. Forces Japan and were developed IAW DoD Instruction 4715.05, Incorporating Change 1, 5 October 2017, *Environmental Compliance at Installations Outside the United States*, the Status of Forces Agreement, and other applicable international agreements. (Tab BB-1 to BB-3)

The chemical levels in the analysis report from 25 June 2020 and 1 July 2020 fall within acceptable thresholds. (Tab W-2) The analysis from 16 July 2020 revealed an elevation in readings on the potential of hydrogen (pH) scale at 9.30; the acceptable threshold is 9.00. (See Figure 17)
