D-5 Report on the Environmental and Social Impact Assessments for the Rehabilitation of the Philip Goldson Highway between Miles 8.5 to 24.5

**Ministry of Works
Belmopan, September 2017**

D-5 Report on the Environmental and Social Impact Assessment

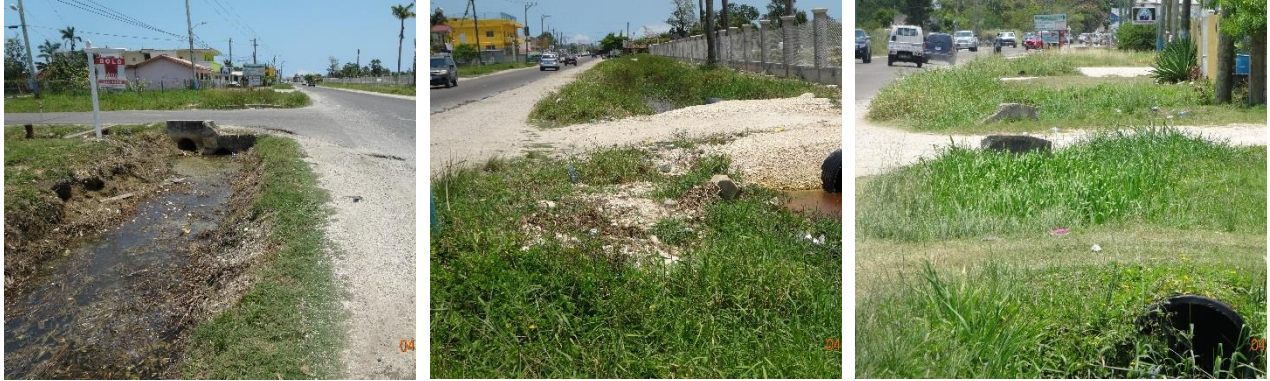
runoff from the side drains (Figure 2.1). Culverts were placed to act as balancing culverts. However, development over time by property owners along the highway has reduced the wetland areas that stored excessive storm water. Also there has been an increase of intense rainfall in the project area.

Figure 2.1 Longitudinal side drains Ladyville Village.

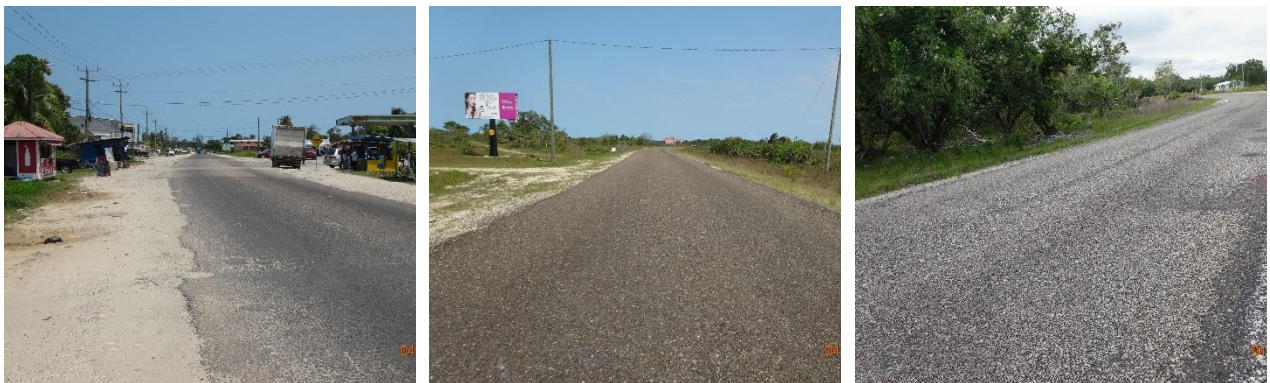
In the Lord’s Bank junction area leading up to the junction with the old Northern Highway there are no defined longitudinal side drains which might have been silted up over time and overgrown with vegetation. The pavement structure in this area was just built higher than the natural surrounding area and culverts were installed to connect water bodies.

Figure 2.2: Longitudinal side drains are not defined between the Lord’s Bank junction area up to the junction with the old Northern Highway.

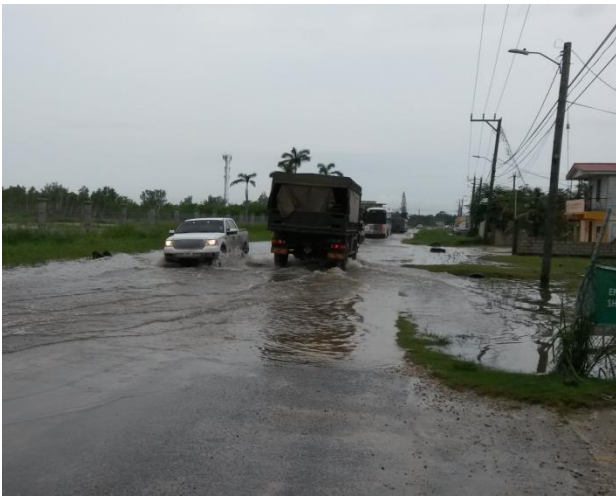
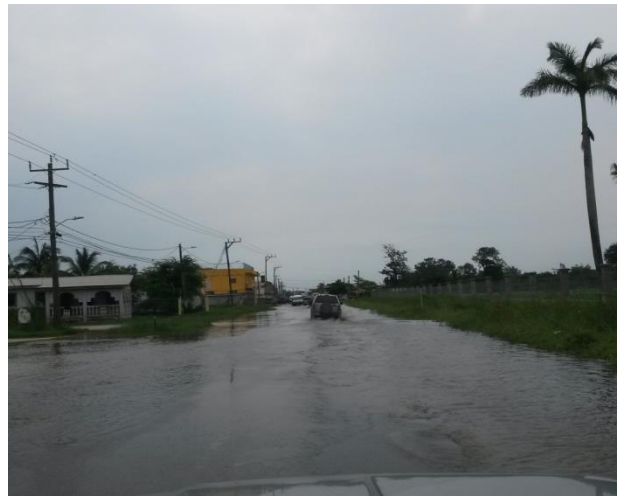
The Ladyville Village portion of the highway was flooded in June 2016 and once again on June 21 June (2017). The flooding has been attributed to the filling of a property estimated to be 14.801 acres in area. The filled lot has a finished fill level higher than the highway surface level and no provision was made for the removal of storm water runoff (Figure 2.7a-e). The drainage of the storm water runoff will require that both longitudinal side drains starting from the Lady of Our Way RC School be re-established to connect with the Link Canal. Recommendation is also being made for the construction of drains along Poinsettia Street up to Perez Road which leads to the Vista del Mar Marina.

Figure 2.7b: Flooded Ladyville Village section of the PGH in June 21, 2017 (same area as in Figure 2.7a). The filled land is to the left of the second photo.

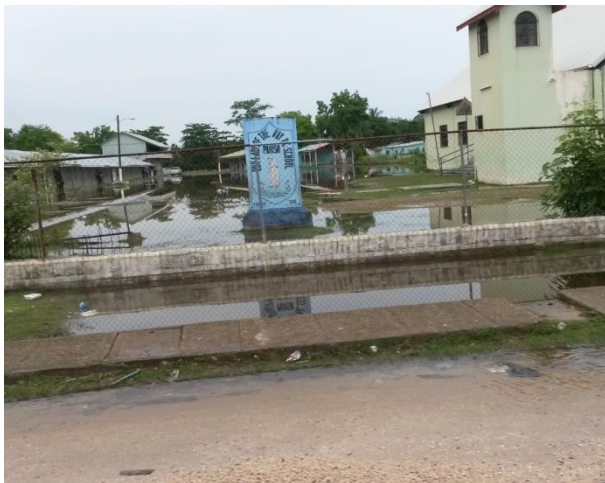
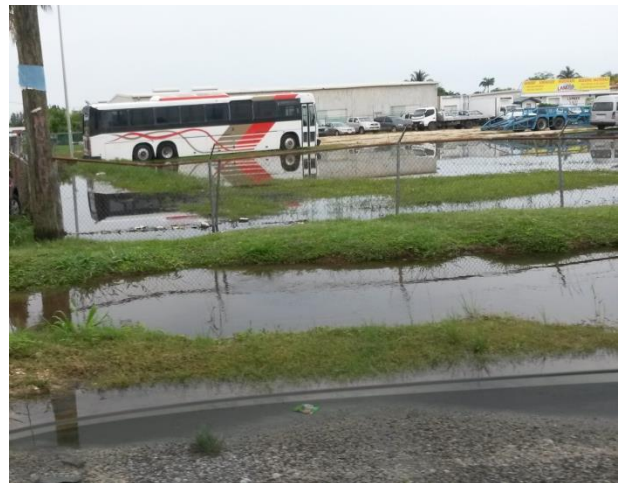
Figure 2.7c: Flooded Lady of Our Way RC School and Ladyville's Industrial Park on June 21, 2017.

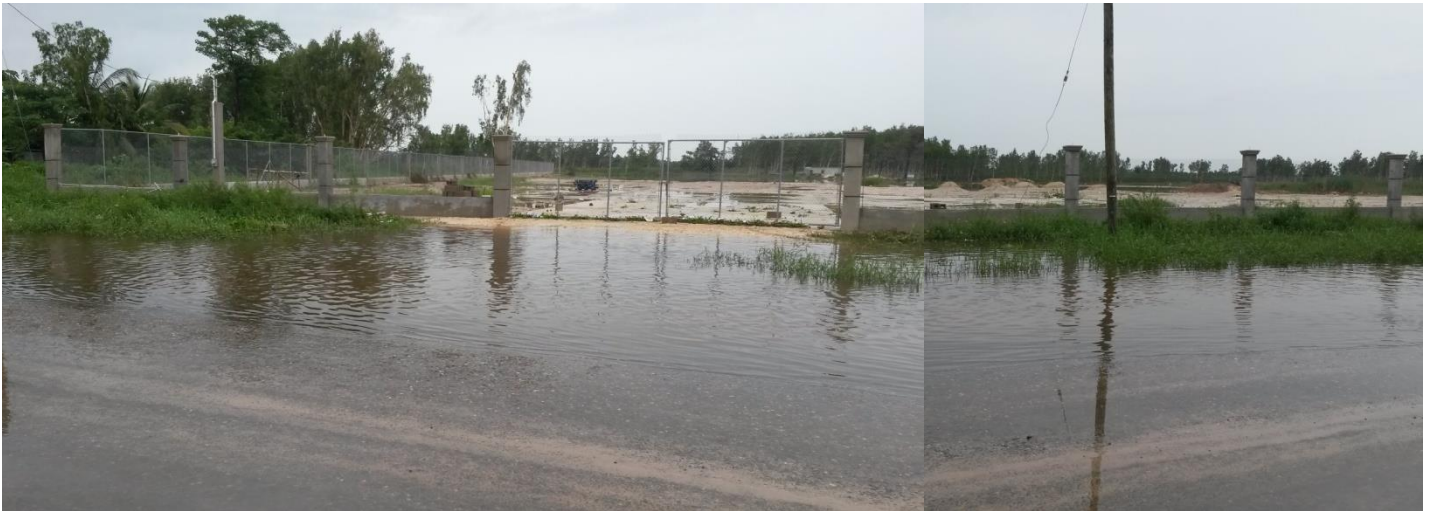
Figure 2.7d: Filled Property in front of Low’s Supermarket, Ladyville.

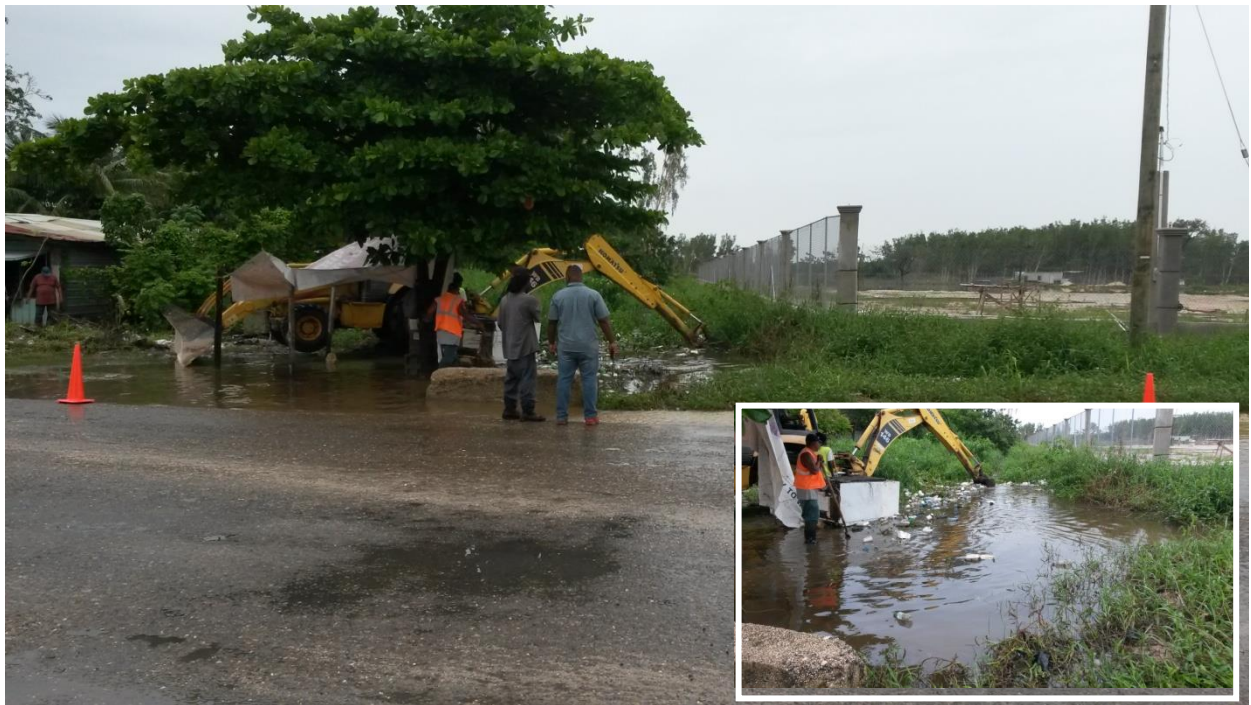
Figure 2.7e: MOW (Belize Office) clearing the clogged drain in front of Low’s Supermarket, Ladyville and to the left of the filled property (June 21, 2017).

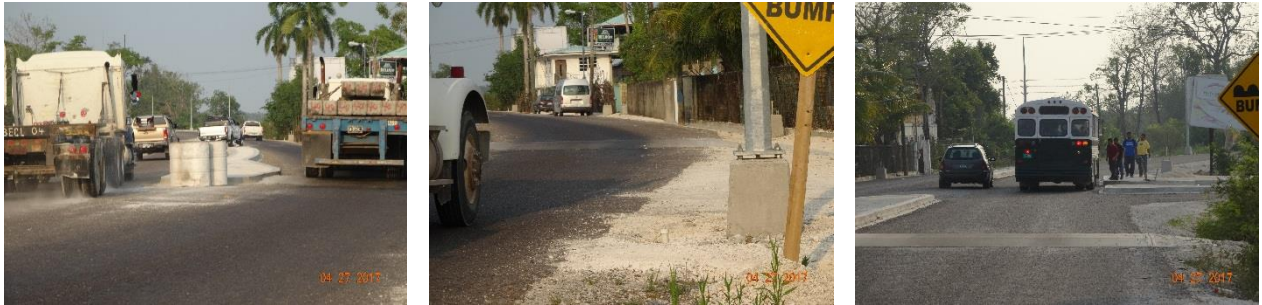
Figure 2.10: Road safety concerns at Vista Del Mar Junction mile 8.5 with the PGH. (Left) Illegal overtaking at junction; (Center) utilities are near the pavement edge and (Right) bus stops lay-bys are required.

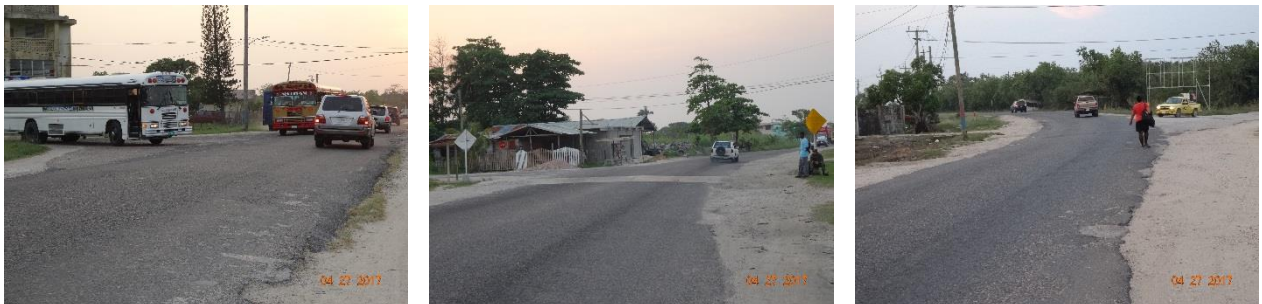
Figure 2.11: Price Barracks at mile 10 junction with the PGH. (Left) No traffic signs nor line markings to guide drivers; (Center) pedestrian crossing signs one is absent the other in dire need of maintenance; and (Right) pedestrian using the road carriageway as foot path.

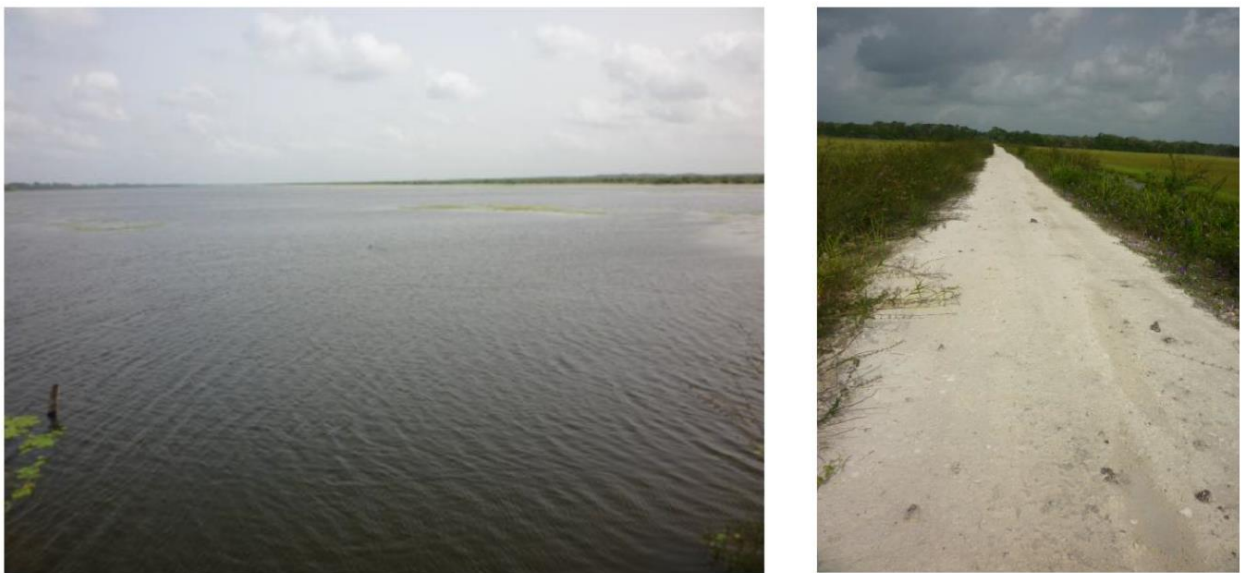
Crooked Tree is an island surrounded by the Crooked Tree Lagoon, sometimes called the Northern Lagoon. The access causeway has two bridges and two culverts that help circulate the flow in the lagoon, but in extreme rainfall events, these hydraulic structures do not have the capacity to facilitate the free flow of rising flood waters, so the access road itself becomes partially inundated, and villagers have to use boats as the only means of transportation to and from Crooked Tree. Information to be derived from the feasibility study and the preparation of designs to upgrade the Crooked Tree Road and Causeway can be used in conjunction with this study to better understand the prevailing hydraulic conditions of the entire wetland system affecting the PGH.

Figure 4.9: (Left) Crooked Tree Northern Lagoon and (Right) View of the causeway to Crooked Tree Village.
