UNITED STATES COAST GUARD

REPORT OF THE INVESTIGATION INTO THE

FPS AUGER

LIFEBOAT FALL WITH LOSS OF LIFE ON JUNE 30, 2019

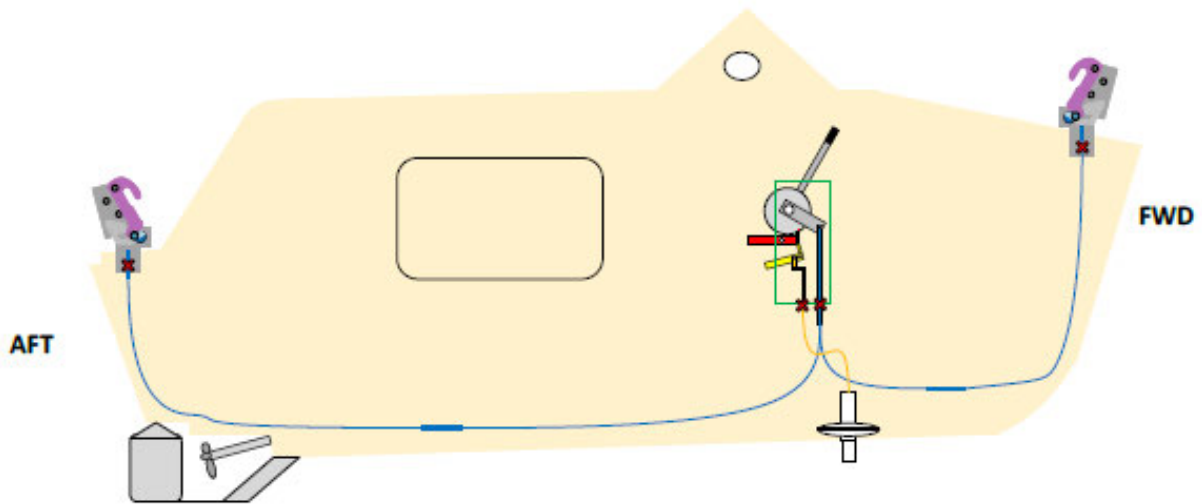
The release mechanism was comprised of two hooks, a hook release unit (located inside the lifeboat adjacent to the helm), a hydrostat unit, and three control (push-pull) cables (see Image 3). One control cable connected the hook release unit to the aft hook, the second control cable connected the release unit to the forward hook, and the third control cable connected the release unit to the hydrostat unit.

Image 3: Drawing of EL24 outfitted with LHR3.5M2 release mechanism. Credit: Shell.

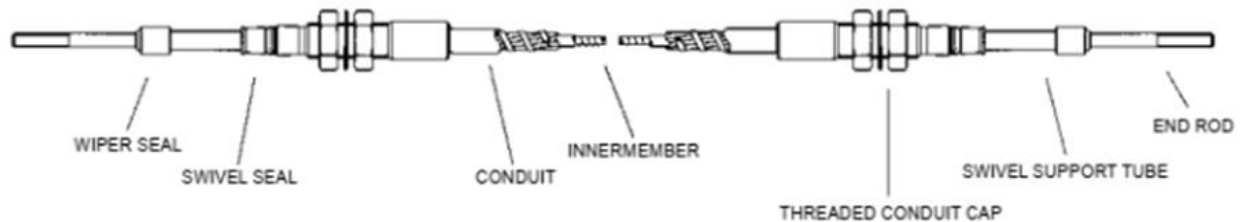
The hook control cables are heavy duty low friction cables with threaded end fittings and four inches of travel at the end rods (see Image 4). Each cable has an outer conduit and an inner member. The conduit is comprised of three layers: a green plastic cover; steel reinforcement; and a white polyethylene liner. The conduit provides a protected path for the steel inner member. With the ends of the conduit fixed at each terminal point (provided it is not fully compromised), the conduit also controls the travel length of the inner member. The inner member transmits linear motion from the hook release unit to the locking shafts located within the hooks via the end rods.

Image 4: Control cable components. Credit: Cablecraft, modified by the USCG.

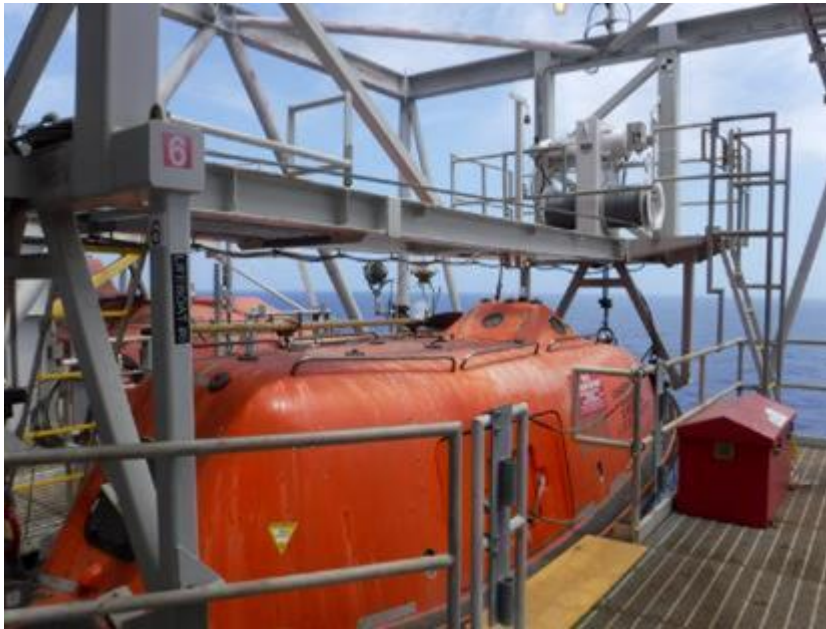
Figure 2: Lifeboat No. 6. Photo credit: Palfinger Marine.

Serial Number	EL24-874/3/84
Manufacturer	Watercraft America ¹
Type	Lifeboat
Lifeboat Station	Lifeboat Station No. 6
Hook Release System	Schat-Harding ² SeaCure LHR3.5M2
Style	Totally enclosed lifeboat – tanker version
Propulsion Type	Motor
Length	23.87 feet ³
Breadth	8.75 feet
Capacity	33 persons
Year Built (Completed)	1984
Year Refurbished	2012

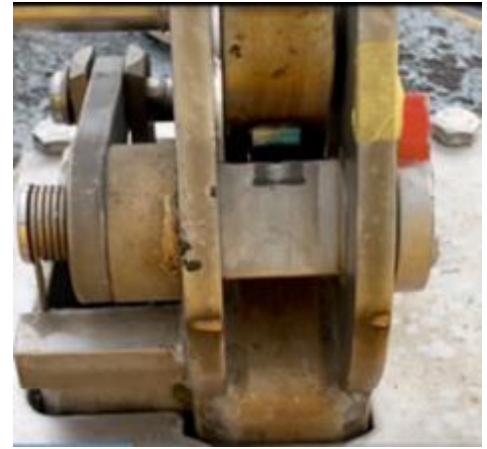
4.1.12. Boat Crew Person 1 had watched the hook locking shaft roll back into place. He looked for and saw the flat face of the locking shaft (see Figure 6). To him, this indicated that the locking shaft was in the correct position and the hooks were correctly reset. He also said he would generally look at the hook indicator on the side of the hook. He noted that if in the closed position, the arrow should be in the red; if in the open position, the arrow would indicate in the green.⁴

Figure 6: The “flat face” of the locking shaft on a LHR 3.5M2 hook (image does not depict Lifeboat No. 6’s hook). Credit: CG.

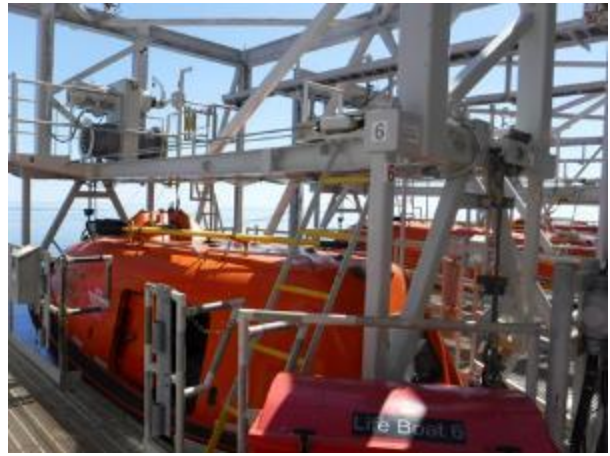
4.1.26. The winch is located on a raised landing above the forward end of the lifeboat (see Figure 7). The BCO reached the winch by climbing a ladder. At the winch, he inserted the handle and started to crank. The winch at Lifeboat Station No. 6 had recently been changed out. While the new winch was not “new,” it had been refurbished in or around 2018 and was in significantly “newer” condition than the previous winch at Lifeboat Station No. 6. Furthermore, it was a more powerful winch: the new winch was converted to a model 9300XL, rated for 9300 kg; while the old model, a 7800XL was rated for only 7800 kg. To the BCO, the winch model looked identical. However, he did note that it was easier to operate. Later, he recalled that it felt “smooth” and “like butter.” He observed, “Where the old one had like maybe two pounds of resistance . . . this one had like a half pound of resistance against it.”

Figure 7: Lifeboat Station No. 6 davit. Figure depicts raised landing where winch is located. Credit: Palfinger, dated May 2015.

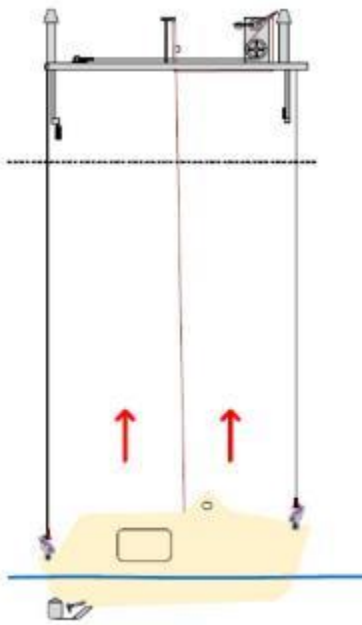
Figure 8: Quarterly lifeboat checks complete, the crew hooks the lifeboat back onto the falls.

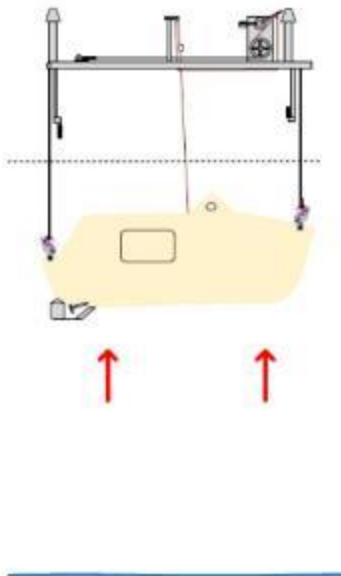
Figure 9: The lifeboat is winched upward using the electrically powered winch.

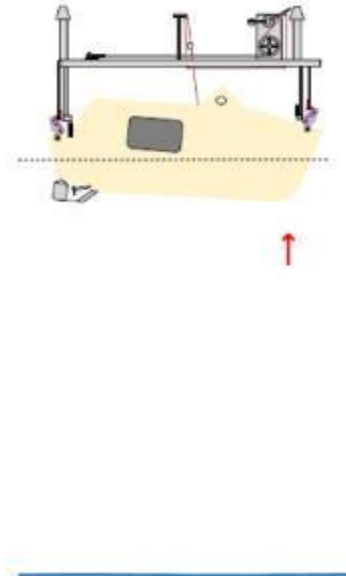
Figure 10: The electrical winch stops when a limit switch is activated. The boat is manually winched to its final position against the forward and aft davit bumpers.

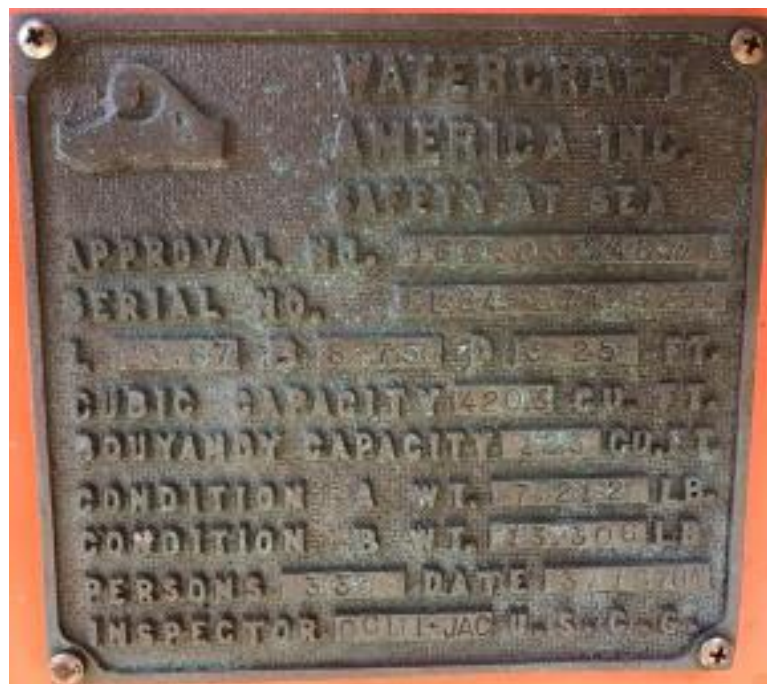
Figure 13: Lifeboat No. 6 data plate. Credit: CG.

4.2.3.2.2. According to Lifeboat No. 6's data plate, the Condition A weight was 7,212 lbs.; its Condition B weight was 13,306 lbs.¹⁰

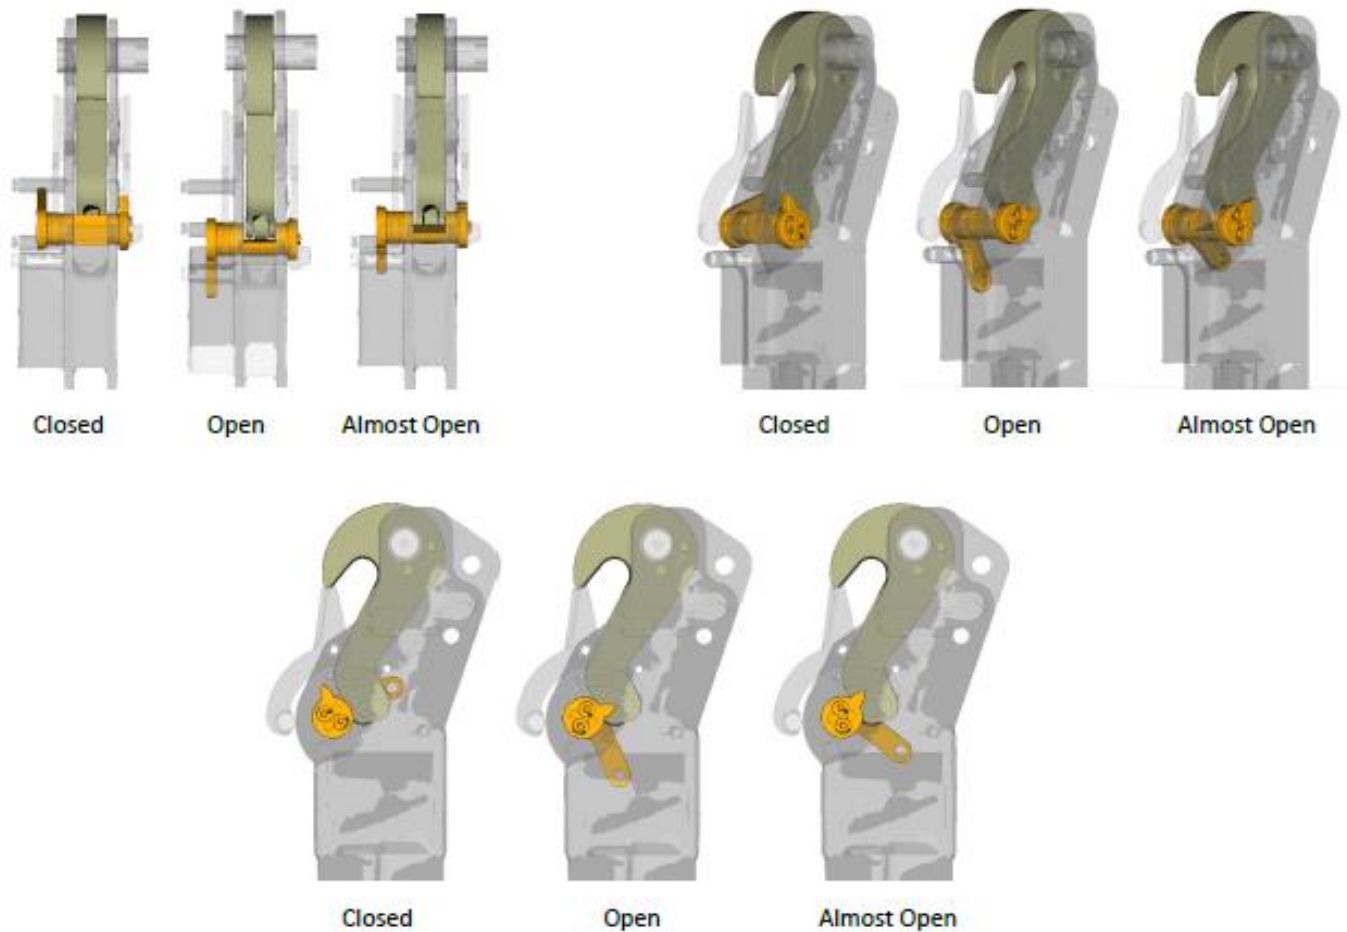
4.2.3.2.17. When the system is properly reset (in the closed position) and the locking shaft and hook roller are contacting at the correct location, the position indicator on the side of the hook will show in the green. If the position indicator is in the red, the locking shaft is either in the open position or “almost open” position.

Figure 17: Hook cutaway views of LHR3.5M2 hook in closed open and almost open positions. Locking shaft depicted in yellow. Credit: CG.

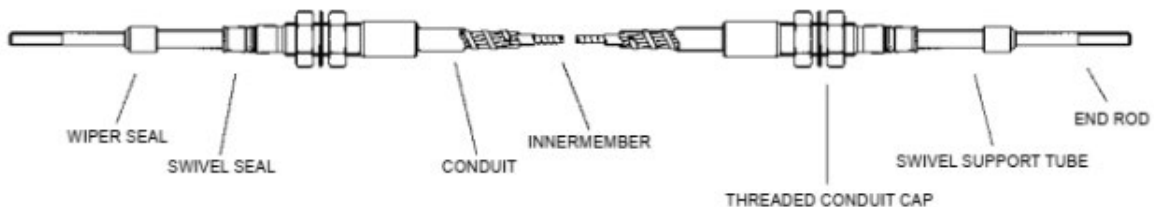
4.2.3.2.25. The construction and components of the control cables are shown in Figures 17 and 18. All external components (conduit cap, support tube and end rod) are stainless steel. The metal components in the conduit (steel band and steel strands) are galvanized and sealed from the outside environment by the outer jacket (cover) and a series of seals from the conduit cap to the end rod. The inner member consists of steel strands and banding, with a thin outer cover that is hydraulically crimped to the end rods and moves within the polyethylene liner of the conduit.

4.2.3.2.26. The inner member transmits linear motion through the end rod. The end rod has two ends: one end attaches to a clevis that is pinned to the release unit and the other end attaches to a clevis that is pinned to the hook locking shaft. The support tube limits the amount of travel in the end rod; the end rods on Lifeboat No. 6 could move approximately 4 inches in either direction.

Figure 18: Control cable components. Credit: Cablecraft, modified by USCG to represent cables in Lifeboat 6.

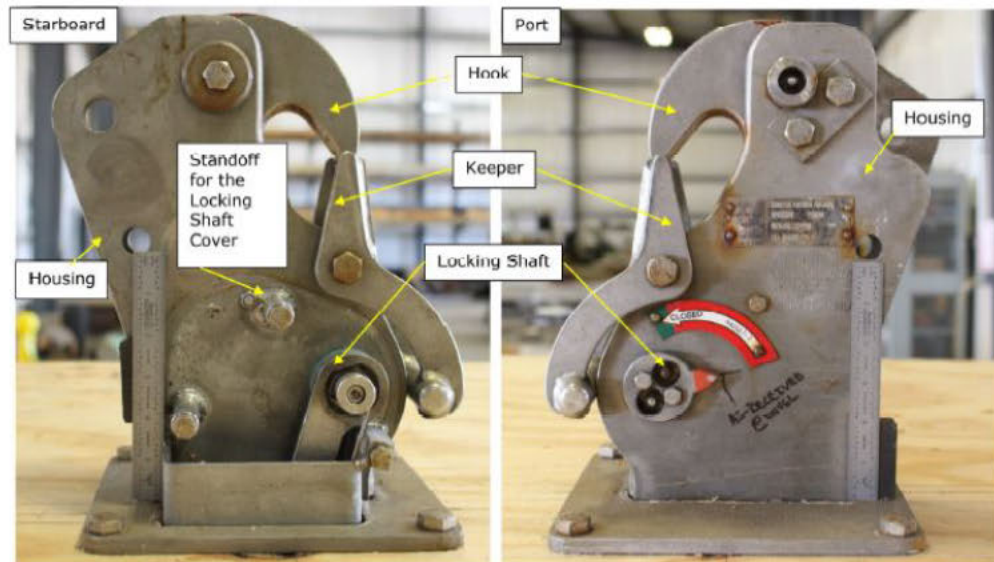
Figure 26: Photographs of the aft hook with the locking shaft removed. Credit: DNV-GL.

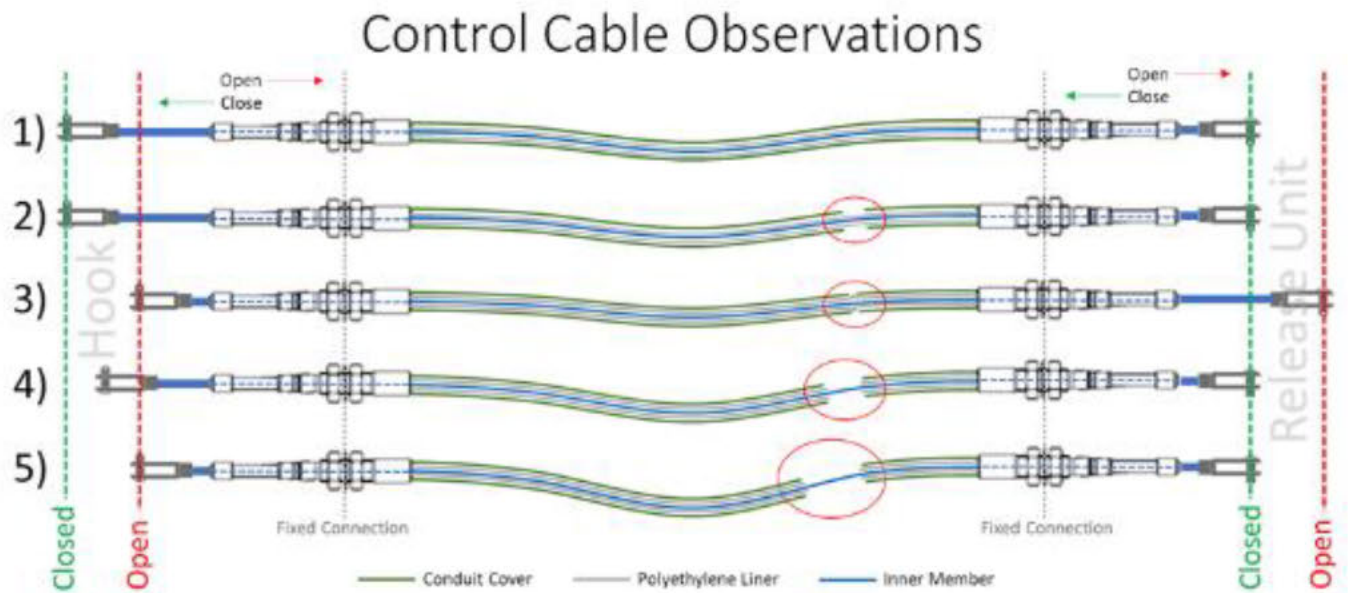
- 1) Hook closed with release handle locked in closed position (cable intact).
- 2) Hook closed with release handle closed. Conduit cover and steel layer removed (9 mm) with liner intact.
- 3) Hook open with release handle open (liner compression noted during testing).
- 4) Polyethylene liner failed during closing with 48 mm of conduit separation and locking shaft in partially-closed position (i.e., closed/locked, but almost open).
- 5) Subsequent release unit actuation after initial liner break extended conduit separation to 91 mm and would not rotate the locking shaft (i.e., hook remained open).

Figure 46: Control cable observations. Credit: CG.

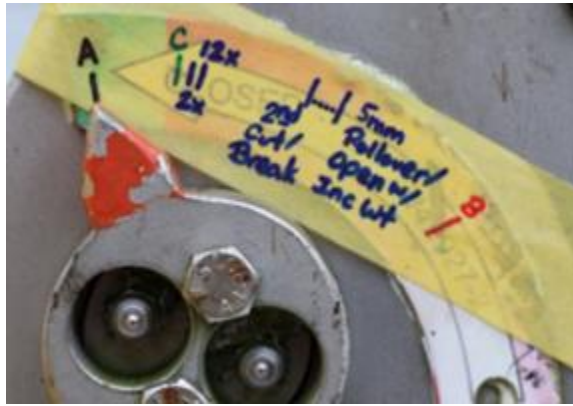
4.2.7.20. In summary, the results of the Coast Guard's experiments show that a separation in the conduit of a control cable, while cycling the release lever, can result in the hook locking shaft stopping between the open and closed positions ("B" and "C" positions, respectively, on Figure 48).

Figure 48: Locking shaft positions during experiment. Credit: CG.

However, it must be emphasized that after the initial liner failure and separation, any further cycling of the system will result in the locking shaft remaining in the open position. With a failed liner, the friction forces cause the cable conduit to freely extend, rendering the system unable to rotate the locking shaft to the closed position. This prevents the hooks from locking, rendering them unable to hold any load.

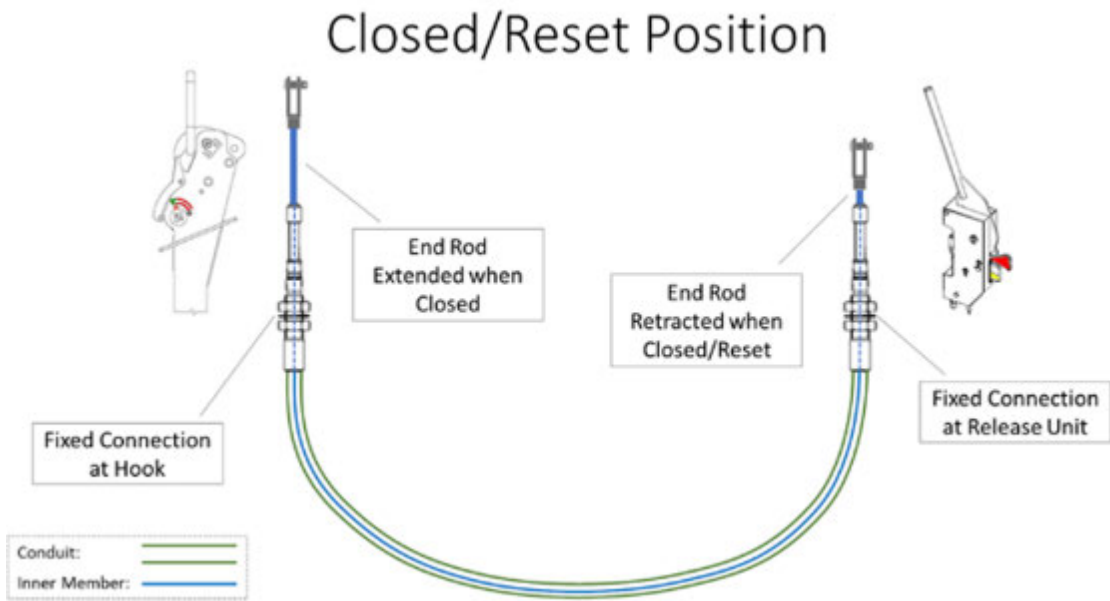
Figure 54: In this figure, the hook is closed or locked. There is no damage to the cable. Credit: CG.

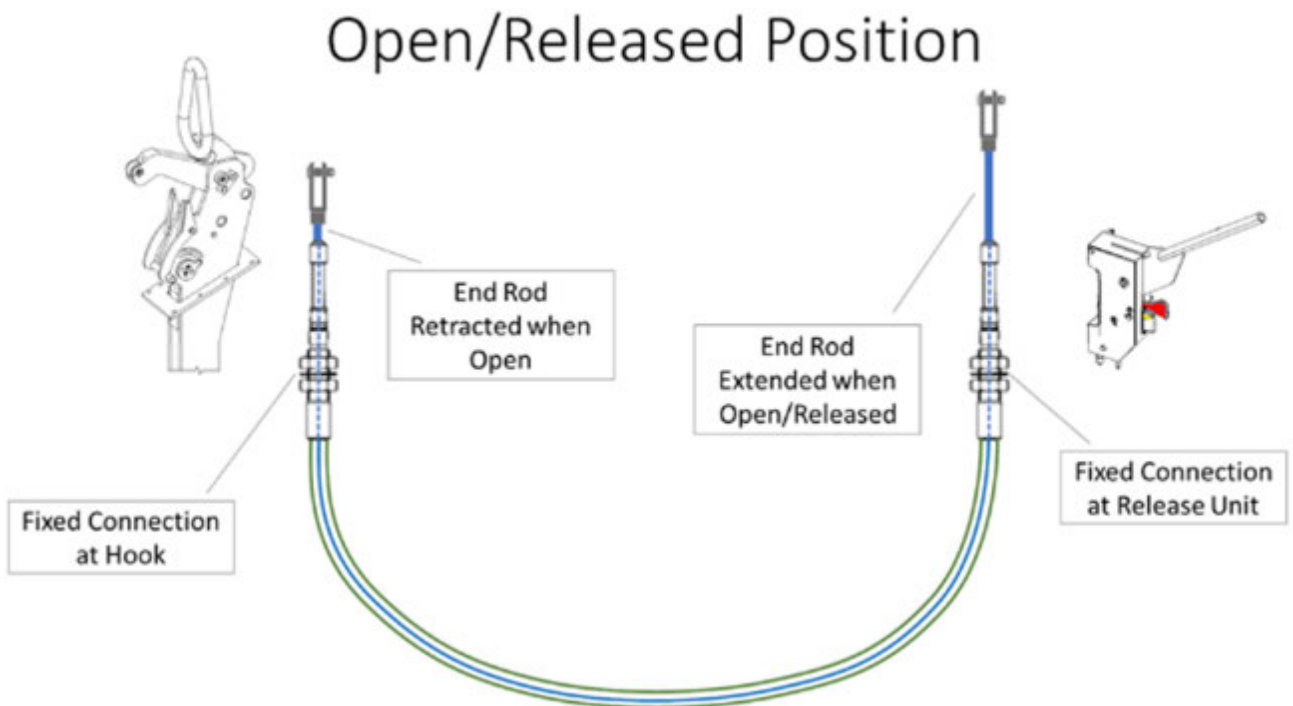
Figure 55: In this figure, the hook is open. There is no damage to the cable. Credit: CG.

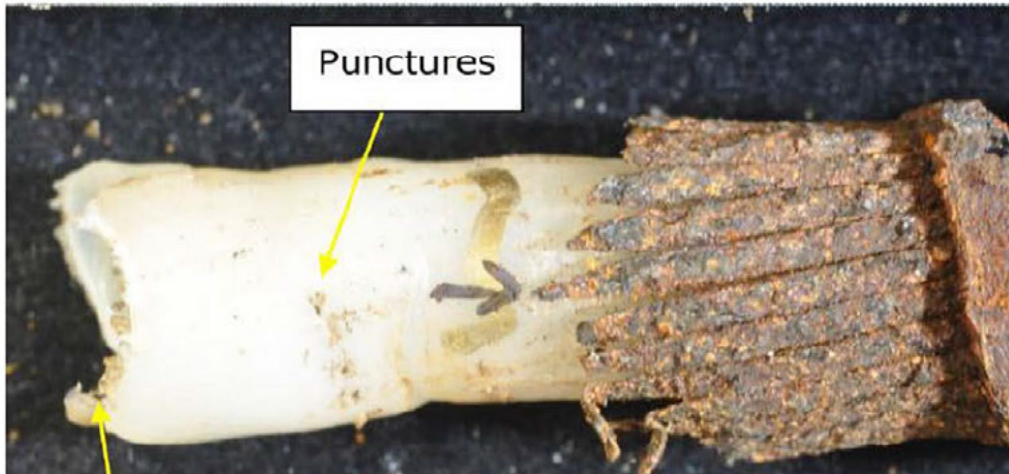
DNV-GL found evidence of buckling, tearing and punctures (see Figure 61) at the site where the white polyethylene liner on Lifeboat No. 6’s aft control cable liner broke. Together, and in absence of an alternative explanation for the break, the evidence discussed above strongly supports the finding that the mechanism of breakage was the combined effect of cycling (compressing and stretching) and puncturing the white polyethylene liner.

Figure 62 (below): Puncture marks found on the polyethylene liner of Lifeboat No. 6's aft control cable. Credit: DNV-GL.
