UNITED STATES COAST GUARD

REPORT OF INVESTIGATION INTO THE SINKING AND LOSS OF FOUR CREW MEMBERS ABOARD THE COMMERCIAL FISHING VESSEL LADY OF GRACE

IN NANTUCKET SOUND ON JANUARY 26, 2007

MISLE ACTIVITY NUMBER: 2863457

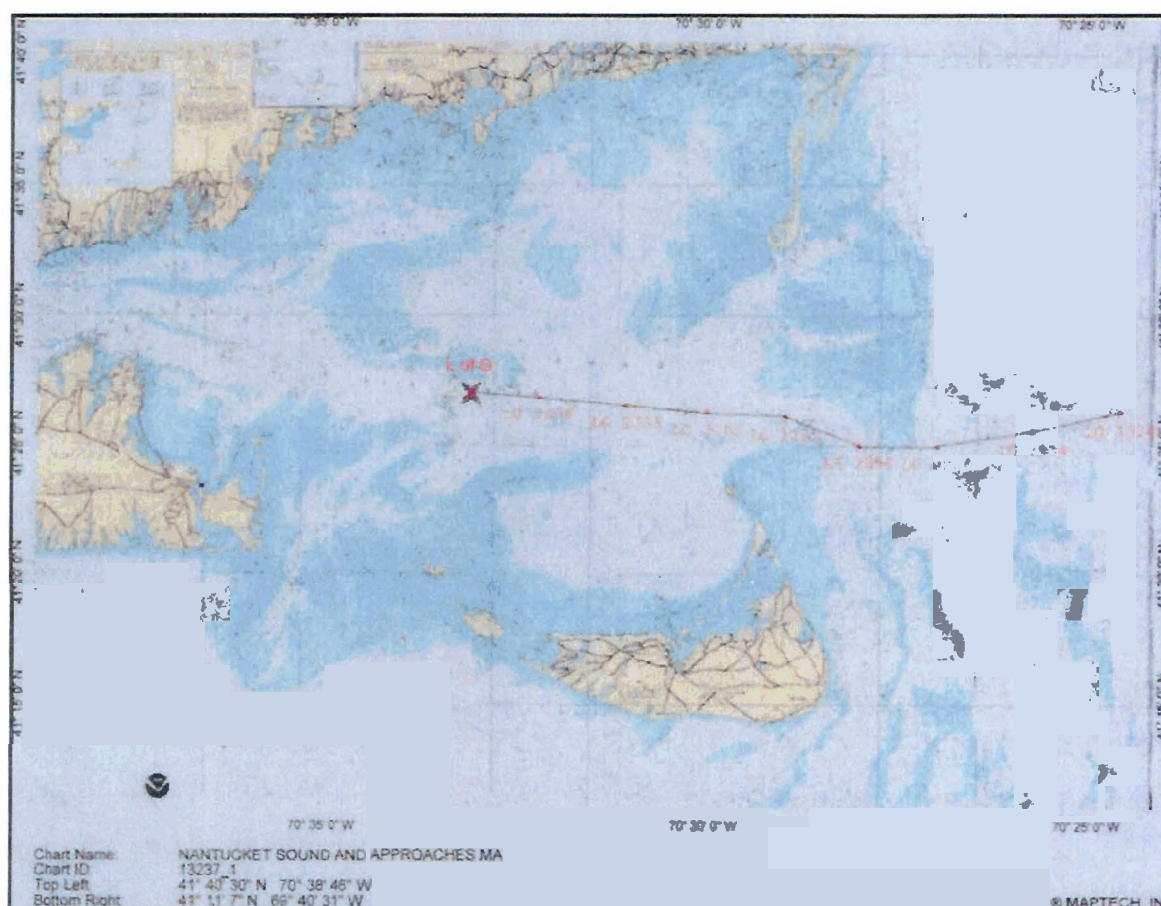
Photo 7: Charted track-line of LADY OF GRACE

The chart below provides a visual display of the route the LADY OF GRACE followed on January 26, 2007 as the vessel transited toward its homeport of New Bedford, MA. The positions denoted on the chart represent reports that were received by the BOATRACS system.

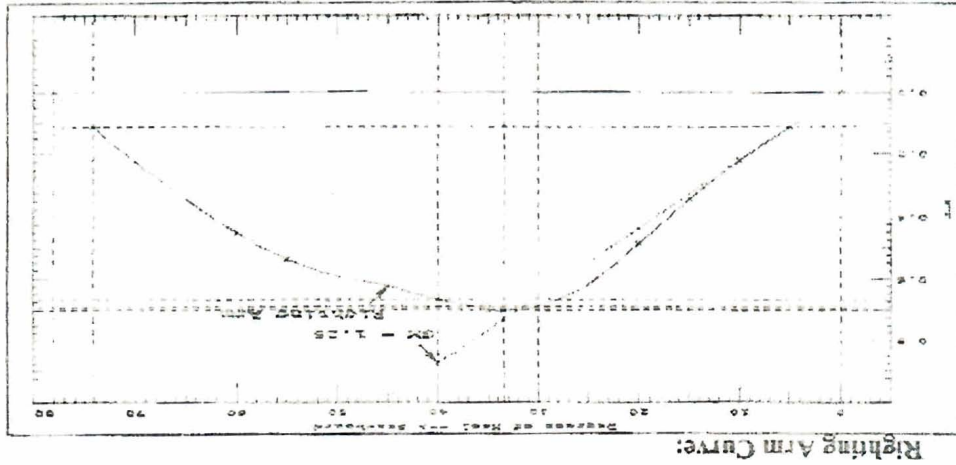
46 CFR 28.570 & 28.575 Stability Criteria:

c. The LADY OF GRACE passed the intact stability requirements of 46 CFR Part 28 for this loading condition marginally. For each of the required metacentric heights

(GM) and righting area criteria, the vessel met the minimum requirement. For the icing required in this "worst case" loading condition, the requirements of 28.550 only call for a calculation of 0.325 inches of ice on each exposed surface as part of the loading condition. As demonstrated later in the analysis, the environmental conditions present at the time of the casualty created the potential for significantly more icing to be present.

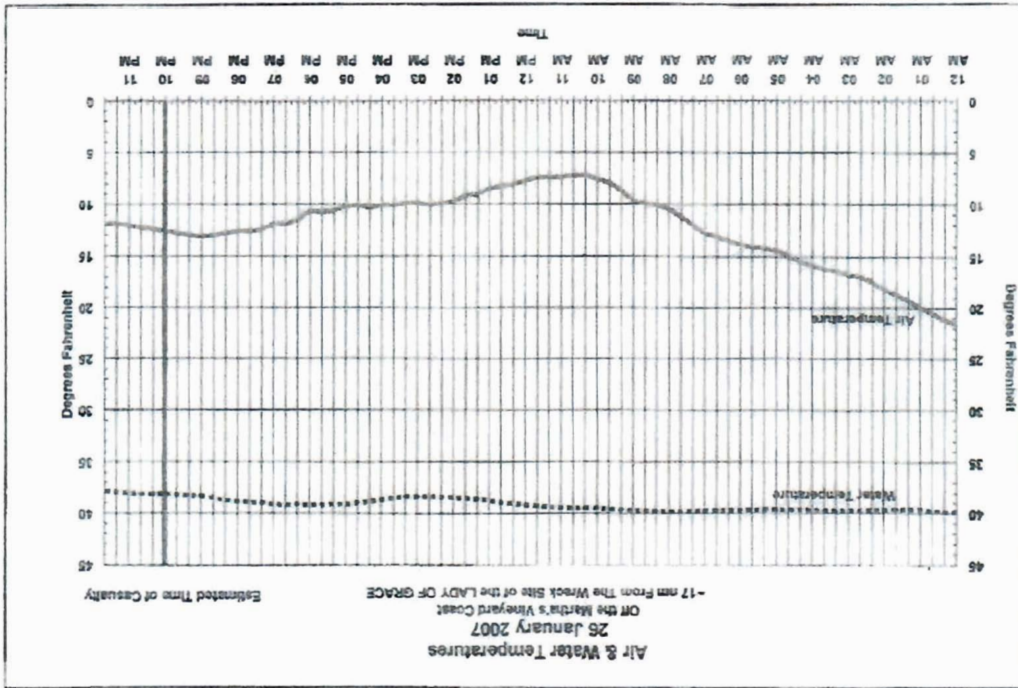
Air & Water Temperatures around the Time of the Casualty

- The air temperature in the area of Nantucket Sound was dropping quickly from around 20 degrees Fahrenheit at midnight of January 25, 2007 to around 7 degrees Fahrenheit at noon on January 26, 2007. The air temperature near the time of the casualty, approximately 2200 EST, had risen to around 12 degrees Fahrenheit.
- The water temperature followed a similar pattern, but with a much smaller shift of only 2 degrees Fahrenheit. The figure below plots the temperatures over time for January 26, 2007.
- An air temperature of 12.4 degrees Fahrenheit and a water temperature of 38.1 degrees Fahrenheit were chosen to determine the susceptibility of icing due to weather conditions near the time the vessel was thought to have been lost.

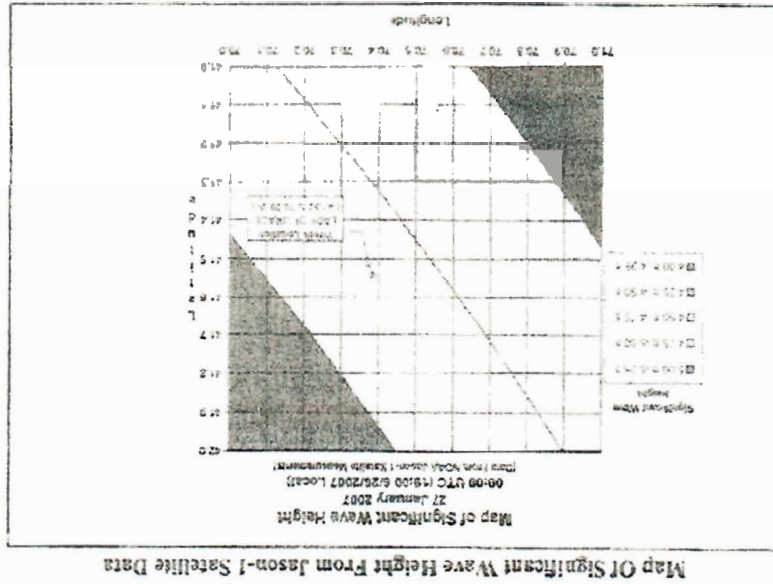
c. In his account of the passage of the DEBBIE SUE, Mr. [REDACTED] states, "Although seas subsided quite a bit, they still were 4-7 feet on the east half of the sound with the occasional bigger swell." This statement supports the significant wave height data. The significant wave height of 4.6 feet represents the root mean square value of the wave heights, not the maximum value. The expected highest wave out of 100 consecutive waves (which will occur over 680 seconds or 11.3 minutes of time) is 7.5 feet (over 1.8 hours, the vessel would expect to see an 8.5 foot maximum wave height, and over 18.8 hours, the expected maximum would be 10.2 feet). It is not surprising that Mr. [REDACTED] impression of the sea state was between 4 and 7 feet since these would be the most prevalent wave sizes.

d. The calculations performed in this investigation use a range of wave heights from 4 to 7 feet.

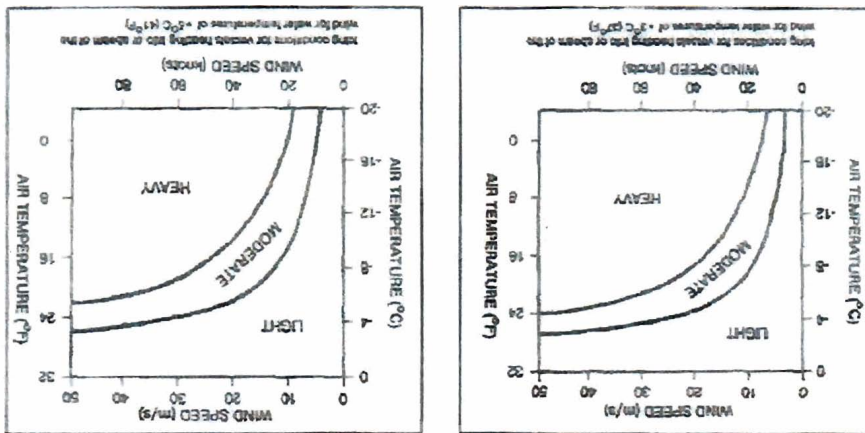
3 Icing Curves for Two Sea Water Temperatures

The Forecasters Handbook for the Arctic defines "cold soaking" as long term exposure of the ship to subzero temperatures and near freezing seas. The ship is considered cold soaked when the heat loss rate drops to the same point as the heat production rate. A cold soaked ship traveling into warmer water temperatures would still be cold enough to accumulate icing, if the other necessary factors are present.

Light Icing - Less than 0.7 cm/hr (0.3 in/hr)
 Moderate Icing - 0.7 cm/hr (0.3 in/hr) to 2.0 cm/hr (0.8 in/hr)
 Heavy Icing - Greater than 2.0 cm/hr (0.8 in/hr)

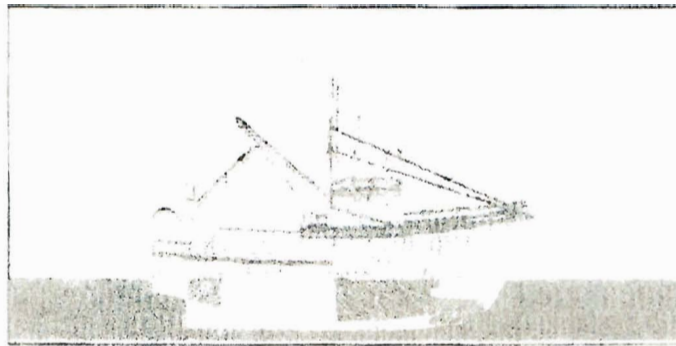
Sample Profile view GHS output (horizontal red lines denote iced surfaces)

b. It was determined that the maximum amount of icing that this vessel could sustain for this assumed loading condition and still remain upright in calm seas would be 2.25 inches. This results in a total addition of 40.7 LT of weight with an aggregate center of gravity 19.5 feet above the baseline and 5.4 feet aft of midships. When compared with the required icing loads used in the naval architect's calculations, this number represents a case that is nearly 12 times more severe than the anticipated amount of icing required by 46 CFR 28.550. It is noted that ice accumulation was likely much greater than 2.25 inches over certain portions of the vessel based on statements from crewmembers on other vessels that were operating in similar weather environments on the day of the casualty.

c. The following shows the righting arm curve for the assumed loading condition with a uniform coating of 2.25 inches of ice. It is noted from the curve that the vessel has taken on a 9 degree list to starboard. GM is 0.18 ft, and there is less than 0.15 ft-degrees of residual righting energy. At this point, the vessel would be likely to capsize in any significant sea state or winds.
