# MEDIEVAL AND EARLY POST-MEDIEVAL MILLS

**A THREAT-RELATED ASSESSMENT 2012-14**

DAT Event Record No. 102665

Report No. 2014/7

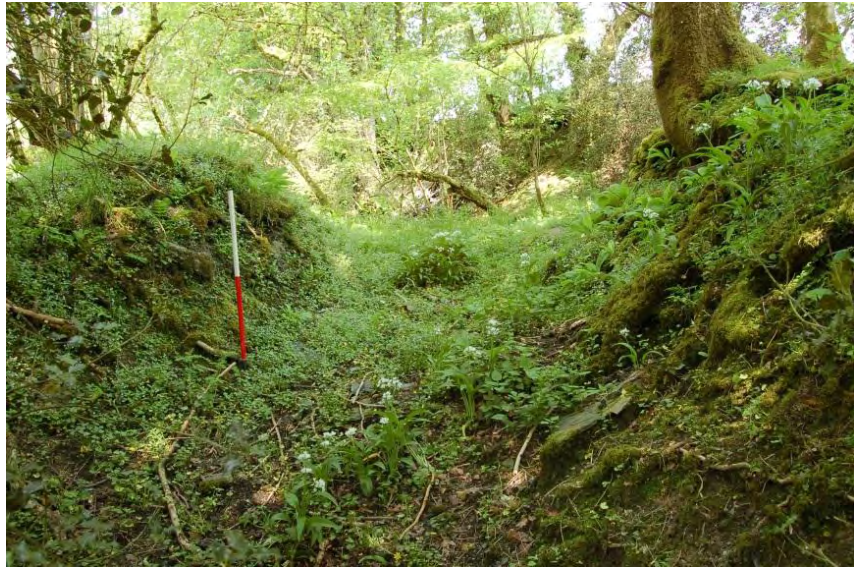
The site was visited during the Cadw funded Mills Survey of 2012-14. It is located within woodland, alongside the Nant Crychiau, at the base of a steep slope. The mill building is now ruinous, with surviving masonry less than 1 metre high, and heavily overgrown. No features could be discerned. Some further masonry, on a possible levelled platform, was noted to the west of the mill,

which appear to be the slight remains of a small, square structure shown on the historical Ordnance Survey maps. Extensive earthworks are also preserved in the vicinity of the mill, although these too were somewhat obscured by vegetation. The mill-race was traced back towards the stream, as far the farm boundary. It runs along the base of the natural, slope with an earthwork bank created on the western side. Two possible holding ponds were apparent above the mill, both now very silted. A channel appears to lead down from the northernmost pond, past the small, square structure - possibly infrastructure for a sluice? - and on to the northwest corner of the mill (M.Ings, 2012)

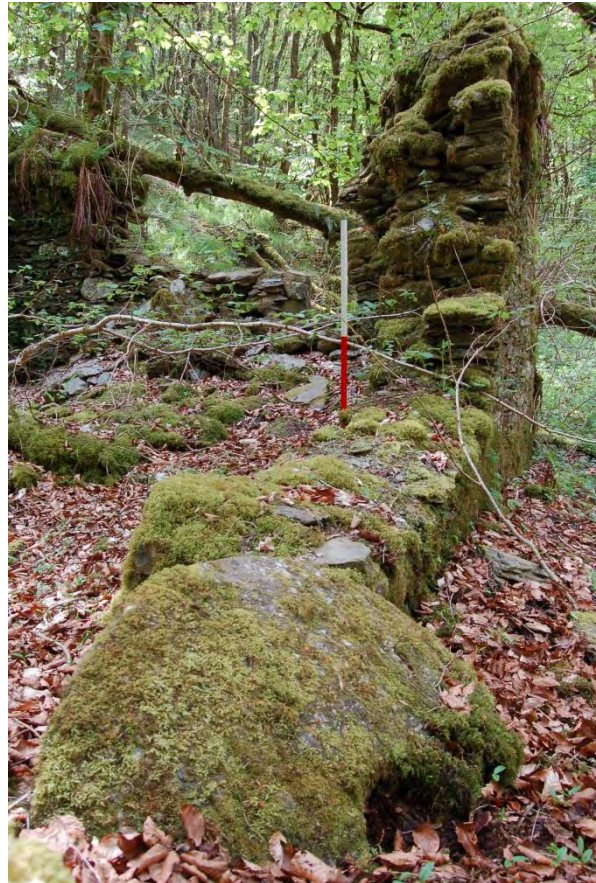
The site was visited during the Cadw funded Mills Survey of 2012-14. The ruinous building stands within thick woodland, beside the river, on a levelled platform built into the bank. Several lengths of walls stand to almost full height but falling trees have caused extensive damage. It appears to comprise a two-cell structure, although the partitioning wall is almost completely destroyed and much of the interior is obscured by stone tumble. There is a possible entrance in the north-facing wall and the remnant of an arched window in the west-facing gable end. A broken millstone lies near the possible entrance. A further stone structure was noted close-by, to the southwest of the mill. This comprises a rear revetment wall built into the bank and two walls projecting out at right-angles. The function of this building is uncertain (M.Ings, 2012)

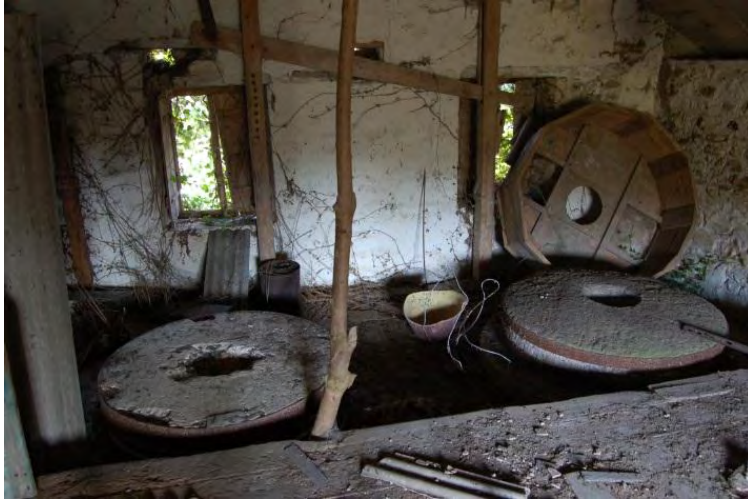
Bishop's Corn Mill is recorded on the historic Ordnance Survey maps, as part of a complex of buildings and standing at right-angles to a saw mill. Both are powered by

holding ponds and a leat diverted from the Afon Sannan to the north. The mill building is still shown on modern mapping but the associated buildings have largely gone (M.Ings, 2013)

The site was visited as part of the Cadw funded Mills Survey of 2012-14. The two-storey mill building still stands, of stone rubble with squared quoins and the half-hipped roof has been re-slatted relatively recently. The wheel-pit is preserved

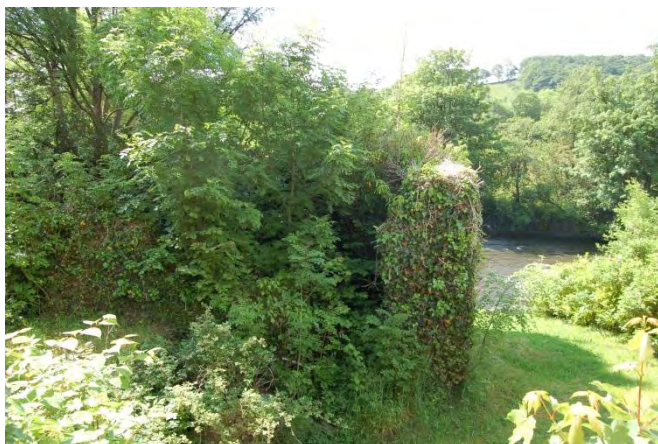
Site of a corn mill, recorded on the 1888 1st edition Ordnance Survey map, located below the Pont Cothi in Abergorlech. It was part of the Ty Mawr estate during the 16th and 17th centuries. Now ruinous (M.Ings, 2012, from various sources)

Access to the mill was not possible as the owners were away but an assessment was made from the roadside. It was evident that a substantial, roofless ruin of rubble stone with squared quoins survives located on a levelled platform on the slope above the river. The 1888 O.S. map depicts a 'T' shaped building but the ruins appeared to comprise a rectilinear of some 8x6 metres. However, the walls were largely obscured with heavy overgrowth and it was unclear whether the rear extension had collapsed or been dismantled at some stage. A possible blocked entranceway with a stone lintel was noted in the south wall, along with an aperture for either a doorway or window. There is also a window with a pitched stone lintel in the east side wall (M.Ings, 2012).

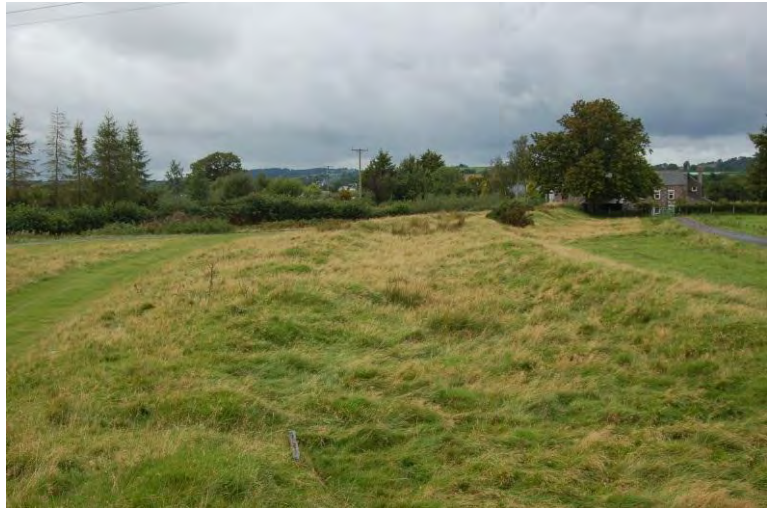
The site was visited during the Cadw funded Mills Survey of 2012-14. The mill-race is largely preserved as a distinctive, grassed-over earthwork running across the rough-grazing of Carreg-

Sawdde Common. The original weir, where the mill-race is shown to divert from the Afon Sawdde on the historic Ordnance Survey maps, is no longer there, although a more recent weir has been established a little further upstream. In parts, the race is some 2m wide and 0.50m deep, while other sections are less distinct. As it approaches the mill it is raised on a wide, partially stone-revetted bank. The tail-race is also well preserved as it runs alongside the track to Godregarreg Farm. The section from the farm back to the river was not seen (M.Ings, 2012)

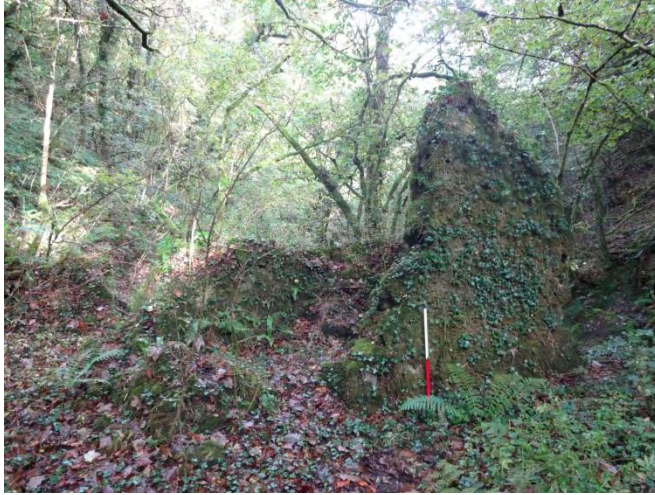
The site was seen during the Cadw funded Mills Survey of 2012-14. The mill-race survives as a distinct earthwork where it passes through scrub woodland, following the contour of the hill-slope above the river. The ditch is a metre wide and some 0.60 metres deep, although heavily silted, with a wide outer bank. The section across pasture fields to the river could not be traced, presumed infilled, and the last section closest to the mill was largely inaccessible due to heavy vegetation (M.Ings, 2013)

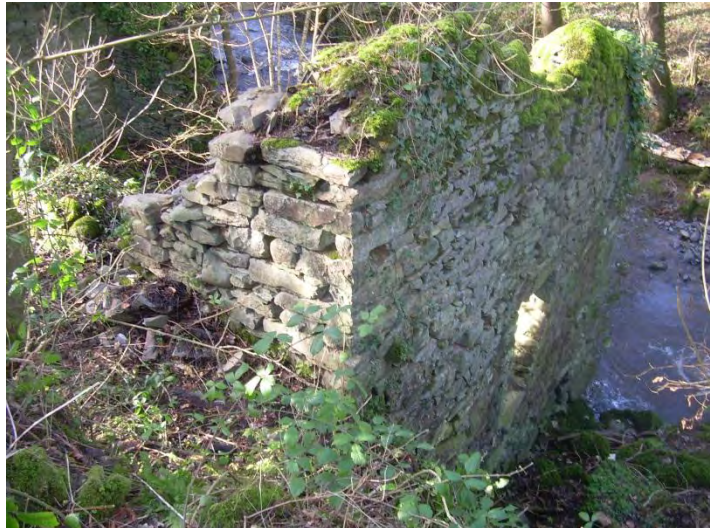
Felin Fach corn mill is recorded on the 1888 1st edition and 1905 2nd edition Ordnance Survey maps, located on the southern bank of the Afon Peris. Its overshot wheel was powered by a mill-race (PRN 105362), diverted from the river by a weir (PRN 105361) to the northeast, to a mill-pond (PRN 105360) located above the mill building. Built of local rubble, with a clay and lime mortar, and slate roofed. The mill-house and associated outbuildings are on the opposite bank. The mill is now ruinous (M.Ings, 2013, from various sources)

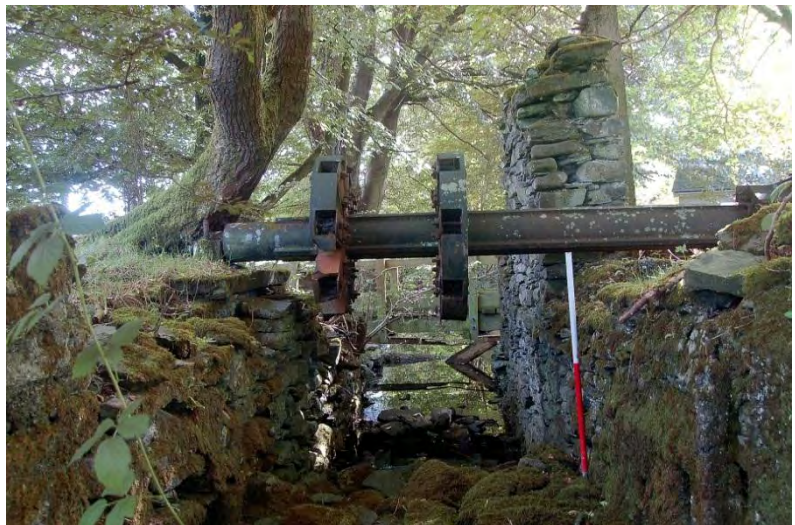
Ordnance Survey maps, powered by a mill race diverted from the Afon Teifi to the north. The mill buildings are no longer shown on modern mapping and it is recorded (RCAHMMW, 1951) as a ruin and named Loventium Mill (M.Ings, 2012, from various sources)  
The site was visited as part of the Cadw funded Mills Survey of 2012-14. The mill is now almost totally destroyed. The historic maps indicate that the mill straddles the mill-race but very little of the structure survives. The only standing masonry is the section of the wall above the west edge of the mill-race and wheel-pit, through which the waterwheel axle shaft is inserted. A concrete pillar stands against the inner side of this wall, presumably a later addition to stabilise the structure. The iron shaft of the waterwheel is still in situ, attached internally to a remnant of the hurst frame. Mill-stone fragments lie on the floor nearby but no other internal machinery survives (M.Ings, 2012)

Ruin. Overshot wheel, wooden arms + floats, iron shaft. 2 pairs of stones.

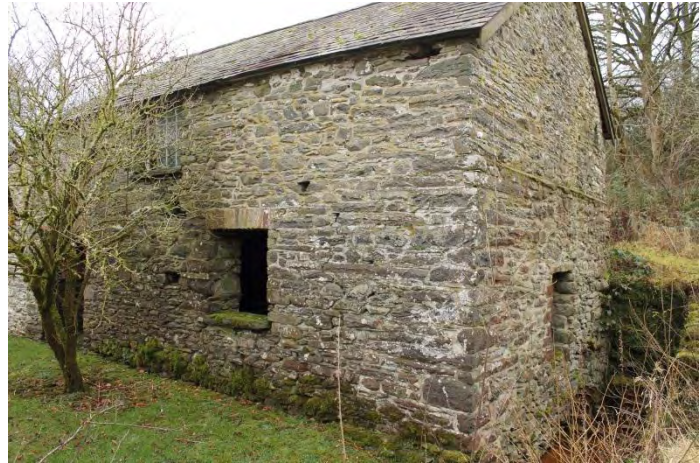
The site was visited as part of the Cadw funded Mills Survey of 2012-14. Unfortunately the current owners were away so a detailed survey of the site was not possible. The gable-ended mill building is of stone rubble with squared quoins and a slate roof. There is a doorway, groundfloor window and first floor window in the east-facing facade. It is built into a steep bank and the window apertures in the rear wall are into the first floor. A later stone building adjoins the south-facing gable. The wheel-pit is alongside the north-facing gable and the iron frame of a wheel is in situ. A low aperture is presumably where the wheel axle passed through the wall. No internal machinery was evident and the building looks to now be used as a workshop. The holding pond and mill race were not explored. Further information was supplied by the current owner (by email): there was a mill on the site at least as early as 1130, belonging to Strata Florida, but the date of the current building is not known. The overshot waterwheel disappeared a long time ago and the current Pelton wheel was installed relatively recently. There are plans to get the mill working again, with help from the Welsh Mills Society, through dredging the mill-pond and replacing the Pelton wheel (M.Ings, 2013)

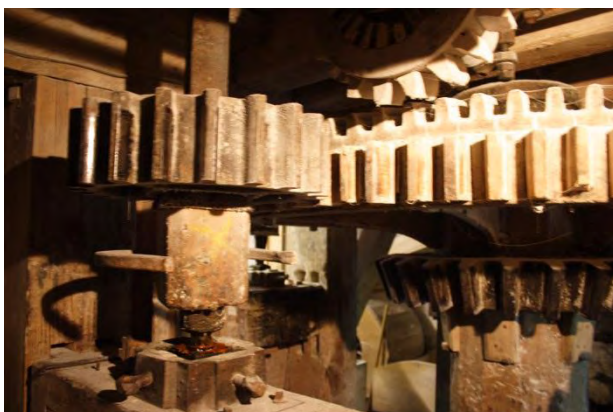
The mill was visited during the Cadw funded Mills Survey of 2012-14. It dates from at least 1640 and is likely to have even earlier origins as part of St Dogmaels Abbey. A third storey to the mill was added and the machinery was renewed in the 1820s. The mill was in use until 1926 before falling into disuse, reopening briefly during the 2nd World War, and the millpond was filled in with rubble. The current owners began restoring the mill in 1980 and now offer guided tours. A replacement overshot wheel was bought from another, closed, Pembrokeshire mill but the original axle and hub were retained. This

powers three pairs of stones, two of French burr for milling wheat and the third for oatmeal and animal feed. The original pond walls survive and it was cleared of debris and re-flooded in 1981. There is a lean-to oat drying kiln adjoining the mill (M.Ings, 2012, from various sources)

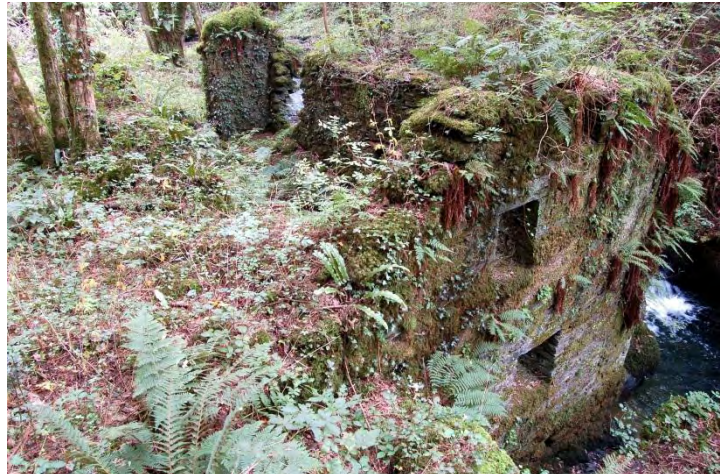
The site was visited as part of the Cadw funded Mills Survey of 2012-14. The mill is now a roofless ruin, within an area of woodland, and no machinery now survives. Roof slates and timbers lie within the interior. The two mill stones are now located near the entrance to the owner's house, named after the mill. The walls, of split slate rubble, stand to almost full height. There is an entrance-way, with a (now fallen) wooden lintel, in the east gable and a possible blocked doorway, with wooden lintel, in the south side wall. The river has caused relatively recent damage to the southeast corner. The wheel was affixed to the western gable and the stone-lined wheel-pit and inner axle-wheel pit are well preserved. The wheel was powered by a mill-race diverted from the Afon Cynllo. The race runs above and parallel to the river, well-preserved although very overgrown in part. It is culverted beneath the trackway that to the north of the mill, emerging at the wheel-pit. A second ruinous, gable-ended building is located to the northwest of the mill. The current owner said that he'd been told that it was possibly a corn-drier. Vegetation obscured the interior and nothing could be seen to confirm its function (M.Ings, 2012)

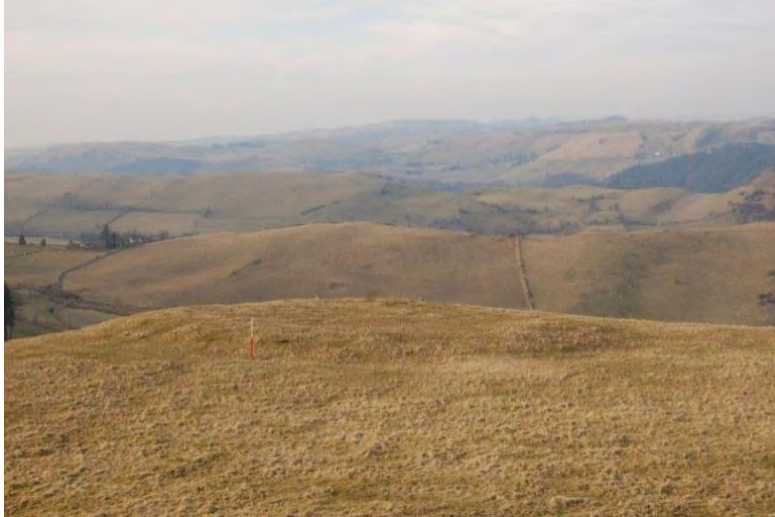
Farm name "Felin-wynt" and field name "Pen Felin-wynt" on the 1887 1st edition and 1905 2nd edition Ordnance Survey maps suggest the presence of a windmill. A low

circular mound in the field has been interpreted as either the base mound for a mill, the remains of a Bronze Age ring barrow or a Roman signal station (M.Ings, from various sources, 2013)

The site was visited as part of the Cadw funded Mills Survey of 2012-14. It stands on the north side of Pen Felin-Wynt in an area of low-intensity grazing. The mound is well-defined, some 16 metres in diameter and

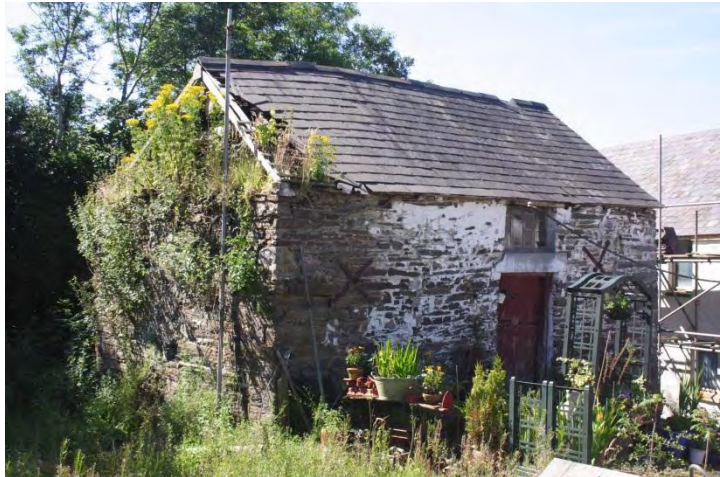
The site was visited as part of the Cadw funded Mills Survey of 2012-14. It is a complex comprising the corn mill, fulling mill (PRN 21369), a corn-drying kiln and farmstead. The two-storey mill is intact, built of local stone rubble with squared quoins and roofed with slate, although there is some structural damage, largely caused by a collapse of the first floor in the central section of the building. Iron cross ties have been positioned on the external walls to help consolidate the structure. The overshot wheel has now gone and the wheel-pit has been infilled. The internal machinery, thought to date to the mid-late 19th century (RCAHMW, 2002) is largely complete, including two pairs of stones within their wooden casings - French burr stones for grinding flour and Anglesey granite stones for grinding barley. The building was raised during the 19th century to create an attic over the first floor. Two further mill stones are propped up against the corn-drying kin, located just to the northeast of the mill (M.Ings, 2012)

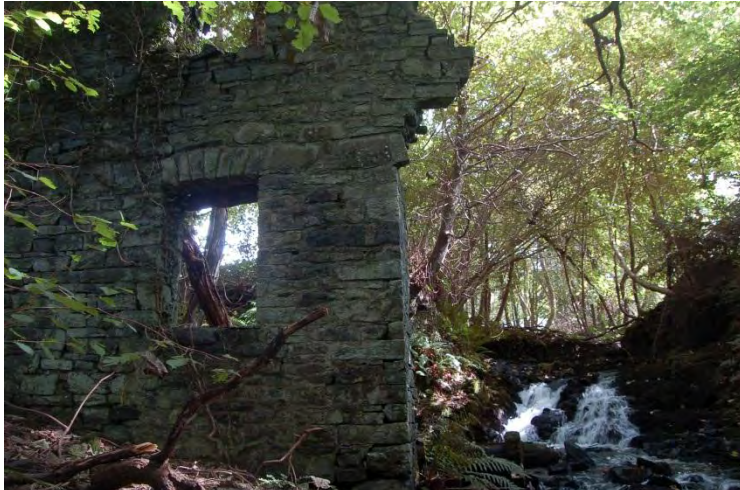
The site was visited during the Cadw funded Mills Survey of 2012-14. The ruins stand beside a fast-flowing stream, just below a waterfall, on a levelled area under a steep bank. Little of the structure survives, with only a section of the west wall, of semi-dressed stone rubble, standing to any height. Here there is a square window and

doorway, both with wooden lintels on the ground floor and a partially preserved square window on the first floor. The historic maps indicate that the mill originally extended over the current stream. Possible masonry is apparent on the far bank, below the waterfall, and it is clear that the first floor of the west wall once extended southward. The wheel would then have been enclosed by the mill building.

Fragments of the north side wall were evident but the whole area is strewn with collapsed masonry. The iron axle shaft from the waterwheel lies on the ground, protruding into the stream and a pair of iron-rimmed millstones stand stacked against the west wall. Possible remnant of a metal sluice mechanism remains in situ where the stream passes through the west wall. The mill-pond, created upstream of the mill, now looks dry and partially vegetated but a possible retaining wall on its west side was noted. A row of ruinous buildings located above the mill, to the north, comprise a stable, wagon-shed and a corn-drying kiln (RCAHMW, 2007). These buildings were inaccessible and heavily vegetated at the time of the visit (M.Ings, 2012)

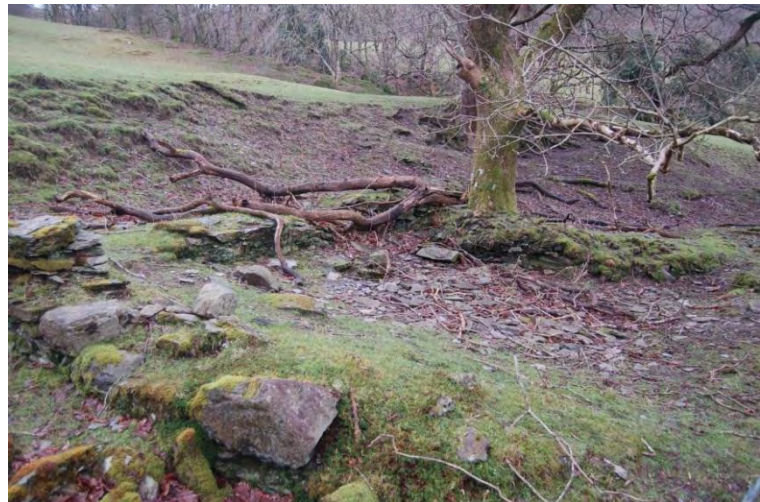
A former water-powered mill, probably the medieval mill of the Nantyrarian grange of Cwmhir abbey. The building is recorded as being reduced to wall bases and there is no trace of the wheel-pit or mill leat.

The site was visited as part of the Cadw funded Mills Project of 2012-14. It is located within the Nant yr Arian stream valley, built into a steep bank at the edge of a pasture field. The drystone walls, now standing no more than 0.50m, are incomplete and largely vegetated over. The building has two-cells. The footprint of the southeast cell is preserved, measuring approximately 6x6m, while a stretch of walling below the bank to the north is the only surviving remnant of the northeast cell. There are no surviving features to denote its function. It is likely that power was obtained by a leat diverted from the fast-flowing Nant yr Arian, to the southeast, but no earthwork could be discerned. A possible, now grassed over, trackway runs north-south, to the east of the building (M.Ings, 2013)

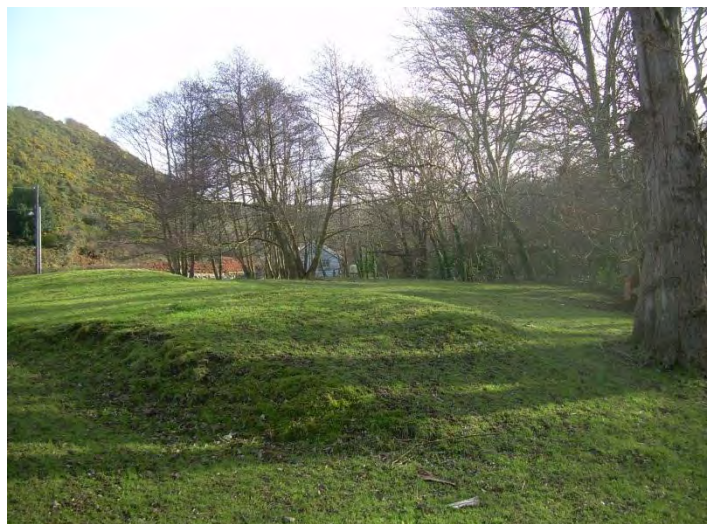
Site of a corn mill recorded on the 1889 1st edition and 1905 2nd edition Ordnance Survey maps,

powered by a mill race diverted from the Afon Cledan to the southeast. An extensive holding pond is shown just to the east of the mill. The site is not shown on modern mapping (M.Ings, 2013)

The site was visited during the Cadw funded Mills Survey of 2012-14. The building has now been reduced to a discrete earthwork, with sharp edges, under cover of grass within a pasture field. A resident living opposite the field had a photograph of the mill as a gable-ended, possibly two-cell structure with an undershot wheel. The mill-pond and mill race could not be seen and are presumed infilled when the field was turned to pasture (M.Ings, 2013)

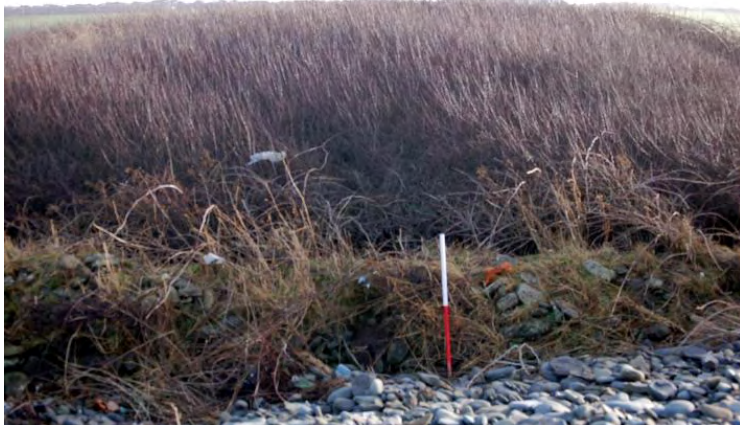
Felin-For is recorded on the 1888 1st edition and 1905 2nd edition Ordnance Survey maps, located on the coast near Llanon. The maps depict two buildings, with a possible enclosure, and the name indicates a probable mill site. They were abandoned in the early 20th century and are no longer shown on modern mapping (M.Ings, 2013)

The site was visited as part of the Cadw funded Mills Survey of 2012-14. It is fenced off from

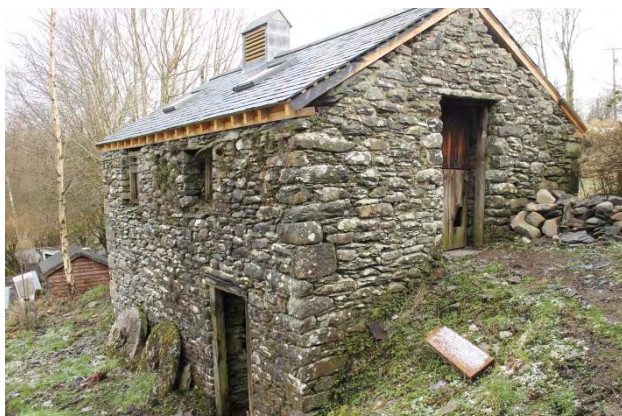
Corn-drying house associated with Swyddffynnon Mill (PRN 8733) The building is recorded, although not labelled, on the 1889 1st edition and 1905 2nd edition Ordnance Survey maps (M.Ings, 2013)

The site was visited as part of the Cadw funded Mills Survey of 2012-14. It is a free-standing, gable-ended stone building located to the south of the now ruinous mill. The ground-floor space is mainly taken up by a large fireplace, with an arched beam, and the corn-drying floor is above. The clay tiles of this floor were taken up and are recorded in 1989 as being stacked inside the lower level. They have now gone. The current owner has recently re-roofed the building with slate. Two mill-stones are propped against the facade (M.Ings, 2013)

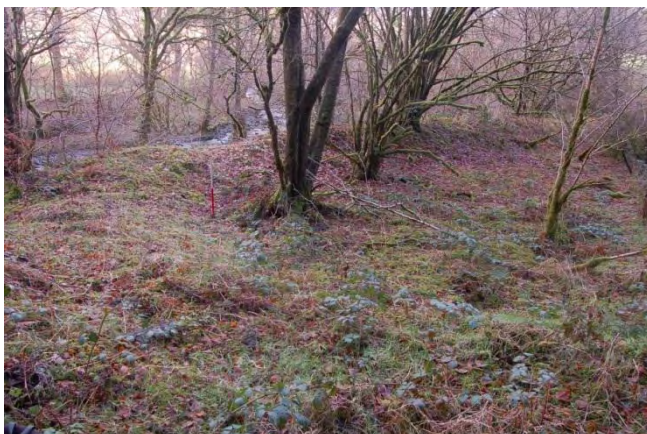
The site was visited during the Cadw funded Mills Survey of 2012-14. It is located within Mill Street in Pontrhydfendigaid. The owner of 'Fferm y Felin', which adjoins the mill building, did not think that any original mill features survive and the mill has been converted to a private house. Unfortunately, the owners of this were away. The shaft hole was not evident on the visible elevations of the building and it may have been obscured by an extension on the eastern gable or by the modern barn that adjoins the rear wall. There was also no sign of preserved water-management features. Farm buildings now occupy the area of the long mill-pond, shown on the historic maps, and it is presumed infilled (M.Ings, 2013)

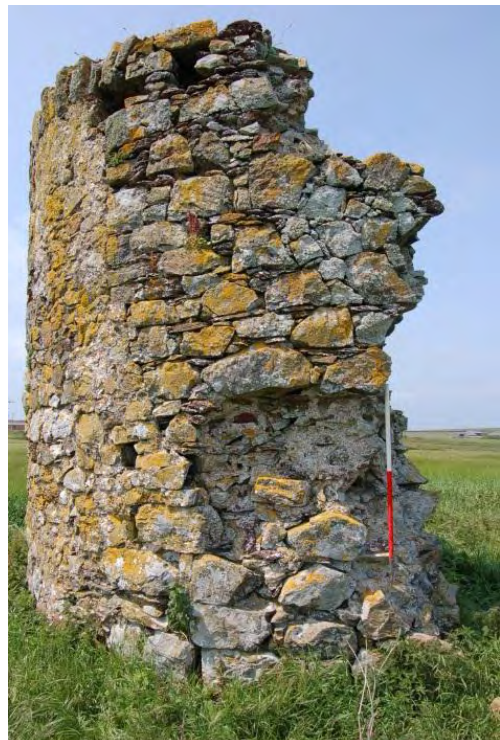
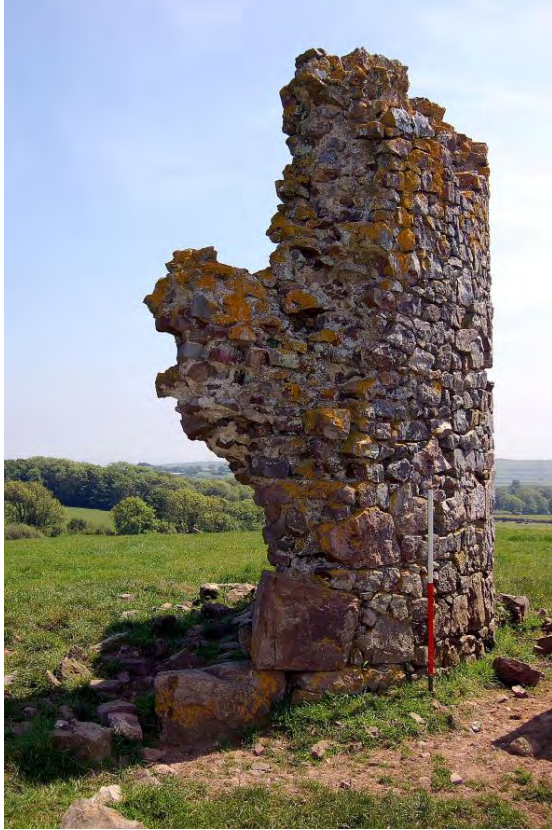
**PRN** 3528

The site is depicted on the 1876 1st edition Ordnance Survey map as a dashed circle, labelled 'Old wall', suggesting it to be ruinous. Modern mapping records it as the remains of a tower. It is thought to be an old windmill "to have been in ruins for a century" (1915) although it has also been suggested to be some form of beacon or lookout (1975). It stands on a hill overlooking Dale Sound (M.Ings, 2013, from various sources)

The site was visited as part of the Cadw funded Mills Survey of 2012-14. It was a round tower, of which approximately a third (on the south side) still stands to some 3 metres in height. It appears similar in dimension, structure and appearance to windmill sites PRN 26367, near Bosherton, and PRN 3528 at Minerton Farm, St Florence. It stands on a stone platform some 5 metres in diameter and is constructed of semi-dressed, mortared stone. A possible fireplace is located within the masonry at ground-level and a large recess, with a pitched stone lintel, is inserted at first floor level. Beam slots are evident either side. It stands on a hill top above Crabhall Farm and, at the time of the visit, it was within a field of barley (M.Ings, 2013)

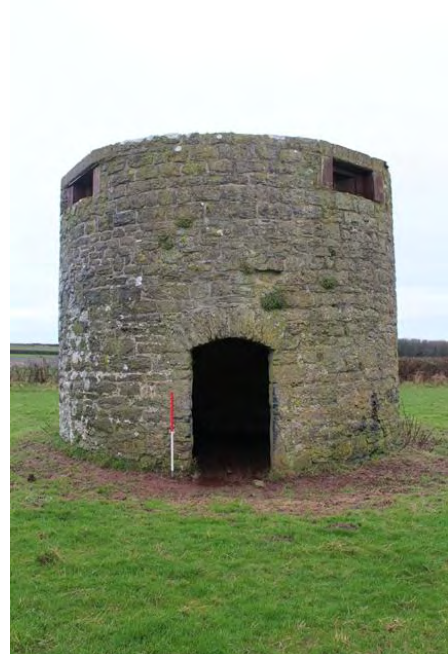
18th century windmill, recorded on the historical Ordnance Survey maps as disused, adapted during the Second World War as a machine-gun post (M.Ings, 2012, from various sources)

18th-19th cylindrical Base of tower. Rough coursed rubble. Opposite doorways ground + first floor filled up. (?)

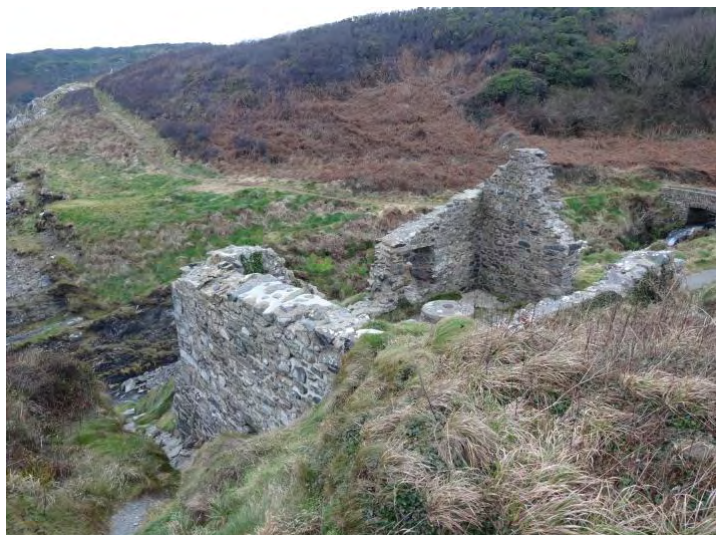
The site was visited as part of the Cadw funded Mills Survey of 2012-14. The mill building is preserved and presented as a ruin, with information board, with a pair of mill stones stacked within its walls. The site is scheduled (SAM PE376), which also includes the ruins of a second building - thought to be the mill house - and part of the mill race running from

the mill pond to the southeast. The mill pond, as depicted on the 1889 1st edition Ordnance Survey map, is not within the scheduled area. Its location is undeveloped, covered with thick scrub and trees which obscured any definition of the feature. The pond was recorded in 1961 to be dry and partly filled in (M.Ings, 2013)

A small, ruined, stone built mill. Remains of the leat, pond, wheel-pit and foundations of the outbuildings also remain (JH based on Cadw 1997)

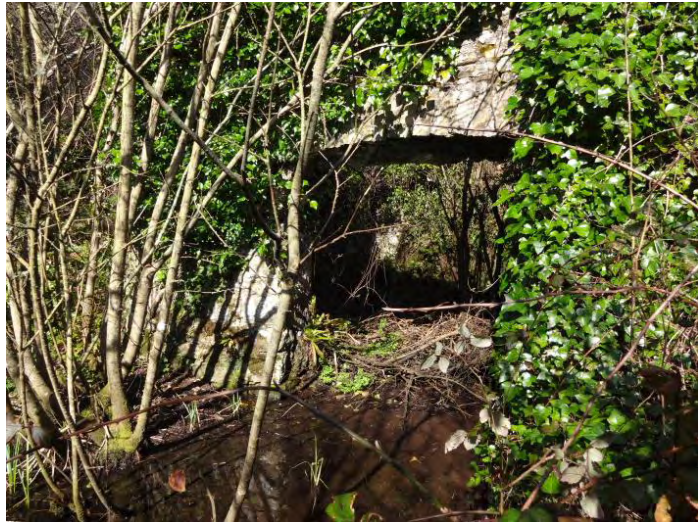
The site was visited as part of the Cadw funded Mills Survey of 2012-14. It is a gable-ended, two-celled building of rubble stone built into a steep bank, with an extension against the southwest-facing elevation. The walls have been consolidated and stand to approximate full height but the roof has gone. There is a doorway, with pitched-stone lintel, in the southeast-facing gable. A wide, arched aperture, for egress of the tail-race, is in the southwest-facing sidewall, through into the second cell at the northwest end of the building. The interior of this second cell proved inaccessible. This is where the overshot wheel was once housed and there is an axle aperture through the internal, dividing wall (M.Ings, 2014).

A three-storey building, now roofless. Some evidence of restoration on south-east end. Two-celled structure internally. No machinery or other features survive. No clear indication of where the wheel-pit was located. The mill is situated against an earth-built dam which would have contained a mill pond, now silted up (KM 1996)

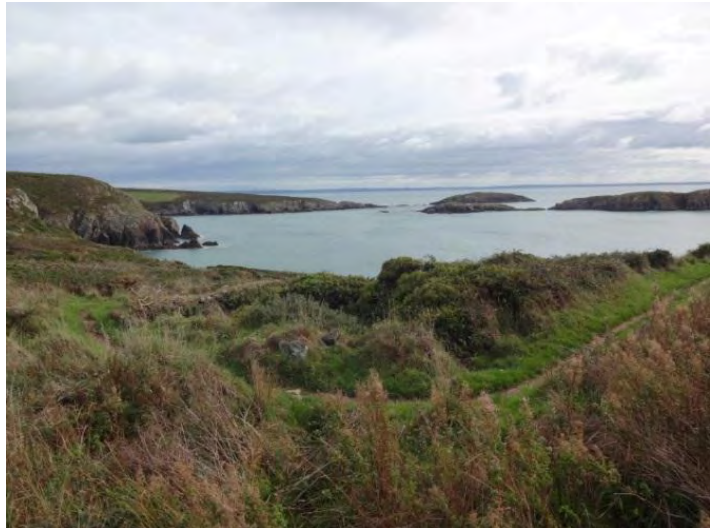
Treginnis Mill is a ruined mill located at the head of a small gully leading to the sea some 75m to the southeast. It was fed by water from a large mill pond to the northwest. The mill remains is a simple rectangular structure whose walls stand to approximately 2m high. At a field visit in 1996 the position of the wheel pit and other features could not

be detected as the site was very overgrown. The mill pond located to the north has now been extended into a large irrigation pond. The mill is marked on the 1st edition Ordnance Survey Map of 1889 as disused indicating abandonment by this date. This suggests that in line with other similar sites in the area it dates from the late 18th century when the Welsh coast saw the rise of small industrial operations in line with the increase of coastal shipping. The building outlines are shown on the most recent Ordnance Survey mapping (Mastermap 2011), indicating survival in a ruined form. This is confirmed by recent aerial photographs (Ordnance Survey Next Perspectives 2009) which show the area overgrown with vegetation and the surrounding area under rough grass.

The site was visited as part of the Cadw funded Mills Survey of 2012-14. A local farmer suggested that it was once a gorse mill, preparing feed for horses. The site was as described previously, ruinous and heavily overgrown with vegetation that obscured the interior. The building is built into the hillside above Porth Henllys, with the Pembrokeshire Coastal Path diverted around it. The only masonry that can be seen clearly is the east-facing wall, which stands some 0.60m externally and 1.40m internally. The north-facing wall revets the hillside and does not survive above ground-level. There is a possible entrance-way in the northeast corner. The wheel-pit appeared to be located adjacent to the west-facing wall, although its edges could not be defined, and some masonry detached from the building (to the north of the footpath) may be associated with a sluice on the leat feeding down from the mill pond above - again, this was all under thick vegetation that prevented a clear view. The slope to the south of the mill drops away sharply (M.Ings, 2013)

The walls of this mill stand to approximately 2m high. The position of the wheel pit and other features are not detectable as the site is very overgrown. The mill pond has now been extended into a large irrigation pond. (Murphy 1996)

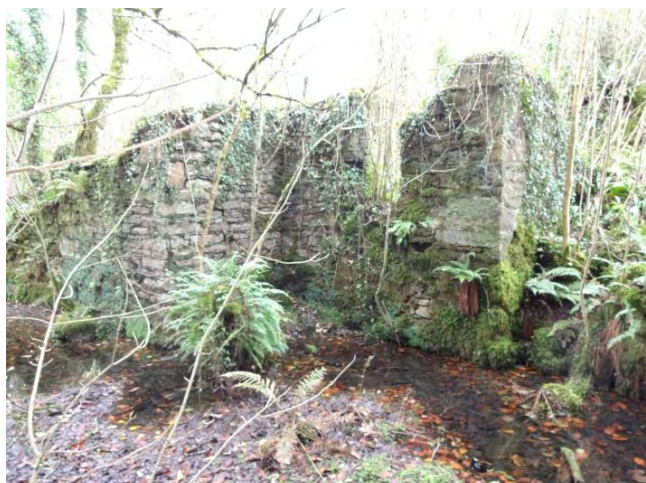
The site was visited as part of the Cadw funded Mills Survey of 2012-14. There are several ruinous buildings in an area of woodland by the side of a stream, a tributary of the Western Cleddau. The

historic maps indicate the mill race to run down between two buildings before the tail race returns it to the stream. The building to the east is a two-cell structure. Some of the walls survive to almost full height, others, particularly the south-facing elevation, have collapsed. The interior is obscured by stone tumble, piled against the interior walls and preventing a view of the building floor, and vegetation. Many young trees are also growing within the ruins. A possible wheel-pit, which would have accommodated an overshot wheel, was noted alongside the west-facing end wall. Here there is an arched aperture through the wall - possibly where the wheel axle once fitted. A rectangular recess in the ground on the inside of this wall may indicate the position of a hurst-frame but no certain mill features were evident. The building to the west is more substantial and the walls survive to approximately full height, with two arched windows in the north-facing elevation and an arched doorway in the west-facing wall. The interior was inaccessible. This was thought to be a house associated with the mill, although it is possible that, given the plurality of the site name, it could be a second mill. No features to indicate it as such were evident. The historic maps suggest the mill race feeds into a holding pond, the flow then controlled by a sluice, to the south of these two buildings. There is a curving stone wall standing some 3 metres high which may be the retaining wall of the pond located above the mill. Thick vegetation prevented further exploration of this feature. The mill race could be seen surviving as an earthwork to the southwest of the buildings but could not be traced far due to access problems (M.Ings, 2014)

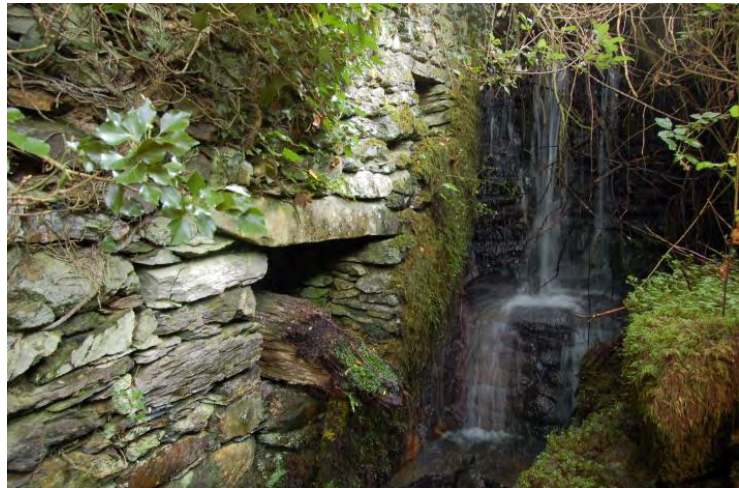
A possible late 18th to early 19th century corn mill shown on tithe map. It is also recorded on the historic Ordnance Survey maps, powered by a mill race diverted from the Afon Bannon via a mill pond south of the mill building. The mill is shown as a ruin on modern maps but the mill pond (PRN 105997) is preserved (M.Ings, 2013)

The site was visited as part of the Cadw funded Mills Survey of 2012-14. The mill building is

now a roofless ruin located in thick woodland. Some roof slate fragments were noted within the interior. The walls stand to varying heights, from approximately full-height to robbed completely. The mill is a two-cell building aligned northwest-southeast. There are entrances in both sidewalls. The stone-lined wheel-pit survives alongside the northeast-facing wall. The axle aperture still has the broken-off wooden wheel axle within it. A niche on the outer wall indicates the position of a wooden launder that would have fed the water to the top of an overshot wheel, but this has now gone. There is a walkway alongside the wheel-pit, accessed by a stone bridge over the tail-race. Within the mill, the iron axle wheel is preserved in situ, although obscured by silting and vegetation. There is also a pair of mill-stones, with iron rims, still slotted onto an iron shaft. The area immediately to the southwest of the mill was heavily overgrown and inaccessible so it wasn't possible to trace the mill-race from the pond but, as water still flows into wheel-pit, it is likely to survive. The pond (PRN 105997) itself is still a substantial feature (M.Ings, 2013)

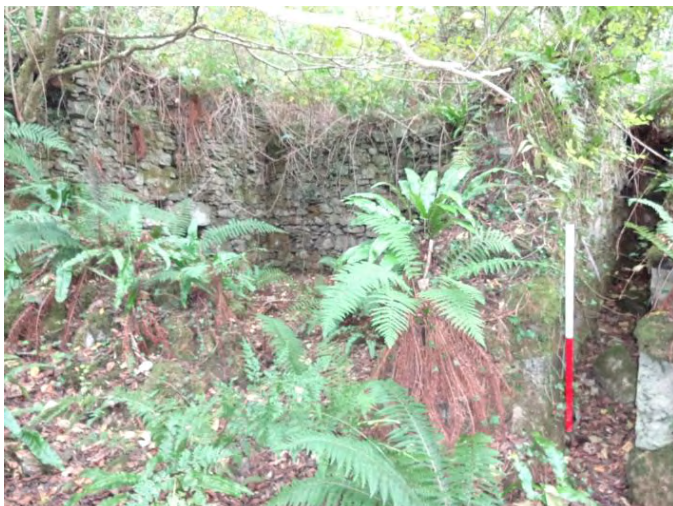
A corn mill on the site of a major industrial and domestic complex adjacent to the Clydach River. The mill machinery was water powered. By the time of the second edition Ordnance Survey map (1908) the site was abandoned. Mytum refers to this as "Llystyn Mill"; on the Tithe and Ordnance Survey maps it is named "Felin Clydach" (MM 2004 based on Mytum 1986 and historic maps)

The site was visited as part of the Cadw Mills Survey of 2012-14. It is located within woodland, by the side of the Clydach river. There is a complex of buildings, now substantial ruin with many of the stone rubble walls surviving to approximately full height. The site was excavated in 1986 (University of York) and interpretation of the site is based on their findings. There is a domestic range of buildings, comprising adjoining dwellings, to the south and two adjoining industrial buildings to the north. The mill stream is diverted off the river, to the south, towards the western industrial building, the wheelhouse. The wheel-pit, recorded to be on the southern side of this building, was totally obscured by thick vegetation at the time of the visit. The second industrial building was more accessible and the furnace was seen (as previously recorded) in the west wall, with an ash box sunken into the floor in front of it. Possibly this building was a corn-dryer (M.Ings, 2014)

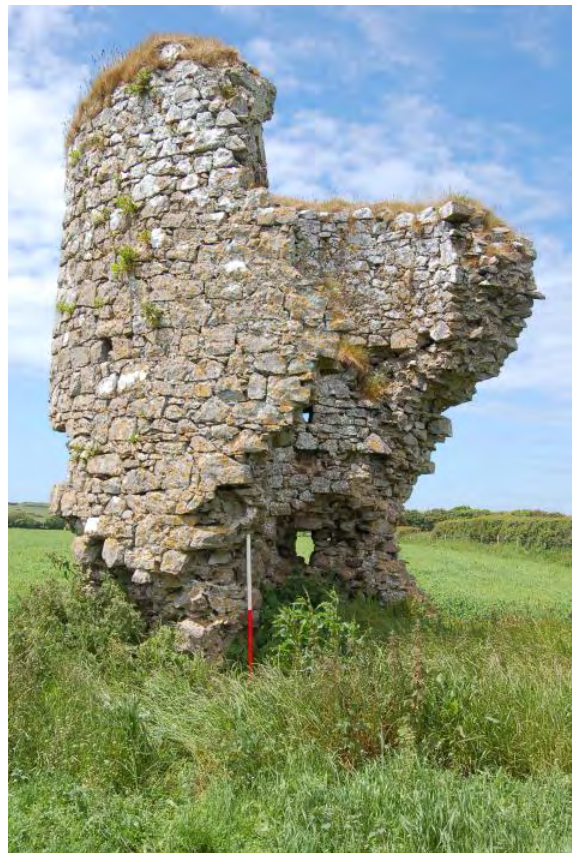
Approximately half the windmill tower base survives, standing over 4 metres high. There is a large, rectangular niche on the interior face, topped by a pitched stone arch, possibly a remnant of the staircase up to the upper floors. The tower is on a flat-topped mound, some 5 metres in diameter, revetted by two courses of stone around its edge. This is strewn with tumbled stone. When visited, it was within a field of barley (M.Ings, 2014)

Remains of circular stone windmill. A.James 1993

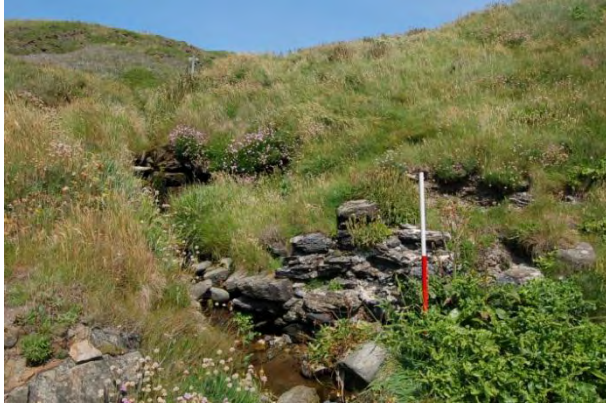
Greatmire Mill is recorded on the 1845 Marloes Parish tithe map and the 1875 1st edition Ordnance Survey map, by which time it is labelled as being in ruins. It is located just above the foreshore of Marloes Sands. Not shown on subsequent mapping. Possibly the same site as a medieval mill (PRN 12491) shown on Rees' map of Wales in the 14th century. Mortared masonry, with possible associated earthworks, was found at the location during a site visit in 1996

The site was visited as part of the Cadw funded Mills Survey of 2012-14. The area is now National Trust property. A small section of mortared masonry was found at the recorded location (as in 1996) below a steep drop at the side of a stream. Possible remnant of a building platform cut into the slope behind the masonry was noted but the area was largely obscured by thick vegetation. Further earthworks were recorded above the mill remnant, again obscured by vegetation and possibly truncated by a track and a walkers' path. These included the probable dam seen in 1996, although it is possible that this formed part of a holding pond. The platform mentioned in 1996 was not seen. The stream that runs down to the mill is diverted from the main stream just below these earthworks, the two then running parallel (M.Ings, 2013)

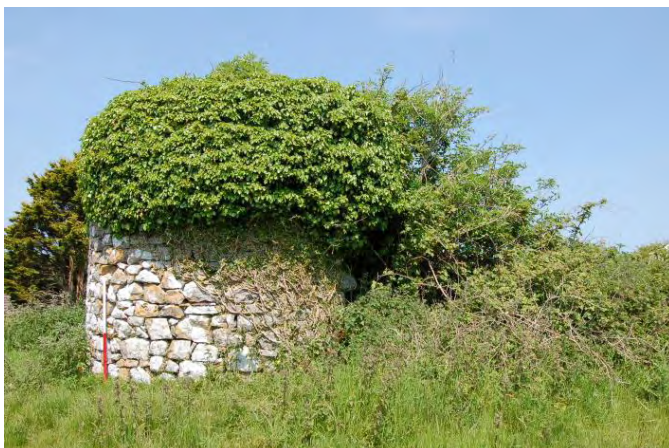
Site of a windmill with a straight-sided tower located near Tarr Farm, on the edge of Manorbier. It is recorded as "Old Windmill" on the 1866 1st edition Ordnance Survey map and presumed disused by this time. The site is still shown on the 1907 2nd ed. OS but not on modern mapping. The ruinous tower is evident on recent (2009) aerial photographs (M.Ings, 2013, from various sources)

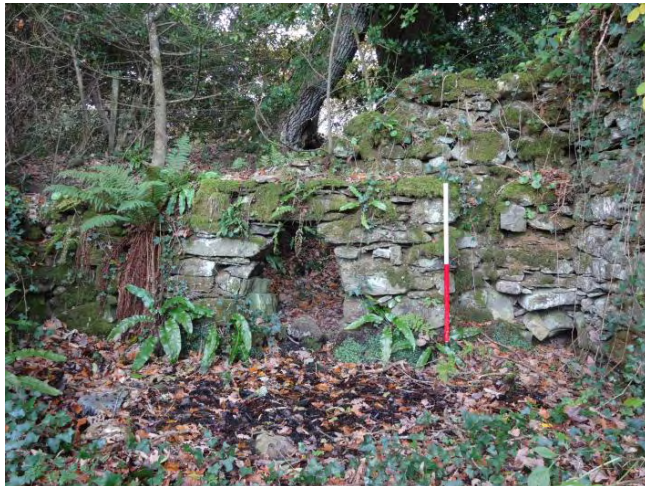
Recorded by the RCAHMW as a corn mill. Buildings appear to be roofless by at least 1907 and are shown as ruinous on modern maps (M.Ings, 2014)

The site was seen as part of the Cadw funded Mills Survey of 2012-14. There are three ruinous buildings, with the mill building standing to the southeast of a possible cottage and outbuilding. The footprint of the mill survives, with walls standing approximately 1m to 1.3m high although the north-facing end wall has largely collapsed. The interior is now obscured by stone

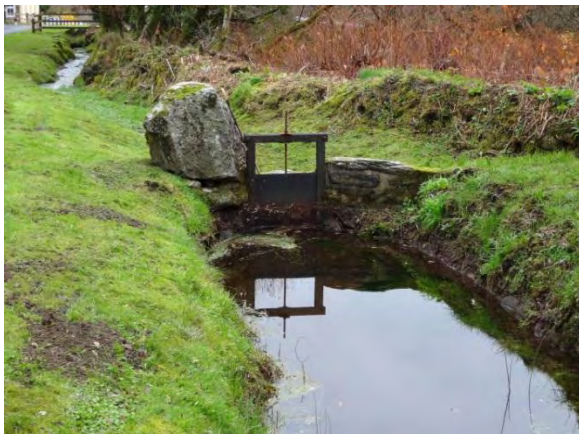
The site was visited as part of the Cadw funded Mills Survey of 2012-14. The mill-race is preserved as a distinctive earthwork, still carrying water from the river to the wheel-pit, where it drained off along the tail-race. Part of the race is hidden beneath a grassed-over culvert, but on the long stretch that is visible there is a sluice gate still in position (M.Ings, 2014)

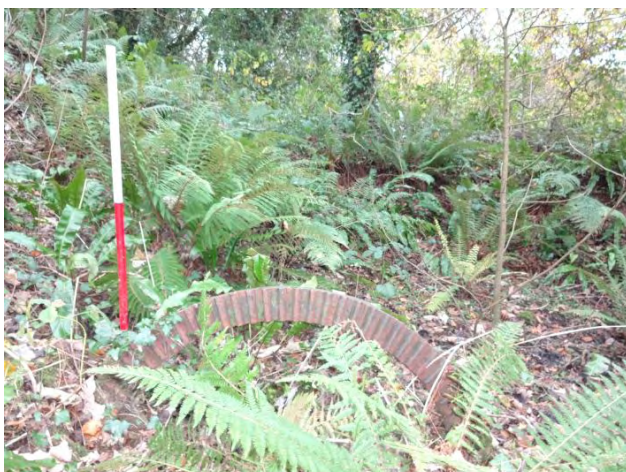
The site was visited as part of the Cadw funded Mills Survey of 2012-14. Its recorded location is at the base of the steep south-facing slope of Walwyn's Castle (PRN 3151), an Iron Age enclosure. This area is now within woodland. No structural evidence for the mill was found but the leat diverted from the stream, as shown on the 1st ed. OS. map, was located and a relatively level area indicated possible building platform below the footpath. The leat would have run alongside the east side wall of the mill and here, now earthfast, was the top of an iron, grooved wheel - probably the axle wheel and seemingly still in situ (M.Ings, 2013)
