## SECTION B – TRAIL AUDIT FINDINGS

## 8 TRAIL AUDIT FINDINGS

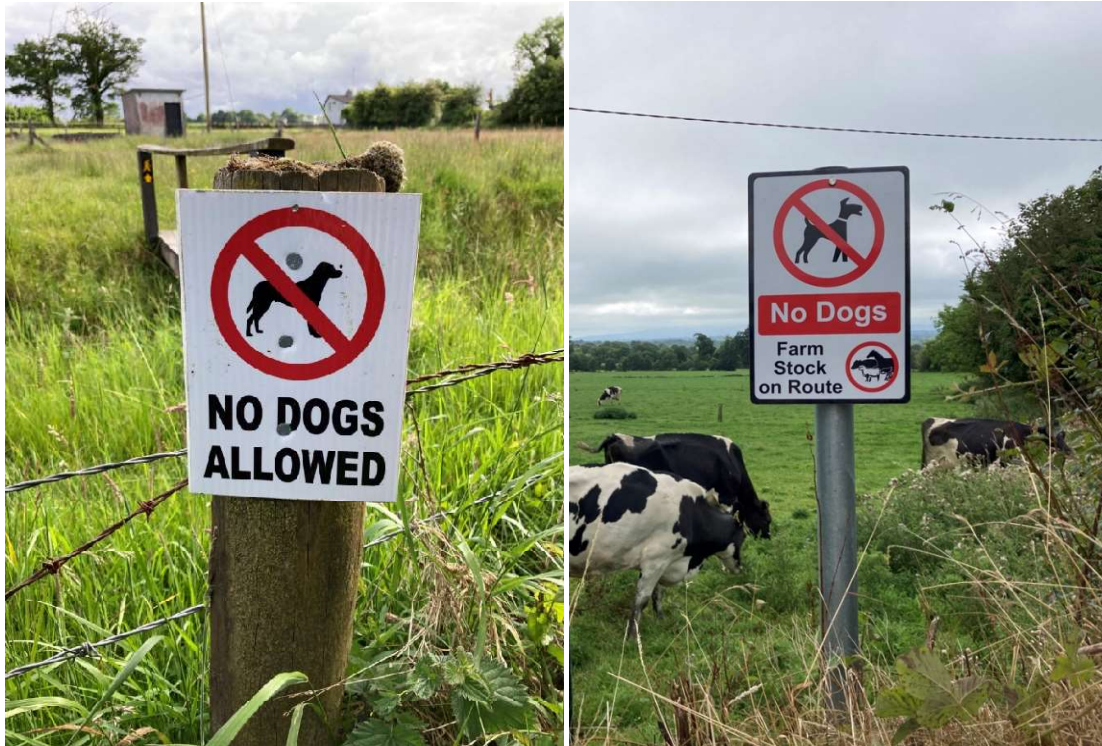
Figure 52 Images of dog warning signs along the route

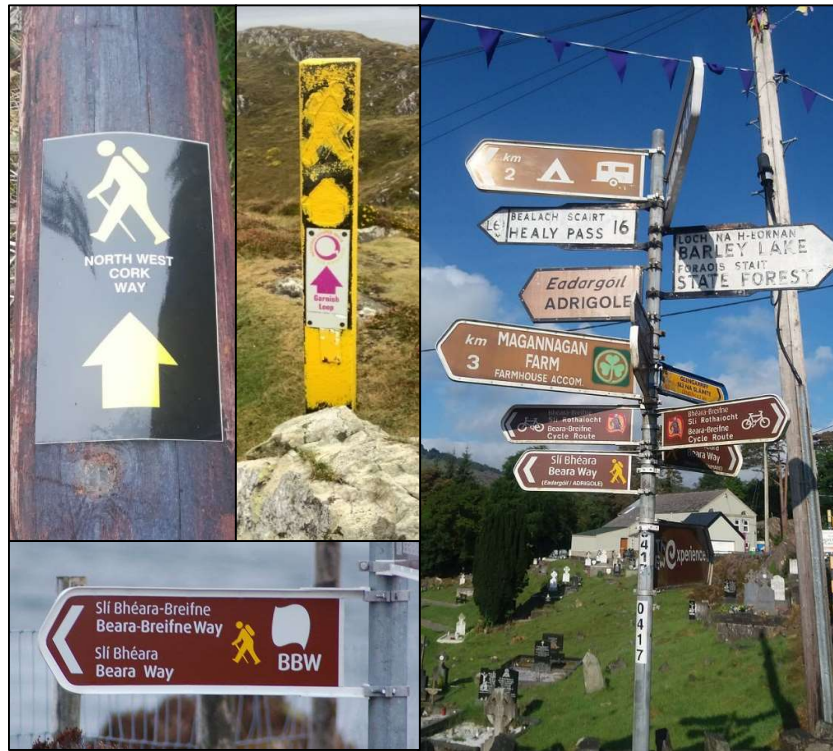
During the audit, it was found that in many locations the BBW waymarking was non-existent, inconsistent or confusing.

Figure 56 A selection of signage examples from the BBW

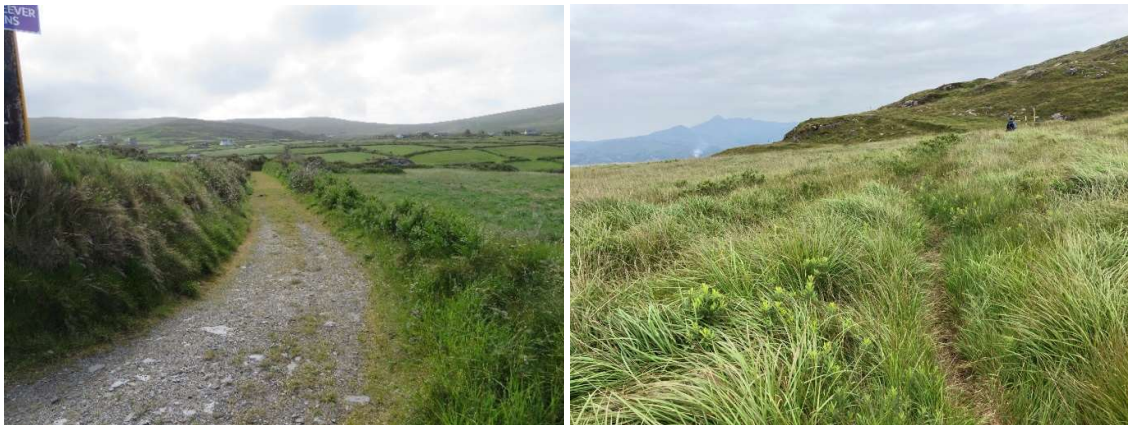
Off-road sections of the trail consist of used and disused vehicle tracks, open hillside with and without desire lines (some of which can be boggy or very wet under foot), and sections of pastoral farmland that are intended to be maintained for walkers (see Figure 59).

*Figure 59 Off-road trail on the Beara Way*

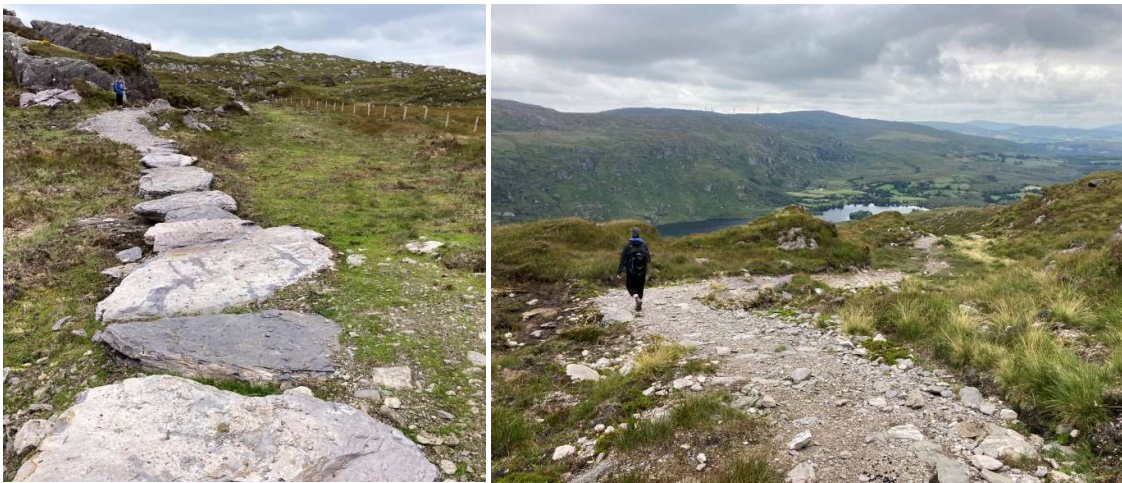
Off-road sections of the trail consist of used and disused vehicle tracks (farm and forestry), open hillside with and without desire lines (some of which can be boggy or wet under foot), built gravel trail (Figure 61), bog bridge, stone stepping and sections of pastoral farmland intended to be maintained for walkers.

*Figure 61 Off-road trail on the Sli Gaeltacht Mhuscraí*

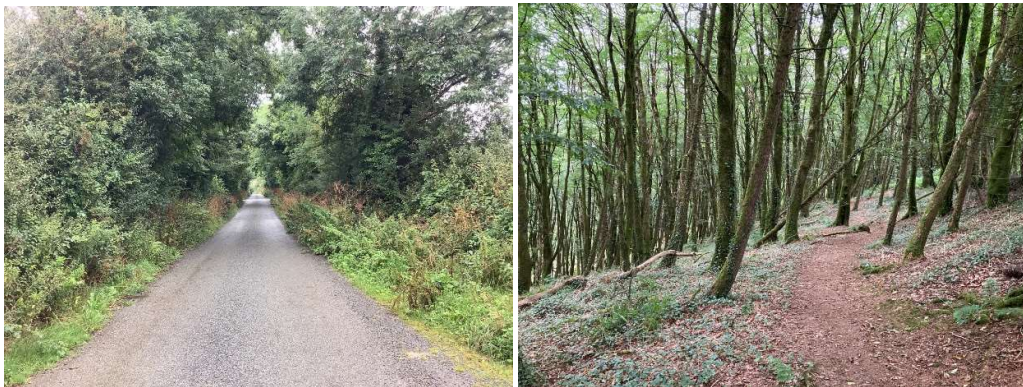
The trail surface along the BBW on the North West Cork Way, in the majority consists of bitmac rural and regional roads. As noted in the previous table, the recommended trail is only 51% off-road and falls short of the National Trails Office standard for off-road to on-road ratio of 70% off-road, and the aim of the BBW project of having 80% of the route off-road. The sections that are on bitmac trail surface are repetitive and lack interest, coupled with high hedgerows often preventing views of the surrounding landscape. It is essential that these sections are taken off-road, using private land and that a sustainable non-bitmac surface is provided.

Off-road sections of the trail consist of farm track, built forest trails and desire lines across wooded areas. Farm tracks and forest trails are constructed using compacted gravel, are robust and provide a welcome alternative to walking on bitmac. Figure 63 shows trail surfaces on the NWCW.

*Figure 63 On-road and off-road trail on the North West Cork Way*

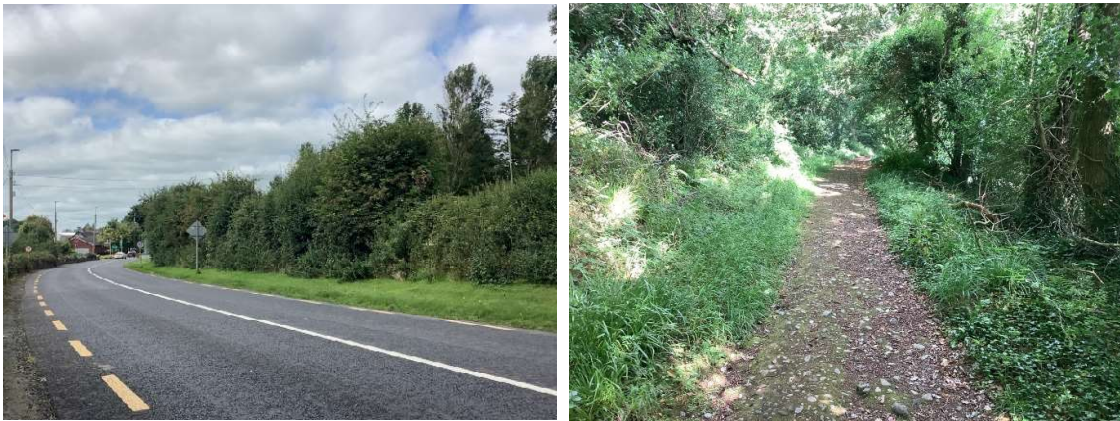
The first 20km of the route from St Johns Bridge to Churchtown, is on a bitmac surface. The other sections that are on bitmac trail surface are on the approach to or leaving settlements, with short section of the route crossing the N20, a busy national road. It is preferable that these on-road sections are taken off-road, using private land and that a sustainable non bitmac surface is provided.

Off-road sections of the trail consist of open hillside which can be boggy underfoot, forest trails and roads, vehicle track and local roads that are not consistently surfaced. See Figure 65.

*Figure 65 On-road trail and off-road trail on the Ballyhoura Way*

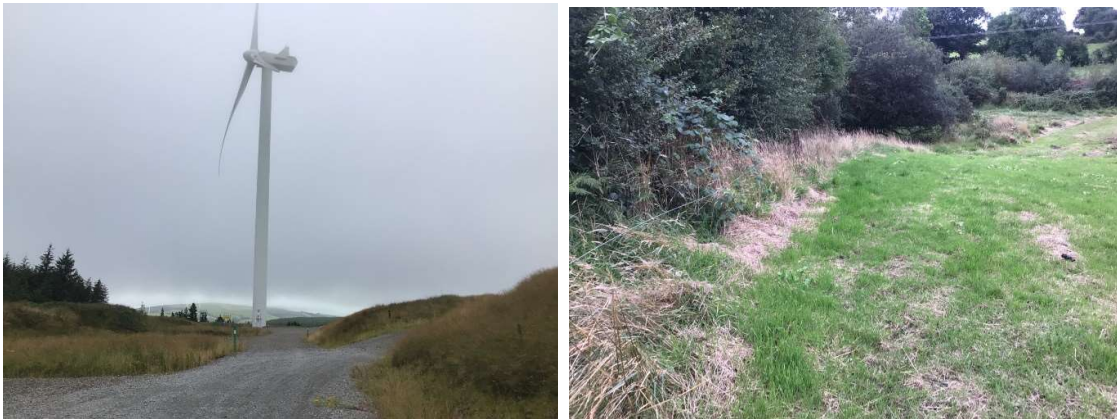
For the recommended route, the first 4.3km of the route is on a rural road with a bitmac surface. Other sections that are on bitmac trail surface, are on the approach to, or leaving settlements. It is preferable that these sections are taken off-road and that a sustainable non bitmac surface is provided.

*Figure 67 Off-road trail on the Multeen Way*

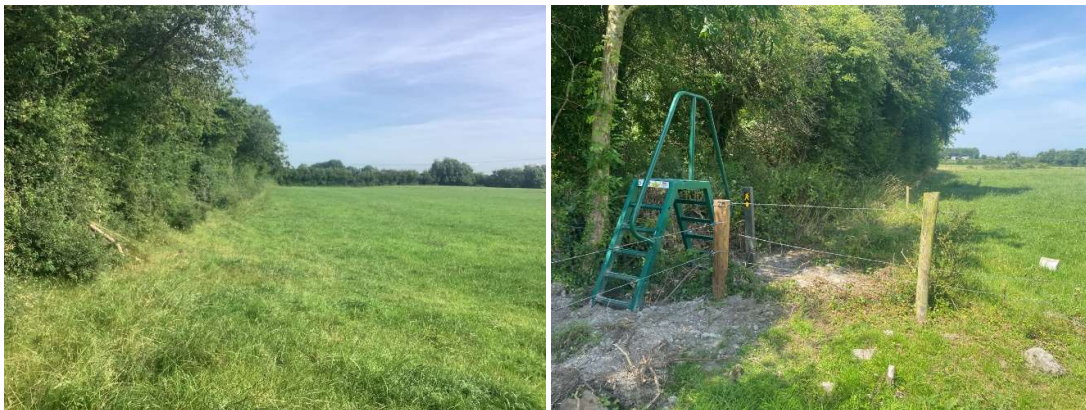
Off-road sections of the trail consist of forest track, pastoral farmland that is (intended to be) maintained for walkers (Figure 69), vehicle tracks and local roads with grass in the middle.

Figure 69 Off-road trail on the Ormond Way

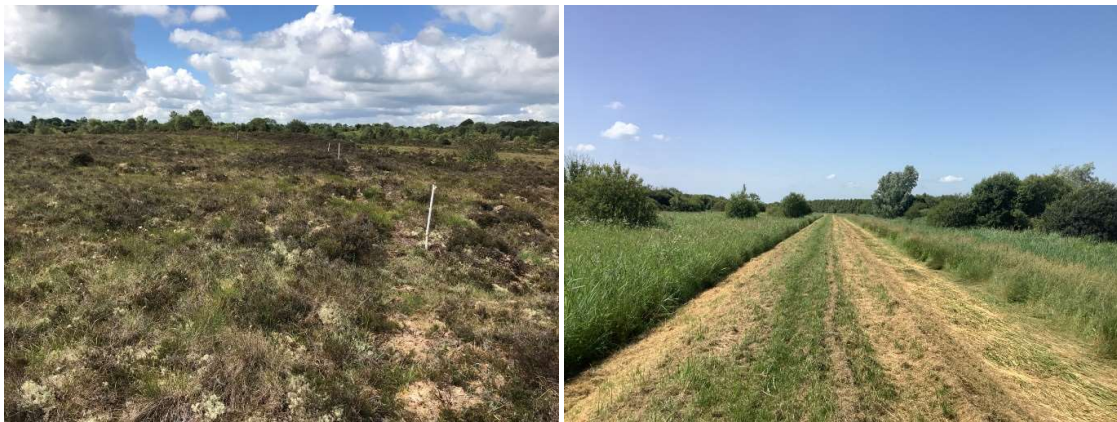
Off-road sections of the trail consist of pastoral farmland that is (intended to be) maintained for walkers, vehicle tracks, open bog and local roads which are not consistently surfaced (Figure 71).

*Figure 71 Off-road trail on the Hymany Way*

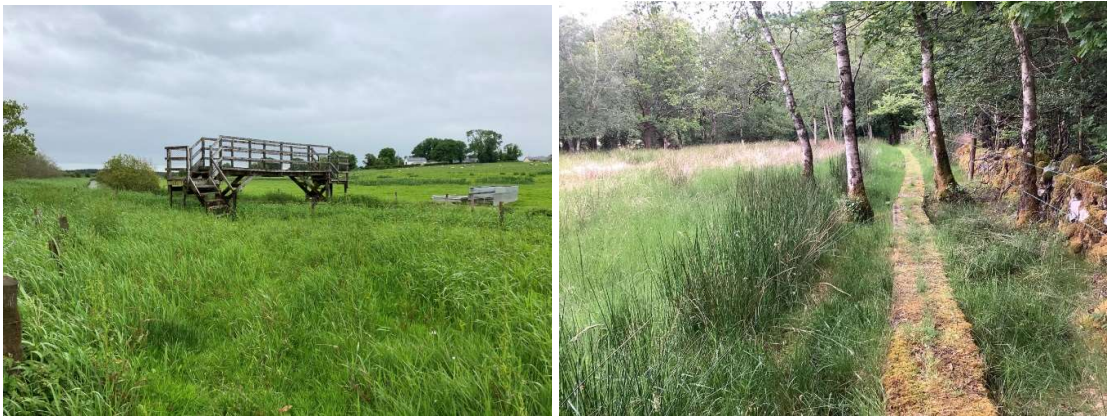
Off-road sections of the trail consist of pastoral farmland that is (intended to be) maintained for walkers, vehicle tracks, forest trail, open bog and local roads which are not consistently surfaced (Figure 73).

*Figure 73 Off-road trail on the Suck Valley Way*

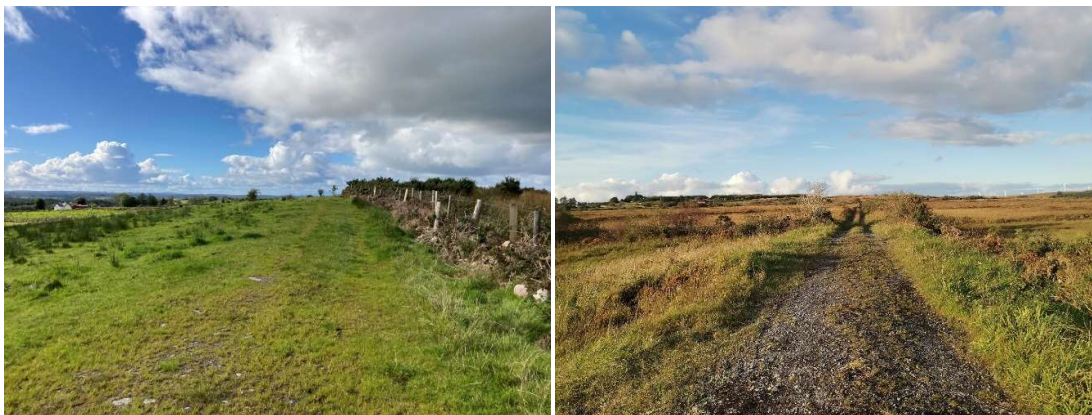
Off-road sections of the trail consist of pastoral farmland that is (intended to be) maintained for walkers, vehicle tracks, open bog and local roads that are not consistently surfaced (Figure 77).

*Figure 77 Off-road trail on the Lung Lough Gara Way*

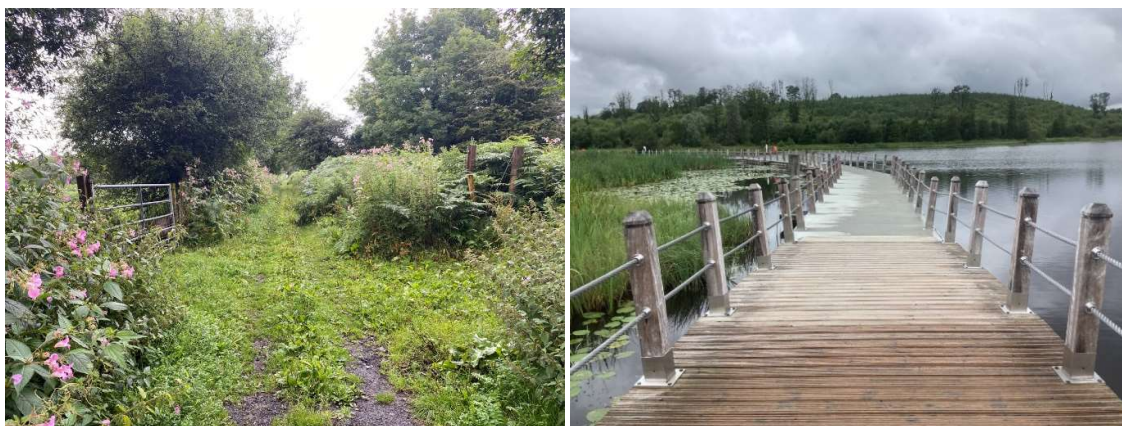
Off-road sections of the trail consist of pastoral farmland, bitmac path, grass track, gravel path, boardwalk and local roads with that are not consistently surfaced (Figure 85).

*Figure 85 Off-road trail on the Leitrim Way*
