Final archaeological report

**St. Marnock's Church
Burrow
Portmarnock
Fingal**

22E0601

7 November 2022

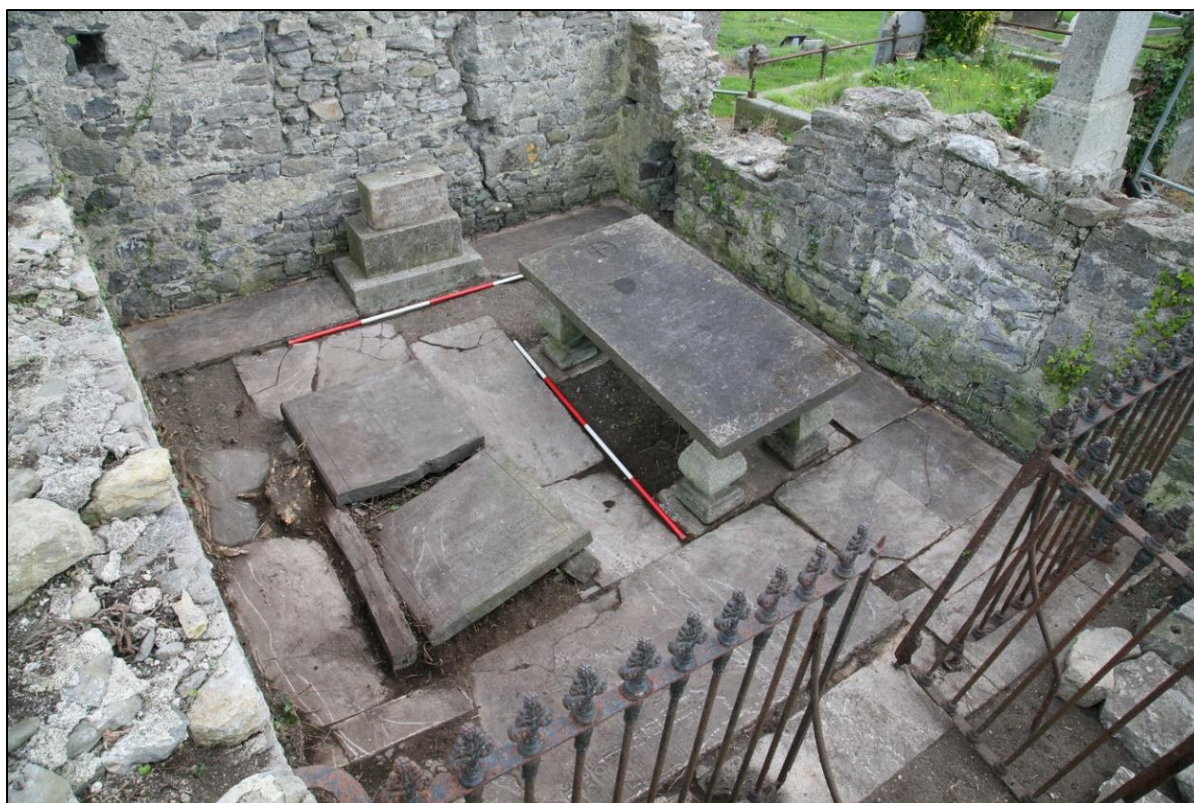
Plate 3 View of chancel area after removal of vegetation, looking southeast

- 3.2 Prior to the erection of scaffolding on the eastern gable, the overgrowth was removed from the chancel and the area was cleaned-off, planned, levelled and photographed (Figure 8, Plates 3-6). In the southeastern corner the *ex situ* monument to Teresa Plunkett was recorded which comprised a limestone memorial (L: 1400mm; W: 550mm, orientated north-south, Plate 7; No. 5 on Figure 8). The monument was set into the ground (probably on a bed of lime mortar visible at the sides), with some cracking (from top centre to centre western side), and was otherwise intact. The monument does not appear to have been recorded by Paddy Healy (who had photographed the Barnwall memorial) and it may have been obscured at the time or was simply illegible. It would appear to have been placed in its present position c. 1862 when the table tomb was erected for John William Plunkett.

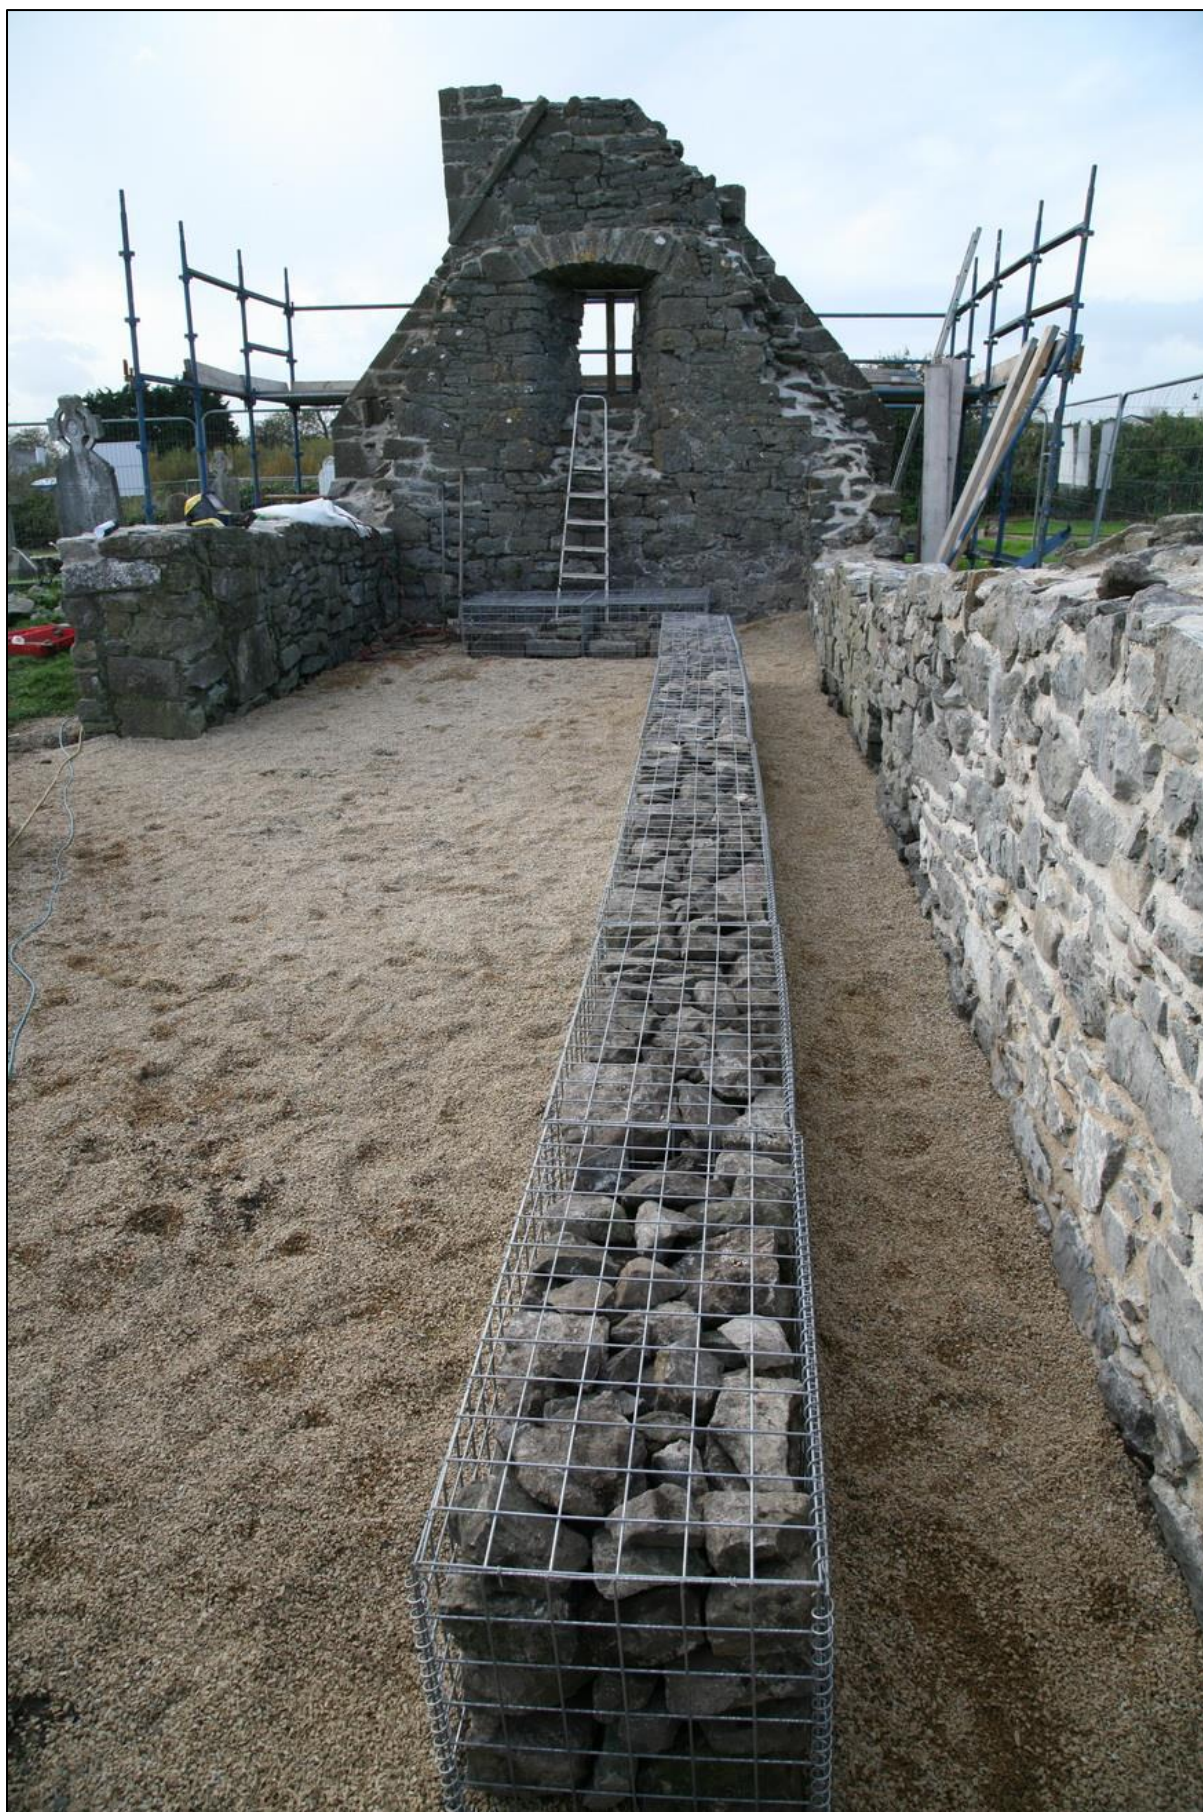
All of the remaining stone was placed in gabions which now sit in the church interior, with the architectural fragments recovered placed in a separate gabion and placed in front of the west gable (Plate 18).

Plate 18 View of the church towards the end of conservation works

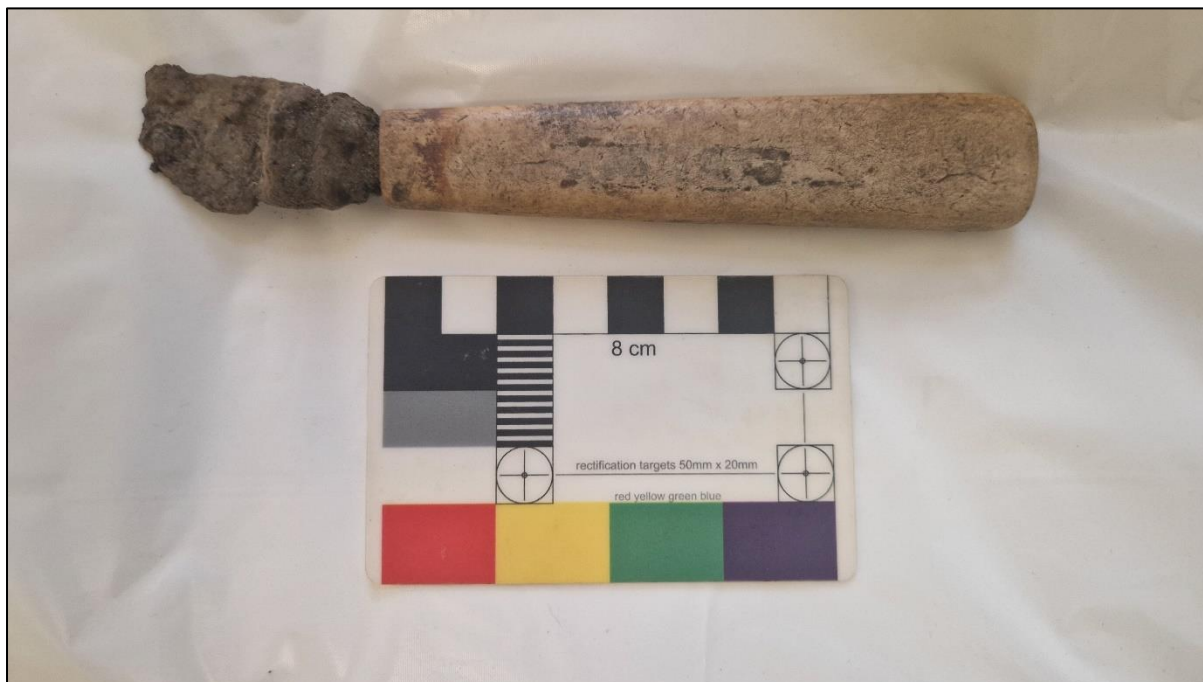
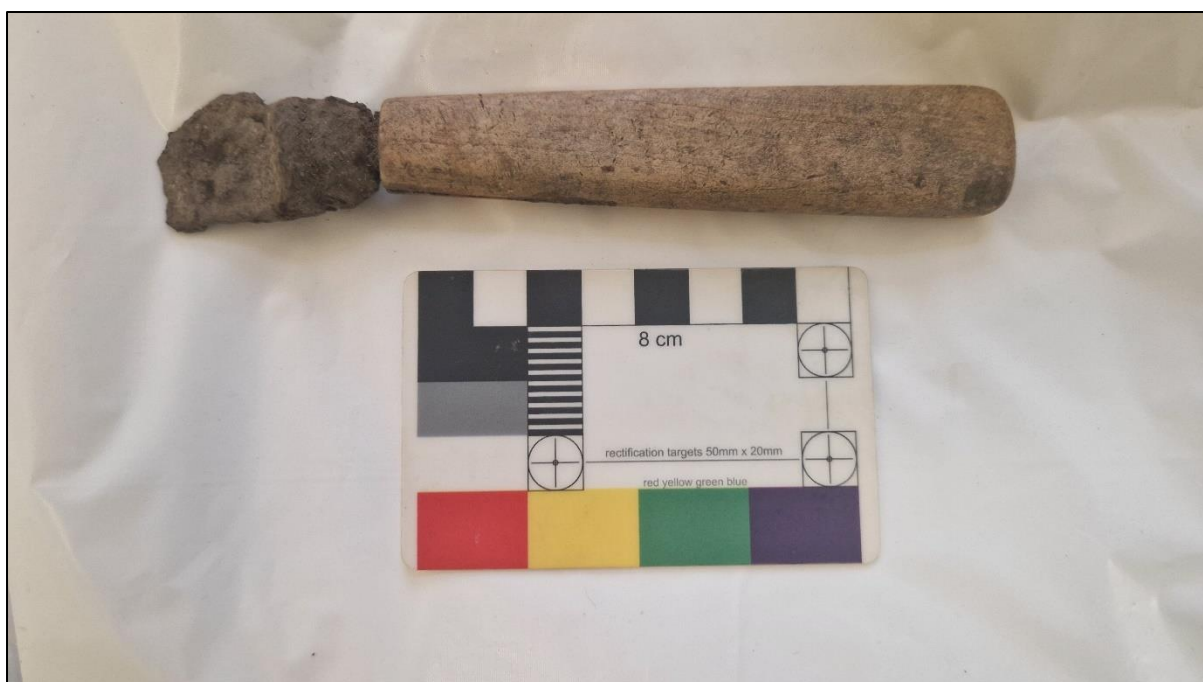
Plate 19

There was one artefact recorded over the course of the monitoring, a bone table knife handle (22E0601:1:1) which was recovered from underneath the western stone pile. The tang is accommodated in the handle and the blade has snapped just beyond the guard. The knife is unlikely to be any earlier than the mid-nineteenth century.

L: 112mm (154mm with blade); W: 24mm, tapering to 14mm at the guard.

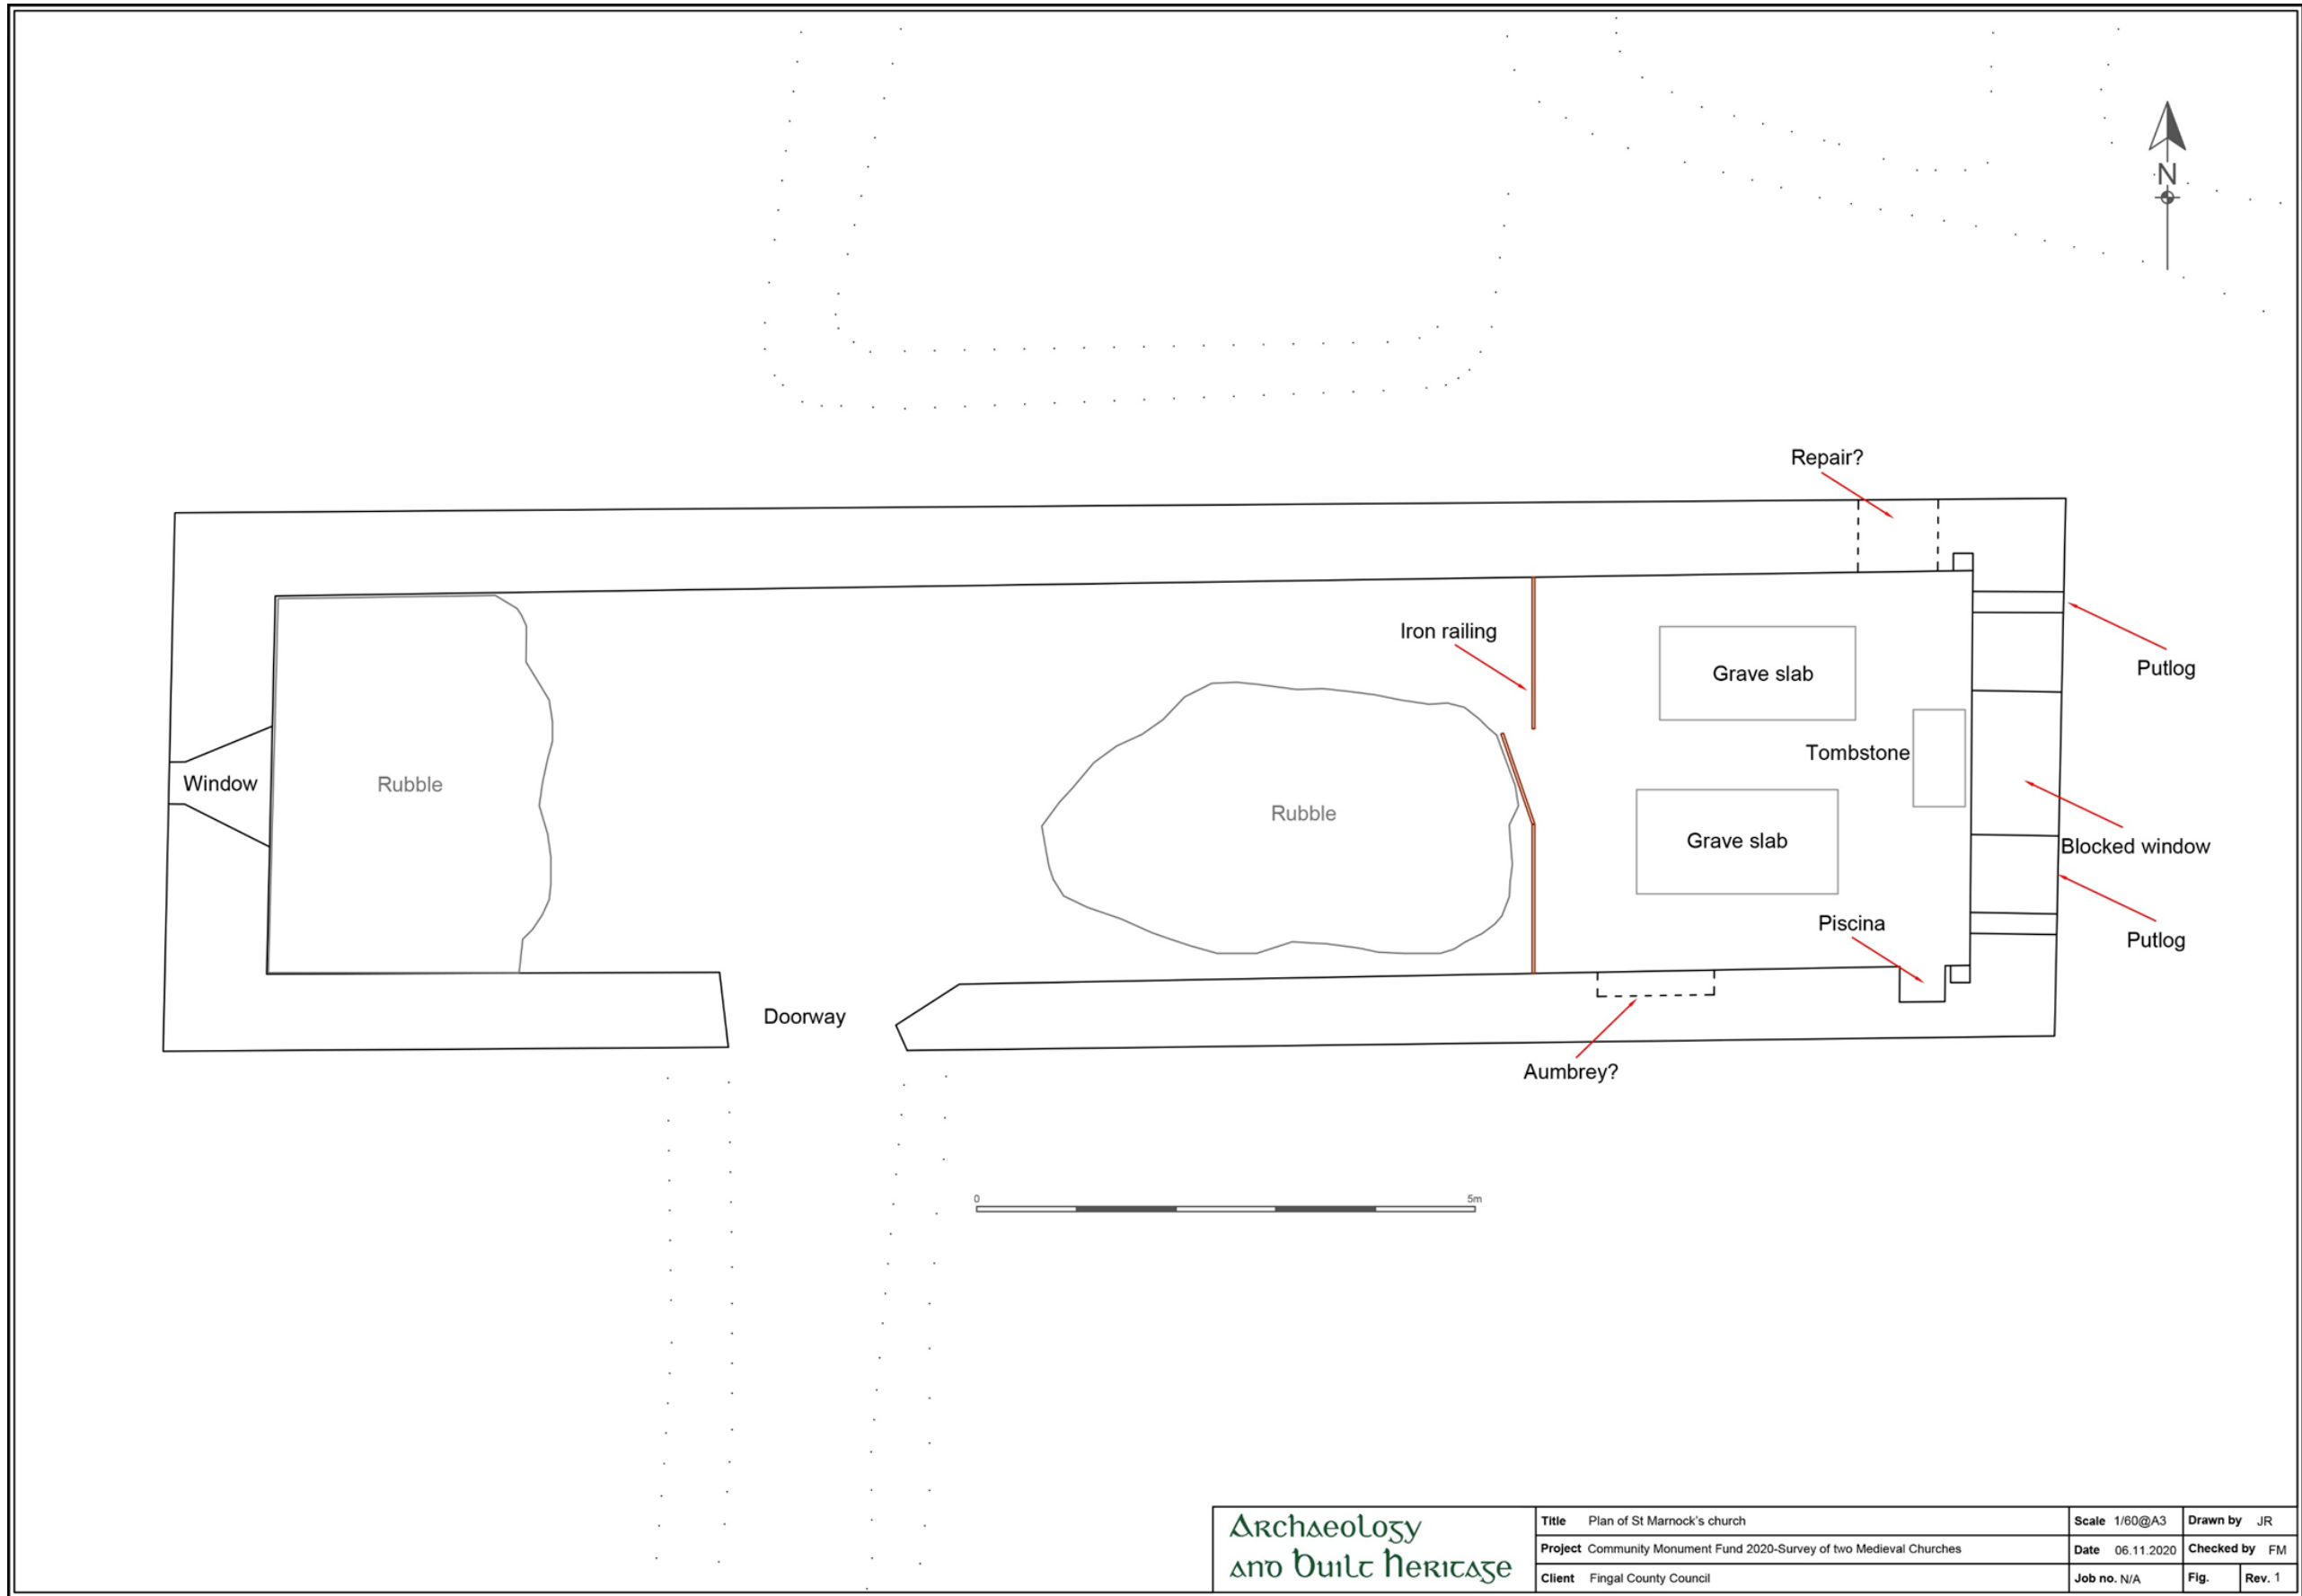
Figure 7

The initial task undertaken was to remove the rubble from the church interior (Figure 7) and sort through the material to recover architectural stone. Seventeen stones were recovered and set aside for recording (see Figure 9, Appendix 1), with one stone obviously a component of the western gable.

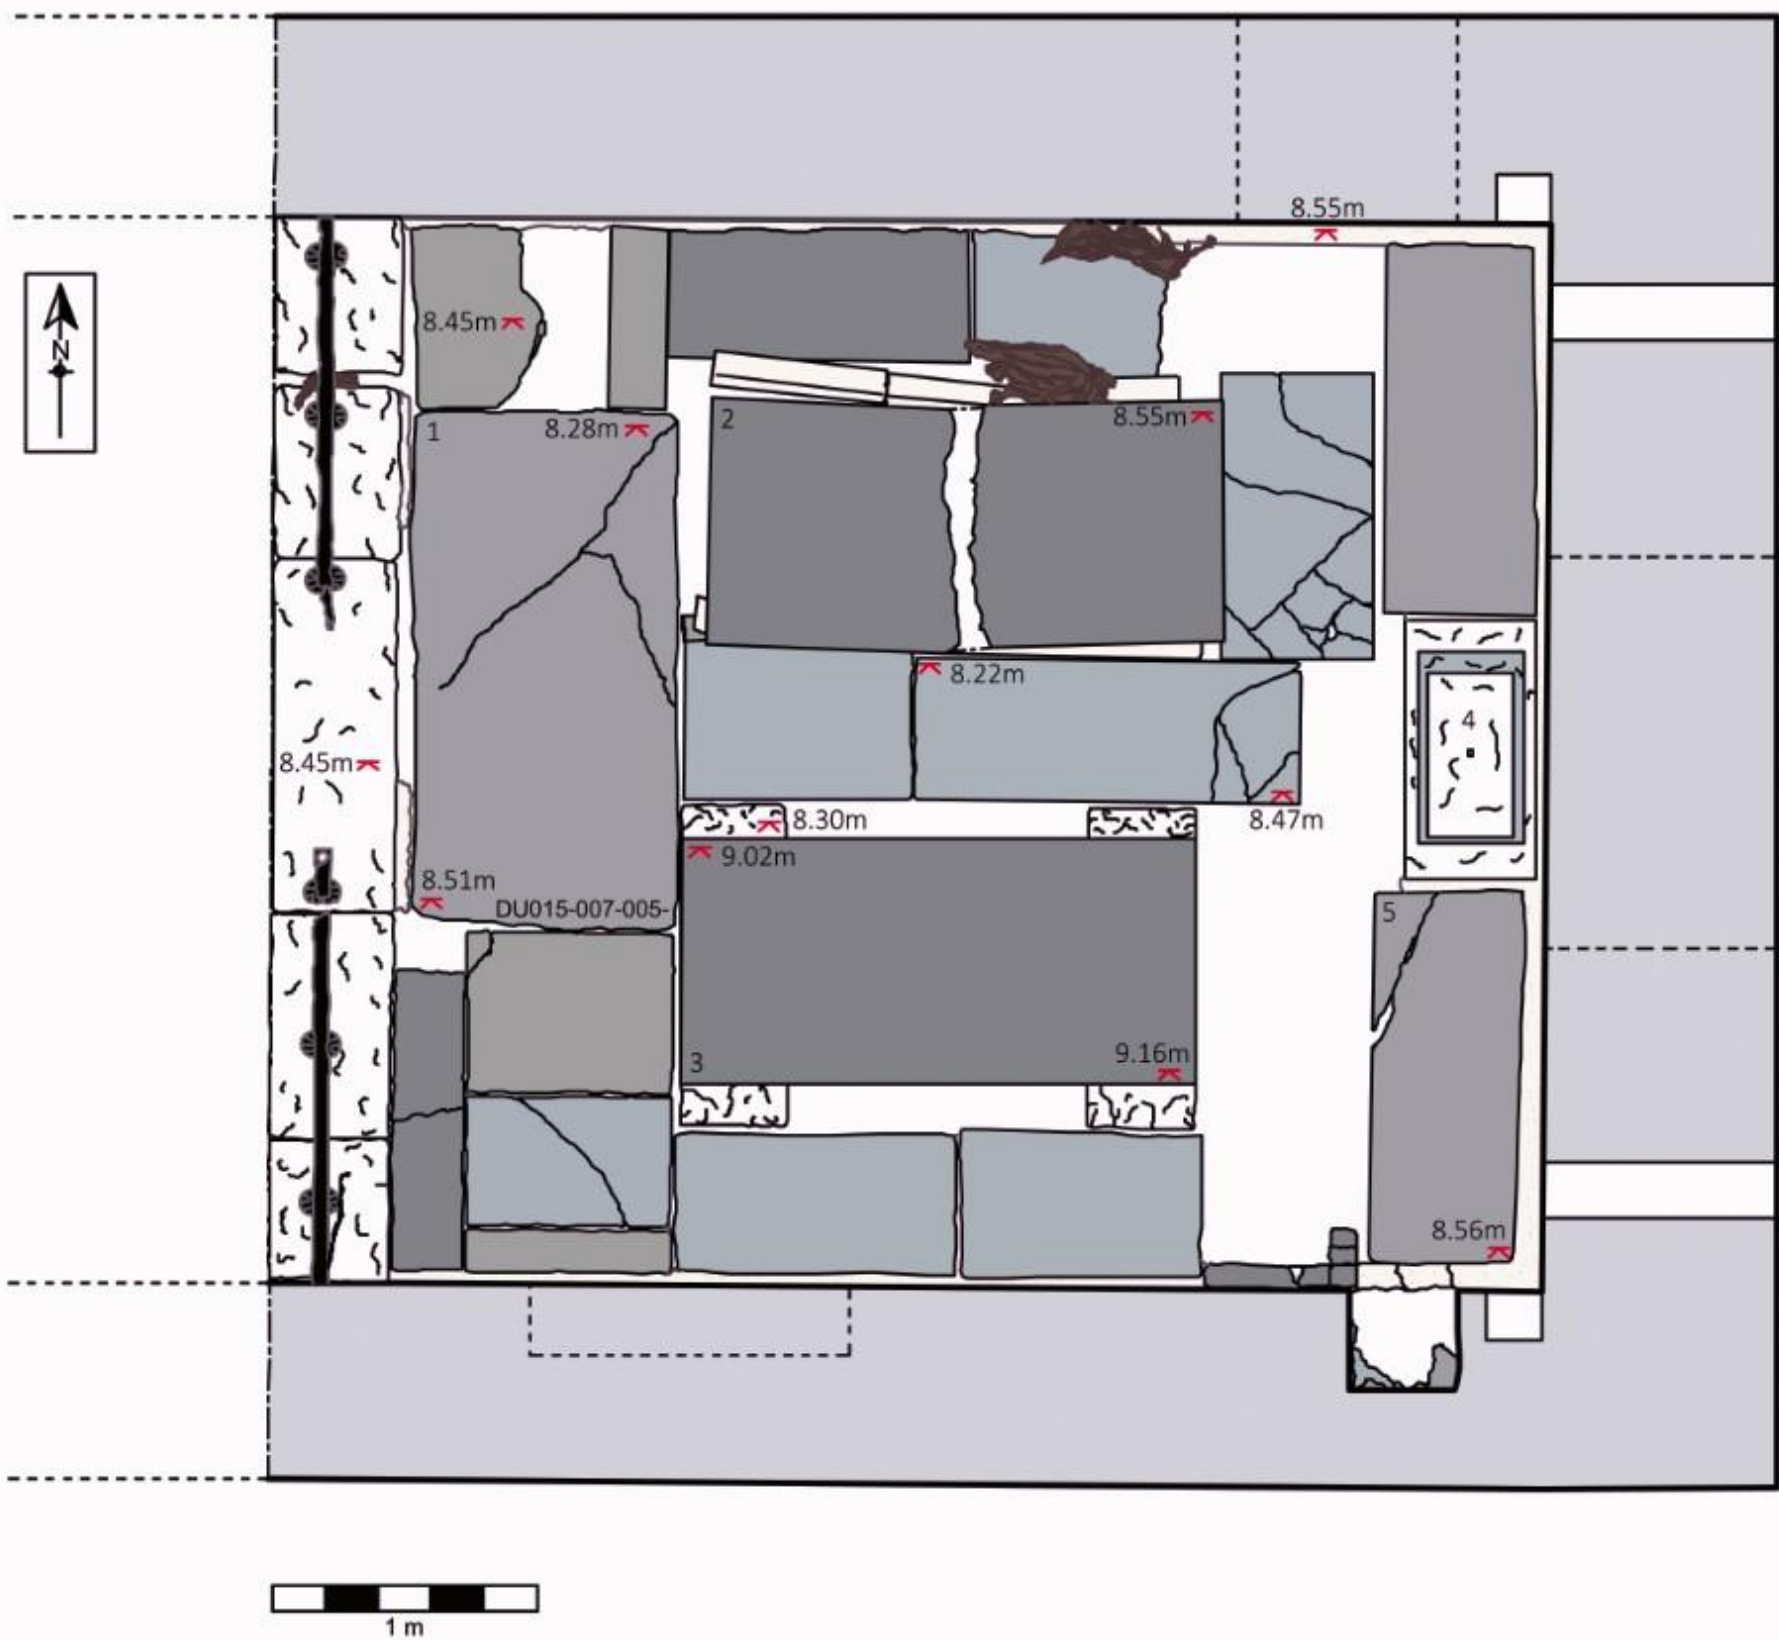
Figure 8 Plan of chancel area after the removal of overgrowth
