VAPOUR CLOUD EXPLOSION AT THE IOC TERMINAL IN JAIPUR

D.M. Johnson, GL Noble Denton, Loughborough, Leics, LE11 3GR

At approximately 6:10pm on 29th October 2009, a leak of gasoline occurred on the Indian Oil Corporation's (IOC) Petroleum Oil Lubricants Terminal at Jaipur, India. This leak continued for some 75 minutes, when the vapour cloud ignited, resulting in a severe vapour cloud explosion (VCE), eleven fatalities and many tank fires. The sequence of events and cause of the spillage were investigated by an independent Indian committee. However, the VCE in the Jaipur incident shared a number of characteristics with the VCE at the Buncefield terminal in the UK in December 2005. Given these similarities, evidence related to the Jaipur VCE was collected by the author over a three day period at the site during February 2010, at which time much of the evidence on the site was relatively undisturbed. The combination of the evidence from the two incidents, supported by information from a small number of previous incidents, provides both an indication of the VCE potential for dense vapour clouds and the nature of key forensic evidence that is likely to be observed following such events.

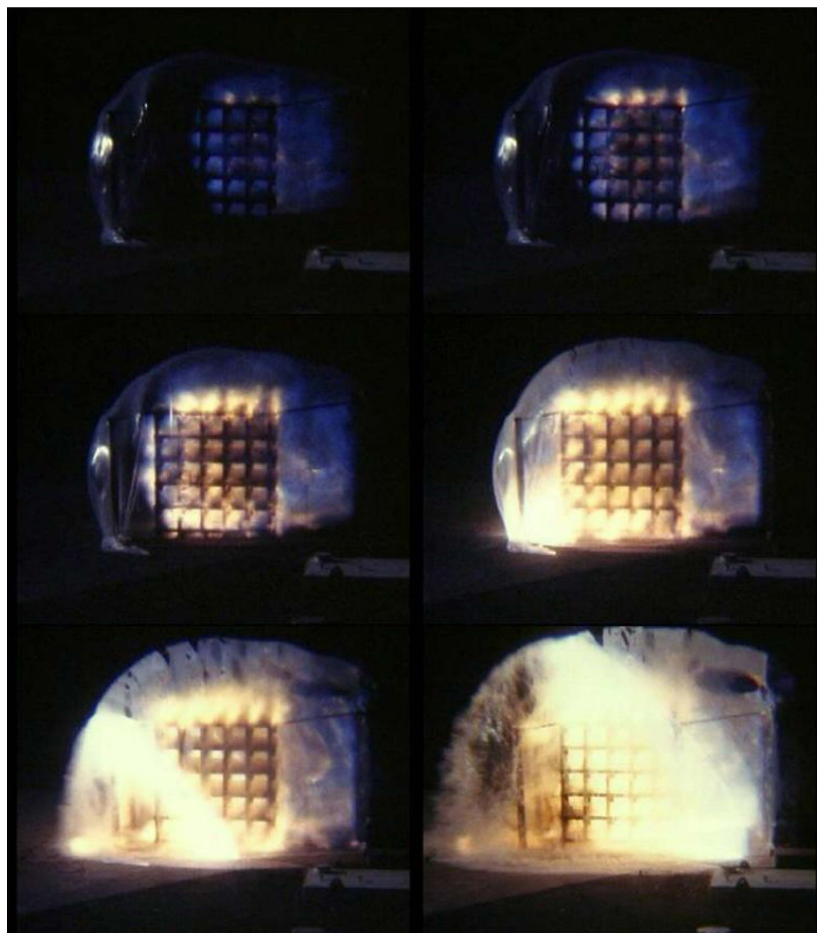
Figure 8. Sequence of Images from High Speed Cine

there was evidence of transition to detonation. Figure 8 shows images taken from high speed cine of a propane-air experiment where the explosion chamber was fitted with a vent panel with one quarter open area and there was no pipework within the chamber and the external regular pipework region being formed by 168 mm diameter pipes giving an

The interpretation of these images is that the deflagration undergoes a transition to detonation as it propagates out of the congested region and this detonation then travels through unburned mixture that surrounds the congested region. The speed of the circular shaped front in the last two frames is consistent with the expected detonation speeds (1800 m/s).
