Analysis of Train Derailment in Collision with a Road-Rail Vehicle in the Station Yard of Kawasaki Station

A deadhead train collided with road-rail vehicle at Kawasaki station on the Keihin-Tohoku line in 2014, resulting in the 1st car being damaged and the 1st and 2nd car overturning. Damage was severe, even though the lead car of the train was designed to absorb the impact of a collision with a dump truck at a level crossing. We therefore investigated the cause of the damage by inferring the situation from collision to overturning from traces found on the train cars, road-rail vehicle, and track. From that, we studied improvements that could be made to safety in collisions similar to this accident.

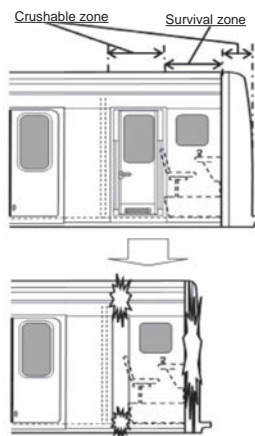
Fig. 2 Measures Against Collisions

As a measure against collision with a dump truck at a level crossing (Fig. 2),²⁾ the lead car that collided with the road-rail vehicle was designed to have a crushable zone that would intentionally deform to absorb impact energy and a survival zone that would reduce deformation in order to protect the crew as well as a shock absorbing coupler between that car and the second car.³⁾ Nevertheless, the collision severely damaged the front and the underframe of the lead car, and the survival zone was greatly deformed while the crushable zone was not deformed much (Fig.3). On top of that, the car overturned.
