Relicensing Study 3.1.2

**Northfield Mountain / Turners Falls
Operations Impact on Existing Erosion and
Potential Bank Instability
Study Report**

Volume III – Appendices

**Northfield Mountain Pumped Storage Project (No. 2485) and
Turners Falls Hydroelectric Project (No. 1889)**

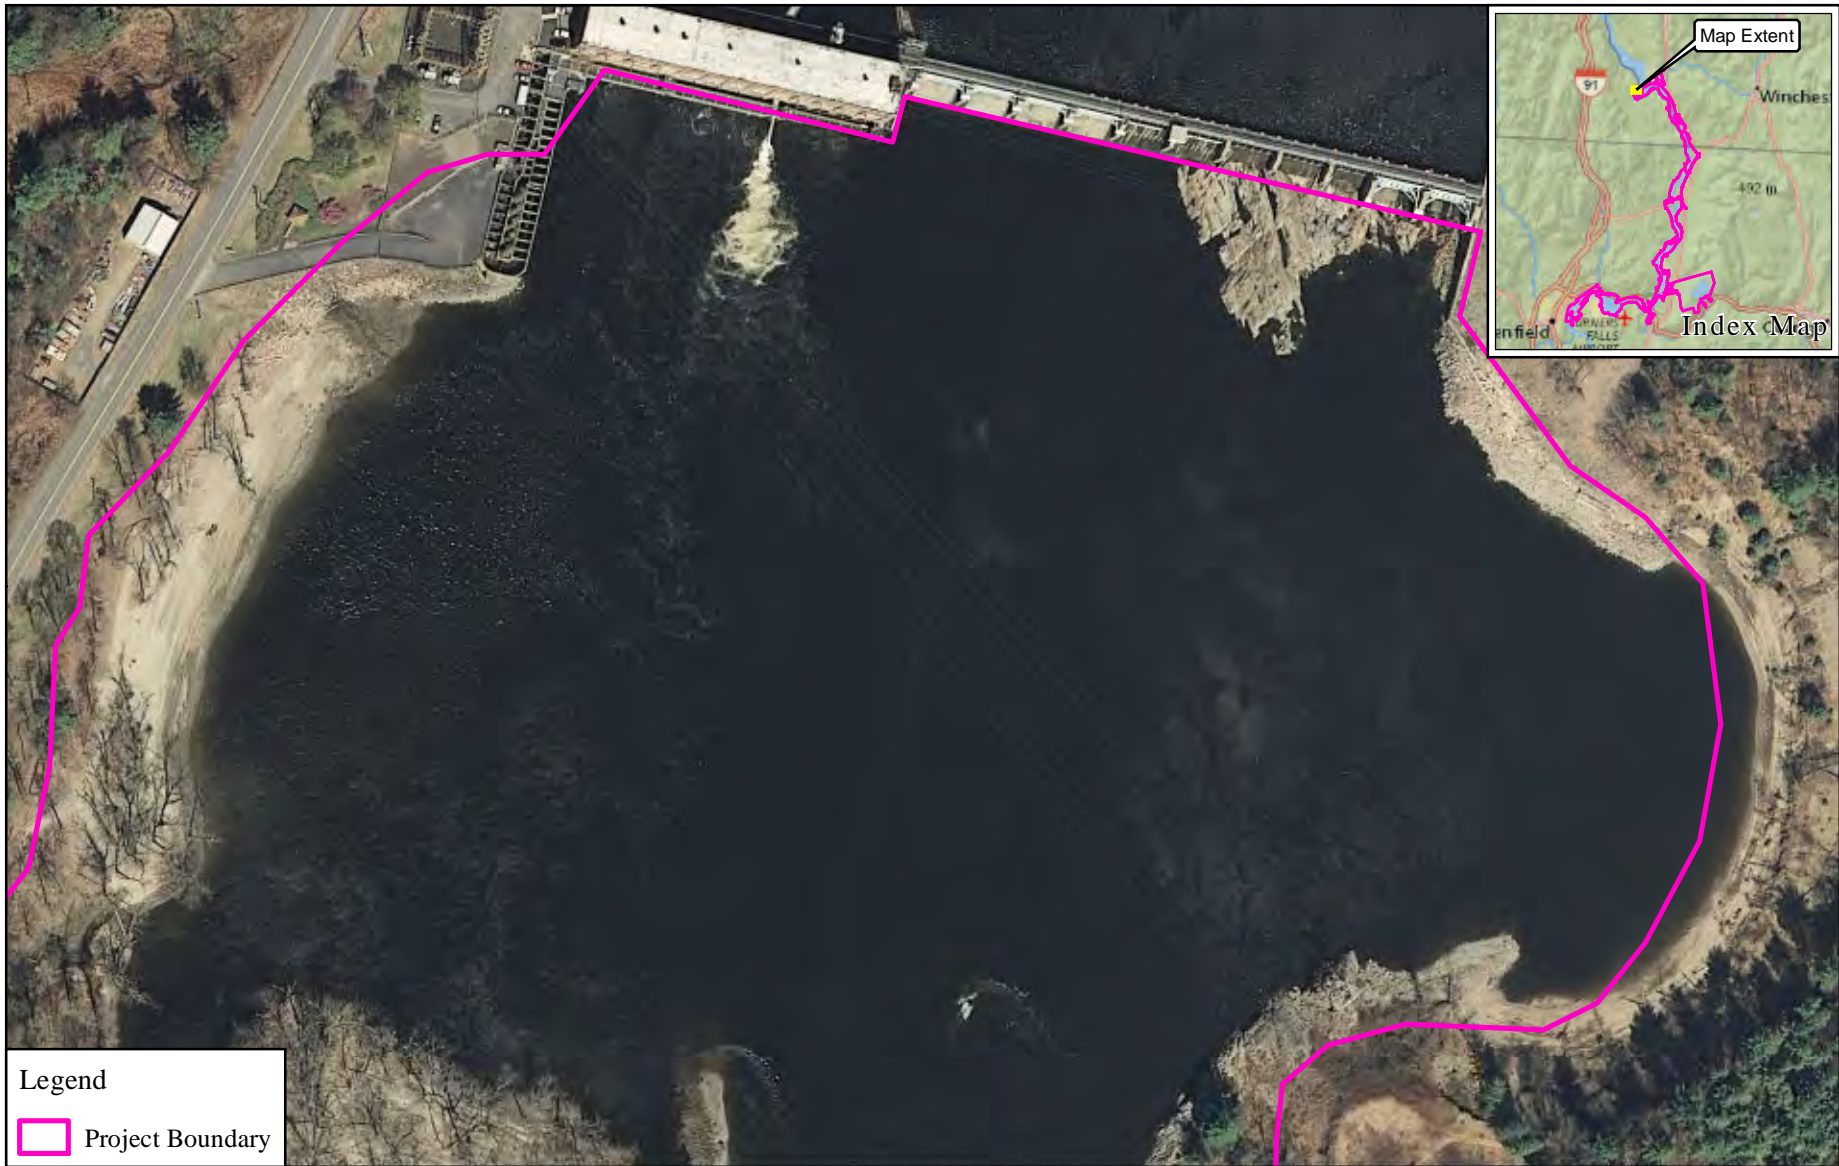
Vernon Dam
 1952 Imagery
 (Source: North by Northeast Survey Company)

The 1952 photograph shows that the top of left bank is near the project boundary line (indicated in fuchsia). Recent photographs show that erosion has progressed beyond the line such that the bottom of the upper bank is beyond the line. The 2008-2010 and the Online Imagery were taken at relatively high flow conditions and show the turbulence and eddying associated with the release of flow through the left gates of Vernon Dam as well as the general turbulence in this reach of the river at these levels of flow.

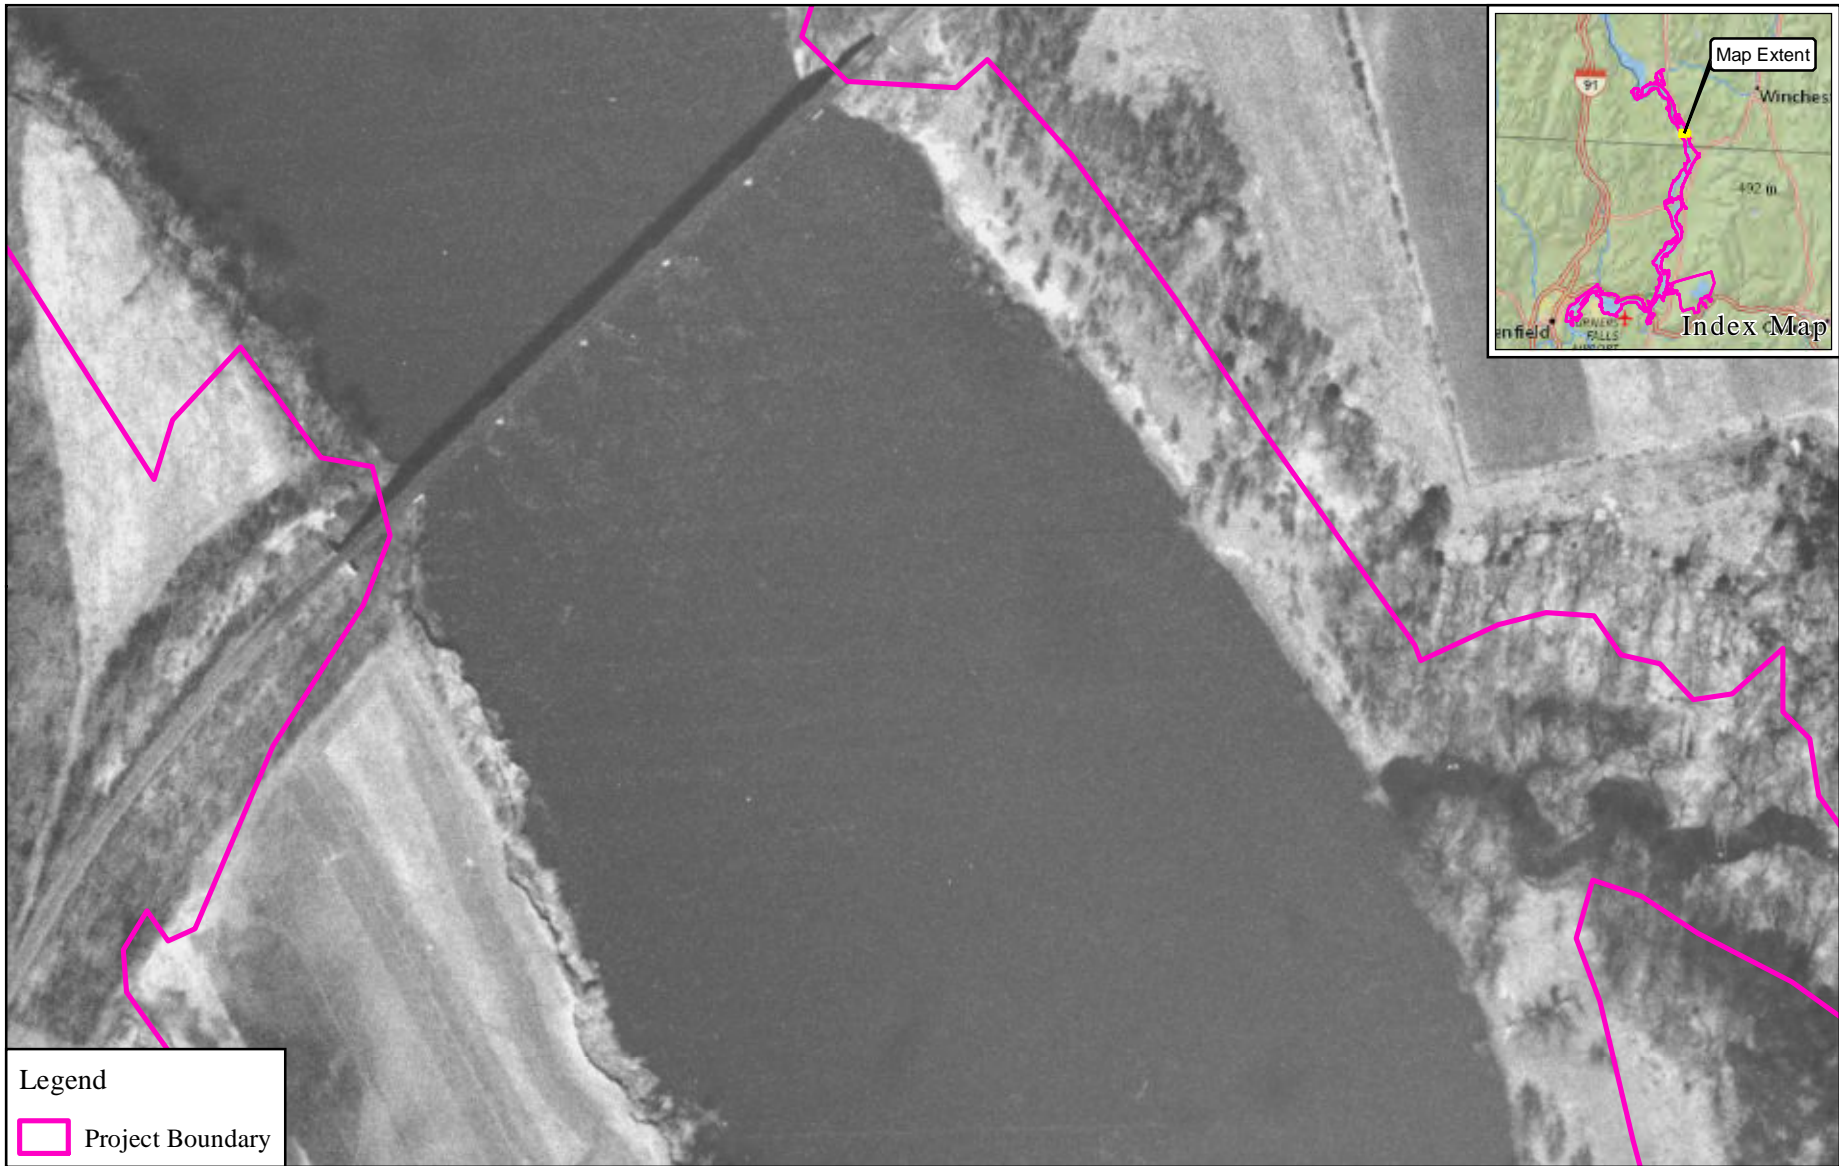
Kendall
 1952 Imagery
 (Source: North by Northeast Survey Company)

In the vicinity of the railroad bridge which has been subsequently abandoned and partially removed, in 1952 the right bank downstream of the bridge supports a band of riparian vegetation while the left bank is sparsely vegetated. In 1962, in the same location on the right bank erosion is evident with the bank shifting landward and no riparian vegetation remaining. On the left bank, a small erosion scallop has formed just downstream of the bridge with segments of reduced riparian vegetation. The bridge super-structure had been removed by the 1990s photograph, with all piers left standing in the river. By the 2008-2010 set of photographs, one of the piers had fallen into the river, probably due to scour around its base and no supporting structure to provide stability from above. The right bank is the Kendall site which was stabilized in 2008 through implementation of the ECP. Subsequent photos show the stabilized right bank and increased riparian vegetation along the left bank.

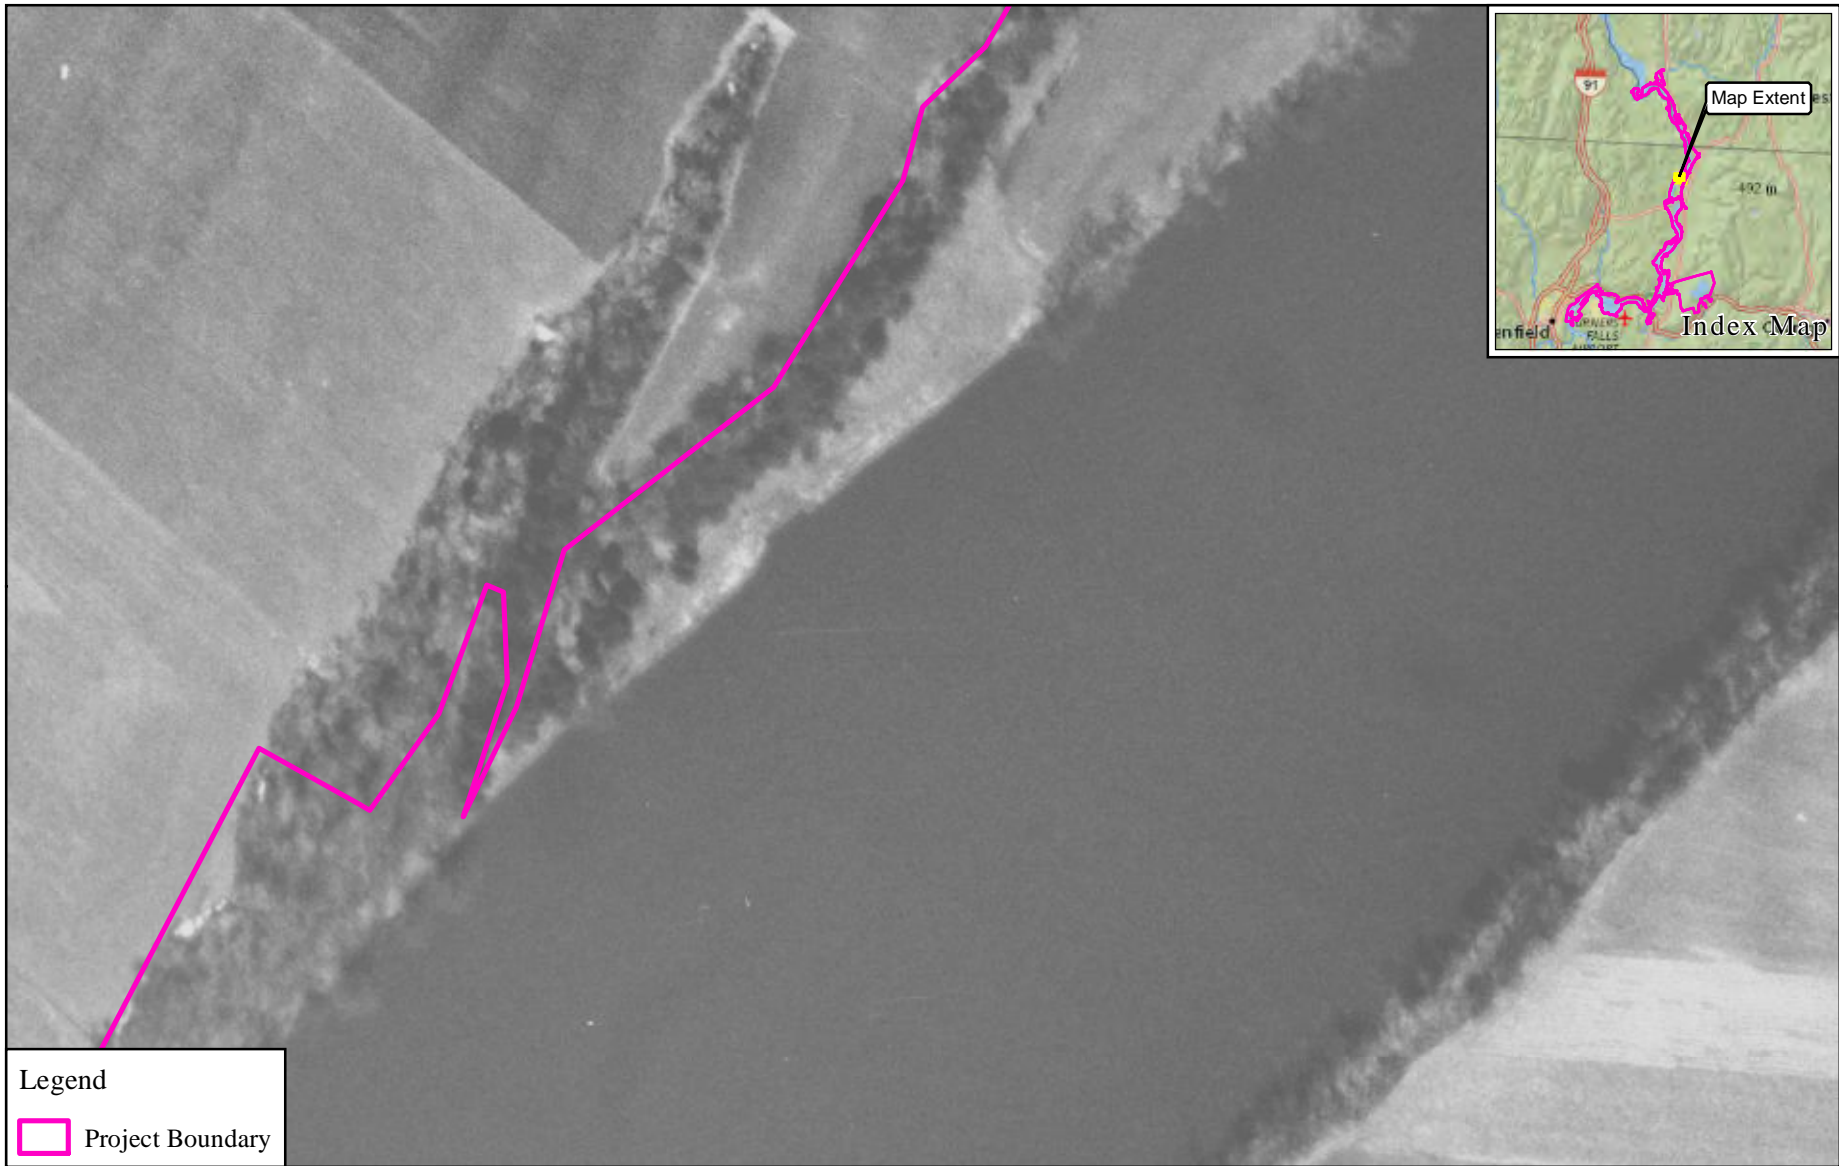
Wickey
 1952 Imagery
 (Source: North by Northeast Survey Company)

In the 1952 and 1960s photographs, there is an eroded section of riverbank with no significant riparian vegetation. During the 1990s, this site was selected for erosion repair, known as the Wickey site (constructed in 1996).

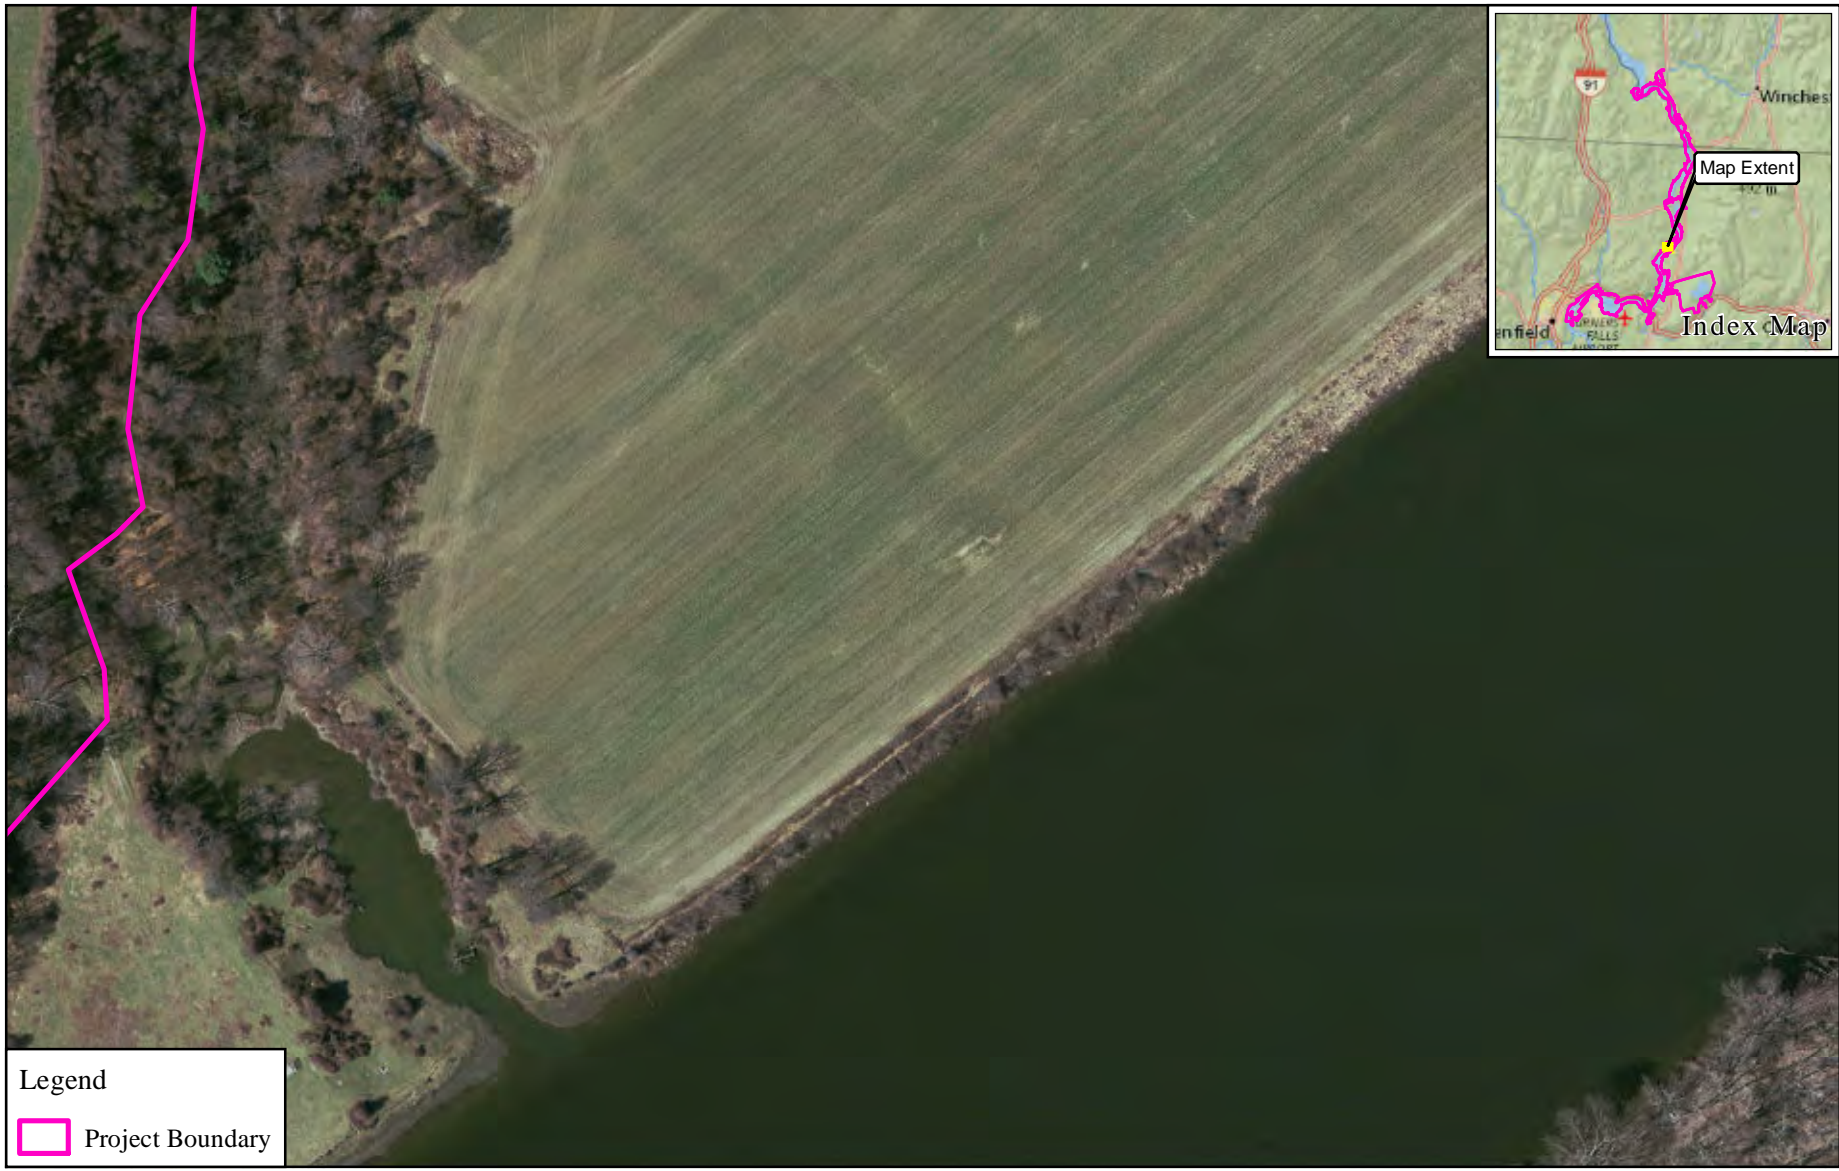
Flagg (upstream of Otter Run)
 1990's Imagery
 (Source: MassGIS)

The right bank upstream of Otter Run follows the same pattern as the segment downstream from 1952 through the 1990s photographs with sparse riverbank vegetation in the 1950s and 1960s and virtually no riparian vegetation and erosion evident in the 1990s. This upstream site was stabilized in 2000 as part of the Flagg site through the ECP. This segment of the site was fenced off without access to cattle and is now densely vegetated and has a rock toe with aquatic vegetation growing on the lower riverbank. The riparian vegetation can be seen in the recent photographs.

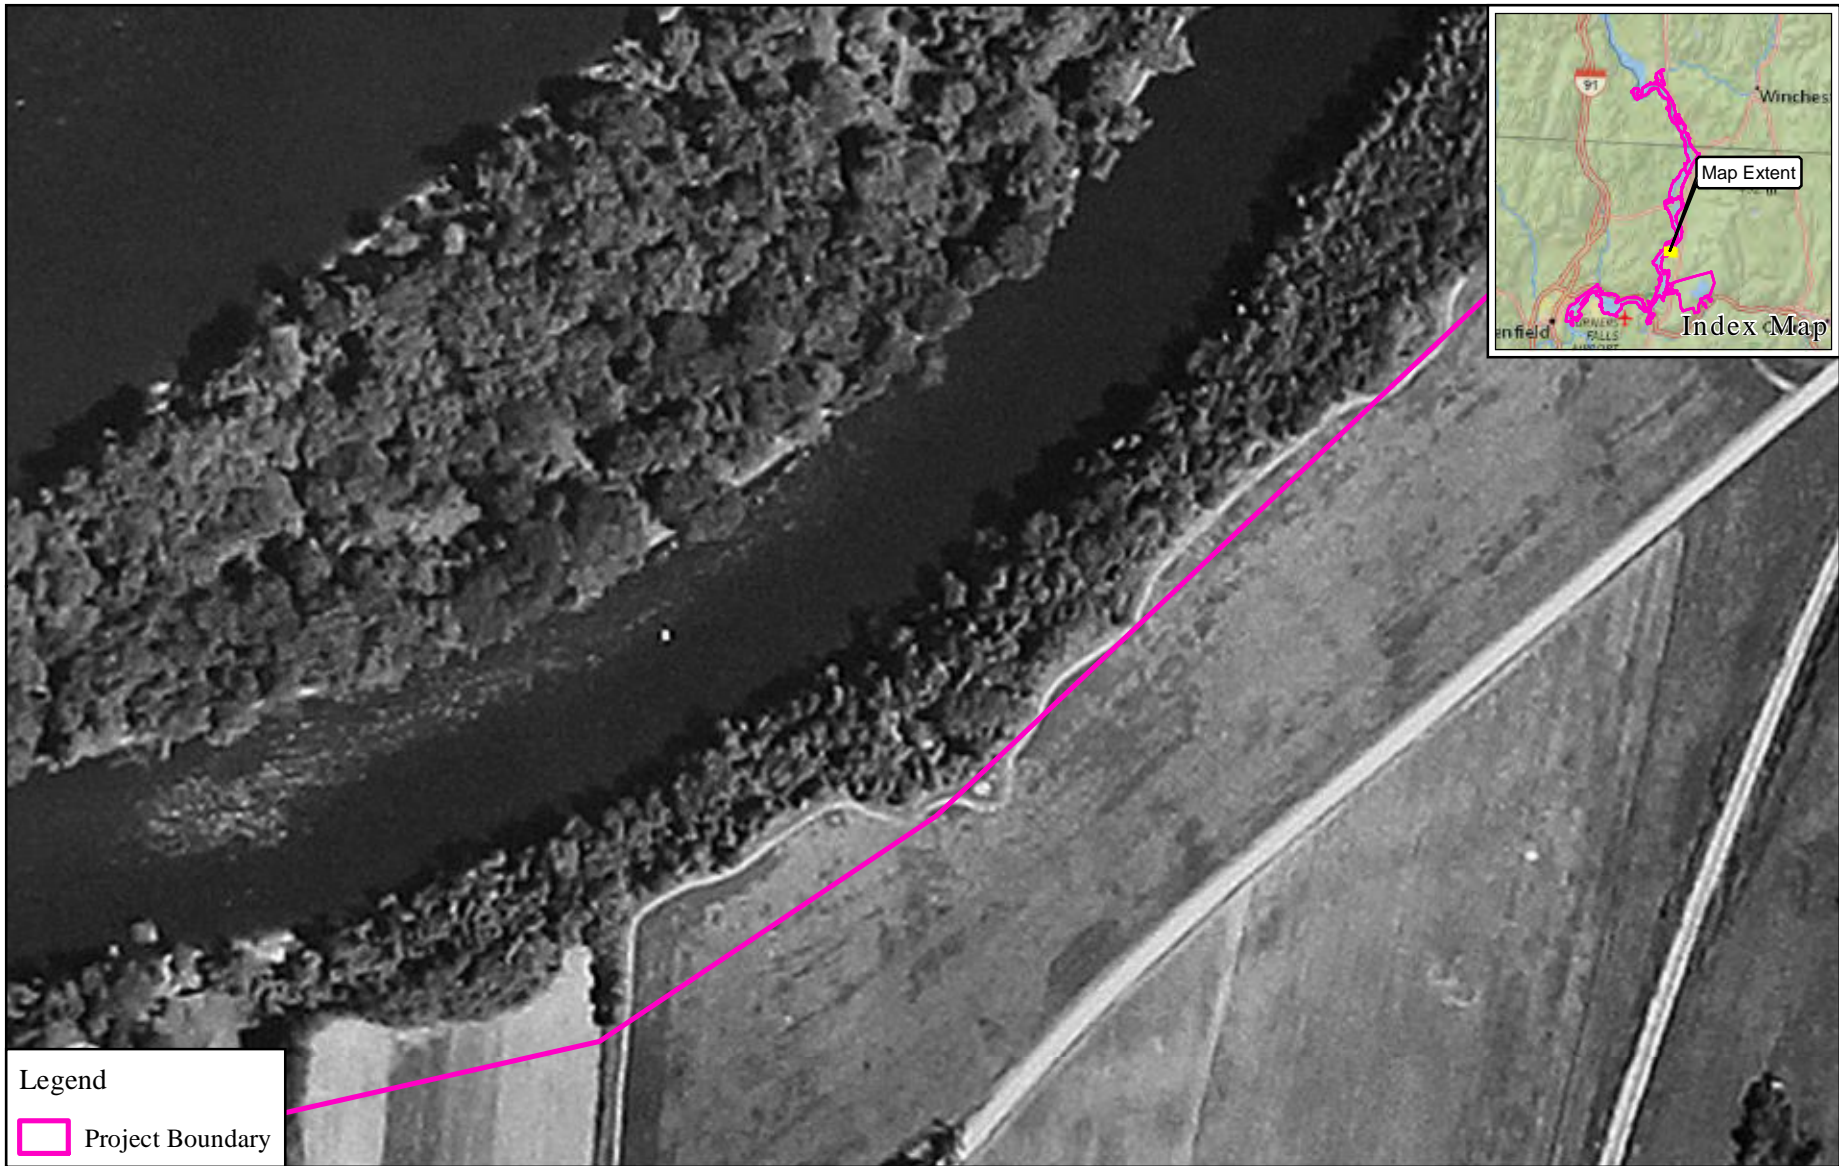
Skalski
 1952 Imagery
 (Source: North by Northeast Survey Company)

The left bank of the river in the vicinity of Kidds Island has a band of riparian vegetation in the 1952, 1960s and 1990s photographs. While not apparent in the photographs, erosion had been occurring along this bank and was identified in the ECP and stabilized in 2004 as the Skalski site as can be seen in the more recent photographs with a rock toe and vegetated upper bank.

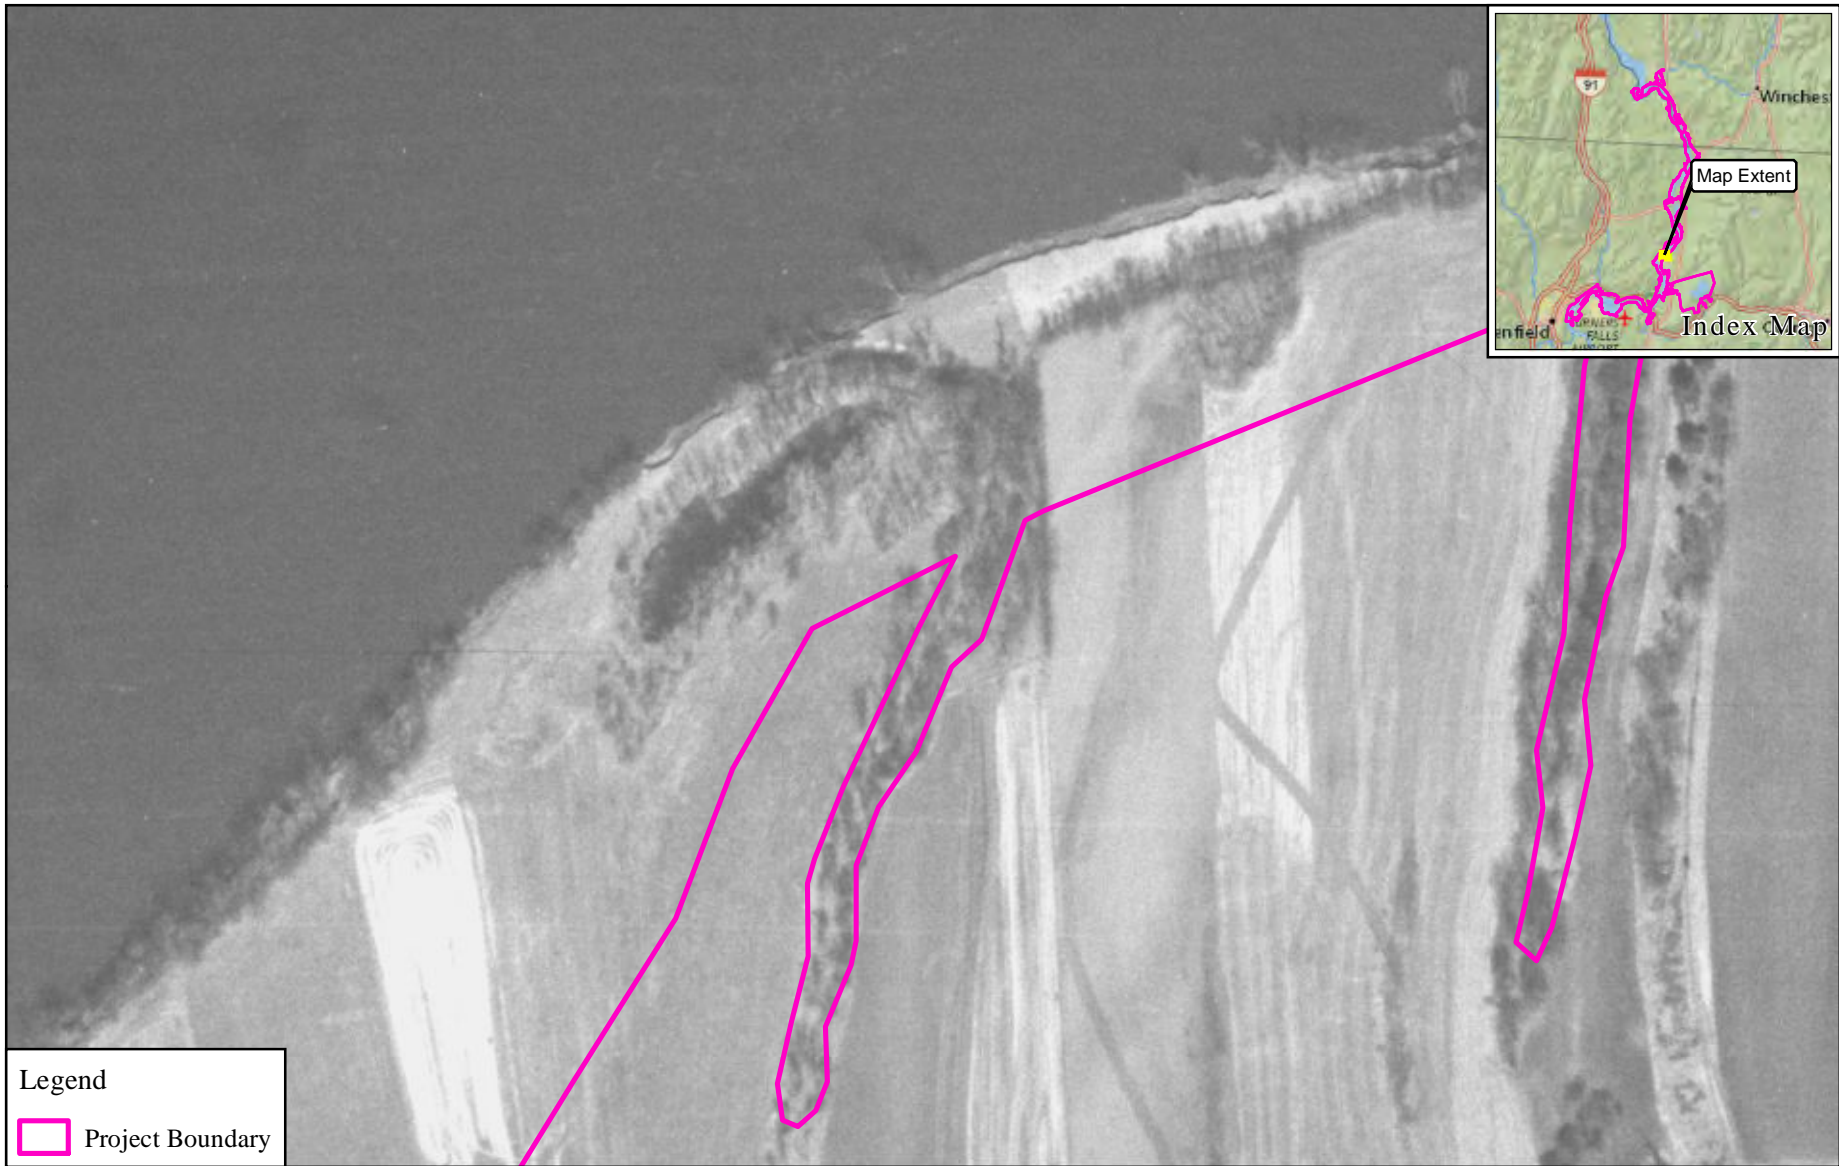
Left Bank Downstream of Kidds Island
 1960's Imagery
 (Source: USGS)

On the left bank downstream of Kidds Island the 1952 and 1960s photographs show eroded conditions with little riparian vegetation. By the 1990s, the narrow remnants of a field appear to have been eroded away and into another band of riparian vegetation.

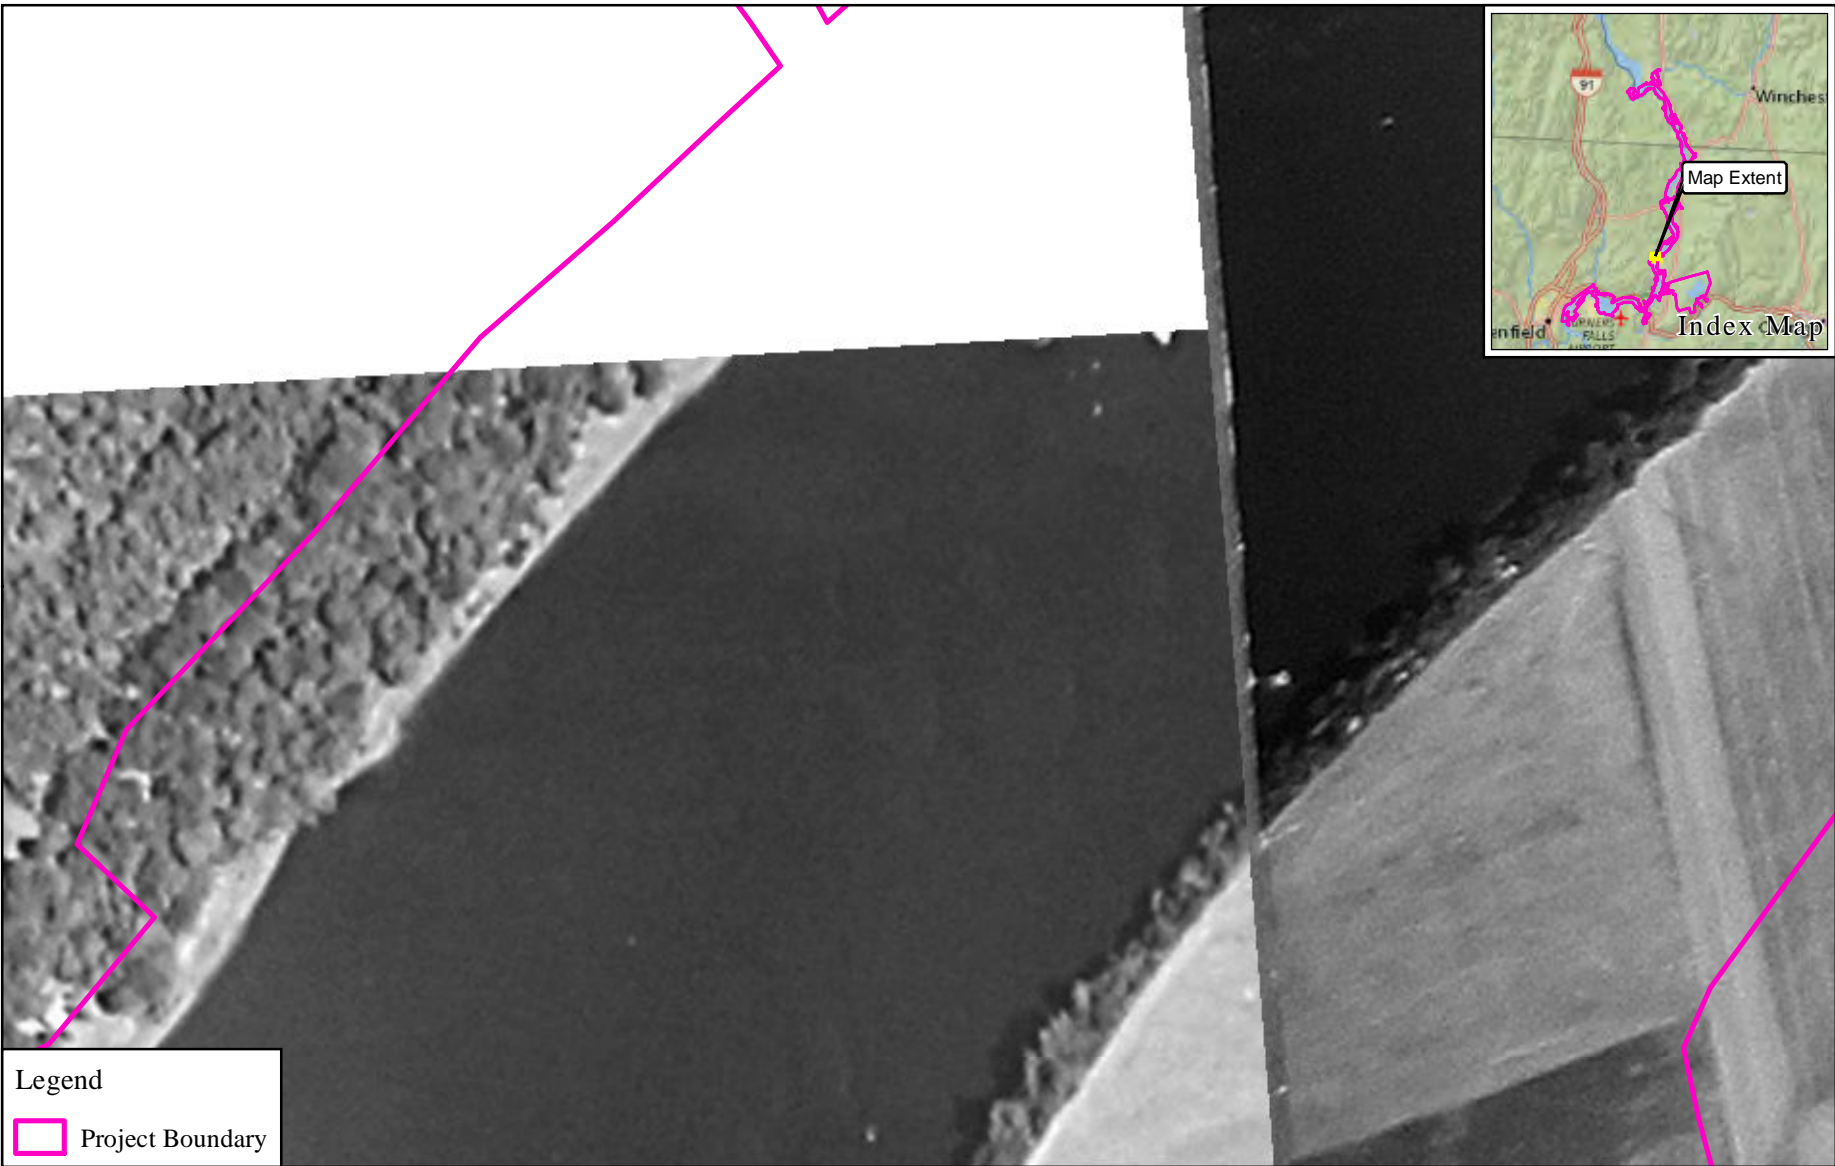
L'Etoile
 1952 Imagery
 (Source: North by Northeast Survey Company)

Another few thousand feet downstream of Kidds Island on the left bank is another area adjacent to an agricultural field with a very narrow band of riparian vegetation which appears to have narrowed over time from 1952 to the 1990s. In 1998 stabilization occurred at what was called the L'Etoile site which can be seen in subsequent photographs.

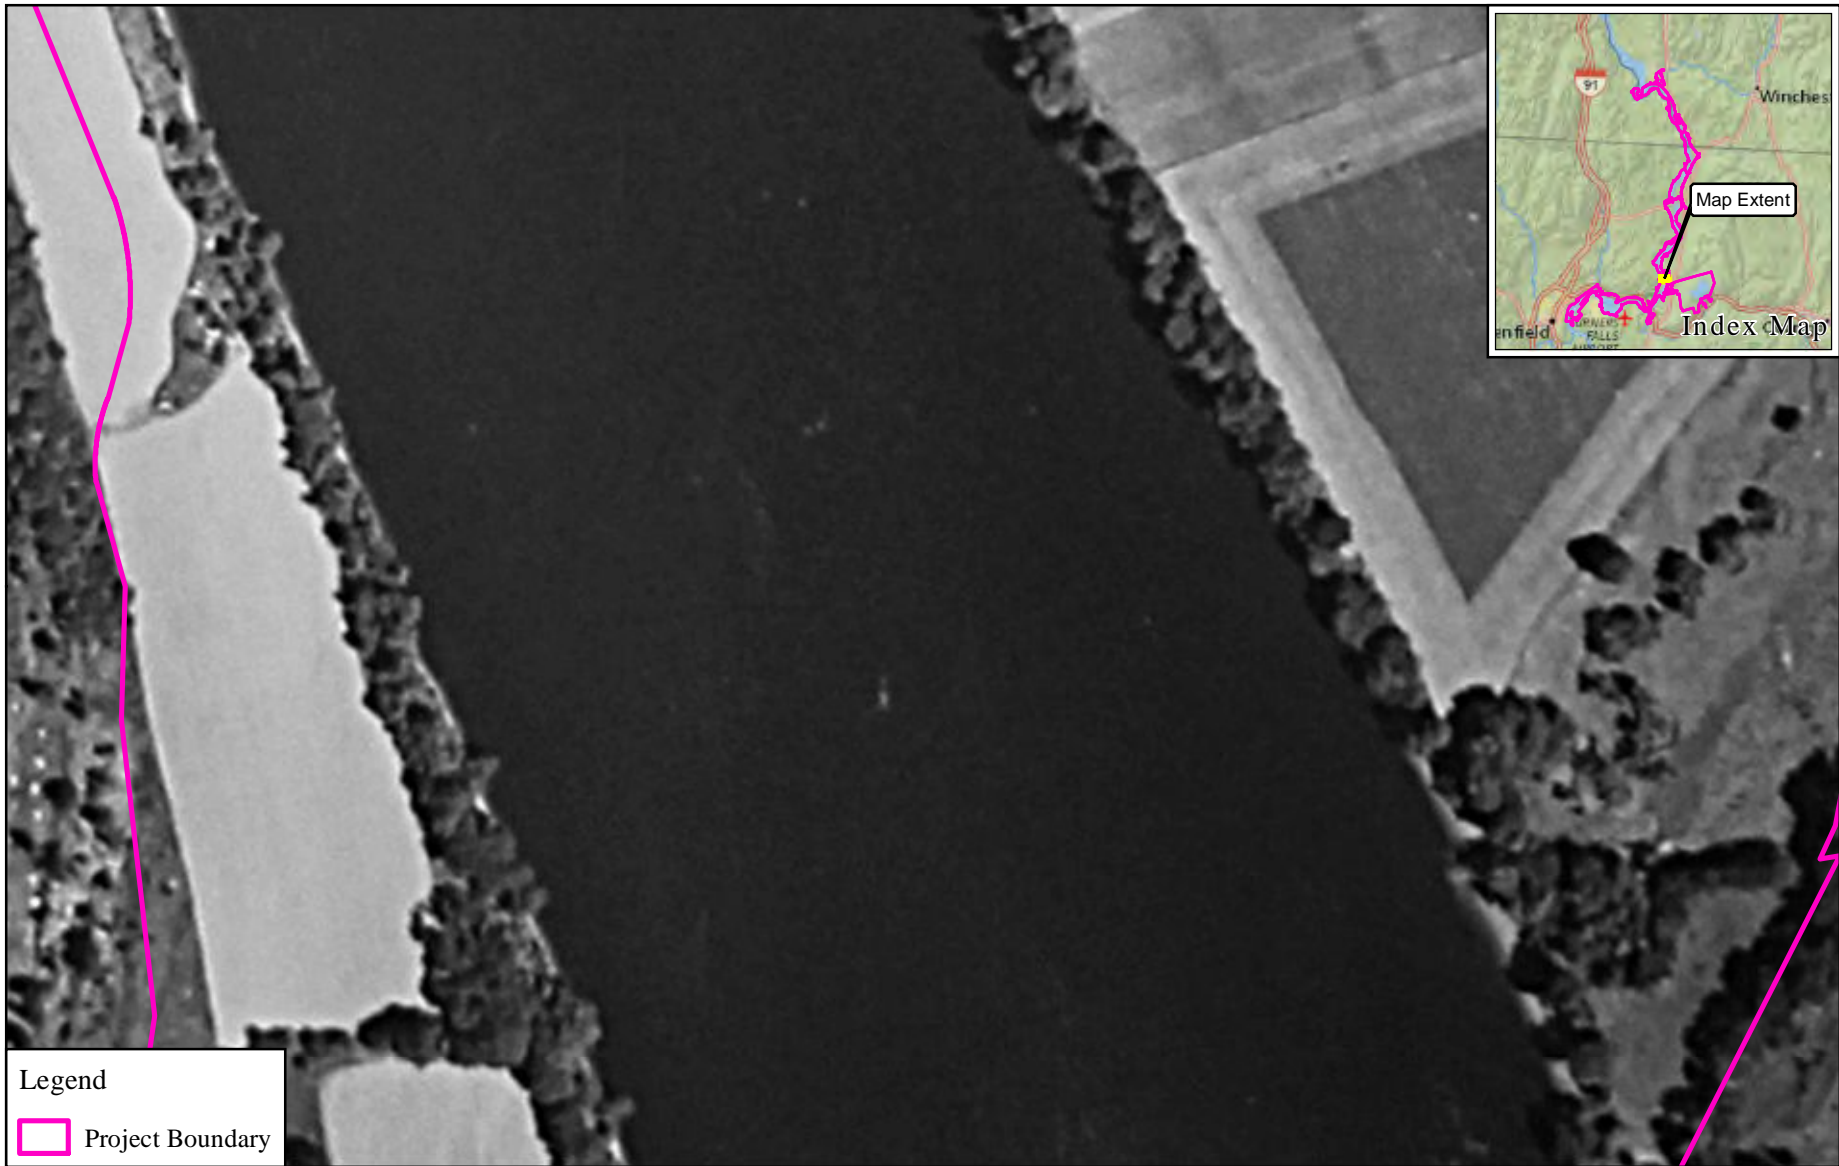
Shearer/Bathory-Gallagher
 1952 Imagery
 (Source: North by Northeast Survey Company)

Upstream of the tailrace along both banks there was a band of riparian vegetation in the 1952 photograph. By the 1960s photograph the riparian zone appear to have decreased and erosion is evident. The left bank was stabilized in 1996 (Shearer site) and the right bank was stabilized through the ECP as the Bathory/Gallagher site in 2012 as can be seen on recent photographs.

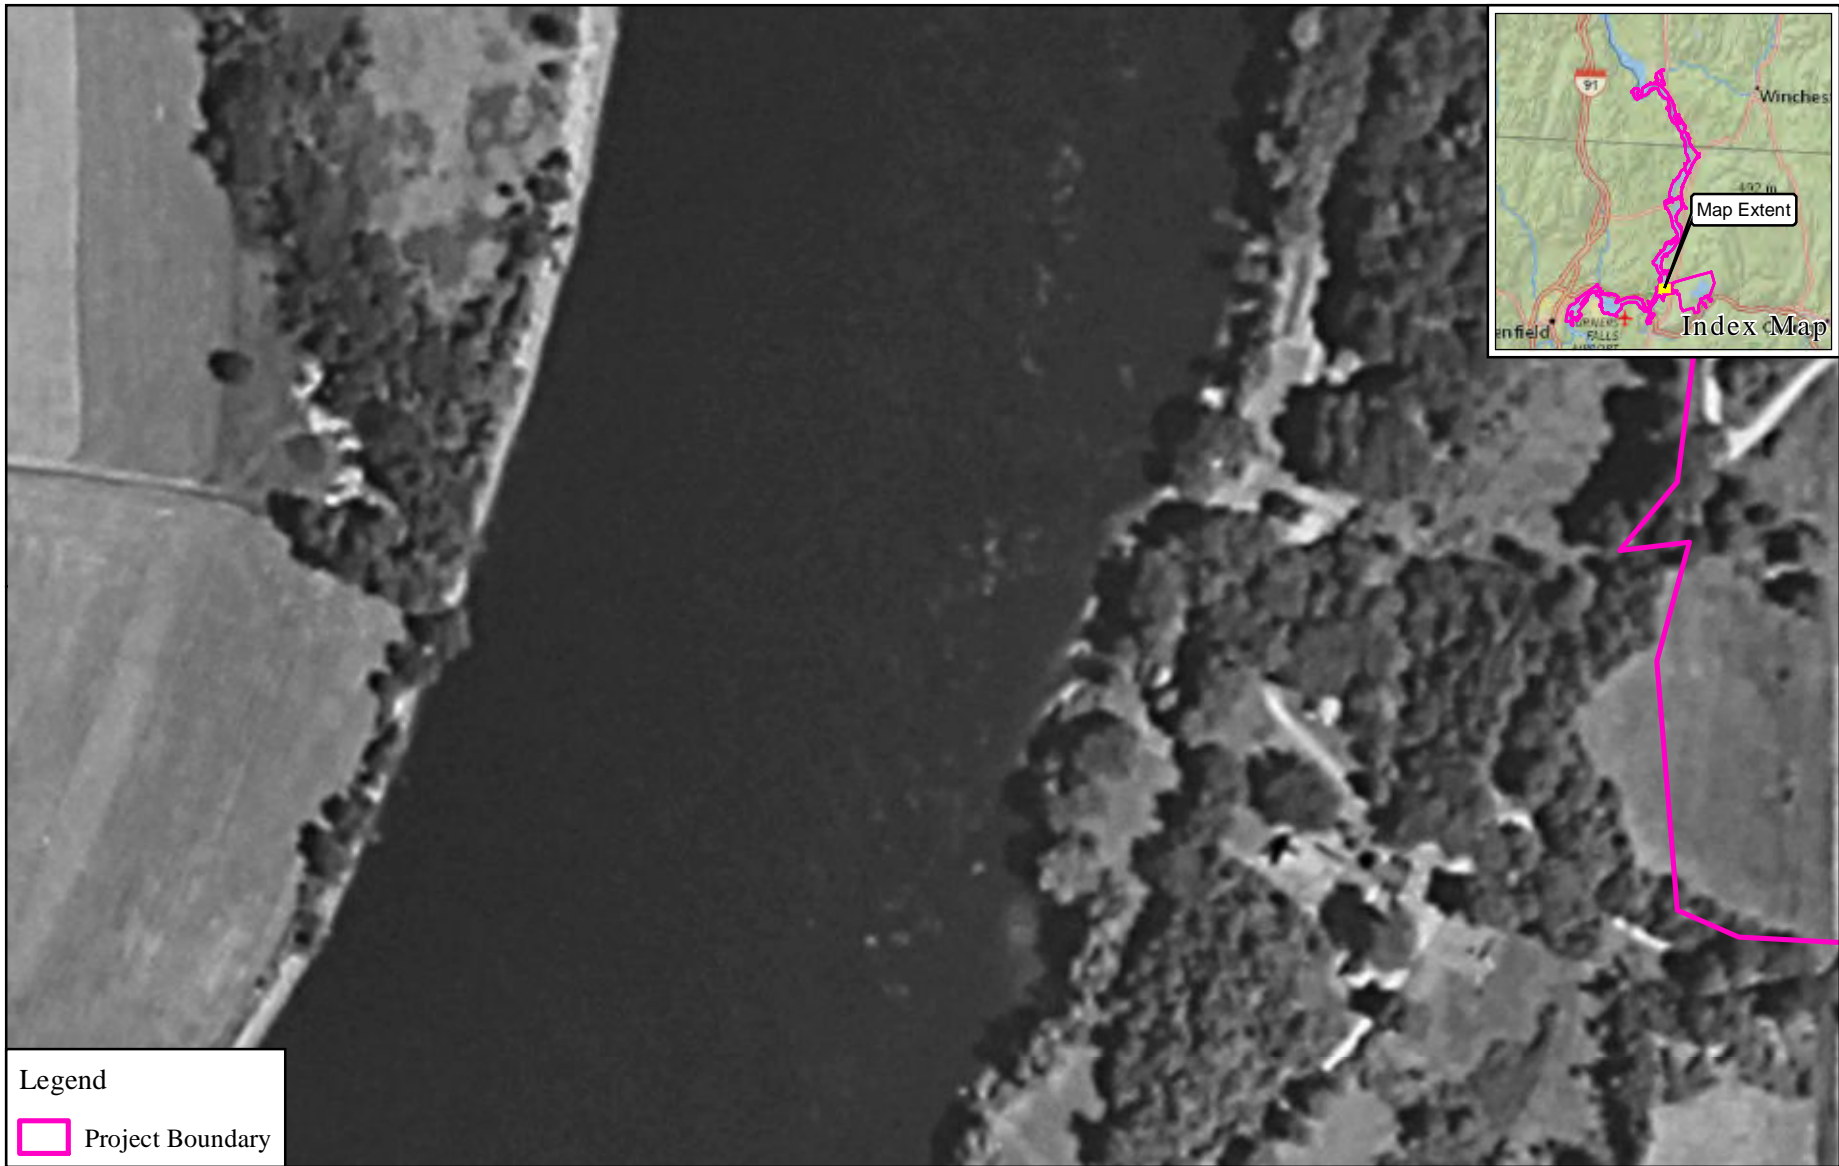
Upper Split River
 1952 Imagery
 (Source: North by Northeast Survey Company)

The right bank of the river in this location is eroded and has little riparian vegetation in the 1952 and 1960s photographs. The lower part of the photograph of the right bank was stabilized using rock (see discussion of tailrace in next segment) while the upper part of the photograph of the right bank was selected as the Upper Split River site and was stabilized in 2010 using a gravel beach and large woody debris as can be seen on the 2014 photograph.

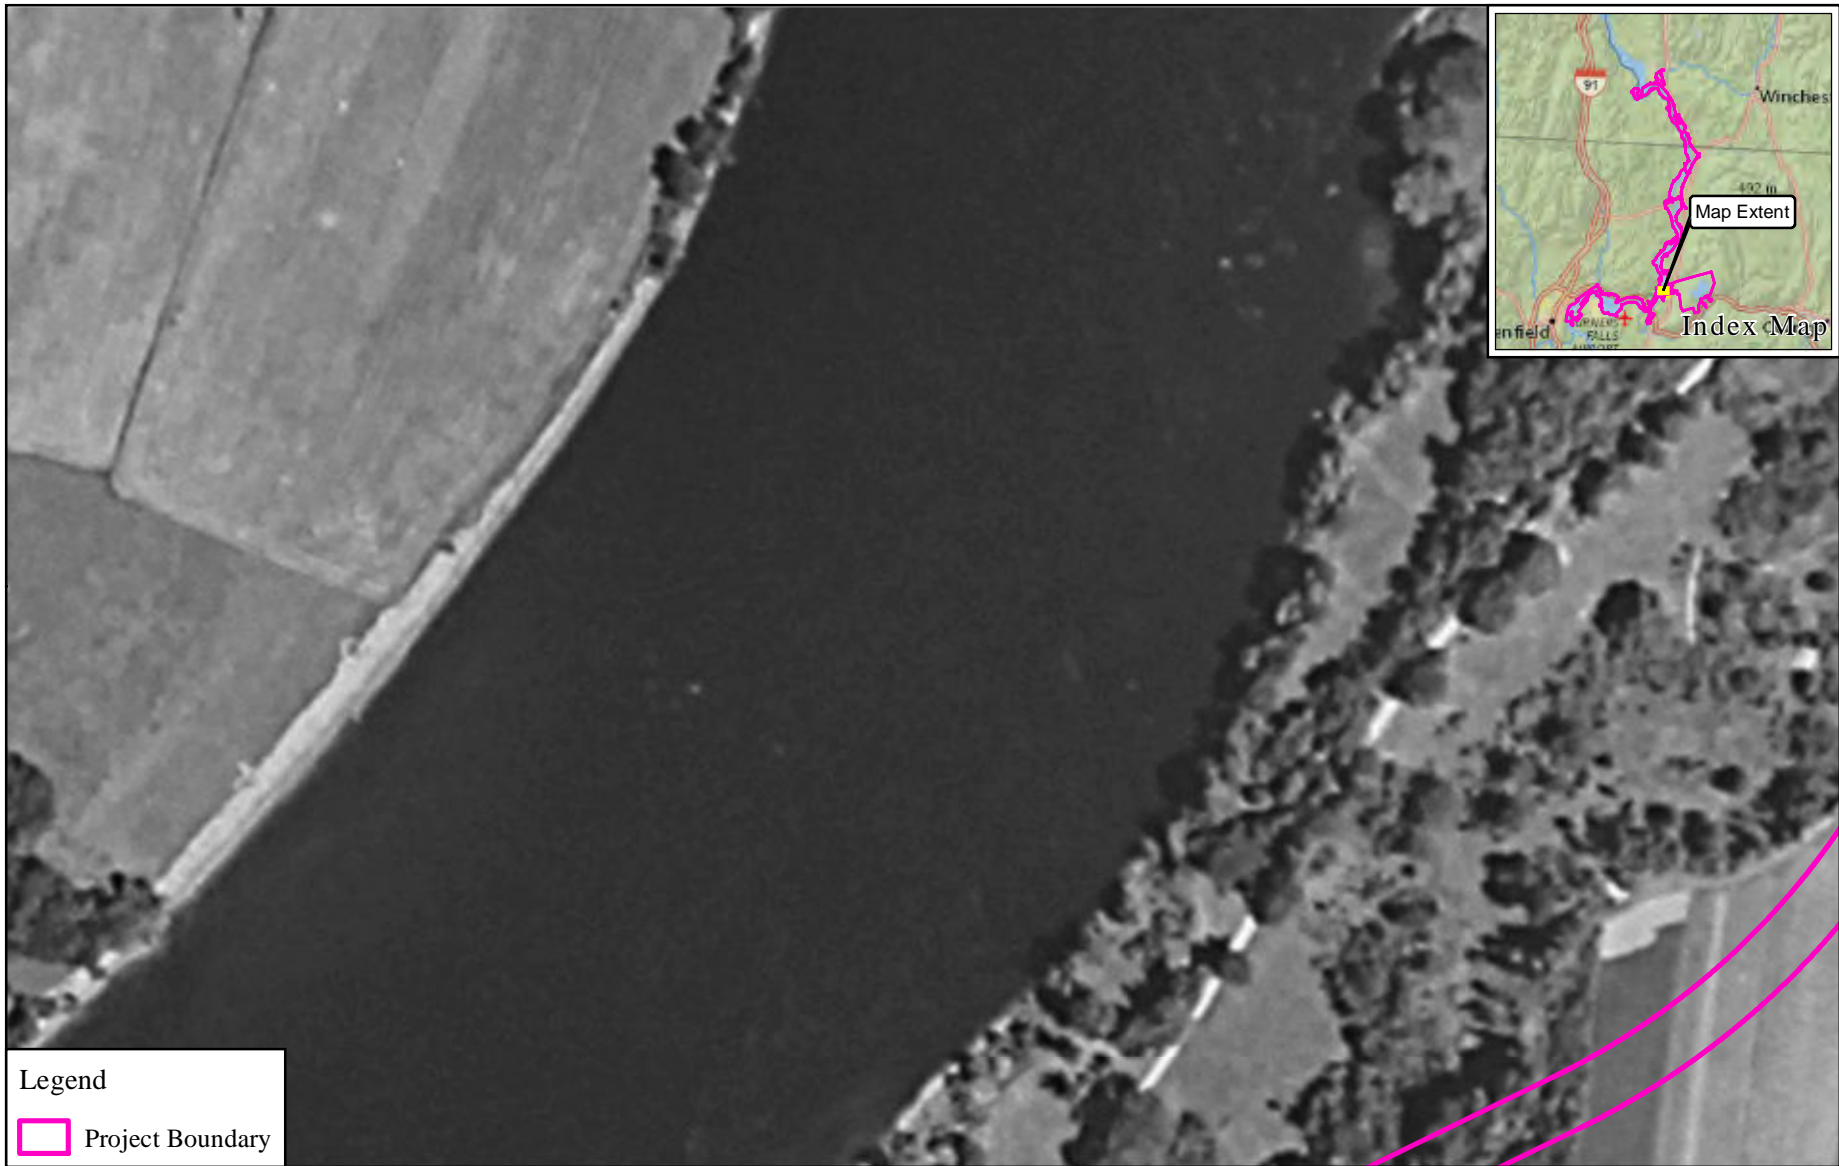
Northfield Mountain Tailrace
 1952 Imagery
 (Source: North by Northeast Survey Company)

The right bank across the river from the future tailrace for Northfield Mountain appears to be eroded and devoid of riparian vegetation in the 1952 and 1960s photographs, before the construction of the project. Rock from project construction was used to stabilize this eroded bank during the construction process. The rock has stabilized the toe of the bank and riparian vegetation has become established above the rock.
