Relicensing Study 3.1.2

**Northfield Mountain / Turners Falls
Operations Impact on Existing Erosion and
Potential Bank Instability
Study Report**

Volume III – Appendices

**Northfield Mountain Pumped Storage Project (No. 2485) and
Turners Falls Hydroelectric Project (No. 1889)**

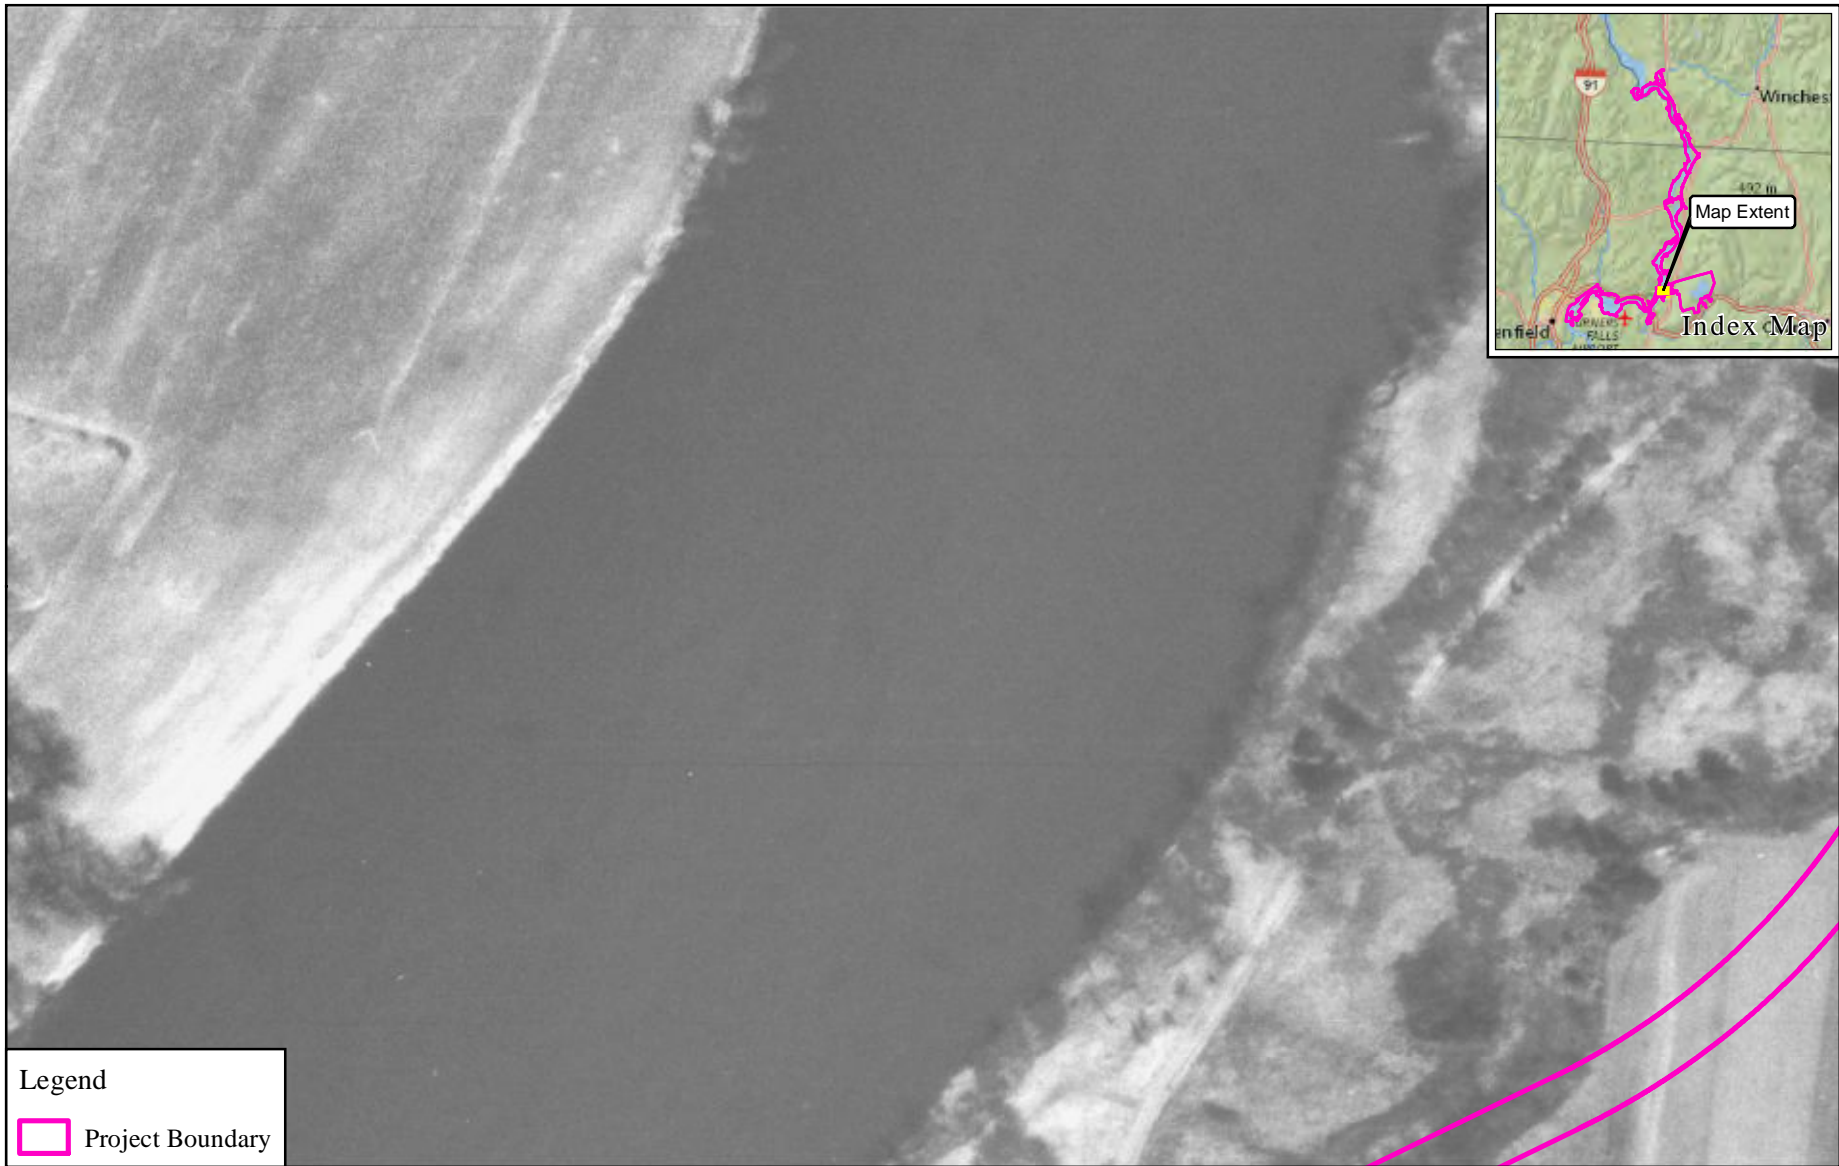
Northfield Mountain Tailrace
 1960's Imagery
 (Source: USGS)

The right bank across the river from the future tailrace for Northfield Mountain appears to be eroded and devoid of riparian vegetation in the 1952 and 1960s photographs, before the construction of the project. Rock from project construction was used to stabilize this eroded bank during the construction process. The rock has stabilized the toe of the bank and riparian vegetation has become established above the rock.

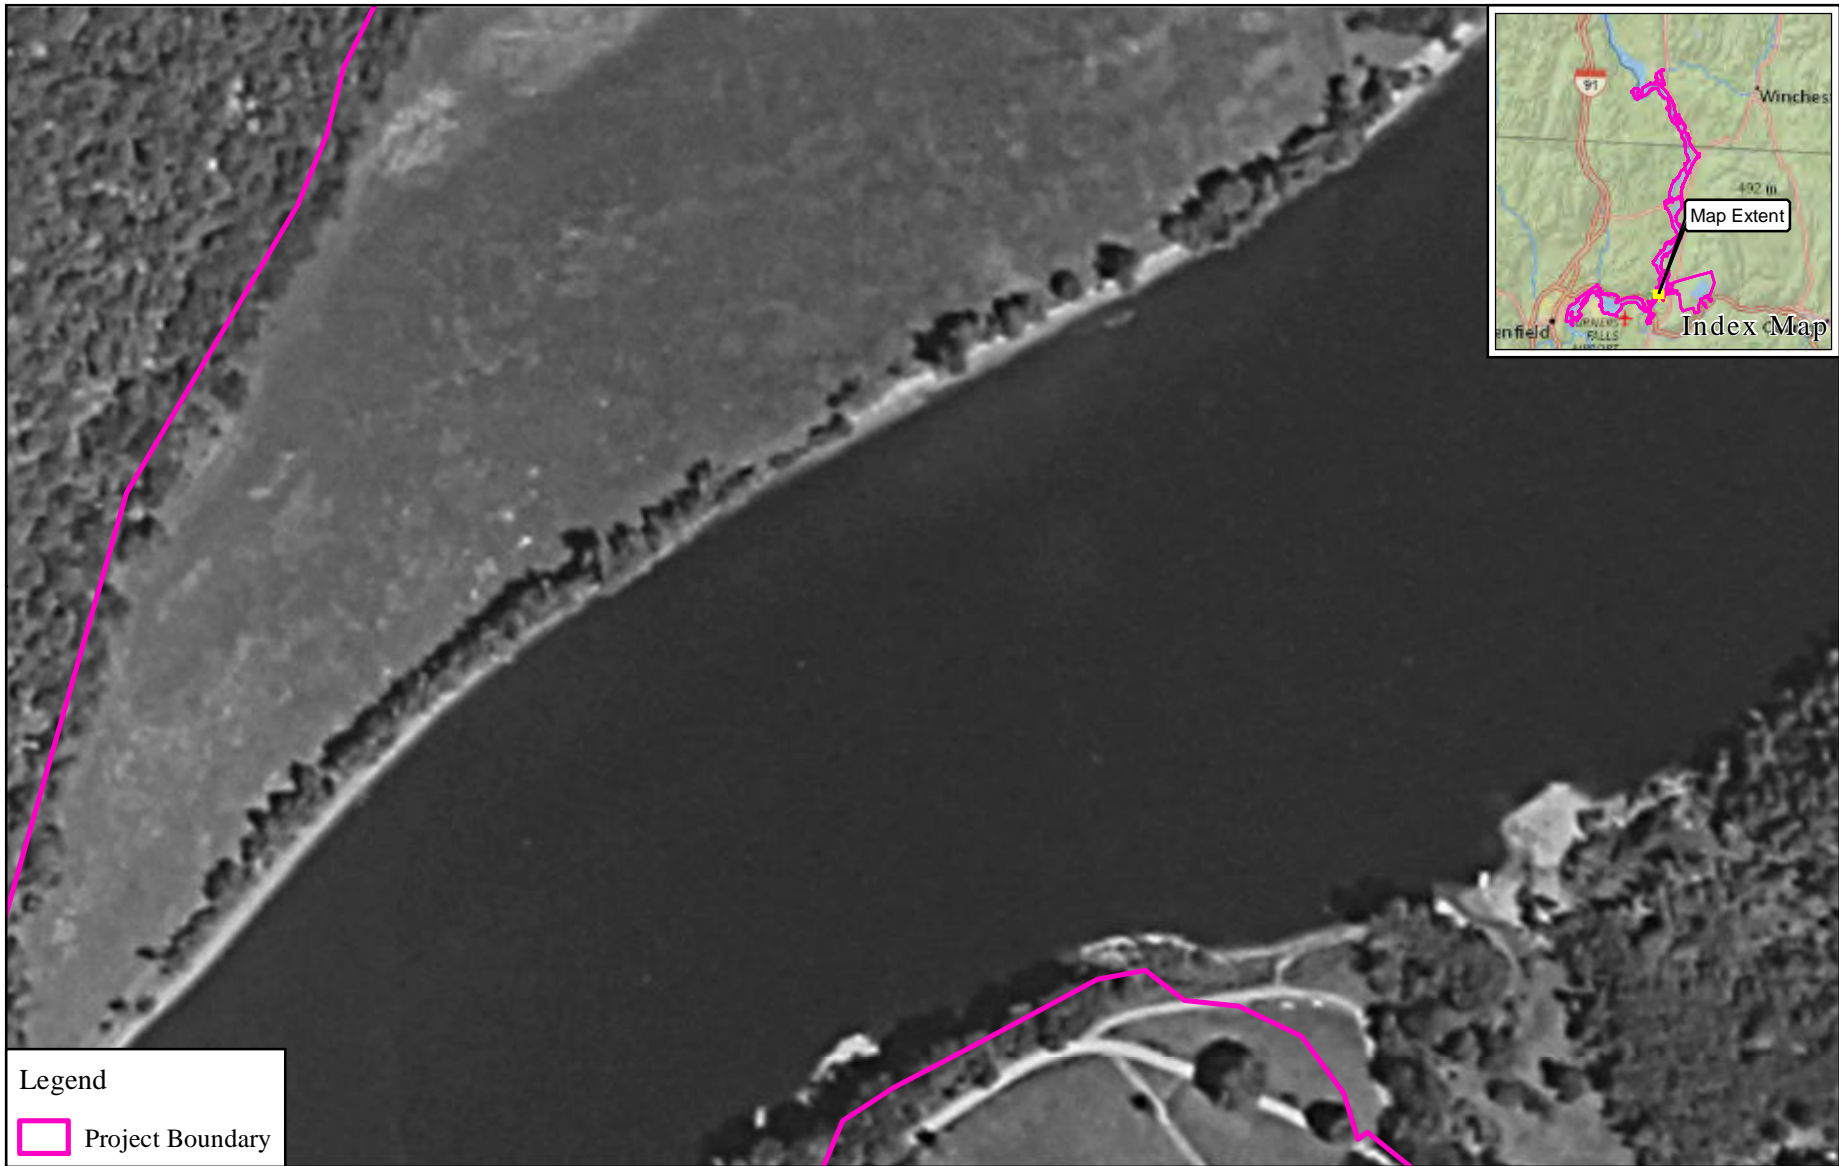
Lower Split River
 1952 Imagery
 (Source: North by Northeast Survey Company)

The right bank in the 1952 photograph is sparsely vegetated with apparent erosion as is a segment of the left bank. By the 1960s photographs erosion of the left bank segment is apparent while the right bank remains sparsely vegetated with some erosion. The right bank site is called the Lower Split River site which was stabilized in 2009 and the left bank segment is called Durkee Point and was stabilized in 2003, both through implementation of the ECP.

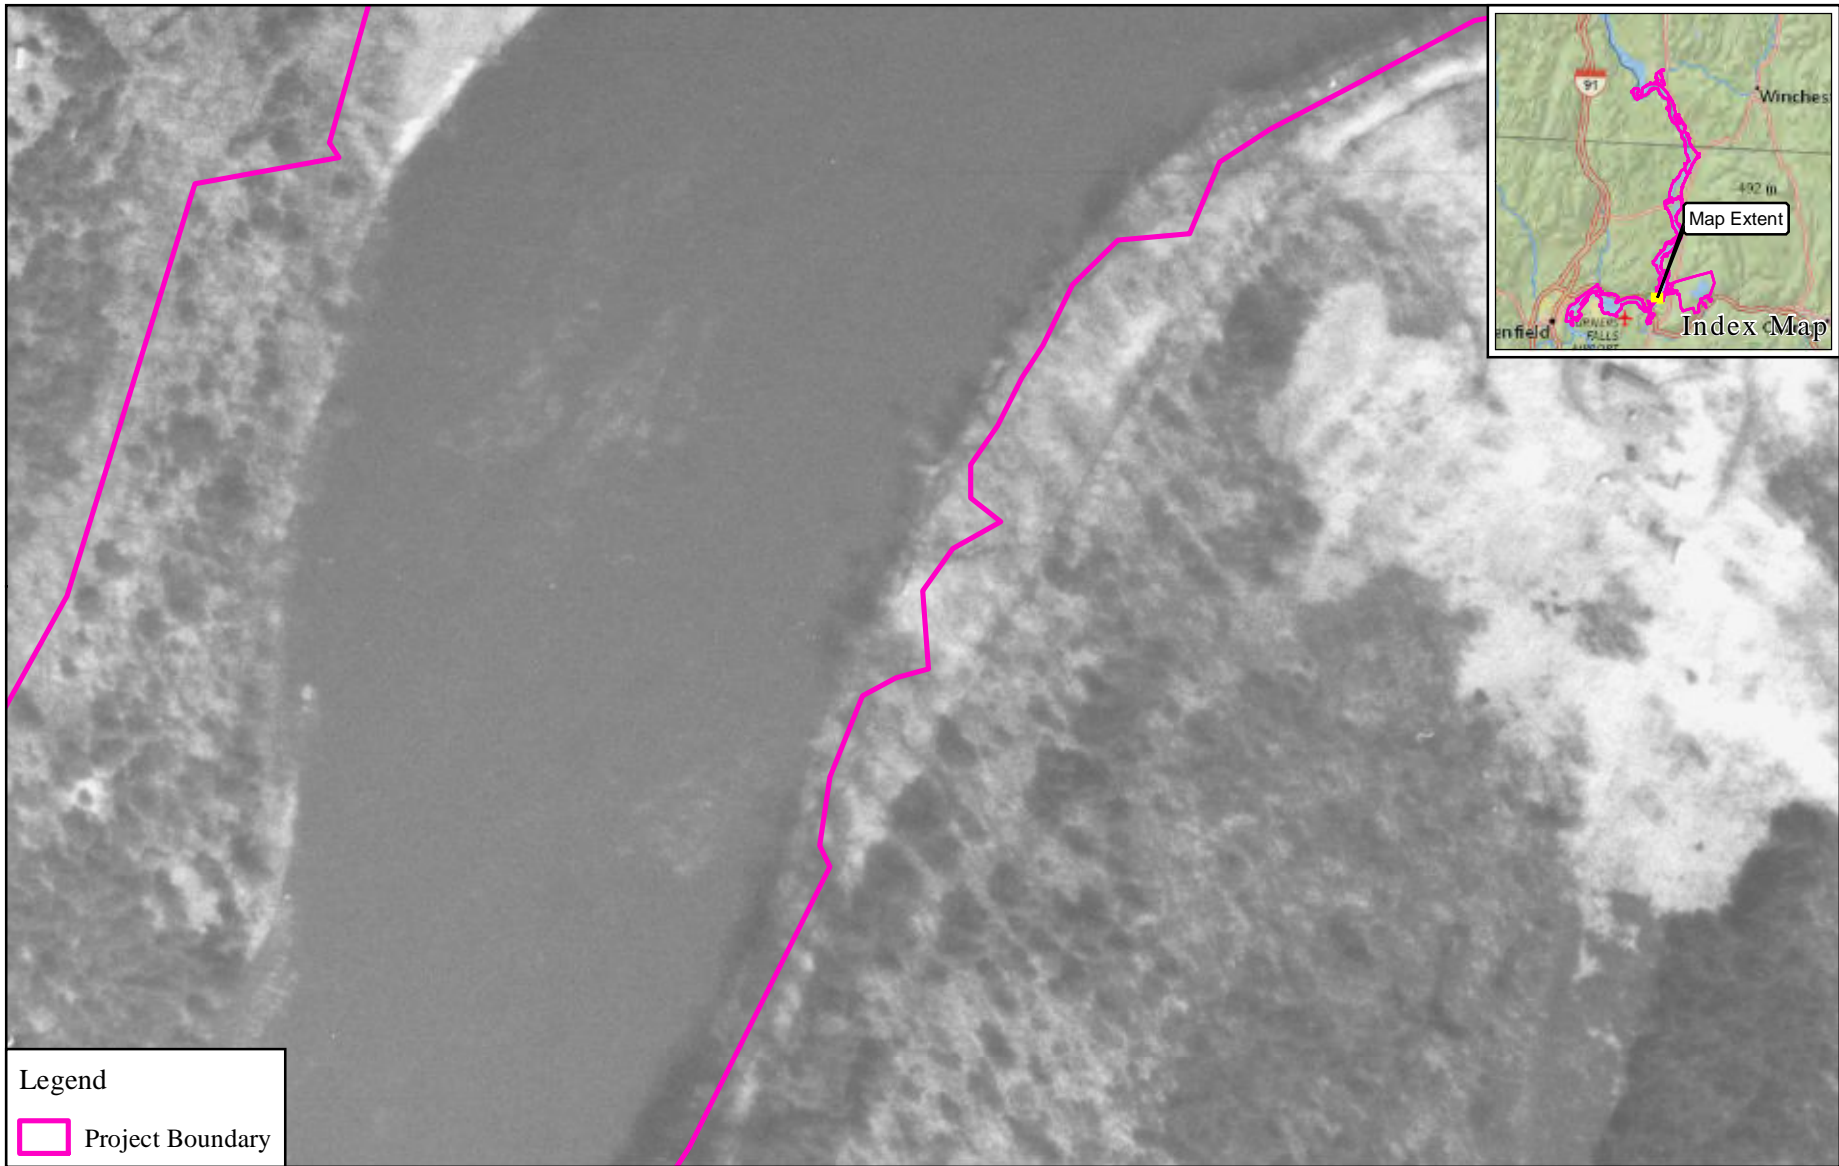
River Road
 1990's Imagery
 (Source: MassGIS)

On the inside of the bend along the left bank erosion has occurred over time with the bank moving landward compared to the project boundary line as noted in changes in the bank from the 1952 to 1960s and subsequent photographs. This area was stabilized in 2003 through the ECP and is called the River Road Site.

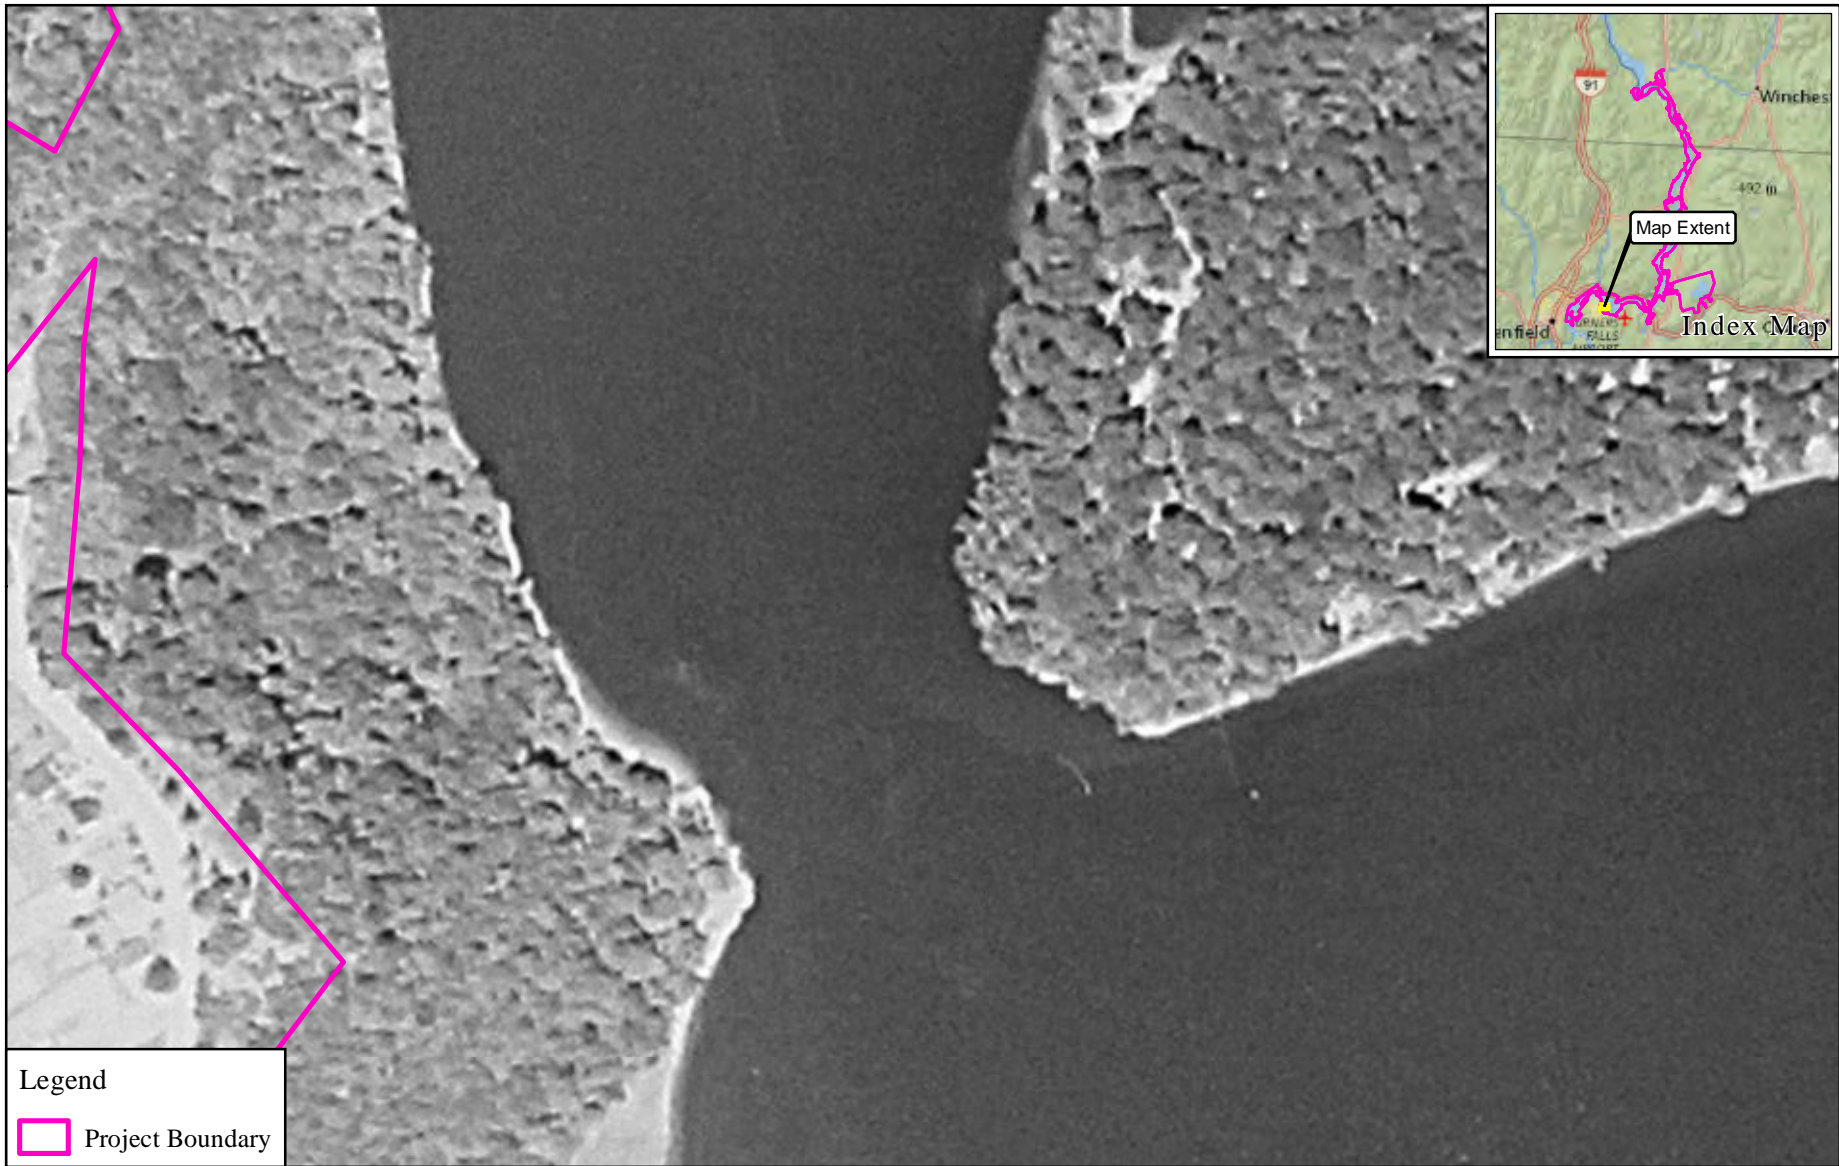
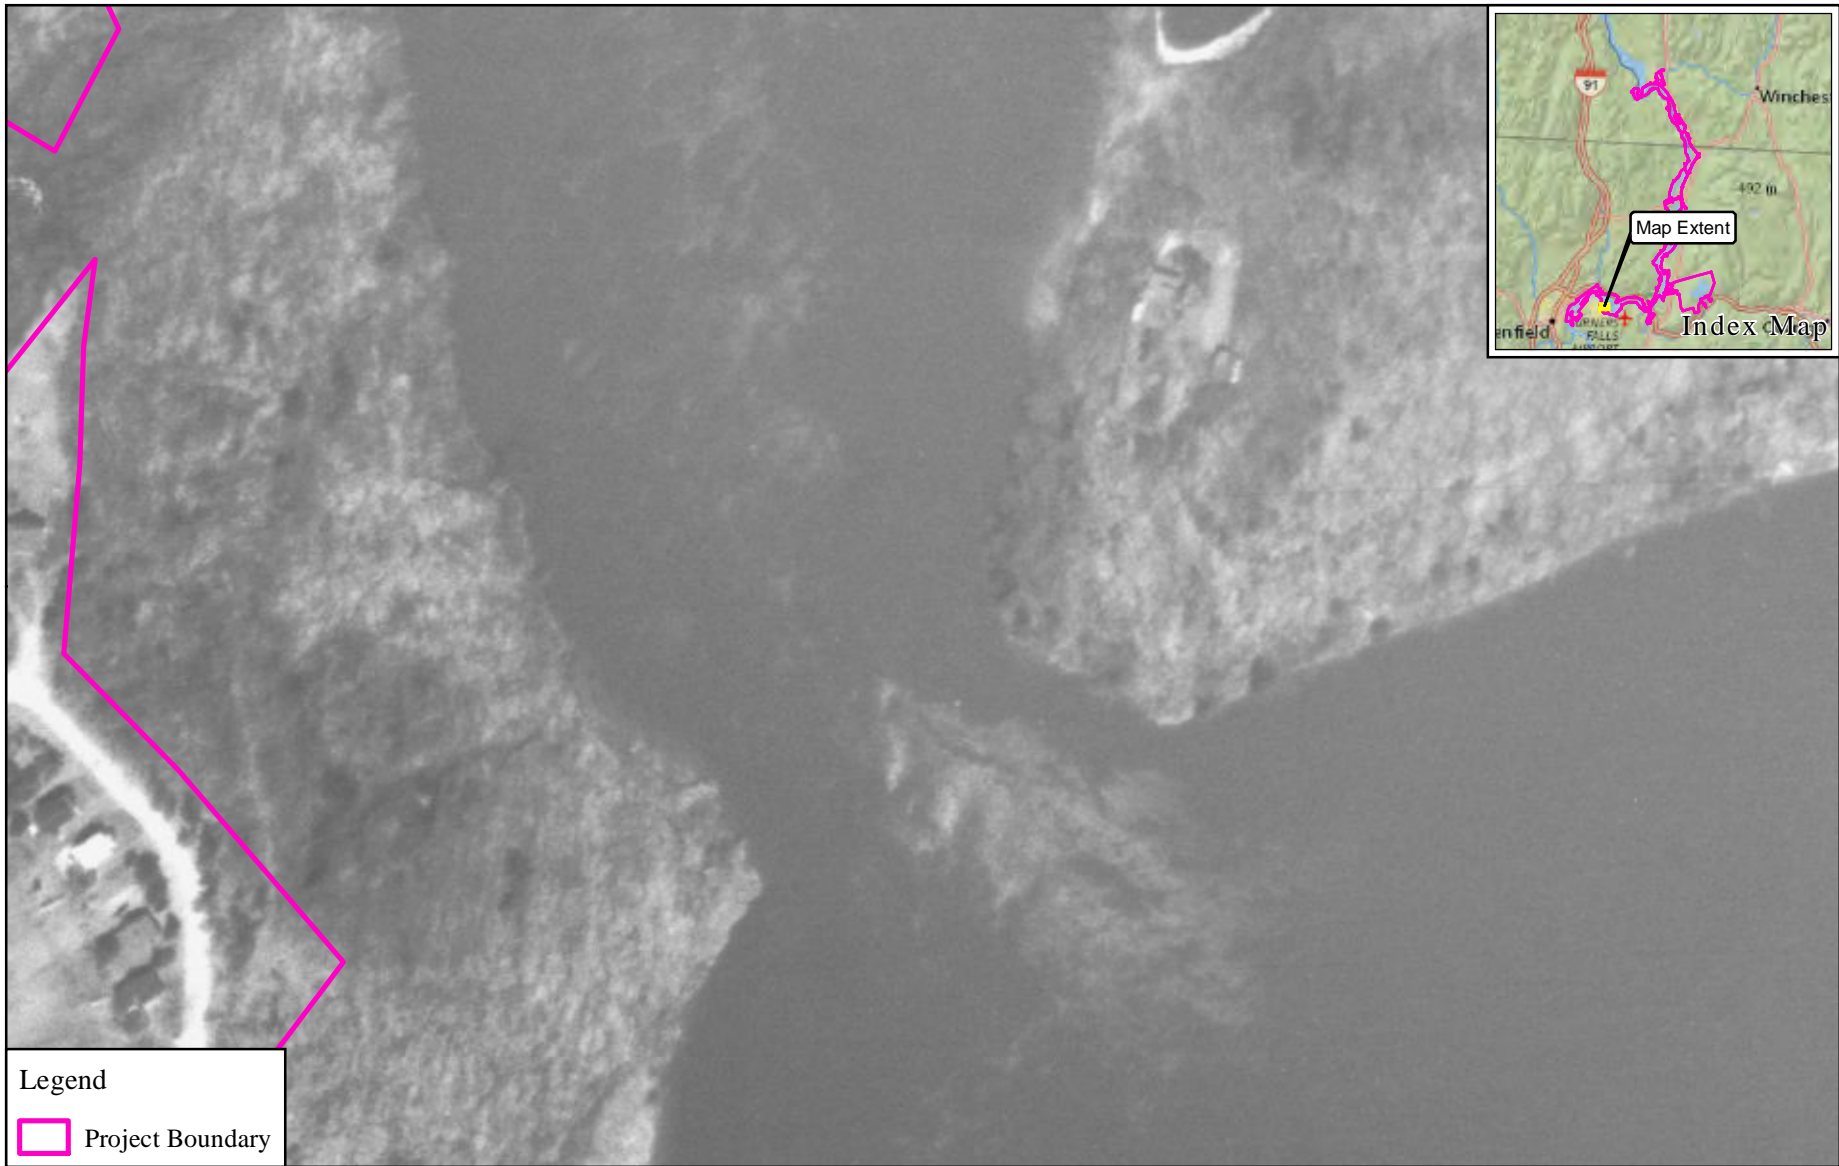
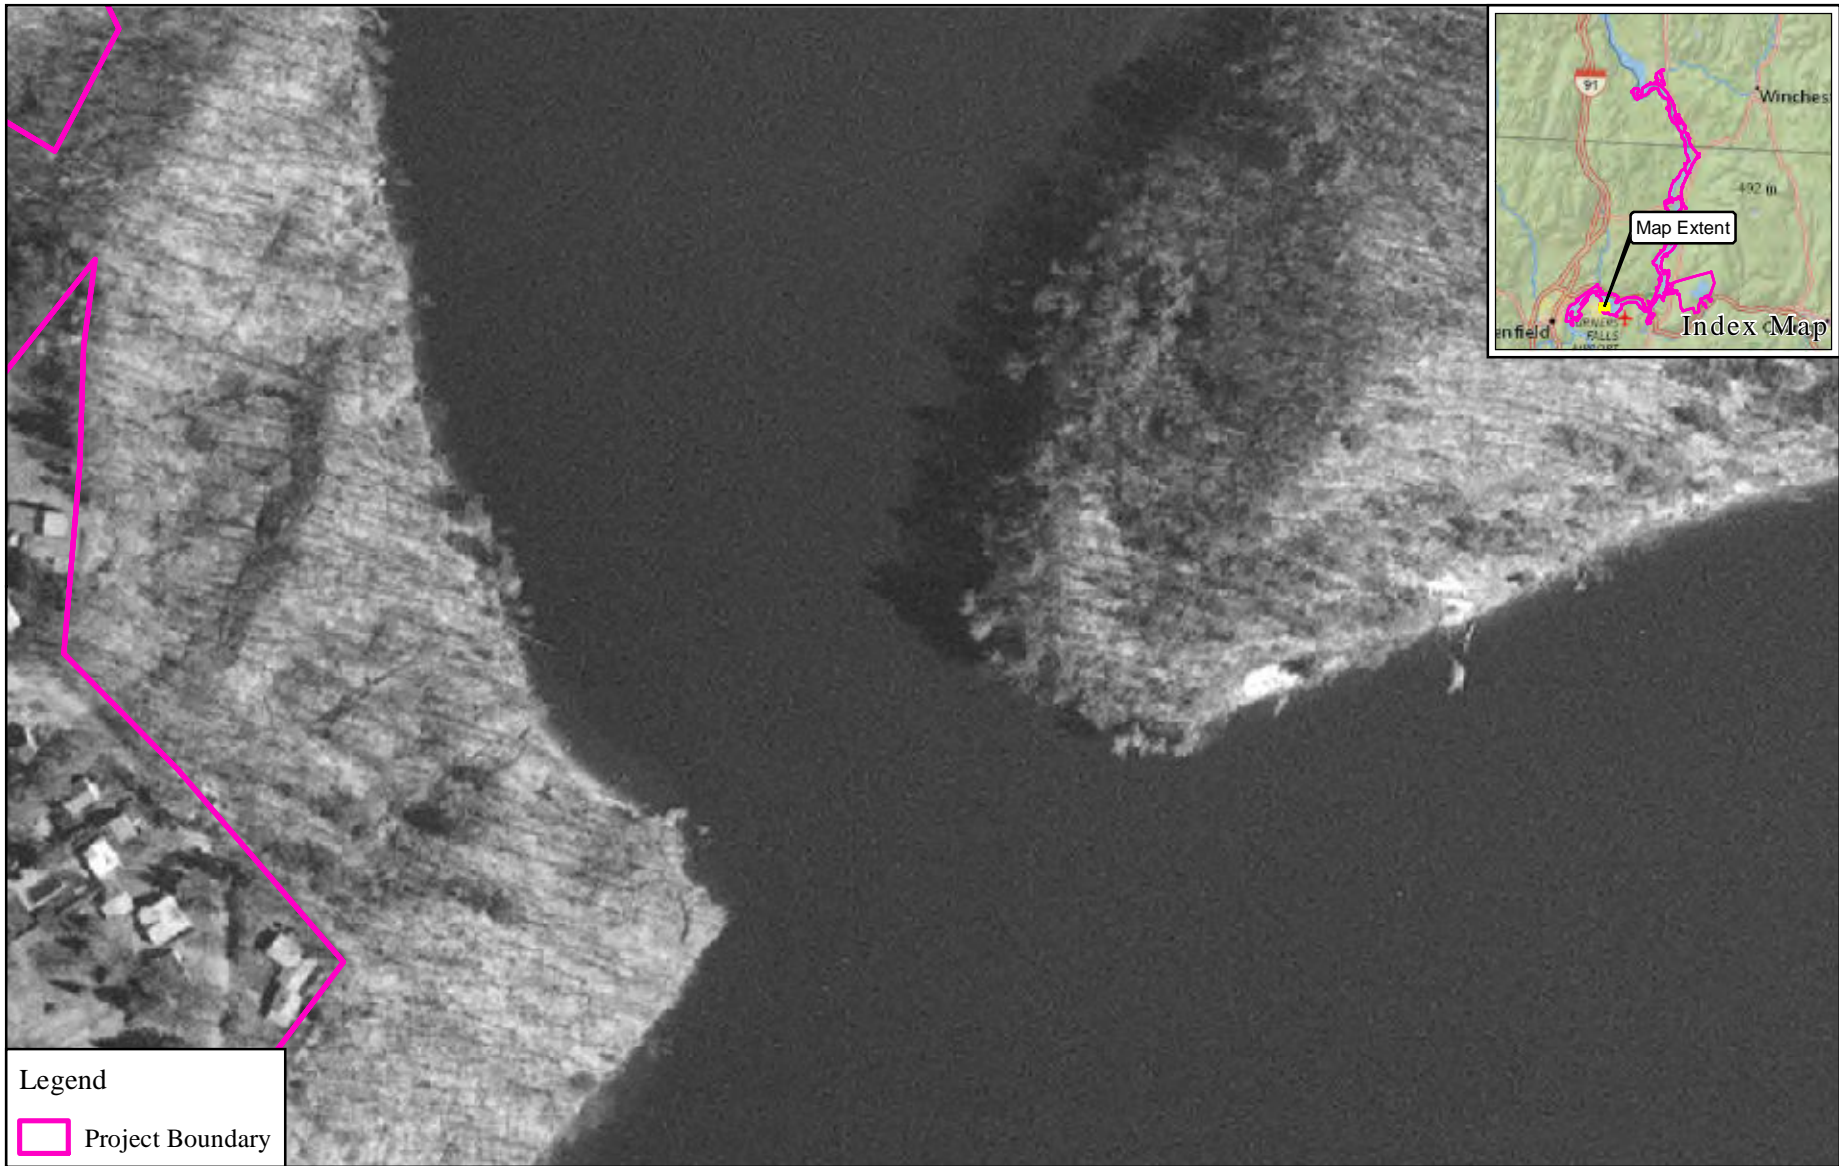
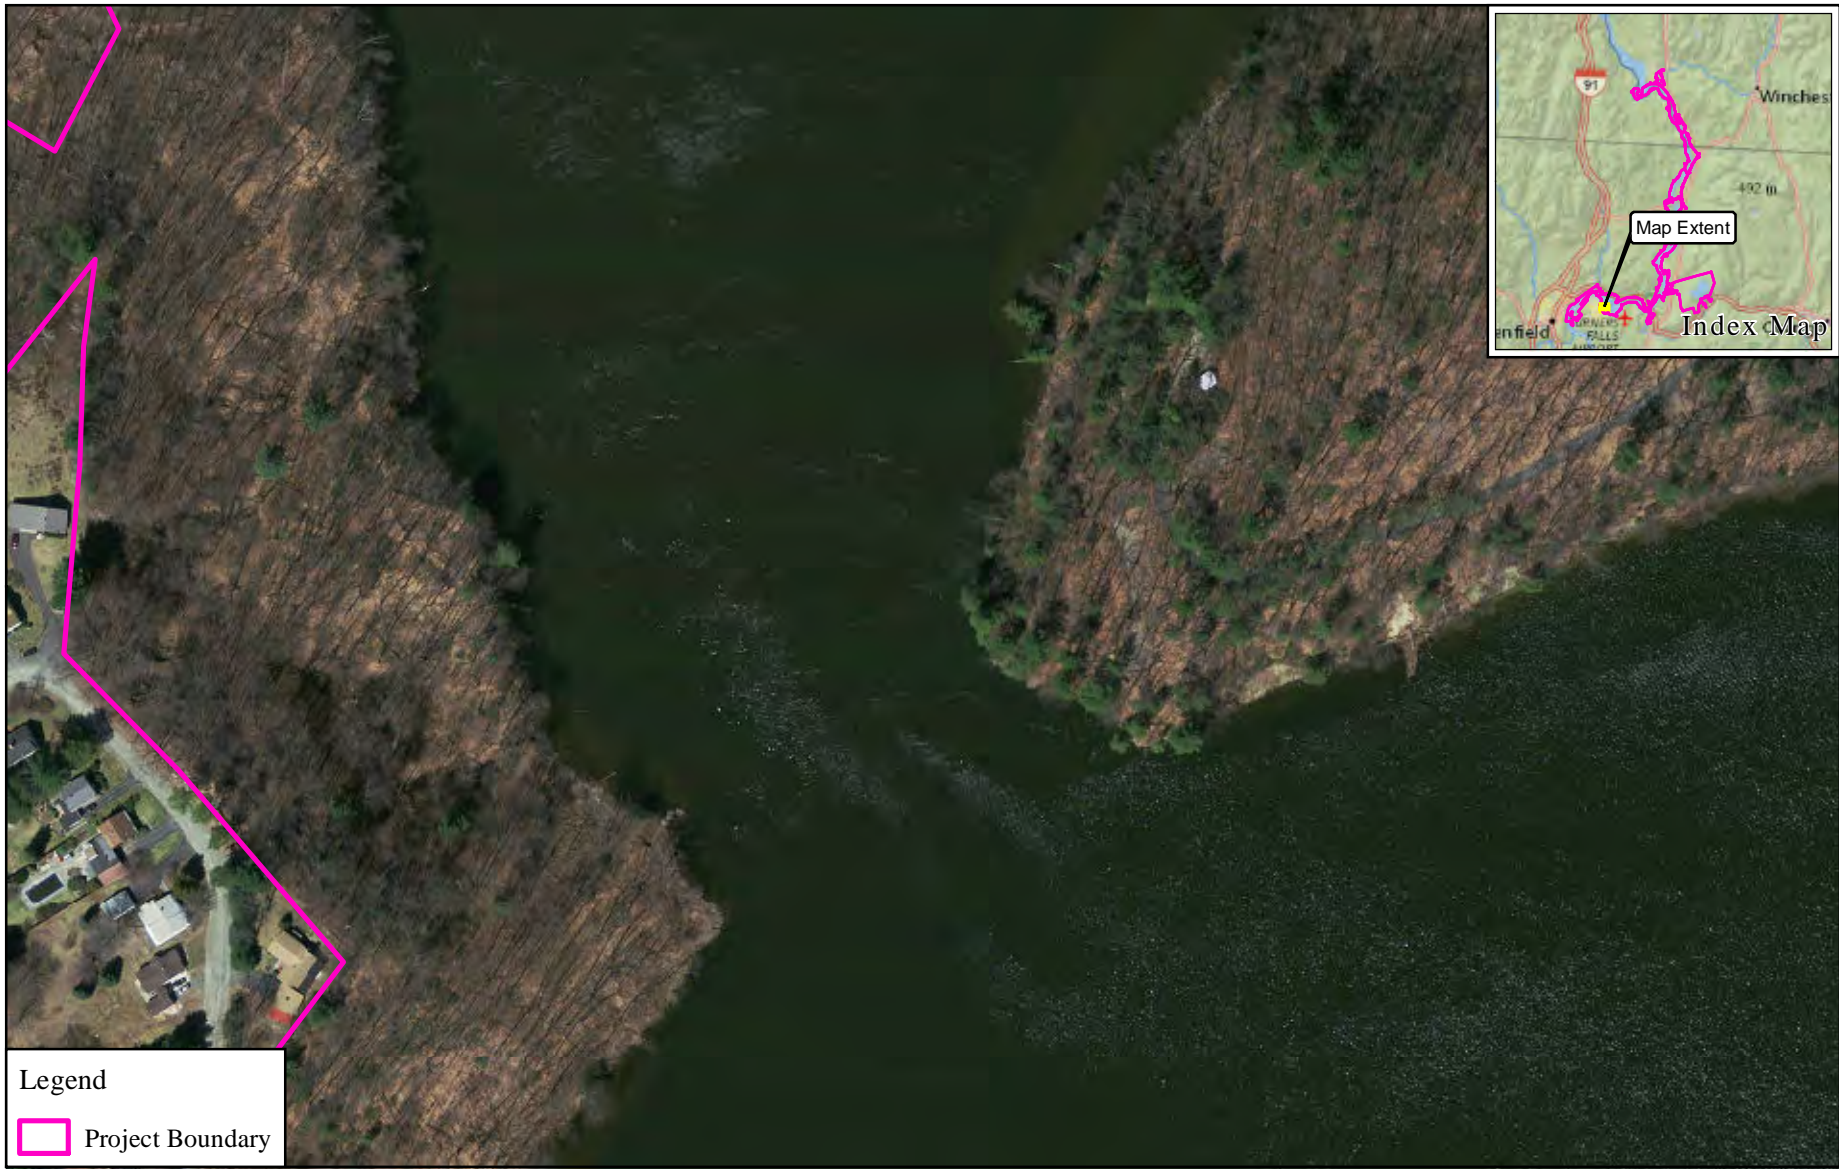
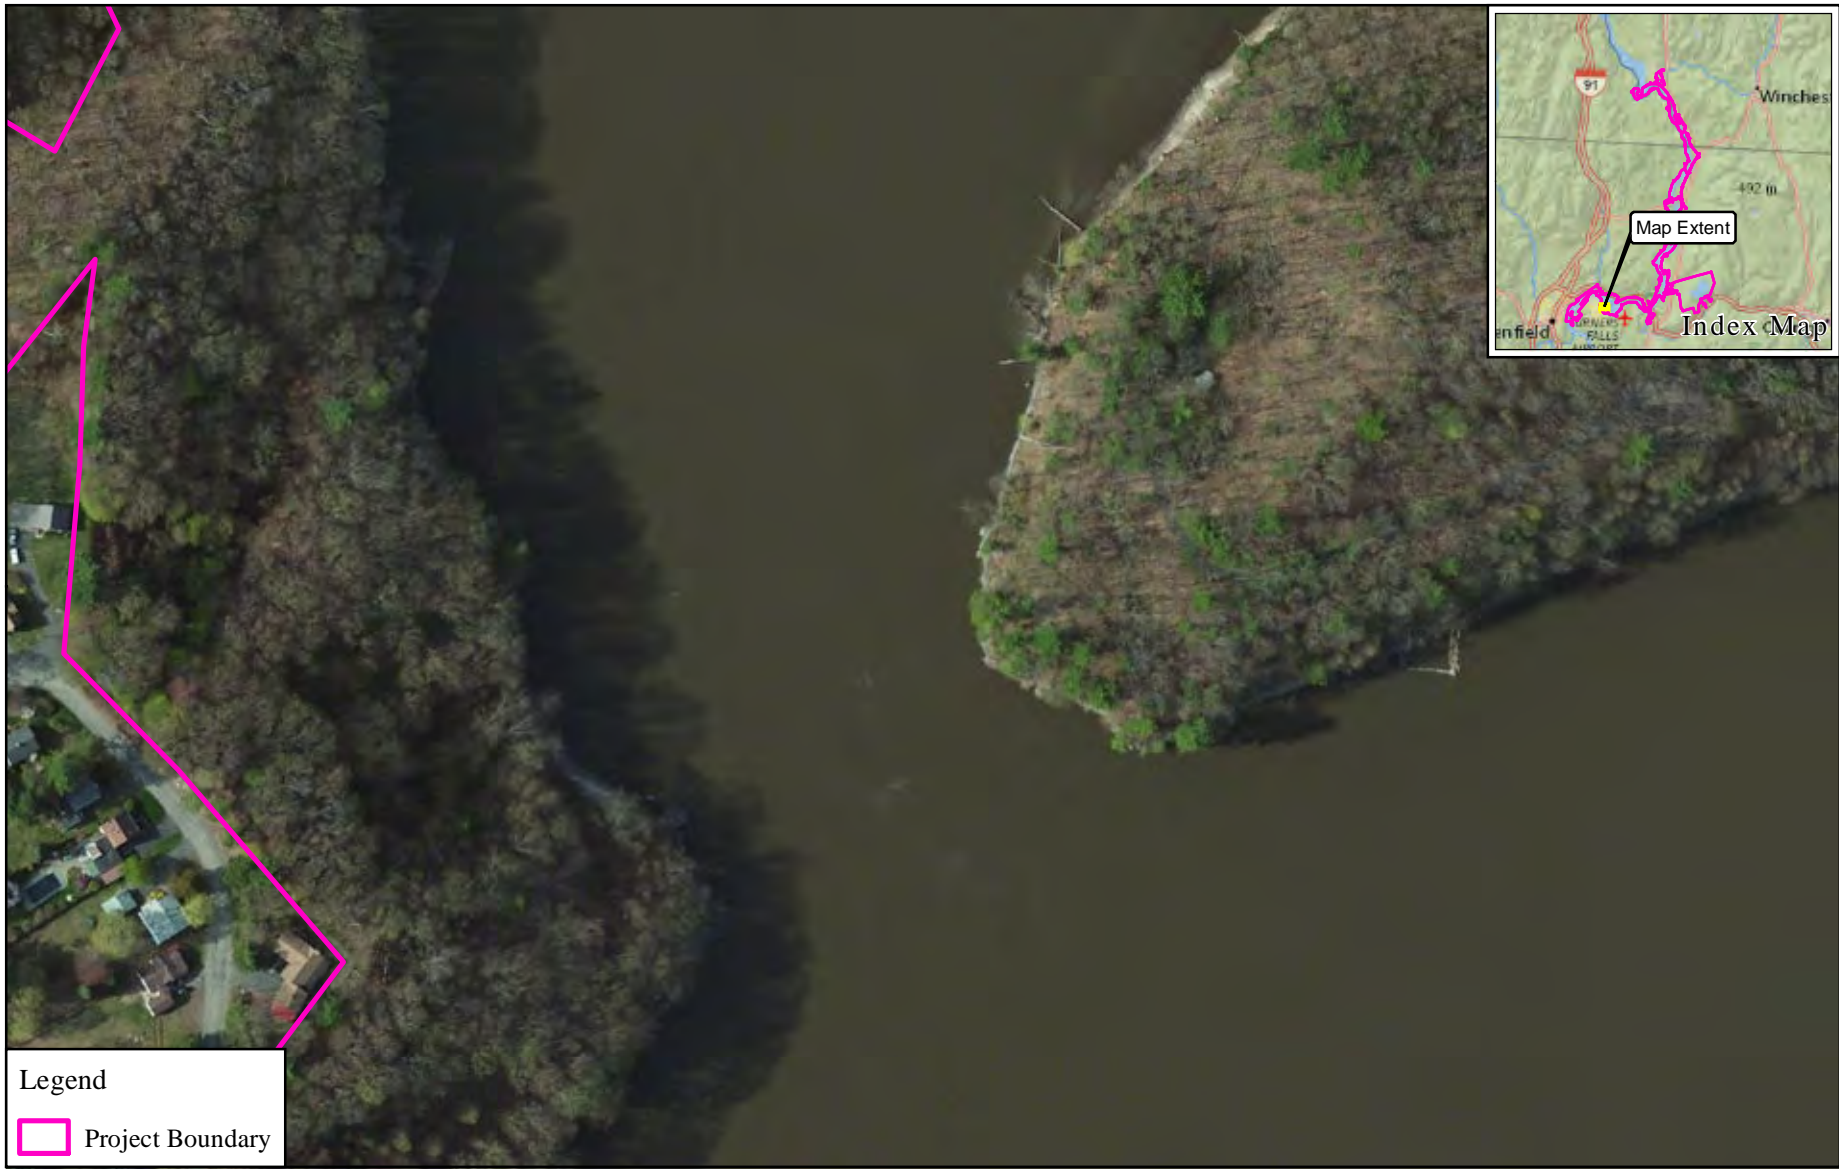
20 CAMPGROUND POINT

Campground Point is the peninsula that separates Barton Cove from the reach of river leading upstream to French King Gorge. Some erosion is evident in the earlier photographs such as 1952 continuing through the 2008 photograph, when it was stabilized as part of the ECP in 2008 as the Campground Point Site. The 2014 photograph shows an increase in vegetation on the stabilized site.

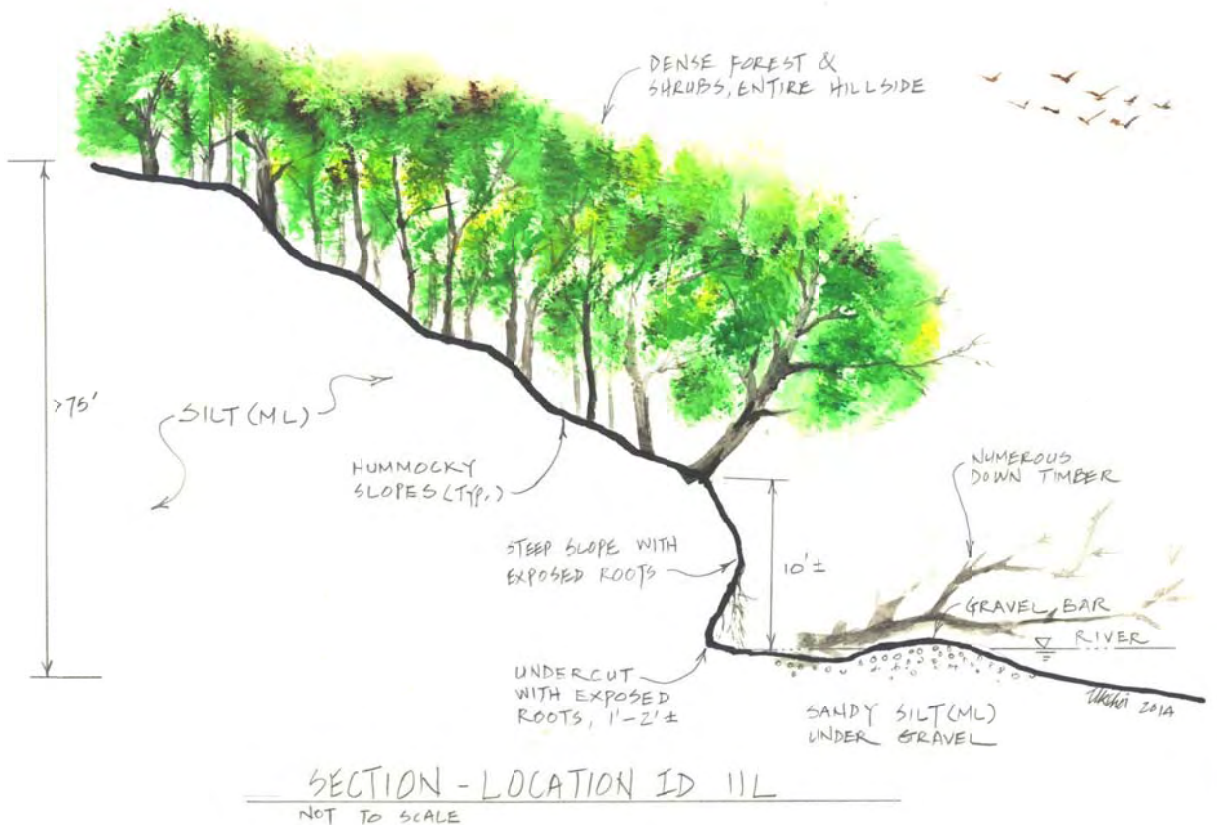
Site Sketch:

- Steep slope at river level (lower 10 feet of Upper Bank)
- Mass wasting with hummocky terrain in upland
- Undercuts with exposed roots
- Some leaning trees
- Numerous down timber
