Relicensing Study 3.1.2

**Northfield Mountain / Turners Falls
Operations Impact on Existing Erosion and
Potential Bank Instability
Study Report**

Volume III – Appendices

**Northfield Mountain Pumped Storage Project (No. 2485) and
Turners Falls Hydroelectric Project (No. 1889)**

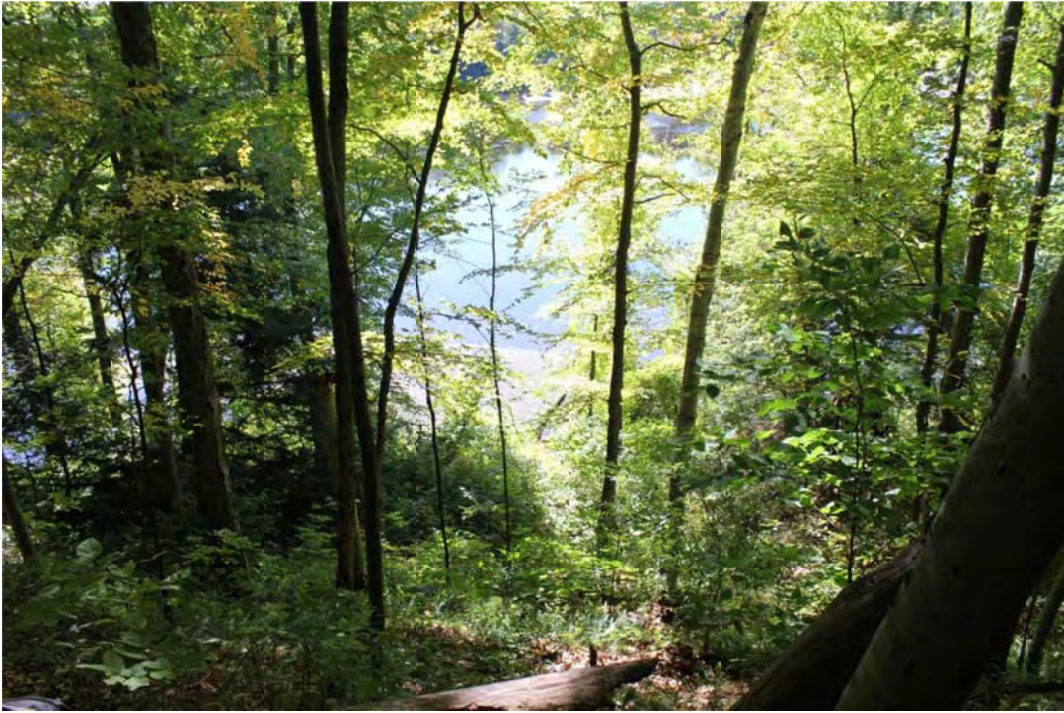
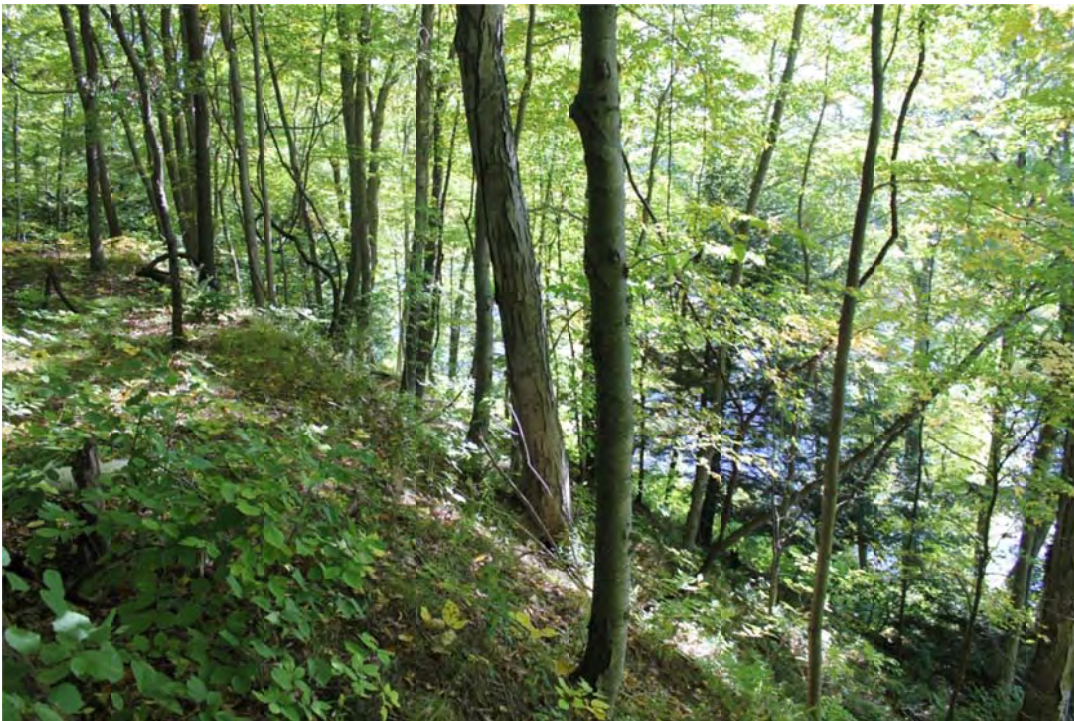
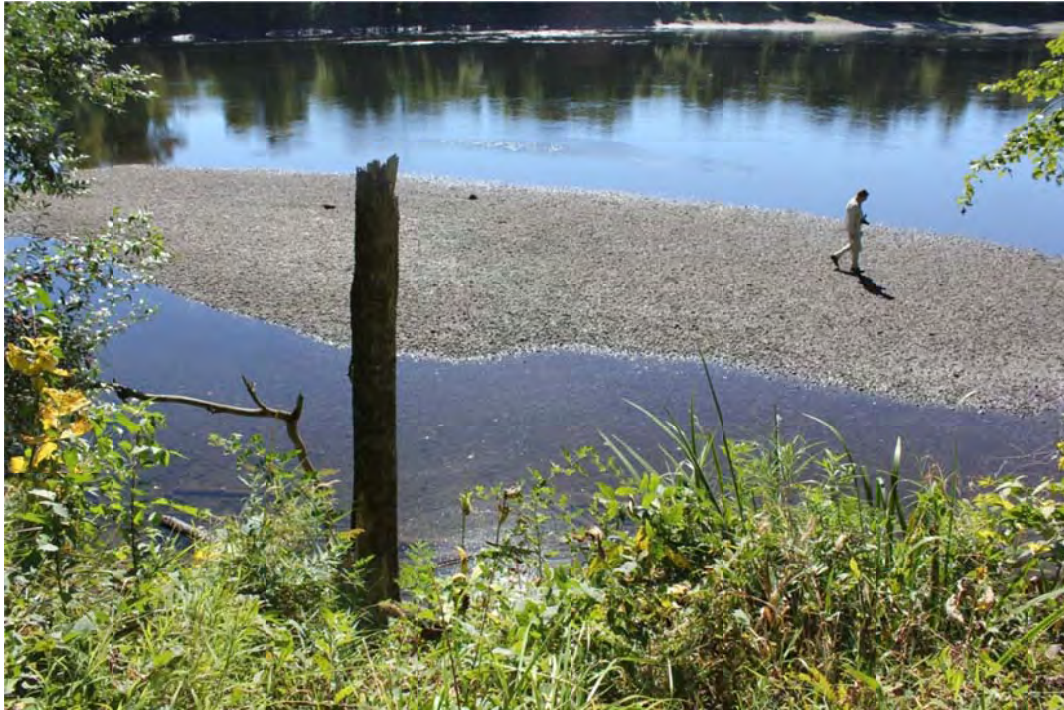
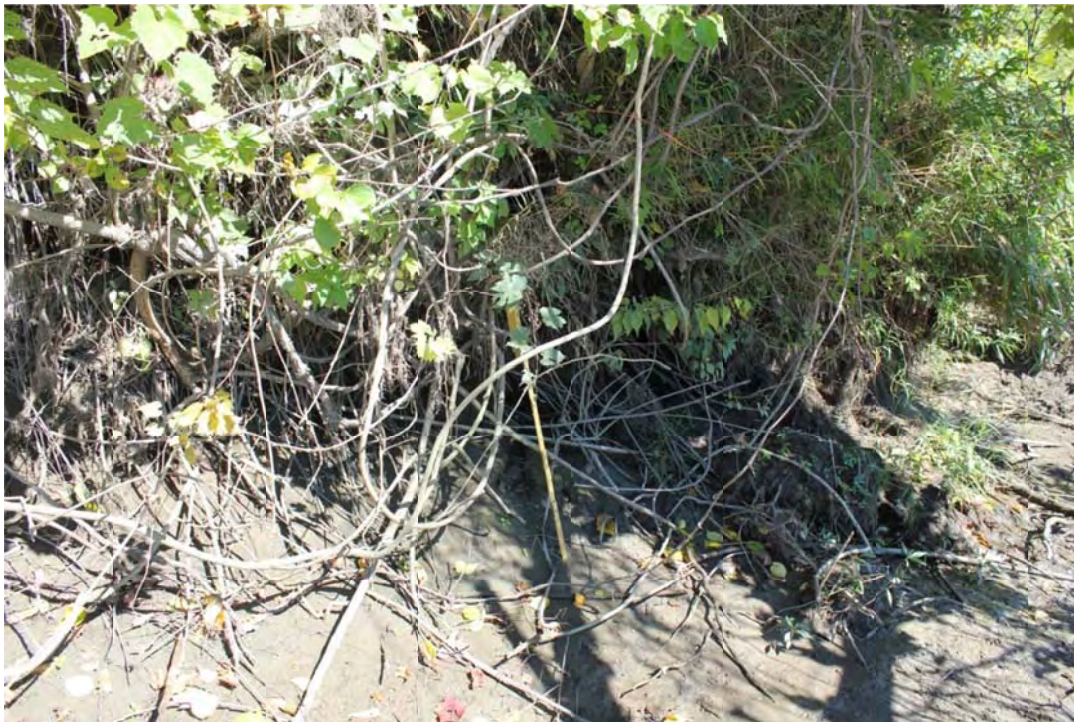
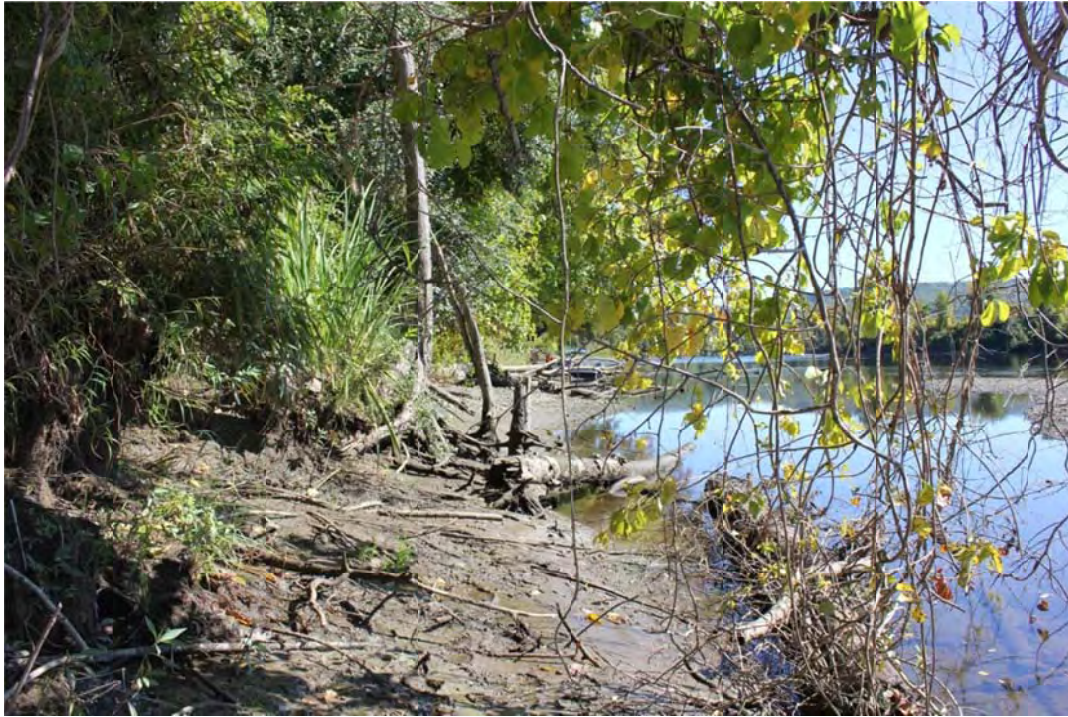
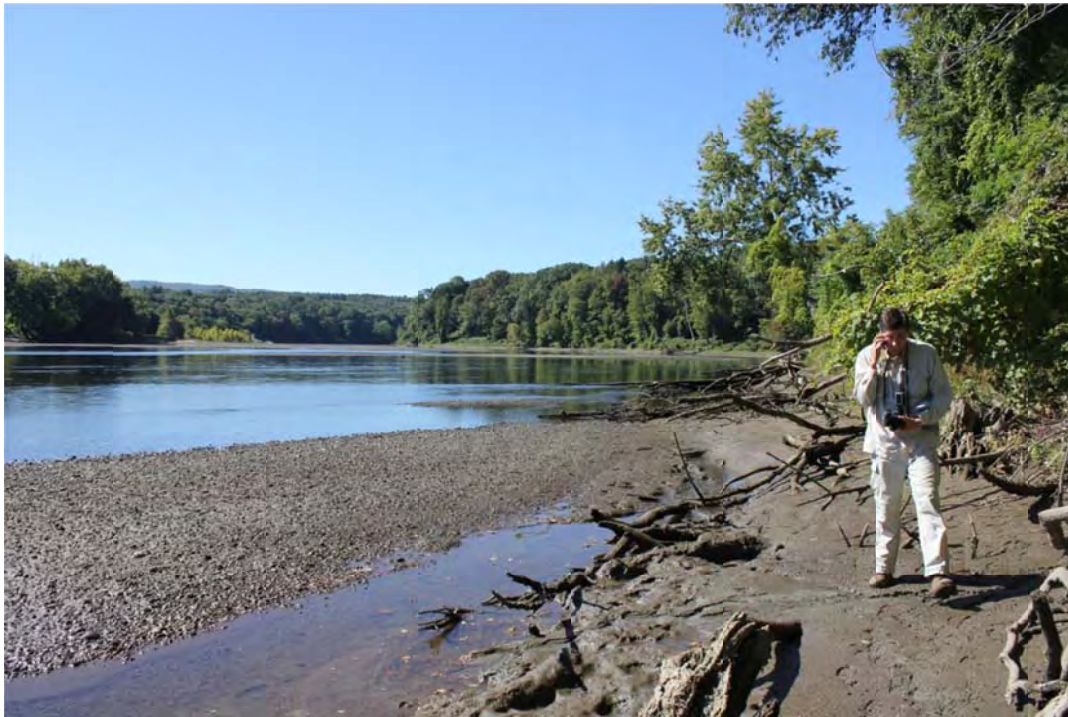
2014 Connecticut River Detailed Site Assessments
Land-Based Survey Photographs Reference No. 802 - 807
Location ID 11L – September 23, 2014

- Steep slope at river level (lower 10 feet of Upper Bank)
- Mass wasting with hummocky terrain in upland
- Undercuts with exposed roots
- Some leaning trees
- Numerous down timber

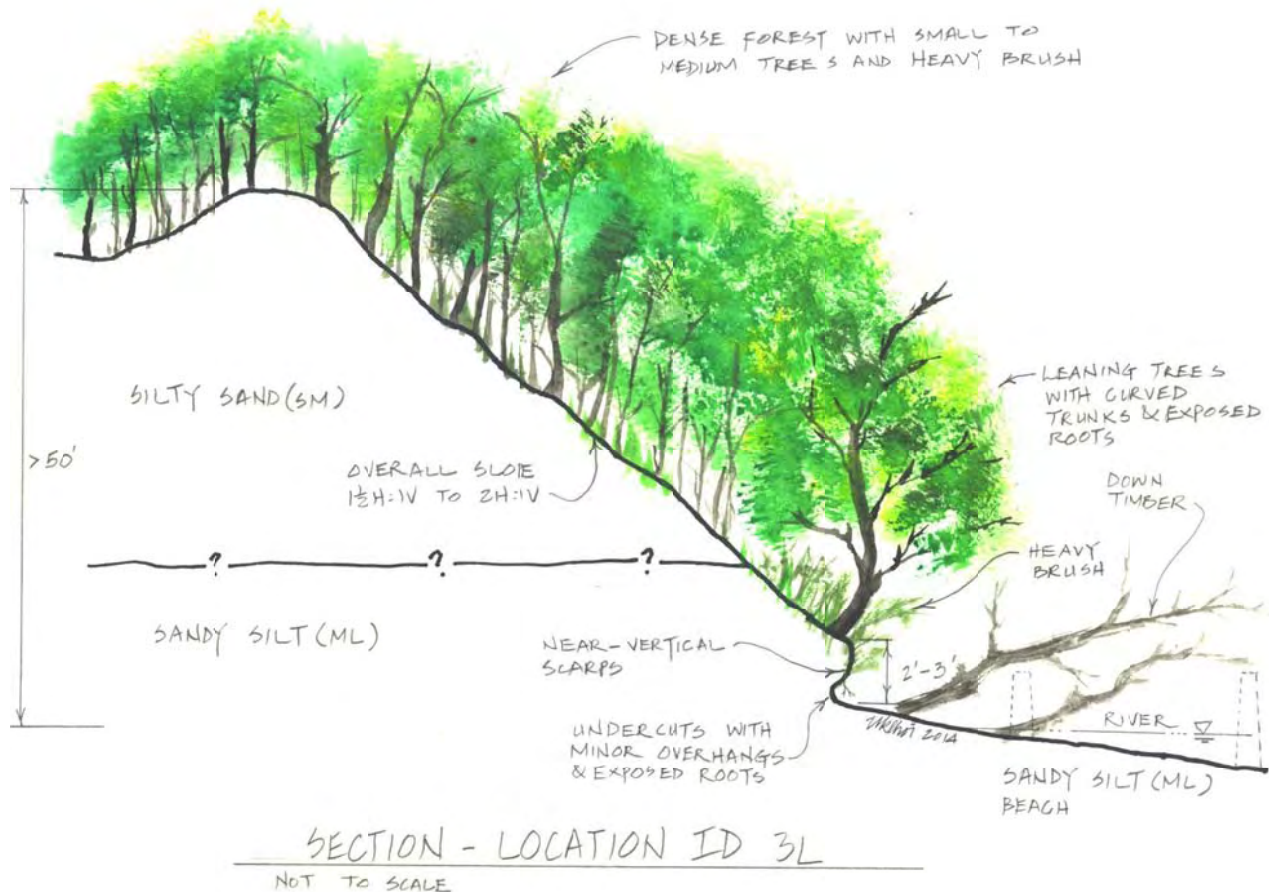
Site Sketch:

- Near vertical scarps with undercuts and exposed roots at river level
- Minor overhangs
- Leaning trees with curved trunks
- Some mass-wasting near river level

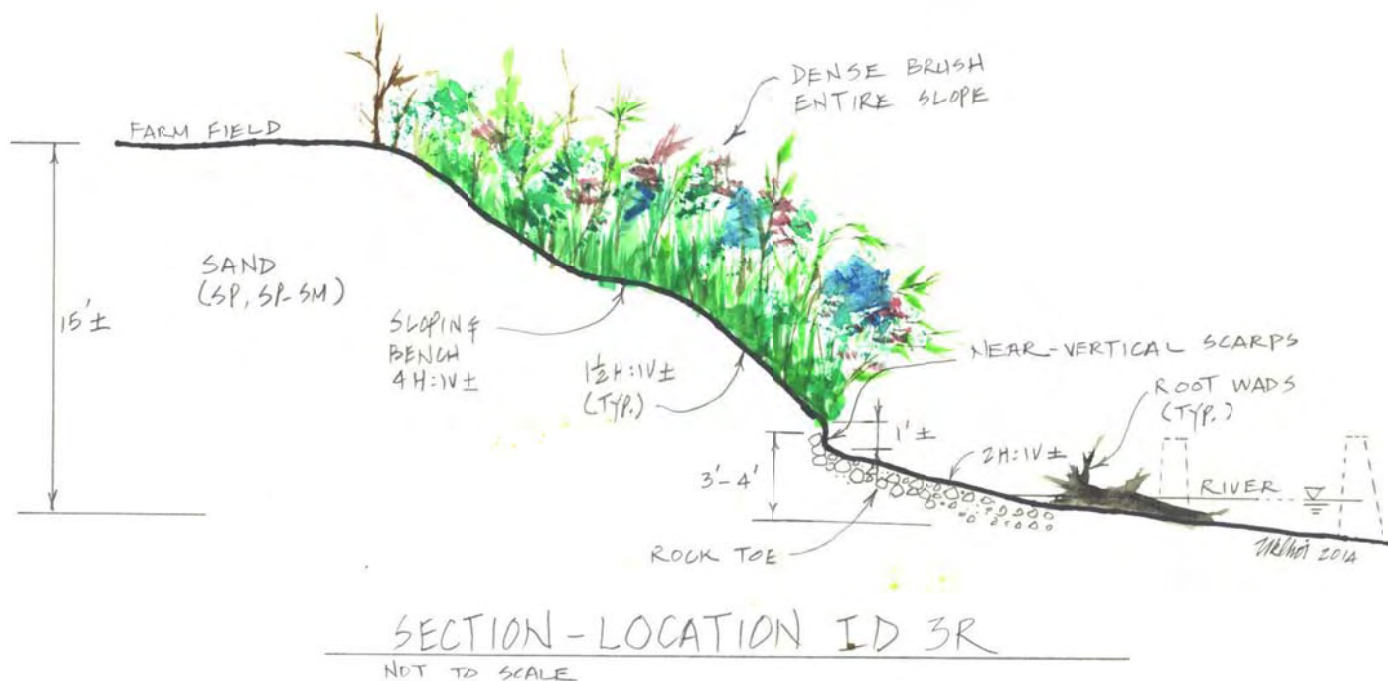
Site Sketch:

ROCK TOE – 1" – 4" riprap rock, angular, hard, minor deterioration.

- Little erosion of stabilized slope.
- Minor near-vertical scarps near the top of rock toe

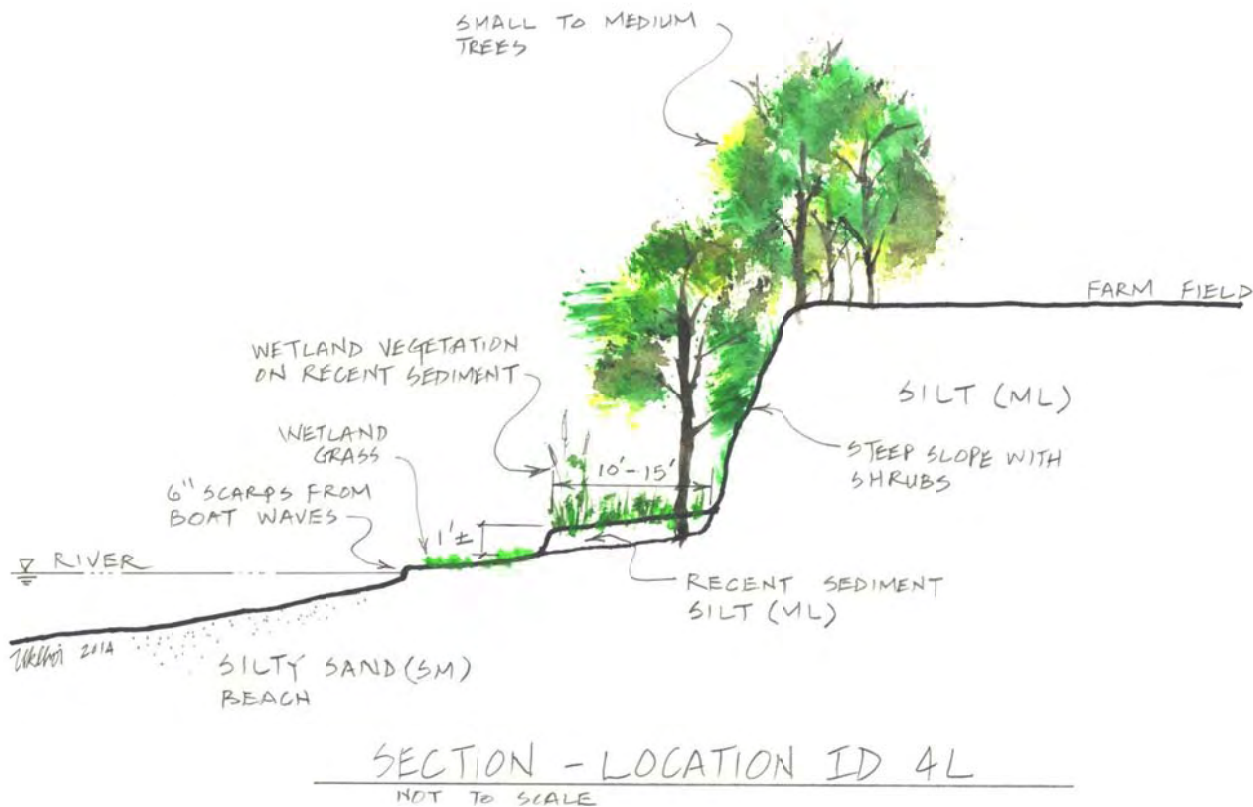
Site Sketch:

- Steep slope, entire Upper Bank.
- Minor erosion of recent sediment where there was no wetland vegetation.
- 6-inch deep erosion scarp at river level from boat waves.

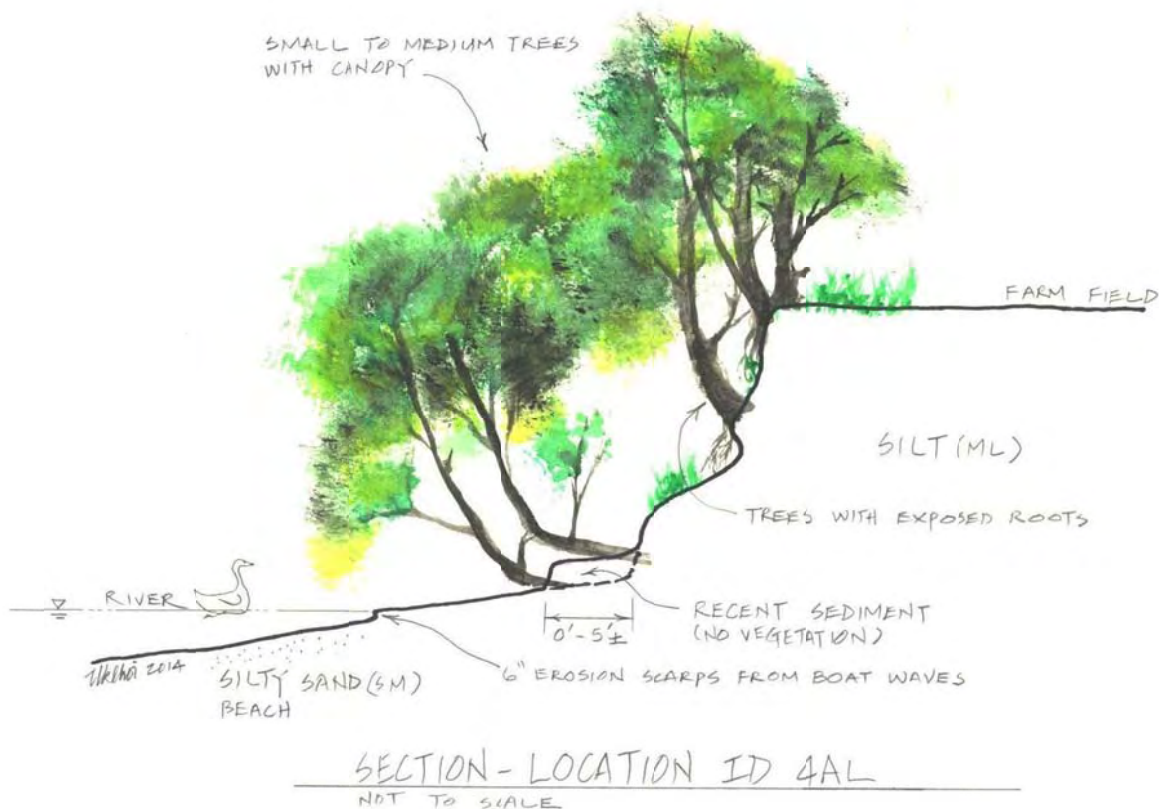
Site Sketch:

- Steep slope, entire Upper Bank.
- Leaning trees and undercuts at toe of Upper Bank, some with exposed roots
- Overhangs with exposed roots near top of Upper Bank
- Significantly less recent sediment compared with Site 4L which is just 100 feet away. Little to no wetland vegetation on recent sediment.
- 6-inch deep erosion scarp at river level from boat waves

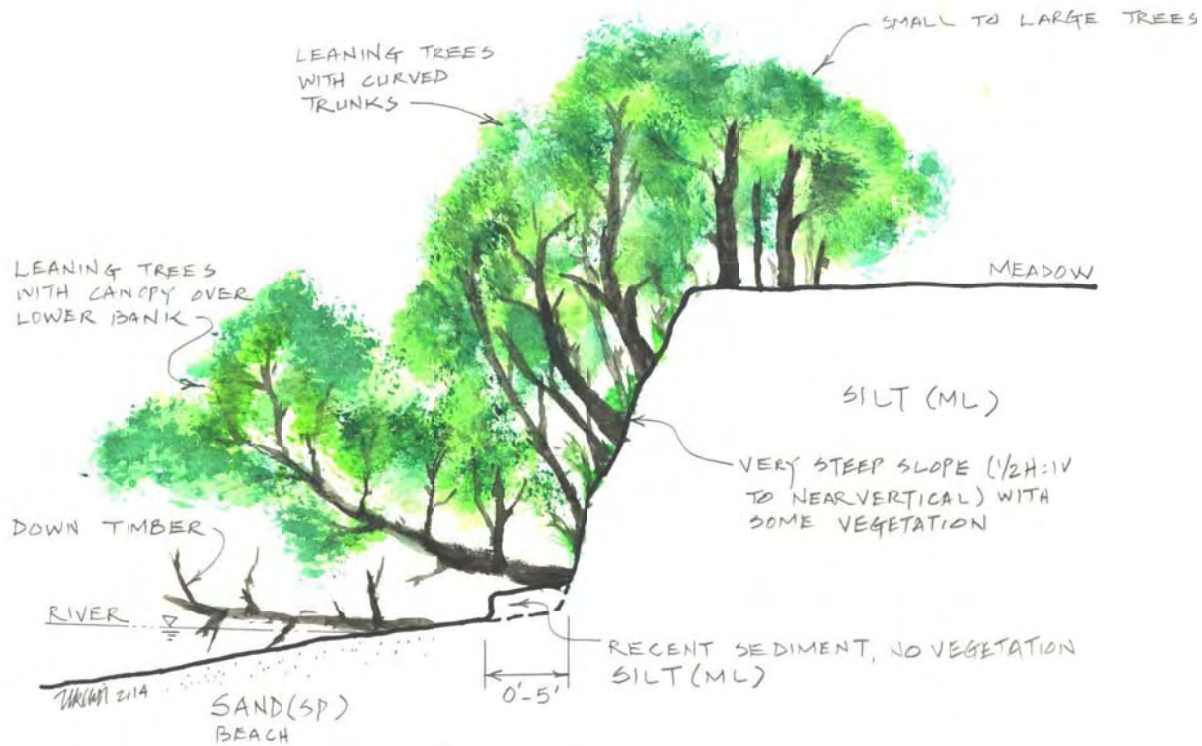
SECTION - LOCATION ID 5CR
NOT TO SCALE

- Leaning trees, some with curved trunks, with exposed roots.
- Very steep slope, entire Upper Bank.
- Minor undercuts
- Recent sediment with no vegetation

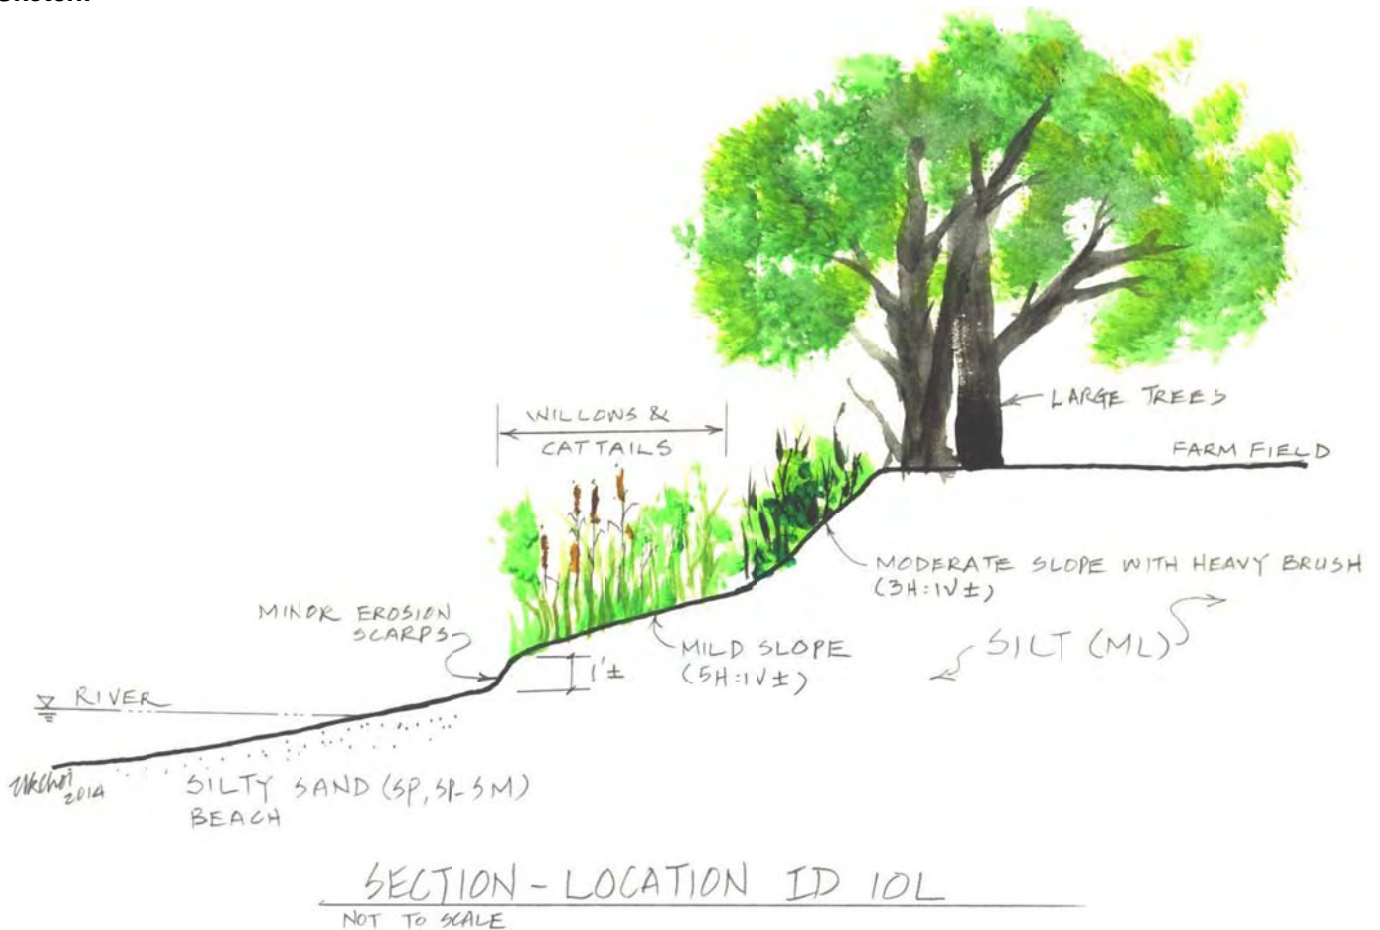
Site Sketch:

- Little to no erosion.
- Minor erosion scarps at the toe of Upper Bank where there was no wetland vegetation.

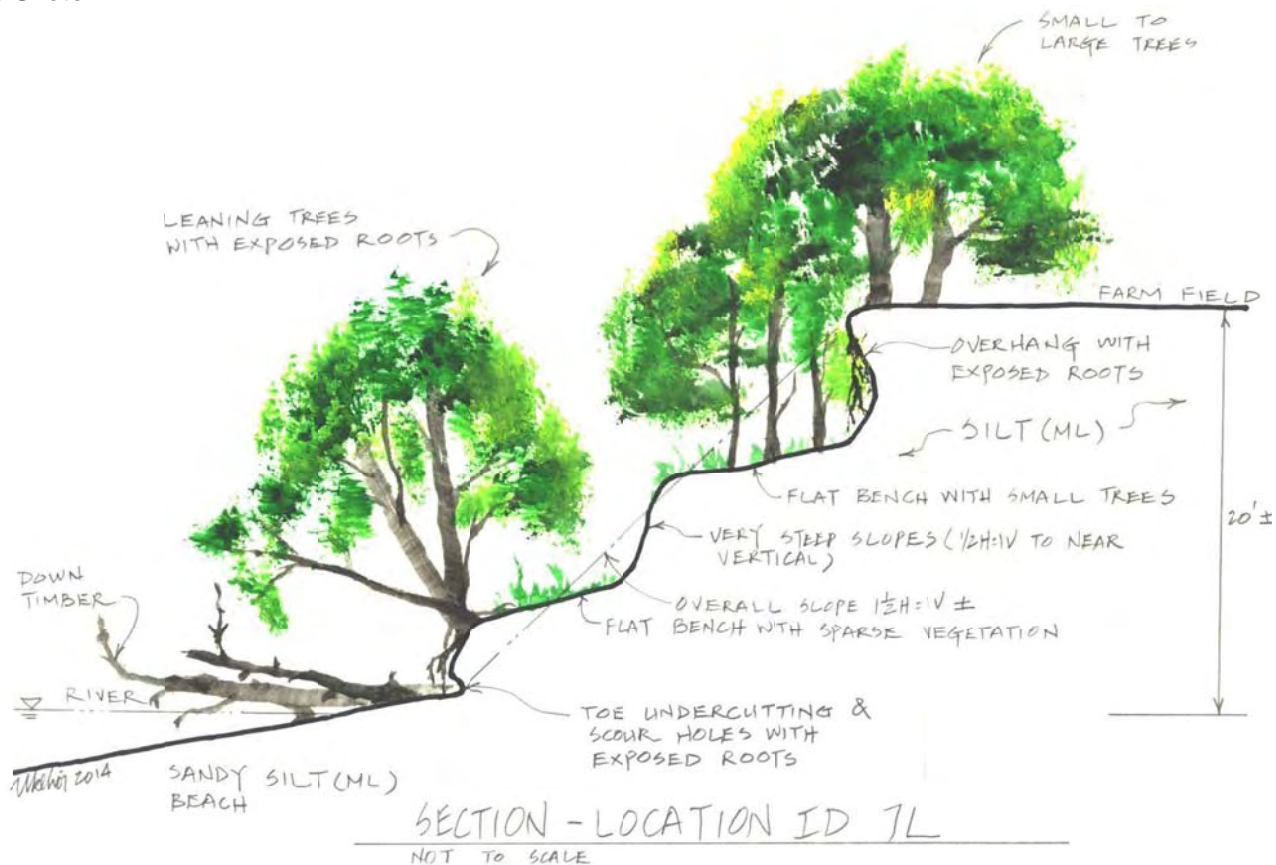
Site Sketch:

- Very steep slopes near top of Upper Bank, with little vegetation.
- Leaning trees with exposed roots at river level.
- Mass wasting with slumping and exposed roots.
- Toe undercutting and localized scour holes between trees at river level.
- Overhangs with exposed roots of large trees at top of Upper Bank.

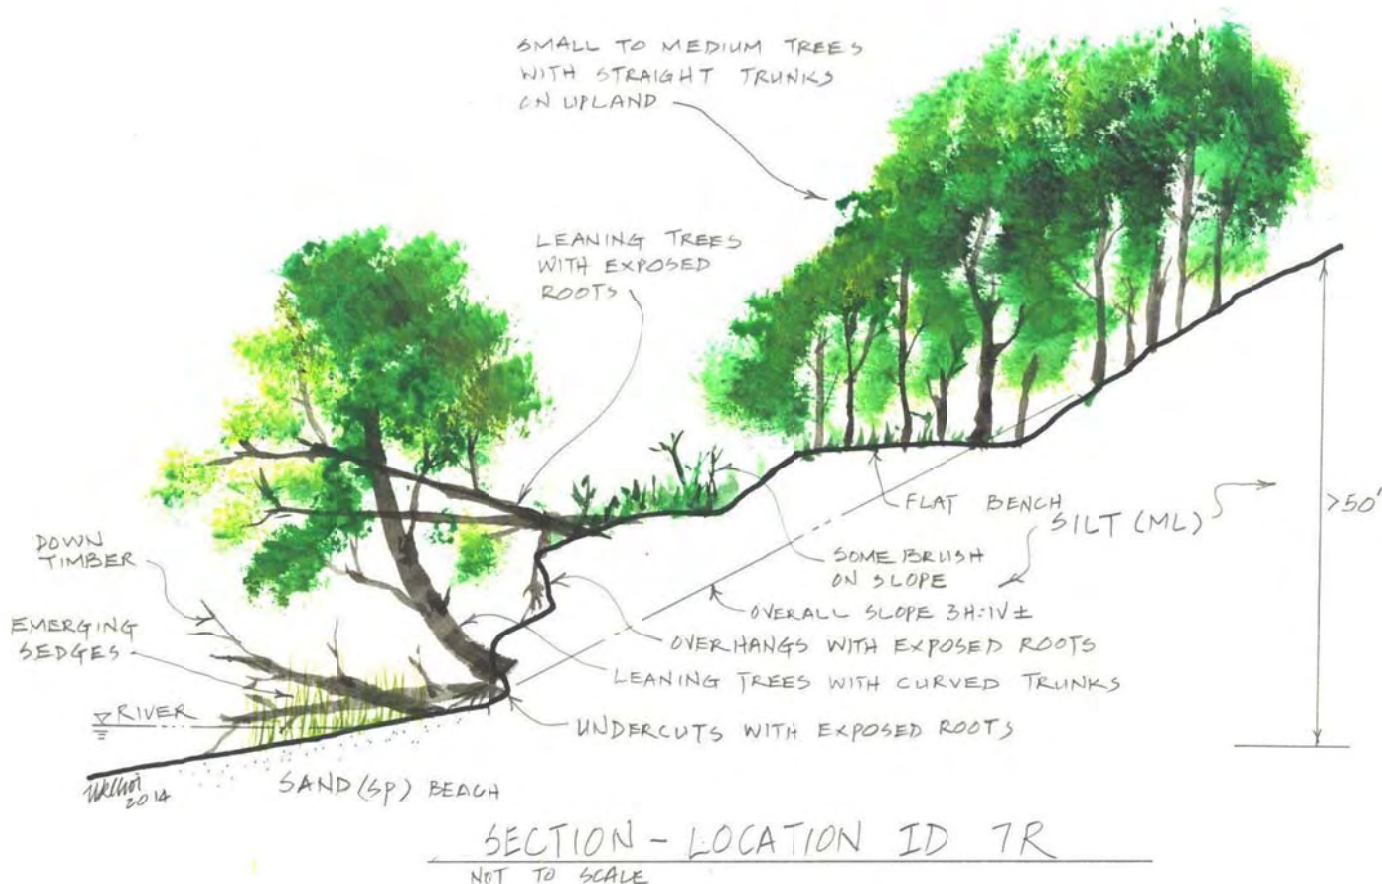
Site Sketch:

- Undercuts with exposed roots at river level.
- Mass-wasting along entire slope.
- Trees on upland area have straight trunks, suggesting the trees post-date the mass-wasting movement.
- Leaning trees with exposed roots at river level and bottom of Upper Bank, some with curved trunks.
- Large scour hole (20' wide x 40' long x 15 feet deep) at mid-slope, with flowing groundwater at bottom of hole.

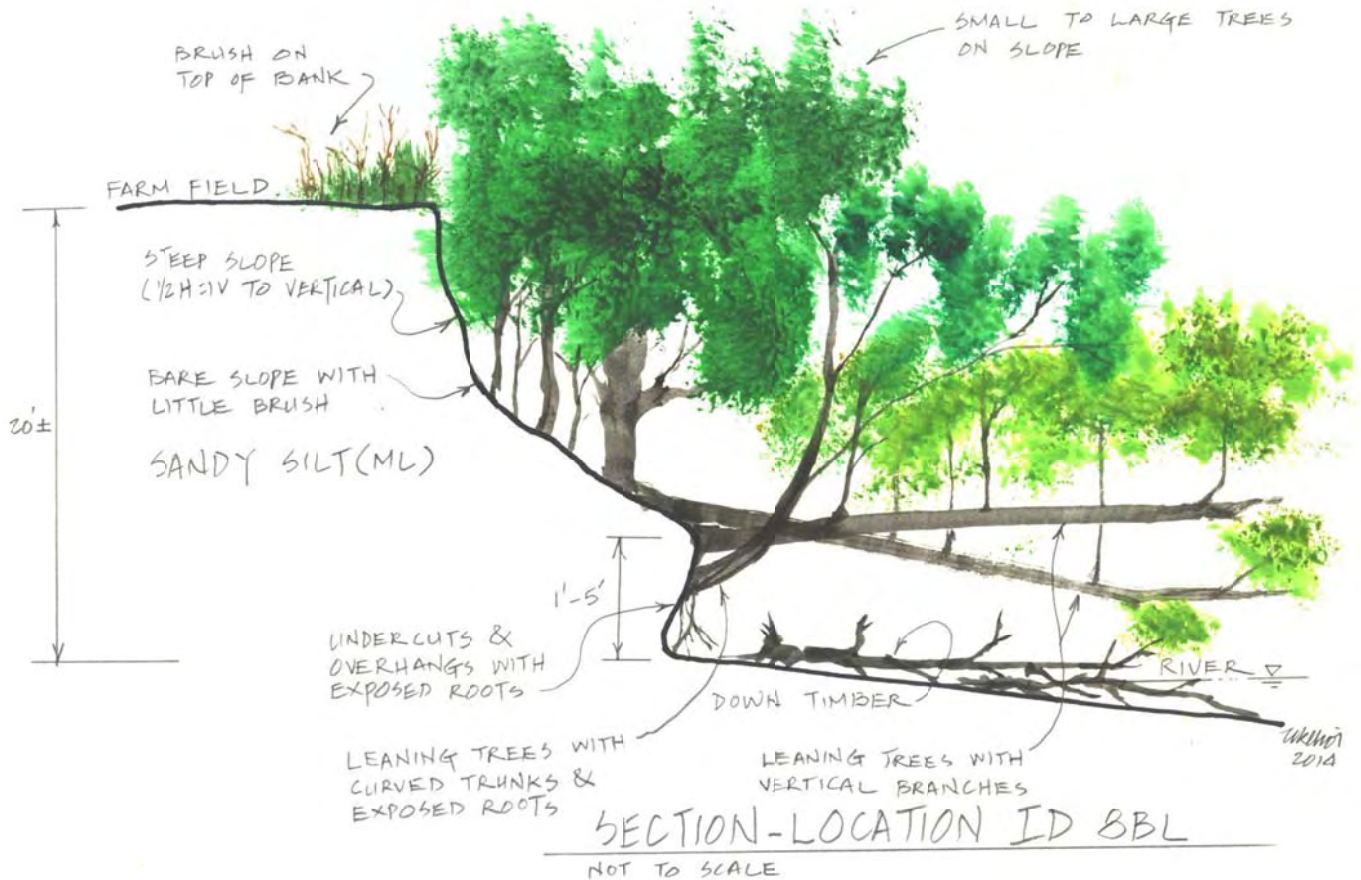
Site Sketch:

- Mass-wasting entire slope on Upper Bank.
- Undercuts and overhangs with exposed roots near river level.
- Leaning trees with exposed roots near river level.
- Very steep slope along entire Upper Bank.

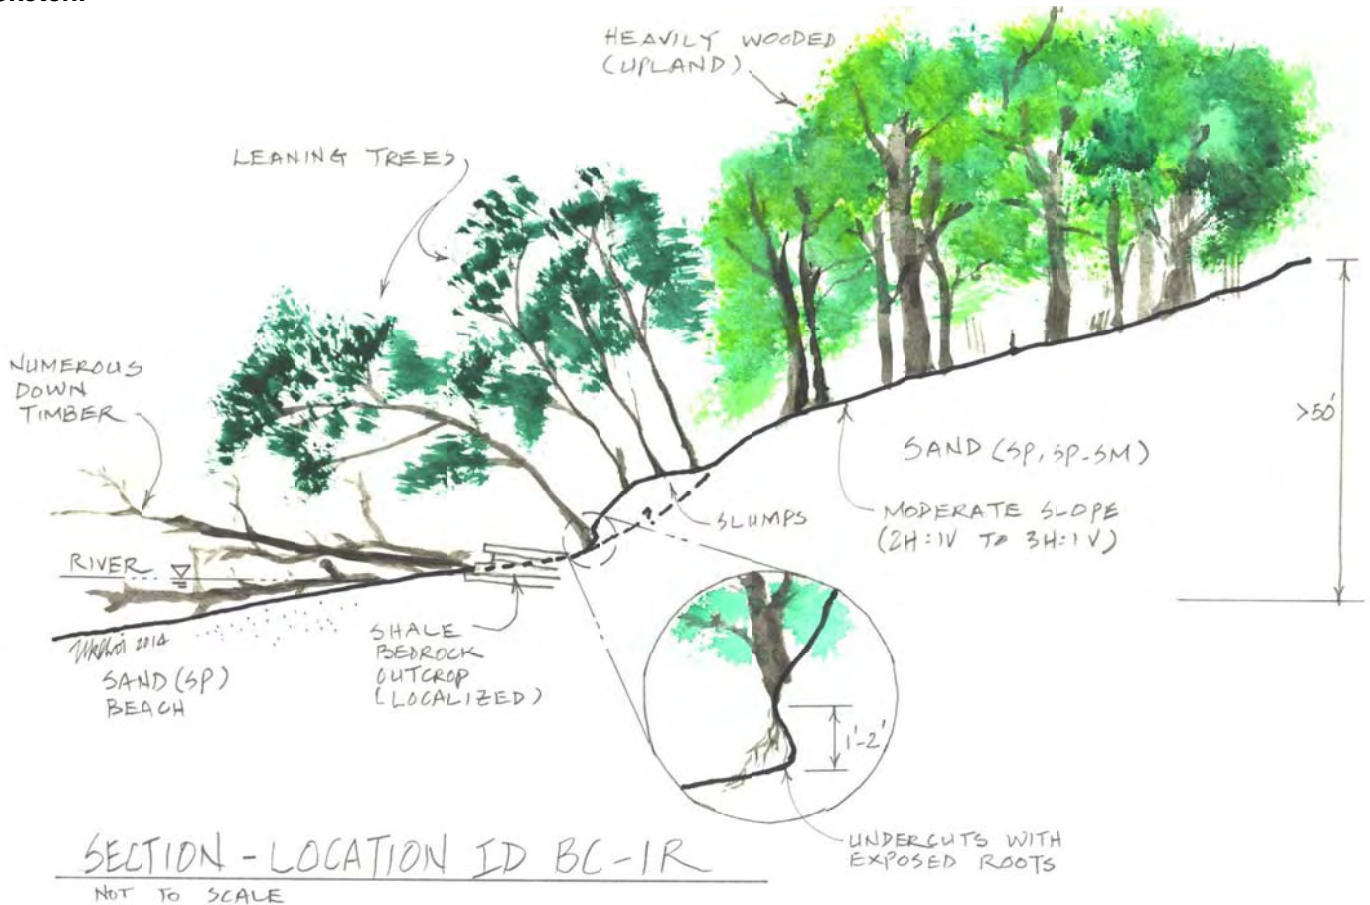
Site Sketch:

- Undercuts with exposed roots
- Leaning trees, some with curved trunks, at bottom of Upper Bank
- Some slumping/mass-wasting near bottom of Upper Bank
- Down timber

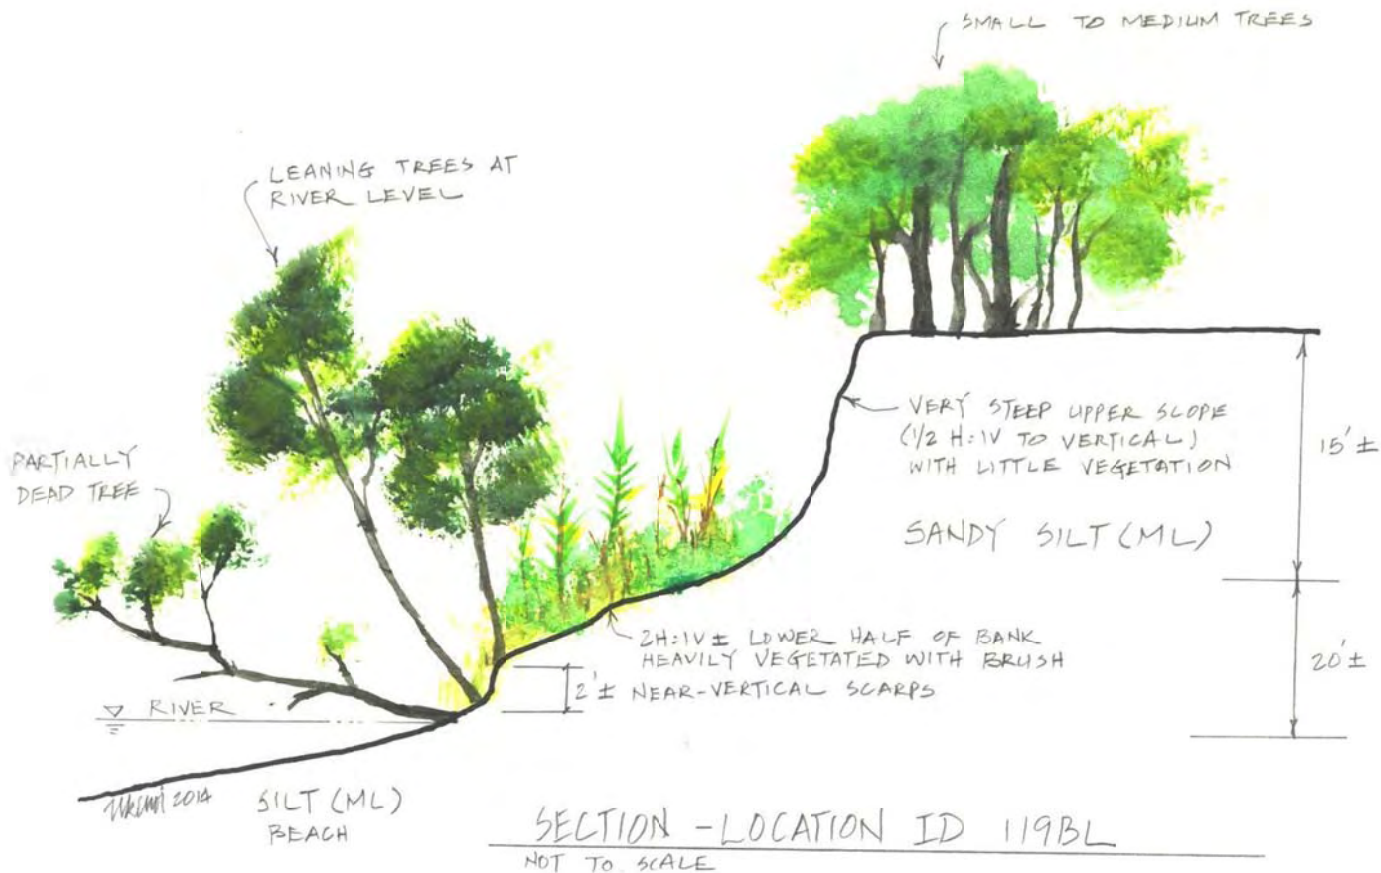
Site Sketch:

- Leaning trees at river level.
- Numerous small slumps on lower half of Upper Bank slope
- Very steep slopes at upper half of Upper Bank
- Near-vertical scarps at river level

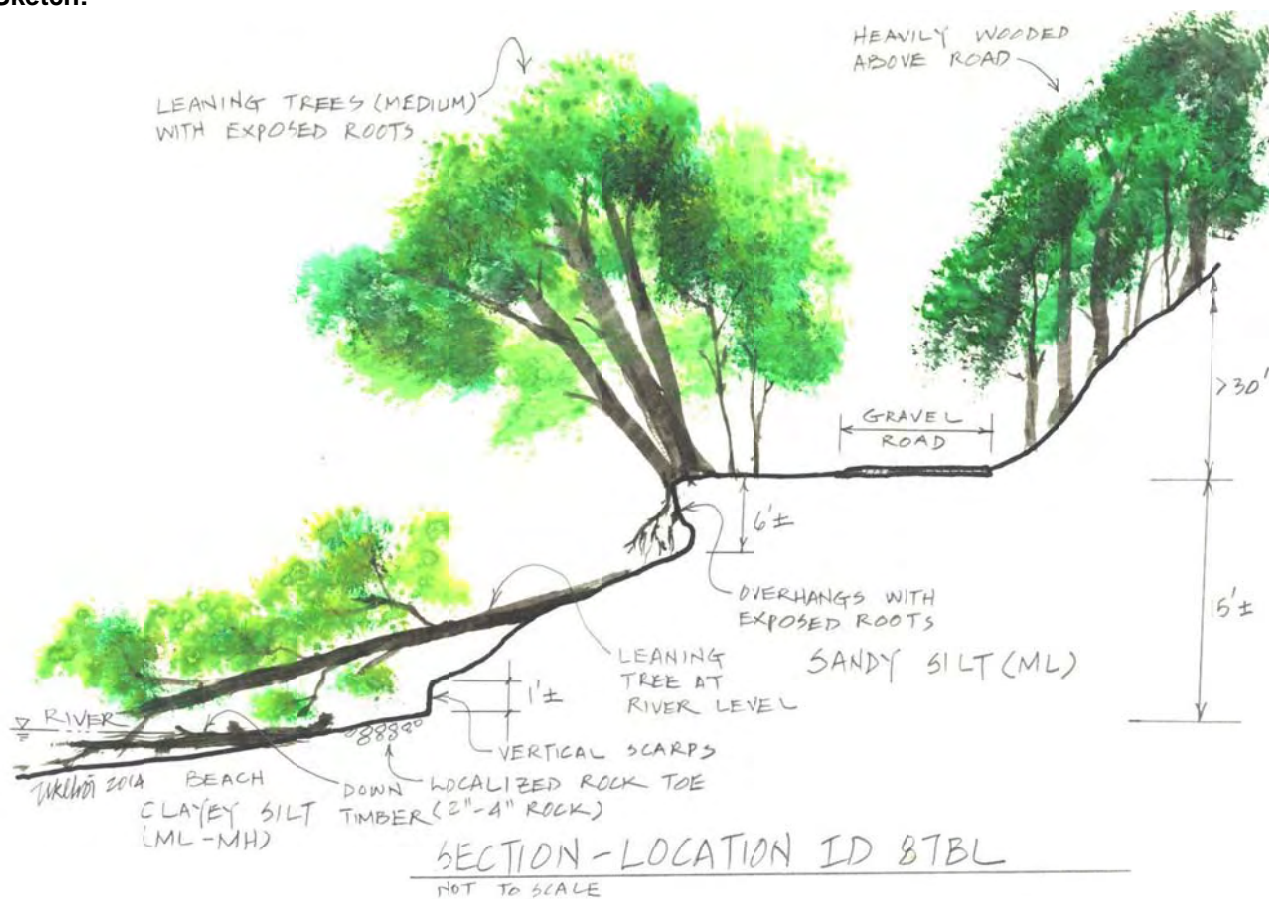
- Overhangs with leaning trees and exposed roots on slopes just below gravel road
- Fallen live trees at river level
- Vertical scarps just above rock toe.

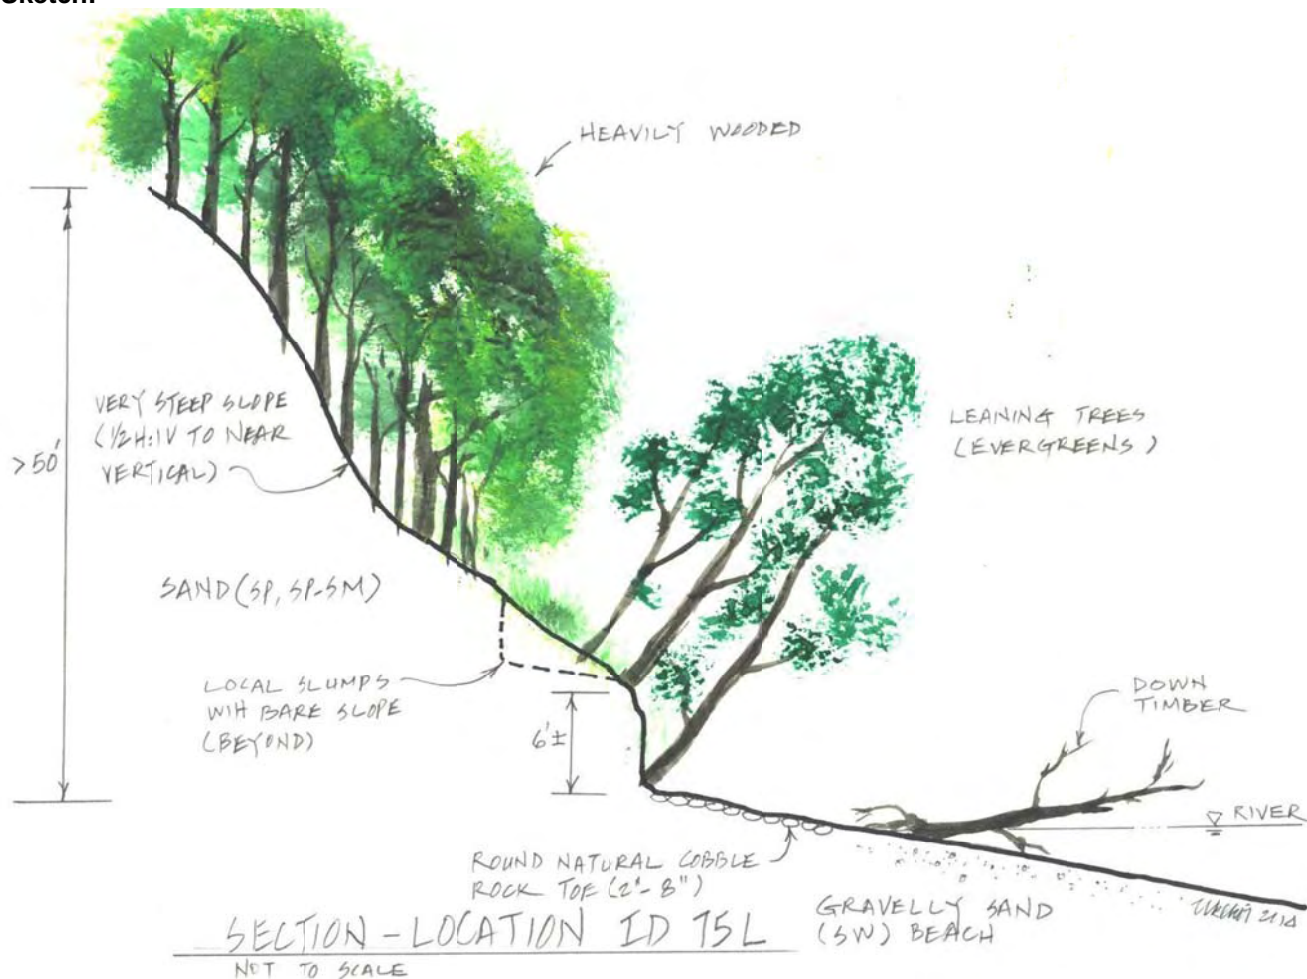
- Very steep slope, entire Upper Bank.
- Near-vertical slope at river level, with some undercuts, leaning trees and exposed roots
- Local slumps and mass-wasting with bare slope, lower half of Upper Bank

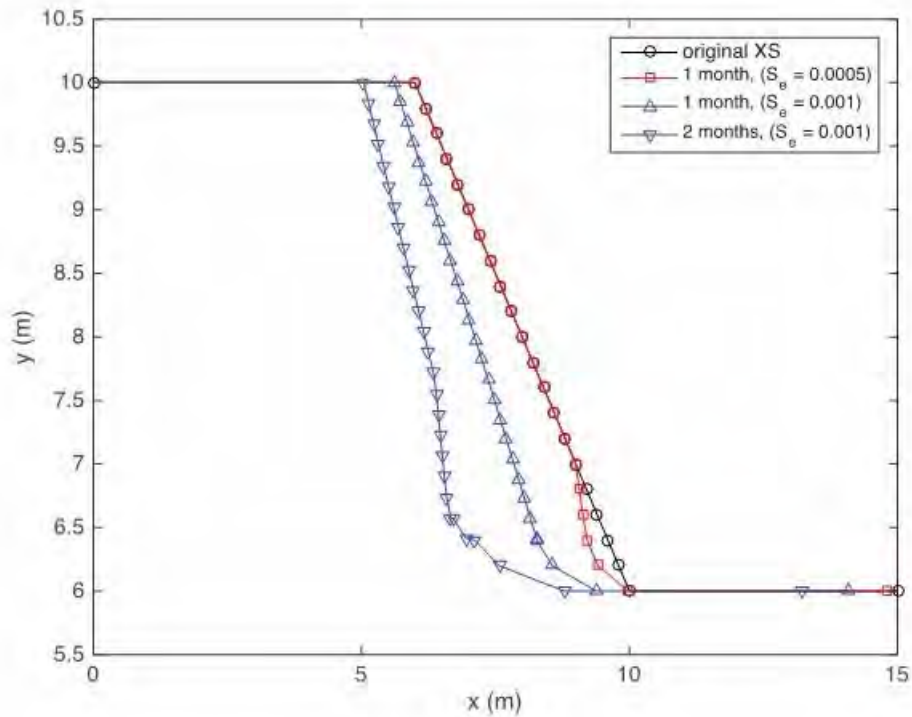
The results of the simulations are compared in Figures 13 through 17. Figure 13 compares 1-month-long simulations with energy slopes of 0.0005 and 0.01, and 2 months long simulation with an energy slope of 0.01. The purpose of these simulations was to test the normal operation of the updated BSTEM model. The boat wave algorithm is not activated in these simulations.

Figure 13. Eroded bank profile without boat waves.

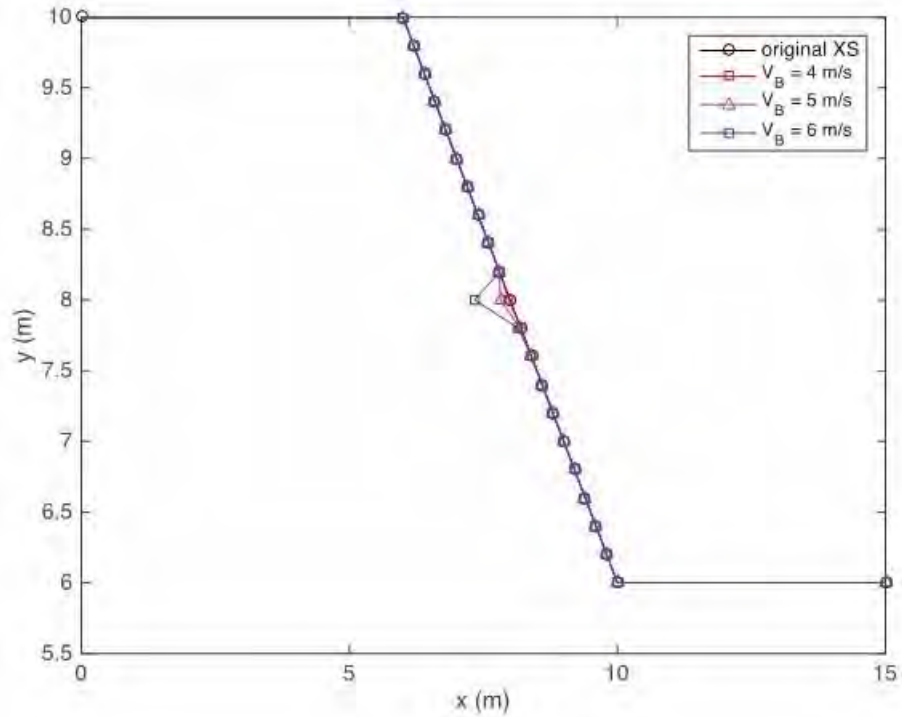
In order to isolate the boat wave algorithm, the energy slope is set to a very small value and the boat data in Table 6 is applied 9 passes a day for 2 months. The simulations were carried out at three different boat speeds 4 m/s, 5m/s and 6m/s. Figure 14 shows the comparison of the eroded profiles with waves. Also, in Table 7 the input and output wave properties are listed.

Figure 14. Eroded bank profile with boat waves only.

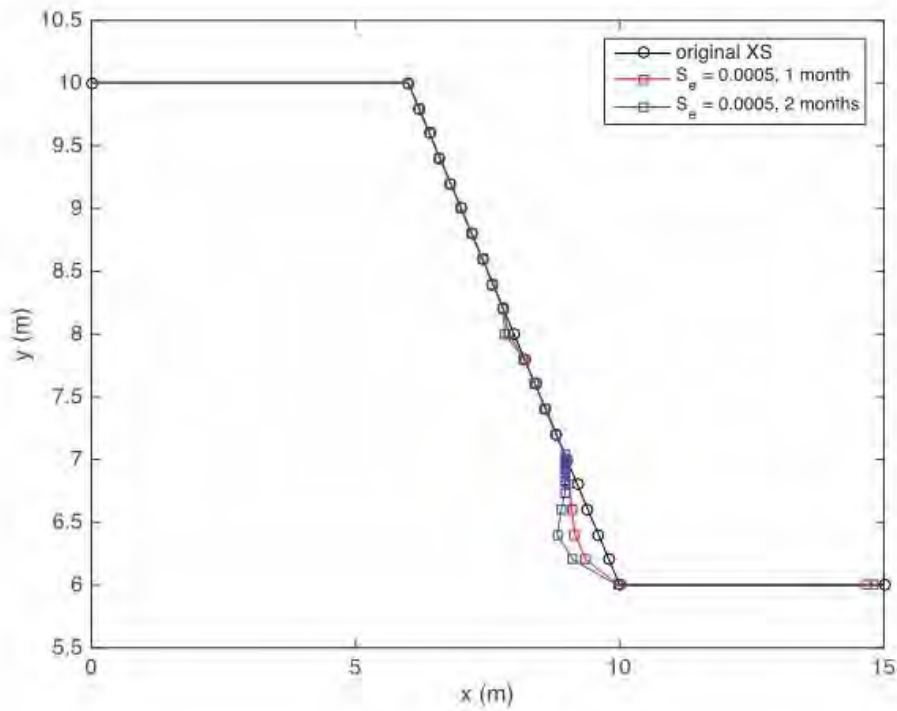
In Figure 15, both toe erosion and boat wave erosion algorithms are activated at $S_0 = 0.0005$. The undercutting boat by the wave and current actions can be seen clearly. No bank failure was observed for this case. When the energy slope is steeper in Figure 16, bank failure was observed for the 2-month period.

Figure 15. Boat wave erosion and toe erosion at $S_0 = 0.0005$.

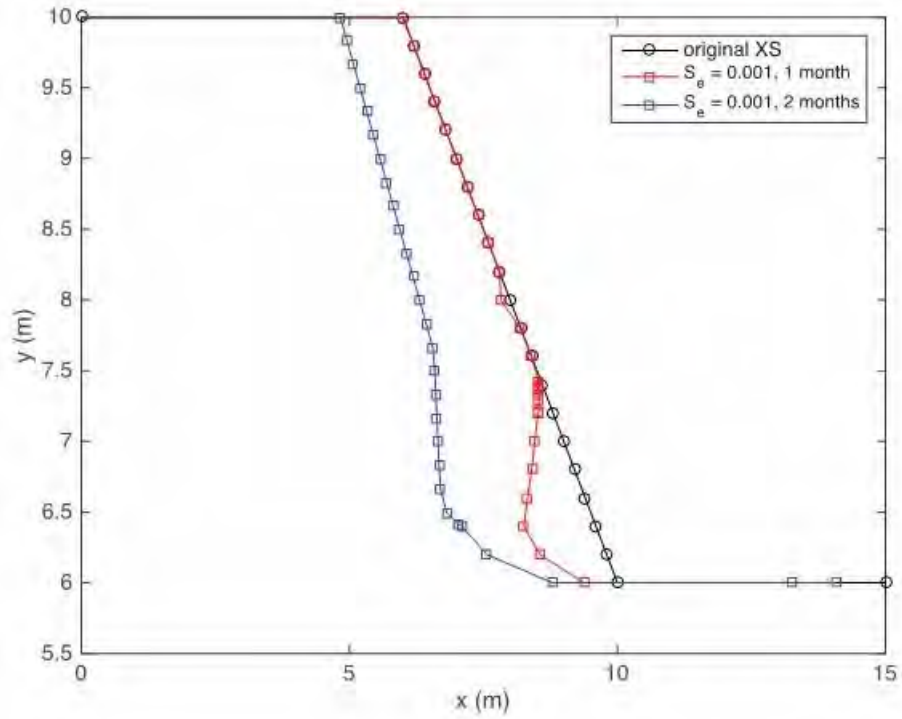
Figure 16. Bank erosion for 1 month and 2 month simulation periods.
