Relicensing Study 3.1.2

**Northfield Mountain / Turners Falls
Operations Impact on Existing Erosion and
Potential Bank Instability
Study Report**

Volume III – Appendices

**Northfield Mountain Pumped Storage Project (No. 2485) and
Turners Falls Hydroelectric Project (No. 1889)**

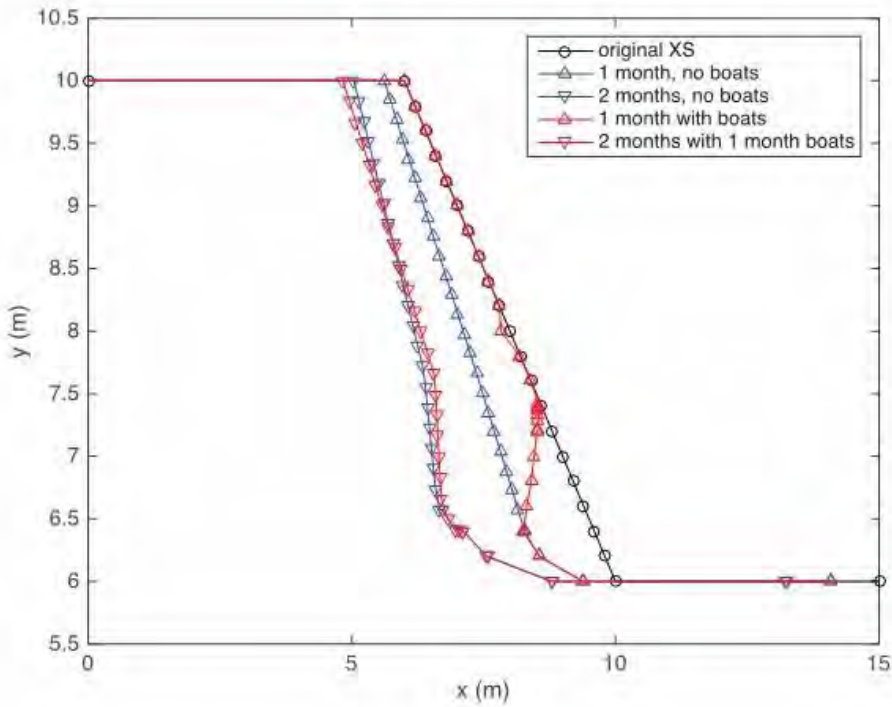
Finally, one and two month simulations with and without the boat wave model are plotted in Figure 17, the boat wave data was 1-month-long for all of the simulations in this plot. It can be seen in the figure that, bank retreat without the boat waves appears to be faster than the case with the waves. This counterintuitive result is can be explained as follows: wave erosion is highest close to the water surface, hence expected to be at a higher elevation compared to the toe erosion. Eroded material reduces the weight of the block, therefore increases factor of safety. Further research is needed to understand the physical basis of the phenomenon.

Figure 17. Comparison of failure profiles with and without boat waves.

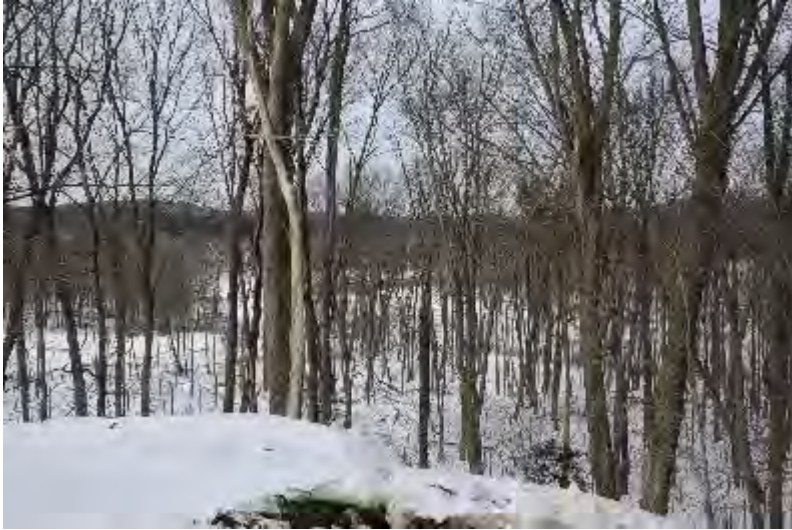
1.

Between MA State Line and Pauchaug Boat Launch

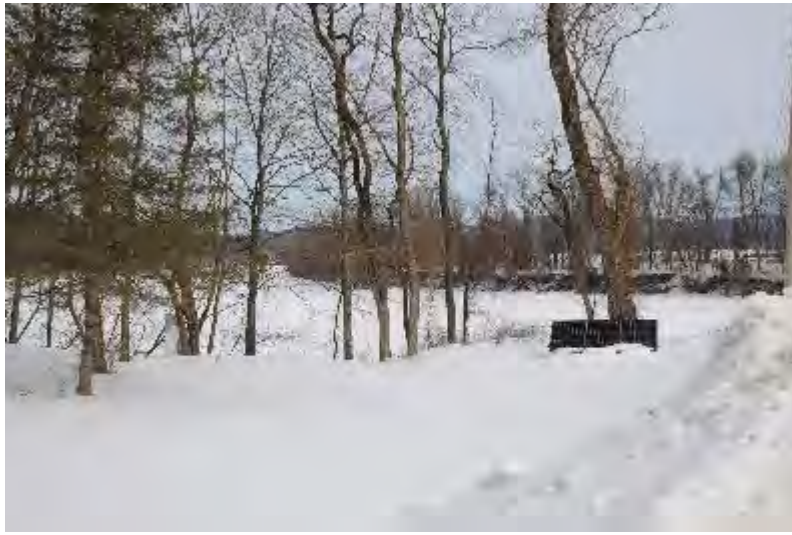
1.

Upstream Route 10 Bridge

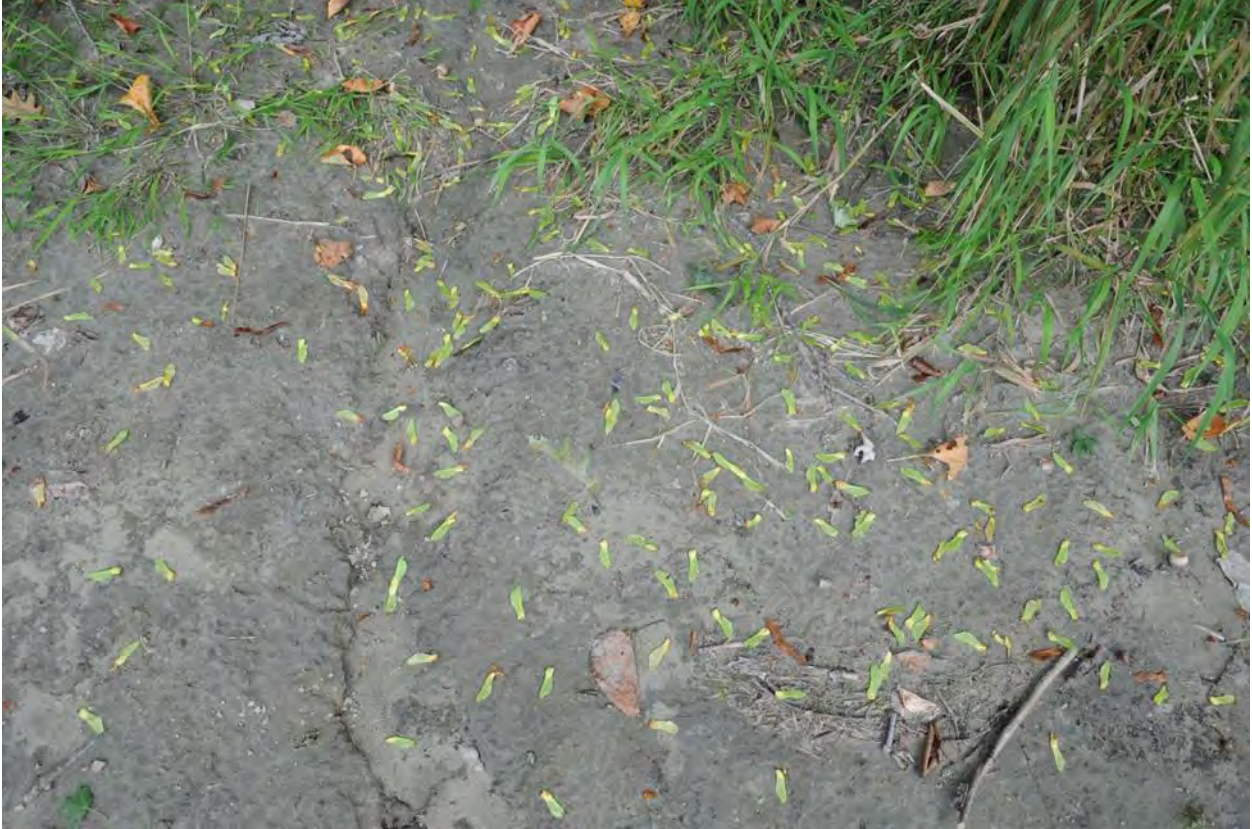
Figure J-4.1 Maple seeds (photo 0202, 9/28/2015)

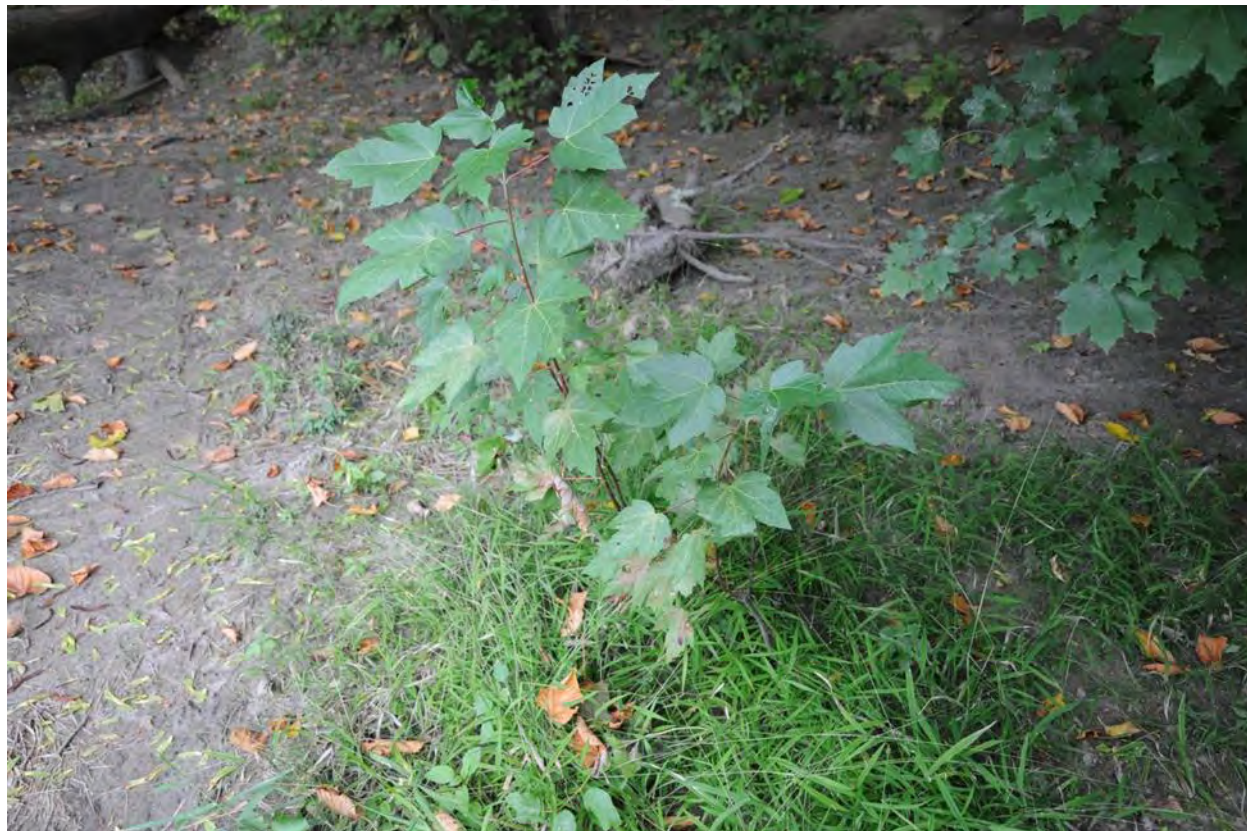
Figure J-4.3 Maple seedlings (photo 0203, 9/28/2015)

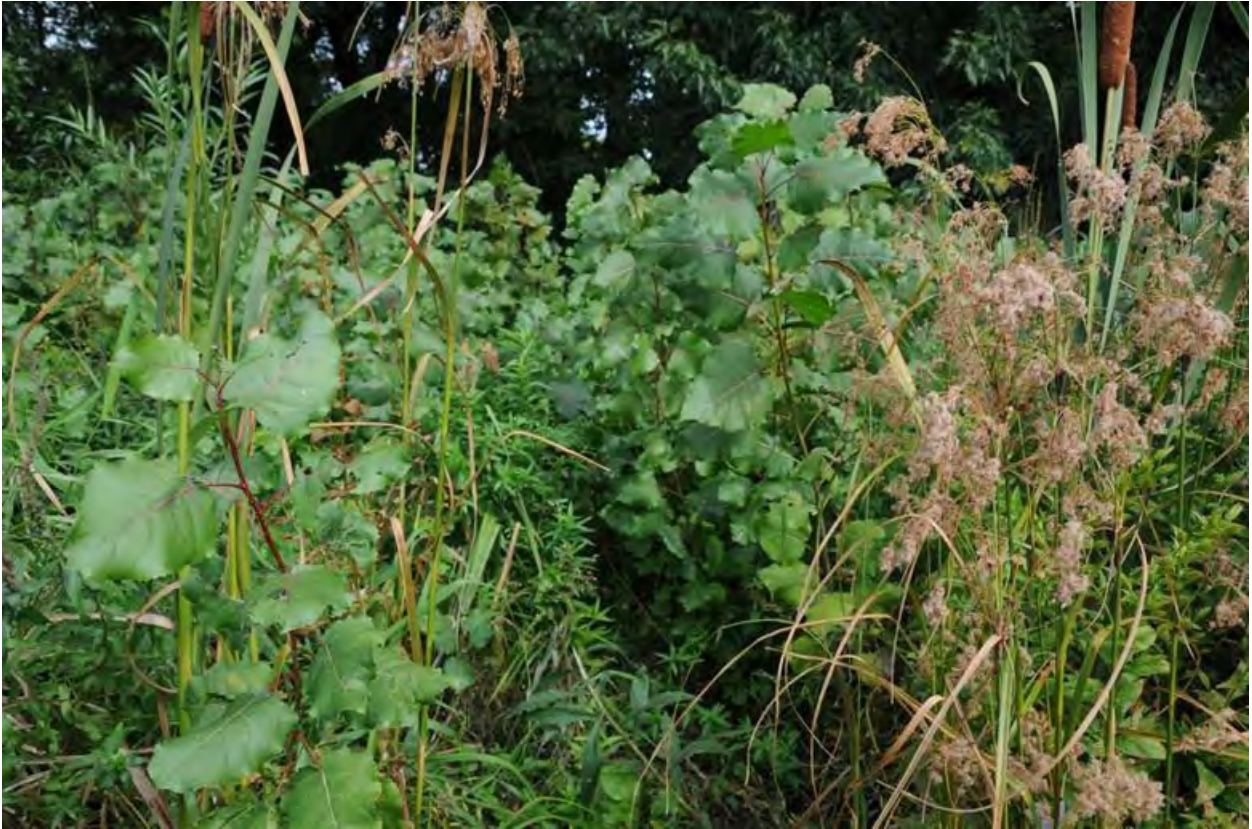
Figure J-4.5 Cottonwood seedlings (photo 0204, 9/28/2015)

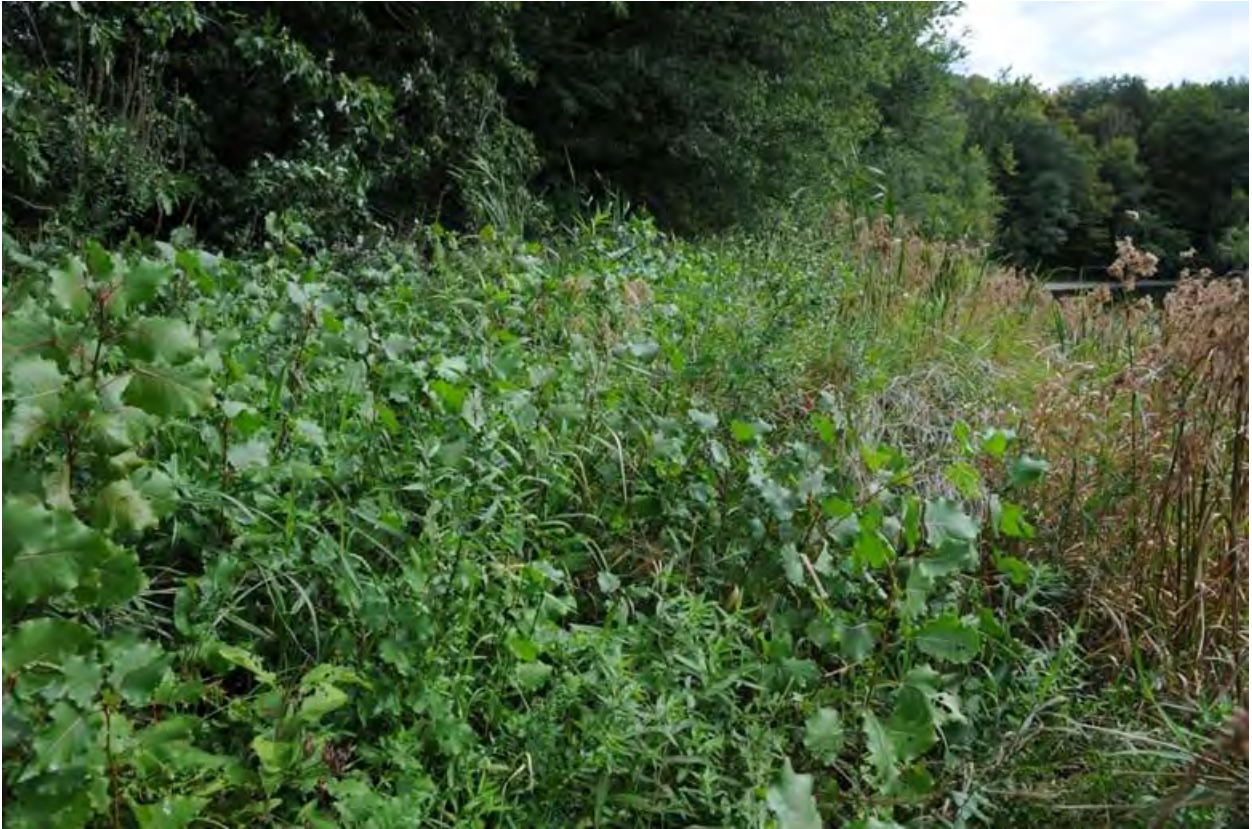
Figure J-4.7 Cottonwood seedlings (photo 0206, 9/28/2015)

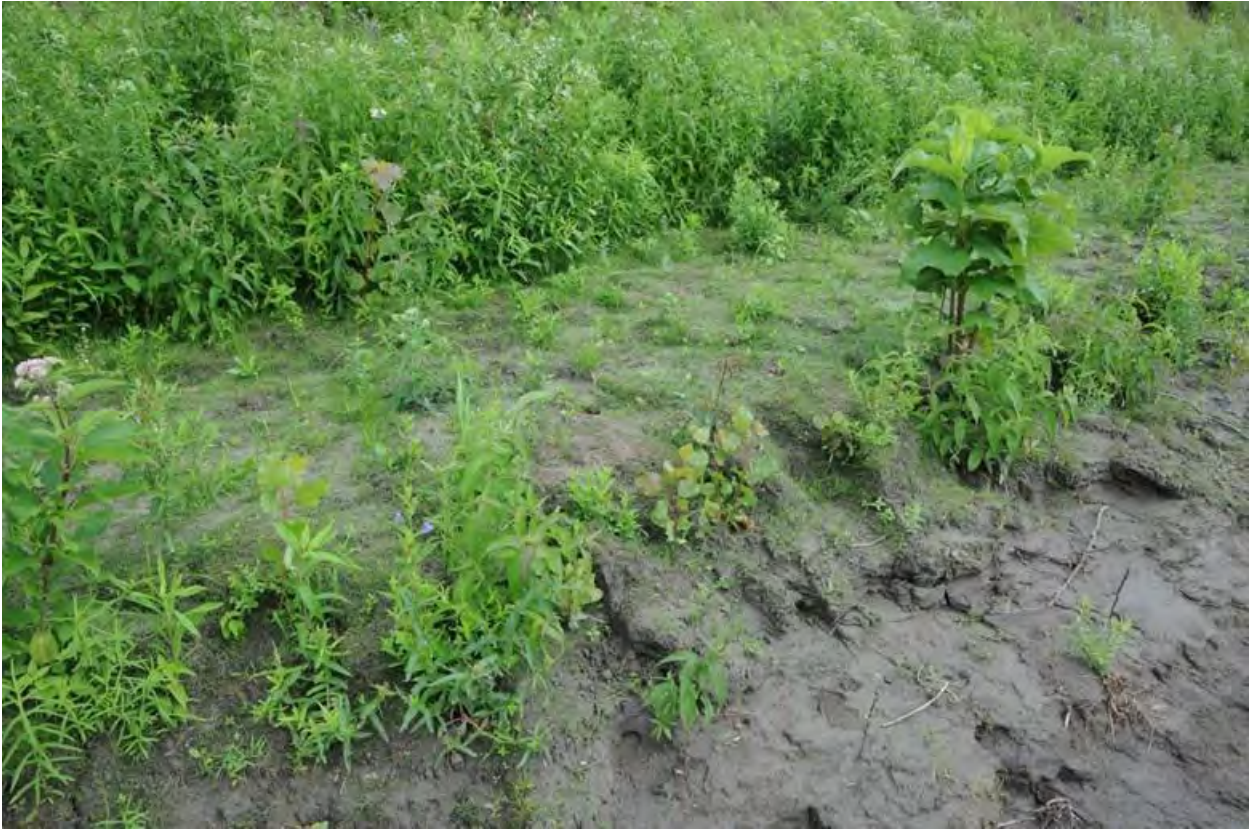
Figure J-4.9 Cottonwood seedlings (photo 6576, 7/15/2014)

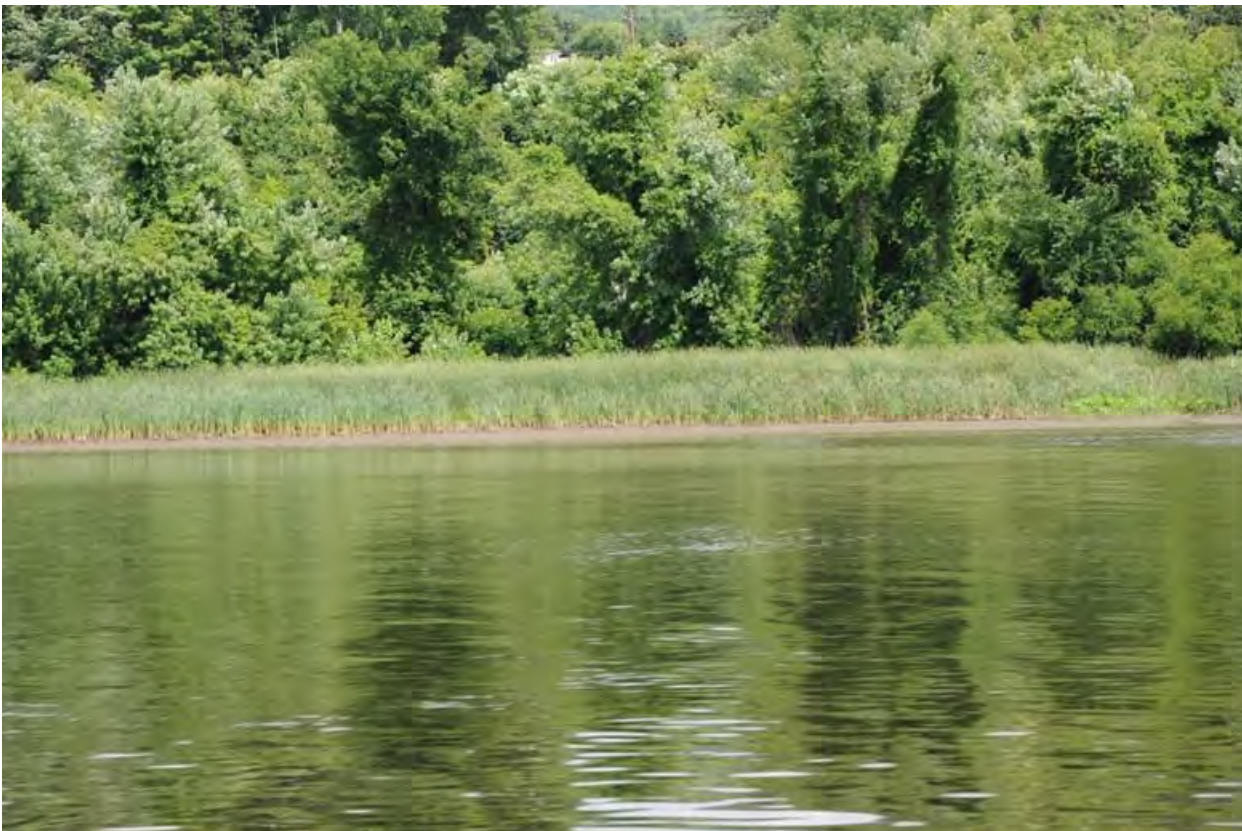
Figure J-4.11 Lower riverbank vegetation (photo 6779, 7/17/2014)

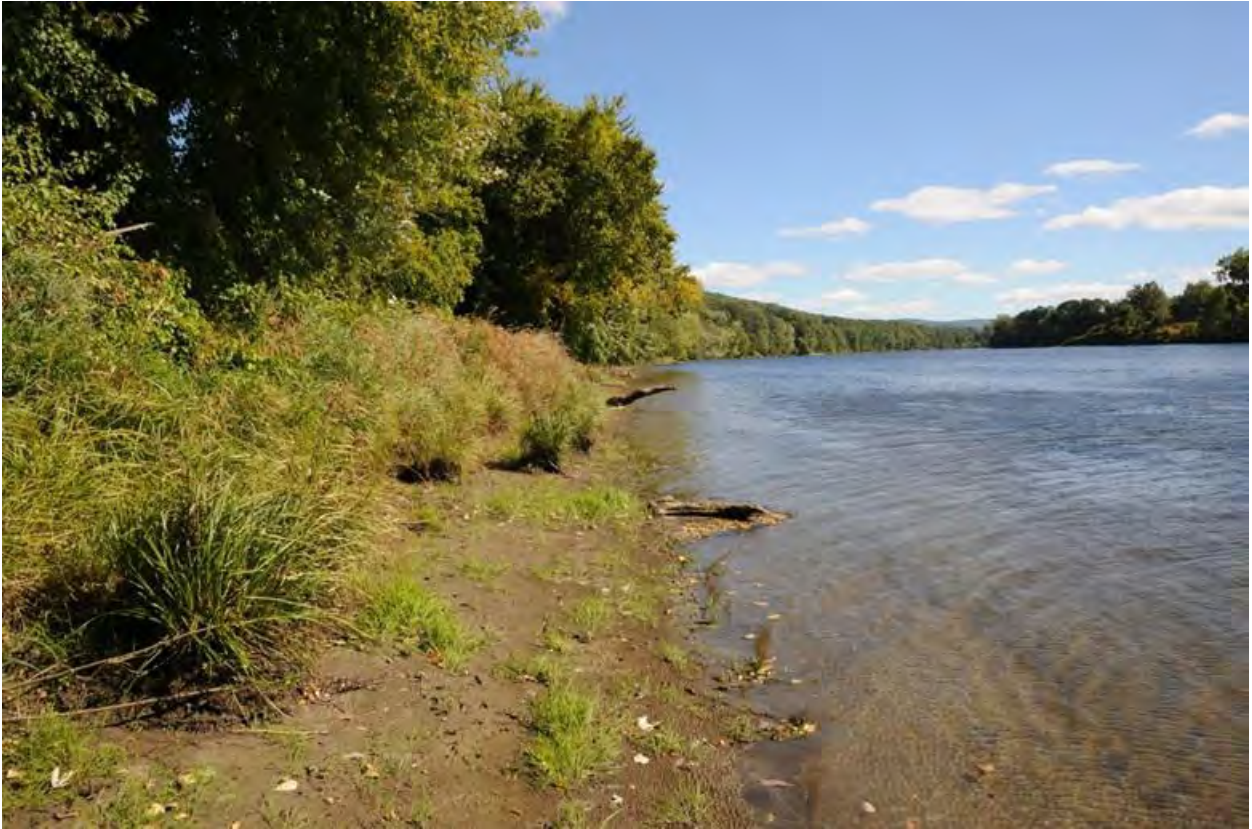
Figure J-4.13 Lower riverbank vegetation with seedlings (photo 9203, 9/22/2014)

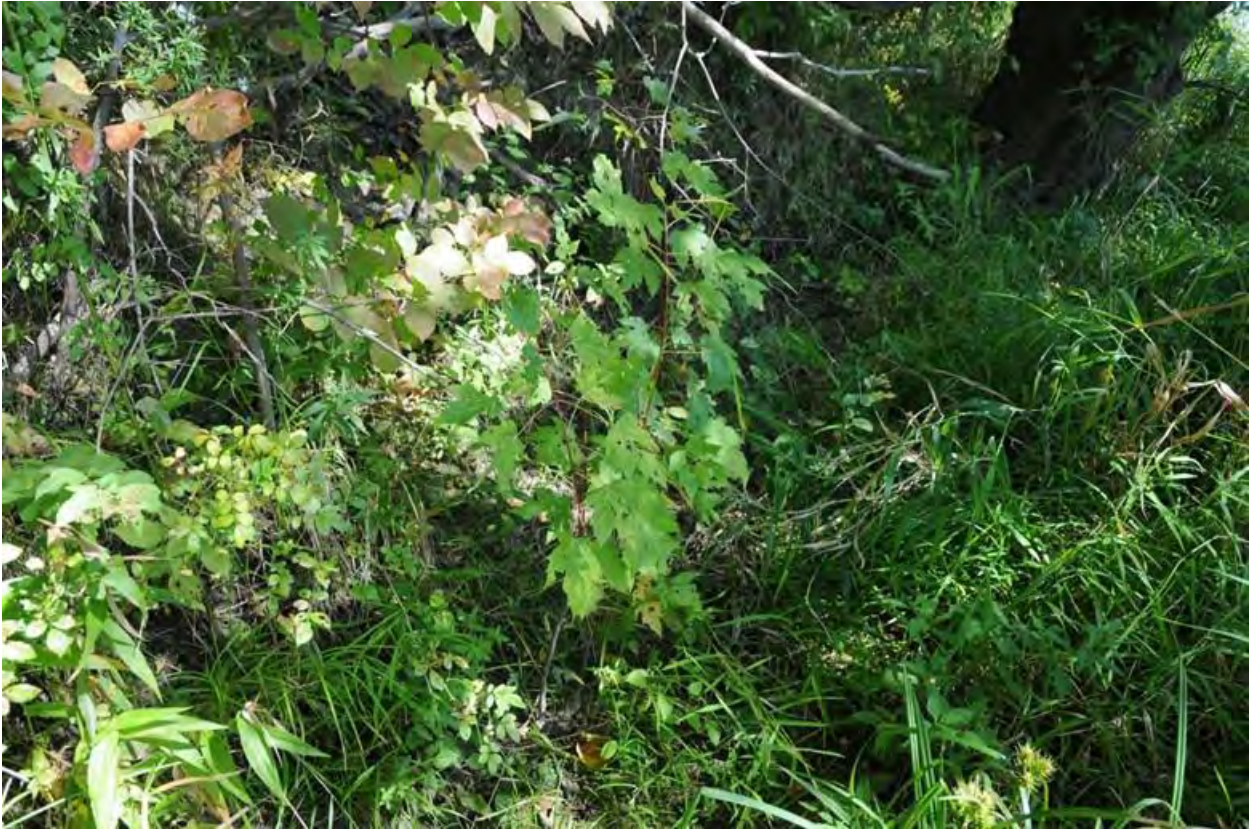
Figure J-4.15 Maple seedling (photo 9217, 9/22/2014)

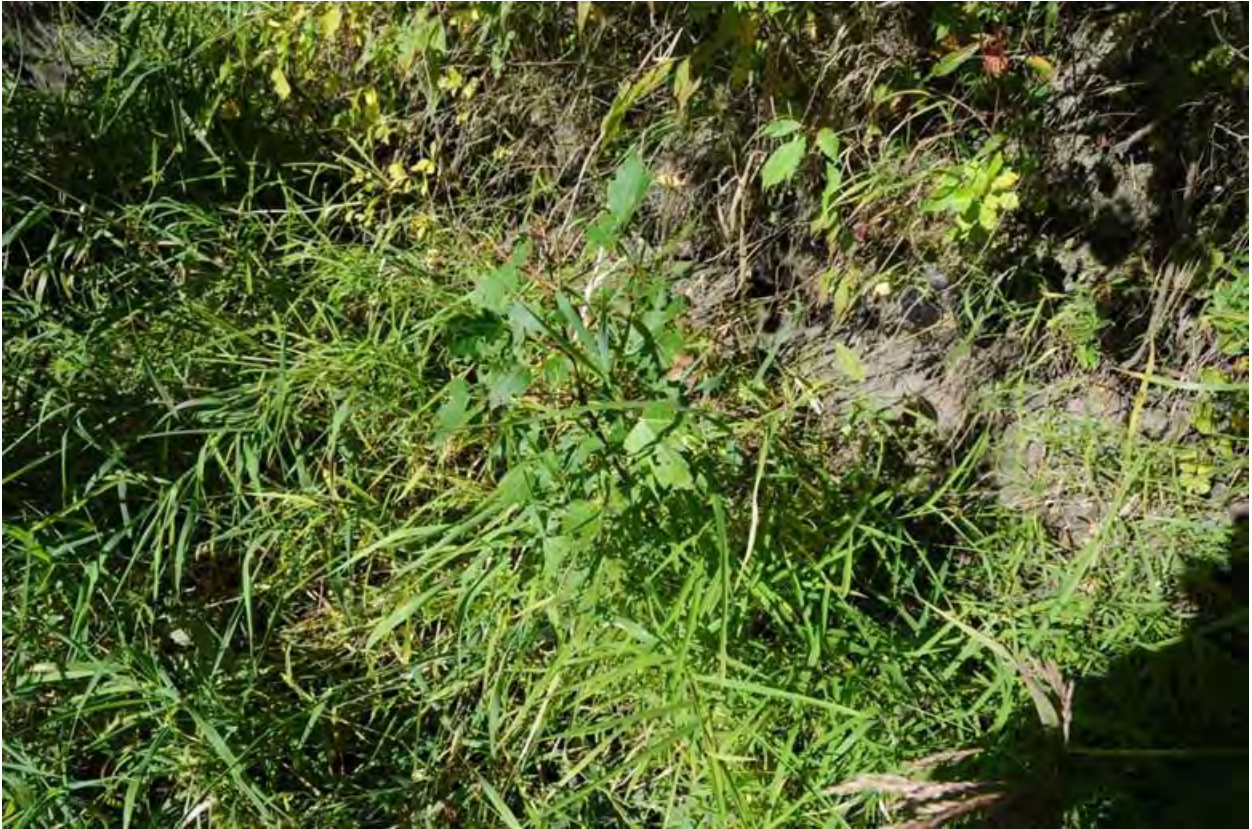
Figure J-4.17 Maple seedling (photo 9218, 9/22/2014)

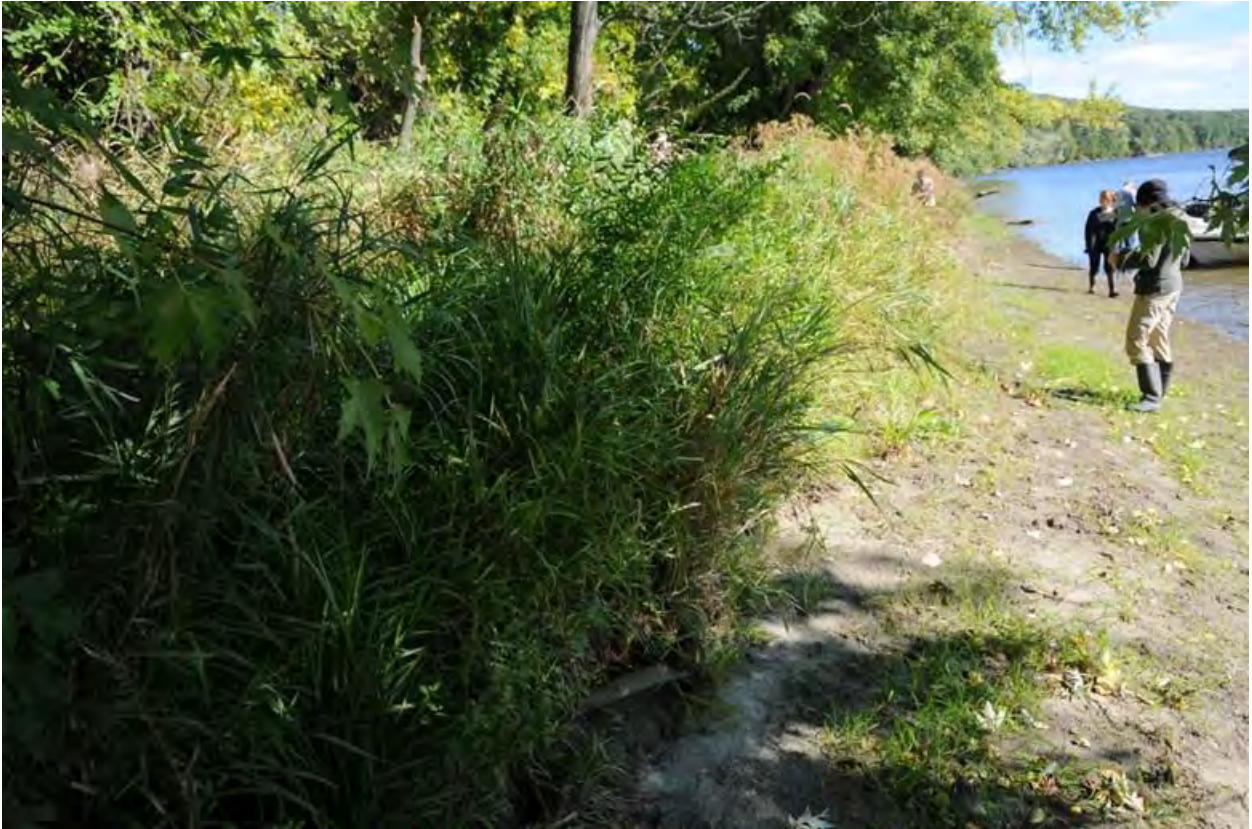
Figure J-4.19 Maple sapling (photo 9219, 9/22/2014)

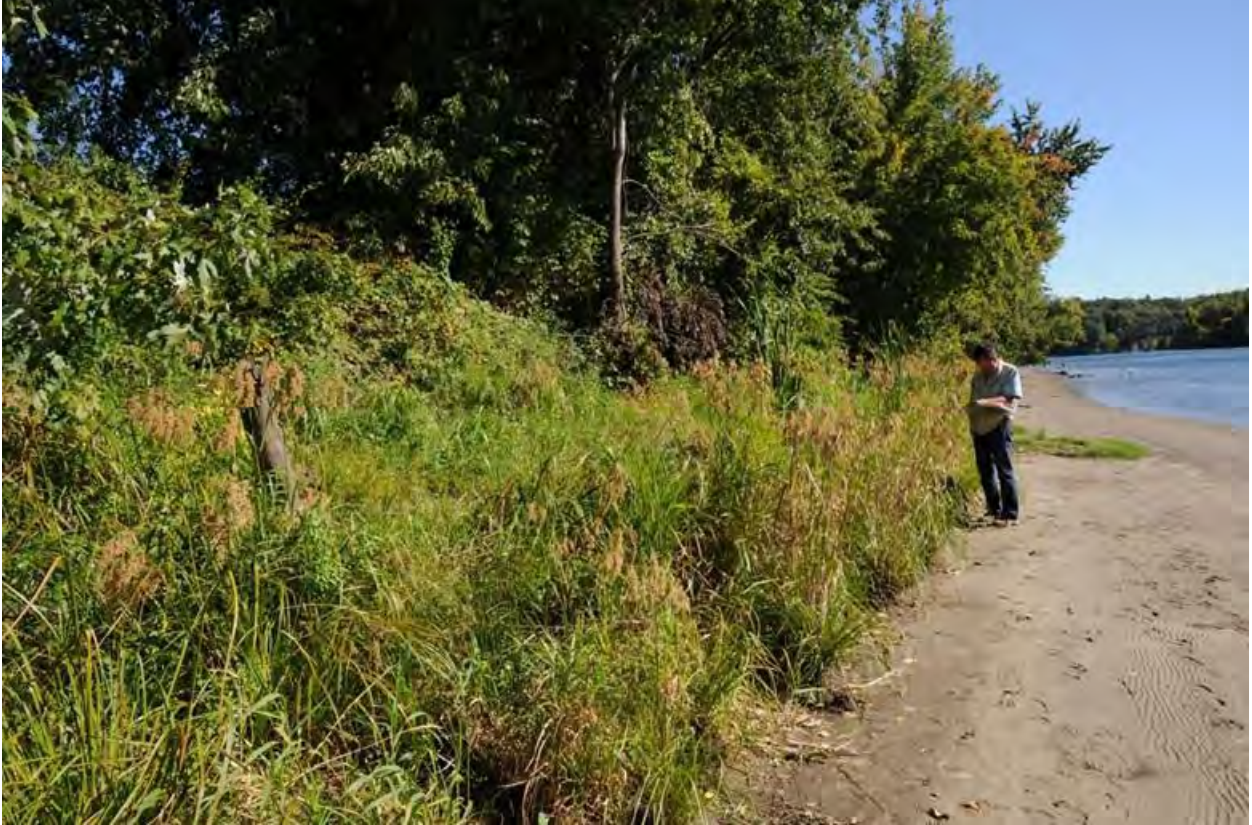
Figure J-4.21 Lower riverbank vegetation with seedlings (photo 9297, 9/23/2014)

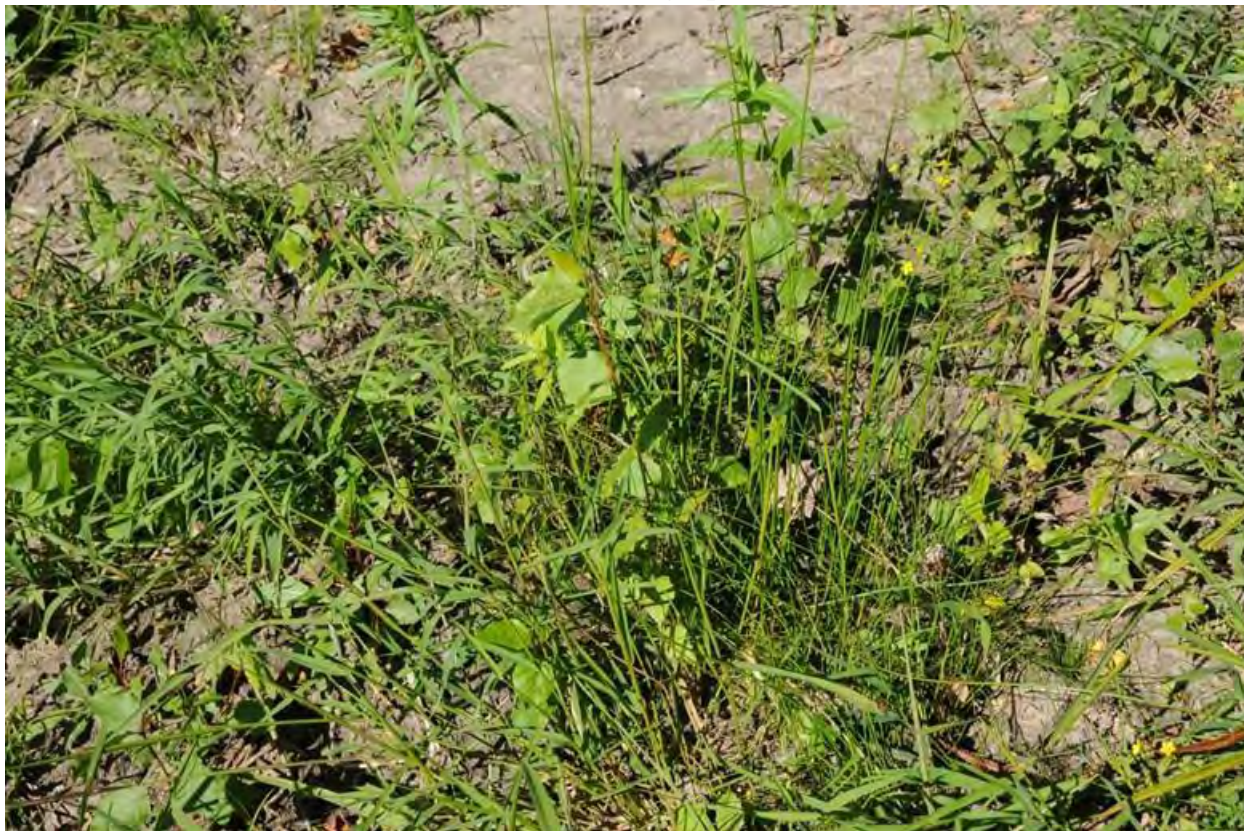
Figure J-4.23 Cottonwood seedlings (photo 9298, 9/23/2014)

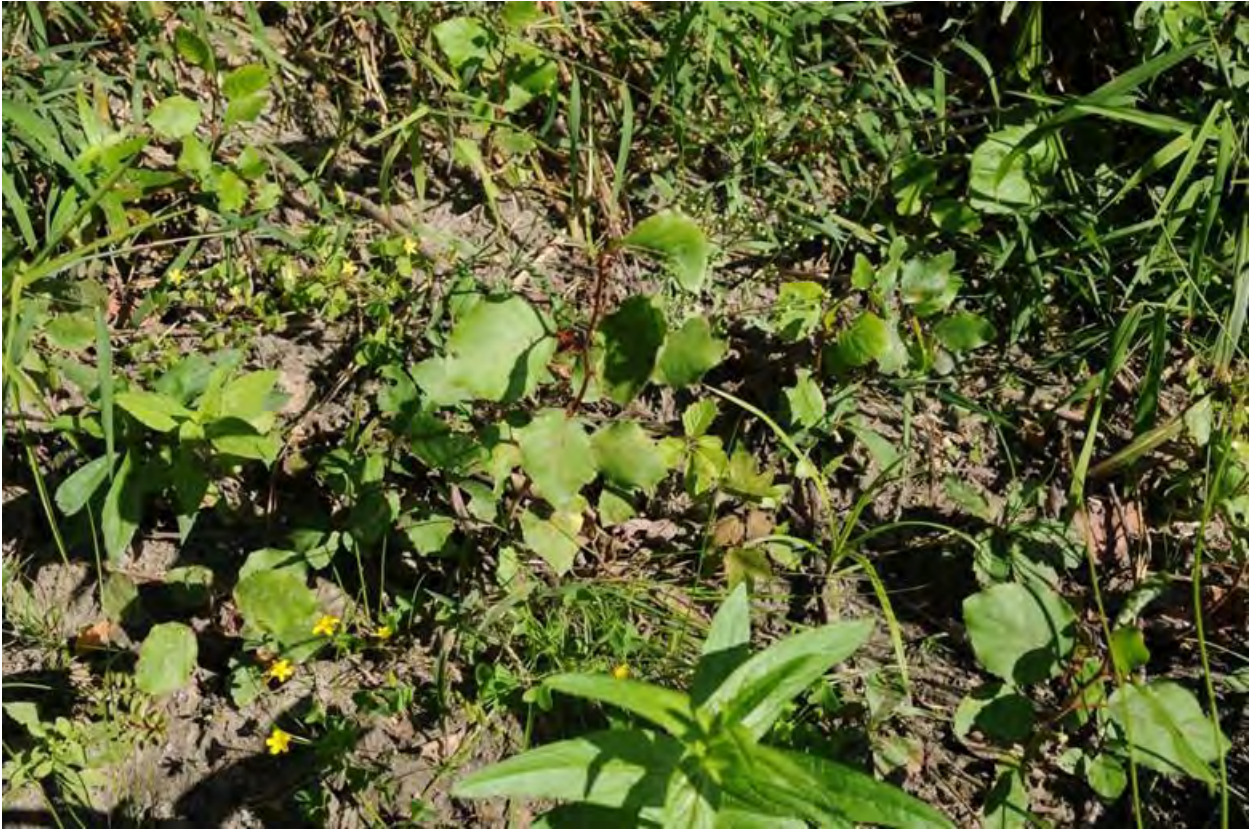
Figure J-4.25 Cottonwood seedlings (photo 9299, 9/23/2014)

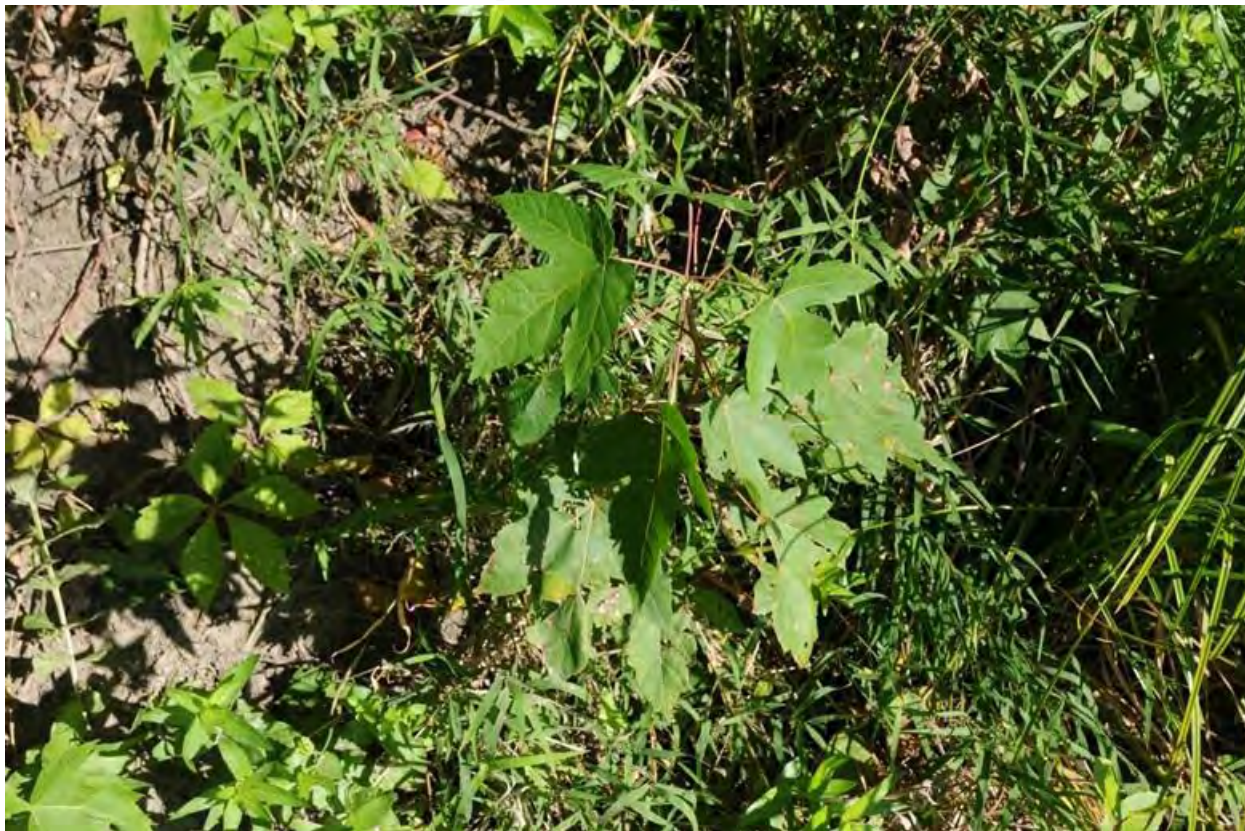
Figure J-4.27 Maple seedlings (photo 9300, 9/23/2014)

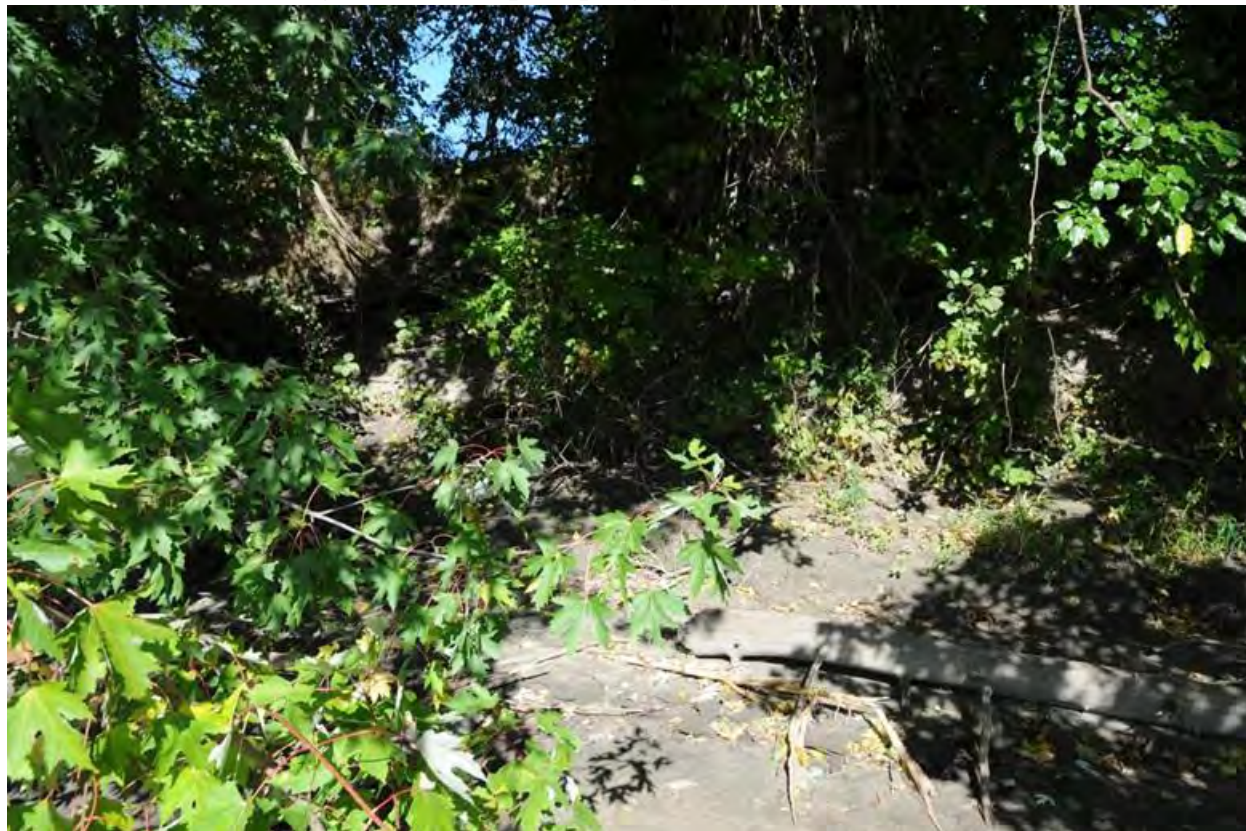
Figure J-4.29 Maple sapling (photo 9307, 9/23/2014)
