SHASS MOUNTAIN PEAT LANDSLIDE

Factual Report

MGE0780RP0001
Shass Mountain Peat
Landslide Factual Report
F01
16th October 2020

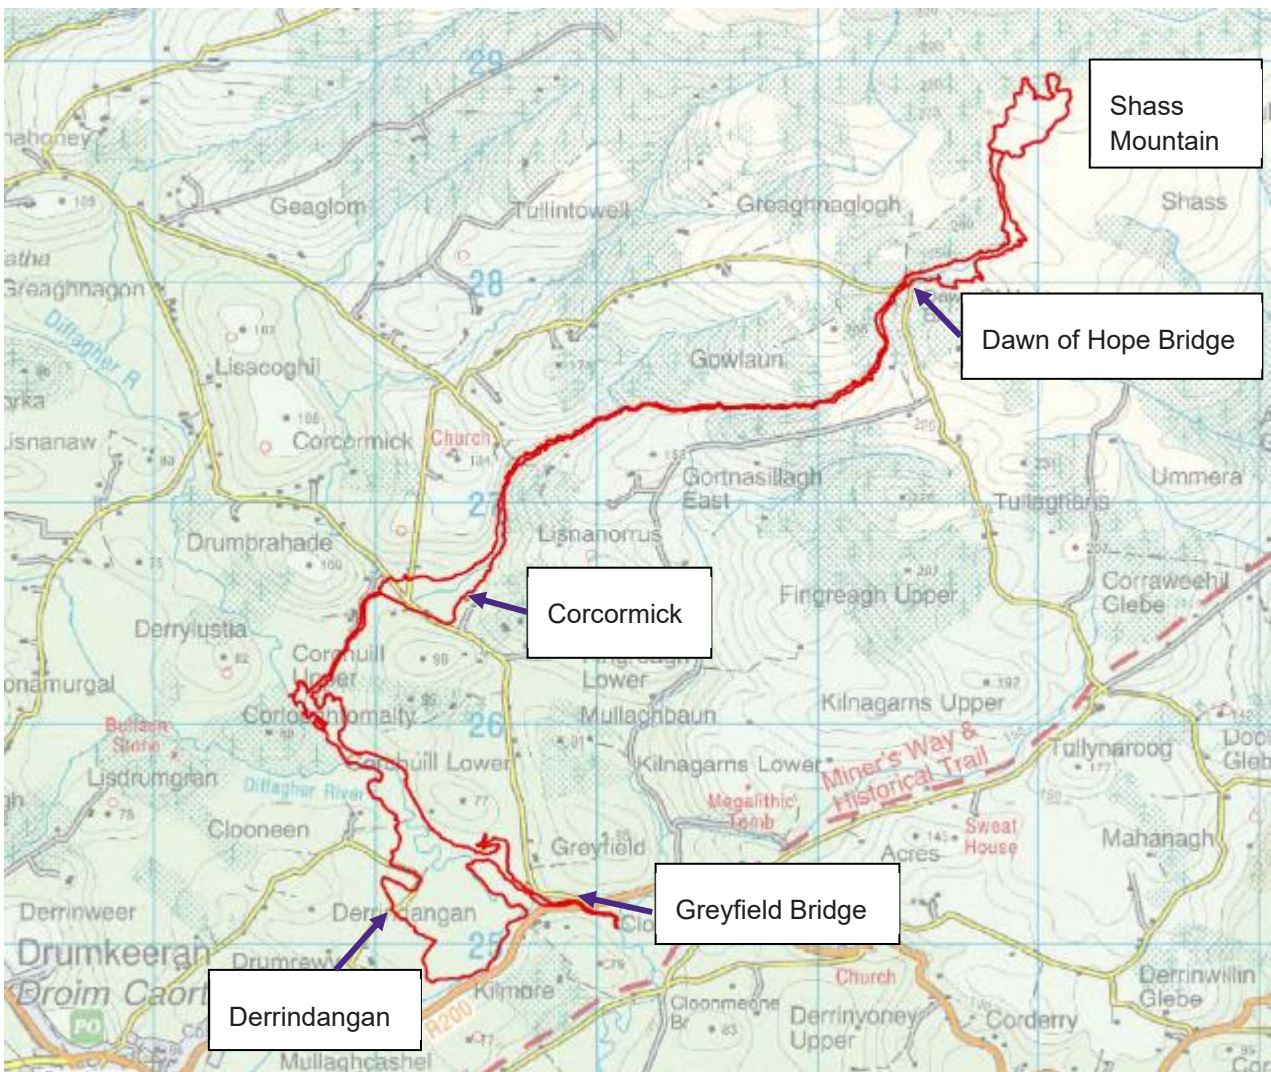
Figure 1-1 Extents of the Landslide

A blanket bog landslide occurred on Shass Mountain, north-east of Drumkeeran, Co. Leitrim on the 28th June 2020, approximately 1.2km upstream of the Dawn of Hope Bridge. The area affected by the peat landslide is shown in red outlined in **Figure 1-1**.

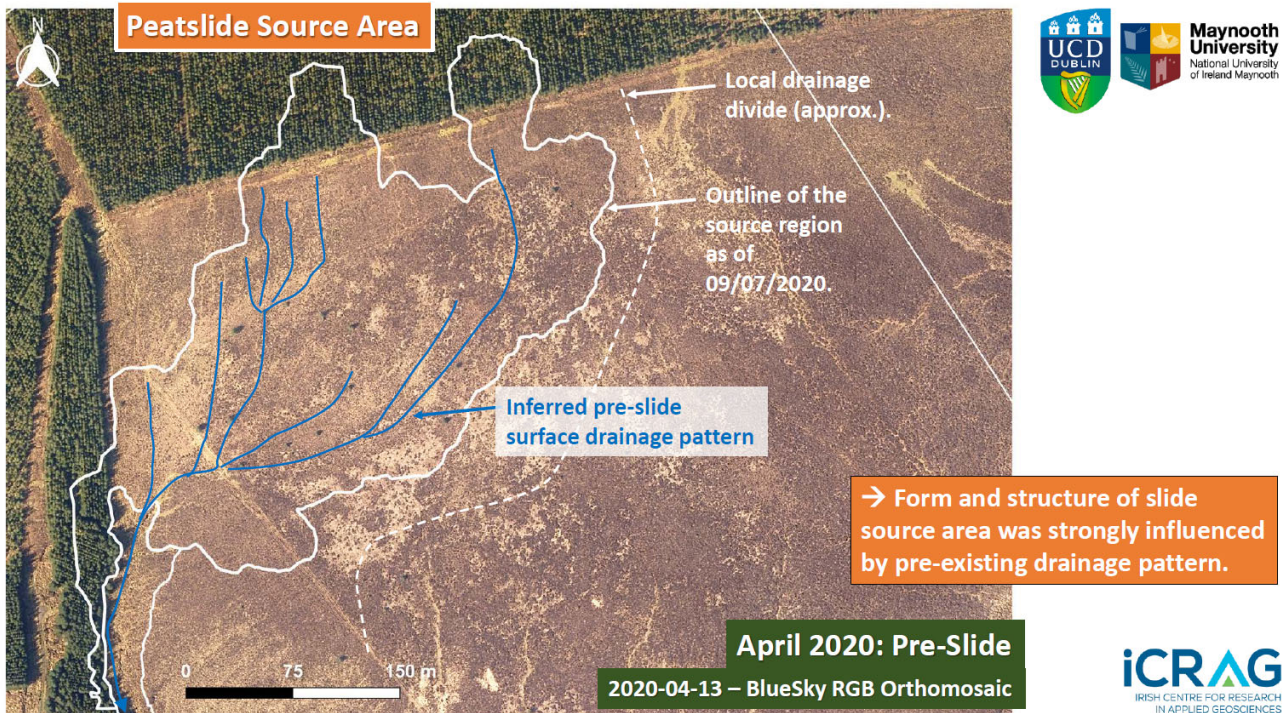
Figure 2-3 Drainage Patterns from iCRAG Research

Work carried out by the Irish Centre for Research in Applied Geoscience (iCRAG) shows the inferred pre-slide surface drainage pattern (**Figure 2-3**) which seems to converge on the area of the hypothesized slip area in **Figure 2-2**. The flow direction in the image is from north to south.

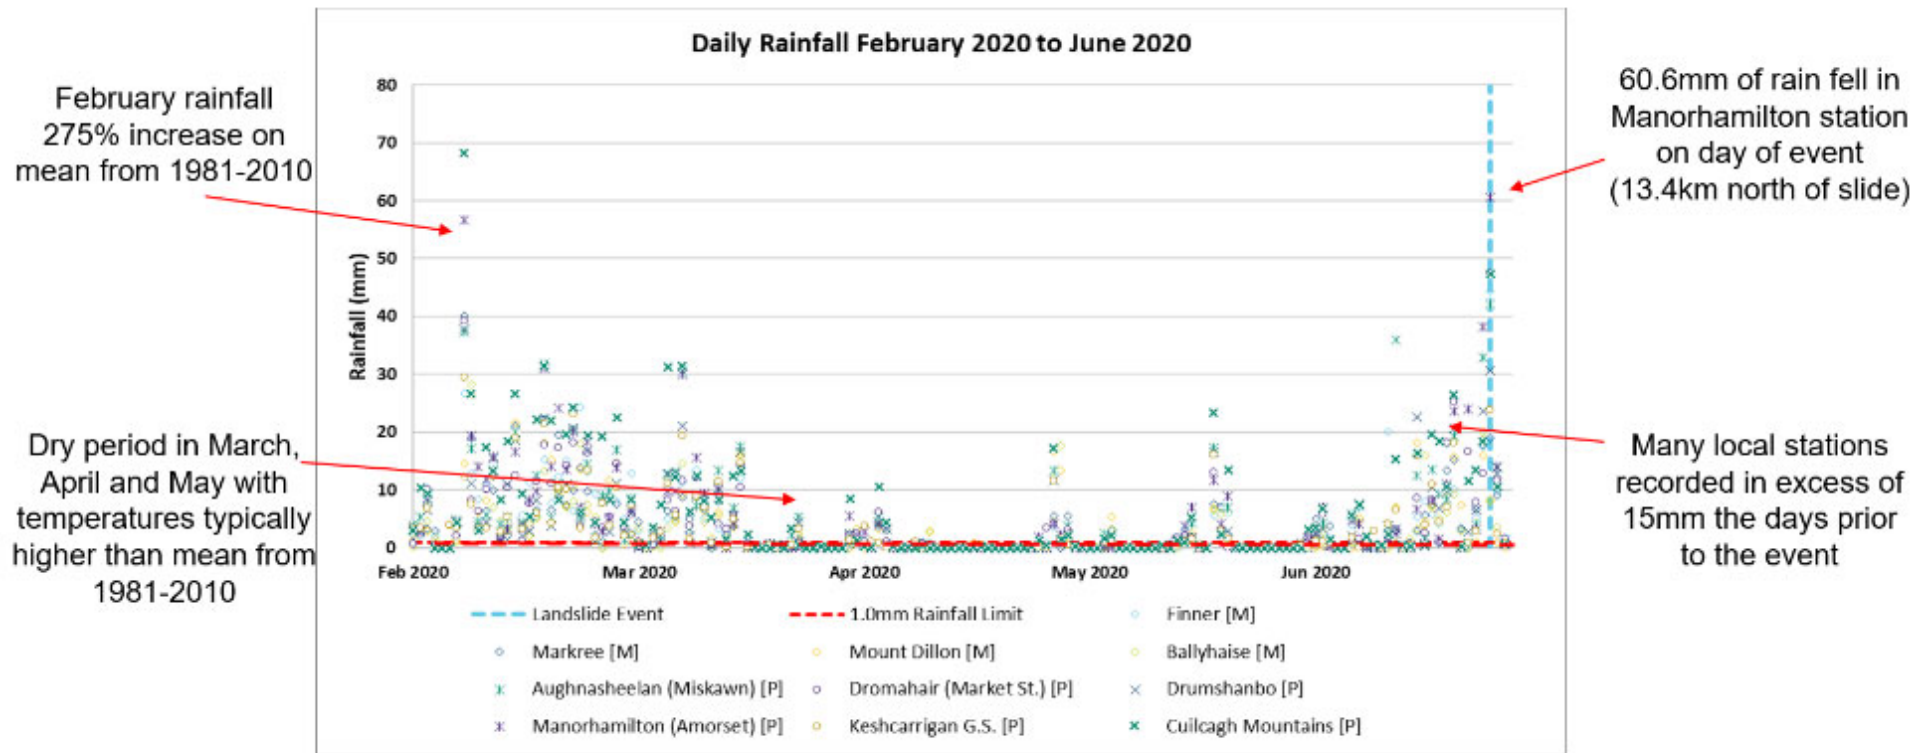
Figure 4-1 Daily rainfall data for February-June 2020¹

Figure 4-1 shows the daily rainfall recorded at the four Met Éireann and six third-party weather observing stations.

Relatively dry spells were recorded at all weather stations throughout the months of March, April and May, with 66 days recording 1.0mm of rain or less at both the Finner Camp and Mount Dillon stations, 68 days at Ballyhaise and 92 days at Markree. Met Éireann describes days with 1.0mm of rainfall or more as 'Wet Days'. The horizontal dashed red line on **Figure 4-1** indicates the 1.0mm limit. It can clearly be seen that there are many days in March, April, May and June that have less than 1.0mm of rainfall at all ten observations sites. The months of March, April and May also saw above average temperatures.

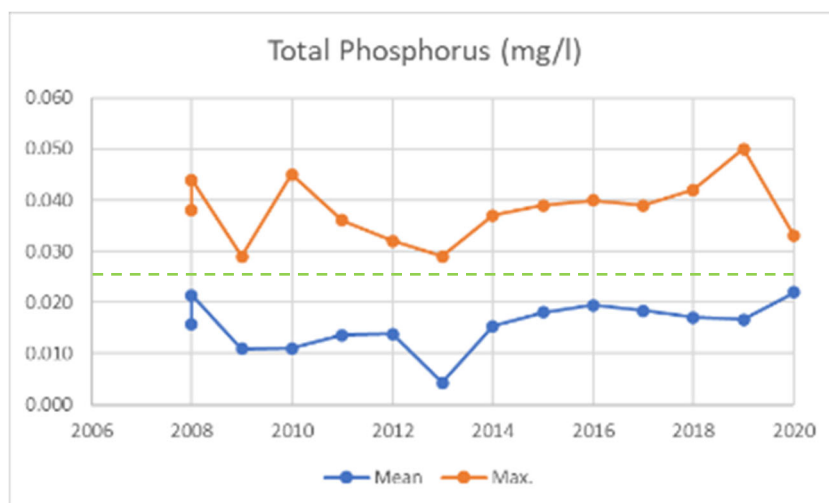
Figure C.10-1 Lough Allen: Total Phosphorous, P(mg/l), 2008-2020

Total-P: annual mean values 2008-2020 are all <0.025mg/l, meeting good status. A declining trend in TP (quality improvement) occurred between 2008 and 2011, but there has been an upwards trend (quality deterioration) since. A brief spike in TP max. occurred in late 2008 and in 2010, which perhaps corresponds (weakly) with a spike in chlorophyll max in 2011. It is difficult to determine if these spikes were related to inputs from the 2008 Owengar event. It's noted that similar spikes in TP max. and chlorophyll max. have also occurred in more recent years and cannot be directly linked to the 2008 Owengar event. The overall trend in mean TP was downward following the 2008 event, then steadily upwards since 2011.

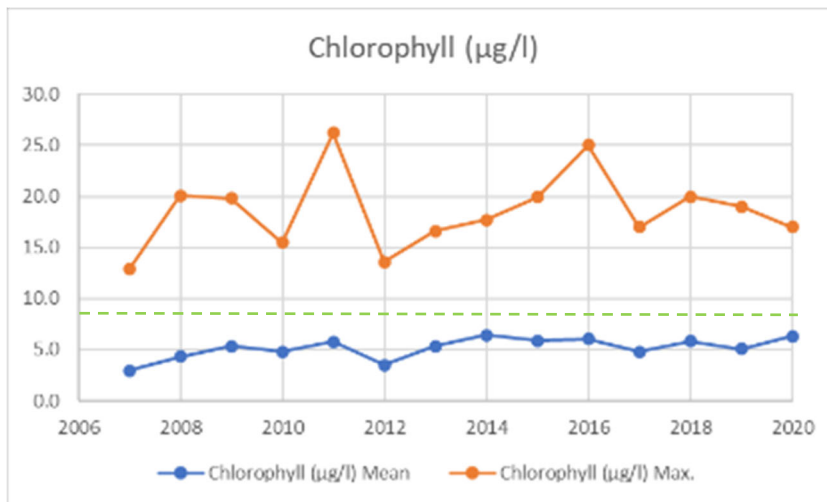
Figure C.10-2 Lough Allen: Chlorophyll a(ug/l), 2007-2020

Chlorophyll: annual mean values tend to show a slow but steady increase (quality deterioration) between 2008 and 2020, but remain within good status. Chlorophyll provides a useful indication of total nutrient level in the lake, with annual maximum values providing a clue into overall ecological quality. A notable spike in chl. max. occurred in 2011, in the 3rd year following the Owengar peat slide, but whether or not this was the sole cause of the spike can't be disentangled from this data. 2016 saw another spike in chlorophyll annual max. value, again the reason for that cannot be determined from the data.

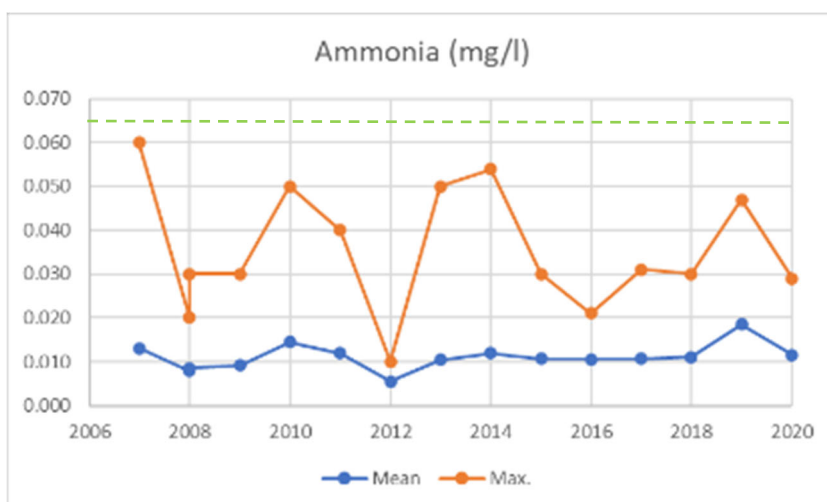
Figure C.10-3 Lough Allen: Ammonia as N (mg/l), 2007-2020

Ammonia trend: annual mean values show a steady, low trend, well within good status criteria. Even the annual maximum values are within good status.

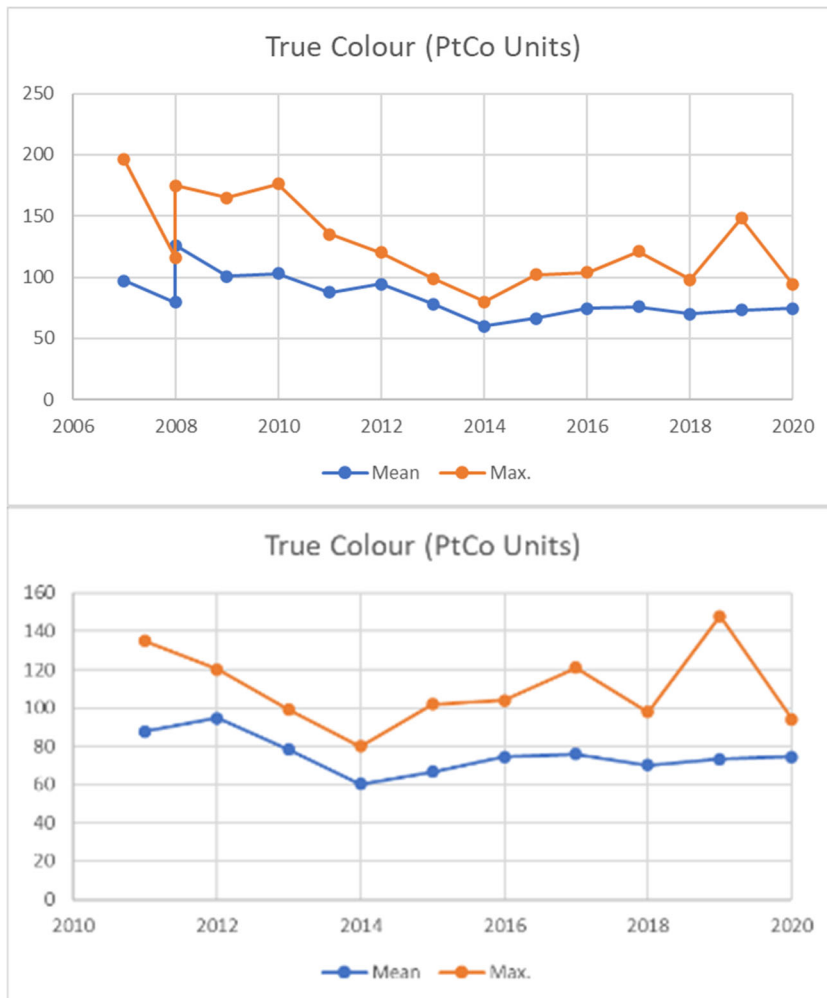
Figure C.10-4 Lough Allen: Tru Colour (PTCo units), 2011-2020

There was a notable spike in colour following the 2008 Owengar event, remaining elevated in mean and maximum values for two years after the event (until 2010). Water colour is a good proxy for dissolved humic substances (organic carbon) present in peat runoff. Figure C.4 shows a slow decline from 2010 to 2014 in mean annual colour to a more consistent, perhaps slightly increasing level, for remaining years from 2015 through to 2020.
