# A Review of Criticality Accidents

2000 Revision

**LA-13638**

**Issued: May 2000**

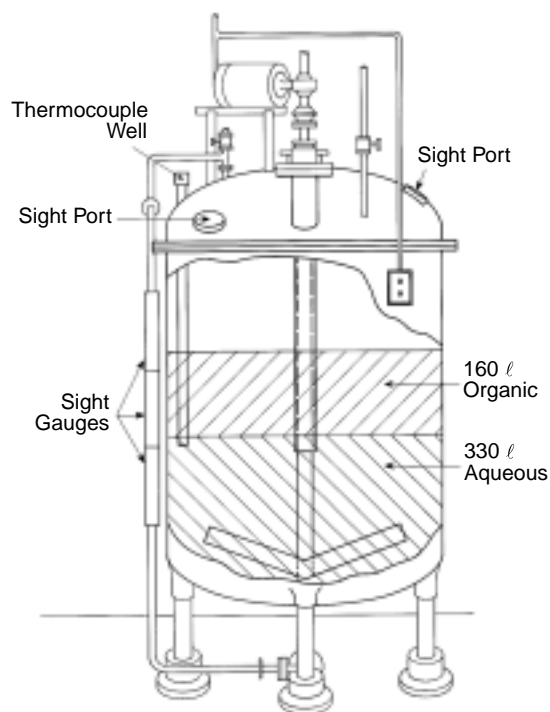
mixing of the layers. The average plutonium content in the fully mixed solution was 6.8 g/ℓ, a value less than the limiting critical concentration for an infinite homogeneous metal-water system.

From these time intervals and the estimate that initially the system was 5 \$ subcritical, the reactivity insertion rate would have been about 5 \$/s. Using coefficients appropriate for the solution, this insertion rate leads to a spike yield of  $2.2 \times 10^{17}$  fissions with the spike completed in 1.65 seconds, that is, 0.45 seconds after prompt criticality was reached. To obtain the observed yield ( $1.5 \times 10^{17}$  fissions) in a single spike, the reactivity insertion rate would have to be reduced to about 2 \$/s. Because this is inconsistent with the time involved (about 3 seconds before complete mixing), the only alternative is to assume that the rate was somewhat less than 5 \$/s and that the excursion was terminated in about 3 seconds by the stirring action. One can surmise that the initial action was thickening of the upper layer at the same time reflection was added by the aqueous liquid. This was followed almost immediately by distortion into a less critical, vortex-like shape by the action of the stirring blades and then permanent shutdown due to a uniform concentration of less than 7 g/ℓ.

Figure 11. Configuration of solutions (aqueous and organic) in the vessel before the accident.

The entire plutonium process area had been reviewed by the Laboratory's Nuclear Criticality Safety Committee about a month before the accident. Plans were underway to replace the large-volume process vessels with a bank of more favorable geometry, limited diameter pipe sections (6 inches in diameter by 10 feet long each). Administrative controls that had been used successfully for more than 7 years were considered acceptable for the additional six to eight months that would be required to obtain and install the improved equipment.

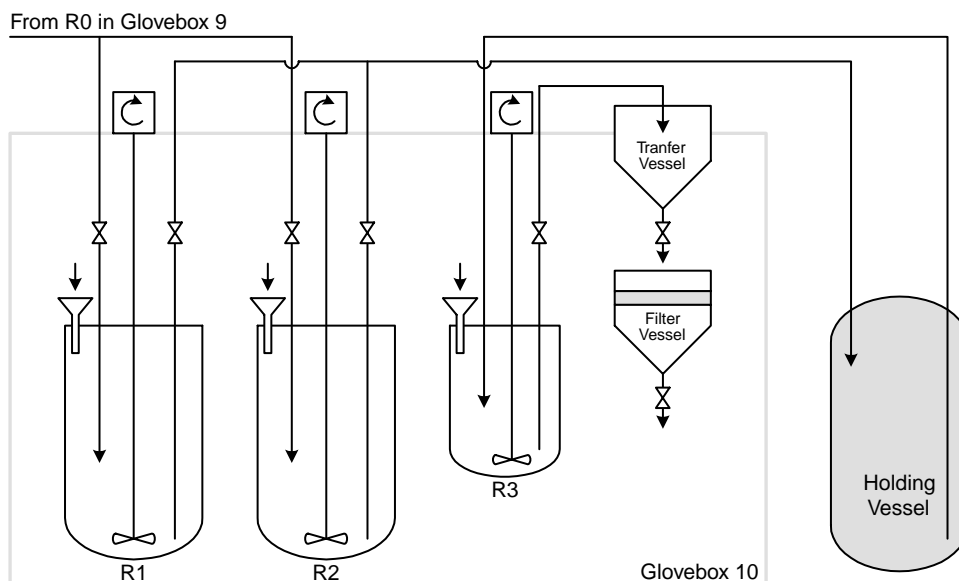
Figure 13 (not to scale) shows the five vessels located in glovebox 10 and the holding vessel located outside but connected directly to vessels inside the glovebox. Table 4 lists the seven vessels related to the reconstruction of the accident, along with their locations, dimensions, and function in the recovery operation. The operation began with a transfer of plutonium nitrate waste solution to vessel R0 in glovebox 9 where the first purification step was performed. This involved an oxalate precipitation of the plutonium, followed by a decanting of the supernatant liquid containing the impurities as well as some plutonium, and then re-dissolution of the plutonium into a carbonate solution. The end product from R0, the plutonium carbonate solution, was then transferred to either vessel R1 or R2 in glovebox 10 for the second purification (oxalate precipitation, supernatant decanting, re-dissolution) step. Vessels R1 and R2 were identical in dimensions and functions and were operated in parallel to increase productivity. The end

Figure 13. Layout of vessels in Glovebox 10 and the holding vessel external to the glovebox.

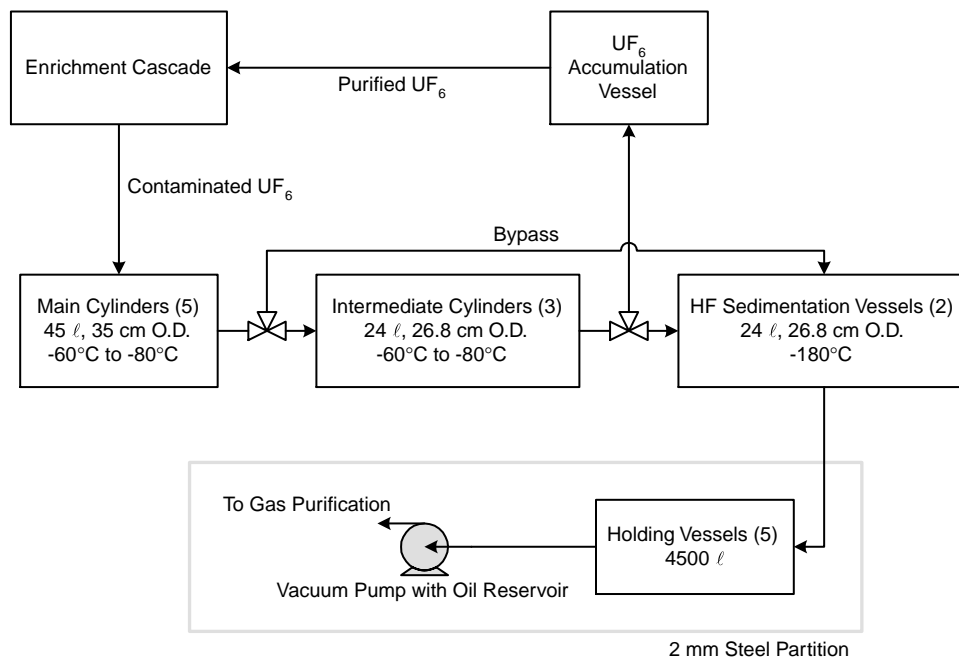
The initial  $UF_6$  sublimation, introduction into the cascade, intermediate purification, and its final desublimation to the solid phase (in cylinders) was conducted in desublimation/sublimation stages (DSS). DSS-6 (Figure 14), occupied a large room (7.2 by 18 m) and was an intermediate purification stage (the enrichment was 22.6% by weight at this point in the cascade). This stage was used to remove contaminants such as air and excess hydrogen fluoride (HF) from the  $UF_6$ . This process was accomplished by

Figure 14. Layout of DSS-6.

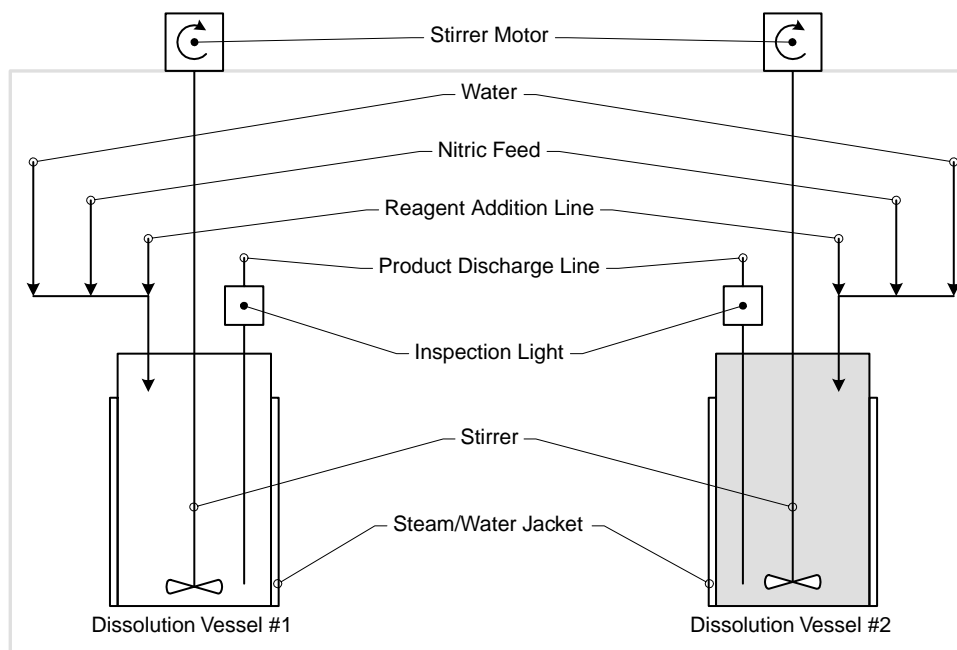
The first step in the recovery process was to dissolve the slag and residues in nitric acid. Typically five cans of residue were combined as the feed for a dissolution batch; procedures limited the number of cans to six. The glovebox used for this had two identical dissolution vessels, shown in Figure 17. While not bearing on this accident, it is interesting to note that this glovebox was an early, conservative design; it was made of 8 mm thick steel and had 50 mm of lead shielding.

Figure 17. Layout of glovebox equipment.

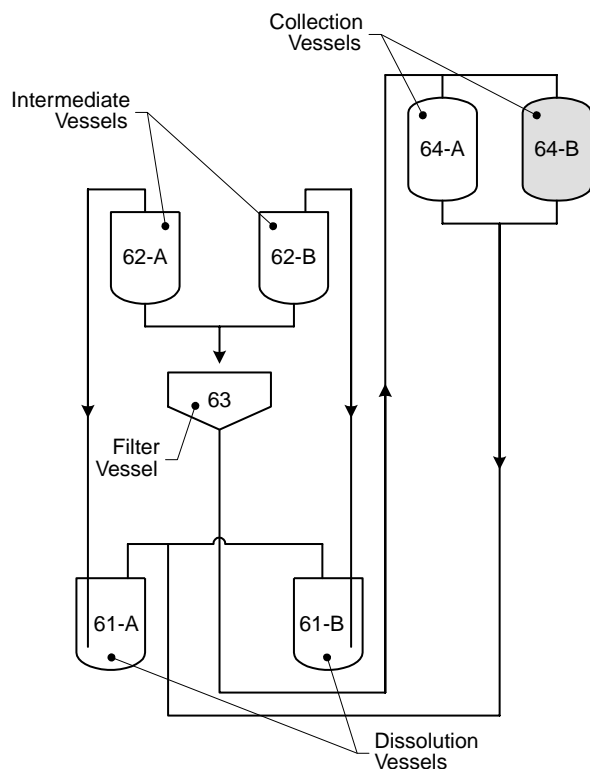
Using the erroneous work orders, an operator loaded 2 kg of precipitate from one container and 5 kg from another into dissolution vessel 61-A, believing the total uranium content to be 126 g when it was actually about 1,260 g. Because of a shift change, a different operator completed the dissolution process. The solution was then filtered and transferred to collection vessel 64-A, where a sample was taken to determine the concentration. Later during that same shift, the operator asked for the sample results by telephone. While this normally would have led to the discovery of the original recording error, the laboratory erroneously reported the results for a vessel other than 64-A. By an unfortunate coincidence, this other vessel contained solution with a uranium concentration 10 times lower than that in 64-A, thus reinforcing the operator's expectations.

The supervisor for the second shift, relying on this erroneous information, decided to recycle this supposedly low concentration solution to dissolve the next batch of dry precipitate. This next batch, still subject to the original recording error, contained ~1,255 g of uranium, about the same as that of the preceding batch. The dry precipitate was loaded into dissolution vessel 61-A and then the solution from collection

Figure 18. Process vessels and material flow diagram.

vessel 64-A was added. The dissolution vessel thus had over 2,500 g of uranium, an amount close to the unreflected critical mass for this diameter vessel. The solution was then filtered in 10 ℓ batches and transferred to the larger diameter collection vessel 64-B. In the course of this filtering/transfer operation, the solution exceeded the critical height in 64-B, and the first excursion occurred at 18:10 on 30 January 1963. The criticality alarm system sounded and all personnel evacuated. The  $\gamma$ -ray detectors were set to activate at 110 mR/h. Several of the personnel were directed to undergo medical assessment.

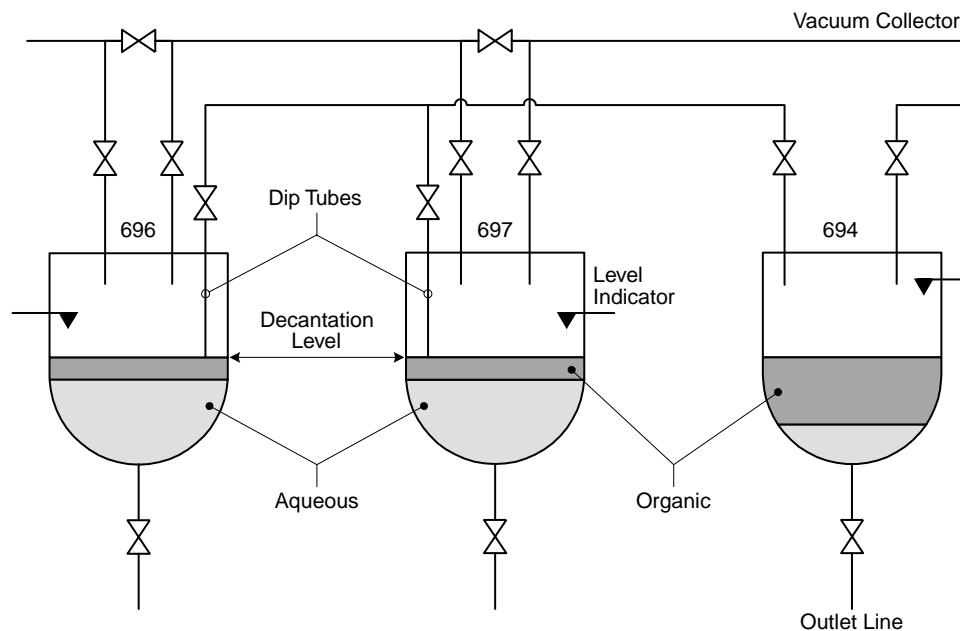
When these vessels were installed, it was believed that only high conductivity aqueous solutions would accumulate in them. However, because organics such as tributylphosphate were transferred in this facility using this same vacuum system, considerable amounts of organic solution were in fact also ending up in these vessels. The very low electrical conductivity of these organic solutions was insufficient to actuate the level indicators.

Figure 19. Schematic of vessels showing organic and aqueous solutions (not intended to imply the exact conditions at the time of the accident).

Because the organic solution was much less dense than the aqueous solution, the liquids separated into different layers within the vessels. Since the organic solution did not actuate the level indicators, it could continue to accumulate until the level of aqueous solution was sufficient to trigger a transfer. In addition, as aqueous solution entered the vessels it would temporarily mix with the organic solution. This caused a portion of the fissile material in the aqueous solution to be extracted into the organic layer, thus increasing its fissile material concentration.

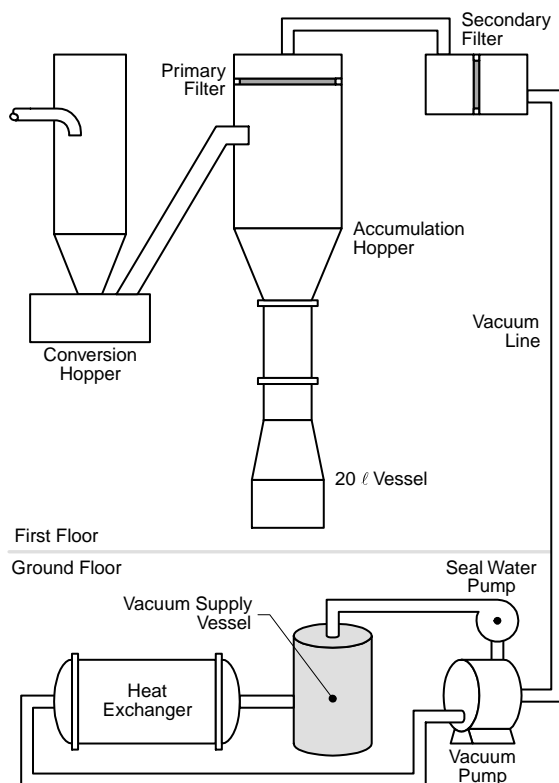
Figure 20 is a layout of the Building 242 uranium hexafluoride to uranium oxide conversion system and associated vacuum system. The uranium hexafluoride was burned in a hydrogen-air atmosphere in the conversion hopper. The resulting uranium oxides were collected at the bottom of the conversion hopper and then transferred by vacuum to the accumulation hopper. The vacuum system was then switched off and the oxides were loaded into geometrically favorable 20 ℓ vessels by gravity. The vessels were then transferred from Building 242 to another location where the oxides underwent defluorination and complete reduction to  $UO_2$  in a rotating calcination furnace.

On 3 November 1965 at 11:10, the criticality accident alarm system sounded in Building 242. All personnel in Building 242 immediately evacuated. The alarm systems of the adjacent buildings did not activate. The facility's chief physicist made the first re-entry into Building 242 about 50 minutes after the building had been evacuated. Using a portable gamma-ray detector, he quickly determined that an accident had occurred in the vacuum supply vessel. At this time he recorded a gamma exposure rate of 3.6 R/h at a distance of 1.5 m from the surface of the vessel.

Figure 20. Layout of  $UF_6$  to uranium oxide conversion equipment and associated vacuum system.

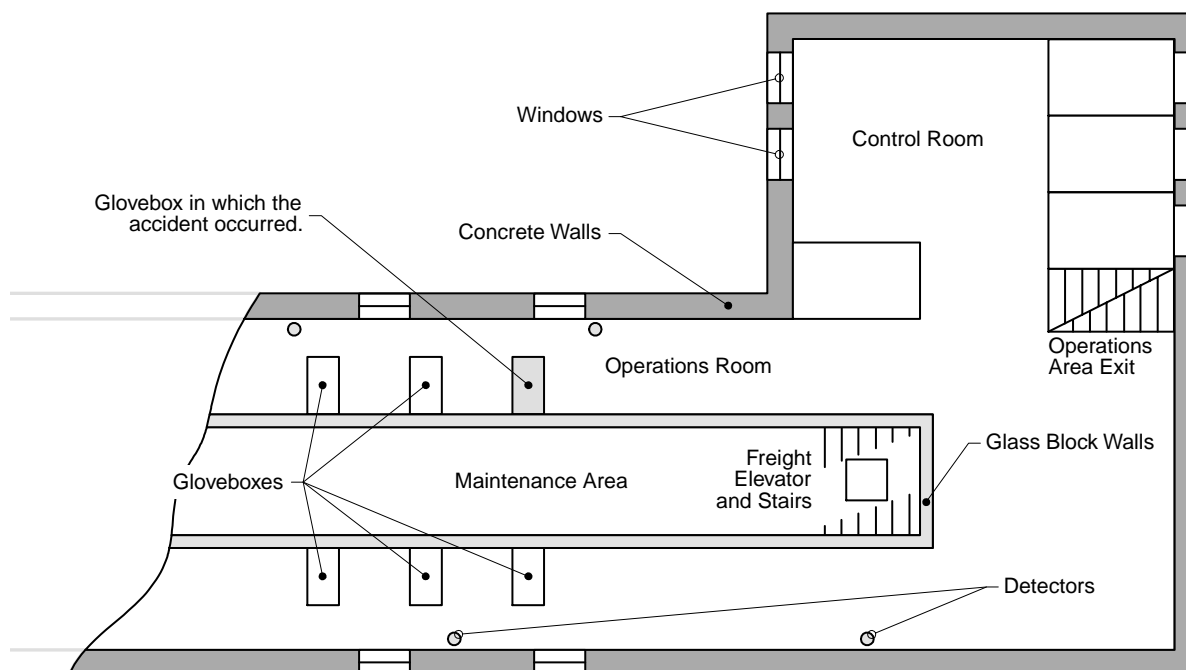
This accident occurred in a residue recovery area of a metal and fissile solution processing building. The residues being recovered were produced from dissolution, precipitation, and reduction processes. A schematic of the residue recovery area is shown in Figure 21. The residues, which were difficult to dissolve, were first calcined to convert the uranium content, usually less than 1% by weight, to  $U_3O_8$ . Residues with abnormally high uranium content, which were occasionally generated (failed castings, cracked crucibles, etc.), were directed by operating procedures to other handling areas subject to special requirements.

Figure 21. Residue recovery area layout.

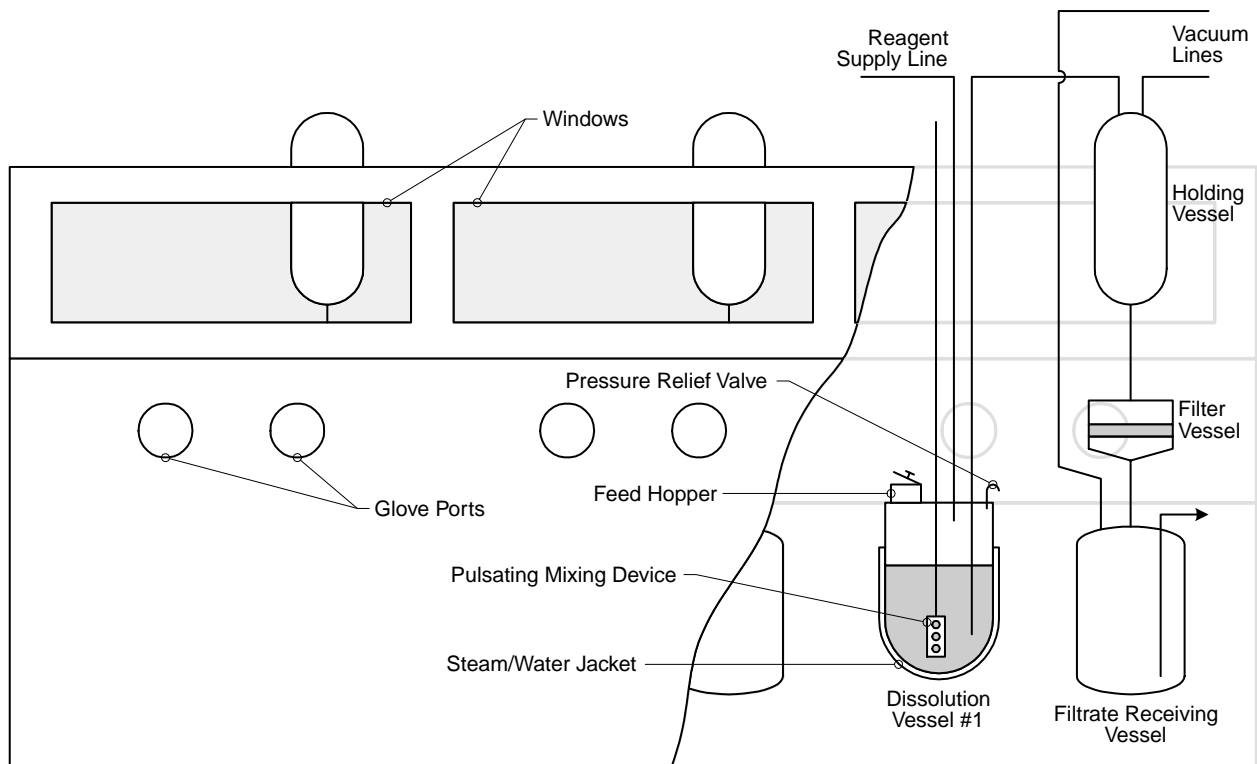
The residue dissolution glovebox where the accident occurred had three identical sets of process equipment as shown in Figure 22. Each set was equipped with a cylindrical dissolution vessel, a holding vessel, a filter vessel, and a filtrate receiving vessel. The dissolution vessels had elliptical bottoms, were 100 l in volume, and 450 mm in diameter, and were equipped with a pulsating device for mixing, a flat cover plate with a feed hopper, and a pressure relief valve. Heating of the dissolution vessels was accomplished with a 25 mm thick, steam-water jacket. Solution was moved within the system through a transfer line by drawing vacuum.

Figure 22. Layout of dissolution glovebox.

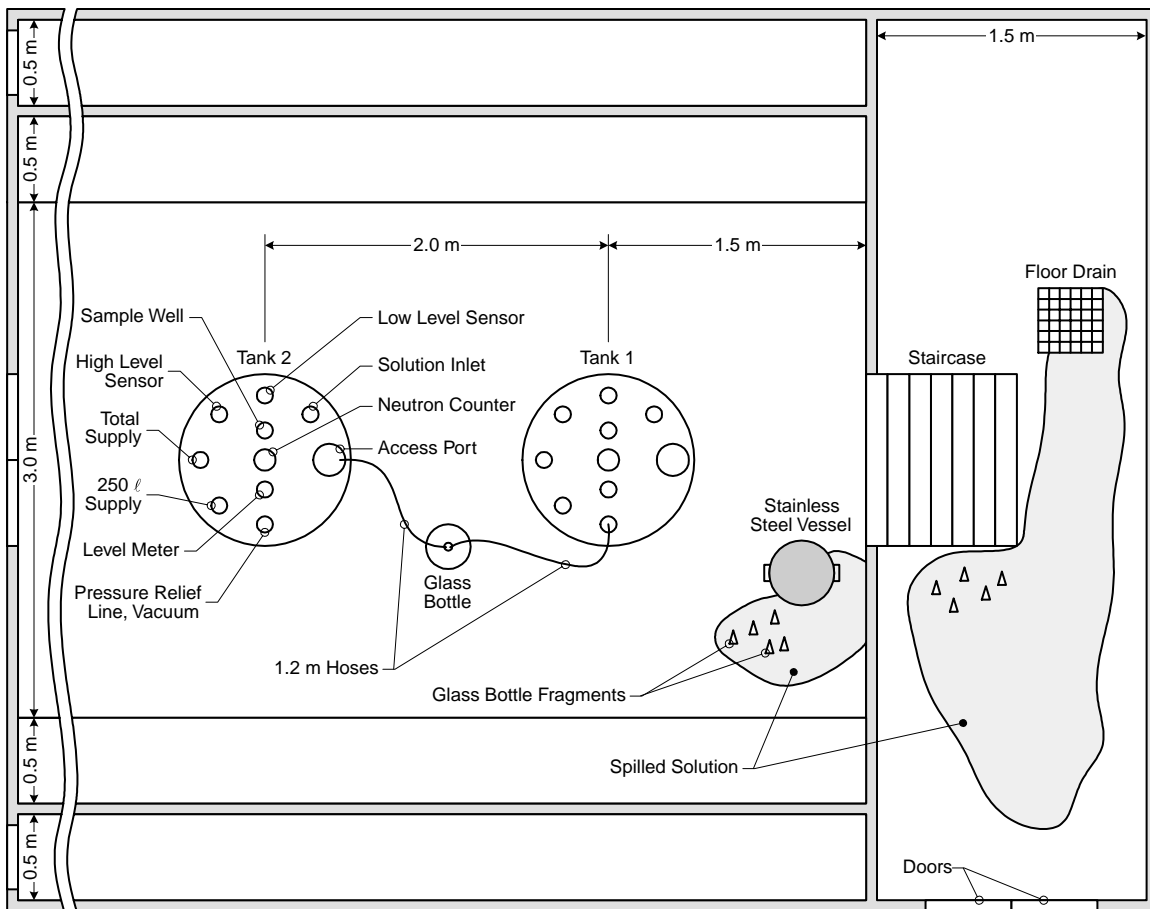
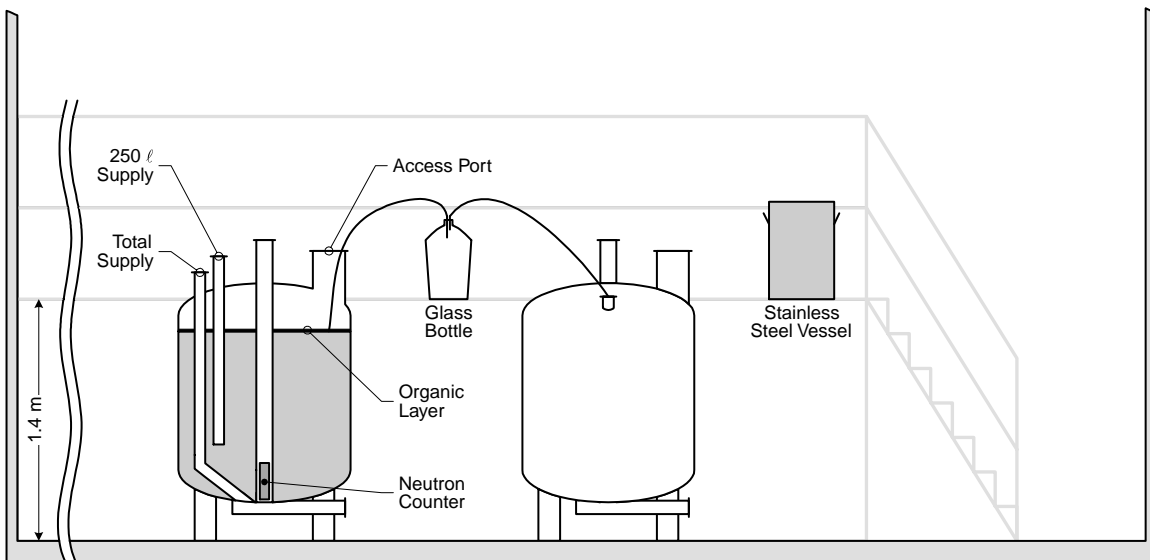
Figures 23 and 24 show plan and elevation views of these tanks, and the other vessels involved in the accident by their location in the basement room. Each tank had an operating volume of 800 ℓ. Each was equipped with neutron detectors located near the bottom to monitor the plutonium concentration and to detect any sediment accumulation.

The temporary arrangement of equipment used to remove the organic solution from tank 2 is shown in Figures 23 and 24. Two reinforced rubber hoses, 1.2 m in length and 13 mm in internal diameter, were fixed into the neck of a 20 ℓ glass bottle (usually used for chemical reagents) with a cloth plug. One hose was connected to the vacuum line on tank 1 and the other was lowered into tank 2 through its access port. If the 20 ℓ bottle became full, it was decided that the contents would be poured into a 60 ℓ vessel usually used for the collection of very low concentration wastes before reprocessing. The bottle and vessel were placed on the platform above tanks 1 and 2. The use of these types of temporary, improvised, setups as well as the use of unfavorable geometry vessels were strictly prohibited by existing regulations.

Figure 23. Plan view of the tanks involved in the accident.

Figure 24. Elevation view of the tanks involved in the accident.

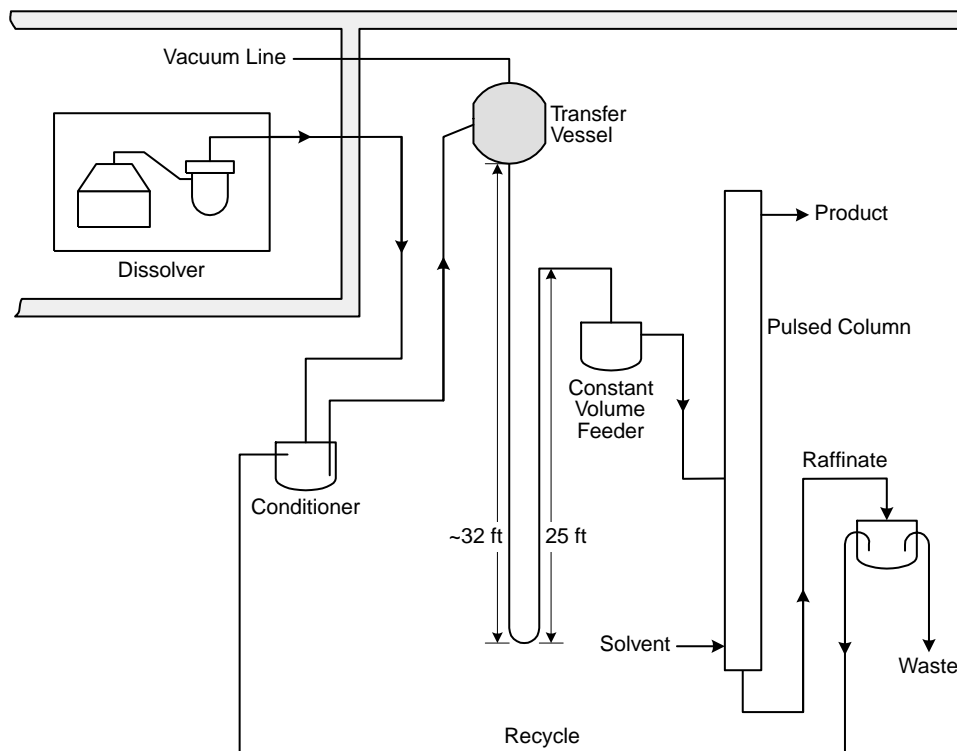
The solution was vacuum lifted from the conditioner to a transfer vessel (Figure 25). When the transfer was

Figure 25. Process equipment related to the criticality accident.

due to any energy based shutdown mechanism. Radiation measurements indicated that the excursion occurred in the transfer vessel, but the solution from the conditioner was too lean to sustain criticality, and the total quantity of plutonium in the batch (300 g) was about 50% of the minimum critical mass. Thus, it was feared that the transfer vessel might contain large quantities of solids, perhaps tens of kilograms and that any disturbance of the system might cause another, possibly much larger, excursion.

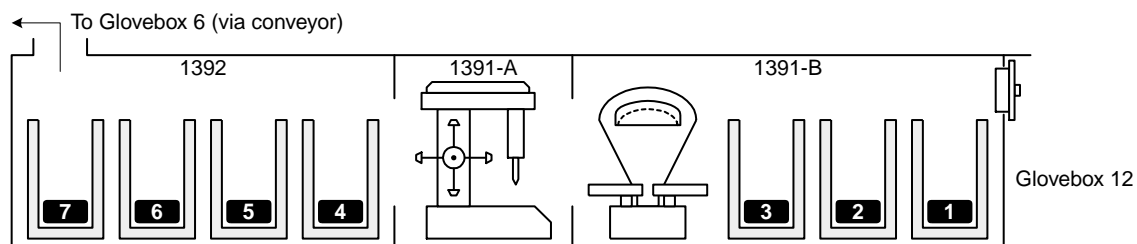
Figure 29. A simplified layout of Glovebox 13.

Glovebox 13, where the criticality accident took place, consisted of three workstations, (1391-A, 1391-B, and 1392, see Figure 29) and was connected to gloveboxes 12 and 6 by a pass-through port and conveyor, respectively. All of the ingots produced at the plant passed through this glovebox operation. For these particular workstations, the administrative limit for the containers was even stricter, allowing only one ingot regardless of its mass. Workstation 1391-A was used for extracting drill samples (up to 0.1 g) for chemical analysis of the impurities. The ingots were weighed in workstation 1391-B, where the samples were also temporarily stored. Workstation 1392 was used for measuring the dimensions of the ingots. Within the workstations the ingots were removed and returned to their original containers one at a time. The workstations were equipped with pass-through ports in the connecting walls, gloveports, and 50 mm thick leaded glass windows. The front of the workstation had a 30 mm thick lead shield to reduce the  $\gamma$ -radiation from the plutonium.

At the beginning of the shift on 13 December 1978, three containers were in workstation 1391-B, and four containers were in workstation 1392, each with one ingot. The ingots are numbered sequentially in Figure 29 for the purpose of the discussion that follows. Although the containers are depicted as being linearly arranged, in actuality the containers holding ingots 4 and 5 were behind those with ingots 6 and 7, making visual inspection of the contents more difficult

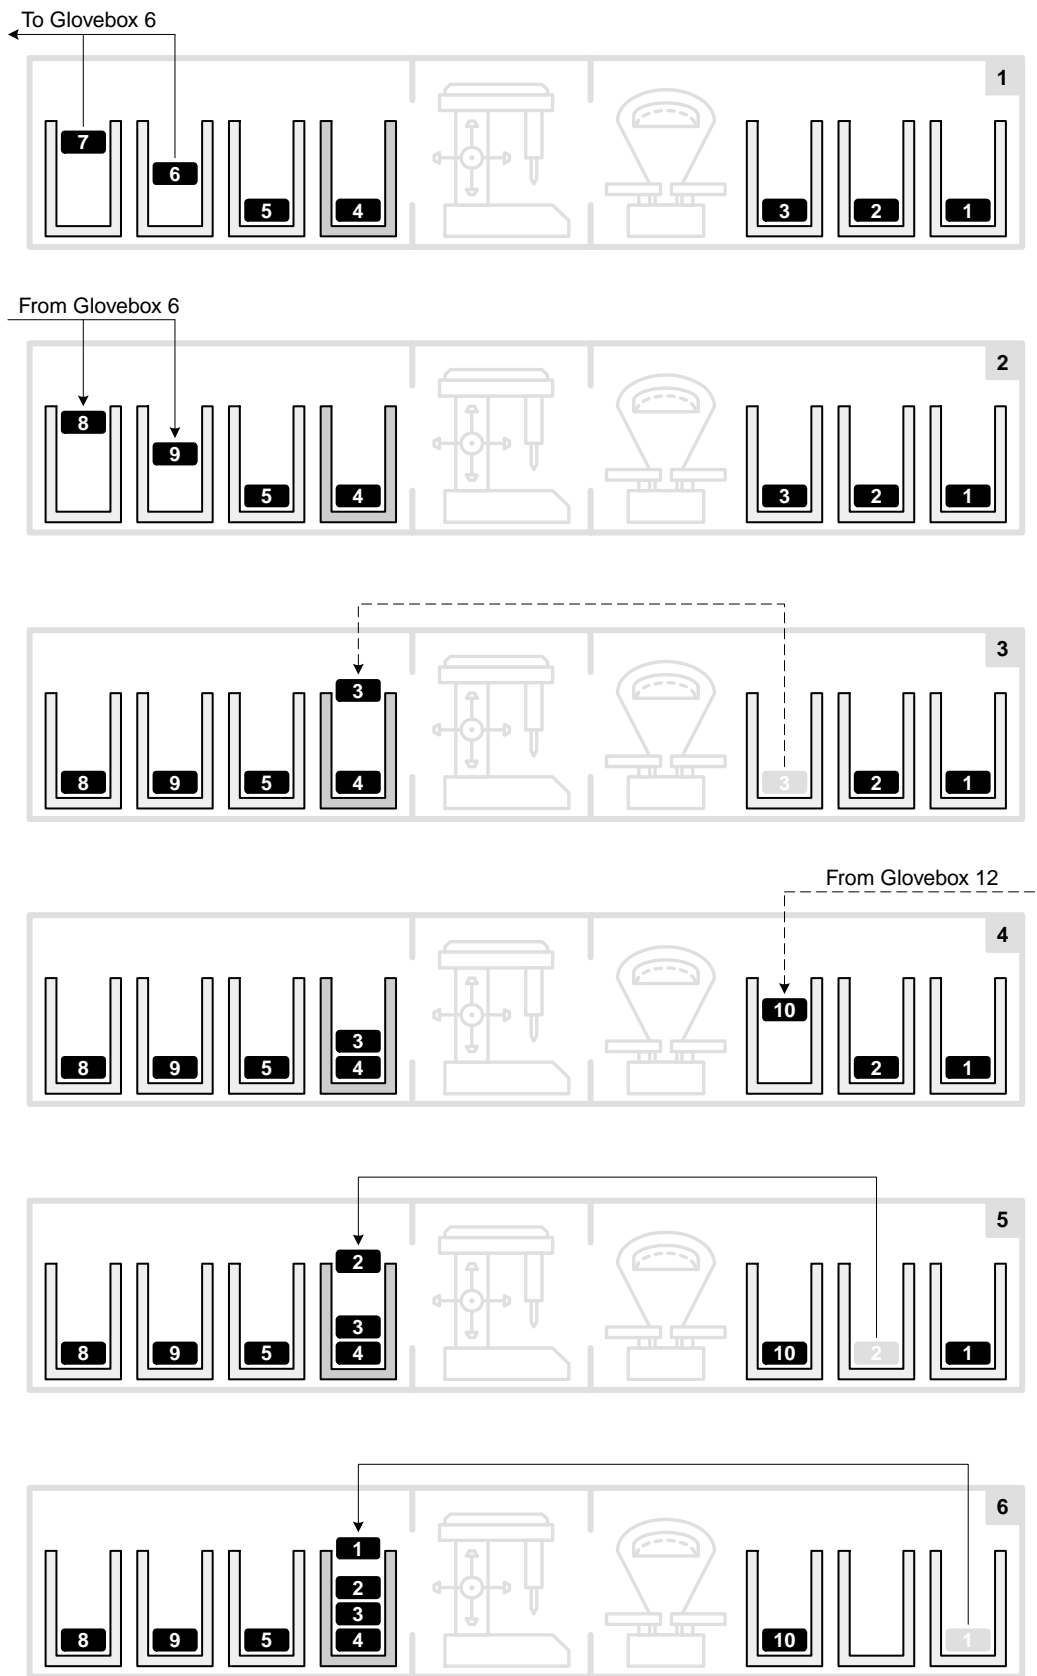
The intended order of ingot transfers, as specified in the shift instructions, is illustrated in Figure 30. The actual order of ingot transfer is shown in Figure 31, Frames 1 through 6. Operator A transferred two ingots, 6 and 7, from workstation 1392 to glovebox 6. These ingots were replaced in workstation 1392 by two ingots, 8 and 9, from glovebox 6. Both of these actions were in accordance with the shift instructions.

Motivated by production pressures to conduct the ingot transfers as soon as practical, Operator A (without authorization and in violation of procedures) requested Operator B to assist him. Operator A then instructed Operator B to transfer ingots 1 and 2 to glovebox 6 and to reload their containers with ingots 10 and 11 from glovebox 12. However, Operator B, who was not working from written instructions, instead transferred ingot 3 into the container already holding ingot 4, violating the container administrative limit. Operator B then transferred ingot 10 from glovebox 12 to the container that previously held ingot 3 within 1391-B.

Figure 31. Actual order of ingot transfers from and to Glovebox 13. The solid lines represent the actions of operator A and the dotted lines the actions of operator B.

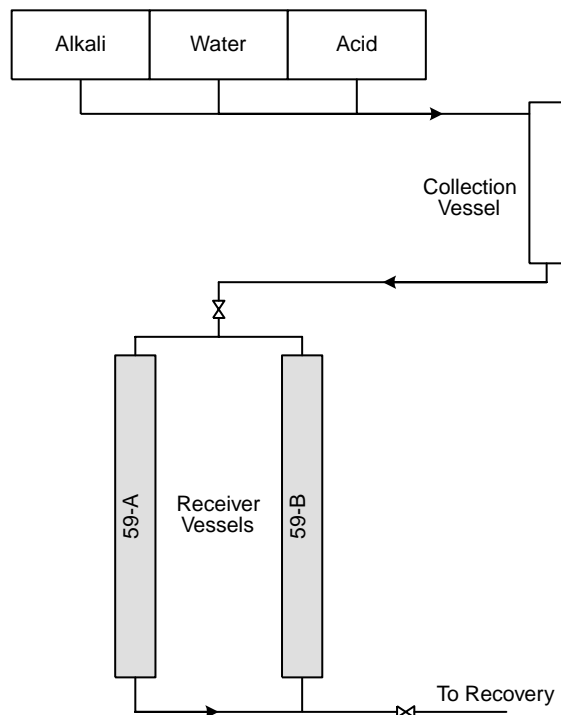
This accident occurred in Building 17 where highly enriched U(90) fuel rods were fabricated from  $\text{UO}_2$  and aluminum, using the powder metallurgy method. The final process prior to placing a rod into its aluminum cladding was chemical etching. The objective of this operation was to remove microscopic defects on the rod surfaces to ensure tight contact between the rod and its cladding. The major components of the process equipment are shown in Figure 32.

Figure 32. Major components of the chemical-etching process.

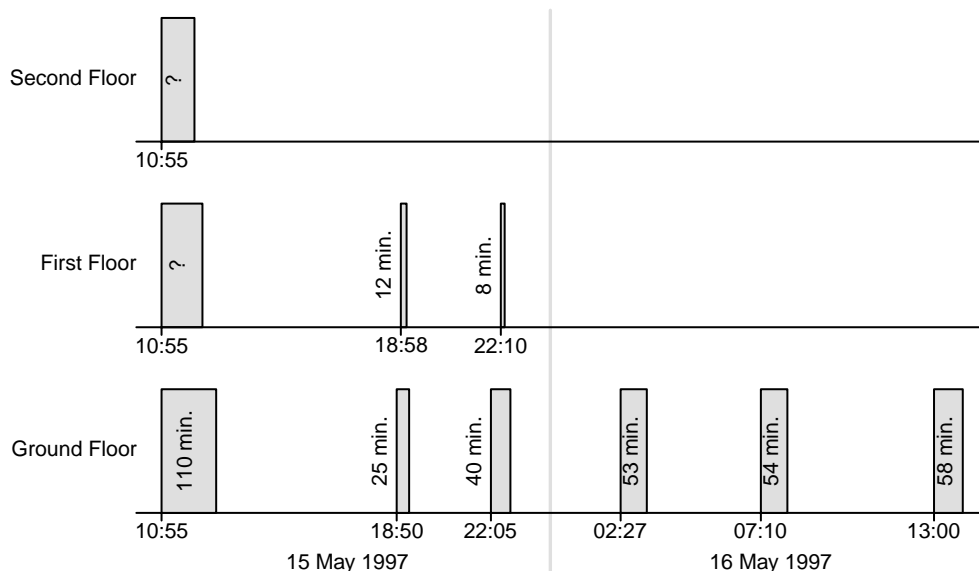
samples of the  $\text{UO}_2$  particles taken on 20 May. The detectors were located at 12 monitoring stations. However, during the excursions, at most only three of the monitoring stations alarmed, indicating very low peak power for each excursion. These three stations were located on the ground, first, and second floors directly above one another. From the central control room, health physicists documented the sequence of excursions, the response of the detectors, and the length of time that the detector alarm threshold ( $36 \text{ mR/h}$ ) was exceeded (Figure 33).

Figure 33. Sequence of alarms and duration that the radiation levels exceeded the alarm level ( $36 \text{ mR/h}$ ).

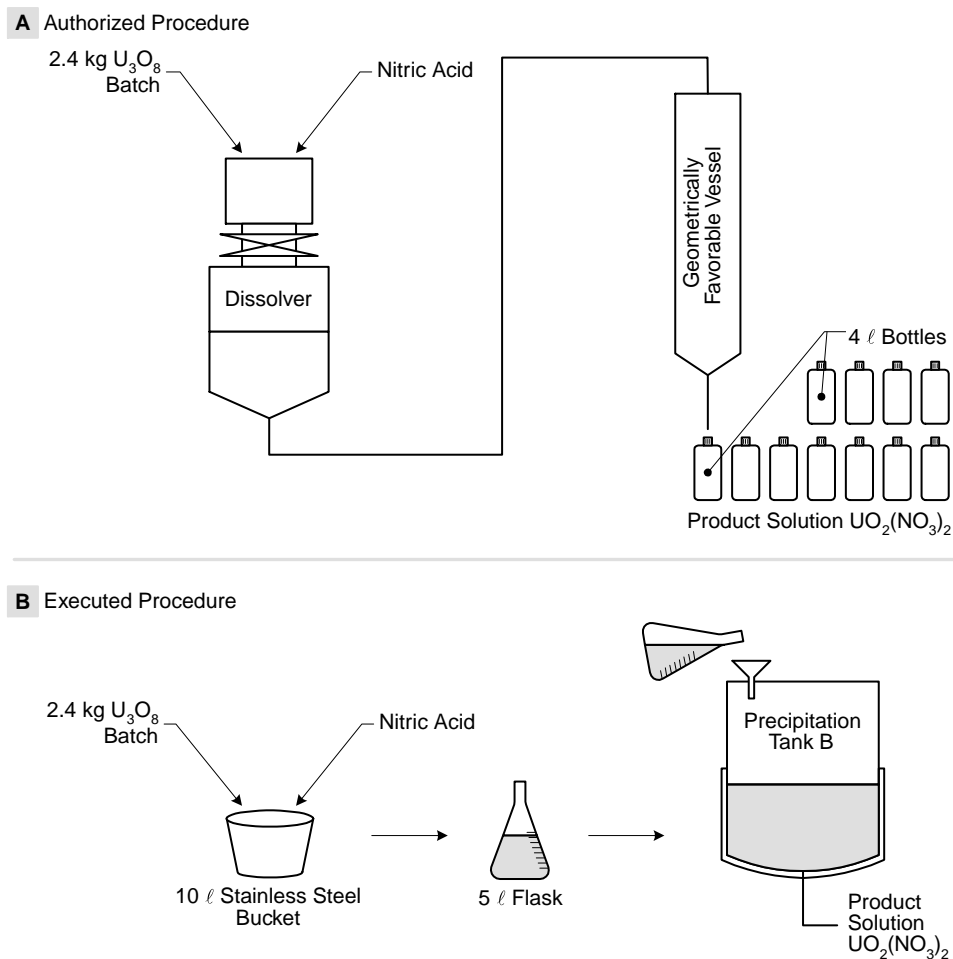
Three operators had begun the task on 29 September, the day prior to the accident, but were operating according to the procedure indicated in Figure 34-B. There were basically two deviations from the license-authorized procedure that were associated with the actual operations. First, the company procedure that the operators were to have followed, specified that the dissolution step was to be conducted in open, 10-liter, stainless steel buckets instead of the dissolution vessel indicated. This change was known to have saved about one hour in dissolution time.

The much more serious procedural departure, however, was the transfer of the nitrate solution into the unfavorable geometry precipitation vessel instead of the prescribed, favorable geometry columns. This deviation was apparently motivated by the difficulty of filling the product containers from the storage columns. The drain cock below the columns was only about 10 cm above the floor. The precipitation vessel had not only a stirrer to assure a uniform product but greatly facilitated the filling of the product containers.

Figure 34. Authorized and executed procedures.

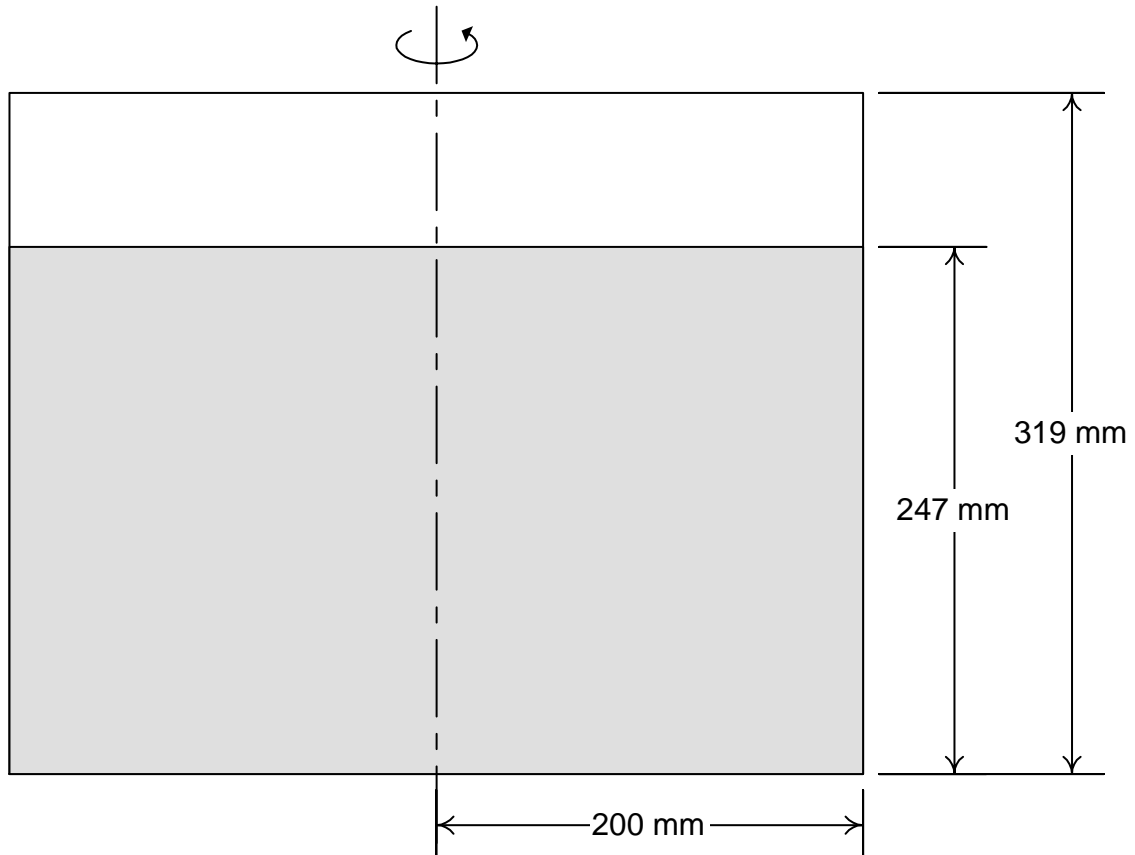
# 1. Mayak Production Association, 15 March 1953

*Plutonium nitrate solution in an interim storage vessel; single excursion; one serious exposure, one significant exposure.*

Vessel Volume	40.0 ℓ
Fissile Volume	31.0 ℓ
Fissile Mass	0.81 kg
Fissile Density	26.1 g/ℓ

Estimated Spherical Critical Mass	0.67 kg
First Spike Yield	unknown
Specific Spike Yield	unknown
Total Yield	$\sim 2.0 \times 10^{17}$

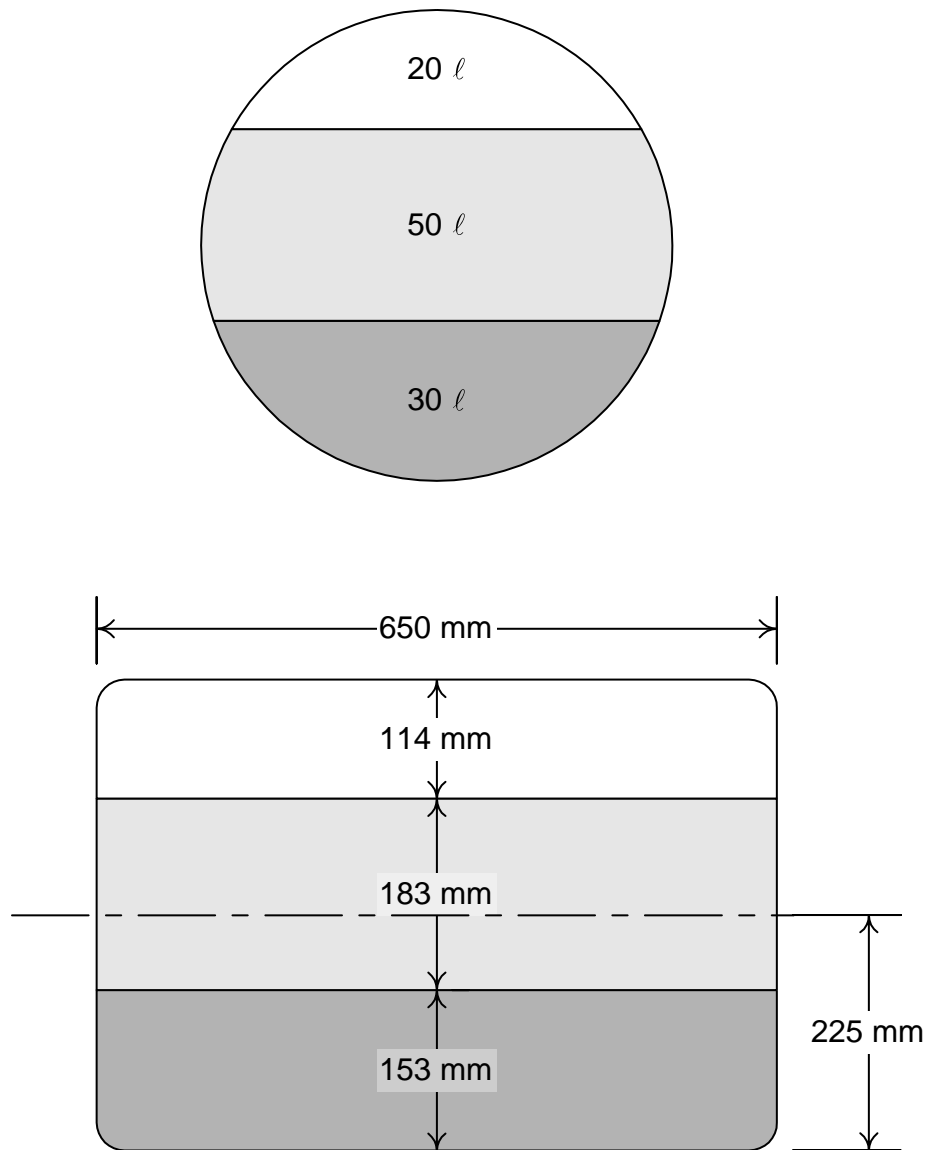
## 2. Mayak Production Association, 21 April 1957

*Uranium precipitate, U(90), buildup in a filtrate receiving vessel; excursion history unknown; one fatality; five other significant exposures.*

Vessel Volume	100.0 l
Fissile Volume	30.0 l
Fissile Mass	3.06 kg
Fissile Density	102.0 g/l

Estimated Spherical Critical Mass	1.09 kg
First Spike Yield	unknown
Specific Spike Yield	unknown
Total Yield	$\sim 1.0 \times 10^{17}$

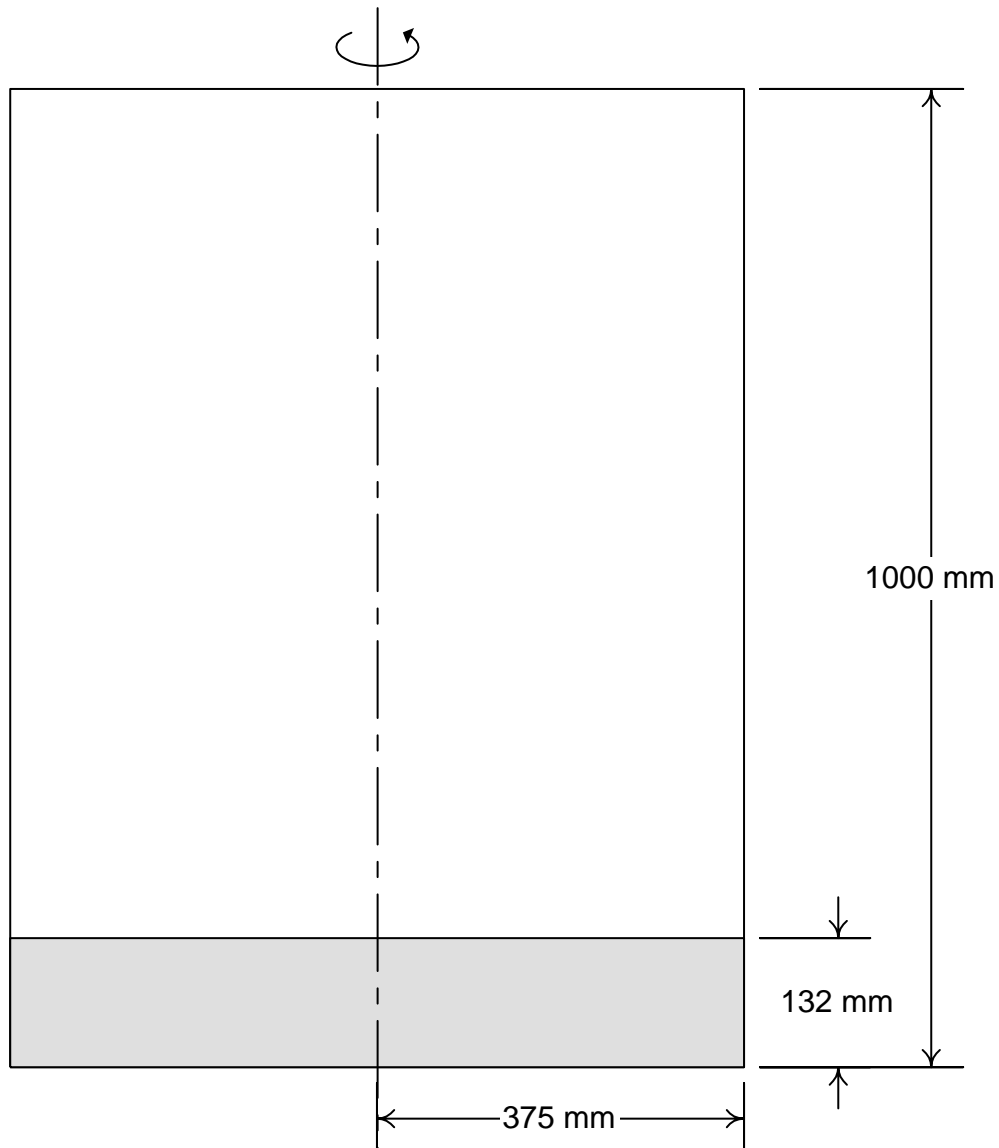
### 3. Mayak Production Association, 2 January 1958

*Uranyl nitrate solution, U(90), in an experiment vessel; one prompt critical burst; three fatalities; one serious exposure.*

Vessel Volume	442.0 ℓ
Fissile Volume	58.4 ℓ
Fissile Mass	22.0 kg
Fissile Density	376.7 g/ℓ

Estimated Spherical Critical Mass	5.24 kg
First Spike Yield	$\sim 2.0 \times 10^{17}$
Specific Spike Yield	$3.4 \times 10^{15}$
Total Yield	$\sim 2.0 \times 10^{17}$

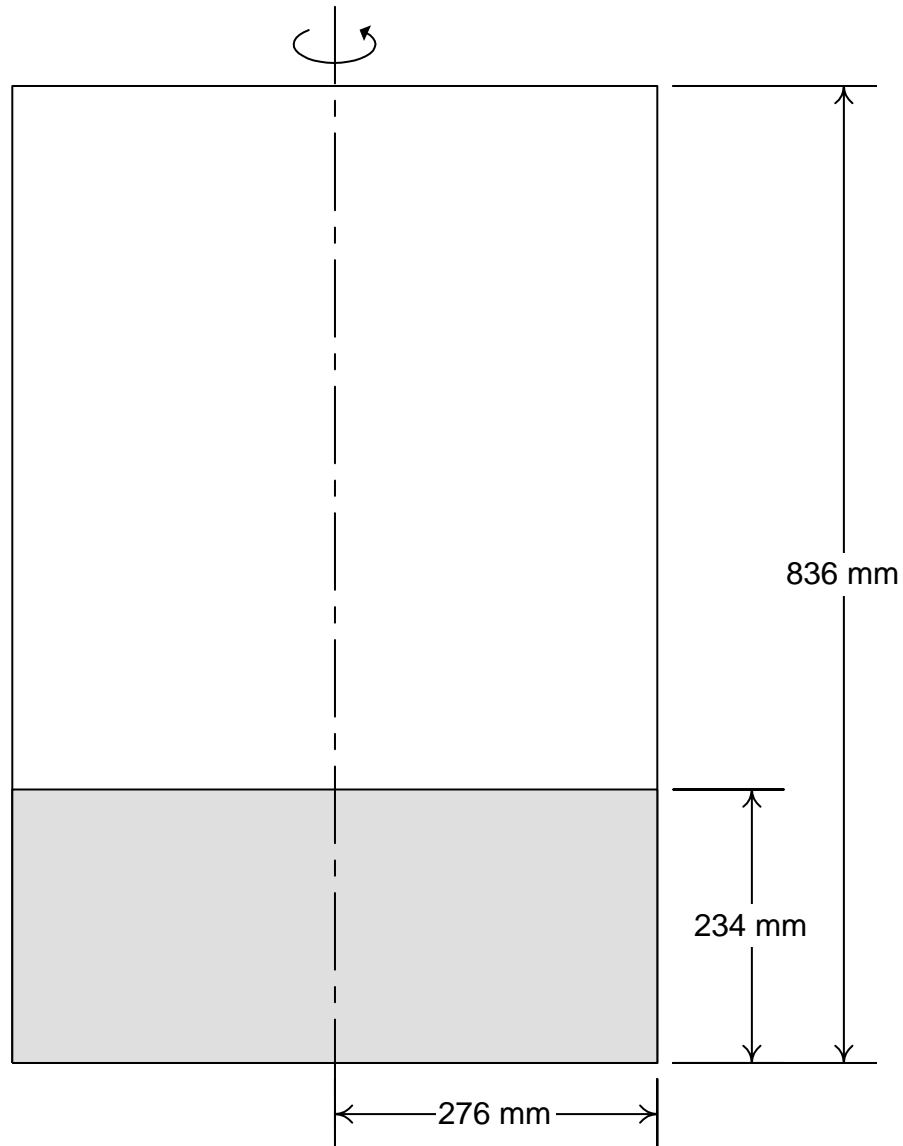
#### 4. Oak Ridge Y-12 Plant, 16 June 1958

*Uranyl nitrate solution, U(93), in a water collection drum; multiple excursions;  
seven significant exposures.*

Vessel Volume	208.0 ℓ
Fissile Volume	56.0 ℓ
Fissile Mass	2.10 kg
Fissile Density	37.5 g/ℓ

Estimated Spherical Critical Mass	1.50 kg
First Spike Yield	$\sim 0.1 \times 10^{17}$
Specific Spike Yield	$0.2 \times 10^{15}$
Total Yield	$13.0 \times 10^{17}$

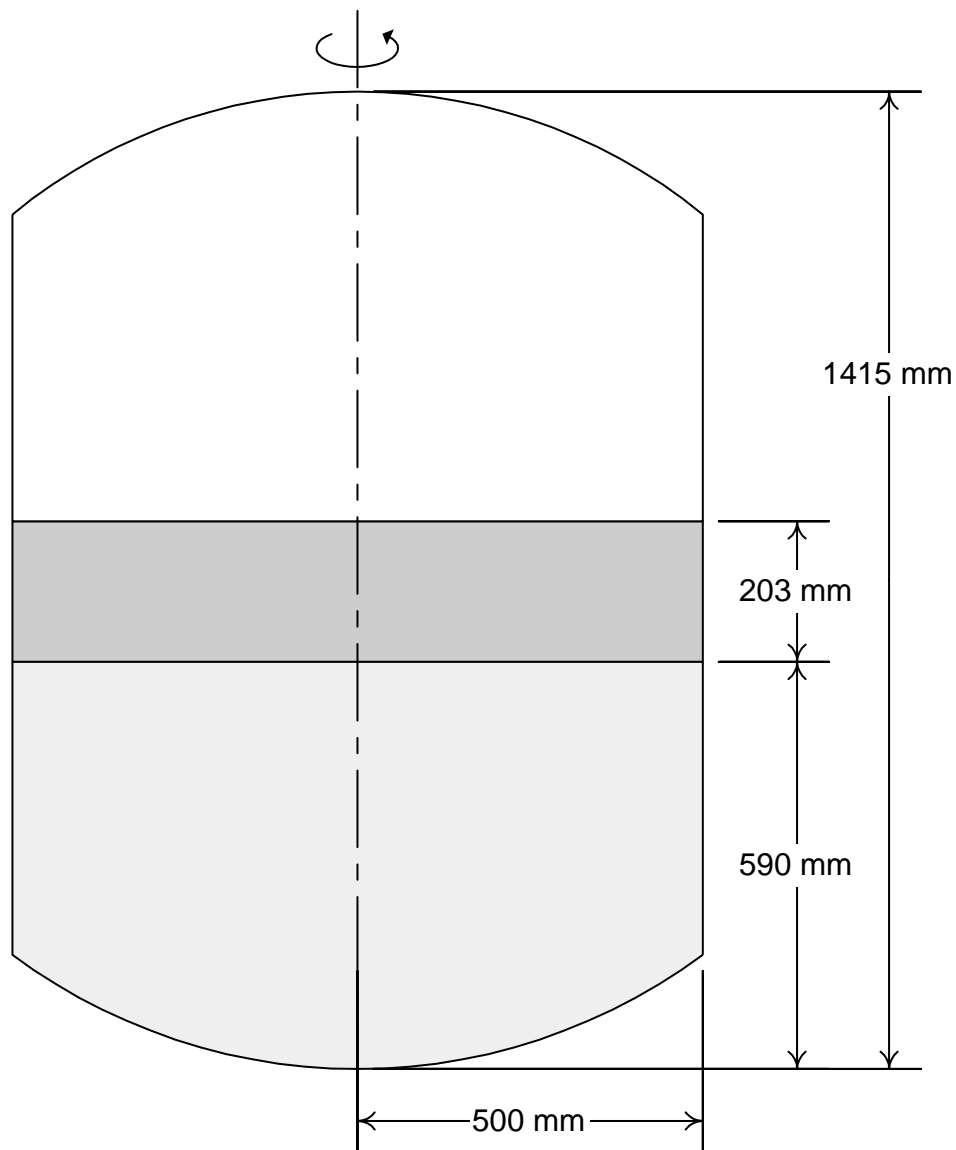
## 5. Los Alamos Scientific Laboratory, 30 December 1958

*Plutonium organic solution in an organic treatment tank; single excursion; one fatality, two significant exposures.*

Vessel Volume	982.0 ℓ
Fissile Volume	160.0 ℓ
Fissile Mass	2.94 kg
Fissile Density	18.4 g/ℓ

Estimated Spherical Critical Mass	0.84 kg
First Spike Yield	$1.5 \times 10^{17}$
Specific Spike Yield	$0.94 \times 10^{15}$
Total Yield	$1.5 \times 10^{17}$
