# A Review of Criticality Accidents

2000 Revision

**LA-13638**

**Issued: May 2000**

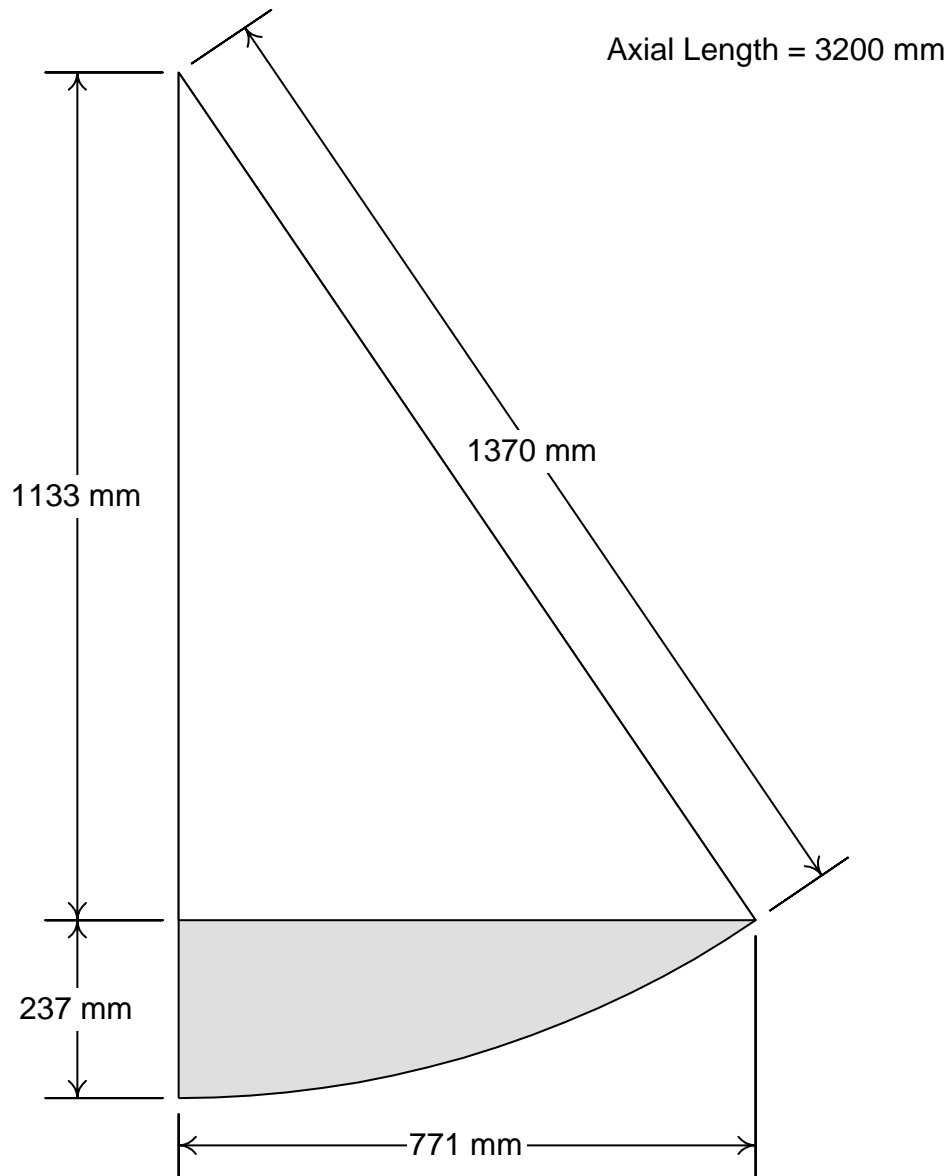
## 6. Idaho Chemical Processing Plant, 16 October 1959

*Uranyl nitrate solution, U(91), in a waste receiving tank; multiple excursions;  
two significant exposures.*

Vessel Volume	18,900 ℓ
Fissile Volume	800.0 ℓ
Fissile Mass	30.9 kg
Fissile Density	38.6 g/ℓ

Estimated Spherical Critical Mass	1.24 kg
First Spike Yield	$\sim 1.0 \times 10^{17}$
Specific Spike Yield	$\sim 0.1 \times 10^{15}$
Total Yield	$400 \times 10^{17}$

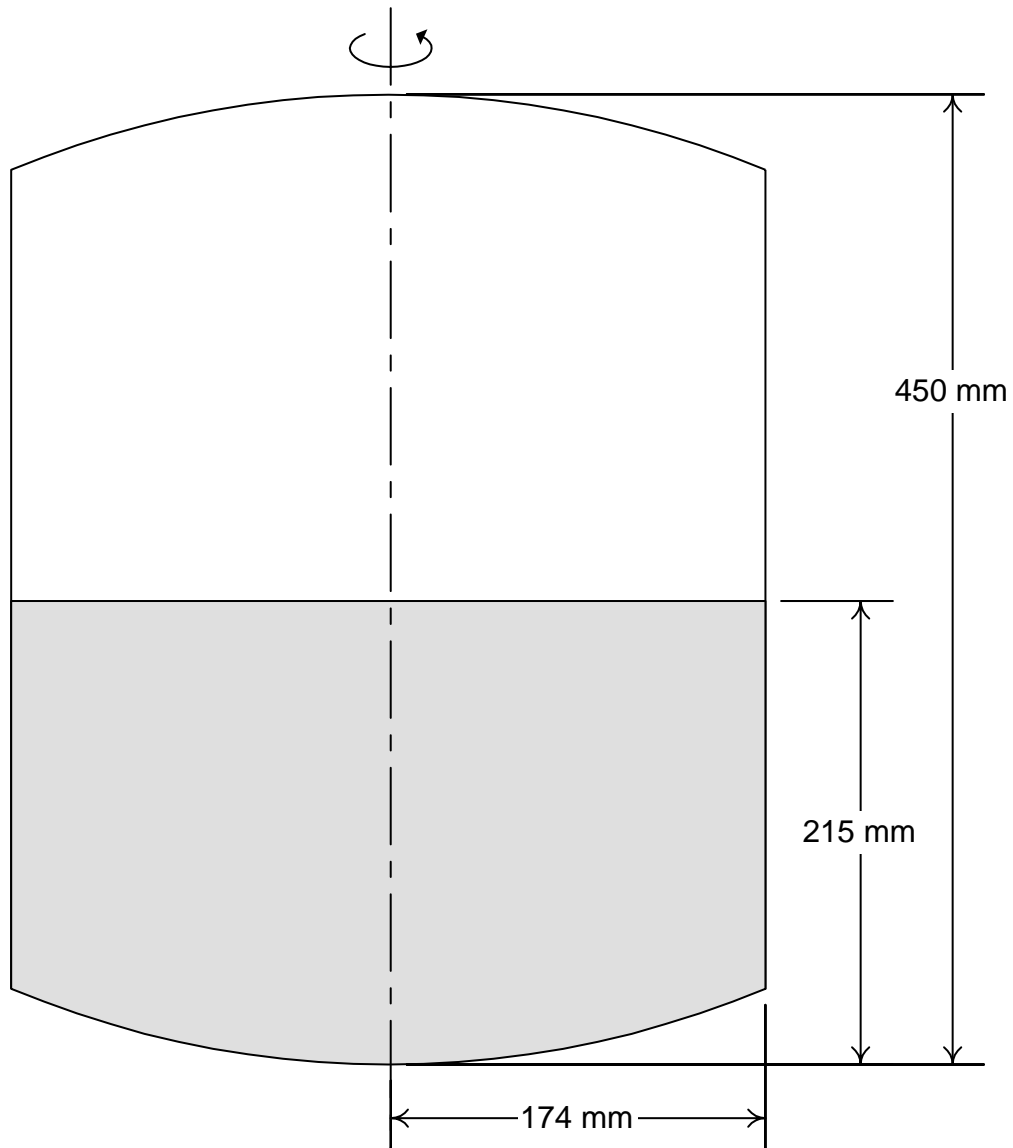
## 7. Mayak Production Association, 5 December 1960

*Plutonium carbonate solution in a holding vessel; multiple excursions;  
insignificant exposures.*

Vessel Volume	40.0 ℓ
Fissile Volume	19.0 ℓ
Fissile Mass	0.85 kg
Fissile Density	44.7 g/ℓ

Estimated Spherical Critical Mass	0.71 kg
First Spike Yield	unknown
Specific Spike Yield	unknown
Total Yield	$\sim 2.5 \times 10^{17}$

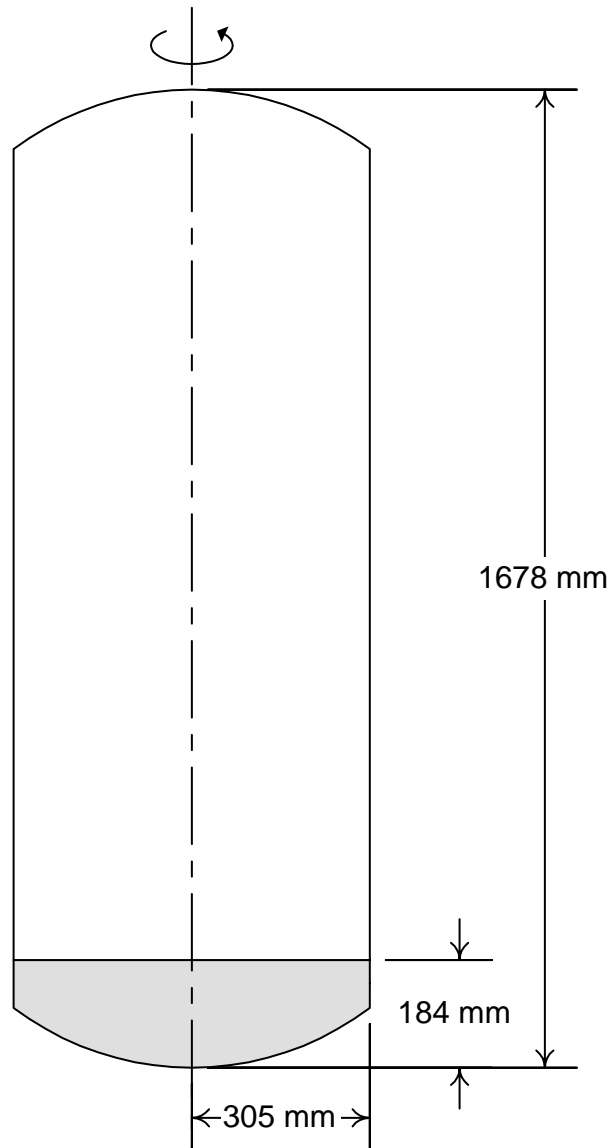
## 8. Idaho Chemical Processing Plant, 25 January 1961

*Uranyl nitrate solution, U(90), in a vapor disengagement vessel; multiple excursions; insignificant exposures.*

Vessel Volume	461.0 ℓ
Fissile Volume	40.0 ℓ
Fissile Mass	7.20 kg
Fissile Density	180.0 g/ℓ

Estimated Spherical Critical Mass	2.48 kg
First Spike Yield	$\sim 0.6 \times 10^{17}$
Specific Spike Yield	$1.5 \times 10^{15}$
Total Yield	$6.0 \times 10^{17}$

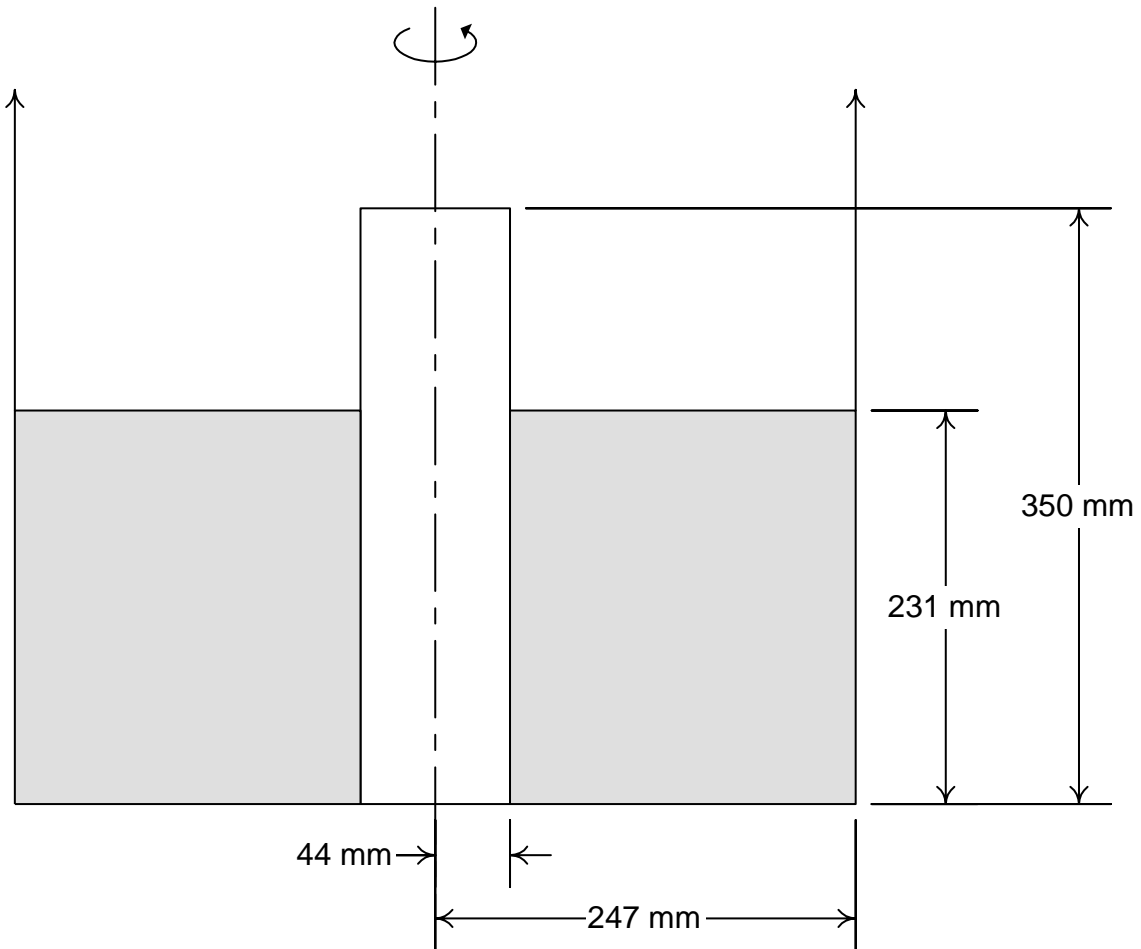
## 9. Siberian Chemical Combine (Tomsk), 14 July 1961

*Uranium hexafluoride, U(22.6), accumulation in a vacuum pump oil reservoir;  
two excursions; one significant exposure.*

Vessel Volume	65.0 ℓ
Fissile Volume	42.9 ℓ
Fissile Mass	1.68 kg
Fissile Density	39.2 g/ℓ

Estimated Spherical Critical Mass	0.9 kg
First Spike Yield	none
Specific Spike Yield	none
Total Yield	$0.12 \times 10^{17}$

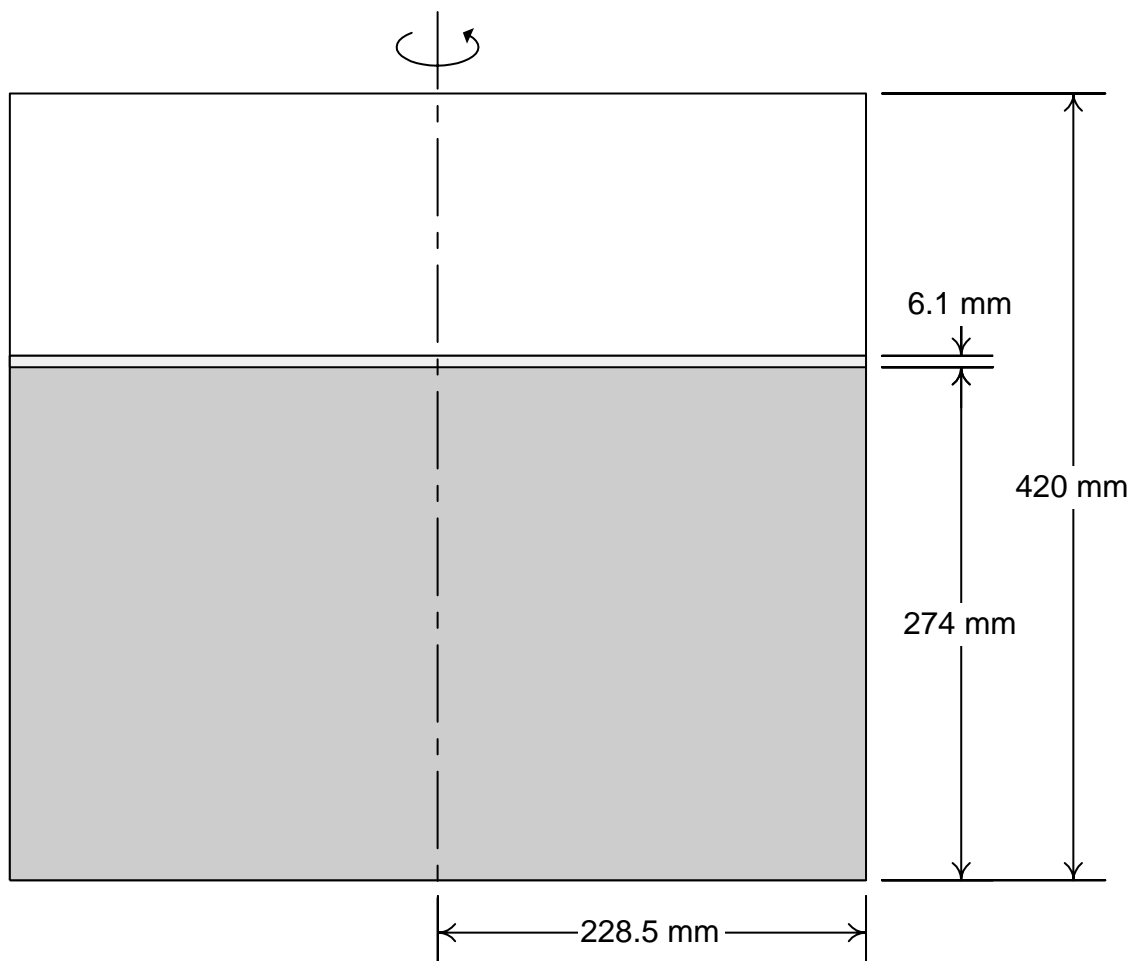
## 10. Hanford Works, 7 April 1962

*Plutonium solution in a transfer vessel; multiple excursions; three significant exposures.*

Vessel Volume	69.0 ℓ
Fissile Volume	45.0 ℓ
Fissile Mass	1.29 kg
Fissile Density	28.7 g/ℓ

Estimated Spherical Critical Mass	1.07 kg
First Spike Yield	$\sim 0.1 \times 10^{17}$
Specific Spike Yield	$0.2 \times 10^{15}$
Total Yield	$8.0 \times 10^{17}$

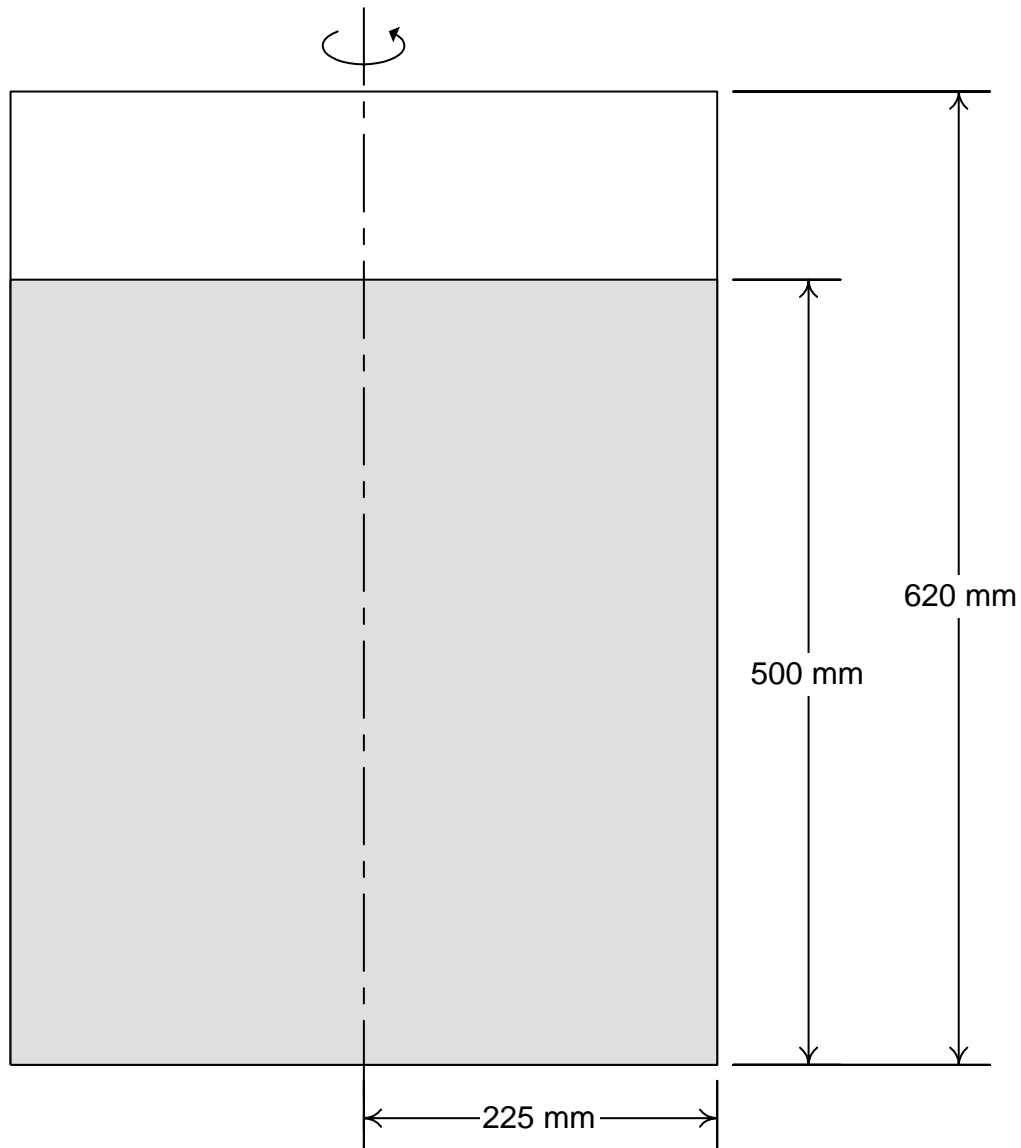
## 11. Mayak Production Association, 7 September 1962

*Plutonium nitrate in a dissolution vessel; three excursions; insignificant exposures.*

Vessel Volume	100.0 ℓ
Fissile Volume	80.0 ℓ
Fissile Mass	1.26 kg
Fissile Density	15.8 g/ℓ

Estimated Spherical Critical Mass	1.05 kg
First Spike Yield	none
Specific Spike Yield	none
Total Yield	$\sim 2.0 \times 10^{17}$

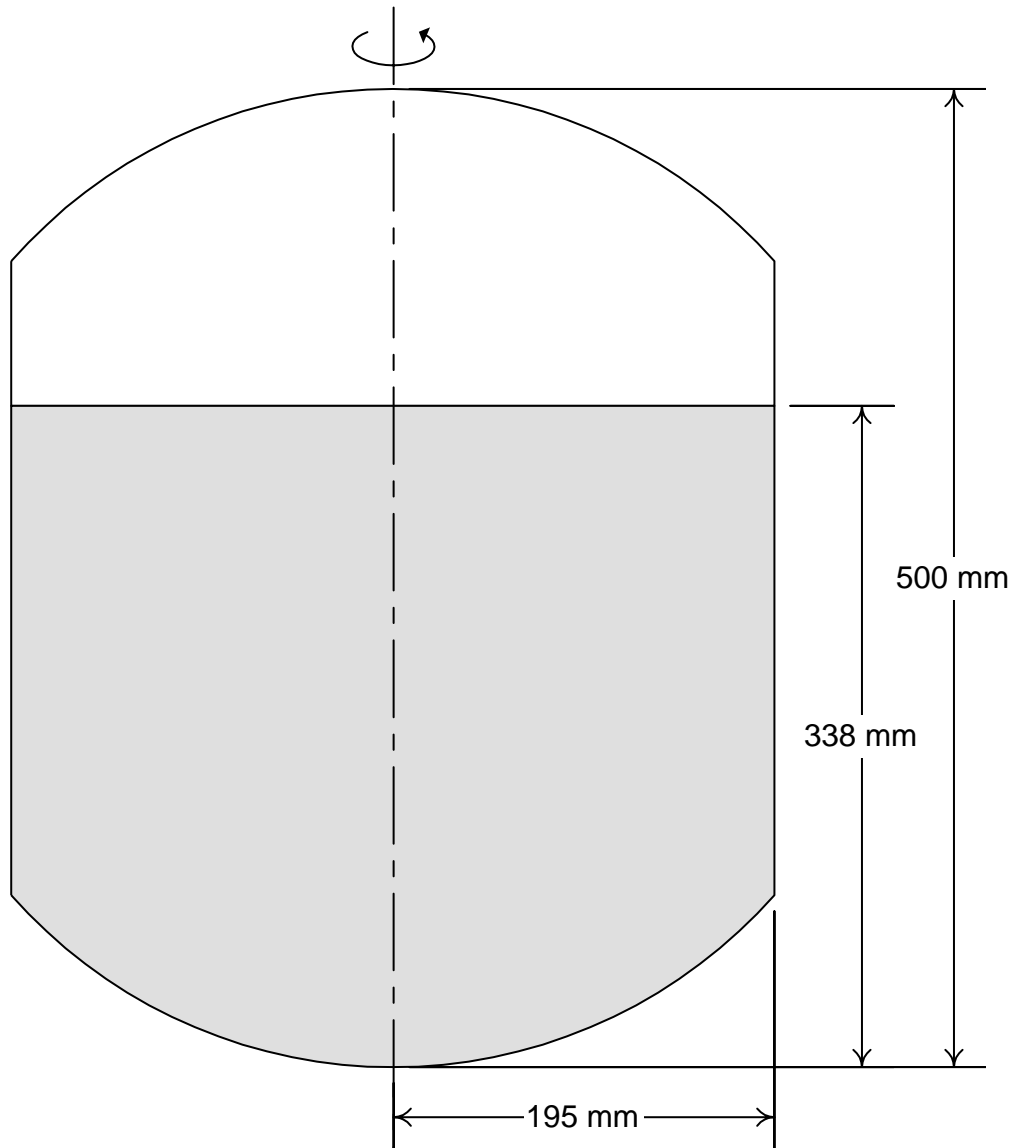
## 12. Siberian Chemical Combine (Tomsk), 30 January 1963

*Uranyl nitrate solution, U(90), in a collection vessel; multiple excursions;  
insignificant exposures.*

Vessel Volume	49.9 ℓ
Fissile Volume	35.5 ℓ
Fissile Mass	2.27 kg
Fissile Density	63.9 g/ℓ

Estimated Spherical Critical Mass	2.06 kg
First Spike Yield	unknown
Specific Spike Yield	unknown
Total Yield	$7.9 \times 10^{17}$

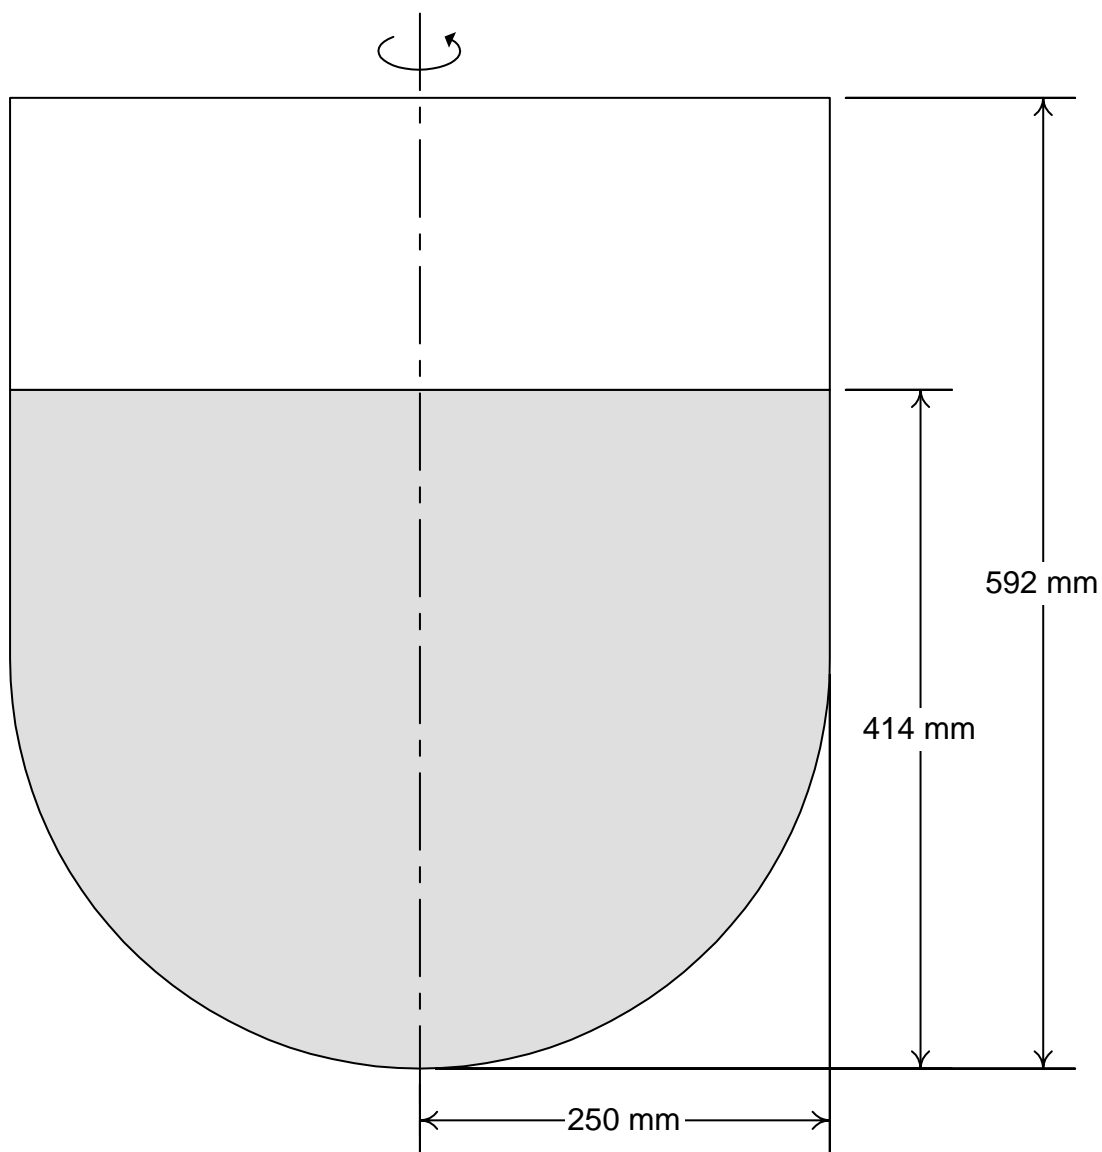
### 13. Siberian Chemical Combine, 2 December 1963

*Uranium organic solution, U(90), in a vacuum system holding vessel; multiple excursions; insignificant exposures.*

Vessel Volume	100.0 ℓ
Fissile Volume	64.8 ℓ
Fissile Mass	1.93 kg
Fissile Density	29.8 g/ℓ

Estimated Spherical Critical Mass	1.38 kg
First Spike Yield	none
Specific Spike Yield	none
Total Yield	$0.16 \times 10^{17}$

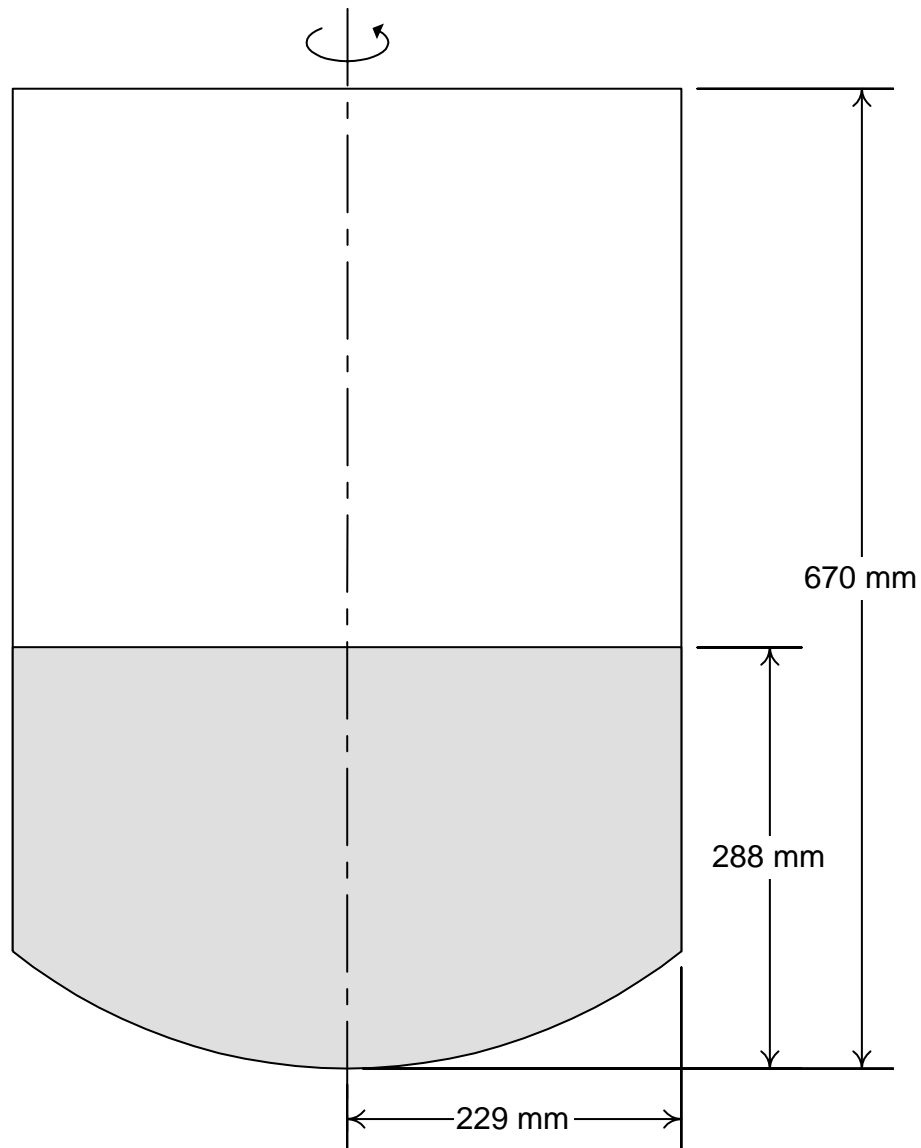
## 14. United Nuclear Fuels Recovery Plant, 24 July 1964

*Uranyl nitrate solution, U(93), in a carbonate reagent makeup vessel; two excursions; one fatality, two significant exposures.*

Vessel Volume	103.7 ℓ
Fissile Volume	41.0 ℓ
Fissile Mass	2.07 kg
Fissile Density	50.5 g/ℓ

Estimated Spherical Critical Mass	1.72 kg
First Spike Yield	$\sim 1.0 \times 10^{17}$
Specific Spike Yield	$2.4 \times 10^{15}$
Total Yield	$\sim 1.3 \times 10^{17}$

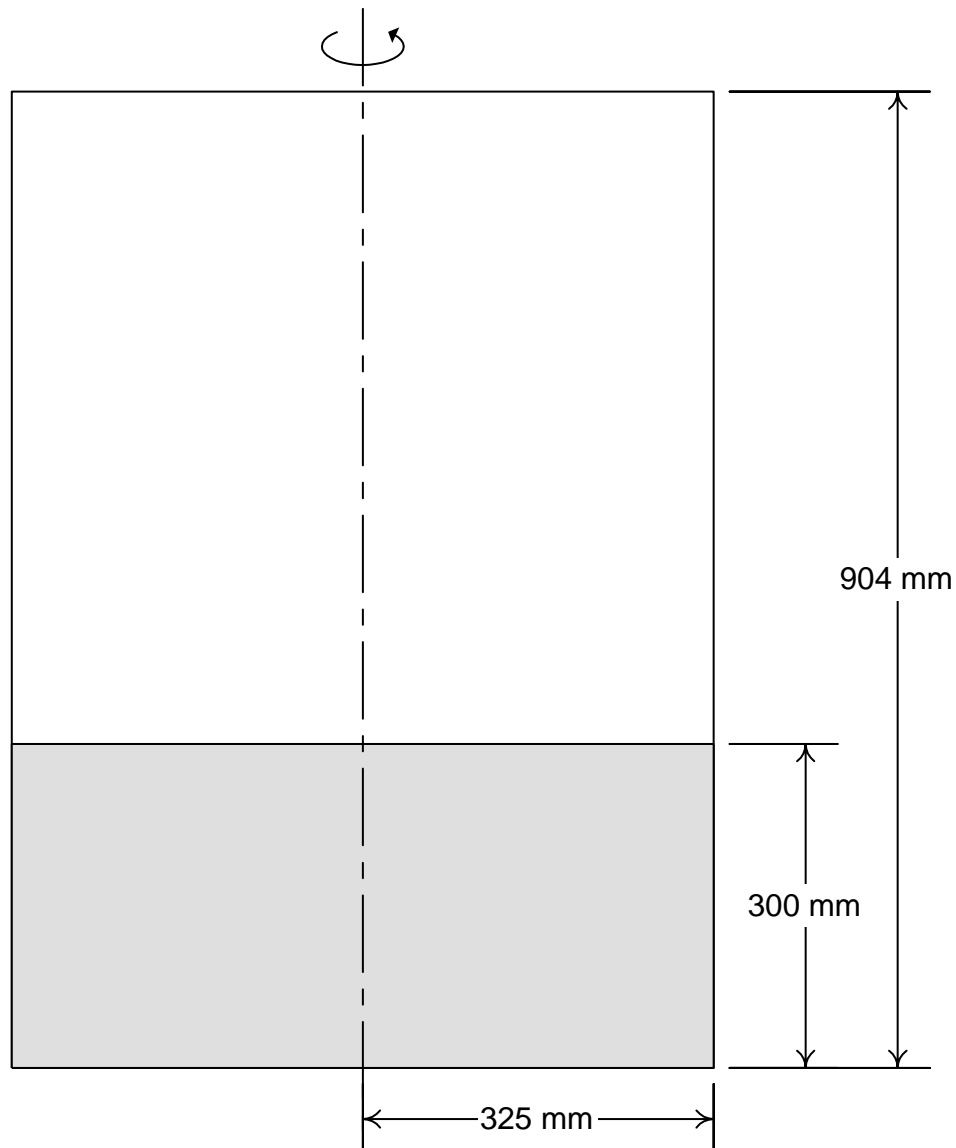
## 15. Electrosta Machine Building Plant, 3 November 1965

*Uranium oxide slurry, U(6.5), in a vacuum system vessel; single excursion;  
insignificant exposures.*

Vessel Volume	300.0 ℓ
Fissile Volume	100.0 ℓ
Fissile Mass	3.65 kg
Fissile Density	36.5 g/ℓ

Estimated Spherical Critical Mass	1.6 kg
First Spike Yield	none
Specific Spike Yield	none
Total Yield	$\sim 0.08 \times 10^{17}$

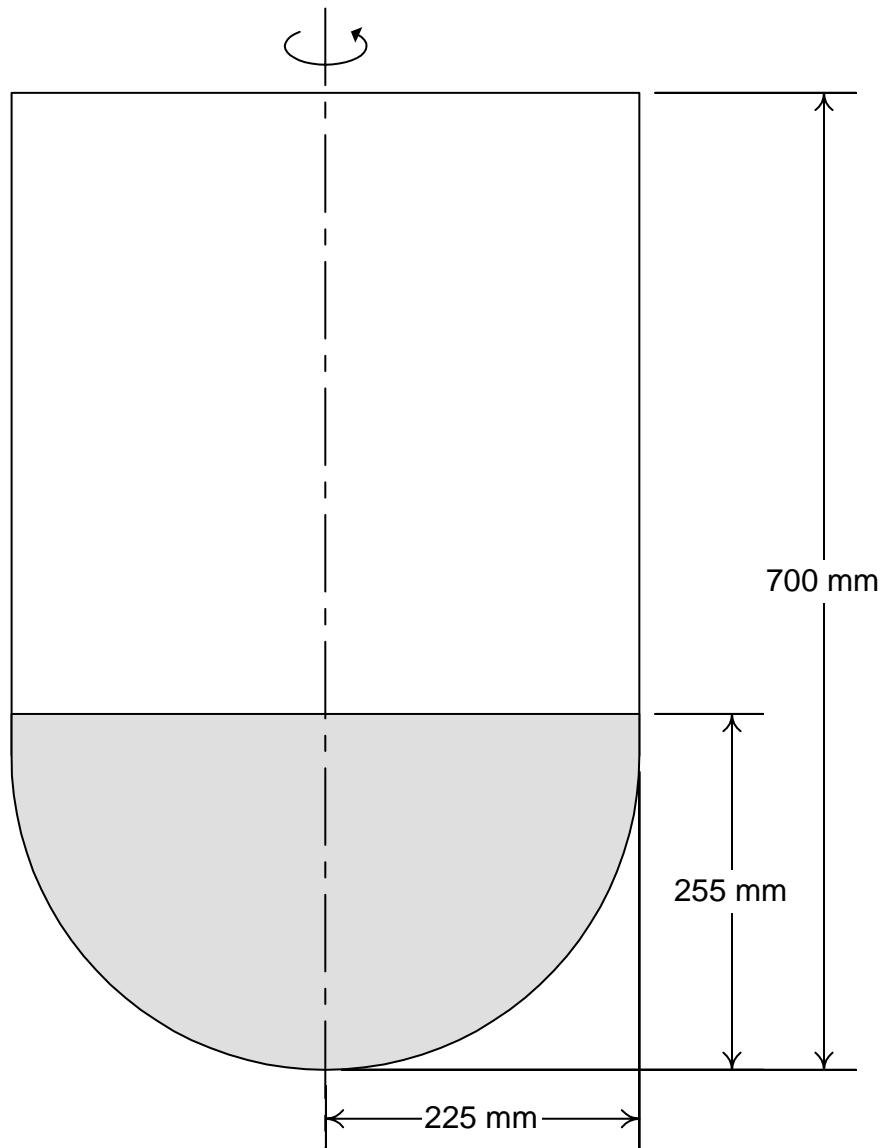
## 16. Mayak Production Association, 16 December 1965

*Uranyl nitrate solution, U(90), in a dissolution vessel; multiple excursions;  
insignificant exposures.*

Vessel Volume	100.0 ℓ
Fissile Volume	28.6 ℓ
Fissile Mass	1.98 kg
Fissile Density	69.2 g/ℓ

Estimated Spherical Critical Mass	1.65 kg
First Spike Yield	none
Specific Spike Yield	none
Total Yield	$\sim 5.5 \times 10^{17}$

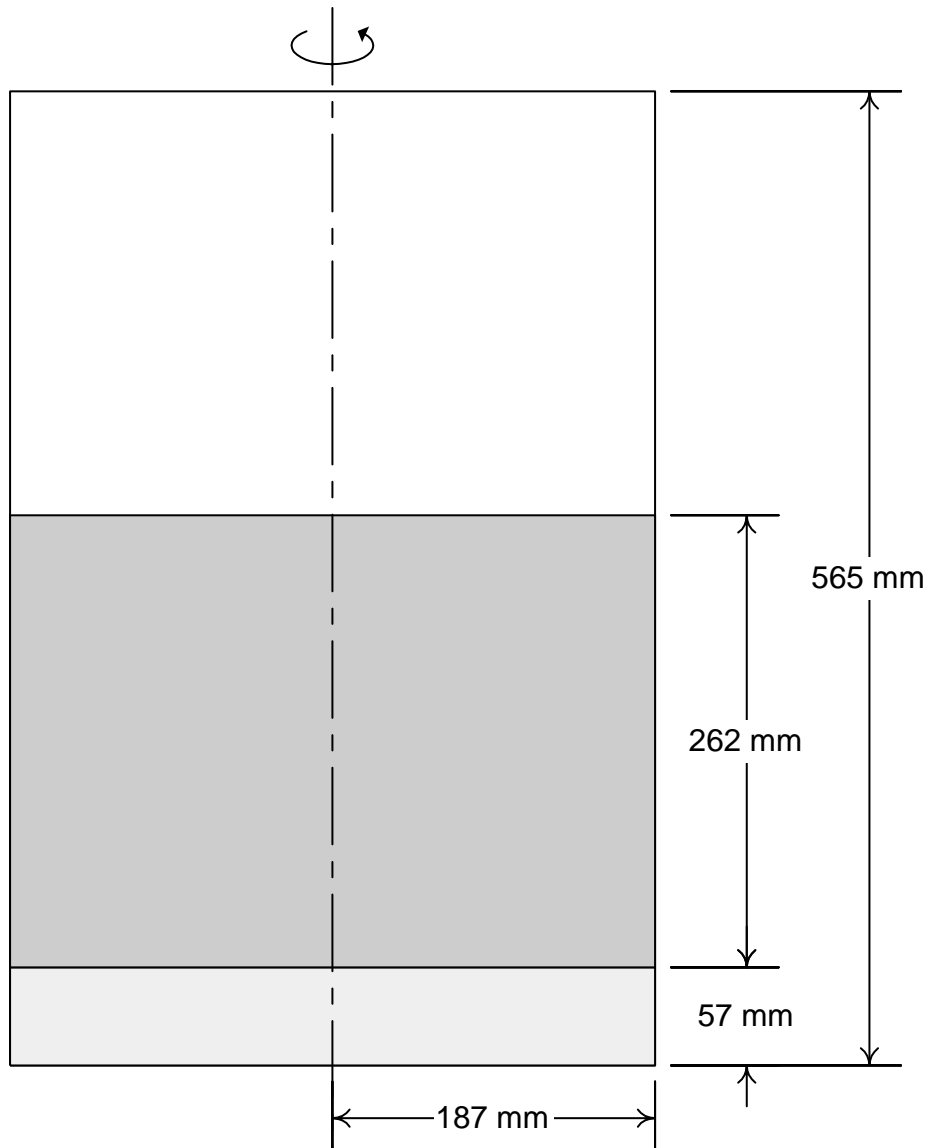
## 17. Mayak Production Association, 10 December 1968

*Plutonium solutions (aqueous and organic) in a 60 liter vessel; three excursions; one fatality, one serious exposure.*

Vessel Volume	62.1 ℓ
Fissile Volume	28.8 ℓ
Fissile Mass	1.50 kg
Fissile Density	52.1 g/ℓ

Estimated Spherical Critical Mass	1.36 kg
First Spike Yield	$0.3 \times 10^{17}$
Specific Spike Yield	$1.0 \times 10^{15}$
Total Yield	$\sim 1.3 \times 10^{17}$

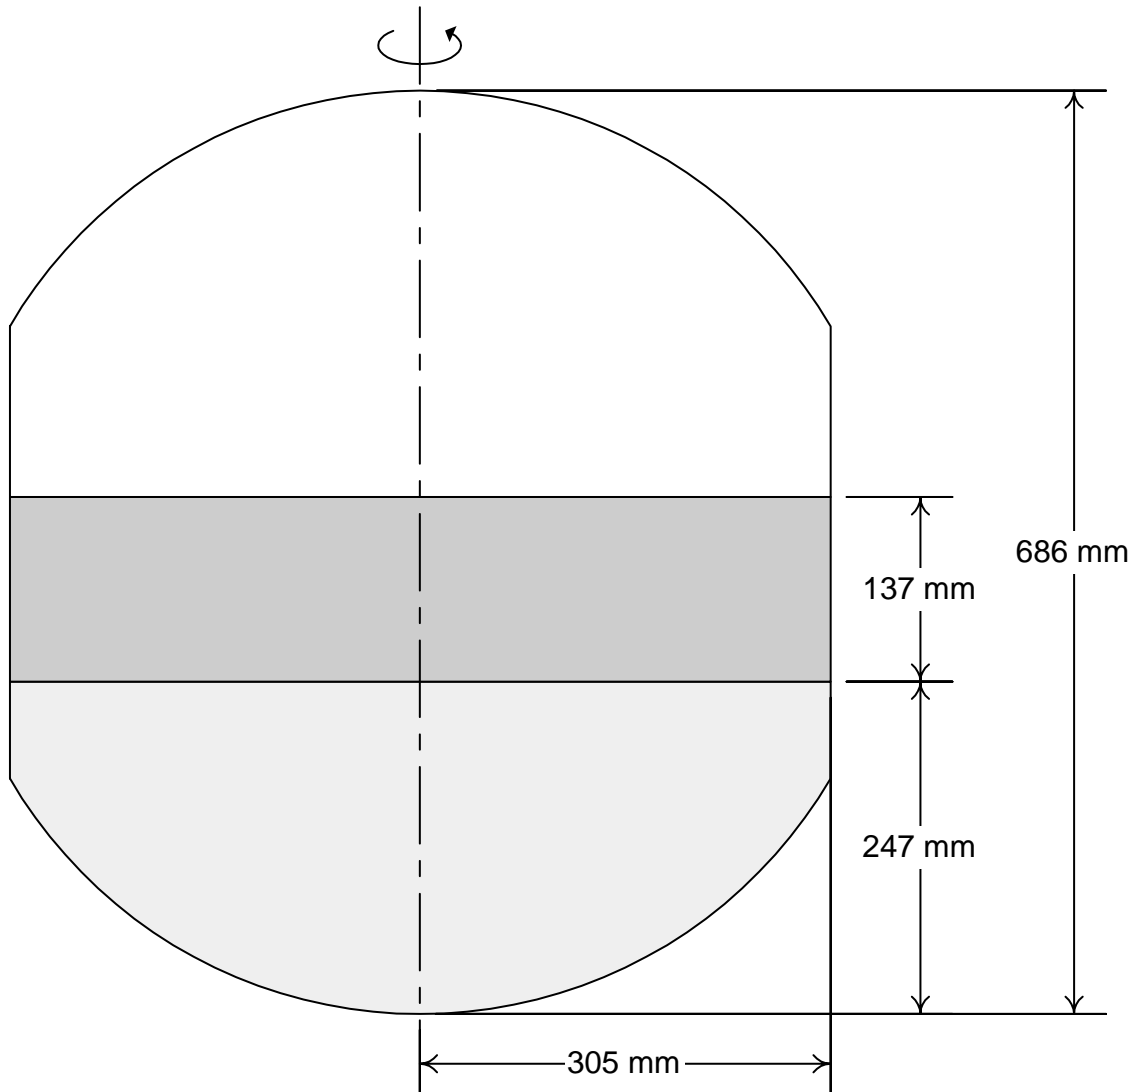
## 18. Windscale Works, 24 August 1970

*Plutonium organic solution in a transfer vessel; one excursion; insignificant exposures.*

Vessel Volume	156.0 ℓ
Fissile Volume	40.0 ℓ
Fissile Mass	2.07 kg
Fissile Density	51.8 g/ℓ

Estimated Spherical Critical Mass	0.69 kg
First Spike Yield	none
Specific Spike Yield	none
Total Yield	$0.01 \times 10^{17}$

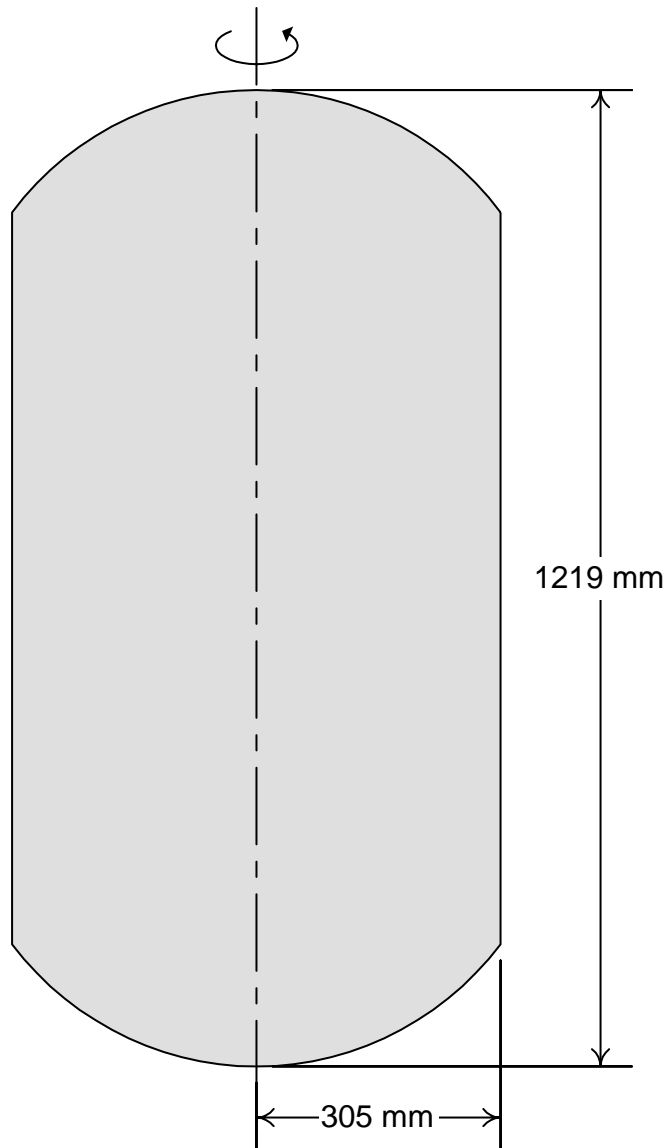
## 19. Idaho Chemical Processing Plant, 17 October 1978

*Uranyl nitrate solution, U(82), in a lower disengagement section of a scrubbing column; excursion history unknown; insignificant exposures.*

Vessel Volume	315.5 ℓ
Fissile Volume	315.5 ℓ
Fissile Mass	6.08 kg
Fissile Density	19.3 g/ℓ

Estimated Spherical Critical Mass	4.34 kg
First Spike Yield	unknown
Specific Spike Yield	unknown
Total Yield	$27.0 \times 10^{17}$

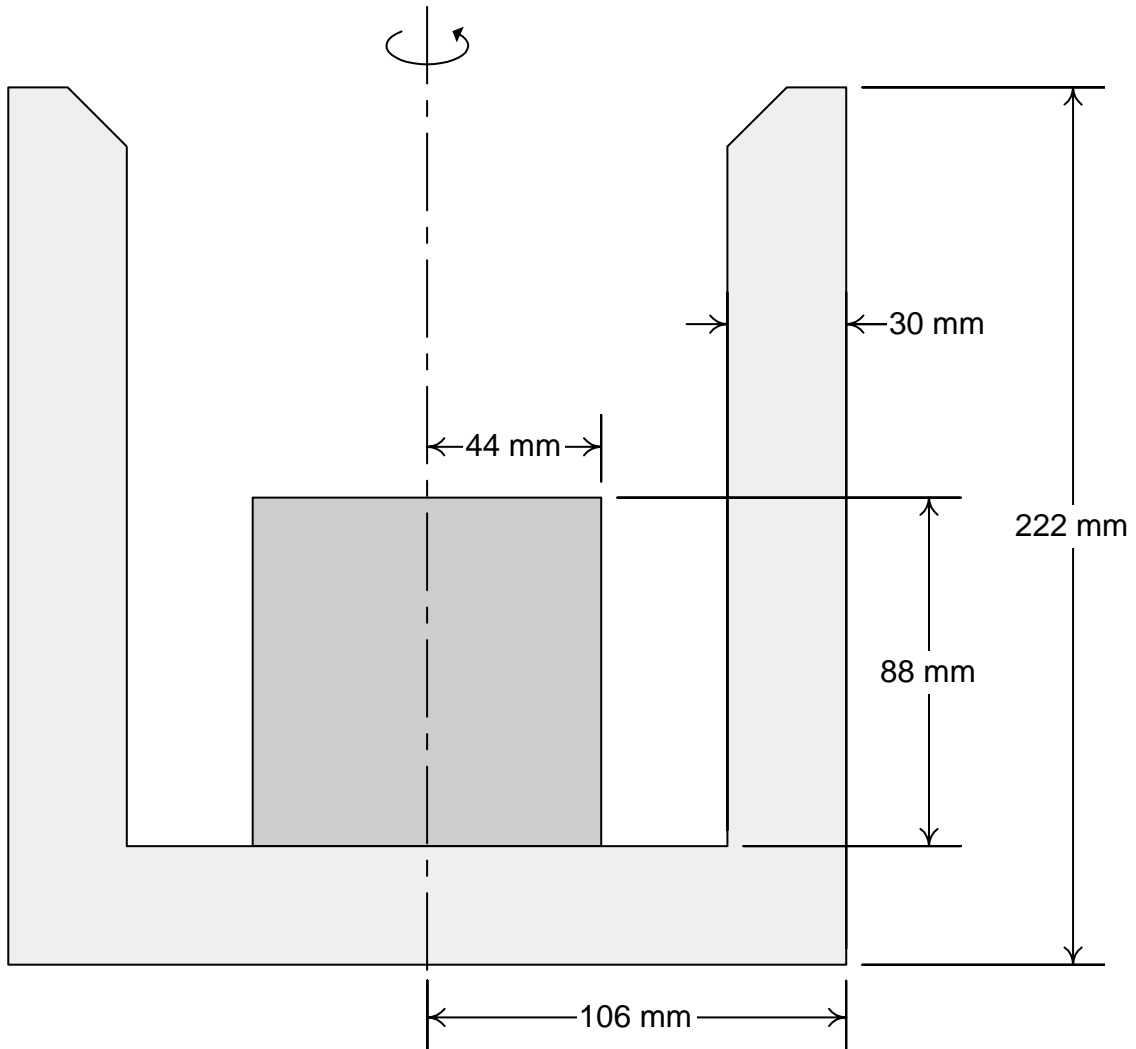
## 20. Siberian Chemical Combine (Tomsk), 13 December 1978

*Plutonium metal ingots in a storage container; single excursion; one serious exposure, seven significant exposures.*

Vessel Volume	3.2 ℓ
Fissile Volume	0.54 ℓ
Fissile Mass	10.1 kg
Fissile Density	18,700 g/ℓ

Estimated Spherical Critical Mass	9.18 kg
First Spike Yield	$0.03 \times 10^{17}$
Specific Spike Yield	$5.6 \times 10^{15}$
Total Yield	$0.03 \times 10^{17}$

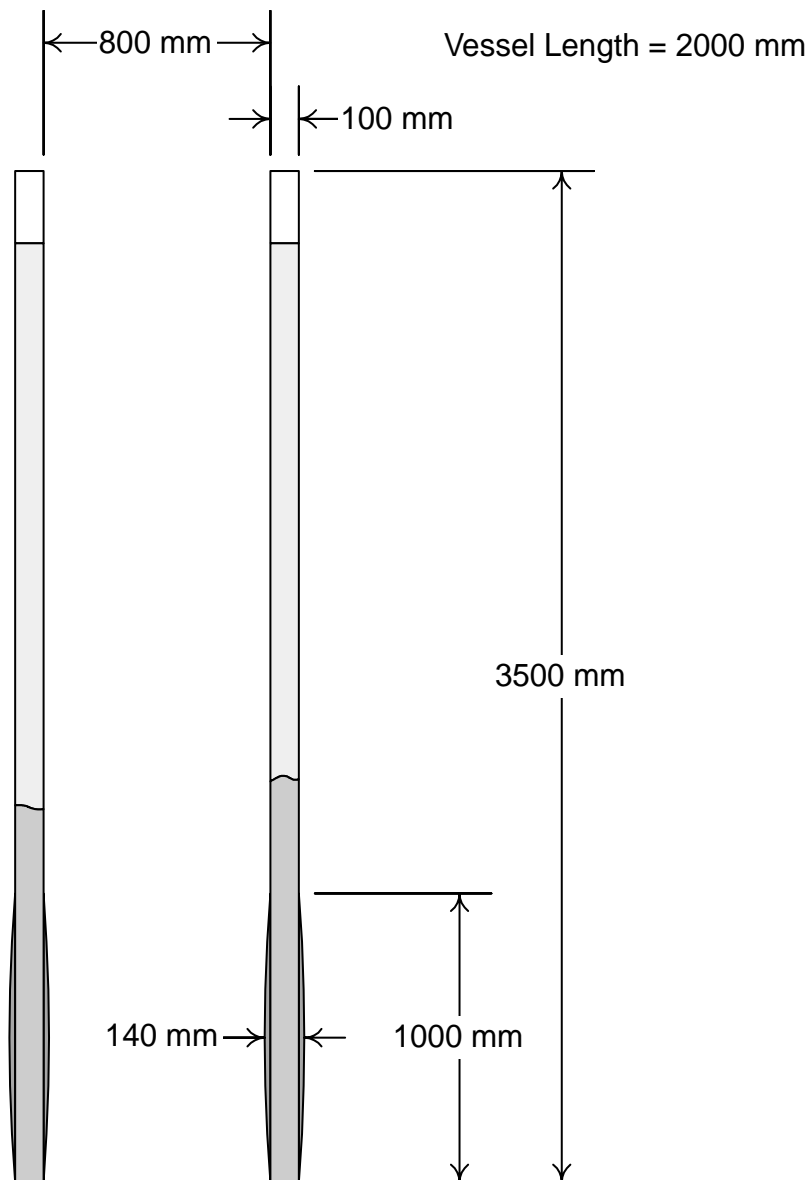
## 21. Novosibirsk Chemical Concentration Plant, 15 May 1997

*Uranium oxide slurry and crust, U(70), in the lower regions of two parallel vessels; multiple excursions; insignificant exposures.*

Vessel Volume	700.0 ℓ per vessel	Estimated Spherical Critical Mass	*
Fissile Volume	*	First Spike Yield	none
Fissile Mass	17.1 kg	Specific Spike Yield	none
Fissile Density	*	Total Yield	$0.055 \times 10^{17}$

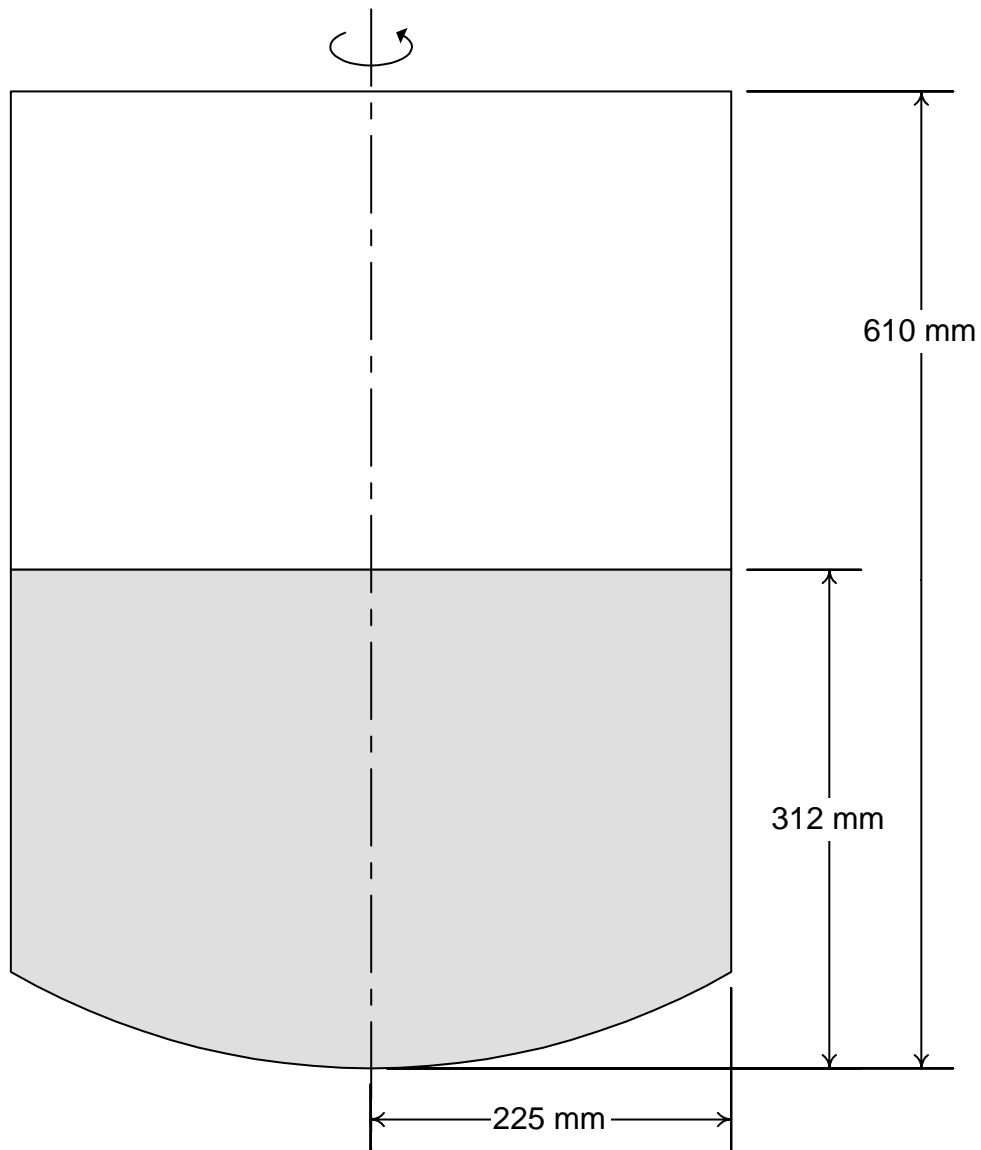
## 22. JCO Fuel Fabrication Plant, 30 September 1999

*Uranyl nitrate solution, U(18.8), in a precipitation vessel; multiple excursions;  
two fatalities, one significant exposure.*

Vessel Volume	100.0 ℓ
Fissile Volume	45.0 ℓ
Fissile Mass	3.12 kg
Fissile Density	69.3 g/ℓ

Estimated Spherical Critical Mass	1.9 kg
First Spike Yield	$\sim 0.5 \times 10^{17}$
Specific Spike Yield	$1.1 \times 10^{15}$
Total Yield	$25 \times 10^{17}$
