NL-16-032

March 16, 2016

SUBJECT: Entergy Transmittal of Indian Point 2 ASME Section XI, IWL Concrete Containment Inspection In Accordance With the Parties' Approved Settlement of License Renewal Contention NYS-24
Indian Point Unit Number 2
Docket No. 50-247
License No. DPR-26

ENTERGY ENGINEERING REPORT IP-RPT-15-00029,
“IP2 ASME SECTION XI, IWL CONCRETE CONTAINMENT
INSPECTION FOR 2015”

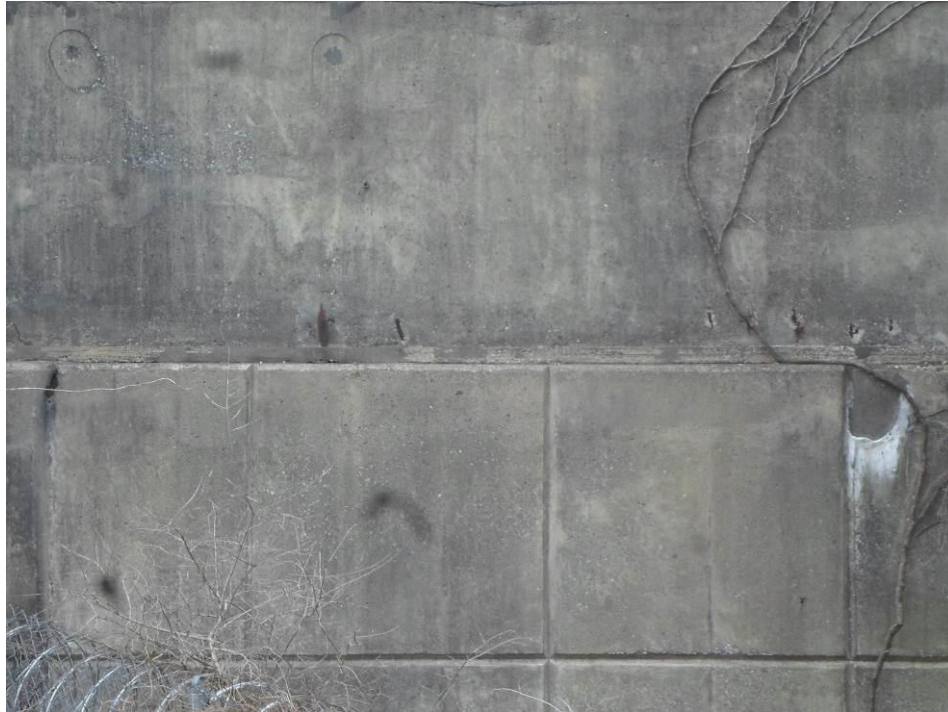
Photo Z1-001

No.	Comment	Initials
1	Minor area of leaching 9" dia. patch at top of basement at junction of wall. The leaching is considered inactive due to past monitoring. See photos Z1-001, Z1-002 and Z1-002A.	JK
2	1" diameter void in concrete with exposed steel. No change from since last inspection. See photos Z1-001, Z1-003 and Z1-003A.	JK
3	Vegetation growth on mat. No change since last inspection. See photos Z1-001 and Z1-003A.	JK
4	Small void 6"x2"x1" deep near left side with vertical crack from top of mat to ground cover < 1/16" wide. Seen in photos from last inspection but not included in report. No change visible. See photos Z1-001 and Z1-004.	JK

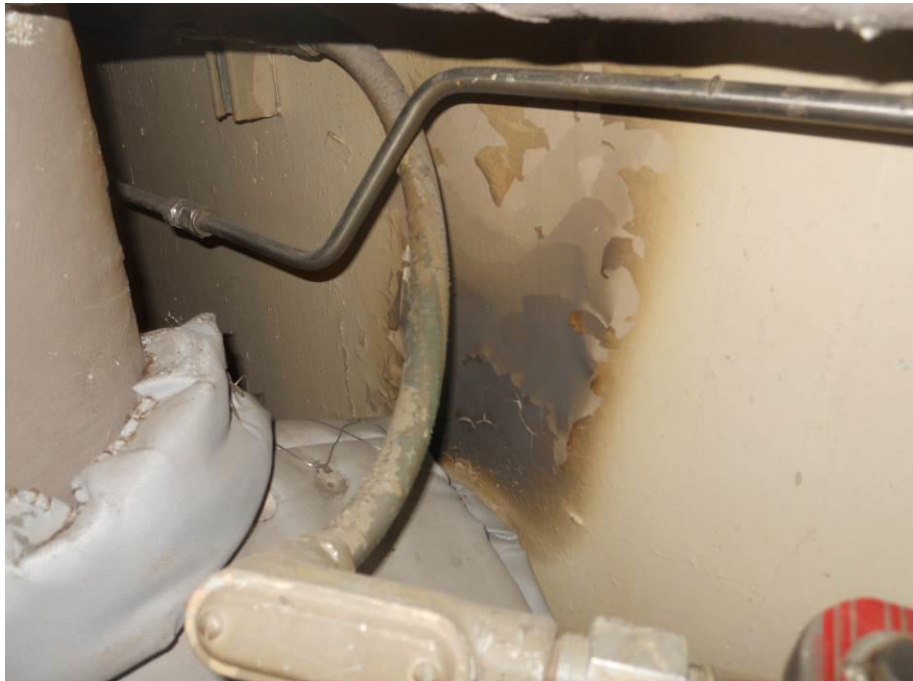
Photo Z2-005

No.	Comment	Initials
1	There are several pockets (8 total all less than 8" long) of unconsolidated concrete ("honeycomb") at the very bottom edge of the mat. These areas are due to lack of proper consolidation or loss of paste during original concrete placement and do not represent degradation. This area continues to be monitored with no changes since the baseline inspection. See photos Z2-001 through Z2-001E .	JK
2	Crack behind unistrut, 56" long & 1/16" wide, ends at ceiling and void below. In same location as item 1. No change since previous inspection. See photos Z2-002, Z2-002A, Z2-002B and Z2-002C .	JK
3	<p>There are a number of areas within this zone where the coating is flaking and peeling. There is no evidence that this is due to degradation of the concrete substrate. It is a coatings related issue and not containment degradation. No notable change since last inspection.</p> <ul style="list-style-type: none"> - Two areas flaking/peeling in main room. See photos Z2-003, Z2-003A, Z2-003B, Z2-004, and Z2-004A. - 9" x 7" area behind PCV-1310-B, Aux. Feed Pump 22 St. Supply, peeling due to heat damage. See photos Z2-005 and Z2-005A. - South corner 36" x 18" flaking/peeling. See photos Z2-006 and Z2-006A. - 	JK

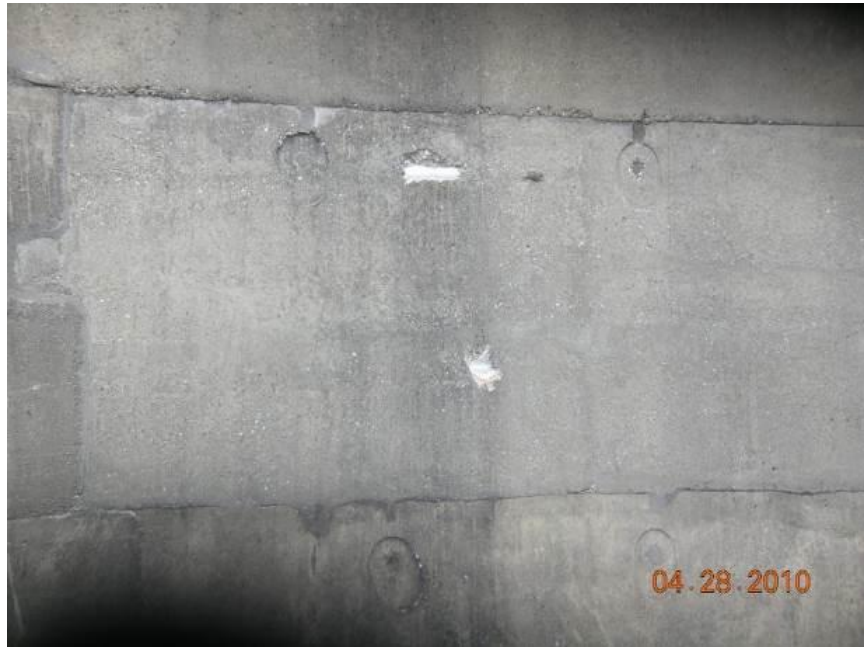
Photo Z1-005

No.	Comment	Initials
1	Cadweld exposure due to 9" x 3" of spalling, insufficient concrete cover (less than 1/2"). The exposed cadweld was coated to inhibit future potential corrosion in 2009. Some degradation to the coating has occurred. Some cracks extend horizontally from the ends of the spall. See photos Z1-005, Z1-005A, Z1-006 and Z1-006A	SK
2	Exposed cadweld at spall. 4" x 2", at El. 51'. The exposed cadweld was coated to inhibit future potential corrosion. Some degradation to the coating has occurred since the last inspection. See photos Z1-005, Z1-005A, Z1-007 and Z1-007A	SK
3	One form tie hole not filled and one partially filled. These holes have remained in the same condition as several previous inspections.	SK
4	Scrap steel exposed at surface with some cracking approx. 6". No change noted since 2010 inspection. See photo Z1-008	SK
5	Leaching over a length of 20' close to joint from grout patch. This area has remained unchanged since the 2010 inspection. There has been no notable change since the baseline inspection. See photos Z1-009 and Z1-009A	SK

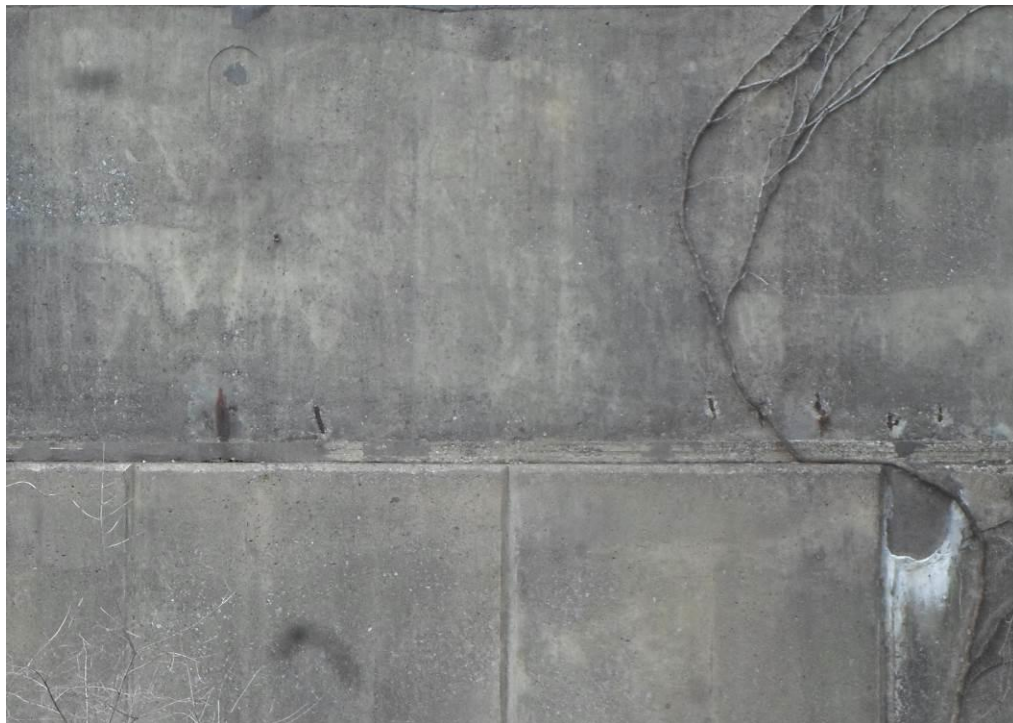
Photo Z1-010

6	Ribs of some embedded steel (scrap) exposed at the surface at El. 44'. Some rust bleeding is apparent. Pitting noted in 2010 inspection was not identified.	SK
7	Vertical rebar exposure with rust marks maximum of 9" at 10 locations over 20' width at basement junction. This area remains unchanged since the previous inspection. See photos Z1-010 to Z1-010C	SK
8	A previously repaired area near AFB has degraded. See photo Z1-011	SK

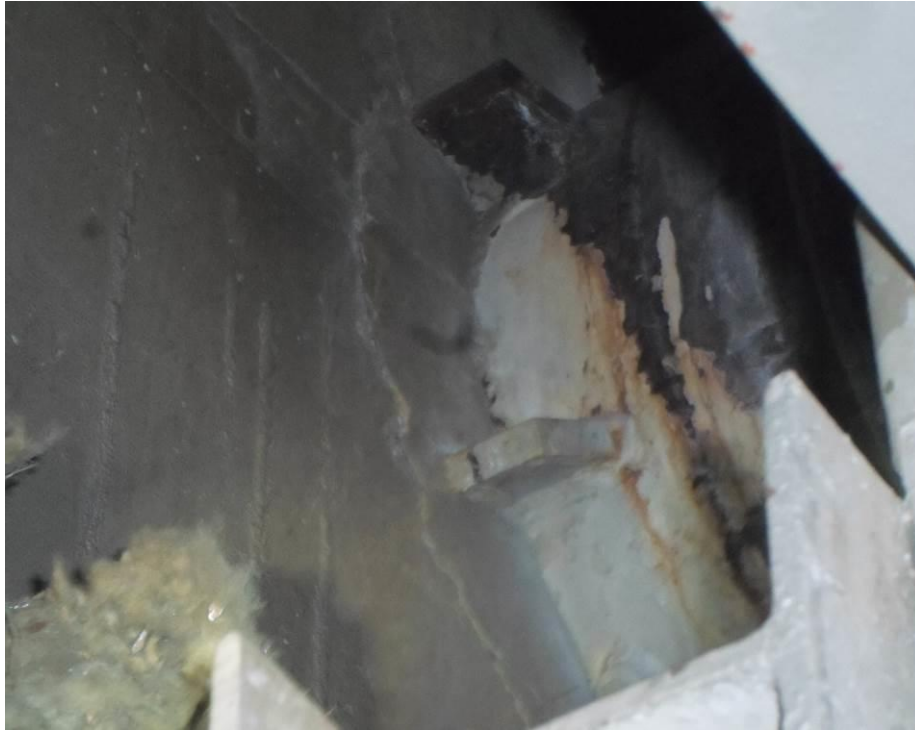
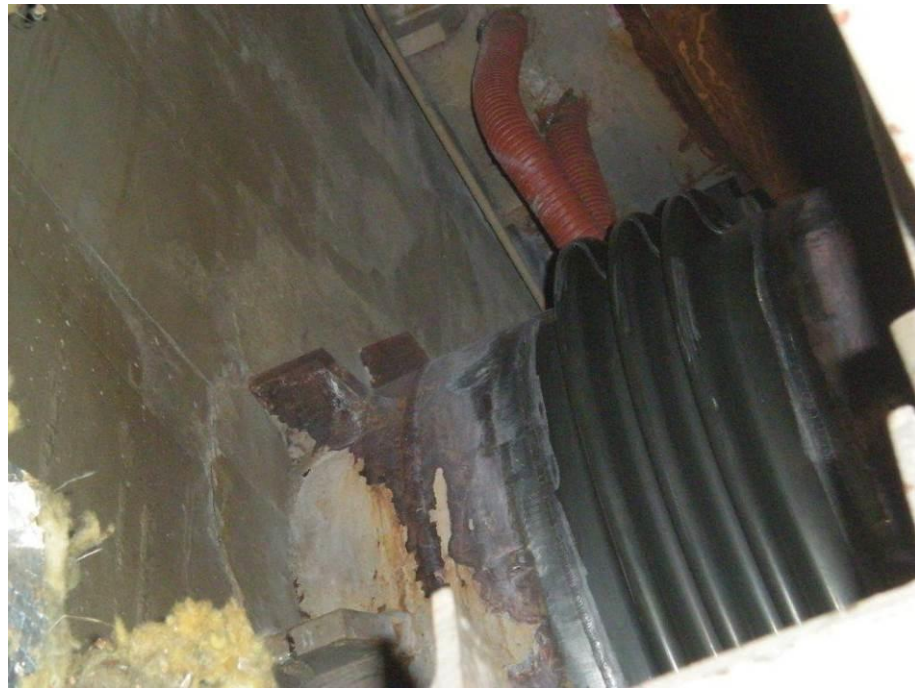
No.	Comment	Initials
1	A spalled area, previously approximated at 10" long, was found at the floor line directly below penetration MP-H. This area appears to have some unconsolidated concrete ("honeycomb") from the original placement of the concrete. This area has remained unchanged since previous inspection. See photos Z2-007, Z2-007A and Z2-007B . Location: Floor level @ BFD-79-3, Steam Generator 23 Aux. Feed Supply Check Valve (valve at head level). Additional Details: - Main spall is 12-1/2" x 3-1/2" with the largest width being 1/4". - Two voids/spalls 2" x 3" x 1/2" and 2" x 2-1/2" x 1/4" - Crack 19' long, 1/32" width (20" from floor) - 3"x2" spall in grout at top left of penetration MP-H. See photo Z2-007C .	JK
2	A crack with apparent delamination was found around the lower left edge of penetration MP-G. There is no notable change to this indication since baseline inspection. See photos Z2-008 and Z2-008A .	JK

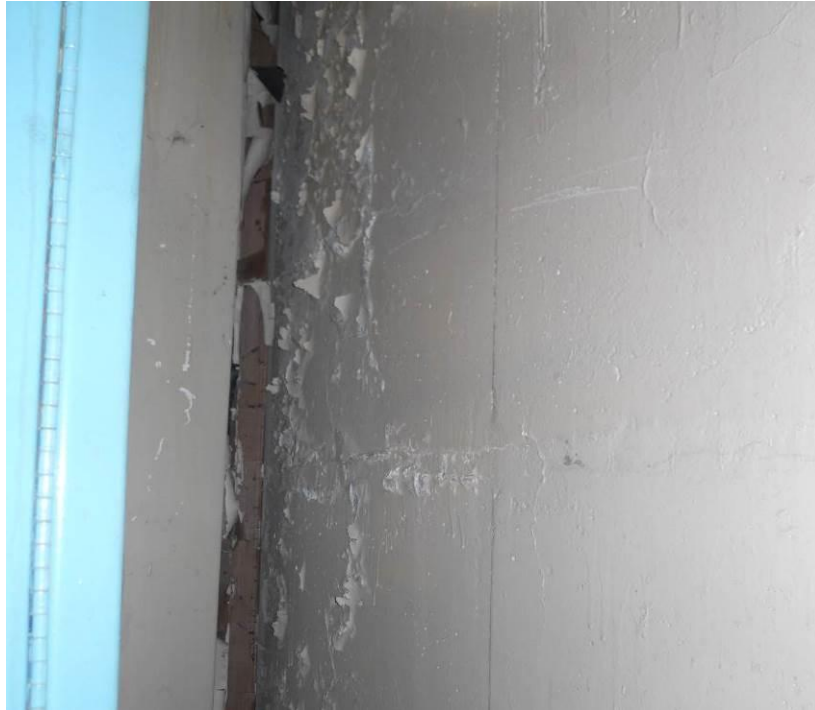
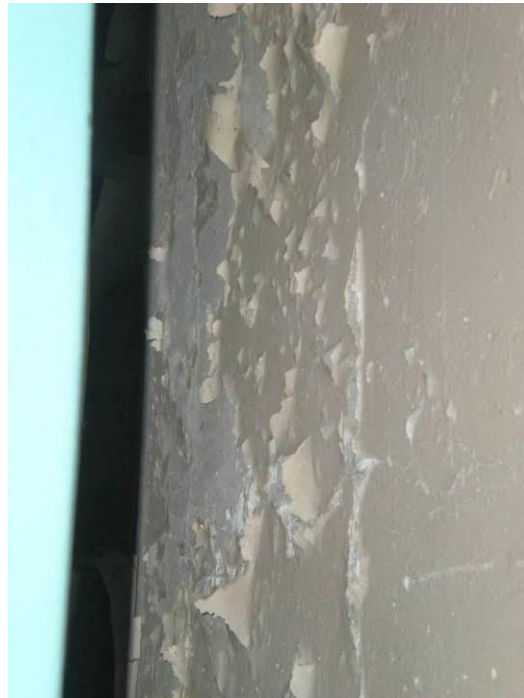
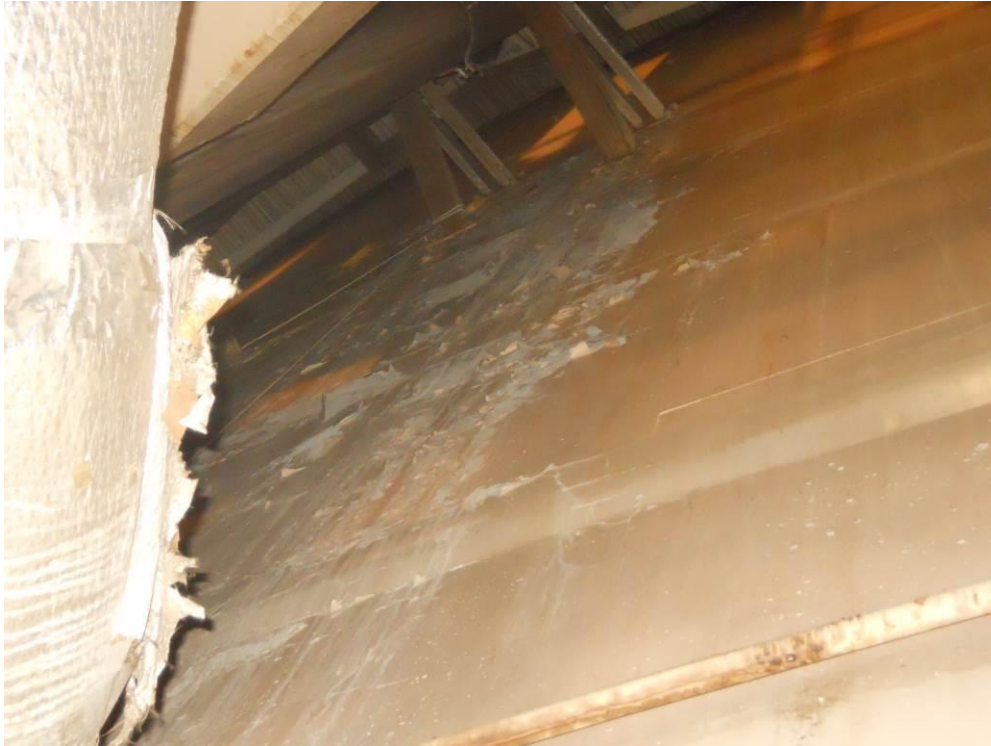
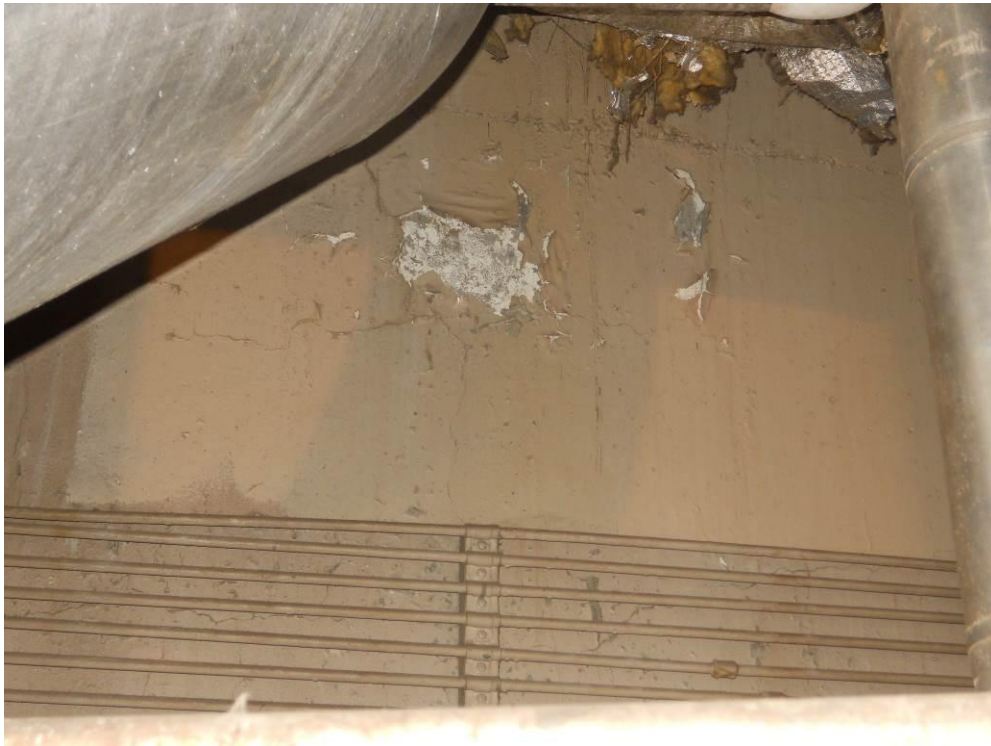
3	A delamination was found at approx. El. 49' behind BFD-6-1. The area was estimated to be 30" at the widest part (top) and 18" at the lower portion by 12" high by combination of visual inspection and sounding the concrete (tapping the surface with a metal object). See photos Z2-009, Z2-009A and Z2-009B .	JK
4	This area was examined from the floor level at El. 43'. The examination distances were a maximum of 20 feet. While this distance exceeds the limits for direct visual examination, it was too short for use of the binoculars due to their minimum focal length. Lighting levels using the flashlight exceeded the 50 foot-candle requirement. The upper 5 feet of this zone were not visible for inspection by direct line of sight due to piping and structural steel obstructions. Area has been coated.	JK
5	There are a number of areas within this section where the coating is flaking and peeling. There is no evidence that this is due to degradation of the concrete substrate. It is a coatings related issue and not containment degradation. See sample photos Z2-010, Z2-010A, Z2-011 and Z2-012 .	JK

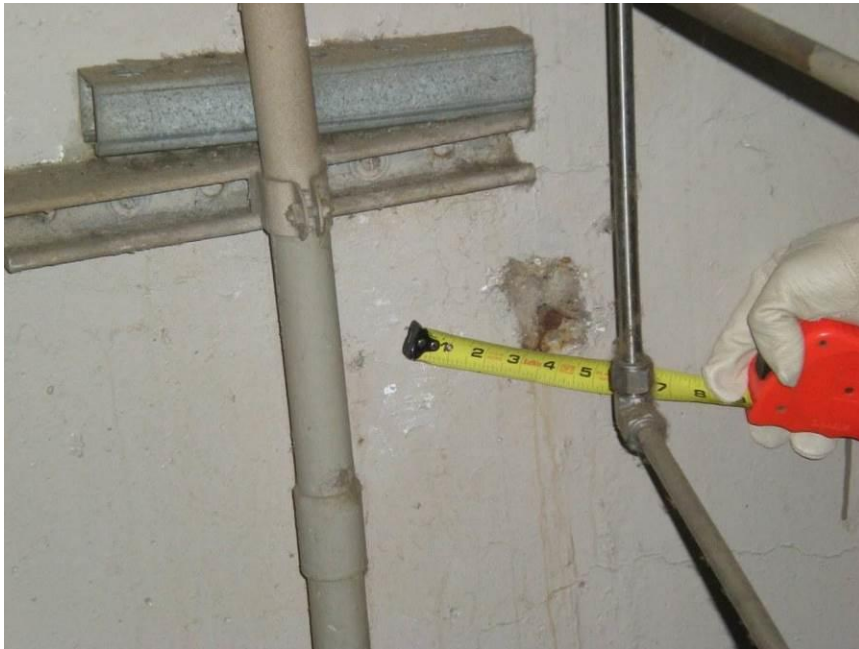
Photo Z2-013

6	Although previously identified as rebar, the steel bar sticking out (~ 3/4" dia.) with rust and staining at El. 46' behind Rack 15 appears to be an anchor cut flush to the concrete and not reinforcement for the Containment concrete. The spall at this location is 2" x 3". See photo Z2-013 .	JK
7	Floor level delamination, 5" x 5" x 1/4" deep, at DPI-7291, 22 Steam Generator ΔP Indicator. See photos Z2-014 and Z2-014A . No notable change since the previous inspection.	JK
8	Spall with exposed cadweld, 11-1/2" x 3" x 3/8" deep (~4" exposed cadweld) having minimal surface rust located at floor level near DPI-7293. See photos Z2-015 and Z2-015A .	JK
9	Pattern cracking in zone believed to be from the ILRT testing performed every ten years. See photo Z2-016 .	JK
10	Sloppy joint with a 4" x 1" void. There is no evidence of rust staining from void. See photo Z2-017 .	JK
11	Leaching approximately 12' up from floor level. See photo Z2-018 .	JK

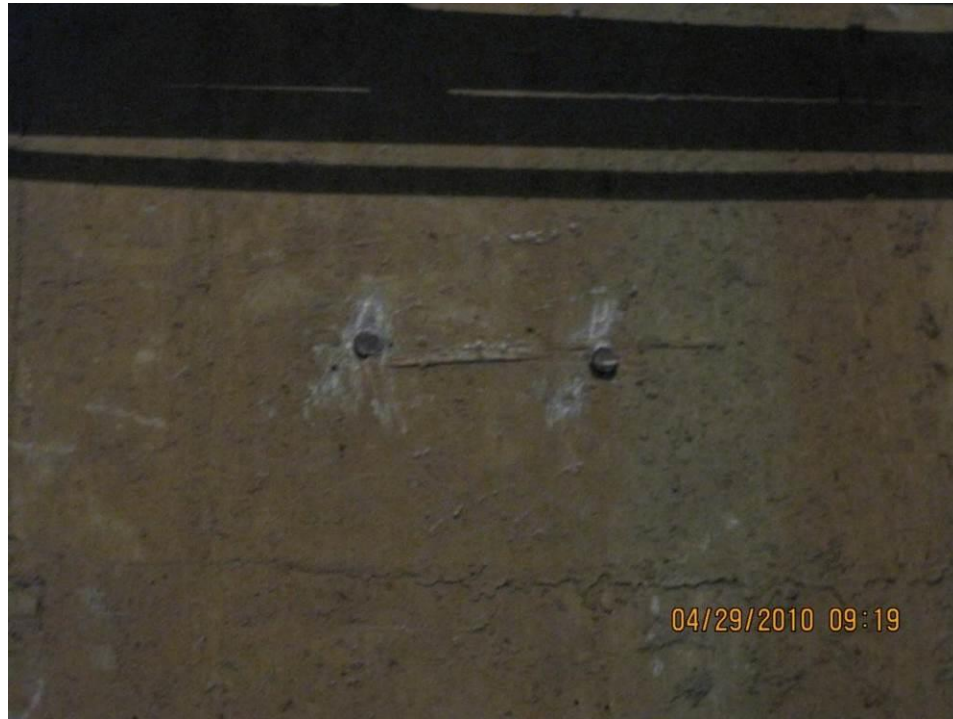
Photo Z3-001

No.	Comment	Initials
1.	Two pieces of embedded steel, appearing to be anchors cut flush, are exposed at the surface of the concrete. Slight rusting is evident but no streaking or staining of the concrete. No notable change since 2005 inspection. See photo Z3-001 .	JK

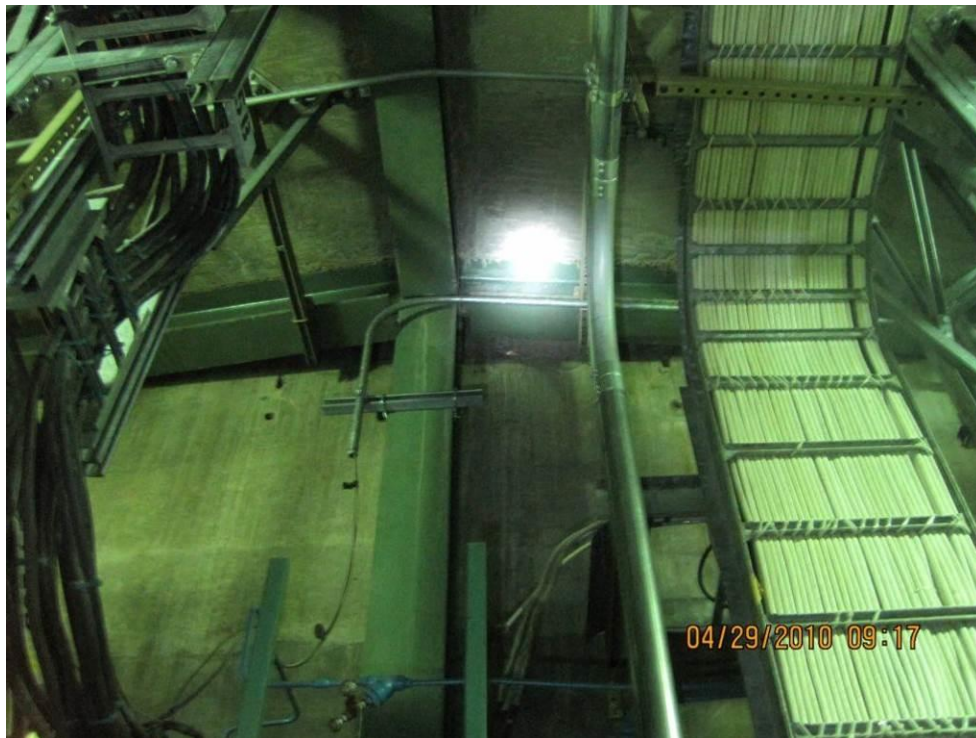
Photo Z3-002

2.	A small surface defect (< 2" dia.) and several unfilled form tie holes were noted but are insignificant relative to containment structural integrity. No notable change since 2005 inspection. See photo Z3-002 .	JK

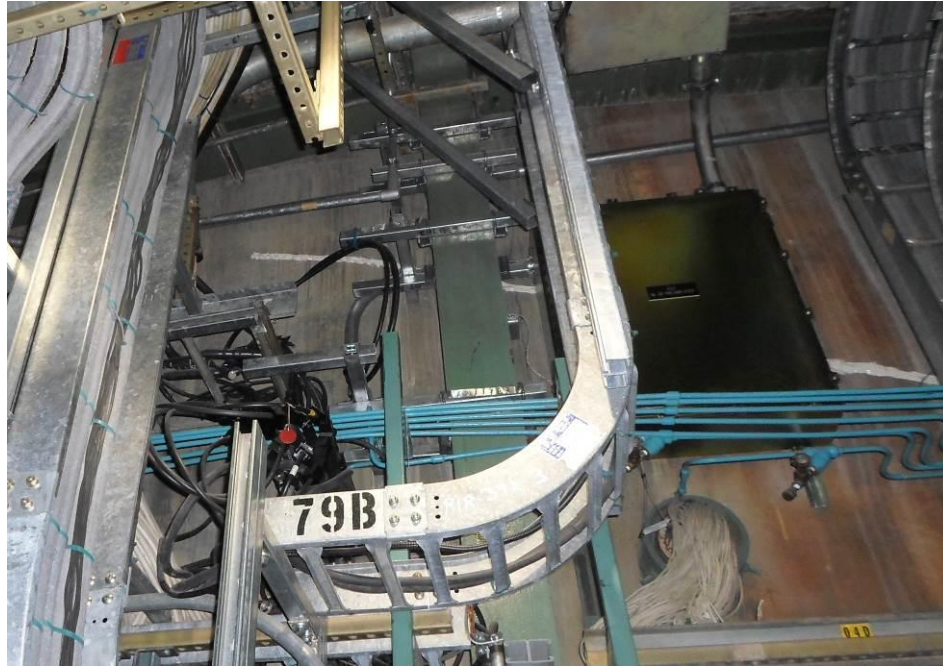
Photo Z3-003

3.	Caulk, possibly covering a crack, diagonally approx. 10' long. Condition remains the same since 2005 inspection. See photos Z3-003 and Z3-003A .	JK
4.	This area was examined from the floor level at El. 46'. The examination distances were a maximum of 20 feet. While this distance exceeds the limits for direct visual examination, it was too short for use of the binoculars due to their minimum focal length. Lighting levels using the flashlight exceeded the 50 foot-candle requirement. Approximately 10% of this zone was not visible for inspection by direct line of sight due to various obstructions.	JK

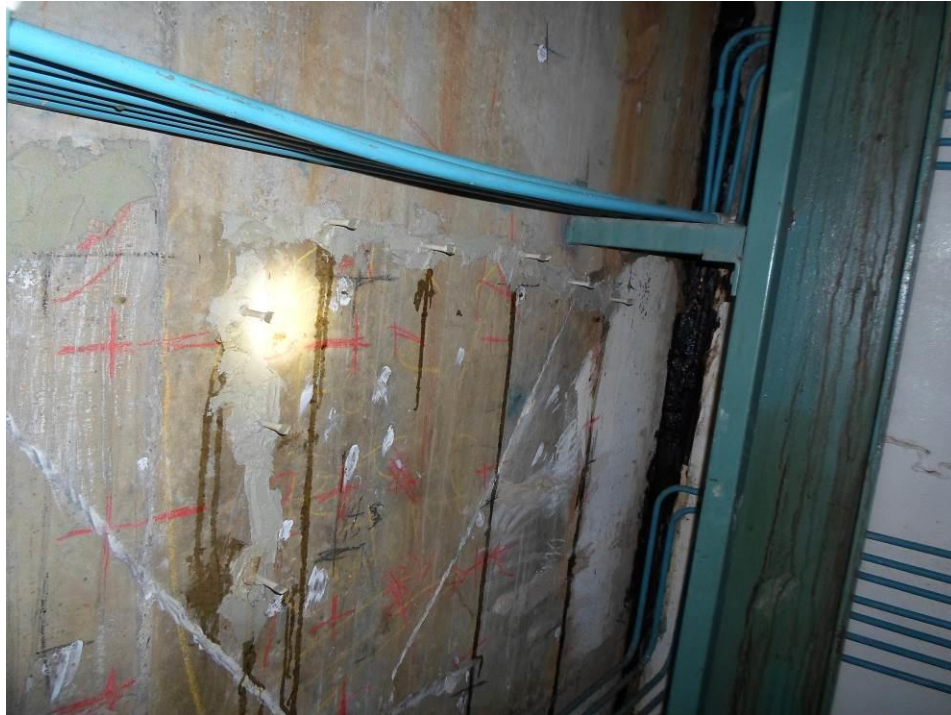
Photo Z3-006

8.	Epoxy injection tubes near Pipe Penetration wall up to ~6'. See photo Z3-006 .	JK
9.	Cut anchors in top corner behind column. Slight corrosion is evident but no streaking or staining of the concrete. See photo Z3-007 .	JK

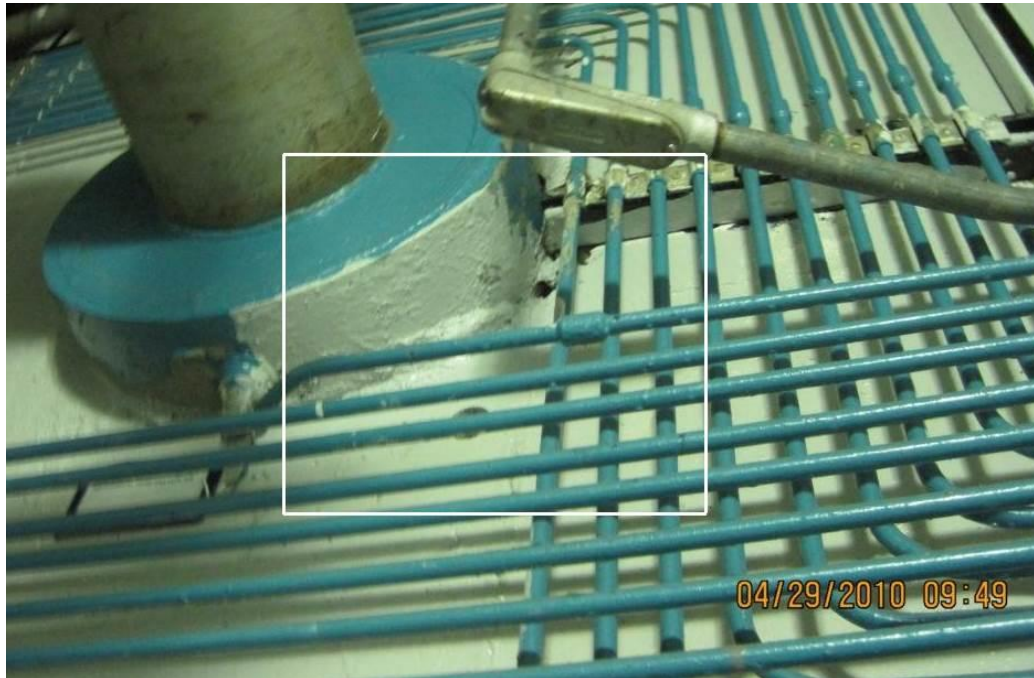
Photo Z4-005

8	1" diameter void, appears to be manmade, and 3/4" void at penetration "GG" (upper first penetration from far right wall). See photos Z4-005 and Z4-005A .	JK
9	Minor pattern cracking and peeling/flaking coating in some areas.	JK

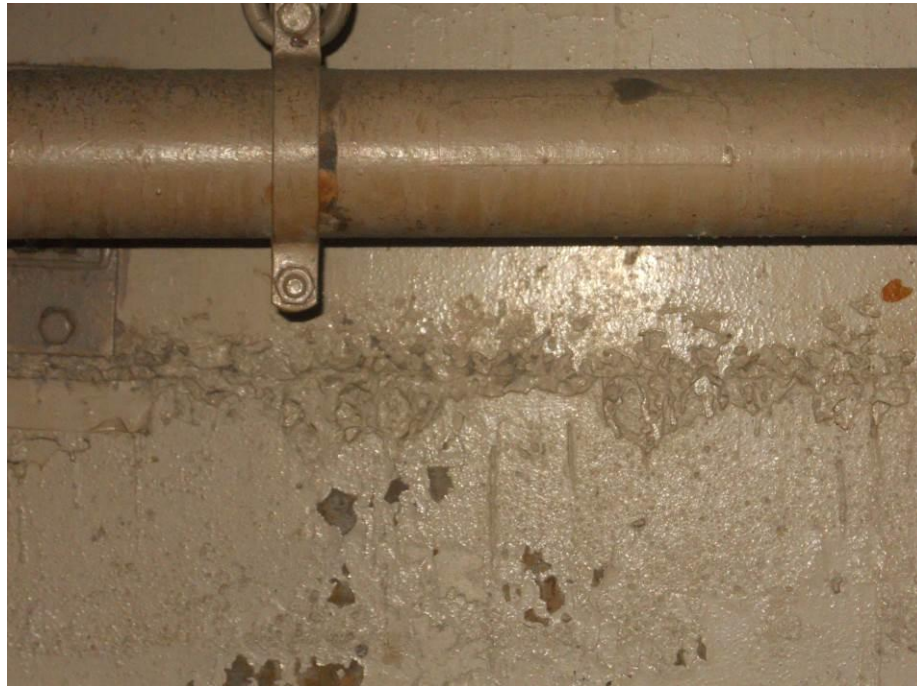
Photo Z2-021

No.	Comment	Initials
1	This area was examined from the platforms at El. 64'-8" and El. 76'-8". The examination distances were a maximum of 20 feet. While this distance exceeds the limits for direct visual examination, it was too short for use of the binoculars due to their minimum focal length. Lighting levels using the flashlight exceeded the 50 foot-candle requirement. Approximately 5% of the concrete surface was not visible for inspection by direct line of sight due to obstructions.	JK
2	There are a number of areas within this section where the coating is flaking and peeling. There is no evidence that this is due to degradation of the concrete substrate. It is a coatings related issue and not containment degradation. See sample photos Z2-020 through Z2-020C .	JK
3	Joint cracking and spalling exposing aggregate with coating covering area at El. 68' over a 20' span. No notable change since 2005 inspection. See photos Z2-021 and Z2-021A .	JK

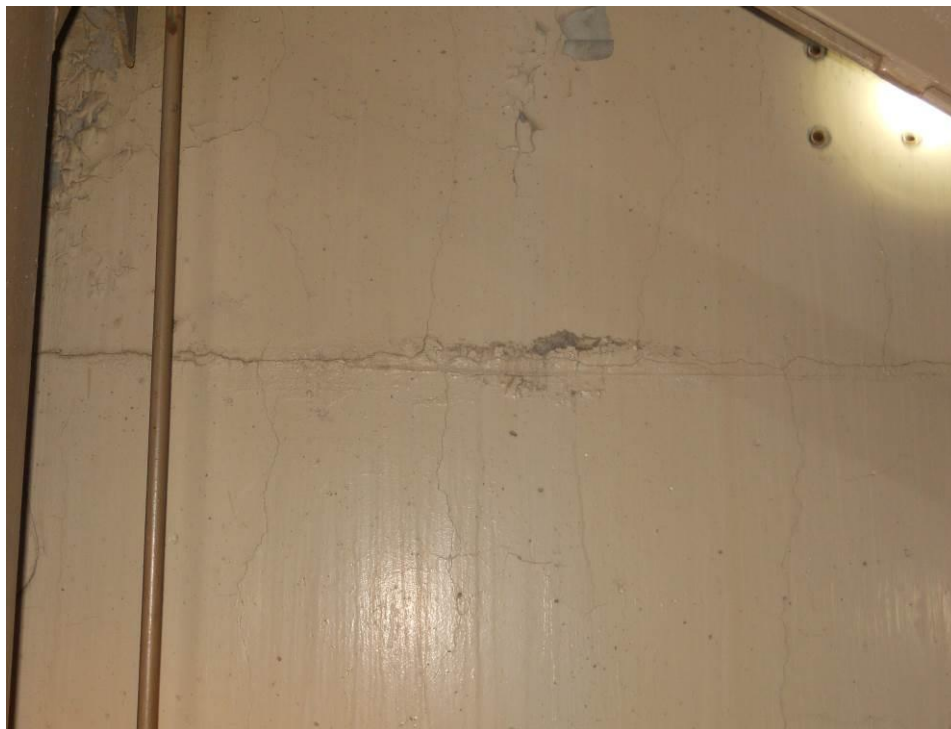
Photo Z2-022

4	Hairline pattern cracking (<1/32") at El. 70' approximately 25' from right boundary. Identified in previous inspection. See photo Z2-022 .	JK
5	Joint cracking, pattern cracking and minor spalling at El. 82', behind S/O Relief MS-45C. Identified in previous inspection. See photo Z2-023	JK
6	1-1/2" x 1-1/2" discolored area (rust color) at El. 68' behind MS-42. Same as last inspection. See photos Z2-024 and Z2-024A .	JK
7	Multiple retired anchors left embedded in containment at El. 77'. No degradation to concrete.	JK
8	There is a small void just below roof level behind MS-48A. See photo Z2-020C .	JK
9	Several form tie holes were found not patched. There is also a sloppily formed joint at this location. These are not significant relative to containment structural integrity. See photo Z2-025 .	JK
10	There is a spall behind the column at the far end of the room. See photo Z2-026 .	JK

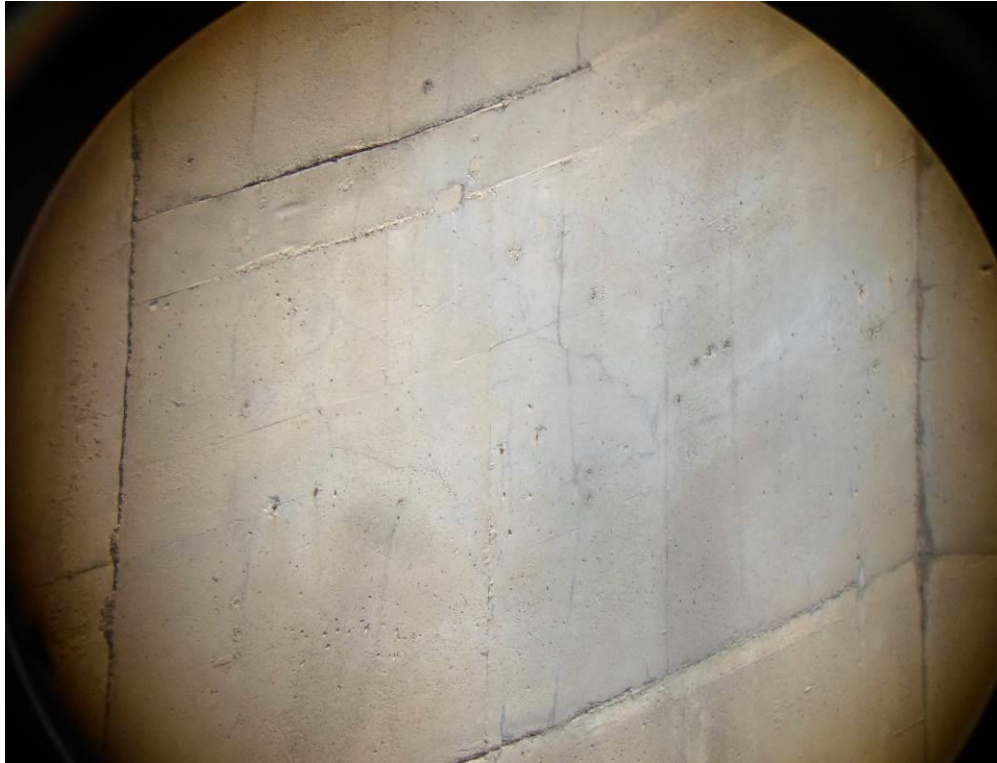
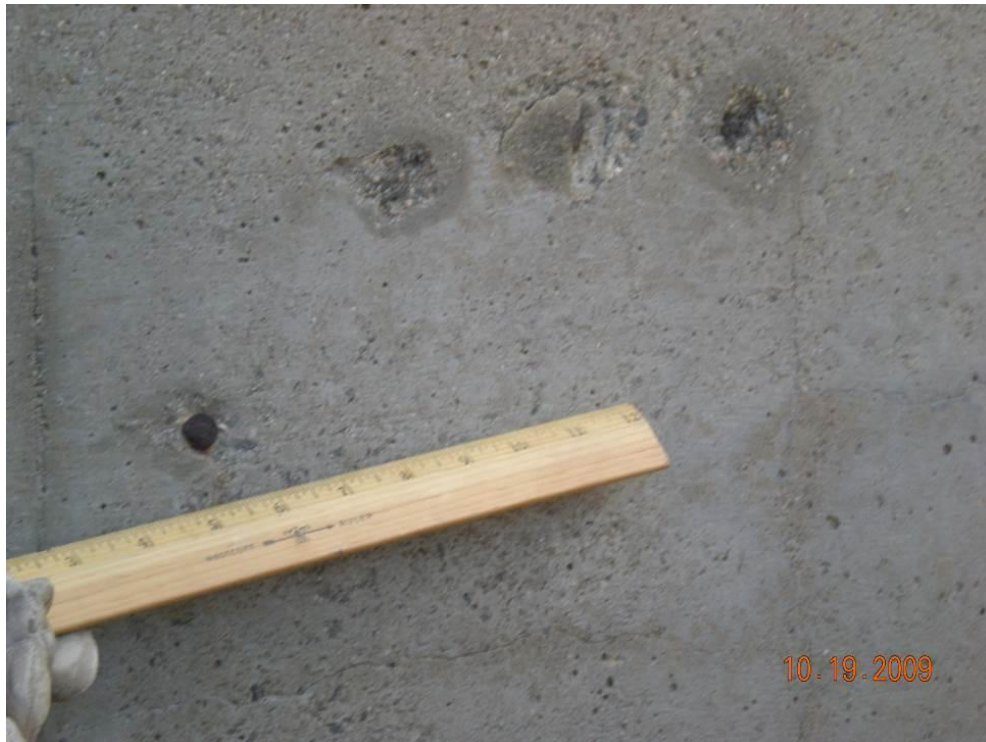
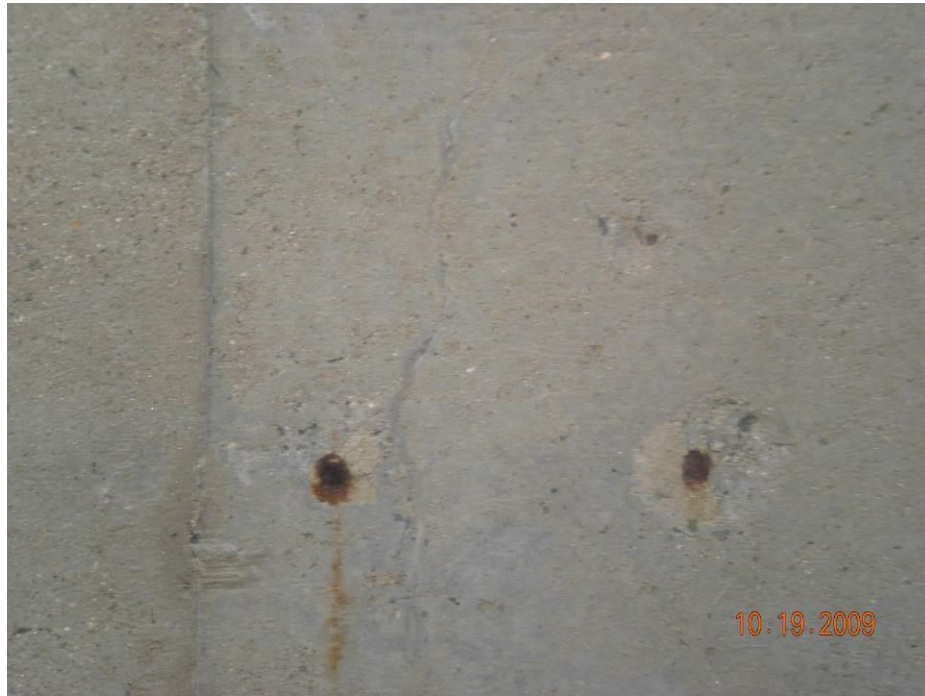
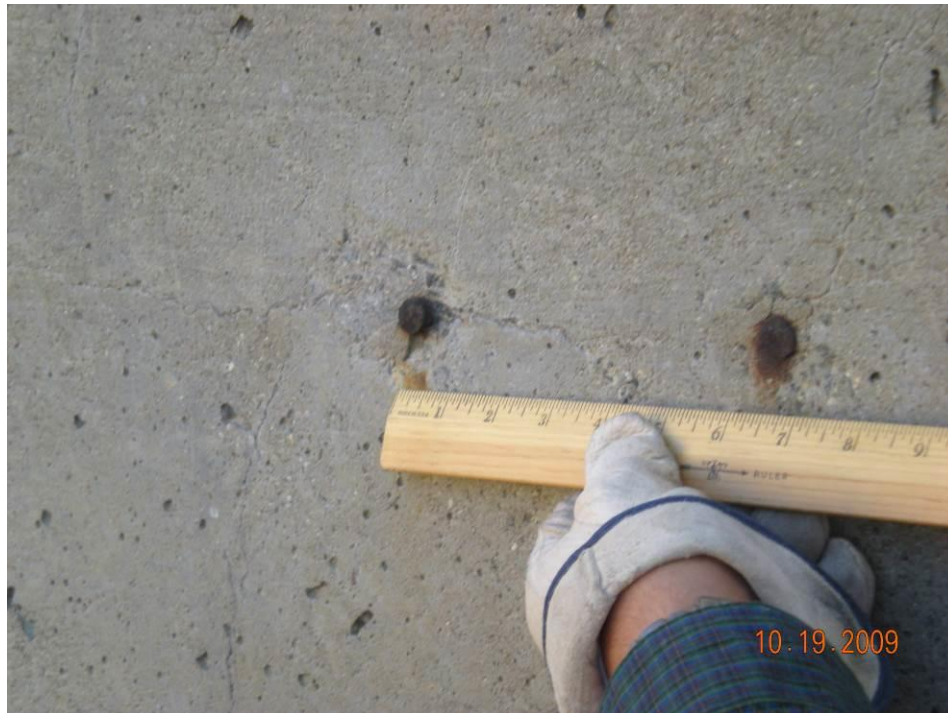
Photo Z3-012

No.	Comment	Initials
1	At El. 68' in the right side of the zone, two possible cadwelds beginning to spall near the red zone. See photo Z3-009 .	JK
2	At El. 79' on the far right side in the red zone there is a possible piece of wood leftover from the formwork. See photo Z3-010 .	JK
3	Exposed miscellaneous wire (3" long) at El. 85'. Coated in 2009, no change in condition since previous inspection. See photos Z3-011 and Z3-011A .	JK
4	Exposed miscellaneous steel (3" long) at El. 87'. Coated in 2009, no change in condition since previous inspection. See photos Z3-011 and Z3-011B .	JK
5	Exposed miscellaneous steel (4" long) at El. 88'. Coated in 2009, no change in condition since previous inspection. See photos Z3-011 and Z3-011C .	JK
6	Exposed miscellaneous steel (1/2" diameter at 7 locations) at El. 88'. This location is in the red zone. Possibly cut off anchors. Some corrosion staining present. Condition previously identified with no noticeable change. See photos Z3-012, Z3-012A, Z3-012B and Z3-012C .	JK

7	3 form holes popouts and 4 partial popouts in the red zone. See photos Z3-013 and Z3-013A .	JK
8	General joint cracking with spalls, pattern cracking, scaling, and bugholes throughout the entire section. These conditions are minor observations that were identified previously.	JK
9	Some hairline cracking in the red zone. See photos Z3-012 and Z3-013A .	JK

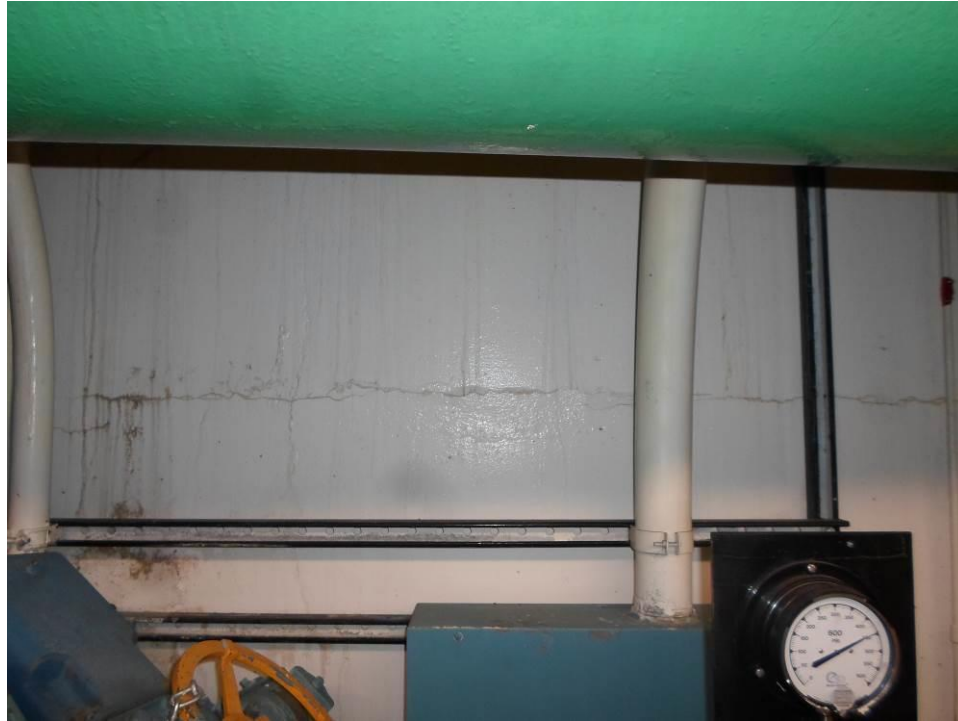
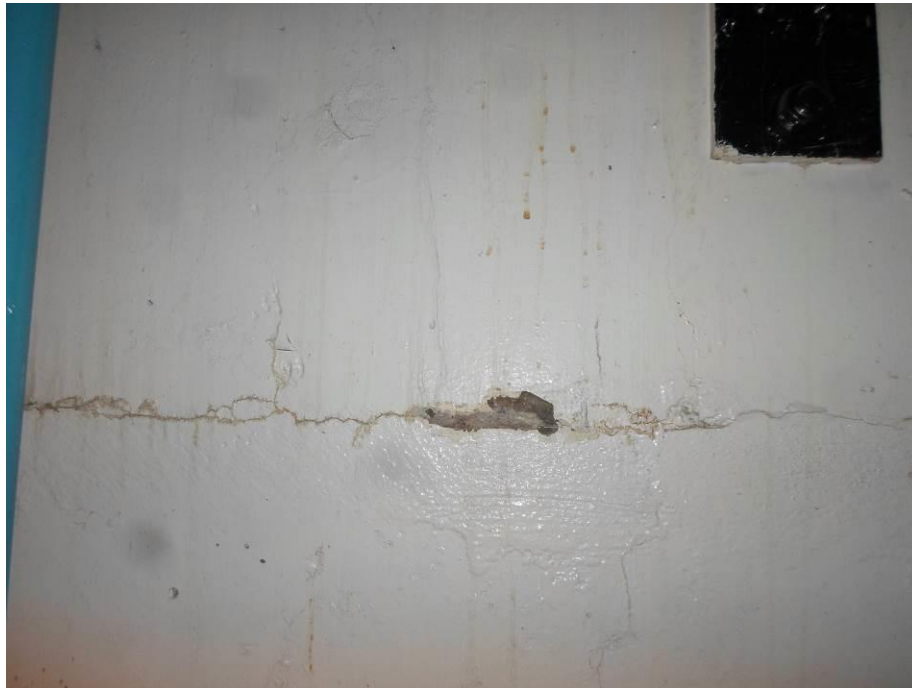
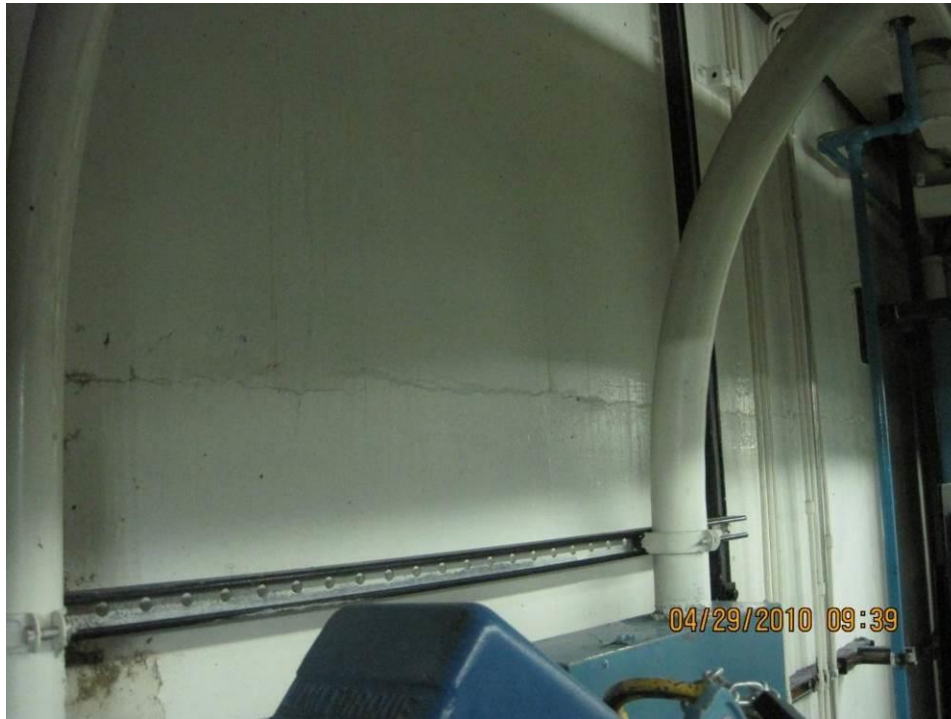
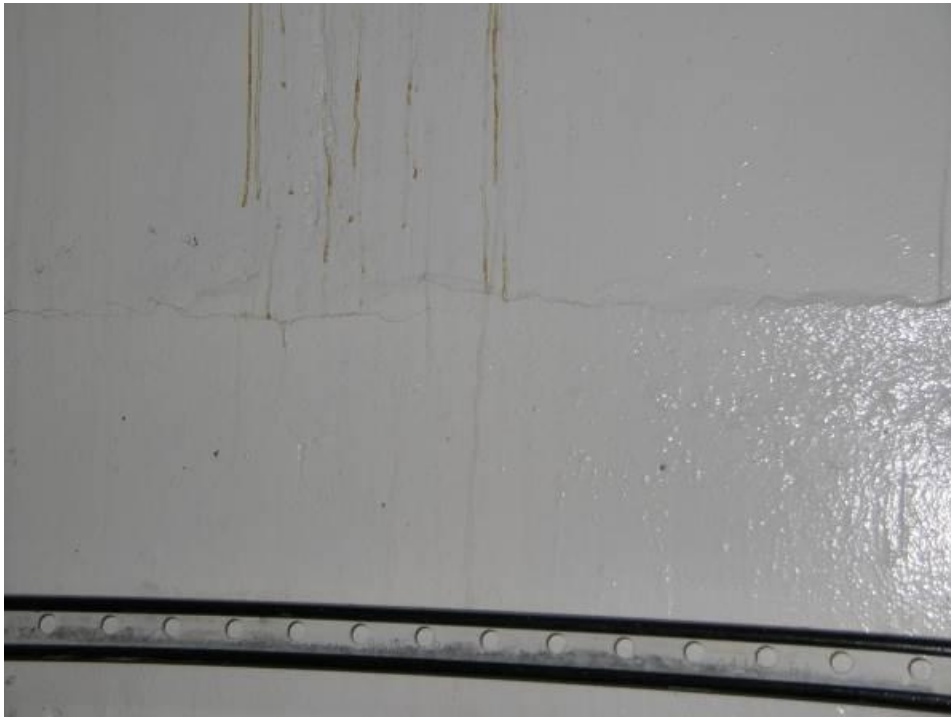
Photo Z4-006

No.	Comment	Initials
1	An area approximately 20' x 8' was not visible for direct visual examination due to obstruction by electrical cabinets.	JK
2	Joint cracking approximately 10' long. Repair to cracked joint is beginning to flake off. See photos Z4-006, Z4-006A, Z4-006B and Z4-006C.	JK
3	General pattern cracking and bugholes. The condition was previously identified. See photos Z4-007, Z4-007A, Z4-007B and Z4-007C.	JK
4	Staining from previous leaching (~18" long) is visible from a patched popout area.	JK
5	6" x 8" area of failed coating on the Mezzanine. Minor degradation to concrete surface in this area has been painted over but is peeling / flaking. See photos Z4-008 and Z4-008A.	JK
6	1" dia. hole appears to be manmade at ceiling line where wall juts out. See photo Z4-009.	JK
7	Several drop-in anchors have been abandoned in-place in the alley between Containment and the Fan House. The anchors were used to erect scaffold around the vent stack. Leaving the anchors will not jeopardize containment integrity. See photo Z4-010 (typical).	JK

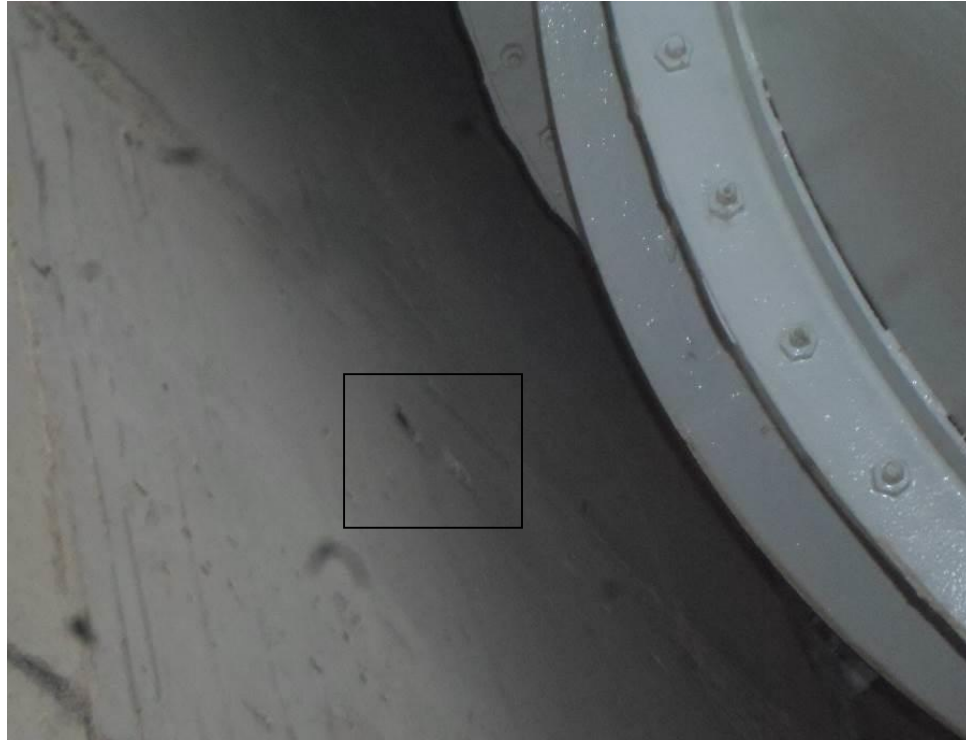
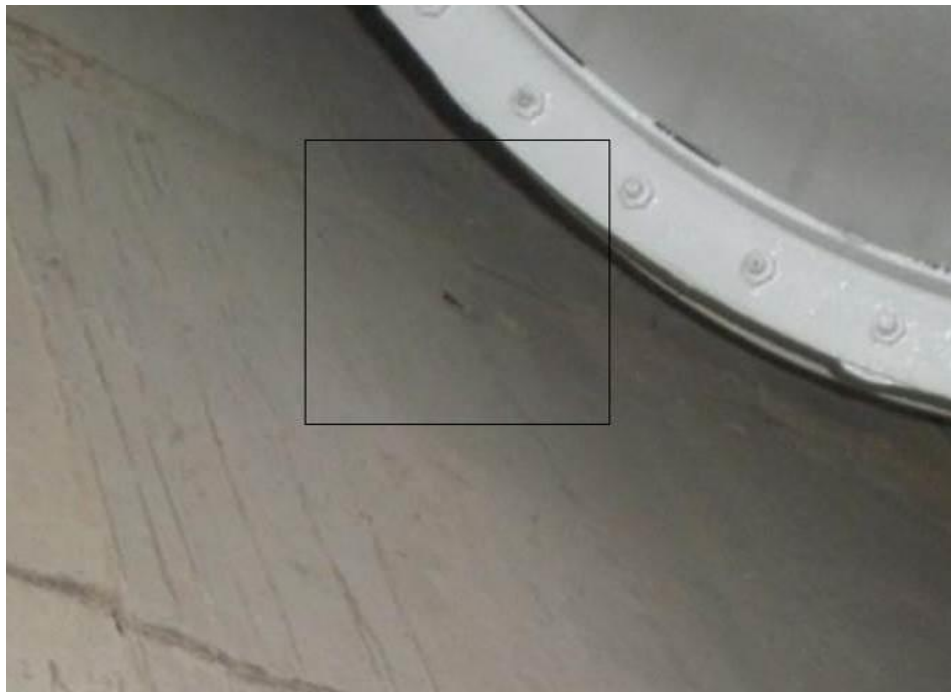
Photo Z4-011

8	1-1/2" diameter void with no rust staining evident behind vent stack in alley. See photos Z4-011 and Z4-011A.	JK
9	Surface discoloration from metal inserts.	JK

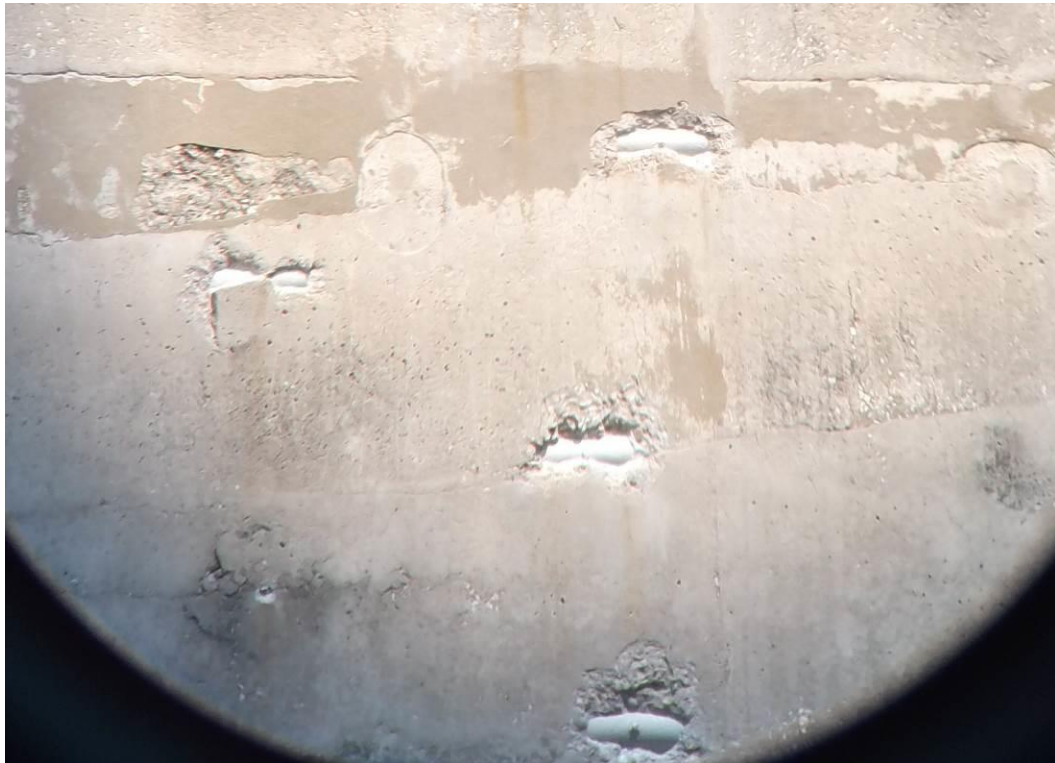
Photo Z4-012

4	Approximately 5 bugholes with rust streaks and local spalling occur between El. 107' and El. 108'. Update => Only 1 bughole remains visible during the 2010 inspection due to the coating efforts in 2009. The rust streak is minimal.	JK
5	Scaling (12" x 5") at El. 107' in cluster of exposed cadwelds listed above. See photos Z4-012, Z4-012A and Z4-012B.	JK
