NL-16-032

March 16, 2016

SUBJECT: Entergy Transmittal of Indian Point 2 ASME Section XI, IWL Concrete Containment Inspection In Accordance With the Parties' Approved Settlement of License Renewal Contention NYS-24
Indian Point Unit Number 2
Docket No. 50-247
License No. DPR-26

ENTERGY ENGINEERING REPORT IP-RPT-15-00029,
“IP2 ASME SECTION XI, IWL CONCRETE CONTAINMENT
INSPECTION FOR 2015”

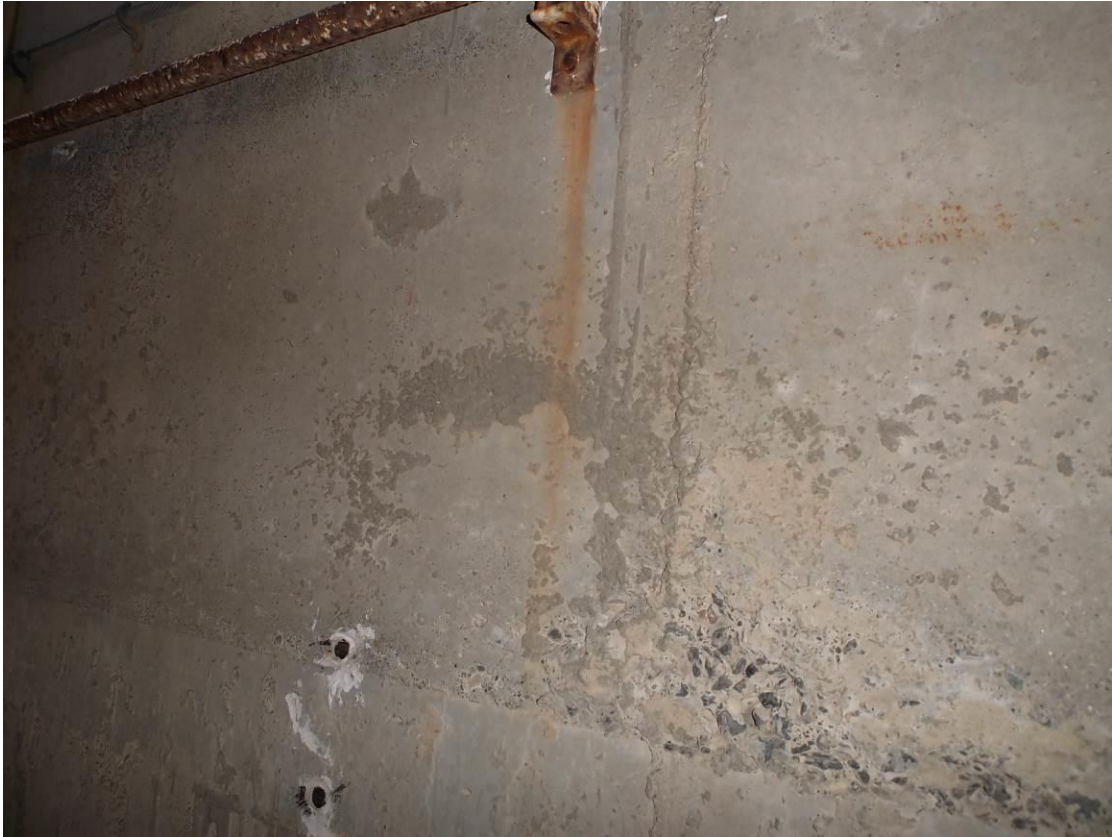
Photo Z5-002A

No.	Comment	Initials
1	Three sets of two popouts (approx. 2" dia.) behind the duct (approx. El. 97', El. 102' and El. 107') possibly from unfilled form ties or drilled holes. See photo Z5-001.	<i>AWD 9-28-15</i>
2	Exposed aggregate due to loss of matrix from initial vibration. Cement paste streaks due to improper form work installation is visible. Rust stains appear from surface mounted steel. No change since 2005 inspection. See photos Z5-002, Z5-002A, Z5-002B and Z5-002C.	<i>AWD 9-28-15</i>
3	An additional 10' of inspected elevation (El. 78' – 88') was added to this component and pertain to comment 2 above.	<i>AWD 9-28-15</i>
4	Drop-in anchors were installed to allow scaffold to be built for painting of the vent stack. See sample photos Z5-002A and Z5-002B.	<i>AWD 9-28-15</i>

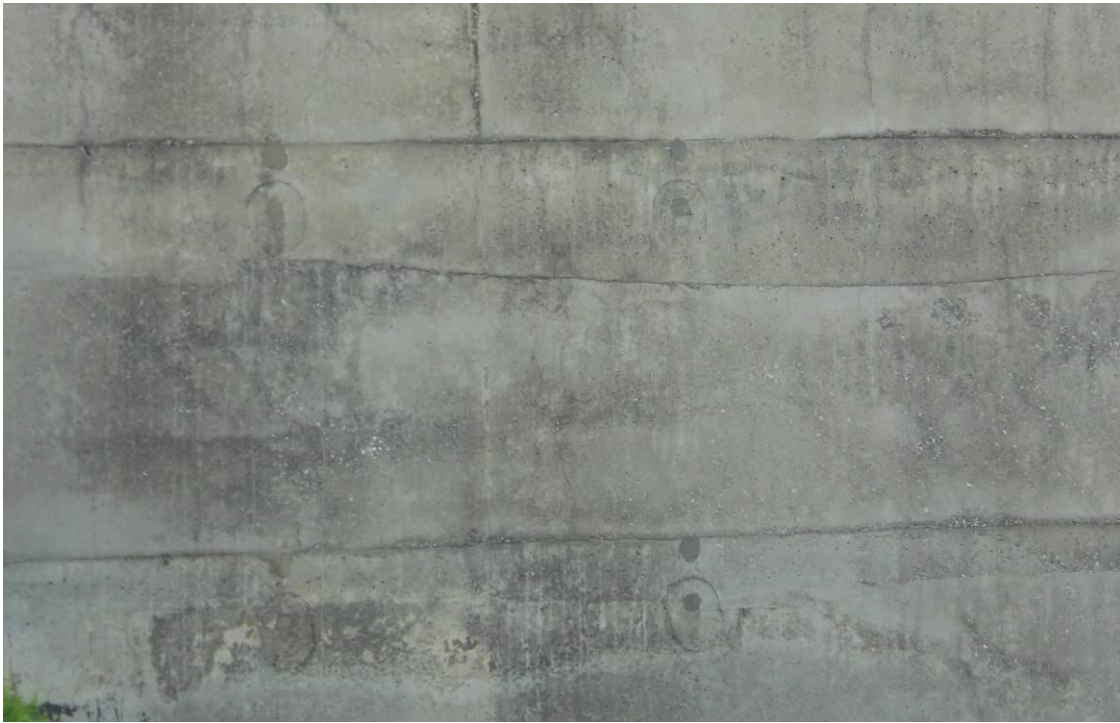
Photo Z6-001

No.	Comment	Initials
1	8' long horizontal crack at El. 91' identified in past inspection. Inspected up close and appears to only be a pour line and is not a structural concern. See photo Z6-001	<i>AMD 9-28-15</i>
2	General pattern cracking, abrasion, and leaching between El. 88' and El. 95'. These deficiencies were previously identified in 2005. All are minor and show no evidence of being active or worsening.	<i>AMD 9-28-15</i>
3	Vegetation growth on the component is very minor only	<i>AMD 9-28-15</i>
4	2" long exposed rebar at El. 93' near hatch area. See photo Z6-002	<i>AMD 9-28-15</i>
5	6' Tall vertical crack on equipment hatch protrusion area. Up to 1/32" wide. Some leaching from the lower portion of the crack. See photo Z6-003	<i>AMD 9-28-15</i>

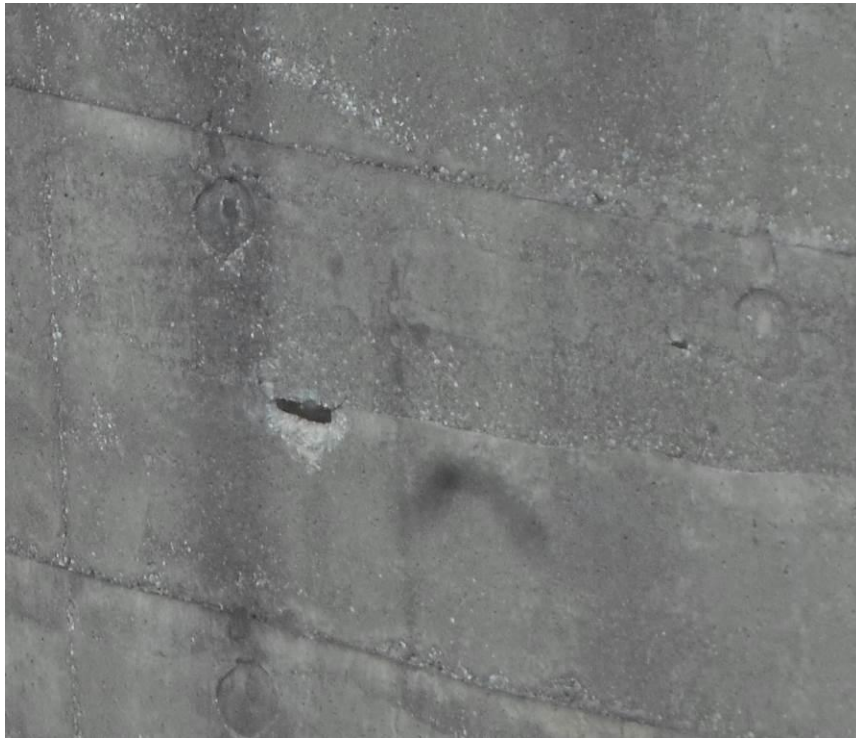
Photo Z2-031

No.	Comment	Initials
1	Exposed cadweld (approx. 9" long) with corrosion apparently due to inadequate cover. The concrete directly above was noted as ready to fall in the previous inspection but there is no change in condition since the 2005 inspection. See photos Z2-031, Z2-031A and Z2-031B.	JK
2	A small spot of corrosion appears on the concrete surface, it is not apparent whether this is reinforcing steel, a cadweld, or miscellaneous steel. No notable change since previous inspection. See photos Z2-031, Z2-031A and Z2-032.	JK
3	A small spot of corrosion appears on the concrete surface, it is not apparent whether this is reinforcing steel, a cadweld, or miscellaneous steel. Additional degradation in the immediate vicinity includes some abrasion, leaching, honeycomb and 8 popouts (2 roughly 1" dia, and 6 smaller). There has been no change since the previous inspection. (Note: This area is on the border of zones 1 and 2.) See photos Z2-033 and Z2-033A.	JK

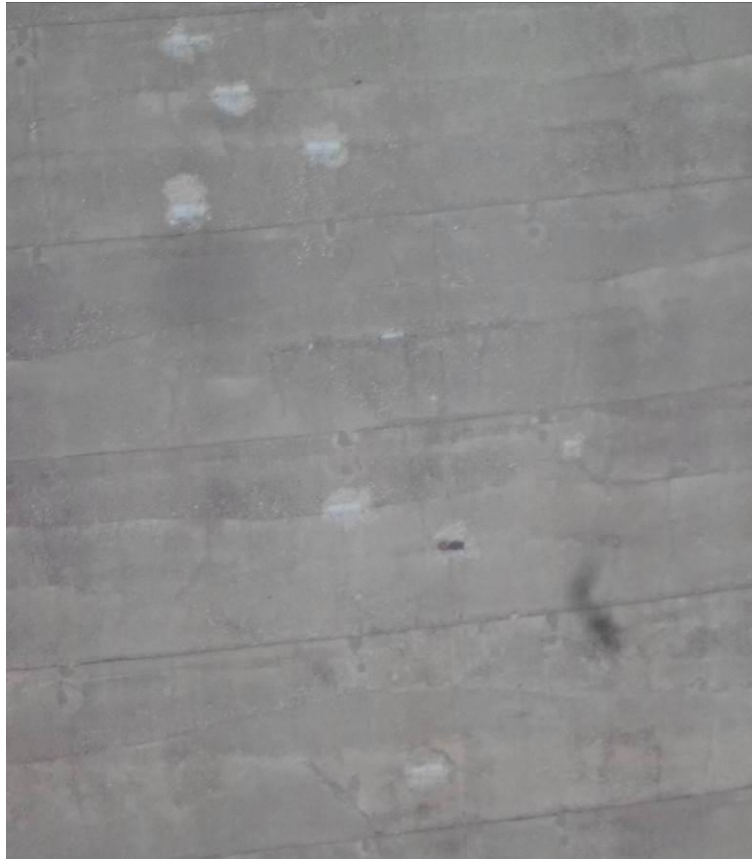
Photo Z3-016

6	Exposed cadweld (5" x 2") at El. 117'. Steel was coated in 2009. No notable change in condition since last inspection. See photos Z3-016, Z3-016A and Z3-022.	JK
7	Exposed rebar (7" x 1-1/2") at El. 120'. Steel was coated in 2009. Additional horizontal cracking has occurred at this location approx. 2-3' long. See photos Z3-016, Z3-016A, Z3-023 and Z3-023A.	JK
8	4 bugholes along a minor horizontal crack ~ 20 mils wide. The condition has not further degraded since the 2009 inspection. The exposed miscellaneous steel (1" long) at El. 120' was coated in 2009. Just left of rebar in comment #7. See photos Z3-023, Z3-023A, Z3-024 and Z3-024A.	JK
9	Two exposed cadwelds (9" x 3") with additional spalled concrete at El. 124'. Steel was coated in 2009. No notable change in condition since last inspection. See photos Z3-016, Z3-016A, Z3-025 and Z3-025A.	JK
10	Exposed cadweld (10" x 3") with additional spalled concrete at El. 125'. Steel was coated in 2009. No notable change in condition since last inspection. See photos Z3-016, Z3-016A and Z3-026.	JK

11	Exposed cadweld (10" x 3") with additional spalled concrete at El. 127'. Steel was coated in 2009. No notable change in condition since last inspection. See photos Z3-016, Z3-016A and Z3-027.	JK
12	Corrosion staining from 1 1/2" void hole. The corrosion staining and the void have remained the same since 2005. The void was coated in 2009.	JK
13	Exposed vertical rebar at El. 109' near the right side of the zone. See photo Z3-028.	JK
14	Exposed cadweld at El. 127' on the far right side of the zone. The steel is coated.	JK

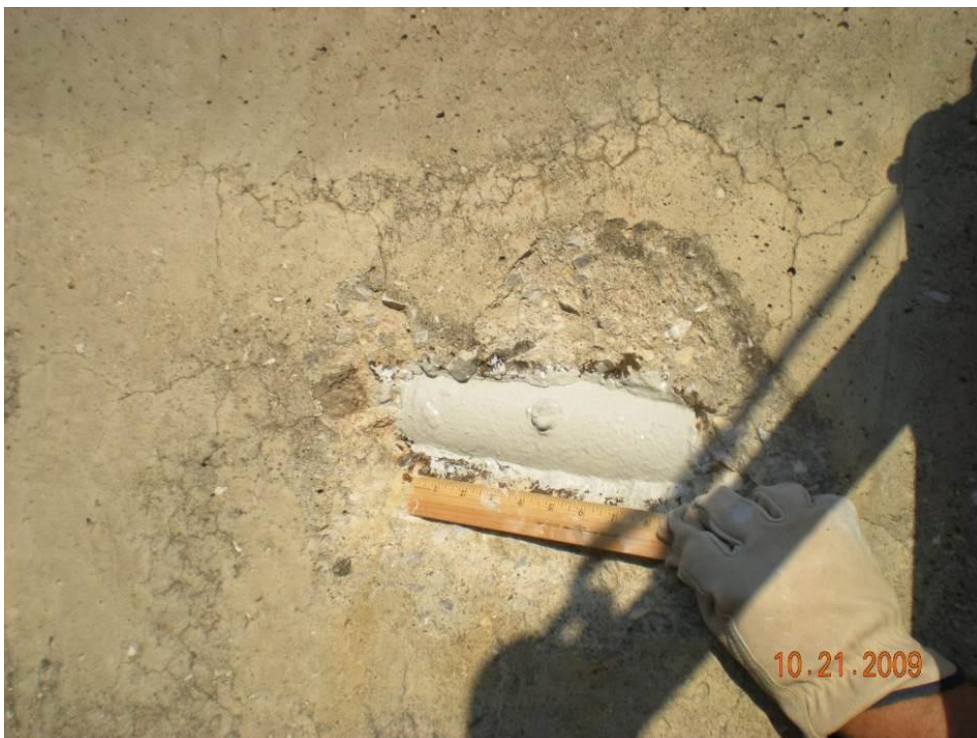
Photo Z3-017

No.	Comment	Initials
1	Exposed cadweld (10" x 3") with additional spalled concrete at El. 109'. Steel was coated in 2009. No notable change in condition since last inspection. See photos Z3-016, Z3-017 and Z3-017A.	JK
2	Exposed miscellaneous steel (1" diameter) at El. 113'. Steel was coated in 2009. No notable change in condition since last inspection. See photos Z3-018 and Z3-019.	JK
3	Exposed miscellaneous steel (1" long) at El. 114'. Steel was coated in 2009. Minor spalling appears to have continued since previous inspection. See photos Z3-018 and Z3-020.	JK
4	Exposed cadweld (8" x 3") at El. 115'. Cadweld is not coated and is newly exposed since the last inspection. See photos Z3-016 and Z3-018.	JK
5	Exposed cadweld (10" x 3") with additional spalled concrete at El. 116'. Steel was coated in 2009. No notable change in condition since last inspection. See photos Z3-016, Z3-016A and Z3-021.	JK

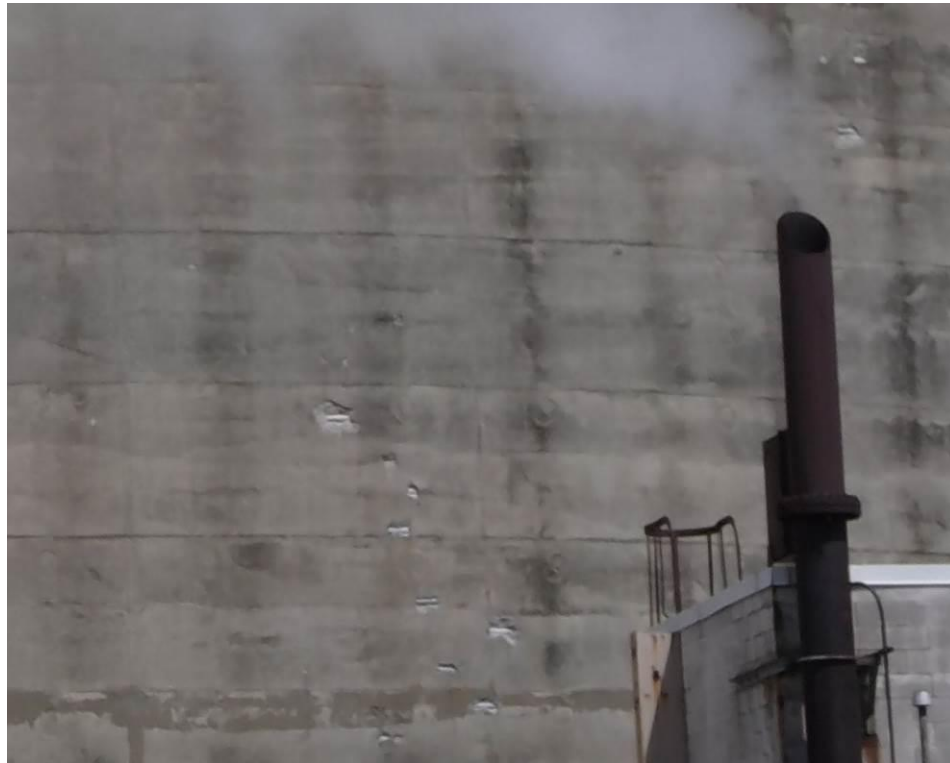
Photo Z4-020

No.	Comment	Initials
1	<p>Refer to photos Z4-020, Z4-020A and Z4-020B for general area / arrangement</p> <ul style="list-style-type: none"> - Exposed miscellaneous steel (1" long) at El. 109'. Previously identified as located at El. 104' in lower section. Steel was coated in 2009. See photo Z4-021. - Exposed cadweld (10" x 2") at Elevation 109'. Steel was coated in 2009. See photos Z4-022 and Z4-022A. - Exposed cadweld (9" x 3") at Elevation 110' with additional spalled concrete above and below and a tight crack vertically down from bottom approx. 20". Steel was coated in 2009. See photos Z4-023 and Z4-023A. - Exposed cadweld (10" x 3") at Elevation 111' with some cracking and 1" dia. exposed misc. steel just to the right. Cadweld was coated in 2009. See photos Z4-024 and Z4-024A. - Exposed cadweld (9" x 2") with additional spalled concrete at Elevation 113'. Steel was coated in 2009. See photos Z4-025 and Z4-025A. - Exposed cadweld (4" x 2") at Elevation 114'. Steel was coated in 2009. Right side continues to crack and push out slightly. See photos Z4-026 and Z4-026A. - Exposed cadweld (5" x 2") with additional spalled concrete at Elevation 115'. Steel was coated in 2009. See photos Z4-027 and Z4-027A. - Exposed miscellaneous steel (2" long) at Elevation 117'. Steel was coated in 2009. See photo Z4-028. - Exposed cadweld (10" x 3") with additional spalled concrete at Elevation 117'. Steel was coated in 2009. See photos Z4-029 and Z4-029A. - Exposed cadweld (2" x 1-1/2" & 1-1/2" x 1-1/2") at Elevation 119'. Steel was coated in 2009. See photos Z4-030 and Z4-030A. - Exposed cadweld previously identified as rebar (1-1/2" x 1-1/2") at Elevation 120'. Steel was coated in 2009. Left side appears to continue to crack and push out. See photos Z4-031 and Z4-031A. - Area beginning to spall at El. 117' near right side of zone below lightning arrestor. Based on size and shape appears to be cadweld. See photo Z4-032. - Exposed miscellaneous steel (1/2" diameter) at Elevation 126'. Steel was coated in 2009. See photo Z4-033. - Exposed cadweld (9" x 3") with additional spalled concrete at Elevation 127'. Steel was coated in 2009. See photo Z4-034. 	<p><i>AWD 9-28-15</i></p>

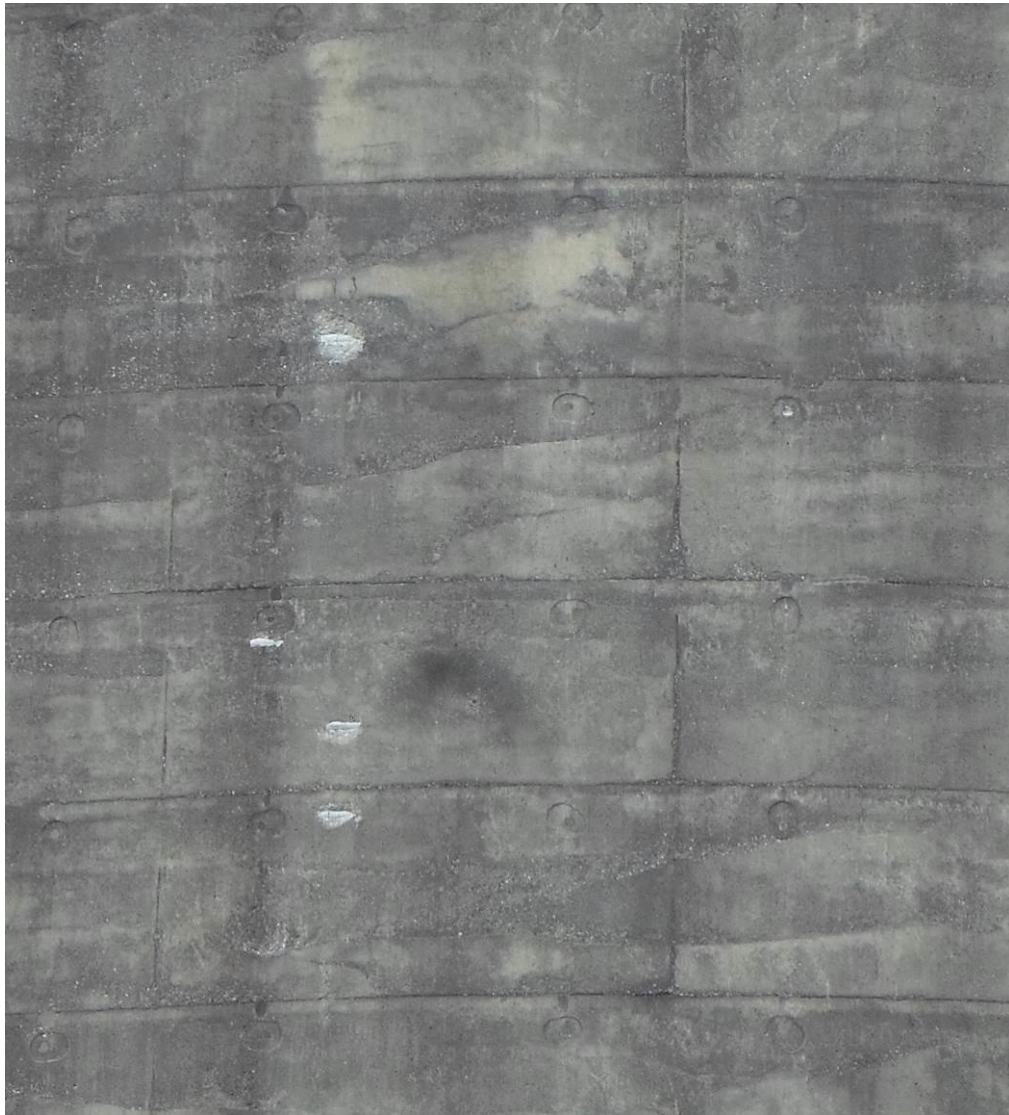
Photo Z1-015

No.	Comment	Initials
1	Exposed cadweld (9" x 3") with additional spalled concrete at El. 144'. Coating that was applied in 2009 is beginning to crack and degrade. See photos Z1-015 and Z1-016.	JK
2	Exposed cadweld (9" x 3") at El. 136'. Coating that was applied in 2009 is beginning to crack and degrade. See photos Z1-015 and Z1-017.	JK
3	Exposed cadweld (9" x 3") with additional spalled concrete at El. 134'. Coating that was applied in 2009 is beginning to crack and degrade. See photos Z1-015 and Z1-018.	JK
4	Exposed cadweld (9" x 3") with additional spalled concrete at El. 132'. Coating that was applied in 2009 is beginning to crack and degrade. See photos Z1-015 and Z1-019.	JK
5	Exposed miscellaneous steel at El. 142'. Coating that was applied in 2009 is beginning to crack and degrade. See photos Z1-015 and Z1-020.	JK
6	Minor leaching stains from construction joints. The leaching was previously identified and shows no signs of further degradation indicating that the leaching is currently inactive.	JK

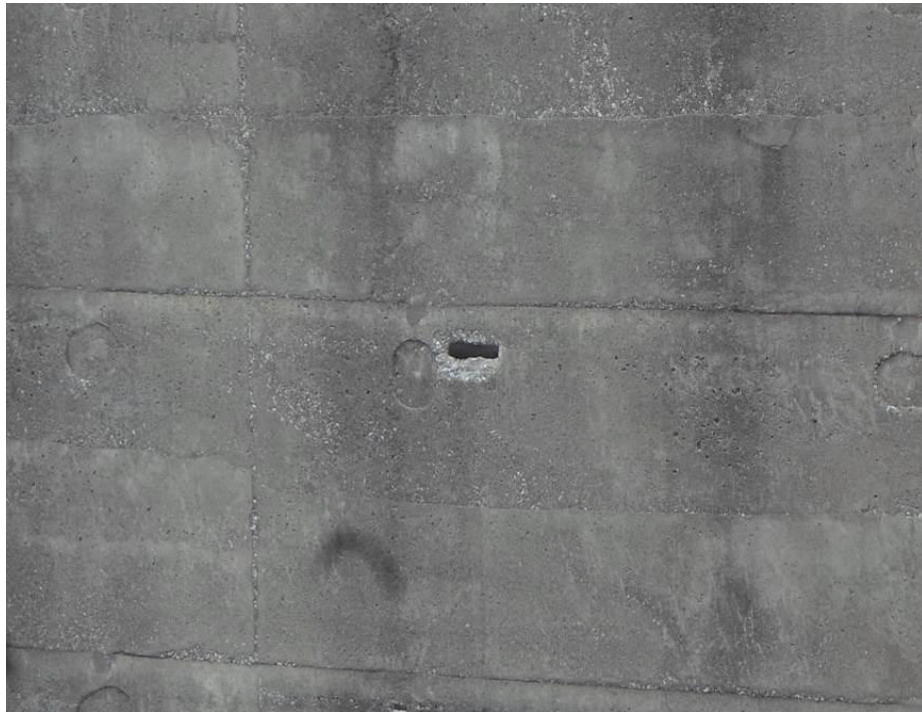
Photo Z2-038

6	Exposed cadweld (9" x 3") with additional spalled concrete at El. 132'. No change in condition since the previous inspection. See photo Z2-038.	JK
7	Exposed cadweld (9" x 2") with additional spalled concrete at El. 141'. Appears to have gotten slightly wider vertically exposing more of the cadweld since the previous inspection. See photo Z2-039.	JK
8	Exposed cadweld (9" x 2") with additional spalled concrete at El. 140'. Appears to have gotten slightly wider vertically exposing more of the cadweld since the previous inspection. See photo Z2-039.	JK
9	Exposed miscellaneous steel at El. 140' and El. 141'. No change in condition since previous inspection.	JK
10	Joint cracking identified in previous inspection along El. 128' is possibly a poor seam along the concrete pour lines.	JK
11	Bugholes appear throughout the entire section.	JK
12	Joint spalls and cracks noted in the previous inspection along El. 133' may just be rough edges of pour lines	JK

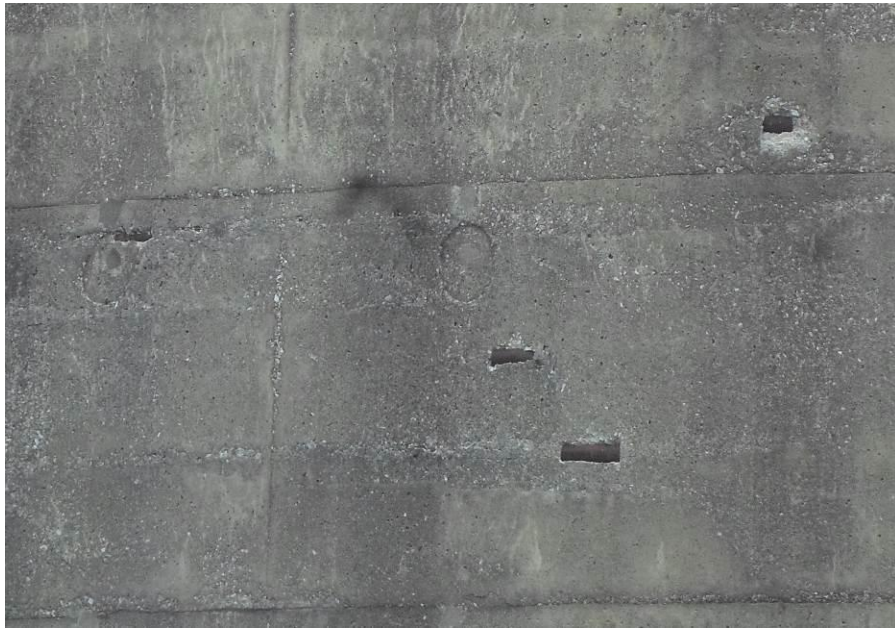
Photo Z2-040A

No.	Comment	Initials
1	Exposed cadweld (8" x 3") at El. 149'. No change in condition since the previous inspection. See photos Z2-040, Z2-040A and Z2-040B.	JK
2	Exposed cadweld (6" x 3") at El. 151'. Condition has expanded from 4" long as noted in the previous inspection. See photos Z2-040, Z2-040A and Z2-040B.	JK
3	Exposed steel appears to be a cadweld (6" x 1") at El. 152'. Visible in photo from previous inspection but not specifically noted. See photos Z2-040, Z2-040A and Z2-040B.	JK
4	Exposed cadweld (4" x 3") with additional spalled concrete at El. 154'. No change in condition since the previous inspection. See photos Z2-040, Z2-040A, Z2-040B, Z2-041 and Z2-041A.	JK
5	Exposed cadweld (4" x 3") with additional spalled concrete at El. 157'. No change in condition since the previous inspection. See photos Z2-040, Z2-041 and Z2-041A.	JK
6	Exposed cadweld (3" x 3") at El. 163'. No change in condition since the previous inspection. See photos Z2-040, Z2-042 and Z2-042A.	JK

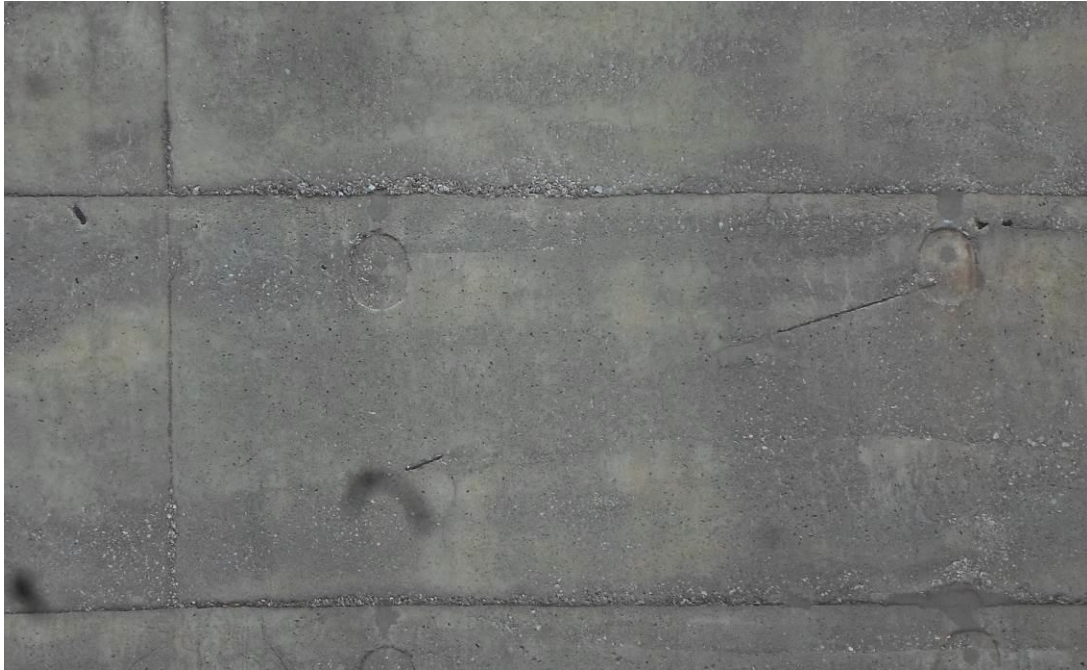
Photo Z2-043

7	Exposed cadweld (two spots 1-1/2" x 1-1/2" each) at El. 152'. The spots have increased just enough to be noticeable since previous inspection. See photos Z2-043, Z2-044, Z2-044A and Z2-044B.	JK
8	A piece of steel is exposed at the concrete surface on a diagonal line approximately 6' long. Previously noted as 3' long however there is no photo of the area to fully compare. See photos Z2-043, Z2-044, Z2-044A and Z2-044B.	JK
9	A small spot of steel (2" long) is exposed with minimal corrosion. It does not appear to be reinforcing steel and there has been no change in condition since previous inspection. See photos Z2-043, Z2-045 and Z2-045A.	JK
10	A joint spall, cracking, and small popouts appear at El. 148' in the center of the zone. This was noted in the previous inspection.	JK
11	A crack with popout (4" x 1" x 1/2" deep) at El. 157'. This was noted in the previous inspection.	JK
12	Pitting in a small area at El. 154'. This was noted in the previous inspection.	JK

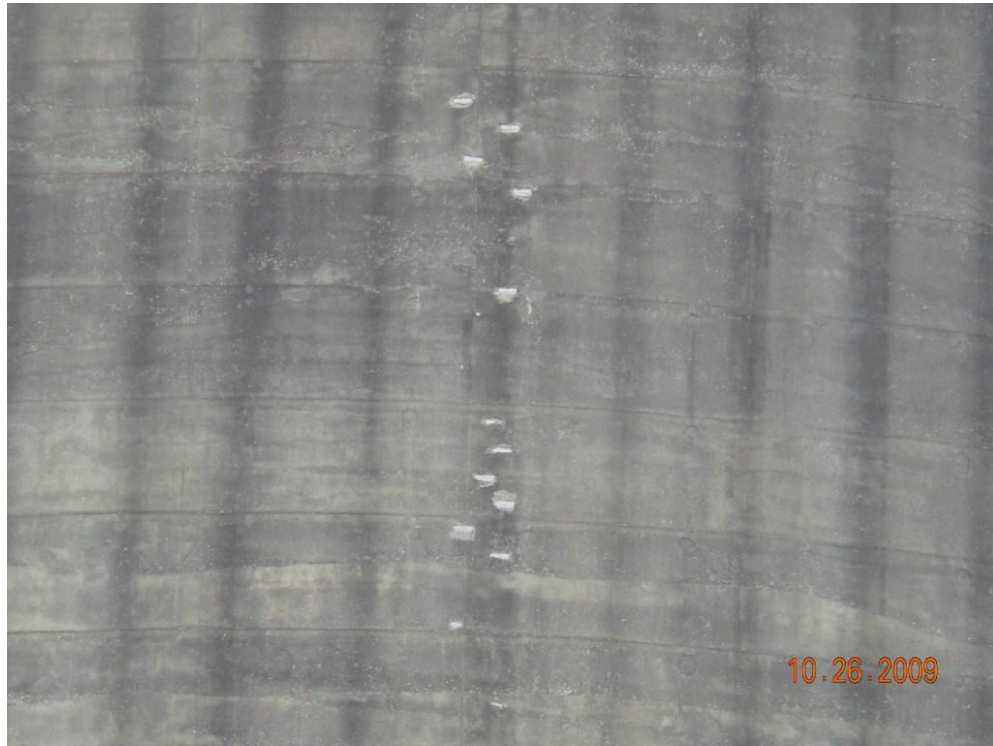
Photo Z6-010

No.	Comment	Initials
1	<p>See photo Z6-010 for 2009 general area photo for some of the identified indications.</p> <ul style="list-style-type: none"> - Exposed cadweld (5" x 2") at Elevation 148'. Steel was coated in 2009. See photos Z6-011 and Z6-012. - Exposed cadweld (9" x 3") at Elevation 151'. Steel was coated in 2009. See photos Z6-011 and Z6-013. - Exposed cadweld (9" x 2') with additional spalled concrete at Elevation 152'. Steel was coated in 2009. See photos Z6-011 and Z6-014. - Exposed cadweld (9" x 3") at Elevation 154'. Steel was coated in 2009. See photos Z6-015 and Z6-016. - Exposed cadweld (9" x 2") at Elevation 155'. Steel was coated in 2009. Concrete is separating more above and some rust bleeding appears to be coming from behind the separating concrete. See photos Z6-015 and Z6-017. - Exposed cadweld (9" x 3") at Elevation 156'. Steel was coated in 2009. Concrete beginning to separate below in the same shape as what is already missing. See photos Z6-015 and Z6-018. - Exposed cadweld (5" x 2") at Elevation 157'. Steel was coated in 2009. Concrete beginning to separate to the right to expose rest of cadweld in future. See photos Z6-019 and Z6-020. - Exposed miscellaneous steel wire (1" long) at Elevation 160'. Steel was coated in 2009. See photo Z6-021. - Exposed miscellaneous steel (3/4" diameter) at Elevation 162'. Steel was coated in 2009. See photos Z6-022 and Z6-023. - Exposed cadweld (9" x 3") with additional spalled concrete at Elevation 163'. Steel was coated in 2009. See photos Z6-023 and Z6-024. - Exposed cadweld (9" x 3') at Elevation 167'. Steel was coated in 2009. See photo Z6-025. <p>Coating beginning to degrade on all cadwelds. Minor cracking and rust bleeding through coating.</p>	<p align="right"><i>AND 9-28-15</i></p>

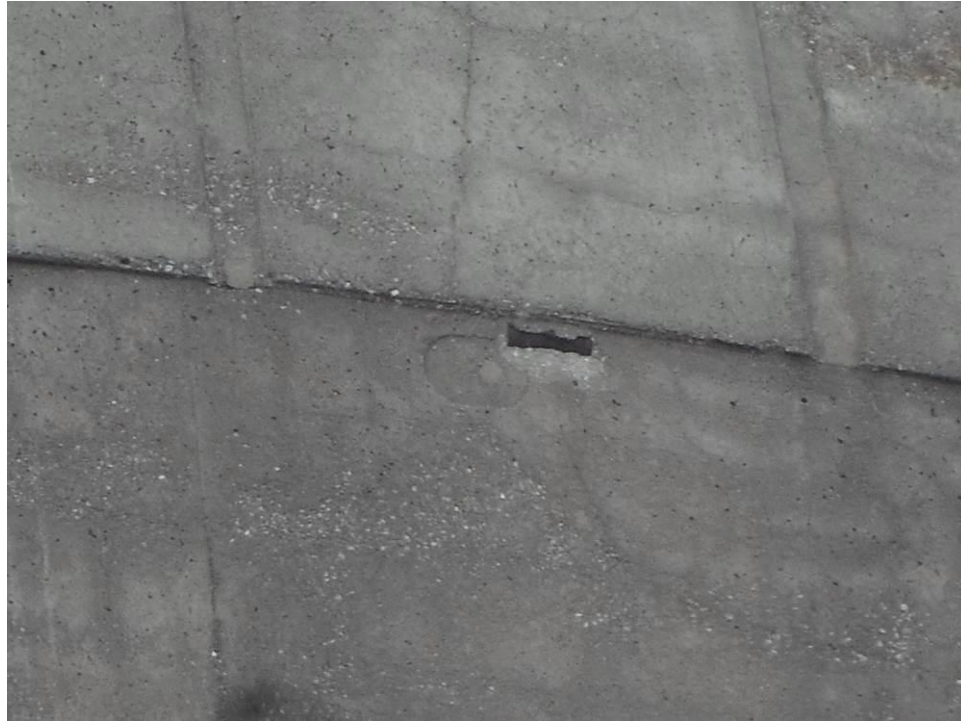
Photo Z2-046

No.	Comment	Initials
1	Exposed cadweld (8" x 2") at El. 188'. See photos Z2-046, Z2-046A and Z2-046B.	JK
2	Two small areas of exposed steel with rust staining at El. 180', one of which is a cadweld that is continuing to spall and appears that another piece will fall off soon. See photos Z2-047 and Z2-047A.	JK
3	Patch of shallow popouts just below El. 188'. Including some cracking and bulging which by comparison to other similar areas is believed to be a cadweld. See photo Z2-048.	JK
4	Between El. 168' and 173' near the middle of the zone there is leaching 6" long. There is also a pour joint just below this location with some separation likely due to consistency during placement. See photo Z2-049.	JK
5	A joint spall and some pitting is visible at El. 173'.	JK
6	Area of light abrasion with a slightly red color approximately 4' long between El. 168' and 178'. See photo Z2-050.	JK
7	Minor crack with light efflorescence on the right side of the section at El. 178'. See photo Z2-051.	JK

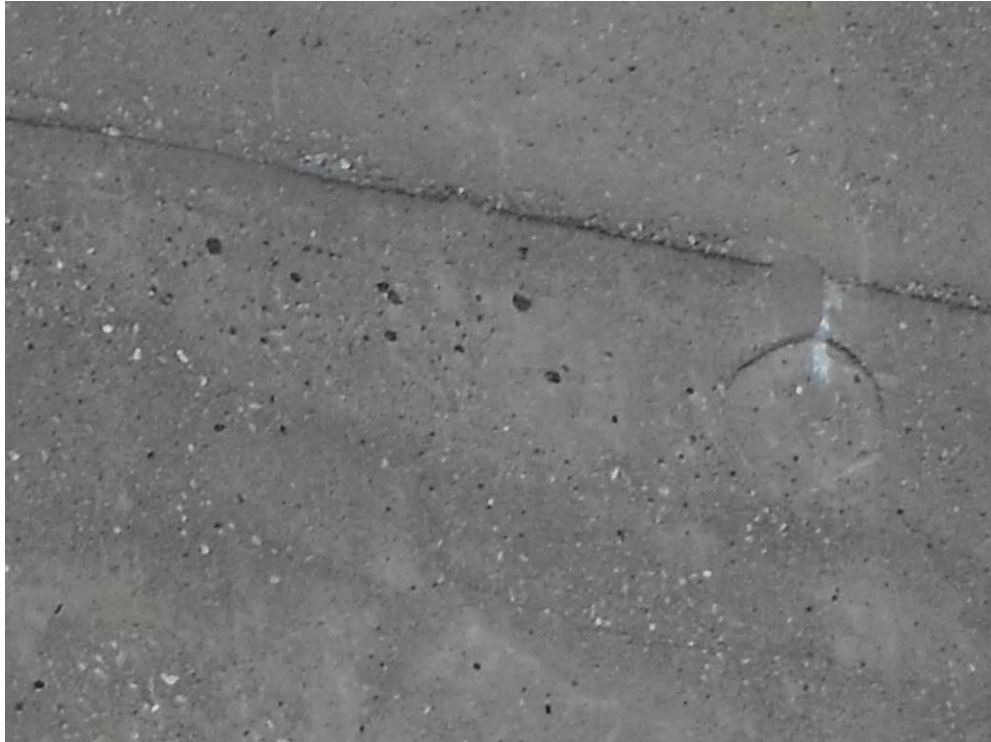
Photo Z2-051

8	General pattern cracking, bugholes, and leaching between El. 168' and 178'. No change in condition since previous inspection. See photos Z2-051 and Z2-052.	JK
9	General Pattern cracking throughout. See photo Z2-052.	JK

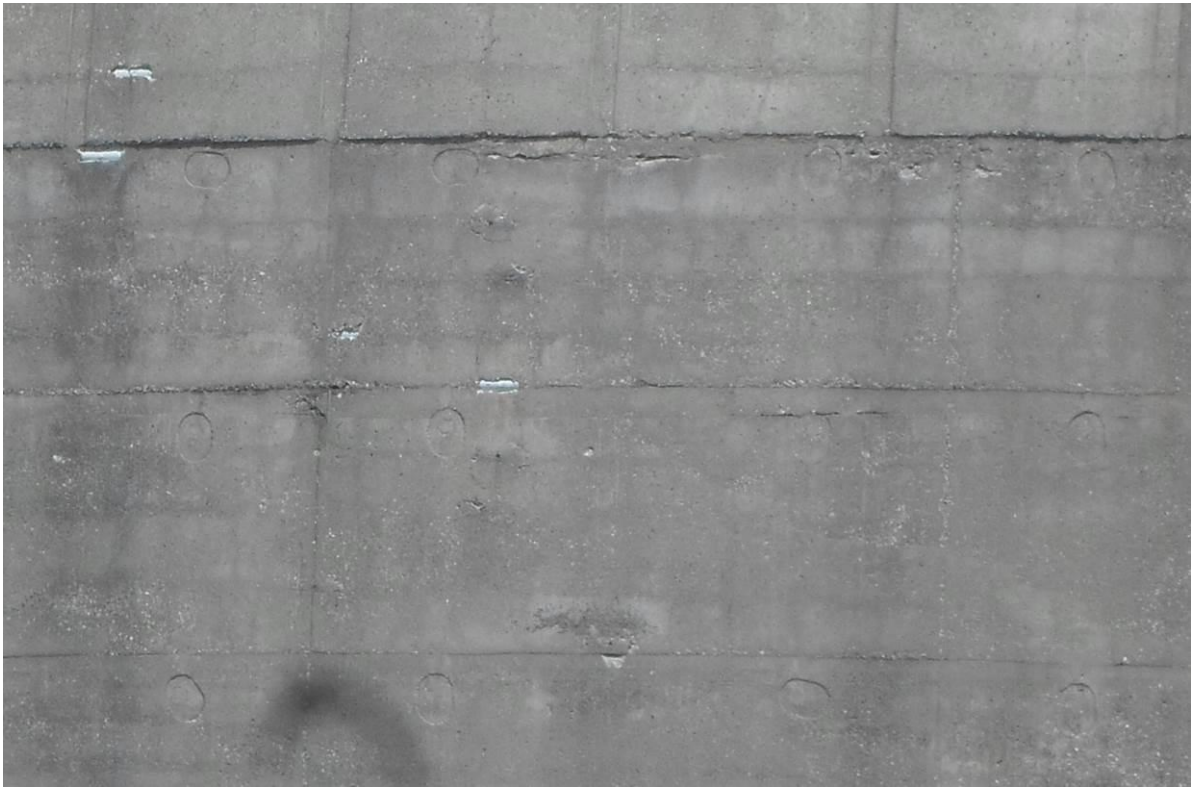
Photo Z3-049

No.	Comment	Initials
1	Exposed cadweld (10" x 3") at El. 183'. Steel was coated in 2009. See photos Z3-049, Z3-049A and Z3-050.	JK
2	Above the exposed cadweld at El. 183', two exposed cadweld nuts with some concrete cracking and beginning to push out. See photos Z3-049 and Z3-049A.	JK
3	Exposed cadweld (5" x 2") at El. 184'. Steel was coated in 2009. No change since last inspection. See photos Z3-049, Z3-049A and Z3-051.	JK
4	Exposed cadweld (9" x 3") at El. 188'. Steel was coated in 2009. No change since last inspection. See photos Z3-049, Z3-049A and Z3-052.	JK
5	Bugholes with visible rust (2" long) at El. 174' in the middle of the zone.	JK
6	General joint cracking, bugholes, and spalls between El. 173' and El. 178'. This was noted in the previous inspection.	JK
7	General pattern cracking, minor joint cracking, and light spalling between El. 178' and El. 183'. This was noted in the previous inspection.	JK

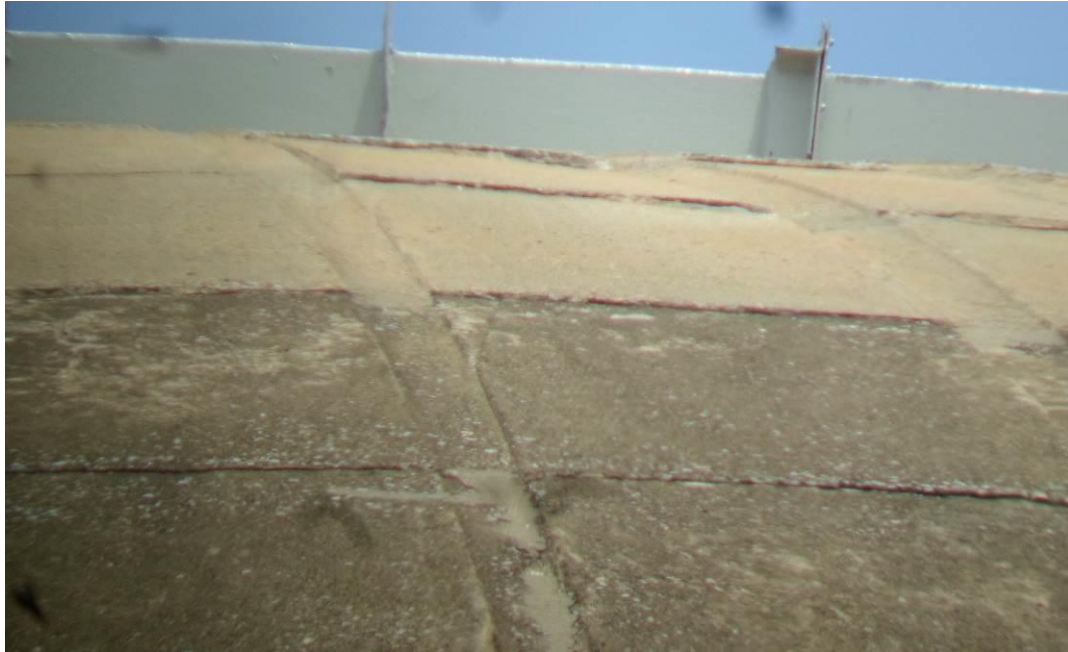
Photo Z3-054

No.	Comment	Initials
1	Over 10' span on the upper right corner of dome, previously identified popouts, joint spalling, and cracking is visible. Mostly appear to be just rough form edges seen from an angle. See photo Z3-054.	JK
2	Two bugholes with visible rust at approx. El. 210' and 15' from right boundary.	JK
3	Two bugholes with possible exposed steel vertically lined between El. 228' and El. 233'. See photo Z3-055.	JK
4	Large amounts of pattern cracking exist between El. 188' and El. 203'.	JK
5	Exposed cadweld due to a 2" spall or popout at El. 197'. See photos Z3-056, Z3-056A and Z3-057.	JK
6	A horizontal joint crack exists greater than a 1/4" wide and approx. 3' long identified in previous inspection. Possibly an old repair that is separating near the left side of the zone at approx. El. 228'.	JK
7	General pattern cracking, light scaling, localized spall areas (2"-4"), numerous bugholes, and joint cracks exist on dome.	JK

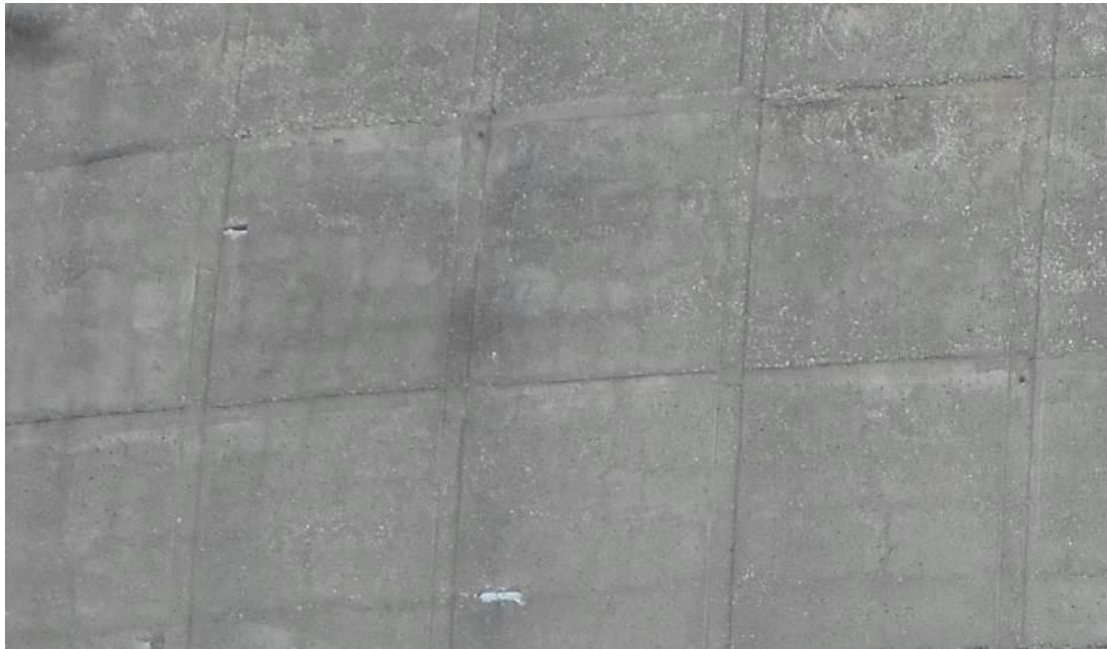
Photo Z3-056

8	A visible honeycomb appears at El. 228' to the right of the middle of the zone.	JK
9	Exposed cadweld (9" x 2") at Elevation 189'. Steel was coated in 2009. See photos Z3-056, Z3-056A and Z3-058.	JK
10	Approximately 4 blocks from the right edge of the zone at El. 190', there is a small 2" x 4" spall with tight horizontal cracks.	JK
11	Discoloration due to concrete leakage through formwork that has chipped off revealing lighter concrete below. Located at El. 233' near the middle of the zone, two blocks wide. See photo Z3-059.	JK
12	Rust staining from the lightning arresters.	JK
13	At the top of the zone at the left side there are 4 small, shallow areas of scaling. See photo Z3-060.	JK

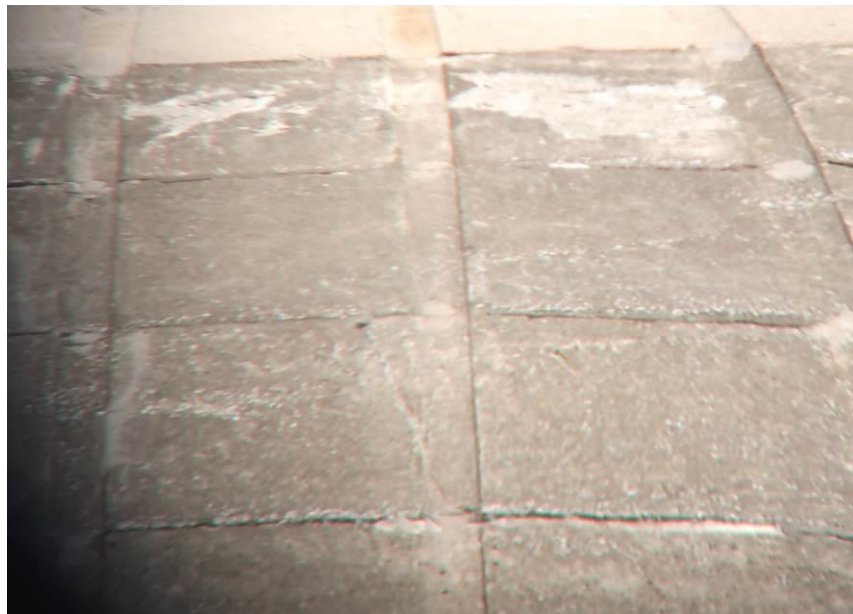
Photo Z4-056

7	Beginning 1 row below the lightning arrestors and continuing upwards there is minor spalling of form edges and shallow delamination of concrete cover. See photos Z4-056 and Z4-056A.	<i>AMD 9-28-15</i>
8	Small (1"-2" dia.) voids or possible abandoned drilled holes in multiple locations behind the vent duct See photo Z4-057.	<i>AMD 9-28-15</i>
