ACCESSION NBR: 8104070395 DOC. DATE: 81/04/02 NOTARIZED: YES DOCKET #
 FACIL: 50-250 Turkey Point Plant, Unit 3, Florida Power and Light Co. 05000250
 AUTH. NAME: UHRIG, R. E. AUTHOR AFFILIATION: Florida Power & Light Co.
 RECIP. NAME: RECIPIENT AFFILIATION:

SUBJECT: Application to amend License DPR-31 requesting permission to return facility to power operation for six equivalent full power months. Class III amend fee encl.

Re: Turkey Point Unit 3
Docket No. 50-250
Steam Generator Inspections

TURKEY POINT 3 STEAM GENERATOR
INSPECTION PROGRAM
March, 1981

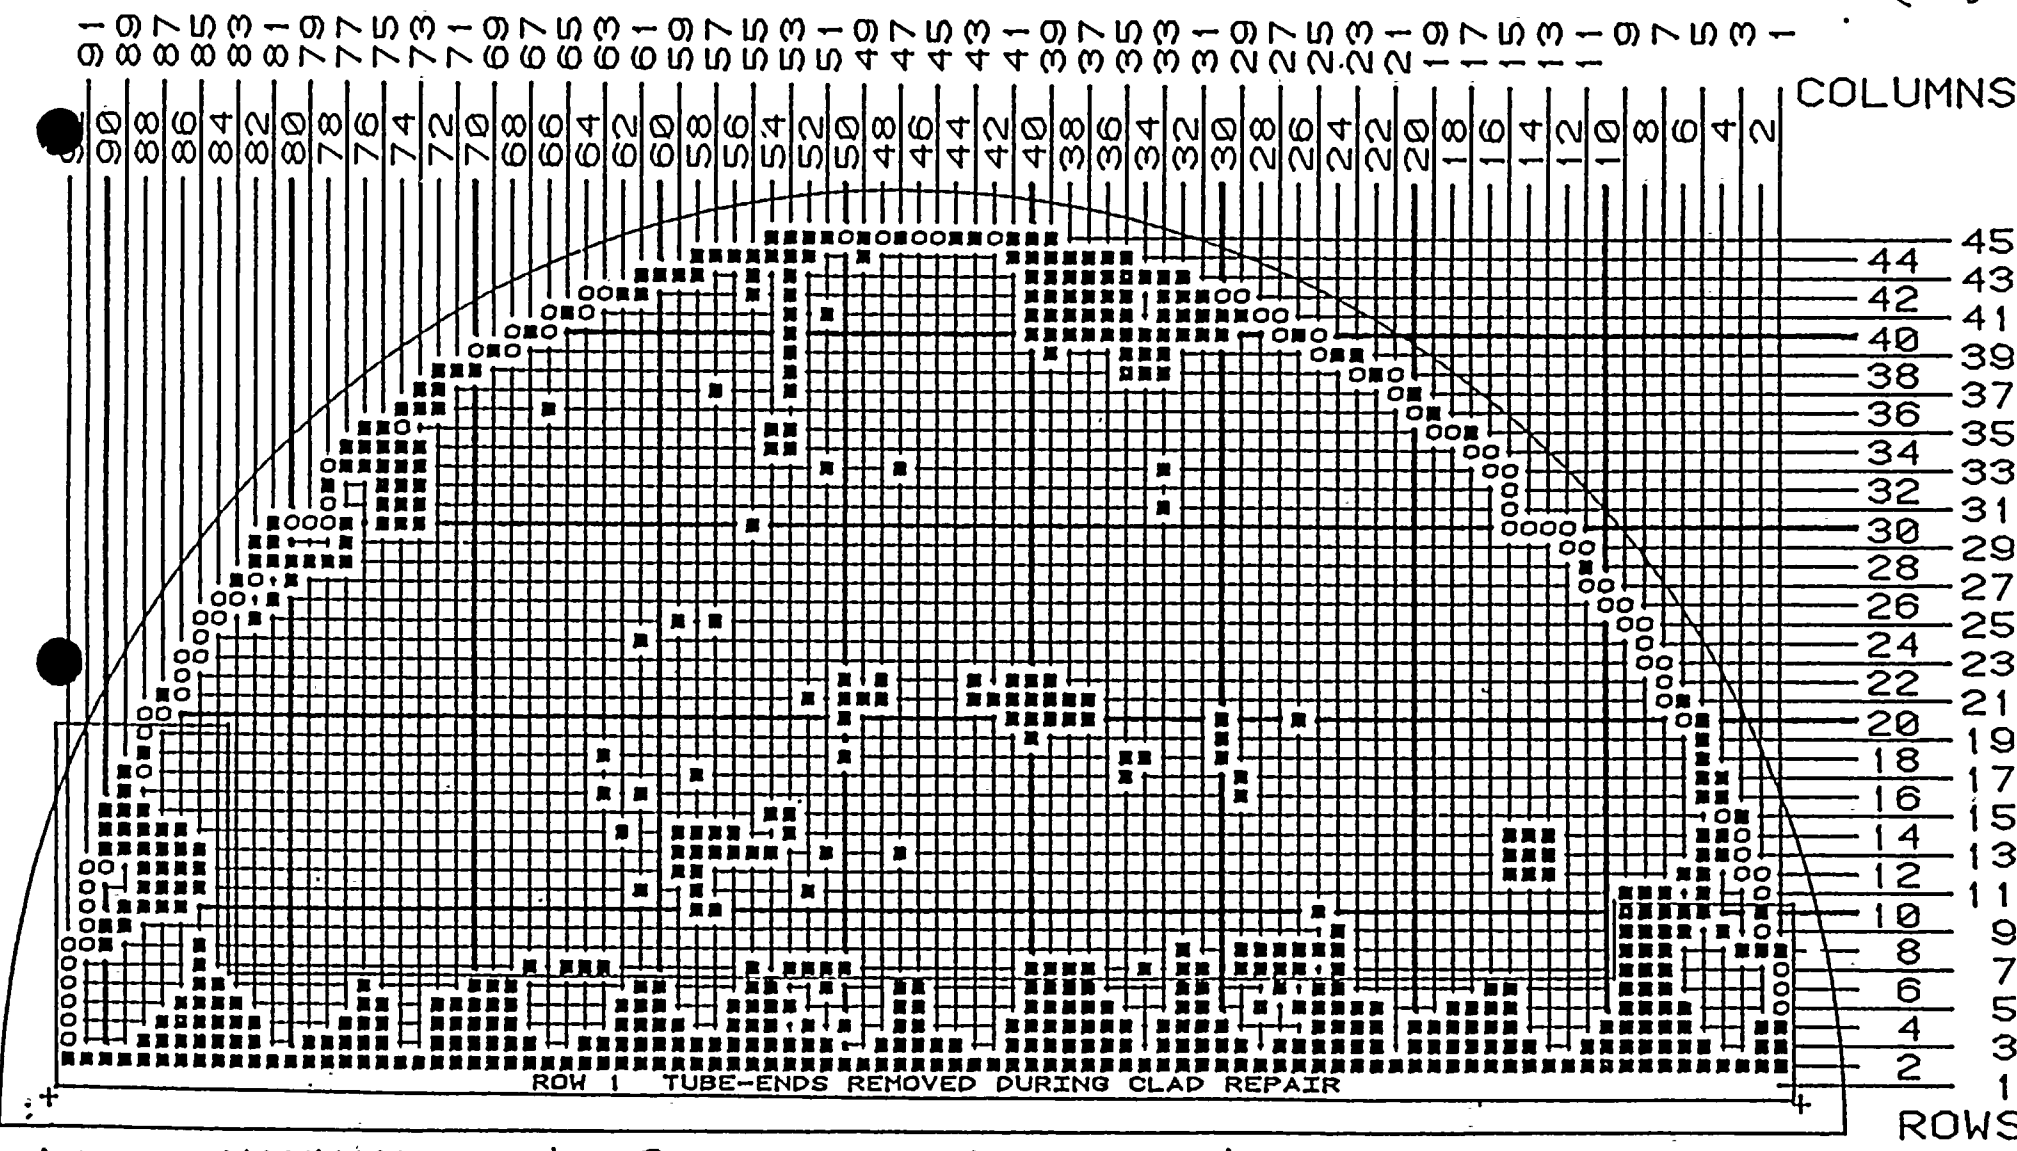
FPL-A
OUTLET (CL)

←--- MANWAY Gauging Program - TEST blocked in Area NOZZLE ---→
w/ mfr through Top Support w/.610 AND .540 probes

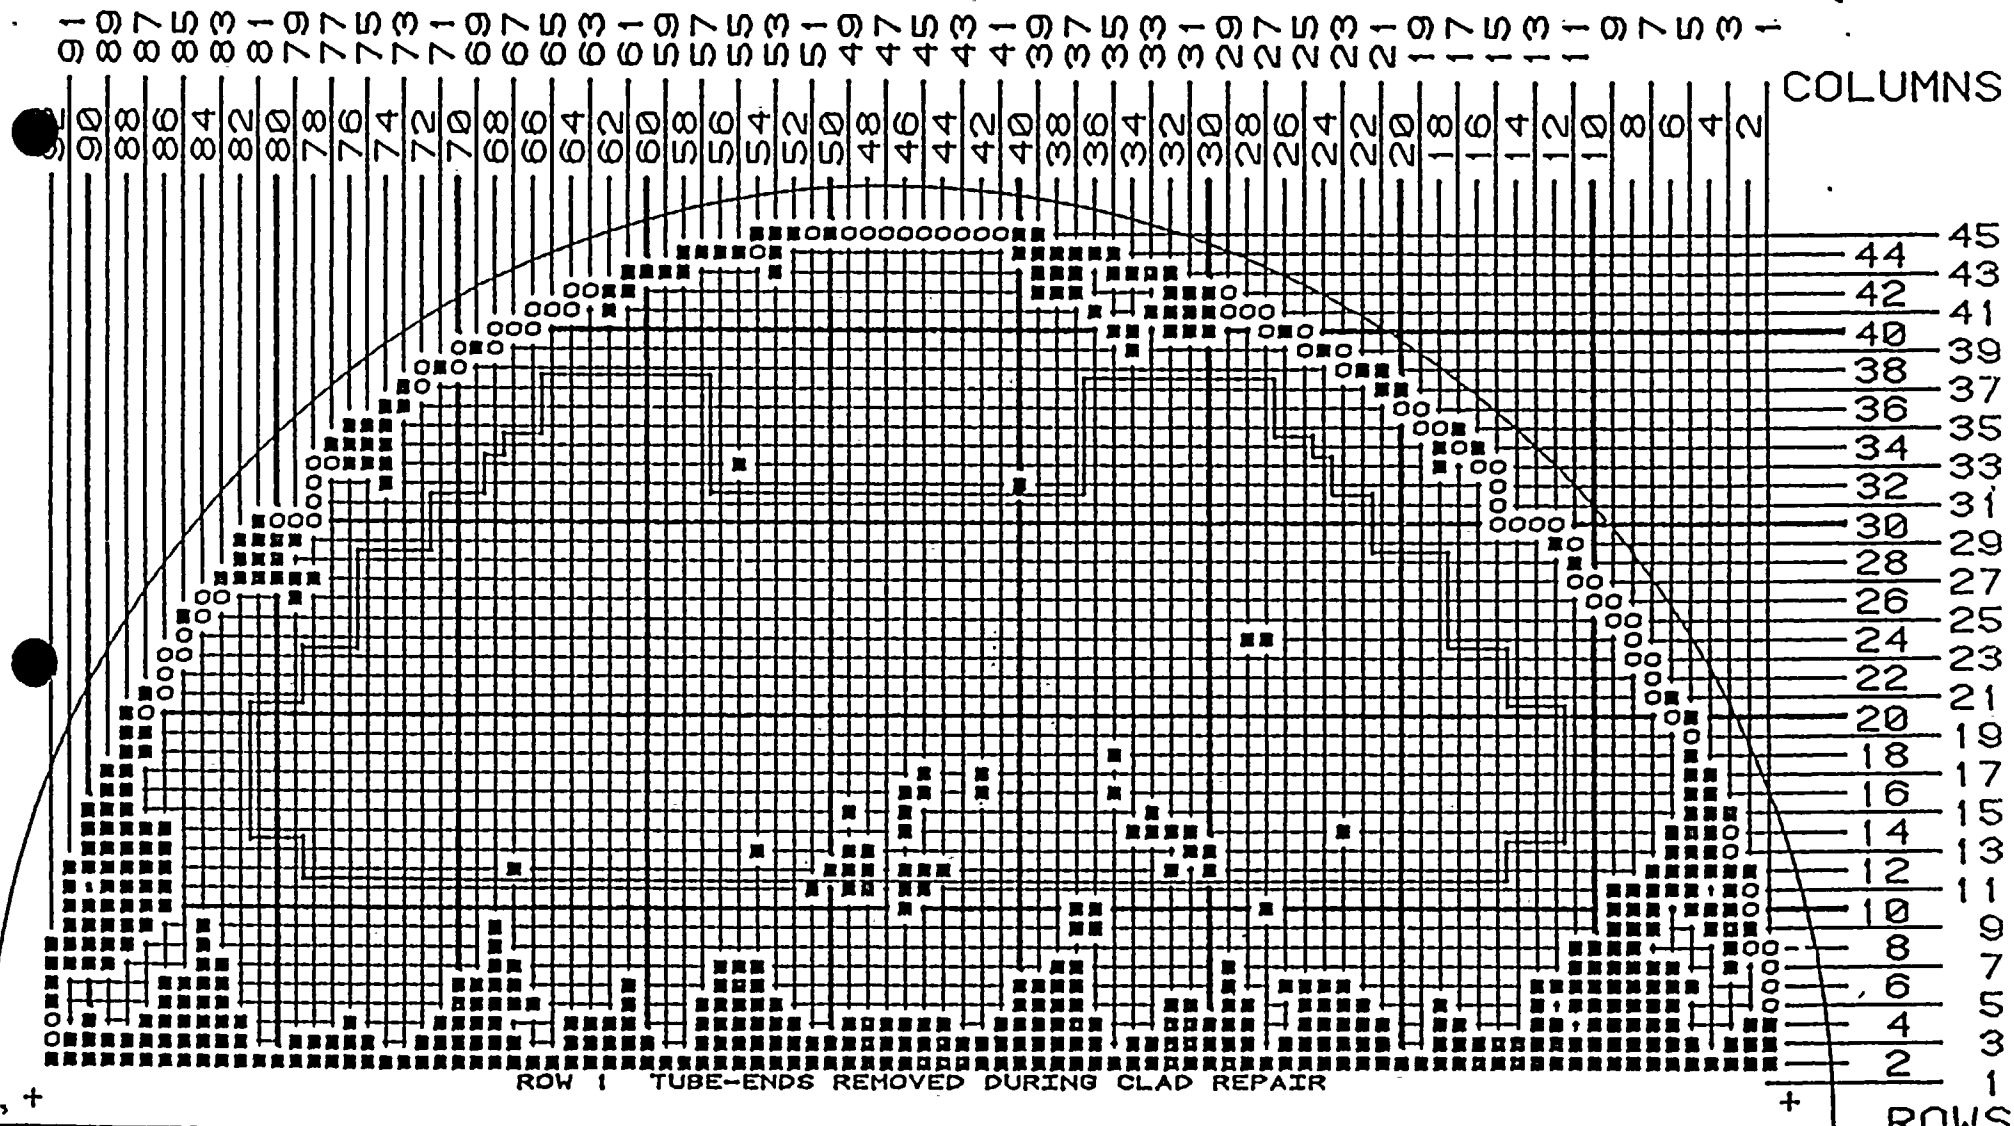
FPL-C
 INLET (HL)

←--- MANWAY Gauging Program - Test Area outside box
 through top support with .650, .610 AND .540
 PROBES. - 1269 TUBES.

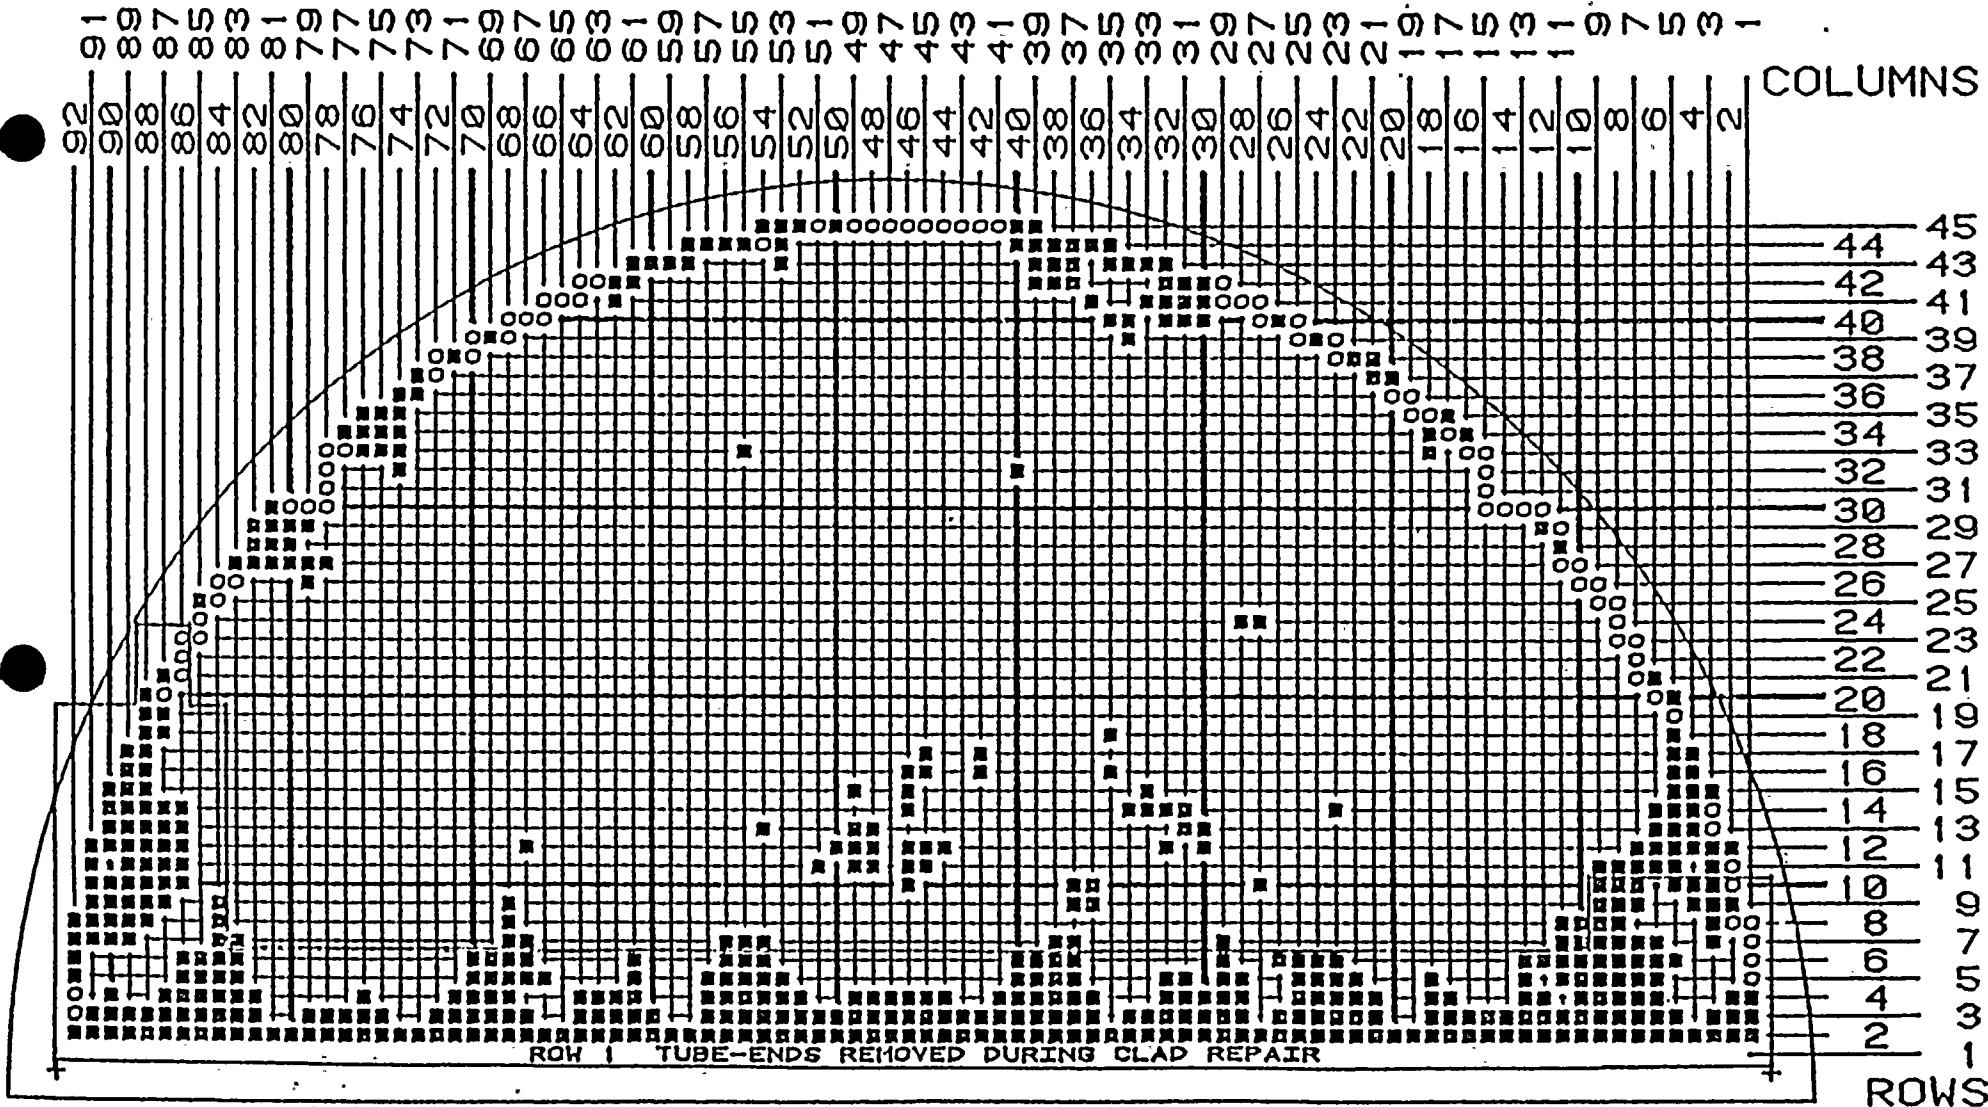
FIGURE 9

The U-bends of unplugged tubes in rows 3 thru 5 in steam generator C were examined with 100 kHz to confirm the integrity of the small radius U-bends in low number rows, as shown in Figure 9.

The U-bends of unplugged tubes in rows 3 thru 5 in steam generator C were examined at 100 kHz. No indications were noted in these small radius U-bends.

←--- MANWAY Gauging Program - Test Blocked in Area NOZZLE ---→
 through Top Support with .610 and .540 probes
 226 Tubes

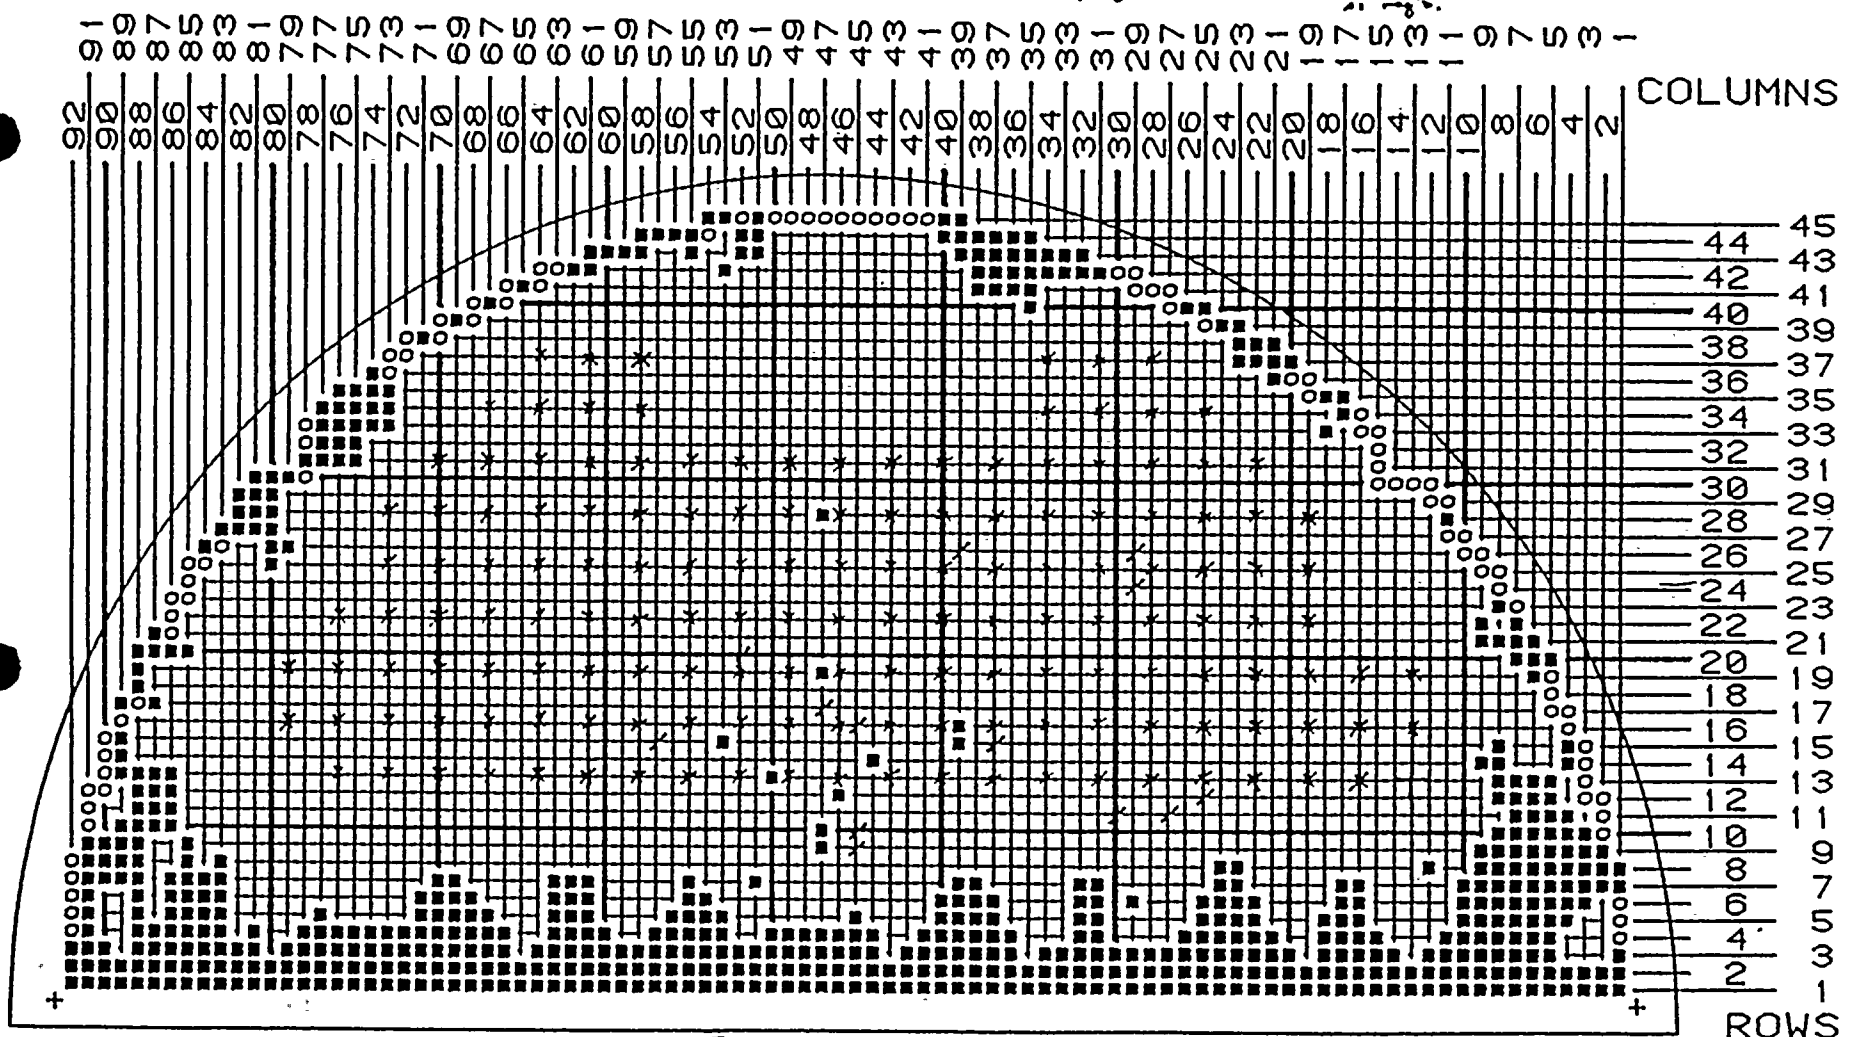
FPL-B
 INLET

1 - Inspect 13 tubes with previous indications thru 1st support with .700F probe. If any tubes are restricted to .700, gauge w/.650 probe thru 6th support. Tubes found restricted to .650 probe shall be boxed in with .650. All restricted tubes shall be gauged down w/.610 - .540 probe as req'd.

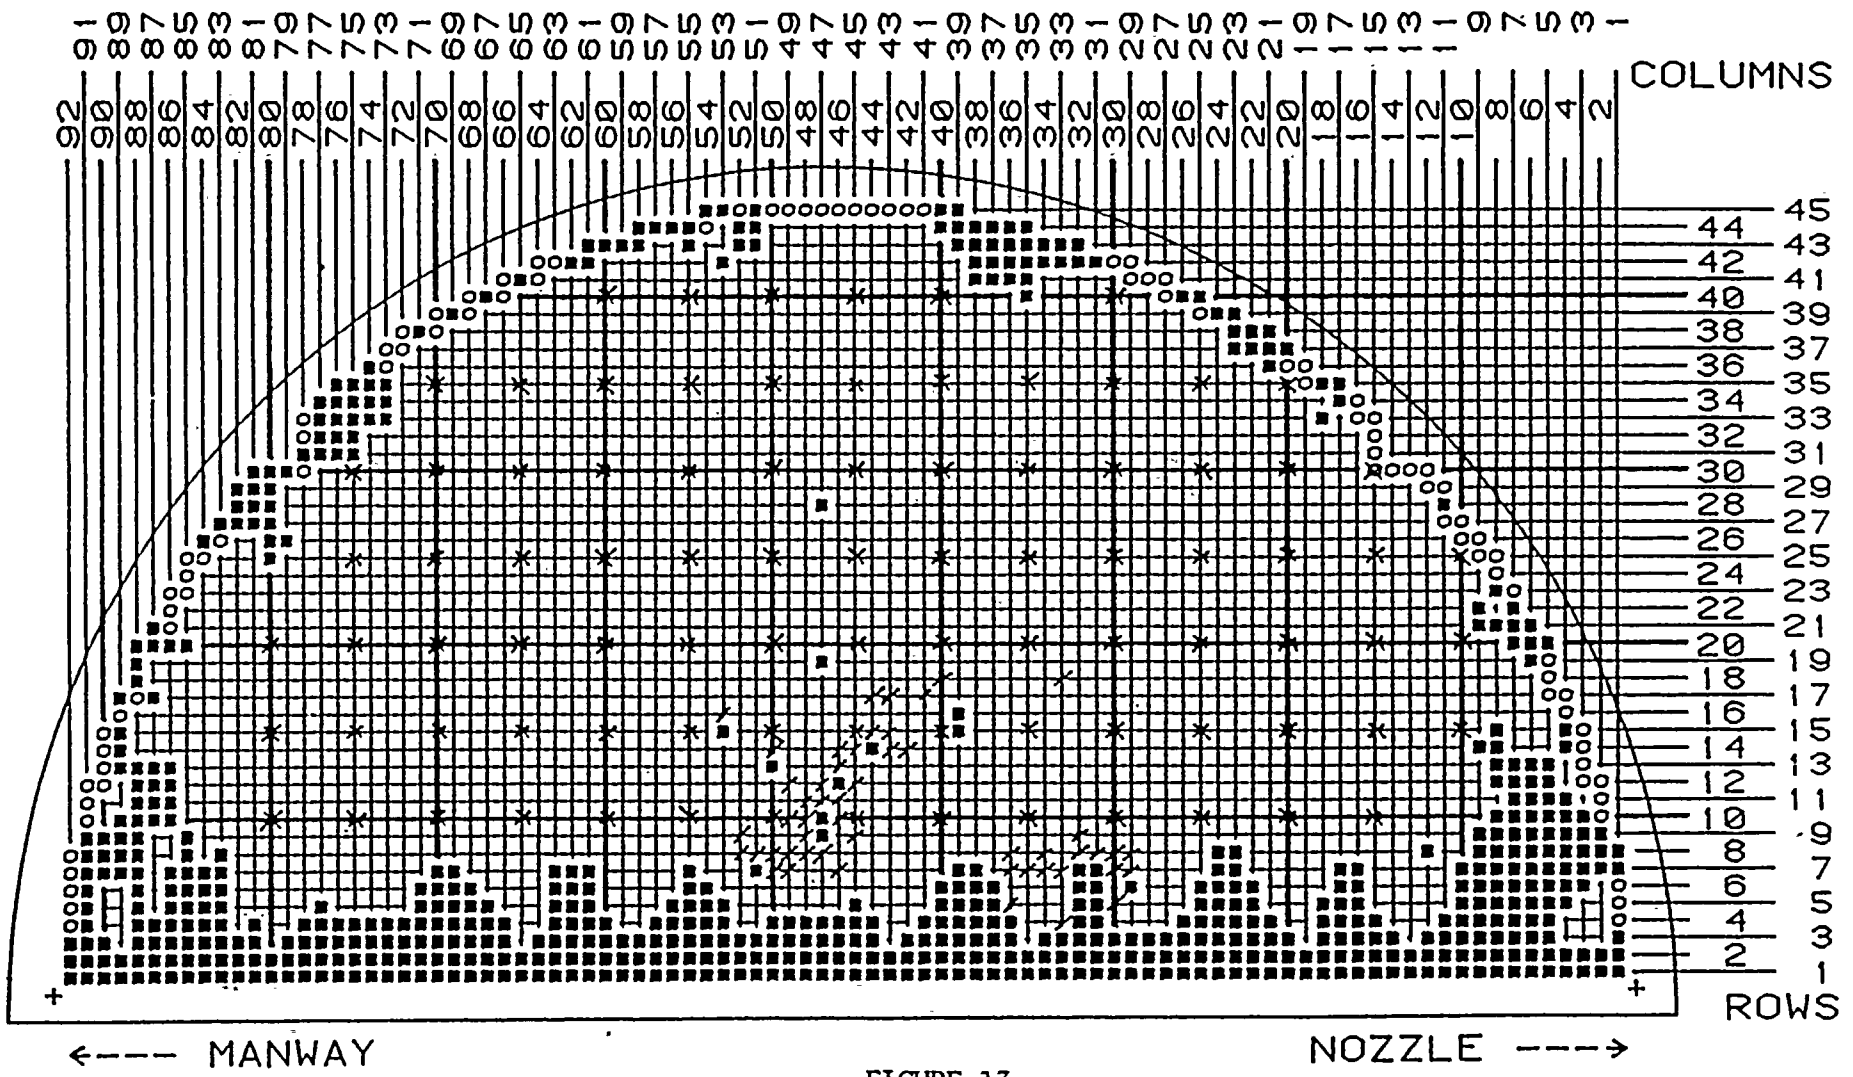
FIGURE 13
TURKEY POINT UNIT #3
STEAM GENERATOR B - COLD LEG
REG. GUIDE 1.83 INSPECTION PROGRAM
MARCH, 1981

X - Reg Guide Inspection. 88 tubes thru 1st support w/700 probe. Same method of inspection will be applied to these tubes as explained above. (These 88 tubes are picked at random, if tube is obstructed (i.e. template plug) to adjacent tube)

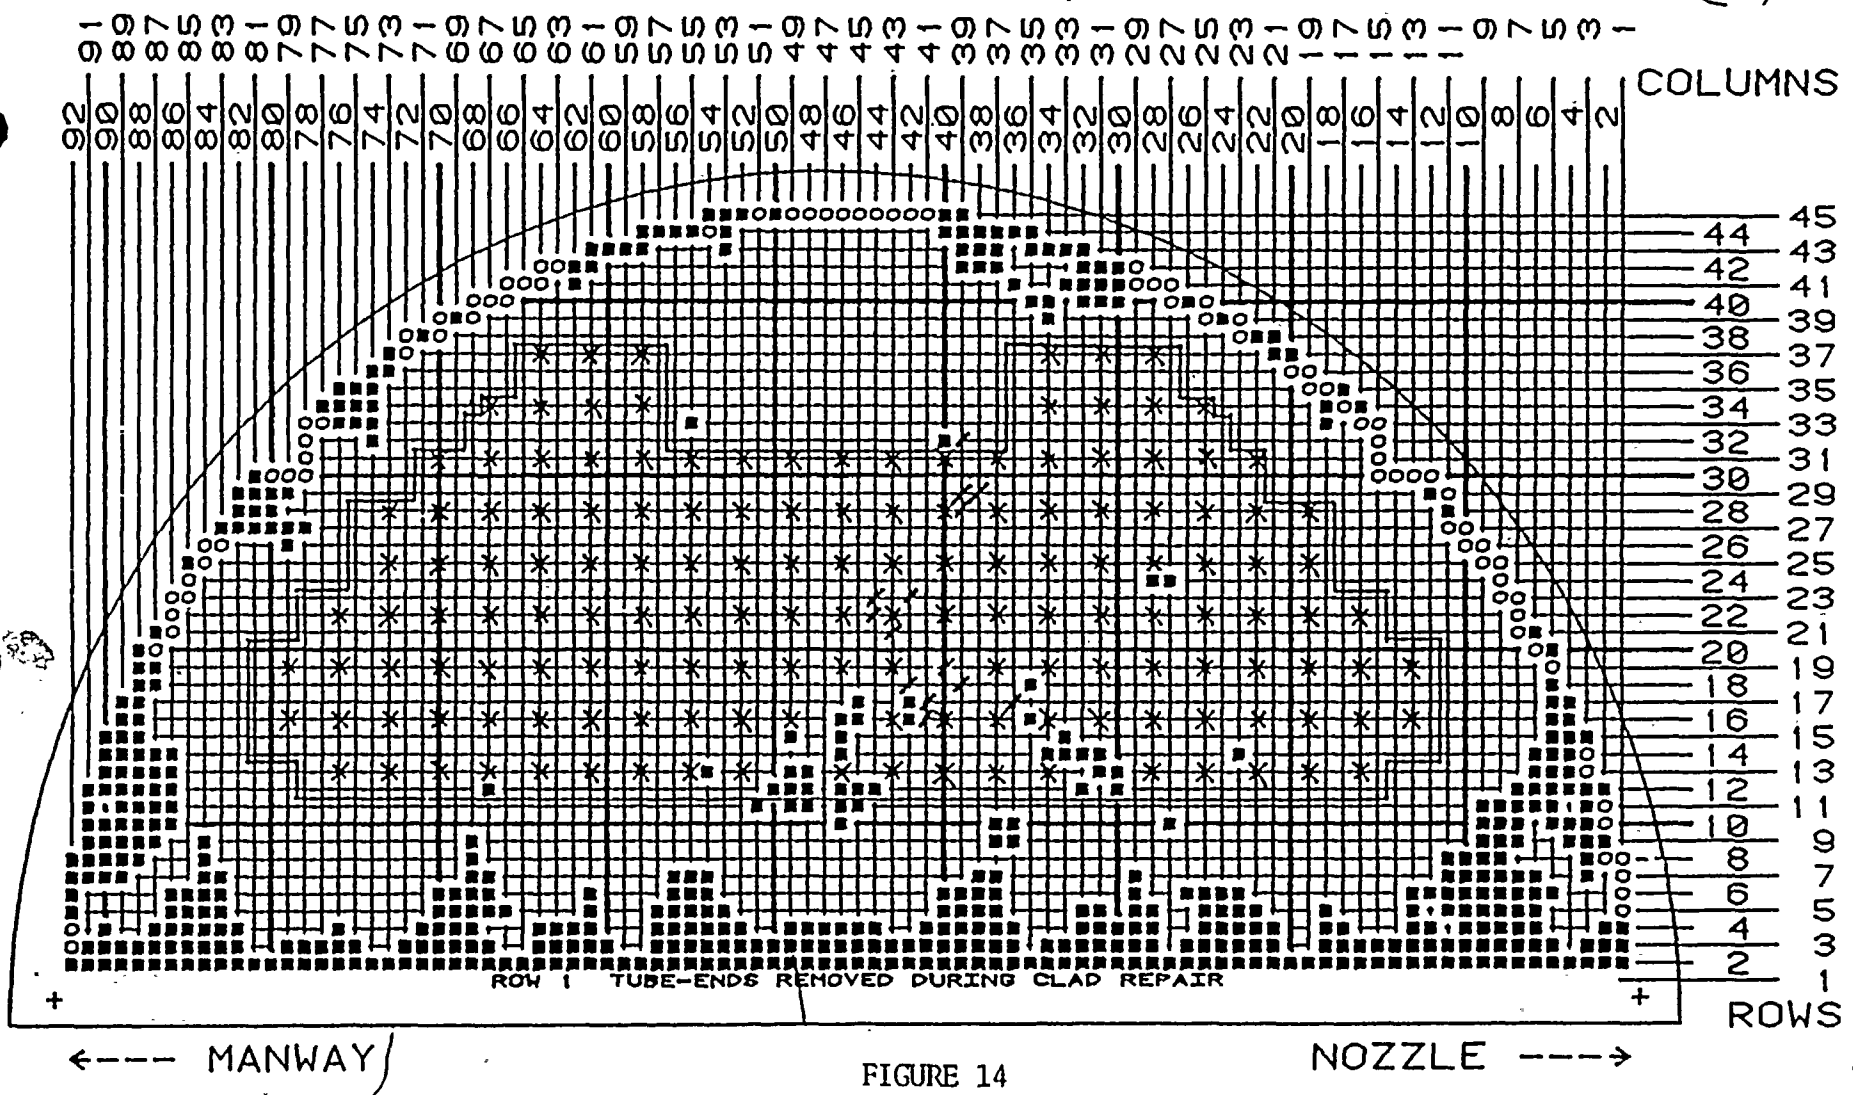
FIGURE 14
 TURKEY POINT UNIT #3
 STEAM GENERATOR C - HOT LEG
 REG. GUIDE 1.83 INSPECTION PROGRAM
 MARCH, 1981

X - REG GUIDE PROGRAM - INSPECT 153 TUBES THRU U-BEND W/ J20 SF (ALT-700 F). IF RESTRICTED
 GUIDE W/ .650 Ø DURING GAMING PROGRAM. (I.O. IN PROGRAM BY "RG" AND EXTENT) IF TUBE RESTRICTS
 CSD, ONLY 2 adjacent tubes with CSD.
 / - INSPECT 14 TUBES W/ PREVIOUS INDICATIONS THRU FRONT SUPPORT PLATE W/ .700 F PROB. IF ANY TUBES ARE
 RESTRICTED TO .700 PROB RANGE W/ .650 PROB TO IN 6TH SUPPORT PLATE. TUBE RESTRICTED TO .650 PROB ARE TO
 BE "BOXED IN" W/ .650 PROB. ALL RESTRICTED TUBES SHALL BE GAUGED DOWN W/ .610-.540 PROB AS REQ'D.
