**JIA - 96-351**

**RESPONSE TO FREEDOM OF INFORMATION ACT (FOIA) REQUEST**

6.	6/17/93	Rod Control System - Failed Components Status - (2 pgs)
7.	6/16/93	NRC Inspection Question/Response Tracking Form - (5 pgs)
8.	6/16/93	Rod Control System - Failed Components Status (15 pgs)

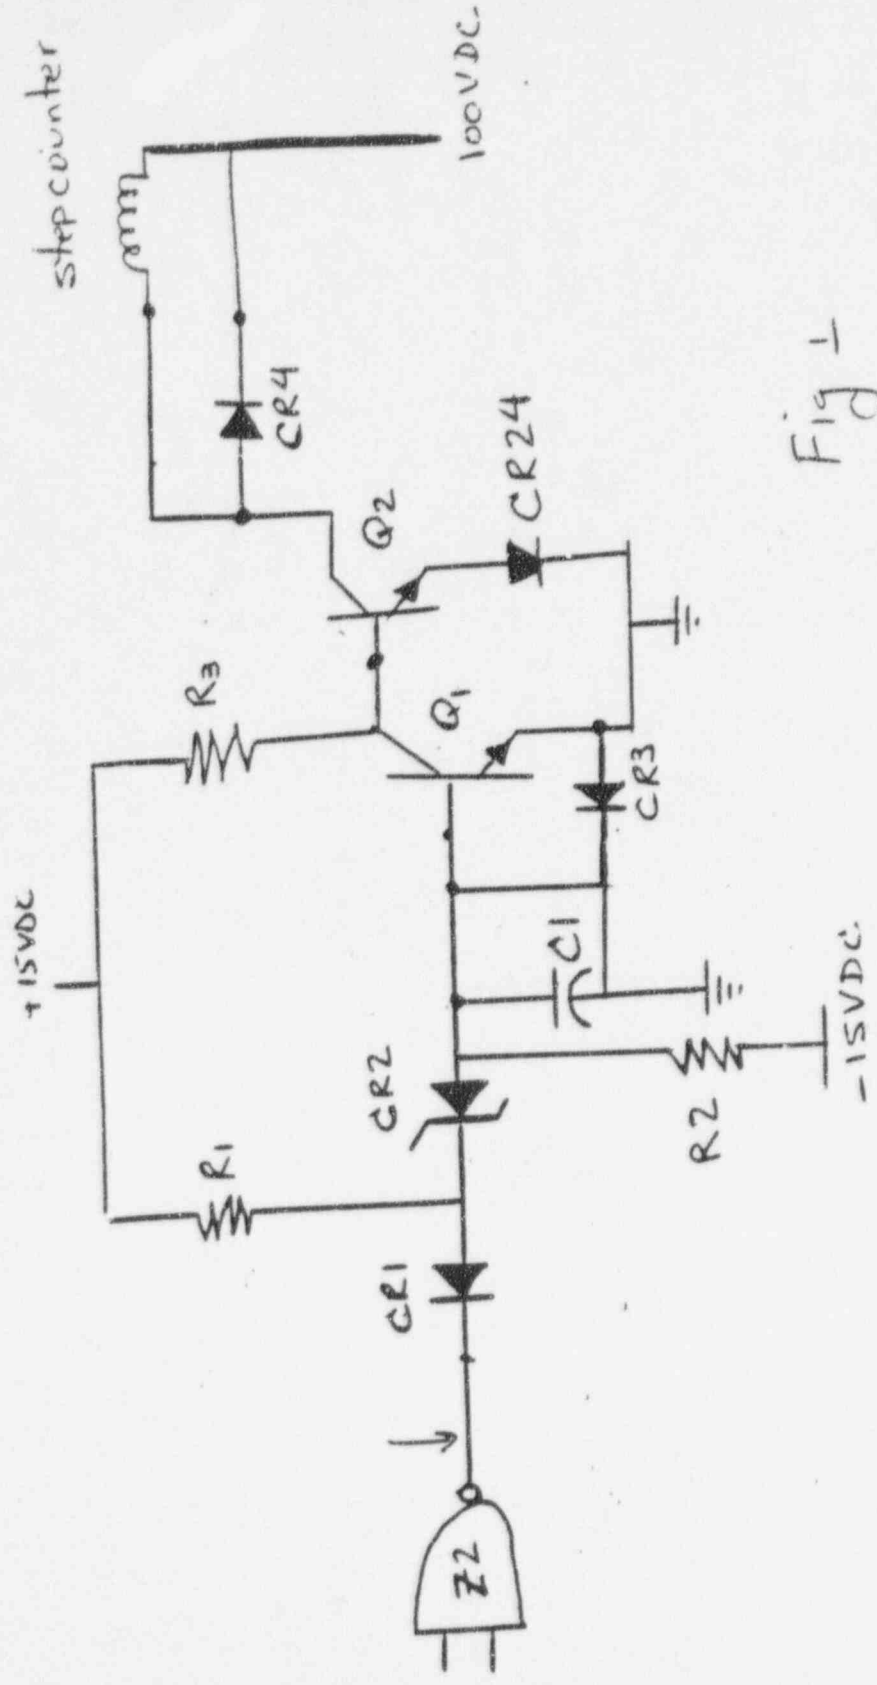
Fig 1

100VDC was shorted to -15VDC through  
circuit components failures (Fig 1)

SIMPLIFIED CIRCUIT FOR  
DATA LOGGER AND RELAY DRIVER CARDS

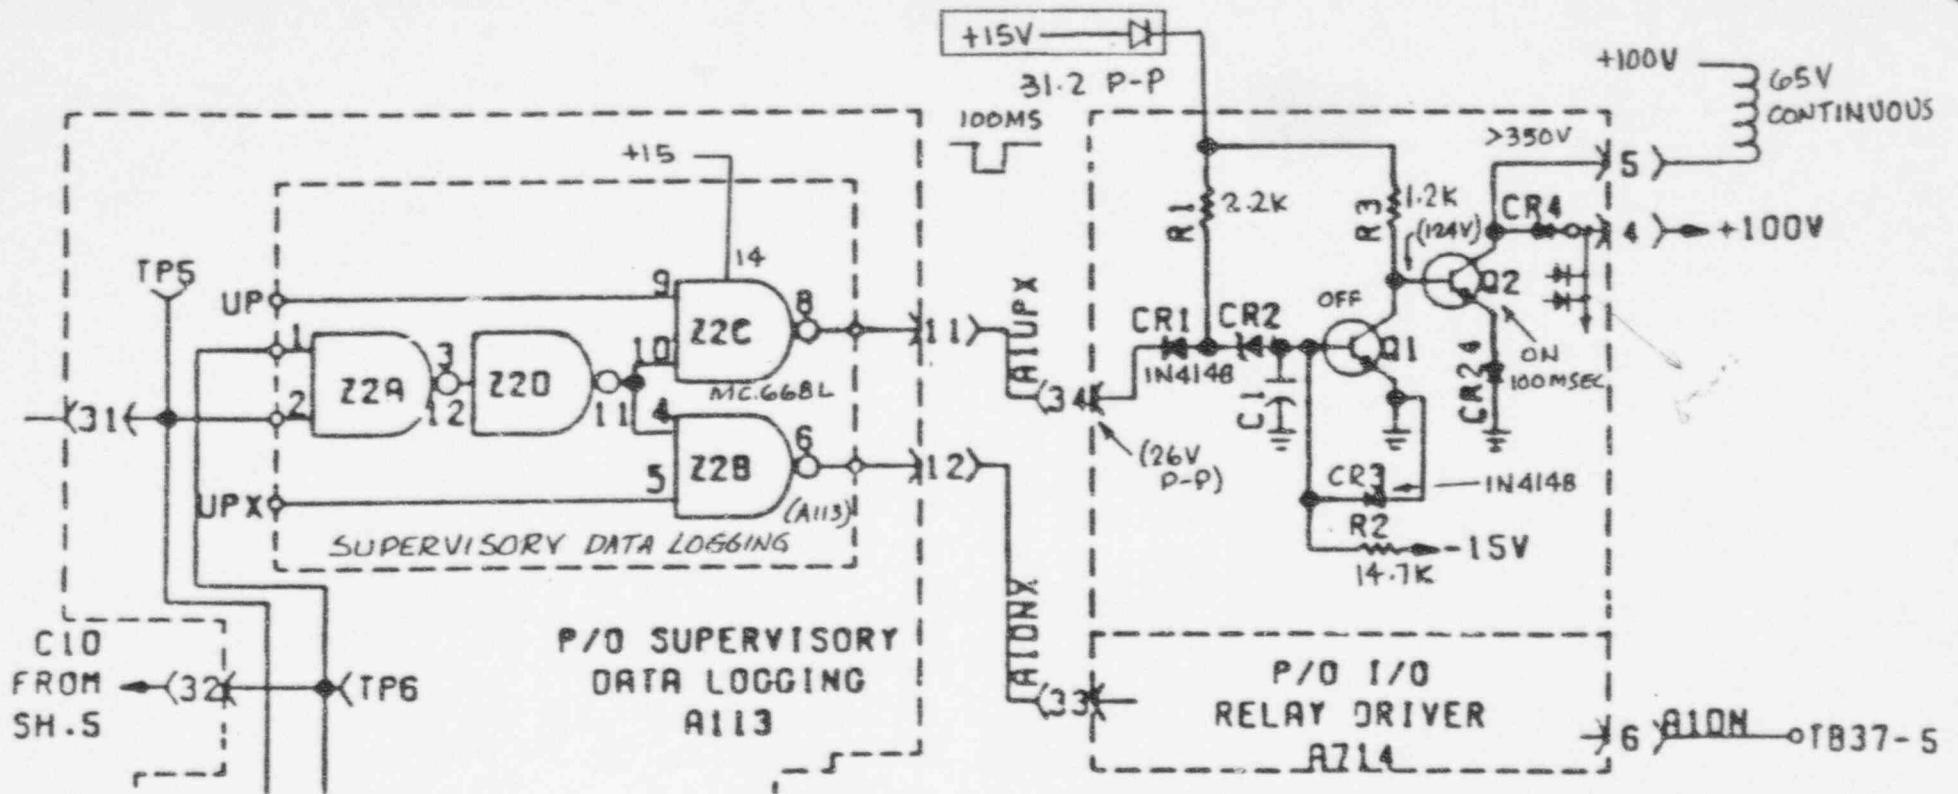
A. Replacement of 4 step counters - CBA1, CBB1, CBC1, SBA2 (later replaces CBB1 & CBB2)

1. Repeated Failures of (Z2C & Z2B)
2. Several (7) failures of blocking diodes (CR1) shorted (NTC and bench test proves short does not affect function nor cause Z2 failure) Note: NTC does not have 100V power supply
3. One failure of output transistor found (Q10) open
4. New Counter Resistance = 512 OHMS vs old coil 900 OHMS
5. W/O surge protection (CR4)

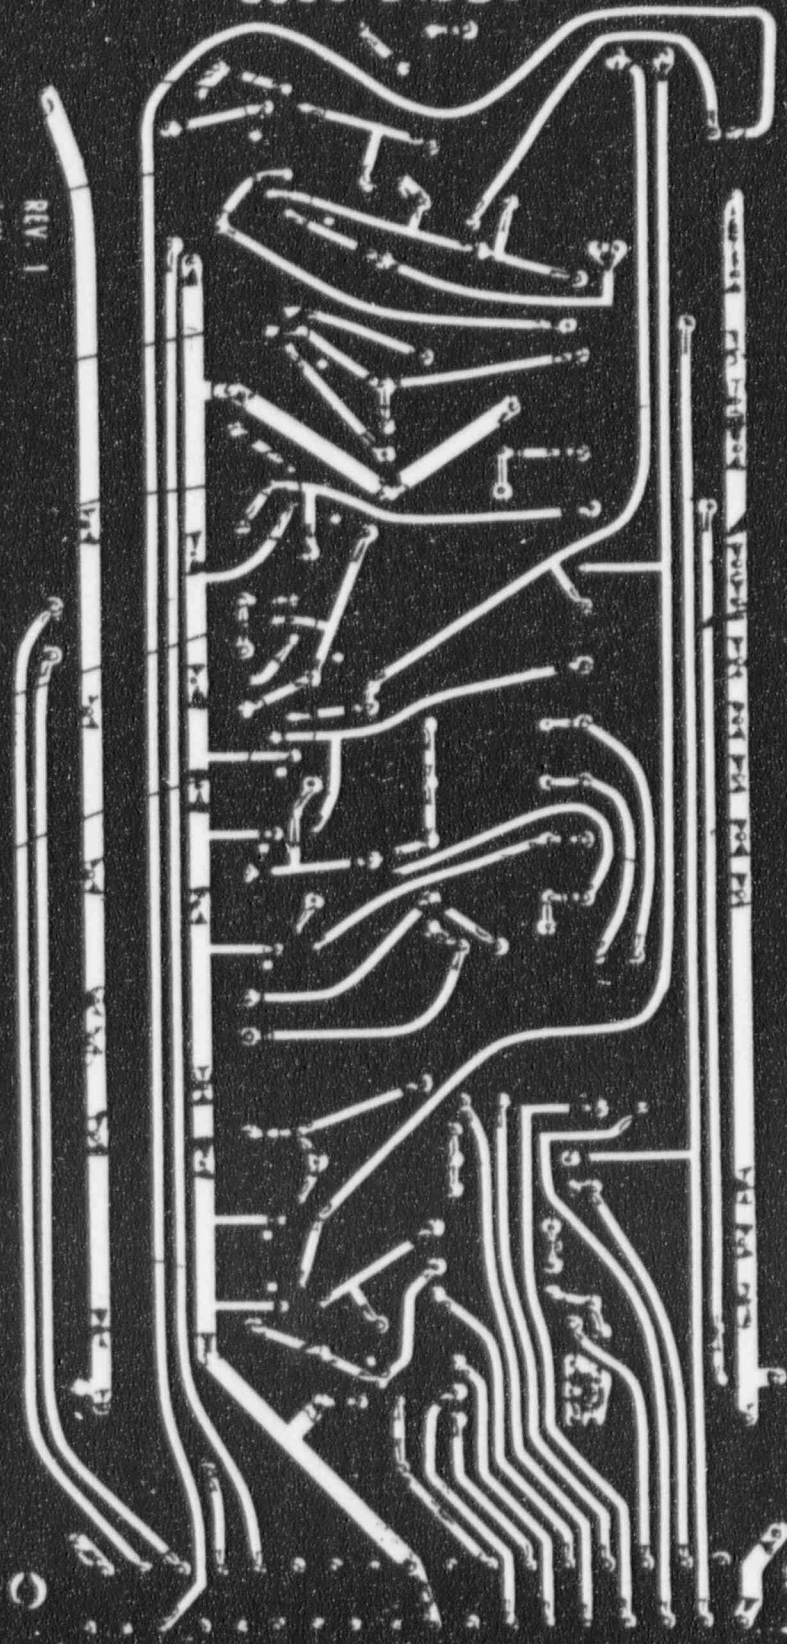
Attachment 4  
Alarm Card - schematic

FAILED Q9 LOCATED ON THIS CARD

TRACE  
FOR ANODE  
OF CR27

SHORTING OF TWO TRACES  
 DESCRIBED IN TEXT JUMPERS  
 +24VDC TO THE ANODE OF CR27  
 (WHICH IS THE JUNCTION OF CR25, CR26, & CR27)

The potential cause of failure of the Q9 transistor on the Alarm Circuitry card was due to the inadvertent jumpering of traces on that card. The 24 VDC bus trace and the trace for the anode of CR27 was momentarily shorted on the Alarm Circuitry card with the Q9 transistor turned on. This caused the base-emitter current to exceed the rating of the transistor.

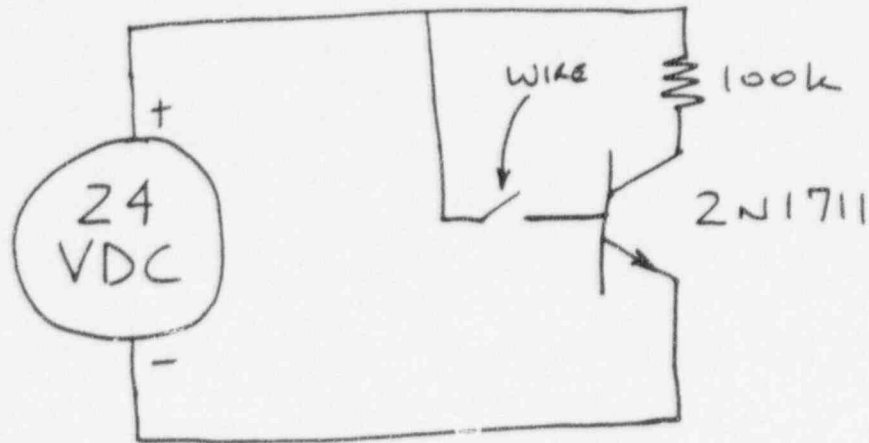
FIGURE A  
VALIDATION OF ALARM  
CIRCUITRY CARD FAILURE

Figure A shows the test circuit which was used to validate the Alarm Circuitry Card failure. The Alarm Circuitry Card equivalent circuit is conservative because the actual circuit card has a 0.47 mfd capacitor at the output of the 11 ohm resistor which upon shorting provided much higher current at the initial stages of the fault. Also, a 10 ohm resistor was used for test purposes.

The test setup used a Lambda power supply model LME-24 which is a 24 VDC supply equivalent to the supply installed in the power cabinet. The test was performed three times. Thus three transistors were used to validate the Alarm Circuitry Card failure.

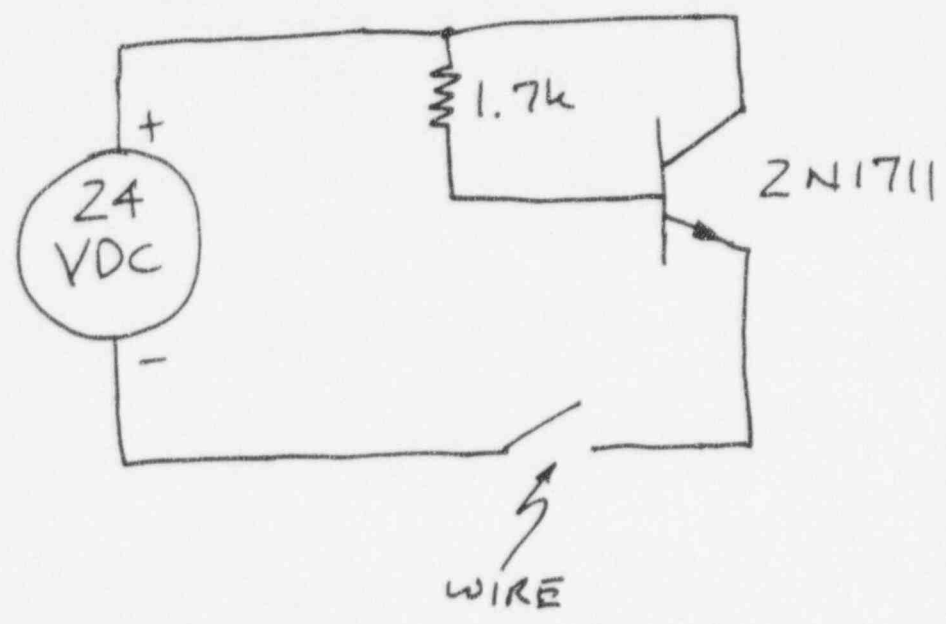
VALIDATION OF SIGNALING  
PROCESS CARD FAILURE

For the Signal Process Card, it is reasonable to postulate that if the shorting jumper discussed above momentarily connected pins 5 & 6 when being inserted into the Failure Detector card edge connector on the backplane, 24 VDC could be applied directly to the collector of Q9 causing damage to Q9.
