CSX Train Derailment with Hazardous Materials
Release
Hyndman, Pennsylvania
August 2, 2017

Accident Report
NTSB/RAR-20/04
PB2020-101012

Railroad Accident Report

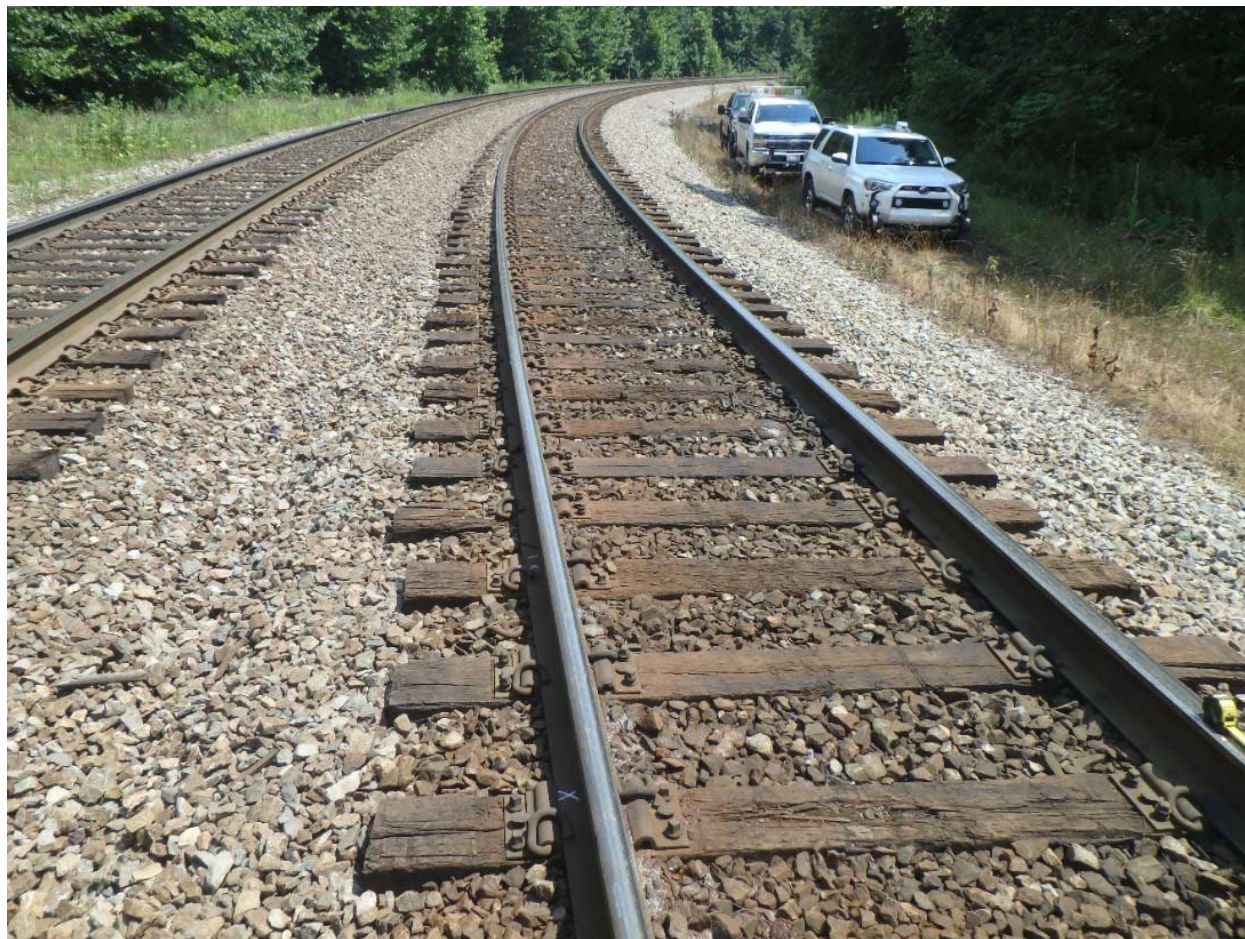
Traveling on main track 2, the train moved through a descending grade beginning at MP 209.8 (top of grade) to MP 192.3 (train resting location). The grade is one of the steepest grades in the CSX system. At the POD (MP 193.8), the train was moving through a right-hand curve that has a permanent speed restriction of 30 mph for freight trains. (See figure 7.) As stated previously, the train had been traveling at 29 mph at the time of derailment.

Figure 7. Accident curve facing east toward direction of accident train travel.

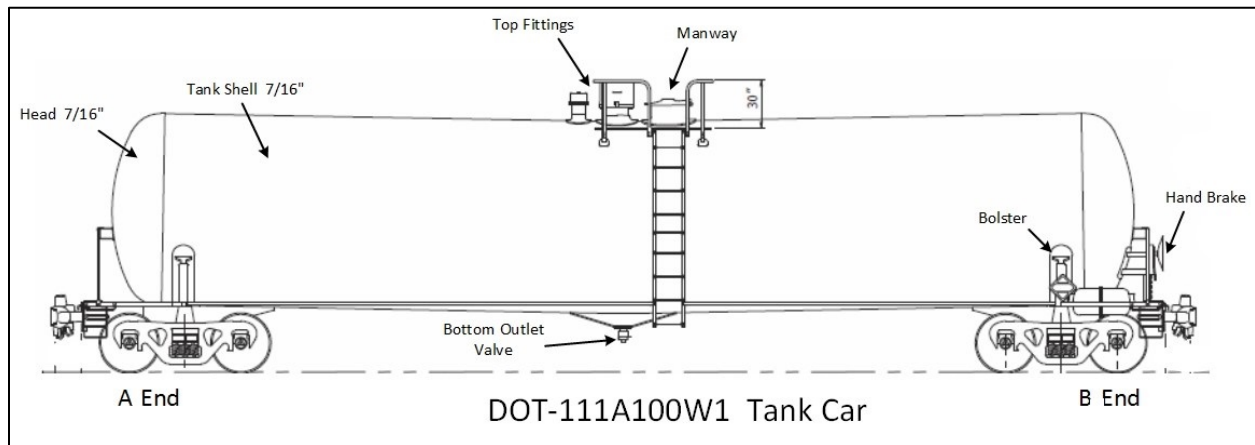
Tank car UTLX643949 carried molten asphalt and was a specification U.S. Department of Transportation (DOT)-111A100W1 tank car that was built in October 2013 and owned by Union Tank Car. The tank car had a load limit of 191,000 pounds and a tank capacity of 23,467 gallons. (See figure 9.)³⁸ The tank heads and shell were constructed of 0.4375-inch A516-70 nonnormalized steel. The tank was equipped with steam coils and covered with 4 inches of fiberglass insulation and an 11-gauge jacket. The tank car did not have head shields or a thermal protection system.

Figure 9. Diagram of a DOT-111A100W1 tank car.³⁹

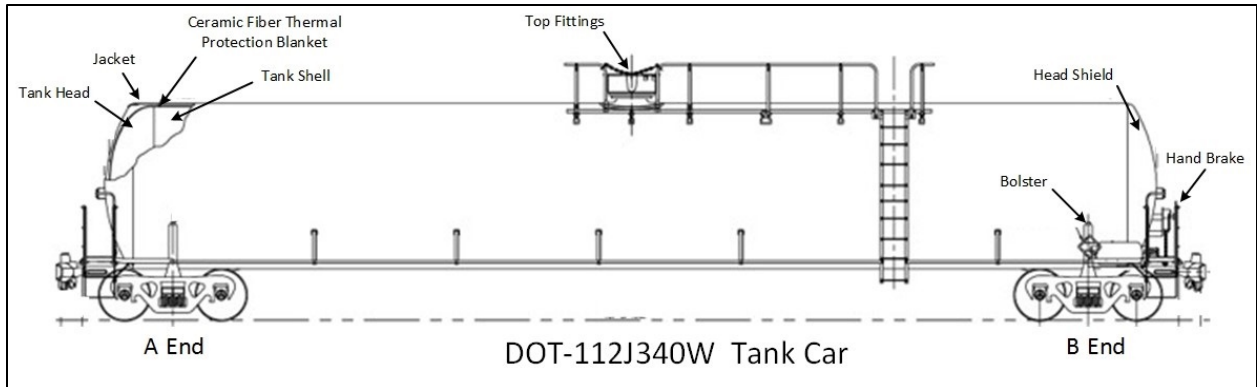
Tank car CBTX 781553 was a specification DOT-112J340W tank car, intended for the transportation of LPG products. Trinity Tank Car constructed the tank car in November 2013. It was owned by CIT Rail, which was responsible for periodic qualification and maintenance. It had a water capacity of 33,710 gallons, a test pressure of 340 psig, and a burst pressure rating of 850 psig. The tank heads and shells were constructed of 0.608-inch TC-128 Grade B TCVN-30F steel. The semi-ellipsoidal heads were protected with full diameter 0.5-inch thick head shields constructed of ASTM A572-50 steel. The tank was equipped with one pressure relief device with a start-to-discharge setting of 280.5 psig. It was also equipped with a thermal protection system consisting of 0.5-inch thick 4.5 lb/ft³ ceramic fiber thermal blanket and an 11-gauge steel jacket. The tank car had not been modified from its original construction configuration. (See figure 12.)

Figure 12. Diagram of tank car CBTX 781553 (a DOT-112J340W tank car).
