PRESERVATION PLAN

WASHINGTON & JEFFERSON COLLEGE

WASHINGTON & JEFFERSON
COLLEGE
WASHINGTON, PENNSYLVANIA

The purpose of this plan is to outline recommendations for the preservation, conservation and continued use of the historic landscape and buildings of Washington & Jefferson College.

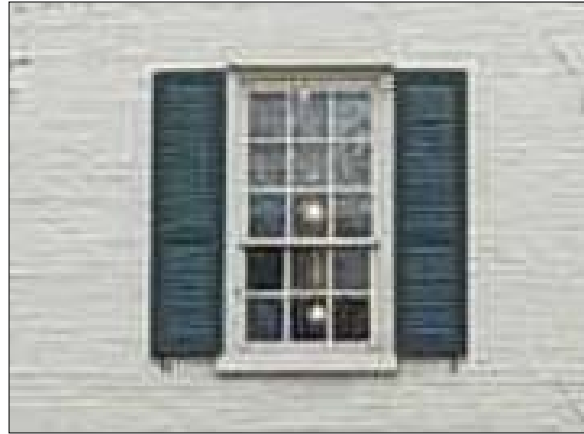
Windows are in fair condition.

Where windows are in fair condition and not subject to constant operation, retention of historic windows is preferable. Interior storm windows can be added in areas where heat loss or occupant comfort is a major concern.

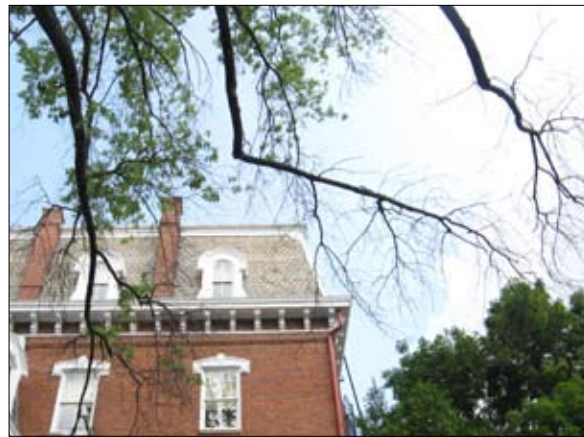
“Trouble up top means trouble down below” goes the old saying, and dead or dying branches often indicate problems at the base of the tree or in the root zone. All trees should be evaluated for good health at the base. Trees should have a natural flare where the trunk enters the ground. If a tree comes straight from the ground like a telephone pole, a problem is evident. Possible issues include mulch that is too thick, mechanical damage to the trunk, a tree planted too deeply, or girdling roots. All can create serious problems to tree health and should be corrected whenever possible. The Airspade is a useful tool to excavate root collars without damage to the trees. Resolving root flare issues will extend and improve the life of campus trees. Older trees would benefit from an ongoing aeration and deep-root fertilization program. Young trees need proper planting, regular watering and close attention to soil conditions to ensure a healthy start.

Dead branches are an indication of other problems.

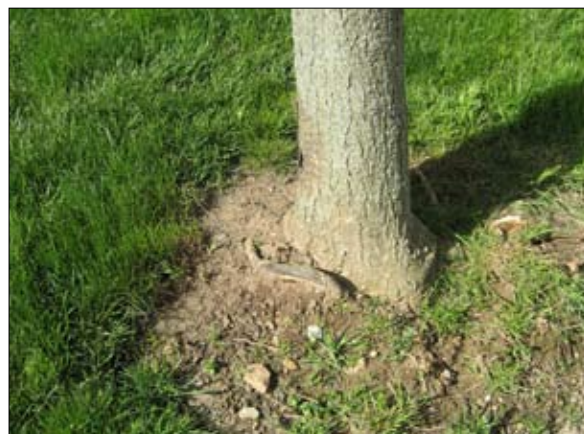
Roots girdling a tree, essentially starving itself to death.

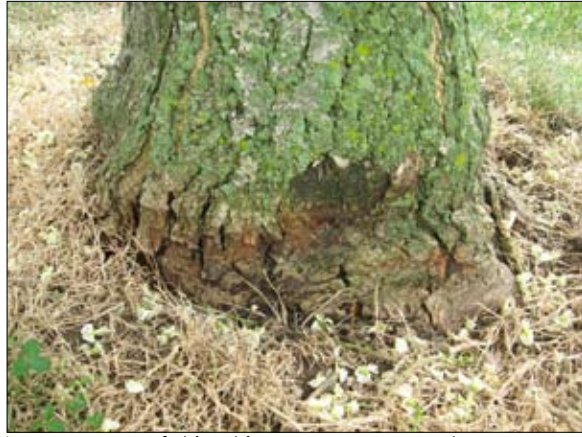
String trimmers, mowers and other mechanical equipment can do great damage to trees, and all trees should have an area clear of grass around the trunk to lessen the chances of this type of damage. Damaged bark creates opportunities for the introduction of insects and disease, and trunk damage can destroy the thin cambium layer, which is the only living part of the trunk. This has serious consequences for the health of the tree.

Improper use of string trimmers can cause damage.

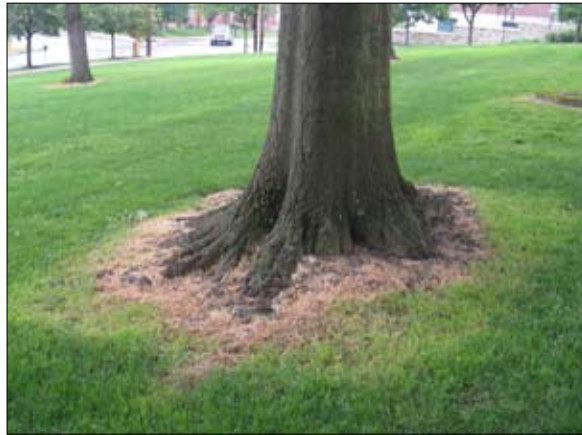
Herbicide use was noted around tree trunks to manage grass. This must be used with caution and must not be used where bark wounds would allow the chemicals to contact the cambium layer, as chemical uptake would affect the health of the tree.

Herbicides used too close to trees can cause damage.

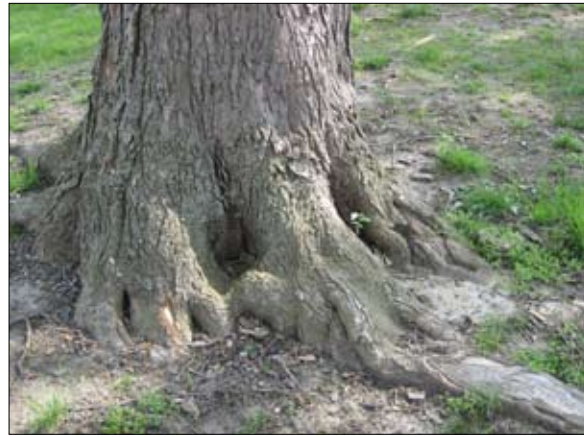
Many trees have no mulch at the base, and this has allowed damage to the lower trunk and root-zone areas. Properly-applied mulch would help lessen mechanical damage, ensuring better tree health.

Significant root flare damage

Proper application is crucial. While the benefits of mulch are well-documented, mulch can be damaging to the health of trees and shrubs when improperly applied. Mulch too close to a plant can keep moisture against the trunk, encouraging rot and creating conditions favorable to insects and disease. Mulch should be kept back from all shrubs 4-5 inches, and from all trees a minimum of 8-12 inches from the edges of the root flare. The flare where the trunk enters the ground should always be visible and free of mulch.

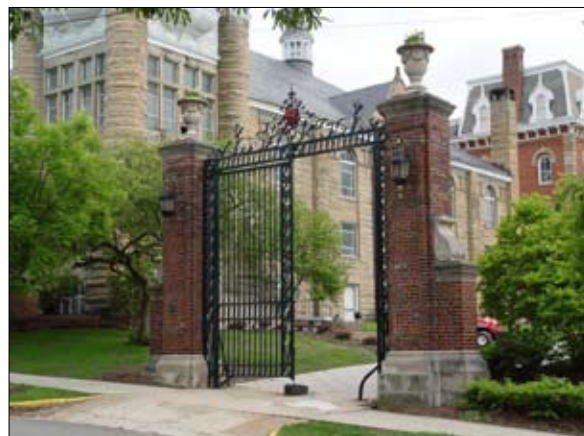
Beau St. gate.

The East Beau Street Gate has damage to base of pillar that should be repaired. A new boxwood hedge south of gate is not parallel to sidewalk. Replant closer to walk and parallel, and consider adding matching hedge to north side of gate as was found in earlier years.

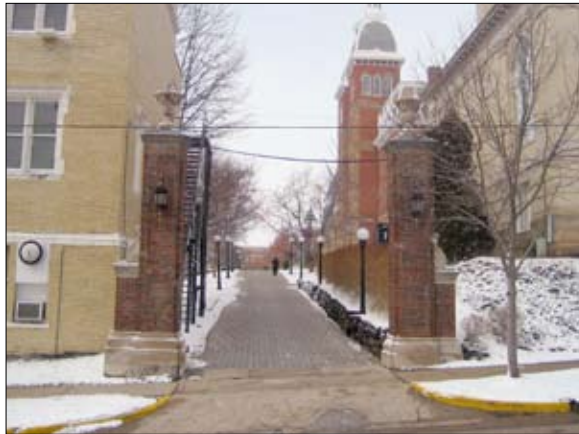
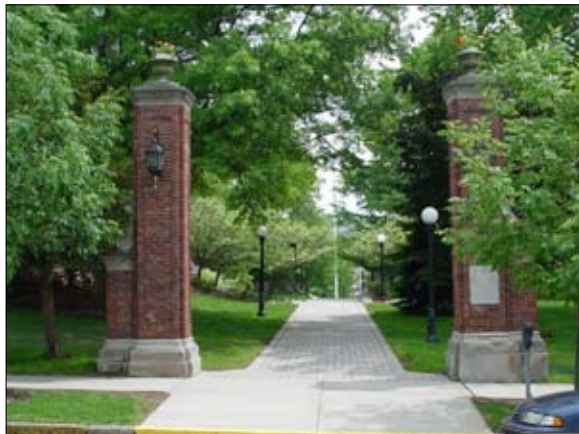
Wheeling St. gate.

The Wheeling Street Gate (Admissions side) has a single yew to the north and nothing to the south. This yew could be removed. If plantings are desired at the gateways they should be symmetrical on either side.

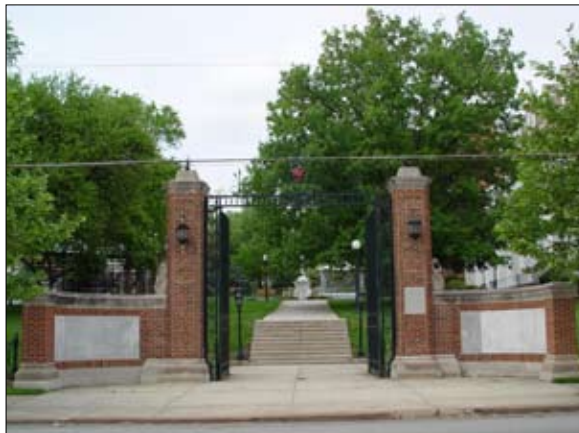
Maiden St. gate

The East Maiden Street Gate is also known as the Algeo Gateway. Trees could be planted behind to either side of the gate to increase the sense of passage and to better enframe the gate.

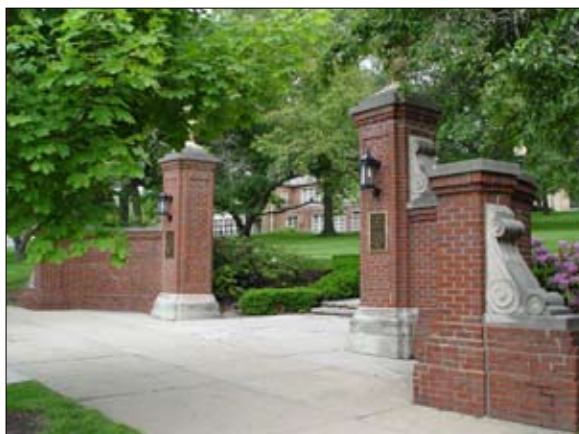
College St. gate.

The College Street gate has damaged brickwork at base and along top edge. Old crab apples were removed from this gate area in the summer of 2008. Consider adding new trees to increase emphasis at gateway.

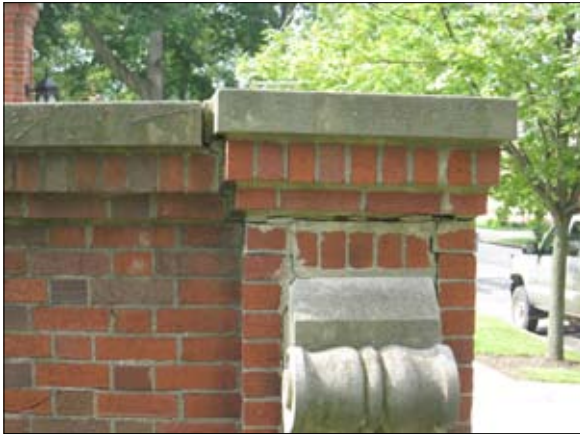
College St. gate damage. Match color and texture.

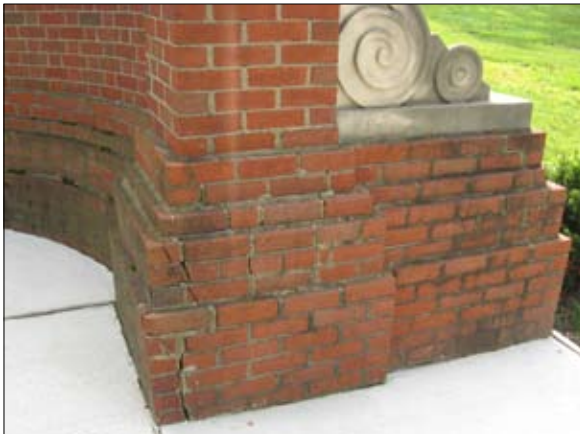
College St. gate damage. Repair.

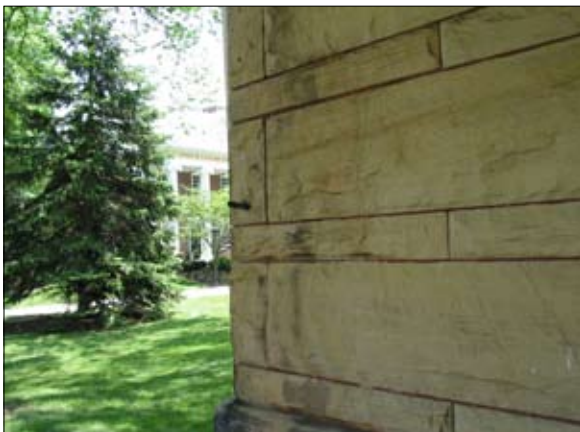
Prune trees back from structures.

- To help prevent damage to paint, prune trees back to eliminate brushing against roof fascia and siding.
- Remove any extraneous hardware from exterior walls. These are normally left behind from electrical services etc. but cause rust stains and spalls on stone.
- Re-point masonry as needed to match original color, size and texture.

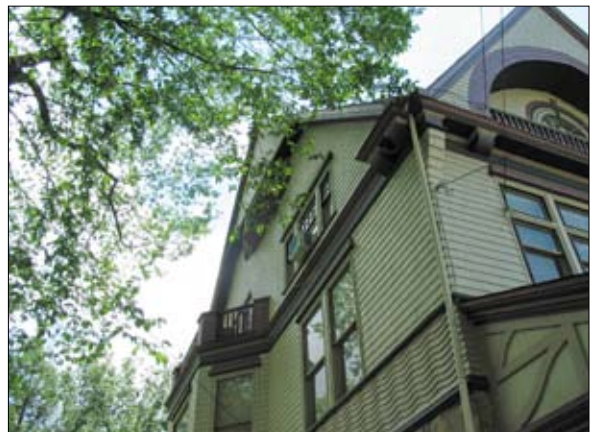
Prune trees back from structures.

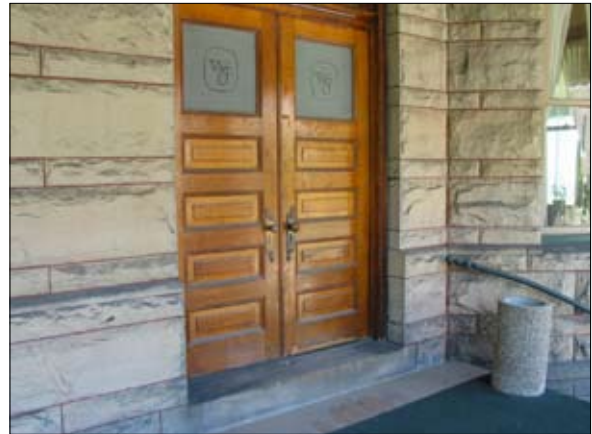
Refinish entry doors.

- Entry doors should be refinished and hardware polished to help eliminate further damage to wood doors and improve historic appearance.
- Check roof and roof flashing at portico if not repaired recently; stains on masonry and damage to underside wood deck indicate a possible leak.
- Scrape, re-glaze, prime and paint, wood windows as needed.
- Remove vegetation from chimney. Vegetation allowed to grow through mortar joints will allow mortars to be released and may lead to brick damage.

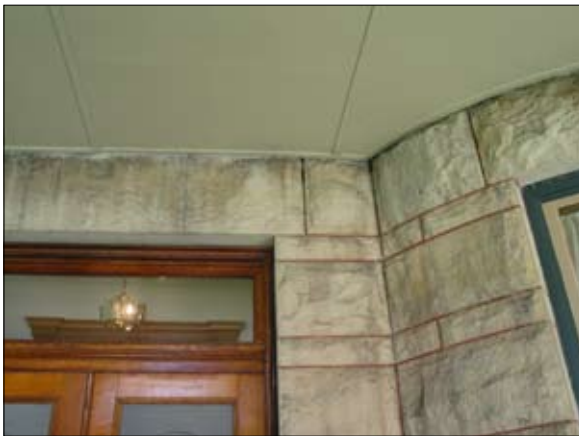
Check roof and flashings. Evidence of water leakage.

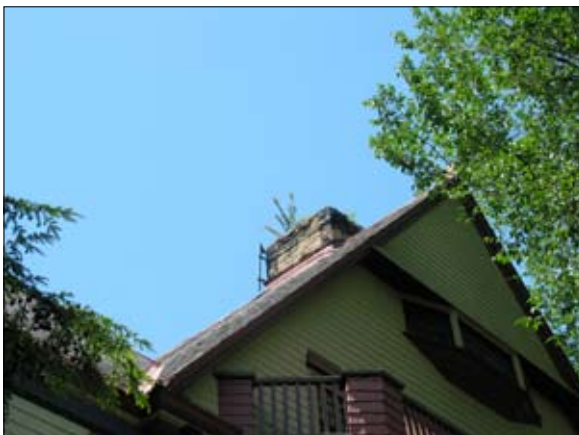
Remove vegetation from chimney.

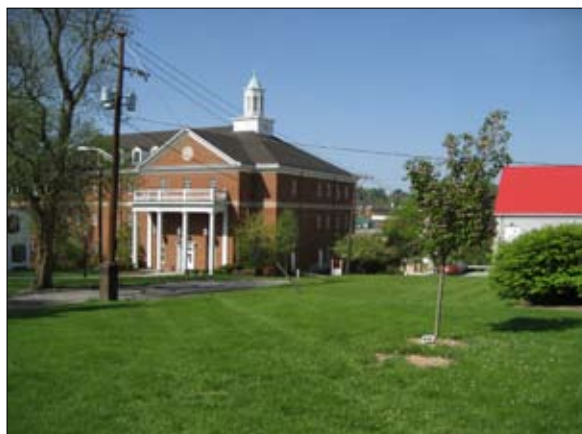
The Burning bush (*Euonymus alatus*) hedge is an effective parking lot screen. This area would benefit from the addition of large canopy trees to help tie together North and South campuses. Currently a young Japanese cherry tree is the only tree in the area.

Add trees to open area.

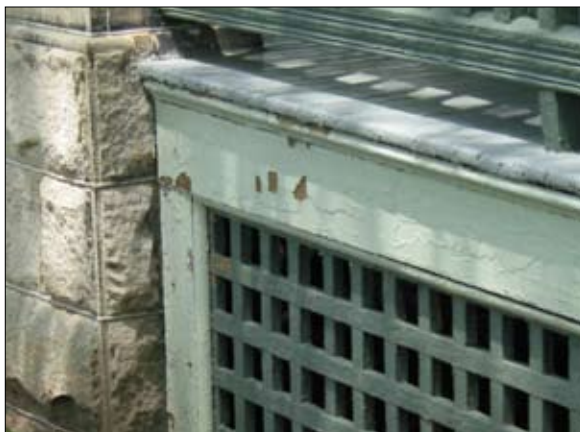
Repair or replace with similar materials.

- Scrape, prime and re-paint all wood trim as needed.
- Re-glaze window sashes as needed, then scrape, prime and re-paint.
- Repair / replace in kind, square wooden porch lattice.
- Keep trees pruned back from roof lines to help eliminate wood damage and roofing issues.
- Repair masonry joints as needed to match original color, texture and size.
- Continue the existing termite treatment. Carpenter ants were observed and it is recommended to safely keep them in check.

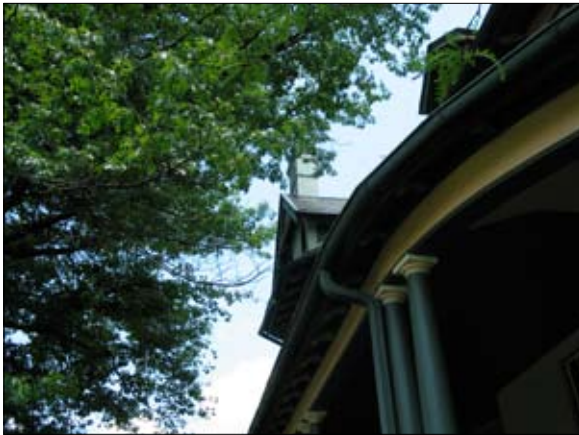
Prune trees back from building.

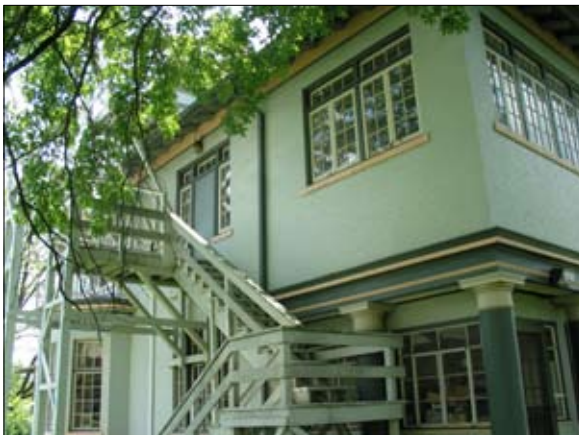
Prune trees back from building.

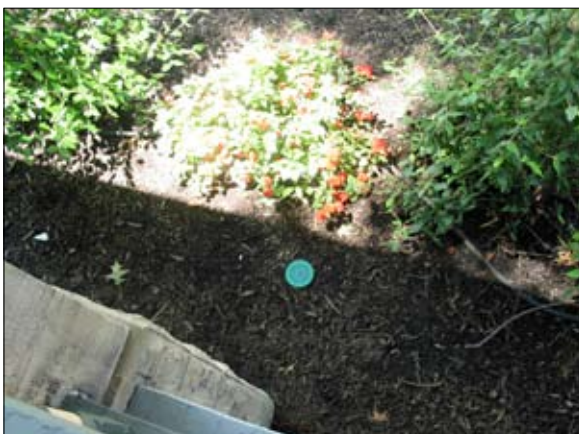
Continue with termite and ant treatment.

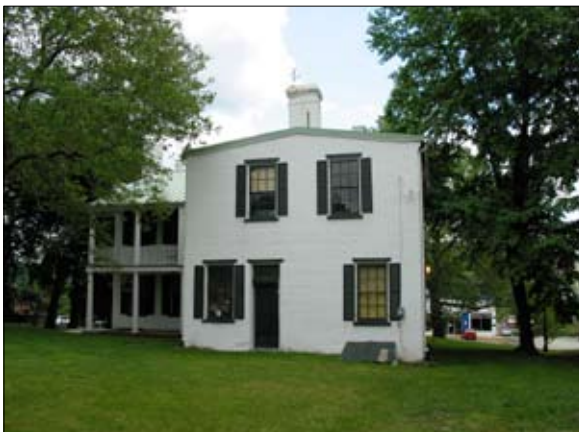
Remove vegetation from chimney.

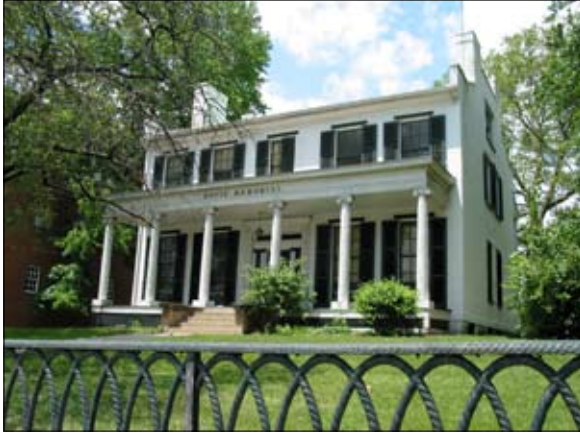
Prune trees back from roof lines

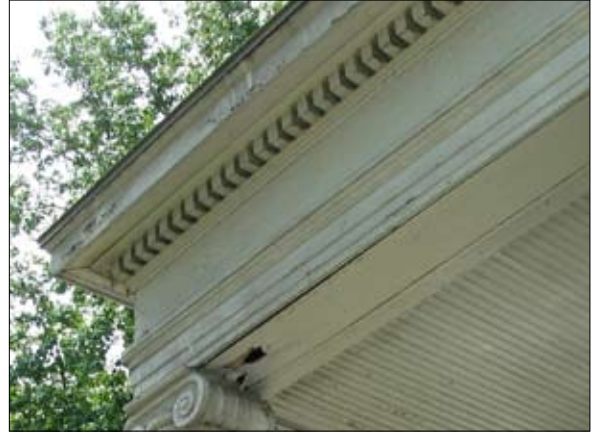
Check flashings and downspouts for obstructions.

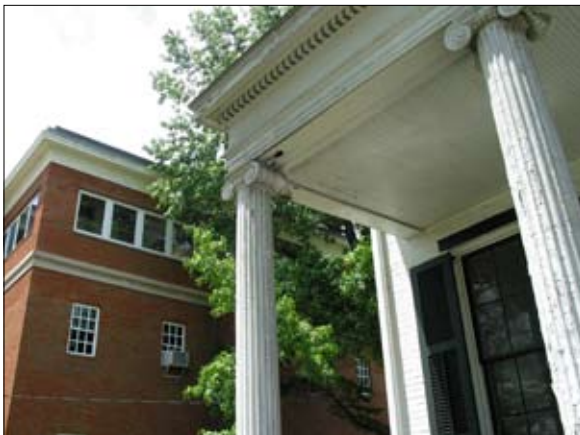
Check flashings and downspouts for obstructions.

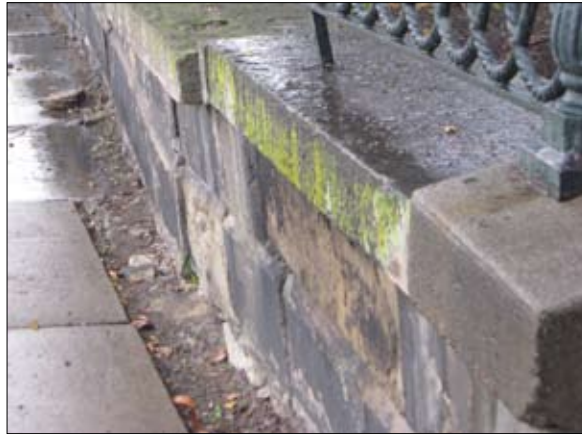
An impressive sycamore gives a high canopy of shade to the lawn area on the East Maiden street side. A stone wall and decorative iron railing separate the lawn from the street. This wall is leaning outward toward the sidewalk. Old crab apples flank the entrance steps. The wall is a potential hazard for pedestrians and should be taken apart and rebuilt to its original condition. Make certain adequate drainage is provided behind it to alleviate future problems.

Repair leaning stone wall.

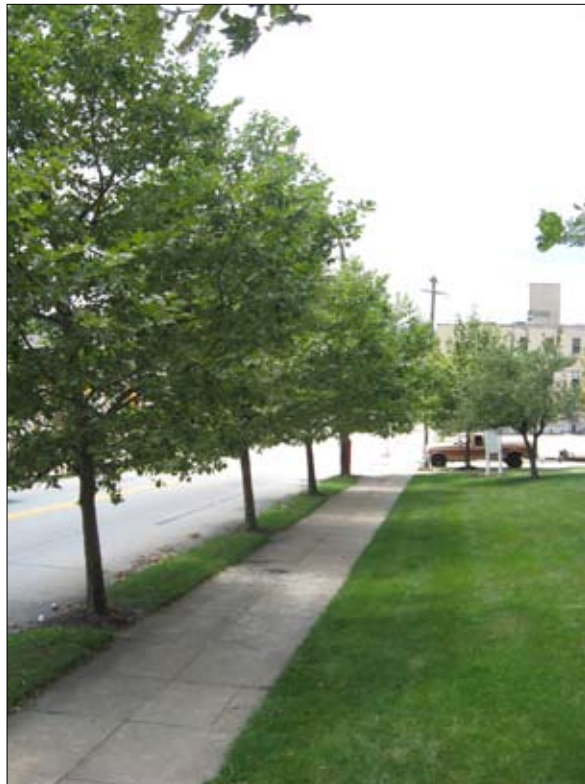
Wrong species for this location. Plane trees will rapidly come in conflict with overhead wires. Consider moving.

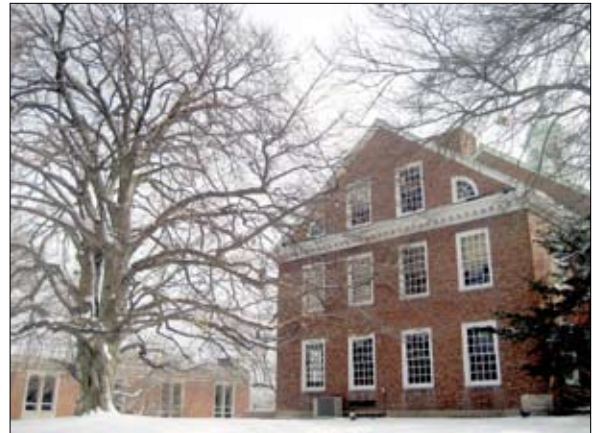
A large and impressive copper beech tree anchors the lawn to the west of Lazear. The tree has large conks (fungal growth) up high on the trunk, a sign of interior rot. Squirrels were noted going into the tree. This tree should be evaluated for soundness by a qualified tree expert and appropriate action taken. Old spotlights should be removed from trunk. Pruning cuts should be taken back to branch collars.

Impressive Copper Beech specimen.

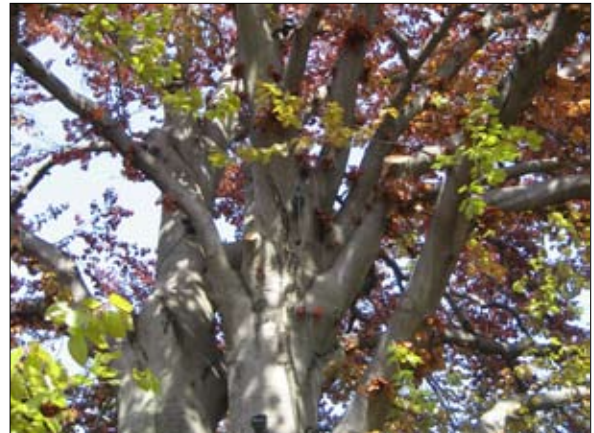
Beech detail.

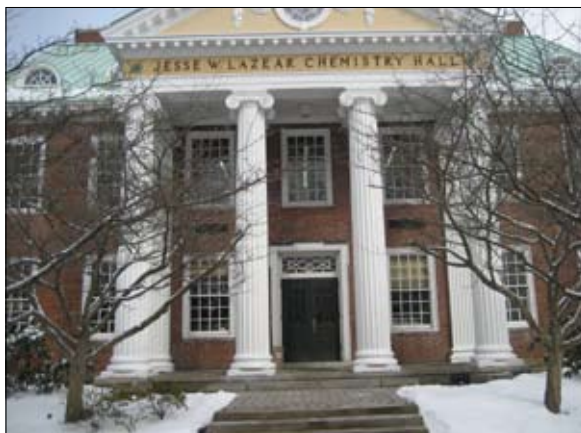
Hawthorns are improperly pruned.

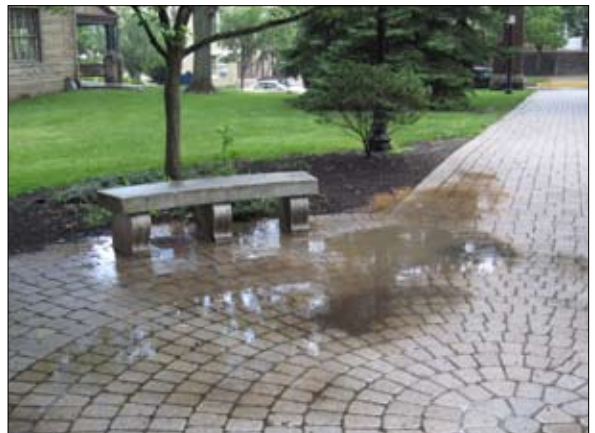
Gutter is spilling onto walkway creating mess.

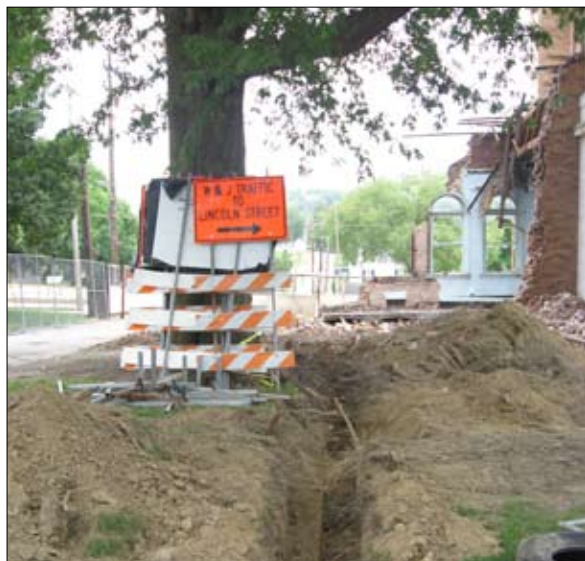
Severe trench cut along side of oak may impact tree health due to root loss. Tree may require some crown-thinning to compensate for reduced water uptake. Root zone should be aerated to address compaction issues and watered regularly to allow tree to rebound from construction-related stress. All trees in vicinity of construction should have root zone aeration after construction is complete.

All trees in location of construction should have root aeration after construction is complete.

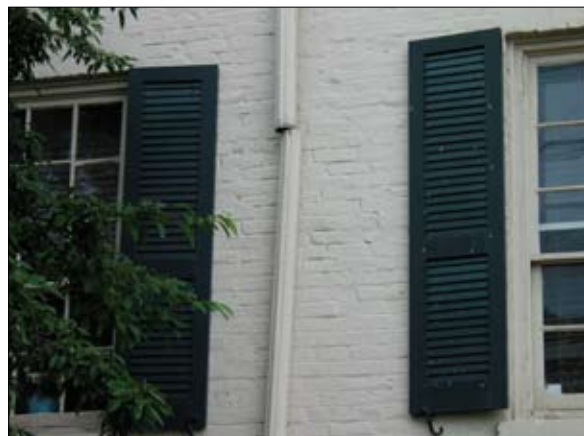
Downspout disconnected. Repair.

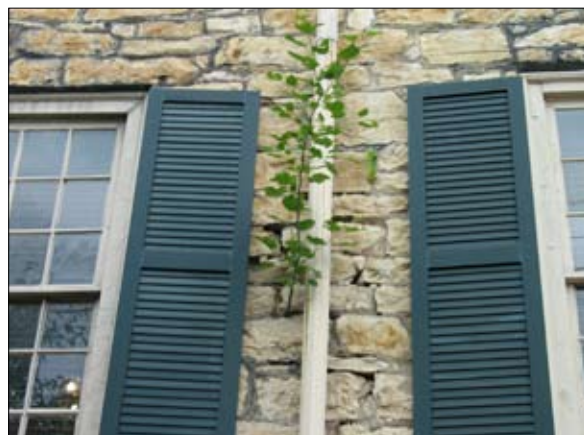
Mortars don't match. Match color and texture.

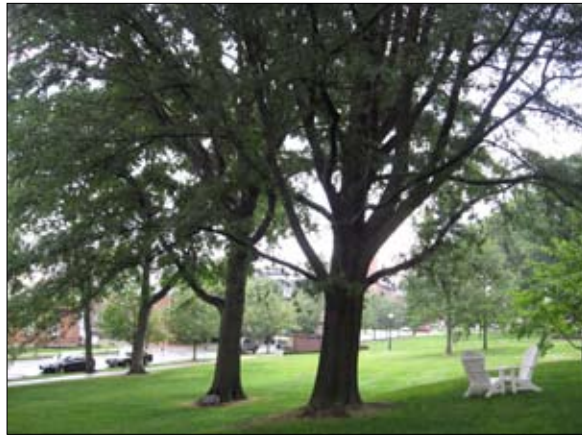
Oaks require qualified attention to maintain health.

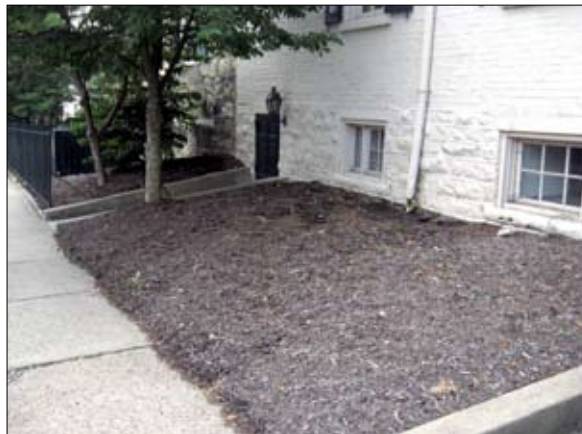
Planting consists of four old crab apples. One is in decline and will need replacement. Another tree could be added toward east corner. Bed appearance would be improved with some ground cover, hostas and ferns in place of bare mulch.

Replace declining crabapples.

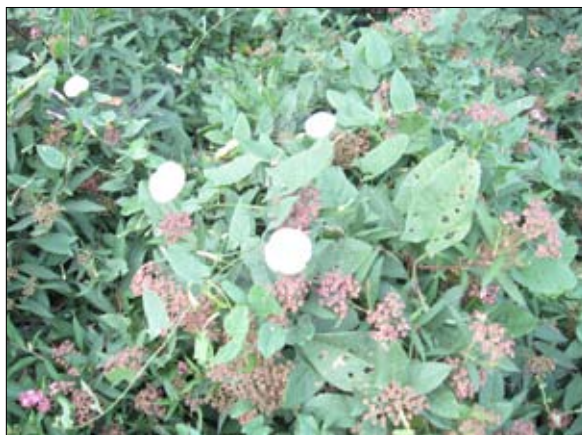
Spirea mass on corner is being overgrown with bindweed. This can be difficult to control but should be managed before it spreads to other beds.

Spirea mass is infested with bindweed. Weed!

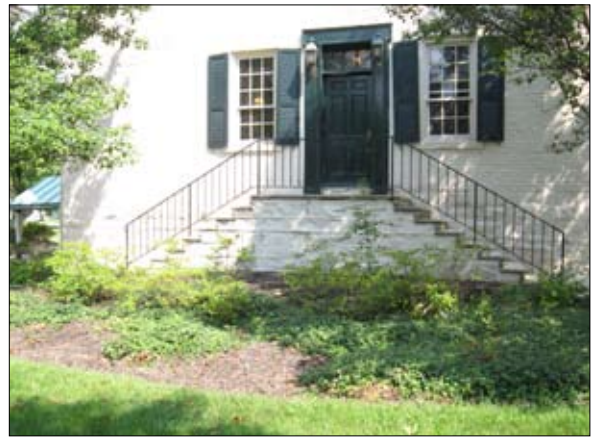
This bed is a candidate for rejuvenation along more historic lines. The pears are a short-lived tree, usually lasting less than twenty years. The plants within the beds are not healthy and will need replacement at some point.

Completely renovate this garden.

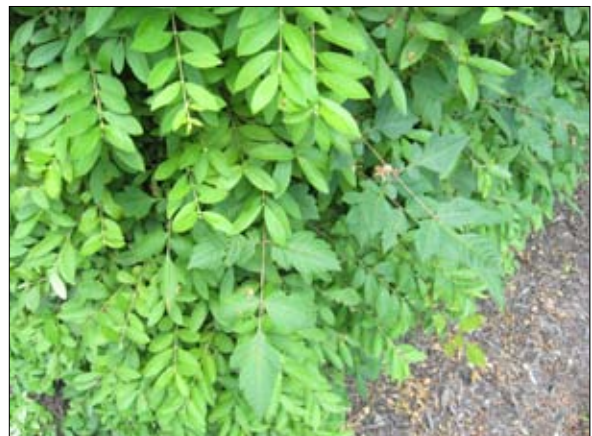
This hedge is neatly trimmed, however it contains numerous tree seedlings that should be weeded out. The hedges should also be trimmed so that the bottom sticks out slightly farther than the top. Currently the top edge of the hedge is wider than the bottom. Over time, this can limit the light reaching the bottom of the hedge and create a thin lower half of the hedge.

Weed out volunteer tree seedlings from hedge.

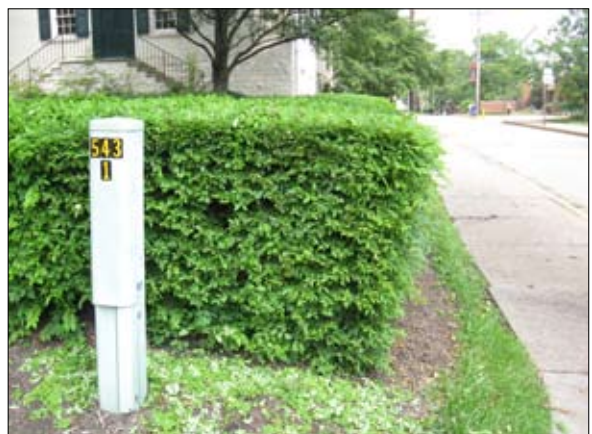
Improperly pruned hedge. Too wide at top.

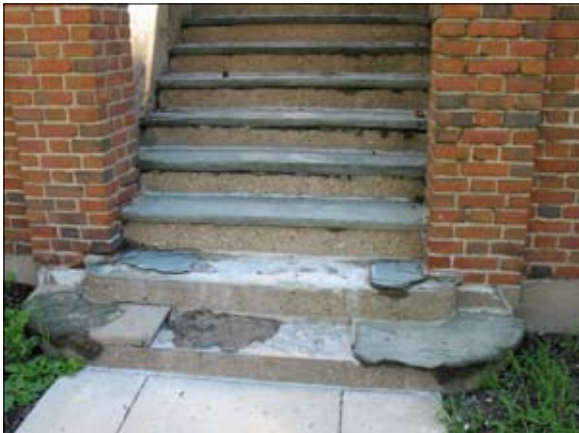
Repair as soon as possible. Liability problem.

- For safety concerns, repair broken stairs as soon as possible.
- Repair damaged cornerstones. Masonry repair products such as Jahn or Mimic work well.
- Repair broken and missing roof slates.
- Repair shutters and hardware as needed.

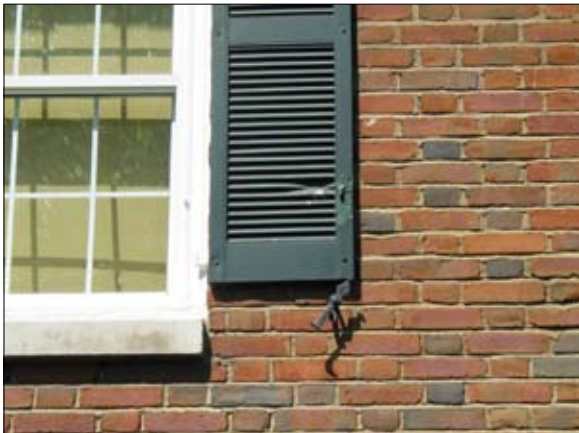
Repair shutters as needed.

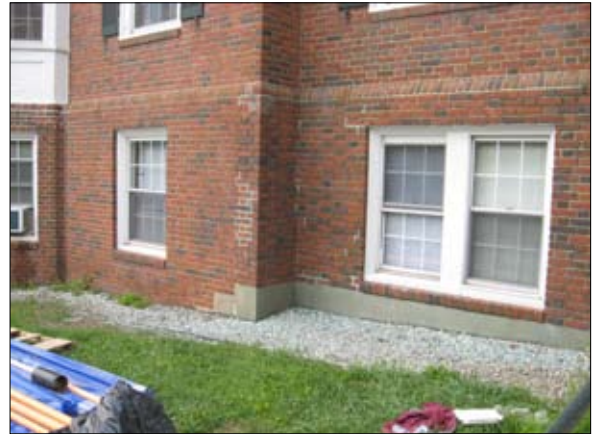
Consider a simple ground cover here.

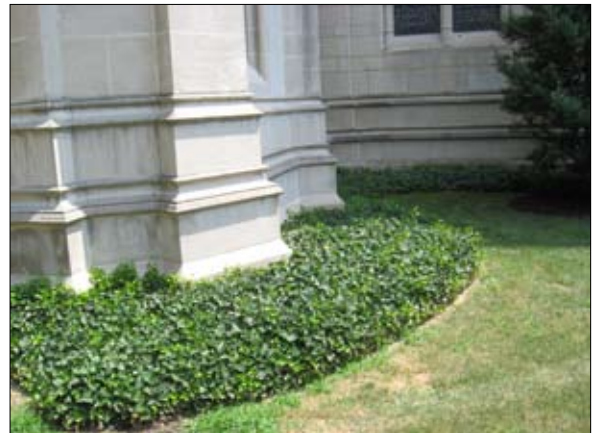
This photo shows how simple ground cover is used.

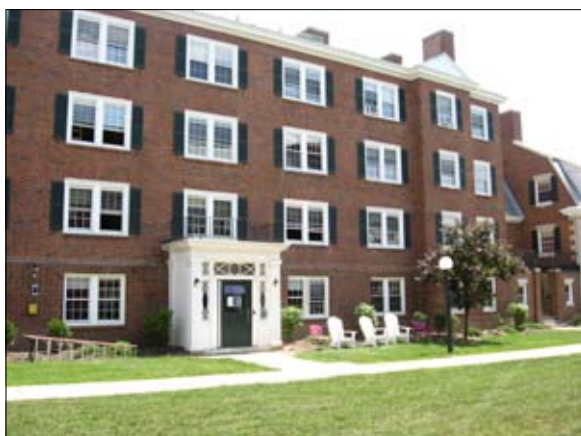
Foundation plantings are sparse. Consider redesigning.

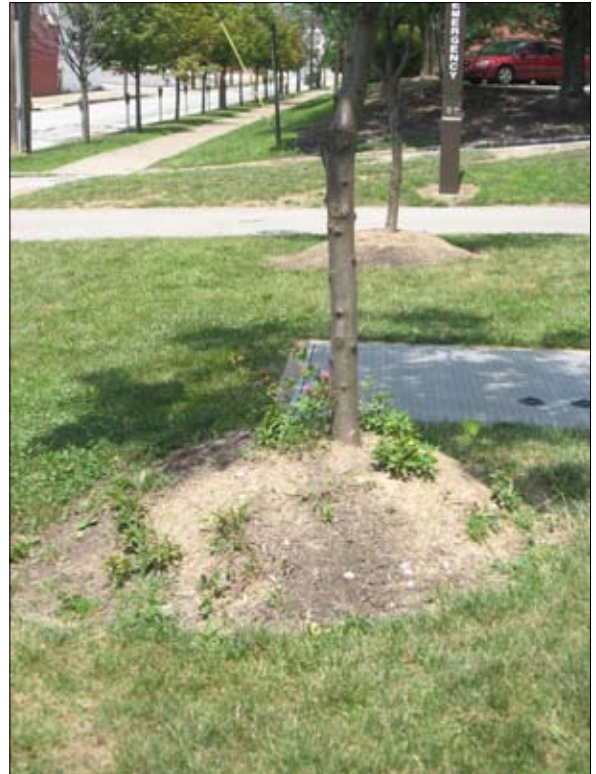
Trees along College Street near New Residence Hall are dead or dying. Honeylocusts planted in front of building are planted too high and are struggling.

Consider moving these trees toward sidewalk.

Consider moving honeylocusts a few feet toward sidewalk and add additional trees to create continuous street effect in front of New Residence Hall. Remove dying street trees and add smaller trees such as *Acer ginnala* under wires along College Street.

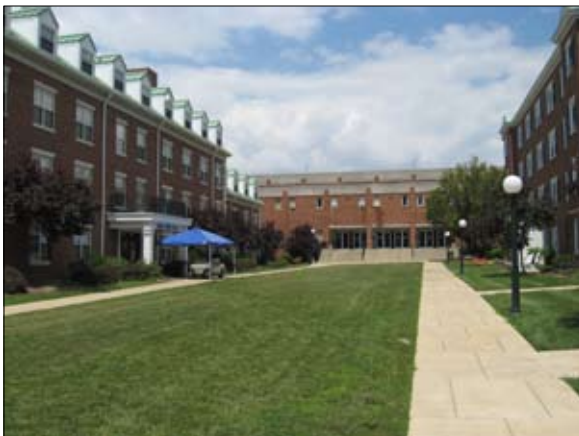
Canopy trees would enhance this area.

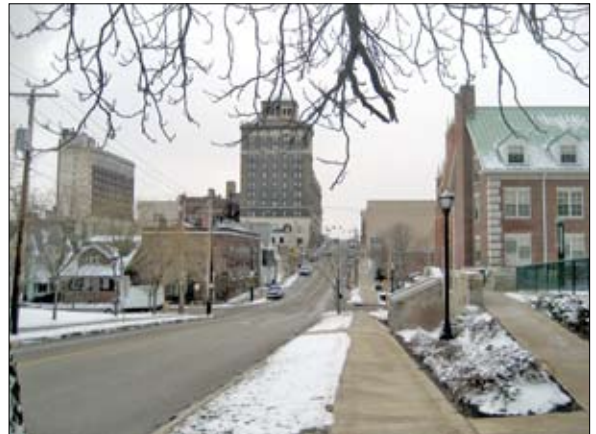
Street trees are needed on East Beau St.

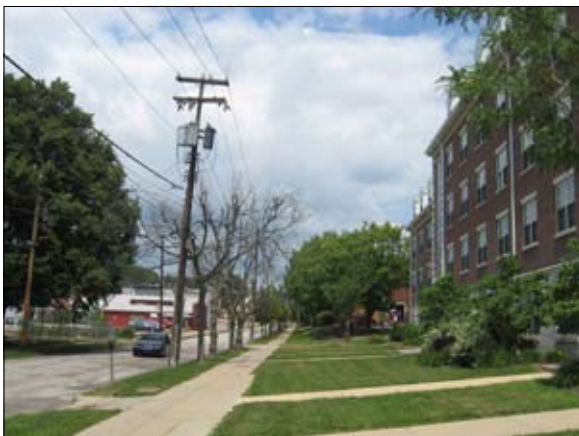
Trees along road are dying. Replace.

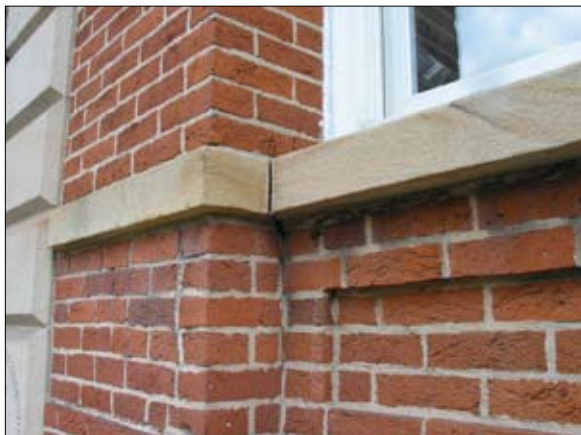
Repoint to match color and texture.

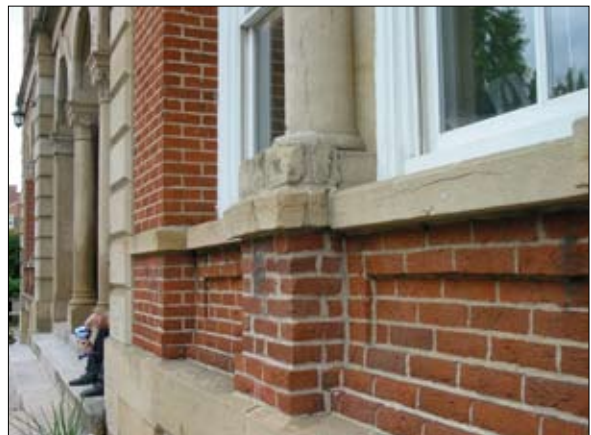
Repoint to match color and texture.

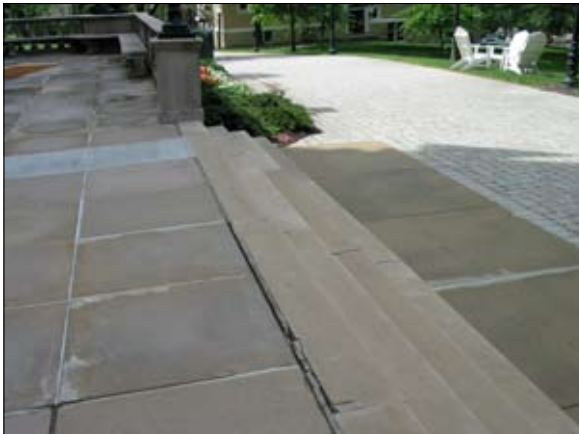
Grout pavers to match stone as needed.

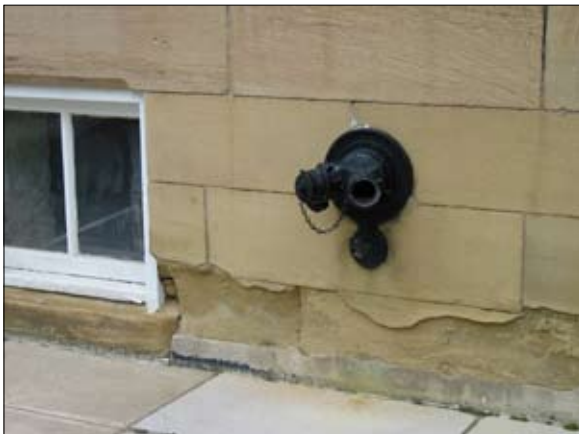
Repair damaged stone to match color and texture.

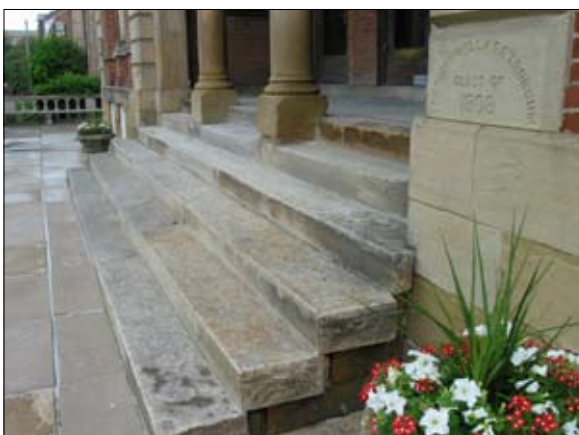
Consider period handrail for safety.

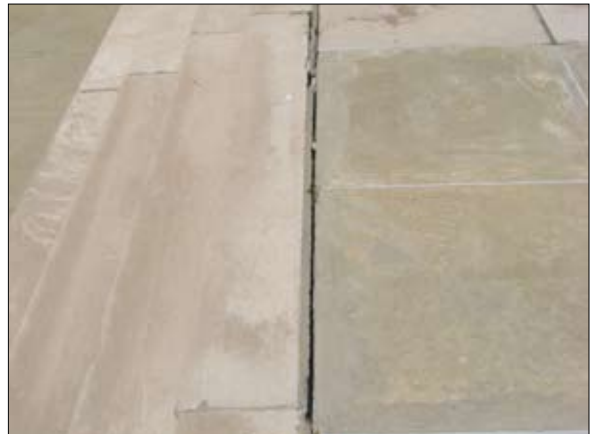
Central stone on steps has shifted. Reset stone in proper position. Seal open joints in patio to prevent future damage.

Seal open joints to prevent further damage.

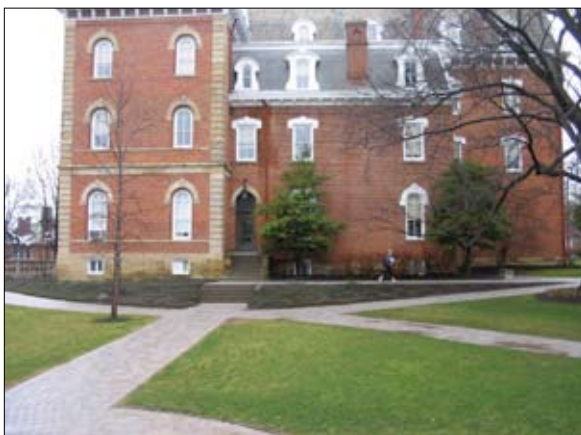
Tulip tree is too close. Move into lawn panel.

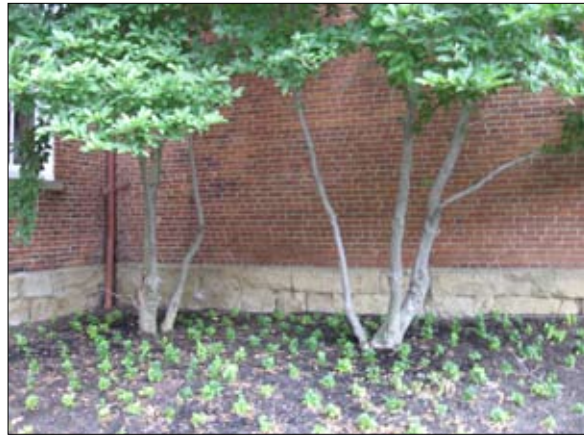
Magnolias have also been limbed up, creating a top-heavy effect. Pachysandra has been recently planted as ground cover beneath magnolias. This area would benefit from a mid-sized shrub such as

Consider a mid-sized shrub in lieu of pachasandra.

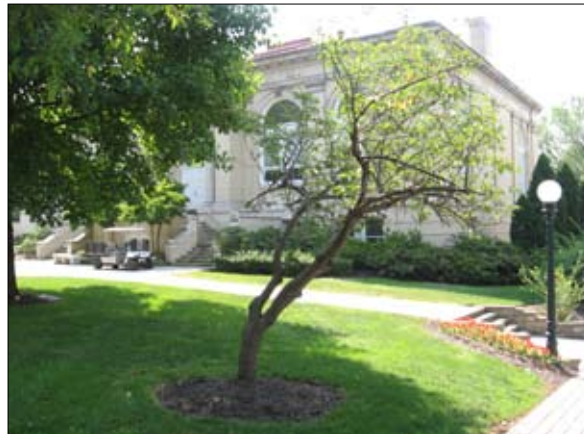
There are two flowering cherry trees between Old Main and Thompson. Smaller one is poorly-shaped and could be replaced. Cherry trees have a short life span and a new tree would be coming to maturity as the older one declines.

Plant replacement cherry now before this one dies.

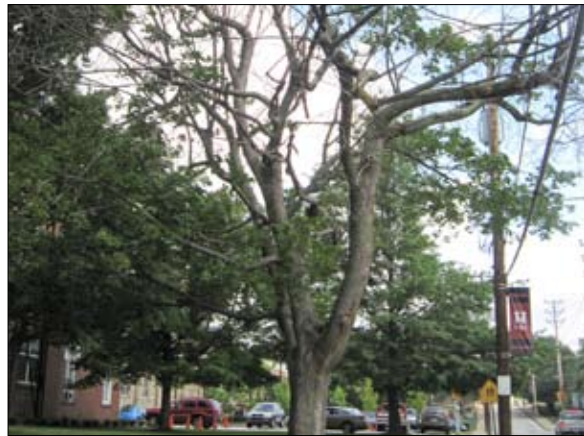
Allow newly-planted boxwood along base of building to grow into hedge. Large maple nearest street almost dead. Remove.

Remove and replace this dying maple.

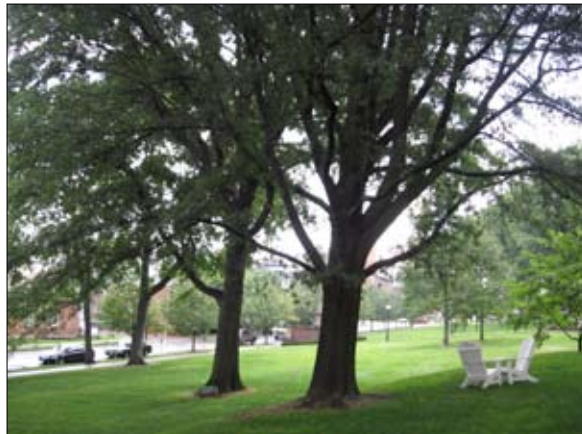
Plan care for these older majestic Oaks .

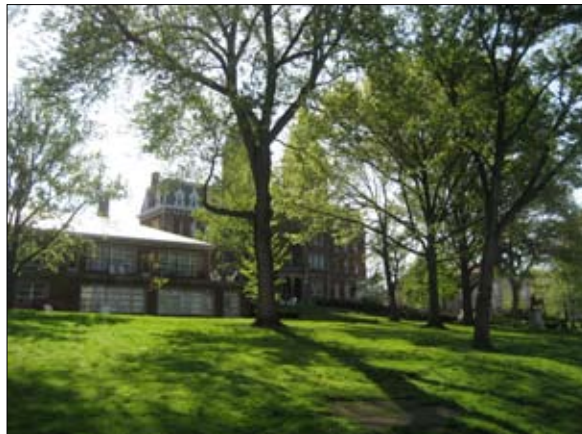
A large silver maple near The Hub also carries a broad canopy. This tree is not generally recommended as it is weak-wooded, and has a shorter lifespan than oaks and other maples. It should be observed and managed as long as possible as it is an impressive presence, but new silver maples are not recommended.

Monitor health of silver maple and substitute if required.

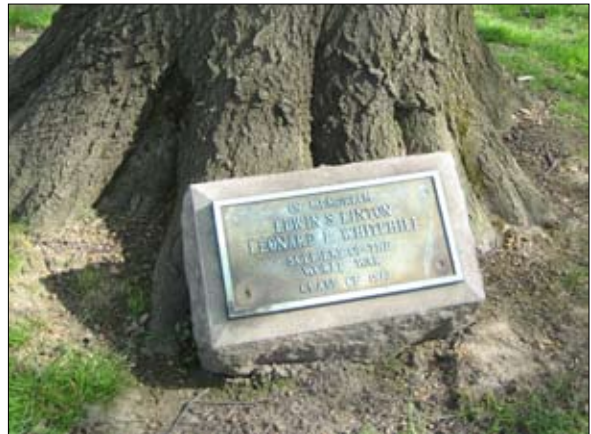
One large oak has a marker set upon the root flare. This could damage the bark and create an opening for insects or disease, and should be lifted off the tree.

Move this plaque forward off of the root flare.

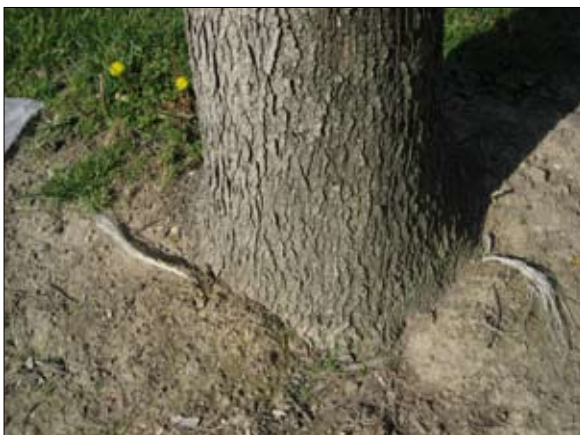
Another tree has nylon string visible from the original ball wrap, and appears to have a girdling root as well. This string will not decay and can cause additional girdling issues. The root collar should be excavated and the problems resolved.

Resolve girdling problem caused by string.

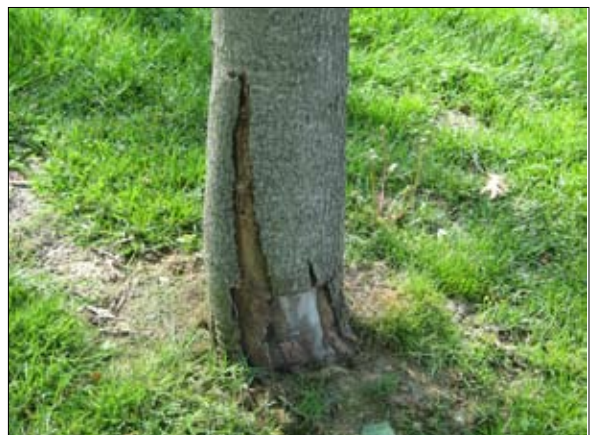
A young tulip tree near the central fountain has severe bark damage, and should be evaluated for long-term health.

Monitor damage to tulip tree. Replace if necessary.

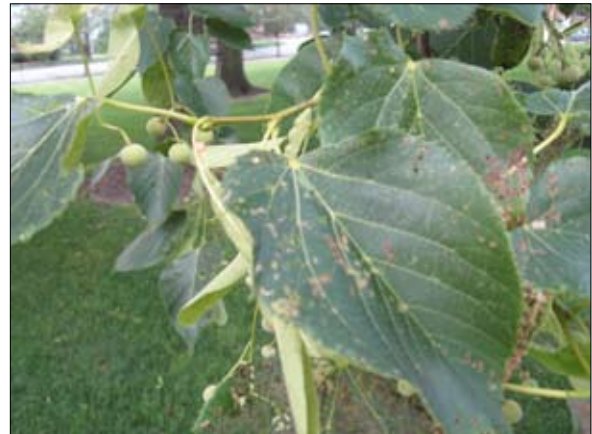
Japanese beetles were noted on numerous trees, especially the Linden trees (*Tilia spp*). These are easiest to treat in the grub stage in the ground, either organically (with Milky Spore), or with insecticidal treatment.

Beetle damage. Effectively treat during grub stage.

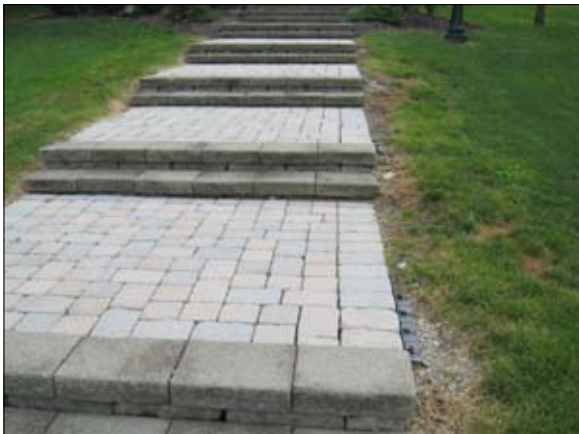
Consider replacing with single-grade walkway.

edges and steps do not show good finish detail. Containment edging is visible at the edges, and the step edges look coarse and unrefined, not in keeping with the elegance of the architecture of Old Main.

Vinyl edges are giving way and the pavers are separating, creating dropped edges and large spaces between pavers. Loose steps have been re-set using construction glue, with material squeezing from the cracks.

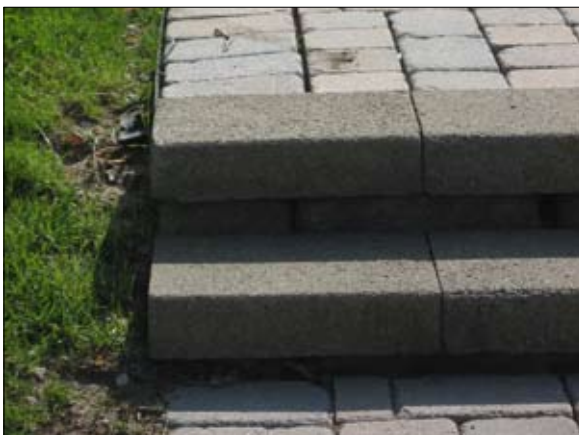
Consider replacing with single-grade walkway.

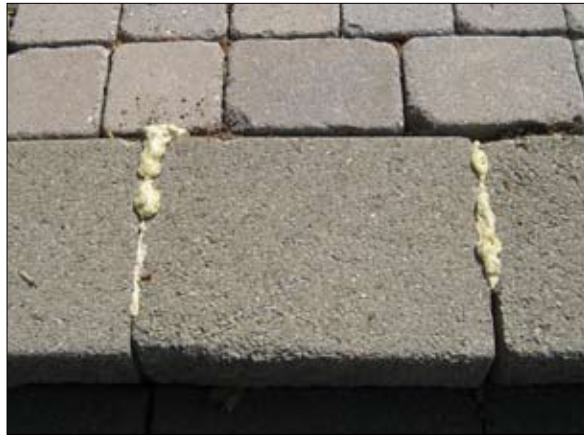
Consider replacing with single-grade walkway.

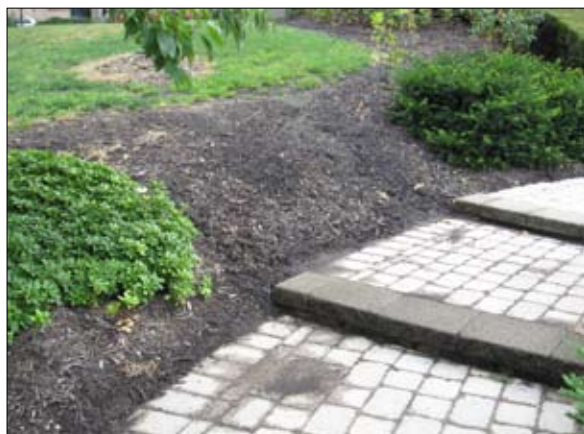
Improper drainage causing mulch to wash out.

steps, especially at the upper edge of the hillside where the walk curves around the fountain. Water is washing mulch onto the walkways. The ground above these areas should be deeply tilled and amended to improve water-holding capacity, and these areas should be planted with shrubs and ground cover to stabilize the bank. In severe cases, drainage tile must be provided to catch the water and funnel it away from the steps, though this approach is less desirable as it often just transfers the erosive problem to another location.

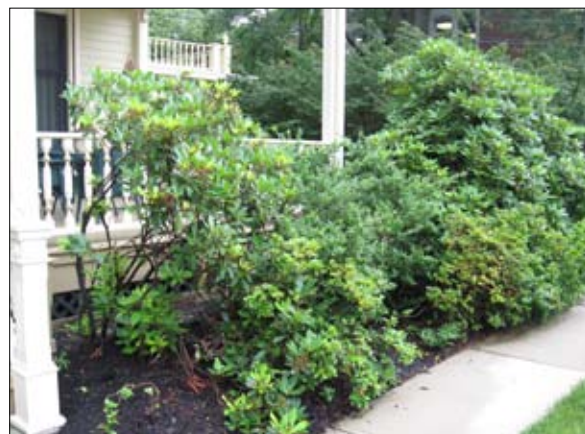
Front porch planting is a mix of rhododendron, azalea and ilex crenata. Plants are crowded and show signs of nutrient deficiency. Parts of porch are exposed. Consider replanting front with a simpler palette.

Consider redesigning with simpler palette of plants.

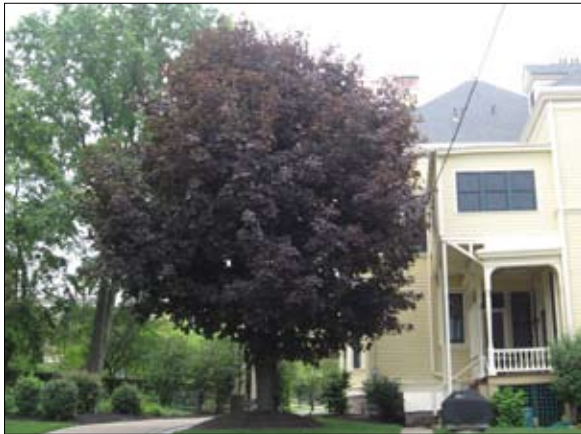
Crimson King is historically out-of-context.
