PRESERVATION PLAN

WASHINGTON & JEFFERSON COLLEGE

WASHINGTON & JEFFERSON
COLLEGE
WASHINGTON, PENNSYLVANIA

The purpose of this plan is to outline recommendations for the preservation, conservation and continued use of the historic landscape and buildings of Washington & Jefferson College.

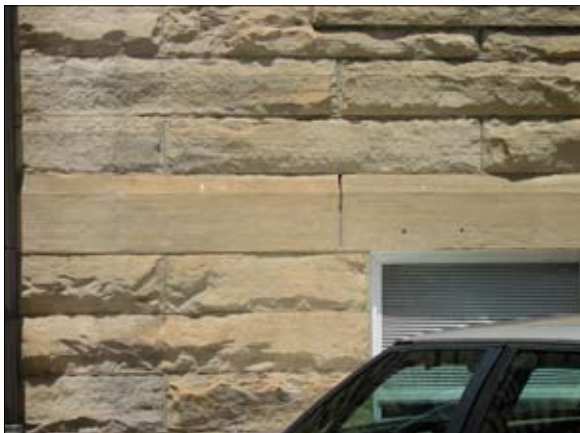
- It is also helpful to remove any extraneous metal anchors from masonry to help reduce rusting stains and spalls that further damage masonry.

Remove abandoned hardware and repair.

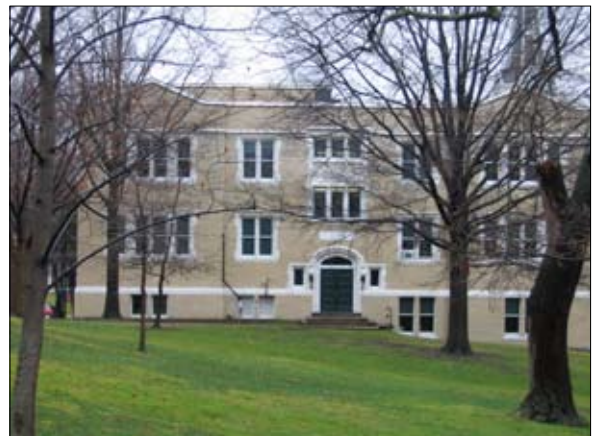
Building has lawn to foundation on three sides. A simple base of evergreen shrubs or ground cover would be appropriate if a foundation planting were desired.

Consider simple evergreen foundation planting.

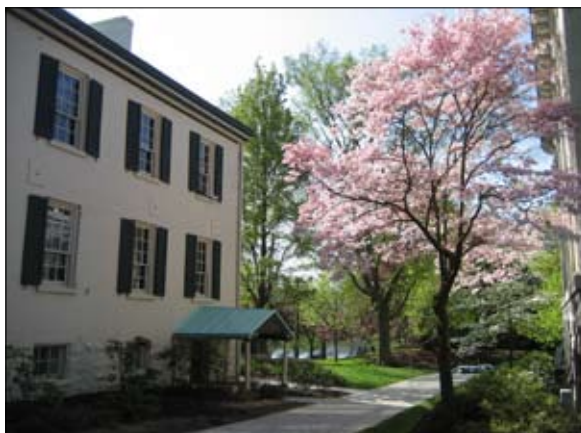
A pink and a white dogwood grow on this side. The pink tree is larger, but shows signs of disease, while the younger one looks healthier. Trees have stubs from improper pruning. Cut stubs at branch collars. Feed and treat trees. Consider adding another pink dogwood to east corner of building.

Inspect larger pink dogwood for disease.

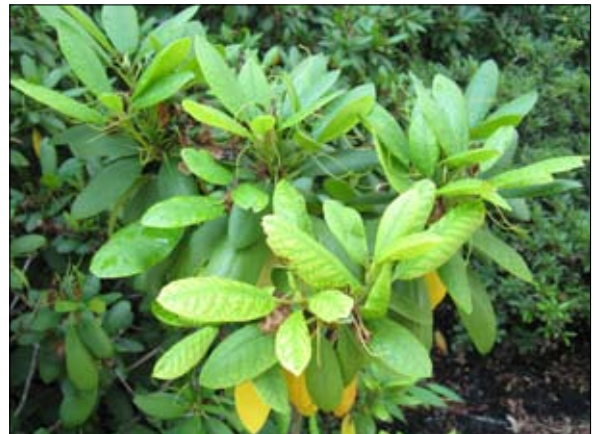
Plants are somewhat chlorotic and gaps are visible in the beds. Some dead bushes found within planting. Azalea has lacebug infestation.

Lacebug infestation evident. Treat as needed.

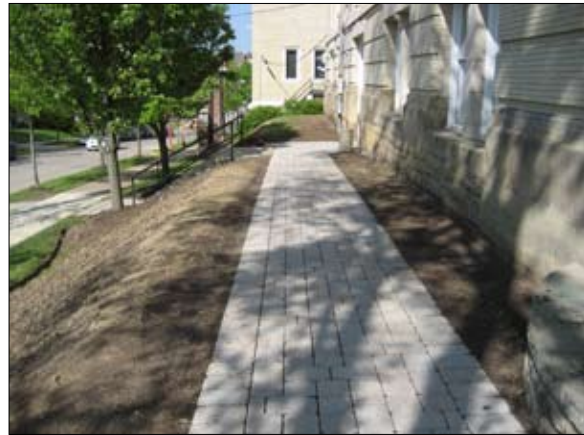
An old row of azaleas was removed from alongside the building in Spring 2008. This area has been planted with ivy. Ivy is suitable for slope, however along the building the bed is narrow. The ivy will encroach on the sidewalk as it matures and may become an ongoing maintenance issue. An ivy planting gets thick over time, with woody stems, and becomes a place for small rodents to live. Thickness will have to be trimmed at sidewalk, leaving an unsightly edge.

Consider a boxwood hedge along walk.

A small boxwood hedge would add height to planting and soften foundation.

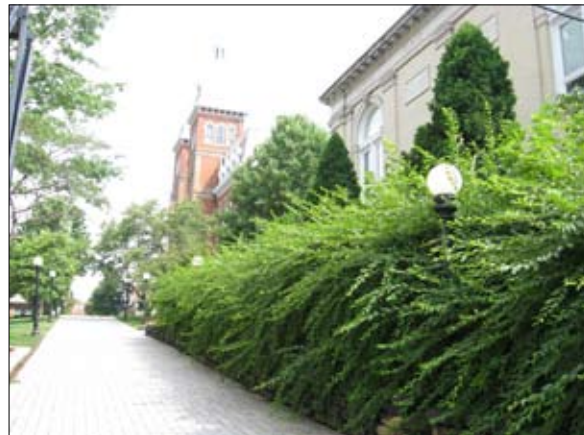
Two new forsythia plants were recently planted to continue the hedge to the steps. They will get too large for this spot. Use a smaller plant near the steps that can then merge with the hedge.

Forsythia is too large next to steps.
