NIST Response to the World Trade Center Disaster

**Federal Building and Fire Safety Investigation
of the World Trade Center Disaster**

Presentation to the Subcommittee on Disaster Reduction

World Trade Center 7

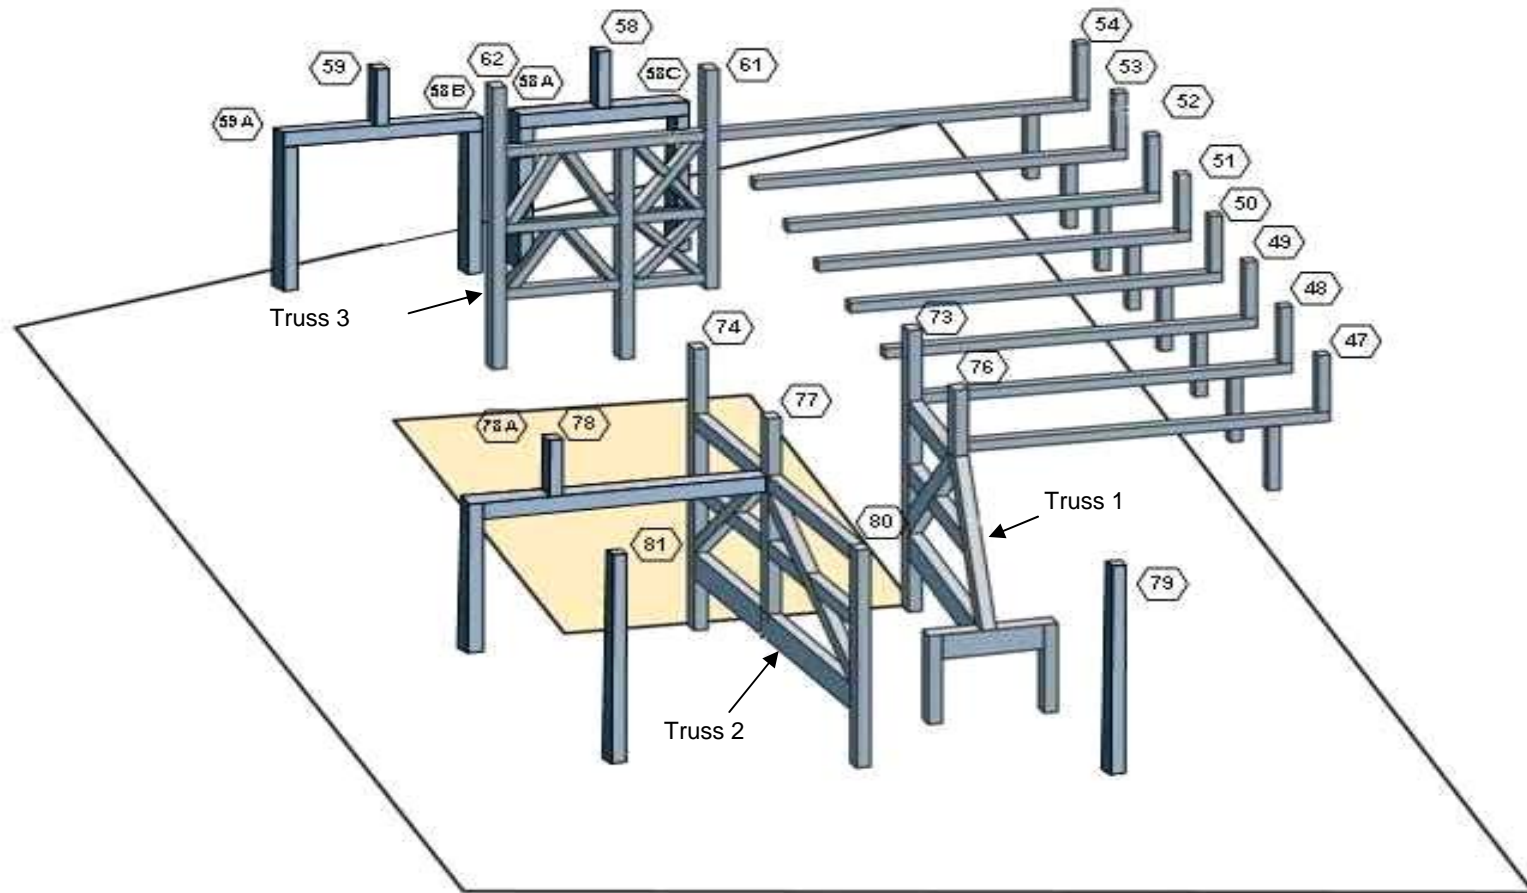
Transfer Trusses and Girders

The layout of the WTC 7 columns did not align with the building foundation and the Con Edison columns. Therefore, a set of *column transfers* were constructed between the 5th and 7th floor slabs.

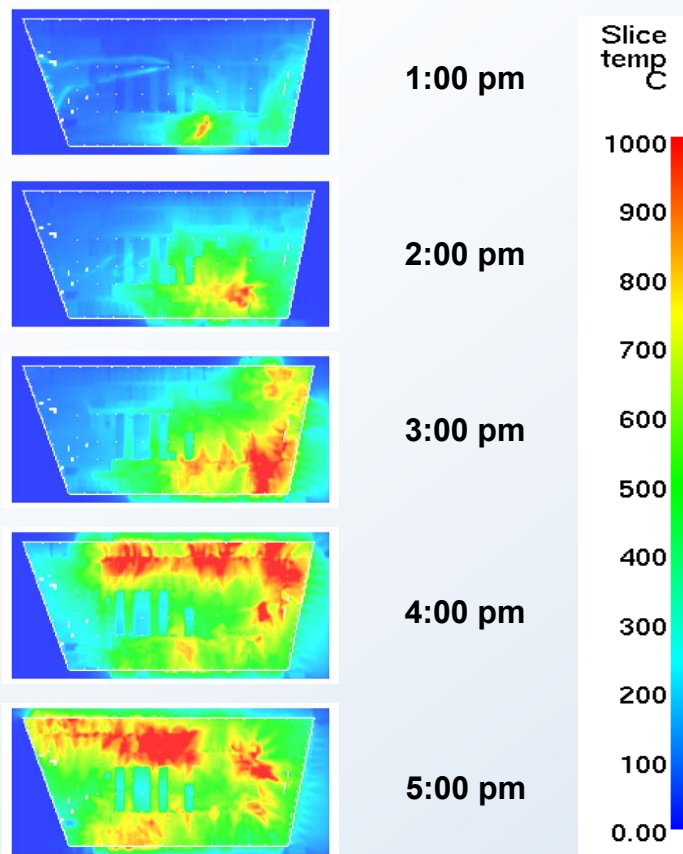
Progression of fires on Floor 12

- The major fires in WTC 7 were modeled using the Fire Dynamics Simulator (FDS) in a manner similar to those for the WTC towers.
- There were far fewer photographs and videos of WTC 7 than of the towers; thus, details of the WTC 7 fires were not as precise as for the towers.
- The fire simulations for WTC 7 were conducted for each floor individually; there were no obvious pathways for the flames and heat to pass from one floor to another, aside from the debris-damaged area in the southwest corner of the building.
- Sustained and/or late fires were observed only on floors 7 through 9 and 11 through 13.
- The actual fires on these floors were most likely initiated at the time of the incidence of the debris from the collapsing towers.
- A typical single floor simulation took up to two days on a Linux cluster with 8 processors.

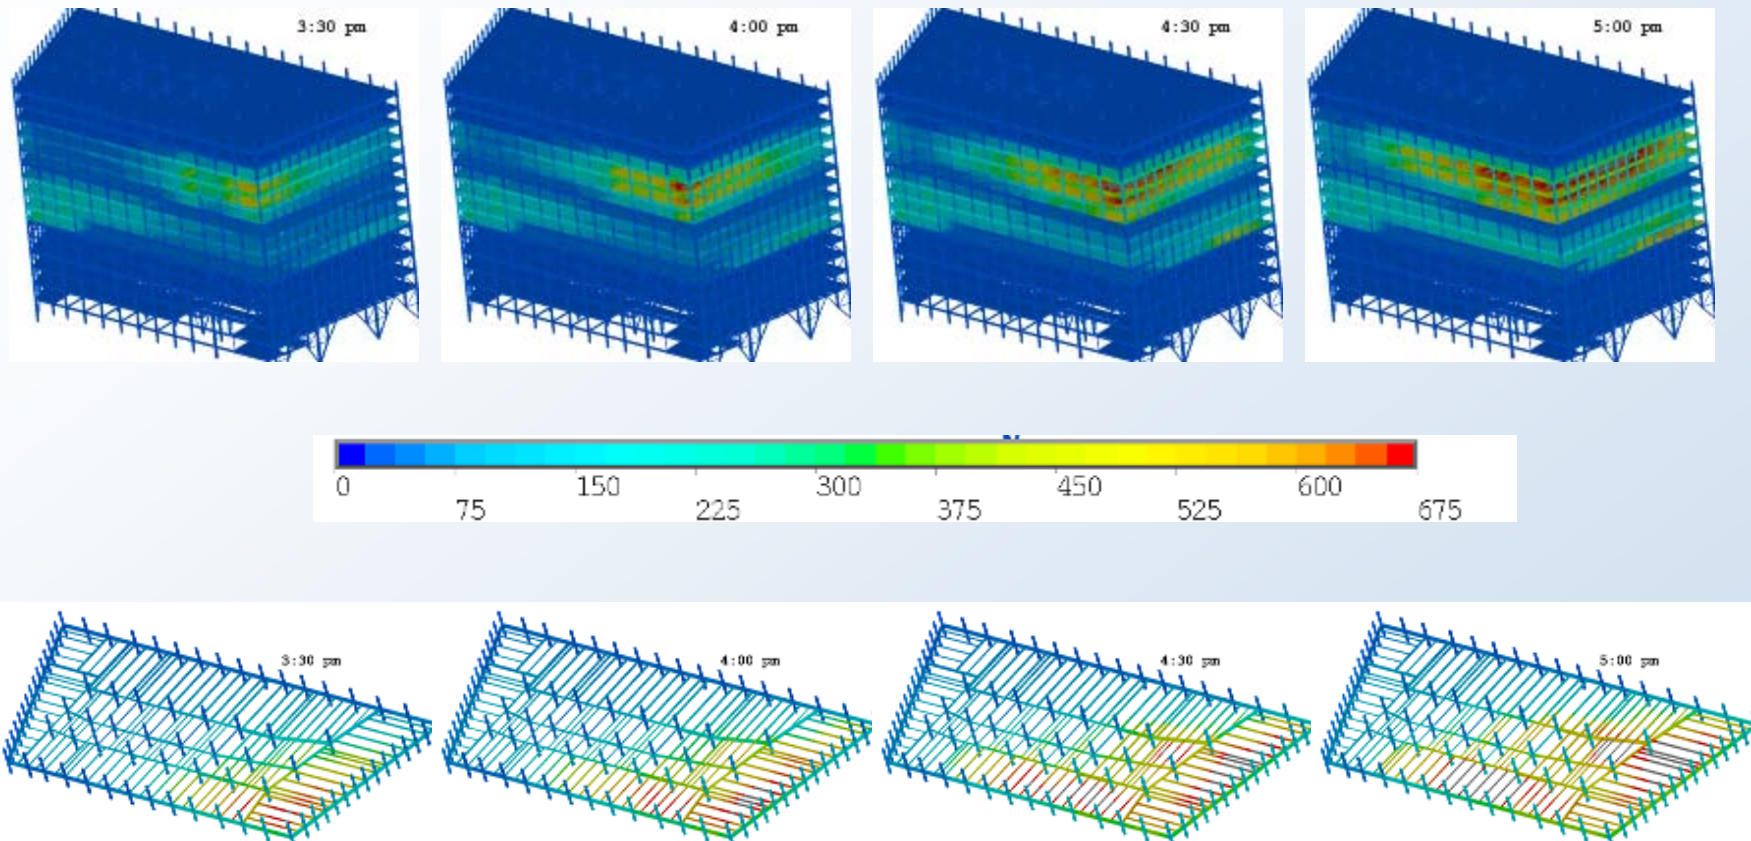
Temperature distribution (°C) on the floor beams of Floor 13.

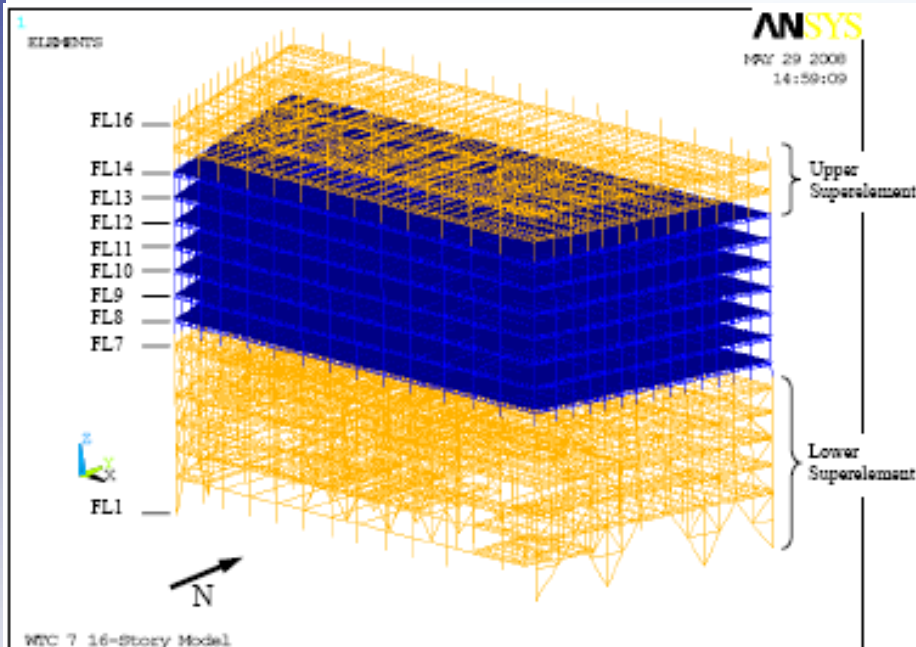
- Fires were observed on Floors 7 to 9 and 11 to 13.
- The floors and columns in these areas were subject to heating and possible thermally induced failures.
- Floor framing between Floors 8 and 14 and columns between Floors 7 and 14 were explicitly modeled while Floor 7 and below and Floors 15 and 16 were modeled using super-elements.

- The 16-story ANSYS model was used to determine the sequence of events that led to fire-induced collapse initiation.
- Software: double precision version of ANSYS 11.0
- Model
 - 93,413 Nodes
 - 101,357 Elements
 - 21,095 beam elements
 - 28,182 rigid beam elements
 - 34,461 shell elements
 - 7,658 contact elements
 - 9,961 break elements
- Computer
 - 64-bit workstation
 - quad-core, 3.0 GHz processor
 - 64 GB of random access memory (RAM)
- Analysis Time: approximately 6 months

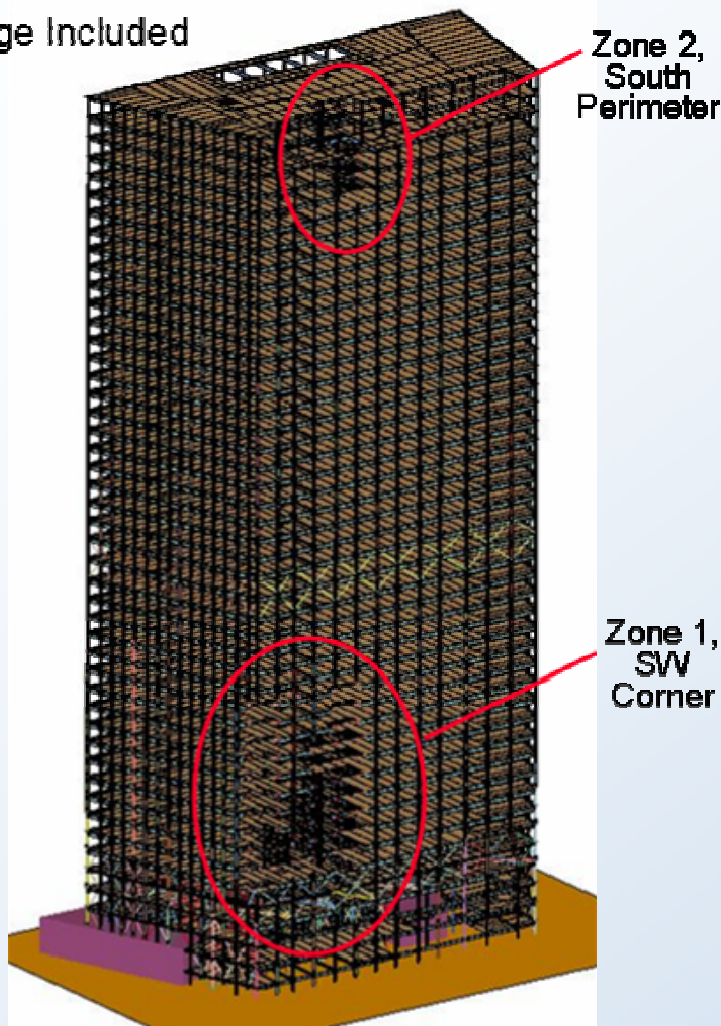
Damage Included

- The LS-DYNA model was used to determine the sequence of events that led to collapse propagation and, ultimately, global collapse.
- Software: double precision version of LS-DYNA
- Model
 - 3,593,049 Nodes
 - 3,045,925 Elements
 - 3,006,910 shell elements
 - 33,364 discrete spring elements
 - 3,190 beam elements
 - 2,461 solid elements
- Computer
 - High speed Linux Beowulf compute cluster.
 - Head node - two 64-bit 2.4 GHz processors, 4 GB of RAM, 1.5 terabytes of RAID 5 disk storage
 - Each compute node - two 64-bit 2.6 GHz processors, with 8 GB to 16 GB of RAM
- Analysis Time
 - Up to 8 weeks

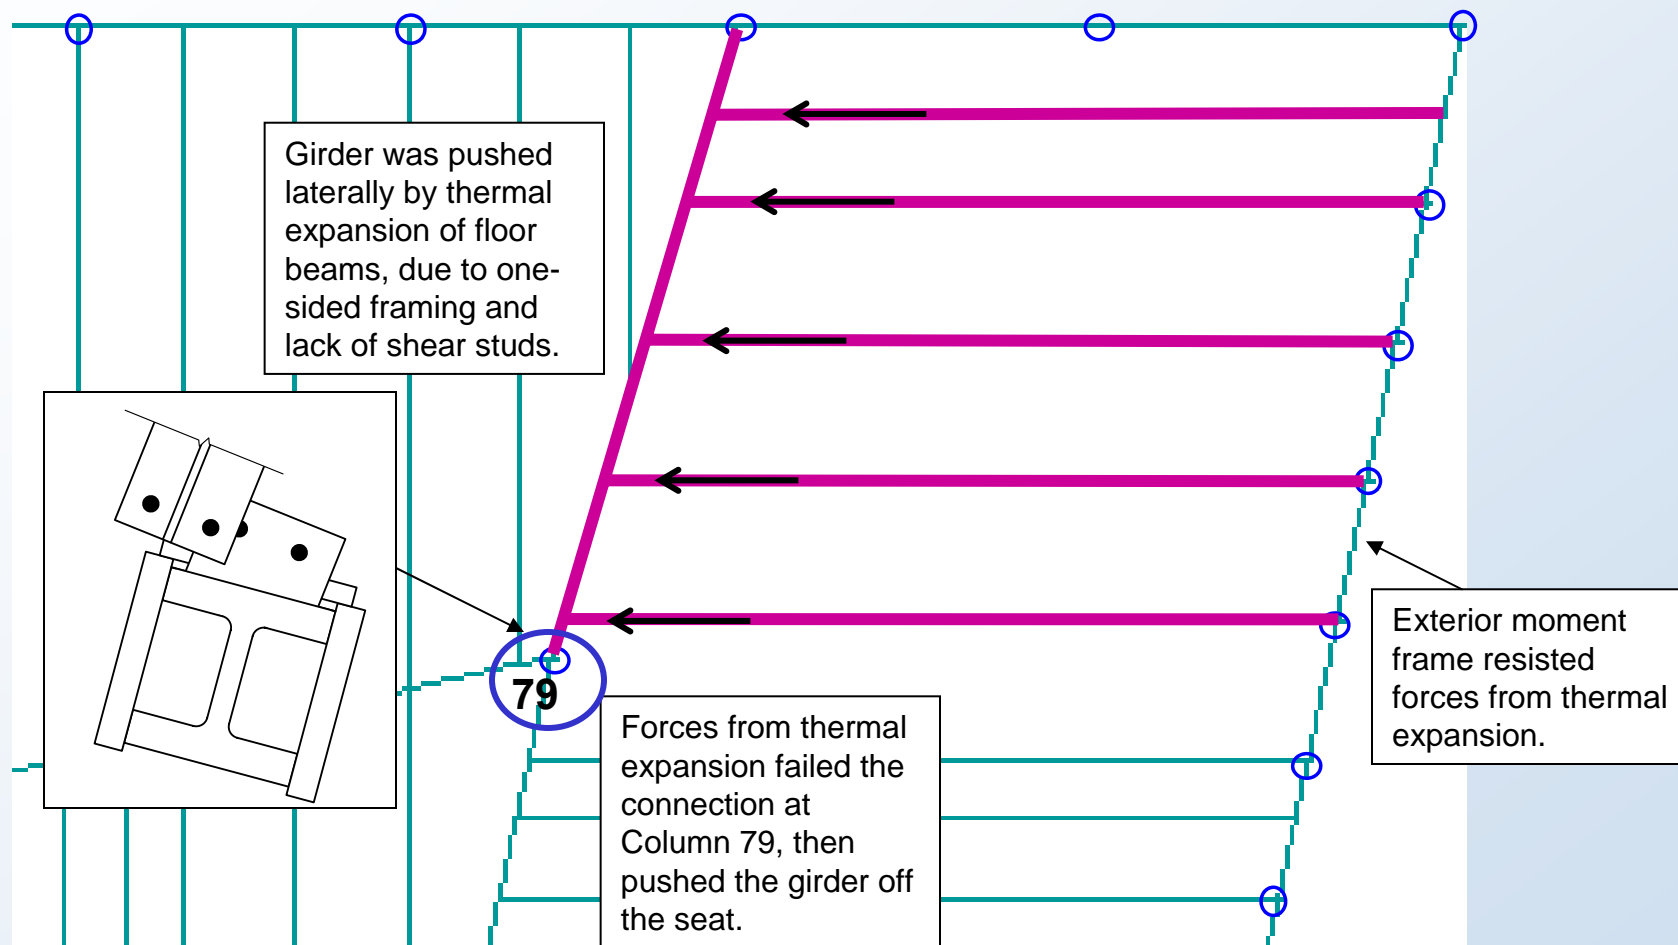
Thermal Response of Northeast Floor Framing

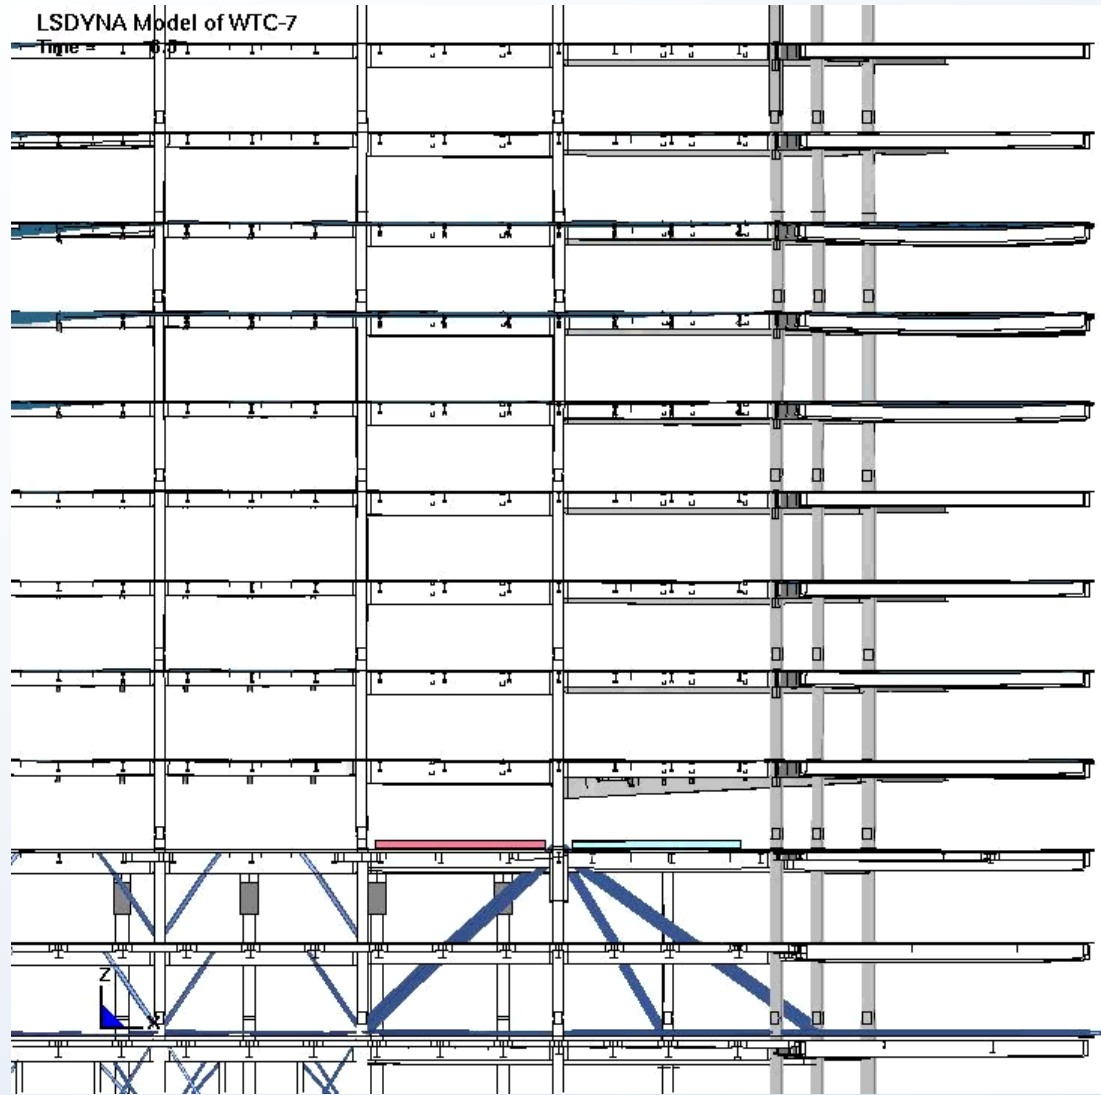
View from
South

Physics-Based Visualization of WTC 7 Collapse Initiation

- Fire-induced thermal expansion of the floor system surrounding Column 79 led to collapse of Floor 13 that triggered a cascade of floor failures.
- This, in turn, led to loss of lateral support to Column 79 over nine stories, resulting in the buckling failure of Column 79.
