SEISMIC RESPONSE OF BNZ BUILDING IN WELLINGTON FOLLOWING THE 2016 KAIKOURA EARTHQUAKE

Umair Siddiqui, Will Parker, Robert Davey, Simon Therkleson¹

[¹WSP Opus International Consultants]

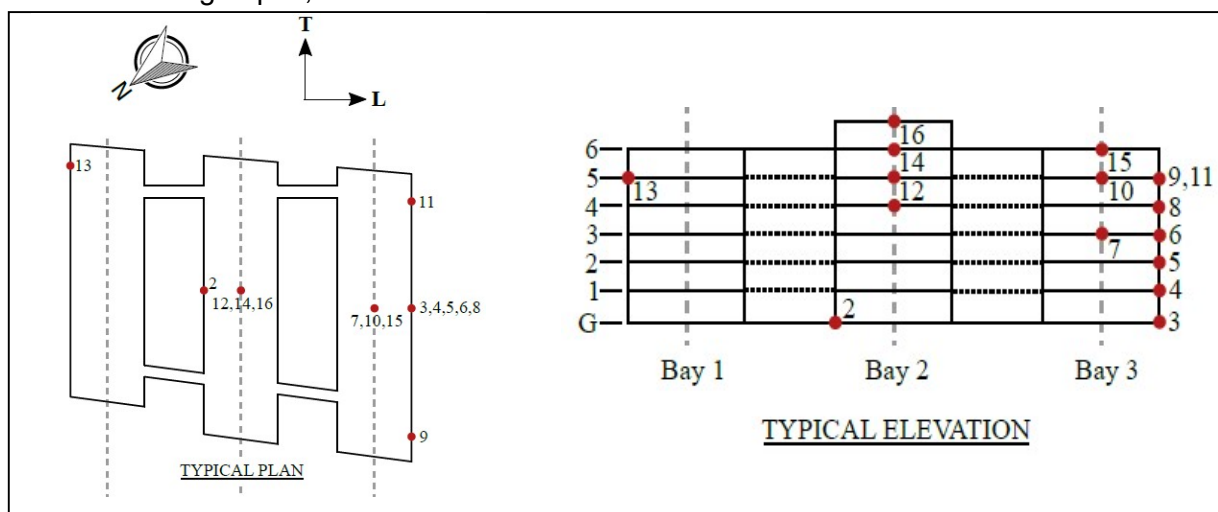
Figure 6. Accelerometer locations (from [10])

On Pier 3 the peak floor acceleration was recorded as 1.02g in the east-west direction and peak building displacement of 227 mm longitudinally and 243mm transversely were recorded at the top (level 5) [10]. Maximum peak interstorey drifts of 1.73% longitudinally and 1.71% transversely were also recorded and reported for Pier 3 [10].

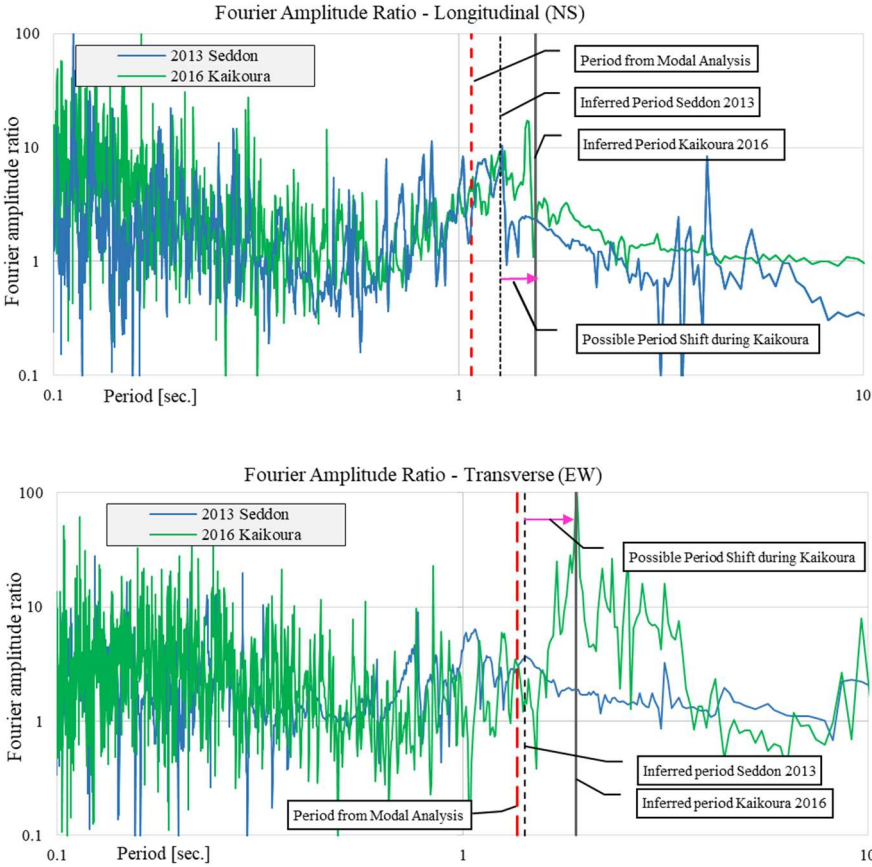
Figure 9. Fourier Transformation Ratio of Recorded Accelerometer Data

The vibration period for piers 2 and 3 are inferred from the processed acceleration time history records using the ratio of their Fourier transformation between the base and at the top storey (Level 5) and the results are presented in Figure 9. Level 5 (19.75m above ground level) has been chosen because the recorded data is available for both piers at top store (Level 5) and at the base to enable the comparison and because the roof displacements gives a better approximation of the overall mode of vibration for a first mode dominant structure. For the purposes of identifying the modes, the records from the 2013 Seddon

earthquake have been used to eliminate the possible effects of period lengthening due to progression of damage in several cycles during the November 2016 Kaikoura earthquake. The period of vibration is inferred from the common peak in these plots which occurs in the Fourier transformation ratio of both piers at the same time to be able to avoid the influence of local peaks and spikes. The unsmoothed Fourier spectra have been used for this analysis. The limitations in using such techniques for period inference are discussed in [10]. Using the Fourier transformation, the fundamental period of vibration for the longitudinal and transverse directions has been estimated to be approximately 1.25 seconds and 1.4 seconds respectively. These values generally compare well with the 3D modal analysis results indicating that the response is slightly stiffer in the longitudinal direction compared to the transverse direction, which also aligns with the original design and the displacement records.

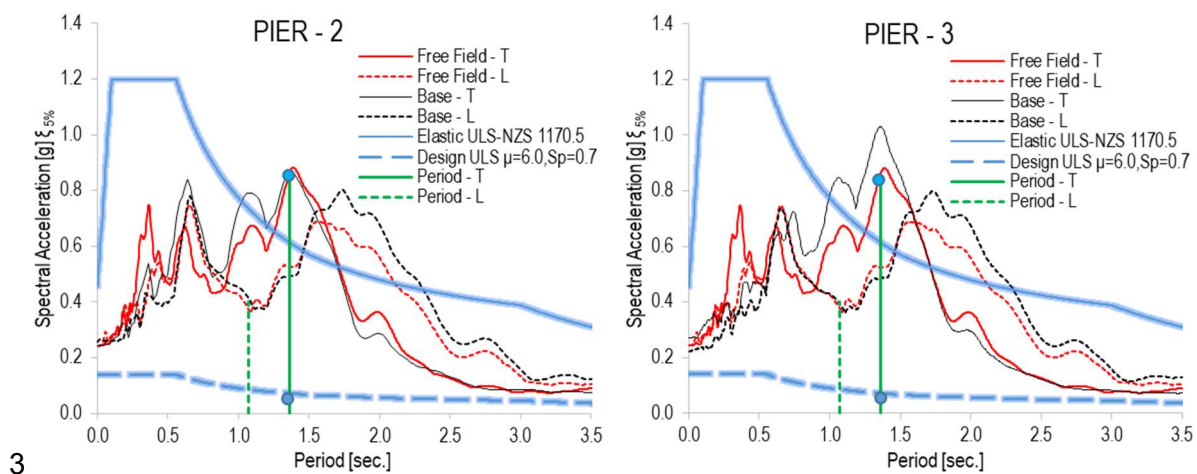
Figure 10. Elastic Acceleration Response Spectra Comparison for Piers 2 & 3 (from [6])

The ground motions under the November 2016 Kaikoura Earthquake recorded near the building site had a peak ground acceleration of about 0.24g. The response spectral ordinates ($\xi=5\%$) of the free-field acceleration time history records and the records at the base of Piers 2 and 3 are plotted and compared with the NZS 1170.5 ULS elastic and design spectra in Figure 10. The solid red and black lines represent the transverse (E-W) direction free field and base demand respectively, and the dotted lines represent the corresponding demand in the longitudinal (N-S) direction. The green vertical lines indicate the fundamental period of the building in the two direction as determined from the modal analysis. The blue solid and dashed lines represent the ULS elastic and design spectral ordinates as per NZS 1170.5 respectively.

Comparing the plots for both piers and for the base and free field spectra, it can be observed that the intensity of ground shaking has exceeded the ULS demand in the transverse direction for periods between 1.0 to 1.5 seconds. The elastic base shear demands were nearly eight times higher than the designed base shear (as per [4] by taking $k_{\mu} = 6.0$ and $S_p = 0.7$). This is due to amplification of the ground motion in the low frequency range associated with the deep soft-soil deposits on which the building is founded. The building-base spectral ordinates are amplified as compared to the free-field spectral ordinate primarily in the transverse direction for period range greater than 1.0 seconds. Refer to [10] for calculations of spectra and the discussions around possible reasons including soil-structure interaction resulting in differences between the free-field and building-base spectral ordinates.

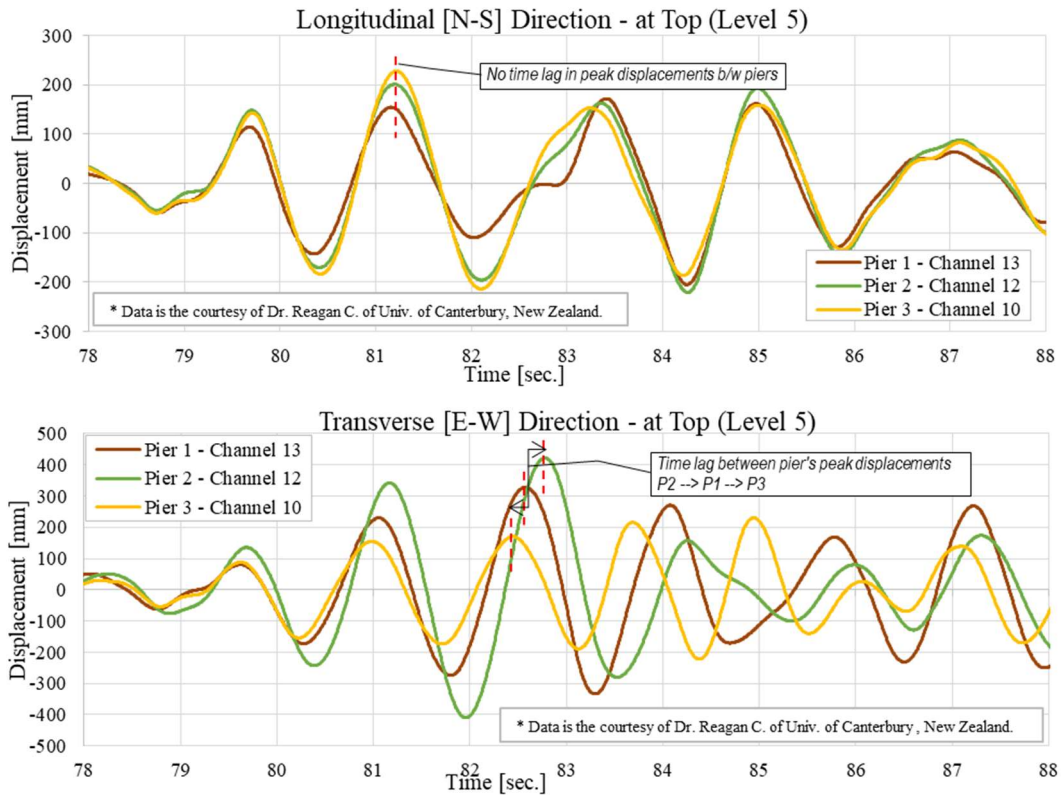
Figure 11. Recorded displacement time-histories at the top (Level 5) of all three piers

The storey displacement time histories for top level (level 5) relative to the base are plotted in Figure 11 for all three piers in both principal directions. Note that this is only presenting the peak ground motion duration.

The comparison between the two principal directions indicates that in the longitudinal direction, the direction of motion of the three piers is *in-phase* with each other in all cycles. In the transverse direction the three piers have a small *time-lag* (with Pier 2 lagging behind piers 1 and 3) between the peaks despite displacing in the same direction as well as reaching the peak displacement in the same cycle. This is consistent with the expected response of the building based on the modal analysis results, which indicate up to 80% of the mass participates in the first mode in the longitudinal direction where the building piers are designed to displace together by virtue of the link bridge.

Larger displacements are recorded in the transverse direction which is consistent with the greater intensity of shaking in the transverse direction and also correlates well with the observations. Of the three piers, the peak displacement of Pier 2 peak displacements is the highest, which is consistent with the larger seismic mass and lesser stiffness of lateral load resisting system by having one frame bay less than piers 1 and 3. Pier 2 also have longer period of vibration compared to Piers 1 and 3. The next highest peak floor displacement at Level 5 occurs in Pier 1, followed by Pier 3. In transverse direction the first mode mass participation of up to 73% is split across two translational modes due to difference in fundamental periods between Pier 2 versus piers 1 and 3.

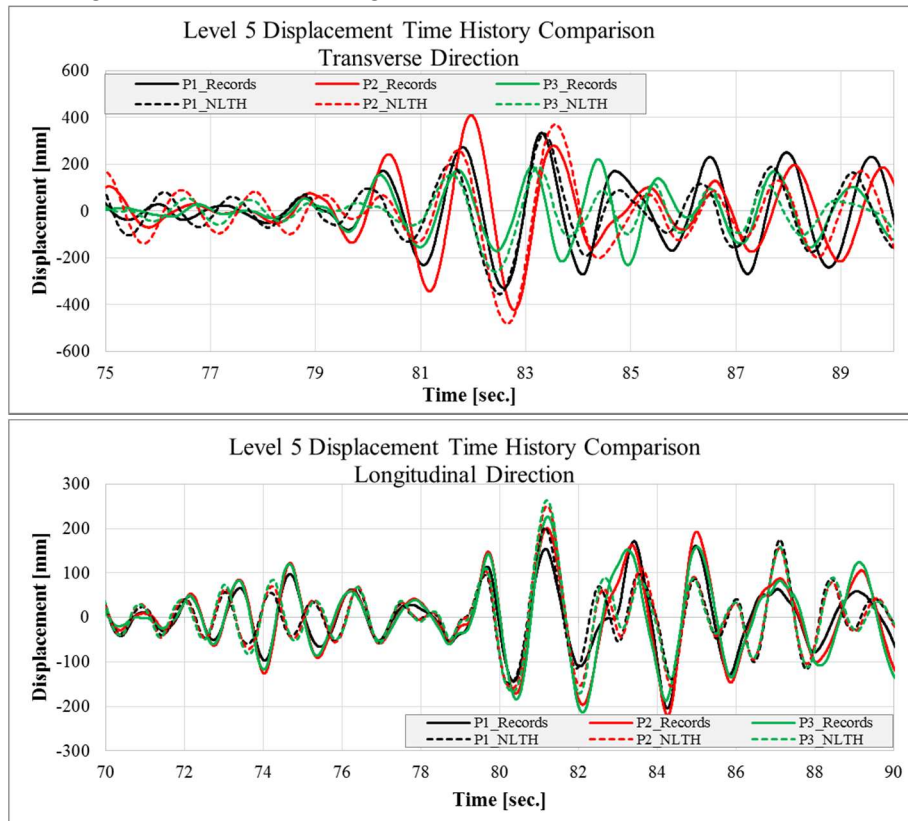
Figure 13. Displacement Time Histories from Records and NLTH Analysis for the 3 piers

The comparison of story displacement time histories (peak duration only) at the Level 5 diaphragm centre of mass (CoM) between the records and the nonlinear direct integration time history analysis (NLTH) under the November 2016 Kaikoura earthquake free-field ground motion are presented in Figure 13. The displacement time histories from the model appears to have reasonably good correlation with that of the recorded response. The trend of the overall building displacement among the piers is also similar to the records.

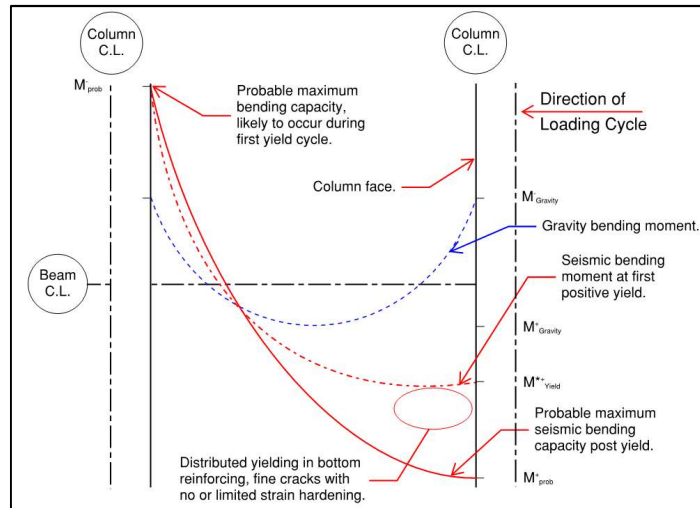
Figure 16. Illustrative bending moment demands on heavily loaded beam in seismic frame

A description of the failure mechanism associated with a moment resisting frame with large gravity loads is provided below along with an illustrative sketch in Figure 16.

- During seismic loading, the negative moment (top) demand at one end of the beam increases (LHS in Figure 16). Under sufficiently large shaking, the top reinforcing bars of the beam yield first and any further increase in demand results in nonlinear deformation. This can be observed as rotation of the section which leads to cracks opening on the top face of the beam and possible compression zone spalling of the cover concrete on the bottom face.

- At the opposite end of the beam (RHS), the positive moment (bottom) demand at the column face increases after overcoming the negative moments from gravity loads, and therefore this end will not reach yield until after the LHS has yielded and has undergone nonlinear rotation. As the seismic demand increases in the same direction yielding of the bottom bars of the beam will occur over a larger area offset from the face of the column. The yielding region on the RHS will shift closer to the column face as the LHS continues to rotate leading to a concentration of yielding near the column face as the demand approaches the probable maximum capacity of the section.

- When the seismic load reverses the red lines in Figure 16 also reverse to match and this leads to the same damage repeating on opposite faces at the top of the beam.
- With each inelastic load cycle the process repeats, and the top bars continue to have relatively larger residual plastic deformation than the bottom bars and eventually concrete crushing on the bottom face leading to increasing downwards rotation of the beam at the column face leads to the so called member level 'ratcheting' with unequal plastic deformation for the top and bottom of the beams.

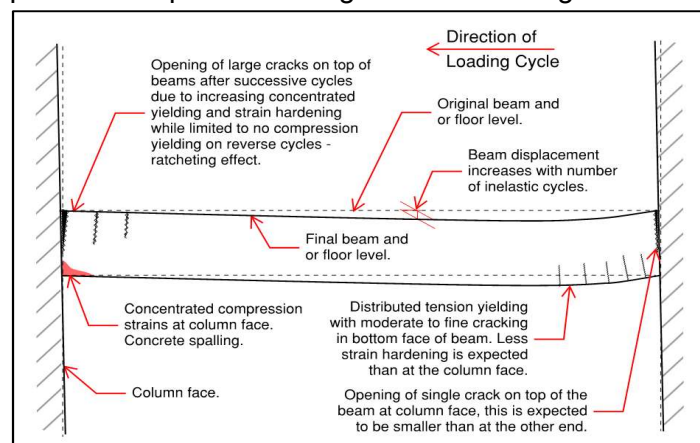
Figure 17. Idealised Beam Hinge Damage after First Major Yield Cycle

An illustrative example of the expected damage is shown in Figure 17 below.

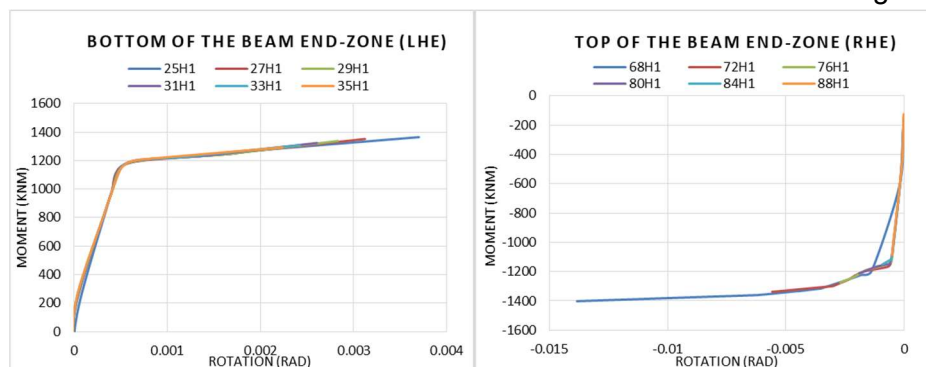
Figure 20. Total rotation demands in the Plastic hinges zones at the top and bottom of beam

The results presented in Figure 20 shows that in the transverse direction the plastic demands on the top of beams (RHE) are higher compared to the bottom of the beams (LHE). The yielding region was found to extend up to 500 mm in length with all hinges yielding. However, the total plastic rotation demand is well distributed in the bottom of the hinge regions. In contrast, at the top of the beam hinge regions, plasticity is concentrated within a plastic hinge length of 100mm to 200mm.

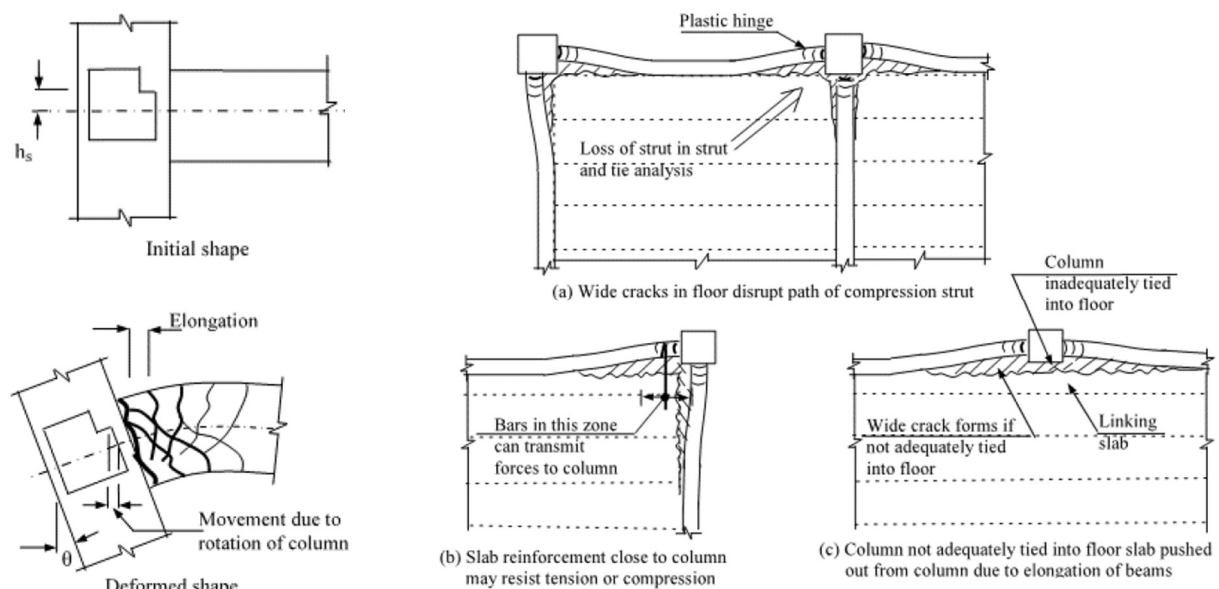
Figure 21. Beam elongation forming large cracks and effect of frame elongations

The main cause of damage to the floor units and associated cast-in concrete toppings is interaction with the supporting frames. As the frames displace in both directions during earthquake shaking, the beams undergo rotations, plastic hinging and elongation and as a result impose stresses to the unit through rotating it and reducing seating length at the support ledge. The effects of the beams elongating are schematically shown in Figure 21.

Zones of permanent elongation are caused by the longitudinal bars of the beam undergoing plastic deformation beyond yield. These zones are called “plastic hinge zones”.

Elongation of plastic hinge zones can push beams supporting precast floor units apart. This reduces the seating length between the precast units and support ledge. The rotation of the supporting beam further stresses the unit and the supporting ledge. See Figure 21.
