SINGLE

POINT

OF

FAILURE

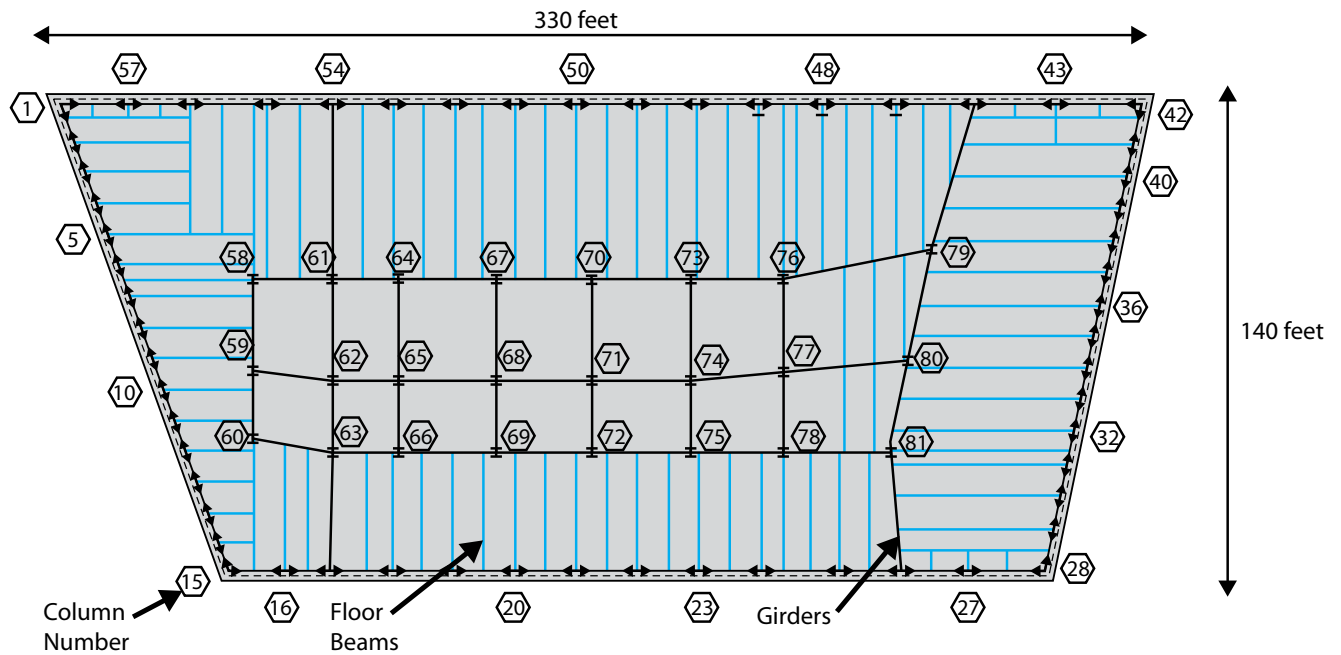
Plan view of typical framing for the upper floors of WTC 7. Columns are identified by number.

The sequence of final collapse can be interpreted using knowledge of the building’s framing from existing plans. For instance, the observed collapse of the east penthouse may signify a failure in a line of columns on the east side of the building (columns 76-81). In particular, interior

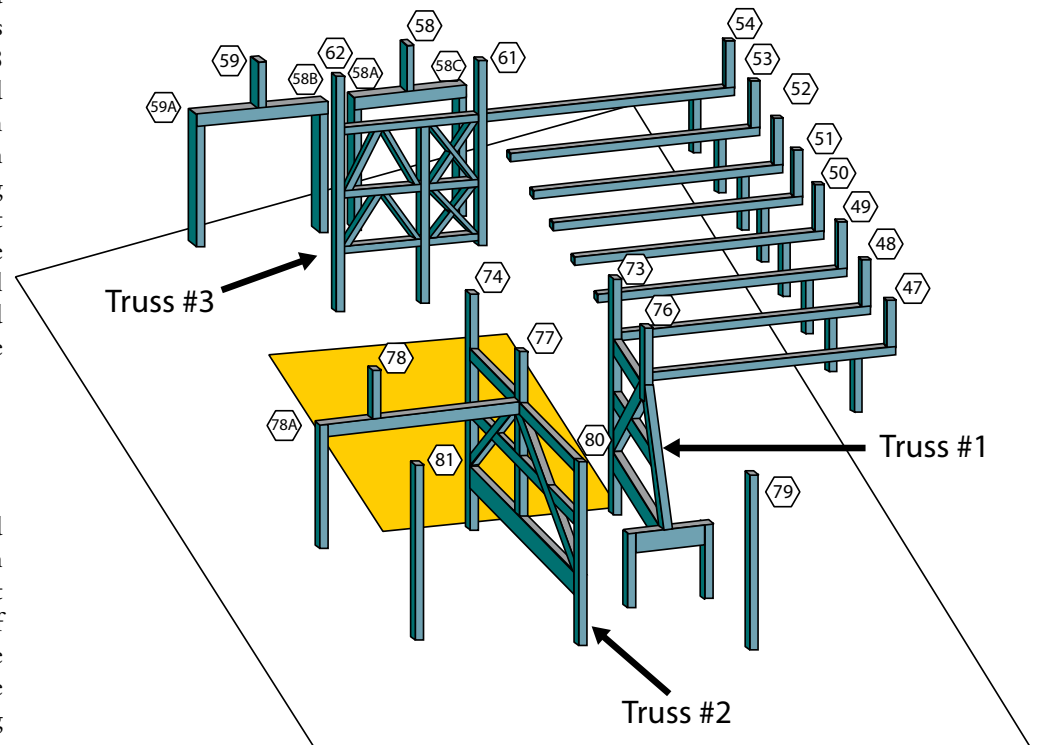
the final footprint of WTC 7 was larger than the originally planned high-rise tower. As a result, there were discontinuities between the columns in the Con Edison substation and the columns for the rest of WTC 7. Braced frames, transfer trusses and transfer girders at floors 5 through 7 transferred loads between the discontinuous columns. These elements, though serving the purpose of shifting loads from one set of columns to another, also essentially “tied” the columns to each other. The columns were numbered for ease of identification and will be referred to by their number herein.

Schematic view of transfer trusses and girders between floors 5 and 7.

- 3) The sinking of the west penthouse, as well as the shifting of a clear kink from the east penthouse towards the middle of the structure, indicates that the collapse then progressed horizontally, as the localized failure of the eastern columns was distributed to the other columns through the transfer elements at floors 5 through 7.
