Coyote Gold Mine – Stage 2, Bald Hill

2014-2015 Annual Compliance Assessment Report

Ministerial Statement No. 749

Prepared for Tanami Gold NL

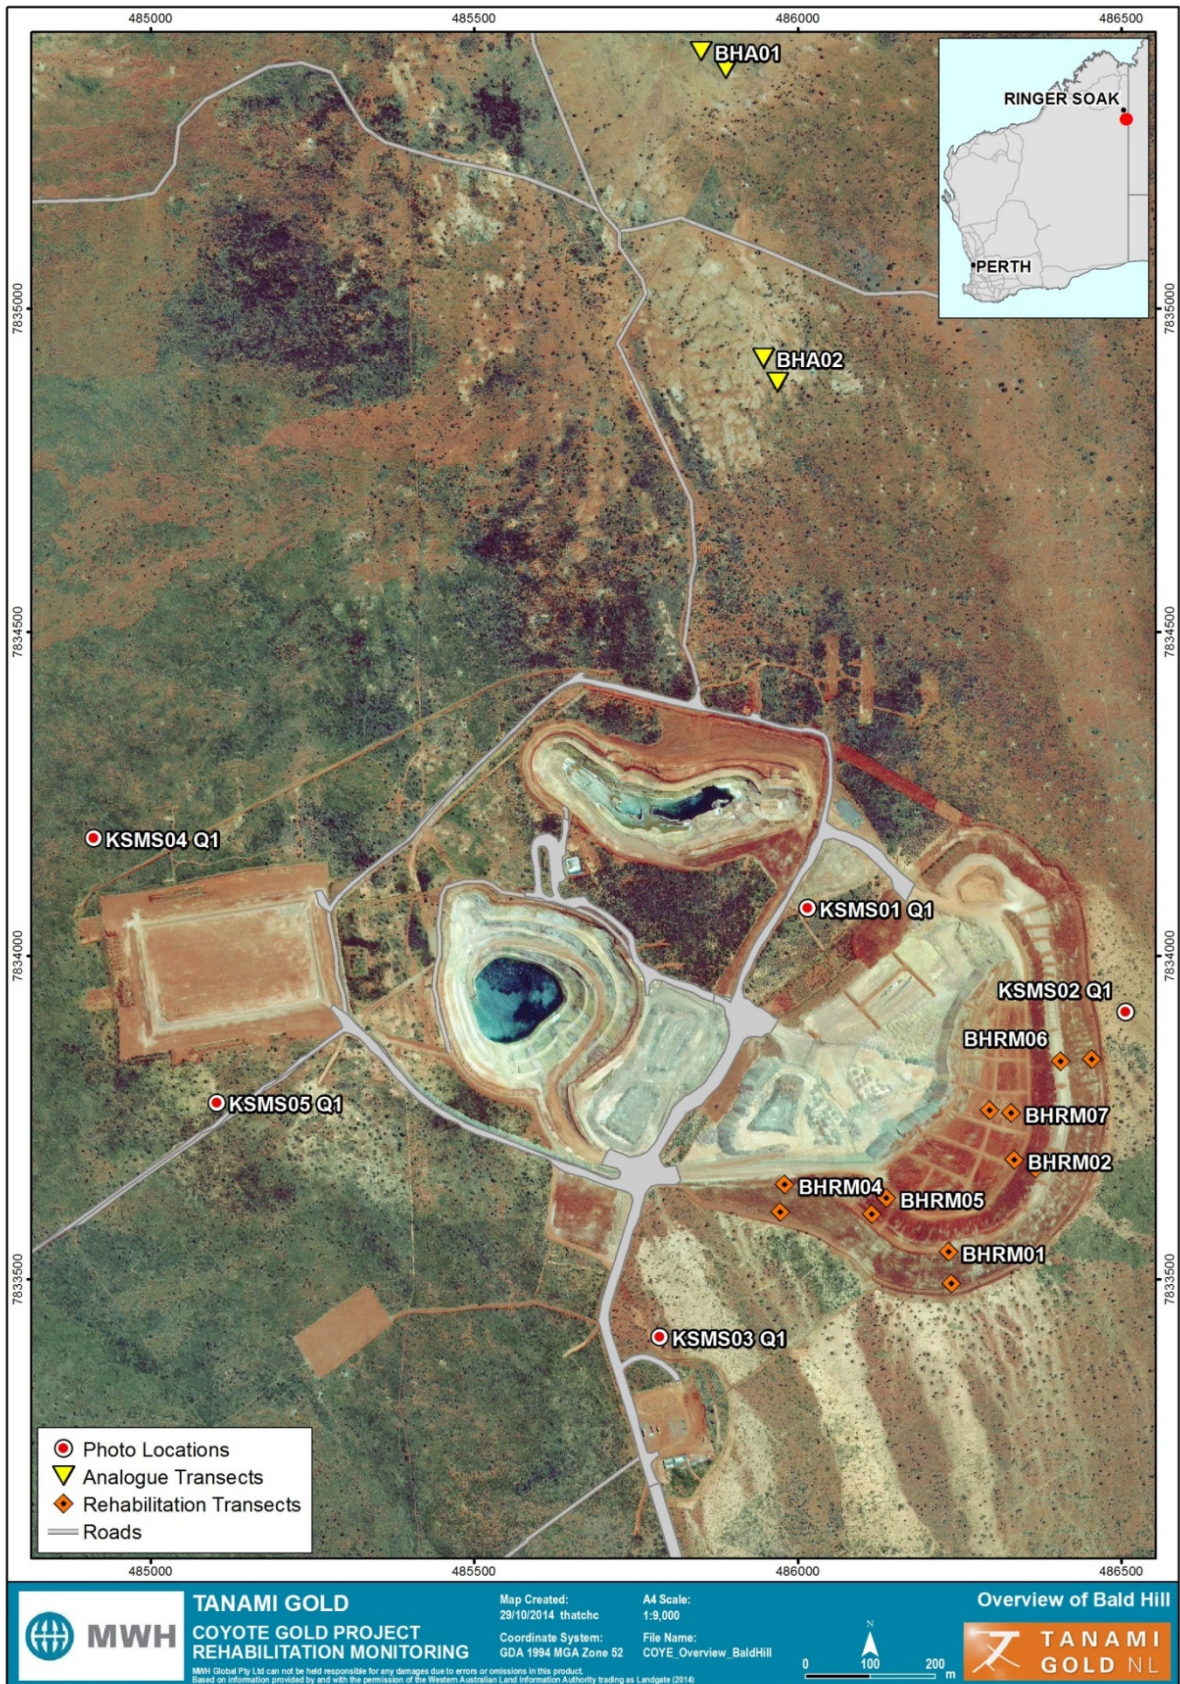
Figure 6-1: Transect and Photo Point Locations monitored in 2014

Ecosystem Function Analysis (EFA) was conducted on all previously-established monitoring sites at Bald Hill in September 2014. The monitoring also included the assessment of six transects on the Bald Hill WRL and ten existing photo monitoring sites were assessed (**Figure 6-1**). Five analogue transects were installed between the Coyote Project and the Bald Hill Project to represent desirable attributes for the final rehabilitation.

- the rehabilitation transects on the Bald Hill WRL had landscape function indices which were lower than the analogue transects, particularly the stability index;
- shrubs dominated the sloping rehabilitation sites, whereas *Triodia* spp. dominated the sloping analogue transects;
- the vegetation composition of the flat rehabilitation transects had a vegetation composition that was more representative of the flat analogue transects, being dominated by perennial grasses and acacias;

- the rehabilitation on the Bald Hill WRL had cover well below the corresponding analogues;
- the sloping rehabilitation on the WRL had a high proportion of erosion features including rills and gullies;
- native fauna tracks and scats were observed on the WRL.

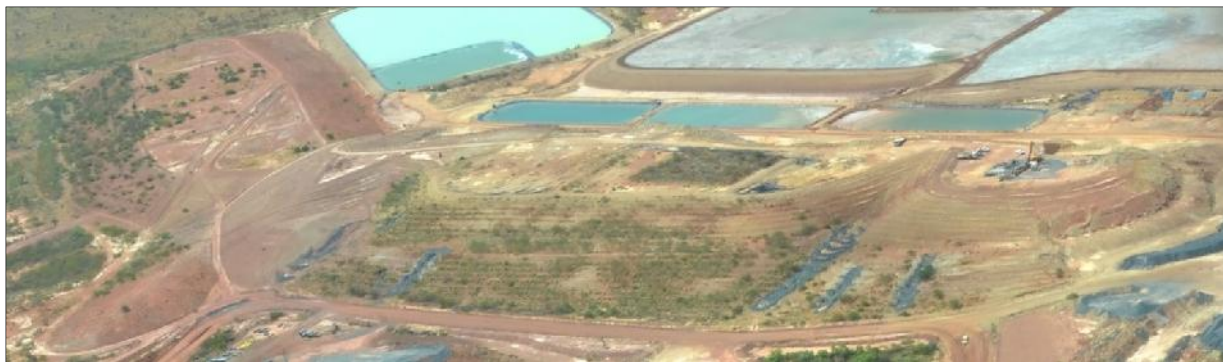
The Coyote WRL was formed with waste generated from mining the Coyote Open Pits between 2006 and 2008, and covers an area of disturbance of 26 hectares (ha) (**Plate 1**). Primary earthworks to reshape and batter down approximately 4 ha of the southern slopes of Coyote WRL to 15 degrees (°) were completed in 2008. This work included constructing bunds around the upper surface for water management and spreading topsoil in a series of simple rehabilitation trials. A small southern finger of the WRL covers a landfill established prior to mining (TGNL 2010a). The north-

eastern slopes adjacent to the leach vats and the eastern end adjacent to the ROM Pad remain largely at an angle of repose in order to provide rehabilitation material at closure.

Plate 1: Coyote WRL looking approximately north, over the southern slopes, November 2013

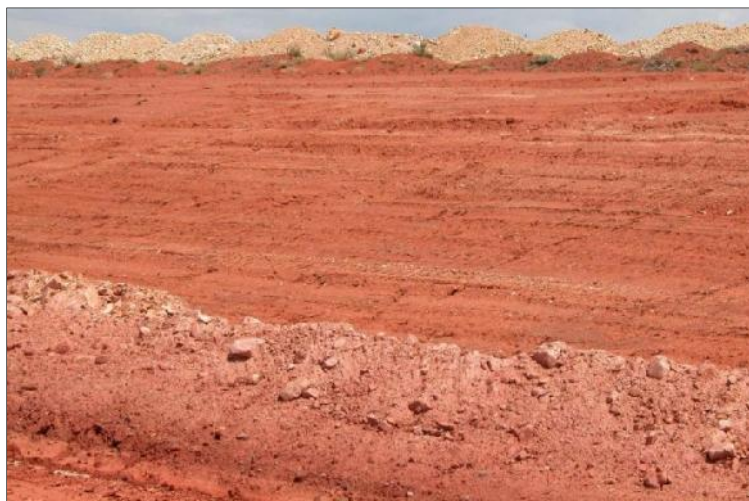
The surface created over areas topsoiled is shown in **Plate 2**. The results of the trial following the 2008 to 2009 wet season demonstrated mixed success. Overall, there was evidence of minor erosion resulting from several short duration high intensity rainfall events; however, the topsoil has largely remained in place. The southern face of the waste dump displayed minor to moderate gullying at the eastern end where topsoil has been applied at greater than 100 mm thickness (**Plate 3**). At the western end of the WRL, where topsoil has been applied thinly and blended with the underlying waste material, a much lower degree of erosion was exhibited (**Plate 4**). The northern side of the WRL did not at the time have topsoil applied and did not exhibit erosion (**Plate 5**) (TGNL 2009).

Plate 2: Coyote WRL following rehabilitation, February 2007 (TGNL 2008b)

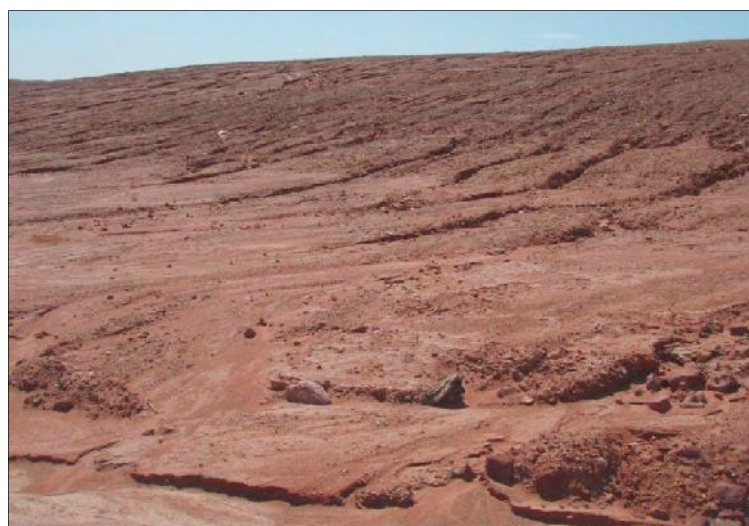
Plate 3: Coyote WRL, east end of southern slopes one year after rehabilitation (TGNL 2009)

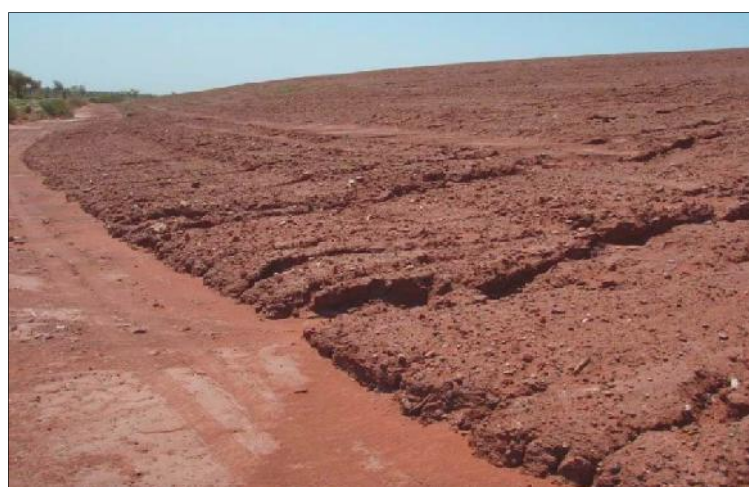
Plate 4: Coyote WRL, west end of southern slopes one year after rehabilitation (TGNL 2009)

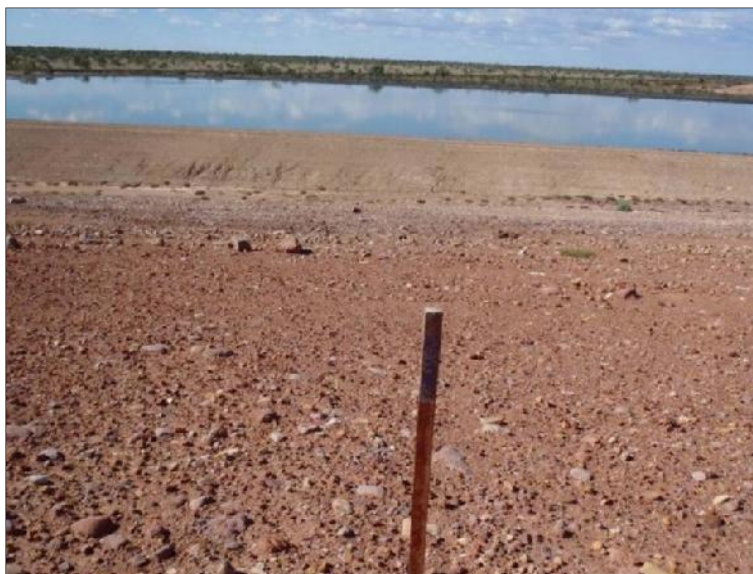
Plate 5: Coyote WRL, west end of northern slopes, trial control surface, no topsoil, approximately four years after establishment (TGNL 2012c)

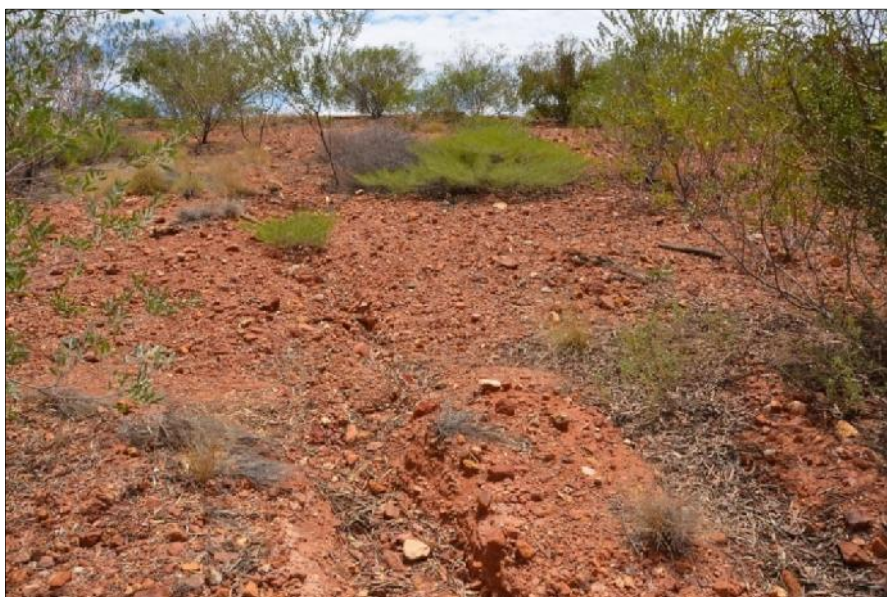
A site inspection by Outback Ecology-MWH in November 2013, confirmed that the rehabilitation of the north-western slopes of the Coyote WRL appears to be successful, with any gullies shallow and self-armouring (**Plate 7**). It was observed that the vegetation in this area is largely dominated by *Acacia* sp., as opposed to the eastern end which is largely dominated by *Triodia* sp. Mature *Acacia* sp. and *Triodia* sp. were observed to be seeding with seedling succession. This difference could be due to one of, or a combination of a number of factors; such as the source of the topsoil, the depth to which the topsoil was applied, or the presence of viable seeds within the topsoil. Slightly different vegetation associations were observed over the Coyote deposit as opposed to the site of the Coyote WRL (see **Table 6**). It was observed during the site inspection that the considerable vegetative cover (and seeds) were attracting a number of species of birds, reptiles, ants and termites.

Plate 7: Stable slopes, Coyote WRL, west end of the southern slopes, November 2013

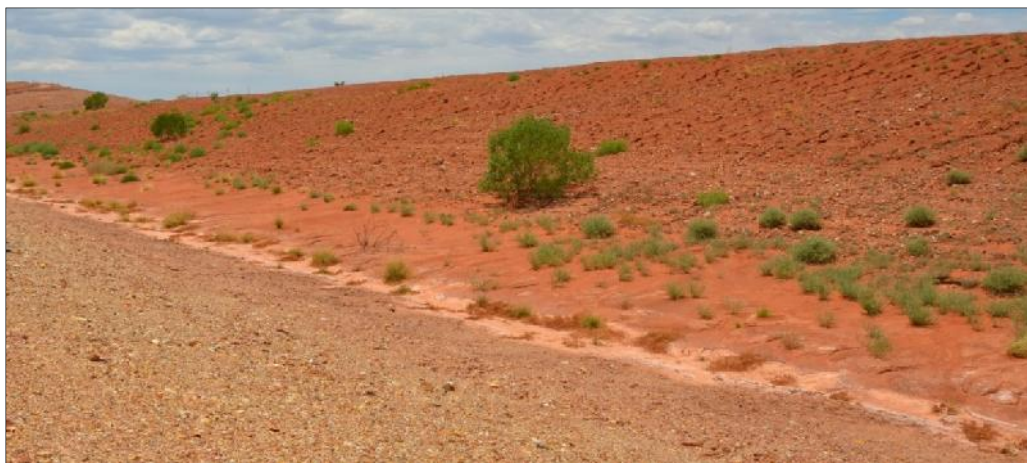
The depth of topsoil applied to the eastern end was observed to be considerably more than applied to the western end. It was later interpreted that a thin layer of topsoil, with shallow ripping (to mix waste rock with topsoil) improves the erosion resistance (TGNL 2012c). Subsequent rehabilitation was undertaken in consideration of this in 2012. In May 2012, the remainder of the western end of the WRL (previously contoured as the trial control surface with no topsoil) was covered with topsoil and lightly ripped along contours. In June 2012, rock drains were installed on the south-eastern slopes with erosion gullies dug out and lined with fresh rock (see **Plate 1**). The work was conducted with the fleet that arrived on site to undertake the embankment raise of the TSF (TGNL 2013). Unfortunately two months after this rehabilitation works an intense rainfall event of approximately 90 mm over one hour washed a portion of topsoil down the slope (**Plate 8**).

Plate 8: Coyote WRL, west end of northern slopes 2012 rehabilitation, November 2013

There is currently no toe bund to capture sediment emanating from the WRL. Consideration will be given to the installation of a toe bund in order to mitigate the impacts to the surrounding vegetation.

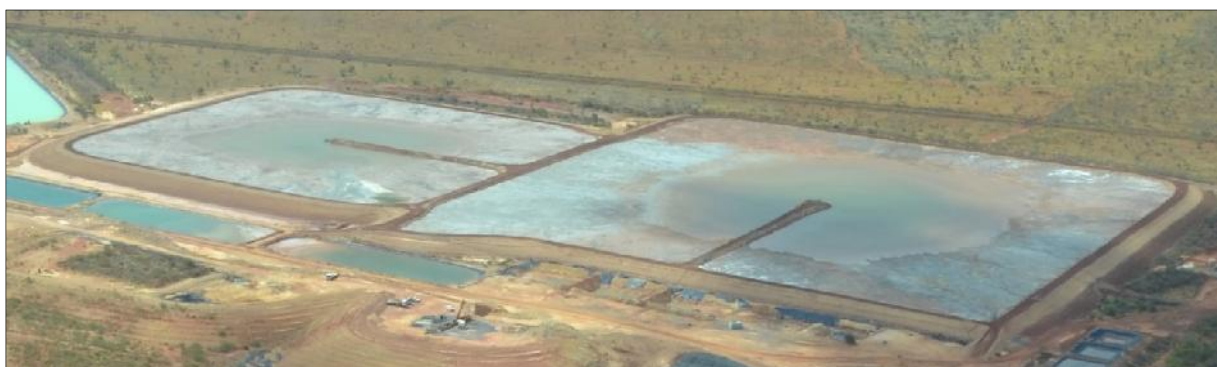
Plate 9: Coyote TSF, November 2013

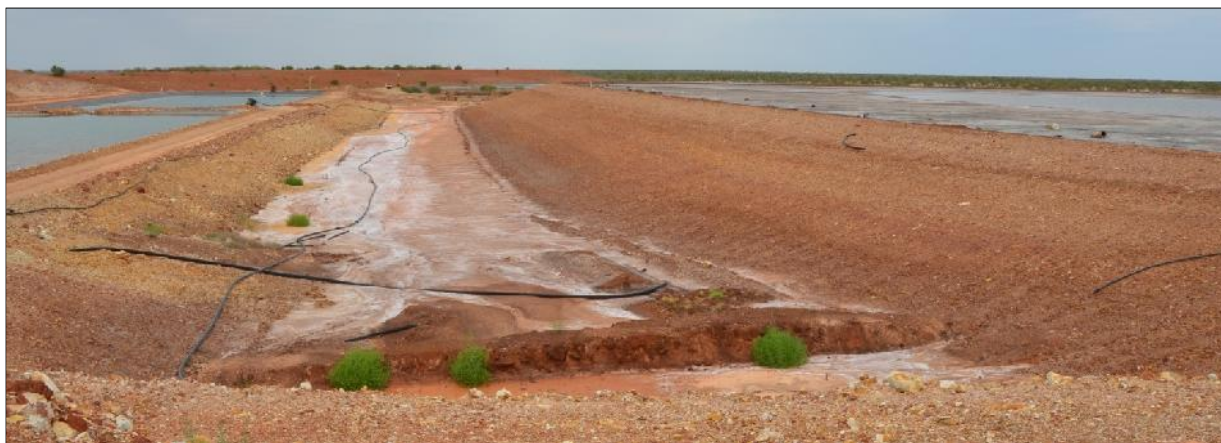
Following a 2008 DMP inspection, it was reported that excess water was being pumped onto the TSF, due to insufficient capacity within the evaporation pond. Later during a 2010 DMP inspection, (Appendix K) evidence of seepage was noted at the south-western corner of cell 2. TGNL inspected

the area further and found no evidence of seepage and responded accordingly to the 2010 inspection (**Appendix L**). No evidence of seepage was noted in the October 2013 TSF audit (Coffey 2013). Observations during the November 2013 site visit, also did not identify any seepage in this area, but did note the build-up of salt, although the source was not be defined (**Plate 11**). It was also observed during this site visit that the pond around the decant was quite large, and that the decant pumps had been removed. The size of the decant pond will affect the time for the tailings to consolidate prior to decommissioning of the TSF.

Plate 11: Seepage Trench between Cell 1 and 2, looking west along the southern embankment

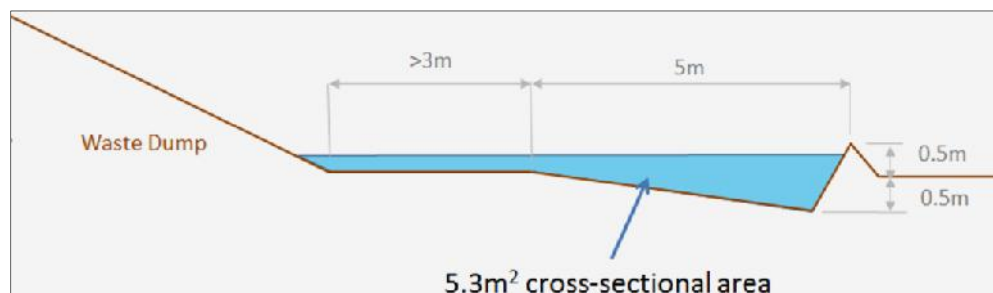
Figure 25: Bald Hill Waste Rock Landform toe drain design

(TGNL 2012c). Following the 2011/12 wet season it was identified that the WRL required a toe drain to capture sediment. The toe drain was engineered to a 1 in 72 hour rainfall event (**Figure 25**) and later installed in 2012. However, a site inspection in November 2013 revealed that the toe bund may not have been built to specification. The southern portion of the WRL adjacent to the south ramp received significant (approximately 300 mm) lateritic topsoil coverage to act as capping to any potentially dispersive material from the Kookaburra and Sandpiper Open Pits. However the cover appears to lack a sufficient proportion of laterite material to provide erosion resistance.

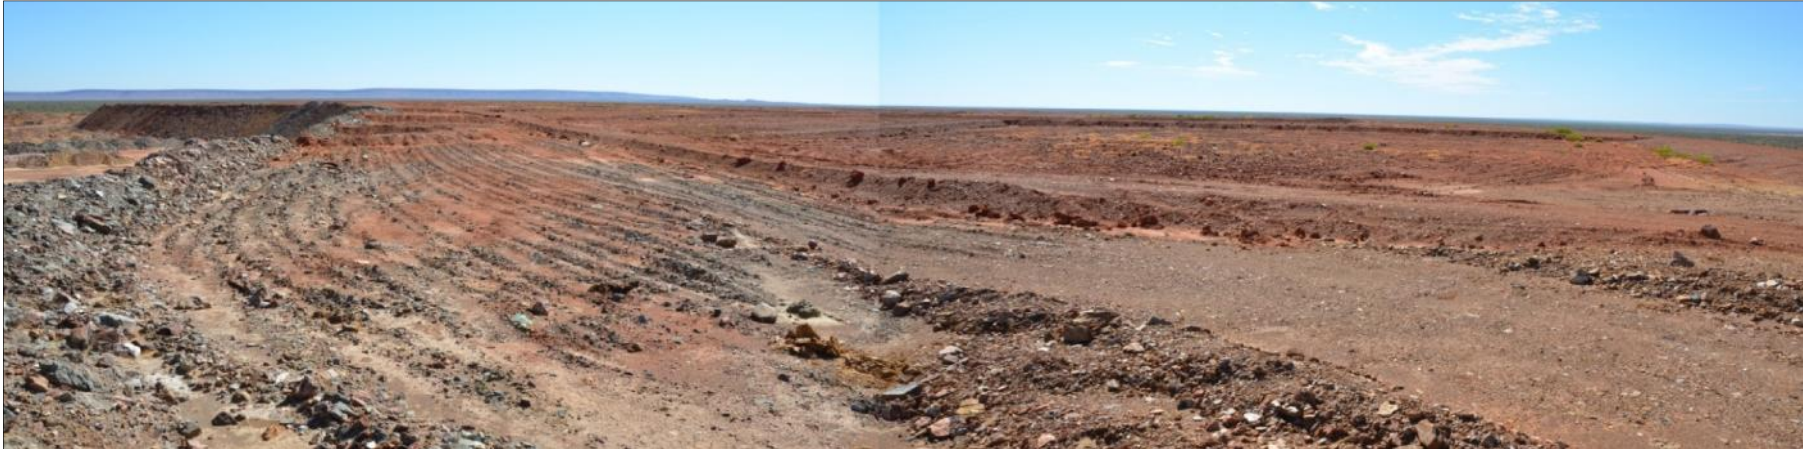
A site visit in November 2013 revealed that the capping topsoil / laterite material is quite erosive, with evidence of significant riling on all of the rehabilitated upper slopes over the Bald Hill WRL. In places a considerable quantity of capping material from the upper slopes has been deposited into the back sloping berm. It is likely that if the upper slopes do not stabilise the back sloping berm may fill with sediment and will no longer provide an effective means of surface water management.

Major rehabilitation works were conducted in May to June 2012 with rehabilitation of the upper surface (**Plate 12**) and completion of works to the northeast, southeast and southwest corners of the WRL. Lateritic material was excavated from a large flood diversion bund and utilised to cap the WRL with topsoil spread over the laterite. The surface was seeded at this time with a mix of native grass seed obtained from Top End Seed and Acacia species collect by TGNL under permit, no fertiliser was applied. At this time the back sloped berm was repaired to ensure no overtopping of accumulated run

Plate 12: Bald Hill WRL upper cell bunding, looking north east, November 2013

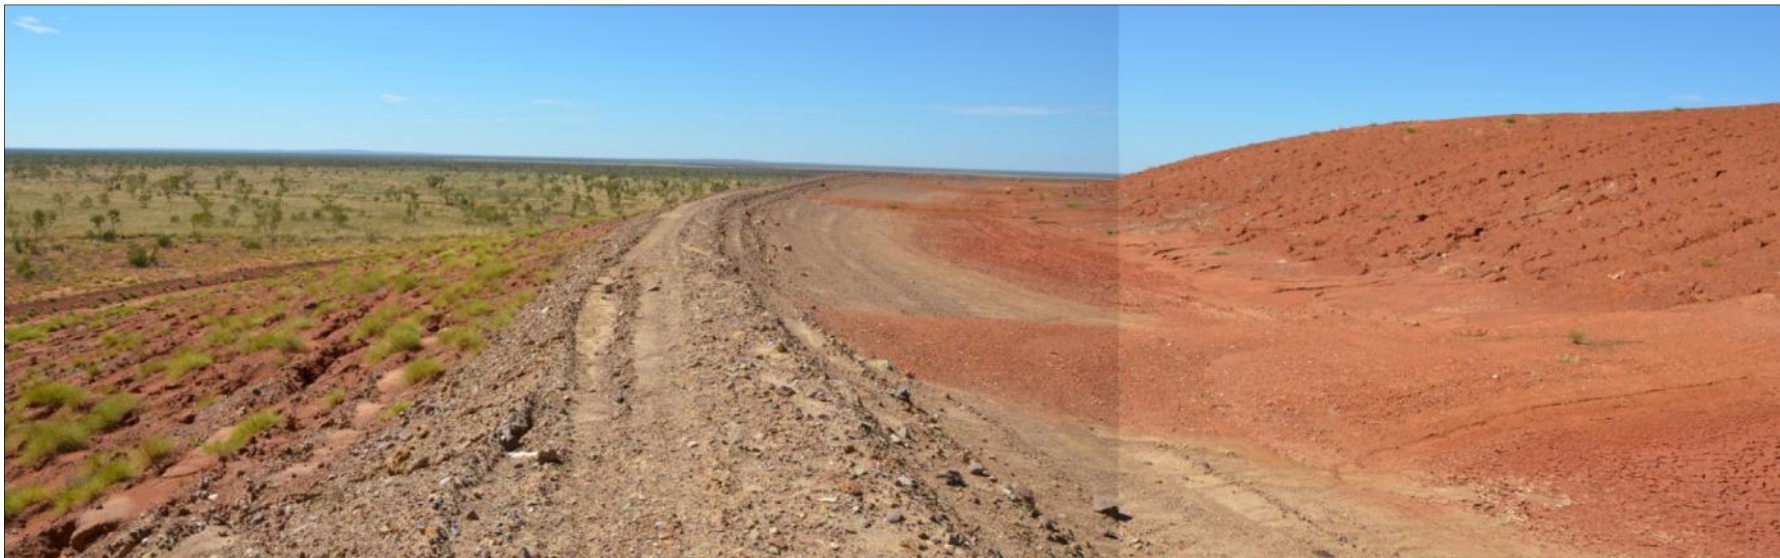
off down the lower bench, as well as the installation of cross bunds established every 50 m as baffles to limit potential flows and reduce catchment areas (**Plate 13**) (TGNL 2013).

Plate 13: Bald Hill WRL slopes, looking south, November 2013

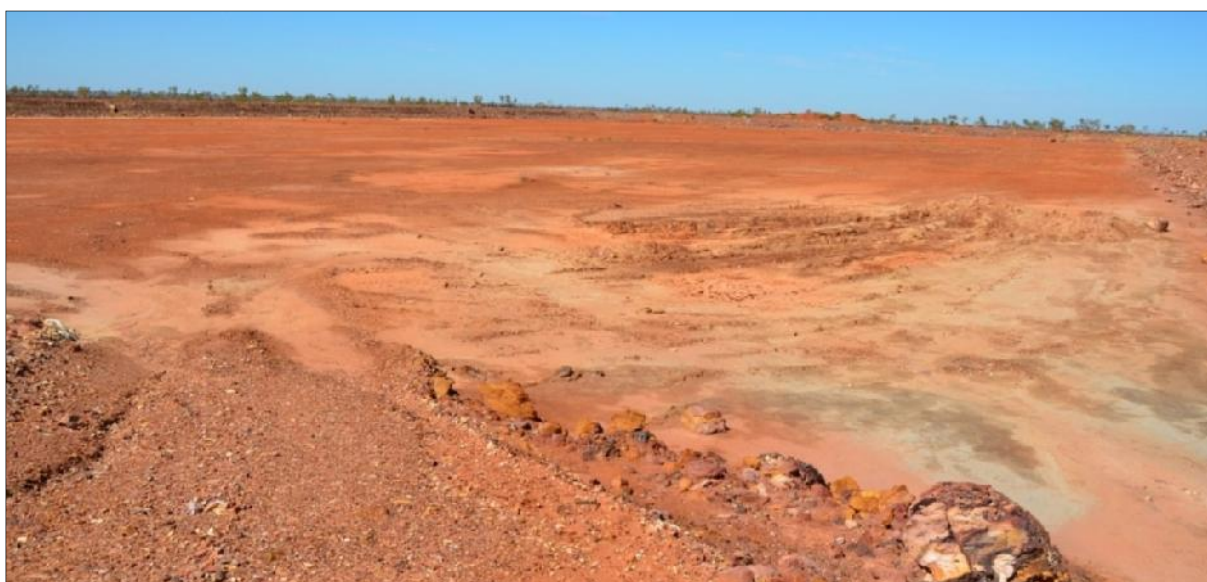
The contents remaining in the floor of the evaporation dam have been windrowed up and trucked away to the Kookaburra Open Pit which already contains saline water. The floor of the evaporation dam (**Plate 32**) was sampled for salinity using both field testing equipment and laboratory analysis (**Table 31**). TGNL have previously committed to repeat the sampling process after 12 months to assess whether any more material requires removal before more permanent rehabilitation, due to the potential for capillary salt rise (TGNL 2012d).

Plate 32: Bald Hill evaporation dam, looking southwest, November 2013

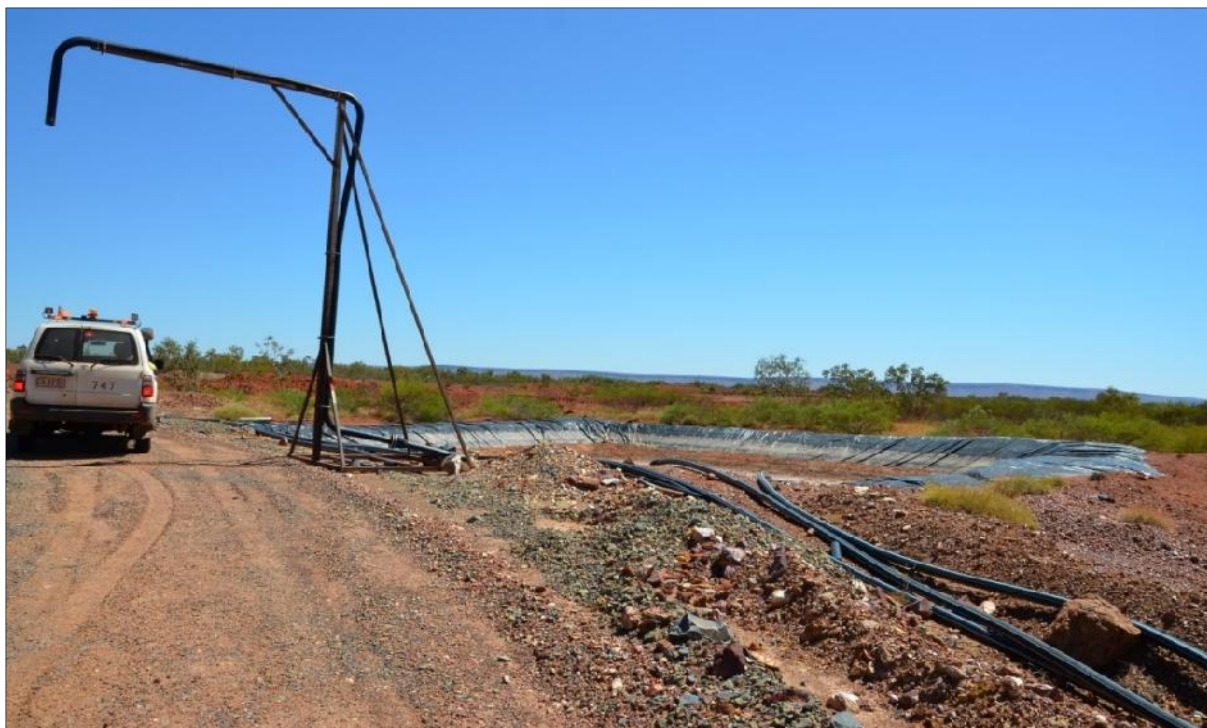
The Bald Hill turkeys nest lies between the Sandpiper and Kookaburra Open Pits and is HDPE lined occupying 0.10 ha. The turkeys nest currently has a pipeline running to the pit lake in the Kookaburra Open Pit for the collection of water. A standpipe is also still connected to allow the filling of water trucks should mining recommence in the area (**Plate 33**). The facility was recently utilised for the recent trial mining of Osprey deposit.

Plate 33 Bald Hill turkeys nest

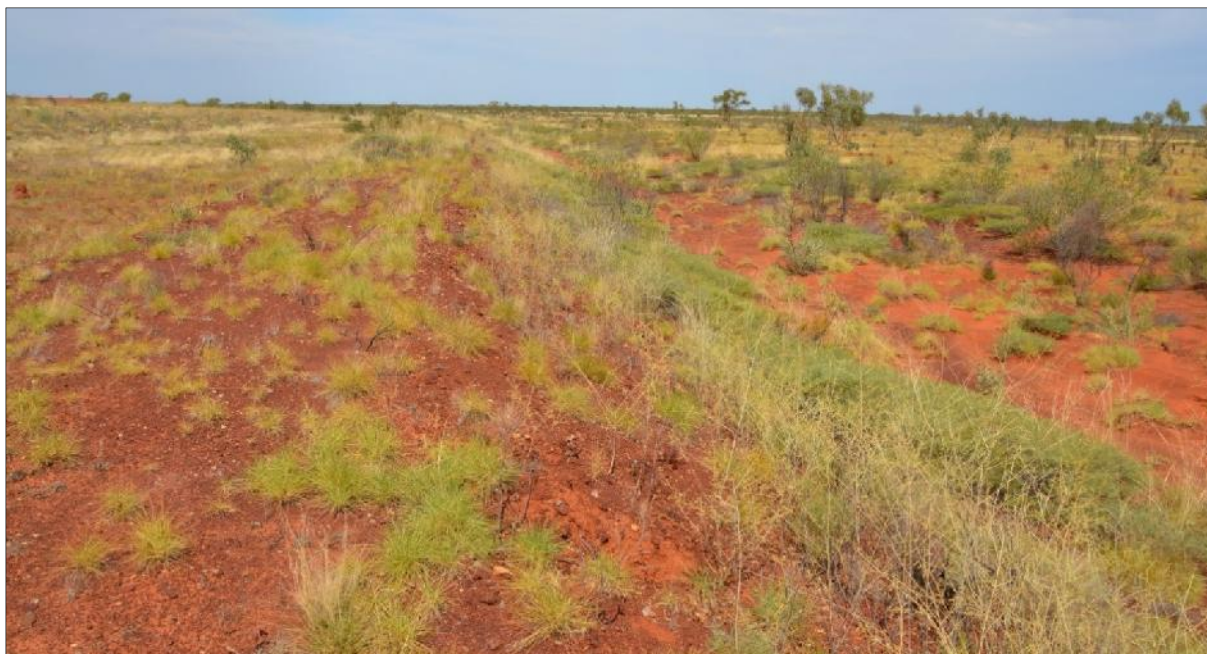
A flood diversion drain and bund surrounds the Coyote site with the exception of the magazine and accommodation village and is composed of two features, a diversion drain and a flood protection and abandonment bund (see Plate 26). The diversion drain runs along the eastern and northern side of the Coyote site to protect the process plant and support facilities, TSF, landfills, EP and topsoil stockpiles from flood waters. The diversion drain consists of an outer channel, against an inner laterite bund for a total width of approximately 20 m. A site inspection in November 2013 revealed the Diversion Drain to be stable and re-vegetated (**Plate 34**).

Plate 34: Coyote Diversion Drain, north of Coyote Tailings Storage Facility

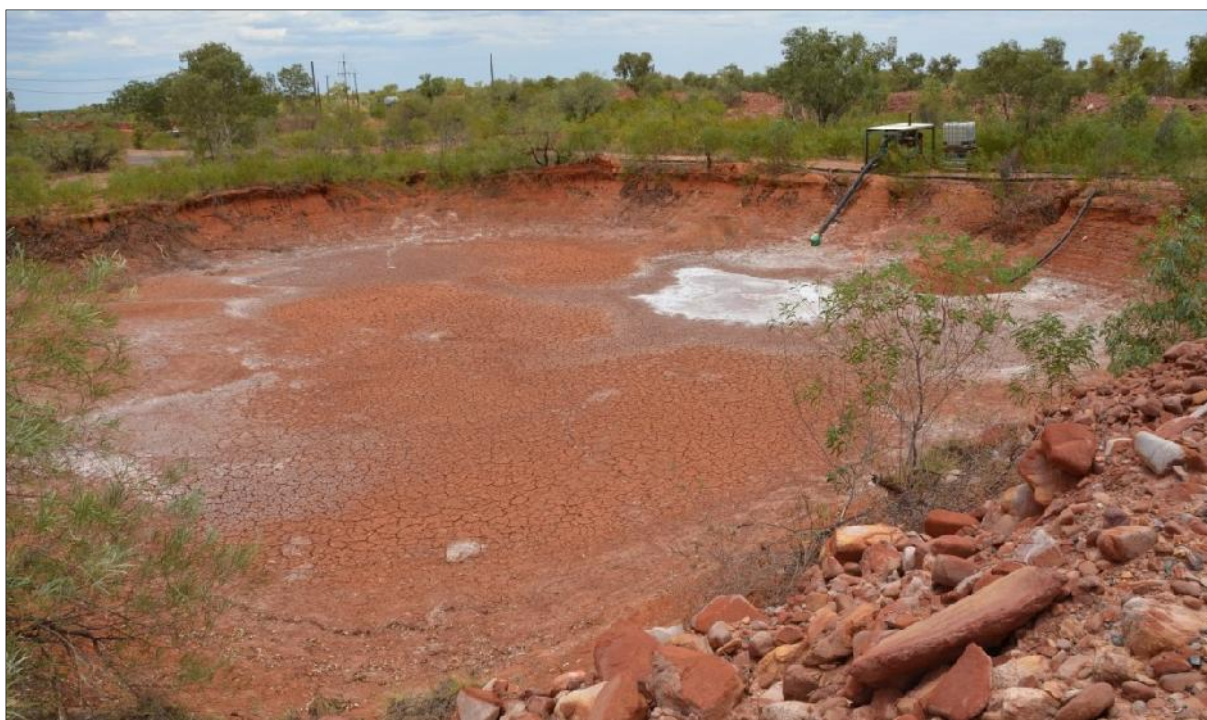
A diesel powered pump and self banded fuel tank is positioned adjacent to the sump (**Plate 35**). Salt scaring is evident in the base of the sump.

Plate 35: Surface water sump within the Coyote flood protection / abandonment bund

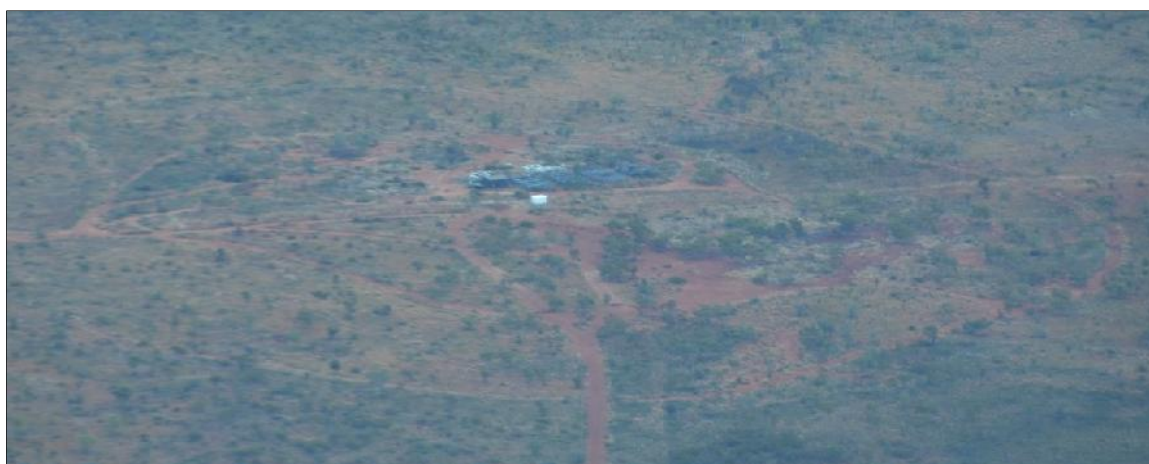
The exploration coreyard is all that remains of the original accommodation village, consisting of a small bore shed, core logging shed and associated core trays covering 0.66 ha. The original accommodation village was decommissioned in December 2007 with the transportable buildings transferred to the mine site or new camp. The exploration coreyard is utilised as part of the exploration programme (**Plate 36**). A grader has attempted to rip compacted areas, however areas have been identified for ripping with a bulldozer (**Figure 31**) which will only be available after the next planned TSF embankment raise.

Plate 36: Exploration coreyard, looking southwest November 2013

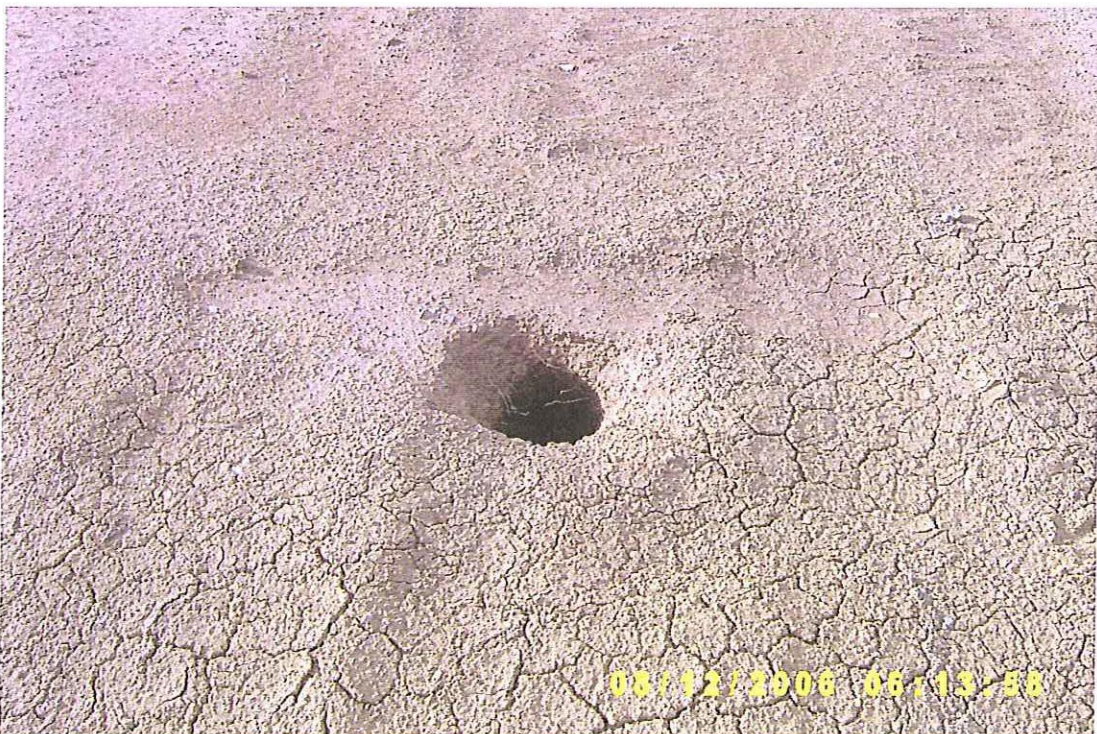
No drill hole capping of the definition drilling at Sandpiper and Kookaburra has has not been undertaken (Photo 2).

Photo 2: Uncapped drill holes at Sandpiper Drilling.

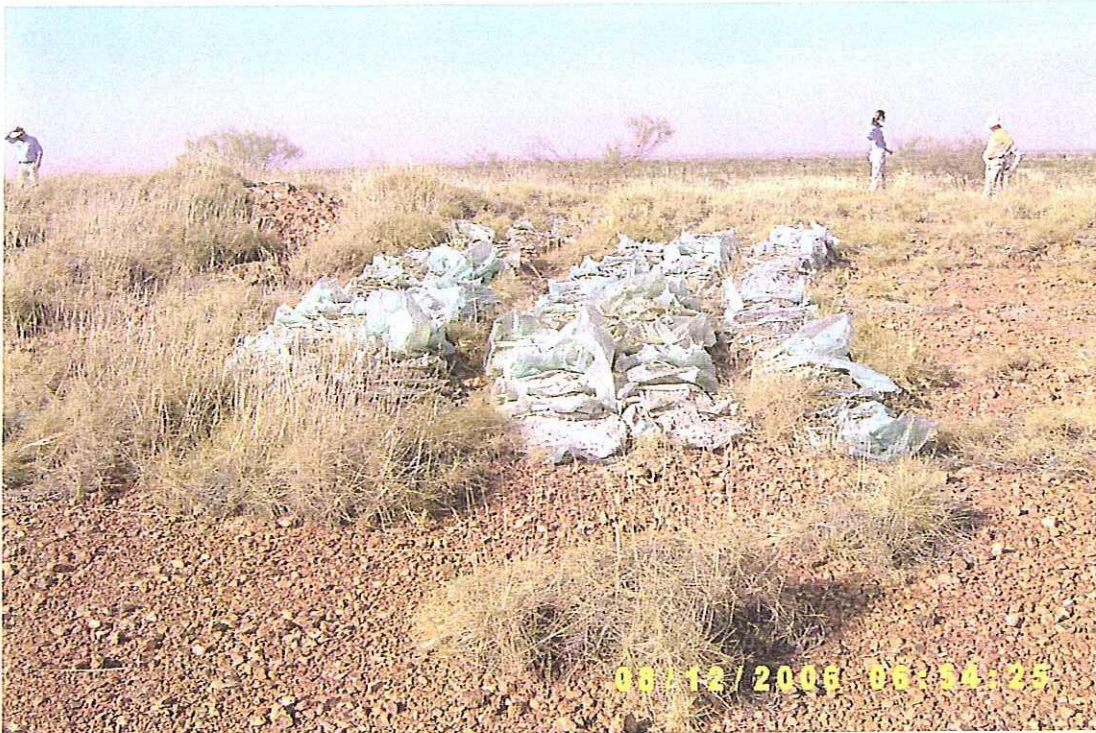
Photo 3: Drill site at Hawk Prospect.

Please ensure after six months all drill holes are capped below surface and drill bags are removed and disposed of appropriately (Photo 3).

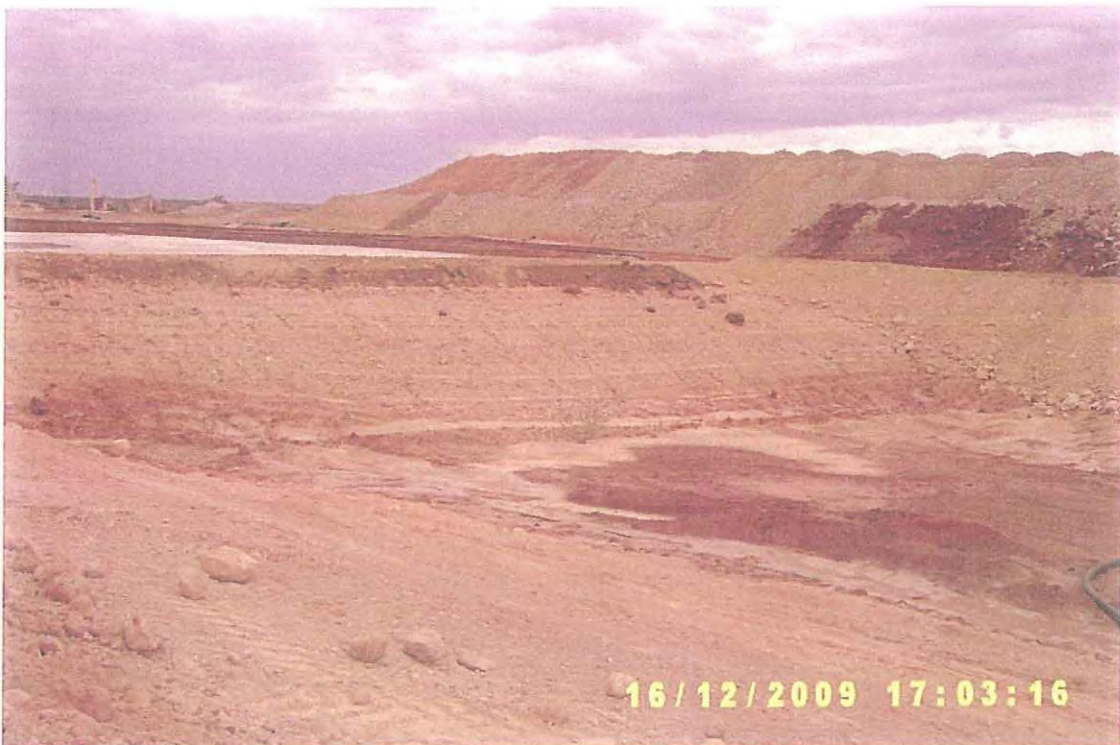
Photo 2: Seepage Visible on External Embankment Wall of TSF 2.

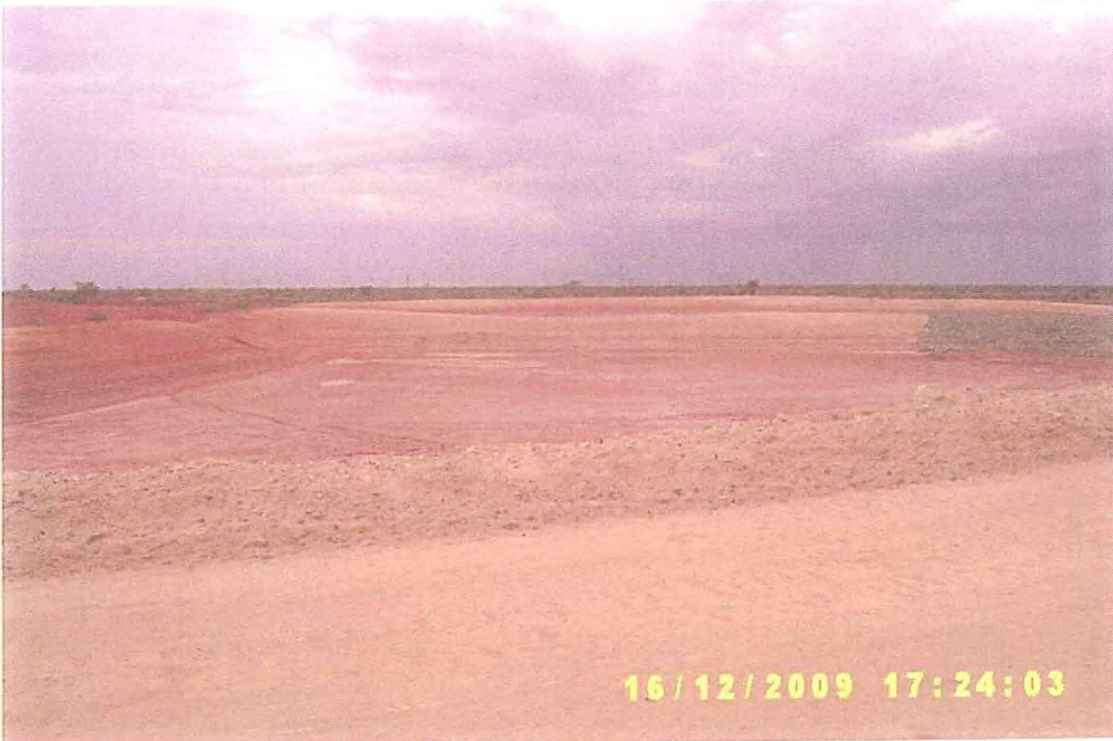
Photo 3: Evaporation/Water Dam constructed without approval.

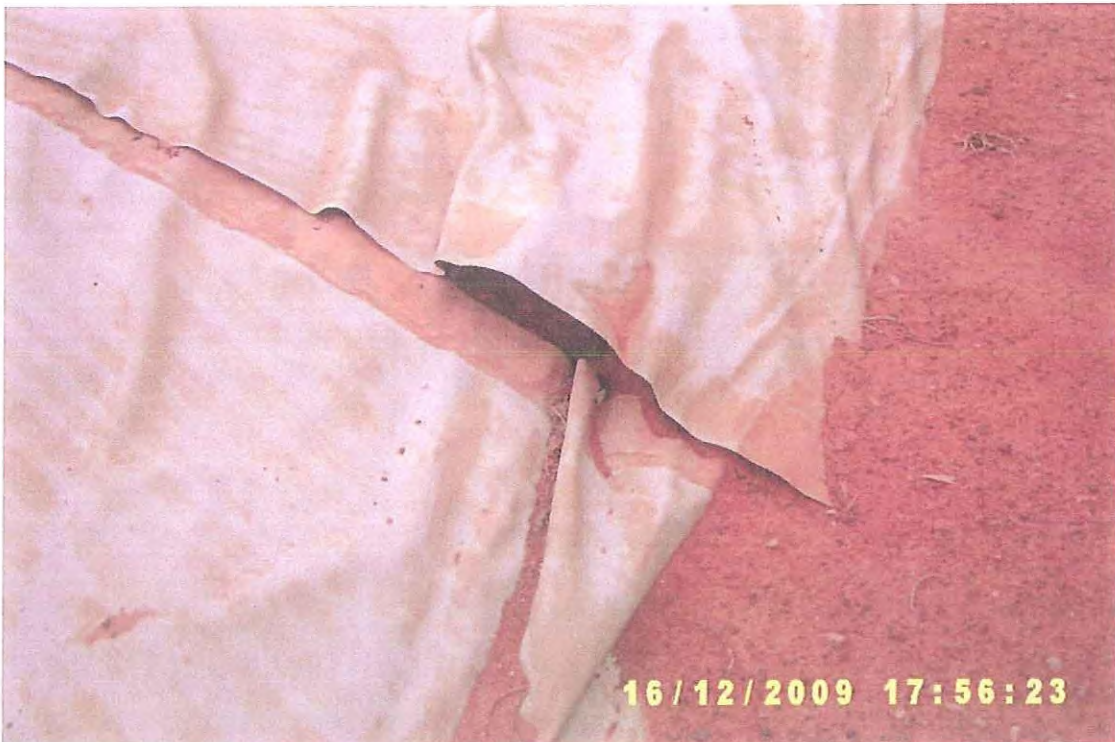
5.	POLLUTION CONTROL & ENVIRONMENTAL MONITORING <i>Comments: Bulk fuel storage liner in poor condition and needs repair. Equipment located in lay down area leaking oil and hydraulic fluid.</i>				2	2

Photo 6: Perished Seams of the Bulk Fuel Storage Facility Liner

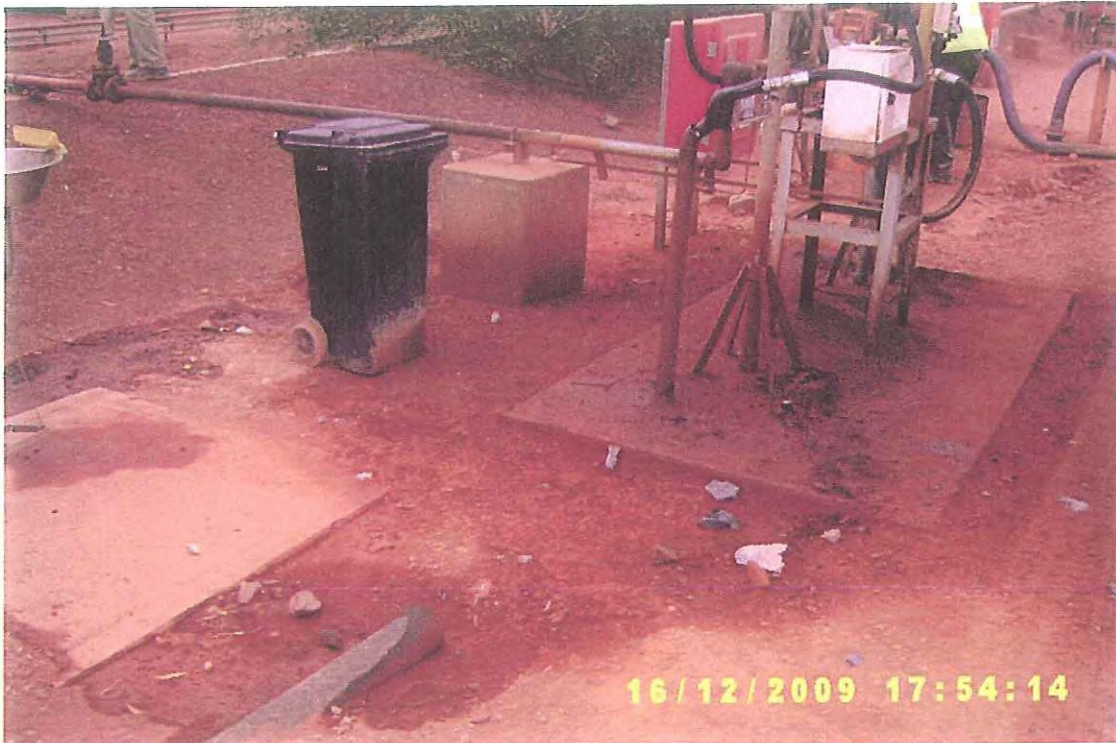
Photo 7: Hydrocarbon Contaminated Area Surrounding the Refuelling Area.

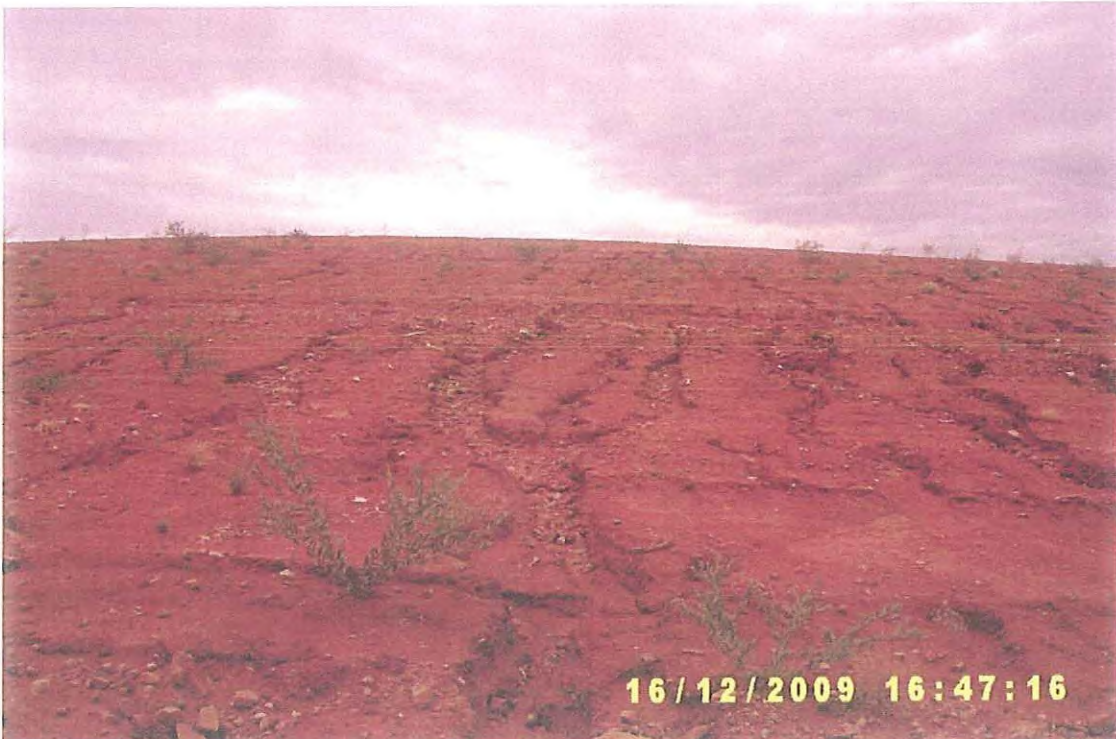
Photo 8: Erosion Gullying at the Coyote Waste Dump.

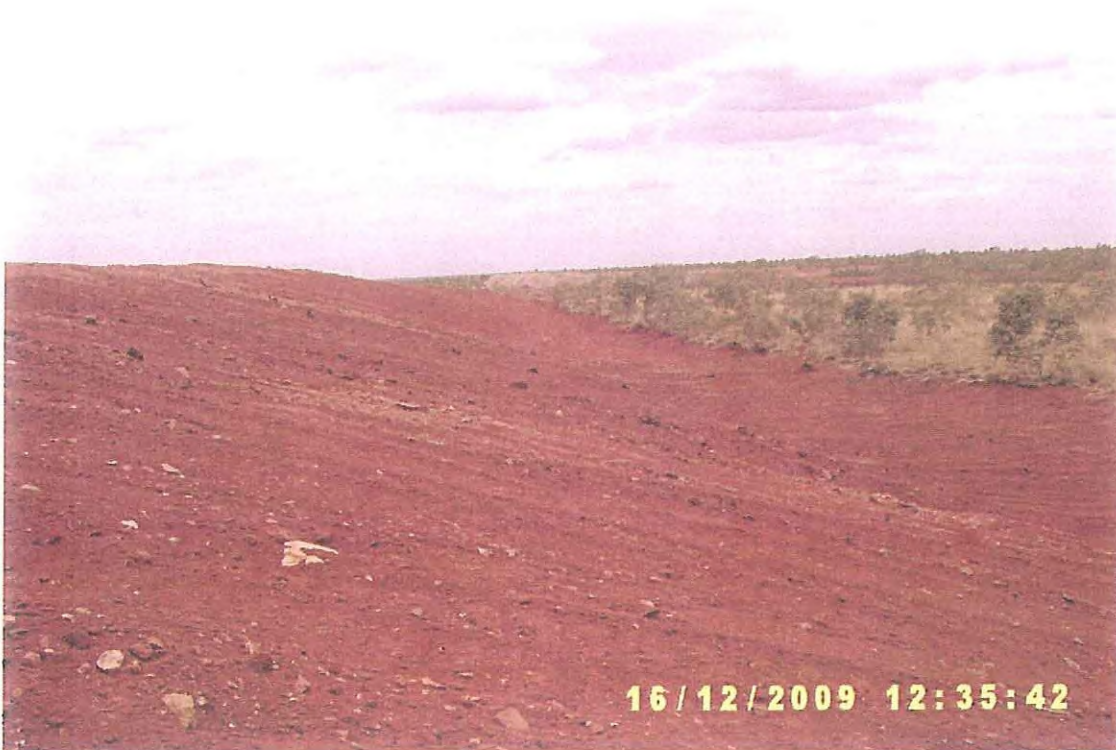
Photo 9: Rehabilitated Waste dump Slope without Ripping at the Sandpiper/Kookaburra.

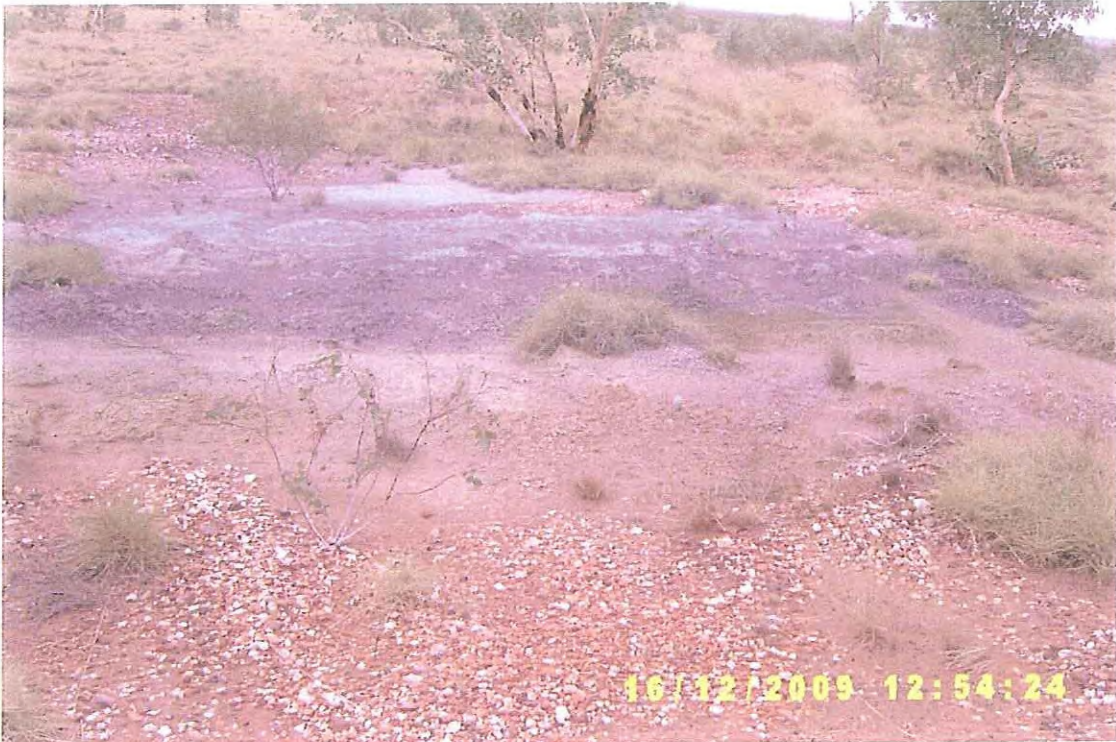
Photo 11: Historical Drill Site with Hard Set Drill Samples
