Coyote Gold Mine – Stage 2, Bald Hill

2014-2015 Annual Compliance Assessment Report

Ministerial Statement No. 749

Prepared for Tanami Gold NL

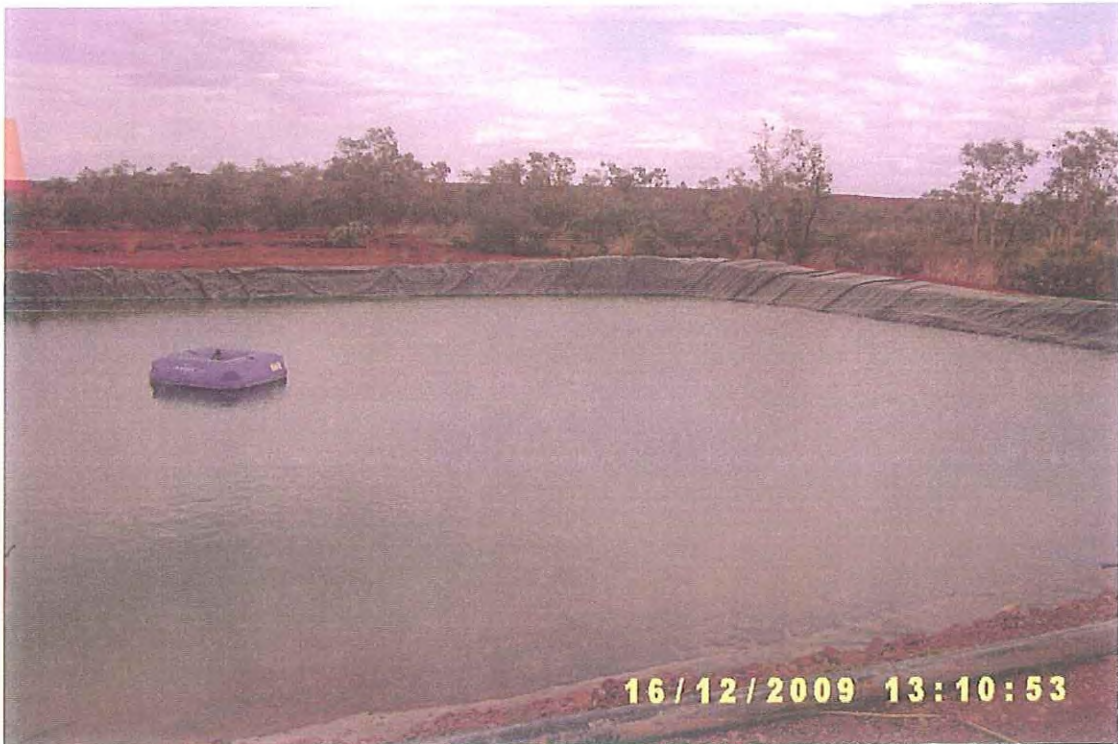
Photo 12: Turkeys Nest Dam at the Sandpiper/Kookaburra Project without Egress Matting.

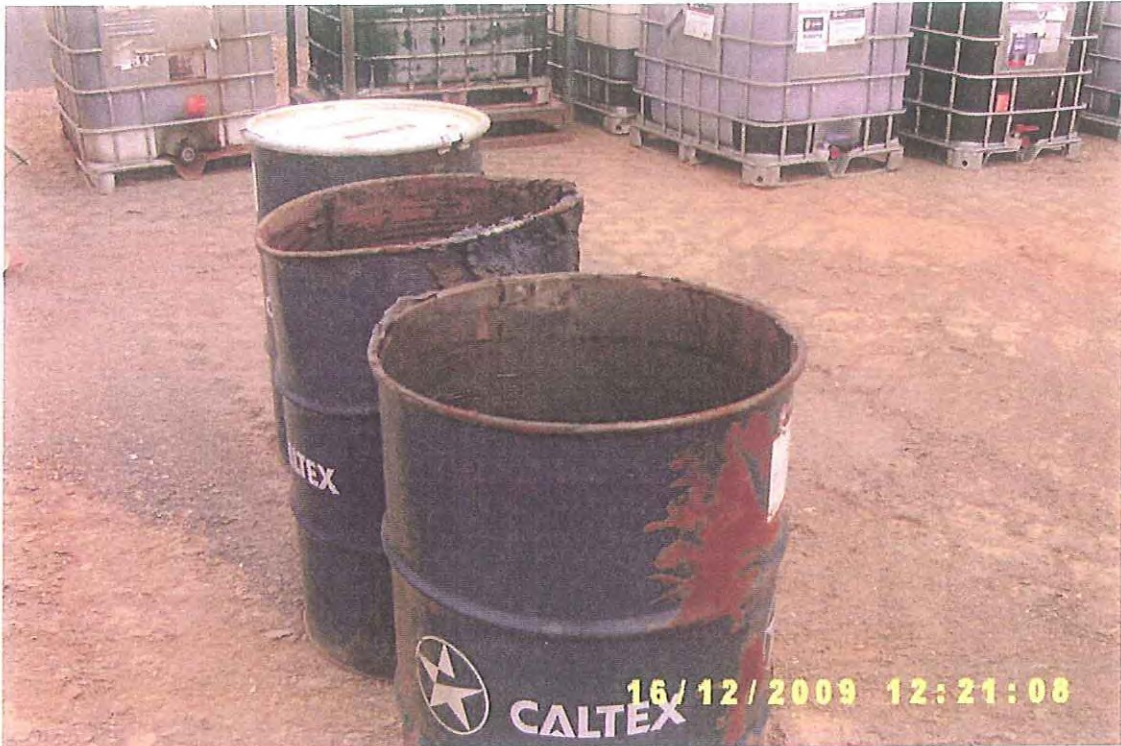
Photo 13: Open Grease Drum at the Brierty Lay Down Area.

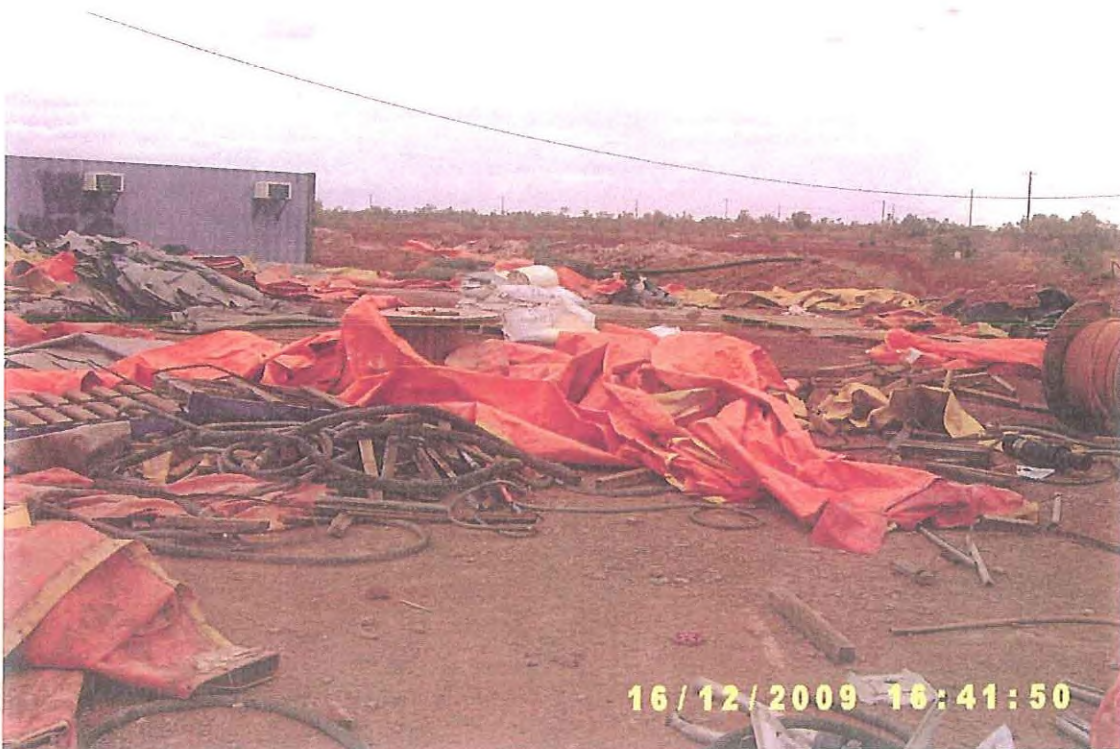
6.	HOUSEKEEPING AND RUBBISH <i>Comments: Underground lay down area requires tidying up.</i>				2	2
7.	OTHER MATTERS <i>Comments: Exploration camp on E80/1515 (dead) yet to be rehabilitated.</i>				2	2

Photo 14: Underground Laydown area at the Coyote Project.

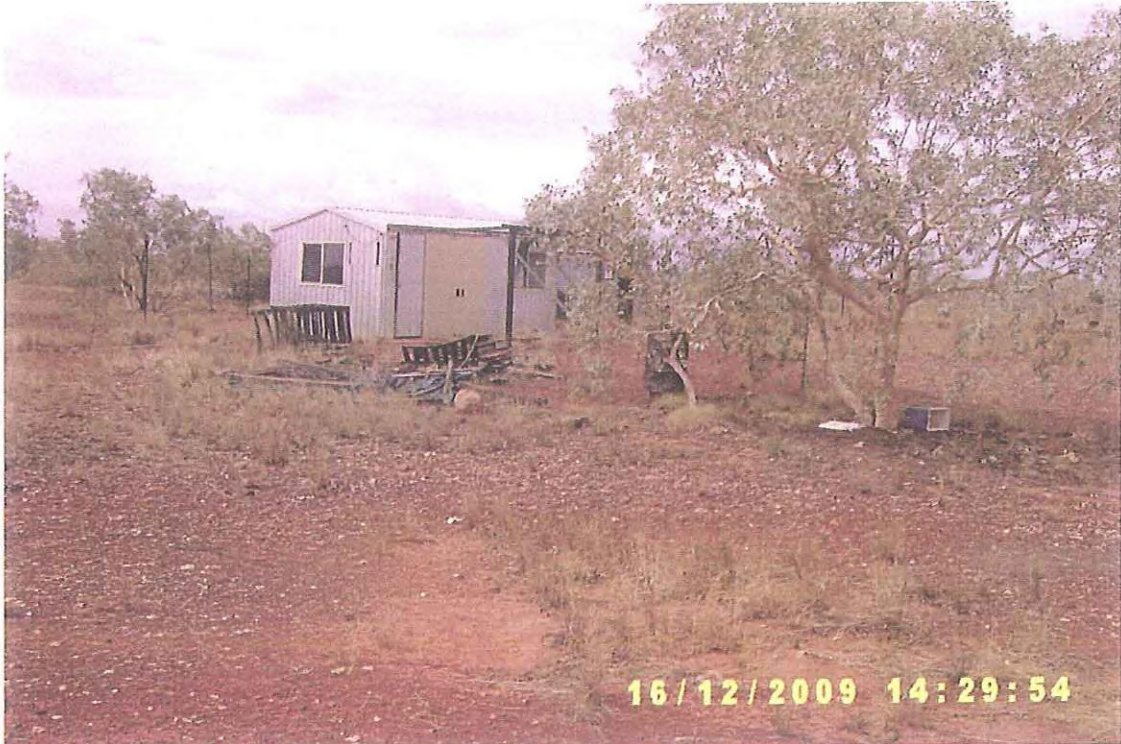
Photo 17: Sheds Remaining at the Old Exploration Camp on E80/1515.

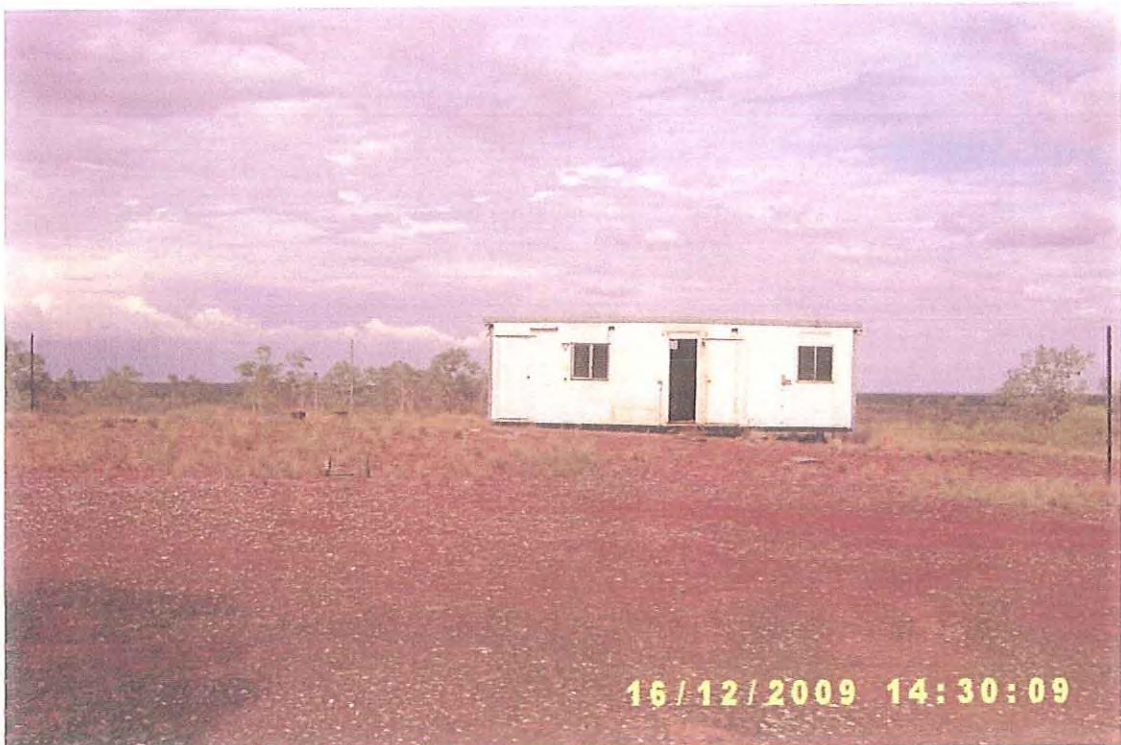
Photo 18: Donga Remaining at the Old Exploration Camp on E80/1515.

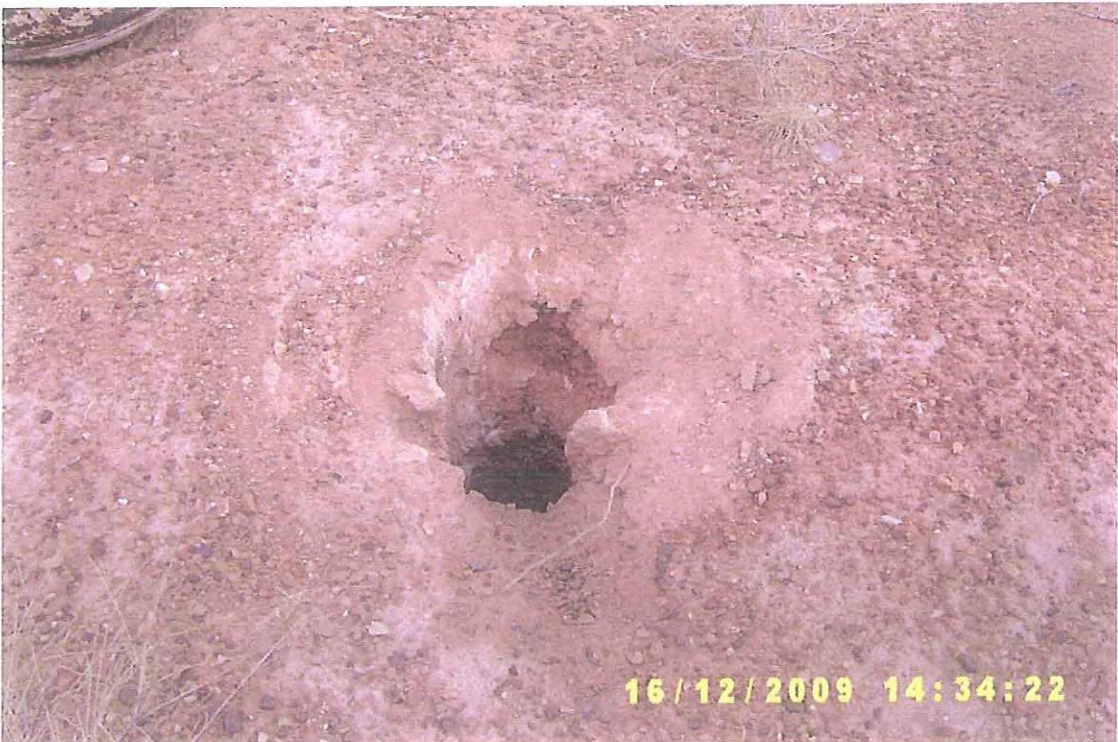
Photo 20: Open toilet hole at the Old Exploration Camp on E80/1515.

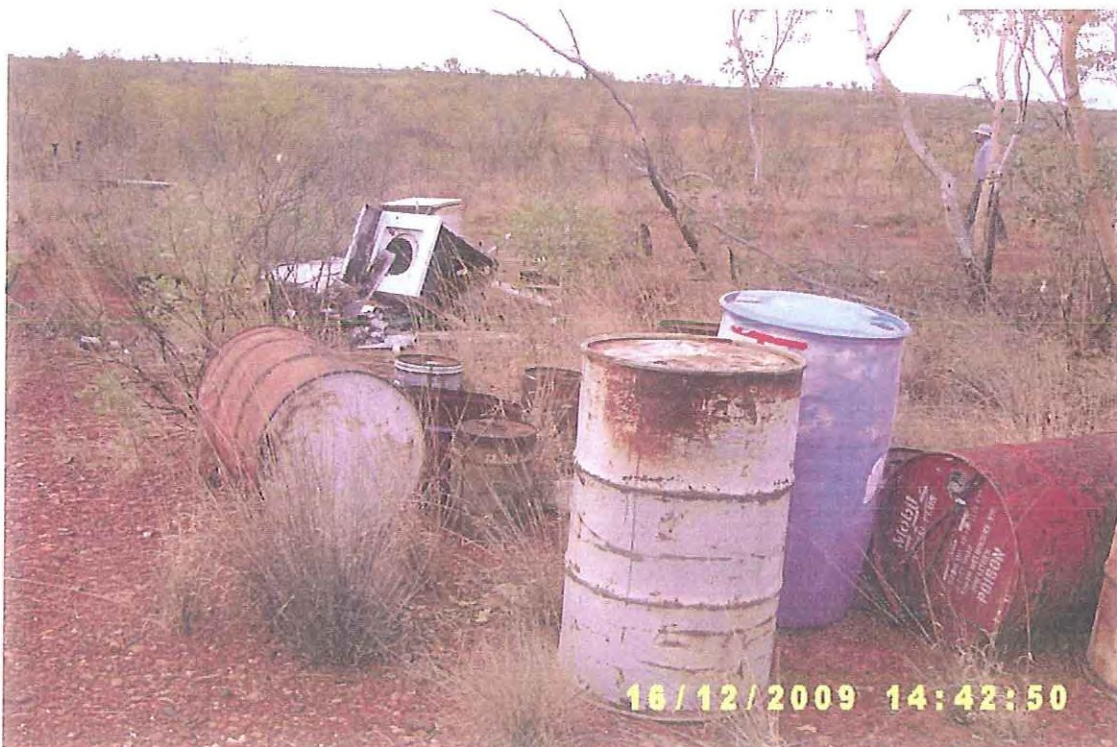
Photo 22: Oil Drums within the Rubbish Tip at the Old Exploration Camp on E80/1515.

1. All infrastructure and rubbish is removed and disposed of appropriately,
2. Toilet holes are sealed,
3. Inappropriate hydrocarbon drums are removed from the rubbish tip and the remainder of the rubbish is buried (Photo 22),
4. The camp area is recontoured/levelled including the fuel storage area, and
5. All compacted areas are ripped.

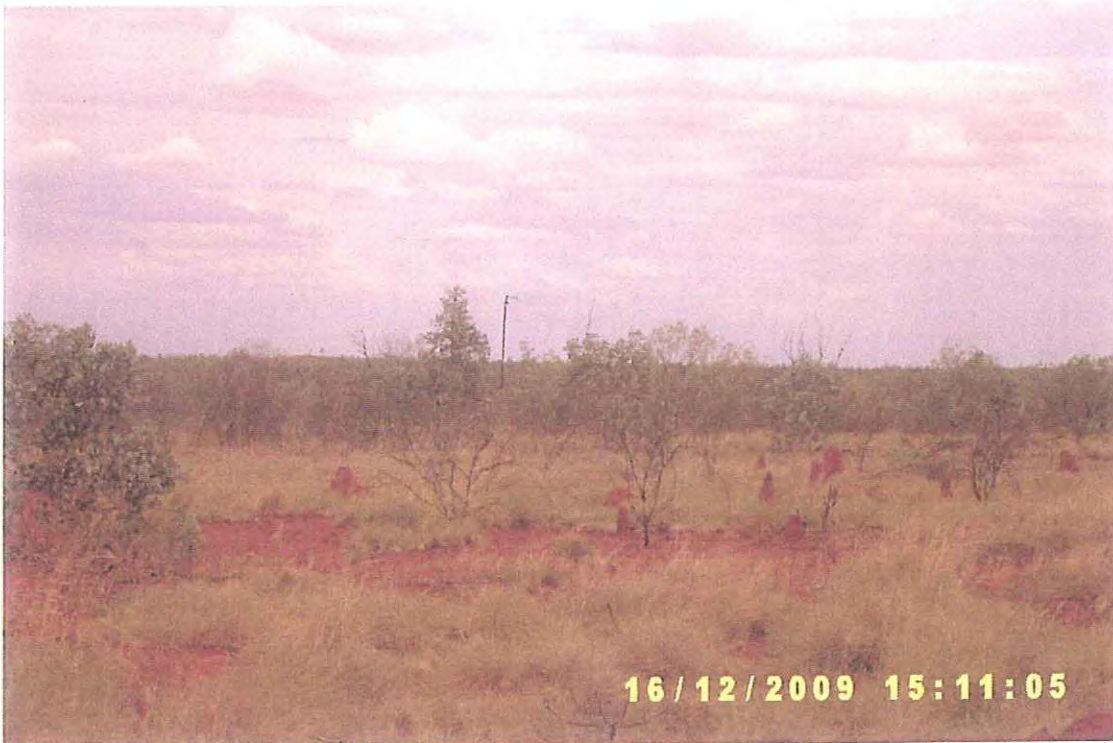
Efforts were made to locate the old airstrip on E80/1512; however the only item to be located was the possible remnants of the windsock stand (Photo 23). Upon return to the office, an investigation using Google imagery indicated that the airstrip was revegetating and no obvious infrastructure remained (Figure 1). Based on this information it will be recommended that the \$10,000 UPB covering the airstrip can be retired.

Photo 23: Remnants of the Windssock at the Old Airstrip located on E80/1512

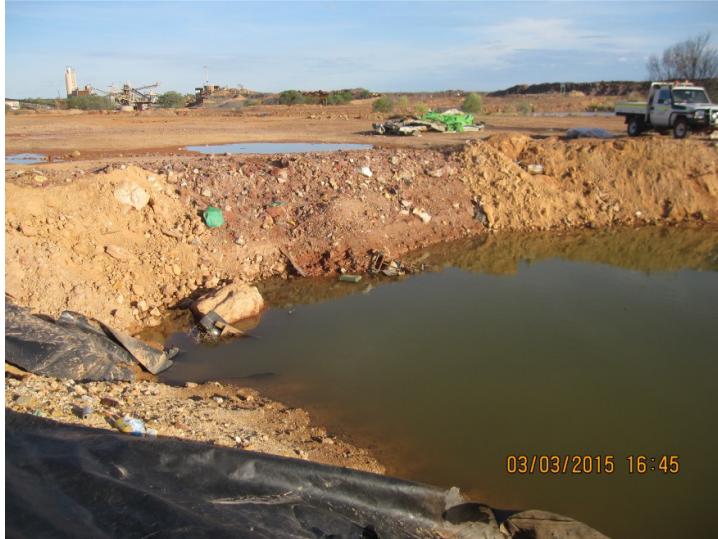
Plate 3: Inert Landfill Facility – Putrescible waste removed

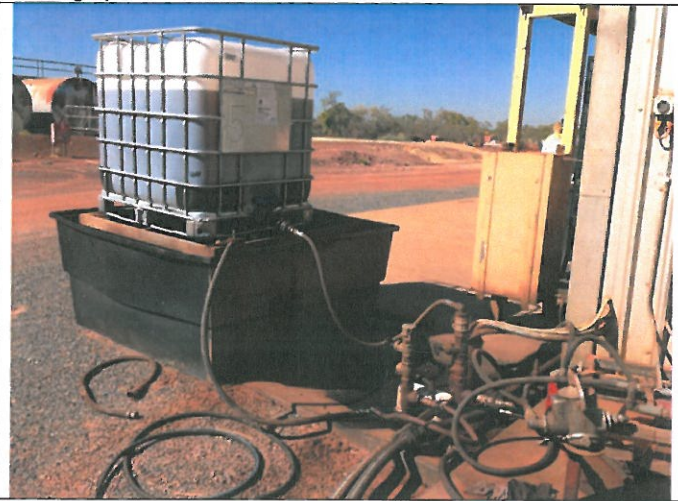
Photograph 21 – Small exhaust spill at power generation station

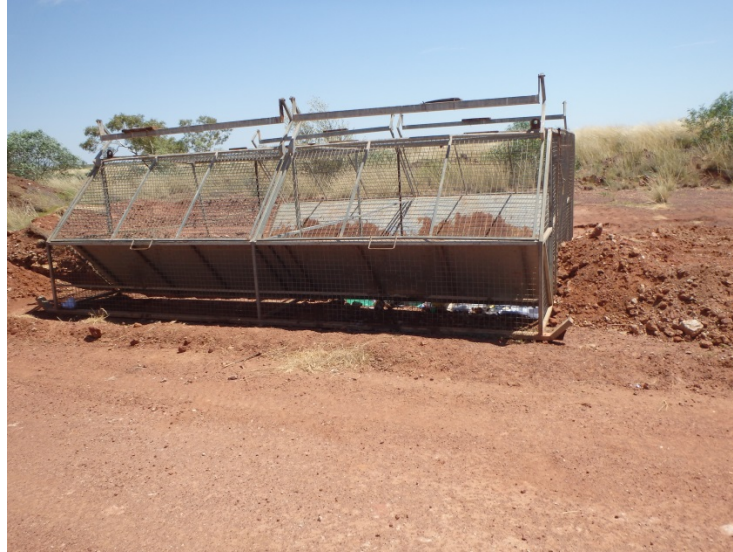
Plate 4-1: Belkan cage at Putrescible Landfill

Waste was not covered on a weekly basis as is required by Licence Condition 2 (v). The belkan cage was re-instated in February 2014 to ensure that the waste is covered at all times, confirmed by MWH during the March site inspection (**Plate 4-1**).

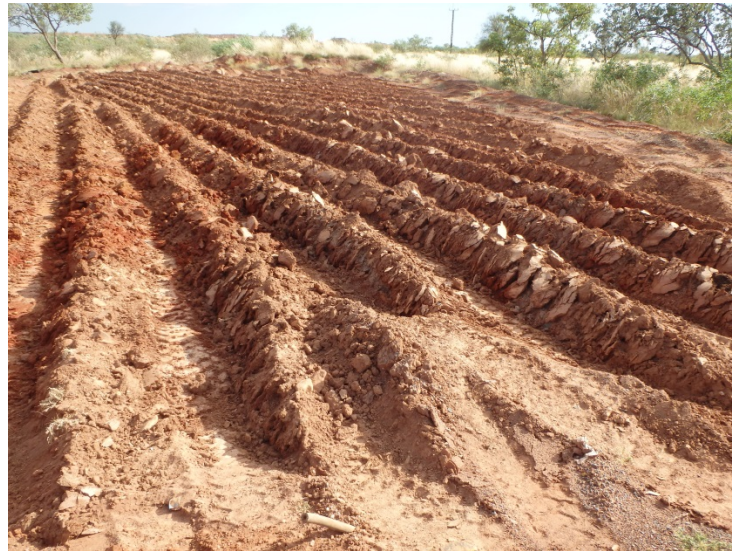
Plate 4-2: Bioremediation Facility

Soil thickness at the bioremediation was maintained between 60 cm and below 1.5 m during the reporting period, confirmed by MWH during the March site inspection (**Plate 4-2**).

Nutrients and water were not added to the soils at the bioremediation facility during the reporting period and monthly tilling was not carried out. This is not considered to be a significant risk to the environment as there is approximate 14 cubic meters at the facility. However this is not compliant with Licence Condition 8.

Tanami have committed to developing a bioremediation management to landfill onsite. The impacted soil will only be removed for use elsewhere once deemed remediated in accordance with the site bioremediation procedure.

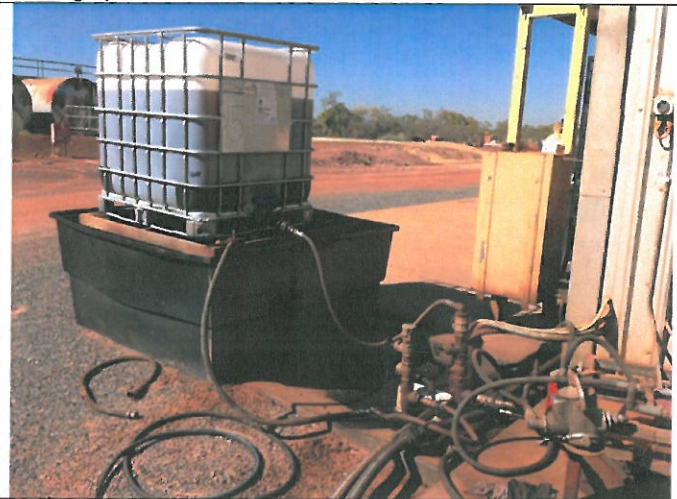
Photograph 21 – Small exhaust spill at power generation station

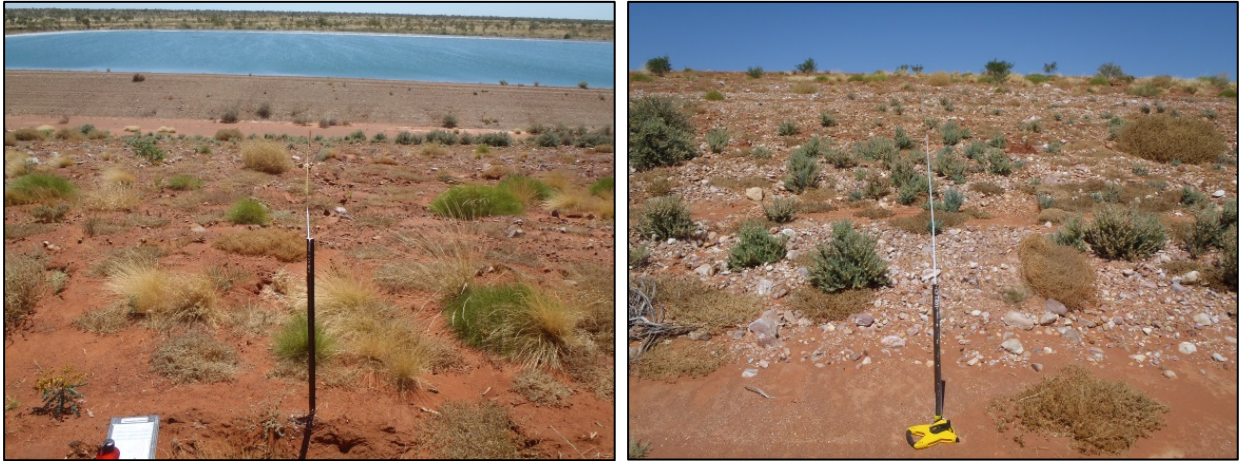
The sloping batters of the Coyote WRL were represented by three transects. Transect CYTR01 (**Plate 6**) was located on the western end of the northern facing batter opposite the evaporation pond. Transect CYTR02 (**Plate 7**) was located on the eastern end of the southern facing batter opposite the old camp road. Transect CYTR03 (**Plate 8**) was located on the bottom lift of the western end of the southern facing batter, opposite the pit. These transects had been previously installed by site personal in September 2014.

Plate 6: Transect CYTR01 in 2014, from 0m (left) and 45m (right)

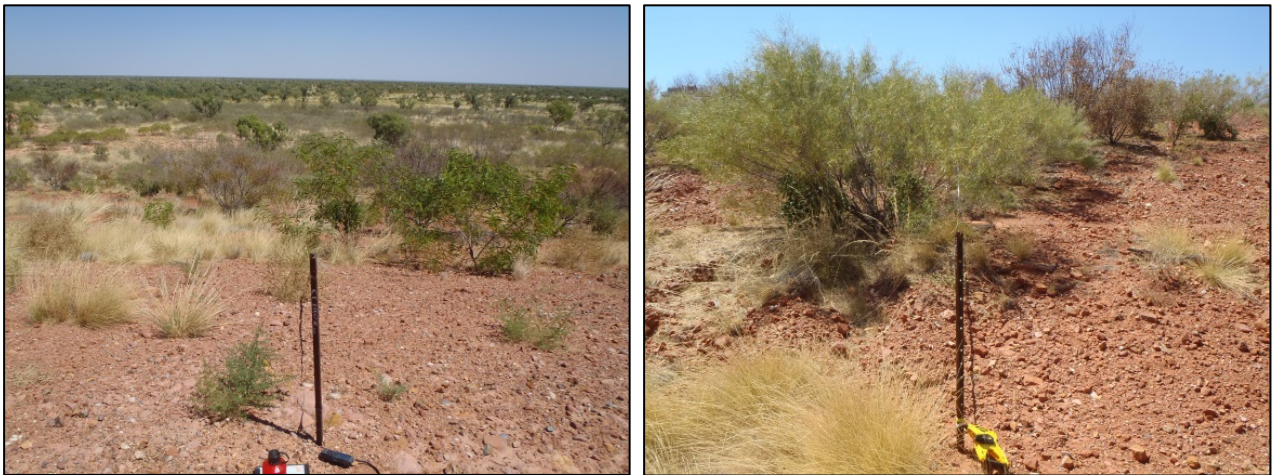
Plate 7: Transect CYTR02 in 2014, from 0m (left) and 50m (right)

The Coyote WRL transect (CYTR02) had the greatest proportion of slope erosion (20%), both transects CYTR01 and CYTR03 had less than 10% erosion (**Figure 3-8**). Transect CYTR02 had the greatest number of rills identified (17), and each of the sloping rehabilitation transects had two gullies (>30cm deep). There was a large gully located 100m to the west of transect CYTR03 which had been caused by water under-cutting an engineered drain, leaving sediment along the drain and at the base of the landform.

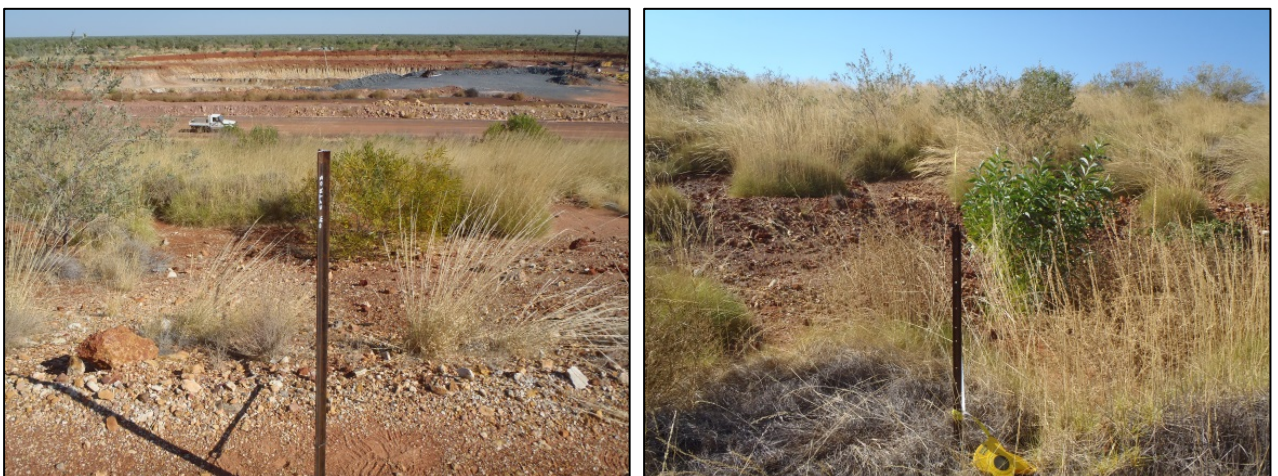
Plate 8: Transect CYTR03 in 2014, from 0m (left) and 42m (right)

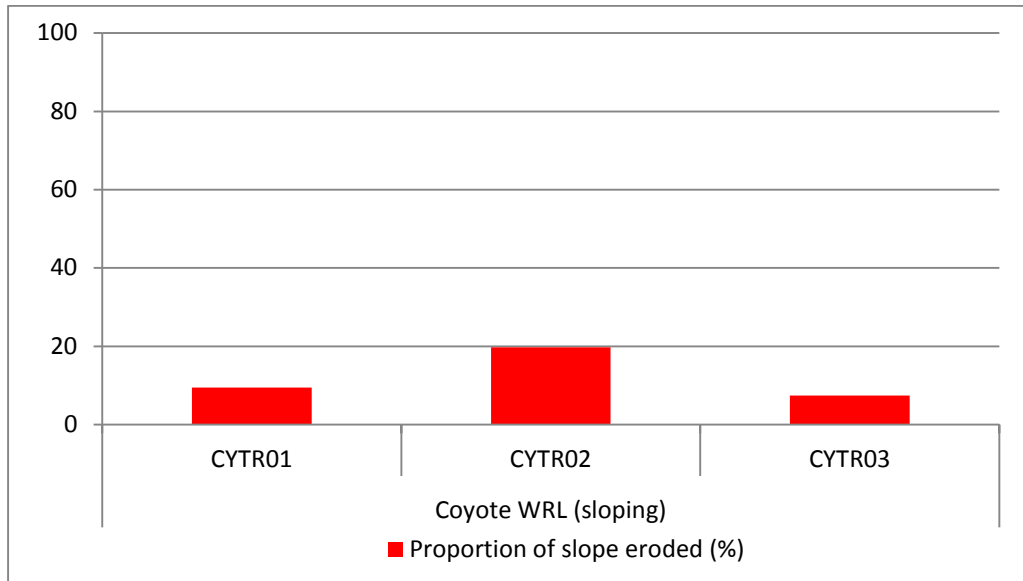
Figure 3-8: Proportion of slope eroded for the 2008 rehabilitation on the Coyote WRL

As the 2014 monitoring was the first complete rehabilitation assessment carried out on the batters and surface flat of the Coyote WRL, it is recommended that a further two years of monitoring are carried out to ascertain a set of baseline data. Future monitoring could include the addition of a second surface flat transect. Given the development of the vegetation on the batters, remediating erosion features should only be considered if erosion continues to increase in the future.

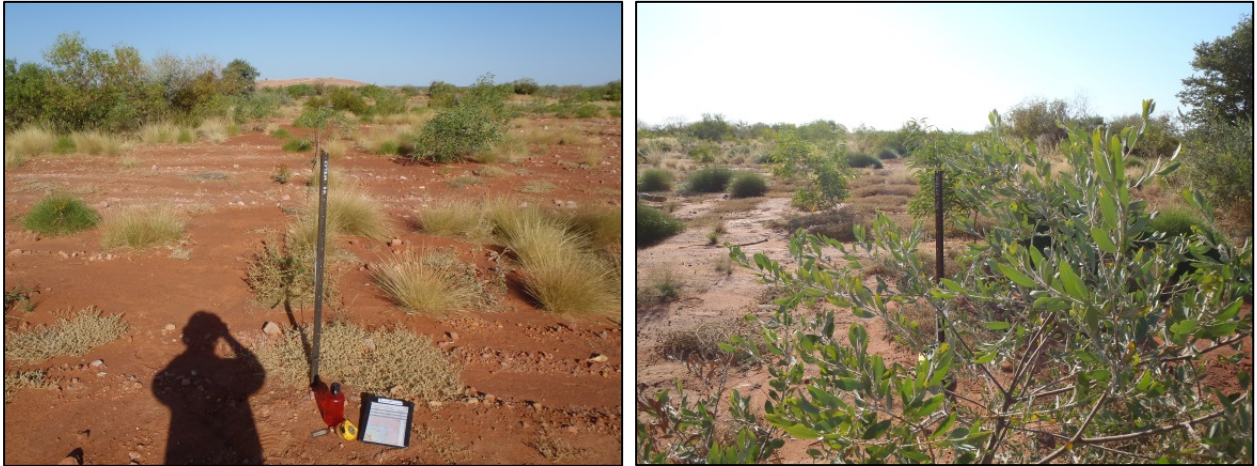
As part of the 2014 rehabilitation assessment on the Coyote WRL a new transect CYTR04 (**Plate 9** Error! Reference source not found.) was installed on the surface flat of the western portion of the landform, within one of the cells demarcated by bunding. Transect CYTR04 was installed within a cell that had good vegetation cover for both lower and upper vegetation stories. Future assessments could include the addition of a flat transect on the eastern portion of the surface flat.

Plate 9: Transect CYTR04 in 2014, from 0m (left) and 50m (right)

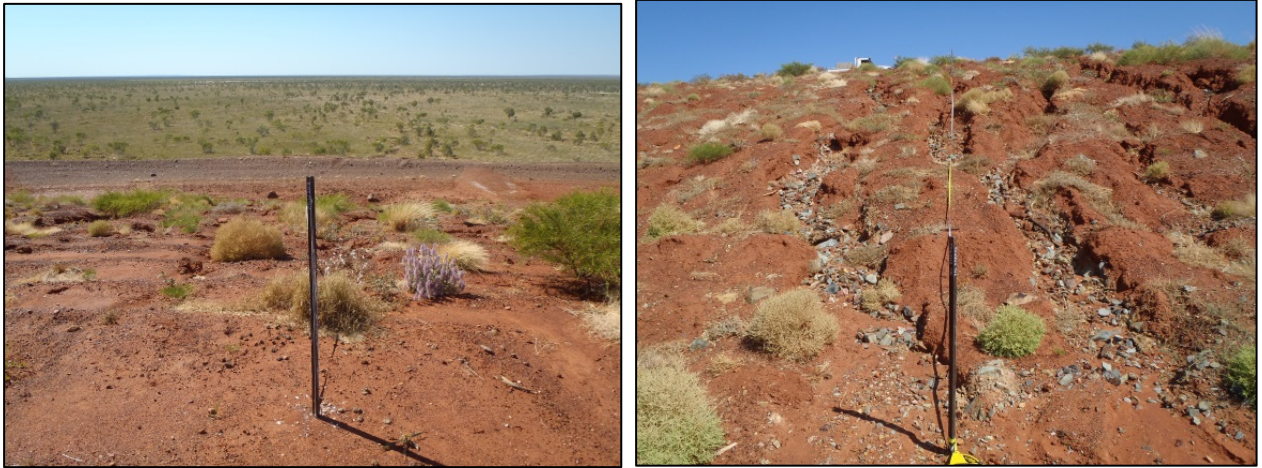
Plate 10: Transect BHRM02 in 2014, from 0m (left) and 36m (right)

Transect BHRM02 had the greatest lower storey vegetation cover of the five sloping rehabilitation transects on the Bald Hill WRL, greater cover than sloping analogues BHA01 and BHA02 (Figure 3-15). The Bald Hill rehabilitation mostly comprises of small shrubs and native grasses, rather than the *Triodia* dominated Bald Hill analogue transects. The density of lower storey species was similar between the rehabilitation transects, ranging from 2,857 plants/ha (BHRM05) to 6,500 plants/ha (BHRM06), however these were well below the densities of the analogue transects. There was no potential upper storey species identified on any of the sloping rehabilitation transects.

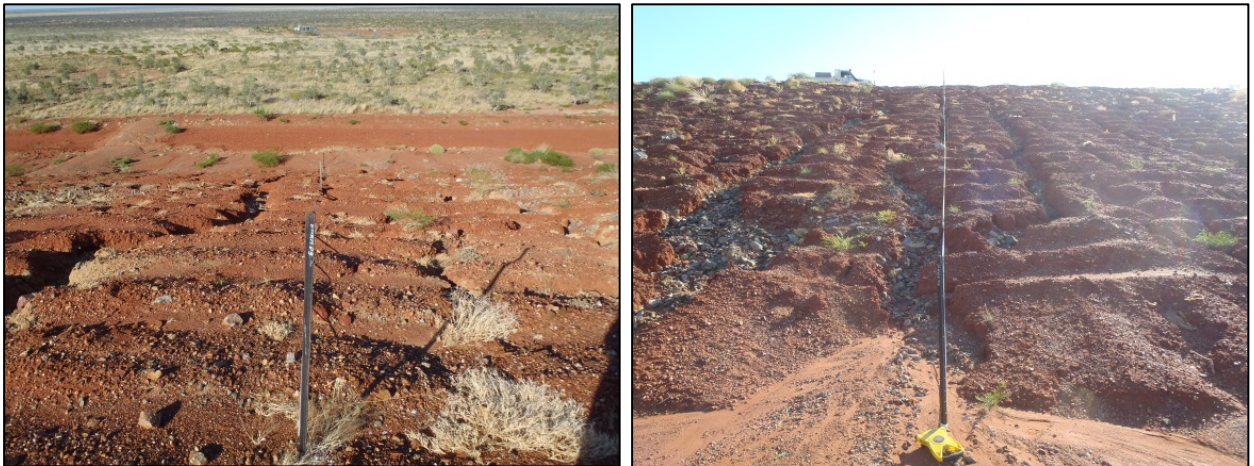
Plate 11: Transect BHRM05 in 2014, from 0m (left) and 33m (right)

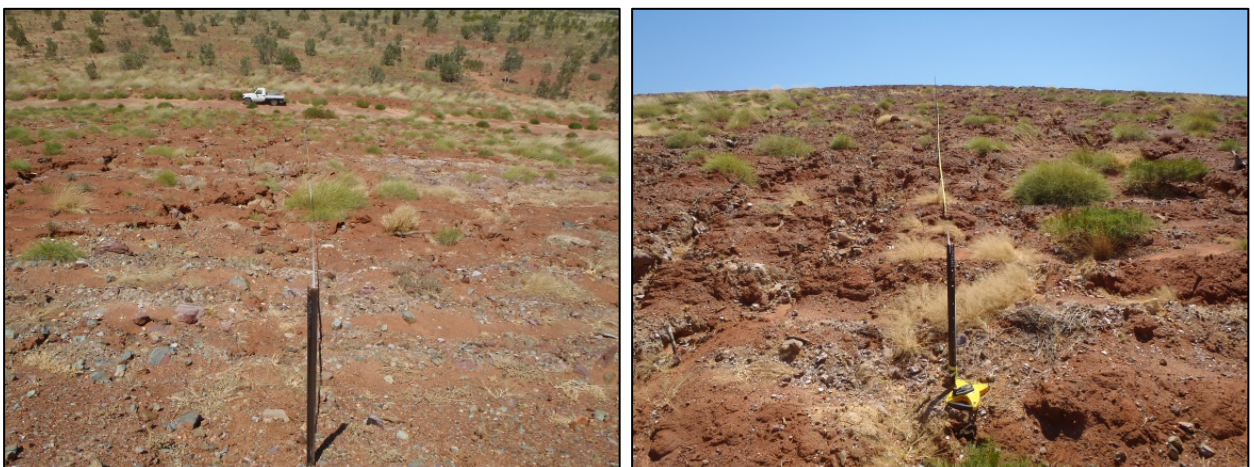
Plate 12: Transect BHRM01 in 2014, from 0m (left) and 50m (right)

The proportion of slope erosion was high across the five sloping rehabilitation transects (**Figure 3-16**). Transect BHRM01 had the greatest proportion of slope erosion (24%), comprising of 15 rills (less than 30cm deep) and seven gullies (over 30cm in depth). Transect BHRM05 had the highest number of rills (21) and BHRM06 had the least (11) gullies. Given the age of the rehabilitation it is likely that the proportion of slope erosion will increase, if this occurs remediation work may be required.

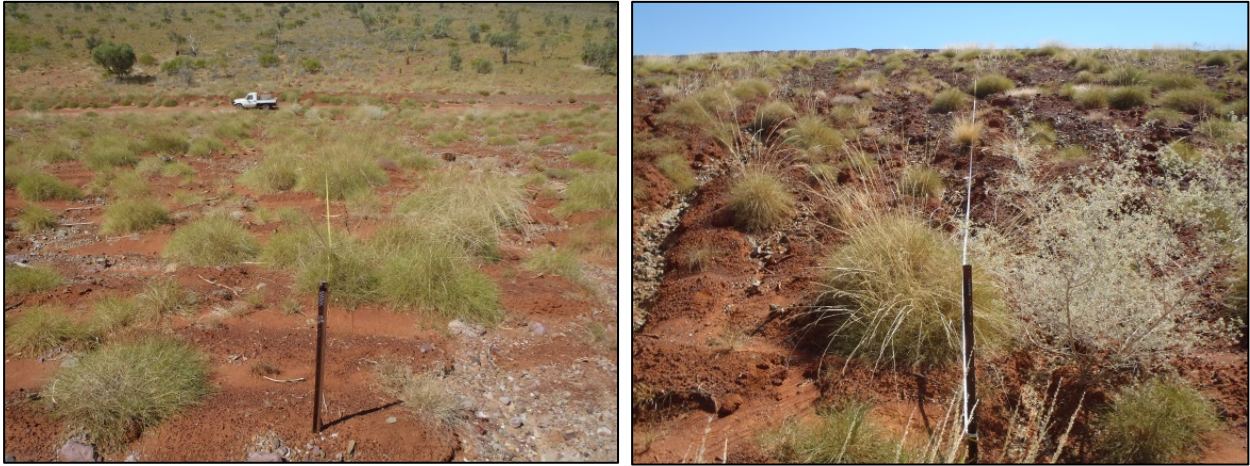
Plate 13: Transect BHRM06 in 2014, from 0m (left) and 50m (right)

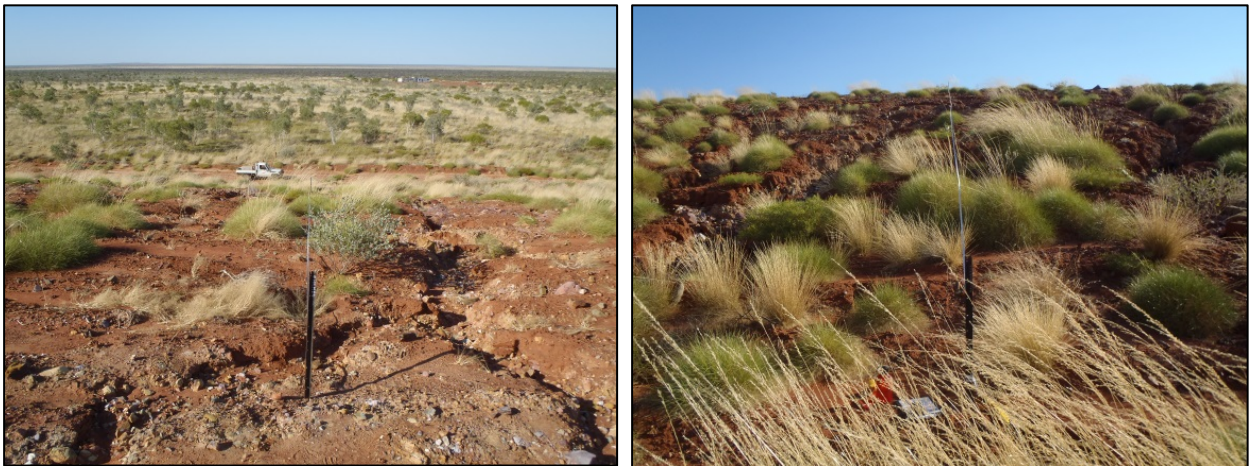
Plate 14: Transect BHRM04 in 2014, from 0m (left) and 43m (right)

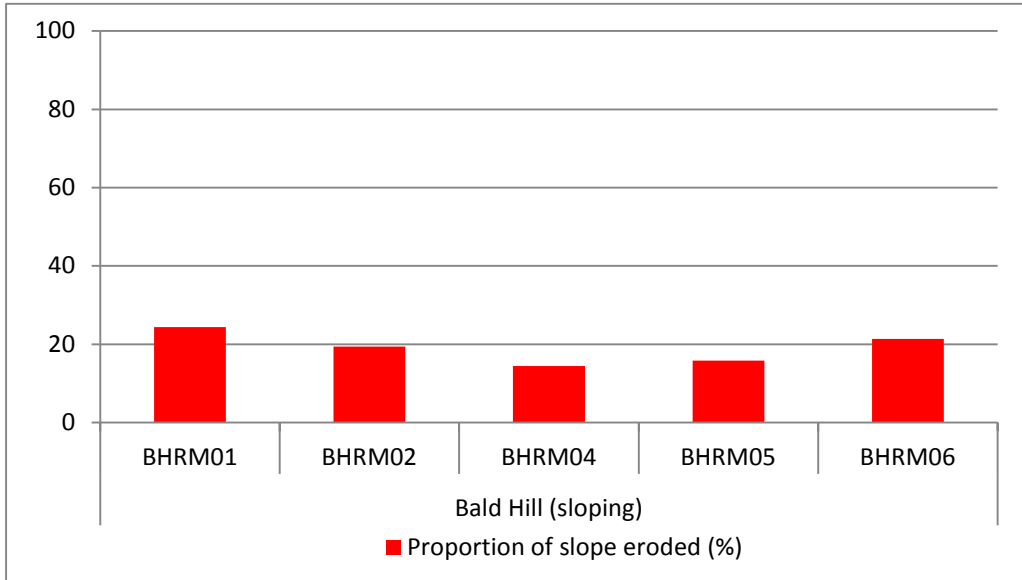
Figure 3-16: Proportion of slope eroded for the 2012 rehabilitation on the Coyote WRL

Given that this was the first complete assessment of the Bald Hill rehabilitation it is recommended that a further two years of monitoring are conducted to complete a set of baseline data for the rehabilitation area. The surface flat of the Bald Hill WRL should to be ripped and have some seed applied prior to the following wet season, November to February. Following this, a second transect could be installed on the surface flat. The remediation of erosion features on the batters could be considered in a selected approach that would not greatly affect the current vegetation cover.

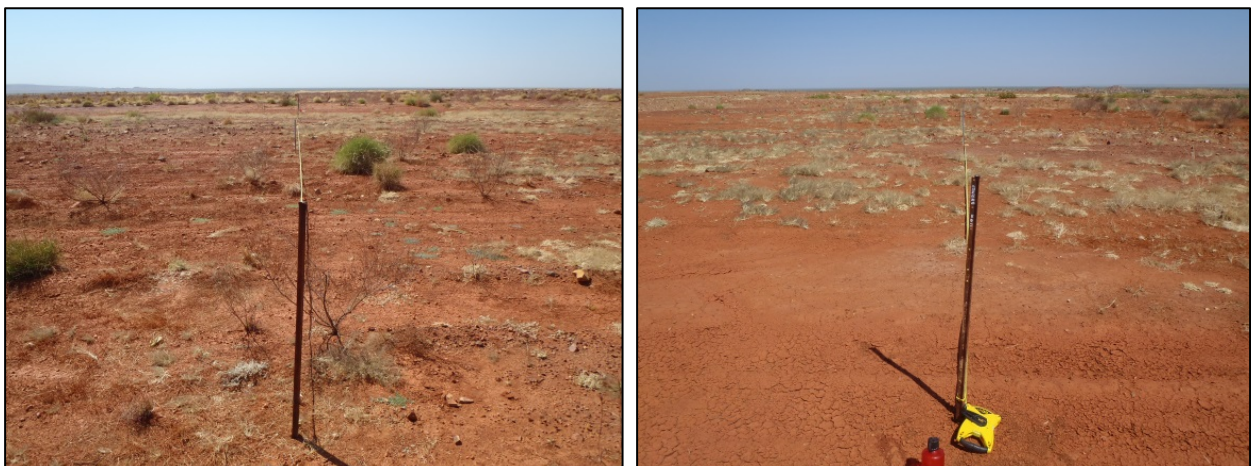
The surface flat of the Bald Hill WRL was divided into cells to aid water management. Previously, transect BHRM07 had been divided up into four sub-transects to better represent the surface of the WRL. The 2014 assessment re-installed a single transect in the only cell that had vegetation present (Plate 15).

Plate 15: Transect BHRM07 in 2014, from 0m (left) and 33m (right)

The surface flat rehabilitation on the Bald Hill WRL had landscape function indices that performed well below the indices of the flat analogue transects (**Figure 3-17**). This was attributed to the flat surface nature of the landform which had no integration of waste rock within the topsoil and the absence of ripping reduce the amount of resource capture zones. The lack of soil surface cover in particular had resulted in a low stability index. Additionally there was very little perennial vegetation development on the surface flat resulting in low infiltration and nutrient cycling indices. The proportion of organic patch zones was less than half the proportion of zones on the flat analogue transects (**Figure 3-18**).

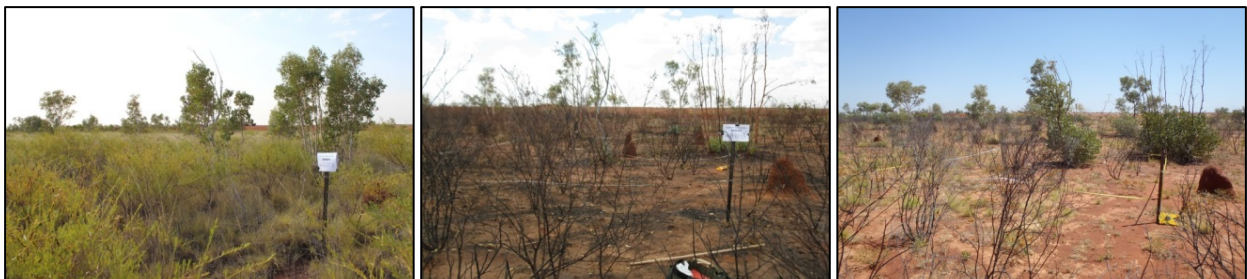
The variations in vegetation health and cover at both Coyote and Bald Hill were related to post fire recovery at these sites, rather than influences related to the mining operations. Three of the Coyote photo monitoring sites, CYMS02, CYMS03 and CYMS05, were burnt in September 2011. As a result there was a high density of *Triodia schinzii* and *Triodia pungens* as well and *Acacia stipuligera*, as these species are known to be stimulated by fire events. Photo point KSMS05 at Bald Hill was burnt in August 2013 (**Plate 16**). This site had previously been dominated by *Acacia hilliana* and *Triodia pungens* and the juveniles of these species were present in 2014. The remaining photo points had shown little change over the previous three years of assessment.

Plate 16: Photo point KSMS05-Q1 pre and post the August 2013 fire, left (2012), middle (2013) and right (2014)
