**Subject: Submittal of the Heavenly Mountain Resort Mitigation and Monitoring Plan  
Annual Report**

# Heavenly Mountain Resort

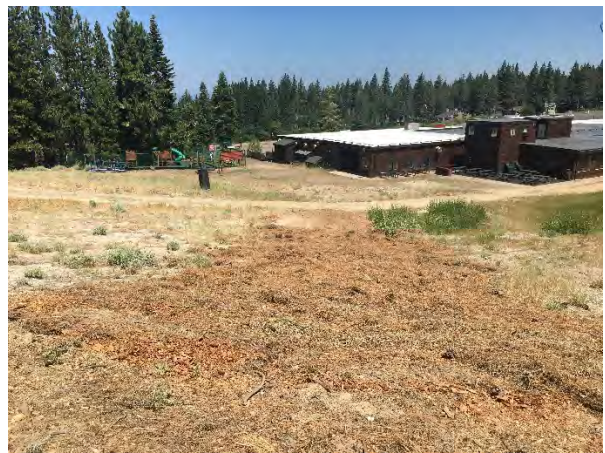
Before: Gully extending across ski slope in erosive soil causing sediment deposition.

After: Area tilled and mulched to provide erosion resistance and effective cover.

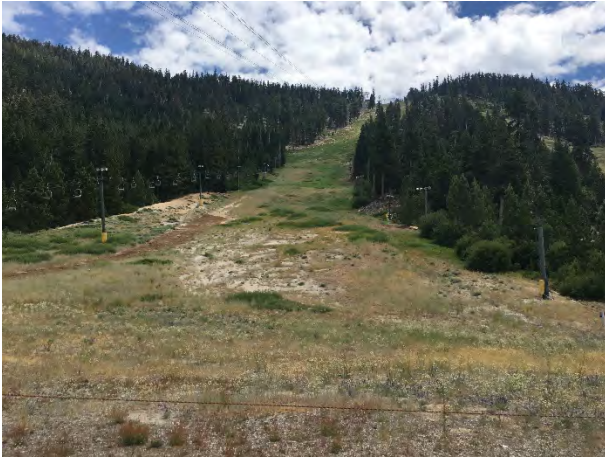
### World Cup

Within the Bijou Creek watershed (CA-6), Heavenly completed two projects related to inventoried hotspots. The gully on World Cup Run was stabilized using native soil and wood chips and the existing drop structures were repaired. The gully on First Ride Run was similarly stabilized with native soil and wood chip mulch, and waterbars were reestablished to direct and manage sediment movement. Photographs of both these projects are included in the Watershed Maintenance and Restoration Program 2018 Annual Report (Appendix I).

Before: Work in progress on covering gully with mulch on steep ski slope.

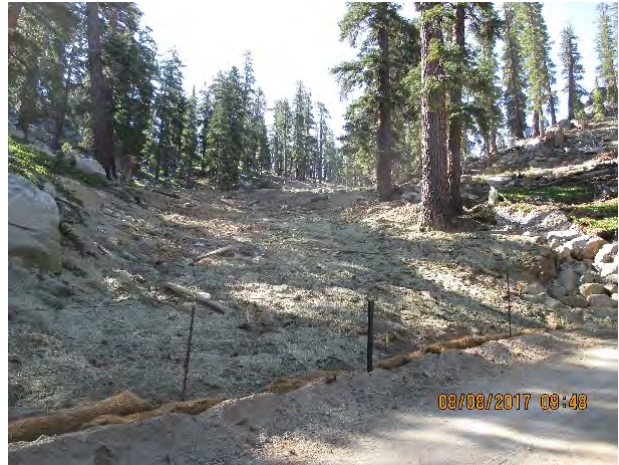
Hand Grenade Chute 2017 Before: bare soils, rilling, water bar minimally functioning

Hand Grenade Chute 2017 After: erosion resistance significantly improved on steep slope and toe of slope protection provided by cutoff ditch and pine needle wattle

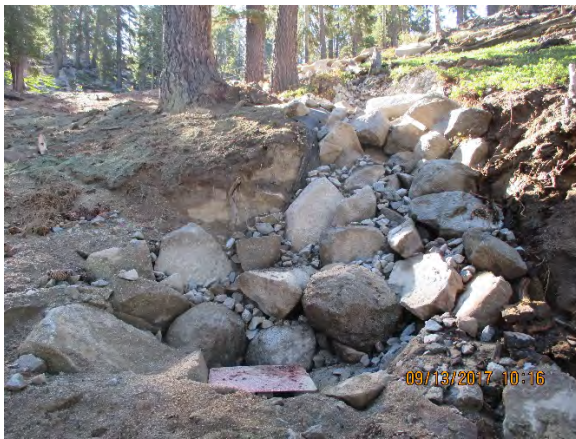
Hand Grenade Chute After 2017: rock riprap protection on gully with geotextile and covered culvert inlet to pass flows across roadway

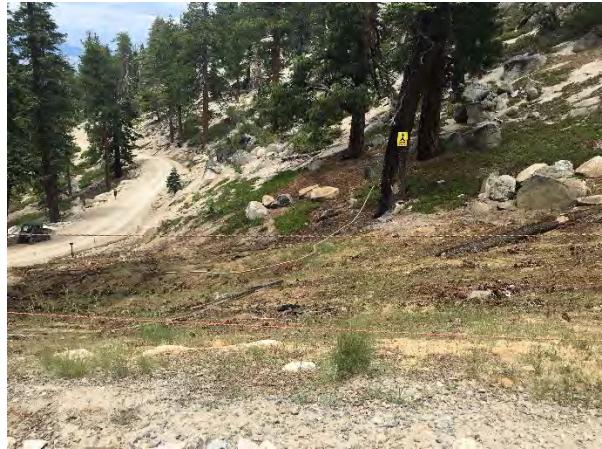
Hand Grenade Chute 2018: erosion resistance significantly improved with revegetation

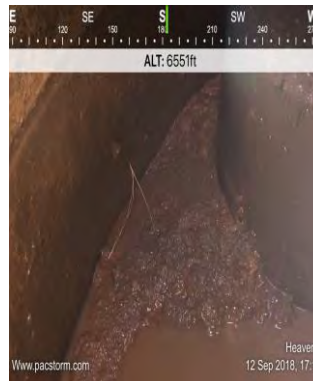
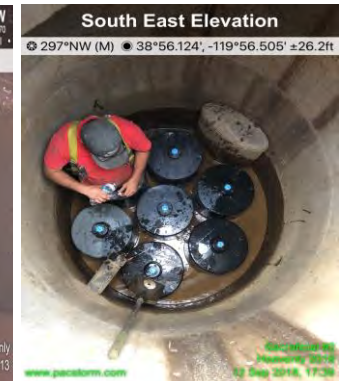
**Implementation**  1) Were BMPs designed to maintain resource protection and meet water quality standards?  
 1 = Meets/Exceeds 2 = Minor concerns 3 = Major concerns 4 = Failure to address BMPs **Implementation Score:**   
 2) Are BMP measures constructed according to contract design specifications/plans?  
 1 = Meets/Exceeds 2 = Minor concerns 3 = Major concerns 4 = Failure to follow design specifications

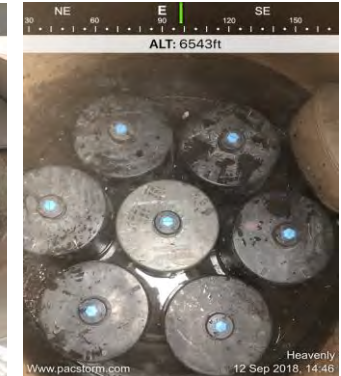
a) Are erosion control measures applied limiting erosion processes and sediment delivery to SEZ?  Meets/Exceeds  Minor Concern  Major Concern  NA

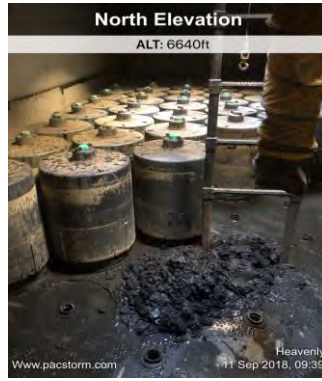
c) Are natural or constructed infiltration zones effectively collecting and treating runoff?  Meets/Exceeds  Minor Concern  Major Concern  NA

a) Are sensitive areas and construction zones adequately delineated?  Meets/Exceeds  Minor Concern  Major Concern  NA

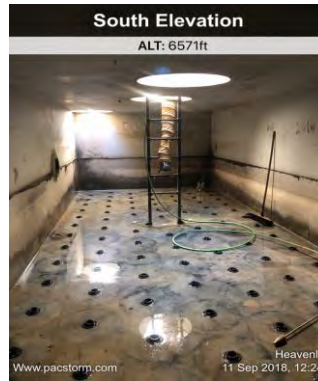
a) Are BMPs for hazardous/toxic substances controlling chemical delivery to soils/water?  Meets/Exceeds  Minor Concern  Major Concern  NA

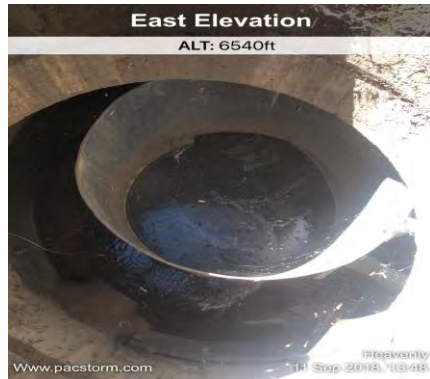
During maintenance

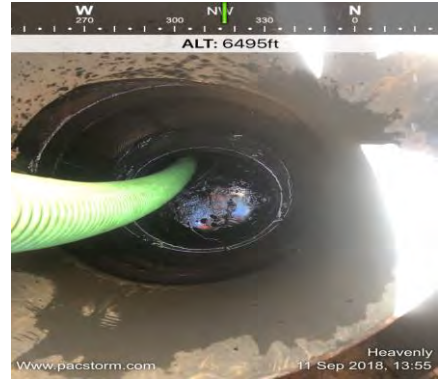
Maintenance completed

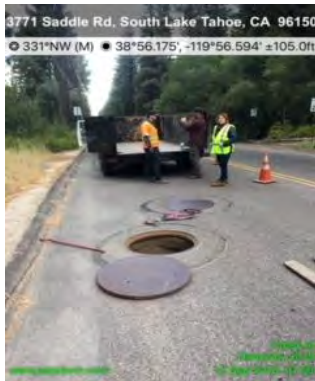
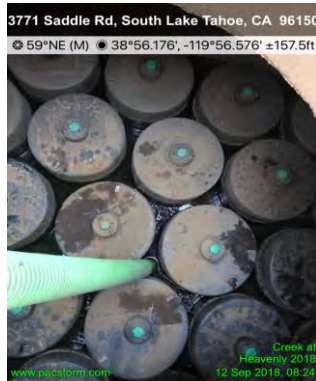
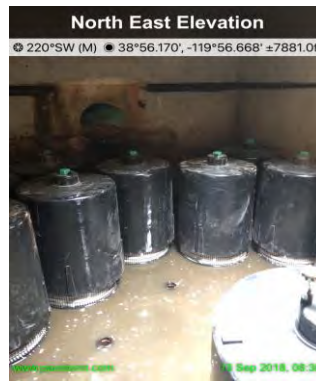
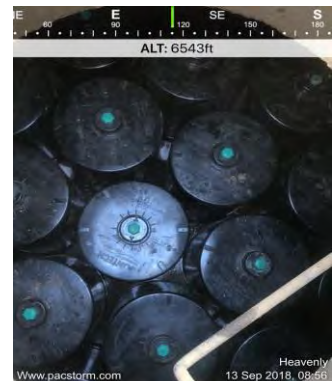
Wildwood Vault

Sediment removed

Filters not replaced

Let it be known that on September 11th and 12th, 2018 Three CONTECH StormFilter systems and one CDS HDS system were maintained by a qualified professional at a frequency and in a manner consistent with the manufacturer's guidelines. Sediment was removed. System internal components were inspected and OEM manufacturer supplied replacement filters were installed. Units 4,5 and 10 were powerwashed and sediment removed. No filters were replaced on these three units due to loose media.

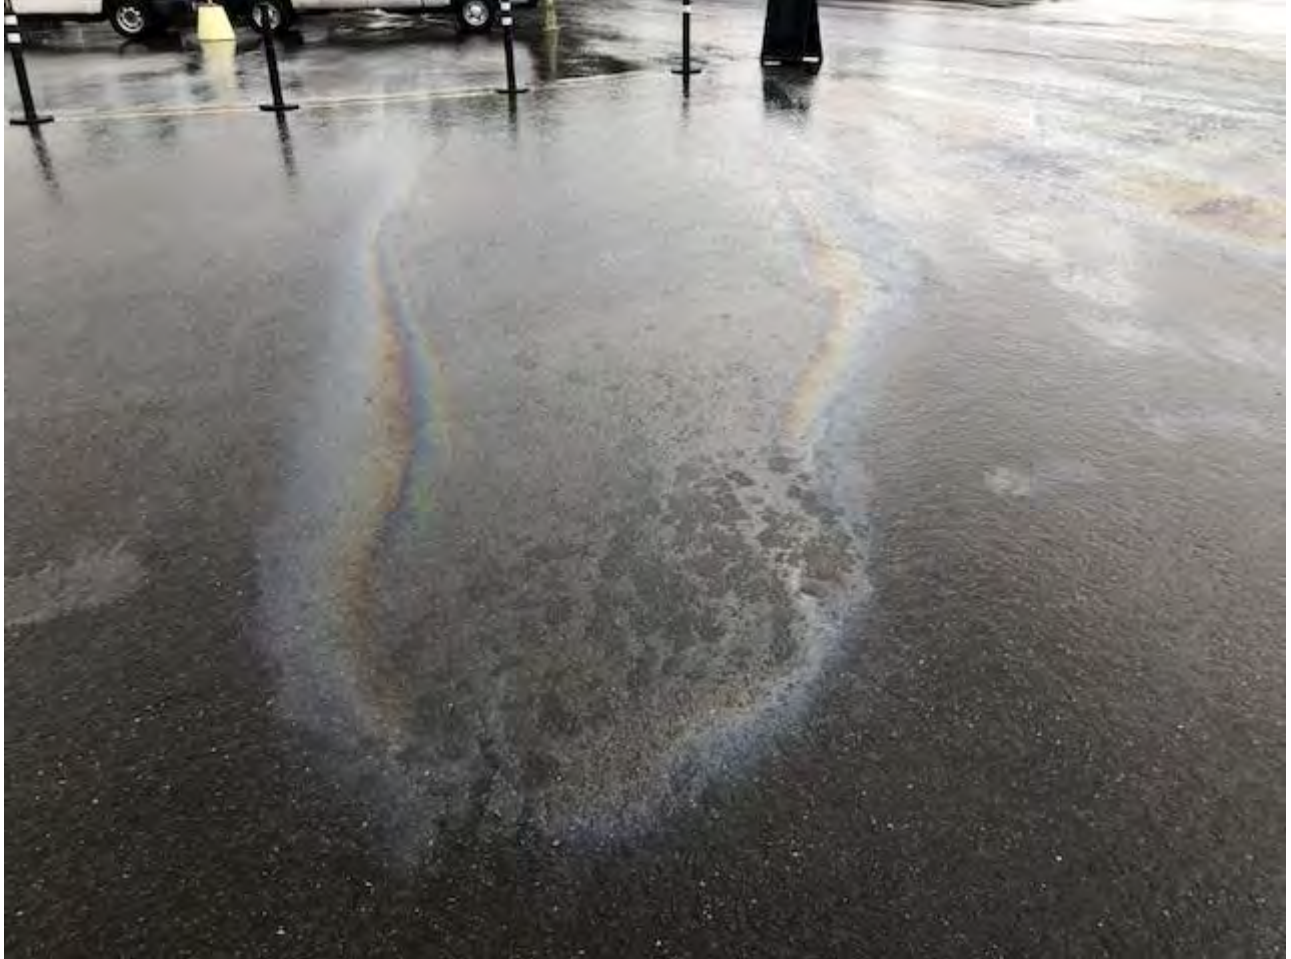
Heavenly Mountain Resort: Tahoe Transportation District Diesel Fuel Release (Estimated 10-15 gallons) from Contracted Skier Shuttle Transit Bus on 4/7/18

**Diesel Sheen in Upper parking lot on 4/7/2018**

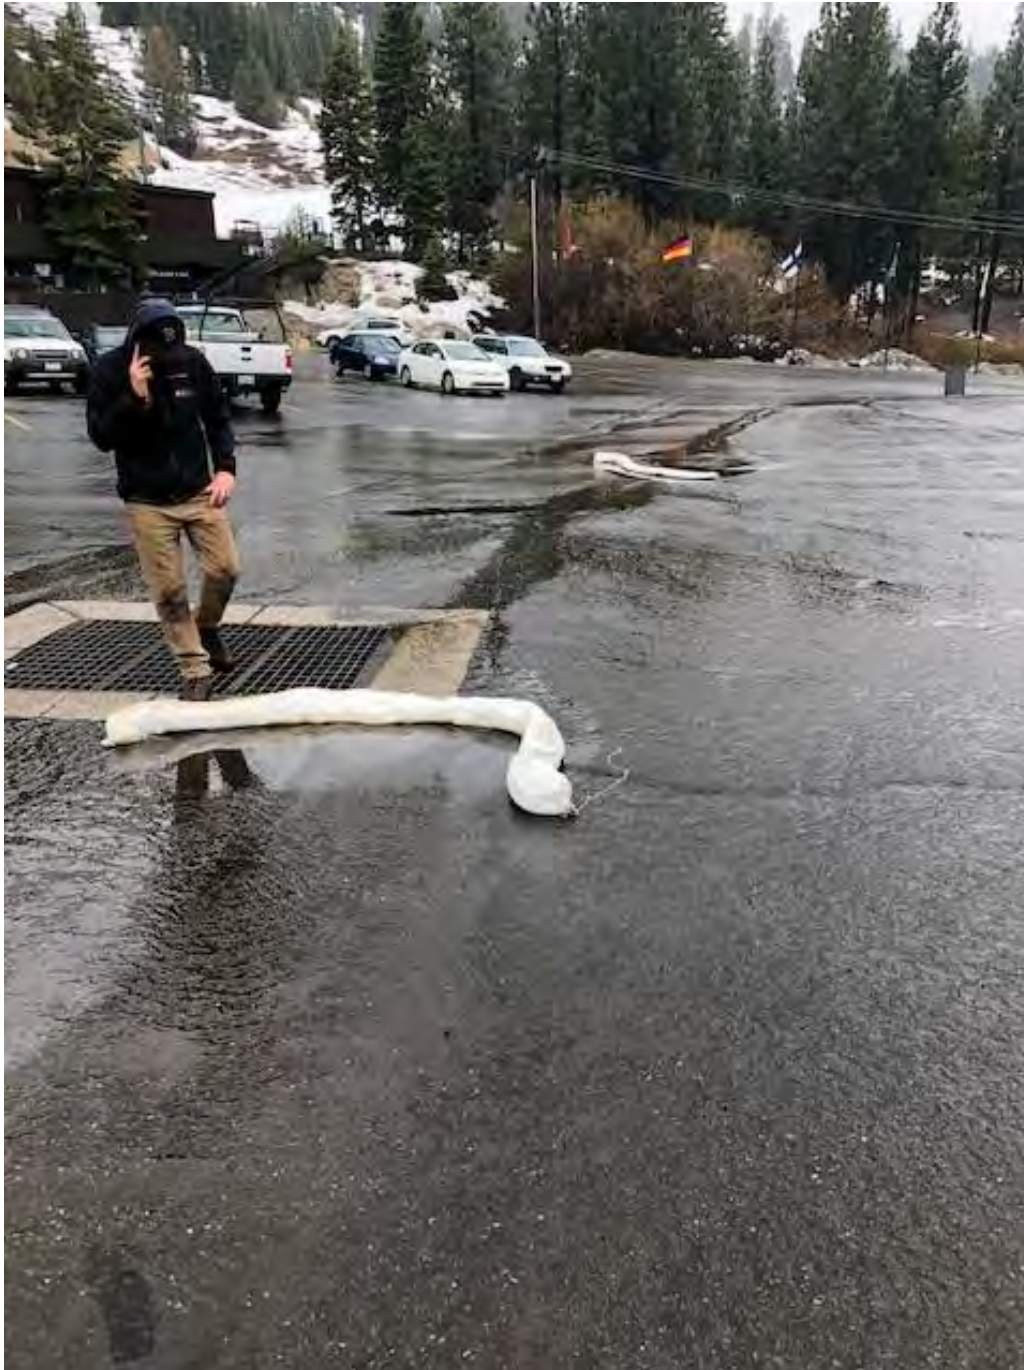
Heavenly Mountain Resort: Tahoe Transportation District Diesel Fuel Release (Estimated 10-15 gallons) from Contracted Skier Shuttle Transit Bus on 4/7/18

**Absorbant Booms deployed at storm drains Upper CML Parking Lot.**

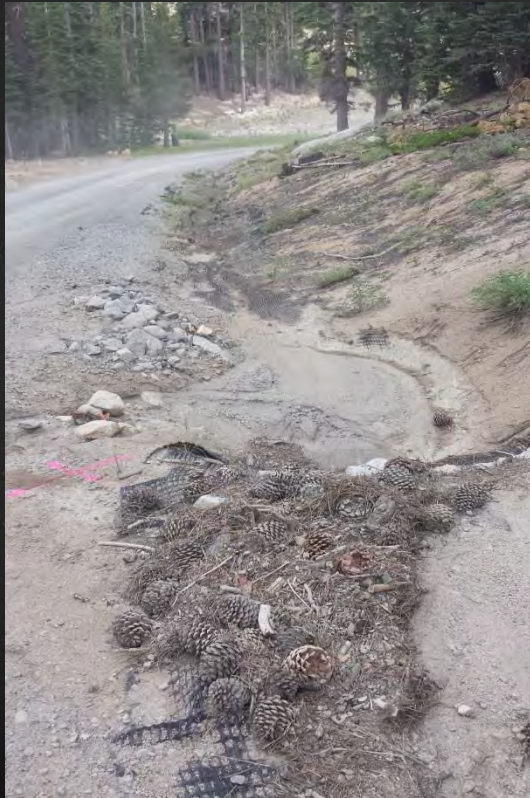
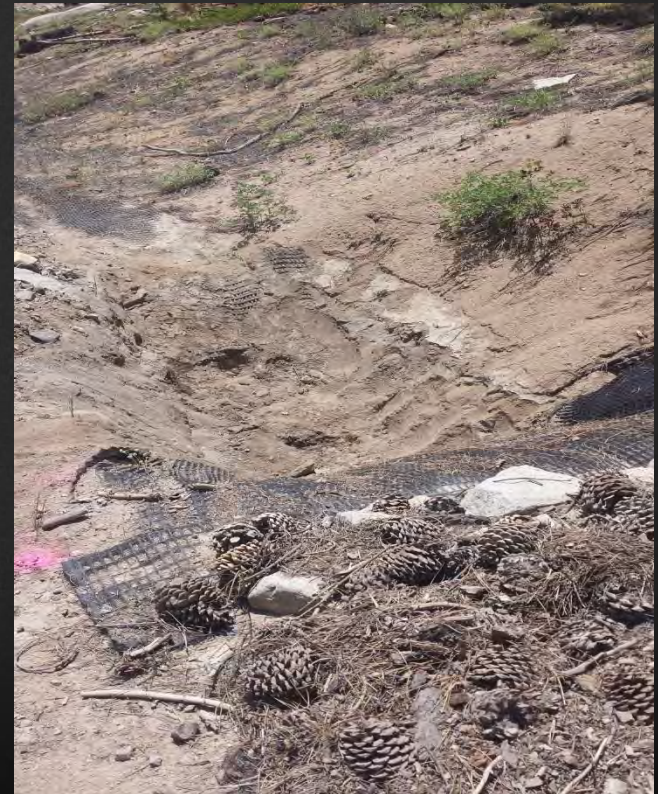
## Maggie's Pits Vacuumed out in October 2014

After picture highlights the improvement in sediment capacity

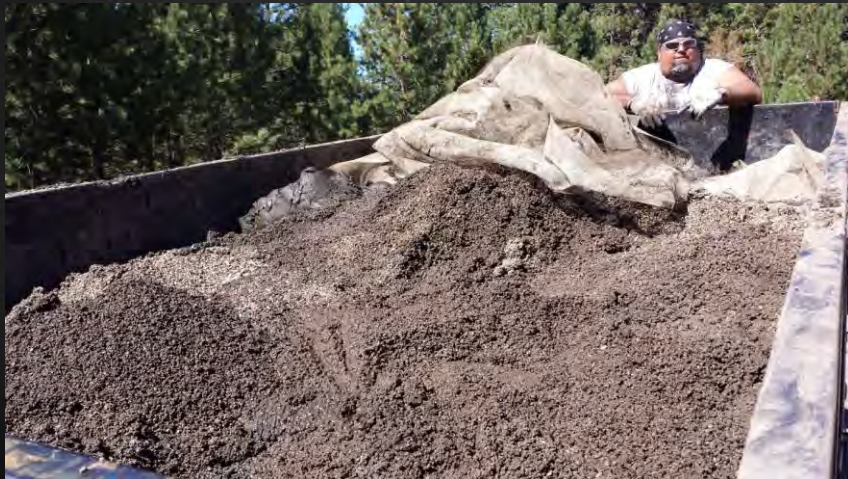
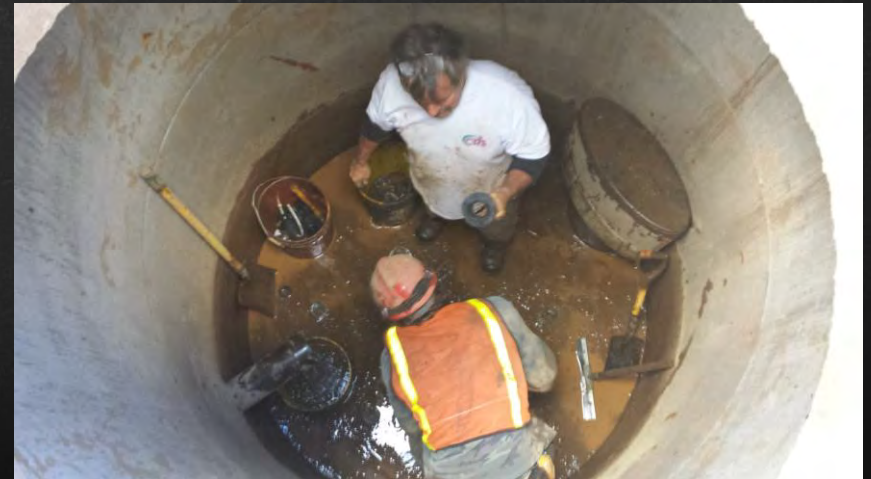
# CML Storm Filters continued

Sacrificial filters being replaced annually with 14 new phosphorus filter media, which is showing some positive improvements in WQ, year 4 of use. Met all WQ standards on November 15<sup>th</sup> 2017 Storm!

~15+ cubic yards of spend filter media and sediment removed in October 2017

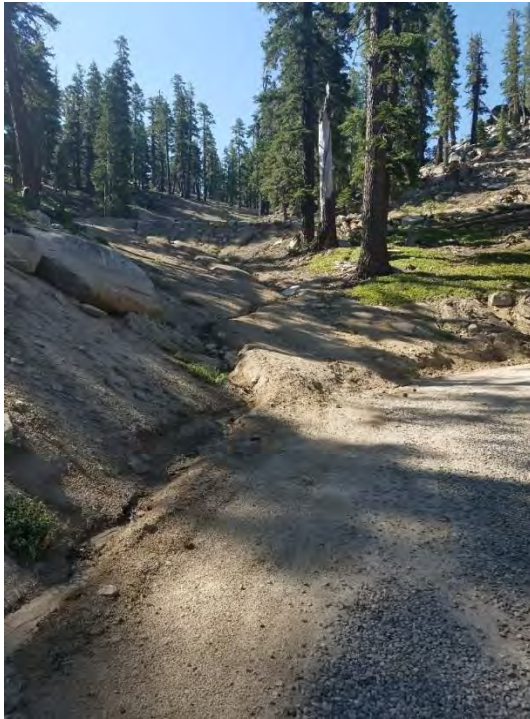
Before ↓

Hand Grenade/Roundabout: Year 2 after restoration site is stable, and vegetation is growing (below right) as of September 2018:

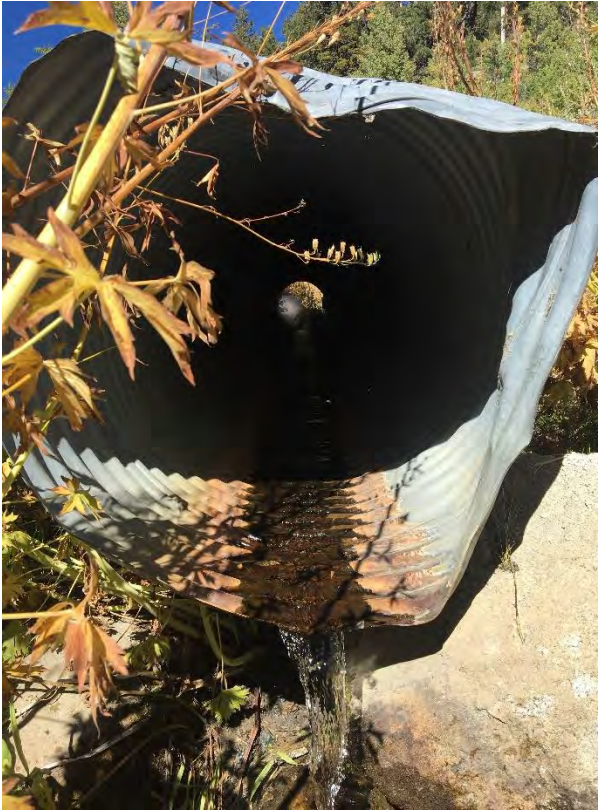
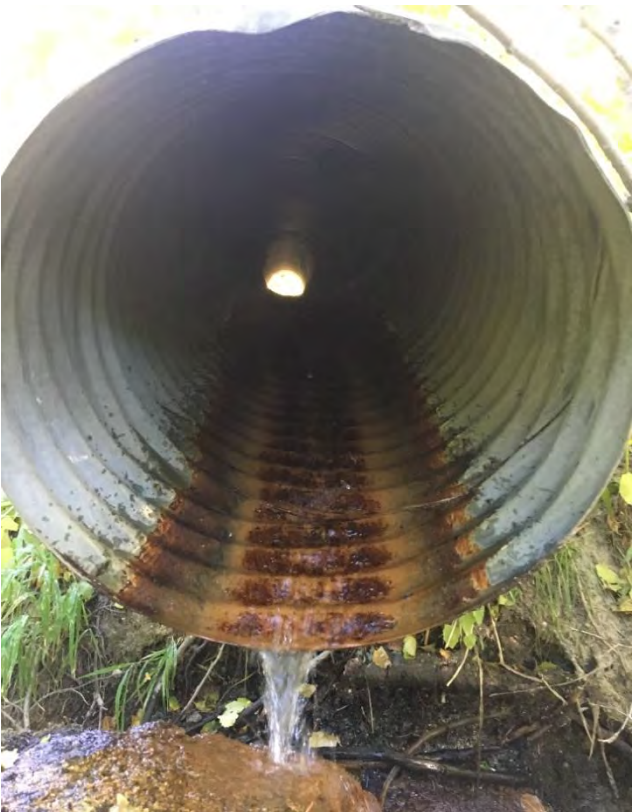
On Mountain Culverts 9-25-18:

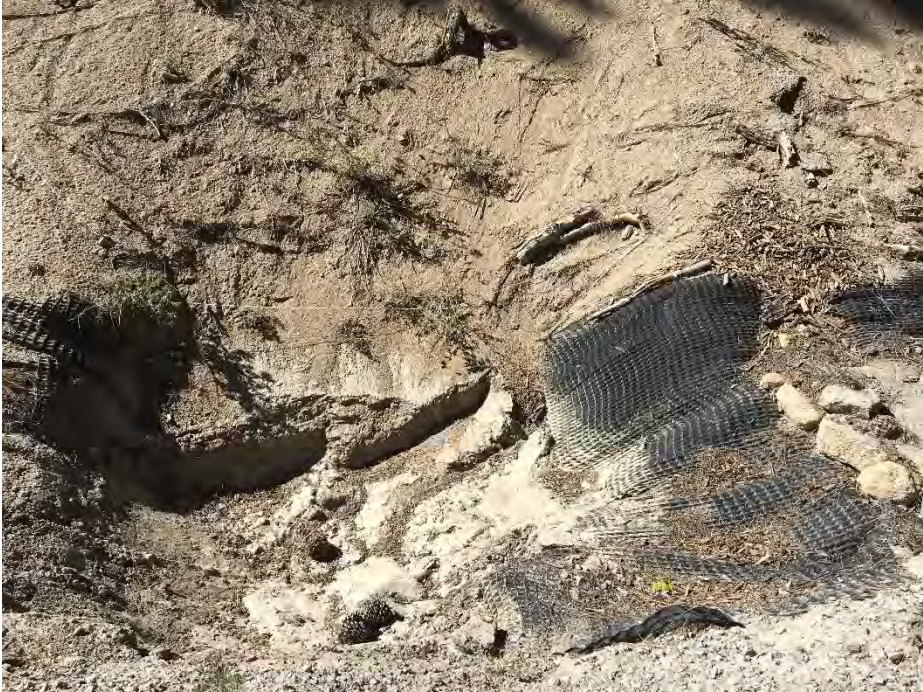
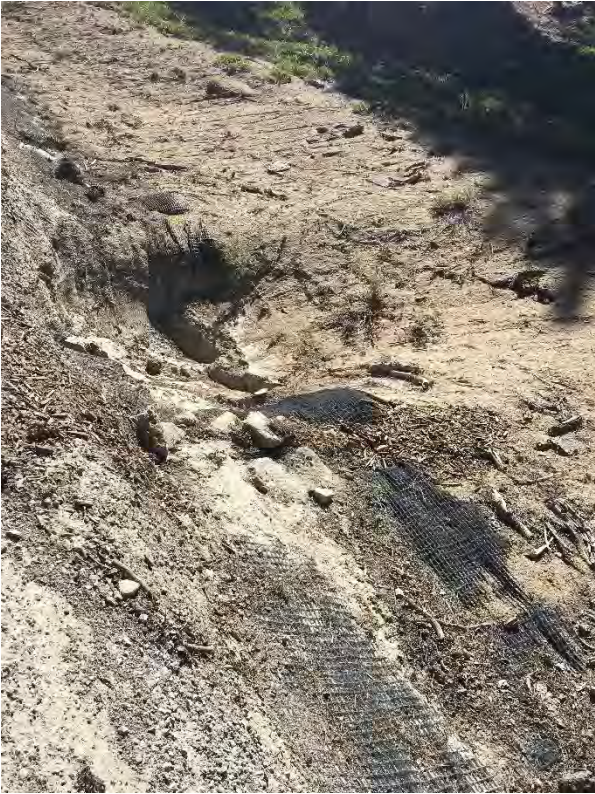
CA Maggies Roadside Drainage Maintenance (Manual and Mechanical removl of sediment) :

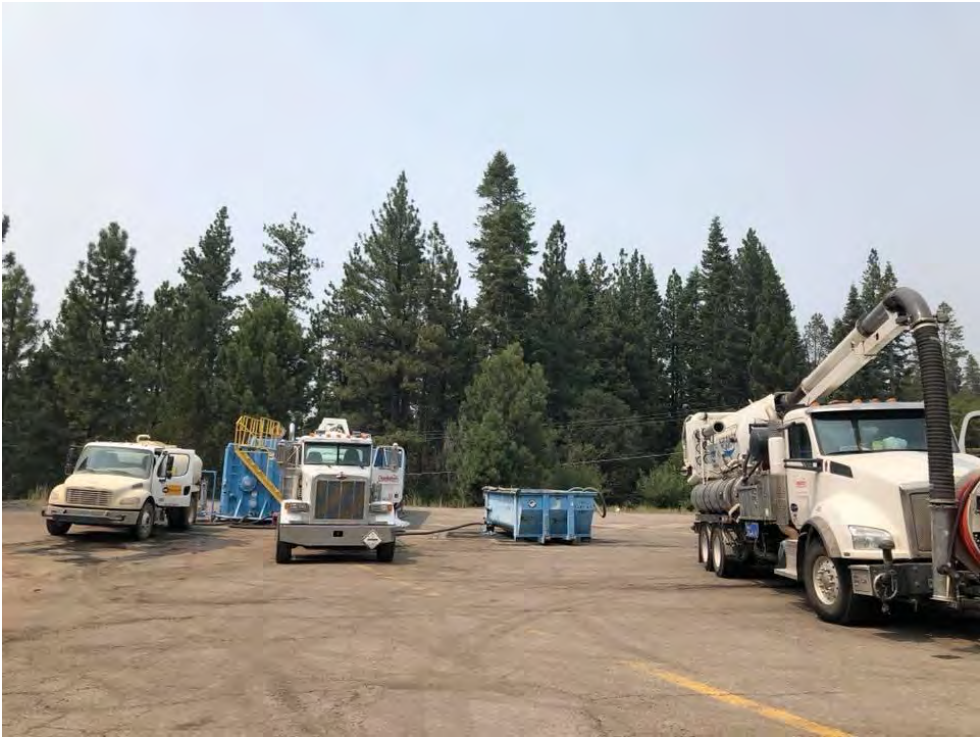
CA Base Storm Drain Maintenance with Clean Harbors August 2018:

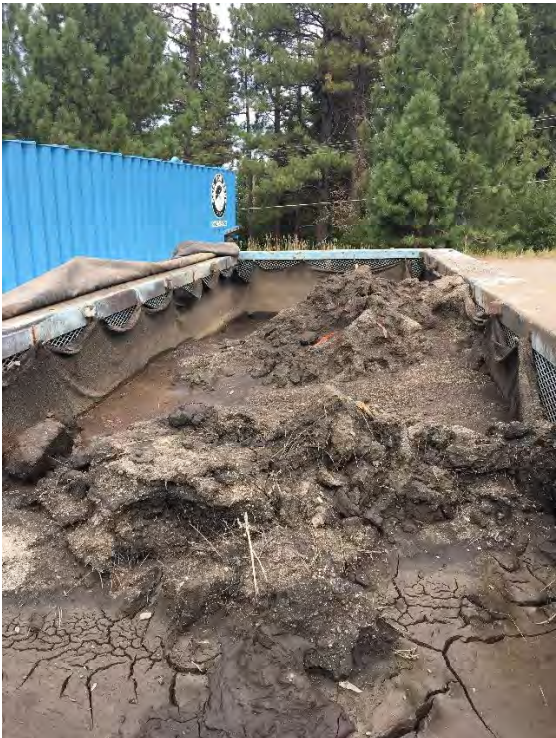
CA Base Storm Drain Annual Maintenance with Clean Harbors August 2018:

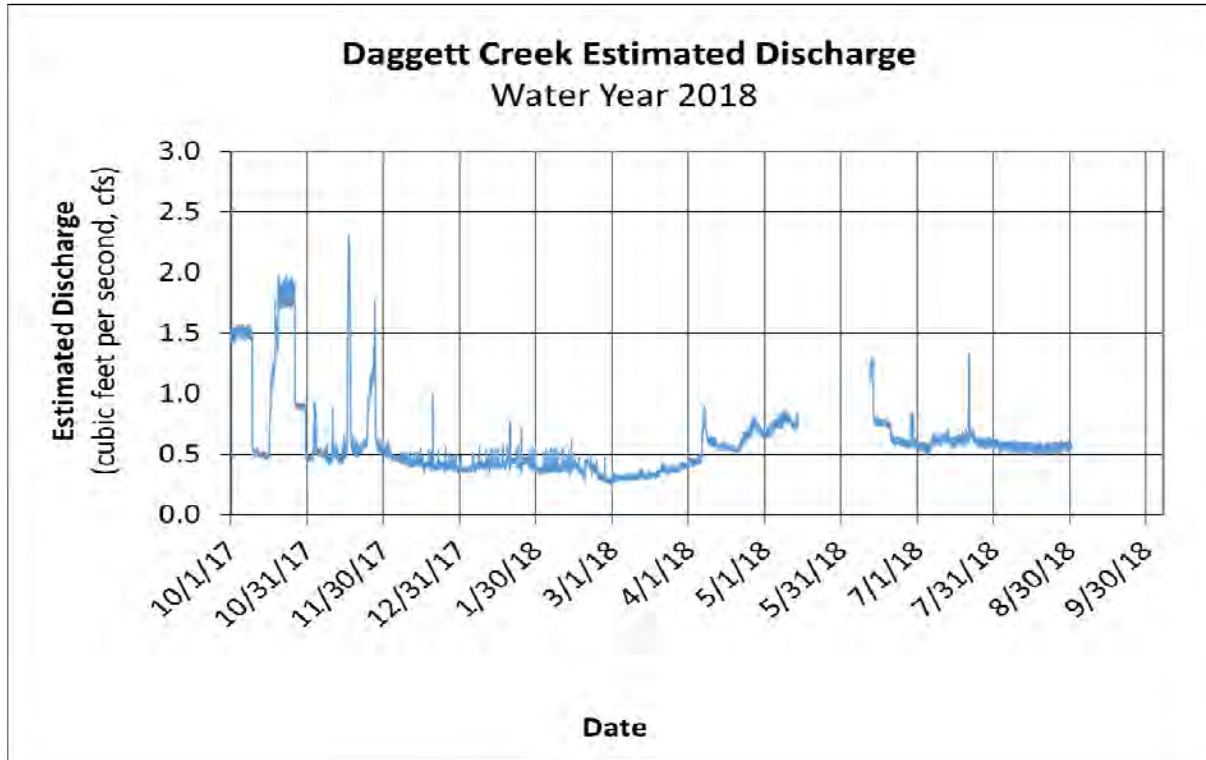
**Figure 1. Daggett Creek Estimated Discharge**  
Water Year 2018

Results of the WY2018 for Daggett Creek discharge are shown in Figure 1 (attached) in cubic feet per second. Elevated runoff from record precipitation during the winter WY2017 carried into the beginning of WY2018. This is reflected in the relatively high creek flows through November 2017 compared to previous monitoring data. Flows normalized over the winter and into the spring of 2018.

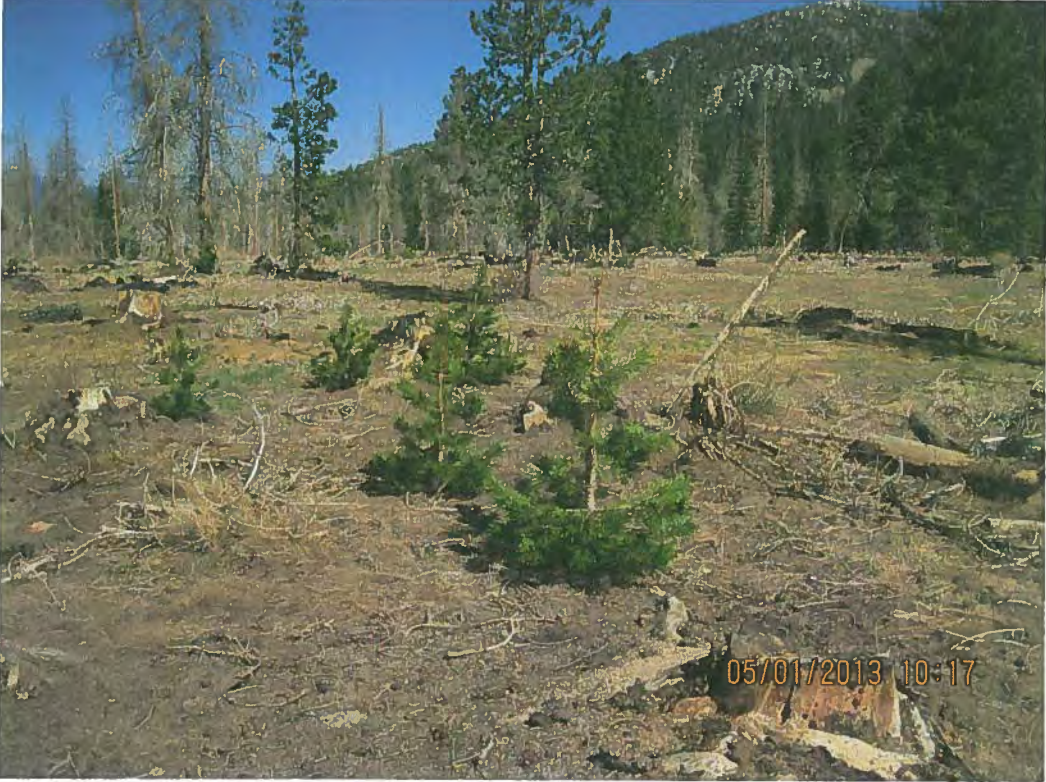
**Photo 2: Natural regeneration occurring within the stand.**

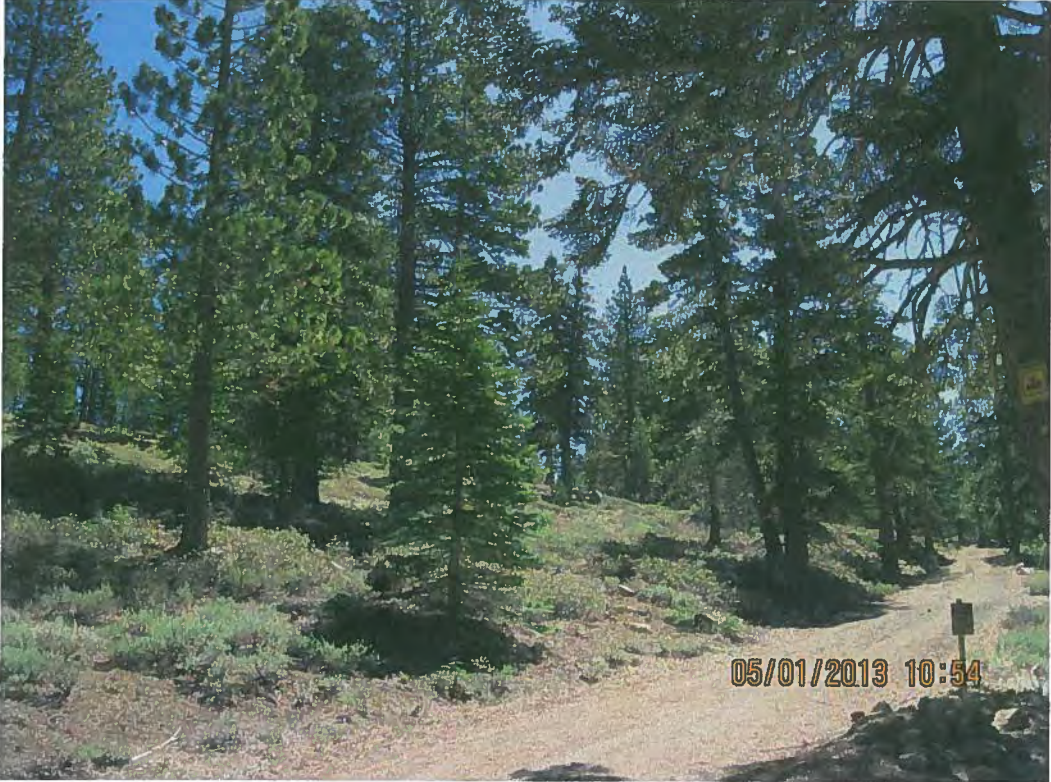
**Photo 3: Enhancement of older forest portion of the stand.**

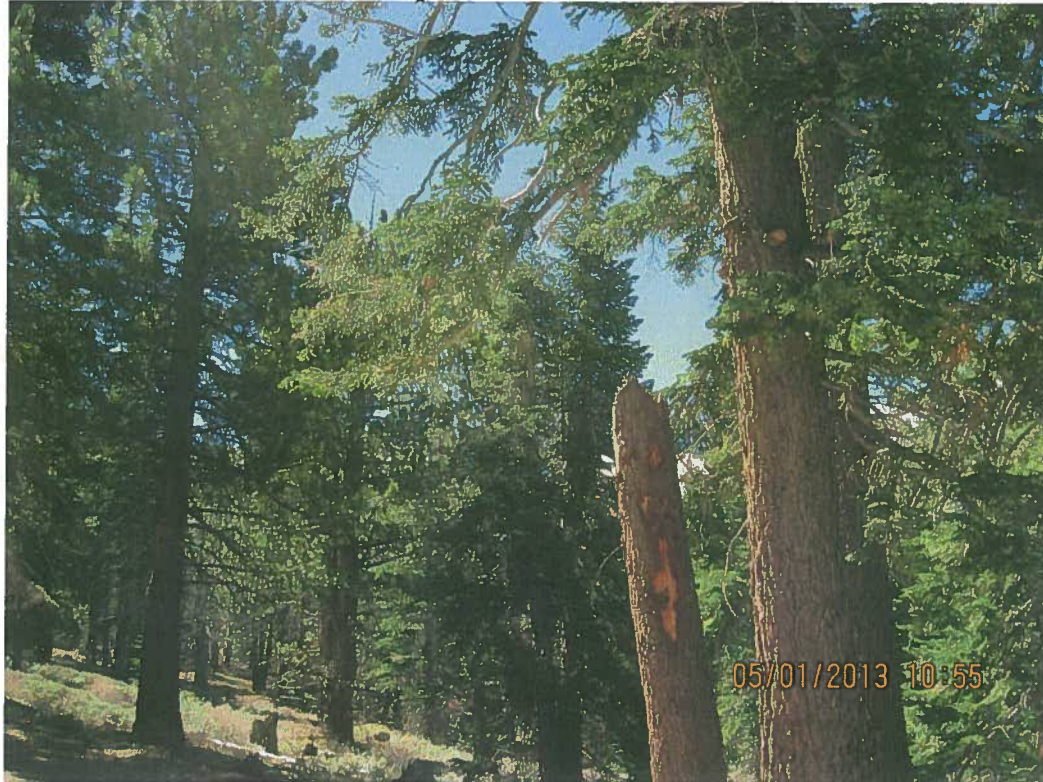
Photo 4: Enhancement of older portion of the stand.
