DALYUP AND WEST DALYUP RIVERS

ACTION PLAN

WATER AND RIVERS COMMISSION
WATER RESOURCE MANAGEMENT SERIES
REPORT NO WRM 34
DECEMBER 2002

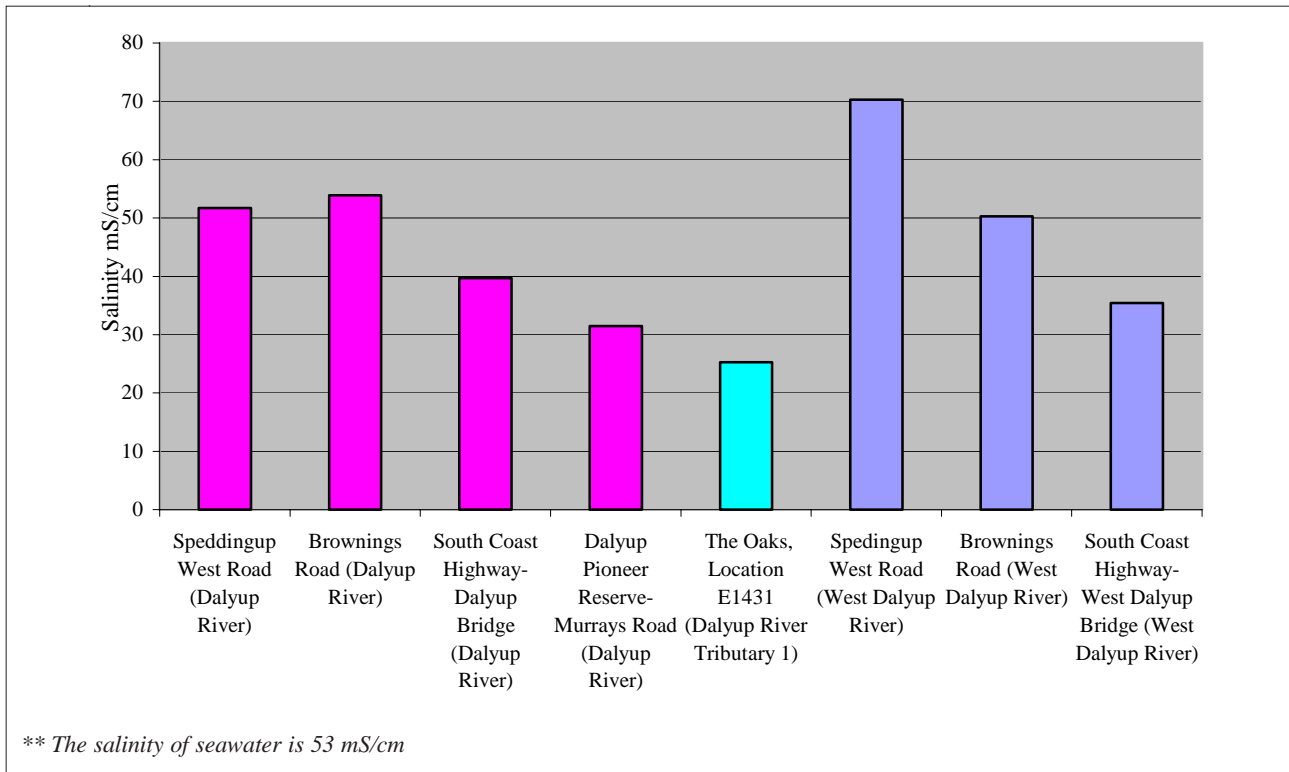
Figure 2. Salinity measurements of the Dalyup and West Dalyup rivers (WRC snapshot results, July 2000).

The salinity of the Dalyup, West Dalyup and Dalyup Tributary 1 ranged from 25.3 mS/cm to 70 mS/cm. The salinity levels decreased further down the catchment suggesting that the water is being diluted with fresh rainwater flowing into the river closer towards the coast. At the top of the catchment, the conductivity was 51.7 mS/cm and 31.5 mS/cm at the Dalyup Pioneer Reserve (Fig. 2).

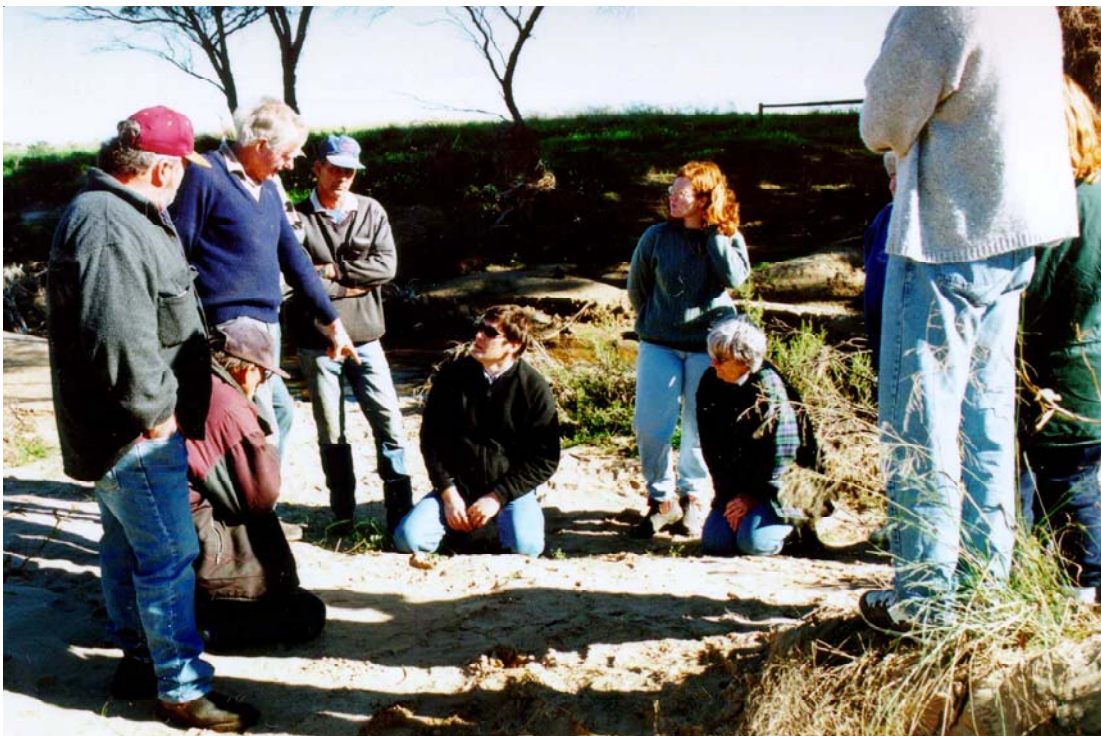
Dalyup Catchment Group discusses various options to control headcuts on the Dalyup River (photograph Jodie Oates, WRC).

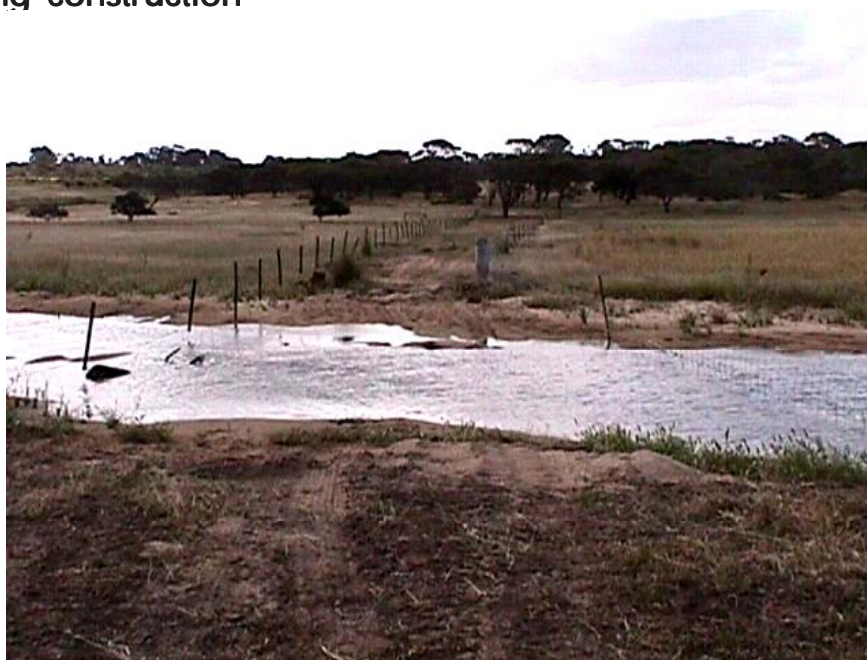
Flood proof fencing on the Dalyup River – note the fence posts are polypipe that will flex during flood events. This section of fencing also has different strainer posts than the fencing along the river, hence won't drag the rest of the fence if impacted by a flood event (photograph Kaylene Parker, WRC).

damaged than those fences running parallel to the direction of the water. Posts or markers located either side of the river could be a cheaper and more effective method of designating a boundary line rather than trying to have a fence across the river. Also fencing across the river would not be required if land managers upstream and downstream also fenced their rivers. In some cases the boundaries of properties could be renegotiated with neighbours so that one neighbour 'owns' or 'manages' the river rather than having a boundary fence through the middle of the river. In some cases the realignment of paddock fences is needed so that paddocks run alongside and not across the river. It is advisable to use plain wire when fencing along the river to reduce resistance. Ringlock holds the debris better than plain wire and therefore has an increased chance of surviving a flood. Using fence posts angled at 45° and simple low-cost sacrificial fencing in the floodplain will help to protect fences during flood events. Some types of low cost sacrificial fencing include star pickets with plain wires, fences that use polypipe posts and low-level electric fences. Star pickets located within the floodway should be braced with short 'tie downs'. These tie downs consist of two 60 cm-long star pickets inserted at 45° angles at the base of the vertical picket to increase the fence's withstanding force.

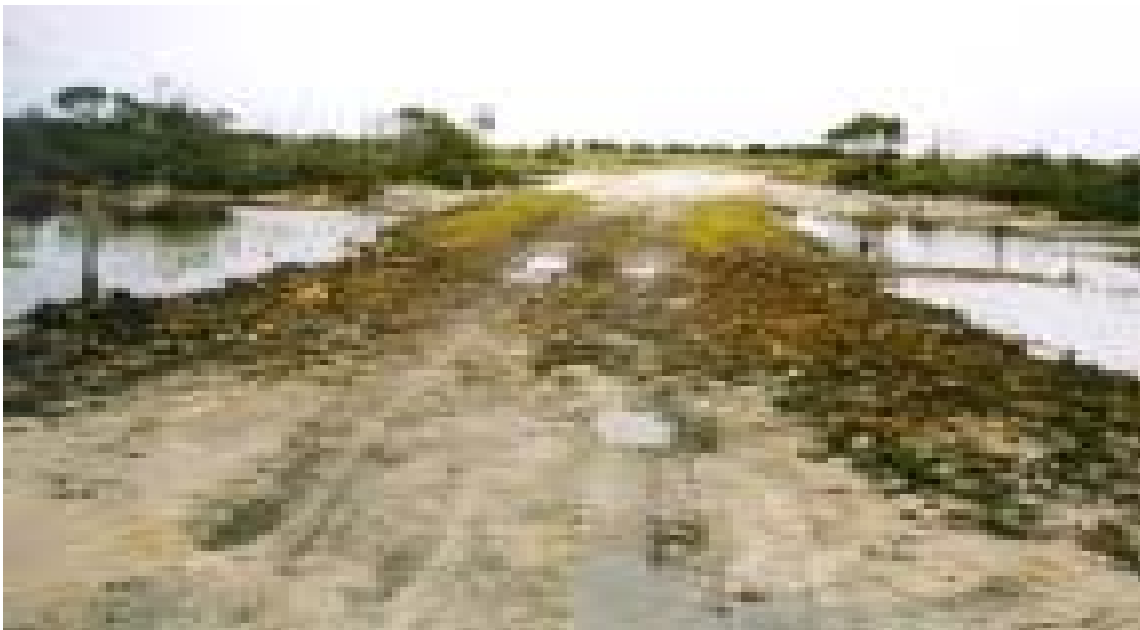
Crossing on Sue and Peter Smithson's property. This is an excellent example of a crossing as it has many small and varied sized rocks, follows the contours of the river and is located in a relatively straight section of the waterway. This design is recommended, as it is more likely to survive flood events and cause less erosion and sedimentation. The rocks cause the water to trickle downstream adding oxygen to the water that is important for aquatic fauna (photograph Kaylene Parker, WRC).

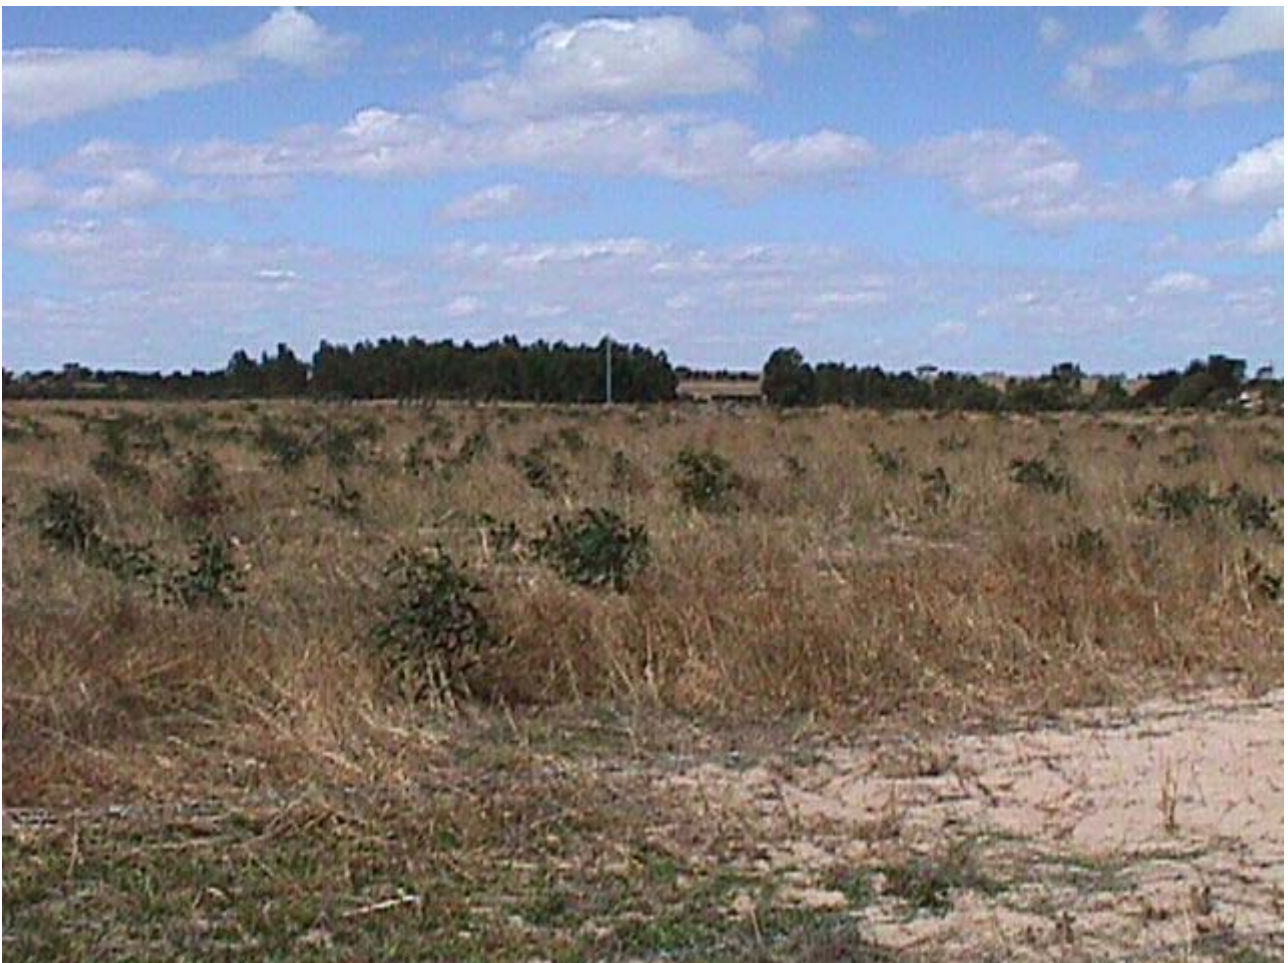
The Dalyup River upstream of the South Coast Highway suffered considerable damage from the flood events of 1999/2000. Previous photos also indicated that the river was in relatively good condition, however it is only the low flow channel that was fenced. The river has an extensive floodplain, which is approximately 100 – 300 metres wide.

Flood damage included the formation of new channels (avulsion), loss of crossings, undercutting and erosion on the original river channel, further loss of riparian vegetation due to flooding, and considerable sedimentation of the main channel.

The floodplain has been fenced to help survive flood events. This includes electric fencing, four line plus flexible pipes that will break during high flows. Also “sacrificial” fencing has been used as boundary fences across the river for flood events. This will not pull the whole fence down, rather the section across the river only. The project will also promote alternative farming uses of the floodplain. Lawrie has also fenced his floodplain and is growing *Acacia saligna* on the floodplain. This area will be grazed differently to the rest of the land hence may help to stabilise the floodplain during future high flow events.

Lawrie Shaw's revegetation of the floodplain with *Acacia saligna* – adjacent the Dalyup River (photograph Kaylene Parker, WRC).

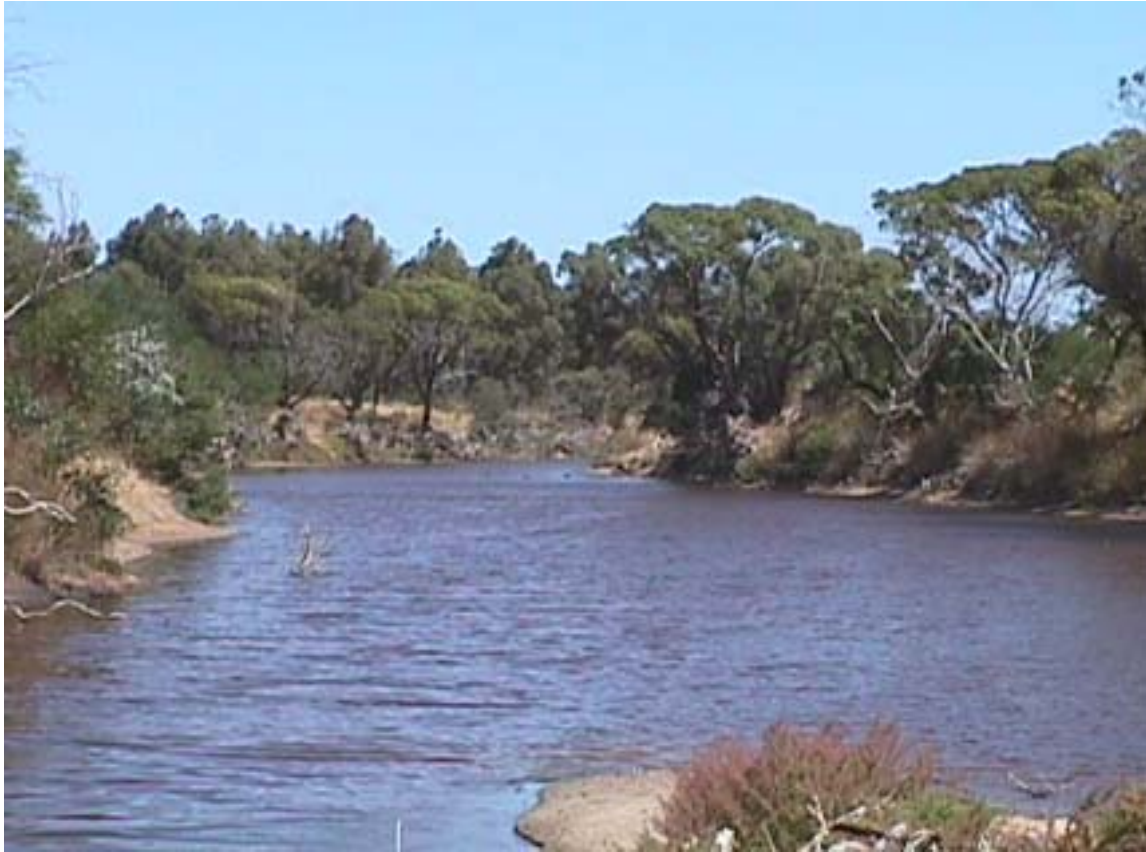
A Grade section of the Dalyup River – showing foreshore vegetation in excellent condition (photograph Catherine Field)

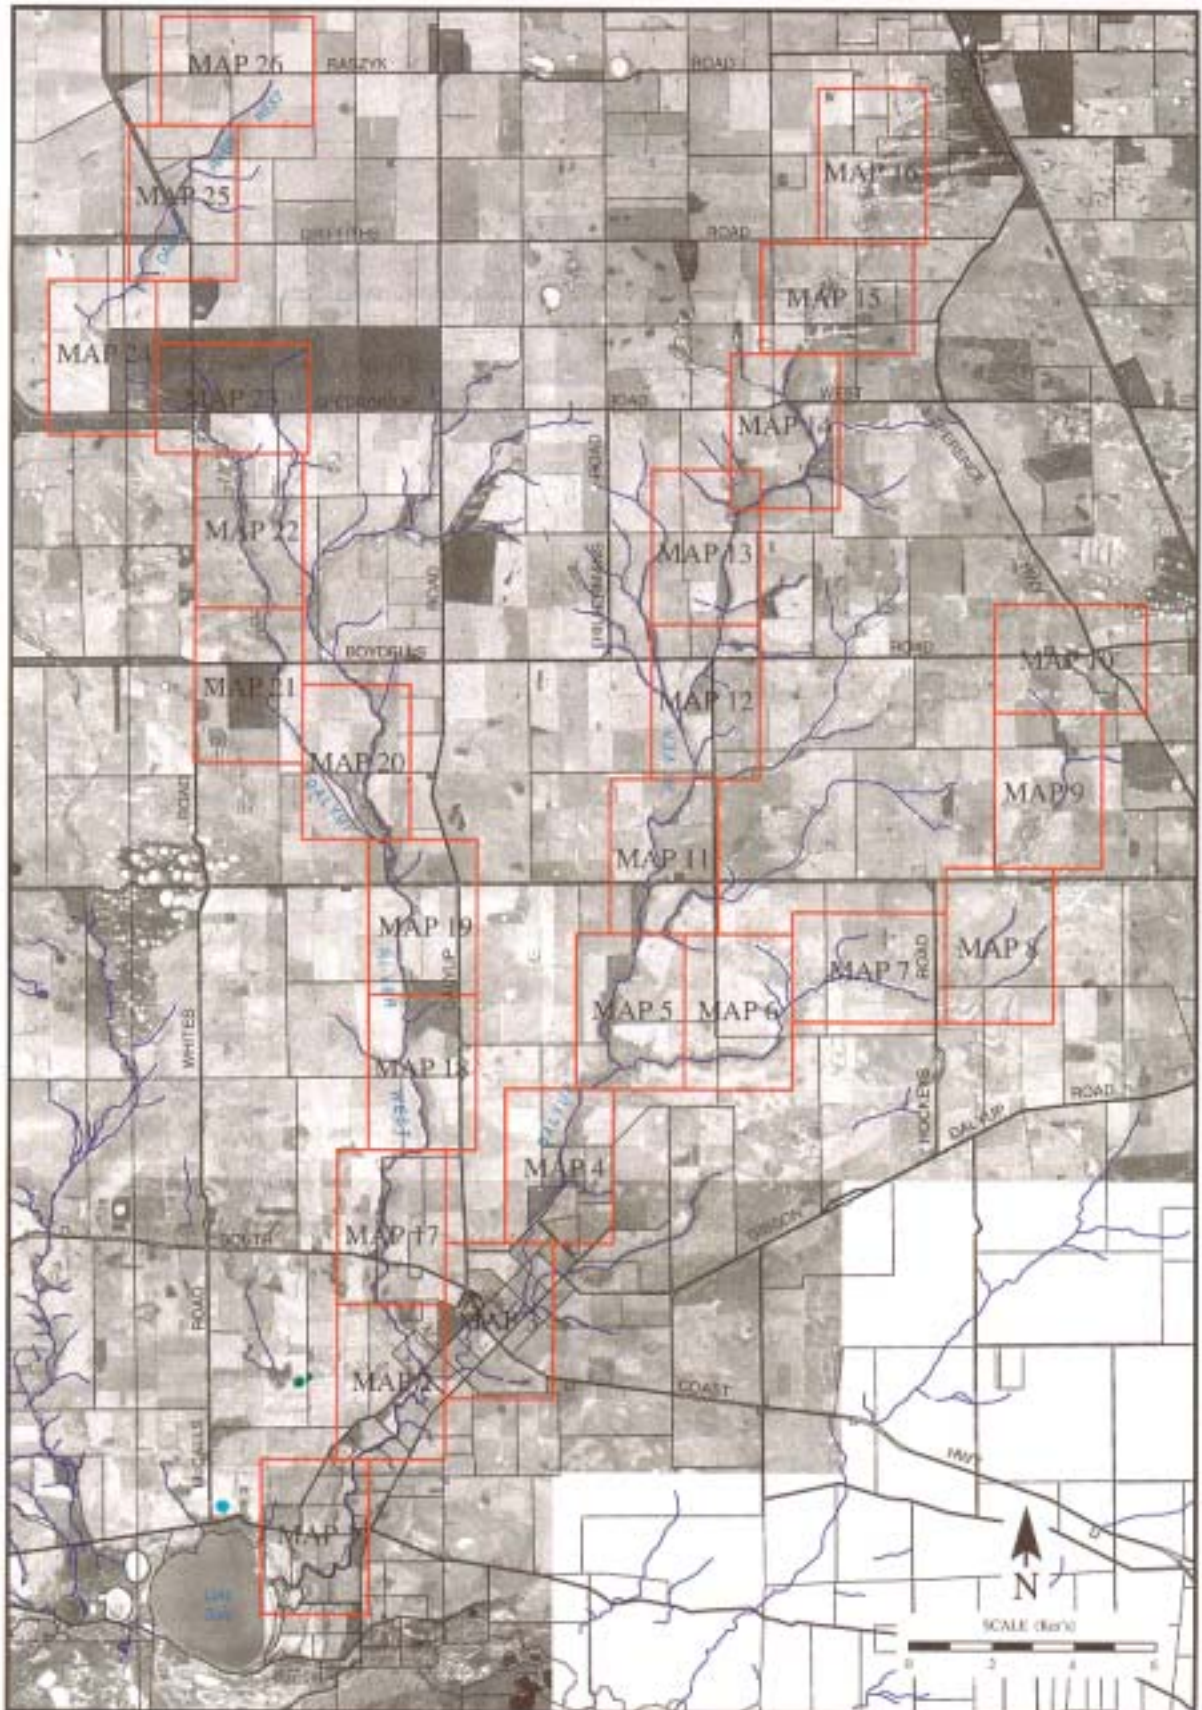
Map 1 – DALYUP RIVER

The foreshore vegetation is showing extensive damage from the 1999/2000 flood events. There are small sections in good condition including the foreshore vegetation in locations D48, D18 and D 19. Many sections of the river are extremely degraded and weeds have colonised flood-damaged areas. Natural regeneration has occurred since the flood, however, supplementary planting is required in most locations. The width of foreshore vegetation needs to be increased along this section of the river to ensure the banks and floodplains of the river are protected from future flood events.

Many fences were lost in this section during the 1999/2000 floods. Many land managers have re-fenced sections, with the fences placed further out to incorporate flood damage. Fences have been replaced in locations D19, D48, D5 and D17. Fencing tributaries draining into the river on location D17 is suggested as this would slow the water sheeting of the adjacent farmland and minimise the risk of paddock erosion. Better fencing is needed between location D25 (Lot 2) and adjoining nature reserve as cattle currently have access to and are degrading the reserve.

There are problems with illegal camping and lighting of fires in reserve 23570 or the Pioneer Reserve, which is causing degradation to the existing vegetation. The Shire of Esperance should be approached to better manage this reserve.

The house on Location D25 (Lot 2) is in danger of being damaged in future floods. The land in front of the house should be revegetated. A levee bank should also be constructed to protect the house.

It is recommended that any future subdivisions or development proposals for this section of the river redraw boundary locations so they do not cross the river. These locations were drawn up in the late 1890s and did not take into account the change in water flow and volume that is now experienced since the clearing of the catchment over the last 100 years. The locations

D6	<ul style="list-style-type: none"> • Stabilise banks and increase the width of the vegetative corridor along the river. • Remove or control deadly Nightshade in the river corridor and Bridal Creeper.
D25 (Lot2)	<ul style="list-style-type: none"> • Repair the fence between location D25 (Lot 2) and the adjoining nature reserve. • Construct flood levee banks to minimise future damage from floods.
Reserve 23570	<ul style="list-style-type: none"> • Approach the Shire of Esperance to advise of problems with illegal camping and lighting of fires in reserve 23570 (Pioneer Reserve), which is causing degradation to the existing vegetation.
D50	<ul style="list-style-type: none"> • Increase the width of the vegetative corridor along the river.
D51	<ul style="list-style-type: none"> • Increase the width of the vegetative corridor along the river.
D21	<ul style="list-style-type: none"> • Increase the width of the vegetative corridor along the river.

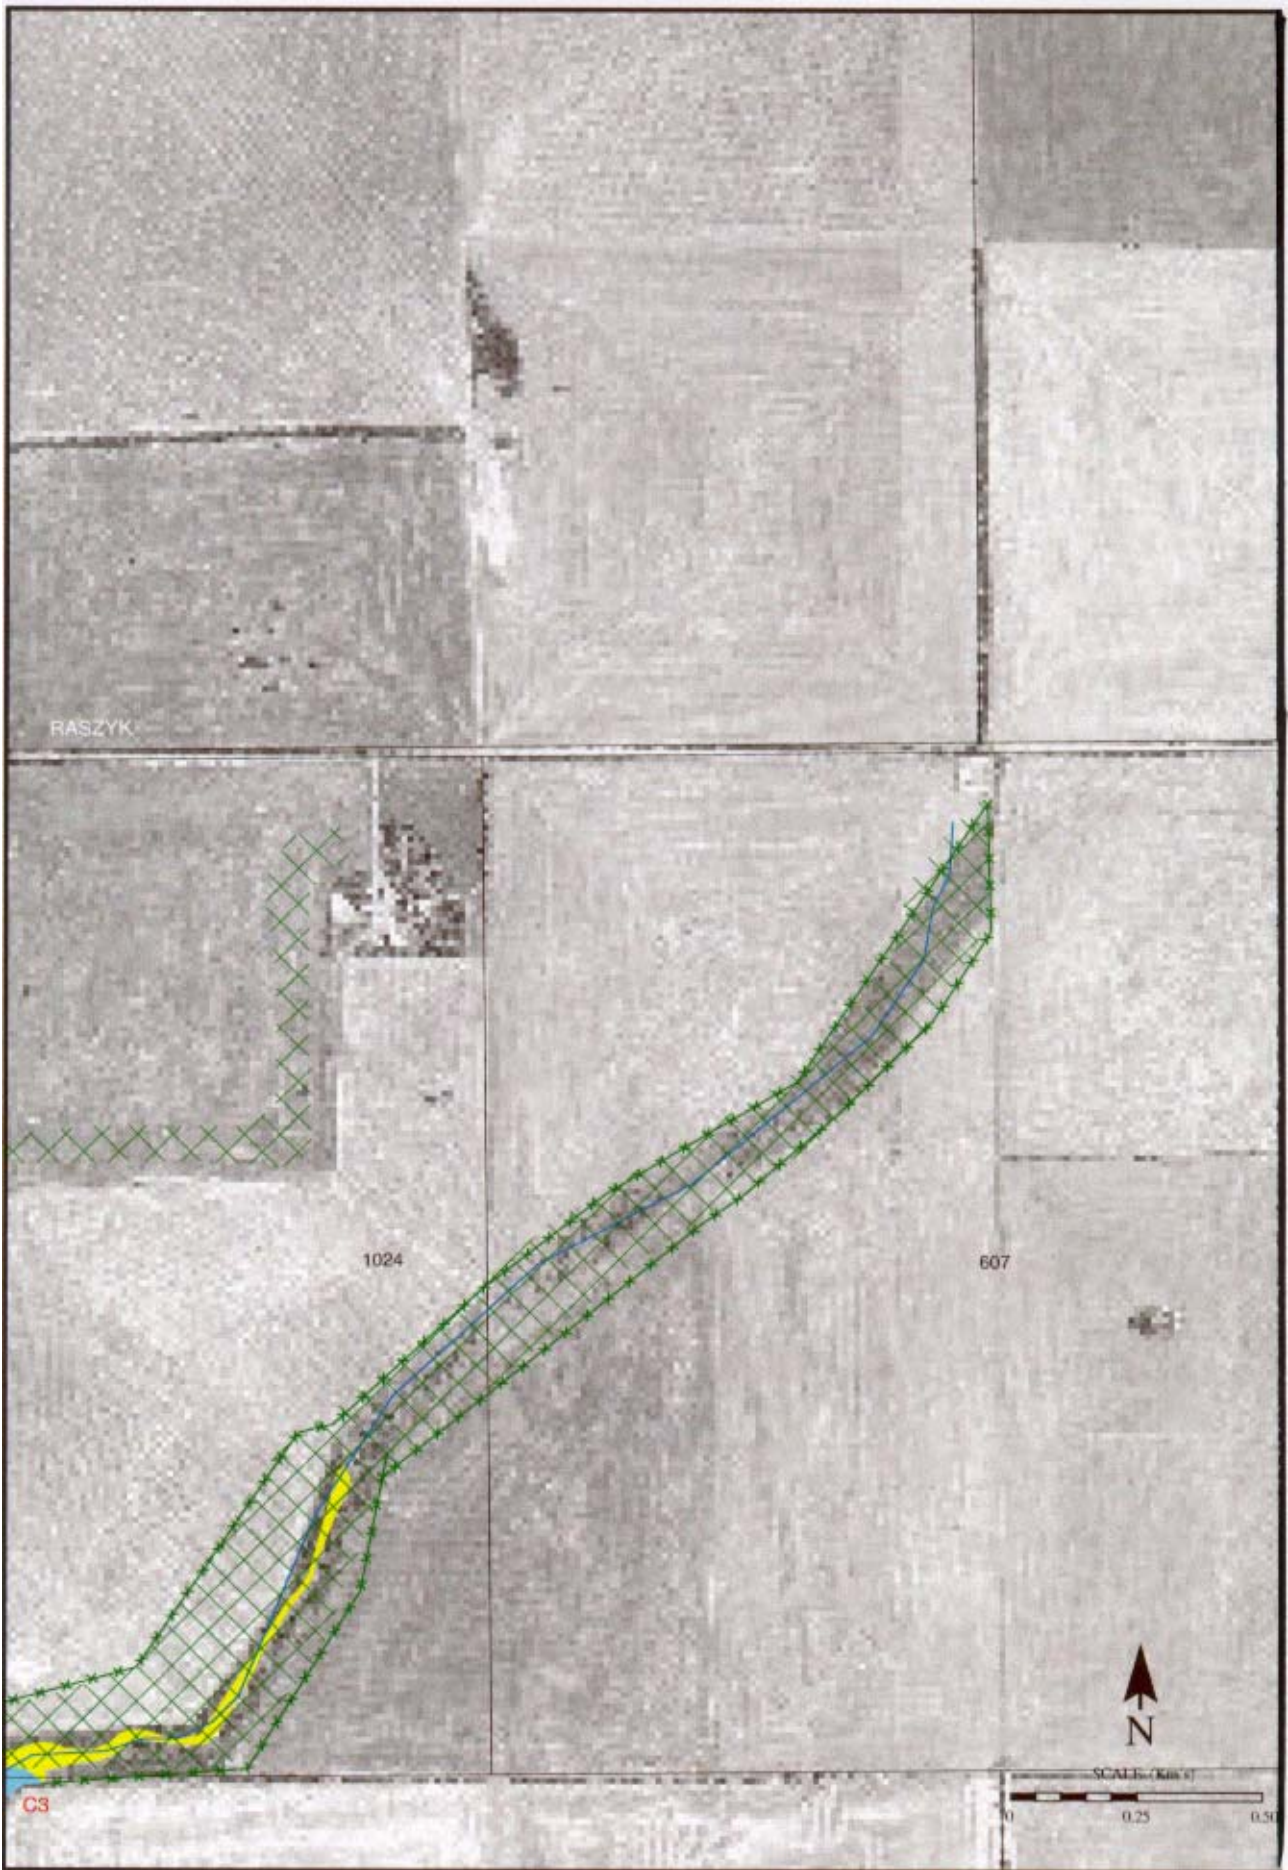
DALYUP RIVER MAP 26

Other Severe salinity problems are occurring along this section of river. Shallow bedrock is evident and is possibly forcing the watertable to the surface. Consult the Department of Agriculture's hydrologist to help locate these bedrock highs to better target where to focus efforts. Recommend focusing on water use across the farm and implementing more high water-use crops and pastures i.e. lucerne, summer crops, kikuyu and tree crops (oil mallees).

607 Some infilling of vegetation with salt tolerant local, native understorey species in areas where the watertable is less than 1 m below the surface is recommended – including *Gahnia trifida* and *Halosarcia* sp. and more *Melaleuca* (paperbarks).

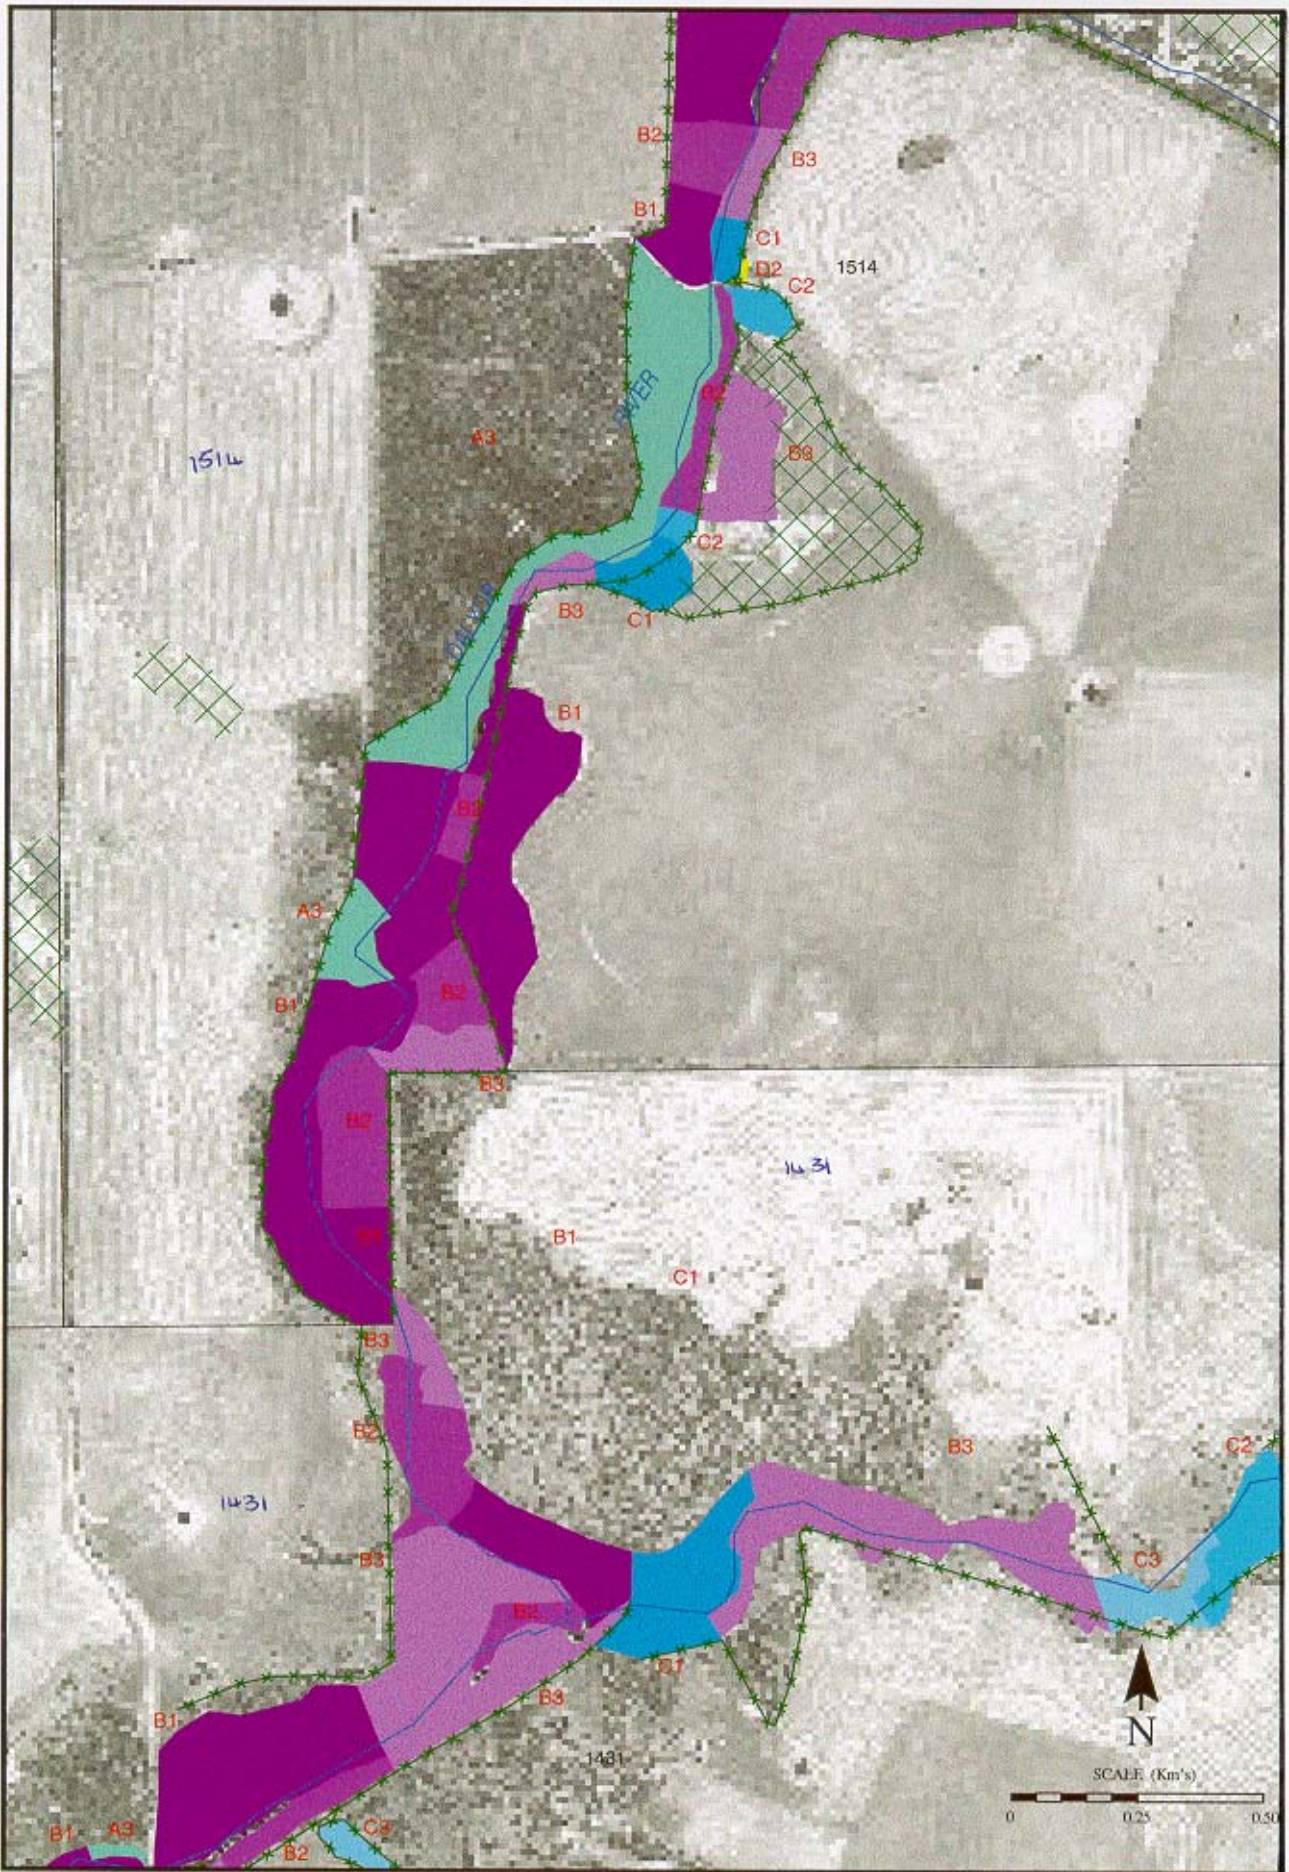
DALYUP RIVER MAP 5

The foreshore vegetation condition in this section is in relatively good condition. The understorey has been lost due to previous grazing by stock. Currently there is adequate vegetation to allow natural regeneration, however some supplementary re-planting may be needed. There are some minor headcuts forming on the southern side of the tributary. The tributary is not fenced in some sections. It is recommended that these sections are fenced.

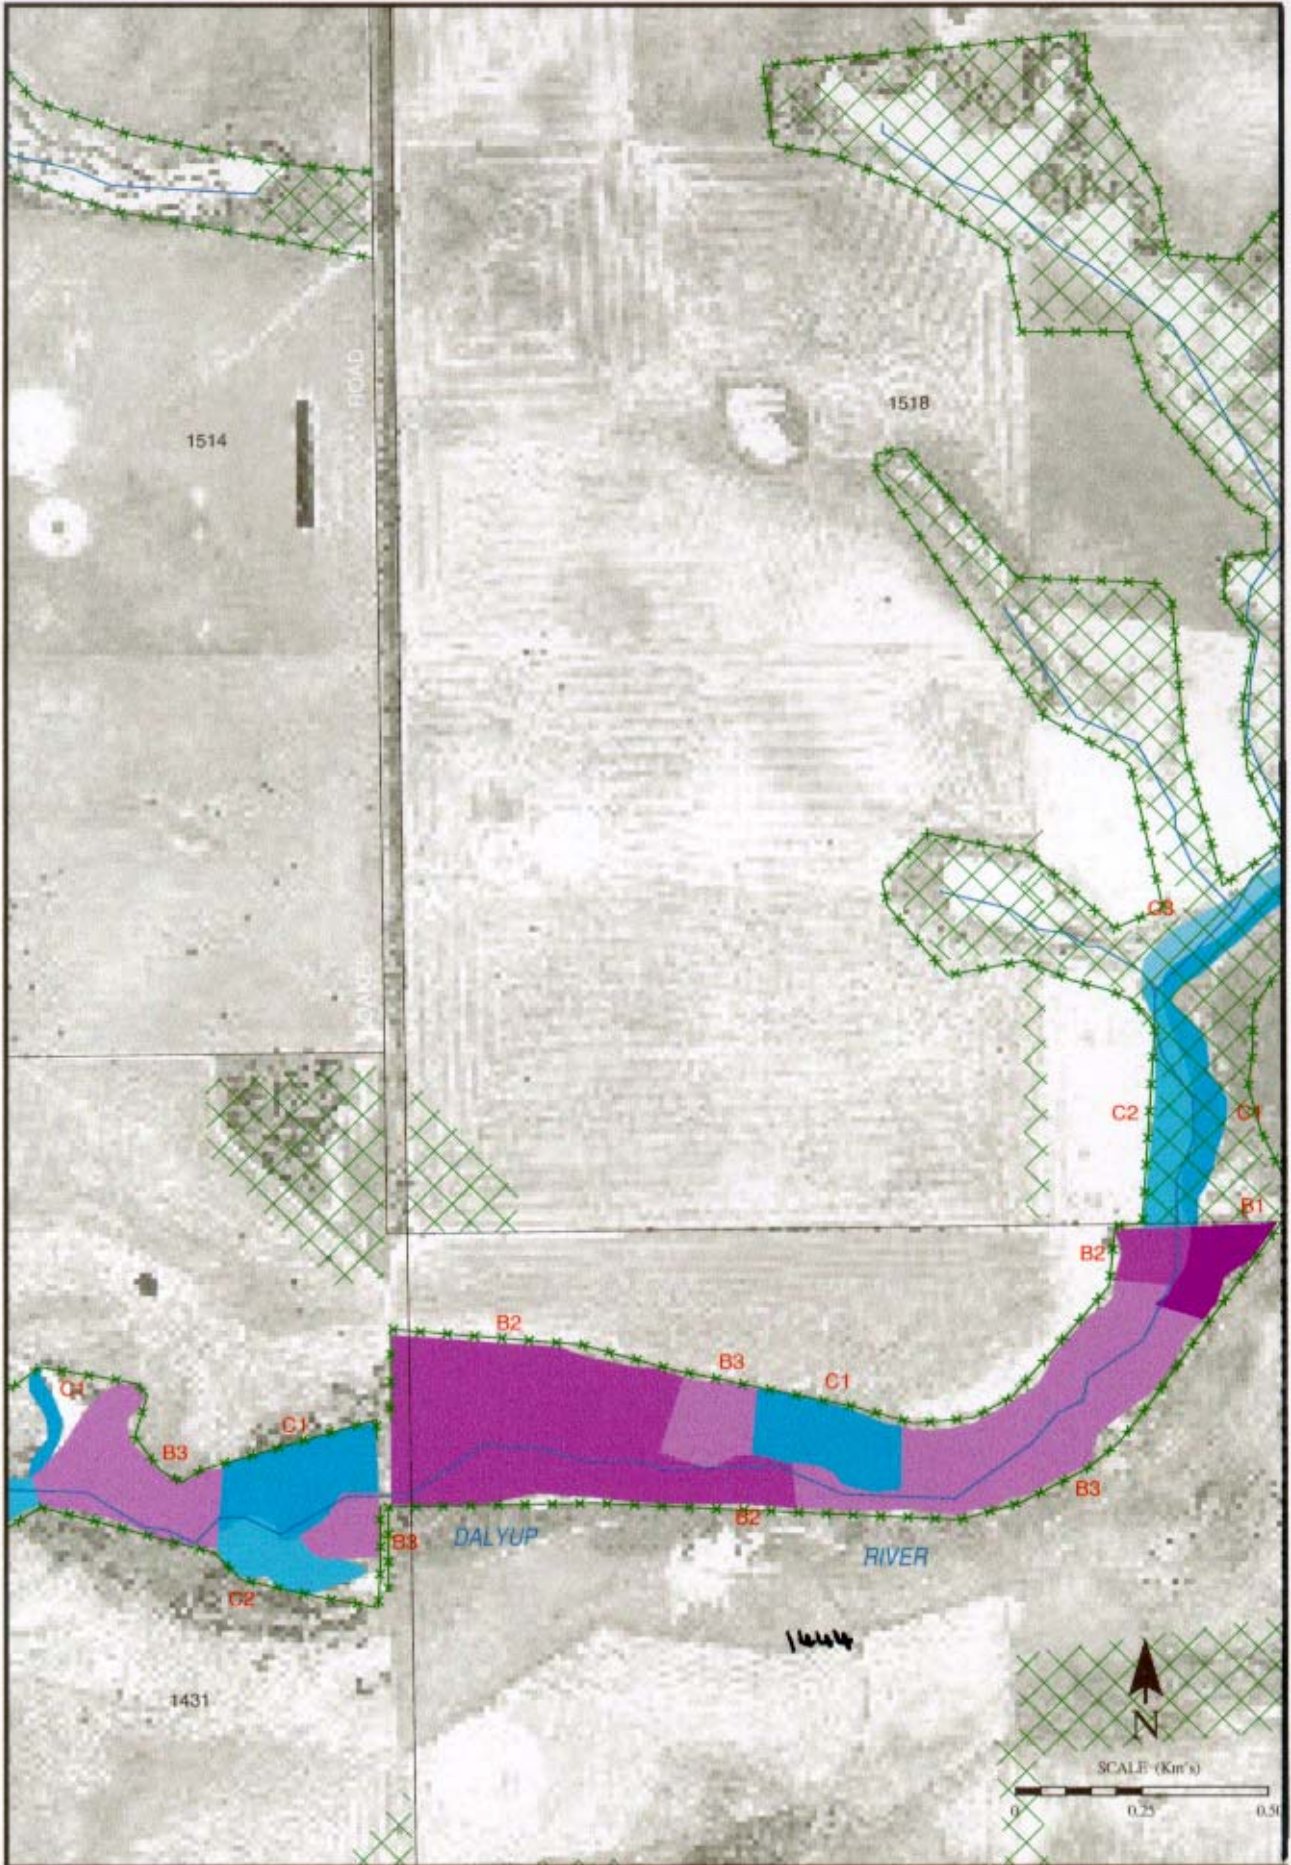
DALYUP RIVER MAP 6

There are major headcuts found along this section of the river. These can be stabilised by placement of rocks and vegetation in the actively eroding area, in addition to addressing surface water management.

- 1431 (pt)**
- Revegetate sections graded as C Grade with salt tolerant, native species.
 - Stabilise the minor headcut.
- 1444**
- Revegetate sections graded as C Grade with salt tolerant, native species.
 - Stabilise headcuts, particularly the major headcut that is forming on the south side of the tributary, near location 1518.
- 1518 (pt)**
- Revegetate sections graded as C Grade with salt tolerant, native species.
 - Fence waterways draining into the major tributary.
 - Use rushes and sedges to stabilise actively eroding bank.

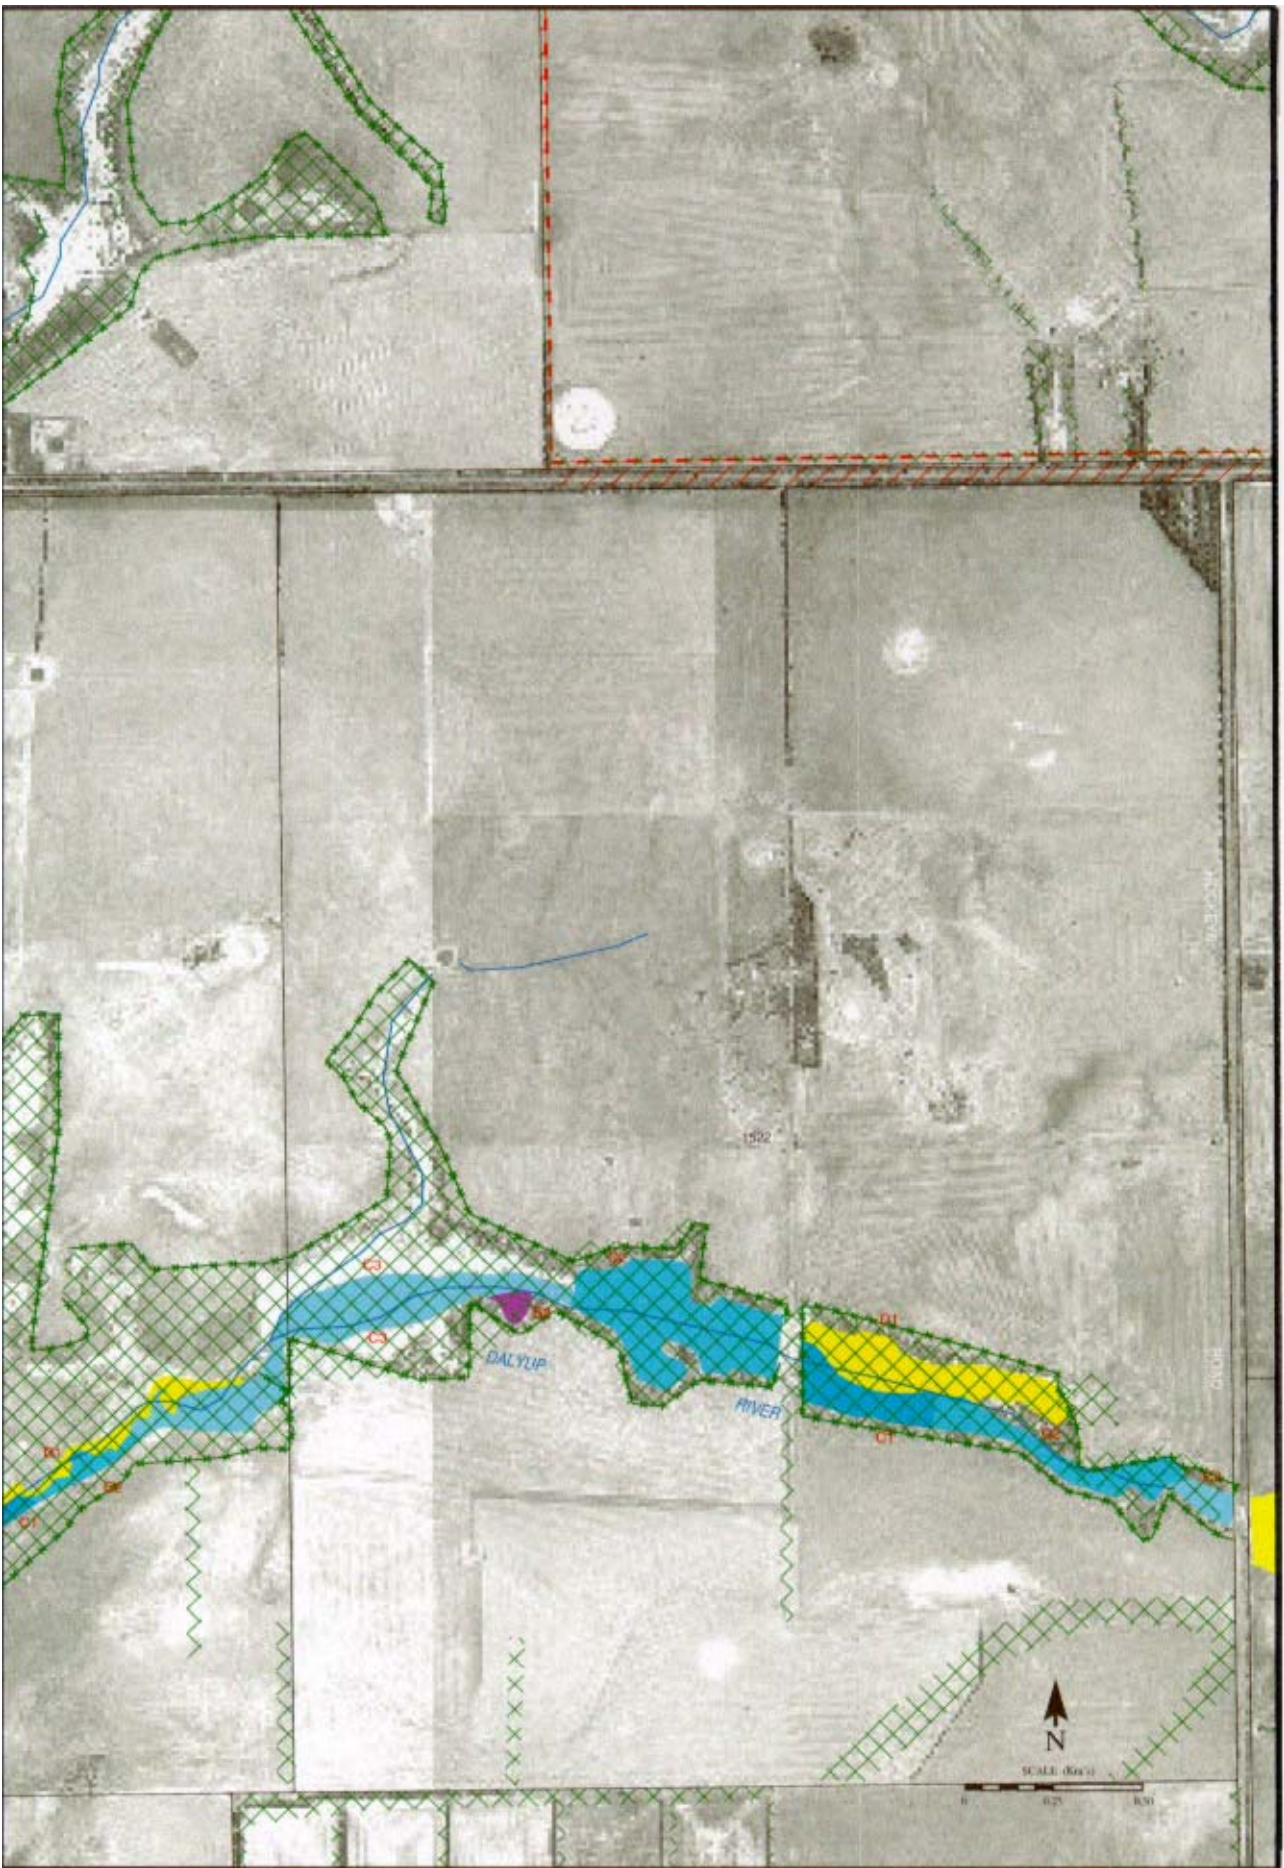
DALYUP RIVER MAP 7

The entire right bank is graded between C1 and C3 except a small section graded in B2 condition. The left bank is graded on average C Grade, with some sections of D Grade where there is little or no vegetation.

The river has been entirely fenced and the buffer width is adequate. It may require some supplementary planting with native species to encourage regeneration. The landholder has done considerable amounts of work to protect this section of the tributary as the entire section has been fenced and revegetated.

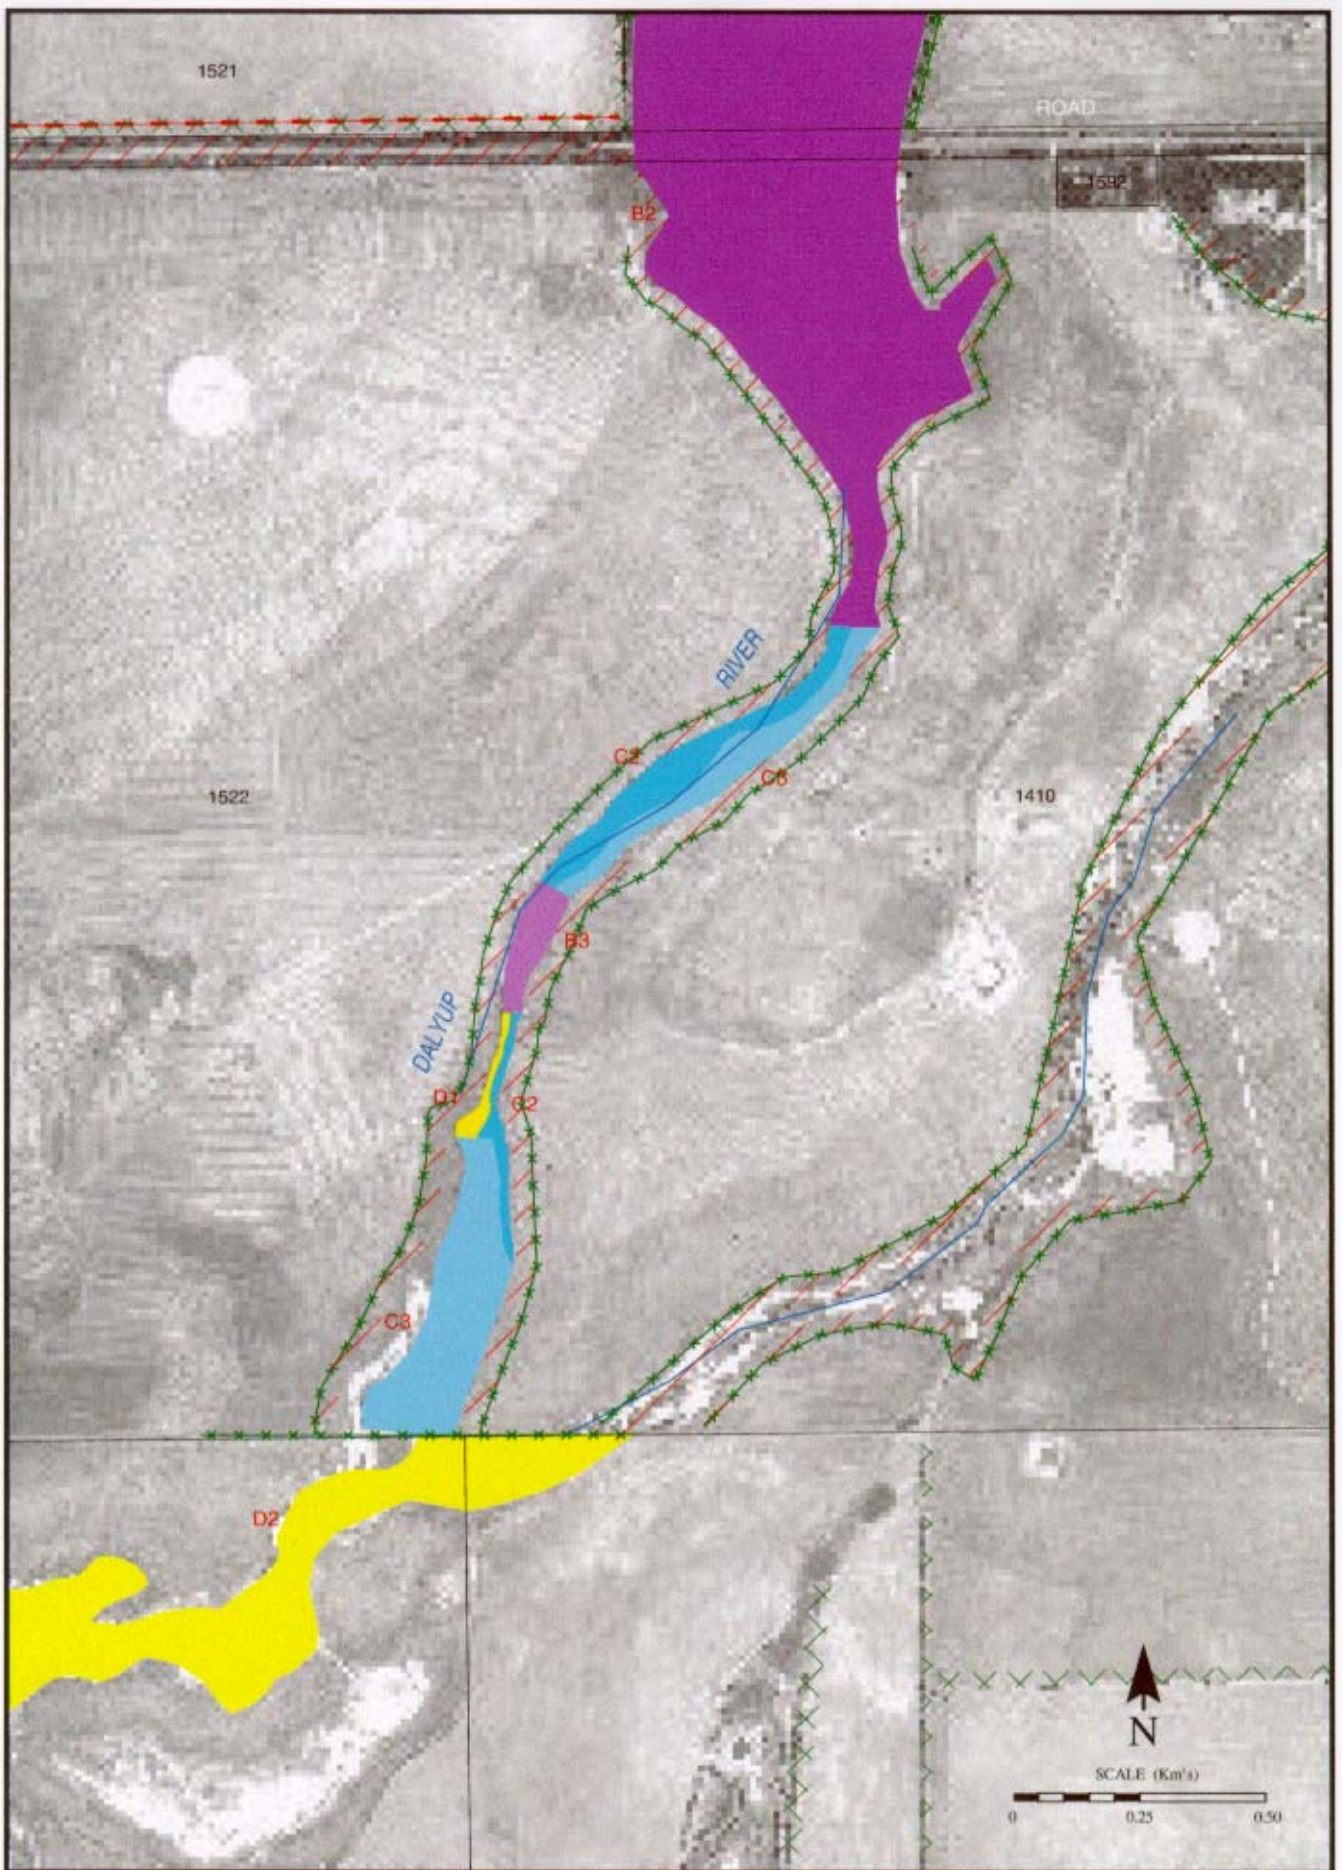
DALYUP RIVER MAP 8

sedimentation along the channel. It is recommended that this section of the river is fenced and revegetated with local, native species. This site would be a priority area to rehabilitate.

Location 1410 and 1522 has sections of vegetation in good condition (B Grade) and the tributary has been entirely fenced. There are however, sections where the vegetative corridor is not wide enough, and fences may need to be moved further out to minimise risk of loss from future high flow events. Areas graded as C or D Grade may also require further revegetation with local, native species. The landholder has done considerable works to protect the waterways in these locations.
