DALYUP AND WEST DALYUP RIVERS

ACTION PLAN

WATER AND RIVERS COMMISSION
WATER RESOURCE MANAGEMENT SERIES
REPORT NO WRM 34
DECEMBER 2002

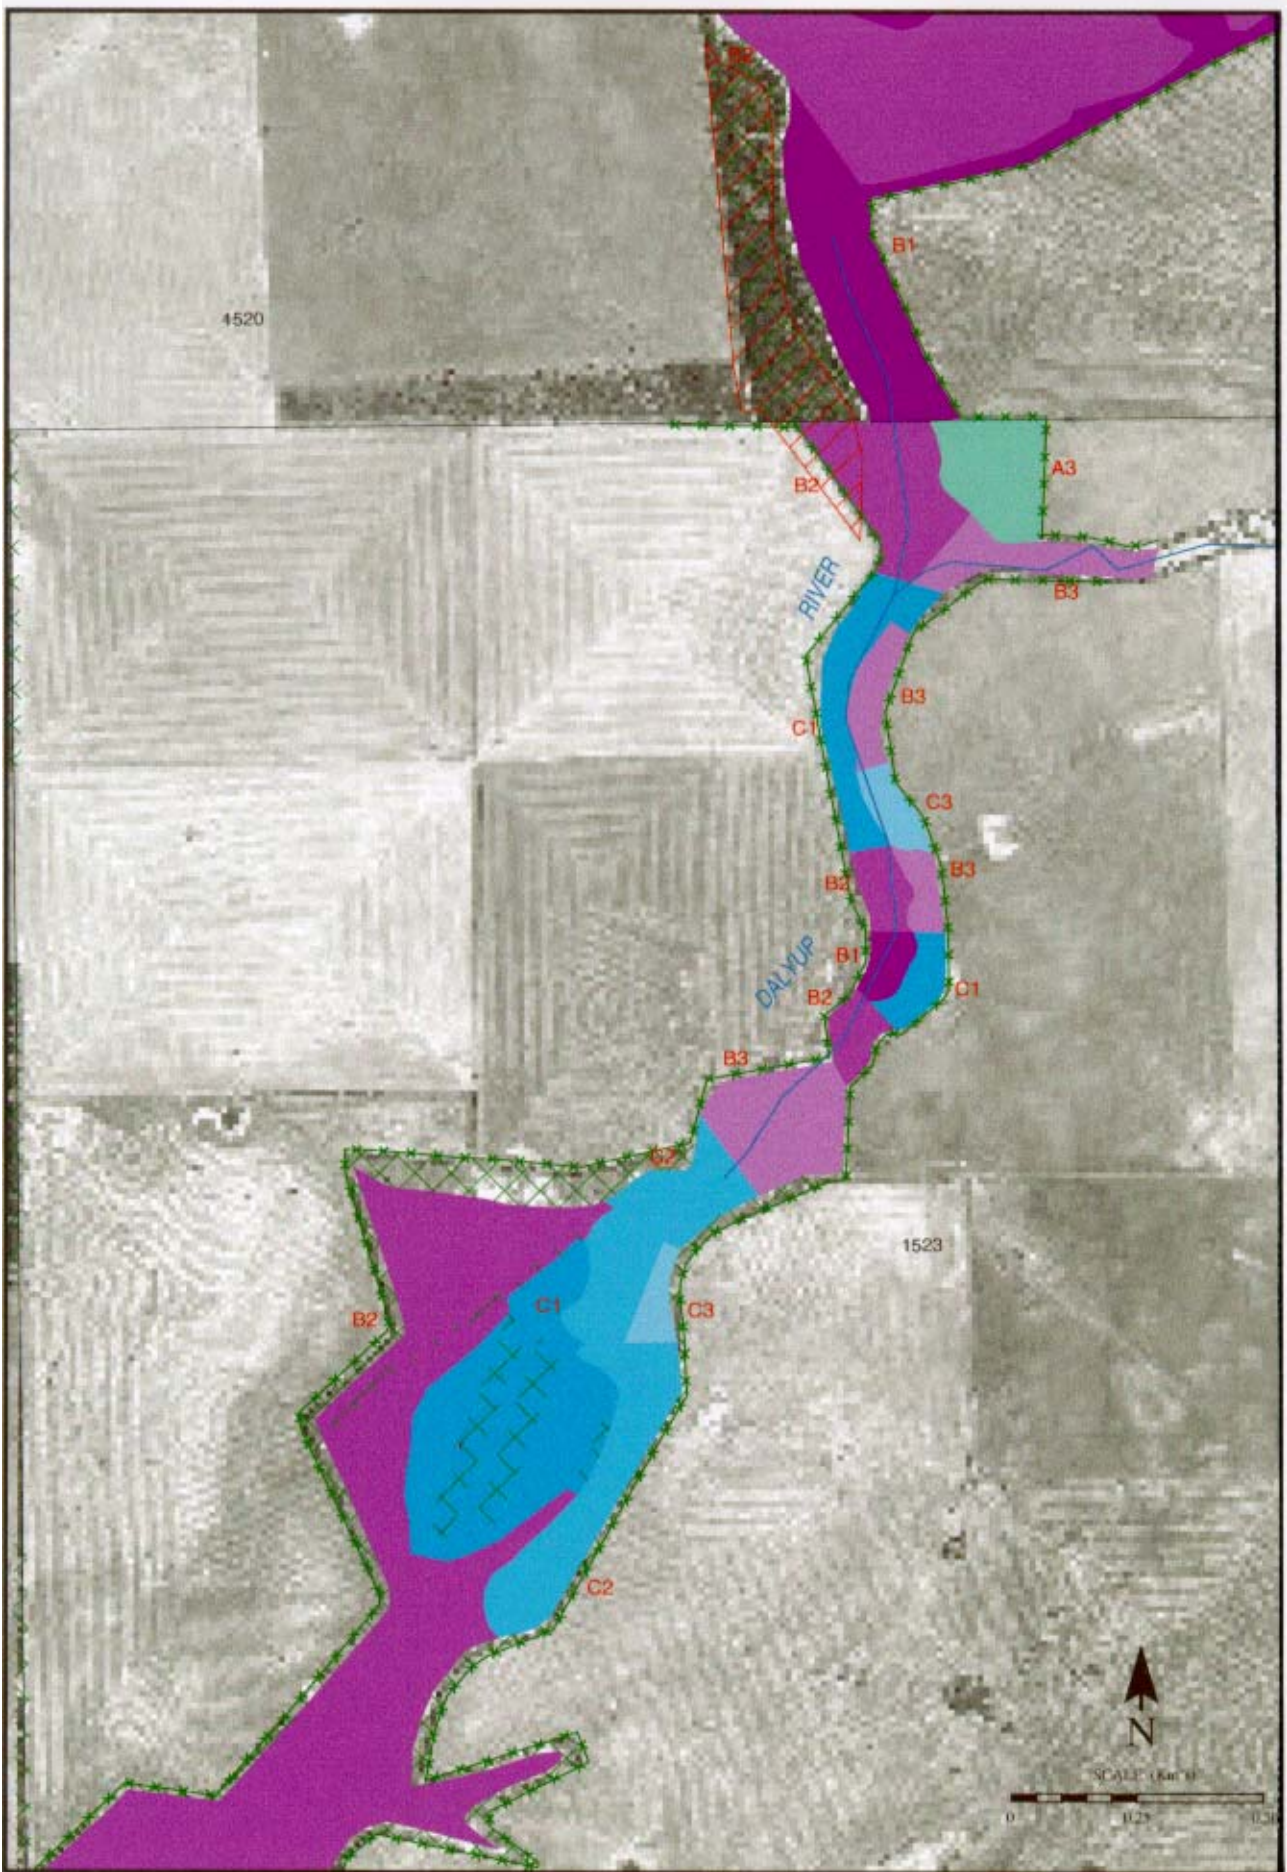
DALYUP RIVER MAP 9

The river in location 1523 has been entirely fenced, and has been revegetated in some areas. Replanting further salt affected areas may be required to minimise the risk of further erosion. There are some sections of vegetation in very good condition. There is a crossing point that has been partly washed out. It is recommended to re-design the crossing to ensure it survives future high flow events.

Location 1520 has vegetation in good condition and the tributary has been fenced. The vegetation includes *Acacia saligna*, *Lechanaulia formasa*, *Melaleuca cuticularis*, *Eucalyptus occidentalis*, *Templetonia retusa*, *Hakea corymbosa* and *Acacia pritzeliana*.

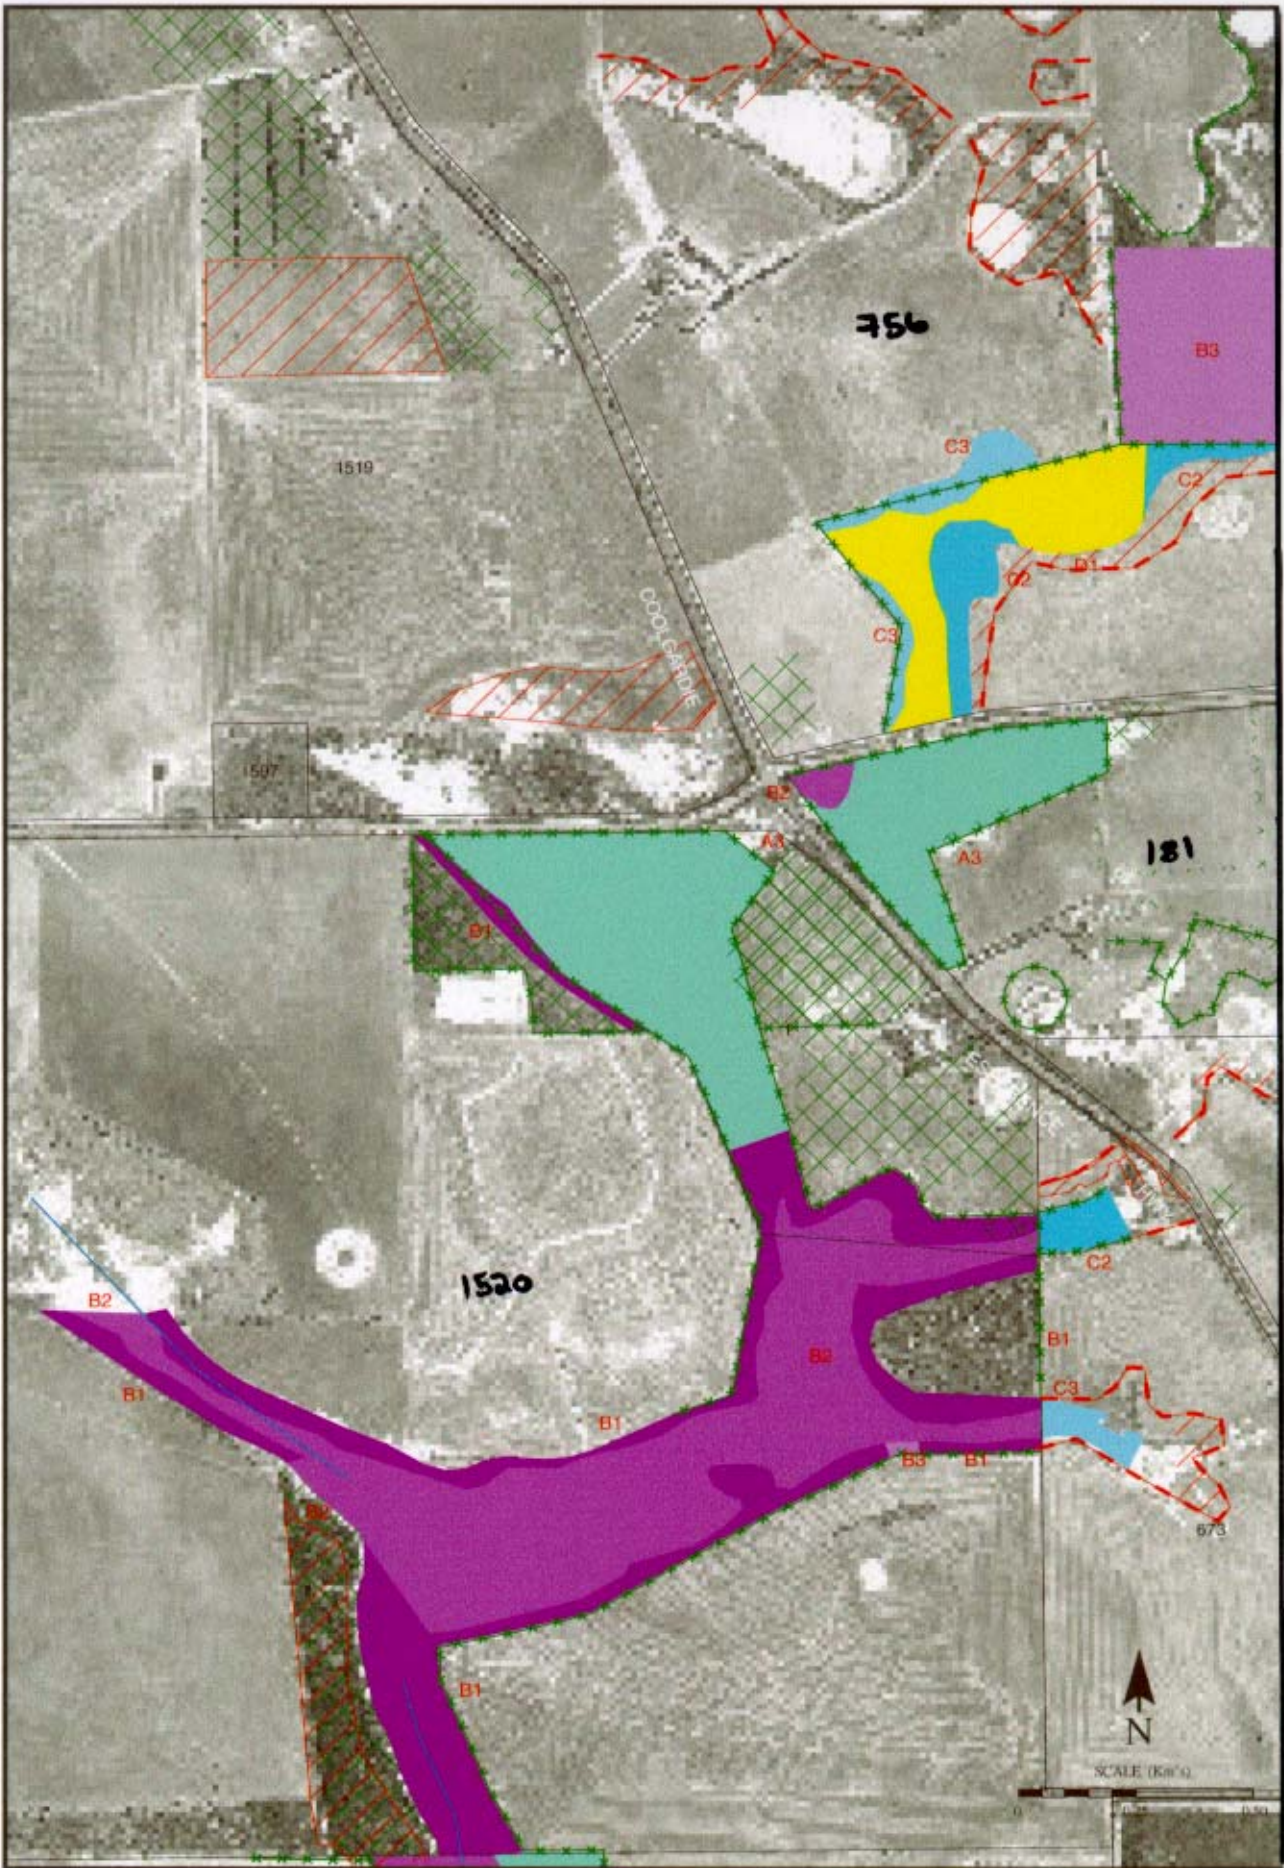
DALYUP RIVER MAP 10

Location 181 is a good example of riparian vegetation that has always been fenced. This is in excellent condition.

Location 756 has had stock access hence the understorey species are grazed. The landholder is planning to fence this section of the waterway over the next year. Stock has not had access since April 2001, and already many native species have been naturally regenerating, including orchids. The proposed section of revegetation west of the Coolgardie Road was completed in September 2001. This is part of a direct seeding trial being coordinated by Bushcare.
